SAN MATEO COUNTY
COMMUNITY
COLLEGE DISTRICT

San Mateo County Community College District Americans with Disabilities Act Self-Evaluation and Transition Plan

Report Prepared by:

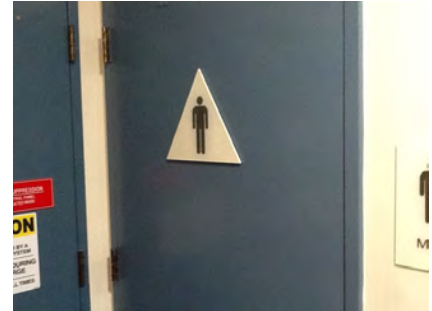
Item no., Rm no. and Name	Existing Architectural Barrier and Proposed Solution	Codes / Mitigation Info	Qty	Unit	Cost	Total
85	<ul style="list-style-type: none"> As-Built Description: Required in CA only: identification symbol centered 58" to 60" high on sanitary facility door that contrasts with the door not provided (women: 12" ø circle, men: 12" triangle, unisex: combined symbol). As-Built: 61" o.c. Proposed Solution: Provide properly mounted sanitary facility symbol when altering area. If wheelchair accessible, include International Symbol of Accessibility on sign. 	PCODE SA15REF Mitigated: <input type="radio"/> YES <input checked="" type="radio"/> NO		REF		
<div style="text-align: right;"> <input type="checkbox"/> Staff Only Priority 4 Severity 3 </div>

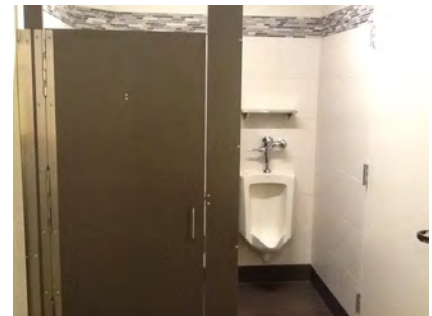
**Restroom**

95	<ul style="list-style-type: none"> As-Built Description: Multiple accommodation restroom not accessible; multiple compliance violations. Proposed Solution: Remodel area to provide accessible restroom with one accessible stall, lavatory (and one urinal at Mens). 	PCODE WA01A ADAAG 91 4.22 ADA 2010 603.1	1	JOB	?	\$105,000
<div style="text-align: right;"> <input type="checkbox"/> Staff Only Priority 4 Severity 1 </div>

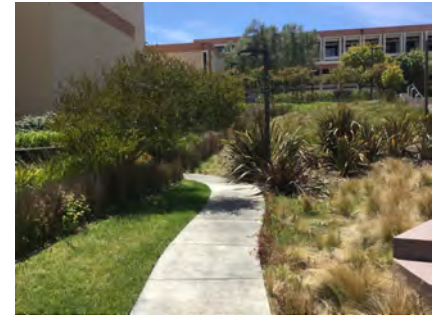
639	<ul style="list-style-type: none"> As-Built Description: Overhead clearance less than 80" above finished floor. As-Built: Tree protrudes 27" up to 80" AFF. Proposed Solution: Modify overhead clearance. 	PCODE EG01 ADAAG 91 4.4.2 ADA 2010 307.4 CBC 2007 1133B.8.6.2 CBC 2016 11B-307.4 Project: SKYB1 Facelift Year to be Completed: 2021/2022 Mitigated: <input type="radio"/> YES <input checked="" type="radio"/> NO	1	JOB	\$300	\$300
-----	---	---	---	-----	-------	-------

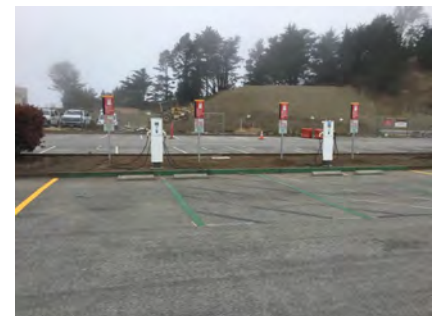
709	<ul style="list-style-type: none"> As-Built Description: Refer to notes for observation and recommendation. Proposed Solution: Notes: Accessible EV parking stall does not provide "Van Accessible Sign" 	PCODE GN01 CBC 2016 11B-502.4 Project: SKYB1 Facelift Year to be Completed: 2021/2022 Mitigated: <input type="radio"/> YES <input checked="" type="radio"/> NO		REF		
-----	--	---	--	-----	--	--

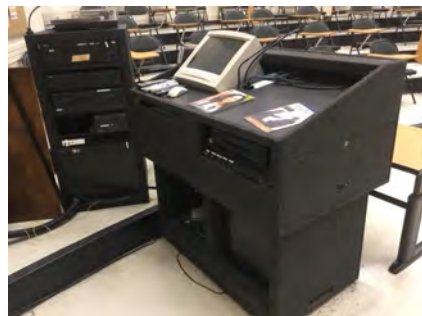
Item no., Rm no. and Name	Existing Architectural Barrier and Proposed Solution	Codes / Mitigation Info	Qty	Unit	Cost	Total
Public Participation Counter						
553	<ul style="list-style-type: none">As-Built Description: Speaker podium is not accessible. Upper edge of podium is more than 34" above the finished floor, and knee space is less than 27" high, 30" wide, and 19" deep.As-Built: 41.5" AFF. No knee clearance.Proposed Solution: Provide additional, integrated, and accessible speaker podium.	<p>PCODE GB02A ADAAG 91 4.32.3 ADA 2010 902.3 CBC 2007 1122B.3 CBC 2016 11B-902.3</p> <p>Project: SKYB1 Facelift</p> <p>Year to be Completed: 2021/2022</p> <p>Mitigated: <input type="radio"/> YES <input checked="" type="radio"/> NO</p>	1	JOB	\$6,000	\$6,000

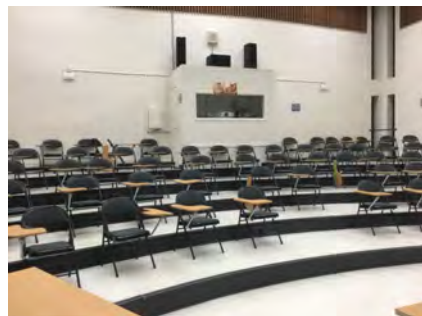
550	<ul style="list-style-type: none">As-Built Description: Refer to notes for observation and recommendation.Proposed Solution:Notes: Projection room not accessible. No accessible route provided. Door 27" wide.	<p>PCODE GN01 CBC 2016 11B-402.2</p> <p>Project: SKYB1 Facelift</p> <p>Year to be Completed: 2021/2022</p> <p>Mitigated: <input type="radio"/> YES <input checked="" type="radio"/> NO</p>				
			<div>REF</div>

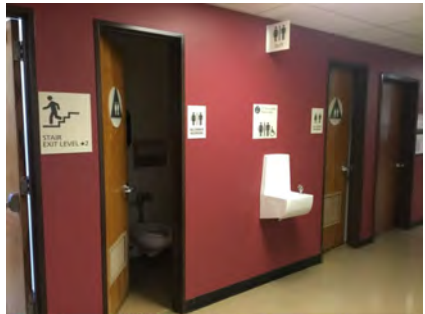
Restroom						
505	<ul style="list-style-type: none"> As-Built Description: Single accommodation restroom not accessible; multiple compliance violations. Proposed Solution: Remodel area to provide single-occupant accessible restroom. Notes: Non-accessible restroom provides directional signage to the nearest accessible restroom. 	PCODE WA01REF ADAAG 91 4.22 ADA 2010 603.1 CBC 2007 1115B.3.2 CBC 2016 11B-603.1 Project: SKYB1 Facelift Year to be Completed: 2021/2022 Mitigated: <input type="radio"/> YES <input checked="" type="radio"/> NO		REF

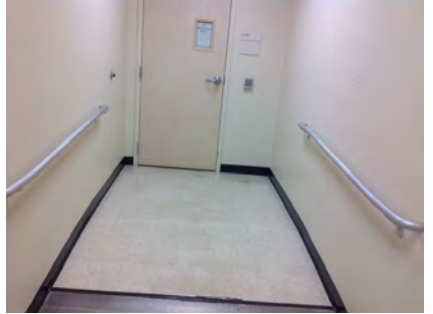
Item no., Rm no. and Name	Existing Architectural Barrier and Proposed Solution	Codes / Mitigation Info	Qty	Unit	Cost	Total
Ramp						
24	<ul style="list-style-type: none"> • <i>As-Built Description:</i> Ramp: Door in any position encroaches on ramp landing, and reduces clear dimension of landing to less than 42" or reduces width more than 3" when fully open. • <i>As-Built:</i> 24" from door to top of ramp run • <i>Proposed Solution:</i> Enlarge landing; demolish existing ramp and replace landing. • <i>Notes:</i> Ramp up to Room 121 	PCODE IJ05F ADAAG 91 4.8.4(4) ADA 2010 405.7.5 CBC 2007 1133B.5.4.3 CBC 2016 11B-405.7.5	1	JOB	\$2,580	\$2,580
		Project: SKYB2 Renovation Year to be Completed: 2021/2022 Mitigated: <input type="radio"/> YES <input checked="" type="radio"/> NO

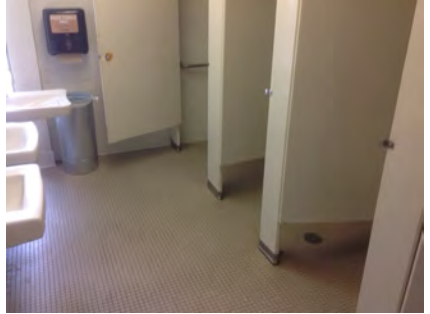
Item no., Rm no. and Name	Existing Architectural Barrier and Proposed Solution	Codes / Mitigation Info	Qty	Unit	Cost	Total
Restroom						
237	<ul style="list-style-type: none"> <i>As-Built Description:</i> Multiple accommodation restroom not accessible; multiple compliance violations. <i>Proposed Solution:</i> Remodel area to provide accessible restroom with one accessible stall, lavatory (and one urinal at Mens). 	PCODE WA01A ADAAG 91 4.22 ADA 2010 603.1 CBC 2007 1115B.3.1 CBC 2016 11B-603.1 Project: SKYB2 Renovation Year to be Completed: 2021/2022 Mitigated: <input type="radio"/> YES <input checked="" type="radio"/> NO	1	JOB	?	\$105,000

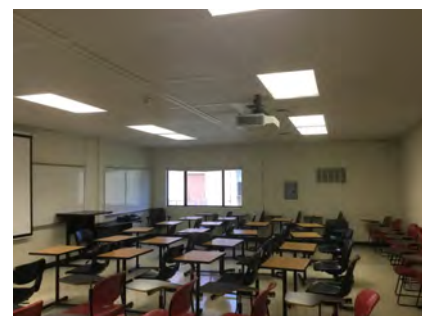
1842	<ul style="list-style-type: none"> As-Built Description: No signs at the building or assembly area entrance to notify patrons that an assistive listening system is available. Proposed Solution: Provide assistive listening signage. 	PCODE GI02REF ADAAG 91 4.1.3(19)(b) ADA 2010 703.7.2.4 CBC 2007 1104B.2.4 CBC 2016 11B-703.7.2.4 Project: SKYB3A-E Portable Replacement Year to be Completed: 2019/2020 Mitigated: <input checked="" type="radio"/> YES <input type="radio"/> NO		REF		
------	--	---	--	-----	--	--

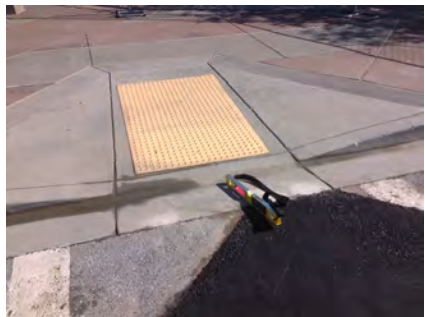
<input type="checkbox"/> Staff Only Priority 1 Severity 3			
756	<ul style="list-style-type: none"> • <i>As-Built Description:</i> Side slopes more than 1:10 (10%). • <i>As-Built:</i> 11.3% • <i>Proposed Solution:</i> Modify curb ramp. Demolish side slopes and replace with 1:10 side slopes if 48" level top landing is provided. 	PCODE EH05A ADAAG 91 4.7.5 ADA 2010 406.3 CBC 2007 1127B.5.3 CBC 2016 11B-406.2.2 Mitigated: <input type="radio"/> YES <input checked="" type="radio"/> NO	1	JOB	\$6,000	\$6,000

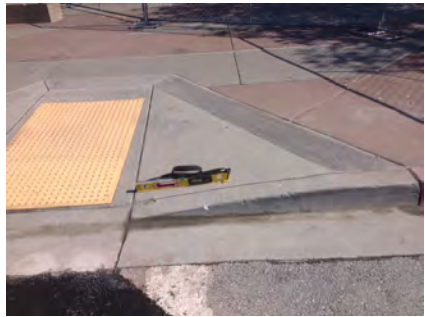
<input type="checkbox"/> Staff Only Priority 1 Severity 4			
757	<ul style="list-style-type: none"> • <i>As-Built Description:</i> Less than 48" level space at top and 1:12 flared sides not provided. • <i>As-Built:</i> 42" wide • <i>Proposed Solution:</i> Demolish existing and provide new curb ramp. 	PCODE EH05B ADAAG 91 4.7.5; Fig.12(a) ADA 2010 406.4 CBC 2007 1127B.5.4 CBC 2016 11B-406.5.3 Mitigated: <input type="radio"/> YES <input checked="" type="radio"/> NO	1	JOB	\$7,500	\$7,500

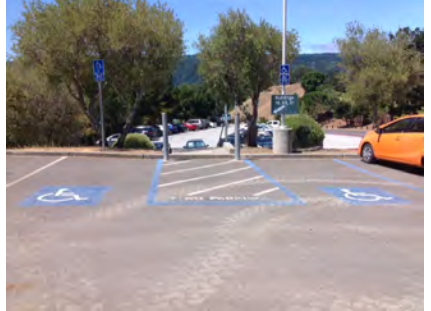
<input type="checkbox"/> Staff Only Priority 1 Severity 3			
330	<ul style="list-style-type: none"> As-Built Description: Disabled persons must wheel or walk behind parked car(s) other than their own. Proposed Solution: Relocate parking and provide curb ramp to accessible route. Notes: Accessible parking serves only stairs and patrons must travel behind cars other than their own. We recommend relocating parking near an accessible route. 	PCODE EA03 ADAAG 91 Fig.9 ADA 2010 502.3 CBC 2007 1129B.3.1 CBC 2016 11B-502.7.1 Mitigated: <input type="radio"/> YES <input checked="" type="radio"/> NO	1	JOB	\$2,190	\$2,190

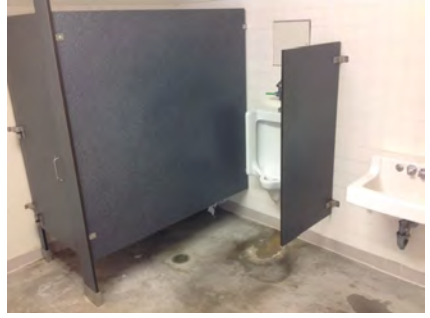
<input type="checkbox"/> Staff Only Priority 3 Severity 1						
291	<ul style="list-style-type: none"> As-Built Description: Multiple accommodation restroom not accessible; multiple compliance violations. Proposed Solution: Remodel area to provide accessible restroom with one accessible stall, lavatory (and one urinal at Mens). 	PCODE WA01A ADAAG 91 4.22 ADA 2010 603.1 CBC 2007 1115B.3.1 CBC 2016 11B-603.1 Mitigated: <input type="radio"/> YES <input checked="" type="radio"/> NO	1	JOB	? \$105,000
