SAN MATEO COUNTY
COMMUNITY
COLLEGE DISTRICT

San Mateo County Community College District Americans with Disabilities Act Self-Evaluation and Transition Plan

Report Prepared by:

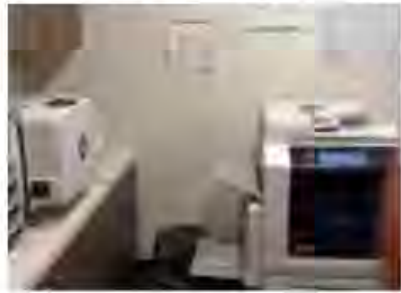
1	2	3	4	5	6	7	8	9	10	11	12
SMCCCD		Access Compliance Survey Report								101-1-2	
Facility: District Office (CSM)						Part: Interior		Floor: Second Floor			
Address: 1700 West Hillsdale Blvd, San Mateo, CA						Year Built: 1978					
Item no., Rm no. and Name	Existing Architectural Barrier and Proposed Solution	Codes / Mitigation Info	Qty	Unit	Cost	Total					
10 - 212 Copy Room											
148	Reach Range <ul style="list-style-type: none"> As-Built Description: Reach height to control or access point, exceeds 48" or is less than 15". As-Built: 53" AFF Proposed Solution: Modify equipment or mounting. Notes: No 30" by 48" approach 	PCODE IE01 ADAAG 91 4.2.5 ADA 2010 308.2.	1	JOB	\$300	\$300

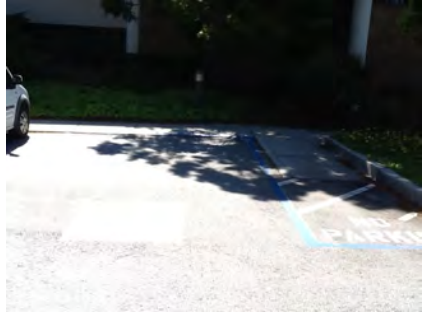
Item no., Rm no. and Name	Existing Architectural Barrier and Proposed Solution	Codes / Mitigation Info	Qty	Unit	Cost	Total
4	<ul style="list-style-type: none">• <i>As-Built Description:</i> CA only: Additional Sign or additional language below the symbol of accessibility stating "Minimum Fine \$250" not provided.• <i>Proposed Solution:</i> Provide compliant parking signage that includes fine information.	PCODE EA04G Mitigated: <input type="radio"/> YES <input checked="" type="radio"/> NO	1	JOB	\$300	\$300

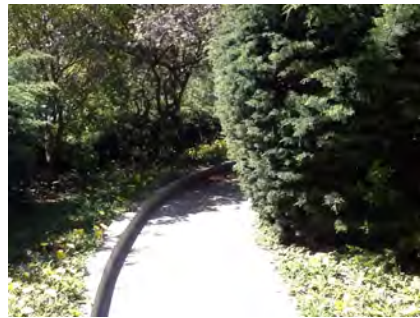
Item no., Rm no. and Name	Existing Architectural Barrier and Proposed Solution	Codes / Mitigation Info	Qty	Unit	Cost	Total
<u>Protrusion Limits</u>						
18	<ul style="list-style-type: none">• <i>As-Built Description:</i> Protruding objects more than 4" from wall, when bottom of object more than 27" or less than 80" above finished floor.• <i>Proposed Solution:</i> Remove/relocate protruding object. Patch existing surface.• <i>Notes:</i> Trim tree out of path of travel	<p>PCODE EG04 ADAAG 91 4.4.1 ADA 2010 307.2</p> <p>Mitigated: <input type="radio"/> YES <input checked="" type="radio"/> NO</p>	1	JOB	\$300	\$300

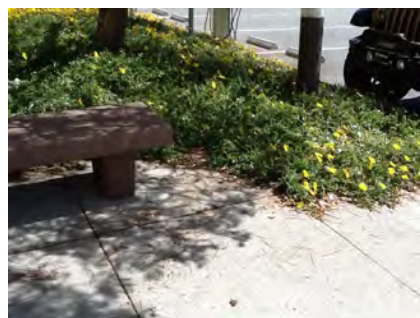
<input type="checkbox"/> Staff Only			
			<div><div>Priority</div><div>1</div></div> <div><div>Severity</div><div>3</div></div>			
<u>Fixed Bench</u>						
32	<ul style="list-style-type: none">• <i>As-Built Description:</i> Clear and level floor or ground space (30" x 48") not overlapping with other clear space requirements, is not provided at at least one end of the bench.• <i>As-Built:</i> 24" wide• <i>Proposed Solution:</i> Provide and position a clear and level floor or ground space to allow wheelchair users to be seated shoulder-to-shoulder with an individual seated on the bench.• <i>Notes:</i> Relocate the bench to provide 30" wide clear space.	<p>PCODE NO07 ADAAG 91 4.32.2 ADA 2010 903.2</p> <p>Mitigated: <input type="radio"/> YES <input checked="" type="radio"/> NO</p>	1	JOB	\$1,500	\$1,500

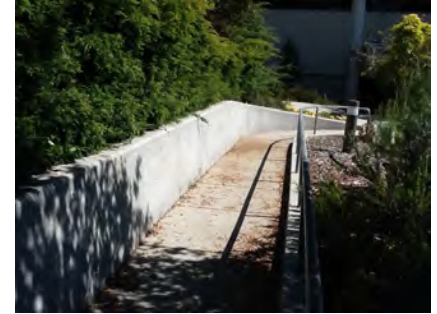
Landing

21	<ul style="list-style-type: none"> • As-Built Description: Ramp intermediate landing length less than 60" long. (CA Only: 72" long.) at change of direction. • Proposed Solution: Demolish existing landing and provide new longer landing. • Notes: No intermediate landings provided at the ramp. Requiring re-grading then entire ramp run. 	PCODE IJ05NT ADAAG 91 4.8.4 ADA 2010 405.7.4 Mitigated: <input type="radio"/> YES <input checked="" type="radio"/> NO	200	SF	\$27	\$5,400
----	---	---	-----	----	------	---------

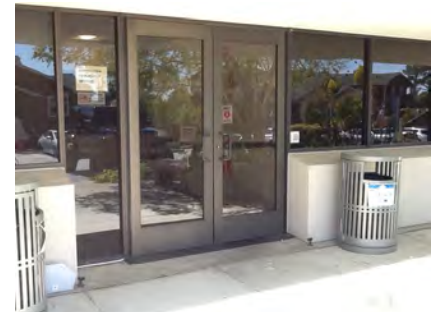
30	<ul style="list-style-type: none"> • As-Built Description: Surface of required maneuvering clearance at door slopes more than 1/4":12" (2.0%). • As-Built: 3.5% • Proposed Solution: Modify surface slope at door. 	PCODE ID11 ADAAG 91 4.13.6 ADA 2010 404.2.4.4 Mitigated: <input type="radio"/> YES <input checked="" type="radio"/> NO	15	SF	\$120	\$1,800
----	---	--	----	----	-------	---------

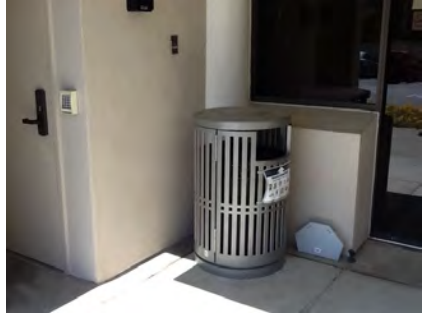
Item no., Rm no. and Name	Existing Architectural Barrier and Proposed Solution	Codes / Mitigation Info	Qty	Unit	Cost	Total
Reach Range						
31	<ul style="list-style-type: none"> As-Built Description: Reach height to control or access point, exceeds 48" or is less than 15". As-Built: 54.5" AFF to doorbell Proposed Solution: Modify equipment or mounting. 	PCODE IE01 ADAAG 91 4.2.5 ADA 2010 308.2.1 Mitigated: <input type="radio"/> YES <input checked="" type="radio"/> NO	1	JOB	\$300	\$300

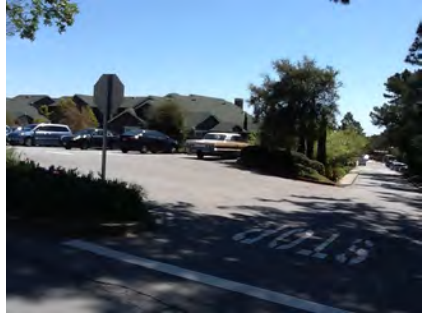
Item no., Rm no. and Name	Existing Architectural Barrier and Proposed Solution	Codes / Mitigation Info	Qty	Unit	Cost	Total
<u>Parking Signage</u>						
37	<ul style="list-style-type: none"> • <i>As-Built Description:</i> No "Tow Away" sign at parking lot entrance (required in CA only). • <i>Proposed Solution:</i> Provide "Tow Away" sign at parking lot entrance when altering area. 	PCODE EA04C Mitigated: <input type="radio"/> YES <input checked="" type="radio"/> NO	1	JOB	\$975	\$975

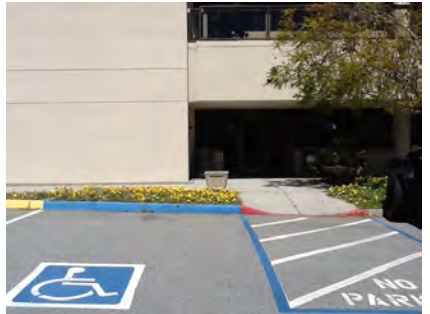
<input type="checkbox"/> Staff Only			
			Priority	Severity		
			1	4		
36	<ul style="list-style-type: none"> • <i>As-Built Description:</i> CA only: Additional Sign or additional language below the symbol of accessibility stating "Minimum Fine \$250" not provided. • <i>Proposed Solution:</i> Provide compliant parking signage that includes fine information. 	PCODE EA04G Mitigated: <input type="radio"/> YES <input checked="" type="radio"/> NO	1	JOB	\$300	\$300

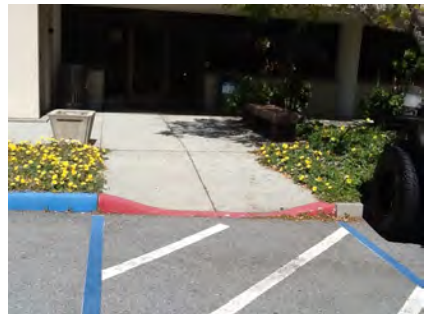
<input type="checkbox"/> Staff Only			
			Priority	Severity		
			<input checked="" type="radio"/> 1	<input checked="" type="radio"/> 2		
40	<ul style="list-style-type: none">As-Built Description: Detectable warning not provided where pedestrian crosses vehicular area.Proposed Solution: Provide detectable warning surface (i.e. in-line truncated domes) at regular curb ramp.	<p>PCODE EH07AREF ADAAG 91 4.7.7 ADA 2010 705.1</p> <p>Mitigated:</p> <p><input type="radio"/> YES <input checked="" type="radio"/> NO</p>		REF

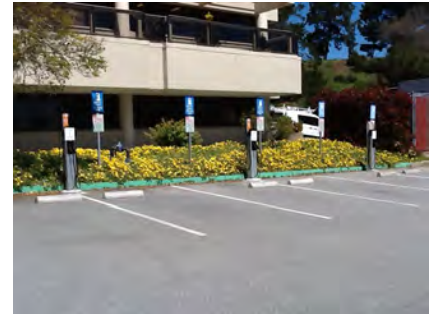
• *Proposed Solution:*• **Notes:****Provide accessible EV charging station with path of travel to entrance. 6 total stations****Mitigated:**☐ YES☒ NO

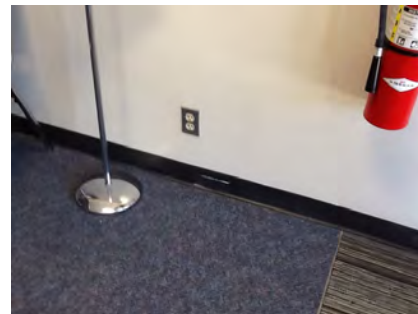
- 48 • *As-Built Description:*
Electric switch or control mounted less than 15" measured to the bottom of the outlet box or greater than 48 inches measured to the top of the outlet box.

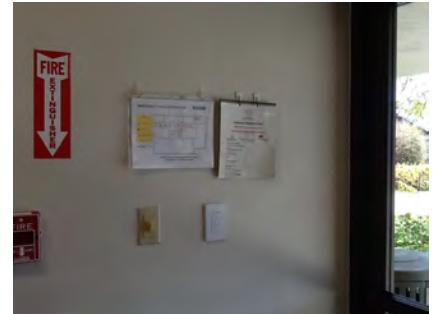
49	<ul style="list-style-type: none"> As-Built Description: Reach height to control or access point, exceeds 48" or is less than 15". As-Built: 58" - 63" AFF Proposed Solution: Modify equipment or mounting. 	PCODE IE01 ADAAG 91 4.2.5 ADA 2010 308.2.1	1	JOB	\$300	\$300
----	---	--	---	-----	-------	-------

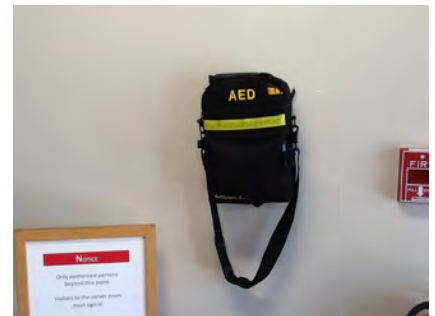
50	<ul style="list-style-type: none"> As-Built Description: Reach height to control or access point, exceeds 48" or is less than 15". As-Built: 60" AFF Proposed Solution: Modify equipment or mounting. 	PCODE IE01 ADAAG 91 4.2.5 ADA 2010 308.2.1	1	JOB	\$300	\$300
----	---	--	---	-----	-------	-------

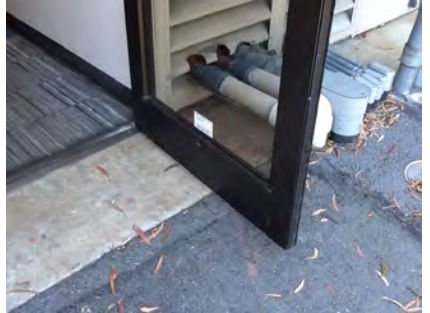
Item no., Rm no. and Name	Existing Architectural Barrier and Proposed Solution	Codes / Mitigation Info	Qty	Unit	Cost	Total
Door						
58	<ul style="list-style-type: none"> As-Built Description: At push side of door on accessible route, bottom 10" does not have a smooth, uninterrupted surface. As-Built: 9" high Proposed Solution: Provide 10" min. "kick plate" covering width of door when altering area. 	PCODE ID06 ADA 2010 404.2.10 Mitigated: <input type="radio"/> YES <input checked="" type="radio"/> NO	1	JOB	\$300	\$300

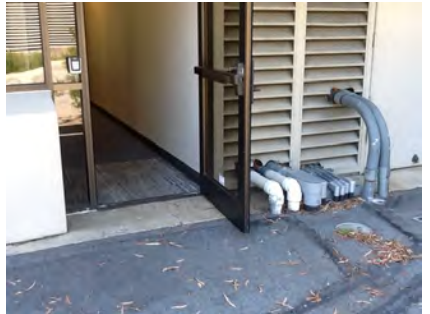
<input type="checkbox"/> Staff Only			
			Priority <input checked="" type="radio"/> 4		Severity <input checked="" type="radio"/> 3	
56	<ul style="list-style-type: none"> As-Built Description: Surface of required maneuvering clearance at door slopes more than 1/4":12" (2.0%). As-Built: 3.4% - 4-7% Proposed Solution: Modify surface slope at door. 	PCODE ID11 ADAAG 91 4.13.6 ADA 2010 404.2.4.4 Mitigated: <input type="radio"/> YES <input checked="" type="radio"/> NO	15	SF	\$120	\$1,800

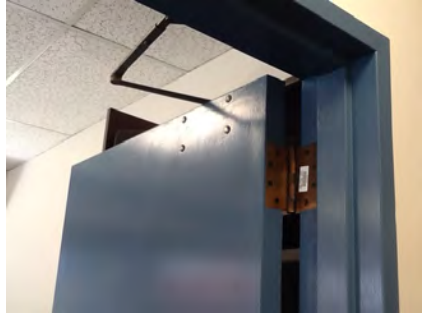
52	<ul style="list-style-type: none"> As-Built Description: Excessive force required to open door. As-Built: 15 lbs. Proposed Solution: Adjust regular door closer to accessible standards (5 lbs. max). 	PCODE ID03 ADAAG 91 4.13.11 ADA 2010 404.2.9 Mitigated: <input type="radio"/> YES <input checked="" type="radio"/> NO	1	JOB	\$75	\$75

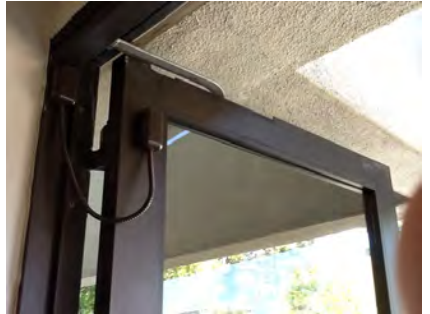
<input type="checkbox"/> Staff Only						
Priority Severity <input checked="" type="radio"/> 4 <input checked="" type="radio"/> 3						
54	<ul style="list-style-type: none"> As-Built Description: Excessive force required to open door. As-Built: 15 lbs. Proposed Solution: Adjust regular door closer to accessible standards (5 lbs. max). 	PCODE ID03REF ADAAG 91 4.13.11 ADA 2010 404.2.9 Mitigated: <input type="radio"/> YES <input checked="" type="radio"/> NO		REF

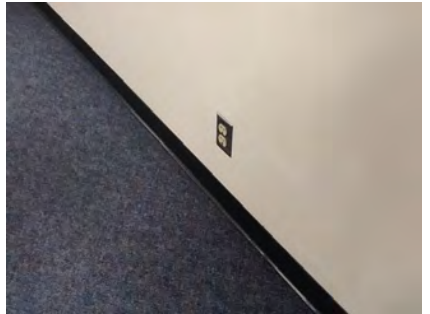
Item no., Rm no. and Name	Existing Architectural Barrier and Proposed Solution	Codes / Mitigation Info	Qty	Unit	Cost	Total
64	<ul style="list-style-type: none"> • <i>As-Built Description:</i> Electric switch or control mounted less than 15" measured to the bottom of the outlet box or greater than 48 inches measured to the top of the outlet box. • <i>As-Built:</i> 13" AFF • <i>Proposed Solution:</i> Relocate light switches or control to between 15" and 48" height. 	PCODE IC01 ADAAG 91 4.2.5 & 6 ADA 2010 308.2.1 & 308.2.2 Mitigated: <input type="radio"/> YES <input checked="" type="radio"/> NO	1	JOB	\$900	\$900

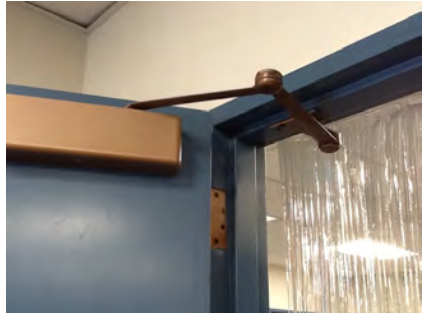
67	<ul style="list-style-type: none"> • <i>As-Built Description:</i> Excessive force required to open door. • <i>As-Built:</i> 10 lbs. • <i>Proposed Solution:</i> Adjust regular door closer to accessible standards (5 lbs. max). 	PCODE ID03 ADAAG 91 4.13.11 ADA 2010 404.2.9 Mitigated: <input type="radio"/> YES <input checked="" type="radio"/> NO	1	JOB	\$75	\$75

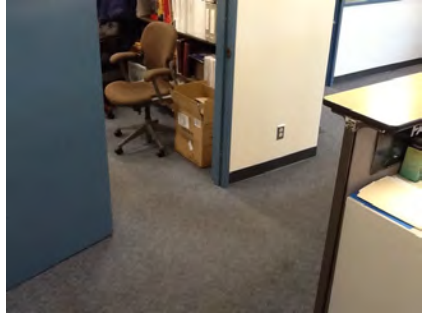
Item no., Rm no. and Name	Existing Architectural Barrier and Proposed Solution	Codes / Mitigation Info	Qty	Unit	Cost	Total
Door Swing						
72	<ul style="list-style-type: none"> As-Built Description: Front approach: At pull side, door does not have clear and level maneuvering space measuring door width plus 18" x 60". (24" x 60" at exterior doors). As-Built: 51" pull side landing to furniture Proposed Solution: Remove or relocate furniture or storage items. 	PCODE ID23A ADAAG 91 Fig. 25(a) ADA 2010 404.2.4 Mitigated: <input type="radio"/> YES <input checked="" type="radio"/> NO	1	JOB	\$150	\$150

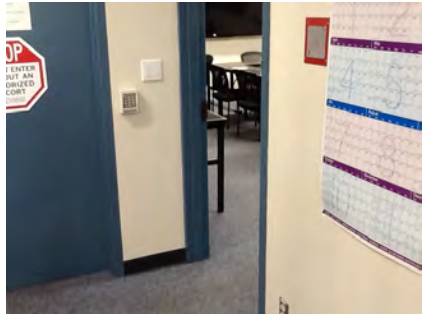
<input type="checkbox"/> Staff Only			
			Priority <input checked="" type="radio"/> 4		Severity <input checked="" type="radio"/> 3	
69	<ul style="list-style-type: none"> As-Built Description: Front approach: At push side, door does not have clear and level maneuvering space measuring door width x 48" (door width plus 12" if door has both, latch and closer). Proposed Solution: Change door swing. 	PCODE ID24 ADAAG 91 Fig. 25(a) ADA 2010 404.2.4 Mitigated: <input type="radio"/> YES <input checked="" type="radio"/> NO	1	JOB	\$1,500	\$1,500

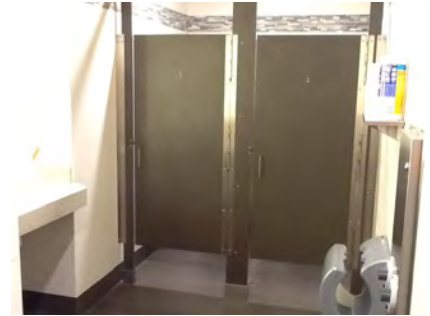
• *As-Built Description:*Multiple accommodation restroom not accessible;
multiple compliance violations.• *Proposed Solution:*Remodel area to provide accessible restroom with
one accessible stall, lavatory (and one urinal at
Mens).

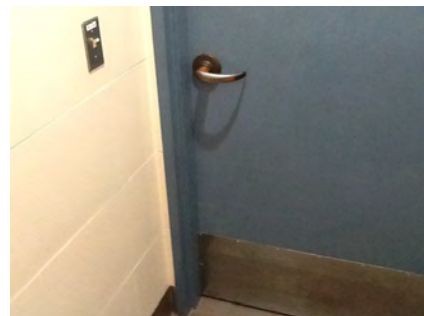
Item no., Rm no. and Name	Existing Architectural Barrier and Proposed Solution	Codes / Mitigation Info	Qty	Unit	Cost	Total
Door Swing						
87	<ul style="list-style-type: none">As-Built Description: Front approach: At push side, door does not have clear and level maneuvering space measuring door width x 48" (door width plus 12" if door has both, latch and closer).As-Built: 2"Proposed Solution: Provide door operator.	<p>PCODE ID24CREf</p> <p>ADAAG 91 Fig. 25(a)</p> <p>ADA 2010 404.2.4</p> <p>Mitigated:</p> <p><input type="radio"/> YES</p> <p><input checked="" type="radio"/> NO</p>				
			REF

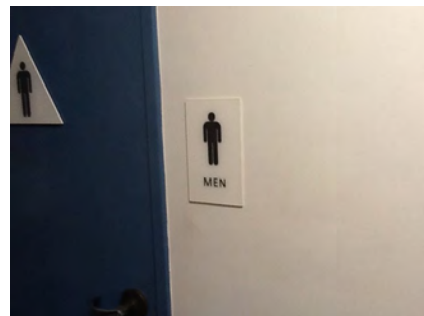
<input type="checkbox"/> Staff Only			
			Priority	Severity		
			<input type="radio"/> 4	<input checked="" type="radio"/> 2		
Signage						
84	<ul style="list-style-type: none">As-Built Description: Entrance to toilet or bathing facility identified with California signage on door leaf not identified with ADAAG compliant signage.As-Built: 8" o.c. from doorProposed Solution: Provide ADAAG compliant sign with raised letters and pictogram, mounted 5' high on center on nearest adjacent wall, on latch side of a single door.	<p>PCODE SA11AREf</p> <p>ADAAG 91 4.1.3(16)(a)</p> <p>ADA 2010 216.8</p> <p>Mitigated:</p> <p><input type="radio"/> YES</p> <p><input checked="" type="radio"/> NO</p>

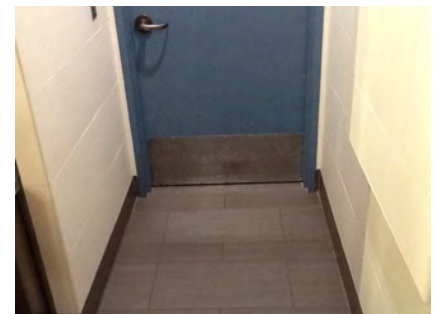
- 88
- *As-Built Description:*
Clear passage width (except doorways) from rest room entry to accessible water closet compartment less than 36" (CA only: 44" wide).
 - *As-Built:* **37 - 40.5"**
 - *Proposed Solution:*
Modify facility passage to be min. 44" wide.
Demolish existing partition and replace.
- PCODE WC02AREF
ADAAG 91 4.3.3
ADA 2010 403.5.1

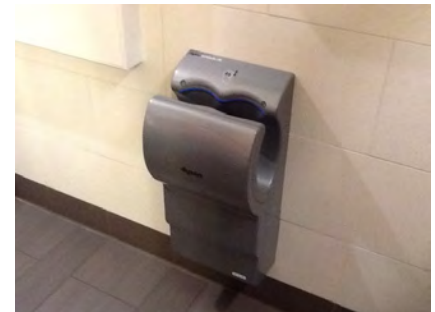
- 94 • *As-Built Description:*
Refer to notes for observation and recommendation.
- PCODE GN01

• *Proposed Solution:*• **Notes:****This type of dryer is no longer accepted by the DSA. Remove or replace with different style of hand dryer.****Mitigated:**

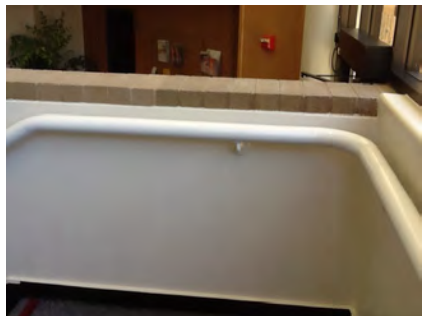
Item no., Rm no. and Name	Existing Architectural Barrier and Proposed Solution	Codes / Mitigation Info	Qty	Unit	Cost	Total
Handrail						
114	<ul style="list-style-type: none"> As-Built Description: Guards (42" high) not provided at side of ramp or landing where drop-off to adjacent grade or floor exceeds 30" height (California building code requirement only). Proposed Solution: Provide new guards, including handrail at ramp. 	PCODE ED08	30	LF	\$360	\$10,800
Mitigated: <input type="radio"/> YES <input checked="" type="radio"/> NO			 			
			<input type="checkbox"/> Staff Only			
			Priority <input checked="" type="radio"/> 1		Severity <input checked="" type="radio"/> 4	
115	<ul style="list-style-type: none"> As-Built Description: Guards (42" high) not provided at side of ramp or landing where drop-off to adjacent grade or floor exceeds 30" height (California building code requirement only). As-Built: 41.5" AFF Proposed Solution: Provide new guards, including handrail at ramp. 	PCODE ED08	6	LF	\$360	\$2,160

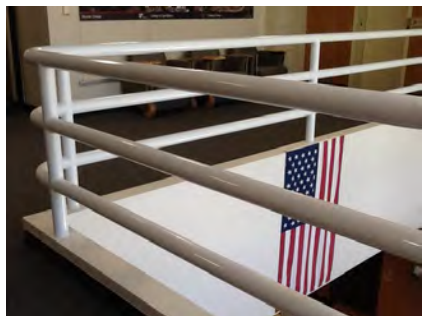
<input type="checkbox"/> Staff Only			
			Priority <input checked="" type="radio"/> 1		Severity <input checked="" type="radio"/> 4	
116	<ul style="list-style-type: none"> As-Built Description: Open guards does not have balusters or ornamental patterns such that a 4-inch-diameter (102 mm) sphere cannot pass through any opening. As-Built: 9" Proposed Solution: Provide new guards which do not allow passage of an 4 inch sphere at any opening. 	PCODE ED08A ADA 2010 405.9.2	20	LF	\$360	\$7,200
Mitigated: <input type="radio"/> YES <input checked="" type="radio"/> NO

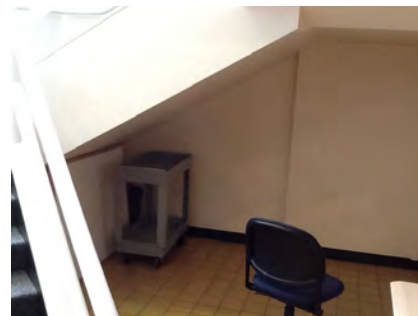
117	<ul style="list-style-type: none"> • <i>As-Built Description:</i> Overhead clearance less than 80" above finished floor. • <i>As-Built:</i> 37" - 74" high • <i>Proposed Solution:</i> Provide under stair cane-detectable railing to mark area of low clearance. 	PCODE EG01A ADAAG 91 4.4.2 ADA 2010 307.4 Mitigated: <input type="radio"/> YES <input checked="" type="radio"/> NO	10	LF	\$300	\$3,000
-----	---	--	----	----	-------	----------------

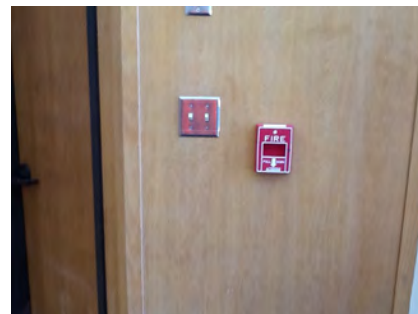
99	<ul style="list-style-type: none"> • <i>As-Built Description:</i> Electric switch or control mounted less than 15" measured to the bottom of the outlet box or greater than 48 inches measured to the top of the outlet box. • <i>As-Built:</i> 52" AFF • <i>Proposed Solution:</i> Relocate light switches or control to between 15" and 48" height. • Notes: Light switch 	PCODE IC01 ADAAG 91 4.2.5 & 6 ADA 2010 308.2.1 & 308.2.2 Mitigated: <input type="radio"/> YES <input checked="" type="radio"/> NO	1	JOB	\$900	\$900
----	--	---	---	-----	-------	--------------

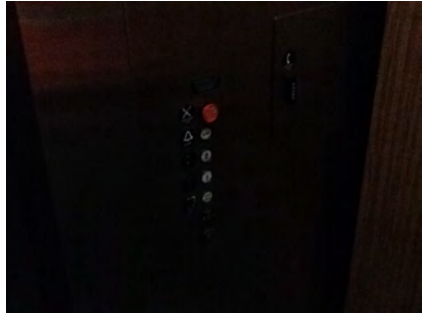
Item no., Rm no. and Name	Existing Architectural Barrier and Proposed Solution	Codes / Mitigation Info	Qty	Unit	Cost	Total
108	<ul style="list-style-type: none"> As-Built Description: Elevator car lacks emergency communication device that is not dependent on speaking/hearing ability of elevator passenger. As-Built: 45" AFF Proposed Solution: Provide elevator communication device that has combination voice and light signal communications. 	PCODE IK06A ADAAG 91 4.10.14 ADA 2010 407.4.9 Mitigated: <input type="radio"/> YES <input checked="" type="radio"/> NO	1	JOB	\$2,100	\$2,100

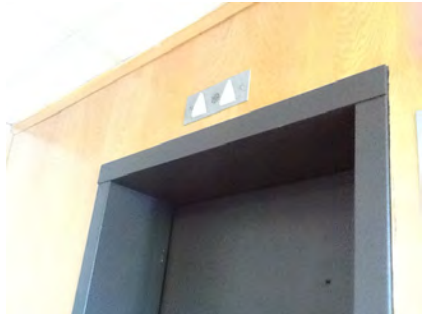
<input type="checkbox"/> Staff Only						
Priority 1 Severity 3						
106	<ul style="list-style-type: none"> As-Built Description: Visual hall lantern, minimum 2-1/2" x 2-1/2", not provided, or installed less than 72" above floor. Proposed Solution: Provide or raise proper visual hall lantern for elevator. Notes: Provided but does not function. 	PCODE IK10A ADAAG 91 4.10.4(1) ADA 2010 407.2.2.2 Mitigated: <input type="radio"/> YES <input checked="" type="radio"/> NO	1	JOB	\$4,650	\$4,650

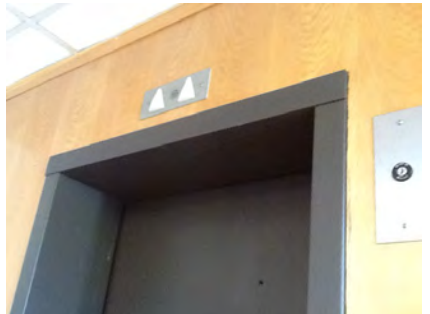
<input type="checkbox"/> Staff Only						
Priority 1 Severity 3						
104	<ul style="list-style-type: none"> As-Built Description: Audible signal not provided (one for up, two for down). Proposed Solution: Provide proper audible hall signal for elevator. 	PCODE IK10B ADAAG 91 4.10.4 ADA 2010 407.2.2.3 Mitigated: <input type="radio"/> YES <input checked="" type="radio"/> NO	1	JOB	\$4,650	\$4,650

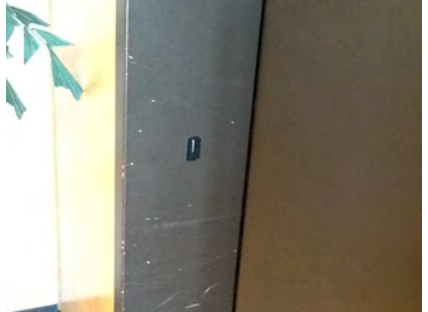
Item no., Rm no. and Name	Existing Architectural Barrier and Proposed Solution	Codes / Mitigation Info	Qty	Unit	Cost	Total
102	<ul style="list-style-type: none"> • <i>As-Built Description:</i> Braille and raised floor numbers on entrance jambs located more or less than 5' above floor. • <i>As-Built:</i> 42" o.c. • <i>Proposed Solution:</i> Relocate Braille and raised floor numbers on entrance jambs to 5' above floor. • <i>Notes:</i> Tactile not 2" high. Ground floor must include a star. 	PCODE IK11C ADAAG 91 4.10.5 ADA 2010 703.4.1 Mitigated: <input type="radio"/> YES <input checked="" type="radio"/> NO	4	JOB	\$360	\$1,440

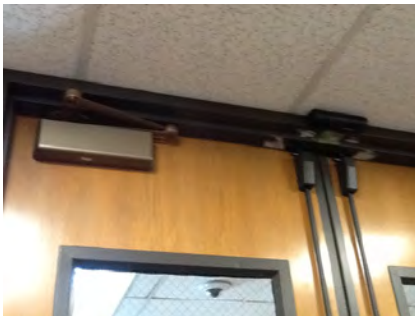
Item no., Rm no. and Name	Existing Architectural Barrier and Proposed Solution	Codes / Mitigation Info	Qty	Unit	Cost	Total
<u>Door Closer</u>						
119	<ul style="list-style-type: none">As-Built Description: Excessive force required to open door.As-Built: 11 lbs.Proposed Solution: Adjust regular door closer to accessible standards (5 lbs. max).	PCODE ID03 ADAAG 91 4.13.11 ADA 2010 404.2.9 Mitigated: <div><input type="radio"/> YES</div> <div><input checked="" type="radio"/> NO</div>	1	JOB	\$75	\$75

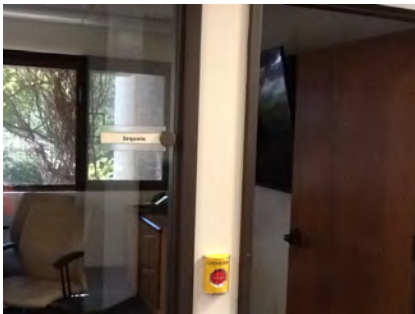
<u>Signage</u>						
121	<ul style="list-style-type: none">As-Built Description: Sign not located on latch side of door and/or not located at 48" min. above to baseline of the lowest Braille cells and 60" max. to baseline of the highest line of raised characters.Proposed Solution: Provide compliant signage including tactile characters and Grade II Braille on latch side of door located at compliant height.Notes: Braille not provided for permanent rooms and spaces.	PCODE SA07 ADAAG 91 4.30.6 ADA 2010 703.4.1 Mitigated: <div><input type="radio"/> YES</div> <div><input checked="" type="radio"/> NO</div>	2	JOB	\$150	\$300

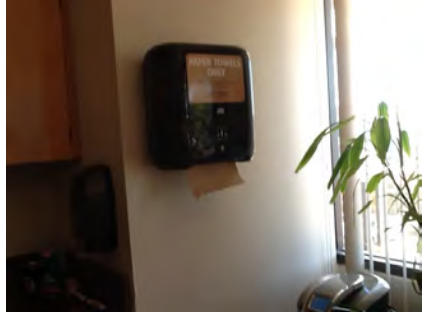
Item no., Rm no. and Name	Existing Architectural Barrier and Proposed Solution	Codes / Mitigation Info	Qty	Unit	Cost	Total
140	<ul style="list-style-type: none"> As-Built Description: Reach height to control or access point, exceeds 48" or is less than 15". As-Built: 54" AFF Proposed Solution: Modify equipment or mounting. 	PCODE IE01 ADAAG 91 4.2.5 ADA 2010 308.2.1 Mitigated: <input type="radio"/> YES <input checked="" type="radio"/> NO	1	JOB	\$300	\$300

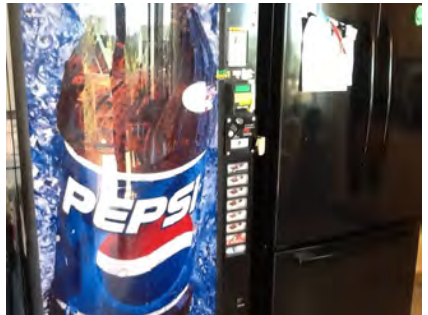
Vending Machine

138	<ul style="list-style-type: none"> As-Built Description: Vending machine coin slot or dispensing outlet, for side reach, more than 48" above floor. As-Built: 53" AFF Proposed Solution: Advise vendor/leasing company to provide accessible vending machine. 	PCODE IL01 ADAAG 91 4.2.6 ADA 2010 308.3.1 Mitigated: <input type="radio"/> YES <input checked="" type="radio"/> NO	1	JOB	\$0

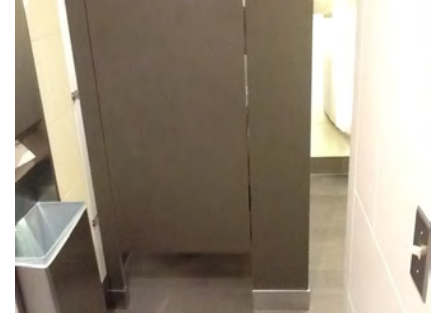
• *As-Built Description:*Multiple accommodation restroom not accessible;
multiple compliance violations.• *Proposed Solution:*Remodel area to provide accessible restroom with
one accessible stall, lavatory (and one urinal at
Mens).

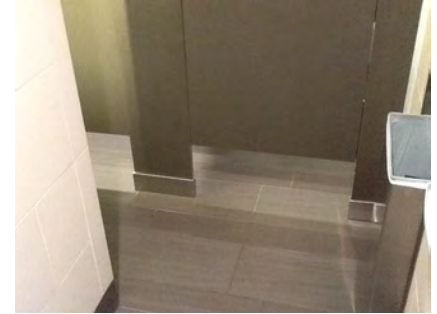
• *As-Built Description:*Multiple accommodation restroom not accessible;
multiple compliance violations.• *Proposed Solution:*Remodel area to provide accessible restroom with
one accessible stall, lavatory (and one urinal at
Mens).

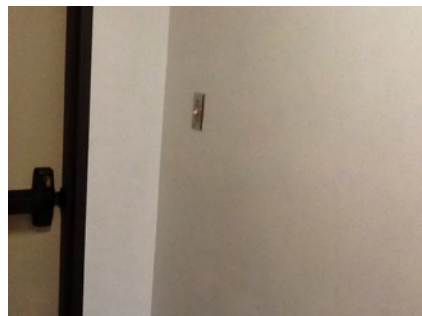
Item no., Rm no. and Name	Existing Architectural Barrier and Proposed Solution	Codes / Mitigation Info	Qty	Unit	Cost	Total
Electrical						
155	<ul style="list-style-type: none">As-Built Description: Electric switch or control mounted less than 15" measured to the bottom of the outlet box or greater than 48 inches measured to the top of the outlet box.As-Built: 54" AFFProposed Solution: Relocate light switches or control to between 15" and 48" height.	<p>PCODE IC01 ADAAG 91 4.2.5 & 6 ADA 2010 308.2.1 & 308.2.2</p> <p>Mitigated:</p> <p><input type="radio"/> YES <input checked="" type="radio"/> NO</p>	3	JOB	\$900	\$2,700

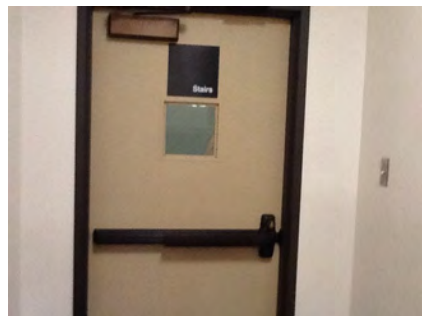
<div><input type="checkbox"/> Staff Only</div> <div><div>Priority</div><div>Severity</div><div><div>4</div><div>4</div></div></div>			
Door						
154	<ul style="list-style-type: none">As-Built Description: Vision Light at door that permits viewing, does not have bottom of at least one glazed panel located 43 inches maximum above the finish floor. (Exception: More than 66" above finished floor.)As-Built: 54.5" AFFProposed Solution: Provide new door with vision panel at 43" max.	<p>PCODE ID06C ADA 2010 404.2.11</p> <p>Mitigated:</p> <p><input type="radio"/> YES <input checked="" type="radio"/> NO</p>	2	JOB	\$7,500	\$15,000

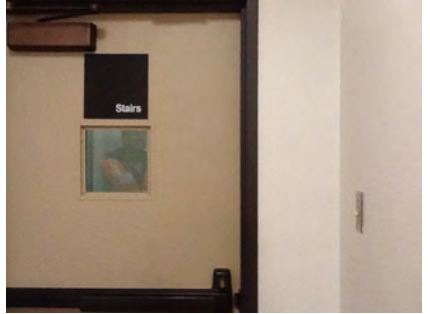
Item no., Rm no. and Name	Existing Architectural Barrier and Proposed Solution	Codes / Mitigation Info	Qty	Unit	Cost	Total
Signage						
156	<ul style="list-style-type: none"> As-Built Description: At door leading into exit stairway: Where required exit signs are installed, signs to provide exiting information for people with vision impairment are not provided. Proposed Solution: Provide raised letter/Braille "EXIT STAIR UP/DOWN" sign at door. 	PCODE SA10B ADAAG 91 4.1.3(16) ADA 2010 216.4.1 Mitigated: <input type="radio"/> YES <input checked="" type="radio"/> NO	2	JOB	\$270	\$540

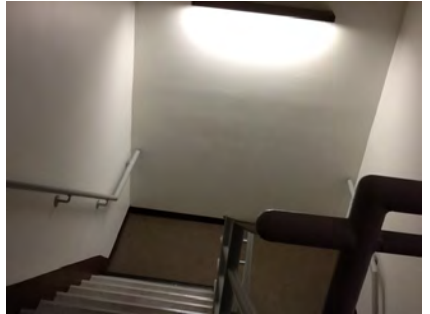
<input type="checkbox"/> Staff Only Priority 4 Severity 3			
161	<ul style="list-style-type: none"> As-Built Description: At enclosed stairwells in high-rise buildings: Floor level information sign in stairwell not provided for people with vision impairment. Proposed Solution: Provide raised letter/Braille sign at door, indicating the floor level and other exiting information. 	PCODE SA10F ADAAG 91 4.1.3(16) Mitigated: <input type="radio"/> YES <input checked="" type="radio"/> NO	3	JOB	\$450	\$1,350

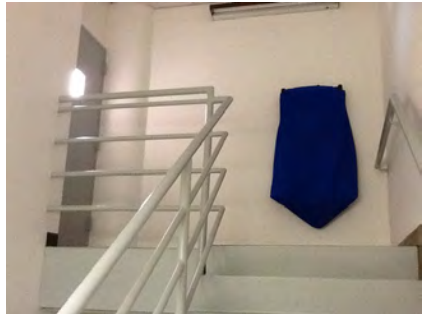
<input type="checkbox"/> Staff Only Priority 4 Severity 3			
162	<ul style="list-style-type: none"> As-Built Description: At enclosed stairwells in high-rise buildings: Floor level information sign in stairwell not provided for people with vision impairment. Proposed Solution: Provide raised letter/Braille sign at door, indicating the floor level and other exiting information. 	PCODE SA10F ADAAG 91 4.1.3(16) Mitigated: <input type="radio"/> YES <input checked="" type="radio"/> NO	1	JOB	\$450	\$450

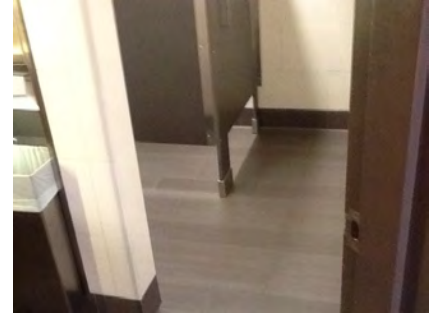
Multiple accommodation restroom not accessible;
multiple compliance violations.

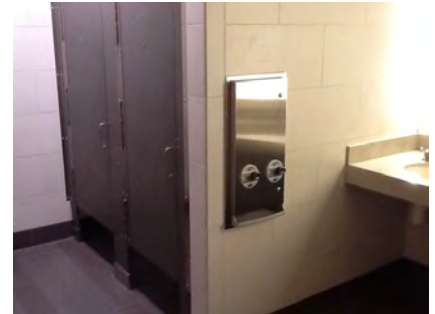
Multiple accommodation restroom not accessible;
multiple compliance violations.

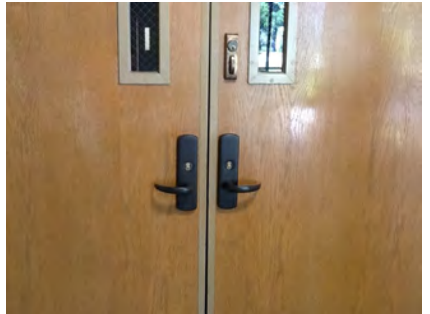
Door Closer

185	<ul style="list-style-type: none"> As-Built Description: Excessive force required to open door. As-Built: 10 lbs. Proposed Solution: Adjust regular door closer to accessible standards (5 lbs. max). 	PCODE ID03 ADAAG 91 4.13.11 ADA 2010 404.2.9 Mitigated: <input type="radio"/> YES <input checked="" type="radio"/> NO	5	JOB	\$75	\$375

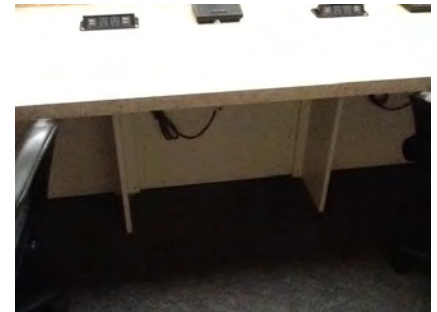
Item no., Rm no. and Name	Existing Architectural Barrier and Proposed Solution	Codes / Mitigation Info	Qty	Unit	Cost	Total
181	<ul style="list-style-type: none"> As-Built Description: Accessible fixed table or desk (top 28" to 34" high; knee space at least 27" high x 19" deep x 30" wide) not provided. As-Built: 26.5" knee clearance Proposed Solution: Provide new fixed accessible table or desk. 	PCODE IN02 ADAAG 91 4.32.3 & .4 ADA 2010 306.1 & 902.3 Mitigated: <input type="radio"/> YES <input checked="" type="radio"/> NO	8	JOB	\$7,500	\$60,000

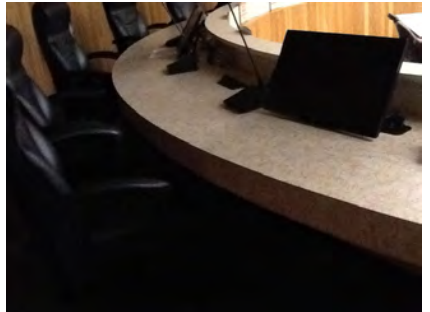
Non-Fixed Desk

174	<ul style="list-style-type: none"> As-Built Description: Accessible non-fixed table or desk (top 28" to 34" high; knee space at least 27" high x 19" deep x 30" wide) not provided. As-Built: 26.5" knee clearance Proposed Solution: Provide table or desk with accessible dimensions when purchasing new furniture. 	PCODE IN02A ADAAG 91 4.32.3 & .4 ADA 2010 306.1 Mitigated: <input type="radio"/> YES <input checked="" type="radio"/> NO	1	JOB	\$4,800	\$4,800

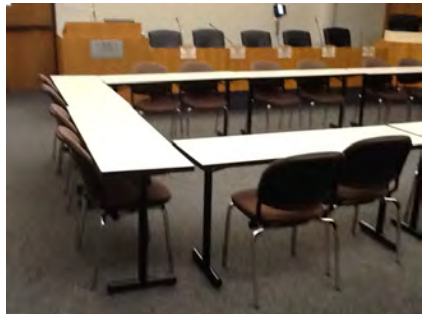
<input type="checkbox"/> Staff Only Priority 2 Severity 2						
179	<ul style="list-style-type: none"> As-Built Description: Accessible non-fixed table or desk (top 28" to 34" high; knee space at least 27" high x 19" deep x 30" wide) not provided. As-Built: 19" wide Proposed Solution: Provide table or desk with accessible dimensions when purchasing new furniture. 	PCODE IN02A ADAAG 91 4.32.3 & .4 ADA 2010 306.1 Mitigated: <input type="radio"/> YES <input checked="" type="radio"/> NO	1	JOB	\$4,800	\$4,800

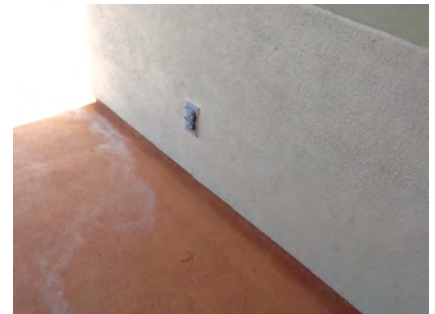
Item no., Rm no. and Name	Existing Architectural Barrier and Proposed Solution	Codes / Mitigation Info	Qty	Unit	Cost	Total
219	<ul style="list-style-type: none"> • <i>As-Built Description:</i> Electric switch or control mounted less than 15" measured to the bottom of the outlet box or greater than 48 inches measured to the top of the outlet box. • <i>As-Built:</i> 53" AFF • <i>Proposed Solution:</i> Relocate light switches or control to between 15" and 48" height. 	PCODE IC01 ADAAG 91 4.2.5 & 6 ADA 2010 308.2.1 & 308.2.2 Mitigated: <input type="radio"/> YES <input checked="" type="radio"/> NO	1	JOB	\$900	\$900

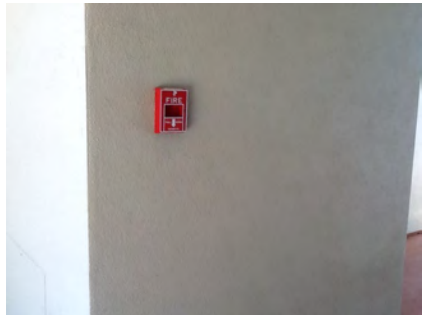
214	<ul style="list-style-type: none"> • <i>As-Built Description:</i> Fire alarm pull stations not 42"-48" from floor to center. Note: Required only at new construction, or where mounting location was or is to be remodeled. • <i>As-Built:</i> 53" AFF • <i>Proposed Solution:</i> Remount fire alarm station to be 42" min., and 48" max. from floor to center. 	PCODE IC03 ADAAG 91 4.2.5 ADA 2010 308.2.1 Mitigated: <input type="radio"/> YES <input checked="" type="radio"/> NO	1	JOB	\$825	\$825

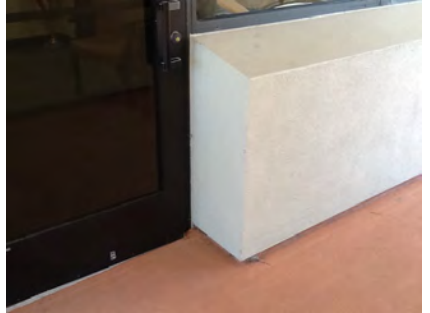
Item no., Rm no. and Name	Existing Architectural Barrier and Proposed Solution	Codes / Mitigation Info	Qty	Unit	Cost	Total
Door Swing						
217	<ul style="list-style-type: none"> As-Built Description: Front approach: At pull side, door does not have clear and level maneuvering space measuring door width plus 18" x 60". (24" x 60" at exterior doors). As-Built: 3" strike side clearance and 13.75" deep Proposed Solution: Provide power door operator. 	PCODE ID23C ADAAG 91 Fig. 25(a) ADA 2010 404.2.4 Mitigated: <input type="radio"/> YES <input checked="" type="radio"/> NO	1	JOB	\$15,000	\$15,000

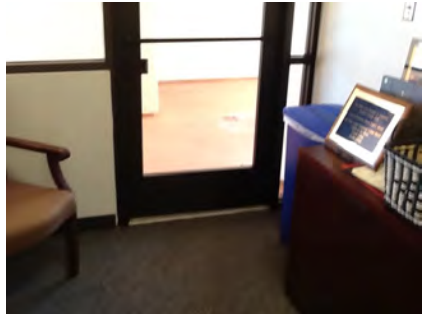
<input type="checkbox"/> Staff Only Priority Severity <input checked="" type="radio"/> 4 <input checked="" type="radio"/> 2			
218	<ul style="list-style-type: none"> As-Built Description: Front approach: At push side, door does not have clear and level maneuvering space measuring door width x 48" (door width plus 12" if door has both, latch and closer). Proposed Solution: Remove or relocate furniture or storage items. 	PCODE ID24A ADAAG 91 Fig. 25(a) ADA 2010 404.2.4 Mitigated: <input type="radio"/> YES <input checked="" type="radio"/> NO	1	JOB	\$150	\$150

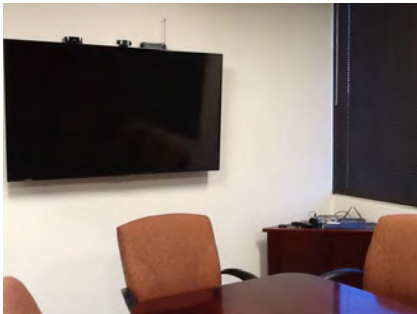
Item no., Rm no. and Name	Existing Architectural Barrier and Proposed Solution	Codes / Mitigation Info	Qty	Unit	Cost	Total
224	<p><u>Assistive Listening</u></p> <ul style="list-style-type: none"> <i>As-Built Description:</i> No portable assistive listening system provided for small meeting room. <i>Proposed Solution:</i> Share existing portable assistive listening system from other facility. 	<p>PCODE GI01E</p> <p>ADAAG 91 4.1.3(19)(b) & ADA 2010 4.33.7 219.1 & 706.1</p> <p>Mitigated:</p> <p><input type="radio"/> YES</p> <p><input checked="" type="radio"/> NO</p>				
					REF

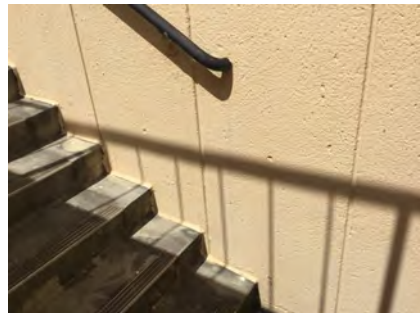
Item no., Rm no. and Name	Existing Architectural Barrier and Proposed Solution	Codes / Mitigation Info	Qty	Unit	Cost	Total
<u>Bottom Extension at Stairs</u>						
677	<ul style="list-style-type: none">As-Built Description: Stair handrail does not extend one tread width sloped plus 12" min. horizontally beyond bottom riser.As-Built: 0"Proposed Solution: Extend stair handrail at bottom (cost for each extension piece).	PCODE ED07NT ADAAG 91 4.9.4(2) ADA 2010 505.10.3 CBC 2007 1133B.4.2.2 CBC 2016 11B-505.10.3 Project: SKYB1 Facelift Year to be Completed: 2021/2022 Mitigated: <div><input type="radio"/> YES</div> <div><input checked="" type="radio"/> NO</div>	2	JOB	\$510	\$1,020

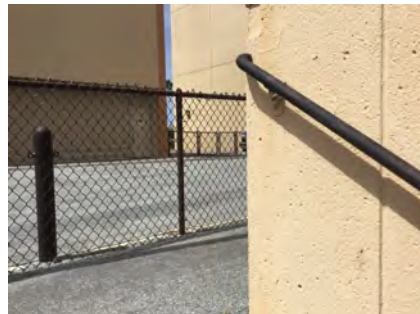
<div><input type="checkbox"/> Staff Only</div> <div><div>Priority</div><div>1</div><div>Severity</div><div>2</div></div>			
<u>Top & Bottom Extension at Stairs</u>						
678	<ul style="list-style-type: none">As-Built Description: Stair handrail does not extend horizontally 12" minimum beyond top nosing, and one tread width sloped, plus 12" minimum horizontally beyond the bottom nosing.As-Built: 0"Proposed Solution: Extend stair handrail at top and bottom (cost for each extension piece).	PCODE ED06 ADAAG 91 4.9.4(2) ADA 2010 505.10.2; CBC 2007 1133B.4.2.2 CBC 2016 11B-505.10.2; 11B-505.10.3 Project: SKYB1 Facelift Year to be Completed: 2021/2022 Mitigated: <div><input type="radio"/> YES</div> <div><input checked="" type="radio"/> NO</div>	4	JOB	\$510	\$2,040

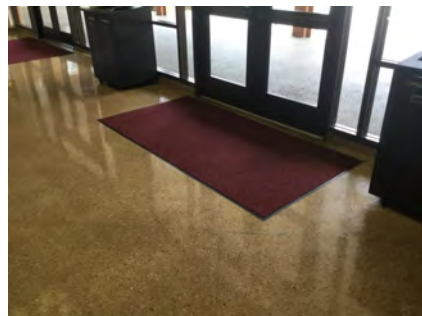
Item no., Rm no. and Name	Existing Architectural Barrier and Proposed Solution	Codes / Mitigation Info	Qty	Unit	Cost	Total
<u>Doormat</u>						
341	<ul style="list-style-type: none">• <i>As-Built Description:</i> Doormat hinders access to disabled persons.• <i>Proposed Solution:</i> Provide new doormat; recess or attach at edges.	<p>PCODE ID05</p> <p>ADAAG 91 4.5.3</p> <p>ADA 2010 302.2</p> <p>CBC 2007 1124B.3</p> <p>CBC 2016 11B-302.2</p> <p>Project: SKYB1 Facelift</p> <p>Year to be Completed: 2021/2022</p> <p>Mitigated:</p> <p><input type="radio"/> YES</p> <p><input checked="" type="radio"/> NO</p>	20	JOB	\$1,500	\$30,000

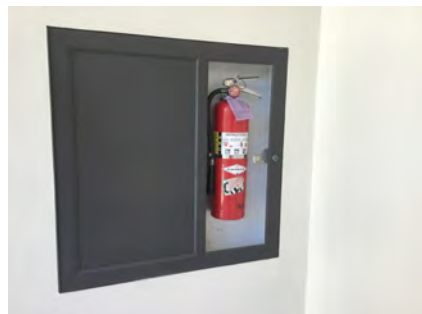
<input type="checkbox"/> Staff Only			
			<div><div>Priority</div><div>1</div><div>Severity</div><div>3</div></div>			
<u>Reach Range</u>						
460	<ul style="list-style-type: none">• <i>As-Built Description:</i> Reach height to control or access point, where side approach is available, exceeds 48" or is less than 15" in height, or exceeds 10" in depth.• <i>As-Built:</i> 66" AFF• <i>Proposed Solution:</i> Modify equipment or mounting.	<p>PCODE IE02</p> <p>ADAAG 91 4.2.6</p> <p>ADA 2010 308.3.1</p> <p>CBC 2007 1118B.6</p> <p>CBC 2016 11B-308.3</p> <p>Project: SKYB1 Facelift</p> <p>Year to be Completed: 2021/2022</p> <p>Mitigated:</p> <p><input type="radio"/> YES</p> <p><input checked="" type="radio"/> NO</p>	20	JOB	\$300	\$6,000

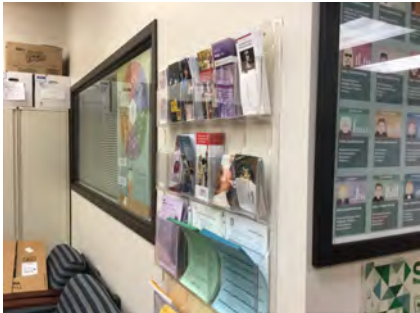
Item no., Rm no. and Name	Existing Architectural Barrier and Proposed Solution	Codes / Mitigation Info	Qty	Unit	Cost	Total
Brochure Bins						
448	<ul style="list-style-type: none">As-Built Description: Information brochure bins mounted above accessible height of 48".As-Built: 72" AFFProposed Solution: Relocate/remount bins at accessible height.Notes: Occurs at consultation and public areas throughout.	<p>PCODE IN08</p> <p>ADAAG 91 4.2.5 & 6</p> <p>ADA 2010 308.2.1</p> <p>CBC 2007 1118B.5</p> <p>CBC 2016 11B-308.2.1</p> <p>Project: SKYB1 Facelift</p> <p>Year to be Completed: 2021/2022</p> <p>Mitigated: <input type="radio"/> YES <input checked="" type="radio"/> NO</p>	8	JOB	\$300	\$2,400

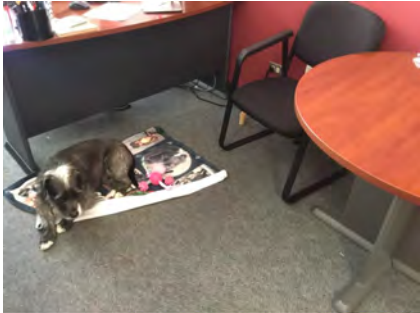
<input type="checkbox"/> Staff Only			
			<div><div>Priority</div><div>2</div><div>Severity</div><div>1</div></div>			
Non-Fixed Desk						
422	<ul style="list-style-type: none">As-Built Description: Recommended only: Accessible non-fixed table or desk (top 28" to 34" high; knee space at least 27" high x 19" deep x 30" wide) not provided.Proposed Solution: Provide table or desk with accessible dimensions when purchasing new furniture.Notes: Consultation offices in building do not have knee clearance at desks and tables. Consider whether writing is required at the desks and tables.	<p>PCODE IN02AREF</p> <p>ADAAG 91 4.32.3 & .4</p> <p>ADA 2010 306.1</p> <p>CBC 2007 1122B.3 & 4</p> <p>CBC 2016 11B-306.1 & 11B-902.3</p> <p>Project: SKYB1 Facelift</p> <p>Year to be Completed: 2021/2022</p> <p>Mitigated: <input type="radio"/> YES <input checked="" type="radio"/> NO</p>

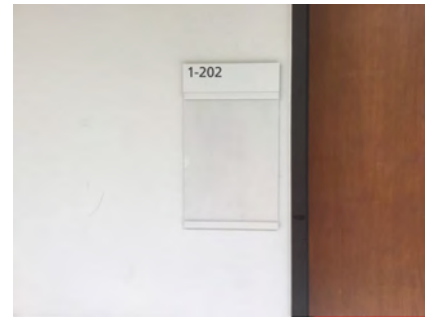
Item no., Rm no. and Name	Existing Architectural Barrier and Proposed Solution	Codes / Mitigation Info	Qty	Unit	Cost	Total	
Signage							
367	<ul style="list-style-type: none">• <i>As-Built Description:</i> Signs containing tactile characters is not located so that a clear floor space of 18" min x 18" min., centered on the tactile characters, is provided beyond the arc of any door swing between the closed position and 45 degree open position.• <i>As-Built:</i> 66.25" to bottom of the highest tactile characters• <i>Proposed Solution:</i> Relocate compliant signage on latch side of door located at compliant height with a clear floor space.	<p>PCODE SA07BREF</p> <p>ADAAG 91 4.30.6</p> <p>ADA 2010 703.4.2</p> <p>CBC 2007 1117B.5.7</p> <p>CBC 2016 11B-703.4.2</p> <p>Project: SKYB1 Facelift</p> <p>Year to be Completed: 2021/2022</p> <p>Mitigated: <input type="radio"/> YES <input checked="" type="radio"/> NO</p>

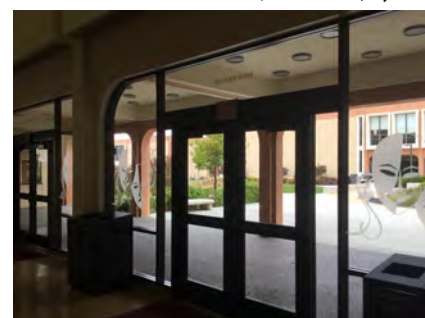
<input type="checkbox"/> Staff Only			
				Priority	Severity		
				2	4		
340	<ul style="list-style-type: none">• <i>As-Built Description:</i> At final exit door to exterior: Where required exit signs are installed, signs to provide exiting information for people with vision impairment are not provided.• <i>Proposed Solution:</i> Provide raised letter/Braille "EXIT" sign at door.	<p>PCODE SA10A</p> <p>ADAAG 91 4.1.3(16)</p> <p>ADA 2010 216.4.1</p> <p>CBC 2007 1011.3</p> <p>CBC 2016 11B-216.4.1</p> <p>Project: SKYB1 Facelift</p> <p>Year to be Completed: 2021/2022</p> <p>Mitigated: <input type="radio"/> YES <input checked="" type="radio"/> NO</p>		20	JOB	\$270	\$5,400

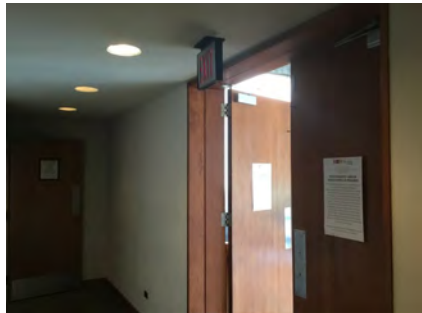
Item no., Rm no. and Name	Existing Architectural Barrier and Proposed Solution	Codes / Mitigation Info	Qty	Unit	Cost	Total
348	<ul style="list-style-type: none"> As-Built Description: At door leading into exit corridor: Where required exit signs are installed, signs to provide exiting information for people with vision impairment are not provided. Proposed Solution: Provide raised letter/Braille "EXIT ROUTE" sign at door. 	PCODE SA10D ADAAG 91 4.1.3(16) ADA 2010 216.4.1 CBC 2007 1011.3 CBC 2016 11B-216.4.1 Project: SKYB1 Facelift Year to be Completed: 2021/2022 Mitigated: <input type="radio"/> YES <input checked="" type="radio"/> NO	20	JOB	\$270	\$5,400

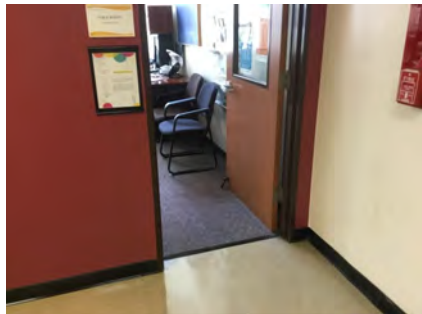
<input type="checkbox"/> Staff Only Priority 2 Severity 3						
<hr/>						
Disabled Seating						
449	<ul style="list-style-type: none"> As-Built Description: Wheelchair space (33"x48") not provided at fixed seating with forward or rear approach. (NOTE: Space must be adjacent to regular seating; can provide easily removable fixed seat). As-Built: No seating in consultation offices throughout Proposed Solution: Remove seating and provide wheelchair space plus necessary maneuvering clearance. 	PCODE GB01A ADAAG 91 4.1.3(19)(a) ADA 2010 221.2 CBC 2007 1104B.3.6 CBC 2016 11B-221.2 Project: SKYB1 Facelift Year to be Completed: 2021/2022 Mitigated: <input type="radio"/> YES <input checked="" type="radio"/> NO	1	JOB	\$1,350	\$1,350

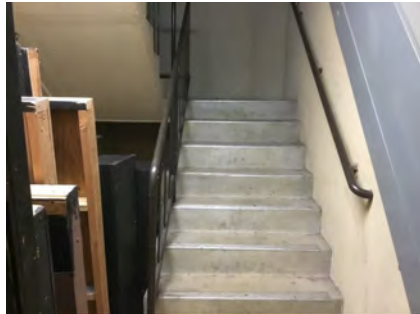
Item no., Rm no. and Name	Existing Architectural Barrier and Proposed Solution	Codes / Mitigation Info	Qty	Unit	Cost	Total
Height						
642	<ul style="list-style-type: none"> As-Built Description: Handrail gripping surface top not mounted between 34" and 38" above ramp surface or stair nosings. As-Built: 40" AFF Proposed Solution: Remove existing and provide new handrail. 	PCODE ED02 ADAAG 91 4.9.4(5) ADA 2010 505.4 CBC 2007 1133B.4.2.1 & CBC 2016 B.5.5.1 11B-505.4 Project: SKYB1 Facelift Year to be Completed: 2021/2022 Mitigated: <input type="radio"/> YES <input checked="" type="radio"/> NO	60	LF	\$225	\$13,500

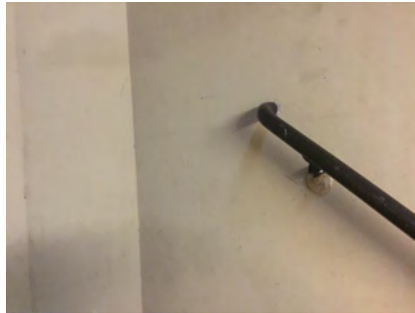
Top & Bottom Extension at Stairs

644	<ul style="list-style-type: none"> As-Built Description: Stair handrail does not extend horizontally 12" minimum beyond top nosing, and one tread width sloped, plus 12" minimum horizontally beyond the bottom nosing. As-Built: 0" Proposed Solution: Extend stair handrail at top and bottom (cost for each extension piece). 	PCODE ED06REF ADAAG 91 4.9.4(2) ADA 2010 505.10.2; CBC 2007 1133B.4.2.2 CBC 2016 11B-505.10.2; 11B-505.10.3 Project: SKYB1 Facelift Year to be Completed: 2021/2022 Mitigated: <input type="radio"/> YES <input checked="" type="radio"/> NO	REF

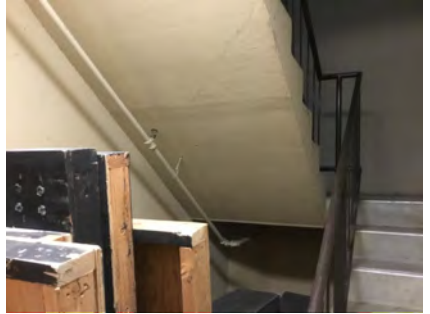
Item no., Rm no. and Name	Existing Architectural Barrier and Proposed Solution	Codes / Mitigation Info	Qty	Unit	Cost	Total
Vertical Clearance						
653	<ul style="list-style-type: none"> As-Built Description: Overhead clearance less than 80" above finished floor. As-Built: 42" up to 80" AFF Proposed Solution: Modify overhead clearance. 	PCODE EG01 ADAAG 91 4.4.2 ADA 2010 307.4 CBC 2007 1133B.8.6.2 CBC 2016 11B-307.4 Project: SKYB1 Facelift Year to be Completed: 2021/2022 Mitigated: <input type="radio"/> YES <input checked="" type="radio"/> NO	1	JOB	\$300	\$300

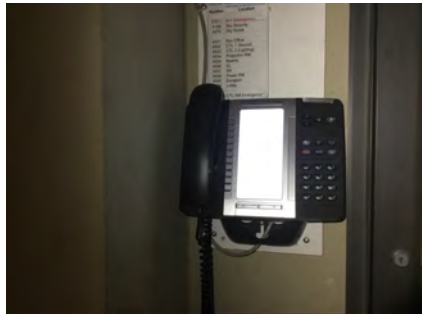
Item no., Rm no. and Name	Existing Architectural Barrier and Proposed Solution	Codes / Mitigation Info	Qty	Unit	Cost	Total
647	<ul style="list-style-type: none"> As-Built Description: Reach height to control or access point, where side approach is available, exceeds 48" or is less than 15" in height, or exceeds 10" in depth. As-Built: 62" AFF Proposed Solution: Modify equipment or mounting. 	PCODE IE02 ADAAG 91 4.2.6 ADA 2010 308.3.1 CBC 2007 1118B.6 CBC 2016 11B-308.3 Project: SKYB1 Facelift Year to be Completed: 2021/2022 Mitigated: <input type="radio"/> YES <input checked="" type="radio"/> NO	1	JOB	\$300	\$300

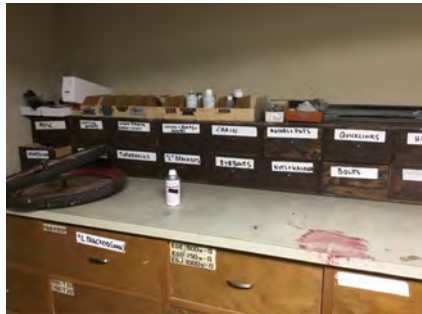
<input type="checkbox"/> Staff Only Priority 2 Severity 2			
648	<ul style="list-style-type: none"> As-Built Description: Reach height to control or access point, where side approach is available, exceeds 48" or is less than 15" in height, or exceeds 10" in depth. As-Built: The reach to storage items is obstructed because the counter is 39" AFF Proposed Solution: Lower the counter or relocate items. 	PCODE IE02 ADAAG 91 4.2.6 ADA 2010 308.3.1 CBC 2007 1118B.6 CBC 2016 11B-308.3 Project: SKYB1 Facelift Year to be Completed: 2021/2022 Mitigated: <input type="radio"/> YES <input checked="" type="radio"/> NO	1	JOB	\$300	\$300

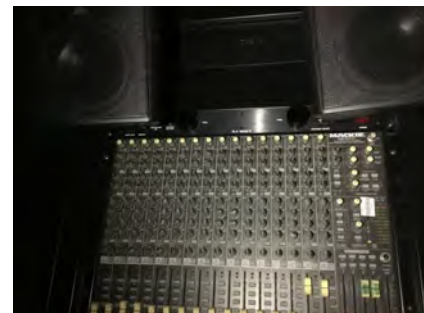
Modify or replace the operable part(s) to not require tight grasping, pinching, or twisting of the wrist with one hand.

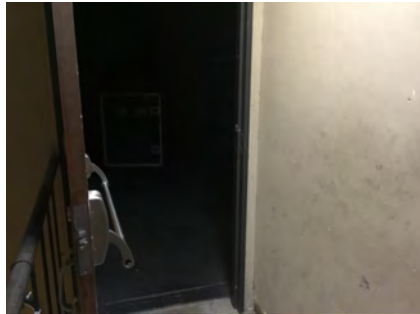
Item no., Rm no. and Name	Existing Architectural Barrier and Proposed Solution	Codes / Mitigation Info	Qty	Unit	Cost	Total
Door Swing						
354	<ul style="list-style-type: none"> As-Built Description: Front approach: At pull side, door does not have clear and level maneuvering space measuring door width plus 18" x 60". (24" x 60" at exterior doors). As-Built: 3.75" strike side clearance Proposed Solution: Provide relocated new door and frame; remodel walls as needed. Notes: Path of Travel to stage from performer area. 	PCODE ID23B ADAAG 91 Fig. 25(a) ADA 2010 404.2.4 CBC 2007 11B-26A(a) CBC 2016 11B-404.2.4 Project: SKYB1 Facelift Year to be Completed: 2021/2022 Mitigated: <input type="radio"/> YES <input checked="" type="radio"/> NO	1	JOB	\$7,800	\$7,800

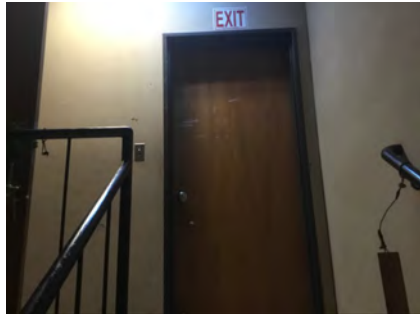
<input type="checkbox"/> Staff Only Priority 2 Severity 2			
355	<ul style="list-style-type: none"> As-Built Description: Front approach: At push side, door does not have clear and level maneuvering space measuring door width x 48" (door width plus 12" if door has both, latch and closer). As-Built: 40.5" to the handrail Proposed Solution: Provide relocated new door and frame; remodel walls as needed. 	PCODE ID24B ADAAG 91 Fig. 25(a) ADA 2010 404.2.4 CBC 2007 11B-26A(a) CBC 2016 11B-404.2.4 Project: SKYB1 Facelift Year to be Completed: 2021/2022 Mitigated: <input type="radio"/> YES <input checked="" type="radio"/> NO	1	JOB	\$7,800	\$7,800

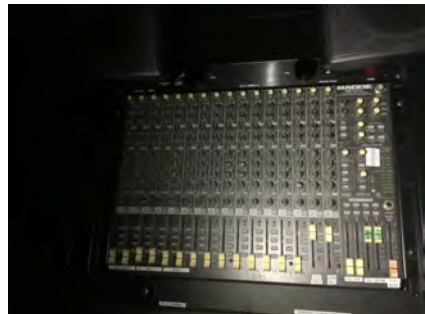
Item no., Rm no. and Name	Existing Architectural Barrier and Proposed Solution	Codes / Mitigation Info	Qty	Unit	Cost	Total
Reach Range						
357	<ul style="list-style-type: none">As-Built Description: Reach height to control or access point, where side approach is available, exceeds 48" or is less than 15" in height, or exceeds 10" in depth.As-Built: 76" AFFProposed Solution: Modify equipment or mounting.Notes: Students use this equipment.	<p>PCODE IE02</p> <p>ADAAG 91 4.2.6</p> <p>ADA 2010 308.3.1</p> <p>CBC 2007 1118B.6</p> <p>CBC 2016 11B-308.3</p> <p>Project: SKYB1 Facelift</p> <p>Year to be Completed: 2021/2022</p> <p>Mitigated:</p> <p><input type="radio"/> YES</p> <p><input checked="" type="radio"/> NO</p>	1	JOB	\$300	\$300

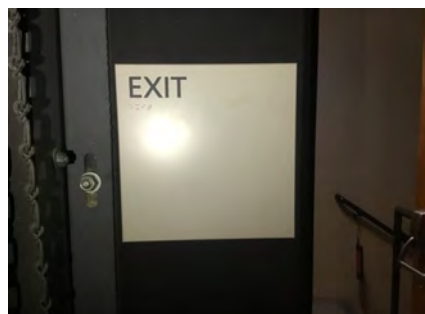
<input type="checkbox"/> Staff Only			
			Priority 2 Severity 1			
Signage						
359	<ul style="list-style-type: none">As-Built Description: Sign not located on latch side of door and/or not located at 48" min. above to baseline of the lowest Braille cells and 60" max. to baseline of the highest line of raised characters.As-Built: 62.5" to bottom of tactileProposed Solution: Provide compliant signage including tactile characters and Grade II Braille on latch side of door located at compliant height.	<p>PCODE SA07</p> <p>ADAAG 91 4.30.6</p> <p>ADA 2010 703.4.1</p> <p>CBC 2007 1117B.5.7</p> <p>CBC 2016 11B-703.4.1</p> <p>Project: SKYB1 Facelift</p> <p>Year to be Completed: 2021/2022</p> <p>Mitigated:</p> <p><input type="radio"/> YES</p> <p><input checked="" type="radio"/> NO</p>	1	JOB	\$150	\$150

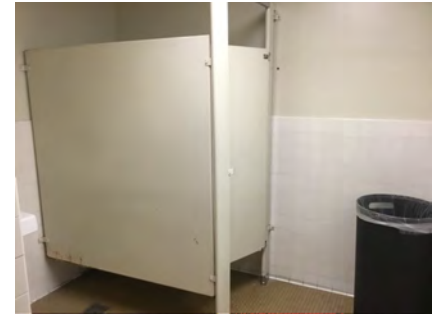
Multiple accommodation restroom not accessible;
multiple compliance violations.
