SAN MATEO COUNTY
COMMUNITY
COLLEGE DISTRICT

San Mateo County Community College District Americans with Disabilities Act Self-Evaluation and Transition Plan

Report Prepared by:

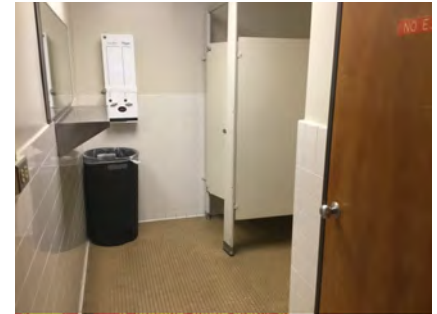
Multiple accommodation restroom not accessible;
multiple compliance violations.

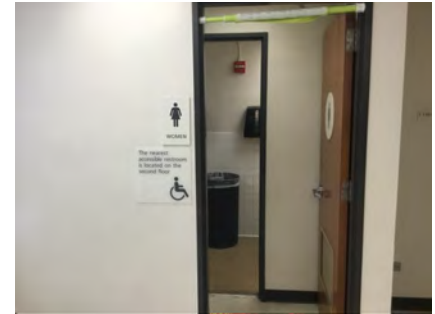
Multiple accommodation restroom not accessible;
multiple compliance violations.

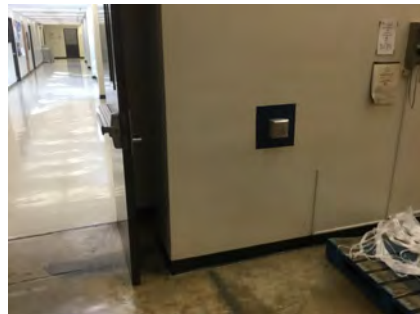
Item no., Rm no. and Name	Existing Architectural Barrier and Proposed Solution	Codes / Mitigation Info	Qty	Unit	Cost	Total
<u>Door</u>						
562	<ul style="list-style-type: none">• <i>As-Built Description:</i> Lower push plate located at 7" minimum and 8" maximum above the floor or ground surface not provided.• <i>Proposed Solution:</i> Provide lower push plate.	<p>PCODE ID13B</p> <p>CBC 2007 1133B.2.3.2</p> <p>CBC 2016 11B-404.2.9 2.C</p> <p>Project: SKYB1 Facelift</p> <p>Year to be Completed: 2021/2022</p> <p>Mitigated: <input type="radio"/> YES <input checked="" type="radio"/> NO</p>	2	JOB	\$1,500	\$3,000

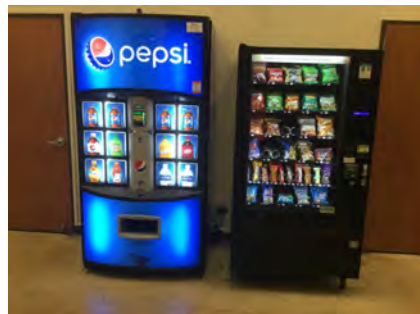
<input type="checkbox"/> Staff Only			
			Priority		Severity	
			<input checked="" type="radio"/> 2		<input checked="" type="radio"/> 2	
<u>Vending Machine</u>						
563	<ul style="list-style-type: none">• <i>As-Built Description:</i> Vending machine coin slot or dispensing outlet, more than 48" above the floor.• <i>As-Built:</i> 11" to the bottom of the dispensing tray 54" to the top of the card reader• <i>Proposed Solution:</i> Advise vendor/leasing company to provide accessible vending machine with highest operable part at 48" max.	<p>PCODE IL02</p> <p>ADAAG 91 4.2.5</p> <p>ADA 2010 308.2.1</p> <p>CBC 2007 1126B</p> <p>CBC 2016 11B-308.2.1</p> <p>Project: SKYB1 Facelift</p> <p>Year to be Completed: 2021/2022</p> <p>Mitigated: <input type="radio"/> YES <input checked="" type="radio"/> NO</p>	2	REF

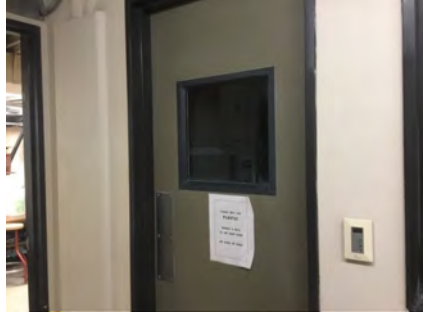
Item no., Rm no. and Name	Existing Architectural Barrier and Proposed Solution	Codes / Mitigation Info	Qty	Unit	Cost	Total
521	<ul style="list-style-type: none"> As-Built Description: Door on accessible route has less than 32" clear and 80" (78" min. to closer if provided) opening width when 90° open. As-Built: 29" wide Proposed Solution: Provide new, larger door and frame with new accessible hardware. 	PCODE ID01 ADAAG 91 4.13.5 ADA 2010 404.2.3 CBC 2007 1133B.1.1.1.1 CBC 2016 11B-404.2.3 Project: SKYB1 Facelift Year to be Completed: 2021/2022 Mitigated: <input type="radio"/> YES <input checked="" type="radio"/> NO	1	JOB	\$7,800	\$7,800

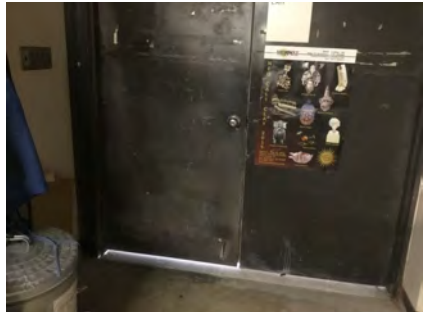
Door Hardware

524	<ul style="list-style-type: none"> As-Built Description: Door does not have accessible operating hardware. Proposed Solution: Provide lever handle or other accessible hardware. 	PCODE ID07 ADAAG 91 4.13.9 ADA 2010 404.2.7 CBC 2007 1133B.2.5.2 CBC 2016 11B-404.2.7 Project: SKYB1 Facelift Year to be Completed: 2021/2022 Mitigated: <input type="radio"/> YES <input checked="" type="radio"/> NO	1	JOB	\$750	\$750

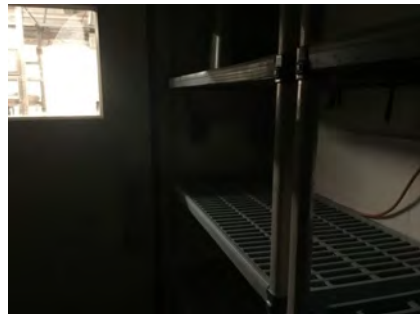
Item no., Rm no. and Name	Existing Architectural Barrier and Proposed Solution	Codes / Mitigation Info	Qty	Unit	Cost	Total
Door Swing						
520	<ul style="list-style-type: none">As-Built Description: Front approach: At pull side, door does not have clear and level maneuvering space measuring door width plus 18" x 60". (24" x 60" at exterior doors).Proposed Solution: Provide power door operator.Notes: It may not be feasible to remove the shelving in this room. It is a specialized room and too small to relocate the shelving.	<p>PCODE ID23C</p> <p>ADAAG 91 Fig. 25(a)</p> <p>ADA 2010 404.2.4</p> <p>CBC 2007 11B-26A(a)</p> <p>CBC 2016 11B-404.2.4</p> <p>Project: SKYB1 Facelift</p> <p>Year to be Completed: 2021/2022</p> <p>Mitigated:</p> <p><input type="radio"/> YES</p> <p><input checked="" type="radio"/> NO</p>	1	JOB	\$15,000	\$15,000

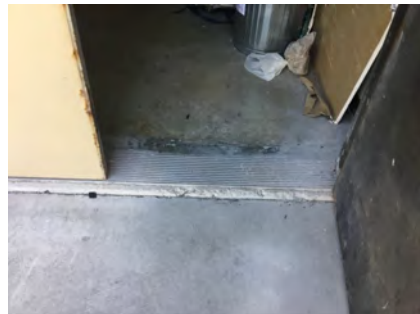
Door Threshold						
525	<ul style="list-style-type: none">As-Built Description: Door inaccessible due to threshold or step at door exceeding 1/2".As-Built: 0.75"Proposed Solution: Modify threshold to be no more than 1/2" by removing existing paving at door and providing landing with edge ramping (slope 1:20 max).	<p>PCODE ID02A</p> <p>ADAAG 91 4.13.8</p> <p>ADA 2010 404.2.5</p> <p>CBC 2007 1133B.2.4.1</p> <p>CBC 2016 11B-404.2.5</p> <p>Project: SKYB1 Facelift</p> <p>Year to be Completed: 2021/2022</p> <p>Mitigated:</p> <p><input type="radio"/> YES</p> <p><input checked="" type="radio"/> NO</p>	1	JOB	\$1,200	\$1,200

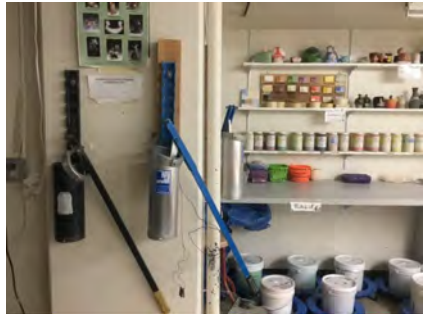
Item no., Rm no. and Name	Existing Architectural Barrier and Proposed Solution	Codes / Mitigation Info	Qty	Unit	Cost	Total
Reach Range						
511	<ul style="list-style-type: none"> As-Built Description: Reach height to control or access point, where side approach is available, exceeds 48" or is less than 15" in height, or exceeds 10" in depth. As-Built: 70" AFF Proposed Solution: Modify equipment or mounting. 	PCODE IE02 ADAAG 91 4.2.6 ADA 2010 308.3.1 CBC 2007 1118B.6 CBC 2016 11B-308.3 Project: SKYB1 Facelift Year to be Completed: 2021/2022 Mitigated: <input type="radio"/> YES <input checked="" type="radio"/> NO	1	JOB	\$300	\$300

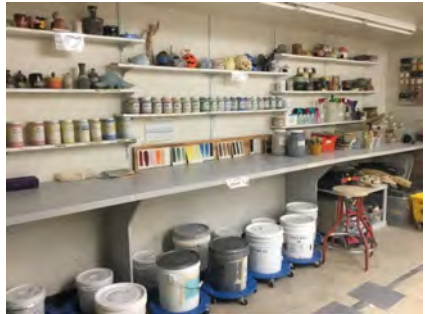
<input type="checkbox"/> Staff Only Priority 2 Severity 1			
512	<ul style="list-style-type: none"> As-Built Description: Reach height to control or access point, where side approach is available, exceeds 48" or is less than 15" in height, or exceeds 10" in depth. As-Built: The reach to storage items is obstructed because the counter is 36" high Proposed Solution: Relocate storage items or lower the counter. 	PCODE IE02 ADAAG 91 4.2.6 ADA 2010 308.3.1 CBC 2007 1118B.6 CBC 2016 11B-308.3 Project: SKYB1 Facelift Year to be Completed: 2021/2022 Mitigated: <input type="radio"/> YES <input checked="" type="radio"/> NO	1	JOB	\$300	\$300

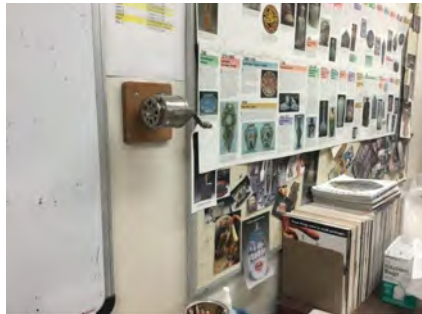
Item no., Rm no. and Name	Existing Architectural Barrier and Proposed Solution	Codes / Mitigation Info	Qty	Unit	Cost	Total
513	<ul style="list-style-type: none"> As-Built Description: Reach height to control or access point, where side approach is available, exceeds 48" or is less than 15" in height, or exceeds 10" in depth. As-Built: 56" AFF Proposed Solution: Modify equipment or mounting. 	PCODE IE02 ADAAG 91 4.2.6 ADA 2010 308.3.1 CBC 2007 1118B.6 CBC 2016 11B-308.3 Project: SKYB1 Facelift Year to be Completed: 2021/2022 Mitigated: <input type="radio"/> YES <input checked="" type="radio"/> NO	1	JOB	\$300	\$300

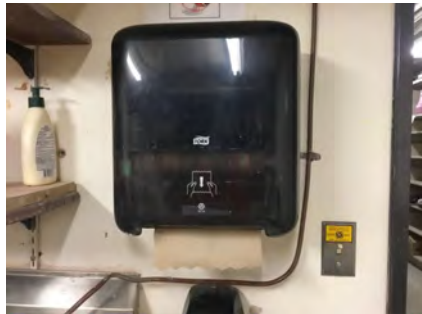
<input type="checkbox"/> Staff Only Priority 2 Severity 3			
518	<ul style="list-style-type: none"> As-Built Description: Reach height to control or access point, where side approach is available, exceeds 48" or is less than 15" in height, or exceeds 10" in depth. As-Built: 52" AFF Proposed Solution: Modify equipment or mounting. 	PCODE IE02 ADAAG 91 4.2.6 ADA 2010 308.3.1 CBC 2007 1118B.6 CBC 2016 11B-308.3 Project: SKYB1 Facelift Year to be Completed: 2021/2022 Mitigated: <input type="radio"/> YES <input checked="" type="radio"/> NO	1	JOB	\$300	\$300

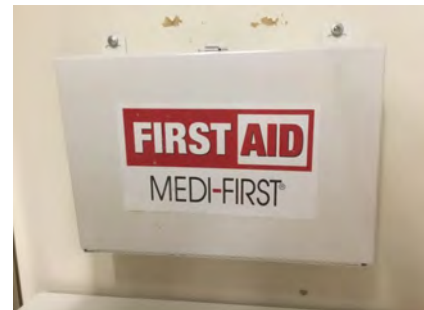
Item no., Rm no. and Name	Existing Architectural Barrier and Proposed Solution	Codes / Mitigation Info	Qty	Unit	Cost	Total
528	<ul style="list-style-type: none"> As-Built Description: Reach height to control or access point, where side approach is available, exceeds 48" or is less than 15" in height, or exceeds 10" in depth. As-Built: 56" AFF Proposed Solution: Modify equipment or mounting. 	PCODE IE02 ADAAG 91 4.2.6 ADA 2010 308.3.1 CBC 2007 1118B.6 CBC 2016 11B-308.3 Project: SKYB1 Facelift Year to be Completed: 2021/2022 Mitigated: <input type="radio"/> YES <input checked="" type="radio"/> NO	1	JOB	\$300	\$300

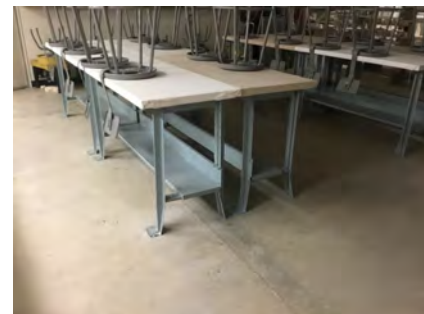
510	<ul style="list-style-type: none"> As-Built Description: Accessible non-fixed table or desk (top 28" to 34" high; knee space at least 27" high x 19" deep x 30" wide) not provided. As-Built: 9" deep knee clearance Proposed Solution: Provide table or desk with accessible dimensions when purchasing new furniture. 	PCODE IN02A ADAAG 91 4.32.3 & .4 ADA 2010 306.1 CBC 2007 1122B.3 & 4 CBC 2016 11B-306.1 & 11B-902.3 Project: SKYB1 Facelift Year to be Completed: 2021/2022 Mitigated: <input type="radio"/> YES <input checked="" type="radio"/> NO	1	JOB	\$4,800	\$4,800
-----	---	--	---	-----	---------	---------

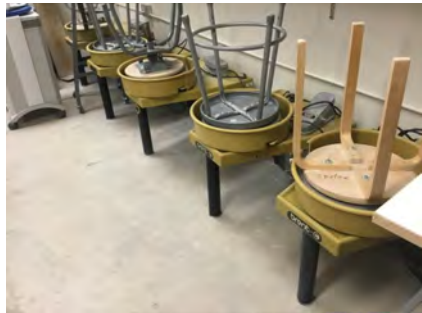
Item no., Rm no. and Name	Existing Architectural Barrier and Proposed Solution	Codes / Mitigation Info	Qty	Unit	Cost	Total
514	<ul style="list-style-type: none"> As-Built Description: Accessible non-fixed table or desk (top 28" to 34" high; knee space at least 27" high x 19" deep x 30" wide) not provided. As-Built: No knee clearance at wheel Proposed Solution: Provide table or desk with accessible dimensions when purchasing new furniture. Notes: 19 pottery wheels, 0 accessible provided 	PCODE IN02A ADAAG 91 4.32.3 & .4 ADA 2010 306.1 CBC 2007 1122B.3 & 4 CBC 2016 11B-306.1 & 11B-902.3 Project: SKYB1 Facelift Year to be Completed: 2021/2022 Mitigated: <input type="radio"/> YES <input checked="" type="radio"/> NO	1	JOB	\$4,800	\$4,800

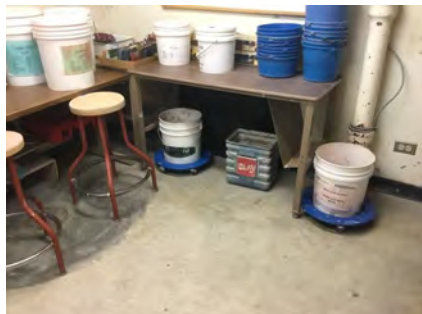
<input type="checkbox"/> Staff Only Priority 2 Severity 2			
515	<ul style="list-style-type: none"> As-Built Description: Accessible non-fixed table or desk (top 28" to 34" high; knee space at least 27" high x 19" deep x 30" wide) not provided. As-Built: Knee clearance in glazing room obstructed by miscellaneous items Proposed Solution: Provide table or desk with accessible dimensions when purchasing new furniture. 	PCODE IN02A ADAAG 91 4.32.3 & .4 ADA 2010 306.1 CBC 2007 1122B.3 & 4 CBC 2016 11B-306.1 & 11B-902.3 Project: SKYB1 Facelift Year to be Completed: 2021/2022 Mitigated: <input type="radio"/> YES <input checked="" type="radio"/> NO	1	JOB	\$4,800	\$4,800

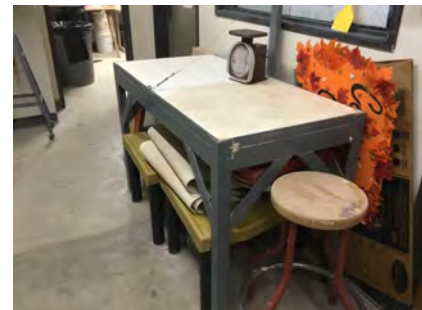
Item no., Rm no. and Name	Existing Architectural Barrier and Proposed Solution	Codes / Mitigation Info	Qty	Unit	Cost	Total
527	<ul style="list-style-type: none"> As-Built Description: Accessible non-fixed table or desk (top 28" to 34" high; knee space at least 27" high x 19" deep x 30" wide) not provided. As-Built: 27" wide 27" high Proposed Solution: Provide table or desk with accessible dimensions when purchasing new furniture. 	PCODE IN02A ADAAG 91 4.32.3 & .4 ADA 2010 306.1 CBC 2007 1122B.3 & 4 CBC 2016 11B-306.1 & 11B-902.3 Project: SKYB1 Facelift Year to be Completed: 2021/2022 Mitigated: <input type="radio"/> YES <input checked="" type="radio"/> NO	1	JOB	\$4,800	\$4,800

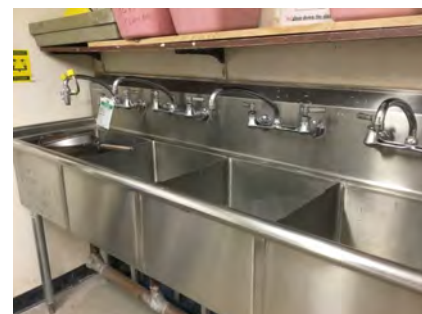
519	<ul style="list-style-type: none"> As-Built Description: Sink rim higher than 34" above floor. As-Built: 39" AFF Proposed Solution: Remodel sink cabinet to lower sink. 	PCODE IN06 ADAAG 91 4.24.2 ADA 2010 606.3 CBC 2007 1115B.4.7.1 CBC 2016 11B-606.3 Project: SKYB1 Facelift Year to be Completed: 2021/2022 Mitigated: <input type="radio"/> YES <input checked="" type="radio"/> NO	1	JOB	\$5,250	\$5,250
-----	---	--	---	-----	---------	---------

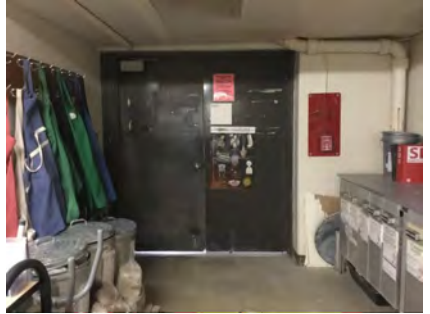
Item no., Rm no. and Name	Existing Architectural Barrier and Proposed Solution	Codes / Mitigation Info	Qty	Unit	Cost	Total
Signage						
523	<ul style="list-style-type: none"> As-Built Description: At door leading into exit stairway: Where required exit signs are installed, signs to provide exiting information for people with vision impairment are not provided. Proposed Solution: Provide raised letter/Braille "EXIT STAIR UP/DOWN" sign at door. Notes: If this is a required exit door, provide exit signage. 	PCODE SA10B ADAAG 91 4.1.3(16) ADA 2010 216.4.1 CBC 2007 1011.3 CBC 2016 11B-216.4.1	1	JOB	\$270	\$270
Project: SKYB1 Facelift Year to be Completed: 2021/2022 Mitigated: <input type="radio"/> YES <input checked="" type="radio"/> NO

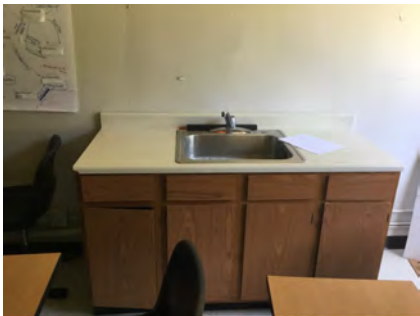
Item no., Rm no. and Name	Existing Architectural Barrier and Proposed Solution	Codes / Mitigation Info	Qty	Unit	Cost	Total
Sink						
531	<ul style="list-style-type: none">As-Built Description: Sink rim higher than 34" above floor.As-Built: 36" AFFProposed Solution: Remodel sink cabinet to lower sink.	<p>PCODE IN06</p> <p>ADAAG 91 4.24.2</p> <p>ADA 2010 606.3</p> <p>CBC 2007 1115B.4.7.1</p> <p>CBC 2016 11B-606.3</p> <p>Project: SKYB1 Facelift</p> <p>Year to be Completed: 2021/2022</p> <p>Mitigated:</p> <p><input type="radio"/> YES</p> <p><input checked="" type="radio"/> NO</p>	1	JOB	\$5,250	\$5,250

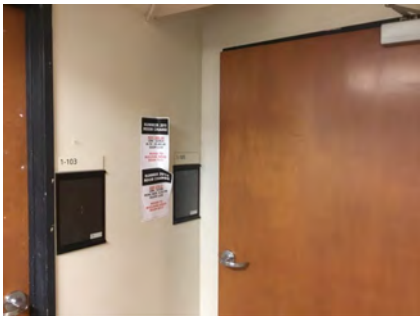
<input type="checkbox"/> Staff Only			
			<p>Priority 2 Severity 4</p>			
Signage						
534	<ul style="list-style-type: none">As-Built Description: Signs containing tactile characters is not located so that a clear floor space of 18" min x 18" min., centered on the tactile characters, is provided beyond the arc of any door swing between the closed position and 45 degree open position.Proposed Solution: Relocate compliant signage on latch side of door located at compliant height with a clear floor space.Notes: The door swings into the sign clear floor space.	<p>PCODE SA07B</p> <p>ADA 2010 703.4.2</p> <p>CBC 2016 11B-703.4.2</p> <p>Project: SKYB1 Facelift</p> <p>Year to be Completed: 2021/2022</p> <p>Mitigated:</p> <p><input type="radio"/> YES</p> <p><input checked="" type="radio"/> NO</p>	1	JOB	\$150	\$150

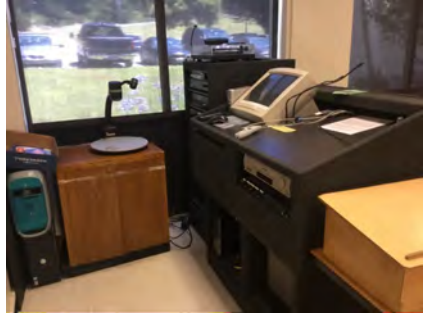
Item no., Rm no. and Name	Existing Architectural Barrier and Proposed Solution	Codes / Mitigation Info	Qty	Unit	Cost	Total
Public Participation Counter						
536	<ul style="list-style-type: none"> As-Built Description: Speaker podium is not accessible. Upper edge of podium is more than 34" above the finished floor, and knee space is less than 27" high, 30" wide, and 19" deep. As-Built: 42" AFF Proposed Solution: Provide additional, integrated, and accessible speaker podium. 	PCODE GB02A ADAAG 91 4.32.3 ADA 2010 902.3 CBC 2007 1122B.3 CBC 2016 11B-902.3 Project: SKYB1 Facelift Year to be Completed: 2021/2022 Mitigated: <input type="radio"/> YES <input checked="" type="radio"/> NO	1	JOB	\$6,000	\$6,000

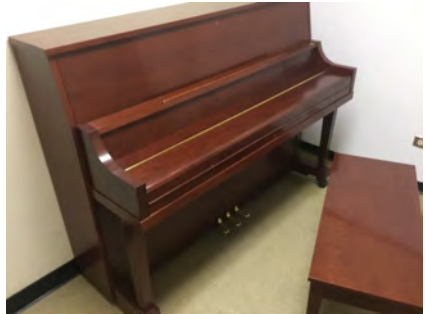
Item no., Rm no. and Name	Existing Architectural Barrier and Proposed Solution	Codes / Mitigation Info	Qty	Unit	Cost	Total
Non-Fixed Desk						
540	<ul style="list-style-type: none"> As-Built Description: Accessible non-fixed table or desk (top 28" to 34" high; knee space at least 27" high x 19" deep x 30" wide) not provided. As-Built: 8" deep Proposed Solution: Provide table or desk with accessible dimensions when purchasing new furniture. Notes: Provide accessible key board for one room. 	PCODE IN02A ADAAG 91 4.32.3 & .4 ADA 2010 306.1 CBC 2007 1122B.3 & 4 CBC 2016 11B-306.1 & 11B-902.3 Project: SKYB1 Facelift Year to be Completed: 2021/2022 Mitigated: <input type="radio"/> YES <input checked="" type="radio"/> NO	1	JOB	\$4,800	\$4,800

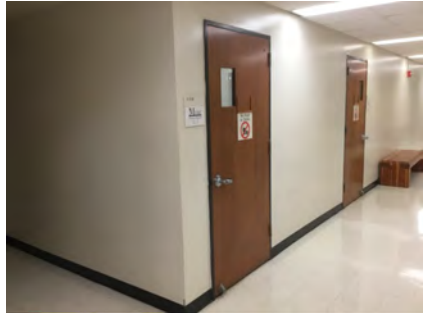
541	<ul style="list-style-type: none"> As-Built Description: Accessible building entrance when not all are accessible not identified with a sign showing the International Symbol of Accessibility. Proposed Solution: Provide building entrance sign that shows international symbol at accessible entrance. Notes: Install ISA at accessible practice room when accessible alterations are made. 	PCODE SA12 ADAAG 91 4.1.2(7)(c) ADA 2010 216.6 CBC 2007 1127B.3 CBC 2016 11B-216.6 Project: SKYB1 Facelift Year to be Completed: 2021/2022 Mitigated: <input type="radio"/> YES <input checked="" type="radio"/> NO	1	JOB	\$150	\$150

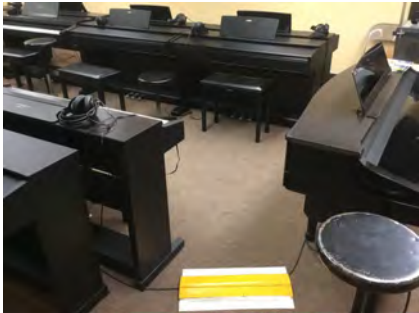
Item no., Rm no. and Name	Existing Architectural Barrier and Proposed Solution	Codes / Mitigation Info	Qty	Unit	Cost	Total
Corridor						
545	<ul style="list-style-type: none">As-Built Description: Corridor, for occupant load less than 10, less than 36" wide.As-Built: 23" wideProposed Solution: Remove or relocate furniture and storage items.	<p>PCODE IH03A</p> <p>ADAAG 91 4.3.3</p> <p>ADA 2010 403.5.1</p> <p>CBC 2007 1133B.3.1</p> <p>CBC 2016 11B-403.5.1</p> <p>Project: SKYB1 Facelift</p> <p>Year to be Completed: 2021/2022</p> <p>Mitigated:</p> <p><input type="radio"/> YES</p> <p><input checked="" type="radio"/> NO</p>	1	JOB	\$150	\$150

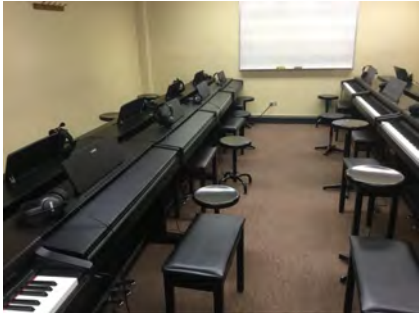
<input type="checkbox"/> Staff Only			
			<p>Priority 2 Severity 1</p>			
Non-Fixed Desk						
544	<ul style="list-style-type: none">As-Built Description: Accessible non-fixed table or desk (top 28" to 34" high; knee space at least 27" high x 19" deep x 30" wide) not provided.As-Built: 24.5" high knee clearance, 6" deepProposed Solution: Provide table or desk with accessible dimensions when purchasing new furniture.Notes: 20 keyboards, 0 accessible keyboard provided	<p>PCODE IN02A</p> <p>ADAAG 91 4.32.3 & .4</p> <p>ADA 2010 306.1</p> <p>CBC 2007 1122B.3 & 4</p> <p>CBC 2016 11B-306.1 & 11B-902.3</p> <p>Project: SKYB1 Facelift</p> <p>Year to be Completed: 2021/2022</p> <p>Mitigated:</p> <p><input type="radio"/> YES</p> <p><input checked="" type="radio"/> NO</p>	1	JOB	\$4,800	\$4,800

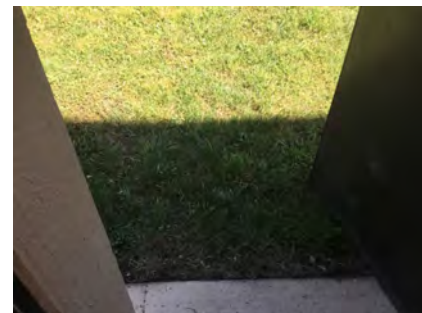
This condition occurs outside the exit door from room 111.

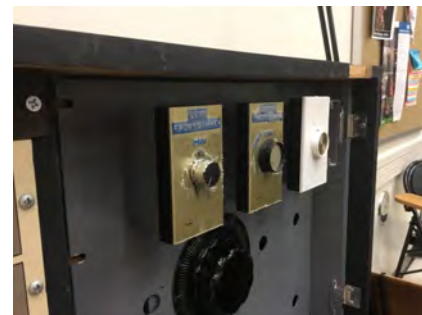
Operable Part

Modify or replace the operable part(s) to not require tight grasping, pinching, or twisting of the wrist with one hand.

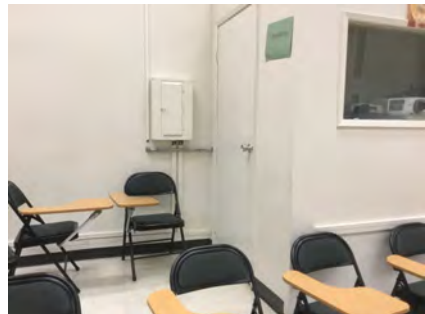
Item no., Rm no. and Name	Existing Architectural Barrier and Proposed Solution	Codes / Mitigation Info	Qty	Unit	Cost	Total
<u>Door Hardware</u>						
549	<ul style="list-style-type: none">• <i>As-Built Description:</i> Door does not have accessible operating hardware.• <i>Proposed Solution:</i> Provide lever handle or other accessible hardware.	<p>PCODE ID07</p> <p>ADAAG 91 4.13.9</p> <p>ADA 2010 404.2.7</p> <p>CBC 2007 1133B.2.5.2</p> <p>CBC 2016 11B-404.2.7</p> <p>Project: SKYB1 Facelift</p> <p>Year to be Completed: 2021/2022</p> <p>Mitigated:</p> <p><input type="radio"/> YES</p> <p><input checked="" type="radio"/> NO</p>	1	JOB	\$750	\$750

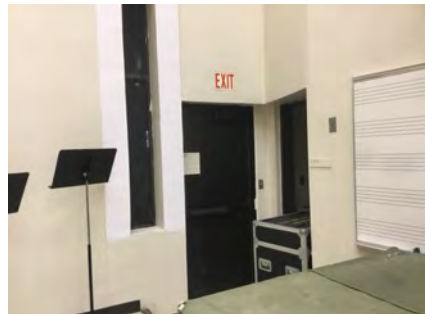
<input type="checkbox"/> Staff Only			
			Priority 2 Severity 3			
<u>Door Swing</u>						
551	<ul style="list-style-type: none">• <i>As-Built Description:</i> Front approach: At push side, door does not have clear and level maneuvering space measuring door width x 48" (door width plus 12" if door has both, latch and closer).• <i>As-Built:</i> 10" deep alcove• <i>Proposed Solution:</i> Provide relocated new door and frame; remodel walls as needed.	<p>PCODE ID24B</p> <p>ADAAG 91 Fig. 25(a)</p> <p>ADA 2010 404.2.4</p> <p>CBC 2007 11B-26A(a)</p> <p>CBC 2016 11B-404.2.4</p> <p>Project: SKYB1 Facelift</p> <p>Year to be Completed: 2021/2022</p> <p>Mitigated:</p> <p><input type="radio"/> YES</p> <p><input checked="" type="radio"/> NO</p>	1	JOB	\$7,800	\$7,800

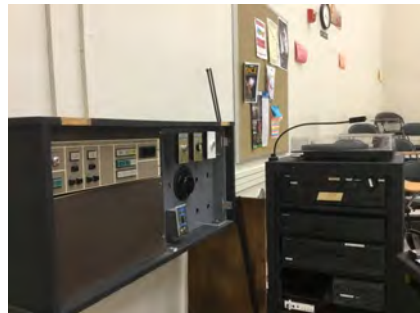
Item no., Rm no. and Name	Existing Architectural Barrier and Proposed Solution	Codes / Mitigation Info	Qty	Unit	Cost	Total
Reach Range						
554	<ul style="list-style-type: none">As-Built Description: Reach height to control or access point, where side approach is available, exceeds 48" or is less than 15" in height, or exceeds 10" in depth.As-Built: 59" AFFProposed Solution: Modify equipment or mounting.	<p>PCODE IE02</p> <p>ADAAG 91 4.2.6</p> <p>ADA 2010 308.3.1</p> <p>CBC 2007 1118B.6</p> <p>CBC 2016 11B-308.3</p> <p>Project: SKYB1 Facelift</p> <p>Year to be Completed: 2021/2022</p> <p>Mitigated:</p> <p><input type="radio"/> YES</p> <p><input checked="" type="radio"/> NO</p>	1	JOB	\$300	\$300

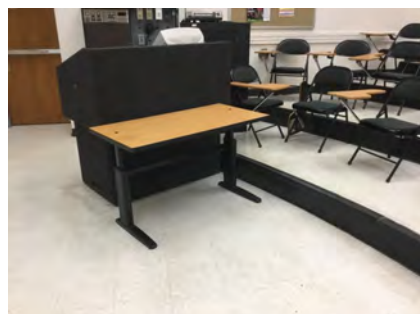
<input type="checkbox"/> Staff Only			
			<div><div>Priority</div><div>2</div></div> <div><div>Severity</div><div>3</div></div>			
Non-Fixed Desk						
548	<ul style="list-style-type: none">As-Built Description: Accessible non-fixed table or desk (top 28" to 34" high; knee space at least 27" high x 19" deep x 30" wide) not provided.16" deep knee clearanceProposed Solution: Provide table or desk with accessible dimensions when purchasing new furniture.Notes: 76 seats, 0 accessible seats.	<p>PCODE IN02A</p> <p>ADAAG 91 4.32.3 & .4</p> <p>ADA 2010 306.1</p> <p>CBC 2007 1122B.3 & 4</p> <p>CBC 2016 11B-306.1 & 11B-902.3</p> <p>Project: SKYB1 Facelift</p> <p>Year to be Completed: 2021/2022</p> <p>Mitigated:</p> <p><input type="radio"/> YES</p> <p><input checked="" type="radio"/> NO</p>	1	JOB	\$4,800	\$4,800

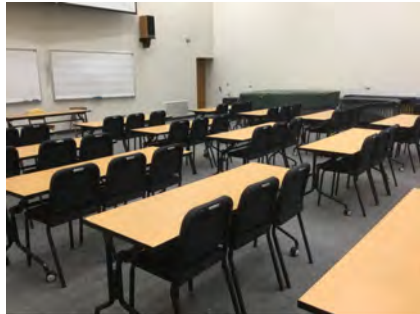
Item no., Rm no. and Name	Existing Architectural Barrier and Proposed Solution	Codes / Mitigation Info	Qty	Unit	Cost	Total
Non-Fixed Desk						
556	<ul style="list-style-type: none"> <i>As-Built Description:</i> Accessible non-fixed table or desk (top 28" to 34" high; knee space at least 27" high x 19" deep x 30" wide) not provided. <i>As-Built:</i> 15" deep knee clearance <i>Proposed Solution:</i> Provide table or desk with accessible dimensions when purchasing new furniture. <i>Notes:</i> 45 seats, 0 accessible seats provided. 	PCODE IN02A ADAAG 91 4.32.3 & .4 ADA 2010 306.1 CBC 2007 1122B.3 & 4 CBC 2016 11B-306.1 & 11B-902.3 Project: SKYB1 Facelift Year to be Completed: 2021/2022 Mitigated: <input type="radio"/> YES <input checked="" type="radio"/> NO	1	JOB	\$4,800	\$4,800

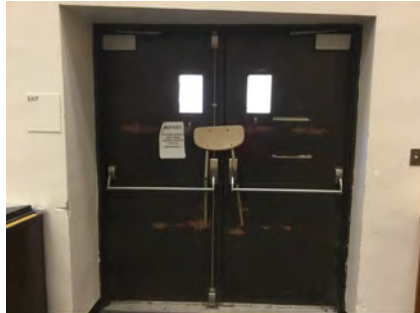
557	<ul style="list-style-type: none"> <i>As-Built Description:</i> Refer to notes for observation and recommendation. <i>Proposed Solution:</i> <i>Notes:</i> Emergency exit door blocked. 	PCODE GN01 CBC 2016 11B-306.1 & 11B-902.3 Project: SKYB1 Facelift Year to be Completed: 2021/2022 Mitigated: <input type="radio"/> YES <input checked="" type="radio"/> NO	REF

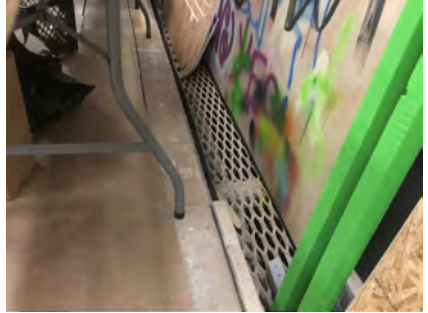
592	<ul style="list-style-type: none"> As-Built Description: Walk: Grating has grid openings greater than 1/2" along the line of traffic flow. As-Built: 5" high change in level Proposed Solution: Install compliant grate at floor height. 	PCODE EF04 ADAAG 91 4.3.6; 4.5.4 ADA 2010 403.2; 302.3 CBC 2007 1133B.7.2 CBC 2016 11B-403.2; 11B-302.3 Project: SKYB1 Facelift Year to be Completed: 2021/2022 Mitigated: <input type="radio"/> YES <input checked="" type="radio"/> NO	1	JOB	\$6,000	\$6,000

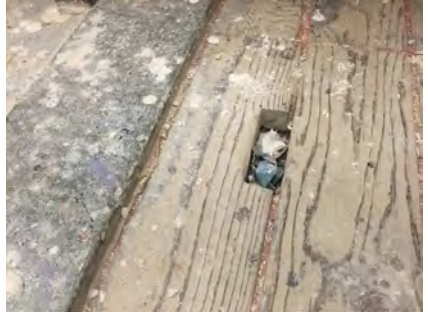
<input type="checkbox"/> Staff Only						
Priority Severity <input checked="" type="radio"/> 2 <input checked="" type="radio"/> 2						
591	<ul style="list-style-type: none"> As-Built Description: Walk: Flooring has openings greater than 1/2" along the line of traffic flow. As-Built: 2" wide gap Proposed Solution: Fill openings. 	PCODE EF04NT ADAAG 91 4.3.6; 4.5.4 ADA 2010 403.2; 302.3 CBC 2007 1133B.7.2 CBC 2016 11B-403.2; 11B-302.3 Project: SKYB1 Facelift Year to be Completed: 2021/2022 Mitigated: <input type="radio"/> YES <input checked="" type="radio"/> NO	1	JOB	\$2,400	\$2,400

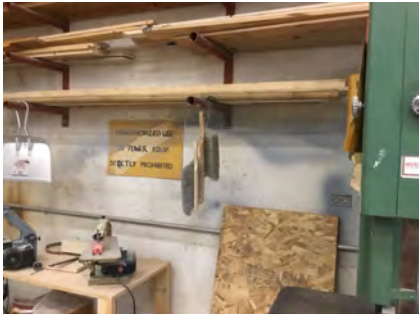
Item no., Rm no. and Name	Existing Architectural Barrier and Proposed Solution	Codes / Mitigation Info	Qty	Unit	Cost	Total
<u>Protrusion Limits</u>						
594	<ul style="list-style-type: none">As-Built Description: Protruding objects more than 4" from wall, when bottom of object more than 27" or less than 80" above finished floor.As-Built: Shelving 18" protrusion at 67" high.Proposed Solution: Provide cane-detectable railing to mark area of low clearance.Notes: Machinery and tasks currently provide cane detection. Ensure permanent objects are installed provide cane detection.	<p>PCODE EG04AREF</p> <p>ADAAG 91 4.4.1</p> <p>ADA 2010 307.2</p> <p>CBC 2007 1133B.8.6.1</p> <p>CBC 2016 11B-307.2</p> <p>Project: SKYB1 Facelift</p> <p>Year to be Completed: 2021/2022</p> <p>Mitigated:</p> <p><input type="radio"/> YES</p> <p><input checked="" type="radio"/> NO</p>				
			REF

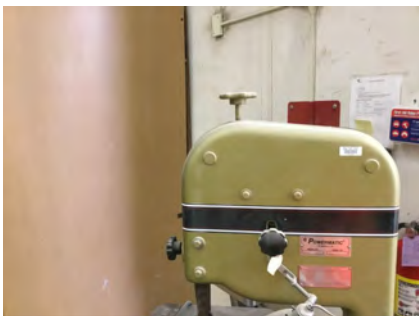
Priority 2 Severity 1			
<u>Operable Part</u>						
581	<ul style="list-style-type: none">As-Built Description: Operable part(s) require tight grasping, pinching, or twisting of the wrist with one hand.As-Built: Tools required tight, grasping and twistingProposed Solution: Modify or replace the operable part(s) to not require tight grasping, pinching, or twisting of the wrist with one hand.	<p>PCODE IC02REF</p> <p>ADAAG 91 4.27.4</p> <p>ADA 2010 309.4</p> <p>CBC 2007 1117B.6.4</p> <p>CBC 2016 11B-309.4</p> <p>Project: SKYB1 Facelift</p> <p>Year to be Completed: 2021/2022</p> <p>Mitigated:</p> <p><input type="radio"/> YES</p> <p><input checked="" type="radio"/> NO</p>				
			REF

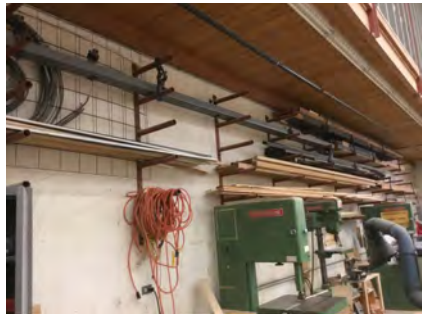
Item no., Rm no. and Name	Existing Architectural Barrier and Proposed Solution	Codes / Mitigation Info	Qty	Unit	Cost	Total
585	<ul style="list-style-type: none"> As-Built Description: Reach height to control or access point, where side approach is available, exceeds 48" or is less than 15" in height, or exceeds 10" in depth. As-Built: Storage +/-12' AFF Proposed Solution: Modify equipment or mounting. 	PCODE IE02 ADAAG 91 4.2.6 ADA 2010 308.3.1 CBC 2007 1118B.6 CBC 2016 11B-308.3 Project: SKYB1 Facelift Year to be Completed: 2021/2022 Mitigated: <input type="radio"/> YES <input checked="" type="radio"/> NO	1	JOB	\$300	\$300

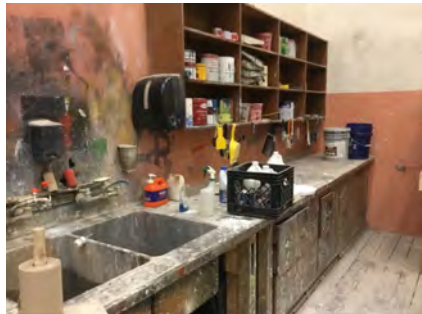
<input type="checkbox"/> Staff Only Priority 2 Severity 1				
588	<ul style="list-style-type: none"> As-Built Description: Reach height to control or access point, where side approach is available, exceeds 48" or is less than 15" in height, or exceeds 10" in depth. As-Built: Reach to storage and controls obstructed by 36.5" high counter and 32" deep reach over counter Proposed Solution: Install narrower counter at <34" AFF. 	PCODE IE02 ADAAG 91 4.2.6 ADA 2010 308.3.1 CBC 2007 1118B.6 CBC 2016 11B-308.3 Project: SKYB1 Facelift Year to be Completed: 2021/2022 Mitigated: <input type="radio"/> YES <input checked="" type="radio"/> NO	1	JOB	\$300	\$300

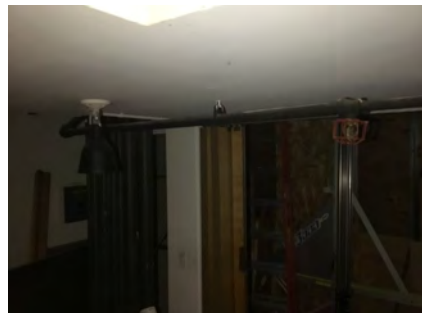
Item no., Rm no. and Name	Existing Architectural Barrier and Proposed Solution	Codes / Mitigation Info	Qty	Unit	Cost	Total
602	<ul style="list-style-type: none">As-Built Description: Overhead clearance less than 80" above finished floor.As-Built: Lights and sprinklers 75" – 79" AFFProposed Solution: Modify overhead clearance.	<p>PCODE EG01 ADAAG 91 4.4.2 ADA 2010 307.4 CBC 2007 1133B.8.6.2 CBC 2016 11B-307.4</p> <p>Project: SKYB1 Facelift</p> <p>Year to be Completed: 2021/2022</p> <p>Mitigated: <input type="radio"/> YES <input checked="" type="radio"/> NO</p>	1	JOB	\$300	\$300

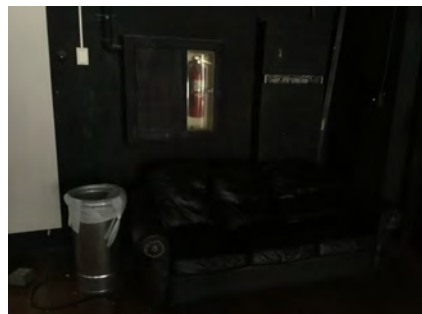
597	<p><u>Clear Space</u></p> <ul style="list-style-type: none">As-Built Description: Clear floor space is not 30" x 48" minimum at all switches, outlets and other controls.Proposed Solution: Relocate existing furniture/obstructions.Notes: Clear floor space blocked by items	<p>PCODE IC06A ADAAG 91 4.1.2(12) & [4.1.3 (13)] ADA 2010 309.2 CBC 2007 1117B.6.2 CBC 2016 11B-309.2</p> <p>Project: SKYB1 Facelift</p> <p>Year to be Completed: 2021/2022</p> <p>Mitigated: <input type="radio"/> YES <input checked="" type="radio"/> NO</p>	1	JOB	\$150	\$150

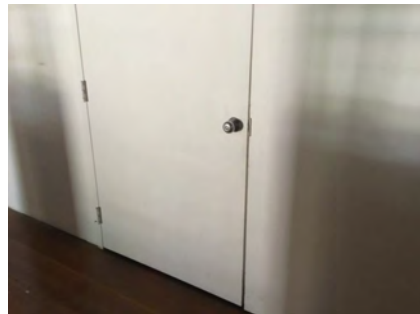
Item no., Rm no. and Name	Existing Architectural Barrier and Proposed Solution	Codes / Mitigation Info	Qty	Unit	Cost	Total
<u>Door Hardware</u>						
600	<ul style="list-style-type: none">• <i>As-Built Description:</i> Non-common use areas within this facility, such as offices, do not have accessible door hardware.• <i>Proposed Solution:</i> Provide lever handle or other accessible hardware when a specific need is identified in the future or when altering area.	<p>PCODE ID07C</p> <p>ADAAG 91 4.13.9</p> <p>ADA 2010 404.2.7</p> <p>CBC 2007 1133B.2.5.2</p> <p>CBC 2016 11B-404.2.7</p> <p>Project: SKYB1 Facelift</p> <p>Year to be Completed: 2021/2022</p> <p>Mitigated:</p> <p><input type="radio"/> YES</p> <p><input checked="" type="radio"/> NO</p>	1	JOB	\$750	\$750

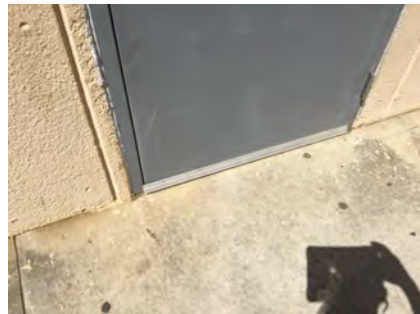
<u>Door Threshold</u>						
605	<ul style="list-style-type: none">• <i>As-Built Description:</i> Door inaccessible due to threshold or step at door exceeding 1/2".• <i>As-Built:</i> 0.75"• <i>Proposed Solution:</i> Build up the interior floor or install a lower threshold.	<p>PCODE ID02A</p> <p>ADAAG 91 4.13.8</p> <p>ADA 2010 404.2.5</p> <p>CBC 2007 1133B.2.4.1</p> <p>CBC 2016 11B-404.2.5</p> <p>Project: SKYB1 Facelift</p> <p>Year to be Completed: 2021/2022</p> <p>Mitigated:</p> <p><input type="radio"/> YES</p> <p><input checked="" type="radio"/> NO</p>	1	JOB	\$1,200	\$1,200

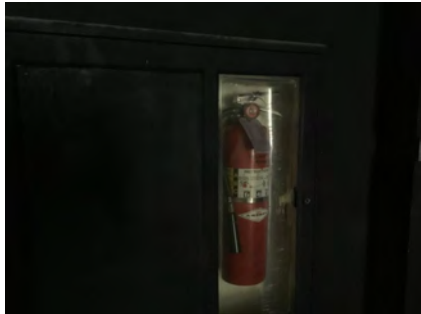
Item no., Rm no. and Name	Existing Architectural Barrier and Proposed Solution	Codes / Mitigation Info	Qty	Unit	Cost	Total
<u>Reach Range</u>						
596	<ul style="list-style-type: none">As-Built Description: Reach height to control or access point, where side approach is available, exceeds 48" or is less than 15" in height, or exceeds 10" in depth.As-Built: 63" AFFProposed Solution: Modify equipment or mounting.	<p>PCODE IE02</p> <p>ADAAG 91 4.2.6</p> <p>ADA 2010 308.3.1</p> <p>CBC 2007 1118B.6</p> <p>CBC 2016 11B-308.3</p> <p>Project: SKYB1 Facelift</p> <p>Year to be Completed: 2021/2022</p> <p>Mitigated:</p> <p><input type="radio"/> YES</p> <p><input checked="" type="radio"/> NO</p>	1	JOB	\$300	\$300

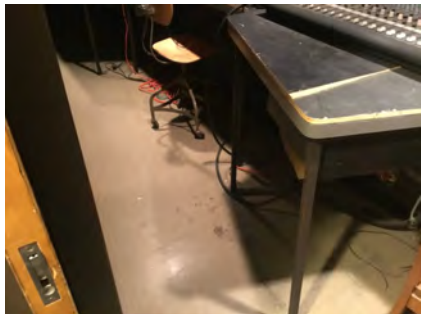
<input type="checkbox"/> Staff Only			
			<div><div>Priority</div><div>2</div></div> <div><div>Severity</div><div>2</div></div>			
<u>Corridor</u>						
604	<ul style="list-style-type: none">As-Built Description: Corridor, for occupant load less than 10, less than 36" wide.As-Built: 20" wideProposed Solution: Remove or relocate furniture and storage items.	<p>PCODE IH03A</p> <p>ADAAG 91 4.3.3</p> <p>ADA 2010 403.5.1</p> <p>CBC 2007 1133B.3.1</p> <p>CBC 2016 11B-403.5.1</p> <p>Project: SKYB1 Facelift</p> <p>Year to be Completed: 2021/2022</p> <p>Mitigated:</p> <p><input type="radio"/> YES</p> <p><input checked="" type="radio"/> NO</p>	1	JOB	\$150	\$150

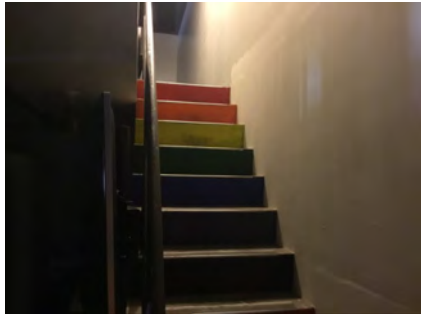
Item no., Rm no. and Name	Existing Architectural Barrier and Proposed Solution	Codes / Mitigation Info	Qty	Unit	Cost	Total
<u>Stairway</u>						
5	<ul style="list-style-type: none">• <i>As-Built Description:</i> The leading 2" of the tread does not have visual contrast of dark-on-light or light-on-dark from the remainder of the tread.• <i>Proposed Solution:</i> Provide 2" min., 4" max. wide contrasting color strip 1" max. from nosing on top & bottom treads when altering area.	<p>PCODE II02B</p> <p>ADA 2010 504.4</p> <p>CBC 2007 1133B.4.4</p> <p>CBC 2016 11B-504.4.1</p> <p>Project: SKYB1 Facelift</p> <p>Year to be Completed: 2021/2022</p> <p>Mitigated: <input type="radio"/> YES <input checked="" type="radio"/> NO</p>	10	LF	\$42	\$420

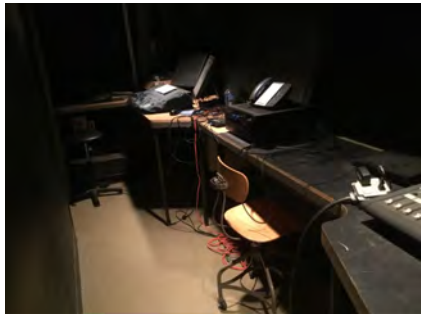
<input type="checkbox"/> Staff Only			
			Priority 2 Severity 3			
<u>Desk</u>						
603	<ul style="list-style-type: none">• <i>As-Built Description:</i> Accessible fixed table or desk (top 28" to 34" high; knee space at least 27" high x 19" deep x 30" wide) not provided.• <i>As-Built:</i> 36" AFF, 17.5" deep• <i>Proposed Solution:</i> Provide new fixed accessible table or desk.	<p>PCODE IN02</p> <p>ADAAG 91 4.32.3 & .4</p> <p>ADA 2010 306.1 & 902.3</p> <p>CBC 2007 1122B.3 & 4</p> <p>CBC 2016 11B-306.1 & 11B-902.3</p> <p>Project: SKYB1 Facelift</p> <p>Year to be Completed: 2021/2022</p> <p>Mitigated: <input type="radio"/> YES <input checked="" type="radio"/> NO</p>	1	JOB	\$7,500	\$7,500

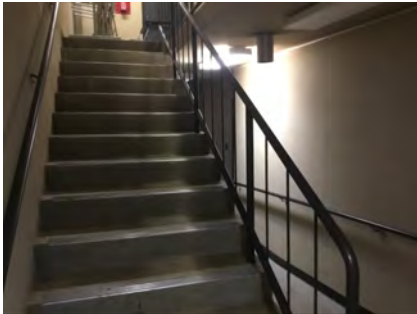
Item no., Rm no. and Name	Existing Architectural Barrier and Proposed Solution	Codes / Mitigation Info	Qty	Unit	Cost	Total
<u>Handrail</u>						
660	<ul style="list-style-type: none">• <i>As-Built Description:</i> Guards (42" high) not provided at side of ramp or landing where drop-off to adjacent grade or floor exceeds 30" height (California building code requirement only).• <i>Proposed Solution:</i> Provide new guards, including handrail at ramp.	<p>PCODE ED08</p> <p>CBC 2007 1133B.5.7</p> <p>CBC 2016 Section 1013.2; 1013.3</p> <p>Project: SKYB1 Facelift</p> <p>Year to be Completed: 2021/2022</p> <p>Mitigated: <input type="radio"/> YES <input checked="" type="radio"/> NO</p>	20	LF	\$360	\$7,200

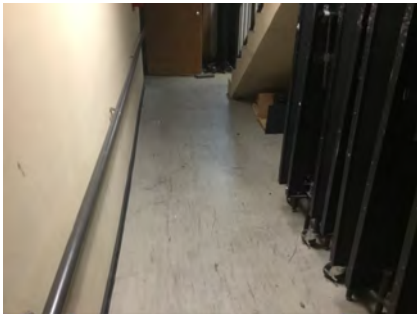
<input type="checkbox"/> Staff Only			
			Priority 2 Severity 4			
<u>Handrails</u>						
655	<ul style="list-style-type: none">• <i>As-Built Description:</i> Handrail not provided at stairs or ramp, required on both sides (not required at curb ramps or adjacent to seating areas).• <i>Proposed Solution:</i> Provide new handrail for each side including extensions.	<p>PCODE ED01</p> <p>ADAAG 91 4.8.5 & 4.9.4</p> <p>ADA 2010 505.2</p> <p>CBC 2007 1133B.4.1.1</p> <p>CBC 2016 & .5.5 11B-505.2</p> <p>Project: SKYB1 Facelift</p> <p>Year to be Completed: 2021/2022</p> <p>Mitigated: <input type="radio"/> YES <input checked="" type="radio"/> NO</p>	15	LF	\$285	\$4,275

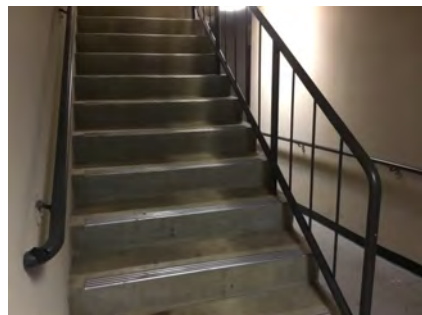
Item no., Rm no. and Name	Existing Architectural Barrier and Proposed Solution	Codes / Mitigation Info	Qty	Unit	Cost	Total
Height						
659	<ul style="list-style-type: none">As-Built Description: Handrail gripping surface top not mounted between 34" and 38" above ramp surface or stair nosings.As-Built: 40" AFFProposed Solution: Remove existing and provide new handrail.	<p>PCODE ED02</p> <p>ADAAG 91 4.9.4(5)</p> <p>ADA 2010 505.4</p> <p>CBC 2007 1133B.4.2.1 &</p> <p>CBC 2016 B.5.5.1</p> <p>11B-505.4</p> <p>Project: SKYB1 Facelift</p> <p>Year to be Completed: 2021/2022</p> <p>Mitigated:</p> <p><input type="radio"/> YES</p> <p><input checked="" type="radio"/> NO</p>	40	LF	\$225	\$9,000

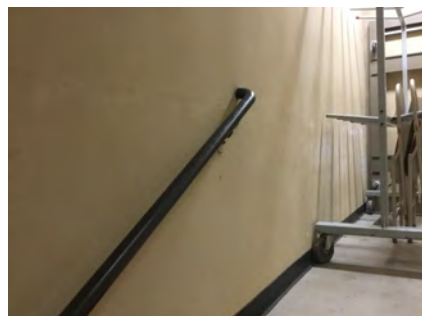
<div><input type="checkbox"/> Staff Only</div> <div><div>Priority</div><div>2</div><div>Severity</div><div>4</div></div>			
Top & Bottom Extension at Stairs						
663	<ul style="list-style-type: none">As-Built Description: Stair handrail does not extend horizontally 12" minimum beyond top nosing, and one tread width sloped, plus 12" minimum horizontally beyond the bottom nosing.As-Built: 0"Proposed Solution: Extend stair handrail at top and bottom (cost for each extension piece).	<p>PCODE ED06</p> <p>ADAAG 91 4.9.4(2)</p> <p>ADA 2010 505.10.2;</p> <p>CBC 2007 1133B.4.2.2</p> <p>CBC 2016 11B-505.10.2;</p> <p>11B-505.10.3</p> <p>Project: SKYB1 Facelift</p> <p>Year to be Completed: 2021/2022</p> <p>Mitigated:</p> <p><input type="radio"/> YES</p> <p><input checked="" type="radio"/> NO</p>	2	JOB	\$510	\$1,020

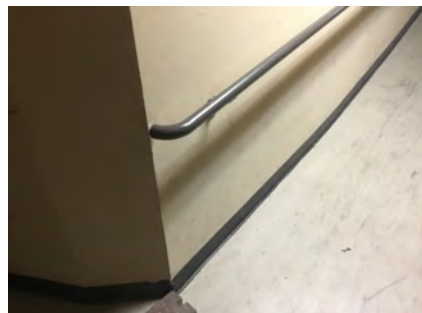
Item no., Rm no. and Name	Existing Architectural Barrier and Proposed Solution	Codes / Mitigation Info	Qty	Unit	Cost	Total
Top and Bottom Extension at Ramps						
656	<ul style="list-style-type: none">• <i>As-Built Description:</i> Ramp handrail does not extend horizontally 12" past top and / or bottom of ramp.• <i>Proposed Solution:</i> Provide ramp handrail extension (cost for each extension piece).• <i>Notes:</i> Handrail extension is not parallel to the ground.	<p>PCODE ED05</p> <p>ADAAG 91 4.8.5(2)</p> <p>ADA 2010 505.10.1</p> <p>CBC 2007 1133B.4.2.2 &</p> <p>CBC 2016 1133B.5.5.1</p> <p>11B-505.10.1</p> <p>Project: SKYB1 Facelift</p> <p>Year to be Completed: 2021/2022</p> <p>Mitigated:</p> <p><input type="radio"/> YES</p> <p><input checked="" type="radio"/> NO</p>	2	JOB	\$510	\$1,020

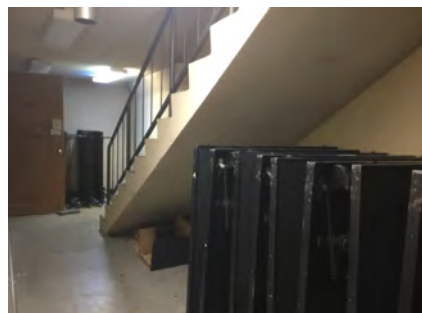
Vertical Clearance						
657	<ul style="list-style-type: none">• <i>As-Built Description:</i> Overhead clearance less than 80" above finished floor.• <i>As-Built:</i> 27" up to 80" AFF• <i>Proposed Solution:</i> Modify overhead clearance.	<p>PCODE EG01</p> <p>ADAAG 91 4.4.2</p> <p>ADA 2010 307.4</p> <p>CBC 2007 1133B.8.6.2</p> <p>CBC 2016 11B-307.4</p> <p>Project: SKYB1 Facelift</p> <p>Year to be Completed: 2021/2022</p> <p>Mitigated:</p> <p><input type="radio"/> YES</p> <p><input checked="" type="radio"/> NO</p>	1	JOB	\$300	\$300

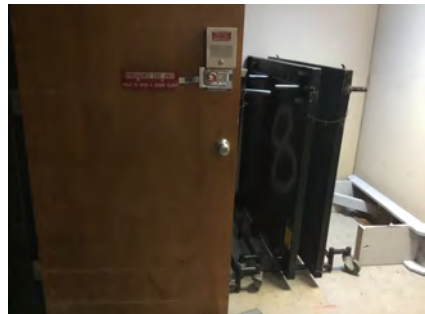
Item no., Rm no. and Name	Existing Architectural Barrier and Proposed Solution	Codes / Mitigation Info	Qty	Unit	Cost	Total
<u>Door Hardware</u>						
658	<ul style="list-style-type: none">• <i>As-Built Description:</i> Door does not have accessible operating hardware.• <i>Proposed Solution:</i> Provide lever handle or other accessible hardware.	<p>PCODE ID07</p> <p>ADAAG 91 4.13.9</p> <p>ADA 2010 404.2.7</p> <p>CBC 2007 1133B.2.5.2</p> <p>CBC 2016 11B-404.2.7</p> <p>Project: SKYB1 Facelift</p> <p>Year to be Completed: 2021/2022</p> <p>Mitigated:</p> <p><input type="radio"/> YES</p> <p><input checked="" type="radio"/> NO</p>	1	JOB	\$750	\$750

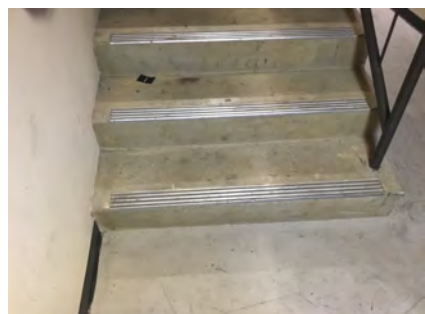
<input type="checkbox"/> Staff Only			
			Priority 2 Severity 3			
<u>Stairway</u>						
661	<ul style="list-style-type: none">• <i>As-Built Description:</i> The leading 2" of the tread does not have visual contrast of dark-on-light or light-on-dark from the remainder of the tread.• <i>Proposed Solution:</i> Provide 2" min., 4" max. wide contrasting color strip 1" max. from nosing on top & bottom treads when altering area.	<p>PCODE II02B</p> <p>ADA 2010 504.4</p> <p>CBC 2007 1133B.4.4</p> <p>CBC 2016 11B-504.4.1</p> <p>Project: SKYB1 Facelift</p> <p>Year to be Completed: 2021/2022</p> <p>Mitigated:</p> <p><input type="radio"/> YES</p> <p><input checked="" type="radio"/> NO</p>	10	LF	\$42	\$420

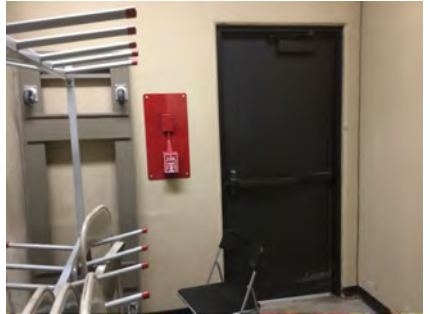
Item no., Rm no. and Name	Existing Architectural Barrier and Proposed Solution	Codes / Mitigation Info	Qty	Unit	Cost	Total
Signage						
664	<ul style="list-style-type: none"> • <i>As-Built Description:</i> At enclosed stairwells in high-rise buildings: Floor level information sign in stairwell not provided for people with vision impairment. • <i>Proposed Solution:</i> Provide raised letter/Braille sign at door, indicating the floor level and other exiting information. 	PCODE SA10F ADAAG 91 4.1.3(16) CBC 2007 1020.1.6 CBC 2016 11B-504.8 Project: SKYB1 Facelift Year to be Completed: 2021/2022 Mitigated: <input type="radio"/> YES <input checked="" type="radio"/> NO	2	JOB	\$450	\$900

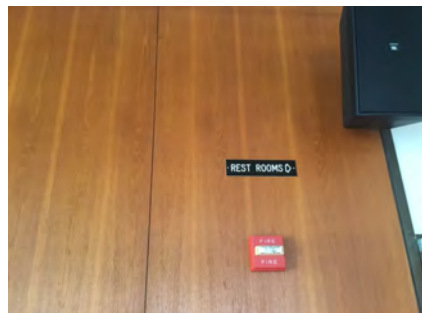
Item no., Rm no. and Name	Existing Architectural Barrier and Proposed Solution	Codes / Mitigation Info	Qty	Unit	Cost	Total
<u>Signage</u>						
343	<ul style="list-style-type: none">As-Built Description: Sign characters not readable because they are not sized for viewing distance.As-Built: 96" AFF, 1.25" hi charactersProposed Solution: Provide compliant signage.	<p>PCODE SA02A ADAAG 91 4.30.3 ADA 2010 703.5.5 CBC 2007 1117B.5.4 CBC 2016 11B-302.2</p> <p>Project: SKYB1 Facelift</p> <p>Year to be Completed: 2021/2022</p> <p>Mitigated: <input type="radio"/> YES <input checked="" type="radio"/> NO</p>	1	JOB	\$270	\$270

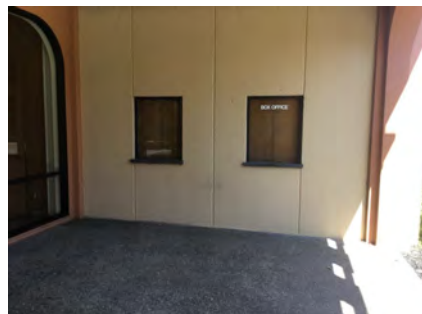
<input type="checkbox"/> Staff Only			
			Priority 2 Severity 4			
<u>Assistive Listening</u>						
454	<ul style="list-style-type: none">As-Built Description: No signs at the building or assembly area entrance to notify patrons that an assistive listening system is available.Proposed Solution: Provide assistive listening signage.	<p>PCODE GI02 ADAAG 91 4.1.3(19)(b) ADA 2010 703.7.2.4 CBC 2007 1104B.2.4 CBC 2016 11B-703.7.2.4</p> <p>Project: SKYB1 Facelift</p> <p>Year to be Completed: 2021/2022</p> <p>Mitigated: <input type="radio"/> YES <input checked="" type="radio"/> NO</p>	1	JOB	\$300	\$300

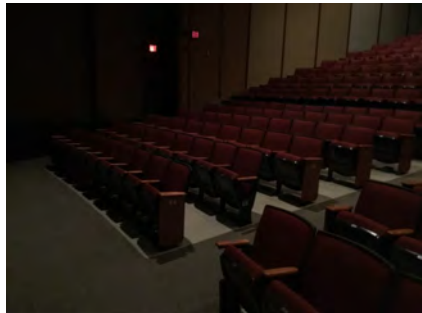
Item no., Rm no. and Name	Existing Architectural Barrier and Proposed Solution	Codes / Mitigation Info	Qty	Unit	Cost	Total
350	<ul style="list-style-type: none"> As-Built Description: Aisle transfer seats not provided (5% of total fixed seats, but not less than 1). Proposed Solution: Provide aisle transfer seats without armrests on the aisle side, or removable or folding armrests on the aisle seat. Include sign or marker identifying such seats. (NOTE: Space must be adjacent to regular seating; can provide easily removable fixed seat). Notes: <i>6 designated aisle seats, 498 seats in theater. In addition the seats are not closest to accessible routes and are not dispersed.</i> 	PCODE GB01E ADAAG 91 4.1.3(19)(a) ADA 2010 802.4 CBC 2007 1104B.3.8 CBC 2016 11B-802.4 Project: SKYB1 Facelift Year to be Completed: 2021/2022 Mitigated: <input type="radio"/> YES <input checked="" type="radio"/> NO	1	JOB	\$450	\$450

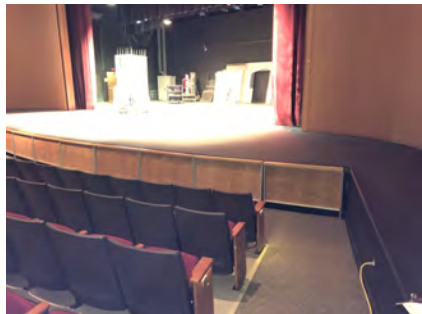
<input type="checkbox"/> Staff Only Priority 2 Severity 3						
Stages						
352	<ul style="list-style-type: none"> As-Built Description: Stage, enclosed and unenclosed platform, backstage areas or orchestra pit not accessible. Proposed Solution: Provide ramp to raised platforms. Notes: No accessible route provided from the auditorium to the stage. 	PCODE GC01BREF ADAAG 91 4.33.5 ADA 2010 206.2.6 CBC 2007 1104B.3.10 CBC 2016 11B-206.2.6 Project: SKYB1 Facelift Year to be Completed: 2021/2022 Mitigated: <input type="radio"/> YES <input checked="" type="radio"/> NO		REF

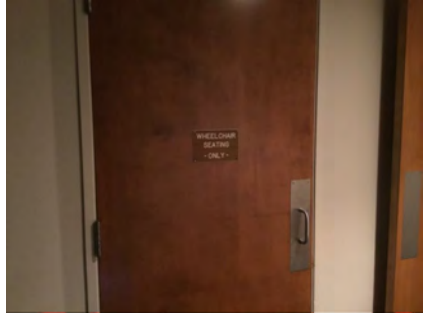
Item no., Rm no. and Name	Existing Architectural Barrier and Proposed Solution	Codes / Mitigation Info	Qty	Unit	Cost	Total
Fixed Seating						
837	<ul style="list-style-type: none"> • <i>As-Built Description:</i> Proper amount of seating for disabled persons at public seating is not provided (4 to 25=1; 26 to 50=2; 51 to 150=4; 151 to 300=5; 301 to 500=6; 501 to 5000=6+1 for each hundred; >5001=46+1 for each 200. • <i>As-Built:</i> 498 seats in Auditorium • <i>Proposed Solution:</i> Modify seating to provide clear and level wheelchair space 33" x 48" or 33" x 60", including companion seat, as required. • <i>Notes:</i> No vertical or horizontal dispersion. 	PCODE GE01 ADAAG 91 4.1.2(19)a ADA 2010 221.2.1 CBC 2007 1104B.3.4 CBC 2016 11B-221.2.1	1	EA	\$1,800	\$1,800
		Project: SKYB1 Facelift Year to be Completed: 2021/2022 Mitigated: <input type="radio"/> YES <input checked="" type="radio"/> NO

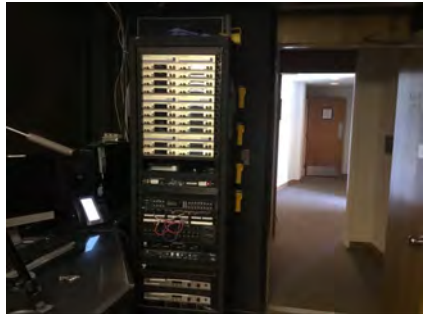
Item no., Rm no. and Name	Existing Architectural Barrier and Proposed Solution	Codes / Mitigation Info	Qty	Unit	Cost	Total
Door Swing						
566	<ul style="list-style-type: none"> As-Built Description: Front approach: At pull side, door does not have clear and level maneuvering space measuring door width plus 18" x 60". (24" x 60" at exterior doors). As-Built: 9" strike side Proposed Solution: Remove or relocate furniture or storage items. 	PCODE ID23A ADAAG 91 Fig. 25(a) ADA 2010 404.2.4 CBC 2007 11B-26A(a) CBC 2016 11B-404.2.4 Project: SKYB1 Facelift Year to be Completed: 2021/2022 Mitigated: <input type="radio"/> YES <input checked="" type="radio"/> NO	1	JOB	\$150	\$150

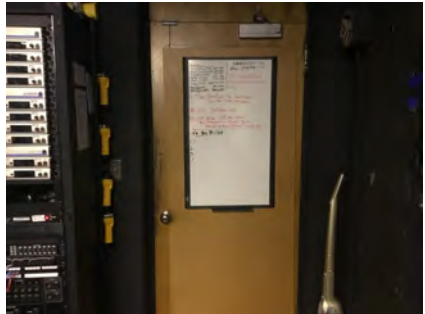
<input checked="" type="checkbox"/> Staff Only Priority Severity <input checked="" type="radio"/> 4 <input checked="" type="radio"/> 3			
567	<ul style="list-style-type: none"> As-Built Description: Front approach: At pull side, door does not have clear and level maneuvering space measuring door width plus 18" x 60". (24" x 60" at exterior doors). As-Built: 9.5" deep alcove Proposed Solution: Provide relocated new door and frame; remodel walls as needed. 	PCODE ID23B ADAAG 91 Fig. 25(a) ADA 2010 404.2.4 CBC 2007 11B-26A(a) CBC 2016 11B-404.2.4 Project: SKYB1 Facelift Year to be Completed: 2021/2022 Mitigated: <input type="radio"/> YES <input checked="" type="radio"/> NO	1	JOB	\$7,800	\$7,800

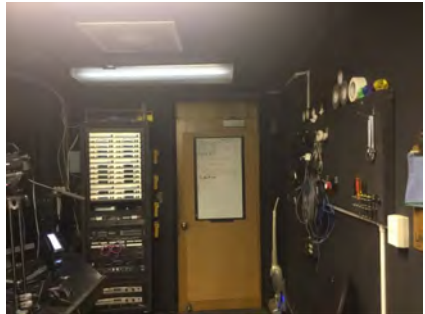
Item no., Rm no. and Name	Existing Architectural Barrier and Proposed Solution	Codes / Mitigation Info	Qty	Unit	Cost	Total
Reach Range						
569	<ul style="list-style-type: none"> As-Built Description: Reach height to control or access point, where side approach is available, exceeds 48" or is less than 15" in height, or exceeds 10" in depth. As-Built: Electronics and tools 74" AFF Proposed Solution: Modify equipment or mounting. 	PCODE IE02 ADAAG 91 4.2.6 ADA 2010 308.3.1 CBC 2007 1118B.6 CBC 2016 11B-308.3 Project: SKYB1 Facelift Year to be Completed: 2021/2022 Mitigated: <input type="radio"/> YES <input checked="" type="radio"/> NO	1	JOB	\$6,000	\$6,000

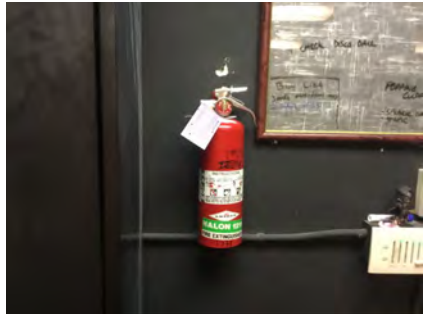
<input checked="" type="checkbox"/> Staff Only Priority Severity <input checked="" type="radio"/> 4 <input checked="" type="radio"/> 1			
570	<ul style="list-style-type: none"> As-Built Description: Reach height to control or access point, where side approach is available, exceeds 48" or is less than 15" in height, or exceeds 10" in depth. As-Built: 63" AFF Proposed Solution: Modify equipment or mounting. 	PCODE IE02 ADAAG 91 4.2.6 ADA 2010 308.3.1 CBC 2007 1118B.6 CBC 2016 11B-308.3 Project: SKYB1 Facelift Year to be Completed: 2021/2022 Mitigated: <input type="radio"/> YES <input checked="" type="radio"/> NO	1	JOB	\$300	\$300

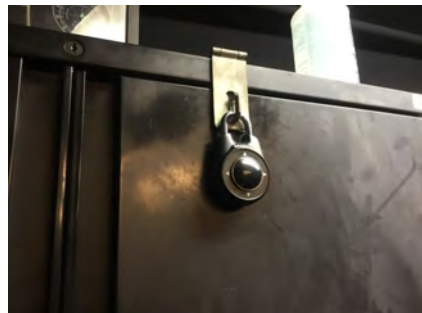
Item no., Rm no. and Name	Existing Architectural Barrier and Proposed Solution	Codes / Mitigation Info	Qty	Unit	Cost	Total
572	<ul style="list-style-type: none">As-Built Description: Reach height to control or access point, where side approach is available, exceeds 48" or is less than 15" in height, or exceeds 10" in depth.As-Built: 75" AFFProposed Solution: Modify equipment or mounting.	<p>PCODE IE02</p> <p>ADAAG 91 4.2.6</p> <p>ADA 2010 308.3.1</p> <p>CBC 2007 1118B.6</p> <p>CBC 2016 11B-308.3</p> <p>Project: SKYB1 Facelift</p> <p>Year to be Completed: 2021/2022</p> <p>Mitigated:</p> <p><input type="radio"/> YES</p> <p><input checked="" type="radio"/> NO</p>	1	JOB	\$300	\$300

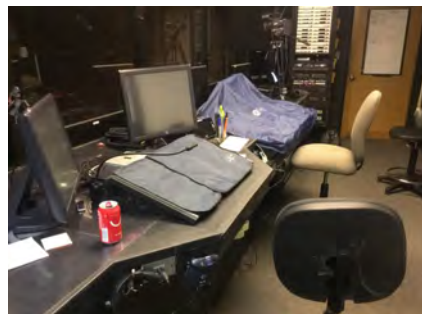
<input checked="" type="checkbox"/> Staff Only				
		<div><div>Priority</div><div>4</div></div> <div><div>Severity</div><div>1</div></div>				
<hr/>						
Desk						
568	<ul style="list-style-type: none">As-Built Description: Accessible fixed table or desk (top 28" to 34" high; knee space at least 27" high x 19" deep x 30" wide) not provided.As-Built: 36" AFF. 25" high, 28" wideProposed Solution: Provide new fixed accessible table or desk.	<p>PCODE IN02</p> <p>ADAAG 91 4.32.3 & .4</p> <p>ADA 2010 306.1 & 902.3</p> <p>CBC 2007 1122B.3 & 4</p> <p>CBC 2016 11B-306.1 & 11B-902.3</p> <p>Project: SKYB1 Facelift</p> <p>Year to be Completed: 2021/2022</p> <p>Mitigated:</p> <p><input type="radio"/> YES</p> <p><input checked="" type="radio"/> NO</p>	1	JOB	\$7,500	\$7,500

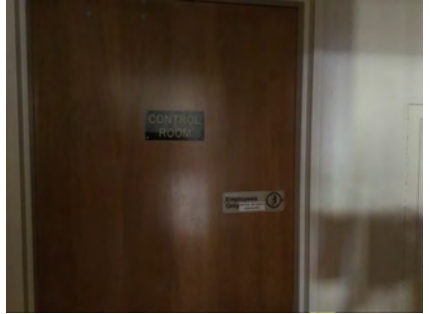
Item no., Rm no. and Name	Existing Architectural Barrier and Proposed Solution	Codes / Mitigation Info	Qty	Unit	Cost	Total
Signage						
363	<ul style="list-style-type: none"> • <i>As-Built Description:</i> Existing sign designating permanent room or space is noncompliant. • <i>Proposed Solution:</i> Provide compliant signage. 	PCODE SA13 ADAAG 91 4.1.3(16)(a) ADA 2010 216.2 CBC 2007 1117B.5 CBC 2016 11B-216.2 Project: SKYB1 Facelift Year to be Completed: 2021/2022 Mitigated: <input type="radio"/> YES <input checked="" type="radio"/> NO	1	JOB	\$450	\$450

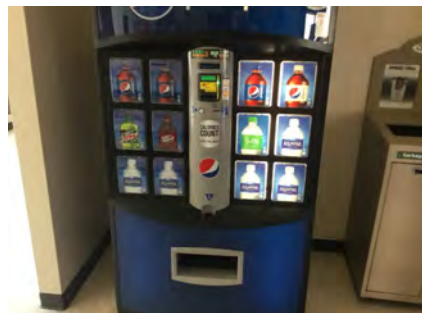
Item no., Rm no. and Name	Existing Architectural Barrier and Proposed Solution	Codes / Mitigation Info	Qty	Unit	Cost	Total
<u>Vending Machine</u>						
364	<ul style="list-style-type: none">As-Built Description: Vending machine coin slot or dispensing outlet, for forward reach, more than 48" above the floor.As-Built: 12.5" to the bottom of the dispensing tray 53" to the top of the card readerProposed Solution: Advise vendor/leasing company to provide accessible vending machine.	<p>PCODE IL02REF</p> <p>ADAAG 91 4.2.5</p> <p>ADA 2010 308.2.1</p> <p>CBC 2007 1126B</p> <p>CBC 2016 11B-308.2.1</p> <p>Project: SKYB1 Facelift</p> <p>Year to be Completed: 2021/2022</p> <p>Mitigated:</p> <p><input type="radio"/> YES</p> <p><input checked="" type="radio"/> NO</p>	3	REF
