SAN MATEO COUNTY
COMMUNITY
COLLEGE DISTRICT

San Mateo County Community College District Americans with Disabilities Act Self-Evaluation and Transition Plan

Report Prepared by:

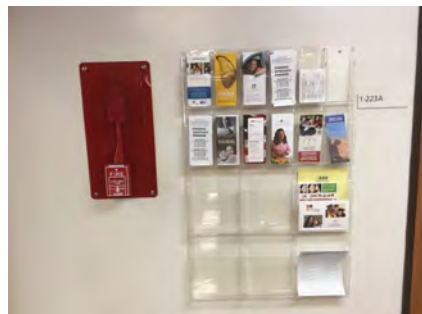
<input type="checkbox"/> Staff Only			
			Priority 2 Severity 3			
<u>Brochure Bins</u>						
370	<ul style="list-style-type: none">As-Built Description: Information brochure bins mounted above accessible height of 48".As-Built: 66" AFFProposed Solution: Relocate/remount bins at accessible height.	<p>PCODE IN08</p> <p>ADAAG 91 4.2.5 & 6</p> <p>ADA 2010 308.2.1</p> <p>CBC 2007 1118B.5</p> <p>CBC 2016 11B-308.2.1</p> <p>Project: SKYB1 Facelift</p> <p>Year to be Completed: 2021/2022</p> <p>Mitigated:</p> <p><input type="radio"/> YES</p> <p><input checked="" type="radio"/> NO</p>	4	JOB	\$300	\$1,200

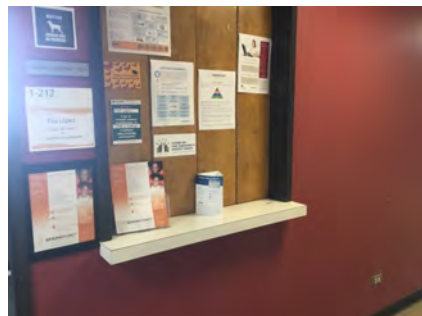
Item no., Rm no. and Name	Existing Architectural Barrier and Proposed Solution	Codes / Mitigation Info	Qty	Unit	Cost	Total
Public Counter						
424	<ul style="list-style-type: none">As-Built Description: Service counter (stand-up): Accessible section min. 36" length and 36" max. height (in CA: 28" to 34" high) not provided.As-Built: 41.5" AFFProposed Solution: Retrofit existing counter to provide accessible section. Interim solution: Provide auxiliary counter, table, or clipboard.	<p>PCODE IN03 ADAAG 91 7.2(2) ADA 2010 904.4 CBC 2007 1122B.4 CBC 2016 11B-904.4</p> <p>Project: SKYB1 Facelift</p> <p>Year to be Completed: 2021/2022</p> <p>Mitigated: <input type="radio"/> YES <input checked="" type="radio"/> NO</p>	1	JOB	\$6,000	\$6,000

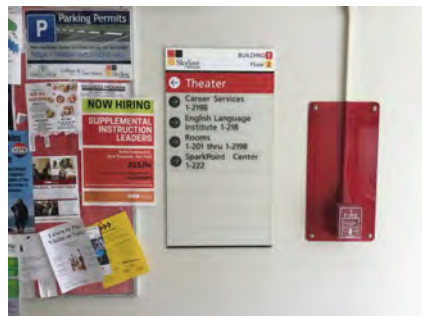
<input type="checkbox"/> Staff Only			
			Priority 2 Severity 3			
Signage						
365	<ul style="list-style-type: none">As-Built Description: Sign characters not readable because they are not sized for viewing distance.As-Built: Characters 0.625" -1.25" hi 72" AFFProposed Solution: Provide compliant signage.	<p>PCODE SA02A ADAAG 91 4.30.3 ADA 2010 703.5.5 CBC 2007 1117B.5.4 CBC 2016 11B-308.2.1</p> <p>Project: SKYB1 Facelift</p> <p>Year to be Completed: 2021/2022</p> <p>Mitigated: <input type="radio"/> YES <input checked="" type="radio"/> NO</p>	4	JOB	\$270	\$1,080

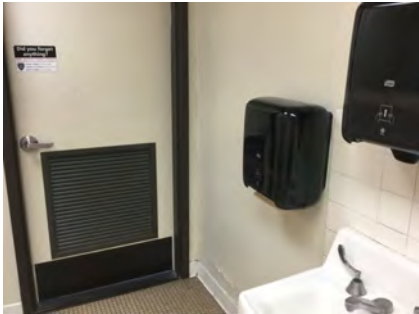
Item no., Rm no. and Name	Existing Architectural Barrier and Proposed Solution	Codes / Mitigation Info	Qty	Unit	Cost	Total
<u>Door Swing</u>						
375	<ul style="list-style-type: none">As-Built Description: Front approach: At push side, door does not have clear and level maneuvering space measuring door width x 48" (door width plus 12" if door has both, latch and closer).As-Built: 34" landing obstructed by paper towel dispenserProposed Solution: Remove or relocate furniture or storage items.	<p>PCODE ID24A</p> <p>ADAAG 91 Fig. 25(a)</p> <p>ADA 2010 404.2.4</p> <p>CBC 2007 11B-26A(a)</p> <p>CBC 2016 11B-404.2.4</p> <p>Project: SKYB1 Facelift</p> <p>Year to be Completed: 2021/2022</p> <p>Mitigated:</p> <p><input type="radio"/> YES</p> <p><input checked="" type="radio"/> NO</p>	1	JOB	\$150	\$150

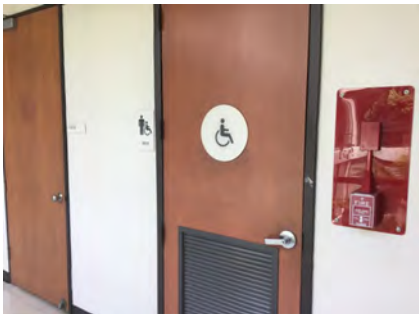
<input type="checkbox"/> Staff Only			
			Priority 3 Severity 2			
<u>Signage</u>						
374	<ul style="list-style-type: none">As-Built Description: Sign not located on latch side of door and/or not located at 48" min. above to baseline of the lowest Braille cells and 60" max. to baseline of the highest line of raised characters.Proposed Solution: Provide compliant signage including tactile characters and Grade II Braille on latch side of door located at compliant height.	<p>PCODE SA07</p> <p>ADAAG 91 4.30.6</p> <p>ADA 2010 703.4.1</p> <p>CBC 2007 1117B.5.7</p> <p>CBC 2016 11B-703.4.1</p> <p>Project: SKYB1 Facelift</p> <p>Year to be Completed: 2021/2022</p> <p>Mitigated:</p> <p><input type="radio"/> YES</p> <p><input checked="" type="radio"/> NO</p>	1	JOB	\$150	\$150

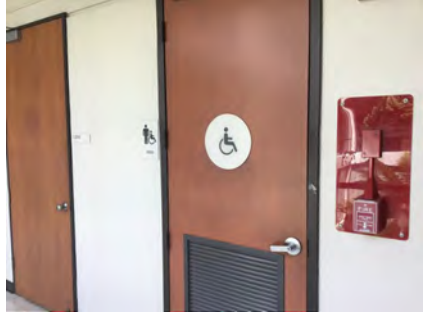
Item no., Rm no. and Name	Existing Architectural Barrier and Proposed Solution	Codes / Mitigation Info	Qty	Unit	Cost	Total
373	<ul style="list-style-type: none"> As-Built Description: Required in CA only: identification symbol centered 58" to 60" high on sanitary facility door that contrasts with the door not provided (women: 12" ø circle, men: 12" triangle, unisex: combined symbol). Proposed Solution: Provide properly mounted sanitary facility symbol when altering area. If wheelchair accessible, include International Symbol of Accessibility on sign. Notes: The men's restroom symbol should be a triangle. 	PCODE SA15 CBC 2007 1115B.6 CBC 2016 11B-703.7.2.6 Project: SKYB1 Facelift Year to be Completed: 2021/2022 Mitigated: <input type="radio"/> YES <input checked="" type="radio"/> NO	1	JOB	\$270	\$270

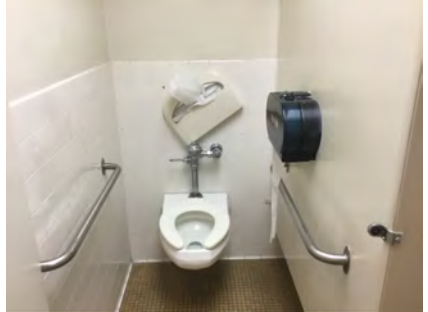
Semi-Ambulant Stall

379	<ul style="list-style-type: none"> As-Built Description: Semi-Ambulant stall with 35-37" width, minimum 60" depth, parallel grab bars, and out-swinging door not provided (one required where 6 or more exist). As-Built: 56" deep Proposed Solution: Provide 36" wide stall with out-swinging door and two side grab bars. Remodel restroom as needed. 	PCODE WB06A ADAAG 91 4.22.4 ADA 2010 213.3.1 & CBC 2007 1115B.3.1.5 CBC 2016 11B-213.3.1 & 11B-604.8.2 Project: SKYB1 Facelift Year to be Completed: 2021/2022 Mitigated: <input type="radio"/> YES <input checked="" type="radio"/> NO	1	JOB	\$5,700	\$5,700

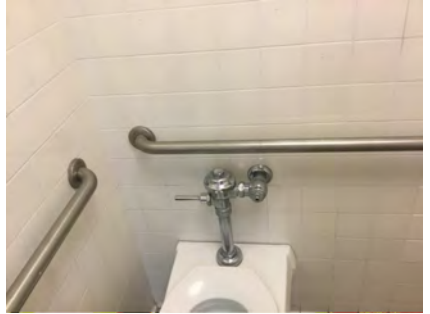
Item no., Rm no. and Name	Existing Architectural Barrier and Proposed Solution	Codes / Mitigation Info	Qty	Unit	Cost	Total
Grab Bars						
387	<ul style="list-style-type: none"> As-Built Description: The rear wall grab is less than 36" min. or does not extend from the centerline of the water closet 12" min. on one side and 24" min. on the other side. As-Built: 9" on the narrow side Proposed Solution: Provide or relocate accessible rear grab bar. 	PCODE WB07B ADAAG 91 4.17.6 ADA 2010 604.5.2 CBC 2007 1115B.4.1.3.2 CBC 2016 11B-604.5.2 Project: SKYB1 Facelift Year to be Completed: 2021/2022 Mitigated: <input type="radio"/> YES <input checked="" type="radio"/> NO	1	JOB	\$1,020	\$1,020

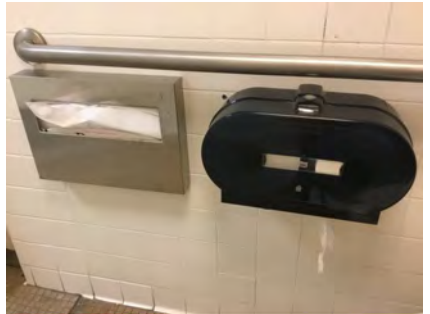
<input type="checkbox"/> Staff Only Priority 3 Severity 3			
386	<ul style="list-style-type: none"> As-Built Description: Accessories/dispensers in accessible stall located closer than 1-1/2" below or 12" above grab bar impedes its use. As-Built: 1.25" below Proposed Solution: Relocate accessories/dispensers to be no closer than 1-1/2" below and 12" above grab bars (except if accessories are recessed, flush with wall, and have no sharp edges). 	PCODE WB071 ADAAG 91 4.26.2 ADA 2010 609.3 CBC 2007 1133B.4.2.5 CBC 2016 11B-609.3 Project: SKYB1 Facelift Year to be Completed: 2021/2022 Mitigated: <input type="radio"/> YES <input checked="" type="radio"/> NO	2	JOB	\$225	\$450

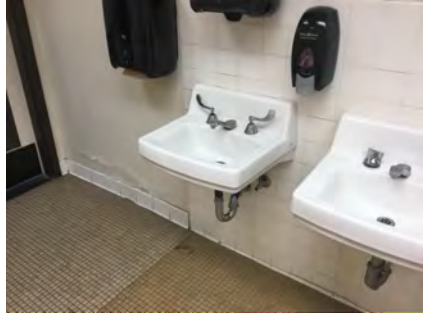
Item no., Rm no. and Name	Existing Architectural Barrier and Proposed Solution	Codes / Mitigation Info	Qty	Unit	Cost	Total
Lavatory						
376	<ul style="list-style-type: none"> • <i>As-Built Description:</i> Wheelchair clearance under lavatory apron or lavatory counter front edge less than 29" high. • <i>Proposed Solution:</i> Raise the lavatory. 	PCODE WD03 ADAAG 91 4.19.2 ADA 2010 606.3 CBC 2007 1115B.4.3.3 CBC 2016 11B-306.3.1 Project: SKYB1 Facelift Year to be Completed: 2021/2022 Mitigated: <input type="radio"/> YES <input checked="" type="radio"/> NO	1	JOB	\$10,200	\$10,200

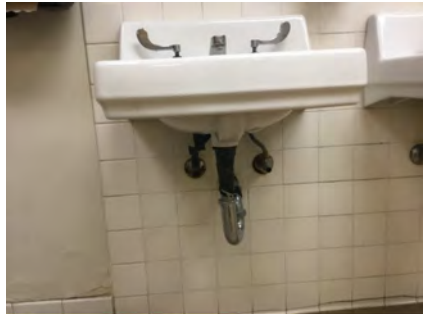
<input type="checkbox"/> Staff Only Priority 3 Severity 2			
377	<ul style="list-style-type: none"> • <i>As-Built Description:</i> Hot or sharp-surfaced water/drain pipe not insulated or covered. • <i>Proposed Solution:</i> Insulate or cover water/drain pipe. 	PCODE WD05 ADAAG 91 4.19.4 ADA 2010 606.5 CBC 2007 1115B.4.3.4 CBC 2016 11B-606.5 Project: SKYB1 Facelift Year to be Completed: 2021/2022 Mitigated: <input type="radio"/> YES <input checked="" type="radio"/> NO	1	JOB	\$360	\$360

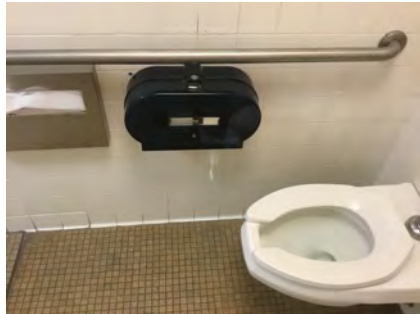
Item no., Rm no. and Name	Existing Architectural Barrier and Proposed Solution	Codes / Mitigation Info	Qty	Unit	Cost	Total
Accessories						
384	<ul style="list-style-type: none"> As-Built Description: Toilet paper dispenser less than 15" (CA: 19") or more than 48" above floor or not within 7" to 9" from front of water closet (Note: CA pre-2010 is allowed within 12" from front of water closet). As-Built: 5.5" from the front of the water closet Proposed Solution: Relocate or provide new toilet paper dispenser. 	PCODE WG02 ADAAG 91 4.16.6 ADA 2010 604.7 CBC 2007 1115B.8.4 CBC 2016 11B-604.7 Project: SKYB1 Facelift Year to be Completed: 2021/2022 Mitigated: <input type="radio"/> YES <input checked="" type="radio"/> NO	1	JOB	\$225	\$225

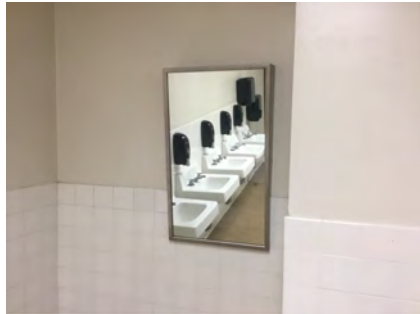
<input type="checkbox"/> Staff Only Priority 3 Severity 4			
378	<ul style="list-style-type: none"> As-Built Description: Bottom of mirror located above lavatories or countertops more than 40" above floor. As-Built: 43.5" not above a lavatory Proposed Solution: Relocate or provide new accessible mirror. 	PCODE WG03 ADAAG 91 4.19.6 ADA 2010 603.3 CBC 2007 1115B.8.1 CBC 2016 11B-603.3 Project: SKYB1 Facelift Year to be Completed: 2021/2022 Mitigated: <input type="radio"/> YES <input checked="" type="radio"/> NO	1	JOB	\$450	\$450

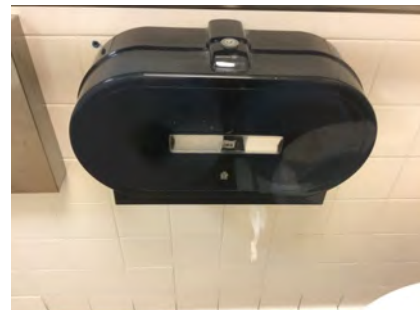
Item no., Rm no. and Name	Existing Architectural Barrier and Proposed Solution	Codes / Mitigation Info	Qty	Unit	Cost	Total
385	<ul style="list-style-type: none"> • <i>As-Built Description:</i> Accessories in sanitary facilities not accessible, hardware requires tight grasping, pinching, or twisting of the wrist. • <i>Proposed Solution:</i> Provide accessories with accessible operating mechanism. 	PCODE WG05REF ADAAG 91 4.27.4 ADA 2010 309.4 CBC 2007 1117B.6 CBC 2016 11B-309.4 Project: SKYB1 Facelift Year to be Completed: 2021/2022 Mitigated: <input type="radio"/> YES <input checked="" type="radio"/> NO

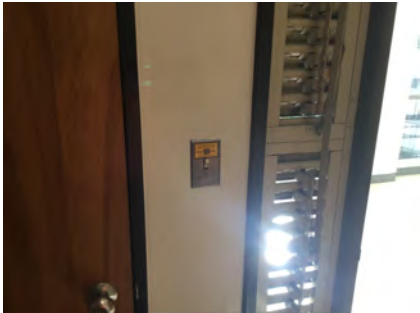
Item no., Rm no. and Name	Existing Architectural Barrier and Proposed Solution	Codes / Mitigation Info	Qty	Unit	Cost	Total
Electrical						
391	<ul style="list-style-type: none">As-Built Description: Electric switch or control mounted less than 15" measured to the bottom of the outlet box or greater than 48 inches measured to the top of the outlet box.As-Built: 50.3" to the top of the switchProposed Solution: Relocate light switches or control to between 15" and 48" height.	<p>PCODE IC01</p> <p>ADAAG 91 4.2.5 & 6</p> <p>ADA 2010 308.2.1 &</p> <p>CBC 2007 1117B.6.3</p> <p>CBC 2016 11B-308.2.1 & 11B-308.2.2</p> <p>Project: SKYB1 Facelift</p> <p>Year to be Completed: 2021/2022</p> <p>Mitigated: <input type="radio"/> YES <input checked="" type="radio"/> NO</p>	1	JOB	\$900	\$900

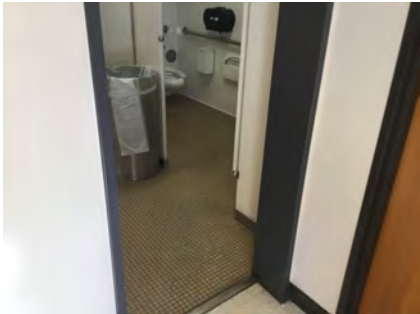
Corridor						
392	<ul style="list-style-type: none">As-Built Description: Corridor, for occupant load less than 10, less than 36" wide.As-Built: 31.875" wideProposed Solution: Widen the doorway.	<p>PCODE IH03A</p> <p>ADAAG 91 4.3.3</p> <p>ADA 2010 403.5.1</p> <p>CBC 2007 1133B.3.1</p> <p>CBC 2016 11B-403.5.1</p> <p>Project: SKYB1 Facelift</p> <p>Year to be Completed: 2021/2022</p> <p>Mitigated: <input type="radio"/> YES <input checked="" type="radio"/> NO</p>	1	JOB	\$150	\$150

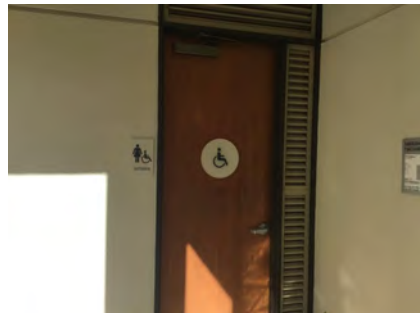
Item no., Rm no. and Name	Existing Architectural Barrier and Proposed Solution	Codes / Mitigation Info	Qty	Unit	Cost	Total
Signage						
390	<ul style="list-style-type: none">As-Built Description: Sign not located on latch side of door and/or not located at 48" min. above to baseline of the lowest Braille cells and 60" max. to baseline of the highest line of raised characters.Proposed Solution: Provide compliant signage including tactile characters and Grade II Braille on latch side of door located at compliant height.	PCODE SA07 ADAAG 91 4.30.6 ADA 2010 703.4.1 CBC 2007 1117B.5.7 CBC 2016 11B-703.4.1 Project: SKYB1 Facelift Year to be Completed: 2021/2022 Mitigated: <div><input type="radio"/> YES</div> <div><input checked="" type="radio"/> NO</div>	1	JOB	\$150	\$150

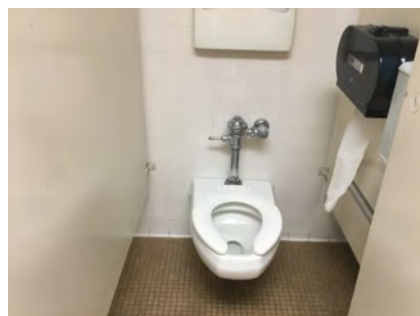
Semi-Ambulant Stall						
405	<ul style="list-style-type: none">As-Built Description: Semi-ambulant stall in restroom not compliant (one required where 6 or more exist).As-Built: 56" deepProposed Solution: Provide grab bars in otherwise compliant stall.Notes: Stall door swings into the stall, no side grab bar provided on both sides.	PCODE WB06B ADAAG 91 4.22.4 ADA 2010 213.3.1 & CBC 2007 1115B.3.1.5 CBC 2016 11B-213.3.1 & 11B-604.8.2 Project: SKYB1 Facelift Year to be Completed: 2021/2022 Mitigated: <div><input type="radio"/> YES</div> <div><input checked="" type="radio"/> NO</div>	1	JOB	\$1,200	\$1,200

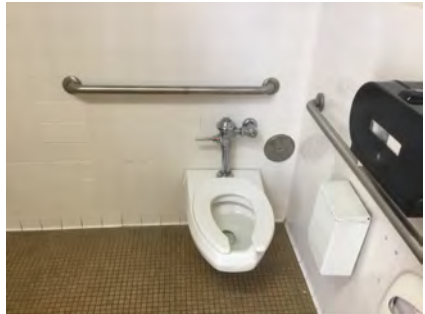
Item no., Rm no. and Name	Existing Architectural Barrier and Proposed Solution	Codes / Mitigation Info	Qty	Unit	Cost	Total
Grab Bars						
397	<ul style="list-style-type: none"> As-Built Description: The rear wall grab is less than 36" min. or does not extend from the centerline of the water closet 12" min. on one side and 24" min. on the other side. As-Built: 8" on the narrow side Proposed Solution: Provide or relocate accessible rear grab bar. 	PCODE WB07B ADAAG 91 4.17.6 ADA 2010 604.5.2 CBC 2007 1115B.4.1.3.2 CBC 2016 11B-604.5.2 Project: SKYB1 Facelift Year to be Completed: 2021/2022 Mitigated: <input type="radio"/> YES <input checked="" type="radio"/> NO	1	JOB	\$1,020	\$1,020

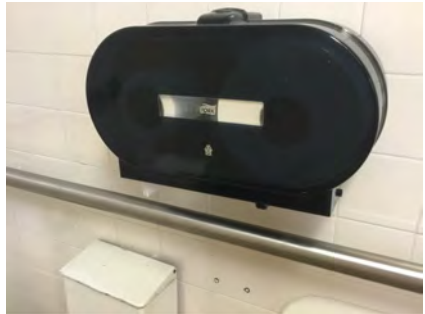
<input type="checkbox"/> Staff Only Priority 3 Severity 3			
400	<ul style="list-style-type: none"> As-Built Description: Accessories/dispensers in accessible stall located closer than 1-1/2" below or 12" above grab bar impedes its use. As-Built: 2" above Proposed Solution: Relocate accessories/dispensers to be no closer than 1-1/2" below and 12" above grab bars (except if accessories are recessed, flush with wall, and have no sharp edges). 	PCODE WB071 ADAAG 91 4.26.2 ADA 2010 609.3 CBC 2007 1133B.4.2.5 CBC 2016 11B-609.3 Project: SKYB1 Facelift Year to be Completed: 2021/2022 Mitigated: <input type="radio"/> YES <input checked="" type="radio"/> NO	1	JOB	\$225	\$225

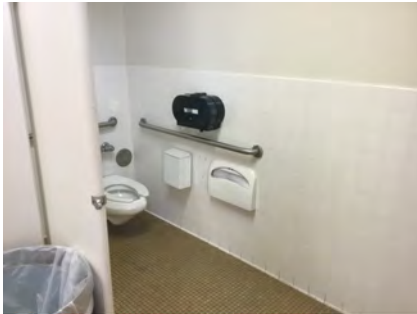
Item no., Rm no. and Name	Existing Architectural Barrier and Proposed Solution	Codes / Mitigation Info	Qty	Unit	Cost	Total
<u>Toilet Stall</u>						
393	<ul style="list-style-type: none">As-Built Description: Toilet stall less than 60" wide.As-Built: 52" wideProposed Solution: Provide new accessible stall.	<p>PCODE WB06</p> <p>ADAAG 91 4.17.3</p> <p>ADA 2010 604.8.1.1</p> <p>CBC 2007 1115B.3.1.4.1</p> <p>CBC 2016 11B-604.8.1.1</p> <p>Project: SKYB1 Facelift</p> <p>Year to be Completed: 2021/2022</p> <p>Mitigated: <input type="radio"/> YES <input checked="" type="radio"/> NO</p>	1	JOB	\$4,500	\$4,500

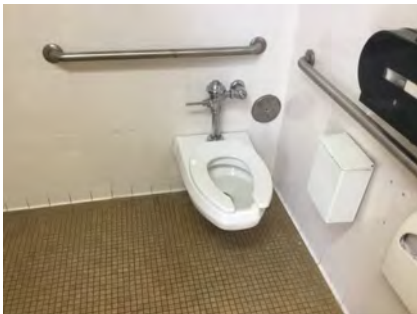
<input type="checkbox"/> Staff Only			
			<div><div>Priority</div><div>3</div></div> <div><div>Severity</div><div>3</div></div>			
<u>Water Closet</u>						
396	<ul style="list-style-type: none">As-Built Description: Water closet not 16"-18" (CA: 17"-18") from near side wall to center line of water closet (2010 ADAAG: 16"-18").As-Built: 15.5" o.c.Proposed Solution: Relocate existing water closet and plumbing, remount with offset closet flange to provide 18" max. from side wall.	<p>PCODE WB02CREF</p> <p>ADAAG 91 Fig. 28</p> <p>ADA 2010 604.2</p> <p>CBC 2007 1115B.4.1.1</p> <p>CBC 2016 11B-604.2</p> <p>Project: SKYB1 Facelift</p> <p>Year to be Completed: 2021/2022</p> <p>Mitigated: <input type="radio"/> YES <input checked="" type="radio"/> NO</p>		REF

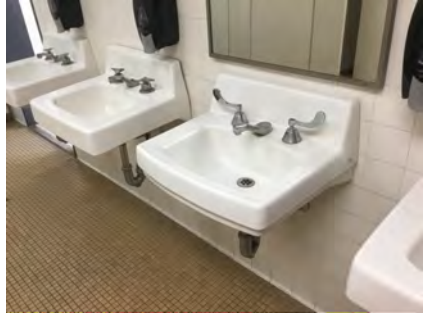
Item no., Rm no. and Name	Existing Architectural Barrier and Proposed Solution	Codes / Mitigation Info	Qty	Unit	Cost	Total
Lavatory						
404	<ul style="list-style-type: none"> As-Built Description: Wheelchair clearance under lavatory apron or lavatory counter front edge less than 29" high. As-Built: 27.5" AFF Proposed Solution: Raise the lavatory. 	PCODE WD03 ADAAG 91 4.19.2 ADA 2010 606.3 CBC 2007 1115B.4.3.3 CBC 2016 11B-306.3.1 Project: SKYB1 Facelift Year to be Completed: 2021/2022 Mitigated: <input type="radio"/> YES <input checked="" type="radio"/> NO	1	JOB	\$10,200	\$10,200

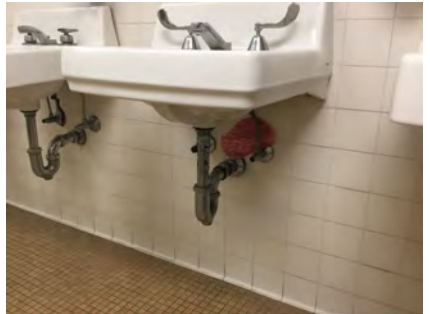
<input type="checkbox"/> Staff Only Priority 3 Severity 2			
403	<ul style="list-style-type: none"> As-Built Description: Hot or sharp-surfaced water/drain pipe not insulated or covered. Proposed Solution: Insulate or cover water/drain pipe. 	PCODE WD05 ADAAG 91 4.19.4 ADA 2010 606.5 CBC 2007 1115B.4.3.4 CBC 2016 11B-606.5 Project: SKYB1 Facelift Year to be Completed: 2021/2022 Mitigated: <input type="radio"/> YES <input checked="" type="radio"/> NO	1	JOB	\$360	\$360

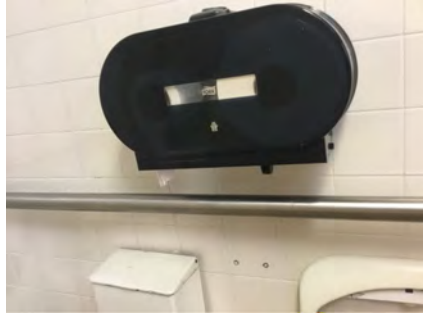
Item no., Rm no. and Name	Existing Architectural Barrier and Proposed Solution	Codes / Mitigation Info	Qty	Unit	Cost	Total
<u>Accessories</u>						
399	<ul style="list-style-type: none"> <i>As-Built Description:</i> Accessories in sanitary facilities not accessible, hardware requires tight grasping, pinching, or twisting of the wrist. <i>Proposed Solution:</i> Provide accessories with accessible operating mechanism. 	PCODE WG05REF ADAAG 91 4.27.4 ADA 2010 309.4 CBC 2007 1117B.6 CBC 2016 11B-309.4				
Project: SKYB1 Facelift Year to be Completed: 2021/2022 Mitigated: <input type="radio"/> YES <input checked="" type="radio"/> NO			REF

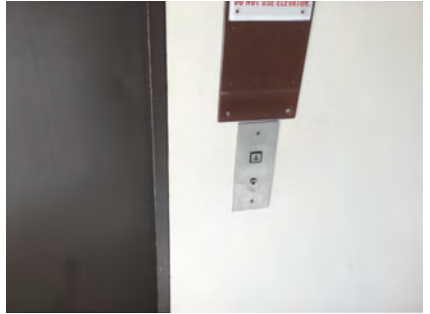
Item no., Rm no. and Name	Existing Architectural Barrier and Proposed Solution	Codes / Mitigation Info	Qty	Unit	Cost	Total
411	<ul style="list-style-type: none"> • <i>As-Built Description:</i> Elevator control panel buttons not illuminated. • <i>Proposed Solution:</i> Provide illuminated elevator control panel buttons . • <i>Notes:</i> Hall call button does not illuminate 	PCODE IK07B ADAAG 91 4.10.12 (2) ADA 2010 407.4.5 CBC 2007 1116B.1.9 CBC 2016 11B-407.4.6.2.3 Project: SKYB1 Facelift Year to be Completed: 2021/2022 Mitigated: <input type="radio"/> YES <input checked="" type="radio"/> NO	1	JOB	\$2,940	\$2,940

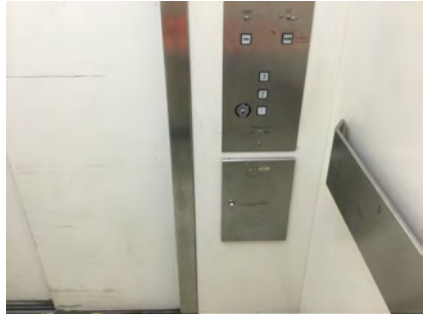
<input type="checkbox"/> Staff Only Priority 2 Severity 3			
415	<ul style="list-style-type: none"> • <i>As-Built Description:</i> Elevator control panel buttons not illuminated. • <i>Proposed Solution:</i> Provide illuminated elevator control panel buttons. 	PCODE IK07B ADAAG 91 4.10.12 (2) ADA 2010 407.4.5 CBC 2007 1116B.1.9 CBC 2016 11B-407.4.6.2.3 Project: SKYB1 Facelift Year to be Completed: 2021/2022 Mitigated: <input type="radio"/> YES <input checked="" type="radio"/> NO	1	JOB	\$2,940	\$2,940

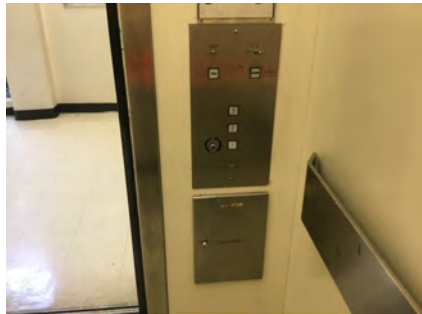
Item no., Rm no. and Name	Existing Architectural Barrier and Proposed Solution	Codes / Mitigation Info	Qty	Unit	Cost	Total
416	<ul style="list-style-type: none"> As-Built Description: Braille or tactile symbols at numerals not provided on elevator control panel. Proposed Solution: Provide Braille and tactile symbols on elevator control panel. 	PCODE IK07D ADAAG 91 4.10.12(2) ADA 2010 407.4.7.1 CBC 2007 1116B.1.9 CBC 2016 11B-407.4.7.1 Project: SKYB1 Facelift Year to be Completed: 2021/2022 Mitigated: <input type="radio"/> YES <input checked="" type="radio"/> NO	1	JOB	\$330	\$330

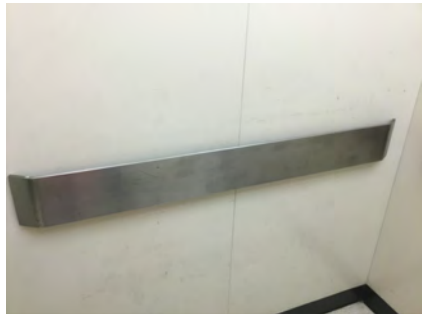
<input type="checkbox"/> Staff Only Priority 2 Severity 3			
418	<ul style="list-style-type: none"> As-Built Description: Handrail not mounted with top 32", plus or minus one inch, above the floor of car. (CA Only) As-Built: 37.5" AFF 1.3" from wall Proposed Solution: Remount handrail at 32" above floor. 	PCODE IK08A CBC 2007 1116B.1.11 CBC 2016 11B-407.4.10 Project: SKYB1 Facelift Year to be Completed: 2021/2022 Mitigated: <input type="radio"/> YES <input checked="" type="radio"/> NO	1	JOB	\$1,080	\$1,080

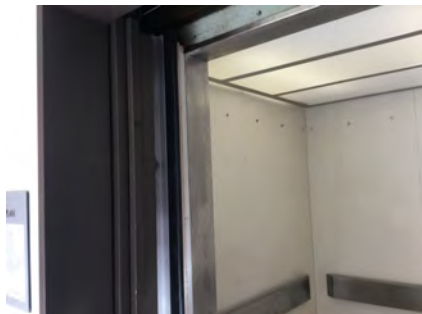
<input type="checkbox"/> Staff Only Priority 2 Severity 3			
412	<ul style="list-style-type: none"> As-Built Description: Visual hall lantern, minimum 2-1/2" x 2-1/2", not provided, or installed less than 72" above floor. Proposed Solution: Provide or raise proper visual hall lantern for elevator. 	PCODE IK10A ADAAG 91 4.10.4(1) ADA 2010 407.2.2.2 CBC 2007 1116B.1.13 CBC 2016 11B-407.2.2.2 Project: SKYB1 Facelift Year to be Completed: 2021/2022 Mitigated: <input type="radio"/> YES <input checked="" type="radio"/> NO	1	JOB	\$4,650	\$4,650

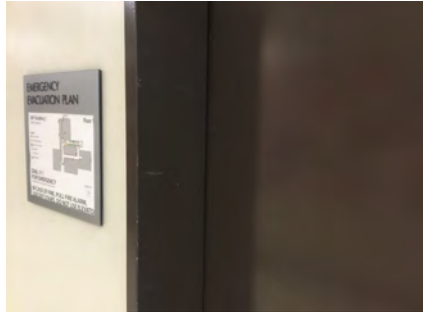
Item no., Rm no. and Name	Existing Architectural Barrier and Proposed Solution	Codes / Mitigation Info	Qty	Unit	Cost	Total
419	<ul style="list-style-type: none"> As-Built Description: Braille and raised floor numbers on entrance jambs located more or less than 5' above floor. Proposed Solution: Relocate Braille and raised floor numbers on entrance jambs to 5' above floor. 	PCODE IK11C ADAAG 91 4.10.5 ADA 2010 703.4.1 CBC 2007 1116B.1.14 CBC 2016 11B-703.4.1 Project: SKYB1 Facelift Year to be Completed: 2021/2022 Mitigated: <input type="radio"/> YES <input checked="" type="radio"/> NO	6	JOB	\$360	\$2,160

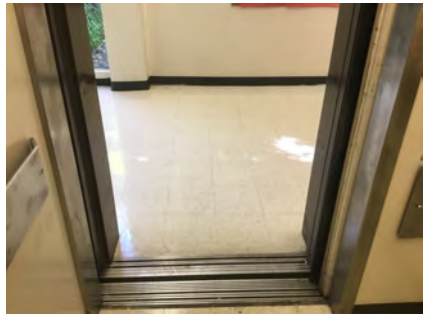
<input type="checkbox"/> Staff Only Priority 2 Severity 3			
421	<ul style="list-style-type: none"> As-Built Description: Door reopening device does not remain effective for at least 20 seconds. Proposed Solution: Adjust timing. Notes: Door reopening device requires contact. 	PCODE IK14 ADAAG 91 4.10.6 ADA 2010 407.3.3.3 CBC 2007 1116B.1.5 CBC 2016 11B-407.3.3.3 Project: SKYB1 Facelift Year to be Completed: 2021/2022 Mitigated: <input type="radio"/> YES <input checked="" type="radio"/> NO	1	JOB	\$150	\$150

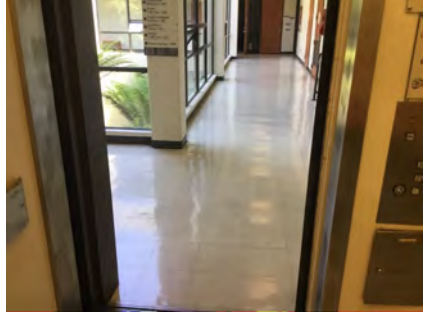
Item no., Rm no. and Name	Existing Architectural Barrier and Proposed Solution	Codes / Mitigation Info	Qty	Unit	Cost	Total
1241	<ul style="list-style-type: none"> As-Built Description: Door reopening device does not remain effective for at least 20 seconds. As-Built: 13 seconds Proposed Solution: Adjust timing. 	PCODE IK14 ADAAG 91 4.10.6 ADA 2010 407.3.3.3 CBC 2007 1116B.1.5 CBC 2016 11B-407.3.3.3 Project: SKYB1 Facelift Year to be Completed: 2021/2022 Mitigated: <input type="radio"/> YES <input checked="" type="radio"/> NO	1	JOB	\$150	\$150

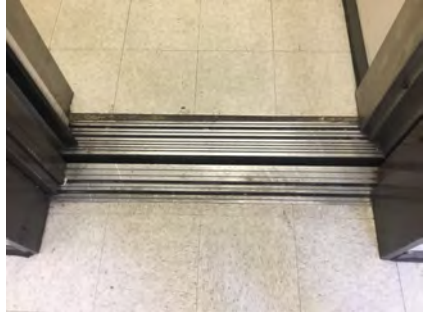
<input type="checkbox"/> Staff Only Priority 2 Severity 3			
420	<ul style="list-style-type: none"> As-Built Description: The clearance between the car platform sill and the edge of any hoistway landing shall be 1.25" maximum. As-Built: 1.375" gap Proposed Solution: Modify elevator as necessary to reduce clearance. 	PCODE IK15 ADA 2010 407.4.3 CBC 2016 11B-407.4.3 Project: SKYB1 Facelift Year to be Completed: 2021/2022 Mitigated: <input type="radio"/> YES <input checked="" type="radio"/> NO	1	JOB	\$5,910	\$5,910

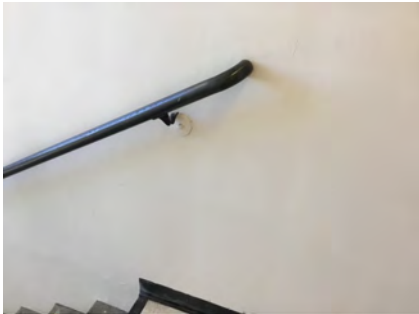
Item no., Rm no. and Name	Existing Architectural Barrier and Proposed Solution	Codes / Mitigation Info	Qty	Unit	Cost	Total
Top & Bottom Extension at Stairs						
430	<ul style="list-style-type: none">As-Built Description: Stair handrail does not extend horizontally 12" minimum beyond top nosing, and one tread width sloped, plus 12" minimum horizontally beyond the bottom nosing.As-Built: 0"- 6"Proposed Solution: Extend stair handrail at top and bottom (cost for each extension piece).	<p>PCODE ED06</p> <p>ADAAG 91 4.9.4(2)</p> <p>ADA 2010 505.10.2;</p> <p>CBC 2007 1133B.4.2.2</p> <p>CBC 2016 11B-505.10.2; 11B-505.10.3</p> <p>Project: SKYB1 Facelift</p> <p>Year to be Completed: 2021/2022</p> <p>Mitigated:</p> <p><input type="radio"/> YES</p> <p><input checked="" type="radio"/> NO</p>	14	JOB	\$510	\$7,140

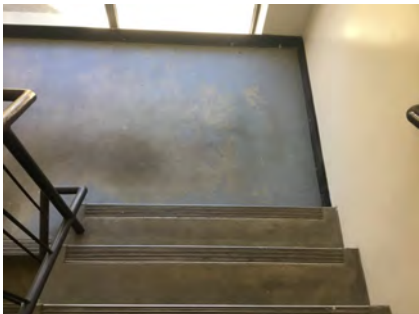
Stairway						
431	<ul style="list-style-type: none">As-Built Description: The leading 2" of the tread does not have visual contrast of dark-on-light or light-on-dark from the remainder of the tread.Proposed Solution: Provide 2" min., 4" max. wide contrasting color strip 1" max. from nosing on top & bottom treads when altering area.	<p>PCODE II02B</p> <p>ADA 2010 504.4</p> <p>CBC 2007 1133B.4.4</p> <p>CBC 2016 11B-504.4.1</p> <p>Project: SKYB1 Facelift</p> <p>Year to be Completed: 2021/2022</p> <p>Mitigated:</p> <p><input type="radio"/> YES</p> <p><input checked="" type="radio"/> NO</p>	50	LF	\$42	\$2,100

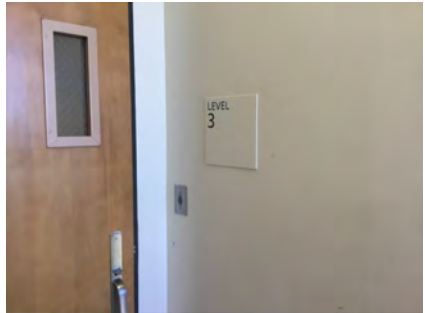
Item no., Rm no. and Name	Existing Architectural Barrier and Proposed Solution	Codes / Mitigation Info	Qty	Unit	Cost	Total
Signage						
434	<ul style="list-style-type: none"> As-Built Description: Signs containing tactile characters is not located so that a clear floor space of 18" min x 18" min., centered on the tactile characters, is provided beyond the arc of any door swing between the closed position and 45 degree open position. As-Built: Located in door swing Proposed Solution: Relocate compliant signage on latch side of door located at compliant height with a clear floor space. 	PCODE SA07B ADA 2010 703.4.2 CBC 2016 11B-703.4.2 Project: SKYB1 Facelift Year to be Completed: 2021/2022 Mitigated: <input type="radio"/> YES <input checked="" type="radio"/> NO	3	JOB	\$150	\$450

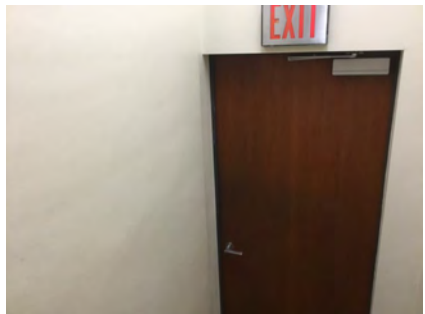
503	<ul style="list-style-type: none"> As-Built Description: At enclosed stairwells in high-rise buildings: Floor level information sign in stairwell not provided for people with vision impairment. Proposed Solution: Provide raised letter/Braille sign at door, indicating the floor level and other exiting information. 	PCODE SA10F ADAAG 91 4.1.3(16) CBC 2007 1020.1.6 CBC 2016 11B-504.8 Project: SKYB1 Facelift Year to be Completed: 2021/2022 Mitigated: <input type="radio"/> YES <input checked="" type="radio"/> NO	1	JOB	\$450	\$450

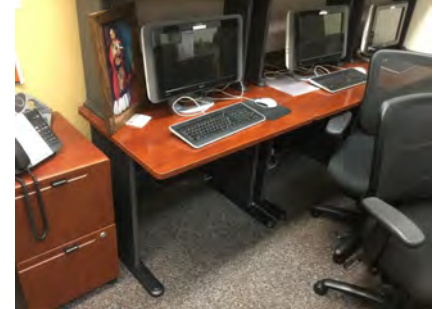
Item no., Rm no. and Name	Existing Architectural Barrier and Proposed Solution	Codes / Mitigation Info	Qty	Unit	Cost	Total
438	<ul style="list-style-type: none"> • <i>As-Built Description:</i> Accessible non-fixed table or desk (top 28" to 34" high; knee space at least 27" high x 19" deep x 30" wide) not provided. • <i>As-Built:</i> 28.5" wide • <i>Proposed Solution:</i> Provide table or desk with accessible dimensions when purchasing new furniture. 	PCODE IN02A ADAAG 91 4.32.3 & .4 ADA 2010 306.1 CBC 2007 1122B.3 & 4 CBC 2016 11B-306.1 & 11B-902.3 Project: SKYB1 Facelift Year to be Completed: 2021/2022 Mitigated: <input type="radio"/> YES <input checked="" type="radio"/> NO	1	JOB	\$4,800	\$4,800

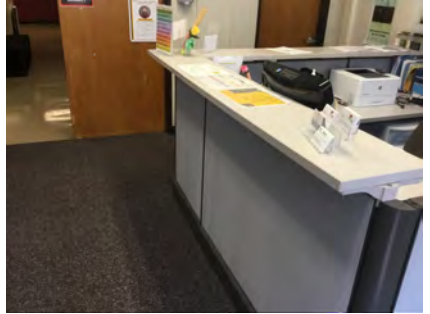
Item no., Rm no. and Name	Existing Architectural Barrier and Proposed Solution	Codes / Mitigation Info	Qty	Unit	Cost	Total
Public Counter						
440	<ul style="list-style-type: none"> • <i>As-Built Description:</i> Service counter (stand-up): Accessible section min. 36" length and 36" max. height (in CA: 28" to 34" high) not provided. • <i>As-Built:</i> 41.5" AFF • <i>Proposed Solution:</i> Retrofit existing counter to provide accessible section. Interim solution: Provide auxiliary counter, table, or clipboard. 	PCODE IN03 ADAAG 91 7.2(2) ADA 2010 904.4 CBC 2007 1122B.4 CBC 2016 11B-904.4 Project: SKYB1 Facelift Year to be Completed: 2021/2022 Mitigated: <input type="radio"/> YES <input checked="" type="radio"/> NO	1	JOB	\$6,000	\$6,000

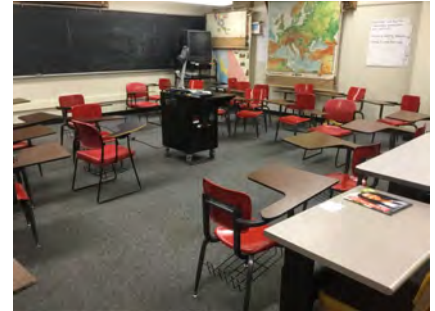
Item no., Rm no. and Name	Existing Architectural Barrier and Proposed Solution	Codes / Mitigation Info	Qty	Unit	Cost	Total
450	<ul style="list-style-type: none"> As-Built Description: Accessible non-fixed table or desk (top 28" to 34" high; knee space at least 27" high x 19" deep x 30" wide) not provided. As-Built: 160 seats, 5 accessible Proposed Solution: Provide table or desk with accessible dimensions when purchasing new furniture. Notes: Some of the accessible desks are currently being used for equipment or appeared to be used by Staff or for other purposes. Ensure the accessible desks are available to students who need them. 	PCODE IN02A ADAAG 91 4.32.3 & .4 ADA 2010 306.1 CBC 2007 1122B.3 & 4 CBC 2016 11B-306.1 & 11B-902.3 Project: SKYB1 Facelift Year to be Completed: 2021/2022 Mitigated: <input type="radio"/> YES <input checked="" type="radio"/> NO	3	JOB	\$4,800	\$14,400

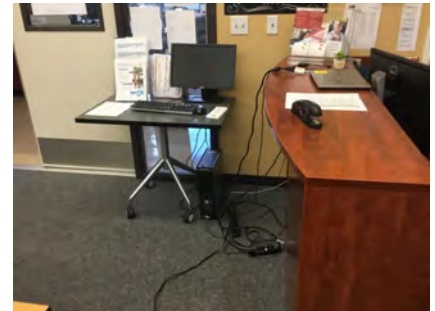
447	<ul style="list-style-type: none"> As-Built Description: Service counter (stand-up): Accessible section min. 36" length and 36" max. height (in CA: 28" to 34" high) not provided. As-Built: 41.5" AFF Proposed Solution: Retrofit existing counter to provide accessible section. Interim solution: Provide auxiliary counter, table, or clipboard. 	PCODE IN03 ADAAG 91 7.2(2) ADA 2010 904.4 CBC 2007 1122B.4 CBC 2016 11B-904.4 Project: SKYB1 Facelift Year to be Completed: 2021/2022 Mitigated: <input type="radio"/> YES <input checked="" type="radio"/> NO	1	JOB	\$6,000	\$6,000
-----	---	--	---	-----	---------	---------

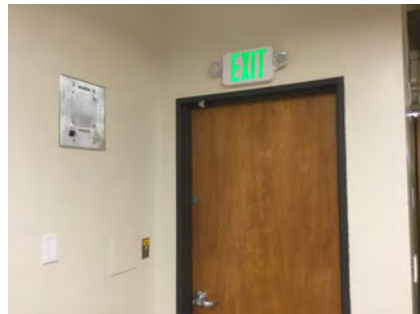
Item no., Rm no. and Name	Existing Architectural Barrier and Proposed Solution	Codes / Mitigation Info	Qty	Unit	Cost	Total
Door						
681	<ul style="list-style-type: none">As-Built Description: Door lock or latch less than 34" or more than 48" above the floor (CA only: 34" to 44").As-Built: 61" AFFProposed Solution: Remove the latch.Notes: This occurs at an exit door. Remove the latch.	<p>PCODE ID17</p> <p>ADAAG 91 4.13.9</p> <p>ADA 2010 404.2.7</p> <p>CBC 2007 1133B.2.5.2</p> <p>CBC 2016 11B-404.2.7</p> <p>Project: SKYB1 Facelift</p> <p>Year to be Completed: 2021/2022</p> <p>Mitigated:</p> <p><input type="radio"/> YES</p> <p><input checked="" type="radio"/> NO</p>	1	JOB	\$900	\$900

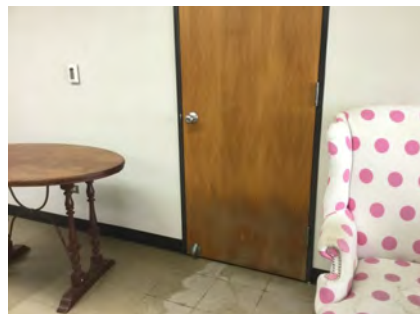
<input type="checkbox"/> Staff Only			
			Priority 2 Severity 1			
Door Hardware						
671	<ul style="list-style-type: none">As-Built Description: Door does not have accessible operating hardware.Proposed Solution: Provide lever handle or other accessible hardware.	<p>PCODE ID07</p> <p>ADAAG 91 4.13.9</p> <p>ADA 2010 404.2.7</p> <p>CBC 2007 1133B.2.5.2</p> <p>CBC 2016 11B-404.2.7</p> <p>Project: SKYB1 Facelift</p> <p>Year to be Completed: 2021/2022</p> <p>Mitigated:</p> <p><input type="radio"/> YES</p> <p><input checked="" type="radio"/> NO</p>	1	JOB	\$750	\$750

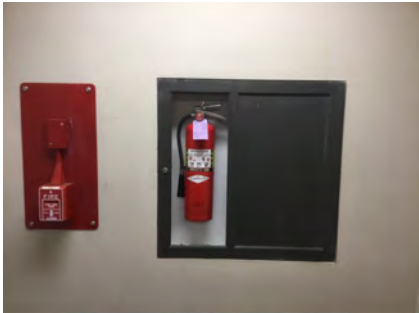
Item no., Rm no. and Name	Existing Architectural Barrier and Proposed Solution	Codes / Mitigation Info	Qty	Unit	Cost	Total
Reach Range						
674	<ul style="list-style-type: none">As-Built Description: Reach height to control or access point, where side approach is available, exceeds 48" or is less than 15" in height, or exceeds 10" in depth.As-Built: 65" AFFProposed Solution: Modify equipment or mounting.	<p>PCODE IE02</p> <p>ADAAG 91 4.2.6</p> <p>ADA 2010 308.3.1</p> <p>CBC 2007 1118B.6</p> <p>CBC 2016 11B-308.3</p> <p>Project: SKYB1 Facelift</p> <p>Year to be Completed: 2021/2022</p> <p>Mitigated:</p> <p><input type="radio"/> YES</p> <p><input checked="" type="radio"/> NO</p>	1	JOB	\$300	\$300

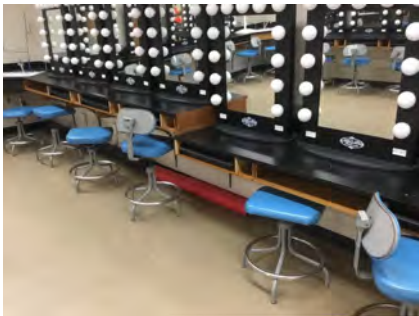
<input type="checkbox"/> Staff Only			
			<div><div>Priority</div><div>2</div></div> <div><div>Severity</div><div>2</div></div>			
Desk						
668	<ul style="list-style-type: none">As-Built Description: Accessible fixed table or desk (top 28" to 34" high; knee space at least 27" high x 19" deep x 30" wide) not provided.As-Built: 35.5" AFF, 24" knee clearanceProposed Solution: Provide new fixed accessible table or desk.	<p>PCODE IN02</p> <p>ADAAG 91 4.32.3 & .4</p> <p>ADA 2010 306.1 & 902.3</p> <p>CBC 2007 1122B.3 & 4</p> <p>CBC 2016 11B-306.1 & 11B-902.3</p> <p>Project: SKYB1 Facelift</p> <p>Year to be Completed: 2021/2022</p> <p>Mitigated:</p> <p><input type="radio"/> YES</p> <p><input checked="" type="radio"/> NO</p>	1	JOB	\$7,500	\$7,500

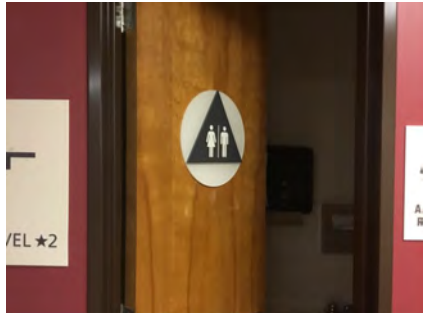
Item no., Rm no. and Name	Existing Architectural Barrier and Proposed Solution	Codes / Mitigation Info	Qty	Unit	Cost	Total
Signage						
506	<ul style="list-style-type: none"> As-Built Description: Required in CA only: identification symbol centered 58" to 60" high on sanitary facility door that contrasts with the door not provided (women: 12" ø circle, men: 12" triangle, unisex: combined symbol). As-Built: 64" AFF Proposed Solution: Provide properly mounted sanitary facility symbol when altering area. If wheelchair accessible, include International Symbol of Accessibility on sign. 	PCODE SA15 CBC 2007 1115B.6 CBC 2016 11B-703.7.2.6 Project: SKYB1 Facelift Year to be Completed: 2021/2022 Mitigated: <input type="radio"/> YES <input checked="" type="radio"/> NO	2	JOB	\$270	\$540

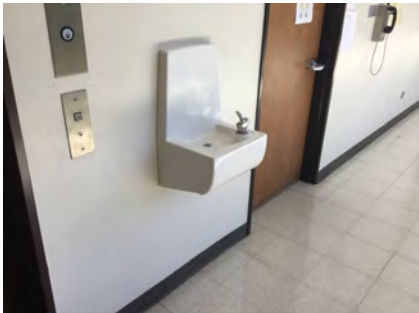
Item no., Rm no. and Name	Existing Architectural Barrier and Proposed Solution	Codes / Mitigation Info	Qty	Unit	Cost	Total
482	<ul style="list-style-type: none">As-Built Description: Wall- and post-mounted cantilevered units: Knee space not provided at drinking fountain (27" high, 8" deep, 30" wide from front of drinking fountain).As-Built: 25.5" knee heightProposed Solution: Provide new, accessible fountain.	<p>PCODE IA02</p> <p>ADAAG 91 4.15.5(1)</p> <p>ADA 2010 602.2</p> <p>CBC 2007 1115B.4.6.2</p> <p>CBC 2016 11B-602.2</p> <p>Project: SKYB1 Facelift</p> <p>Year to be Completed: 2021/2022</p> <p>Mitigated:</p> <p><input type="radio"/> YES</p> <p><input checked="" type="radio"/> NO</p>	1	JOB	\$9,600	\$9,600

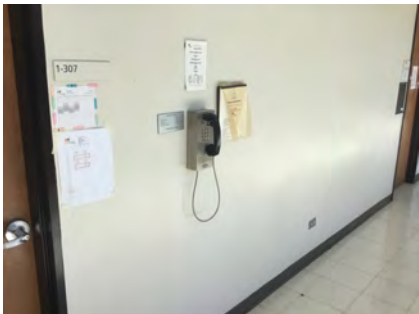
<input type="checkbox"/> Staff Only			
			Priority 3 Severity 2			
<hr/>						
458	<p>TTY</p> <ul style="list-style-type: none">As-Built Description: Interior public text telephone (TTY) not provided at type of facility required to have a public text telephone.Proposed Solution: Provide text telephone.Notes: No TTY throughout building	<p>PCODE IB10</p> <p>ADAAG 91 4.1.3(17)(c)</p> <p>ADA 2010 216.9</p> <p>CBC 2007 1117B.2.9.1</p> <p>CBC 2016 11B-216.9</p> <p>Project: SKYB1 Facelift</p> <p>Year to be Completed: 2021/2022</p> <p>Mitigated:</p> <p><input type="radio"/> YES</p> <p><input checked="" type="radio"/> NO</p>	1	JOB	\$3,450	\$3,450

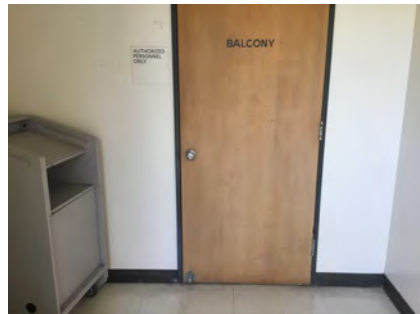
Item no., Rm no. and Name	Existing Architectural Barrier and Proposed Solution	Codes / Mitigation Info	Qty	Unit	Cost	Total
<u>Door Hardware</u>						
459	<ul style="list-style-type: none">• <i>As-Built Description:</i> Non-common use areas within this facility, such as offices, do not have accessible door hardware.• <i>Proposed Solution:</i> Provide lever handle or other accessible hardware when a specific need is identified in the future or when altering area.	<p>PCODE ID07C ADAAG 91 4.13.9 ADA 2010 404.2.7 CBC 2007 1133B.2.5.2 CBC 2016 11B-404.2.7</p> <p>Project: SKYB1 Facelift</p> <p>Year to be Completed: 2021/2022</p> <p>Mitigated: <input type="radio"/> YES <input checked="" type="radio"/> NO</p>	1	JOB	\$750	\$750

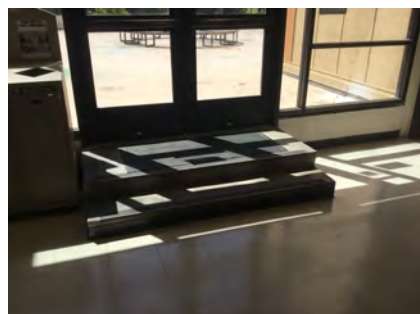
<input type="checkbox"/> Staff Only			
			Priority 2 Severity 3			
<u>Stairway</u>						
463	<ul style="list-style-type: none">• <i>As-Built Description:</i> The leading 2" of the tread does not have visual contrast of dark-on-light or light-on-dark from the remainder of the tread.• <i>Proposed Solution:</i> Provide 2" min., 4" max. wide contrasting color strip 1" max. from nosing on top & bottom treads when altering area.	<p>PCODE II02B ADA 2010 504.4 CBC 2007 1133B.4.4 CBC 2016 11B-504.4.1</p> <p>Project: SKYB1 Facelift</p> <p>Year to be Completed: 2021/2022</p> <p>Mitigated: <input type="radio"/> YES <input checked="" type="radio"/> NO</p>	10	LF	\$42	\$420

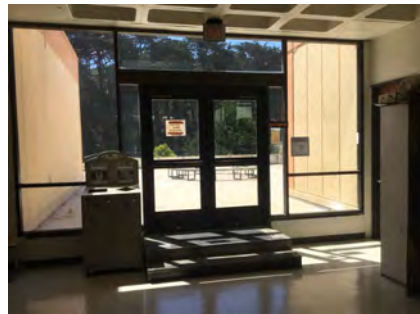
Item no., Rm no. and Name	Existing Architectural Barrier and Proposed Solution	Codes / Mitigation Info	Qty	Unit	Cost	Total
Route Sign						
462	<ul style="list-style-type: none">• <i>As-Built Description:</i> No sign by inaccessible route directing persons to an accessible route.• <i>Proposed Solution:</i> Provide directional sign.• <i>Notes:</i> Install directional sign at in accessible means of egress.	<p>PCODE SA20 ADAAG 91 35.163(b) ADA 2010 216.3 CBC 2007 1127B.3 CBC 2016 11B-216.3</p> <p>Project: SKYB1 Facelift</p> <p>Year to be Completed: 2021/2022</p> <p>Mitigated: <input type="radio"/> YES <input checked="" type="radio"/> NO</p>	1	JOB	\$510	\$510

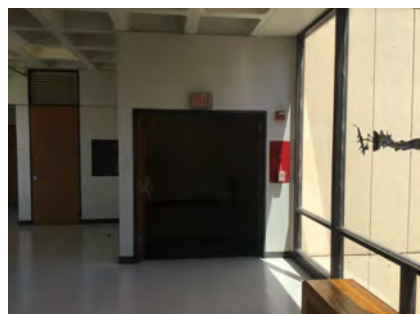
<input type="checkbox"/> Staff Only			
			Priority 2 Severity 4			
Signage						
476	<ul style="list-style-type: none">• <i>As-Built Description:</i> At door leading into exit stairway: Where required exit signs are installed, signs to provide exiting information for people with vision impairment are not provided.• <i>Proposed Solution:</i> Provide raised letter/Braille "EXIT STAIR UP/DOWN" sign at door.	<p>PCODE SA10B ADAAG 91 4.1.3(16) ADA 2010 216.4.1 CBC 2007 1011.3 CBC 2016 11B-216.4.1</p> <p>Project: SKYB1 Facelift</p> <p>Year to be Completed: 2021/2022</p> <p>Mitigated: <input type="radio"/> YES <input checked="" type="radio"/> NO</p>	2	JOB	\$270	\$540

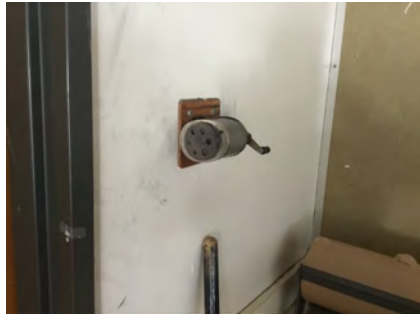
Item no., Rm no. and Name	Existing Architectural Barrier and Proposed Solution	Codes / Mitigation Info	Qty	Unit	Cost	Total
Reach Range						
469	<ul style="list-style-type: none"> As-Built Description: Reach height to control or access point, where side approach is available, exceeds 48" or is less than 15" in height, or exceeds 10" in depth. As-Built: 58" AFF Proposed Solution: Modify equipment or mounting. 	PCODE IE02 ADAAG 91 4.2.6 ADA 2010 308.3.1 CBC 2007 1118B.6 CBC 2016 11B-308.3 Project: SKYB1 Facelift Year to be Completed: 2021/2022 Mitigated: <input type="radio"/> YES <input checked="" type="radio"/> NO	2	JOB	\$300	\$600

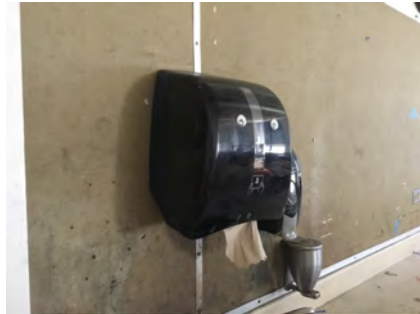
<input type="checkbox"/> Staff Only Priority 2 Severity 3			
470	<ul style="list-style-type: none"> As-Built Description: Reach height to control or access point, where side approach is available, exceeds 48" or is less than 15" in height, or exceeds 10" in depth. As-Built: 50" and 53" AFF Proposed Solution: Modify equipment or mounting. 	PCODE IE02 ADAAG 91 4.2.6 ADA 2010 308.3.1 CBC 2007 1118B.6 CBC 2016 11B-308.3 Project: SKYB1 Facelift Year to be Completed: 2021/2022 Mitigated: <input type="radio"/> YES <input checked="" type="radio"/> NO	4	JOB	\$300	\$1,200

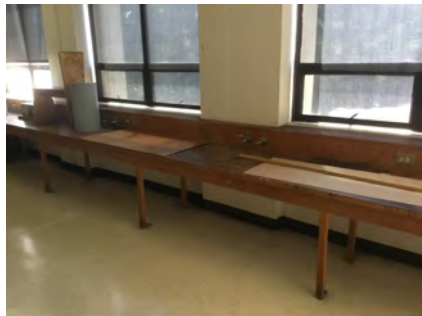
Item no., Rm no. and Name	Existing Architectural Barrier and Proposed Solution	Codes / Mitigation Info	Qty	Unit	Cost	Total
Non-Fixed Desk						
467	<ul style="list-style-type: none"> As-Built Description: Accessible non-fixed table or desk (top 28" to 34" high; knee space at least 27" high x 19" deep x 30" wide) not provided. As-Built: 23.5" knee clearance Proposed Solution: Provide table or desk with accessible dimensions when purchasing new furniture. 	PCODE IN02A ADAAG 91 4.32.3 & .4 ADA 2010 306.1 CBC 2007 1122B.3 & 4 CBC 2016 11B-306.1 & 11B-902.3 Project: SKYB1 Facelift Year to be Completed: 2021/2022 Mitigated: <input type="radio"/> YES <input checked="" type="radio"/> NO	1	JOB	\$4,800	\$4,800

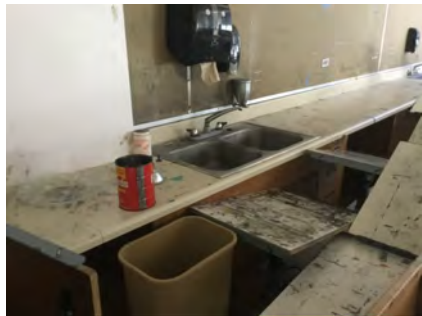
Sink						
468	<ul style="list-style-type: none"> As-Built Description: Sink rim higher than 34" above floor. As-Built: 36.5" AFF Proposed Solution: Remodel sink cabinet to lower sink. 	PCODE IN06 ADAAG 91 4.24.2 ADA 2010 606.3 CBC 2007 1115B.4.7.1 CBC 2016 11B-606.3 Project: SKYB1 Facelift Year to be Completed: 2021/2022 Mitigated: <input type="radio"/> YES <input checked="" type="radio"/> NO	2	JOB	\$5,250	\$10,500

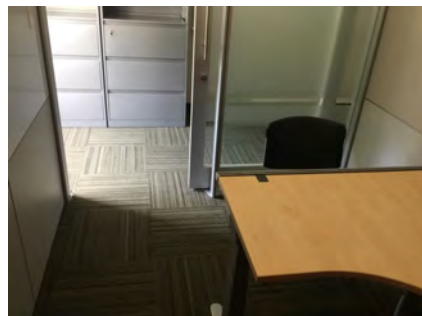
Item no., Rm no. and Name	Existing Architectural Barrier and Proposed Solution	Codes / Mitigation Info	Qty	Unit	Cost	Total
<u>Sliding/Folding Door</u>						
1250	<ul style="list-style-type: none">• <i>As-Built Description:</i> Front approach: Sliding or folding door does not have clear and level maneuvering space measuring door width x 48".• <i>As-Built:</i> 36" to desk• <i>Proposed Solution:</i> Remove or relocate furniture or storage items.	<p>PCODE ID21A ADAAG 91 Fig. 25(d) ADA 2010 404.2.4 CBC 2007 11B-26A CBC 2016 11B-404.2.4</p> <p>Project: SKYB1 Facelift</p> <p>Year to be Completed: 2021/2022</p> <p>Mitigated: <input type="radio"/> YES <input checked="" type="radio"/> NO</p>	1	JOB	\$150	\$150

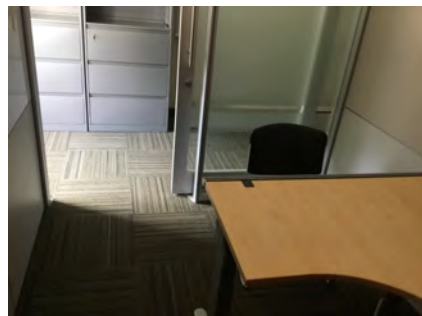
<input type="checkbox"/> Staff Only			
			Priority 2 Severity 3			
<u>Turning Space</u>						
1251	<ul style="list-style-type: none">• <i>As-Built Description:</i> The area does not provide a minimum 60" diameter turning space within to allow maneuvering through the space.• <i>Proposed Solution:</i> Modify area to provide sufficient maneuvering space.• <i>Notes:</i> Enlarge the spaces or use other rooms for people who need more maneuvering clearance.	<p>PCODE IH05 ADA 2010 304.3 CBC 2016 11B-304.3</p> <p>Project: SKYB1 Facelift</p> <p>Year to be Completed: 2021/2022</p> <p>Mitigated: <input type="radio"/> YES <input checked="" type="radio"/> NO</p>	1	JOB	\$1,500	\$1,500

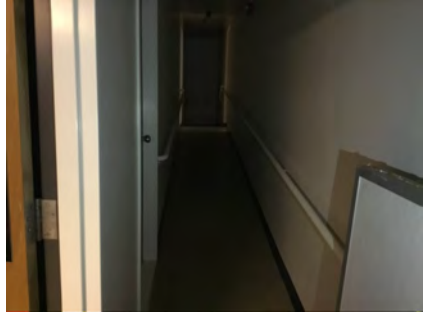
492	<ul style="list-style-type: none"> As-Built Description: Handrail gripping surface top not mounted between 34" and 38" above ramp surface or stair nosings. As-Built: 33" AFF Proposed Solution: Remove existing and provide new handrail. 	PCODE ED02 ADAAG 91 4.9.4(5) ADA 2010 505.4 CBC 2007 1133B.4.2.1 & CBC 2016 B.5.5.1 11B-505.4 Project: SKYB1 Facelift Year to be Completed: 2021/2022 Mitigated: <input type="radio"/> YES <input checked="" type="radio"/> NO	30	LF	\$225	\$6,750
-----	--	---	----	----	-------	---------

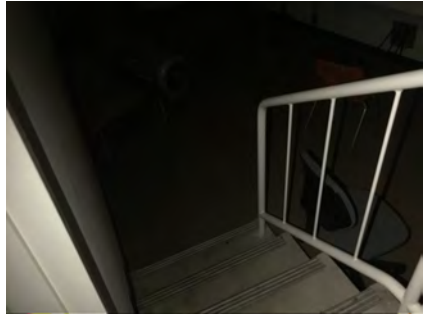
485	<ul style="list-style-type: none"> As-Built Description: Stair handrail does not extend horizontally 12" minimum beyond top nosing, and one tread width sloped, plus 12" minimum horizontally beyond the bottom nosing. As-Built: 0" Proposed Solution: Extend stair handrail at top and bottom (cost for each extension piece). 	PCODE ED06 ADAAG 91 4.9.4(2) ADA 2010 505.10.2; CBC 2007 1133B.4.2.2 CBC 2016 11B-505.10.2; 11B-505.10.3 Project: SKYB1 Facelift Year to be Completed: 2021/2022 Mitigated: <input type="radio"/> YES <input checked="" type="radio"/> NO	1	JOB	\$510	\$510
-----	--	--	---	-----	-------	-------

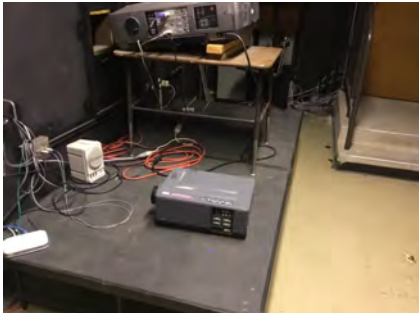
Item no., Rm no. and Name	Existing Architectural Barrier and Proposed Solution	Codes / Mitigation Info	Qty	Unit	Cost	Total
Clear Space						
488	<ul style="list-style-type: none">• <i>As-Built Description:</i> Clear floor space is not 30" x 48" minimum at all switches, outlets and other controls.• <i>Proposed Solution:</i> Relocate existing furniture/obstructions.• <i>Notes:</i> Clear floor space obstructed by platform.	<p>PCODE IC06A</p> <p>ADAAG 91 4.1.2(12) & [4.1.3 (13)]</p> <p>ADA 2010 309.2</p> <p>CBC 2007 1117B.6.2</p> <p>CBC 2016 11B-309.2</p> <p>Project: SKYB1 Facelift</p> <p>Year to be Completed: 2021/2022</p> <p>Mitigated: <input type="radio"/> YES <input checked="" type="radio"/> NO</p>	1	JOB	\$150	\$150

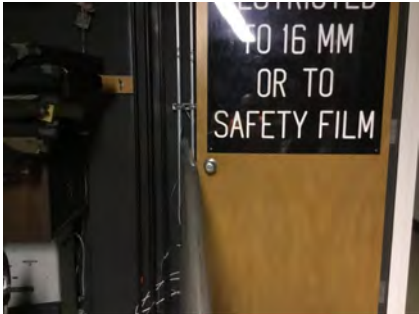
489	<ul style="list-style-type: none">• <i>As-Built Description:</i> Door does not have accessible operating hardware.• <i>Proposed Solution:</i> Provide lever handle or other accessible hardware.	<p>PCODE ID07</p> <p>ADAAG 91 4.13.9</p> <p>ADA 2010 404.2.7</p> <p>CBC 2007 1133B.2.5.2</p> <p>CBC 2016 11B-404.2.7</p> <p>Project: SKYB1 Facelift</p> <p>Year to be Completed: 2021/2022</p> <p>Mitigated: <input type="radio"/> YES <input checked="" type="radio"/> NO</p>	2	JOB	\$750	\$1,500

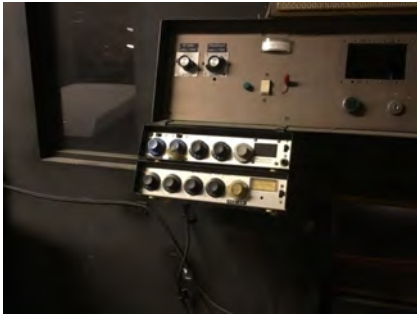
Item no., Rm no. and Name	Existing Architectural Barrier and Proposed Solution	Codes / Mitigation Info	Qty	Unit	Cost	Total
<u>Reach Range</u>						
487	<ul style="list-style-type: none">As-Built Description: Reach height to control or access point, where side approach is available, exceeds 48" or is less than 15" in height, or exceeds 10" in depth.As-Built: 63" AFFProposed Solution: Modify equipment or mounting.	<p>PCODE IE02</p> <p>ADAAG 91 4.2.6</p> <p>ADA 2010 308.3.1</p> <p>CBC 2007 1118B.6</p> <p>CBC 2016 11B-308.3</p> <p>Project: SKYB1 Facelift</p> <p>Year to be Completed: 2021/2022</p> <p>Mitigated:</p> <p><input type="radio"/> YES</p> <p><input checked="" type="radio"/> NO</p>	1	JOB	\$300	\$300

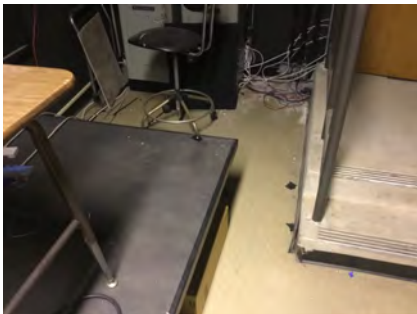
<input checked="" type="checkbox"/> Staff Only			
			<div><div>Priority</div><div>4</div></div> <div><div>Severity</div><div>2</div></div>			
<u>Corridor</u>						
486	<ul style="list-style-type: none">As-Built Description: Corridor, for occupant load less than 10, less than 36" wide.As-Built: 12" wideProposed Solution: Remove or relocate furniture and storage items.	<p>PCODE IH03A</p> <p>ADAAG 91 4.3.3</p> <p>ADA 2010 403.5.1</p> <p>CBC 2007 1133B.3.1</p> <p>CBC 2016 11B-403.5.1</p> <p>Project: SKYB1 Facelift</p> <p>Year to be Completed: 2021/2022</p> <p>Mitigated:</p> <p><input type="radio"/> YES</p> <p><input checked="" type="radio"/> NO</p>	1	JOB	\$150	\$150

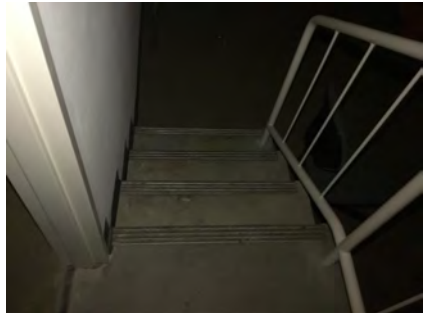
Item no., Rm no. and Name	Existing Architectural Barrier and Proposed Solution	Codes / Mitigation Info	Qty	Unit	Cost	Total
<u>Stairway</u>						
484	<ul style="list-style-type: none"> As-Built Description: The leading 2" of the tread does not have visual contrast of dark-on-light or light-on-dark from the remainder of the tread. Proposed Solution: Provide 2" min., 4" max. wide contrasting color strip 1" max. from nosing on top & bottom treads when altering area. 	PCODE I102B ADA 2010 504.4 CBC 2007 1133B.4.4 CBC 2016 11B-504.4.1 Project: SKYB1 Facelift Year to be Completed: 2021/2022 Mitigated: <input type="radio"/> YES <input checked="" type="radio"/> NO	16	LF	\$42	\$672

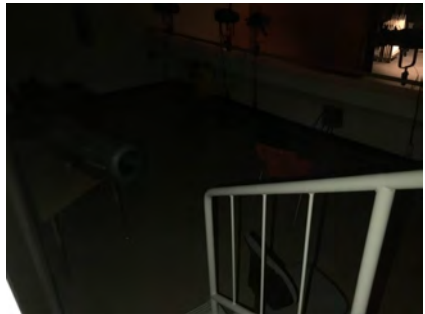
<u>Elevator</u>						
483	<ul style="list-style-type: none"> As-Built Description: Freight elevator not accessible for primary path of travel. Proposed Solution: Retrofit freight elevator to comply as passenger elevator; itemized changes to follow. Notes: Not accessible due to stairs. The room is curved and therefore difficult to measure however it appears to be less than 300 ft.². Consider whether it is feasible to make this area accessible. Considered developing a policy to utilize the more accessible lighting for students who cannot use stairs. 	PCODE IK01AREF ADAAG 91 4.10.1 ADA 2010 402.2 CBC 2007 1007.2.1 CBC 2016 11B-402.2 Project: SKYB1 Facelift Year to be Completed: 2021/2022 Mitigated: <input type="radio"/> YES <input checked="" type="radio"/> NO		REF

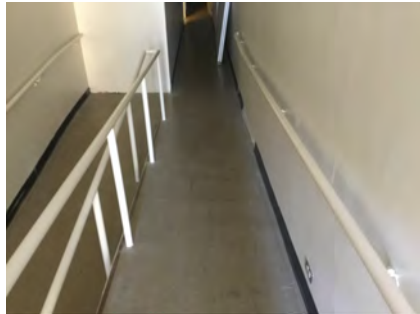
Item no., Rm no. and Name	Existing Architectural Barrier and Proposed Solution	Codes / Mitigation Info	Qty	Unit	Cost	Total
<u>Height</u>						
498	<ul style="list-style-type: none"> As-Built Description: Handrail gripping surface top not mounted between 34" and 38" above ramp surface or stair nosings. As-Built: 33" AFF Proposed Solution: Remove existing and provide new handrail. 	PCODE ED02 ADAAG 91 4.9.4(5) ADA 2010 505.4 CBC 2007 1133B.4.2.1 & CBC 2016 B.5.5.1 11B-505.4 Project: SKYB1 Facelift Year to be Completed: 2021/2022 Mitigated: <input type="radio"/> YES <input checked="" type="radio"/> NO	30	LF	\$225	\$6,750

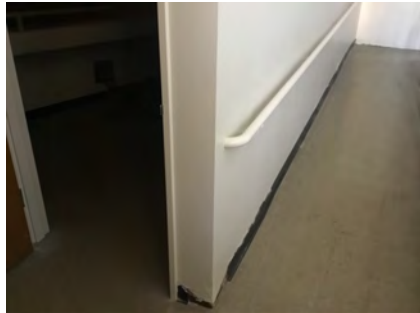
501	<ul style="list-style-type: none"> As-Built Description: Ramp handrail does not extend horizontally 12" past top and / or bottom of ramp. Proposed Solution: Provide ramp handrail extension (cost for each extension piece). 	PCODE ED05 ADAAG 91 4.8.5(2) ADA 2010 505.10.1 CBC 2007 1133B.4.2.2 & CBC 2016 1133B.5.5.1 11B-505.10.1 Project: SKYB1 Facelift Year to be Completed: 2021/2022 Mitigated: <input type="radio"/> YES <input checked="" type="radio"/> NO	1	JOB	\$510	\$510
