SAN MATEO COUNTY
COMMUNITY
COLLEGE DISTRICT

San Mateo County Community College District Americans with Disabilities Act Self-Evaluation and Transition Plan

Report Prepared by:

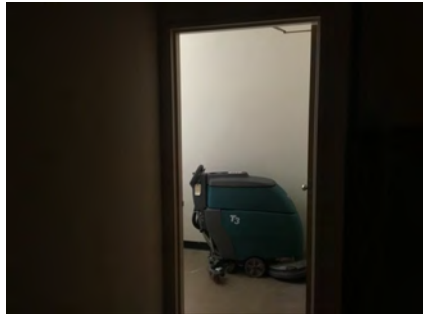
Item no., Rm no. and Name	Existing Architectural Barrier and Proposed Solution	Codes / Mitigation Info	Qty	Unit	Cost	Total
Door Swing						
500	<ul style="list-style-type: none"> As-Built Description: Front approach: At push side, door does not have clear and level maneuvering space measuring door width x 48" (door width plus 12" if door has both, latch and closer). Proposed Solution: Remove the closer and/or latch. 	PCODE ID24A ADAAG 91 Fig. 25(a) ADA 2010 404.2.4 CBC 2007 11B-26A(a) CBC 2016 11B-404.2.4 Project: SKYB1 Facelift Year to be Completed: 2021/2022 Mitigated: <input type="radio"/> YES <input checked="" type="radio"/> NO	1	JOB	\$150	\$150

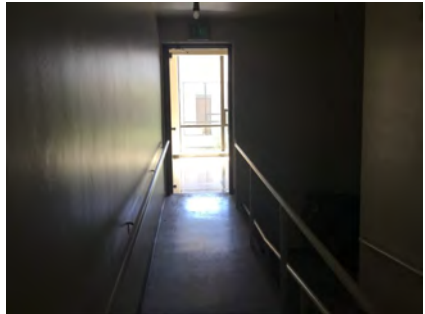
<input checked="" type="checkbox"/> Staff Only Priority 4 Severity 4			
496	<ul style="list-style-type: none"> As-Built Description: Front approach: At push side, door does not have clear and level maneuvering space measuring door width x 48" (door width plus 12" if door has both, latch and closer). As-Built: 0" strike side clearance Proposed Solution: Provide relocated new door and frame; remodel walls as needed. 	PCODE ID24B ADAAG 91 Fig. 25(a) ADA 2010 404.2.4 CBC 2007 11B-26A(a) CBC 2016 11B-404.2.4 Project: SKYB1 Facelift Year to be Completed: 2021/2022 Mitigated: <input type="radio"/> YES <input checked="" type="radio"/> NO	1	JOB	\$7,800	\$7,800

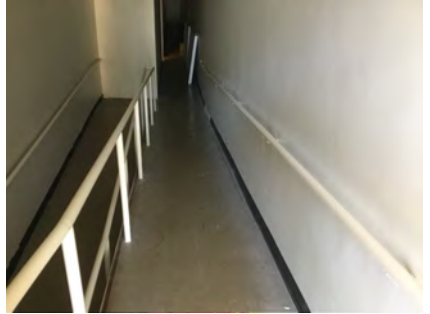
Item no., Rm no. and Name	Existing Architectural Barrier and Proposed Solution	Codes / Mitigation Info	Qty	Unit	Cost	Total
Corridor						
494	<ul style="list-style-type: none"> • <i>As-Built Description:</i> Corridor, for occupant load less than 10, less than 36" wide. • <i>As-Built:</i> 34.25" wide between handrails • <i>Proposed Solution:</i> Remove or relocate furniture and storage items. • <i>Notes:</i> 38" wide between the wall and handrail. 	PCODE IH03AREF ADAAG 91 4.3.3 ADA 2010 403.5.1 CBC 2007 1133B.3.1 CBC 2016 11B-403.5.1 Project: SKYB1 Facelift Year to be Completed: 2021/2022 Mitigated: <input type="radio"/> YES <input checked="" type="radio"/> NO				
			REF

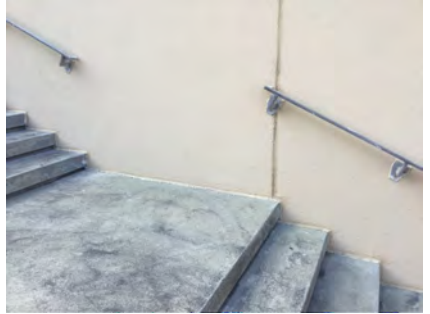
Item no., Rm no. and Name	Existing Architectural Barrier and Proposed Solution	Codes / Mitigation Info	Qty	Unit	Cost	Total
Top & Bottom Extension at Stairs						
688	<ul style="list-style-type: none"> As-Built Description: Stair handrail does not extend horizontally 12" minimum beyond top nosing, and one tread width sloped, plus 12" minimum horizontally beyond the bottom nosing. As-Built: 0" Proposed Solution: Extend stair handrail at top and bottom (cost for each extension piece). Notes: There is an accessible route connecting levels on the north side of the building. Therefore the extensions are only required in alterations. 	PCODE ED06REF ADAAG 91 4.9.4(2) ADA 2010 505.10.2; CBC 2007 1133B.4.2.2 CBC 2016 11B-505.10.2; 11B-505.10.3 Project: SKYB2 Renovation Year to be Completed: 2021/2022 Mitigated: <input type="radio"/> YES <input checked="" type="radio"/> NO				
			REF

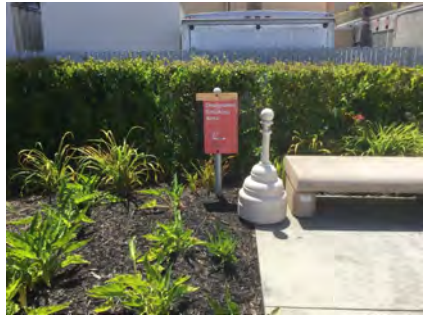
Item no., Rm no. and Name	Existing Architectural Barrier and Proposed Solution	Codes / Mitigation Info	Qty	Unit	Cost	Total
Signage						
2268	<ul style="list-style-type: none"> As-Built Description: Sign characters not readable because they are not sized for viewing distance. As-Built: Characters are 32" AFF Proposed Solution: Provide compliant signage. Notes: Character height 40" high minimum per CBC 11B-703.5.5. 	PCODE SA02A ADAAG 91 4.30.3 ADA 2010 703.5.5 CBC 2007 1117B.5.4 CBC 2016 11B-502.6 Project: SKYB2 Renovation Year to be Completed: 2021/2022 Mitigated: <input type="radio"/> YES <input checked="" type="radio"/> NO	1	JOB	\$270	\$270

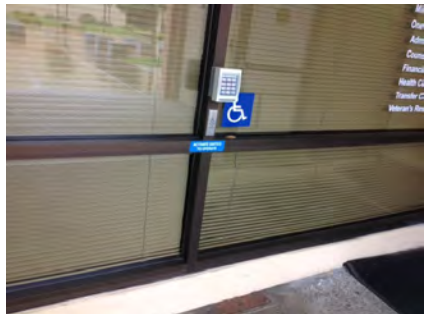
Item no., Rm no. and Name	Existing Architectural Barrier and Proposed Solution	Codes / Mitigation Info	Qty	Unit	Cost	Total
8	<ul style="list-style-type: none"> As-Built Description: Push plate to operate automatic door not a minimum 4" in diameter or a minimum of 4" x 4" square. As-Built: 2" by 4" Proposed Solution: Provide compliant push plate. 	PCODE ID13C CBC 2016 11B-404.2.9 2.C Project: SKYB2 Renovation Year to be Completed: 2021/2022 Mitigated: <input type="radio"/> YES <input checked="" type="radio"/> NO	1	JOB	\$1,500	\$1,500

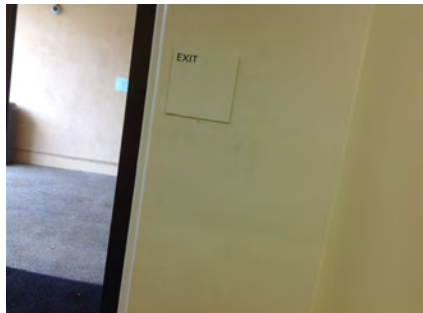
Signage

10	<ul style="list-style-type: none"> As-Built Description: Signs containing tactile characters is not located so that a clear floor space of 18" min x 18" min., centered on the tactile characters, is provided beyond the arc of any door swing between the closed position and 45 degree open position. As-Built: 62" above finished floor Proposed Solution: Relocate compliant signage on latch side of door located at compliant height with a clear floor space. 	PCODE SA07B ADA 2010 703.4.2 CBC 2016 11B-703.4.2 Project: SKYB2 Renovation Year to be Completed: 2021/2022 Mitigated: <input type="radio"/> YES <input checked="" type="radio"/> NO	1	JOB	\$150	\$150

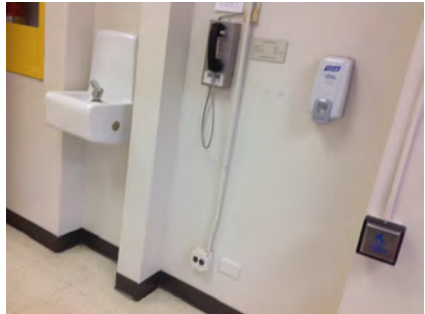
Item no., Rm no. and Name	Existing Architectural Barrier and Proposed Solution	Codes / Mitigation Info	Qty	Unit	Cost	Total
Reach Range						
11	<ul style="list-style-type: none"> As-Built Description: Reach height to control or access point, exceeds 48" or is less than 15". As-Built: 54" above finished floor to telephone Proposed Solution: Modify equipment or mounting. 	PCODE IE01 ADAAG 91 4.2.5 ADA 2010 308.2.1 CBC 2007 1118B.5 CBC 2016 11B-308.2.1 Project: SKYB2 Renovation Year to be Completed: 2021/2022 Mitigated: <input type="radio"/> YES <input checked="" type="radio"/> NO	1	JOB	\$300	\$300

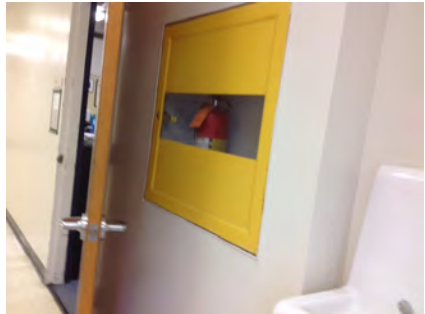
<input type="checkbox"/> Staff Only Priority 2 Severity 3			
14	<ul style="list-style-type: none"> As-Built Description: Reach height to control or access point, exceeds 48" or is less than 15". As-Built: 54" above finished floor Proposed Solution: Modify equipment or mounting. 	PCODE IE01 ADAAG 91 4.2.5 ADA 2010 308.2.1 CBC 2007 1118B.5 CBC 2016 11B-308.2.1 Project: SKYB2 Renovation Year to be Completed: 2021/2022 Mitigated: <input type="radio"/> YES <input checked="" type="radio"/> NO	1	JOB	\$300	\$300

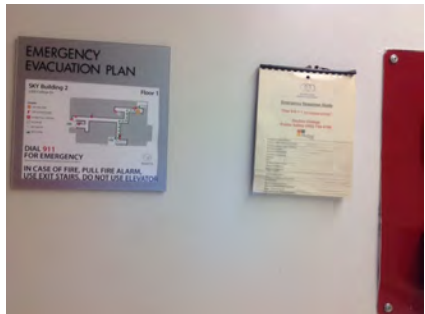
Item no., Rm no. and Name	Existing Architectural Barrier and Proposed Solution	Codes / Mitigation Info	Qty	Unit	Cost	Total
16	<ul style="list-style-type: none"> As-Built Description: Reach height to control or access point, exceeds 48" or is less than 15". As-Built: 54" above finished floor Proposed Solution: Modify equipment or mounting. 	PCODE IE01 ADAAG 91 4.2.5 ADA 2010 308.2.1 CBC 2007 1118B.5 CBC 2016 11B-308.2.1 Project: SKYB2 Renovation Year to be Completed: 2021/2022 Mitigated: <input type="radio"/> YES <input checked="" type="radio"/> NO	1	JOB	\$300	\$300

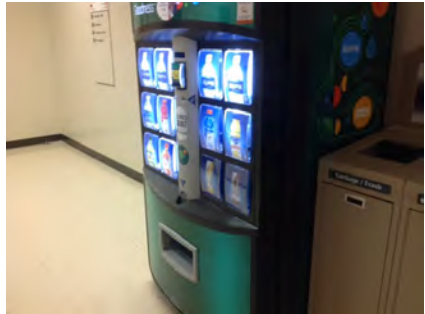
Vending Machine

15	<ul style="list-style-type: none"> As-Built Description: Vending machine coin slot or dispensing outlet, more than 48" above the floor. As-Built: 52" above finished floor Proposed Solution: Advise vendor/leasing company to provide accessible vending machine with highest operable part at 48" max. 	PCODE IL02 ADAAG 91 4.2.5 ADA 2010 308.2.1 CBC 2007 1126B CBC 2016 11B-308.2.1 Project: SKYB2 Renovation Year to be Completed: 2021/2022 Mitigated: <input type="radio"/> YES <input checked="" type="radio"/> NO

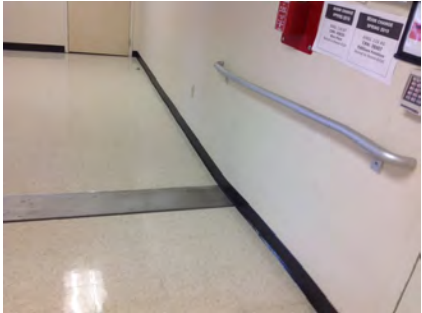
Item no., Rm no. and Name	Existing Architectural Barrier and Proposed Solution	Codes / Mitigation Info	Qty	Unit	Cost	Total
23	<ul style="list-style-type: none"> As-Built Description: Ramp handrail does not extend horizontally 12" past top and / or bottom of ramp. As-Built: 9" long Proposed Solution: Provide ramp handrail extension (cost for each extension piece). Notes: Near emergency exit 	PCODE ED05 ADAAG 91 4.8.5(2) ADA 2010 505.10.1 CBC 2007 1133B.4.2.2 & CBC 2016 1133B.5.5.1 11B-505.10.1 Project: SKYB2 Renovation Year to be Completed: 2021/2022 Mitigated: <input type="radio"/> YES <input checked="" type="radio"/> NO	4	JOB	\$510	\$2,040

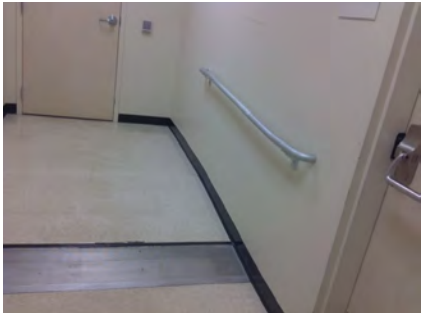
<input type="checkbox"/> Staff Only Priority Severity <input checked="" type="radio"/> 2 <input checked="" type="radio"/> 3
25	<ul style="list-style-type: none"> As-Built Description: Ramp handrail does not extend horizontally 12" past top and / or bottom of ramp. As-Built: 10" extensions Proposed Solution: Provide ramp handrail extension (cost for each extension piece). 	PCODE ED05 ADAAG 91 4.8.5(2) ADA 2010 505.10.1 CBC 2007 1133B.4.2.2 & CBC 2016 1133B.5.5.1 11B-505.10.1 Project: SKYB2 Renovation Year to be Completed: 2021/2022 Mitigated: <input type="radio"/> YES <input checked="" type="radio"/> NO	4	JOB	\$510	\$2,040

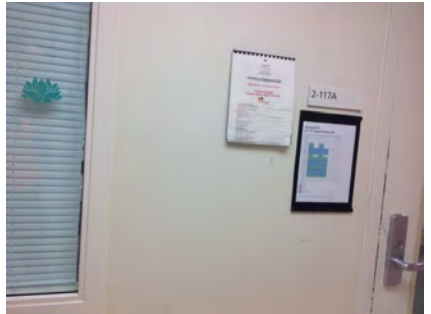
Item no., Rm no. and Name	Existing Architectural Barrier and Proposed Solution	Codes / Mitigation Info	Qty	Unit	Cost	Total
Reach Range						
18	<ul style="list-style-type: none"> As-Built Description: Reach height to control or access point, exceeds 48" or is less than 15". As-Built: 52" above finished floor Proposed Solution: Modify equipment or mounting. 	PCODE IE01 ADAAG 91 4.2.5 ADA 2010 308.2.1 CBC 2007 1118B.5 CBC 2016 11B-308.2.1 Project: SKYB2 Renovation Year to be Completed: 2021/2022 Mitigated: <input type="radio"/> YES <input checked="" type="radio"/> NO	1	JOB	\$300	\$300

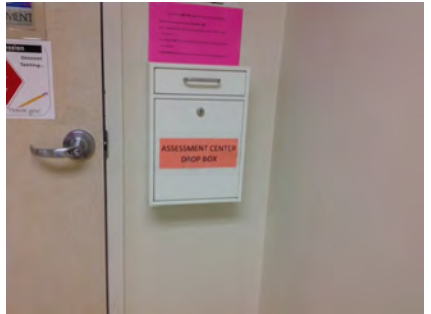
<input type="checkbox"/> Staff Only Priority 2 Severity 4			
19	<ul style="list-style-type: none"> As-Built Description: Reach height to control or access point, exceeds 48" or is less than 15". As-Built: 51" above finished floor Proposed Solution: Modify equipment or mounting. 	PCODE IE01 ADAAG 91 4.2.5 ADA 2010 308.2.1 CBC 2007 1118B.5 CBC 2016 11B-308.2.1 Project: SKYB2 Renovation Year to be Completed: 2021/2022 Mitigated: <input type="radio"/> YES <input checked="" type="radio"/> NO	1	JOB	\$300	\$300

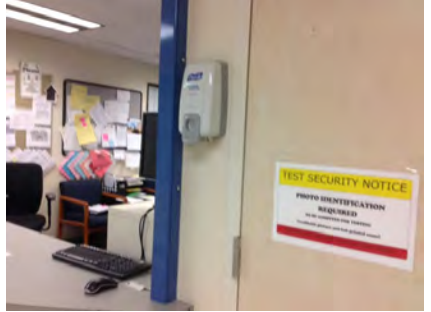
Item no., Rm no. and Name	Existing Architectural Barrier and Proposed Solution	Codes / Mitigation Info	Qty	Unit	Cost	Total
20	<ul style="list-style-type: none"> As-Built Description: Reach height to control or access point, exceeds 48" or is less than 15". As-Built: 52" above finished floor Proposed Solution: Modify equipment or mounting. 	PCODE IE01 ADAAG 91 4.2.5 ADA 2010 308.2.1 CBC 2007 1118B.5 CBC 2016 11B-308.2.1 Project: SKYB2 Renovation Year to be Completed: 2021/2022 Mitigated: <input type="radio"/> YES <input checked="" type="radio"/> NO	1	JOB	\$300	\$300

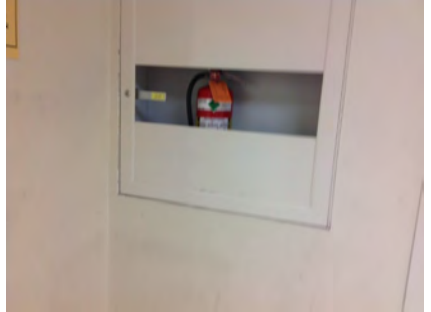
<input type="checkbox"/> Staff Only Priority 2 Severity 4			
21	<ul style="list-style-type: none"> As-Built Description: Reach height to control or access point, exceeds 48" or is less than 15". As-Built: 50" above finished floor Proposed Solution: Modify equipment or mounting. 	PCODE IE01 ADAAG 91 4.2.5 ADA 2010 308.2.1 CBC 2007 1118B.5 CBC 2016 11B-308.2.1 Project: SKYB2 Renovation Year to be Completed: 2021/2022 Mitigated: <input type="radio"/> YES <input checked="" type="radio"/> NO	1	JOB	\$300	\$300

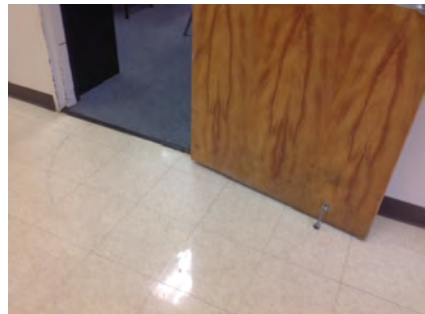
Item no., Rm no. and Name	Existing Architectural Barrier and Proposed Solution	Codes / Mitigation Info	Qty	Unit	Cost	Total
<u>Door Stopper</u>						
26	<ul style="list-style-type: none">• <i>As-Built Description:</i> At push side of door on accessible route, bottom 10" does not have a smooth, uninterrupted surface.• <i>Proposed Solution:</i> Remove door stopper when altering area. Provide rubber wedge.	<p>PCODE ID06A</p> <p>ADA 2010 404.2.10</p> <p>CBC 2007 1133B.2.6</p> <p>CBC 2016 11B-404.2.10</p> <p>Project: SKYB2 Renovation</p> <p>Year to be Completed: 2021/2022</p> <p>Mitigated: <input type="radio"/> YES <input checked="" type="radio"/> NO</p>	1	JOB	\$75	\$75

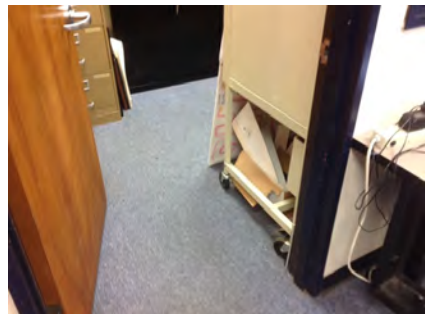
<input type="checkbox"/> Staff Only			
			Priority 2 Severity 3			
<u>Door Swing</u>						
30	<ul style="list-style-type: none">• <i>As-Built Description:</i> Front approach: At pull side, door does not have clear and level maneuvering space measuring door width plus 18" x 60". (24" x 60" at exterior doors).• <i>Proposed Solution:</i> Remove or relocate furniture or storage items.	<p>PCODE ID23A</p> <p>ADAAG 91 Fig. 25(a)</p> <p>ADA 2010 404.2.4</p> <p>CBC 2007 11B-26A(a)</p> <p>CBC 2016 11B-404.2.4</p> <p>Project: SKYB2 Renovation</p> <p>Year to be Completed: 2021/2022</p> <p>Mitigated: <input type="radio"/> YES <input checked="" type="radio"/> NO</p>	1	JOB	\$150	\$150

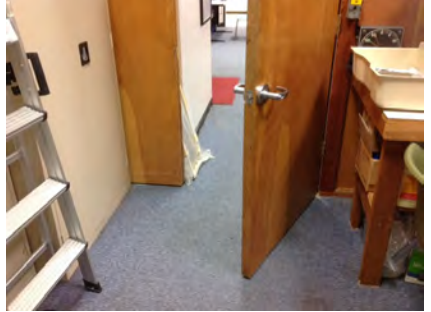
Item no., Rm no. and Name	Existing Architectural Barrier and Proposed Solution	Codes / Mitigation Info	Qty	Unit	Cost	Total
33	<ul style="list-style-type: none"> As-Built Description: Front approach: At pull side, door does not have clear and level maneuvering space measuring door width plus 18" x 60". (24" x 60" at exterior doors). As-Built: 15" strike to cabinet Proposed Solution: Remove or relocate furniture or storage items. 	PCODE ID23A ADAAG 91 Fig. 25(a) ADA 2010 404.2.4 CBC 2007 11B-26A(a) CBC 2016 11B-404.2.4 Project: SKYB2 Renovation Year to be Completed: 2021/2022 Mitigated: <input type="radio"/> YES <input checked="" type="radio"/> NO	1	JOB	\$150	\$150

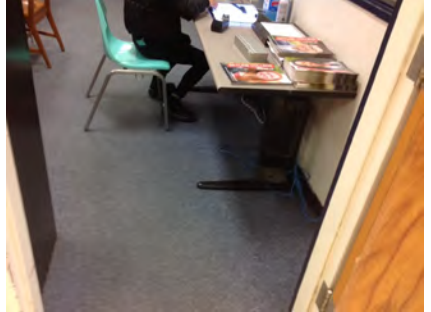
<input type="checkbox"/> Staff Only Priority 2 Severity 4			
27	<ul style="list-style-type: none"> As-Built Description: Front approach: At push side, door does not have clear and level maneuvering space measuring door width x 48" (door width plus 12" if door has both, latch and closer). Proposed Solution: Remove or relocate furniture or storage items. 	PCODE ID24A ADAAG 91 Fig. 25(a) ADA 2010 404.2.4 CBC 2007 11B-26A(a) CBC 2016 11B-404.2.4 Project: SKYB2 Renovation Year to be Completed: 2021/2022 Mitigated: <input type="radio"/> YES <input checked="" type="radio"/> NO	1	JOB	\$150	\$150

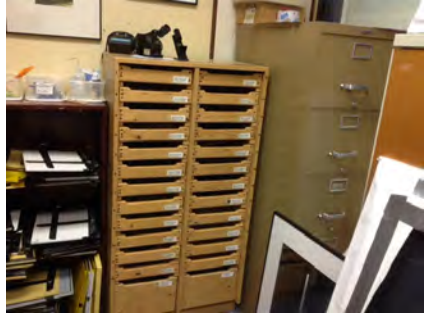
Item no., Rm no. and Name	Existing Architectural Barrier and Proposed Solution	Codes / Mitigation Info	Qty	Unit	Cost	Total
Reach Range						
31	<ul style="list-style-type: none"> As-Built Description: Reach height to control or access point, exceeds 48" or is less than 15". As-Built: 50" above finished floor Proposed Solution: Modify equipment or mounting. 	PCODE IE01 ADAAG 91 4.2.5 ADA 2010 308.2.1 CBC 2007 1118B.5 CBC 2016 11B-308.2.1 Project: SKYB2 Renovation Year to be Completed: 2021/2022 Mitigated: <input type="radio"/> YES <input checked="" type="radio"/> NO	1	JOB	\$300	\$300

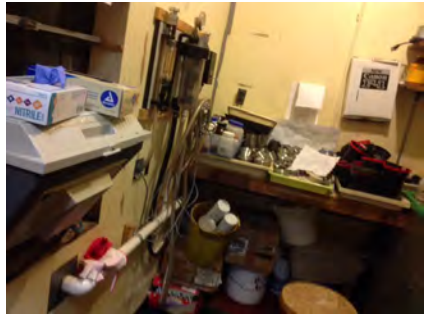
<input type="checkbox"/> Staff Only Priority 2 Severity 4			
39	<ul style="list-style-type: none"> As-Built Description: Reach height to control or access point, exceeds 48" or is less than 15". As-Built: 50" - 54" high Proposed Solution: Modify equipment or mounting. 	PCODE IE01 ADAAG 91 4.2.5 ADA 2010 308.2.1 CBC 2007 1118B.5 CBC 2016 11B-308.2.1 Project: SKYB2 Renovation Year to be Completed: 2021/2022 Mitigated: <input type="radio"/> YES <input checked="" type="radio"/> NO	1	JOB	\$300	\$300

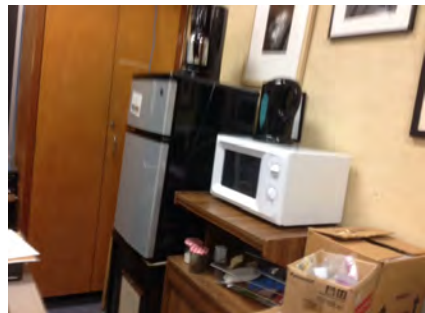
Item no., Rm no. and Name	Existing Architectural Barrier and Proposed Solution	Codes / Mitigation Info	Qty	Unit	Cost	Total
41	<ul style="list-style-type: none">As-Built Description: Reach height to control or access point, exceeds 48" or is less than 15".As-Built: 60" above finished floorProposed Solution: Modify equipment or mounting.	PCODE IE01 ADAAG 91 4.2.5 ADA 2010 308.2.1 CBC 2007 1118B.5 CBC 2016 11B-308.2.1 Project: SKYB2 Renovation Year to be Completed: 2021/2022 Mitigated: <div><input type="radio"/> YES</div> <div><input checked="" type="radio"/> NO</div>	1	JOB	\$300	\$300

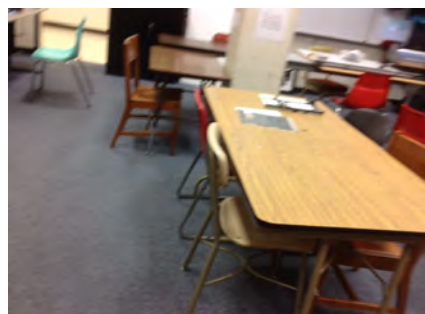
<div><input type="checkbox"/> Staff Only</div> <div><div>Priority</div><div>2</div><div>Severity</div><div>2</div></div>			
<hr/>						
29	<u>Non-Fixed Desk</u> <ul style="list-style-type: none">As-Built Description: Accessible non-fixed table or desk (top 28" to 34" high; knee space at least 27" high x 19" deep x 30" wide) not provided.Proposed Solution: Provide table or desk with accessible dimensions when purchasing new furniture.Notes: 22 total seats, no accessible seats provided.	PCODE IN02A ADAAG 91 4.32.3 & .4 ADA 2010 306.1 CBC 2007 1122B.3 & 4 CBC 2016 11B-306.1 & 11B-902.3 Project: SKYB2 Renovation Year to be Completed: 2021/2022 Mitigated: <div><input type="radio"/> YES</div> <div><input checked="" type="radio"/> NO</div>	2	JOB	\$4,800	\$9,600

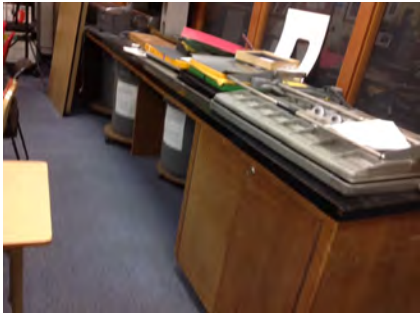
Item no., Rm no. and Name	Existing Architectural Barrier and Proposed Solution	Codes / Mitigation Info	Qty	Unit	Cost	Total
Public Counter						
28	<ul style="list-style-type: none">As-Built Description: Sales and service counter: Accessible section not provided (knee space min. 27" high x 19" deep x 30" wide)As-Built: 36" above finished floorProposed Solution: Retrofit existing counter to provide accessible seating section. Interim solution: Provide auxiliary counter, table, or clipboard.Notes: Where counters serve different amenities and purposes, each must be 34" high. If a work surface, knee depth must be required.	<p>PCODE IN03A</p> <p>ADAAG 91 4.32.3 & 4</p> <p>ADA 2010 306.3; 904.4</p> <p>CBC 2007 1122B.3 & 4</p> <p>CBC 2016 11B-306.3; 11B-904.4</p> <p>Project: SKYB2 Renovation</p> <p>Year to be Completed: 2021/2022</p> <p>Mitigated: <input type="radio"/> YES <input checked="" type="radio"/> NO</p>	1	JOB	\$6,000	\$6,000

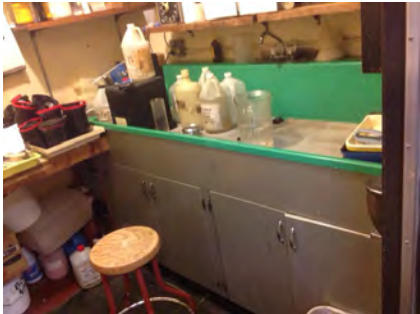
<input type="checkbox"/> Staff Only			
			Priority 2 Severity 2			
Sink						
36	<ul style="list-style-type: none">As-Built Description: Sink rim higher than 34" above floor.As-Built: 37" above finished floorProposed Solution: Remodel sink cabinet to lower sink.	<p>PCODE IN06</p> <p>ADAAG 91 4.24.2</p> <p>ADA 2010 606.3</p> <p>CBC 2007 1115B.4.7.1</p> <p>CBC 2016 11B-606.3</p> <p>Project: SKYB2 Renovation</p> <p>Year to be Completed: 2021/2022</p> <p>Mitigated: <input type="radio"/> YES <input checked="" type="radio"/> NO</p>	1	JOB	\$5,250	\$5,250

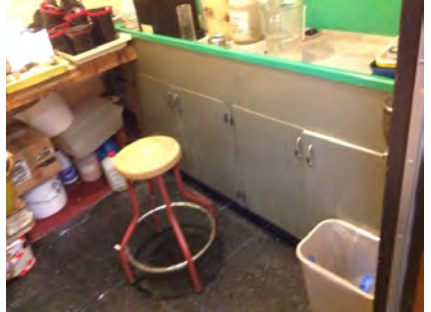
Item no., Rm no. and Name	Existing Architectural Barrier and Proposed Solution	Codes / Mitigation Info	Qty	Unit	Cost	Total
37	<ul style="list-style-type: none"> As-Built Description: Sink does not have knee space min. 27" high x 19" deep x 30" wide. Proposed Solution: Remodel sink cabinet. 	PCODE IN06A ADAAG 91 4.24.3 ADA 2010 606.2 CBC 2007 1115B.4.7.1 CBC 2016 11B-606.2 Project: SKYB2 Renovation Year to be Completed: 2021/2022 Mitigated: <input type="radio"/> YES <input checked="" type="radio"/> NO	1	JOB	\$5,250	\$5,250

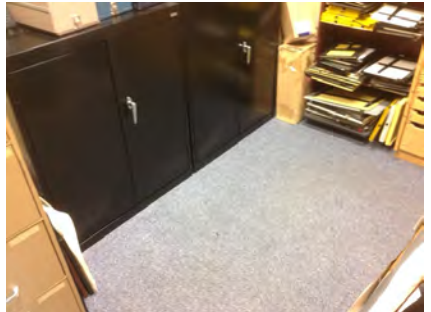
32	<ul style="list-style-type: none"> As-Built Description: Less than 60" diameter or T-shaped space provided for wheelchair turns. Proposed Solution: Retrofit space to provide 60" diameter or T-turn. 	PCODE IN04 ADAAG 91 4.2.3 ADA 2010 304.1 CBC 2007 1118B.3 CBC 2016 11B-304.1 Project: SKYB2 Renovation Year to be Completed: 2021/2022 Mitigated: <input type="radio"/> YES <input checked="" type="radio"/> NO	1	JOB	\$2,775	\$2,775

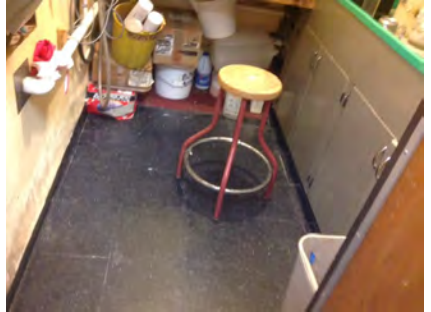
Item no., Rm no. and Name	Existing Architectural Barrier and Proposed Solution	Codes / Mitigation Info	Qty	Unit	Cost	Total
38	<ul style="list-style-type: none"> As-Built Description: Less than 60" diameter or T-shaped space provided for wheelchair turns. Proposed Solution: Retrofit space to provide 60" diameter or T-turn. 	PCODE IN04 ADAAG 91 4.2.3 ADA 2010 304.1 CBC 2007 1118B.3 CBC 2016 11B-304.1 Project: SKYB2 Renovation Year to be Completed: 2021/2022 Mitigated: <input type="radio"/> YES <input checked="" type="radio"/> NO	1	JOB	\$2,775	\$2,775

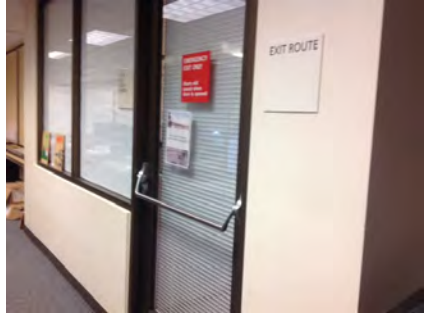
Item no., Rm no. and Name	Existing Architectural Barrier and Proposed Solution	Codes / Mitigation Info	Qty	Unit	Cost	Total
Signage						
44	<ul style="list-style-type: none"> • <i>As-Built Description:</i> Sign not located on latch side of door and/or not located at 48" min. above to baseline of the lowest Braille cells and 60" max. to baseline of the highest line of raised characters. • <i>As-Built:</i> 62" to bottom of tactile • <i>Proposed Solution:</i> Provide compliant signage including tactile characters and Grade II Braille on latch side of door located at compliant height. 	PCODE SA07 ADAAG 91 4.30.6 ADA 2010 703.4.1 CBC 2007 1117B.5.7 CBC 2016 11B-703.4.1 Project: SKYB2 Renovation Year to be Completed: 2021/2022 Mitigated: <input type="radio"/> YES <input checked="" type="radio"/> NO	1	JOB	\$150	\$150

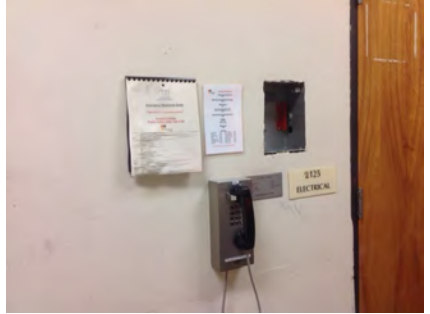
Item no., Rm no. and Name	Existing Architectural Barrier and Proposed Solution	Codes / Mitigation Info	Qty	Unit	Cost	Total
Reach Range						
52	<ul style="list-style-type: none"> As-Built Description: Reach height to control or access point, exceeds 48" or is less than 15". As-Built: 57" above finished floor Proposed Solution: Modify equipment or mounting. 	PCODE IE01 ADAAG 91 4.2.5 ADA 2010 308.2.1 CBC 2007 1118B.5 CBC 2016 11B-308.2.1 Project: SKYB2 Renovation Year to be Completed: 2021/2022 Mitigated: <input type="radio"/> YES <input checked="" type="radio"/> NO	1	JOB	\$300	\$300

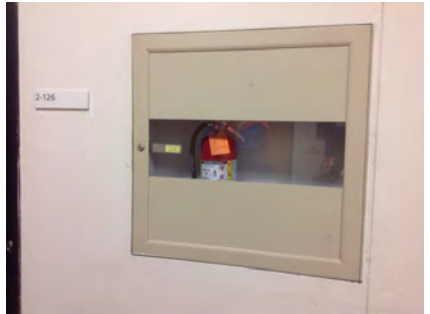
<input type="checkbox"/> Staff Only Priority 2 Severity 3			
53	<ul style="list-style-type: none"> As-Built Description: Reach height to control or access point, exceeds 48" or is less than 15". As-Built: 57" above finished floor Proposed Solution: Modify equipment or mounting. 	PCODE IE01 ADAAG 91 4.2.5 ADA 2010 308.2.1 CBC 2007 1118B.5 CBC 2016 11B-308.2.1 Project: SKYB2 Renovation Year to be Completed: 2021/2022 Mitigated: <input type="radio"/> YES <input checked="" type="radio"/> NO	1	JOB	\$300	\$300

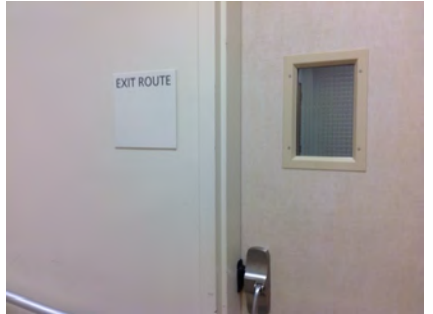
Item no., Rm no. and Name	Existing Architectural Barrier and Proposed Solution	Codes / Mitigation Info	Qty	Unit	Cost	Total
Signage						
50	<ul style="list-style-type: none"> • <i>As-Built Description:</i> Signs containing tactile characters is not located so that a clear floor space of 18" min x 18" min., centered on the tactile characters, is provided beyond the arc of any door swing between the closed position and 45 degree open position. • <i>As-Built:</i> 62" above finished floor • <i>Proposed Solution:</i> Relocate compliant signage on latch side of door located at compliant height with a clear floor space. 	PCODE SA07B ADA 2010 703.4.2 CBC 2016 11B-703.4.2 Project: SKYB2 Renovation Year to be Completed: 2021/2022 Mitigated: <input type="radio"/> YES <input checked="" type="radio"/> NO	2	JOB	\$150	\$300

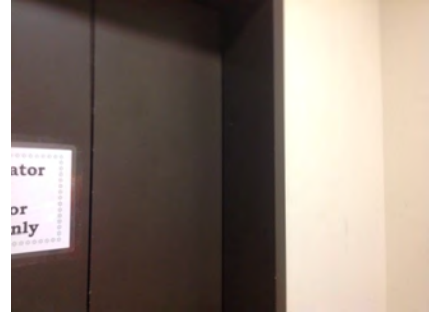
Item no., Rm no. and Name	Existing Architectural Barrier and Proposed Solution	Codes / Mitigation Info	Qty	Unit	Cost	Total
55	<ul style="list-style-type: none"> • <i>As-Built Description:</i> Braille and raised floor numbers on entrance jambs located more or less than 5' above floor. • <i>Proposed Solution:</i> Relocate Braille and raised floor numbers on entrance jambs to 5' above floor. 	PCODE IK11C ADAAG 91 4.10.5 ADA 2010 703.4.1 CBC 2007 1116B.1.14 CBC 2016 11B-703.4.1 Project: SKYB2 Renovation Year to be Completed: 2021/2022 Mitigated: <input type="radio"/> YES <input checked="" type="radio"/> NO	4	JOB	\$360	\$1,440

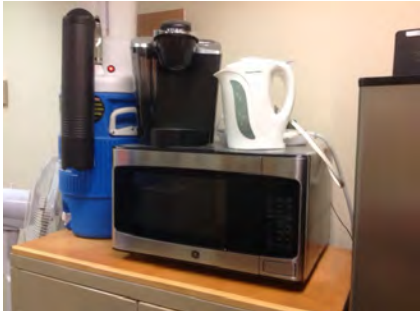
Item no., Rm no. and Name	Existing Architectural Barrier and Proposed Solution	Codes / Mitigation Info	Qty	Unit	Cost	Total
61	<ul style="list-style-type: none">As-Built Description: Reach height to control or access point, exceeds 48" or is less than 15".As-Built: 51"- 62" above finished floorProposed Solution: Modify equipment or mounting.Notes: Staff only area	<p>PCODE IE01</p> <p>ADAAG 91 4.2.5</p> <p>ADA 2010 308.2.1</p> <p>CBC 2007 1118B.5</p> <p>CBC 2016 11B-308.2.1</p> <p>Project: SKYB2 Renovation</p> <p>Year to be Completed: 2021/2022</p> <p>Mitigated:</p> <p><input type="radio"/> YES</p> <p><input checked="" type="radio"/> NO</p>	1	JOB	\$300	\$300

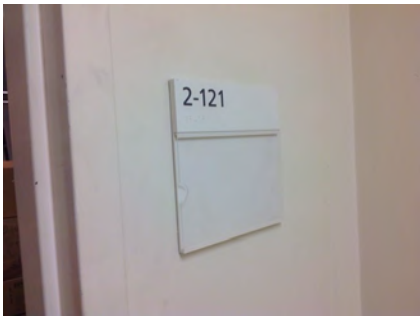
<div><input checked="" type="checkbox"/> Staff Only</div> <div><div>Priority</div><div>4</div><div>Severity</div><div>2</div></div>			
<hr/>						
Signage						
59	<ul style="list-style-type: none">As-Built Description: Sign not located on latch side of door and/or not located at 48" min. above to baseline of the lowest Braille cells and 60" max. to baseline of the highest line of raised characters.As-Built: 62" to bottom of tactileProposed Solution: Provide compliant signage including tactile characters and Grade II Braille on latch side of door located at compliant height.	<p>PCODE SA07</p> <p>ADAAG 91 4.30.6</p> <p>ADA 2010 703.4.1</p> <p>CBC 2007 1117B.5.7</p> <p>CBC 2016 11B-703.4.1</p> <p>Project: SKYB2 Renovation</p> <p>Year to be Completed: 2021/2022</p> <p>Mitigated:</p> <p><input type="radio"/> YES</p> <p><input checked="" type="radio"/> NO</p>	1	JOB	\$150	\$150

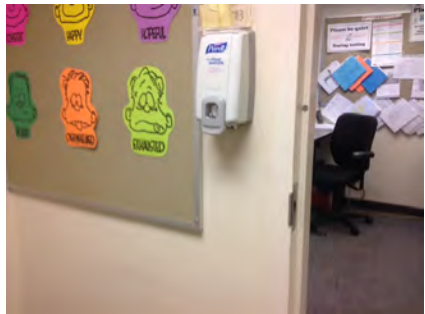
Item no., Rm no. and Name	Existing Architectural Barrier and Proposed Solution	Codes / Mitigation Info	Qty	Unit	Cost	Total
250	<ul style="list-style-type: none"> As-Built Description: Reach height to control or access point, exceeds 48" or is less than 15". As-Built: 51" above finished floor Proposed Solution: Modify equipment or mounting. 	PCODE IE01 ADAAG 91 4.2.5 ADA 2010 308.2.1 CBC 2007 1118B.5 CBC 2016 11B-308.2.1 Project: SKYB2 Renovation Year to be Completed: 2021/2022 Mitigated: <input type="radio"/> YES <input checked="" type="radio"/> NO	1	JOB	\$300	\$300

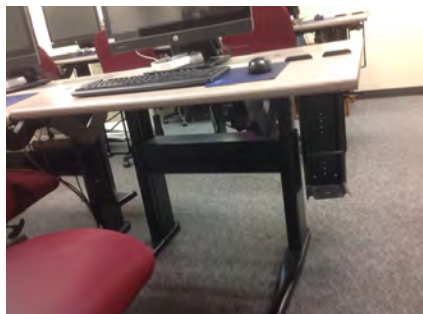
248	<ul style="list-style-type: none"> As-Built Description: Accessible non-fixed table or desk (top 28" to 34" high; knee space at least 27" high x 19" deep x 30" wide) not provided. As-Built: 25" wide Proposed Solution: Provide table or desk with accessible dimensions when purchasing new furniture. Notes: 20 seats, no accessible seat provided 	PCODE IN02A ADAAG 91 4.32.3 & .4 ADA 2010 306.1 CBC 2007 1122B.3 & 4 CBC 2016 11B-306.1 & 11B-902.3 Project: SKYB2 Renovation Year to be Completed: 2021/2022 Mitigated: <input type="radio"/> YES <input checked="" type="radio"/> NO	1	JOB	\$4,800	\$4,800

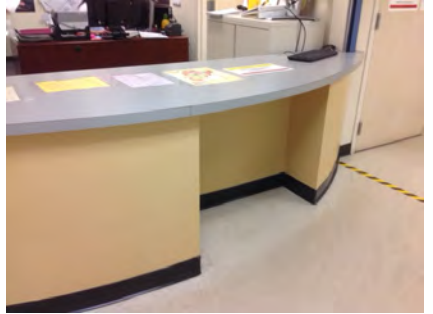
Item no., Rm no. and Name	Existing Architectural Barrier and Proposed Solution	Codes / Mitigation Info	Qty	Unit	Cost	Total
Public Counter						
62	<ul style="list-style-type: none"> • <i>As-Built Description:</i> Service counter (stand-up): Accessible section min. 36" length and 36" max. height (in CA: 28" to 34" high) not provided. • <i>As-Built:</i> 34.25" above finished floor • <i>Proposed Solution:</i> Retrofit existing counter to provide accessible section. Interim solution: Provide auxiliary counter, table, or clipboard. 	PCODE IN03 ADAAG 91 7.2(2) ADA 2010 904.4 CBC 2007 1122B.4 CBC 2016 11B-904.4 Project: SKYB2 Renovation Year to be Completed: 2021/2022 Mitigated: <input type="radio"/> YES <input checked="" type="radio"/> NO	1	JOB	\$6,000	\$6,000

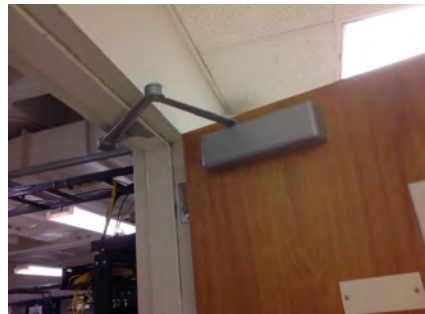
Item no., Rm no. and Name	Existing Architectural Barrier and Proposed Solution	Codes / Mitigation Info	Qty	Unit	Cost	Total
<u>Door Closer</u>						
65	<ul style="list-style-type: none">As-Built Description: Excessive force required to open door.As-Built: 8 lbs.Proposed Solution: Adjust regular door closer to accessible standards (5 lbs. max).	<p>PCODE ID03</p> <p>ADAAG 91 4.13.11</p> <p>ADA 2010 404.2.9</p> <p>CBC 2007 1133B.2.5</p> <p>CBC 2016 11B-404.2.9</p> <p>Project: SKYB2 Renovation</p> <p>Year to be Completed: 2021/2022</p> <p>Mitigated:</p> <p><input type="radio"/> YES</p> <p><input checked="" type="radio"/> NO</p>	1	JOB	\$75	\$75

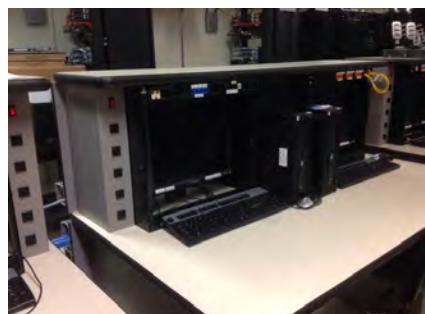
<input type="checkbox"/> Staff Only			
			<div><div>Priority</div><div>2</div></div> <div><div>Severity</div><div>4</div></div>			
<u>Reach Range</u>						
68	<ul style="list-style-type: none">As-Built Description: Reach height to control or access point, exceeds 48" or is less than 15".As-Built: 25" deep reach to outletsProposed Solution: Modify equipment or mounting.	<p>PCODE IE01</p> <p>ADAAG 91 4.2.5</p> <p>ADA 2010 308.2.1</p> <p>CBC 2007 1118B.5</p> <p>CBC 2016 11B-308.2.1</p> <p>Project: SKYB2 Renovation</p> <p>Year to be Completed: 2021/2022</p> <p>Mitigated:</p> <p><input type="radio"/> YES</p> <p><input checked="" type="radio"/> NO</p>	1	JOB	\$300	\$300

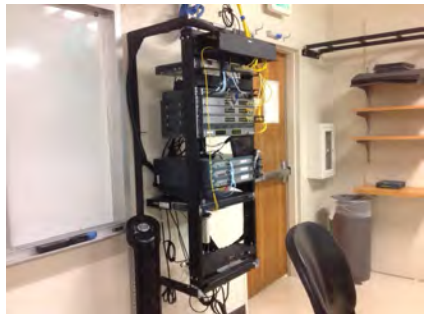
Item no., Rm no. and Name	Existing Architectural Barrier and Proposed Solution	Codes / Mitigation Info	Qty	Unit	Cost	Total
69	<ul style="list-style-type: none"> As-Built Description: Reach height to control or access point, exceeds 48" or is less than 15". As-Built: 64" above finished floor Proposed Solution: Modify equipment or mounting. 	PCODE IE01 ADAAG 91 4.2.5 ADA 2010 308.2.1 CBC 2007 1118B.5 CBC 2016 11B-308.2.1 Project: SKYB2 Renovation Year to be Completed: 2021/2022 Mitigated: <input type="radio"/> YES <input checked="" type="radio"/> NO	1	JOB	\$300	\$300

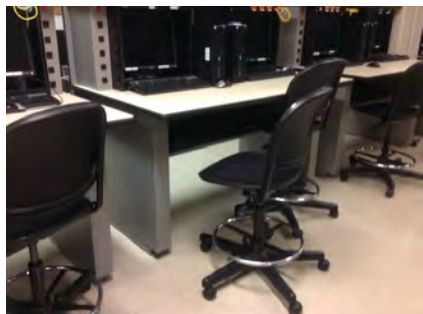
67	<ul style="list-style-type: none"> As-Built Description: Accessible non-fixed table or desk (top 28" to 34" high; knee space at least 27" high x 19" deep x 30" wide) not provided. As-Built: 17" knee depth Proposed Solution: Provide table or desk with accessible dimensions when purchasing new furniture. Notes: 22 total seats with no accessible table provided 	PCODE IN02A ADAAG 91 4.32.3 & .4 ADA 2010 306.1 CBC 2007 1122B.3 & 4 CBC 2016 11B-306.1 & 11B-902.3 Project: SKYB2 Renovation Year to be Completed: 2021/2022 Mitigated: <input type="radio"/> YES <input checked="" type="radio"/> NO	2	JOB	\$4,800	\$9,600

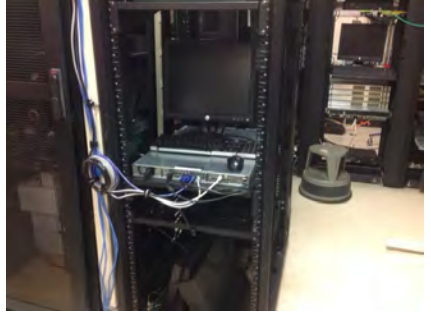
Item no., Rm no. and Name	Existing Architectural Barrier and Proposed Solution	Codes / Mitigation Info	Qty	Unit	Cost	Total
70	<ul style="list-style-type: none"> As-Built Description: Accessible non-fixed table or desk (top 28" to 34" high; knee space at least 27" high x 19" deep x 30" wide) not provided. Proposed Solution: Provide table or desk with accessible dimensions when purchasing new furniture. Notes: 13 server stations with computers with no knee space. Provide accessible tables where stations serve different purpose and uses. 	PCODE IN02A ADAAG 91 4.32.3 & .4 ADA 2010 306.1 CBC 2007 1122B.3 & 4 CBC 2016 11B-306.1 & 11B-902.3	1	JOB	\$4,800	\$4,800
Project: SKYB2 Renovation Year to be Completed: 2021/2022 Mitigated: <input type="radio"/> YES <input checked="" type="radio"/> NO

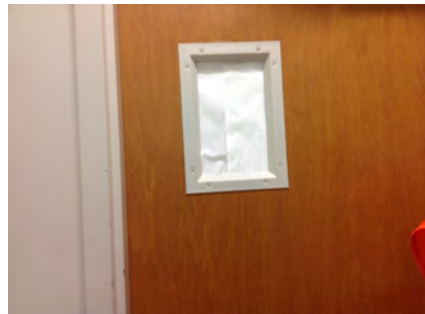
Item no., Rm no. and Name	Existing Architectural Barrier and Proposed Solution	Codes / Mitigation Info	Qty	Unit	Cost	Total
Door						
71	<ul style="list-style-type: none">As-Built Description: Vision Light at door that permits viewing, does not have bottom of at least one glazed panel located 43 inches maximum above the finish floor. (Exception: More than 66" above finished floor.)As-Built: 60" above finished floorProposed Solution: Provide new door with vision panel at 43" max.	<p>PCODE ID06C ADA 2010 404.2.11 CBC 2016 11B-404.2.11</p> <p>Project: SKYB2 Renovation</p> <p>Year to be Completed: 2021/2022</p> <p>Mitigated: <input type="radio"/> YES <input checked="" type="radio"/> NO</p>	1	JOB	\$7,500	\$7,500

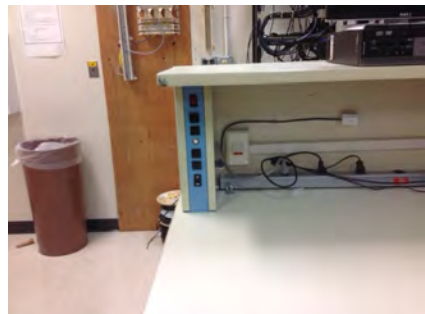
<input type="checkbox"/> Staff Only			
			Priority 2 Severity 1			
Reach Range						
75	<ul style="list-style-type: none">As-Built Description: Reach height to control or access point, exceeds 48" or is less than 15".As-Built: 26" deep reach to outletProposed Solution: Modify equipment or mounting.	<p>PCODE IE01 ADAAG 91 4.2.5 ADA 2010 308.2.1 CBC 2007 1118B.5 CBC 2016 11B-308.2.1</p> <p>Project: SKYB2 Renovation</p> <p>Year to be Completed: 2021/2022</p> <p>Mitigated: <input type="radio"/> YES <input checked="" type="radio"/> NO</p>	1	JOB	\$300	\$300

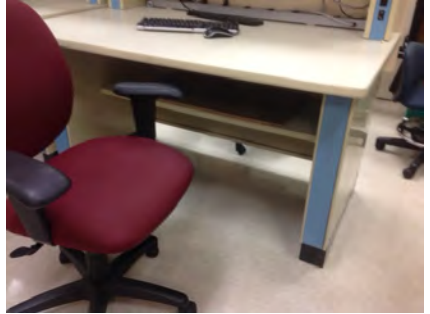
Item no., Rm no. and Name	Existing Architectural Barrier and Proposed Solution	Codes / Mitigation Info	Qty	Unit	Cost	Total
Non-Fixed Desk						
74	<ul style="list-style-type: none"> • <i>As-Built Description:</i> Accessible non-fixed table or desk (top 28" to 34" high; knee space at least 27" high x 19" deep x 30" wide) not provided. • <i>As-Built:</i> 17" knee depth • <i>Proposed Solution:</i> Provide table or desk with accessible dimensions when purchasing new furniture. • <i>Notes:</i> 10 seats with no accessible table provided 	PCODE IN02A ADAAG 91 4.32.3 & .4 ADA 2010 306.1 CBC 2007 1122B.3 & 4 CBC 2016 11B-306.1 & 11B-902.3 Project: SKYB2 Renovation Year to be Completed: 2021/2022 Mitigated: <input type="radio"/> YES <input checked="" type="radio"/> NO	1	JOB	\$4,800	\$4,800

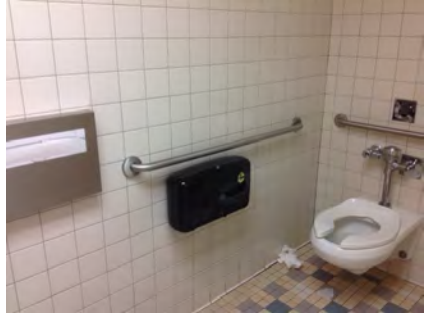
Item no., Rm no. and Name	Existing Architectural Barrier and Proposed Solution	Codes / Mitigation Info	Qty	Unit	Cost	Total
Grab Bars						
91	<ul style="list-style-type: none"> As-Built Description: Side grab bar less than 42" long, or located more than 12 inches max. from the rear wall, or extending less than 54" from rear wall (CA only: front end min. 24" in front of water closet). As-Built: 53" from rear wall Proposed Solution: Provide or relocate accessible side grab bar. 	PCODE WB07A ADAAG 91 Fig. 29(b) ADA 2010 604.5.1 CBC 2007 1115B.4.1.3.1 CBC 2016 11B-604.5.1 Project: SKYB2 Renovation Year to be Completed: 2021/2022 Mitigated: <input type="radio"/> YES <input checked="" type="radio"/> NO	1	JOB	\$780	\$780

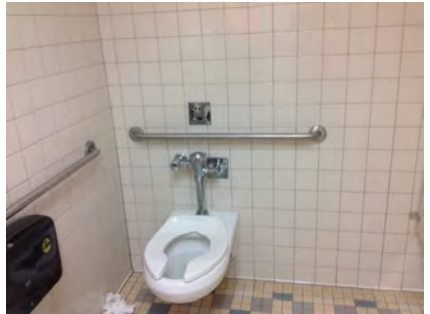
<input type="checkbox"/> Staff Only Priority 3 Severity 4			
90	<ul style="list-style-type: none"> As-Built Description: The rear wall grab is less than 36" min. or does not extend from the centerline of the water closet 12" min. on one side and 24" min. on the other side. As-Built: 23" offset Proposed Solution: Provide or relocate accessible rear grab bar. 	PCODE WB07B ADAAG 91 4.17.6 ADA 2010 604.5.2 CBC 2007 1115B.4.1.3.2 CBC 2016 11B-604.5.2 Project: SKYB2 Renovation Year to be Completed: 2021/2022 Mitigated: <input type="radio"/> YES <input checked="" type="radio"/> NO	1	JOB	\$1,020	\$1,020

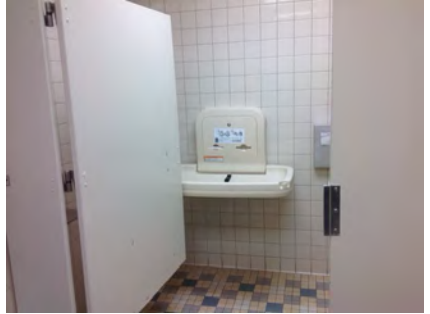
Item no., Rm no. and Name	Existing Architectural Barrier and Proposed Solution	Codes / Mitigation Info	Qty	Unit	Cost	Total
<u>Stall Door</u>						
87	<ul style="list-style-type: none"> • <i>As-Built Description:</i> Stall door to accessible compartment not self closing. • <i>Proposed Solution:</i> Adjust closer. 	PCODE WB05B ADAAG 91 4.22.4 ADA 2010 604.8.1.2 CBC 2007 1115B.3.1.4.4 CBC 2016 11B-604.8.1.2 Project: SKYB2 Renovation Year to be Completed: 2021/2022 Mitigated: <input type="radio"/> YES <input checked="" type="radio"/> NO	1	JOB	\$75	\$75

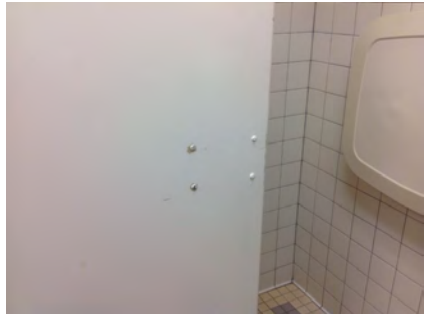
<input type="checkbox"/> Staff Only Priority 3 Severity 4			
88	<ul style="list-style-type: none"> • <i>As-Built Description:</i> Stall door does not have accessible operating hardware (U-pulls on both sides, flip-over or sliding lock). • <i>Proposed Solution:</i> Provide new accessible locking hardware that does not require grasping, pinching, or twisting and U-pulls on both sides. 	PCODE WB05C ADAAG 91 4.17.5 ADA 2010 604.8.1.2 CBC 2007 1115B.3.1.4.5 CBC 2016 11B-604.8.1.2 Project: SKYB2 Renovation Year to be Completed: 2021/2022 Mitigated: <input type="radio"/> YES <input checked="" type="radio"/> NO	1	JOB	\$300	\$300

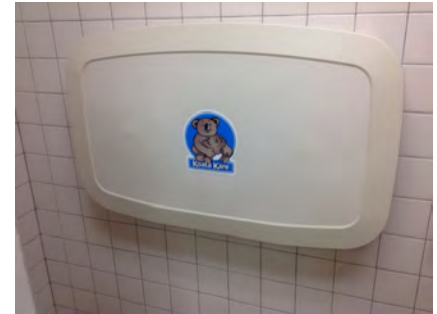
92	<ul style="list-style-type: none"> • <i>As-Built Description:</i> Baby changing tables shall not be located in accessible toilet compartments. • <i>Proposed Solution:</i> Relocate baby changing table outside of accessible toilet compartment. 	PCODE WB01C CBC 2016 11B-226.4 Project: SKYB2 Renovation Year to be Completed: 2021/2022 Mitigated: <input type="radio"/> YES <input checked="" type="radio"/> NO	1	JOB	\$300	\$300
----	---	--	---	-----	-------	-------

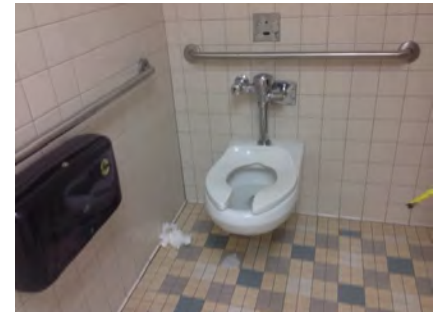
89	<ul style="list-style-type: none"> • <i>As-Built Description:</i> Water closet not 16"-18" (CA: 17"-18") from near side wall to center line of water closet (2010 ADAAG: 16"-18"). • <i>As-Built:</i> 18.5" o.c. • <i>Proposed Solution:</i> Relocate existing water closet and plumbing, remount with offset closet flange to provide 18" max. from side wall. 	PCODE WB02C ADAAG 91 Fig. 28 ADA 2010 604.2 CBC 2007 1115B.4.1.1 CBC 2016 11B-604.2 Project: SKYB2 Renovation Year to be Completed: 2021/2022 Mitigated: <input type="radio"/> YES <input checked="" type="radio"/> NO	1	JOB	\$1,500	\$1,500
----	---	--	---	-----	---------	---------

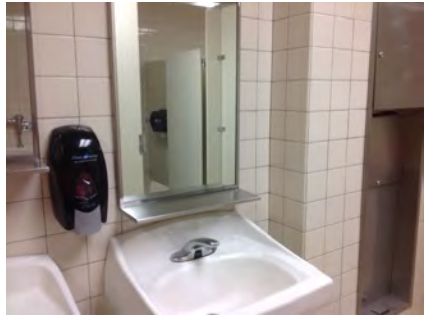
Item no., Rm no. and Name	Existing Architectural Barrier and Proposed Solution	Codes / Mitigation Info	Qty	Unit	Cost	Total
<u>Accessories</u>						
86	<ul style="list-style-type: none"> • <i>As-Built Description:</i> Bottom of mirror located above lavatories or countertops more than 40" above floor. • <i>As-Built:</i> 41" to reflective surface • <i>Proposed Solution:</i> Relocate or provide new accessible mirror. 	PCODE WG03 ADAAG 91 4.19.6 ADA 2010 603.3 CBC 2007 1115B.8.1 CBC 2016 11B-603.3 Project: SKYB2 Renovation Year to be Completed: 2021/2022 Mitigated: <input type="radio"/> YES <input checked="" type="radio"/> NO	1	JOB	\$450	\$450

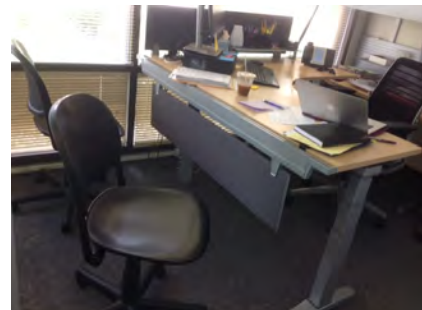
Item no., Rm no. and Name	Existing Architectural Barrier and Proposed Solution	Codes / Mitigation Info	Qty	Unit	Cost	Total
256	<ul style="list-style-type: none"> As-Built Description: Accessible non-fixed table or desk (top 28" to 34" high; knee space at least 27" high x 19" deep x 30" wide) not provided. Proposed Solution: Provide table or desk with accessible dimensions when purchasing new furniture. 	PCODE IN02A ADAAG 91 4.32.3 & .4 ADA 2010 306.1 CBC 2007 1122B.3 & 4 CBC 2016 11B-306.1 & 11B-902.3 Project: SKYB2 Renovation Year to be Completed: 2021/2022 Mitigated: <input type="radio"/> YES <input checked="" type="radio"/> NO	1	JOB	\$4,800	\$4,800

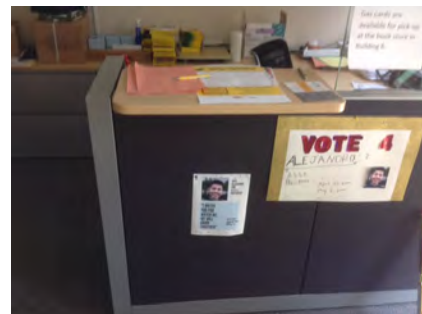
253	<ul style="list-style-type: none"> As-Built Description: Service counter (stand-up): Accessible section min. 36" length and 36" max. height (in CA: 28" to 34" high) not provided. As-Built: 43" above finished floor Proposed Solution: Retrofit existing counter to provide accessible section. Interim solution: Provide auxiliary counter, table, or clipboard. 	PCODE IN03 ADAAG 91 7.2(2) ADA 2010 904.4 CBC 2007 1122B.4 CBC 2016 11B-904.4 Project: SKYB2 Renovation Year to be Completed: 2021/2022 Mitigated: <input type="radio"/> YES <input checked="" type="radio"/> NO	1	JOB	\$6,000	\$6,000
-----	--	--	---	-----	---------	---------

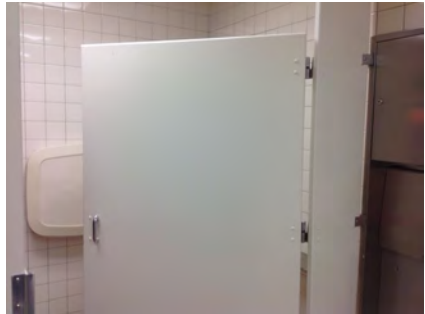
Item no., Rm no. and Name	Existing Architectural Barrier and Proposed Solution	Codes / Mitigation Info	Qty	Unit	Cost	Total
<u>Stall Door</u>						
80	<ul style="list-style-type: none"> • <i>As-Built Description:</i> Stall door to accessible compartment not self closing. • <i>Proposed Solution:</i> Adjust closer. 	PCODE WB05B ADAAG 91 4.22.4 ADA 2010 604.8.1.2 CBC 2007 1115B.3.1.4.4 CBC 2016 11B-604.8.1.2 Project: SKYB2 Renovation Year to be Completed: 2021/2022 Mitigated: <input type="radio"/> YES <input checked="" type="radio"/> NO	1	JOB	\$75	\$75

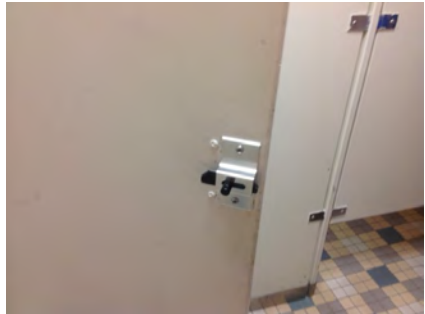
<input type="checkbox"/> Staff Only Priority 3 Severity 4			
81	<ul style="list-style-type: none"> • <i>As-Built Description:</i> Stall door does not have accessible operating hardware (U-pulls on both sides, flip-over or sliding lock). • <i>Proposed Solution:</i> Provide new accessible locking hardware that does not require grasping, pinching, or twisting and U-pulls on both sides. 	PCODE WB05C ADAAG 91 4.17.5 ADA 2010 604.8.1.2 CBC 2007 1115B.3.1.4.5 CBC 2016 11B-604.8.1.2 Project: SKYB2 Renovation Year to be Completed: 2021/2022 Mitigated: <input type="radio"/> YES <input checked="" type="radio"/> NO	1	JOB	\$300	\$300

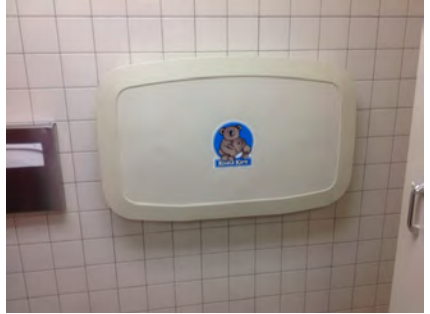
Item no., Rm no. and Name	Existing Architectural Barrier and Proposed Solution	Codes / Mitigation Info	Qty	Unit	Cost	Total
Toilet Stall						
84	<ul style="list-style-type: none"> • <i>As-Built Description:</i> Baby changing tables shall not be located in accessible toilet compartments. • <i>Proposed Solution:</i> Relocate baby changing table outside of accessible toilet compartment. 	PCODE WB01C CBC 2016 11B-226.4 Project: SKYB2 Renovation Year to be Completed: 2021/2022 Mitigated: <input type="radio"/> YES <input checked="" type="radio"/> NO	1	JOB	\$300	\$300

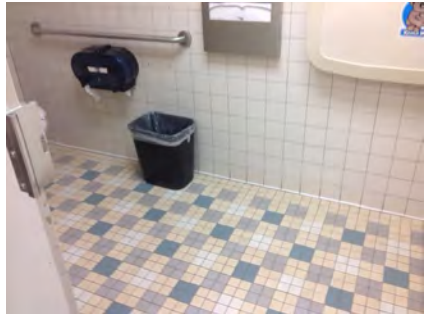
<input type="checkbox"/> Staff Only Priority 3 Severity 3			
82	<ul style="list-style-type: none"> • <i>As-Built Description:</i> Toilet stall less than 60" wide. • <i>As-Built:</i> 58.5" wide • <i>Proposed Solution:</i> Provide new accessible stall. 	PCODE WB06 ADAAG 91 4.17.3 ADA 2010 604.8.1.1 CBC 2007 1115B.3.1.4.1 CBC 2016 11B-604.8.1.1 Project: SKYB2 Renovation Year to be Completed: 2021/2022 Mitigated: <input type="radio"/> YES <input checked="" type="radio"/> NO	1	JOB	\$4,500	\$4,500

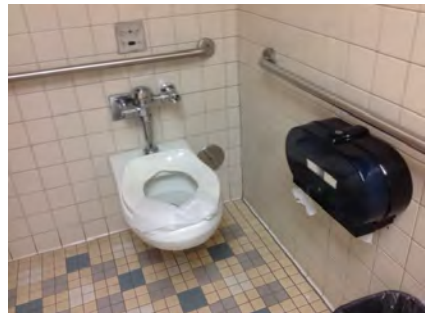
Item no., Rm no. and Name	Existing Architectural Barrier and Proposed Solution	Codes / Mitigation Info	Qty	Unit	Cost	Total
Water Closet						
83	<ul style="list-style-type: none">• <i>As-Built Description:</i> Water closet not 16"-18" (CA: 17"-18") from near side wall to center line of water closet (2010 ADAAG: 16"-18").• <i>As-Built:</i> 18.5" o.c.• <i>Proposed Solution:</i> Relocate existing water closet and plumbing, remount with offset closet flange to provide 18" max. from side wall.	<p>PCODE WB02C ADAAG 91 Fig. 28 ADA 2010 604.2 CBC 2007 1115B.4.1.1 CBC 2016 11B-604.2</p> <p>Project: SKYB2 Renovation</p> <p>Year to be Completed: 2021/2022</p> <p>Mitigated: <input type="radio"/> YES <input checked="" type="radio"/> NO</p>	1	JOB	\$1,500	\$1,500

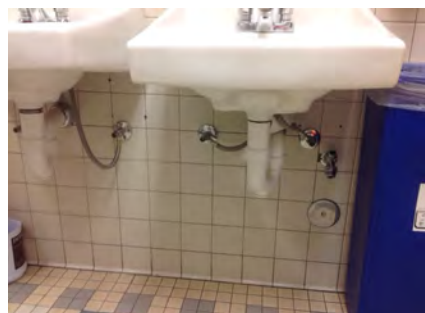
<input type="checkbox"/> Staff Only			
			Priority 3 Severity 4			
Lavatory						
78	<ul style="list-style-type: none">• <i>As-Built Description:</i> Knee clearance 27" min. high starting 8" back from the front edge of the lavatory towards the wall is not provided.• <i>As-Built:</i> 26.5" knee clearance• <i>Proposed Solution:</i> Remount compliant fixture to accessible height.	<p>PCODE WD04A ADAAG 91 Fig. 31 ADA 2010 306.3.3 CBC 2007 1115B.4.3 CBC 2016 11B-306.3.3</p> <p>Project: SKYB2 Renovation</p> <p>Year to be Completed: 2021/2022</p> <p>Mitigated: <input type="radio"/> YES <input checked="" type="radio"/> NO</p>	1	JOB	\$4,500	\$4,500

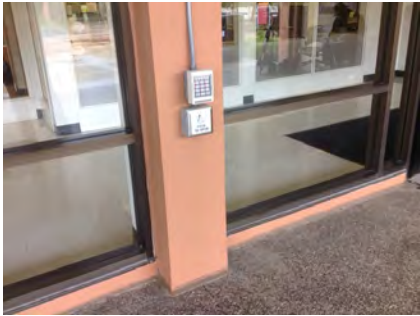
Item no., Rm no. and Name	Existing Architectural Barrier and Proposed Solution	Codes / Mitigation Info	Qty	Unit	Cost	Total
Door						
102	<ul style="list-style-type: none">As-Built Description: Lower push plate located at 7" minimum and 8" maximum above the floor or ground surface not provided.Proposed Solution: Provide lower push plate.	PCODE ID13B CBC 2007 1133B.2.3.2 CBC 2016 11B-404.2.9 2.C Project: SKYB2 Renovation Year to be Completed: 2021/2022 Mitigated: <div><input type="radio"/> YES</div> <div><input checked="" type="radio"/> NO</div>	1	JOB	\$1,500	\$1,500

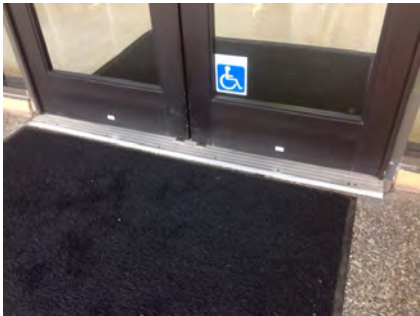
<div><input type="checkbox"/> Staff Only</div> <div><div>Priority</div><div>1</div><div>Severity</div><div>2</div></div>			
Door Threshold						
104	<ul style="list-style-type: none">As-Built Description: Door inaccessible due to threshold or step at door exceeding 1/2".As-Built: 0.75"Proposed Solution: Modify threshold to be no more than 1/2" by removing existing paving at door and providing landing with edge ramping (slope 1:20 max).	PCODE ID02A ADAAG 91 4.13.8 ADA 2010 404.2.5 CBC 2007 1133B.2.4.1 CBC 2016 11B-404.2.5 Project: SKYB2 Renovation Year to be Completed: 2021/2022 Mitigated: <div><input type="radio"/> YES</div> <div><input checked="" type="radio"/> NO</div>	4	JOB	\$1,200	\$4,800

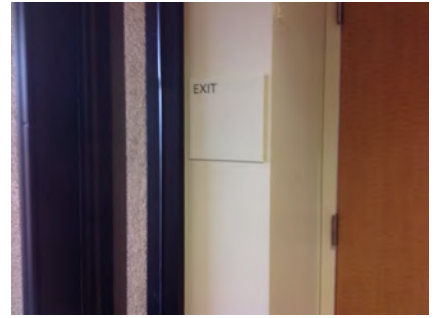
Item no., Rm no. and Name	Existing Architectural Barrier and Proposed Solution	Codes / Mitigation Info	Qty	Unit	Cost	Total
Signage						
97	<ul style="list-style-type: none"> As-Built Description: Sign not located on latch side of door and/or not located at 48" min. above to baseline of the lowest Braille cells and 60" max. to baseline of the highest line of raised characters. As-Built: 62" to bottom of tactile Proposed Solution: Provide compliant signage including tactile characters and Grade II Braille on latch side of door located at compliant height. 	PCODE SA07 ADAAG 91 4.30.6 ADA 2010 703.4.1 CBC 2007 1117B.5.7 CBC 2016 11B-703.4.1 Project: SKYB2 Renovation Year to be Completed: 2021/2022 Mitigated: <input type="radio"/> YES <input checked="" type="radio"/> NO	1	JOB	\$150	\$150

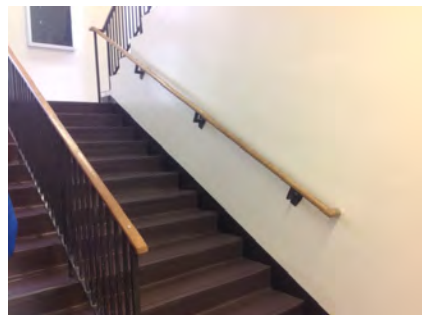
Item no., Rm no. and Name	Existing Architectural Barrier and Proposed Solution	Codes / Mitigation Info	Qty	Unit	Cost	Total
Top & Bottom Extension at Stairs						
111	<ul style="list-style-type: none">• <i>As-Built Description:</i> Stair handrail does not extend horizontally 12" minimum beyond top nosing, and one tread width sloped, plus 12" minimum horizontally beyond the bottom nosing.• <i>Proposed Solution:</i> Extend stair handrail at top and bottom (cost for each extension piece).	<p>PCODE ED06</p> <p>ADAAG 91 4.9.4(2)</p> <p>ADA 2010 505.10.2;</p> <p>CBC 2007 1133B.4.2.2</p> <p>CBC 2016 11B-505.10.2; 11B-505.10.3</p> <p>Project: SKYB2 Renovation</p> <p>Year to be Completed: 2021/2022</p> <p>Mitigated: <input type="radio"/> YES <input checked="" type="radio"/> NO</p>	12	JOB	\$510	\$6,120

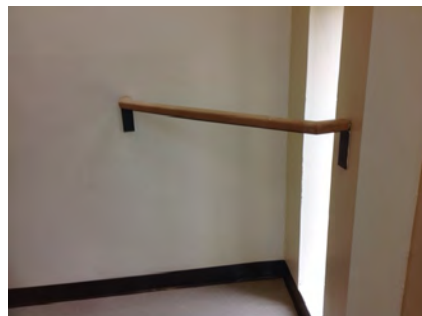
Protrusion Limits						
114	<ul style="list-style-type: none">• <i>As-Built Description:</i> Protruding objects more than 4" from wall, when bottom of object more than 27" or less than 80" above finished floor.• <i>As-Built:</i> Rail protrudes 14" at 40" high.• <i>Proposed Solution:</i> Remove/relocate protruding object. Patch existing surface.	<p>PCODE EG04</p> <p>ADAAG 91 4.4.1</p> <p>ADA 2010 307.2</p> <p>CBC 2007 1133B.8.6.1</p> <p>CBC 2016 11B-307.2</p> <p>Project: SKYB2 Renovation</p> <p>Year to be Completed: 2021/2022</p> <p>Mitigated: <input type="radio"/> YES <input checked="" type="radio"/> NO</p>	1	JOB	\$300	\$300

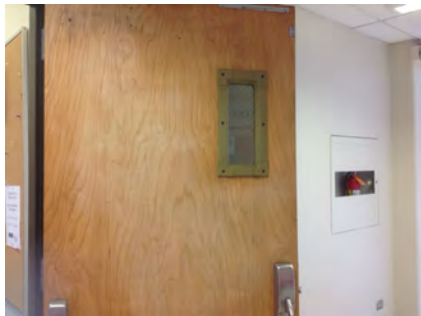
Item no., Rm no. and Name	Existing Architectural Barrier and Proposed Solution	Codes / Mitigation Info	Qty	Unit	Cost	Total
<u>Door</u>						
115	<ul style="list-style-type: none">• <i>As-Built Description:</i> Vision Light at door that permits viewing, does not have bottom of at least one glazed panel located 43 inches maximum above the finish floor. (Exception: More than 66" above finished floor.)• <i>As-Built:</i> 60" above finished floor• <i>Proposed Solution:</i> Provide new door with vision panel at 43" max.	<p>PCODE ID06C</p> <p>ADA 2010 404.2.11</p> <p>CBC 2016 11B-404.2.11</p> <p>Project: SKYB2 Renovation</p> <p>Year to be Completed: 2021/2022</p> <p>Mitigated: <input type="radio"/> YES <input checked="" type="radio"/> NO</p>	4	JOB	\$7,500	\$30,000
