SAN MATEO COUNTY
COMMUNITY
COLLEGE DISTRICT

San Mateo County Community College District Americans with Disabilities Act Self-Evaluation and Transition Plan

Report Prepared by:

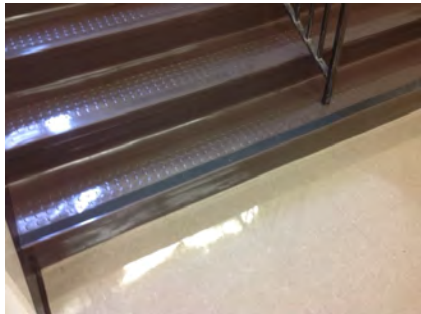
<input type="checkbox"/> Staff Only			
			Priority		Severity	
			2		1	
<u>Stairway</u>						
110	<ul style="list-style-type: none">• <i>As-Built Description:</i> The leading 2" of the tread does not have visual contrast of dark-on-light or light-on-dark from the remainder of the tread.• <i>Proposed Solution:</i> Provide 2" min., 4" max. wide contrasting color strip 1" max. from nosing on top & bottom treads when altering area.• <i>Notes:</i> The existing stripe does not contrast. Must be Dark on light or light on dark.	<p>PCODE II02B</p> <p>ADA 2010 504.4</p> <p>CBC 2007 1133B.4.4</p> <p>CBC 2016 11B-504.4.1</p> <p>Project: SKYB2 Renovation</p> <p>Year to be Completed: 2021/2022</p> <p>Mitigated: <input type="radio"/> YES <input checked="" type="radio"/> NO</p>	40	LF	\$42	\$1,680

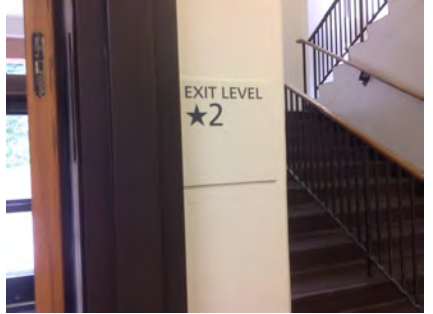
Item no., Rm no. and Name	Existing Architectural Barrier and Proposed Solution	Codes / Mitigation Info	Qty	Unit	Cost	Total
Signage						
109	<ul style="list-style-type: none"> As-Built Description: Sign not located on latch side of door and/or not located at 48" min. above to baseline of the lowest Braille cells and 60" max. to baseline of the highest line of raised characters. As-Built: 62" to bottom of tactile Proposed Solution: Provide compliant signage including tactile characters and Grade II Braille on latch side of door located at compliant height. 	PCODE SA07 ADAAG 91 4.30.6 ADA 2010 703.4.1 CBC 2007 1117B.5.7 CBC 2016 11B-703.4.1 Project: SKYB2 Renovation Year to be Completed: 2021/2022 Mitigated: <input type="radio"/> YES <input checked="" type="radio"/> NO	1	JOB	\$150	\$150

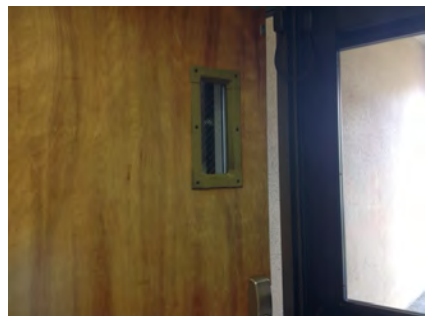
Item no., Rm no. and Name	Existing Architectural Barrier and Proposed Solution	Codes / Mitigation Info	Qty	Unit	Cost	Total
<u>Door</u>						
116	<ul style="list-style-type: none">As-Built Description: Vision Light at door that permits viewing, does not have bottom of at least one glazed panel located 43 inches maximum above the finish floor. (Exception: More than 66" above finished floor.)As-Built: 60" above finished floorProposed Solution: Provide new door with vision panel at 43" max.	PCODE ID06C ADA 2010 404.2.11 CBC 2016 11B-404.2.11 Project: SKYB2 Renovation Year to be Completed: 2021/2022 Mitigated: <input type="radio"/> YES <input checked="" type="radio"/> NO	5	JOB	\$7,500	\$37,500

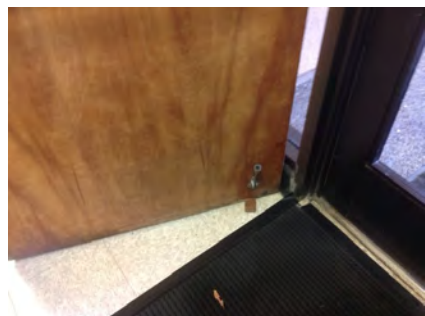
<input type="checkbox"/> Staff Only Priority 2 Severity 1			
<u>Door Stopper</u>						
117	<ul style="list-style-type: none">As-Built Description: At push side of door on accessible route, bottom 10" does not have a smooth, uninterrupted surface.Proposed Solution: Remove door stopper when altering area. Provide rubber wedge.	PCODE ID06A ADA 2010 404.2.10 CBC 2007 1133B.2.6 CBC 2016 11B-404.2.10 Project: SKYB2 Renovation Year to be Completed: 2021/2022 Mitigated: <input type="radio"/> YES <input checked="" type="radio"/> NO	1	JOB	\$75	\$75

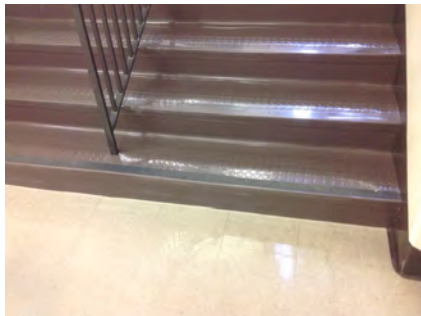
Item no., Rm no. and Name	Existing Architectural Barrier and Proposed Solution	Codes / Mitigation Info	Qty	Unit	Cost	Total
Stairway						
118	<ul style="list-style-type: none">• <i>As-Built Description:</i> The leading 2" of the tread does not have visual contrast of dark-on-light or light-on-dark from the remainder of the tread.• <i>Proposed Solution:</i> Provide 2" min., 4" max. wide contrasting color strip 1" max. from nosing on top & bottom treads when altering area.	<p>PCODE II02B</p> <p>ADA 2010 504.4</p> <p>CBC 2007 1133B.4.4</p> <p>CBC 2016 11B-504.4.1</p> <p>Project: SKYB2 Renovation</p> <p>Year to be Completed: 2021/2022</p> <p>Mitigated: <input type="radio"/> YES <input checked="" type="radio"/> NO</p>	80	LF	\$42	\$3,360

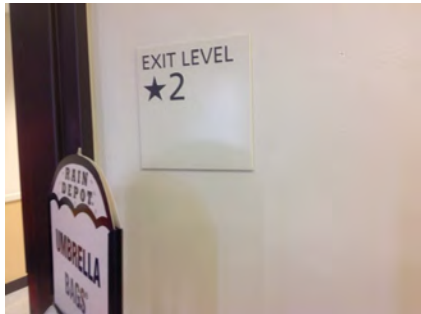
<input type="checkbox"/> Staff Only			
			Priority 2 Severity 3			
Signage						
121	<ul style="list-style-type: none">• <i>As-Built Description:</i> Signs containing tactile characters is not located so that a clear floor space of 18" min x 18" min., centered on the tactile characters, is provided beyond the arc of any door swing between the closed position and 45 degree open position.• <i>As-Built:</i> 62" above finished floor• <i>Proposed Solution:</i> Relocate compliant signage on latch side of door located at compliant height with a clear floor space.	<p>PCODE SA07B</p> <p>ADA 2010 703.4.2</p> <p>CBC 2016 11B-703.4.2</p> <p>Project: SKYB2 Renovation</p> <p>Year to be Completed: 2021/2022</p> <p>Mitigated: <input type="radio"/> YES <input checked="" type="radio"/> NO</p>	1	JOB	\$150	\$150

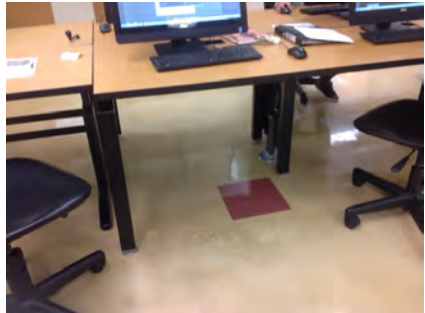
Item no., Rm no. and Name	Existing Architectural Barrier and Proposed Solution	Codes / Mitigation Info	Qty	Unit	Cost	Total
Non-Fixed Desk						
127	<ul style="list-style-type: none"> As-Built Description: Accessible non-fixed table or desk (top 28" to 34" high; knee space at least 27" high x 19" deep x 30" wide) not provided. As-Built: 24" knee height Proposed Solution: Provide table or desk with accessible dimensions when purchasing new furniture. Notes: 12 desks, no accessible provided 	PCODE IN02A ADAAG 91 4.32.3 & .4 ADA 2010 306.1 CBC 2007 1122B.3 & 4 CBC 2016 11B-306.1 & 11B-902.3 Project: SKYB2 Renovation Year to be Completed: 2021/2022 Mitigated: <input type="radio"/> YES <input checked="" type="radio"/> NO	1	JOB	\$4,800	\$4,800

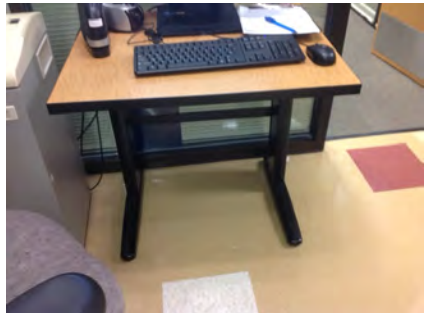
<input type="checkbox"/> Staff Only Priority Severity <input checked="" type="radio"/> 2 <input checked="" type="radio"/> 2			
130	<ul style="list-style-type: none"> As-Built Description: Accessible non-fixed table or desk (top 28" to 34" high; knee space at least 27" high x 19" deep x 30" wide) not provided. As-Built: 22" wide Proposed Solution: Provide table or desk with accessible dimensions when purchasing new furniture. 	PCODE IN02A ADAAG 91 4.32.3 & .4 ADA 2010 306.1 CBC 2007 1122B.3 & 4 CBC 2016 11B-306.1 & 11B-902.3 Project: SKYB2 Renovation Year to be Completed: 2021/2022 Mitigated: <input type="radio"/> YES <input checked="" type="radio"/> NO	1	JOB	\$4,800	\$4,800

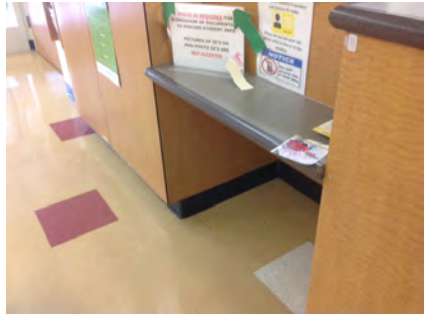
Item no., Rm no. and Name	Existing Architectural Barrier and Proposed Solution	Codes / Mitigation Info	Qty	Unit	Cost	Total
Public Counter						
125	<ul style="list-style-type: none"> • <i>As-Built Description:</i> Service counter (stand-up): Accessible section min. 36" length and 36" max. height (in CA: 28" to 34" high) not provided. • <i>As-Built:</i> 32" long • <i>Proposed Solution:</i> Retrofit existing counter to provide accessible section. Interim solution: Provide auxiliary counter, table, or clipboard. 	PCODE IN03 ADAAG 91 7.2(2) ADA 2010 904.4 CBC 2007 1122B.4 CBC 2016 11B-904.4 Project: SKYB2 Renovation Year to be Completed: 2021/2022 Mitigated: <input type="radio"/> YES <input checked="" type="radio"/> NO	1	JOB	\$6,000	\$6,000

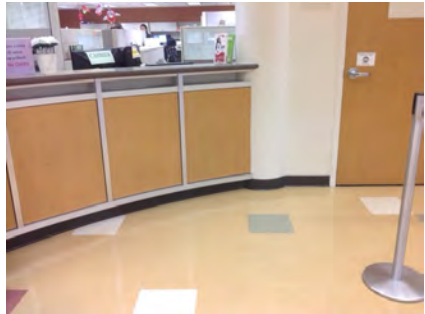
<input type="checkbox"/> Staff Only Priority 2 Severity 4			
126	<ul style="list-style-type: none"> • <i>As-Built Description:</i> Service counter (stand-up): Accessible section min. 36" length and 36" max. height (in CA: 28" to 34" high) not provided. • <i>Proposed Solution:</i> Retrofit existing counter to provide accessible section. Interim solution: Provide auxiliary counter, table, or clipboard. • Notes: No lowered counter provided 	PCODE IN03 ADAAG 91 7.2(2) ADA 2010 904.4 CBC 2007 1122B.4 CBC 2016 11B-904.4 Project: SKYB2 Renovation Year to be Completed: 2021/2022 Mitigated: <input type="radio"/> YES <input checked="" type="radio"/> NO	1	JOB	\$6,000	\$6,000

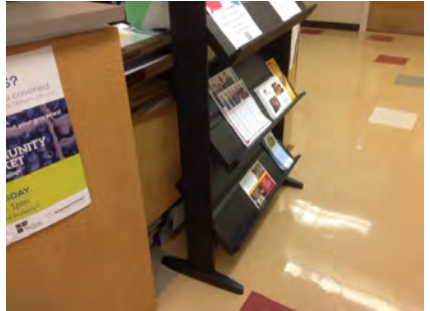
Item no., Rm no. and Name	Existing Architectural Barrier and Proposed Solution	Codes / Mitigation Info	Qty	Unit	Cost	Total
128	<ul style="list-style-type: none"> As-Built Description: Service counter (stand-up): Accessible section min. 36" length and 36" max. height (in CA: 28" to 34" high) not provided. Proposed Solution: Retrofit existing counter to provide accessible section. Interim solution: Provide auxiliary counter, table, or clipboard. Notes: Lowered counter is provided, must be kept clear and usable 	PCODE IN03 ADAAG 91 7.2(2) ADA 2010 904.4 CBC 2007 1122B.4 CBC 2016 11B-904.4 Project: SKYB2 Renovation Year to be Completed: 2021/2022 Mitigated: <input type="radio"/> YES <input checked="" type="radio"/> NO	1	JOB	\$6,000	\$6,000

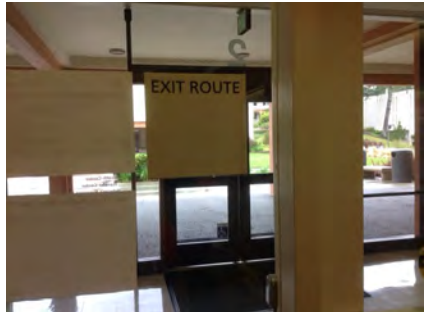
<input type="checkbox"/> Staff Only Priority 2 Severity 1						
<hr/>						
123	Signage <ul style="list-style-type: none"> As-Built Description: Signs containing tactile characters is not located so that a clear floor space of 18" min x 18" min., centered on the tactile characters, is provided beyond the arc of any door swing between the closed position and 45 degree open position. As-Built: 63" above finished floor Proposed Solution: Relocate compliant signage on latch side of door located at compliant height with a clear floor space. 	PCODE SA07B ADA 2010 703.4.2 CBC 2016 11B-703.4.2 Project: SKYB2 Renovation Year to be Completed: 2021/2022 Mitigated: <input type="radio"/> YES <input checked="" type="radio"/> NO	2	JOB	\$150	\$300

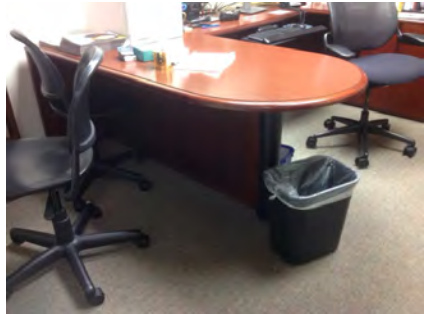
Item no., Rm no. and Name	Existing Architectural Barrier and Proposed Solution	Codes / Mitigation Info	Qty	Unit	Cost	Total
Non-Fixed Desk						
135	<ul style="list-style-type: none"> <i>As-Built Description:</i> Accessible non-fixed table or desk (top 28" to 34" high; knee space at least 27" high x 19" deep x 30" wide) not provided. <i>As-Built:</i> 16" deep <i>Proposed Solution:</i> Provide table or desk with accessible dimensions when purchasing new furniture. 	PCODE IN02A ADAAG 91 4.32.3 & .4 ADA 2010 306.1 CBC 2007 1122B.3 & 4 CBC 2016 11B-306.1 & 11B-902.3 Project: SKYB2 Renovation Year to be Completed: 2021/2022 Mitigated: <input type="radio"/> YES <input checked="" type="radio"/> NO	3	JOB	\$4,800	\$14,400

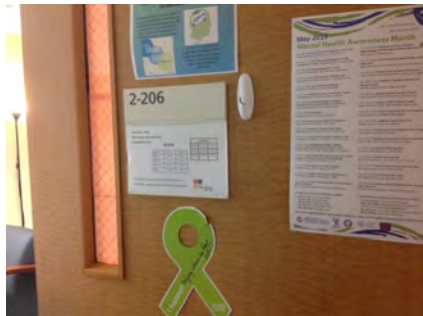
Signage						
131	<ul style="list-style-type: none"> <i>As-Built Description:</i> Sign not located on latch side of door and/or not located at 48" min. above to baseline of the lowest Braille cells and 60" max. to baseline of the highest line of raised characters. <i>Proposed Solution:</i> Provide compliant signage including tactile characters and Grade II Braille on latch side of door located at compliant height. 	PCODE SA07 ADAAG 91 4.30.6 ADA 2010 703.4.1 CBC 2007 1117B.5.7 CBC 2016 11B-703.4.1 Project: SKYB2 Renovation Year to be Completed: 2021/2022 Mitigated: <input type="radio"/> YES <input checked="" type="radio"/> NO	1	JOB	\$150	\$150

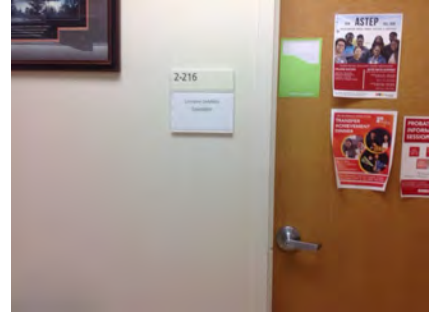
Item no., Rm no. and Name	Existing Architectural Barrier and Proposed Solution	Codes / Mitigation Info	Qty	Unit	Cost	Total
137	<ul style="list-style-type: none"> • <i>As-Built Description:</i> Signs containing tactile characters is not located so that a clear floor space of 18" min x 18" min., centered on the tactile characters, is provided beyond the arc of any door swing between the closed position and 45 degree open position. • <i>As-Built:</i> 61" above finished floor • <i>Proposed Solution:</i> Relocate compliant signage on latch side of door located at compliant height with a clear floor space. 	PCODE SA07B ADA 2010 703.4.2 CBC 2016 11B-703.4.2 Project: SKYB2 Renovation Year to be Completed: 2021/2022 Mitigated: <input type="radio"/> YES <input checked="" type="radio"/> NO	13	JOB	\$150	\$1,950

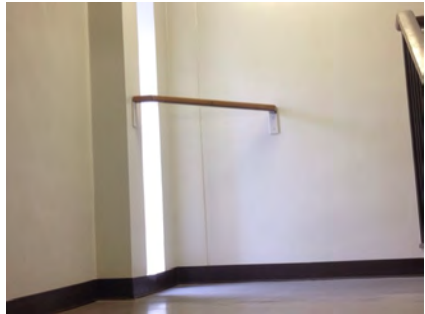
Item no., Rm no. and Name	Existing Architectural Barrier and Proposed Solution	Codes / Mitigation Info	Qty	Unit	Cost	Total
Protrusion Limits						
141	<ul style="list-style-type: none"> As-Built Description: Protruding objects more than 4" from wall, when bottom of object more than 27" or less than 80" above finished floor. As-Built: Rail protrudes 14" at 40" high. Proposed Solution: Remove/relocate protruding object. Patch existing surface. 	PCODE EG04 ADAAG 91 4.4.1 ADA 2010 307.2 CBC 2007 1133B.8.6.1 CBC 2016 11B-307.2 Project: SKYB2 Renovation Year to be Completed: 2021/2022 Mitigated: <input type="radio"/> YES <input checked="" type="radio"/> NO	3	JOB	\$300	\$900

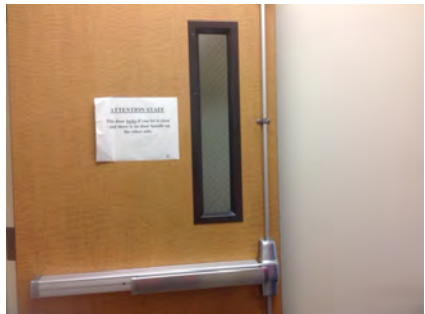
Door						
138	<ul style="list-style-type: none"> As-Built Description: Vision Light at door that permits viewing, does not have bottom of at least one glazed panel located 43 inches maximum above the finish floor. (Exception: More than 66" above finished floor.) As-Built: 48" above finished floor Proposed Solution: Provide new door with vision panel at 43" max. 	PCODE ID06C ADA 2010 404.2.11 CBC 2016 11B-404.2.11 Project: SKYB2 Renovation Year to be Completed: 2021/2022 Mitigated: <input type="radio"/> YES <input checked="" type="radio"/> NO	1	JOB	\$7,500	\$7,500

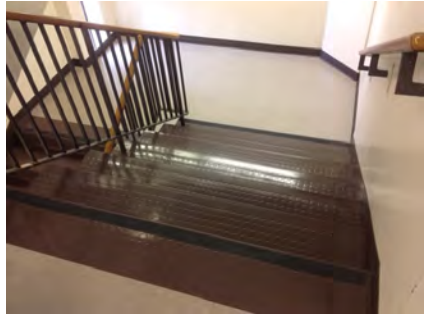
Item no., Rm no. and Name	Existing Architectural Barrier and Proposed Solution	Codes / Mitigation Info	Qty	Unit	Cost	Total
<u>Stairway</u>						
139	<ul style="list-style-type: none"> • <i>As-Built Description:</i> The leading 2" of the tread does not have visual contrast of dark-on-light or light-on-dark from the remainder of the tread. • <i>Proposed Solution:</i> Provide 2" min., 4" max. wide contrasting color strip 1" max. from nosing on top & bottom treads when altering area. 	PCODE II02B ADA 2010 504.4 CBC 2007 1133B.4.4 CBC 2016 11B-504.4.1	70	LF	\$42	\$2,940
Project: SKYB2 Renovation Year to be Completed: 2021/2022 Mitigated: <input type="radio"/> YES <input checked="" type="radio"/> NO

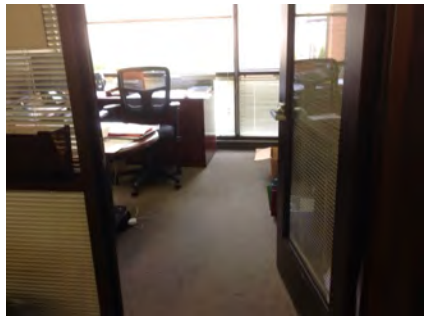
Item no., Rm no. and Name	Existing Architectural Barrier and Proposed Solution	Codes / Mitigation Info	Qty	Unit	Cost	Total
Door Swing						
143	<ul style="list-style-type: none"> As-Built Description: Front approach: At pull side, door does not have clear and level maneuvering space measuring door width plus 18" x 60". (24" x 60" at exterior doors). Proposed Solution: Remove or relocate furniture or storage items. 	PCODE ID23A ADAAG 91 Fig. 25(a) ADA 2010 404.2.4 CBC 2007 11B-26A(a) CBC 2016 11B-404.2.4 Project: SKYB2 Renovation Year to be Completed: 2021/2022 Mitigated: <input type="radio"/> YES <input checked="" type="radio"/> NO	1	JOB	\$150	\$150

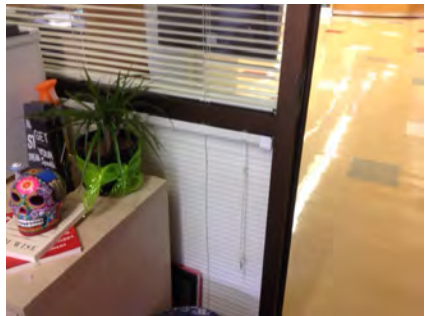
<input type="checkbox"/> Staff Only Priority 2 Severity 3			
145	<ul style="list-style-type: none"> As-Built Description: Front approach: At pull side, door does not have clear and level maneuvering space measuring door width plus 18" x 60". (24" x 60" at exterior doors). As-Built: 12" strike side clearance Proposed Solution: Remove or relocate furniture or storage items. 	PCODE ID23A ADAAG 91 Fig. 25(a) ADA 2010 404.2.4 CBC 2007 11B-26A(a) CBC 2016 11B-404.2.4 Project: SKYB2 Renovation Year to be Completed: 2021/2022 Mitigated: <input type="radio"/> YES <input checked="" type="radio"/> NO	1	JOB	\$150	\$150

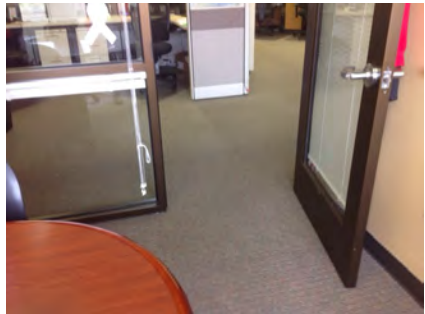
Item no., Rm no. and Name	Existing Architectural Barrier and Proposed Solution	Codes / Mitigation Info	Qty	Unit	Cost	Total
148	<ul style="list-style-type: none"> As-Built Description: Front approach: At pull side, door does not have clear and level maneuvering space measuring door width plus 18" x 60". (24" x 60" at exterior doors). As-Built: 48" pull landing to desk Proposed Solution: Remove or relocate furniture or storage items. 	PCODE ID23A ADAAG 91 Fig. 25(a) ADA 2010 404.2.4 CBC 2007 11B-26A(a) CBC 2016 11B-404.2.4 Project: SKYB2 Renovation Year to be Completed: 2021/2022 Mitigated: <input type="radio"/> YES <input checked="" type="radio"/> NO	1	JOB	\$150	\$150

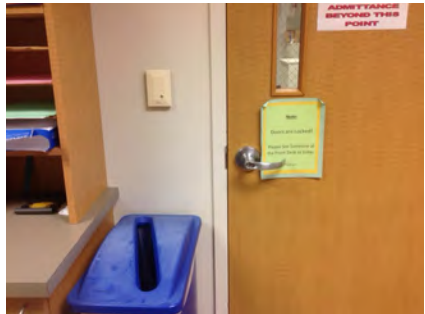
<input type="checkbox"/> Staff Only Priority Severity <input checked="" type="radio"/> 4 <input checked="" type="radio"/> 3			
150	<ul style="list-style-type: none"> As-Built Description: Front approach: At pull side, door does not have clear and level maneuvering space measuring door width plus 18" x 60". (24" x 60" at exterior doors). As-Built: 16" strike side clearance Proposed Solution: Remove or relocate furniture or storage items. 	PCODE ID23A ADAAG 91 Fig. 25(a) ADA 2010 404.2.4 CBC 2007 11B-26A(a) CBC 2016 11B-404.2.4 Project: SKYB2 Renovation Year to be Completed: 2021/2022 Mitigated: <input type="radio"/> YES <input checked="" type="radio"/> NO	1	JOB	\$150	\$150

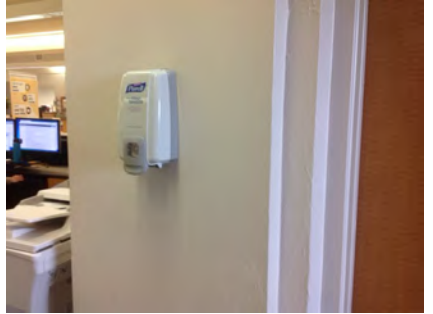
Item no., Rm no. and Name	Existing Architectural Barrier and Proposed Solution	Codes / Mitigation Info	Qty	Unit	Cost	Total
Reach Range						
147	<ul style="list-style-type: none"> As-Built Description: Reach height to control or access point, exceeds 48" or is less than 15". As-Built: 51" above finished floor Proposed Solution: Modify equipment or mounting. 	PCODE IE01 ADAAG 91 4.2.5 ADA 2010 308.2.1 CBC 2007 1118B.5 CBC 2016 11B-308.2.1 Project: SKYB2 Renovation Year to be Completed: 2021/2022 Mitigated: <input type="radio"/> YES <input checked="" type="radio"/> NO	1	JOB	\$300	\$300

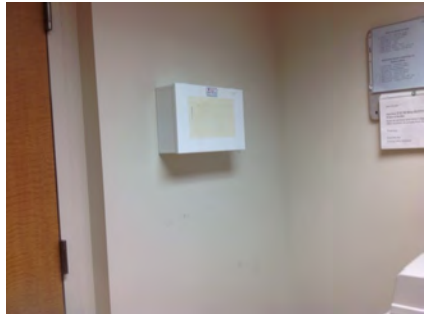
<input type="checkbox"/> Staff Only Priority Severity <input checked="" type="radio"/> 4 <input checked="" type="radio"/> 4			
152	<ul style="list-style-type: none"> As-Built Description: Reach height to control or access point, where side approach is available, exceeds 48" or is less than 15" in height, or exceeds 10" in depth. As-Built: 68" above finished floor Proposed Solution: Modify equipment or mounting. 	PCODE IE02 ADAAG 91 4.2.6 ADA 2010 308.3.1 CBC 2007 1118B.6 CBC 2016 11B-308.3 Project: SKYB2 Renovation Year to be Completed: 2021/2022 Mitigated: <input type="radio"/> YES <input checked="" type="radio"/> NO	1	JOB	\$300	\$300

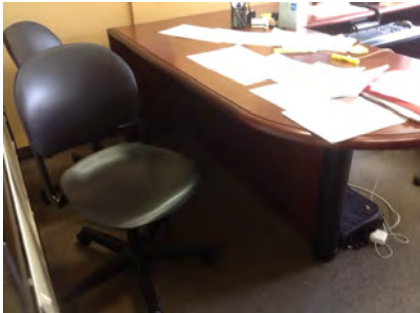
Item no., Rm no. and Name	Existing Architectural Barrier and Proposed Solution	Codes / Mitigation Info	Qty	Unit	Cost	Total
<u>Non-Fixed Desk</u>						
144	<ul style="list-style-type: none">As-Built Description: Accessible non-fixed table or desk (top 28" to 34" high; knee space at least 27" high x 19" deep x 30" wide) not provided.As-Built: 23" wide approach spaceProposed Solution: Provide table or desk with accessible dimensions when purchasing new furniture.	<p>PCODE IN02A</p> <p>ADAAG 91 4.32.3 & .4</p> <p>ADA 2010 306.1</p> <p>CBC 2007 1122B.3 & 4</p> <p>CBC 2016 11B-306.1 & 11B-902.3</p> <p>Project: SKYB2 Renovation</p> <p>Year to be Completed: 2021/2022</p> <p>Mitigated:</p> <p><input type="radio"/> YES</p> <p><input checked="" type="radio"/> NO</p>	1	JOB	\$4,800	\$4,800

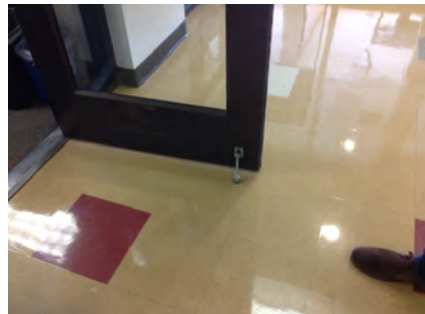
Item no., Rm no. and Name	Existing Architectural Barrier and Proposed Solution	Codes / Mitigation Info	Qty	Unit	Cost	Total
Door Stopper						
156	<ul style="list-style-type: none">• <i>As-Built Description:</i> At push side of door on accessible route, bottom 10" does not have a smooth, uninterrupted surface.• <i>Proposed Solution:</i> Remove door stopper when altering area. Provide rubber wedge.	<p>PCODE ID06A</p> <p>ADA 2010 404.2.10</p> <p>CBC 2007 1133B.2.6</p> <p>CBC 2016 11B-404.2.10</p> <p>Project: SKYB2 Renovation</p> <p>Year to be Completed: 2021/2022</p> <p>Mitigated: <input type="radio"/> YES <input checked="" type="radio"/> NO</p>	2	JOB	\$75	\$150

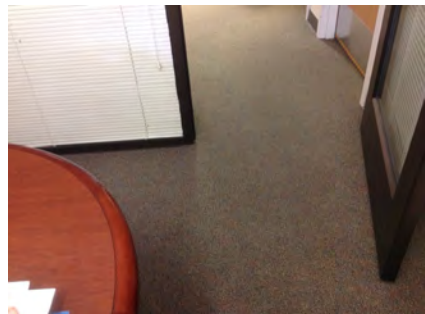
<input type="checkbox"/> Staff Only			
			Priority 2 Severity 3			
Door Swing						
160	<ul style="list-style-type: none">• <i>As-Built Description:</i> Front approach: At pull side, door does not have clear and level maneuvering space measuring door width plus 18" x 60". (24" x 60" at exterior doors).• <i>As-Built:</i> 36" pull landing to desk• <i>Proposed Solution:</i> Remove or relocate furniture or storage items.	<p>PCODE ID23A</p> <p>ADAAG 91 Fig. 25(a)</p> <p>ADA 2010 404.2.4</p> <p>CBC 2007 11B-26A(a)</p> <p>CBC 2016 11B-404.2.4</p> <p>Project: SKYB2 Renovation</p> <p>Year to be Completed: 2021/2022</p> <p>Mitigated: <input type="radio"/> YES <input checked="" type="radio"/> NO</p>	2	JOB	\$150	\$300

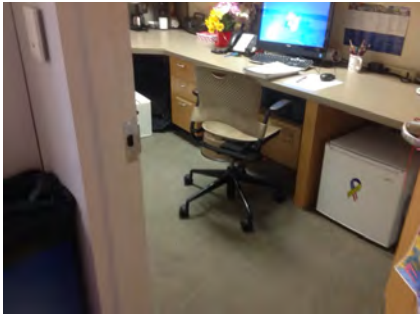
Item no., Rm no. and Name	Existing Architectural Barrier and Proposed Solution	Codes / Mitigation Info	Qty	Unit	Cost	Total
<u>Turning Space</u>						
161	<ul style="list-style-type: none">• <i>As-Built Description:</i> The area does not provide a minimum 60" diameter turning space within to allow maneuvering through the space.• <i>As-Built:</i> 50" wide• <i>Proposed Solution:</i> Modify area to provide sufficient maneuvering space.	<p>PCODE IH05 ADA 2010 304.3 CBC 2016 11B-304.3</p> <p>Project: SKYB2 Renovation</p> <p>Year to be Completed: 2021/2022</p> <p>Mitigated: <input type="radio"/> YES <input checked="" type="radio"/> NO</p>	1	JOB	\$1,500	\$1,500

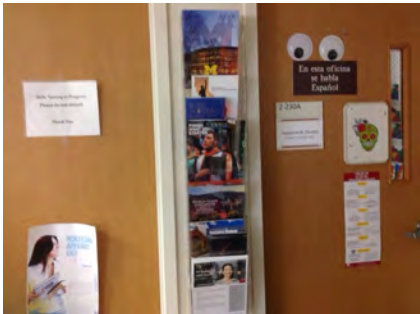
<input type="checkbox"/> Staff Only			
			Priority 2 Severity 3			
<u>Brochure Bins</u>						
162	<ul style="list-style-type: none">• <i>As-Built Description:</i> Information brochure bins mounted above accessible height of 48".• <i>As-Built:</i> 72" high above finished floor• <i>Proposed Solution:</i> Relocate/remount bins at accessible height.	<p>PCODE IN08 ADAAG 91 4.2.5 & 6 ADA 2010 308.2.1 CBC 2007 1118B.5 CBC 2016 11B-308.2.1</p> <p>Project: SKYB2 Renovation</p> <p>Year to be Completed: 2021/2022</p> <p>Mitigated: <input type="radio"/> YES <input checked="" type="radio"/> NO</p>	3	JOB	\$300	\$900

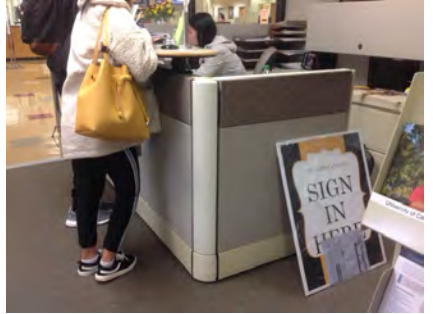
Item no., Rm no. and Name	Existing Architectural Barrier and Proposed Solution	Codes / Mitigation Info	Qty	Unit	Cost	Total
Public Counter						
158	<ul style="list-style-type: none"> • <i>As-Built Description:</i> Service counter (stand-up): Accessible section min. 36" length and 36" max. height (in CA: 28" to 34" high) not provided. • <i>As-Built:</i> 40" above finished floor • <i>Proposed Solution:</i> Retrofit existing counter to provide accessible section. Interim solution: Provide auxiliary counter, table, or clipboard. 	PCODE IN03 ADAAG 91 7.2(2) ADA 2010 904.4 CBC 2007 1122B.4 CBC 2016 11B-904.4 Project: SKYB2 Renovation Year to be Completed: 2021/2022 Mitigated: <input type="radio"/> YES <input checked="" type="radio"/> NO	1	JOB	\$6,000	\$6,000

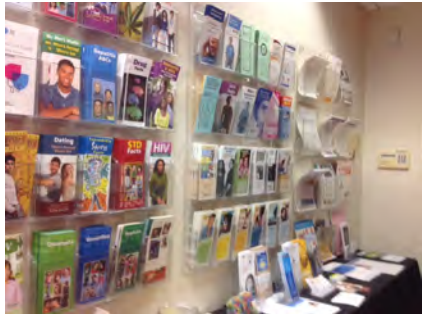
Item no., Rm no. and Name	Existing Architectural Barrier and Proposed Solution	Codes / Mitigation Info	Qty	Unit	Cost	Total
<u>Reach Range</u>						
167	<ul style="list-style-type: none">As-Built Description: Reach height to control or access point, exceeds 48" or is less than 15".As-Built: 65" above finished floorProposed Solution: Modify equipment or mounting.	<p>PCODE IE01</p> <p>ADAAG 91 4.2.5</p> <p>ADA 2010 308.2.1</p> <p>CBC 2007 1118B.5</p> <p>CBC 2016 11B-308.2.1</p> <p>Project: SKYB2 Renovation</p> <p>Year to be Completed: 2021/2022</p> <p>Mitigated:</p> <p><input type="radio"/> YES</p> <p><input checked="" type="radio"/> NO</p>	1	JOB	\$300	\$300

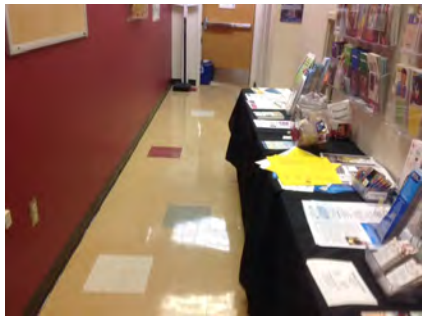
<input type="checkbox"/> Staff Only			
			<div><div>Priority</div><div>2</div><div>Severity</div><div>2</div></div>			
<u>Corridor</u>						
168	<ul style="list-style-type: none">As-Built Description: Corridor less than 44" wide.As-Built: 36" wideProposed Solution: Enlarge corridor to 44" wide; relocate stud wall.Notes: Remove tables	<p>PCODE IH03</p> <p>ADAAG 91 4.3.3</p> <p>ADA 2010 403.5.1</p> <p>CBC 2007 1133B.3.1</p> <p>CBC 2016 11B-403.5.1</p> <p>Project: SKYB2 Renovation</p> <p>Year to be Completed: 2021/2022</p> <p>Mitigated:</p> <p><input type="radio"/> YES</p> <p><input checked="" type="radio"/> NO</p>	12	LF	\$420	\$5,040

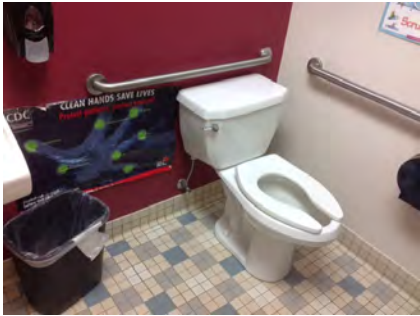
Item no., Rm no. and Name	Existing Architectural Barrier and Proposed Solution	Codes / Mitigation Info	Qty	Unit	Cost	Total
<u>Toilet Stall</u>						
172	<ul style="list-style-type: none">As-Built Description: Toilet stall less than 60" wide.As-Built: 55" from side wall to lavatoryProposed Solution: Provide new accessible stall.Notes: 28" between toilet and lavatory	<p>PCODE WB06</p> <p>ADAAG 91 4.17.3</p> <p>ADA 2010 604.8.1.1</p> <p>CBC 2007 1115B.3.1.4.1</p> <p>CBC 2016 11B-604.8.1.1</p> <p>Project: SKYB2 Renovation</p> <p>Year to be Completed: 2021/2022</p> <p>Mitigated: <input type="radio"/> YES <input checked="" type="radio"/> NO</p>	1	JOB	\$4,500	\$4,500

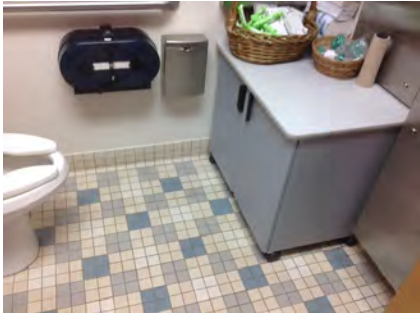
<input type="checkbox"/> Staff Only			
			Priority 3 Severity 4			
<u>Water Closet</u>						
174	<ul style="list-style-type: none">As-Built Description: CA only: In single-accommodation restroom less than 48" in front of water closet provided.As-Built: 28" to cabinetProposed Solution: Remodel restroom to provide at least 48" in front of water closet.Notes: Relocate furniture	<p>PCODE WB03A</p> <p>CBC 2007 1115B.3.2.1</p> <p>CBC 2016 11B-604.3.1</p> <p>Project: SKYB2 Renovation</p> <p>Year to be Completed: 2021/2022</p> <p>Mitigated: <input type="radio"/> YES <input checked="" type="radio"/> NO</p>	1	JOB	\$15,000	\$15,000

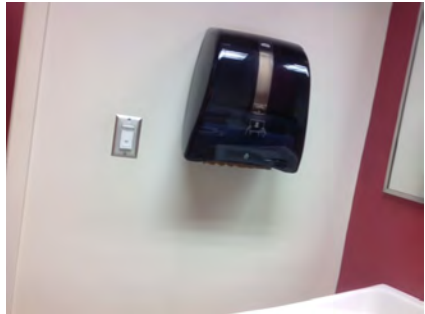
Item no., Rm no. and Name	Existing Architectural Barrier and Proposed Solution	Codes / Mitigation Info	Qty	Unit	Cost	Total
Accessories						
171	<ul style="list-style-type: none"> As-Built Description: Dispensers in sanitary facilities, such as for towels, soap, sanitary napkins, seat covers, etc., and waste receptacles more than 48" (CA only: 40") from floor to highest operating slot or control. As-Built: Paper towel dispenser 47" above finished floor Proposed Solution: Relocate existing restroom accessories. 	PCODE WG01A ADAAG 91 4.23.7 ADA 2010 308.2.1 CBC 2007 1115B.8.3 CBC 2016 11B-603.5 Project: SKYB2 Renovation Year to be Completed: 2021/2022 Mitigated: <input type="radio"/> YES <input checked="" type="radio"/> NO	1	JOB	\$300	\$300

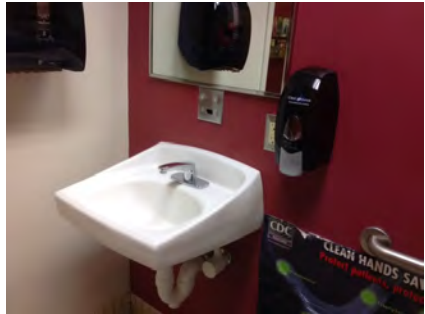
<input type="checkbox"/> Staff Only Priority 3 Severity 3			
170	<ul style="list-style-type: none"> As-Built Description: Bottom of mirror located above lavatories or countertops more than 40" above floor. As-Built: 48" above finished floor Proposed Solution: Relocate or provide new accessible mirror. 	PCODE WG03 ADAAG 91 4.19.6 ADA 2010 603.3 CBC 2007 1115B.8.1 CBC 2016 11B-603.3 Project: SKYB2 Renovation Year to be Completed: 2021/2022 Mitigated: <input type="radio"/> YES <input checked="" type="radio"/> NO	1	JOB	\$450	\$450

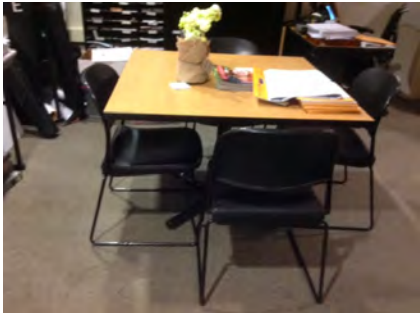
Item no., Rm no. and Name	Existing Architectural Barrier and Proposed Solution	Codes / Mitigation Info	Qty	Unit	Cost	Total
<u>Non-Fixed Desk</u>						
178	<ul style="list-style-type: none">• <i>As-Built Description:</i> Accessible non-fixed table or desk (top 28" to 34" high; knee space at least 27" high x 19" deep x 30" wide) not provided.• <i>Proposed Solution:</i> Provide table or desk with accessible dimensions when purchasing new furniture.	<p>PCODE IN02A</p> <p>ADAAG 91 4.32.3 & .4</p> <p>ADA 2010 306.1</p> <p>CBC 2007 1122B.3 & 4</p> <p>CBC 2016 11B-306.1 & 11B-902.3</p> <p>Project: SKYB2 Renovation</p> <p>Year to be Completed: 2021/2022</p> <p>Mitigated:</p> <p><input type="radio"/> YES</p> <p><input checked="" type="radio"/> NO</p>	1	JOB	\$4,800	\$4,800

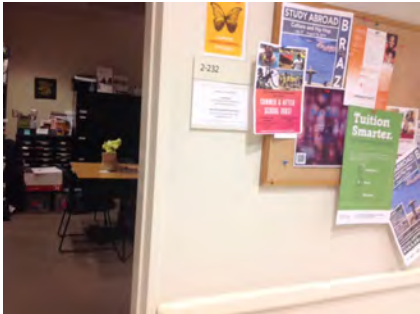
<input type="checkbox"/> Staff Only			
			Priority 2 Severity 2			
<u>Signage</u>						
176	<ul style="list-style-type: none">• <i>As-Built Description:</i> Sign not located on latch side of door and/or not located at 48" min. above to baseline of the lowest Braille cells and 60" max. to baseline of the highest line of raised characters.• <i>As-Built:</i> 61" above finished floor• <i>Proposed Solution:</i> Provide compliant signage including tactile characters and Grade II Braille on latch side of door located at compliant height.	<p>PCODE SA07</p> <p>ADAAG 91 4.30.6</p> <p>ADA 2010 703.4.1</p> <p>CBC 2007 1117B.5.7</p> <p>CBC 2016 11B-703.4.1</p> <p>Project: SKYB2 Renovation</p> <p>Year to be Completed: 2021/2022</p> <p>Mitigated:</p> <p><input type="radio"/> YES</p> <p><input checked="" type="radio"/> NO</p>	1	JOB	\$150	\$150

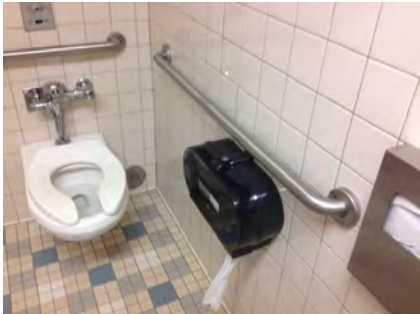
Item no., Rm no. and Name	Existing Architectural Barrier and Proposed Solution	Codes / Mitigation Info	Qty	Unit	Cost	Total
Grab Bars						
187	<ul style="list-style-type: none">As-Built Description: Side grab bar less than 42" long, or located more than 12 inches max. from the rear wall, or extending less than 54" from rear wall (CA only: front end min. 24" in front of water closet).As-Built: 51" from rear wallProposed Solution: Provide or relocate accessible side grab bar.	<p>PCODE WB07A ADAAG 91 Fig. 29(b) ADA 2010 604.5.1 CBC 2007 1115B.4.1.3.1 CBC 2016 11B-604.5.1</p> <p>Project: SKYB2 Renovation</p> <p>Year to be Completed: 2021/2022</p> <p>Mitigated: <input type="radio"/> YES <input checked="" type="radio"/> NO</p>	1	JOB	\$780	\$780

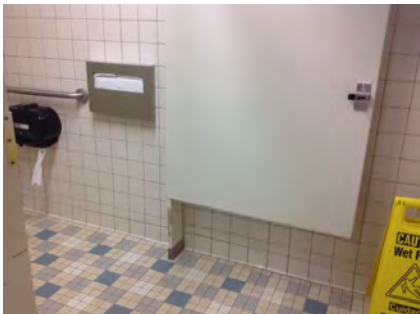
<input type="checkbox"/> Staff Only			
			Priority 3 Severity 3			
Stall Door						
185	<ul style="list-style-type: none">As-Built Description: Stall door to accessible compartment not self closing.Proposed Solution: Adjust closer.	<p>PCODE WB05B ADAAG 91 4.22.4 ADA 2010 604.8.1.2 CBC 2007 1115B.3.1.4.4 CBC 2016 11B-604.8.1.2</p> <p>Project: SKYB2 Renovation</p> <p>Year to be Completed: 2021/2022</p> <p>Mitigated: <input type="radio"/> YES <input checked="" type="radio"/> NO</p>	1	JOB	\$75	\$75

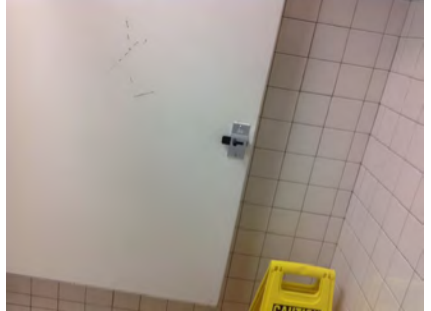
Item no., Rm no. and Name	Existing Architectural Barrier and Proposed Solution	Codes / Mitigation Info	Qty	Unit	Cost	Total
184	<ul style="list-style-type: none"> As-Built Description: Stall door does not have accessible operating hardware (U-pulls on both sides, flip-over or sliding lock). Proposed Solution: Provide new accessible locking hardware that does not require grasping, pinching, or twisting and U-pulls on both sides. 	PCODE WB05C ADAAG 91 4.17.5 ADA 2010 604.8.1.2 CBC 2007 1115B.3.1.4.5 CBC 2016 11B-604.8.1.2 Project: SKYB2 Renovation Year to be Completed: 2021/2022 Mitigated: <input type="radio"/> YES <input checked="" type="radio"/> NO	2	JOB	\$300	\$600

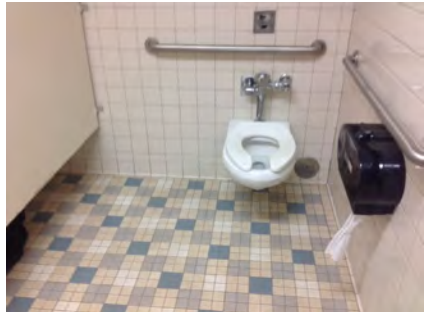
<input type="checkbox"/> Staff Only Priority 3 Severity 3						
<hr/>						
<u>Toilet Stall</u>						
186	<ul style="list-style-type: none"> As-Built Description: Toilet stall less than 60" wide. As-Built: 55" to stall partition Proposed Solution: Provide new accessible stall. Notes: 32" side of toilet 	PCODE WB06 ADAAG 91 4.17.3 ADA 2010 604.8.1.1 CBC 2007 1115B.3.1.4.1 CBC 2016 11B-604.8.1.1 Project: SKYB2 Renovation Year to be Completed: 2021/2022 Mitigated: <input type="radio"/> YES <input checked="" type="radio"/> NO	1	JOB	\$4,500	\$4,500

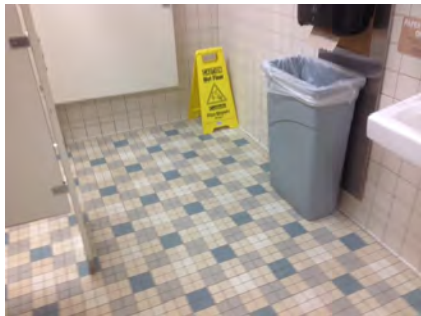
Item no., Rm no. and Name	Existing Architectural Barrier and Proposed Solution	Codes / Mitigation Info	Qty	Unit	Cost	Total
<u>Wheelchair Clearance</u>						
182	<ul style="list-style-type: none">As-Built Description: Clear passage width (except doorways) from rest room entry to accessible water closet compartment less than 36" (CA only: 44" wide).As-Built: 42" wide at lavatoryProposed Solution: Modify facility passage to be min. 44" wide. Demolish existing partition and replace.	<p>PCODE WC02A ADAAG 91 4.3.3 ADA 2010 403.5.1 CBC 2007 1115B.3.2.4 CBC 2016 11B-403.5.1</p> <p>Project: SKYB2 Renovation</p> <p>Year to be Completed: 2021/2022</p> <p>Mitigated: <input type="radio"/> YES <input checked="" type="radio"/> NO</p>	1	LF	\$510	\$510

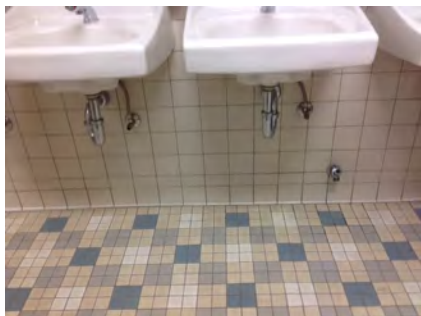
<input type="checkbox"/> Staff Only			
			Priority 3 Severity 2			
<u>Lavatory</u>						
180	<ul style="list-style-type: none">As-Built Description: Hot or sharp-surfaced water/drain pipe not insulated or covered.Proposed Solution: Insulate or cover water/drain pipe.	<p>PCODE WD05 ADAAG 91 4.19.4 ADA 2010 606.5 CBC 2007 1115B.4.3.4 CBC 2016 11B-606.5</p> <p>Project: SKYB2 Renovation</p> <p>Year to be Completed: 2021/2022</p> <p>Mitigated: <input type="radio"/> YES <input checked="" type="radio"/> NO</p>	1	JOB	\$360	\$360

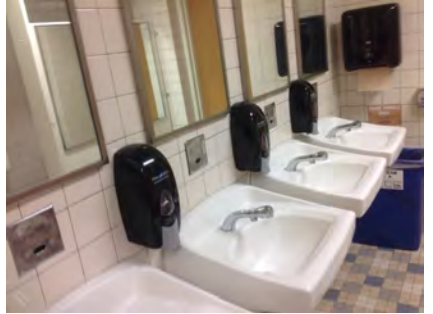
Item no., Rm no. and Name	Existing Architectural Barrier and Proposed Solution	Codes / Mitigation Info	Qty	Unit	Cost	Total
<u>Accessories</u>						
181	<ul style="list-style-type: none"> • <i>As-Built Description:</i> Bottom of mirror located above lavatories or countertops more than 40" above floor. • <i>As-Built:</i> 48" above finished floor • <i>Proposed Solution:</i> Relocate or provide new accessible mirror. 	PCODE WG03 ADAAG 91 4.19.6 ADA 2010 603.3 CBC 2007 1115B.8.1 CBC 2016 11B-603.3 Project: SKYB2 Renovation Year to be Completed: 2021/2022 Mitigated: <input type="radio"/> YES <input checked="" type="radio"/> NO	1	JOB	\$450	\$450

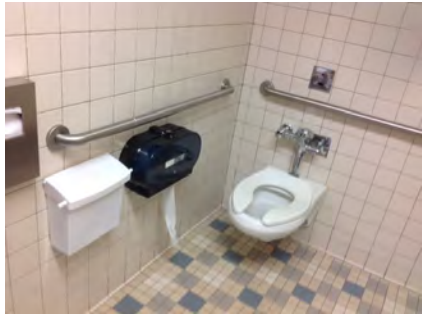
Item no., Rm no. and Name	Existing Architectural Barrier and Proposed Solution	Codes / Mitigation Info	Qty	Unit	Cost	Total
Grab Bars						
195	<ul style="list-style-type: none">As-Built Description: Side grab bar less than 42" long, or located more than 12 inches max. from the rear wall, or extending less than 54" from rear wall (CA only: front end min. 24" in front of water closet).Proposed Solution: Provide or relocate accessible side grab bar.	<p>PCODE WB07A ADAAG 91 Fig. 29(b) ADA 2010 604.5.1 CBC 2007 1115B.4.1.3.1 CBC 2016 11B-604.5.1</p> <p>Project: SKYB2 Renovation</p> <p>Year to be Completed: 2021/2022</p> <p>Mitigated: <input type="radio"/> YES <input checked="" type="radio"/> NO</p>	1	JOB	\$780	\$780

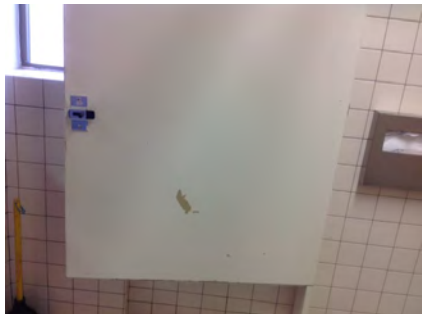
<input type="checkbox"/> Staff Only			
			Priority 3 Severity 4			
Stall Door						
193	<ul style="list-style-type: none">As-Built Description: Stall door to accessible compartment not self closing.Proposed Solution: Adjust closer.	<p>PCODE WB05B ADAAG 91 4.22.4 ADA 2010 604.8.1.2 CBC 2007 1115B.3.1.4.4 CBC 2016 11B-604.8.1.2</p> <p>Project: SKYB2 Renovation</p> <p>Year to be Completed: 2021/2022</p> <p>Mitigated: <input type="radio"/> YES <input checked="" type="radio"/> NO</p>	1	JOB	\$75	\$75

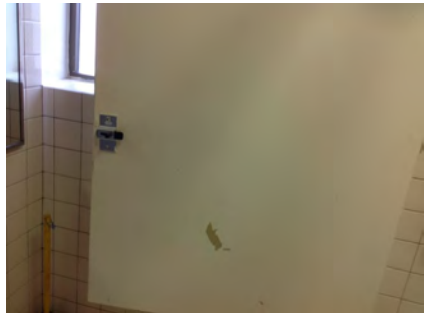
Item no., Rm no. and Name	Existing Architectural Barrier and Proposed Solution	Codes / Mitigation Info	Qty	Unit	Cost	Total
192	<ul style="list-style-type: none"> As-Built Description: Stall door does not have accessible operating hardware (U-pulls on both sides, flip-over or sliding lock). Proposed Solution: Provide new accessible locking hardware that does not require grasping, pinching, or twisting and U-pulls on both sides. 	PCODE WB05C ADAAG 91 4.17.5 ADA 2010 604.8.1.2 CBC 2007 1115B.3.1.4.5 CBC 2016 11B-604.8.1.2 Project: SKYB2 Renovation Year to be Completed: 2021/2022 Mitigated: <input type="radio"/> YES <input checked="" type="radio"/> NO	1	JOB	\$300	\$300

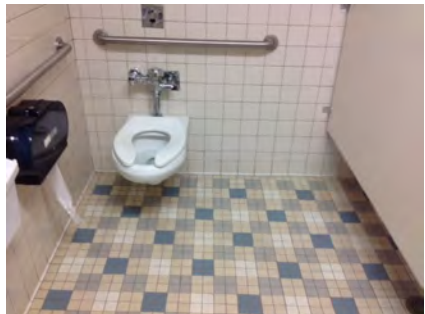
<input type="checkbox"/> Staff Only Priority 3 Severity 3						
<hr/>						
194	Toilet Stall <ul style="list-style-type: none"> As-Built Description: Toilet stall less than 60" wide. As-Built: 57" to stall partition Proposed Solution: Provide new accessible stall. Notes: 32" side of toilet 	PCODE WB06 ADAAG 91 4.17.3 ADA 2010 604.8.1.1 CBC 2007 1115B.3.1.4.1 CBC 2016 11B-604.8.1.1 Project: SKYB2 Renovation Year to be Completed: 2021/2022 Mitigated: <input type="radio"/> YES <input checked="" type="radio"/> NO	1	JOB	\$4,500	\$4,500

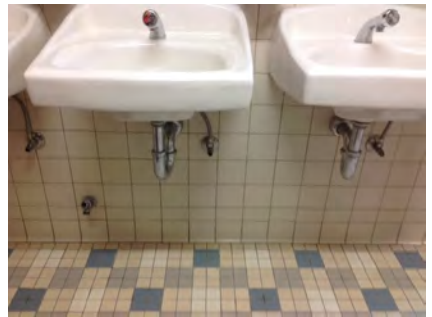
Item no., Rm no. and Name	Existing Architectural Barrier and Proposed Solution	Codes / Mitigation Info	Qty	Unit	Cost	Total
Lavatory						
190	<ul style="list-style-type: none">As-Built Description: Hot or sharp-surfaced water/drain pipe not insulated or covered.Proposed Solution: Insulate or cover water/drain pipe.	PCODE WD05 ADAAG 91 4.19.4 ADA 2010 606.5 CBC 2007 1115B.4.3.4 CBC 2016 11B-606.5 Project: SKYB2 Renovation Year to be Completed: 2021/2022 Mitigated: <div><input type="radio"/> YES</div> <div><input checked="" type="radio"/> NO</div>	1	JOB	\$360	\$360

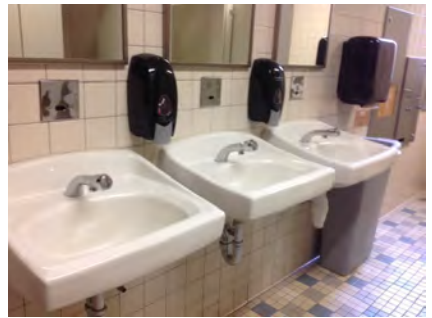
<div><input type="checkbox"/> Staff Only</div> <div><div>Priority</div><div>3</div><div>Severity</div><div>3</div></div>			
Accessories						
189	<ul style="list-style-type: none">As-Built Description: Bottom of mirror located above lavatories or countertops more than 40" above floor.As-Built: 48" above finished floorProposed Solution: Relocate or provide new accessible mirror.	PCODE WG03 ADAAG 91 4.19.6 ADA 2010 603.3 CBC 2007 1115B.8.1 CBC 2016 11B-603.3 Project: SKYB2 Renovation Year to be Completed: 2021/2022 Mitigated: <div><input type="radio"/> YES</div> <div><input checked="" type="radio"/> NO</div>	1	JOB	\$450	\$450

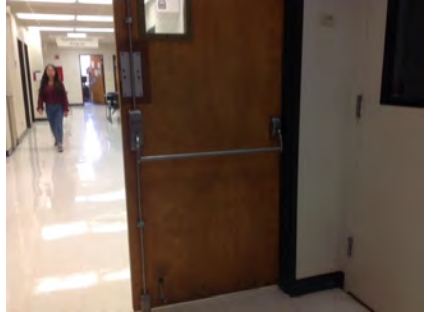
Item no., Rm no. and Name	Existing Architectural Barrier and Proposed Solution	Codes / Mitigation Info	Qty	Unit	Cost	Total
197	<ul style="list-style-type: none"> As-Built Description: Vision Light at door that permits viewing, does not have bottom of at least one glazed panel located 43 inches maximum above the finish floor. (Exception: More than 66" above finished floor.) Proposed Solution: Provide new door with vision panel at 43" max. 	PCODE ID06C ADA 2010 404.2.11 CBC 2016 11B-404.2.11 Project: SKYB2 Renovation Year to be Completed: 2021/2022 Mitigated: <input type="radio"/> YES <input checked="" type="radio"/> NO	4	JOB	\$7,500	\$30,000

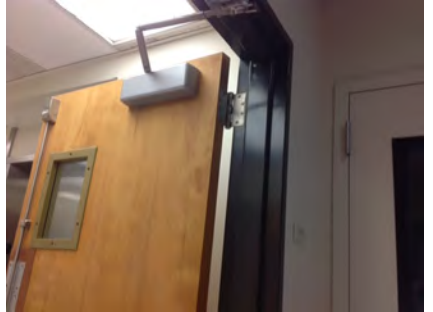
199	<ul style="list-style-type: none"> As-Built Description: Excessive force required to open door. As-Built: 7 lbs. Proposed Solution: Adjust regular door closer to accessible standards (5 lbs. max). 	PCODE ID03 ADAAG 91 4.13.11 ADA 2010 404.2.9 CBC 2007 1133B.2.5 CBC 2016 11B-404.2.9 Project: SKYB2 Renovation Year to be Completed: 2021/2022 Mitigated: <input type="radio"/> YES <input checked="" type="radio"/> NO	2	JOB	\$75	\$150

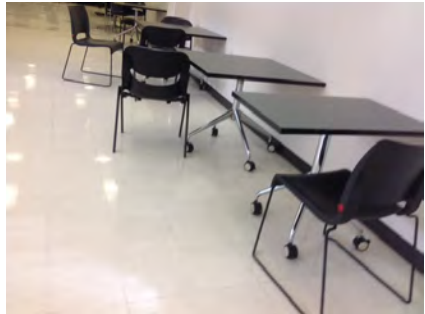
Item no., Rm no. and Name	Existing Architectural Barrier and Proposed Solution	Codes / Mitigation Info	Qty	Unit	Cost	Total
Non-Fixed Desk						
200	<ul style="list-style-type: none"> As-Built Description: Accessible non-fixed table or desk (top 28" to 34" high; knee space at least 27" high x 19" deep x 30" wide) not provided. Proposed Solution: Provide table or desk with accessible dimensions when purchasing new furniture. Notes: 35 seats, no accessible table 	PCODE IN02A ADAAG 91 4.32.3 & .4 ADA 2010 306.1 CBC 2007 1122B.3 & 4 CBC 2016 11B-306.1 & 11B-902.3 Project: SKYB2 Renovation Year to be Completed: 2021/2022 Mitigated: <input type="radio"/> YES <input checked="" type="radio"/> NO	1	JOB	\$4,800	\$4,800

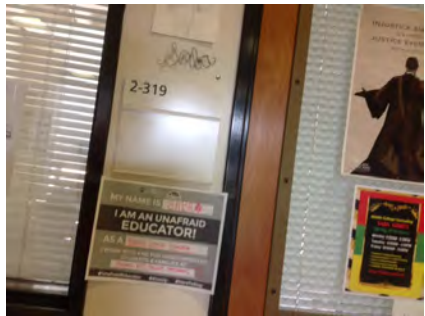
Signage						
201	<ul style="list-style-type: none"> As-Built Description: Sign not located on latch side of door and/or not located at 48" min. above to baseline of the lowest Braille cells and 60" max. to baseline of the highest line of raised characters. As-Built: 61" above finished floor Proposed Solution: Provide compliant signage including tactile characters and Grade II Braille on latch side of door located at compliant height. 	PCODE SA07 ADAAG 91 4.30.6 ADA 2010 703.4.1 CBC 2007 1117B.5.7 CBC 2016 11B-703.4.1 Project: SKYB2 Renovation Year to be Completed: 2021/2022 Mitigated: <input type="radio"/> YES <input checked="" type="radio"/> NO	1	JOB	\$150	\$150

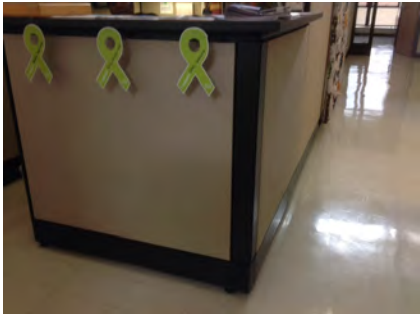
Item no., Rm no. and Name	Existing Architectural Barrier and Proposed Solution	Codes / Mitigation Info	Qty	Unit	Cost	Total
Public Counter						
205	<ul style="list-style-type: none">• <i>As-Built Description:</i> Service counter (stand-up): Accessible section min. 36" length and 36" max. height (in CA: 28" to 34" high) not provided.• <i>As-Built:</i> 42" above finished floor• <i>Proposed Solution:</i> Retrofit existing counter to provide accessible section. Interim solution: Provide auxiliary counter, table, or clipboard.	<p>PCODE IN03 ADAAG 91 7.2(2) ADA 2010 904.4 CBC 2007 1122B.4 CBC 2016 11B-904.4</p> <p>Project: SKYB2 Renovation</p> <p>Year to be Completed: 2021/2022</p> <p>Mitigated: <input type="radio"/> YES <input checked="" type="radio"/> NO</p>	1	JOB	\$6,000	\$6,000

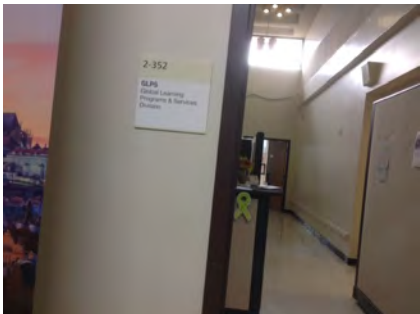
<input type="checkbox"/> Staff Only			
			Priority 2 Severity 3			
Signage						
204	<ul style="list-style-type: none">• <i>As-Built Description:</i> Sign not located on latch side of door and/or not located at 48" min. above to baseline of the lowest Braille cells and 60" max. to baseline of the highest line of raised characters.• <i>As-Built:</i> 62" above finished floor• <i>Proposed Solution:</i> Provide compliant signage including tactile characters and Grade II Braille on latch side of door located at compliant height.	<p>PCODE SA07 ADAAG 91 4.30.6 ADA 2010 703.4.1 CBC 2007 1117B.5.7 CBC 2016 11B-703.4.1</p> <p>Project: SKYB2 Renovation</p> <p>Year to be Completed: 2021/2022</p> <p>Mitigated: <input type="radio"/> YES <input checked="" type="radio"/> NO</p>	1	JOB	\$150	\$150

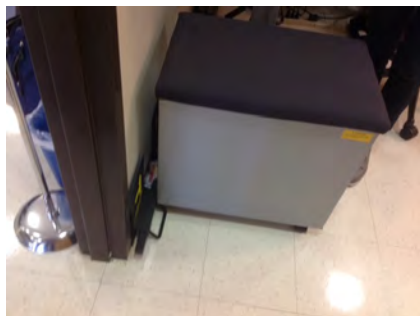
Item no., Rm no. and Name	Existing Architectural Barrier and Proposed Solution	Codes / Mitigation Info	Qty	Unit	Cost	Total
Door Swing						
215	<ul style="list-style-type: none">As-Built Description: Front approach: At pull side, door does not have clear and level maneuvering space measuring door width plus 18" x 60". (24" x 60" at exterior doors).As-Built: 8" strike side clearanceProposed Solution: Remove or relocate furniture or storage items.	<p>PCODE ID23A</p> <p>ADAAG 91 Fig. 25(a)</p> <p>ADA 2010 404.2.4</p> <p>CBC 2007 11B-26A(a)</p> <p>CBC 2016 11B-404.2.4</p> <p>Project: SKYB2 Renovation</p> <p>Year to be Completed: 2021/2022</p> <p>Mitigated: <input type="radio"/> YES <input checked="" type="radio"/> NO</p>	1	JOB	\$150	\$150

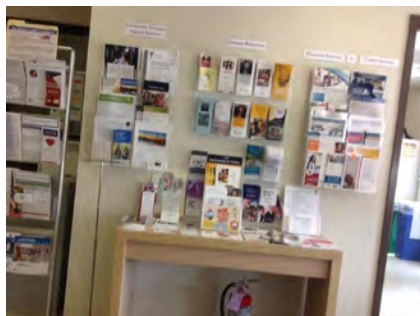
<input type="checkbox"/> Staff Only			
			Priority 2 Severity 3			
Reach Range						
210	<ul style="list-style-type: none">As-Built Description: Reach height to control or access point, exceeds 48" or is less than 15".As-Built: 65" above finished floorProposed Solution: Modify equipment or mounting.	<p>PCODE IE01</p> <p>ADAAG 91 4.2.5</p> <p>ADA 2010 308.2.1</p> <p>CBC 2007 1118B.5</p> <p>CBC 2016 11B-308.2.1</p> <p>Project: SKYB2 Renovation</p> <p>Year to be Completed: 2021/2022</p> <p>Mitigated: <input type="radio"/> YES <input checked="" type="radio"/> NO</p>	1	JOB	\$300	\$300

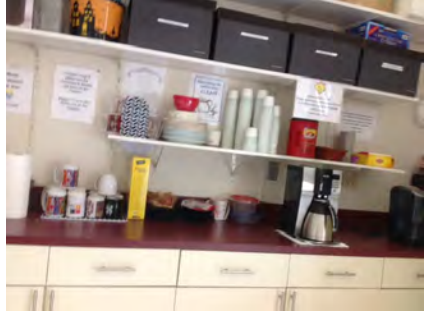
Item no., Rm no. and Name	Existing Architectural Barrier and Proposed Solution	Codes / Mitigation Info	Qty	Unit	Cost	Total
212	<ul style="list-style-type: none"> As-Built Description: Reach height to control or access point, exceeds 48" or is less than 15". As-Built: 56" above finished floor Proposed Solution: Modify equipment or mounting. 	PCODE IE01 ADAAG 91 4.2.5 ADA 2010 308.2.1 CBC 2007 1118B.5 CBC 2016 11B-308.2.1 Project: SKYB2 Renovation Year to be Completed: 2021/2022 Mitigated: <input type="radio"/> YES <input checked="" type="radio"/> NO	1	JOB	\$300	\$300

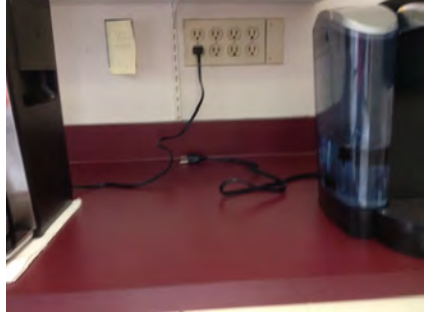
<input type="checkbox"/> Staff Only Priority 2 Severity 3			
213	<ul style="list-style-type: none"> As-Built Description: Reach height to control or access point, exceeds 48" or is less than 15". As-Built: 25" deep to outlet Proposed Solution: Modify equipment or mounting. 	PCODE IE01 ADAAG 91 4.2.5 ADA 2010 308.2.1 CBC 2007 1118B.5 CBC 2016 11B-308.2.1 Project: SKYB2 Renovation Year to be Completed: 2021/2022 Mitigated: <input type="radio"/> YES <input checked="" type="radio"/> NO	1	JOB	\$300	\$300

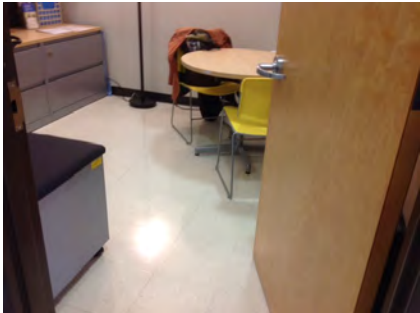
Item no., Rm no. and Name	Existing Architectural Barrier and Proposed Solution	Codes / Mitigation Info	Qty	Unit	Cost	Total
<u>Non-Fixed Desk</u>						
214	<ul style="list-style-type: none">• <i>As-Built Description:</i> Accessible non-fixed table or desk (top 28" to 34" high; knee space at least 27" high x 19" deep x 30" wide) not provided.• <i>Proposed Solution:</i> Provide table or desk with accessible dimensions when purchasing new furniture.	<p>PCODE IN02A</p> <p>ADAAG 91 4.32.3 & .4</p> <p>ADA 2010 306.1</p> <p>CBC 2007 1122B.3 & 4</p> <p>CBC 2016 11B-306.1 & 11B-902.3</p> <p>Project: SKYB2 Renovation</p> <p>Year to be Completed: 2021/2022</p> <p>Mitigated:</p> <p><input type="radio"/> YES</p> <p><input checked="" type="radio"/> NO</p>	2	JOB	\$4,800	\$9,600

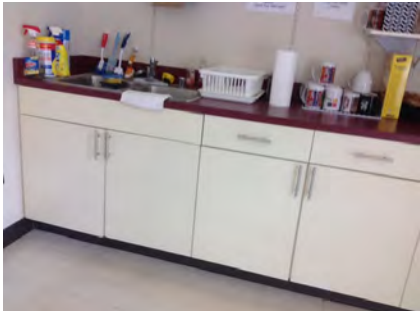
<u>Sink</u>						
211	<ul style="list-style-type: none">• <i>As-Built Description:</i> Sink rim higher than 34" above floor.• <i>As-Built:</i> 36" above finished floor• <i>Proposed Solution:</i> Remodel sink cabinet to lower sink.	<p>PCODE IN06</p> <p>ADAAG 91 4.24.2</p> <p>ADA 2010 606.3</p> <p>CBC 2007 1115B.4.7.1</p> <p>CBC 2016 11B-606.3</p> <p>Project: SKYB2 Renovation</p> <p>Year to be Completed: 2021/2022</p> <p>Mitigated:</p> <p><input type="radio"/> YES</p> <p><input checked="" type="radio"/> NO</p>	1	JOB	\$5,250	\$5,250

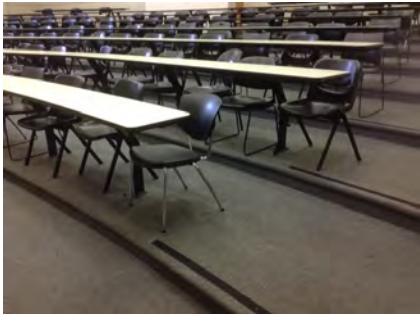
Item no., Rm no. and Name	Existing Architectural Barrier and Proposed Solution	Codes / Mitigation Info	Qty	Unit	Cost	Total
<u>Fixed Seating</u>						
220	<ul style="list-style-type: none">• <i>As-Built Description:</i> Proper amount of seating for disabled persons at public seating is not provided (4 to 25=1; 26 to 50=2; 51 to 150=4; 151 to 300=5; 301 to 500=6; 501 to 5000=6+1 for each hundred; >5001=46+1 for each 200.• <i>Proposed Solution:</i> Modify seating to provide clear and level wheelchair space 33" x 48" or 33" x 60", including companion seat, as required.• <i>Notes:</i> 200 total seats with no accessible wheelchair seating due to step.	<p>PCODE GE01</p> <p>ADAAG 91 4.1.2(19)a</p> <p>ADA 2010 221.2.1</p> <p>CBC 2007 1104B.3.4</p> <p>CBC 2016 11B-221.2.1</p> <p>Project: SKYB2 Renovation</p> <p>Year to be Completed: 2021/2022</p> <p>Mitigated: <input type="radio"/> YES <input checked="" type="radio"/> NO</p>	1	EA	\$1,800	\$1,800

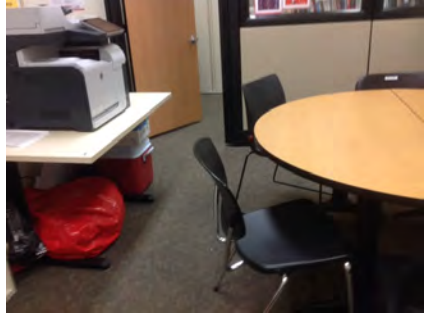
Item no., Rm no. and Name	Existing Architectural Barrier and Proposed Solution	Codes / Mitigation Info	Qty	Unit	Cost	Total
Corridor						
223	<ul style="list-style-type: none"> • <i>As-Built Description:</i> Corridor, for occupant load less than 10, less than 36" wide. • <i>As-Built:</i> 28" wide • <i>Proposed Solution:</i> Remove or relocate furniture and storage items. 	PCODE IH03A ADAAG 91 4.3.3 ADA 2010 403.5.1 CBC 2007 1133B.3.1 CBC 2016 11B-403.5.1	1	JOB	\$150	\$150
		Project: SKYB2 Renovation Year to be Completed: 2021/2022 Mitigated: <input type="radio"/> YES <input checked="" type="radio"/> NO

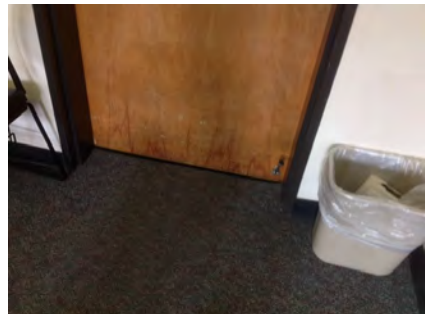
Item no., Rm no. and Name	Existing Architectural Barrier and Proposed Solution	Codes / Mitigation Info	Qty	Unit	Cost	Total
Door Stopper						
226	<ul style="list-style-type: none">• <i>As-Built Description:</i> At push side of door on accessible route, bottom 10" does not have a smooth, uninterrupted surface.• <i>Proposed Solution:</i> Remove door stopper when altering area. Provide rubber wedge.	<p>PCODE ID06A</p> <p>ADA 2010 404.2.10</p> <p>CBC 2007 1133B.2.6</p> <p>CBC 2016 11B-404.2.10</p> <p>Project: SKYB2 Renovation</p> <p>Year to be Completed: 2021/2022</p> <p>Mitigated: <input type="radio"/> YES <input checked="" type="radio"/> NO</p>	1	JOB	\$75	\$75

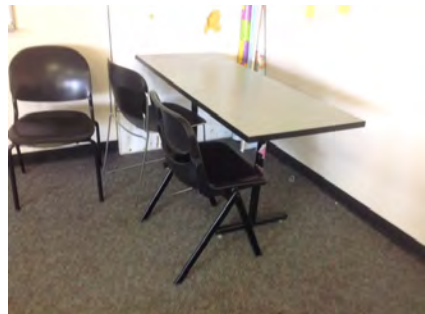
<input type="checkbox"/> Staff Only			
			Priority 2 Severity 3			
Non-Fixed Desk						
228	<ul style="list-style-type: none">• <i>As-Built Description:</i> Accessible non-fixed table or desk (top 28" to 34" high; knee space at least 27" high x 19" deep x 30" wide) not provided.• <i>Proposed Solution:</i> Provide table or desk with accessible dimensions when purchasing new furniture.• <i>Notes:</i> 42 seats 1 accessible table provided. 2 additional required.	<p>PCODE IN02A</p> <p>ADAAG 91 4.32.3 & .4</p> <p>ADA 2010 306.1</p> <p>CBC 2007 1122B.3 & 4</p> <p>CBC 2016 11B-306.1 & 11B-902.3</p> <p>Project: SKYB2 Renovation</p> <p>Year to be Completed: 2021/2022</p> <p>Mitigated: <input type="radio"/> YES <input checked="" type="radio"/> NO</p>	1	JOB	\$4,800	\$4,800
