SAN MATEO COUNTY
COMMUNITY
COLLEGE DISTRICT

San Mateo County Community College District Americans with Disabilities Act Self-Evaluation and Transition Plan

Report Prepared by:

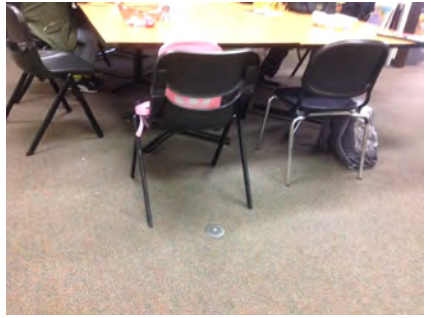
Item no., Rm no. and Name	Existing Architectural Barrier and Proposed Solution	Codes / Mitigation Info	Qty	Unit	Cost	Total
Non-Fixed Desk						
231	<ul style="list-style-type: none"> As-Built Description: Accessible non-fixed table or desk (top 28" to 34" high; knee space at least 27" high x 19" deep x 30" wide) not provided. Proposed Solution: Provide table or desk with accessible dimensions when purchasing new furniture. Notes: 10 seats, no accessible seats provided 	PCODE IN02A ADAAG 91 4.32.3 & .4 ADA 2010 306.1 CBC 2007 1122B.3 & 4 CBC 2016 11B-306.1 & 11B-902.3	1	JOB	\$4,800	\$4,800

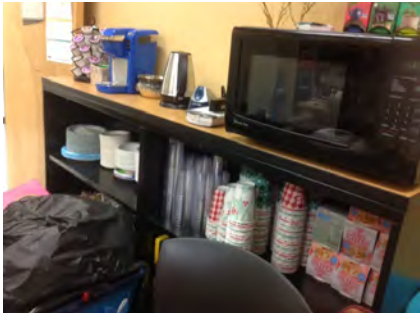
Item no., Rm no. and Name	Existing Architectural Barrier and Proposed Solution	Codes / Mitigation Info	Qty	Unit	Cost	Total
<u>Reach Range</u>						
235	<ul style="list-style-type: none">As-Built Description: Reach height to control or access point, exceeds 48" or is less than 15".As-Built: 52" above finished floorProposed Solution: Modify equipment or mounting.	<p>PCODE IE01</p> <p>ADAAG 91 4.2.5</p> <p>ADA 2010 308.2.1</p> <p>CBC 2007 1118B.5</p> <p>CBC 2016 11B-308.2.1</p> <p>Project: SKYB2 Renovation</p> <p>Year to be Completed: 2021/2022</p> <p>Mitigated:</p> <p><input type="radio"/> YES</p> <p><input checked="" type="radio"/> NO</p>	1	JOB	\$300	\$300

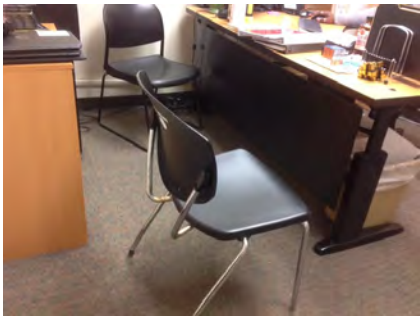
<input type="checkbox"/> Staff Only			
			<div><div>Priority</div><div>2</div></div> <div><div>Severity</div><div>4</div></div>			
<u>Non-Fixed Desk</u>						
236	<ul style="list-style-type: none">As-Built Description: Accessible non-fixed table or desk (top 28" to 34" high; knee space at least 27" high x 19" deep x 30" wide) not provided.As-Built: no knee spaceProposed Solution: Provide table or desk with accessible dimensions when purchasing new furniture.	<p>PCODE IN02A</p> <p>ADAAG 91 4.32.3 & .4</p> <p>ADA 2010 306.1</p> <p>CBC 2007 1122B.3 & 4</p> <p>CBC 2016 11B-306.1 & 11B-902.3</p> <p>Project: SKYB2 Renovation</p> <p>Year to be Completed: 2021/2022</p> <p>Mitigated:</p> <p><input type="radio"/> YES</p> <p><input checked="" type="radio"/> NO</p>	1	JOB	\$4,800	\$4,800

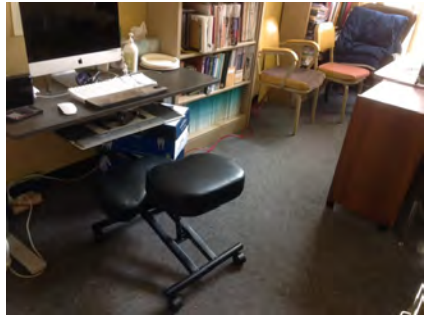
Item no., Rm no. and Name	Existing Architectural Barrier and Proposed Solution	Codes / Mitigation Info	Qty	Unit	Cost	Total
Non-Fixed Desk						
245	<ul style="list-style-type: none"> As-Built Description: Accessible non-fixed table or desk (top 28" to 34" high; knee space at least 27" high x 19" deep x 30" wide) not provided. Proposed Solution: Provide table or desk with accessible dimensions when purchasing new furniture. 	PCODE IN02A ADAAG 91 4.32.3 & .4 ADA 2010 306.1 CBC 2007 1122B.3 & 4 CBC 2016 11B-306.1 & 11B-902.3	1	JOB	\$4,800	\$4,800

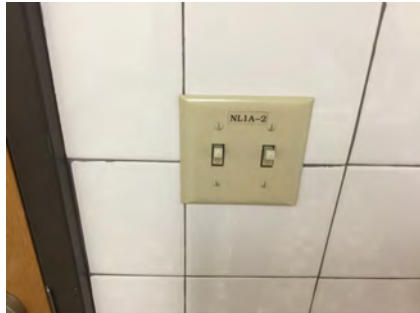
Item no., Rm no. and Name	Existing Architectural Barrier and Proposed Solution	Codes / Mitigation Info	Qty	Unit	Cost	Total
Electrical						
1282	<ul style="list-style-type: none"> • <i>As-Built Description:</i> Electric switch or control mounted less than 15" measured to the bottom of the outlet box or greater than 48 inches measured to the top of the outlet box. • <i>As-Built:</i> 49.5" to top of electrical box. 48.25" to top of switch. • <i>Proposed Solution:</i> Relocate light switches or control to between 15" and 48" height. 	PCODE IC01 ADAAG 91 4.2.5 & 6 ADA 2010 308.2.1 & CBC 2007 1117B.6.3 CBC 2016 11B-308.2.1 & 11B-308.2.2 Mitigated: <input type="radio"/> YES <input checked="" type="radio"/> NO	1	JOB	\$900	\$900

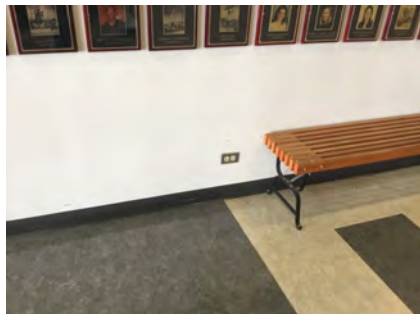
<input type="checkbox"/> Staff Only Priority 2 Severity 4			
1329	<ul style="list-style-type: none"> • <i>As-Built Description:</i> Electric switch or control mounted less than 15" measured to the bottom of the outlet box or greater than 48 inches measured to the top of the outlet box. • <i>As-Built:</i> 11.5" high • <i>Proposed Solution:</i> Relocate light switches or control to between 15" and 48" height. 	PCODE IC01 ADAAG 91 4.2.5 & 6 ADA 2010 308.2.1 & CBC 2007 1117B.6.3 CBC 2016 11B-308.2.1 & 11B-308.2.2 Mitigated: <input type="radio"/> YES <input checked="" type="radio"/> NO	1	JOB	\$900	\$900

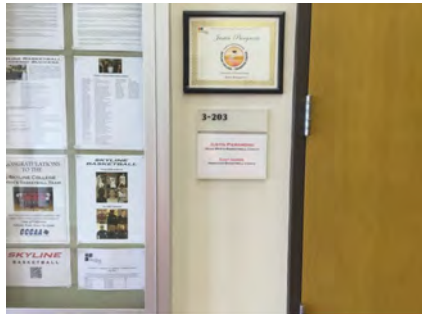
Item no., Rm no. and Name	Existing Architectural Barrier and Proposed Solution	Codes / Mitigation Info	Qty	Unit	Cost	Total
1122	<ul style="list-style-type: none"> As-Built Description: Signs containing tactile characters is not located so that a clear floor space of 18" min x 18" min., centered on the tactile characters, is provided beyond the arc of any door swing between the closed position and 45 degree open position. As-Built: 63" to the bottom of the highest tactile character. 60" to the center of the sign Proposed Solution: Relocate compliant signage on latch side of door located at compliant height with a clear floor space. 	PCODE SA07B ADA 2010 703.4.2 CBC 2016 11B-703.4.2 Mitigated: <input type="radio"/> YES <input checked="" type="radio"/> NO	1	JOB	\$150	\$150

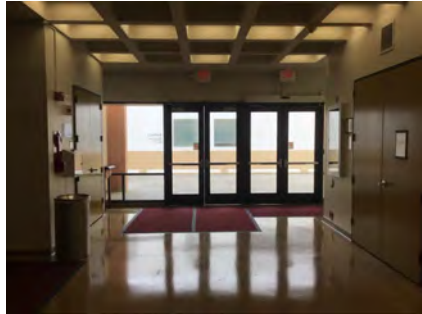
<input type="checkbox"/> Staff Only						
Priority 2 Severity 4						
1135	<ul style="list-style-type: none"> As-Built Description: At final exit door to exterior: Where required exit signs are installed, signs to provide exiting information for people with vision impairment are not provided. Proposed Solution: Provide raised letter/Braille "EXIT" sign at door. 	PCODE SA10A ADAAG 91 4.1.3(16) ADA 2010 216.4.1 CBC 2007 1011.3 CBC 2016 11B-216.4.1 Mitigated: <input type="radio"/> YES <input checked="" type="radio"/> NO	2	JOB	\$270	\$540

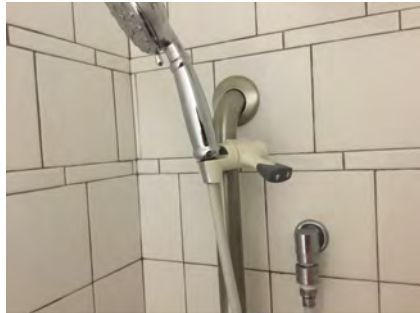
Item no., Rm no. and Name	Existing Architectural Barrier and Proposed Solution	Codes / Mitigation Info	Qty	Unit	Cost	Total
Shower						
1173	<ul style="list-style-type: none"> As-Built Description: Mounting height of shower spray bracket exceeds 48" max.height or is more than 27" from rear edge of folding seat. As-Built: 61" high Proposed Solution: Provide or remount shower spray bracket within 27" from rear edge of seat and at 48" max. height. 	PCODE WF05B ADA 2010 608.5 CBC 2007 1115B.4.4.5.3 CBC 2016 11B-608.5 Mitigated: <input type="radio"/> YES <input checked="" type="radio"/> NO	1	JOB	\$1,500	\$1,500

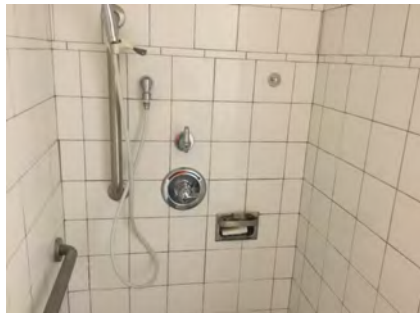
<input type="checkbox"/> Staff Only Priority 3 Severity 2			
1176	<ul style="list-style-type: none"> As-Built Description: Mounting height of shower spray bracket exceeds 48" max.height or is more than 27" from rear edge of folding seat. As-Built: Shower spray bracket 29" from the seat wall Proposed Solution: Provide or remount shower spray bracket within 27" from rear edge of seat and at 48" max. height. 	PCODE WF05B ADA 2010 608.5 CBC 2007 1115B.4.4.5.3 CBC 2016 11B-608.5 Mitigated: <input type="radio"/> YES <input checked="" type="radio"/> NO	1	JOB	\$1,500	\$1,500

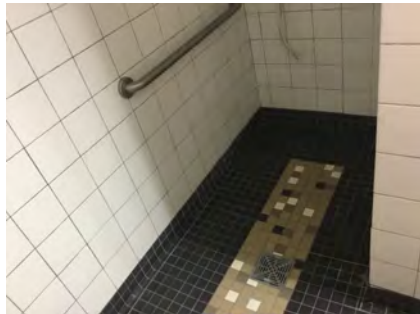
<input type="checkbox"/> Staff Only Priority 3 Severity 4			
1169	<ul style="list-style-type: none"> As-Built Description: Floor surface sloped greater than 2.0% (1:48) due to drain. As-Built: 4% Proposed Solution: Remodel floor surface to compliance. 	PCODE WF06A ADA 2010 608.9 CBC 2016 11B-608.9 Mitigated: <input type="radio"/> YES <input checked="" type="radio"/> NO	1	JOB	\$1,500	\$1,500

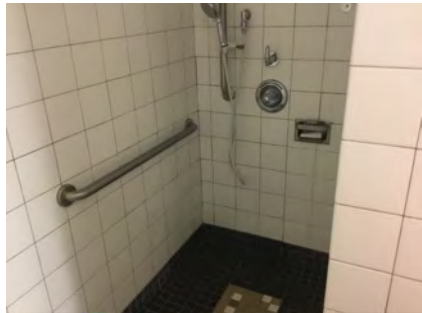
Item no., Rm no. and Name	Existing Architectural Barrier and Proposed Solution	Codes / Mitigation Info	Qty	Unit	Cost	Total
1170	<ul style="list-style-type: none"> As-Built Description: In 36" x 36" (CA: 30" x 60") stall, seat at 17" to 19" height above floor opposite controls not provided As-Built: No seat provided in shower Proposed Solution: Provide new, or relocate, folding wall-mounted shower seat. 	PCODE WF07 ADAAG 91 4.21.3 ADA 2010 608.4 CBC 2007 1115B.4.4.8.1 CBC 2016 11B-608.4 Mitigated: <input type="radio"/> YES <input checked="" type="radio"/> NO	1	JOB	\$1,650	\$1,650

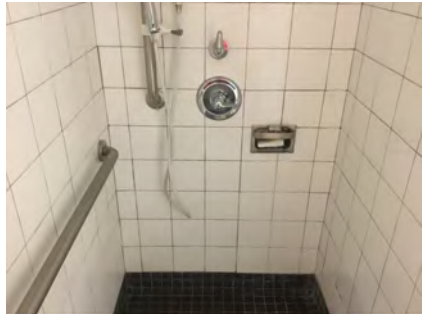
<input type="checkbox"/> Staff Only Priority 3 Severity 3				
1172	<ul style="list-style-type: none"> As-Built Description: In 36" x 36" shower stall, L-shaped grab bar that is located along the full depth of the control wall (opposite the seat) and halfway along the back wall (18") is not provided. As-Built: No L-shaped grab bar in shower Proposed Solution: Provide new grab bar in shower. 	PCODE WF08A ADAAG 91 Fig. 37(a) ADA 2010 608.3 CBC 2016 11B-608.3 Mitigated: <input type="radio"/> YES <input checked="" type="radio"/> NO	1	JOB	\$1,500	\$1,500

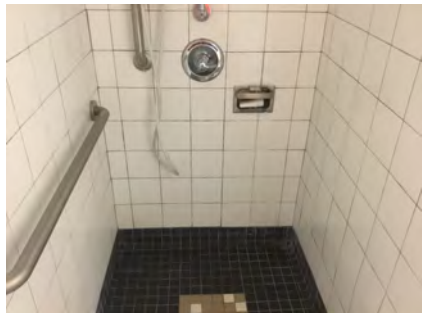
<input type="checkbox"/> Staff Only Priority 3 Severity 3				
1171	<ul style="list-style-type: none"> As-Built Description: Controls not located at 40" max. height or not within a range of no less than 19" and no more than 27" from the seat wall. As-Built: Control 18" from the bench wall Proposed Solution: Provide new, or relocate, shower controls. 	PCODE WF12 ADAAG 91 4.27.3 ADA 2010 608.5 CBC 2007 1115B.4.4.4.1 CBC 2016 11B-608.5 Mitigated: <input type="radio"/> YES <input checked="" type="radio"/> NO	1	JOB	\$2,400	\$2,400

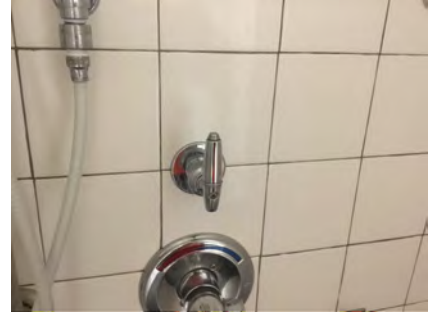
Item no., Rm no. and Name	Existing Architectural Barrier and Proposed Solution	Codes / Mitigation Info	Qty	Unit	Cost	Total
1175	<ul style="list-style-type: none"> As-Built Description: Controls not located at 40" max. height or not within a range of no less than 19" and no more than 27" from the seat wall. As-Built: Shower diverter 50" AFF Proposed Solution: Provide new, or relocate, shower controls. 	PCODE WF12 ADAAG 91 4.27.3 ADA 2010 608.5 CBC 2007 1115B.4.4.4.1 CBC 2016 11B-608.5 Mitigated: <input type="radio"/> YES <input checked="" type="radio"/> NO	1	JOB	\$2,400	\$2,400

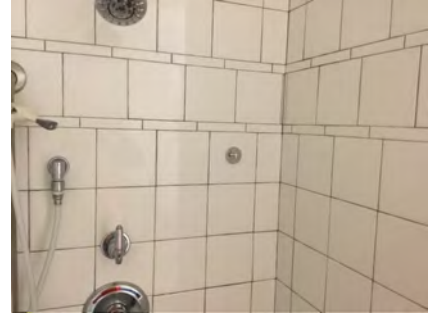
Coat Hook

1174	<ul style="list-style-type: none"> As-Built Description: Accessible coat hook not within reach range. As-Built: 57" high Proposed Solution: Adjust existing or provide new coat hook at maximum 48" height. 	PCODE WG03A ADAAG 91 4.2.5 ADA 2010 603.4 CBC 2007 1118B.5 CBC 2016 11B-603.4 Mitigated: <input type="radio"/> YES <input checked="" type="radio"/> NO	1	JOB	\$150	\$150

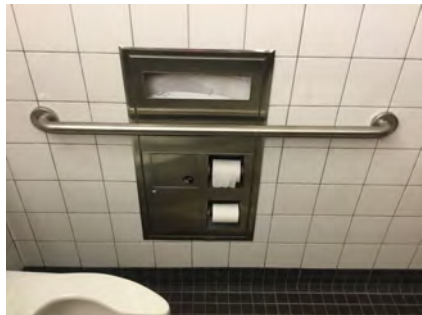
Item no., Rm no. and Name	Existing Architectural Barrier and Proposed Solution	Codes / Mitigation Info	Qty	Unit	Cost	Total
Grab Bars						
1181	<ul style="list-style-type: none"> • <i>As-Built Description:</i> Side grab bar less than 42" long, or located more than 12 inches max. from the rear wall, or extending less than 54" from rear wall (CA only: front end min. 24" in front of water closet). • <i>As-Built:</i> 42" side grab bar extends 52" from the rear wall • <i>Proposed Solution:</i> Provide or relocate accessible side grab bar. 	PCODE WB07A ADAAG 91 Fig. 29(b) ADA 2010 604.5.1 CBC 2007 1115B.4.1.3.1 CBC 2016 11B-604.5.1 Mitigated: <input type="radio"/> YES <input checked="" type="radio"/> NO	2	JOB	\$780	\$1,560

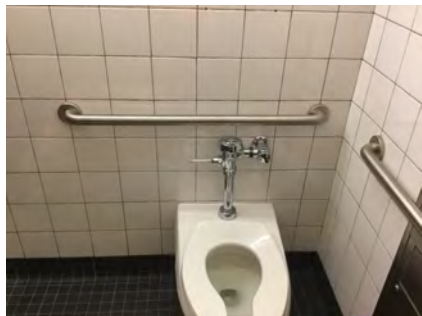
<input type="checkbox"/> Staff Only			
			Priority 3 Severity 4			
1182	<ul style="list-style-type: none"> • <i>As-Built Description:</i> The rear wall grab is less than 36" min. or does not extend from the centerline of the water closet 12" min. on one side and 24" min. on the other side. • <i>As-Built:</i> 23" on the wide side • <i>Proposed Solution:</i> Provide or relocate accessible rear grab bar. 	PCODE WB07B ADAAG 91 4.17.6 ADA 2010 604.5.2 CBC 2007 1115B.4.1.3.2 CBC 2016 11B-604.5.2 Mitigated: <input type="radio"/> YES <input checked="" type="radio"/> NO	1	JOB	\$1,020	\$1,020

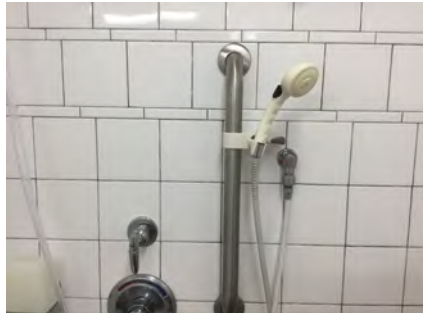
Item no., Rm no. and Name	Existing Architectural Barrier and Proposed Solution	Codes / Mitigation Info	Qty	Unit	Cost	Total
Shower						
1183	<ul style="list-style-type: none"> As-Built Description: Mounting height of shower spray bracket exceeds 48" max. height or is more than 27" from rear edge of folding seat. As-Built: Up to 63" AFF Proposed Solution: Provide or remount shower spray bracket within 27" from rear edge of seat and at 48" max. height. 	PCODE WF05B ADA 2010 608.5 CBC 2007 1115B.4.4.5.3 CBC 2016 11B-608.5 Mitigated: <input type="radio"/> YES <input checked="" type="radio"/> NO	1	JOB	\$1,500	\$1,500

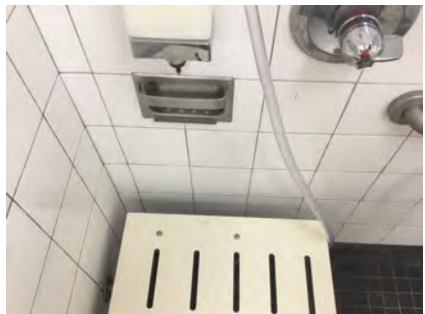
<input type="checkbox"/> Staff Only			
			Priority 3 Severity 2			
1184	<ul style="list-style-type: none"> As-Built Description: ADAAG: L-shaped shower seat extending the full depth of the stall. The seat shall be located 1-1/2 inches (38 mm) maximum from the wall. The front of the seat (nearest to the opening) shall extend a maximum 16 inches (330 mm) from the wall. The back of the seat (against the back wall) shall extend a maximum of 23 inches (582 mm) from the side As-Built: The seat is 2.5" from the wall Proposed Solution: Provide new, or relocate, folding wall-mounted shower seat. 	PCODE WF07A ADAAG 91 4.21.3 ADA 2010 610.3.2 CBC 2007 1115B.4.4.8.1 CBC 2016 11B-610.3.2 Mitigated: <input type="radio"/> YES <input checked="" type="radio"/> NO	1	JOB	\$1,650	\$1,650

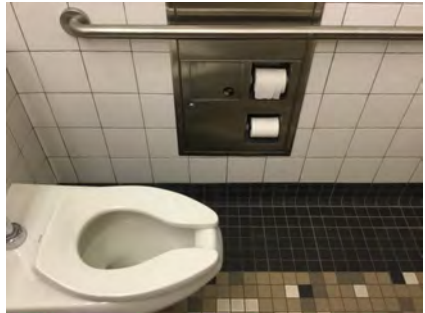
Item no., Rm no. and Name	Existing Architectural Barrier and Proposed Solution	Codes / Mitigation Info	Qty	Unit	Cost	Total
Accessories						
1180	<ul style="list-style-type: none"> • <i>As-Built Description:</i> Toilet paper dispenser less than 15" (CA: 19") or more than 48" above floor or not within 7" to 9" from front of water closet (Note: CA pre-2010 is allowed within 12" from front of water closet). • <i>As-Built:</i> 6.5" to the centerline of the toilet paper rolls from the front of the water closet • <i>Proposed Solution:</i> Relocate or provide new toilet paper dispenser. 	PCODE WG02 ADAAG 91 4.16.6 ADA 2010 604.7 CBC 2007 1115B.8.4 CBC 2016 11B-604.7 Mitigated: <input type="radio"/> YES <input checked="" type="radio"/> NO	1	JOB	\$225	\$225

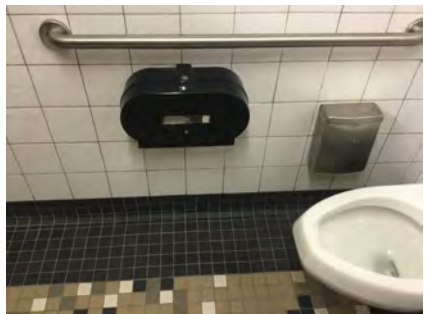
<input type="checkbox"/> Staff Only Priority 3 Severity 4			
1186	<ul style="list-style-type: none"> • <i>As-Built Description:</i> Toilet paper dispenser less than 15" (CA: 19") or more than 48" above floor or not within 7" to 9" from front of water closet (Note: CA pre-2010 is allowed within 12" from front of water closet). • <i>As-Built:</i> 12.5" from the front of the water closet • <i>Proposed Solution:</i> Relocate or provide new toilet paper dispenser. 	PCODE WG02 ADAAG 91 4.16.6 ADA 2010 604.7 CBC 2007 1115B.8.4 CBC 2016 11B-604.7 Mitigated: <input type="radio"/> YES <input checked="" type="radio"/> NO	1	JOB	\$225	\$225

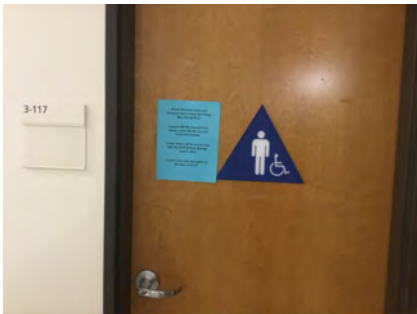
Item no., Rm no. and Name	Existing Architectural Barrier and Proposed Solution	Codes / Mitigation Info	Qty	Unit	Cost	Total
1195	<ul style="list-style-type: none">As-Built Description: Required in CA only: identification symbol centered 58" to 60" high on sanitary facility door that contrasts with the door not provided (women: 12" ø circle, men: 12" triangle, unisex: combined symbol).As-Built: Not eased. No radius.Proposed Solution: Provide properly mounted sanitary facility symbol when altering area. If wheelchair accessible, include International Symbol of Accessibility on sign.	PCODE SA15 CBC 2007 1115B.6 CBC 2016 11B-703.7.2.6 Mitigated: <div><input type="radio"/> YES</div> <div><input checked="" type="radio"/> NO</div>	1	JOB	\$270	\$270

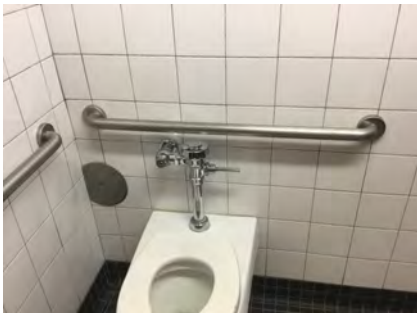
<div><input type="checkbox"/> Staff Only</div> <div>Priority <div>3</div>Severity <div>3</div></div>			
<hr/>						
Grab Bars						
1203	<ul style="list-style-type: none">As-Built Description: The rear wall grab is less than 36" min. or does not extend from the centerline of the water closet 12" min. on one side and 24" min. on the other side.As-Built: 21.5" the wide sideProposed Solution: Provide or relocate accessible rear grab bar.	PCODE WB07B ADAAG 91 4.17.6 ADA 2010 604.5.2 CBC 2007 1115B.4.1.3.2 CBC 2016 11B-604.5.2 Mitigated: <div><input type="radio"/> YES</div> <div><input checked="" type="radio"/> NO</div>	1	JOB	\$1,020	\$1,020

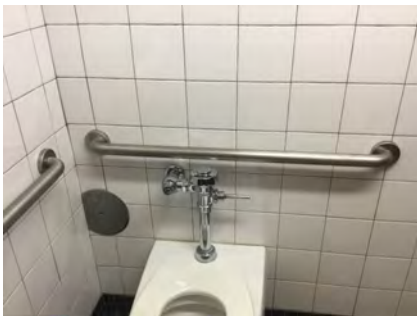
<div><input type="checkbox"/> Staff Only</div> <div>Priority <div>3</div>Severity <div>3</div></div>			
<hr/>						
1202	<ul style="list-style-type: none">As-Built Description: Accessories/dispensers in accessible stall located closer than 1-1/2" below or 12" above grab bar impedes its use.As-Built: 1.125" above the plumbingProposed Solution: Raise the grab bar.	PCODE WB07I ADAAG 91 4.26.2 ADA 2010 609.3 CBC 2007 1133B.4.2.5 CBC 2016 11B-609.3 Mitigated: <div><input type="radio"/> YES</div> <div><input checked="" type="radio"/> NO</div>	1	JOB	\$225	\$225

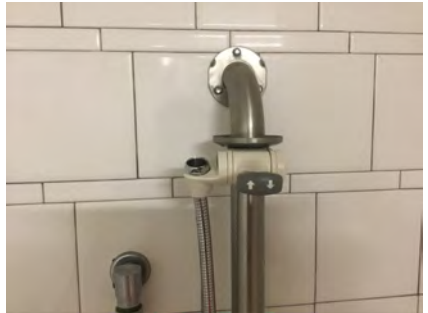
Item no., Rm no. and Name	Existing Architectural Barrier and Proposed Solution	Codes / Mitigation Info	Qty	Unit	Cost	Total
Shower						
1201	<ul style="list-style-type: none"> • <i>As-Built Description:</i> Mounting height of shower spray bracket exceeds 48" max. height or is more than 27" from rear edge of folding seat. • <i>As-Built:</i> Up to 65" high • <i>Proposed Solution:</i> Provide or remount shower spray bracket within 27" from rear edge of seat and at 48" max. height. 	PCODE WF05B ADA 2010 608.5 CBC 2007 1115B.4.4.5.3 CBC 2016 11B-608.5 Mitigated: <input type="radio"/> YES <input checked="" type="radio"/> NO	1	JOB	\$1,500	\$1,500

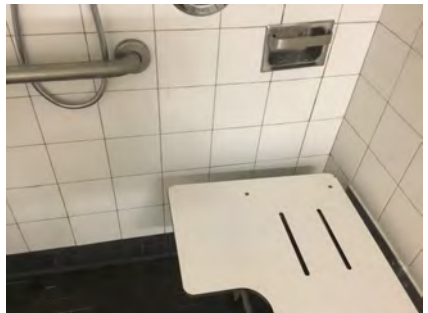
<input type="checkbox"/> Staff Only			
			Priority 3 Severity 2			
1199	<ul style="list-style-type: none"> • <i>As-Built Description:</i> ADAAG: L-shaped shower seat extending the full depth of the stall. The seat shall be located 1-1/2 inches (38 mm) maximum from the wall. The front of the seat (nearest to the opening) shall extend a maximum 16 inches (330 mm) from the wall. The back of the seat (against the back wall) shall extend a maximum of 23 inches (582 mm) from the side • <i>As-Built:</i> 3.75" from the side wall • <i>Proposed Solution:</i> Provide new, or relocate, folding wall-mounted shower seat. 	PCODE WF07A ADAAG 91 4.21.3 ADA 2010 610.3.2 CBC 2007 1115B.4.4.8.1 CBC 2016 11B-610.3.2 Mitigated: <input type="radio"/> YES <input checked="" type="radio"/> NO	1	JOB	\$1,650	\$1,650

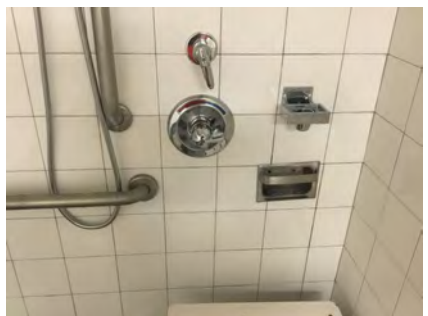
<input type="checkbox"/> Staff Only			
			Priority 3 Severity 3			
1200	<ul style="list-style-type: none"> • <i>As-Built Description:</i> Controls not located at 40" max. height or not within a range of no less than 19" and no more than 27" from the seat wall. • <i>As-Built:</i> 16.5"-17.5" from wall behind bench • <i>Proposed Solution:</i> Provide new, or relocate, shower controls. 	PCODE WF12 ADAAG 91 4.27.3 ADA 2010 608.5 CBC 2007 1115B.4.4.4.1 CBC 2016 11B-608.5 Mitigated: <input type="radio"/> YES <input checked="" type="radio"/> NO	1	JOB	\$2,400	\$2,400

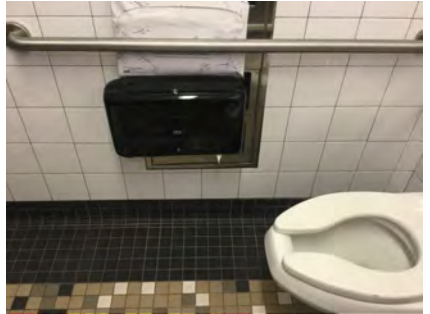
Item no., Rm no. and Name	Existing Architectural Barrier and Proposed Solution	Codes / Mitigation Info	Qty	Unit	Cost	Total
Accessories						
1204	<ul style="list-style-type: none"> • <i>As-Built Description:</i> Toilet paper dispenser less than 15" (CA: 19") or more than 48" above floor or not within 7" to 9" from front of water closet (Note: CA pre-2010 is allowed within 12" from front of water closet). • <i>As-Built:</i> 10.25" to the centerline of the dispenser in front of the water closet • <i>Proposed Solution:</i> Relocate or provide new toilet paper dispenser. 	PCODE WG02 ADAAG 91 4.16.6 ADA 2010 604.7 CBC 2007 1115B.8.4 CBC 2016 11B-604.7 Mitigated: <input type="radio"/> YES <input checked="" type="radio"/> NO	1	JOB	\$225	\$225

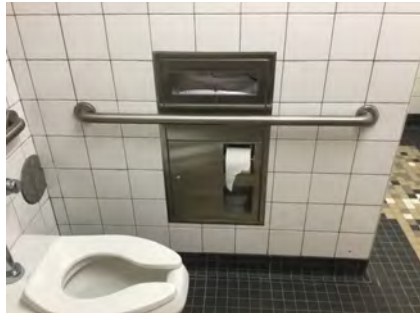
Item no., Rm no. and Name	Existing Architectural Barrier and Proposed Solution	Codes / Mitigation Info	Qty	Unit	Cost	Total
Grab Bars						
1276	<ul style="list-style-type: none"> • <i>As-Built Description:</i> Side grab bar less than 42" long, or located more than 12 inches max. from the rear wall, or extending less than 54" from rear wall (CA only: front end min. 24" in front of water closet). • <i>As-Built:</i> 42" side grab bar extends 51.5" from the rear wall • <i>Proposed Solution:</i> Provide or relocate accessible side grab bar. 	PCODE WB07A ADAAG 91 Fig. 29(b) ADA 2010 604.5.1 CBC 2007 1115B.4.1.3.1 CBC 2016 11B-604.5.1 Mitigated: <input type="radio"/> YES <input checked="" type="radio"/> NO	1	JOB	\$780	\$780

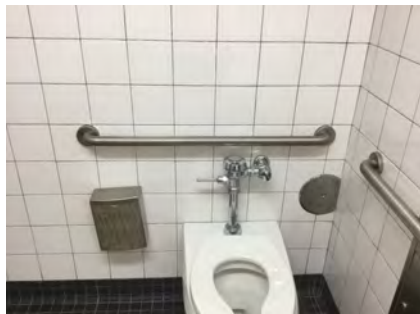
<input type="checkbox"/> Staff Only			
			Priority	Severity		
			3	3		
1275	<ul style="list-style-type: none"> • <i>As-Built Description:</i> The rear wall grab is less than 36" min. or does not extend from the centerline of the water closet 12" min. on one side and 24" min. on the other side. • <i>As-Built:</i> 22" on the wide side • <i>Proposed Solution:</i> Provide or relocate accessible rear grab bar. 	PCODE WB07B ADAAG 91 4.17.6 ADA 2010 604.5.2 CBC 2007 1115B.4.1.3.2 CBC 2016 11B-604.5.2 Mitigated: <input type="radio"/> YES <input checked="" type="radio"/> NO	1	JOB	\$1,020	\$1,020

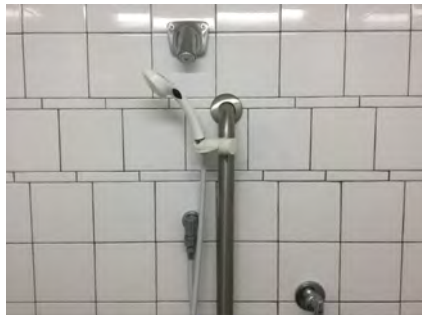
Item no., Rm no. and Name	Existing Architectural Barrier and Proposed Solution	Codes / Mitigation Info	Qty	Unit	Cost	Total
Shower						
1281	<ul style="list-style-type: none"> As-Built Description: Mounting height of shower spray bracket exceeds 48" max. height or is more than 27" from rear edge of folding seat. As-Built: Shower spray bracket up to 65" high Proposed Solution: Provide or remount shower spray bracket within 27" from rear edge of seat and at 48" max. height. 	PCODE WF05B ADA 2010 608.5 CBC 2007 1115B.4.4.5.3 CBC 2016 11B-608.5 Mitigated: <input type="radio"/> YES <input checked="" type="radio"/> NO	1	JOB	\$1,500	\$1,500

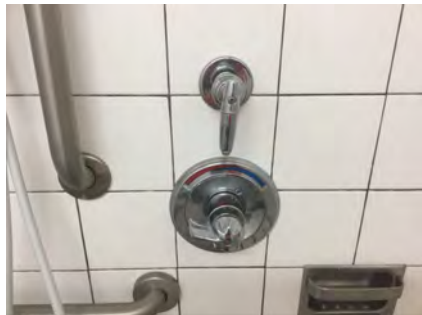
<input type="checkbox"/> Staff Only Priority 3 Severity 2			
1280	<ul style="list-style-type: none"> As-Built Description: Controls are less than 19" from the seat wall. As-Built: 17.5" and 18" Proposed Solution: Remount controls. 	PCODE WF05BNT ADA 2010 608.5 CBC 2007 1115B.4.4.5.3 CBC 2016 11B-608.5 Mitigated: <input type="radio"/> YES <input checked="" type="radio"/> NO	2	JOB	\$1,500	\$3,000

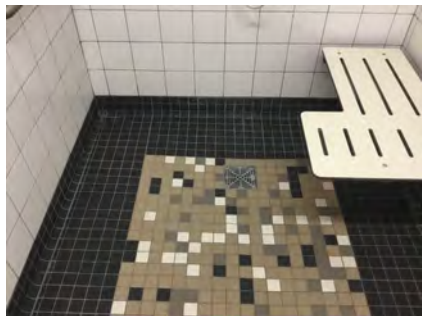
<input type="checkbox"/> Staff Only Priority 3 Severity 4			
1278	<ul style="list-style-type: none"> As-Built Description: Floor surface sloped greater than 2.0% (1:48) due to drain. As-Built: 4.4% Proposed Solution: Remodel floor surface to compliance. 	PCODE WF06A ADA 2010 608.9 CBC 2016 11B-608.9 Mitigated: <input type="radio"/> YES <input checked="" type="radio"/> NO	1	JOB	\$1,500	\$1,500

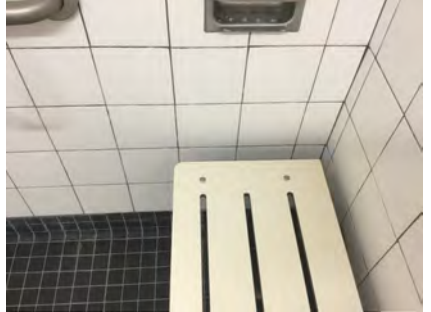
Item no., Rm no. and Name	Existing Architectural Barrier and Proposed Solution	Codes / Mitigation Info	Qty	Unit	Cost	Total
1279	<ul style="list-style-type: none"> As-Built Description: ADAAG: L-shaped shower seat extending the full depth of the stall. The seat shall be located 1-1/2 inches (38 mm) maximum from the wall. The front of the seat (nearest to the opening) shall extend a maximum 16 inches (330 mm) from the wall. The back of the seat (against the back wall) shall extend a maximum of 23 inches (582 mm) from the side As-Built: 2.25" from the side wall Proposed Solution: Provide new, or relocate, folding wall-mounted shower seat. 	PCODE WF07A ADAAG 91 4.21.3 ADA 2010 610.3.2 CBC 2007 1115B.4.4.8.1 CBC 2016 11B-610.3.2 Mitigated: <input type="radio"/> YES <input checked="" type="radio"/> NO	1	JOB	\$1,650	\$1,650

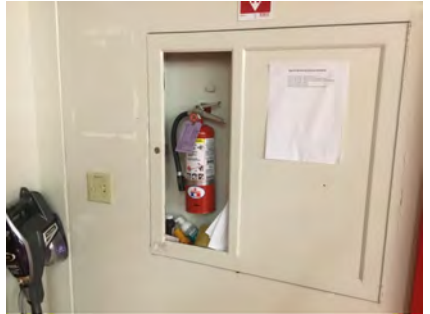
Item no., Rm no. and Name	Existing Architectural Barrier and Proposed Solution	Codes / Mitigation Info	Qty	Unit	Cost	Total
Reach Range						
1285	<ul style="list-style-type: none"> • <i>As-Built Description:</i> Reach height to control or access point, where side approach is available, exceeds 48" or is less than 15" in height, or exceeds 10" in depth. • <i>As-Built:</i> Top of fire extinguisher 61" high. Bottom of fire extinguisher 45.5" high. • <i>Proposed Solution:</i> Modify equipment or mounting. 	PCODE IE02 ADAAG 91 4.2.6 ADA 2010 308.3.1 CBC 2007 1118B.6 CBC 2016 11B-308.3 Mitigated: <input type="radio"/> YES <input checked="" type="radio"/> NO	1	JOB	\$300	\$300

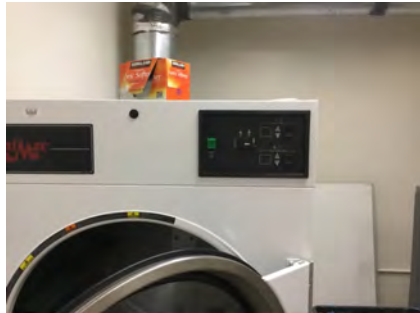
Item no., Rm no. and Name	Existing Architectural Barrier and Proposed Solution	Codes / Mitigation Info	Qty	Unit	Cost	Total
Reach Range						
1287	<ul style="list-style-type: none"> As-Built Description: Reach height to control or access point, where side approach is available, exceeds 48" or is less than 15" in height, or exceeds 10" in depth. As-Built: 63.5" high Proposed Solution: Modify equipment or mounting. Notes: There are laundry instructions in the room which suggests that the equipment is not staff only. 	PCODE IE02 ADAAG 91 4.2.6 ADA 2010 308.3.1 CBC 2007 1118B.6 CBC 2016 11B-308.3 Mitigated: <input type="radio"/> YES <input checked="" type="radio"/> NO	1	JOB	\$300	\$300

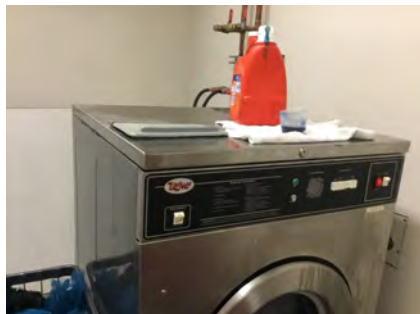
<input type="checkbox"/> Staff Only			
			Priority	Severity		
			2	2		
1288	<ul style="list-style-type: none"> As-Built Description: Reach height to control or access point, where side approach is available, exceeds 48" or is less than 15" in height, or exceeds 10" in depth. As-Built: 54" high Proposed Solution: Modify equipment or mounting. 	PCODE IE02 ADAAG 91 4.2.6 ADA 2010 308.3.1 CBC 2007 1118B.6 CBC 2016 11B-308.3 Mitigated: <input type="radio"/> YES <input checked="" type="radio"/> NO	1	JOB	\$300	\$300

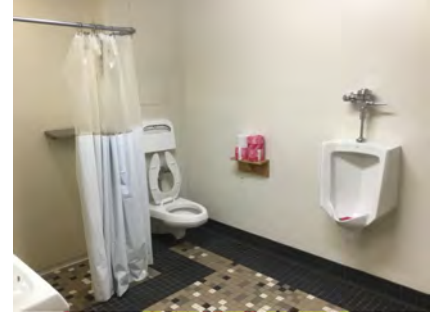
Single accommodation restroom not accessible;
multiple compliance violations.

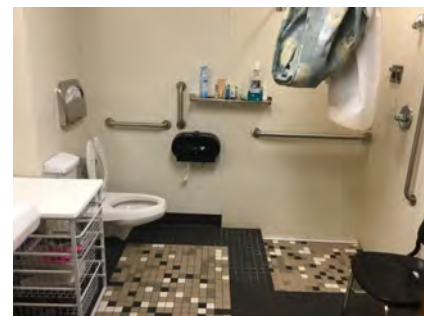
Single accommodation restroom not accessible; multiple compliance violations.

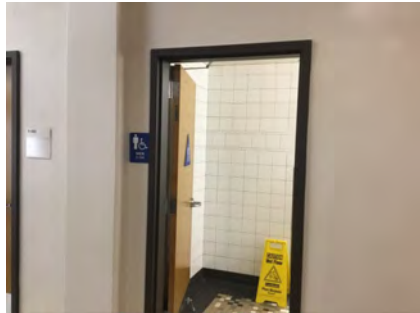
Item no., Rm no. and Name	Existing Architectural Barrier and Proposed Solution	Codes / Mitigation Info	Qty	Unit	Cost	Total
Signage						
1304	<ul style="list-style-type: none"> As-Built Description: Sign not located on latch side of door and/or not located at 48" min. above to baseline of the lowest Braille cells and 60" max. to baseline of the highest line of raised characters. Proposed Solution: Provide compliant signage including tactile characters and Grade II Braille on latch side of door located at compliant height. 	PCODE SA07 ADAAG 91 4.30.6 ADA 2010 703.4.1 CBC 2007 1117B.5.7 CBC 2016 11B-703.4.1 Mitigated: <input type="radio"/> YES <input checked="" type="radio"/> NO	1	JOB	\$150	\$150

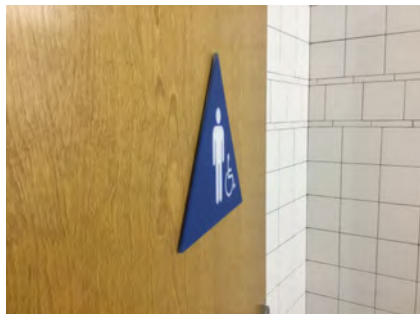
<input type="checkbox"/> Staff Only			
			Priority <input checked="" type="radio"/> 3	Severity <input checked="" type="radio"/> 3		
1305	<ul style="list-style-type: none"> As-Built Description: Required in CA only: identification symbol centered 58" to 60" high on sanitary facility door that contrasts with the door not provided (women: 12" ø circle, men: 12" triangle, unisex: combined symbol). As-Built: Not beveled. No radius. Proposed Solution: Provide properly mounted sanitary facility symbol when altering area. If wheelchair accessible, include International Symbol of Accessibility on sign. 	PCODE SA15 CBC 2007 1115B.6 CBC 2016 11B-703.7.2.6 Mitigated: <input type="radio"/> YES <input checked="" type="radio"/> NO	1	JOB	\$270	\$270

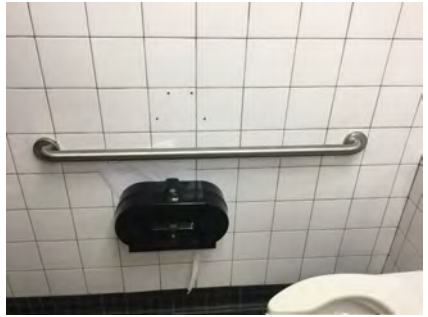
Item no., Rm no. and Name	Existing Architectural Barrier and Proposed Solution	Codes / Mitigation Info	Qty	Unit	Cost	Total
Grab Bars						
1313	<ul style="list-style-type: none"> As-Built Description: Side grab bar less than 42" long, or located more than 12 inches max. from the rear wall, or extending less than 54" from rear wall (CA only: front end min. 24" in front of water closet). As-Built: Side of grab bar extends 52.75" from the rear wall Proposed Solution: Provide or relocate accessible side grab bar. 	PCODE WB07A ADAAG 91 Fig. 29(b) ADA 2010 604.5.1 CBC 2007 1115B.4.1.3.1 CBC 2016 11B-604.5.1 Mitigated: <input type="radio"/> YES <input checked="" type="radio"/> NO	1	JOB	\$780	\$780

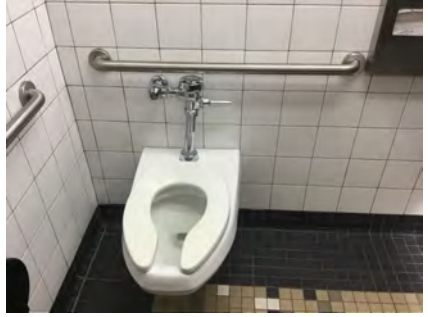
<input type="checkbox"/> Staff Only Priority 3 Severity 4			
1311	<ul style="list-style-type: none"> As-Built Description: The rear wall grab is less than 36" min. or does not extend from the centerline of the water closet 12" min. on one side and 24" min. on the other side. As-Built: 22.5" on the wide side Proposed Solution: Provide or relocate accessible rear grab bar. 	PCODE WB07B ADAAG 91 4.17.6 ADA 2010 604.5.2 CBC 2007 1115B.4.1.3.2 CBC 2016 11B-604.5.2 Mitigated: <input type="radio"/> YES <input checked="" type="radio"/> NO	1	JOB	\$1,020	\$1,020

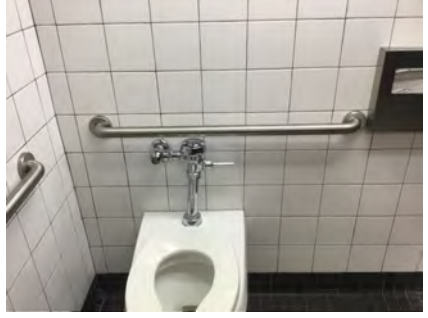
<input type="checkbox"/> Staff Only Priority 3 Severity 4			
1309	<ul style="list-style-type: none"> As-Built Description: Accessories/dispensers in accessible stall located closer than 1-1/2" below or 12" above grab bar impedes its use. As-Built: 0.5" above the flush valve Proposed Solution: Relocate accessories/dispensers to be no closer than 1-1/2" below and 12" above grab bars (except if accessories are recessed, flush with wall, and have no sharp edges). 	PCODE WB07I ADAAG 91 4.26.2 ADA 2010 609.3 CBC 2007 1133B.4.2.5 CBC 2016 11B-609.3 Mitigated: <input type="radio"/> YES <input checked="" type="radio"/> NO	1	JOB	\$225	\$225

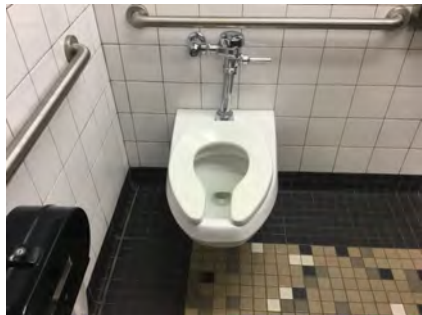
Item no., Rm no. and Name	Existing Architectural Barrier and Proposed Solution	Codes / Mitigation Info	Qty	Unit	Cost	Total
Water Closet						
1308	<ul style="list-style-type: none"> • <i>As-Built Description:</i> Water closet not 16"-18" (CA: 17"-18") from near side wall to center line of water closet (2010 ADAAG: 16"-18"). • <i>As-Built:</i> 18.5" o.c. • <i>Proposed Solution:</i> Relocate existing water closet and plumbing, remount with offset closet flange to provide 18" max. from side wall. 	PCODE WB02C ADAAG 91 Fig. 28 ADA 2010 604.2 CBC 2007 1115B.4.1.1 CBC 2016 11B-604.2 Mitigated: <input type="radio"/> YES <input checked="" type="radio"/> NO	1	JOB	\$1,500	\$1,500

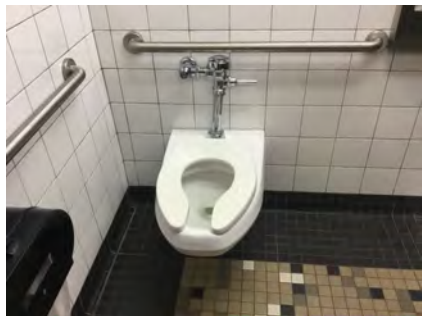
<input type="checkbox"/> Staff Only			
			Priority		Severity	
			3		4	
1310	<ul style="list-style-type: none"> • <i>As-Built Description:</i> Height of water closet seat less than 17" or more than 19" from floor. • <i>As-Built:</i> 19.8" high • <i>Proposed Solution:</i> Provide new accessible water closet. 	PCODE WB08 ADAAG 91 4.16.3 ADA 2010 604.4 CBC 2007 1115B.4.1.4 CBC 2016 11B-604.4 Mitigated: <input type="radio"/> YES <input checked="" type="radio"/> NO	1	JOB	\$4,200	\$4,200

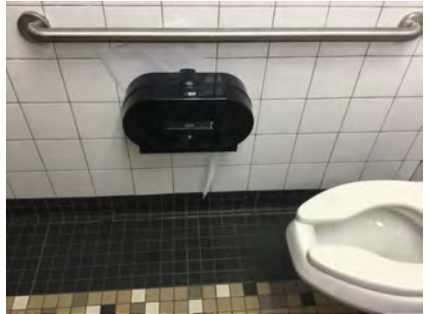
Item no., Rm no. and Name	Existing Architectural Barrier and Proposed Solution	Codes / Mitigation Info	Qty	Unit	Cost	Total
<u>Accessories</u>						
1312	<ul style="list-style-type: none"> • <i>As-Built Description:</i> Toilet paper dispenser less than 15" (CA: 19") or more than 48" above floor or not within 7" to 9" from front of water closet (Note: CA pre-2010 is allowed within 12" from front of water closet). • <i>As-Built:</i> 10.5" from the front of the water closet • <i>Proposed Solution:</i> Relocate or provide new toilet paper dispenser. 	PCODE WG02 ADAAG 91 4.16.6 ADA 2010 604.7 CBC 2007 1115B.8.4 CBC 2016 11B-604.7 Mitigated: <input type="radio"/> YES <input checked="" type="radio"/> NO	1	JOB	\$225	\$225

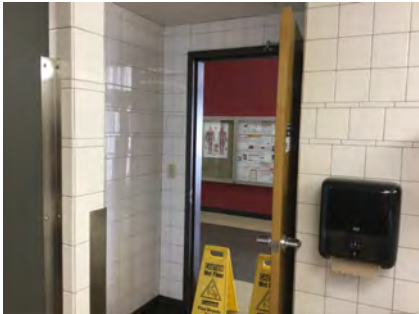
Item no., Rm no. and Name	Existing Architectural Barrier and Proposed Solution	Codes / Mitigation Info	Qty	Unit	Cost	Total
Door Swing						
1317	<ul style="list-style-type: none">As-Built Description: Front approach: At pull side, door does not have clear and level maneuvering space measuring door width plus 18" x 60". (24" x 60" at exterior doors).As-Built: 12" at strike sideProposed Solution: Change door swing.	<p>PCODE ID23</p> <p>ADAAG 91 Fig. 25(a)</p> <p>ADA 2010 404.2.4</p> <p>CBC 2007 11B-26A(a)</p> <p>CBC 2016 11B-404.2.4</p> <p>Mitigated:</p> <p><input type="radio"/> YES</p> <p><input checked="" type="radio"/> NO</p>	1	JOB	\$1,500	\$1,500

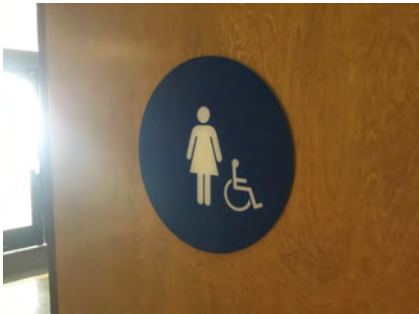
<input type="checkbox"/> Staff Only			
			Priority		Severity	
			3		4	
Signage						
1316	<ul style="list-style-type: none">As-Built Description: Required in CA only: identification symbol centered 58" to 60" high on sanitary facility door that contrasts with the door not provided (women: 12" ø circle, men: 12" triangle, unisex: combined symbol).As-Built: Edges not easedProposed Solution: Provide properly mounted sanitary facility symbol when altering area. If wheelchair accessible, include International Symbol of Accessibility on sign.	<p>PCODE SA15</p> <p>CBC 2007 1115B.6</p> <p>CBC 2016 11B-703.7.2.6</p> <p>Mitigated:</p> <p><input type="radio"/> YES</p> <p><input checked="" type="radio"/> NO</p>	1	JOB	\$270	\$270

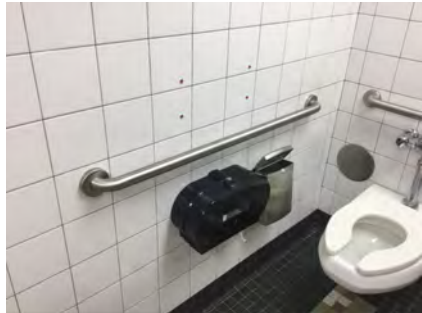
Item no., Rm no. and Name	Existing Architectural Barrier and Proposed Solution	Codes / Mitigation Info	Qty	Unit	Cost	Total
Grab Bars						
1322	<ul style="list-style-type: none"> As-Built Description: Side grab bar less than 42" long, or located more than 12 inches max. from the rear wall, or extending less than 54" from rear wall (CA only: front end min. 24" in front of water closet). As-Built: Side grab bar extends 53" from the rear wall Proposed Solution: Provide or relocate accessible side grab bar. 	PCODE WB07A ADAAG 91 Fig. 29(b) ADA 2010 604.5.1 CBC 2007 1115B.4.1.3.1 CBC 2016 11B-604.5.1 Mitigated: <input type="radio"/> YES <input checked="" type="radio"/> NO	1	JOB	\$780	\$780

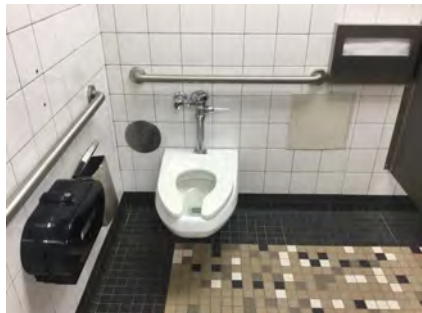
<input type="checkbox"/> Staff Only Priority 3 Severity 4			
1321	<ul style="list-style-type: none"> As-Built Description: The rear wall grab bar is less than 36" min. or does not extend from the centerline of the water closet 12" min. on one side and 24" min. on the other side. As-Built: 23.5" on the wider side Proposed Solution: Provide or relocate accessible rear grab bar. 	PCODE WB07B ADAAG 91 4.17.6 ADA 2010 604.5.2 CBC 2007 1115B.4.1.3.2 CBC 2016 11B-604.5.2 Mitigated: <input type="radio"/> YES <input checked="" type="radio"/> NO	1	JOB	\$1,020	\$1,020

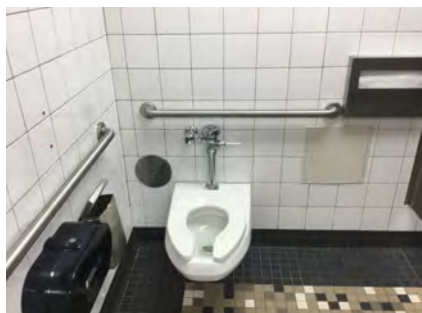
<input type="checkbox"/> Staff Only Priority 3 Severity 4			
1323	<ul style="list-style-type: none"> As-Built Description: Accessories/dispensers in accessible stall located closer than 1-1/2" below or 12" above grab bar impedes its use. As-Built: 1.375" above the flush valve Proposed Solution: Relocate the grab bar. 	PCODE WB07I ADAAG 91 4.26.2 ADA 2010 609.3 CBC 2007 1133B.4.2.5 CBC 2016 11B-609.3 Mitigated: <input type="radio"/> YES <input checked="" type="radio"/> NO	1	JOB	\$225	\$225

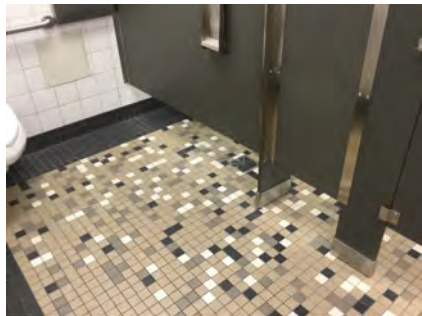
Item no., Rm no. and Name	Existing Architectural Barrier and Proposed Solution	Codes / Mitigation Info	Qty	Unit	Cost	Total
Toilet Stall						
1319	<ul style="list-style-type: none"> • <i>As-Built Description:</i> Toilet stall less than 60" wide. • <i>As-Built:</i> 59.125" wide at the partition support • <i>Proposed Solution:</i> Provide new accessible stall. 	PCODE WB06 ADAAG 91 4.17.3 ADA 2010 604.8.1.1 CBC 2007 1115B.3.1.4.1 CBC 2016 11B-604.8.1.1 Mitigated: <input type="radio"/> YES <input checked="" type="radio"/> NO	1	JOB	\$4,500	\$4,500

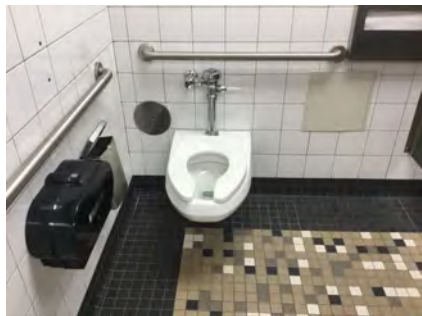
<input type="checkbox"/> Staff Only			
			Priority		Severity	
			3		4	
Water Closet						
1320	<ul style="list-style-type: none"> • <i>As-Built Description:</i> Water closet not 16"-18" (CA: 17"-18") from near side wall to center line of water closet (2010 ADAAG: 16"-18"). • <i>As-Built:</i> 18.5" o.c. • <i>Proposed Solution:</i> Relocate existing water closet and plumbing, remount with offset closet flange to provide 18" max. from side wall. 	PCODE WB02C ADAAG 91 Fig. 28 ADA 2010 604.2 CBC 2007 1115B.4.1.1 CBC 2016 11B-604.2 Mitigated: <input type="radio"/> YES <input checked="" type="radio"/> NO	1	JOB	\$1,500	\$1,500

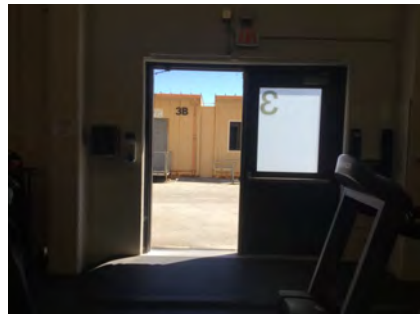
Item no., Rm no. and Name	Existing Architectural Barrier and Proposed Solution	Codes / Mitigation Info	Qty	Unit	Cost	Total
Door						
1335	<ul style="list-style-type: none">As-Built Description: Surface of required maneuvering clearance at door slopes more than 1/4":12" (2.0%).As-Built: 9.1%Proposed Solution: Modify surface slope at door.	PCODE ID11 ADAAG 91 4.13.6 ADA 2010 404.2.4.4 CBC 2007 1133B.2.4 CBC 2016 11B-404.2.4 Mitigated: <input type="radio"/> YES <input checked="" type="radio"/> NO	60	SF	\$120	\$7,200

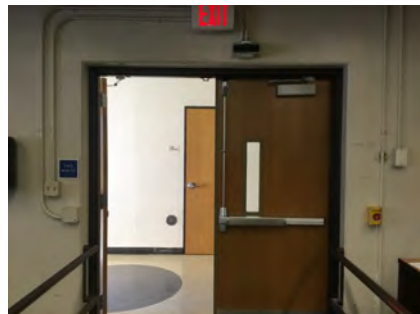
<input type="checkbox"/> Staff Only			
			Priority	Severity		
			2	2		
Door Swing						
1330	<ul style="list-style-type: none">As-Built Description: Front approach: At push side, door does not have clear and level maneuvering space measuring door width x 48" (door width plus 12" if door has both, latch and closer).As-Built: Handrails protrude 2" into the door maneuvering clearance at the hinge sides of the doorsProposed Solution: Remove or relocate handrails.	PCODE ID24A ADAAG 91 Fig. 25(a) ADA 2010 404.2.4 CBC 2007 11B-26A(a) CBC 2016 11B-404.2.4 Mitigated: <input type="radio"/> YES <input checked="" type="radio"/> NO	1	JOB	\$150	\$150

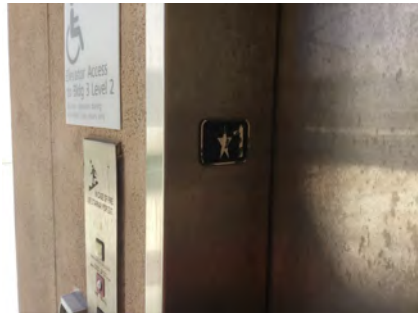
Item no., Rm no. and Name	Existing Architectural Barrier and Proposed Solution	Codes / Mitigation Info	Qty	Unit	Cost	Total
1365	<ul style="list-style-type: none"> As-Built Description: The button for the main entry floor is not designated by a raised star. As-Built: Star 1.2" wide Proposed Solution: Provide a raised star to the left of the main entry floor button located on the control panel. 	PCODE IK07E ADAAG 91 4.10.12(2) ADA 2010 407.4.7.1.3 CBC 2007 1116B.1.9 CBC 2016 11B-407.4.7.1.3 Mitigated: <input type="radio"/> YES <input checked="" type="radio"/> NO	1	JOB	\$150	\$150

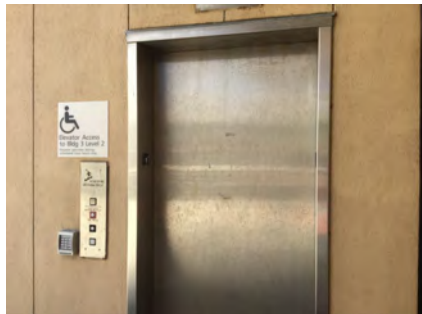
<input type="checkbox"/> Staff Only				
		Priority 2 Severity 3				
1367	<ul style="list-style-type: none"> As-Built Description: Audible signal not provided (one for up, two for down). Proposed Solution: Provide proper audible hall signal for elevator. 	PCODE IK10B ADAAG 91 4.10.4 ADA 2010 407.2.2.3 CBC 2007 1116B.1.13 CBC 2016 11B-407.2.2.3 Mitigated: <input type="radio"/> YES <input checked="" type="radio"/> NO	1	JOB	\$4,650	\$4,650

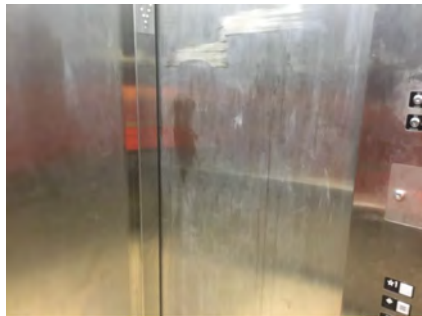
<input type="checkbox"/> Staff Only				
		Priority 2 Severity 3				
1364	<ul style="list-style-type: none"> As-Built Description: Door reopening device does not remain effective for at least 20 seconds. As-Built: Door reopening device causes door to remain open for 4 seconds Proposed Solution: Adjust timing. 	PCODE IK14 ADAAG 91 4.10.6 ADA 2010 407.3.3.3 CBC 2007 1116B.1.5 CBC 2016 11B-407.3.3.3 Mitigated: <input type="radio"/> YES <input checked="" type="radio"/> NO	1	JOB	\$150	\$150

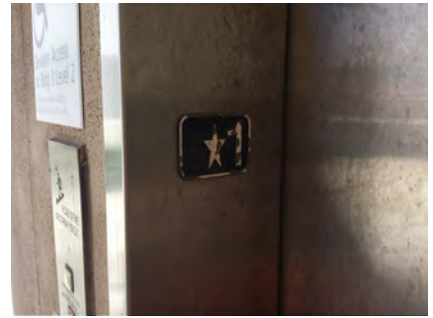
Item no., Rm no. and Name	Existing Architectural Barrier and Proposed Solution	Codes / Mitigation Info	Qty	Unit	Cost	Total
Signage						
1366	<ul style="list-style-type: none"> • <i>As-Built Description:</i> Sign does not have non-glare finish and/or good color contrast (dark on light or light on dark). • <i>Proposed Solution:</i> Provide compliant signage. 	PCODE SA03 ADAAG 91 4.30.5 ADA 2010 703.5.1 CBC 2007 1117B.5.5 CBC 2016 11B-407.4.6.2.3 Mitigated: <input type="radio"/> YES <input checked="" type="radio"/> NO	2	JOB	\$270	\$540

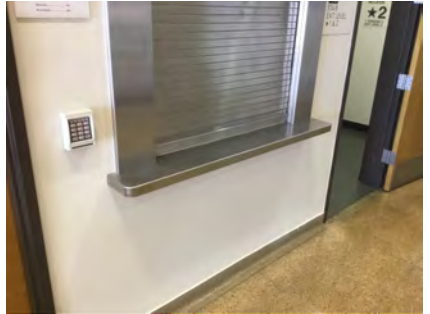
Item no., Rm no. and Name	Existing Architectural Barrier and Proposed Solution	Codes / Mitigation Info	Qty	Unit	Cost	Total
Public Counter						
1128	<ul style="list-style-type: none"> • <i>As-Built Description:</i> Service counter (stand-up): Accessible section min. 36" length and 36" max. height (in CA: 28" to 34" high) not provided. • <i>As-Built:</i> 34.2" high • <i>Proposed Solution:</i> Retrofit existing counter to provide accessible section. Interim solution: Provide auxiliary counter, table, or clipboard. 	PCODE IN03 ADAAG 91 7.2(2) ADA 2010 904.4 CBC 2007 1122B.4 CBC 2016 11B-904.4 Mitigated: <input type="radio"/> YES <input checked="" type="radio"/> NO	1	JOB	\$6,000	\$6,000

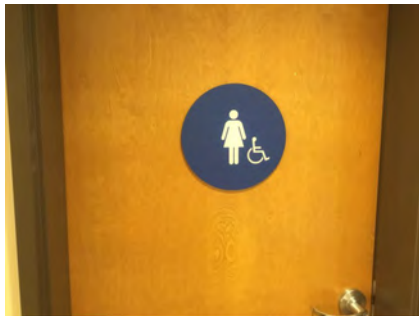
Item no., Rm no. and Name	Existing Architectural Barrier and Proposed Solution	Codes / Mitigation Info	Qty	Unit	Cost	Total
<u>Signage</u>						
1138	<ul style="list-style-type: none">As-Built Description: Required in CA only: identification symbol centered 58" to 60" high on sanitary facility door that contrasts with the door not provided (women: 12" ø circle, men: 12" triangle, unisex: combined symbol).As-Built: Edges not easedProposed Solution: Provide properly mounted sanitary facility symbol when altering area. If wheelchair accessible, include International Symbol of Accessibility on sign.	PCODE SA15 CBC 2007 1115B.6 CBC 2016 11B-703.7.2.6 Mitigated: <input type="radio"/> YES <input checked="" type="radio"/> NO	1	JOB	\$270	\$270

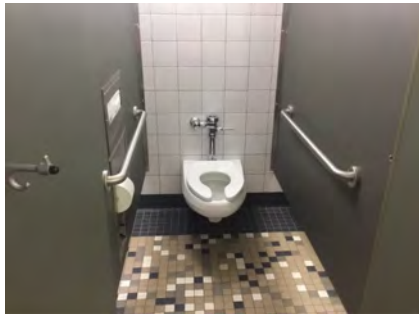
<input type="checkbox"/> Staff Only			
			Priority		Severity	
			3		3	
<u>Semi-Ambulant Stall</u>						
1142	<ul style="list-style-type: none">As-Built Description: Semi-Ambulant stall with 35-37" width, minimum 60" depth, parallel grab bars, and out-swinging door not provided (one required where 6 or more exist).As-Built: 59.5" deepProposed Solution: Provide 36" wide x 60 deep stall with out-swinging door and two side grab bars. Remodel restroom as needed.	PCODE WB06A ADAAG 91 4.22.4 ADA 2010 213.3.1 & CBC 2007 1115B.3.1.5 CBC 2016 11B-213.3.1 & 11B-604.8.2 Mitigated: <input type="radio"/> YES <input checked="" type="radio"/> NO	1	JOB	\$5,700	\$5,700

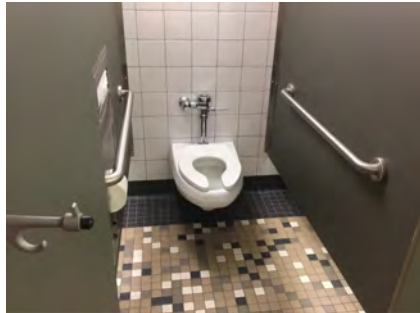
Item no., Rm no. and Name	Existing Architectural Barrier and Proposed Solution	Codes / Mitigation Info	Qty	Unit	Cost	Total
Grab Bars						
1143	<ul style="list-style-type: none"> As-Built Description: Side grab bar less than 42" long, or located more than 12 inches max. from the rear wall, or extending less than 54" from rear wall (CA only: front end min. 24" in front of water closet). As-Built: 42" side grab bars extend 48" from rear wall Proposed Solution: Provide or relocate accessible side grab bar. 	PCODE WB07A ADAAG 91 Fig. 29(b) ADA 2010 604.5.1 CBC 2007 1115B.4.1.3.1 CBC 2016 11B-604.5.1 Mitigated: <input type="radio"/> YES <input checked="" type="radio"/> NO	2	JOB	\$780	\$1,560

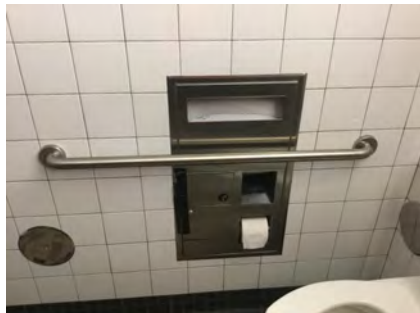
<input type="checkbox"/> Staff Only			
			Priority	Severity		
			3	2		
1144	<ul style="list-style-type: none"> As-Built Description: Side grab bar less than 42" long, or located more than 12 inches max. from the rear wall, or extending less than 54" from rear wall (CA only: front end min. 24" in front of water closet). As-Built: Side grab bar extends 51" from the rear wall Proposed Solution: Provide or relocate accessible side grab bar. 	PCODE WB07A ADAAG 91 Fig. 29(b) ADA 2010 604.5.1 CBC 2007 1115B.4.1.3.1 CBC 2016 11B-604.5.1 Mitigated: <input type="radio"/> YES <input checked="" type="radio"/> NO	1	JOB	\$780	\$780

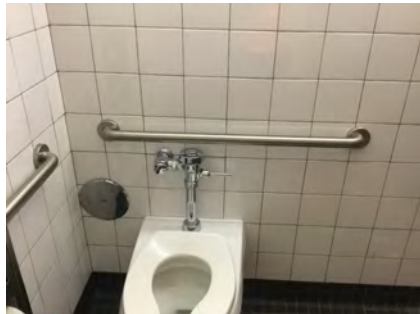
<input type="checkbox"/> Staff Only			
			Priority	Severity		
			3	3		
1145	<ul style="list-style-type: none"> As-Built Description: Accessories/dispensers in accessible stall located closer than 1-1/2" below or 12" above grab bar impedes its use. As-Built: Flush valve 0.75" below the rear grab bar Proposed Solution: Raise the rear grab bar. 	PCODE WB071 ADAAG 91 4.26.2 ADA 2010 609.3 CBC 2007 1133B.4.2.5 CBC 2016 11B-609.3 Mitigated: <input type="radio"/> YES <input checked="" type="radio"/> NO	1	JOB	\$225	\$225

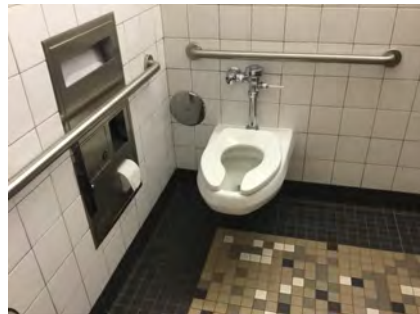
Item no., Rm no. and Name	Existing Architectural Barrier and Proposed Solution	Codes / Mitigation Info	Qty	Unit	Cost	Total
Water Closet						
1146	<ul style="list-style-type: none">As-Built Description: Height of water closet seat less than 17" or more than 19" from floor.As-Built: 19.625" highProposed Solution: Provide new accessible water closet.	PCODE WB08 ADAAG 91 4.16.3 ADA 2010 604.4 CBC 2007 1115B.4.1.4 CBC 2016 11B-604.4 Mitigated: <input type="radio"/> YES <input checked="" type="radio"/> NO	1	JOB	\$4,200	\$4,200

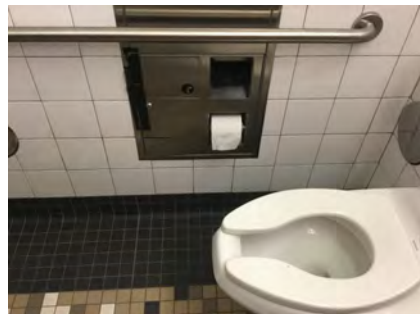
<input type="checkbox"/> Staff Only			
			Priority		Severity	
			3		4	
Accessories						
1147	<ul style="list-style-type: none">As-Built Description: Toilet paper dispenser less than 15" (CA: 19") or more than 48" above floor or not within 7" to 9" from front of water closet (Note: CA pre-2010 is allowed within 12" from front of water closet).As-Built: Centerline of entire dispenser 1" in front of water closetProposed Solution: Relocate or provide new toilet paper dispenser.	PCODE WG02REF ADAAG 91 4.16.6 ADA 2010 604.7 CBC 2007 1115B.8.4 CBC 2016 11B-604.7 Mitigated: <input type="radio"/> YES <input checked="" type="radio"/> NO		REF

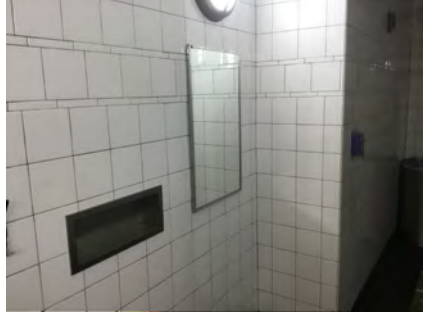
Item no., Rm no. and Name	Existing Architectural Barrier and Proposed Solution	Codes / Mitigation Info	Qty	Unit	Cost	Total
1141	<ul style="list-style-type: none"> As-Built Description: Bottom of flat, not tilted mirror not located above lavatories or countertops mounted with bottom edge more than 35" above floor or top edge less than 74" above floor. As-Built: Mirror which is not above a lavatory 39.5" high Proposed Solution: Relocate or provide new accessible mirror. Notes: There is a mirror in the room that is not above the lavatory with the bottom edge less than 35" AFF. 	PCODE WG03B ADAAG 91 4.19.6 ADA 2010 603.3 CBC 2007 1115B.8.1 CBC 2016 11B-603.3 Mitigated: <input type="radio"/> YES <input checked="" type="radio"/> NO	1	JOB	\$450	\$450

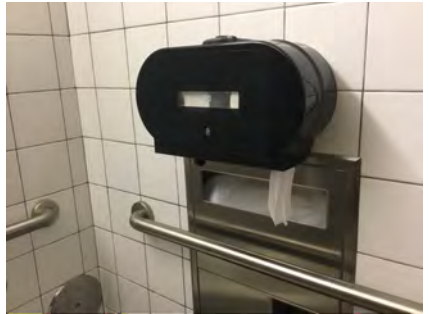
Item no., Rm no. and Name	Existing Architectural Barrier and Proposed Solution	Codes / Mitigation Info	Qty	Unit	Cost	Total
1153	<ul style="list-style-type: none"> • <i>As-Built Description:</i> Accessories/dispensers in accessible stall located closer than 1-1/2" below or 12" above grab bar impedes its use. • <i>As-Built:</i> 8.5" above side grab bar • <i>Proposed Solution:</i> Relocate accessories/dispensers to be no closer than 1-1/2" below and 12" above grab bars (except if accessories are recessed, flush with wall, and have no sharp edges). 	PCODE WB071 ADAAG 91 4.26.2 ADA 2010 609.3 CBC 2007 1133B.4.2.5 CBC 2016 11B-609.3 Mitigated: <input type="radio"/> YES <input checked="" type="radio"/> NO	1	JOB	\$225	\$225

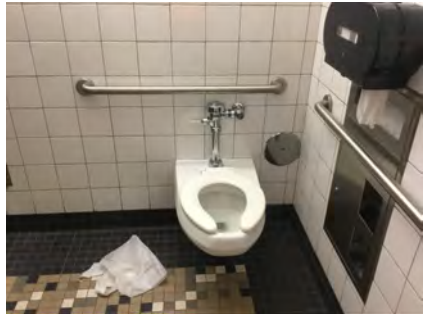
1152	<ul style="list-style-type: none"> • <i>As-Built Description:</i> Water closet not 16"-18" (CA: 17"-18") from near side wall to center line of water closet (2010 ADAAG: 16"-18"). • <i>As-Built:</i> 18.3" o.c. • <i>Proposed Solution:</i> Relocate existing water closet and plumbing, remount with offset closet flange to provide 18" max. from side wall. 	PCODE WB02C ADAAG 91 Fig. 28 ADA 2010 604.2 CBC 2007 1115B.4.1.1 CBC 2016 11B-604.2 Mitigated: <input type="radio"/> YES <input checked="" type="radio"/> NO	1	JOB	\$1,500	\$1,500
