SAN MATEO COUNTY
COMMUNITY
COLLEGE DISTRICT

San Mateo County Community College District Americans with Disabilities Act Self-Evaluation and Transition Plan

Report Prepared by:

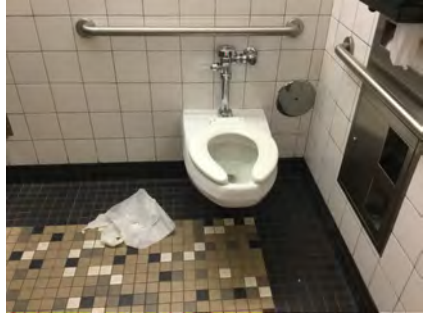
<input type="checkbox"/> Staff Only Priority 3 Severity 4						
1156	<ul style="list-style-type: none"> • <i>As-Built Description:</i> Height of water closet seat less than 17" or more than 19" from floor. • <i>As-Built:</i> 19.3" AFF • <i>Proposed Solution:</i> Provide new accessible water closet. 	PCODE WB08 ADAAG 91 4.16.3 ADA 2010 604.4 CBC 2007 1115B.4.1.4 CBC 2016 11B-604.4 Mitigated: <input type="radio"/> YES <input checked="" type="radio"/> NO	1	JOB	\$4,200	\$4,200

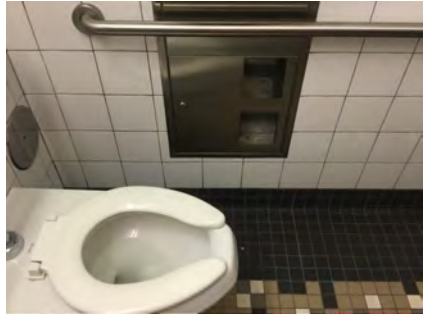
Item no., Rm no. and Name	Existing Architectural Barrier and Proposed Solution	Codes / Mitigation Info	Qty	Unit	Cost	Total
<u>Accessories</u>						
1154	<ul style="list-style-type: none"> • <i>As-Built Description:</i> Toilet paper dispenser less than 15" (CA: 19") or more than 48" above floor or not within 7" to 9" from front of water closet (Note: CA pre-2010 is allowed within 12" from front of water closet). • <i>As-Built:</i> 3.5" to the centerline of the toilet paper rolls in front of the water closet • <i>Proposed Solution:</i> Relocate or provide new toilet paper dispenser. 	PCODE WG02 ADAAG 91 4.16.6 ADA 2010 604.7 CBC 2007 1115B.8.4 CBC 2016 11B-604.7 Mitigated: <input type="radio"/> YES <input checked="" type="radio"/> NO	1	JOB	\$225	\$225

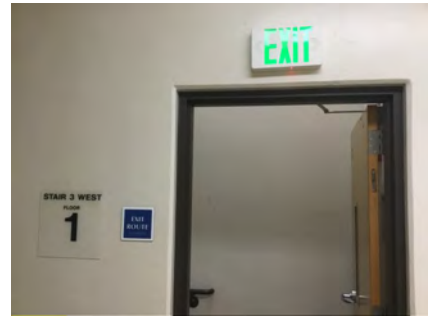
Item no., Rm no. and Name	Existing Architectural Barrier and Proposed Solution	Codes / Mitigation Info	Qty	Unit	Cost	Total
<u>Signage</u>						
1162	<ul style="list-style-type: none"> • <i>As-Built Description:</i> At door leading into exit stairway: Where required exit signs are installed, signs to provide exiting information for people with vision impairment are not provided. • <i>Proposed Solution:</i> Provide raised letter/Braille "EXIT STAIR UP/DOWN" sign at door. 	PCODE SA10B ADAAG 91 4.1.3(16) ADA 2010 216.4.1 CBC 2007 1011.3 CBC 2016 11B-216.4.1 Mitigated: <input type="radio"/> YES <input checked="" type="radio"/> NO	2	JOB	\$270	\$540

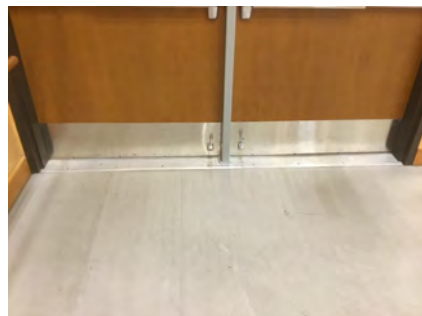
Item no., Rm no. and Name	Existing Architectural Barrier and Proposed Solution	Codes / Mitigation Info	Qty	Unit	Cost	Total
<u>Door Stopper</u>						
1348	<ul style="list-style-type: none">• <i>As-Built Description:</i> At push side of door on accessible route, bottom 10" does not have a smooth, uninterrupted surface.• <i>Proposed Solution:</i> Remove door stopper when altering area. Provide rubber wedge.	<p>PCODE ID06A</p> <p>ADA 2010 404.2.10</p> <p>CBC 2007 1133B.2.6</p> <p>CBC 2016 11B-404.2.10</p> <p>Mitigated:</p> <p><input type="radio"/> YES</p> <p><input checked="" type="radio"/> NO</p>	1	JOB	\$75	\$75

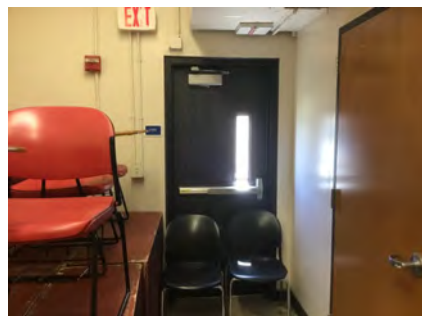
<input type="checkbox"/> Staff Only			
			Priority 2 Severity 3			
<u>Door Swing</u>						
1356	<ul style="list-style-type: none">• <i>As-Built Description:</i> Front approach: At push side, door does not have clear and level maneuvering space measuring door width x 48" (door width plus 12" if door has both, latch and closer).• <i>As-Built:</i> 8.25" at strike side• <i>Proposed Solution:</i> Change door swing.• <i>Notes:</i> Changing the door swing may require the addition of some paving on the exterior.	<p>PCODE ID24</p> <p>ADAAG 91 Fig. 25(a)</p> <p>ADA 2010 404.2.4</p> <p>CBC 2007 11B-26A(a)</p> <p>CBC 2016 11B-404.2.4</p> <p>Mitigated:</p> <p><input type="radio"/> YES</p> <p><input checked="" type="radio"/> NO</p>	1	JOB	\$1,500	\$1,500

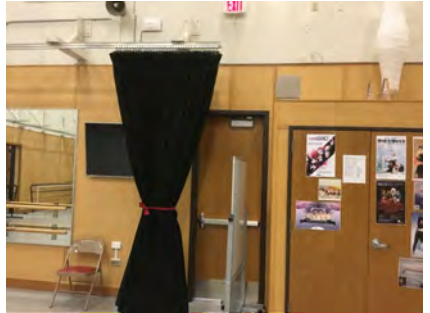
Item no., Rm no. and Name	Existing Architectural Barrier and Proposed Solution	Codes / Mitigation Info	Qty	Unit	Cost	Total
1350	<ul style="list-style-type: none"> As-Built Description: Front approach: At push side, door does not have clear and level maneuvering space measuring door width x 48" (door width plus 12" if door has both, latch and closer). As-Built: Curtain 20" from the door Proposed Solution: Remove or relocate furniture or storage items. 	PCODE ID24A ADAAG 91 Fig. 25(a) ADA 2010 404.2.4 CBC 2007 11B-26A(a) CBC 2016 11B-404.2.4 Mitigated: <input type="radio"/> YES <input checked="" type="radio"/> NO	1	JOB	\$150	\$150

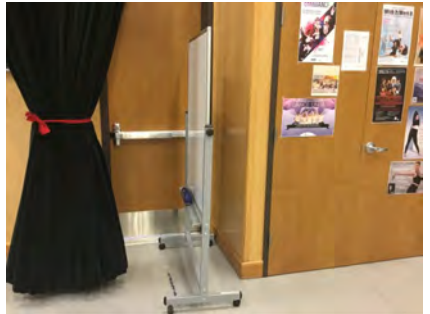
<input type="checkbox"/> Staff Only			
			Priority 2 Severity 2			
1351	<ul style="list-style-type: none"> As-Built Description: Front approach: At push side, door does not have clear and level maneuvering space measuring door width x 48" (door width plus 12" if door has both, latch and closer). As-Built: White board obstructs door maneuvering space Proposed Solution: Remove or relocate furniture or storage items. 	PCODE ID24A ADAAG 91 Fig. 25(a) ADA 2010 404.2.4 CBC 2007 11B-26A(a) CBC 2016 11B-404.2.4 Mitigated: <input type="radio"/> YES <input checked="" type="radio"/> NO	1	JOB	\$150	\$150

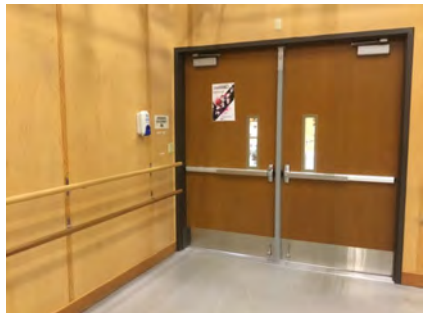
<input type="checkbox"/> Staff Only			
			Priority 2 Severity 4			
1352	<ul style="list-style-type: none"> As-Built Description: Front approach: At push side, door does not have clear and level maneuvering space measuring door width x 48" (door width plus 12" if door has both, latch and closer). As-Built: Ballet bar protrudes 6" into the door maneuvering clearance at the hinge side. Proposed Solution: Remove or relocate furniture or storage items. Notes: The clear width of the doorway between the bar and steel post in the center of the door way is 41.5". The door is not marked with an illuminated exit sign. Check exiting requirements before making alterations. 	PCODE ID24A ADAAG 91 Fig. 25(a) ADA 2010 404.2.4 CBC 2007 11B-26A(a) CBC 2016 11B-404.2.4 Mitigated: <input type="radio"/> YES <input checked="" type="radio"/> NO	1	JOB	\$150	\$150

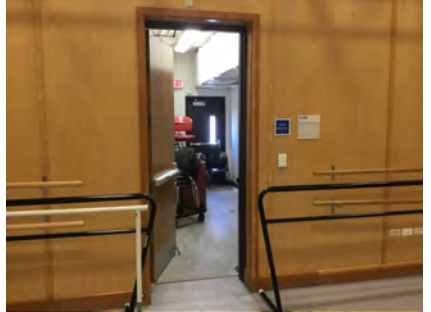
Item no., Rm no. and Name	Existing Architectural Barrier and Proposed Solution	Codes / Mitigation Info	Qty	Unit	Cost	Total
1355	<ul style="list-style-type: none"> As-Built Description: Front approach: At push side, door does not have clear and level maneuvering space measuring door width x 48" (door width plus 12" if door has both, latch and closer). As-Built: 14" deep alcove Proposed Solution: Provide relocated new door and frame; remodel walls as needed. 	PCODE ID24B ADAAG 91 Fig. 25(a) ADA 2010 404.2.4 CBC 2007 11B-26A(a) CBC 2016 11B-404.2.4 Mitigated: <input type="radio"/> YES <input checked="" type="radio"/> NO	1	JOB	\$7,800	\$7,800

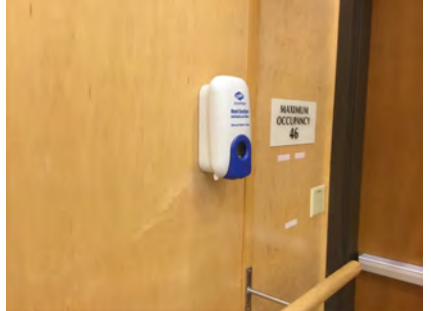
1349	<ul style="list-style-type: none"> As-Built Description: Reach height to control or access point, where side approach is available, exceeds 48" or is less than 15" in height, or exceeds 10" in depth. As-Built: 57" high Proposed Solution: Modify equipment or mounting. 	PCODE IE02 ADAAG 91 4.2.6 ADA 2010 308.3.1 CBC 2007 1118B.6 CBC 2016 11B-308.3 Mitigated: <input type="radio"/> YES <input checked="" type="radio"/> NO	1	JOB	\$300	\$300

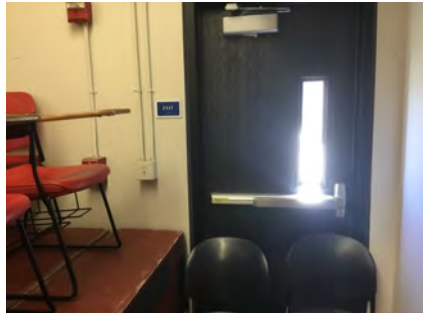
Item no., Rm no. and Name	Existing Architectural Barrier and Proposed Solution	Codes / Mitigation Info	Qty	Unit	Cost	Total
Signage						
1357	<ul style="list-style-type: none"> As-Built Description: Sign not located on latch side of door and/or not located at 48" min. above to baseline of the lowest Braille cells and 60" max. to baseline of the highest line of raised characters. Proposed Solution: Provide compliant signage including tactile characters and Grade II Braille on latch side of door located at compliant height. 	PCODE SA07 ADAAG 91 4.30.6 ADA 2010 703.4.1 CBC 2007 1117B.5.7 CBC 2016 11B-703.4.1 Mitigated: <input type="radio"/> YES <input checked="" type="radio"/> NO	1	JOB	\$150	\$150

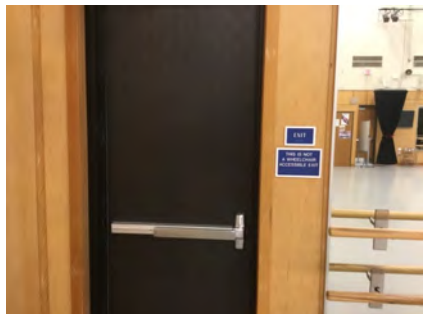
<input type="checkbox"/> Staff Only			
			Priority		Severity	
			2		3	
1353	<ul style="list-style-type: none"> As-Built Description: At door leading into exit stairway: Where required exit signs are installed, signs to provide exiting information for people with vision impairment are not provided. Proposed Solution: Provide raised letter/Braille "EXIT STAIR UP/DOWN" sign at door. Notes: The sign below the exit sign may not be necessary when "exit stair down" sign is installed. 	PCODE SA10B ADAAG 91 4.1.3(16) ADA 2010 216.4.1 CBC 2007 1011.3 CBC 2016 11B-216.4.1 Mitigated: <input type="radio"/> YES <input checked="" type="radio"/> NO	1	JOB	\$270	\$270

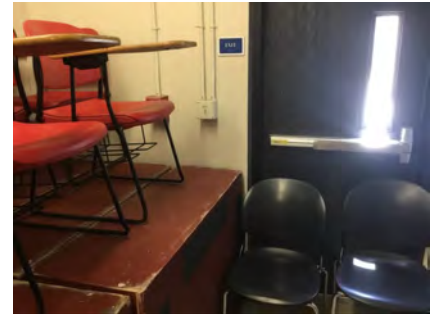
• **Notes:****Clear floor space at exit sign obstructed by movable objects.****Mitigated:**☐ YES☒ NO

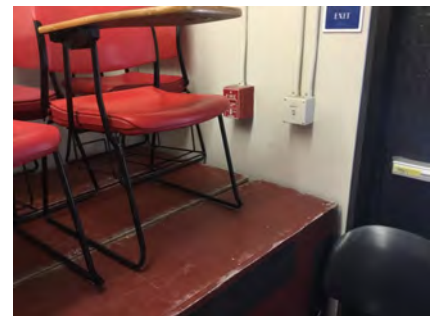
• **Notes:****Alarm pull station clear for space obstructed.****Mitigated:**☐ YES☒ NO

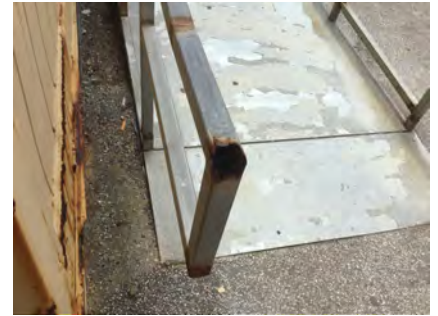
• *Proposed Solution:*• **Notes:****Handrail sharp. This condition occurs in multiple locations where handrail is rusty.**

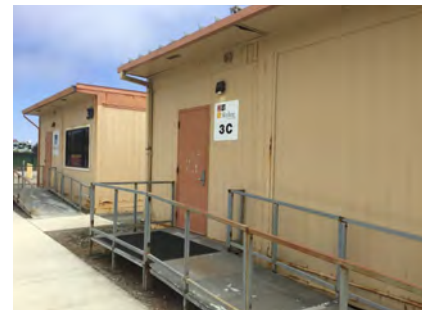
Item no., Rm no. and Name	Existing Architectural Barrier and Proposed Solution	Codes / Mitigation Info	Qty	Unit	Cost	Total
1868	<ul style="list-style-type: none"> As-Built Description: Existing sign designating permanent room or space is noncompliant. Proposed Solution: Provide compliant signage. 	PCODE SA13REF ADAAG 91 4.1.3(16)(a) ADA 2010 216.2 CBC 2007 1117B.5 CBC 2016 11B-216.2 Project: SKYB3A-E Portable Replacement Year to be Completed: 2019/2020 Mitigated: <input checked="" type="radio"/> YES <input type="radio"/> NO		REF	\$450

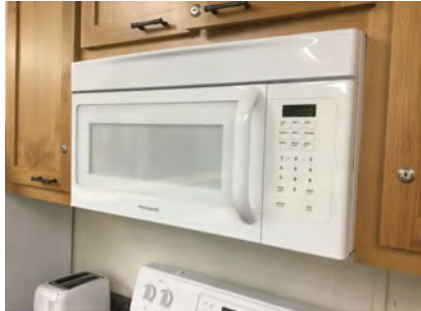
Item no., Rm no. and Name	Existing Architectural Barrier and Proposed Solution	Codes / Mitigation Info	Qty	Unit	Cost	Total
1865	<ul style="list-style-type: none">As-Built Description: Reach height to control or access point, where side approach is available, exceeds 48" or is less than 15" in height, or exceeds 10" in depth.As-Built: 66" highProposed Solution: Modify equipment or mounting.	<p>PCODE IE02REF</p> <p>ADAAG 91 4.2.6</p> <p>ADA 2010 308.3.1</p> <p>CBC 2007 1118B.6</p> <p>CBC 2016 11B-308.3</p> <p>Project: SKYB3A-E Portable Replacement</p> <p>Year to be Completed: 2019/2020</p> <p>Mitigated:</p> <p><input checked="" type="radio"/> YES</p> <p><input type="radio"/> NO</p>	REF

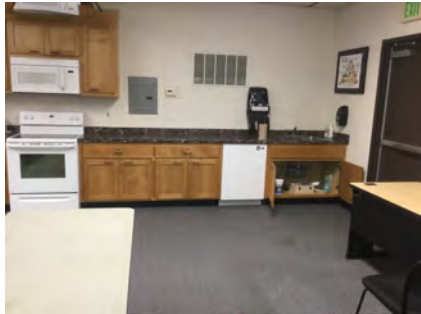
<input type="checkbox"/> Staff Only			
			<div><div>Priority</div><div>2</div></div> <div><div>Severity</div><div>1</div></div>			
<hr/>						
Sink						
1863	<ul style="list-style-type: none">As-Built Description: Sink does not have knee space min. 27" high x 19" deep x 30" wide.Proposed Solution: Remodel sink cabinet.	<p>PCODE IN06AREF</p> <p>ADAAG 91 4.24.3</p> <p>ADA 2010 606.2</p> <p>CBC 2007 1115B.4.7.1</p> <p>CBC 2016 11B-606.2</p> <p>Project: SKYB3A-E Portable Replacement</p> <p>Year to be Completed: 2019/2020</p> <p>Mitigated:</p> <p><input checked="" type="radio"/> YES</p> <p><input type="radio"/> NO</p>	REF

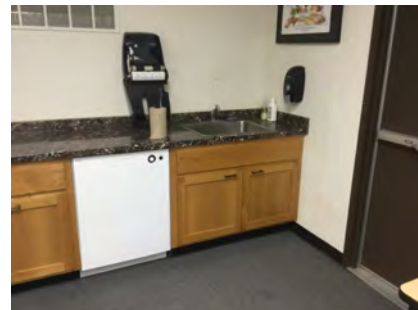
Item no., Rm no. and Name	Existing Architectural Barrier and Proposed Solution	Codes / Mitigation Info	Qty	Unit	Cost	Total
1862	<ul style="list-style-type: none"> As-Built Description: Sink rim higher than 34" above floor. As-Built: 36.5" high Proposed Solution: Remodel sink cabinet to lower sink. 	PCODE IN06REF ADAAG 91 4.24.2 ADA 2010 606.3 CBC 2007 1115B.4.7.1 CBC 2016 11B-606.3 Project: SKYB3A-E Portable Replacement Year to be Completed: 2019/2020 Mitigated: <input checked="" type="radio"/> YES <input type="radio"/> NO

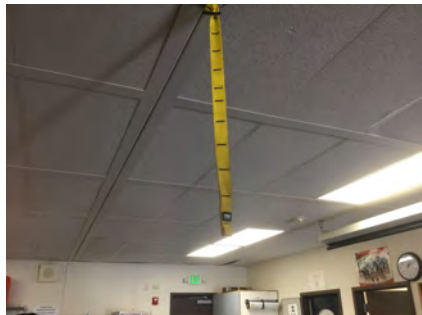
Item no., Rm no. and Name	Existing Architectural Barrier and Proposed Solution	Codes / Mitigation Info	Qty	Unit	Cost	Total
Reach Range						
1876	<ul style="list-style-type: none"> As-Built Description: Reach height to control or access point, where side approach is available, exceeds 48" or is less than 15" in height, or exceeds 10" in depth. As-Built: 75" high Proposed Solution: Modify equipment or mounting. 	PCODE IE02REF ADAAG 91 4.2.6 ADA 2010 308.3.1 CBC 2007 1118B.6 CBC 2016 11B-308.3 Project: SKYB3A-E Portable Replacement Year to be Completed: 2019/2020 Mitigated: <input checked="" type="radio"/> YES <input type="radio"/> NO				
						REF

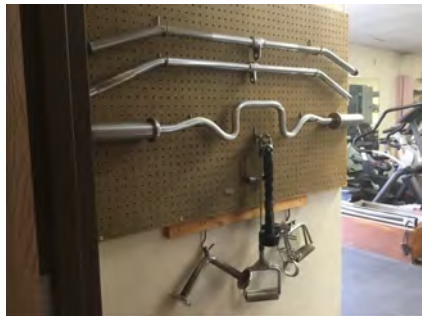
<input type="checkbox"/> Staff Only Priority Severity <input checked="" type="radio"/> 2 <input checked="" type="radio"/> 1
1889	<ul style="list-style-type: none"> As-Built Description: Reach height to control or access point, where side approach is available, exceeds 48" or is less than 15" in height, or exceeds 10" in depth. As-Built: 62" high Proposed Solution: Modify equipment or mounting. 	PCODE IE02REF ADAAG 91 4.2.6 ADA 2010 308.3.1 CBC 2007 1118B.6 CBC 2016 11B-308.3 Project: SKYB3A-E Portable Replacement Year to be Completed: 2019/2020 Mitigated: <input checked="" type="radio"/> YES <input type="radio"/> NO

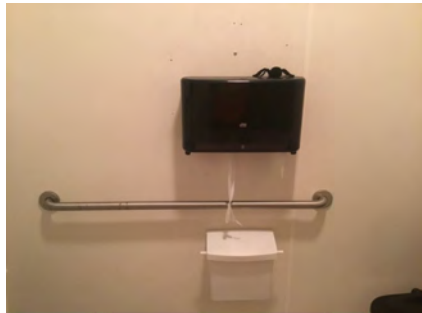
Item no., Rm no. and Name	Existing Architectural Barrier and Proposed Solution	Codes / Mitigation Info	Qty	Unit	Cost	Total
1880	<ul style="list-style-type: none"> As-Built Description: Accessories/dispensers in accessible stall located closer than 1-1/2" below or 12" above grab bar impedes its use. As-Built: Toilet paper dispenser 7.5" above grab bar Proposed Solution: Relocate accessories/dispensers to be no closer than 1-1/2" below and 12" above grab bars (except if accessories are recessed, flush with wall, and have no sharp edges). 	PCODE WB07IREF ADAAG 91 4.26.2 ADA 2010 609.3 CBC 2007 1133B.4.2.5 CBC 2016 11B-609.3 Project: SKYB3A-E Portable Replacement Year to be Completed: 2019/2020 Mitigated: <input checked="" type="radio"/> YES <input type="radio"/> NO				REF

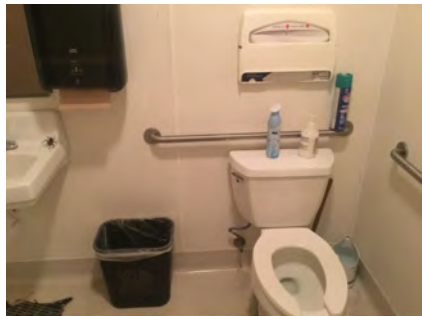
<u>Toilet Stall</u>						
1883	<ul style="list-style-type: none"> As-Built Description: 60" min. clearance around a water closet measured perpendicular from the side wall not provided (Fixtures are not allowed to overlap this clearance). As-Built: 56.5" to the edge of the lavatory Proposed Solution: Remove adjacent fixture and provide new enclosure at accessible water closet. Notes: 28" between WC and lavatory 	PCODE WB01AREF ADA 2010 604.3.1; 604.3.2 CBC 2007 1115B.7.1.3 CBC 2016 11B-604.3.1; 11B-604.3.2 Project: SKYB3A-E Portable Replacement Year to be Completed: 2019/2020 Mitigated: <input checked="" type="radio"/> YES <input type="radio"/> NO				REF

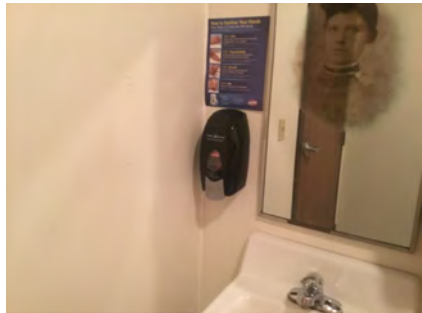
Item no., Rm no. and Name	Existing Architectural Barrier and Proposed Solution	Codes / Mitigation Info	Qty	Unit	Cost	Total
1885	<ul style="list-style-type: none"> As-Built Description: Dispensers in sanitary facilities, such as for towels, soap, sanitary napkins, seat covers, etc., and waste receptacles more than 48" (CA only: 40") from floor to highest operating slot or control. As-Built: 43" high Proposed Solution: Relocate existing restroom accessories. 	PCODE WG01AREF ADAAG 91 4.23.7 ADA 2010 308.2.1 CBC 2007 1115B.8.3 CBC 2016 11B-603.5 Project: SKYB3A-E Portable Replacement Year to be Completed: 2019/2020 Mitigated: <input checked="" type="radio"/> YES <input type="radio"/> NO				
						REF

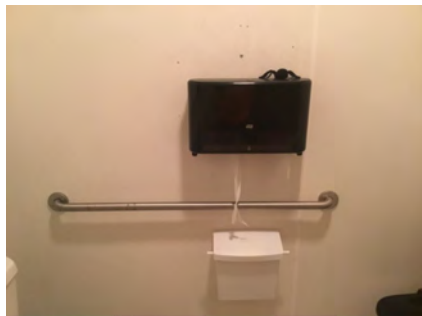
<input type="checkbox"/> Staff Only
						Priority Severity
						3 4
1881	<ul style="list-style-type: none"> As-Built Description: Toilet paper dispenser less than 15" (CA: 19") or more than 48" above floor or not within 7" to 9" from front of water closet (Note: CA pre-2010 is allowed within 12" from front of water closet). As-Built: Above the grab bar Proposed Solution: Relocate or provide new toilet paper dispenser. 	PCODE WG02REF ADAAG 91 4.16.6 ADA 2010 604.7 CBC 2007 1115B.8.4 CBC 2016 11B-604.7 Project: SKYB3A-E Portable Replacement Year to be Completed: 2019/2020 Mitigated: <input checked="" type="radio"/> YES <input type="radio"/> NO

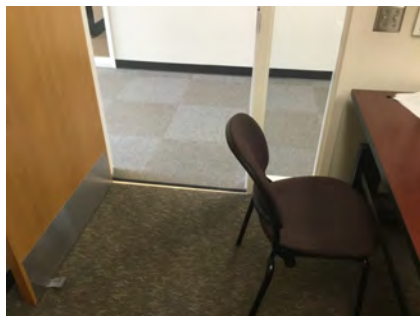
Item no., Rm no. and Name	Existing Architectural Barrier and Proposed Solution	Codes / Mitigation Info	Qty	Unit	Cost	Total
Door Swing						
1101	<ul style="list-style-type: none">• <i>As-Built Description:</i> Front approach: At pull side, door does not have clear and level maneuvering space measuring door width plus 18" x 60". (24" x 60" at exterior doors).• <i>Proposed Solution:</i> Remove or relocate furniture or storage items.• <i>Notes:</i> Occurs in offices throughout. Consider using conference rooms or larger rooms for people who need maneuvering clearance.	<p>PCODE ID23A</p> <p>ADAAG 91 Fig. 25(a)</p> <p>ADA 2010 404.2.4</p> <p>CBC 2007 11B-26A(a)</p> <p>CBC 2016 11B-404.2.4</p> <p>Mitigated:</p> <p><input type="radio"/> YES</p> <p><input checked="" type="radio"/> NO</p>	20	JOB	\$150	\$3,000

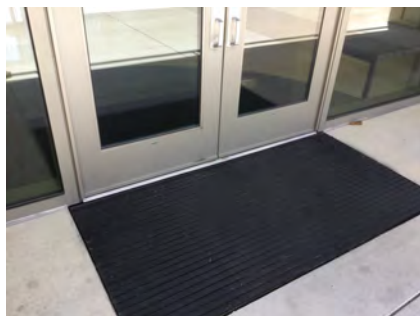
952	<ul style="list-style-type: none">• <i>As-Built Description:</i> Door inaccessible due to threshold or step at door exceeding 1/2".• <i>As-Built:</i> 0.9"• <i>Proposed Solution:</i> Replace threshold with lower profile design.	<p>PCODE ID02A</p> <p>ADAAG 91 4.13.8</p> <p>ADA 2010 404.2.5</p> <p>CBC 2007 1133B.2.4.1</p> <p>CBC 2016 11B-404.2.5</p> <p>Mitigated:</p> <p><input type="radio"/> YES</p> <p><input checked="" type="radio"/> NO</p>	9	JOB	\$600	\$5,400

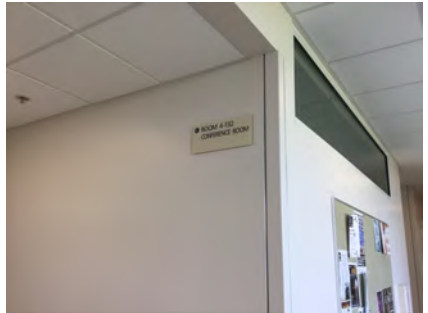
Item no., Rm no. and Name	Existing Architectural Barrier and Proposed Solution	Codes / Mitigation Info	Qty	Unit	Cost	Total
Signage						
1021	<ul style="list-style-type: none"> As-Built Description: Sign characters not readable because they are not sized for viewing distance. As-Built: 95" AFF, 1" high characters Proposed Solution: Provide compliant signage with character height of 2" minimum. 	PCODE SA02A ADAAG 91 4.30.3 ADA 2010 703.5.5 CBC 2007 1117B.5.4 CBC 2016 11B-403.5.1 Mitigated: <input type="radio"/> YES <input checked="" type="radio"/> NO	10	JOB	\$270	\$2,700

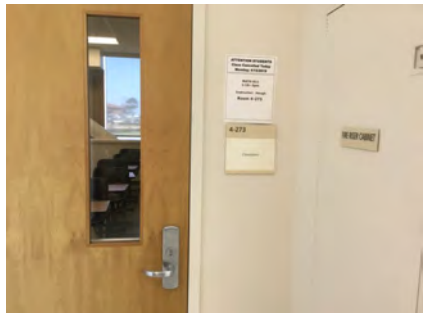
<input type="checkbox"/> Staff Only Priority 2 Severity 4			
941	<ul style="list-style-type: none"> As-Built Description: Signs containing tactile characters is not located so that a clear floor space of 18" min x 18" min., centered on the tactile characters, is provided beyond the arc of any door swing between the closed position and 45 degree open position. As-Built: Center of 18"x18" braille and tactile CLFS is 7.5" from door swing Proposed Solution: Relocate compliant signage on latch side of door located at compliant height with a clear floor space. 	PCODE SA07B ADA 2010 703.4.2 CBC 2016 11B-703.4.2 Mitigated: <input type="radio"/> YES <input checked="" type="radio"/> NO	1	JOB	\$150	\$150

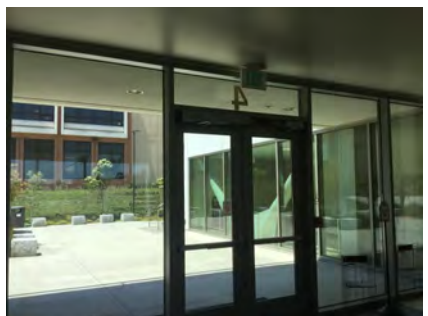
<input type="checkbox"/> Staff Only Priority 2 Severity 4			
937	<ul style="list-style-type: none"> As-Built Description: At final exit door to exterior: Where required exit signs are installed, signs to provide exiting information for people with vision impairment are not provided. Proposed Solution: Provide raised letter/Braille "EXIT" sign at door. 	PCODE SA10A ADAAG 91 4.1.3(16) ADA 2010 216.4.1 CBC 2007 1011.3 CBC 2016 11B-216.4.1 Mitigated: <input type="radio"/> YES <input checked="" type="radio"/> NO	12	JOB	\$270	\$3,240

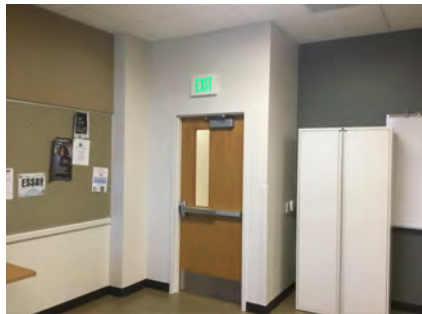
Item no., Rm no. and Name	Existing Architectural Barrier and Proposed Solution	Codes / Mitigation Info	Qty	Unit	Cost	Total
939	<ul style="list-style-type: none"> As-Built Description: At door leading into exit corridor: Where required exit signs are installed, signs to provide exiting information for people with vision impairment are not provided. Proposed Solution: Provide raised letter/Braille "EXIT ROUTE" sign at door. 	PCODE SA10D ADAAG 91 4.1.3(16) ADA 2010 216.4.1 CBC 2007 1011.3 CBC 2016 11B-216.4.1 Mitigated: <input type="radio"/> YES <input checked="" type="radio"/> NO	30	JOB	\$270	\$8,100

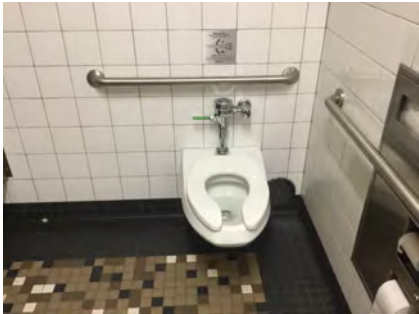
Item no., Rm no. and Name	Existing Architectural Barrier and Proposed Solution	Codes / Mitigation Info	Qty	Unit	Cost	Total
Grab Bars						
995	<ul style="list-style-type: none">As-Built Description: The rear wall grab is less than 36" min. or does not extend from the centerline of the water closet 12" min. on one side and 24" min. on the other side.As-Built: 23.5" on the wide sideProposed Solution: Provide or relocate accessible rear grab bar.	PCODE WB07B ADAAG 91 4.17.6 ADA 2010 604.5.2 CBC 2007 1115B.4.1.3.2 CBC 2016 11B-604.5.2 Mitigated: <input type="radio"/> YES <input checked="" type="radio"/> NO	1	JOB	\$1,020	\$1,020

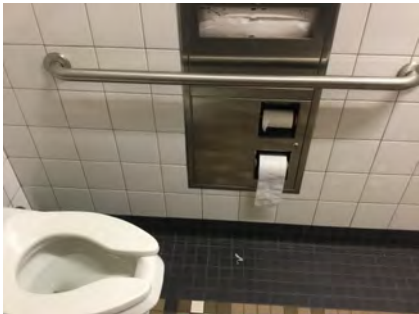
<input type="checkbox"/> Staff Only			
			Priority	Severity		
			3	4		
Accessories						
994	<ul style="list-style-type: none">As-Built Description: Toilet paper dispenser less than 15" (CA: 19") or more than 48" above floor or not within 7" to 9" from front of water closet (Note: CA pre-2010 is allowed within 12" from front of water closet).As-Built: 13.5" from the front of the water closet to the centerline of the toilet paper rollsProposed Solution: Relocate or provide new toilet paper dispenser.	PCODE WG02 ADAAG 91 4.16.6 ADA 2010 604.7 CBC 2007 1115B.8.4 CBC 2016 11B-604.7 Mitigated: <input type="radio"/> YES <input checked="" type="radio"/> NO	1	JOB	\$225	\$225

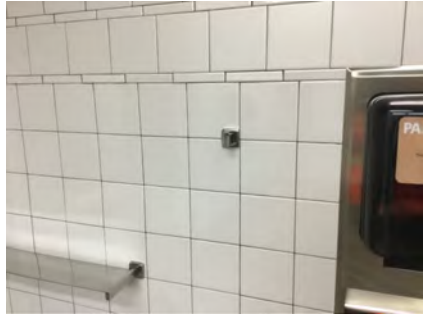
Item no., Rm no. and Name	Existing Architectural Barrier and Proposed Solution	Codes / Mitigation Info	Qty	Unit	Cost	Total
<u>Coat Hook</u>						
991	<ul style="list-style-type: none"> As-Built Description: Accessible coat hook not within reach range. As-Built: 54" Proposed Solution: Adjust existing or provide new coat hook at maximum 48" height. 	PCODE WG03A ADAAG 91 4.2.5 ADA 2010 603.4 CBC 2007 1118B.5 CBC 2016 11B-603.4 Mitigated: <input type="radio"/> YES <input checked="" type="radio"/> NO	1	JOB	\$150	\$150

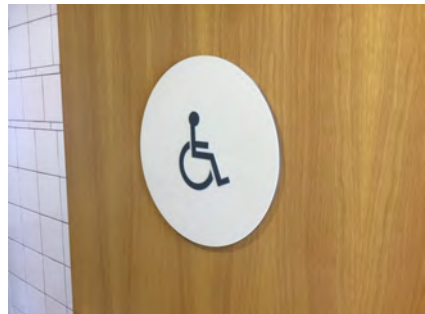
Item no., Rm no. and Name	Existing Architectural Barrier and Proposed Solution	Codes / Mitigation Info	Qty	Unit	Cost	Total
Signage						
998	<ul style="list-style-type: none">As-Built Description: Required in CA only: identification symbol centered 58" to 60" high on sanitary facility door that contrasts with the door not provided (women: 12" ø circle, men: 12" triangle, unisex: combined symbol).As-Built: Not easedProposed Solution: Provide properly mounted sanitary facility symbol when altering area. If wheelchair accessible, include International Symbol of Accessibility on sign.	PCODE SA15 CBC 2007 1115B.6 CBC 2016 11B-703.7.2.6 Mitigated: <input type="radio"/> YES <input checked="" type="radio"/> NO	1	JOB	\$270	\$270

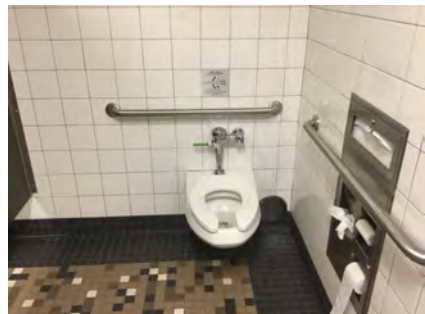
<input type="checkbox"/> Staff Only			
			Priority		Severity	
			3		3	
Grab Bars						
1004	<ul style="list-style-type: none">As-Built Description: The rear wall grab is less than 36" min. or does not extend from the centerline of the water closet 12" min. on one side and 24" min. on the other side.As-Built: 23.5" on the widest sideProposed Solution: Provide or relocate accessible rear grab bar.	PCODE WB07B ADAAG 91 4.17.6 ADA 2010 604.5.2 CBC 2007 1115B.4.1.3.2 CBC 2016 11B-604.5.2 Mitigated: <input type="radio"/> YES <input checked="" type="radio"/> NO	1	JOB	\$1,020	\$1,020

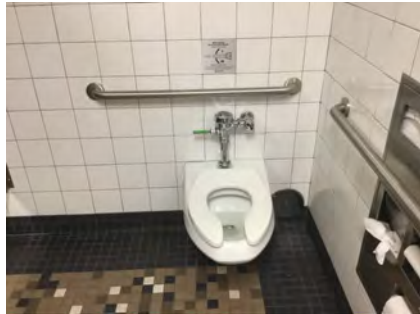
Item no., Rm no. and Name	Existing Architectural Barrier and Proposed Solution	Codes / Mitigation Info	Qty	Unit	Cost	Total
<u>Water Closet</u>						
1003	<ul style="list-style-type: none"> • <i>As-Built Description:</i> Water closet not 16"-18" (CA: 17"-18") from near side wall to center line of water closet (2010 ADAAG: 16"-18"). • <i>As-Built:</i> 18.5 o.c. • <i>Proposed Solution:</i> Relocate existing water closet and plumbing, remount with offset closet flange to provide 18" max. from side wall. 	PCODE WB02C ADAAG 91 Fig. 28 ADA 2010 604.2 CBC 2007 1115B.4.1.1 CBC 2016 11B-604.2 Mitigated: <input type="radio"/> YES <input checked="" type="radio"/> NO	1	JOB	\$1,500	\$1,500

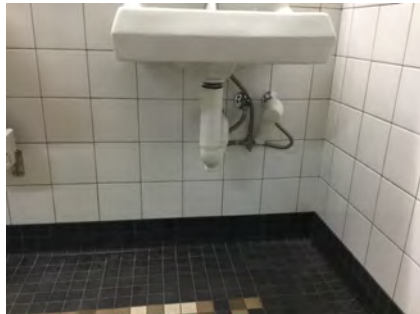
<input type="checkbox"/> Staff Only			
			Priority		Severity	
			3		4	
<u>Lavatory</u>						
1001	<ul style="list-style-type: none"> • <i>As-Built Description:</i> Hot or sharp-surfaced water/drain pipe not insulated or covered. • <i>Proposed Solution:</i> Insulate or cover water/drain pipe. 	PCODE WD05 ADAAG 91 4.19.4 ADA 2010 606.5 CBC 2007 1115B.4.3.4 CBC 2016 11B-606.5 Mitigated: <input type="radio"/> YES <input checked="" type="radio"/> NO	1	JOB	\$360	\$360

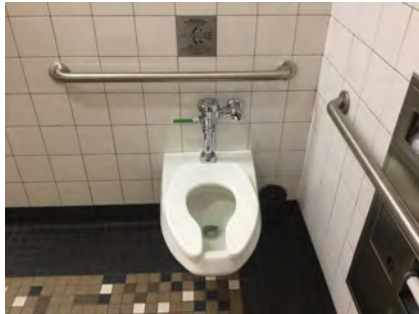
Item no., Rm no. and Name	Existing Architectural Barrier and Proposed Solution	Codes / Mitigation Info	Qty	Unit	Cost	Total
<u>Water Closet</u>						
1011	<ul style="list-style-type: none">• <i>As-Built Description:</i> Water closet not 16"-18" (CA: 17"-18") from near side wall to center line of water closet (2010 ADAAG: 16"-18").• <i>As-Built:</i> 18.25" o.c.• <i>Proposed Solution:</i> Relocate existing water closet and plumbing, remount with offset closet flange to provide 18" max. from side wall.	<p>PCODE WB02C ADAAG 91 Fig. 28 ADA 2010 604.2 CBC 2007 1115B.4.1.1 CBC 2016 11B-604.2</p> <p>Mitigated: <input type="radio"/> YES <input checked="" type="radio"/> NO</p>	1	JOB	\$1,500	\$1,500

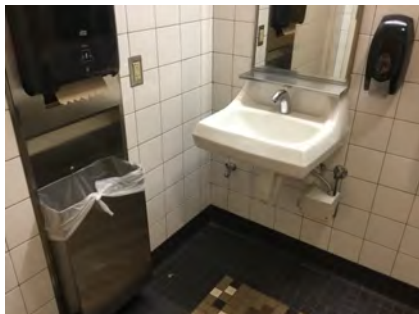
<input type="checkbox"/> Staff Only			
			Priority		Severity	
			3		4	
<u>Lavatory</u>						
1007	<ul style="list-style-type: none">• <i>As-Built Description:</i> Clear floor space, 30" x 48" in front of fixture, extending 19" max. under the lavatory, not provided (CA only: Less than 18" from side wall to centerline of lavatory).• <i>As-Built:</i> Centerline of the lavatory 17.75" from the side wall• <i>Proposed Solution:</i> Provide new accessible lavatory. Remodel restroom as needed.• Notes: 13.25" from the wall-mounted trash can and paper towel dispenser.	<p>PCODE WD01 ADAAG 91 4.19.3 ADA 2010 606.2 CBC 2007 1115B.4.3 CBC 2016 11B-606.2, 11B-606.6</p> <p>Mitigated: <input type="radio"/> YES <input checked="" type="radio"/> NO</p>	1	JOB	\$10,200	\$10,200

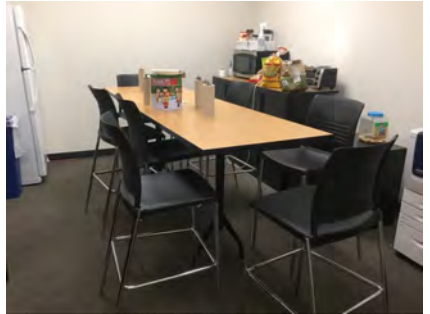
Item no., Rm no. and Name	Existing Architectural Barrier and Proposed Solution	Codes / Mitigation Info	Qty	Unit	Cost	Total
Non-Fixed Desk						
1013	<ul style="list-style-type: none"> As-Built Description: Accessible non-fixed table or desk (top 28" to 34" high; knee space at least 27" high x 19" deep x 30" wide) not provided. As-Built: 40.5" to top Proposed Solution: Provide table or desk with accessible dimensions when purchasing new furniture. Notes: Staff Only 	PCODE IN02A ADAAG 91 4.32.3 & .4 ADA 2010 306.1 CBC 2007 1122B.3 & 4 CBC 2016 11B-306.1 & 11B-902.3 Mitigated: <input type="radio"/> YES <input checked="" type="radio"/> NO	1	JOB	\$4,800	\$4,800

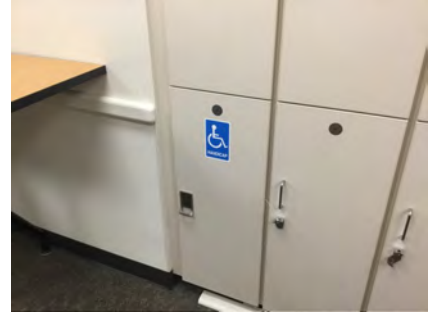
Item no., Rm no. and Name	Existing Architectural Barrier and Proposed Solution	Codes / Mitigation Info	Qty	Unit	Cost	Total
1020	<ul style="list-style-type: none"> • <i>As-Built Description:</i> Refer to notes for observation and recommendation. • <i>Proposed Solution:</i> • <i>Notes:</i> Incorrect or offensive language used. Remove "handicap" and provide only ISA. 	PCODE GN01 CBC 2016 11B-403.5.1 Mitigated: <input type="radio"/> YES <input checked="" type="radio"/> NO		REF

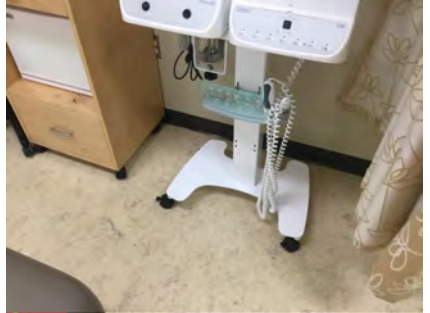
Item no., Rm no. and Name	Existing Architectural Barrier and Proposed Solution	Codes / Mitigation Info	Qty	Unit	Cost	Total
Reach Range						
1025	<ul style="list-style-type: none"> As-Built Description: Reach height to control or access point, where side approach is available, exceeds 48" or is less than 15" in height, or exceeds 10" in depth. As-Built: Wheel locks on portable workstations 1.5" high Proposed Solution: Modify equipment or mounting. 	PCODE IE02 ADAAG 91 4.2.6 ADA 2010 308.3.1 CBC 2007 1118B.6 CBC 2016 11B-308.3 Mitigated: <input type="radio"/> YES <input checked="" type="radio"/> NO	1	JOB	\$300	\$300

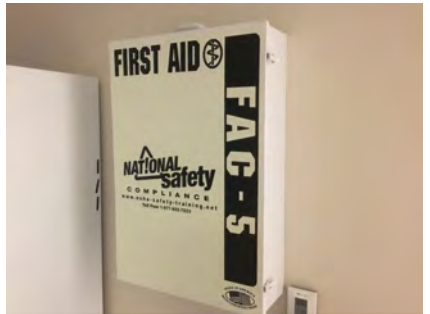
<input type="checkbox"/> Staff Only			
			Priority		Severity	
			2		1	
1029	<ul style="list-style-type: none"> As-Built Description: Reach height to control or access point, where side approach is available, exceeds 48" or is less than 15" in height, or exceeds 10" in depth. As-Built: 69" high Proposed Solution: Modify equipment or mounting. 	PCODE IE02 ADAAG 91 4.2.6 ADA 2010 308.3.1 CBC 2007 1118B.6 CBC 2016 11B-308.3 Mitigated: <input type="radio"/> YES <input checked="" type="radio"/> NO	1	JOB	\$300	\$300

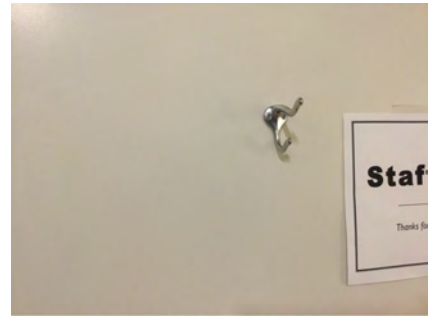
Item no., Rm no. and Name	Existing Architectural Barrier and Proposed Solution	Codes / Mitigation Info	Qty	Unit	Cost	Total
<u>Coat Hook</u>						
1031	<ul style="list-style-type: none"> • <i>As-Built Description:</i> Accessible coat hook not within reach range. • <i>Proposed Solution:</i> Adjust existing or provide new coat hook at maximum 48" height. • <i>Notes:</i> Staff Only 	PCODE WG03A ADAAG 91 4.2.5 ADA 2010 603.4 CBC 2007 1118B.5 CBC 2016 11B-603.4 Mitigated: <input type="radio"/> YES <input checked="" type="radio"/> NO	1	JOB	\$150	\$150

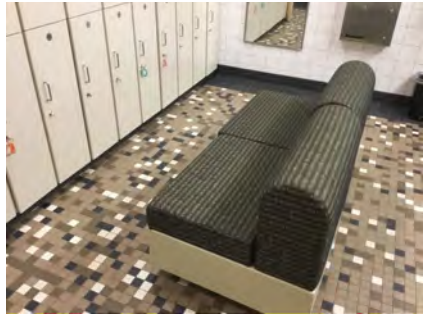
Item no., Rm no. and Name	Existing Architectural Barrier and Proposed Solution	Codes / Mitigation Info	Qty	Unit	Cost	Total
1045	<ul style="list-style-type: none"> As-Built Description: Bench, measuring 20" min., & 24" max. x 42" long (CA Only: 48") and fixed to the wall with the longer dimension, not provided Proposed Solution: Demolish existing and provide new 48" wide bench. Remodel walls as needed. Notes: Not located against a wall, back rest 12 " high. Must be 18" high minimum when not located against a wall. 	PCODE RE04 ADAAG 91 4.35.4 ADA 2010 803.4 CBC 2007 1117B.8 CBC 2016 11B-803.4 Mitigated: <input type="radio"/> YES <input checked="" type="radio"/> NO	1	JOB	\$3,000	\$3,000

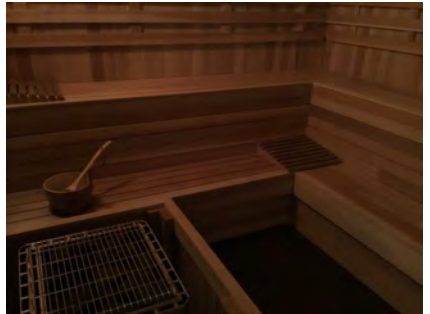
<input type="checkbox"/> Staff Only Priority 3 Severity 3						
1036	<ul style="list-style-type: none"> As-Built Description: Clear floor space to allow parallel transfer onto bench not provided. Proposed Solution: Remodel room to provide 30" x 48" alongside bench. 	PCODE RE04B ADAAG 91 4.35.4 ADA 2010 803.4 CBC 2007 1117B.8 CBC 2016 11B-803.4 Mitigated: <input type="radio"/> YES <input checked="" type="radio"/> NO	1	JOB	\$4,500	\$4,500

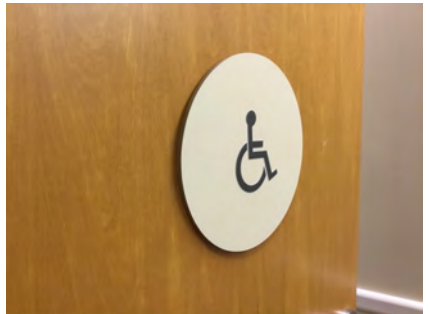
<input type="checkbox"/> Staff Only Priority 3 Severity 2						
Signage						
1034	<ul style="list-style-type: none"> As-Built Description: Entrance to toilet or bathing facility not identified with ADAAG compliant signage. As-Built: Not eased Proposed Solution: Provide ADA compliant sign mounted at 48" min. above to baseline of the lowest Braille cells and 60" max. to baseline of the highest line of raised characters on nearest adjacent wall, on latch side of a single door (located not to cause a Braille reader to stand within the door swing). 	PCODE SA11A ADAAG 91 4.1.3(16)(a) ADA 2010 216.8 CBC 2016 11B-216.8 Mitigated: <input type="radio"/> YES <input checked="" type="radio"/> NO	2	JOB	\$270	\$540

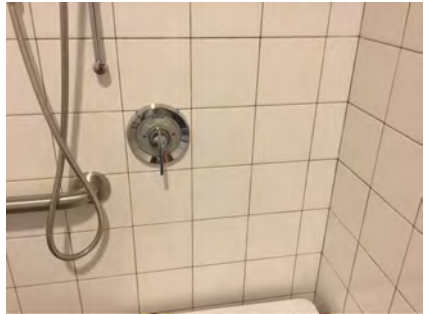
Item no., Rm no. and Name	Existing Architectural Barrier and Proposed Solution	Codes / Mitigation Info	Qty	Unit	Cost	Total
1039	<ul style="list-style-type: none"> As-Built Description: CA only: Mounting height of shower spray bracket exceeds 48" max. or is less than 19" from rear edge of folding seat wall. As-Built: 15" Proposed Solution: Provide or remount shower spray bracket within 19"- 27" from rear wall. Notes: Not above grab bar. 	PCODE WF05BNT ADA 2010 608.5 CBC 2007 1115B.4.4.5.3 CBC 2016 11B-608.5 Mitigated: <input type="radio"/> YES <input checked="" type="radio"/> NO	1	JOB	\$1,500	\$1,500

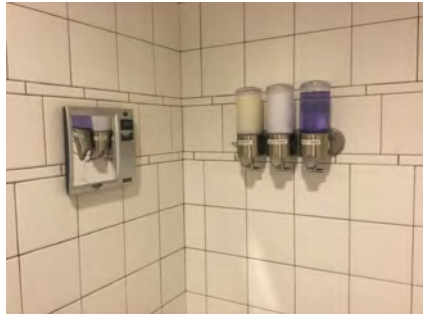
1041	<ul style="list-style-type: none"> As-Built Description: Dispensers in sanitary facilities, such as for towels, soap, sanitary napkins, seat covers, etc., and waste receptacles more than 48" (CA only: 40") from floor to highest operating slot or control. As-Built: Soap and light on mirror 65" to 69" AFF. Proposed Solution: Relocate existing restroom accessories. 	PCODE WG01A ADAAG 91 4.23.7 ADA 2010 308.2.1 CBC 2007 1115B.8.3 CBC 2016 11B-603.5 Mitigated: <input type="radio"/> YES <input checked="" type="radio"/> NO	1	JOB	\$300	\$300

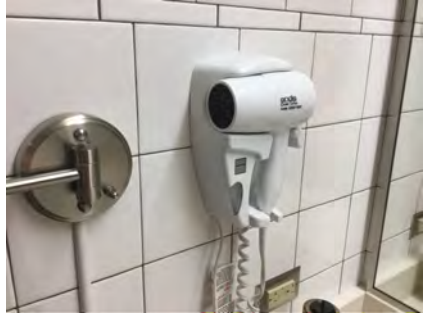
1051	<ul style="list-style-type: none"> As-Built Description: Dispensers in sanitary facilities, such as for towels, soap, sanitary napkins, seat covers, etc., and waste receptacles more than 48" (CA only: 40") from floor to highest operating slot or control. As-Built: 53" AFF Proposed Solution: Relocate existing restroom accessories. 	PCODE WG01A ADAAG 91 4.23.7 ADA 2010 308.2.1 CBC 2007 1115B.8.3 CBC 2016 11B-603.5 Mitigated: <input type="radio"/> YES <input checked="" type="radio"/> NO	1	JOB	\$300	\$300

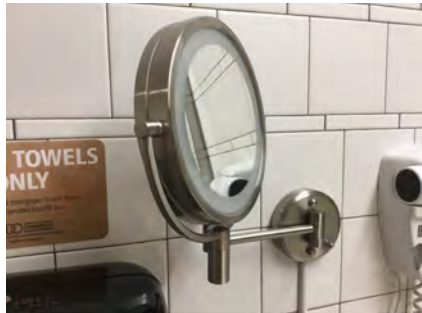
Item no., Rm no. and Name	Existing Architectural Barrier and Proposed Solution	Codes / Mitigation Info	Qty	Unit	Cost	Total
1054	<ul style="list-style-type: none"> As-Built Description: Dispensers in sanitary facilities, such as for towels, soap, sanitary napkins, seat covers, etc., and waste receptacles more than 48" (CA only: 40") from floor to highest operating slot or control. As-Built: 57" high Proposed Solution: Relocate existing restroom accessories. 	PCODE WG01A ADAAG 91 4.23.7 ADA 2010 308.2.1 CBC 2007 1115B.8.3 CBC 2016 11B-603.5 Mitigated: <input type="radio"/> YES <input checked="" type="radio"/> NO	1	JOB	\$300	\$300

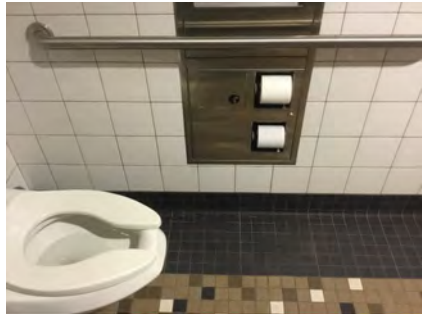
<input type="checkbox"/> Staff Only						
Priority 3 Severity 2						
1047	<ul style="list-style-type: none"> As-Built Description: Toilet paper dispenser less than 15" (CA: 19") or more than 48" above floor or not within 7" to 9" from front of water closet (Note: CA pre-2010 is allowed within 12" from front of water closet). As-Built: 14" from the front of the water closet to the centerline of toilet paper rolls Proposed Solution: Relocate or provide new toilet paper dispenser. 	PCODE WG02 ADAAG 91 4.16.6 ADA 2010 604.7 CBC 2007 1115B.8.4 CBC 2016 11B-604.7 Mitigated: <input type="radio"/> YES <input checked="" type="radio"/> NO	1	JOB	\$225	\$225

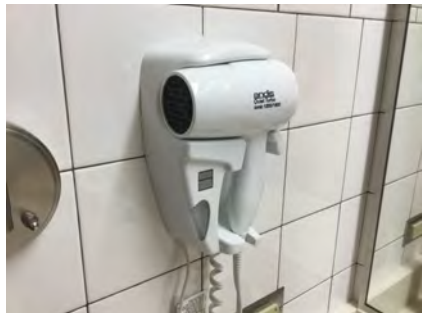
<input type="checkbox"/> Staff Only						
Priority 3 Severity 3						
1052	<ul style="list-style-type: none"> As-Built Description: Accessories in sanitary facilities not accessible, hardware requires tight grasping, pinching, or twisting of the wrist. Proposed Solution: Provide accessories with accessible operating mechanism. 	PCODE WG05 ADAAG 91 4.27.4 ADA 2010 309.4 CBC 2007 1117B.6 CBC 2016 11B-309.4 Mitigated: <input type="radio"/> YES <input checked="" type="radio"/> NO	1	JOB	\$1,200	\$1,200

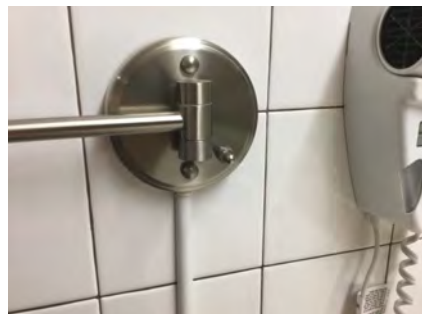
Item no., Rm no. and Name	Existing Architectural Barrier and Proposed Solution	Codes / Mitigation Info	Qty	Unit	Cost	Total
1053	<ul style="list-style-type: none">• As-Built Description: Accessories in sanitary facilities not accessible, hardware requires tight grasping, pinching, or twisting of the wrist.• Proposed Solution: Provide accessories with accessible operating mechanism.	PCODE WG05 ADAAG 91 4.27.4 ADA 2010 309.4 CBC 2007 1117B.6 CBC 2016 11B-309.4 Mitigated: <input type="radio"/> YES <input checked="" type="radio"/> NO	1	JOB	\$1,200	\$1,200

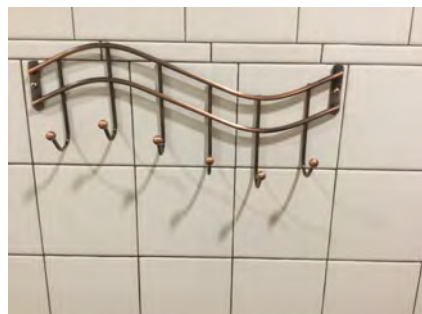
<input type="checkbox"/> Staff Only Priority 3 Severity 2			
<hr/>						
Coat Hook						
1038	<ul style="list-style-type: none">• As-Built Description: Accessible coat hook not within reach range.• As-Built: 54" high• Proposed Solution: Adjust existing or provide new coat hook at maximum 48" height.	PCODE WG03A ADAAG 91 4.2.5 ADA 2010 603.4 CBC 2007 1118B.5 CBC 2016 11B-603.4 Mitigated: <input type="radio"/> YES <input checked="" type="radio"/> NO	1	JOB	\$150	\$150

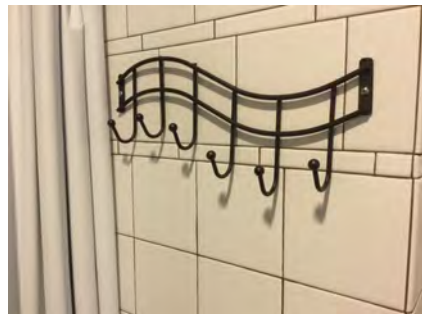
<input type="checkbox"/> Staff Only Priority 3 Severity 3			
<hr/>						
1043	<ul style="list-style-type: none">• As-Built Description: Accessible coat hook not within reach range.• As-Built: 60" high• Proposed Solution: Adjust existing or provide new coat hook at maximum 48" height.	PCODE WG03A ADAAG 91 4.2.5 ADA 2010 603.4 CBC 2007 1118B.5 CBC 2016 11B-603.4 Mitigated: <input type="radio"/> YES <input checked="" type="radio"/> NO	1	JOB	\$150	\$150

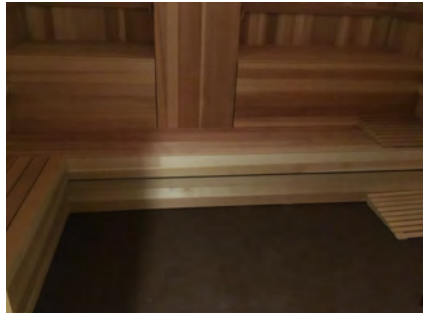
Item no., Rm no. and Name	Existing Architectural Barrier and Proposed Solution	Codes / Mitigation Info	Qty	Unit	Cost	Total
Bench						
1060	<ul style="list-style-type: none"> As-Built Description: Bench, measuring 20" min., & 24" max. x 42" long (CA Only: 48") and fixed to the wall with the longer dimension, not provided As-Built: 18" deep Proposed Solution: Demolish existing and provide new 48" wide bench. Remodel walls as needed. 	PCODE RE04 ADAAG 91 4.35.4 ADA 2010 803.4 CBC 2007 1117B.8 CBC 2016 11B-803.4 Mitigated: <input type="radio"/> YES <input checked="" type="radio"/> NO	1	JOB	\$3,000	\$3,000

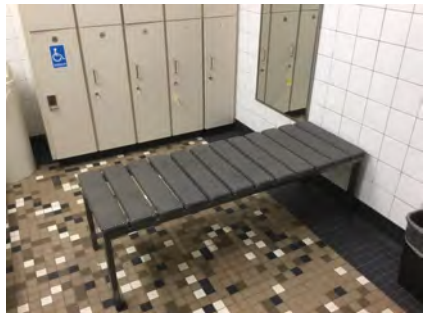
<input type="checkbox"/> Staff Only Priority 3 Severity 4			
1068	<ul style="list-style-type: none"> As-Built Description: Bench, measuring 20" min., & 24" max. x 42" long (CA Only: 48") and fixed to the wall with the longer dimension, not provided As-Built: No back rest Proposed Solution: Demolish existing and provide new 48" wide bench. Remodel walls as needed. Notes: Solution re-position the bench against a wall. 	PCODE RE04 ADAAG 91 4.35.4 ADA 2010 803.4 CBC 2007 1117B.8 CBC 2016 11B-803.4 Mitigated: <input type="radio"/> YES <input checked="" type="radio"/> NO	1	JOB	\$3,000	\$3,000

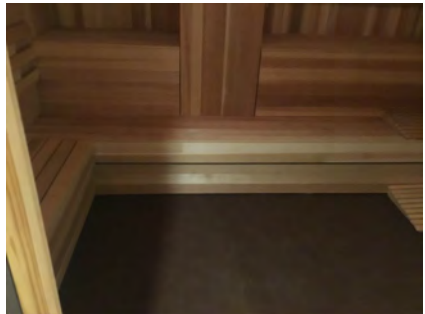
<input type="checkbox"/> Staff Only Priority 3 Severity 3			
1059	<ul style="list-style-type: none"> As-Built Description: Clear floor space to allow parallel transfer onto bench not provided. Proposed Solution: Remodel room to provide 30" x 48" alongside bench. 	PCODE RE04B ADAAG 91 4.35.4 ADA 2010 803.4 CBC 2007 1117B.8 CBC 2016 11B-803.4 Mitigated: <input type="radio"/> YES <input checked="" type="radio"/> NO	1	JOB	\$4,500	\$4,500

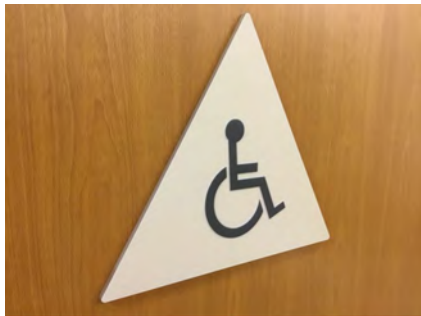
Item no., Rm no. and Name	Existing Architectural Barrier and Proposed Solution	Codes / Mitigation Info	Qty	Unit	Cost	Total
<u>Signage</u>						
1057	<ul style="list-style-type: none">As-Built Description: Required in CA only: identification symbol centered 58" to 60" high on sanitary facility door that contrasts with the door not provided (women: 12" ø circle, men: 12" triangle, unisex: combined symbol).As-Built: Not easedProposed Solution: Provide properly mounted sanitary facility symbol when altering area. If wheelchair accessible, include International Symbol of Accessibility on sign.	PCODE SA15 CBC 2007 1115B.6 CBC 2016 11B-703.7.2.6 Mitigated: <input type="radio"/> YES <input checked="" type="radio"/> NO	1	JOB	\$270	\$270

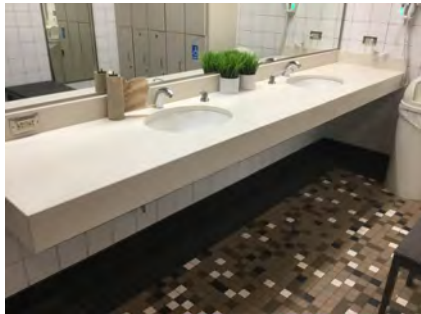
<input type="checkbox"/> Staff Only			
			Priority		Severity	
			3		3	
<u>Lavatory</u>						
1067	<ul style="list-style-type: none">As-Built Description: Wheelchair clearance under lavatory apron or lavatory counter front edge less than 29" high.As-Built: 28.8" highProposed Solution: Provide new accessible lavatory. Remodel restroom as needed.	PCODE WD03 ADAAG 91 4.19.2 ADA 2010 606.3 CBC 2007 1115B.4.3.3 CBC 2016 11B-306.3.1 Mitigated: <input type="radio"/> YES <input checked="" type="radio"/> NO	1	JOB	\$10,200	\$10,200

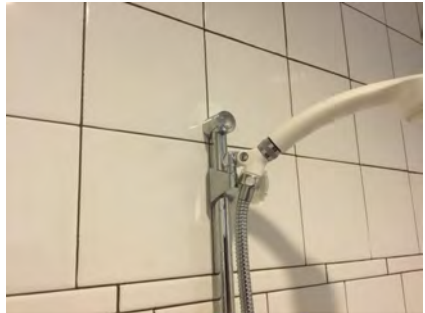
Item no., Rm no. and Name	Existing Architectural Barrier and Proposed Solution	Codes / Mitigation Info	Qty	Unit	Cost	Total
Shower						
1062	<ul style="list-style-type: none"> • <i>As-Built Description:</i> Mounting height of shower spray bracket exceeds 48" max. height or is more than 27" from rear edge of folding seat. • <i>As-Built:</i> 73" high • <i>Proposed Solution:</i> Provide or remount shower spray bracket within 27" from rear edge of seat and at 48" max. height. 	PCODE WF05B ADA 2010 608.5 CBC 2007 1115B.4.4.5.3 CBC 2016 11B-608.5 Mitigated: <input type="radio"/> YES <input checked="" type="radio"/> NO	1	JOB	\$1,500	\$1,500

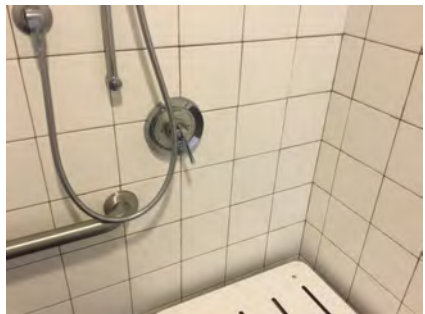
<input type="checkbox"/> Staff Only			
			Priority <input checked="" type="radio"/> 3		Severity <input checked="" type="radio"/> 1	
1063	<ul style="list-style-type: none"> • <i>As-Built Description:</i> Controls not located at 40" max. height or not within a range of no less than 19" and no more than 27" from the seat wall. • <i>As-Built:</i> Control valve is not above the grab bar and is 16" from the rear wall • <i>Proposed Solution:</i> Provide new, or relocate, shower controls. 	PCODE WF12 ADAAG 91 4.27.3 ADA 2010 608.5 CBC 2007 1115B.4.4.4.1 CBC 2016 11B-608.5 Mitigated: <input type="radio"/> YES <input checked="" type="radio"/> NO	1	JOB	\$2,400	\$2,400

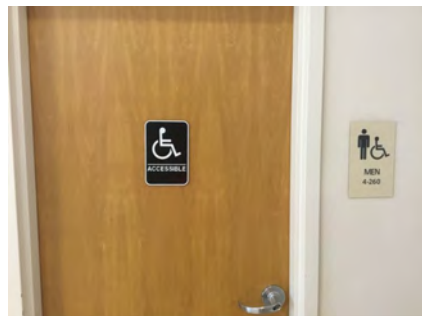
Item no., Rm no. and Name	Existing Architectural Barrier and Proposed Solution	Codes / Mitigation Info	Qty	Unit	Cost	Total
Signage						
314	<ul style="list-style-type: none">As-Built Description: Required in CA only: identification symbol centered 58" to 60" high on sanitary facility door that contrasts with the door not provided (women: 12" ø circle, men: 12" triangle, unisex: combined symbol).As-Built: No triangleProposed Solution: Provide properly mounted sanitary facility symbol when altering area. If wheelchair accessible, include International Symbol of Accessibility on sign.	PCODE SA15 CBC 2007 1115B.6 CBC 2016 11B-703.7.2.6 Mitigated: <input type="radio"/> YES <input checked="" type="radio"/> NO	1	JOB	\$270	\$270

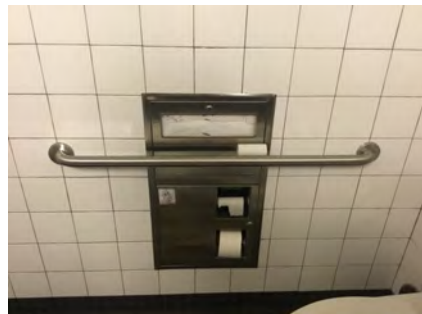
<input type="checkbox"/> Staff Only			
			Priority		Severity	
			<input checked="" type="radio"/> 3		<input checked="" type="radio"/> 3	
Grab Bars						
321	<ul style="list-style-type: none">As-Built Description: Side grab bar less than 42" long, or located more than 12 inches max. from the rear wall, or extending less than 54" from rear wall (CA only: front end min. 24" in front of water closet).As-Built: Side grab bar extends 53" from the rear wallProposed Solution: Provide or relocate accessible side grab bar.	PCODE WB07A ADAAG 91 Fig. 29(b) ADA 2010 604.5.1 CBC 2007 1115B.4.1.3.1 CBC 2016 11B-604.5.1 Mitigated: <input type="radio"/> YES <input checked="" type="radio"/> NO	1	JOB	\$780	\$780

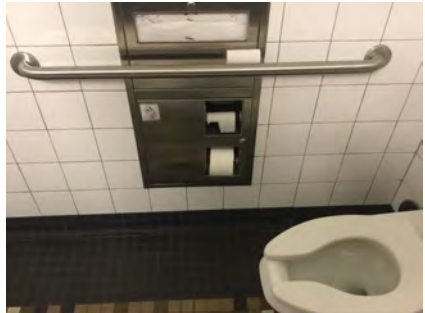
Item no., Rm no. and Name	Existing Architectural Barrier and Proposed Solution	Codes / Mitigation Info	Qty	Unit	Cost	Total
Accessories						
322	<ul style="list-style-type: none"> • <i>As-Built Description:</i> Toilet paper dispenser less than 15" (CA: 19") or more than 48" above floor or not within 7" to 9" from front of water closet (Note: CA pre-2010 is allowed within 12" from front of water closet). • <i>As-Built:</i> 3.5" from the front of the water closet • <i>Proposed Solution:</i> Relocate or provide new toilet paper dispenser. 	PCODE WG02 ADAAG 91 4.16.6 ADA 2010 604.7 CBC 2007 1115B.8.4 CBC 2016 11B-604.7 Mitigated: <input type="radio"/> YES <input checked="" type="radio"/> NO	1	JOB	\$225	\$225

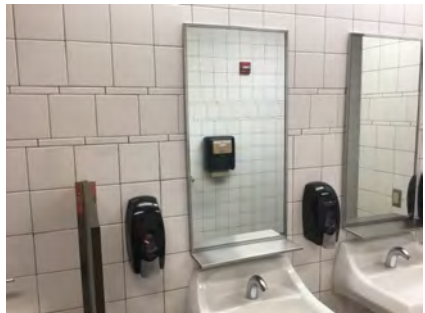
<input type="checkbox"/> Staff Only Priority 3 Severity 3			
320	<ul style="list-style-type: none"> • <i>As-Built Description:</i> Bottom of mirror located above lavatories or countertops more than 40" above floor. • <i>As-Built:</i> 41.4" high • <i>Proposed Solution:</i> Relocate or provide new accessible mirror. 	PCODE WG03 ADAAG 91 4.19.6 ADA 2010 603.3 CBC 2007 1115B.8.1 CBC 2016 11B-603.3 Mitigated: <input type="radio"/> YES <input checked="" type="radio"/> NO	1	JOB	\$450	\$450

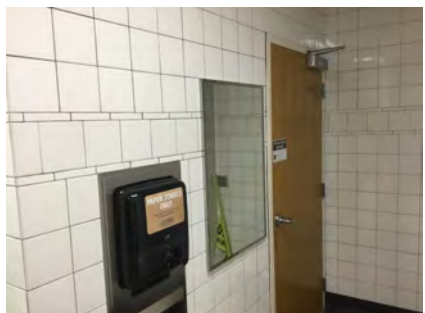
<input type="checkbox"/> Staff Only Priority 3 Severity 4			
317	<ul style="list-style-type: none"> • <i>As-Built Description:</i> Bottom of flat, not tilted mirror not located above lavatories or countertops mounted with bottom edge more than 35" above floor or top edge less than 74" above floor. • <i>As-Built:</i> 37.75" not above a lavatory • <i>Proposed Solution:</i> Relocate or provide new accessible mirror. 	PCODE WG03B ADAAG 91 4.19.6 ADA 2010 603.3 CBC 2007 1115B.8.1 CBC 2016 11B-603.3 Mitigated: <input type="radio"/> YES <input checked="" type="radio"/> NO	1	JOB	\$450	\$450

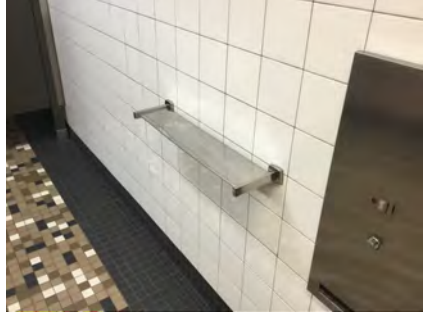
Item no., Rm no. and Name	Existing Architectural Barrier and Proposed Solution	Codes / Mitigation Info	Qty	Unit	Cost	Total
327	<ul style="list-style-type: none"> As-Built Description: Protruding objects more than 4" from wall, when bottom of object more than 27" or less than 80" above finished floor. As-Built: 6.5" deep at 34" high Proposed Solution: Remove/relocate protruding object. Patch existing surface. 	PCODE EG04 ADAAG 91 4.4.1 ADA 2010 307.2 CBC 2007 1133B.8.6.1 CBC 2016 11B-307.2 Mitigated: <input type="radio"/> YES <input checked="" type="radio"/> NO	1	JOB	\$300	\$300

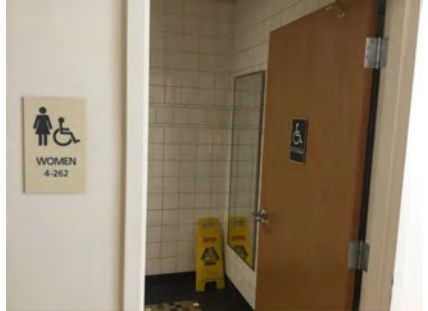
325	<ul style="list-style-type: none"> As-Built Description: Required in CA only: identification symbol centered 58" to 60" high on sanitary facility door that contrasts with the door not provided (women: 12" ø circle, men: 12" triangle, unisex: combined symbol). As-Built: No circle Proposed Solution: Provide properly mounted sanitary facility symbol when altering area. If wheelchair accessible, include International Symbol of Accessibility on sign. 	PCODE SA15 CBC 2007 1115B.6 CBC 2016 11B-703.7.2.6 Mitigated: <input type="radio"/> YES <input checked="" type="radio"/> NO	1	JOB	\$270	\$270

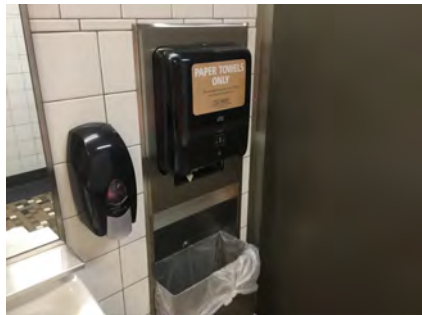
Item no., Rm no. and Name	Existing Architectural Barrier and Proposed Solution	Codes / Mitigation Info	Qty	Unit	Cost	Total
Accessories						
329	<ul style="list-style-type: none"> • <i>As-Built Description:</i> Dispensers in sanitary facilities, such as for towels, soap, sanitary napkins, seat covers, etc., and waste receptacles more than 48" (CA only: 40") from floor to highest operating slot or control. • <i>As-Built:</i> 43" high • <i>Proposed Solution:</i> Relocate existing restroom accessories. 	PCODE WG01AREF ADAAG 91 4.23.7 ADA 2010 308.2.1 CBC 2007 1115B.8.3 CBC 2016 11B-603.5 Mitigated: <input type="radio"/> YES <input checked="" type="radio"/> NO				
			REF
