SAN MATEO COUNTY
COMMUNITY
COLLEGE DISTRICT

San Mateo County Community College District Americans with Disabilities Act Self-Evaluation and Transition Plan

Report Prepared by:

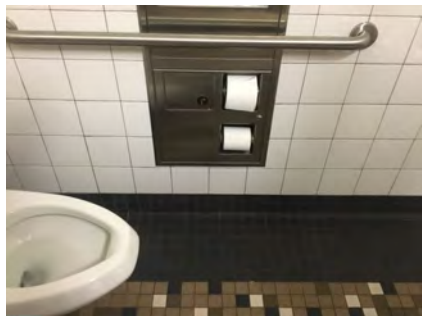
<input type="checkbox"/> Staff Only			
			Priority <input checked="" type="radio"/> 3		Severity <input checked="" type="radio"/> 4	
332	<ul style="list-style-type: none"> • <i>As-Built Description:</i> Toilet paper dispenser less than 15" (CA: 19") or more than 48" above floor or not within 7" to 9" from front of water closet (Note: CA pre-2010 is allowed within 12" from front of water closet). • <i>As-Built:</i> 12" from the front of the water closet • <i>Proposed Solution:</i> Relocate or provide new toilet paper dispenser. 	PCODE WG02 ADAAG 91 4.16.6 ADA 2010 604.7 CBC 2007 1115B.8.4 CBC 2016 11B-604.7 Mitigated: <input type="radio"/> YES <input checked="" type="radio"/> NO

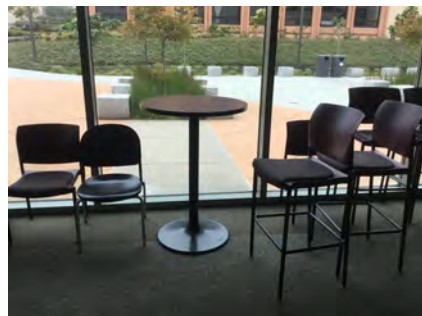
Item no., Rm no. and Name	Existing Architectural Barrier and Proposed Solution	Codes / Mitigation Info	Qty	Unit	Cost	Total
<u>Non-Fixed Desk</u>						
336	<ul style="list-style-type: none">• <i>As-Built Description:</i> Accessible non-fixed table or desk (top 28" to 34" high; knee space at least 27" high x 19" deep x 30" wide) not provided.• <i>As-Built:</i> 12 seats, 0 accessible, 42" AFF• <i>Proposed Solution:</i> Provide table or desk with accessible dimensions when purchasing new furniture.	<p>PCODE IN02A</p> <p>ADAAG 91 4.32.3 & .4</p> <p>ADA 2010 306.1</p> <p>CBC 2007 1122B.3 & 4</p> <p>CBC 2016 11B-306.1 & 11B-902.3</p> <p>Mitigated:</p> <p><input type="radio"/> YES</p> <p><input checked="" type="radio"/> NO</p>	1	JOB	\$4,800	\$4,800

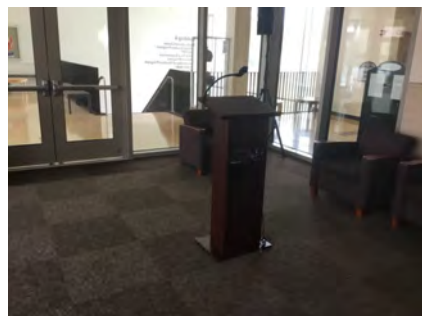
<input type="checkbox"/> Staff Only			
			<div>Priority 2Severity 2</div>			
<u>Public Participation Counter</u>						
335	<ul style="list-style-type: none">• <i>As-Built Description:</i> Speaker podium is not accessible. Upper edge of podium is more than 34" above the finished floor, and knee space is less than 27" high, 30" wide, and 19" deep.• <i>As-Built:</i> 43" AFF• <i>Proposed Solution:</i> Provide additional, integrated, and accessible speaker podium.	<p>PCODE GB02A</p> <p>ADAAG 91 4.32.3</p> <p>ADA 2010 902.3</p> <p>CBC 2007 1122B.3</p> <p>CBC 2016 11B-902.3</p> <p>Mitigated:</p> <p><input type="radio"/> YES</p> <p><input checked="" type="radio"/> NO</p>	1	JOB	\$6,000	\$6,000

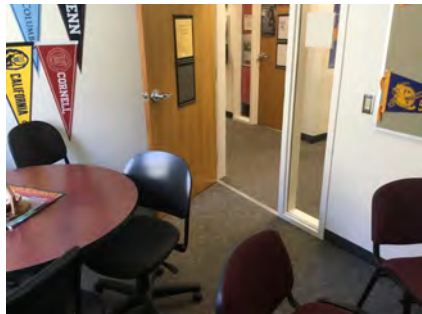
Item no., Rm no. and Name	Existing Architectural Barrier and Proposed Solution	Codes / Mitigation Info	Qty	Unit	Cost	Total
947	<ul style="list-style-type: none"> As-Built Description: Front approach: At pull side, door does not have clear and level maneuvering space measuring door width plus 18" x 60". (24" x 60" at exterior doors). Proposed Solution: Remove or relocate furniture or storage items. 	PCODE ID23A ADAAG 91 Fig. 25(a) ADA 2010 404.2.4 CBC 2007 11B-26A(a) CBC 2016 11B-404.2.4 Mitigated: <input type="radio"/> YES <input checked="" type="radio"/> NO	2	JOB	\$150	\$300

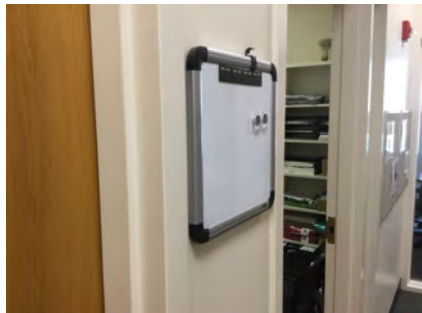
948	<ul style="list-style-type: none"> As-Built Description: Reach height to control or access point, where side approach is available, exceeds 48" or is less than 15" in height, or exceeds 10" in depth. As-Built: 54.5" to bottom Proposed Solution: Modify equipment or mounting. 	PCODE IE02 ADAAG 91 4.2.6 ADA 2010 308.3.1 CBC 2007 1118B.6 CBC 2016 11B-308.3 Mitigated: <input type="radio"/> YES <input checked="" type="radio"/> NO	1	JOB	\$300	\$300

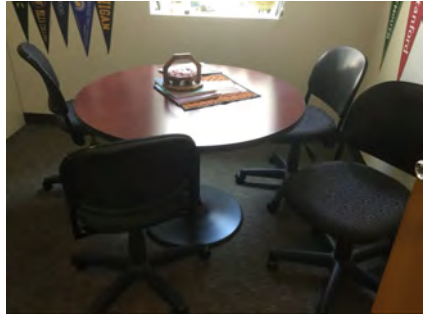
Item no., Rm no. and Name	Existing Architectural Barrier and Proposed Solution	Codes / Mitigation Info	Qty	Unit	Cost	Total
Non-Fixed Desk						
946	<ul style="list-style-type: none"> <i>As-Built Description:</i> Accessible non-fixed table or desk (top 28" to 34" high; knee space at least 27" high x 19" deep x 30" wide) not provided. <i>Proposed Solution:</i> Provide table or desk with accessible dimensions when purchasing new furniture. 	PCODE IN02A ADAAG 91 4.32.3 & .4 ADA 2010 306.1 CBC 2007 1122B.3 & 4 CBC 2016 11B-306.1 & 11B-902.3	2	JOB	\$4,800	\$9,600
Mitigated: <input type="radio"/> YES <input checked="" type="radio"/> NO

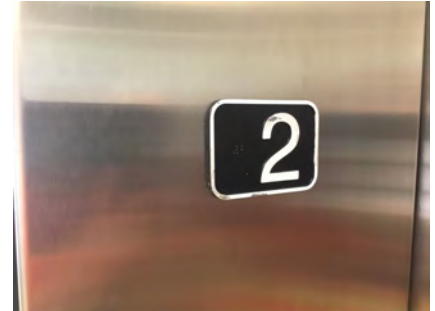
Item no., Rm no. and Name	Existing Architectural Barrier and Proposed Solution	Codes / Mitigation Info	Qty	Unit	Cost	Total
949	<ul style="list-style-type: none"> As-Built Description: Grade 2 Braille (1/10" dot spacing) not provided at floor identifying jamb signs. As-Built: Braille located incorrectly Proposed Solution: Provide compliant floor numbering on elevator door jambs (each floor). 	PCODE IK11A ADA 2010 407.2.3.1 CBC 2007 1116B.1.14 CBC 2016 11B-407.2.3.1 Mitigated: <input type="radio"/> YES <input checked="" type="radio"/> NO	6	SET	\$150	\$900

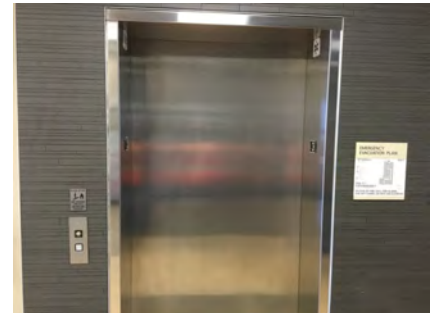
950	<ul style="list-style-type: none"> As-Built Description: Door reopening device does not remain effective for at least 20 seconds. As-Built: Door stays open 2 seconds after reopening Proposed Solution: Adjust timing. 	PCODE IK14 ADAAG 91 4.10.6 ADA 2010 407.3.3.3 CBC 2007 1116B.1.5 CBC 2016 11B-407.3.3.3 Mitigated: <input type="radio"/> YES <input checked="" type="radio"/> NO	1	JOB	\$150	\$150
-----	---	--	---	-----	-------	-------

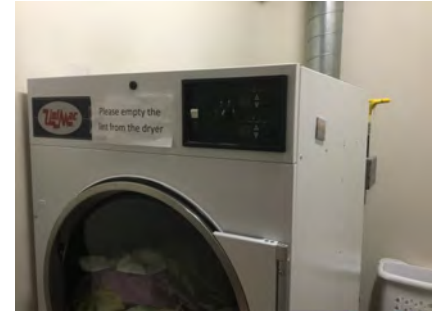
Item no., Rm no. and Name	Existing Architectural Barrier and Proposed Solution	Codes / Mitigation Info	Qty	Unit	Cost	Total
959	<ul style="list-style-type: none"> As-Built Description: Reach height to control or access point, where side approach is available, exceeds 48" or is less than 15" in height, or exceeds 10" in depth. As-Built: 62" high Proposed Solution: Modify equipment or mounting. 	PCODE IE02 ADAAG 91 4.2.6 ADA 2010 308.3.1 CBC 2007 1118B.6 CBC 2016 11B-308.3	1	JOB	\$300	\$300

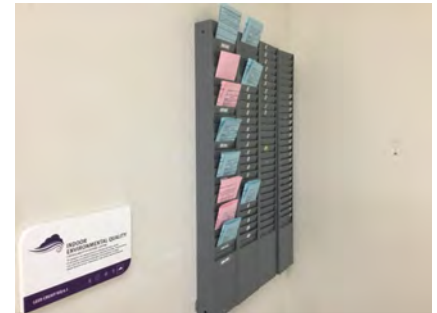
961	<ul style="list-style-type: none"> As-Built Description: Reach height to control or access point, where side approach is available, exceeds 48" or is less than 15" in height, or exceeds 10" in depth. As-Built: 50"-74" high Proposed Solution: Modify equipment or mounting. Notes: 200 message slots. 0 within reach range. 	PCODE IE02 ADAAG 91 4.2.6 ADA 2010 308.3.1 CBC 2007 1118B.6 CBC 2016 11B-308.3	1	JOB	\$300	\$300
-----	---	--	---	-----	-------	-------

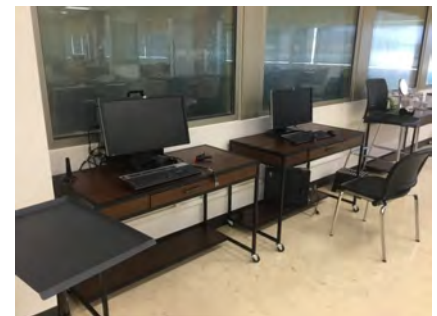
1**Non-Fixed Desk**

960	<ul style="list-style-type: none"> As-Built Description: Accessible non-fixed table or desk (top 28" to 34" high; knee space at least 27" high x 19" deep x 30" wide) not provided. As-Built: 25" high knee clearance Proposed Solution: Provide table or desk with accessible dimensions when purchasing new furniture. 	PCODE IN02A ADAAG 91 4.32.3 & .4 ADA 2010 306.1 CBC 2007 1122B.3 & 4 CBC 2016 11B-306.1 & 11B-902.3	1	JOB	\$4,800	\$4,800
-----	--	---	---	-----	---------	---------

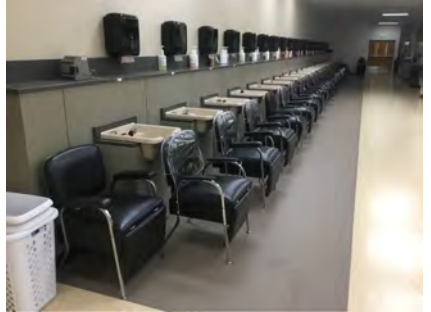
Item no., Rm no. and Name	Existing Architectural Barrier and Proposed Solution	Codes / Mitigation Info	Qty	Unit	Cost	Total
955	<ul style="list-style-type: none">• <i>As-Built Description:</i> Refer to notes for observation and recommendation.• <i>Proposed Solution:</i>• <i>Notes:</i> Clear floor space at hair washing sinks is not provided. 21 sinks, 1 sink with clear floor space is provided. Ensure 5% are accessible.	<p>PCODE GN01</p> <p>CBC 2016 11B-606.3</p> <p>Mitigated:</p> <p><input type="radio"/> YES</p> <p><input checked="" type="radio"/> NO</p>				
REF

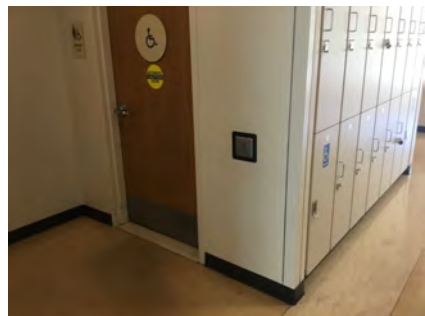
Item no., Rm no. and Name	Existing Architectural Barrier and Proposed Solution	Codes / Mitigation Info	Qty	Unit	Cost	Total
<u>Door</u>						
963	<ul style="list-style-type: none">• <i>As-Built Description:</i> Lower push plate located at 7" minimum and 8" maximum above the floor or ground surface not provided.• <i>Proposed Solution:</i> Provide lower push plate.	<p>PCODE ID13B</p> <p>CBC 2007 1133B.2.3.2</p> <p>CBC 2016 11B-404.2.9 2.C</p> <p>Mitigated:</p> <p><input type="radio"/> YES</p> <p><input checked="" type="radio"/> NO</p>	1	JOB	\$1,500	\$1,500

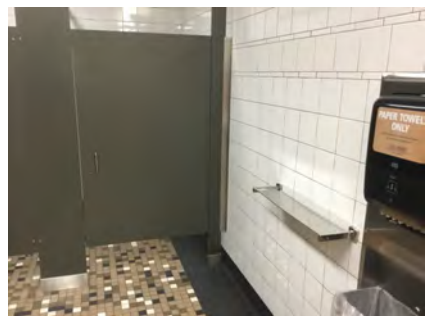
<input type="checkbox"/> Staff Only			
			Priority Severity			
			<input checked="" type="radio"/> 3 <input checked="" type="radio"/> 2			
<u>Door Swing</u>						
967	<ul style="list-style-type: none">• <i>As-Built Description:</i> Front approach: At push side, door does not have clear and level maneuvering space measuring door width x 48" (door width plus 12" if door has both, latch and closer).• <i>As-Built:</i> Shelf 33.75" from the face of the compartment door• <i>Proposed Solution:</i> Remove or relocate furniture or storage items.• <i>Notes:</i> The shelf protrudes approximately 0.75" into the door maneuvering clearance.	<p>PCODE ID24AREF</p> <p>ADAAG 91 Fig. 25(a)</p> <p>ADA 2010 404.2.4</p> <p>CBC 2007 11B-26A(a)</p> <p>CBC 2016 11B-404.2.4</p> <p>Mitigated:</p> <p><input type="radio"/> YES</p> <p><input checked="" type="radio"/> NO</p>		REF

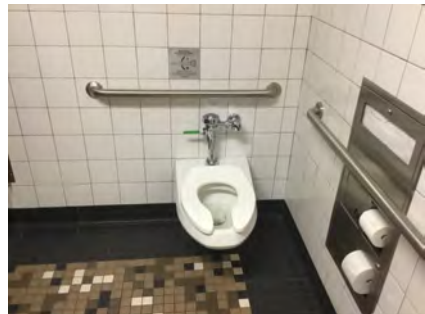
Item no., Rm no. and Name	Existing Architectural Barrier and Proposed Solution	Codes / Mitigation Info	Qty	Unit	Cost	Total
Grab Bars						
969	<ul style="list-style-type: none">As-Built Description: The rear wall grab is less than 36" min. or does not extend from the centerline of the water closet 12" min. on one side and 24" min. on the other side.As-Built: 23" on the wide sideProposed Solution: Provide or relocate accessible rear grab bar.	PCODE WB07B ADAAG 91 4.17.6 ADA 2010 604.5.2 CBC 2007 1115B.4.1.3.2 CBC 2016 11B-604.5.2 Mitigated: <input type="radio"/> YES <input checked="" type="radio"/> NO	1	JOB	\$1,020	\$1,020

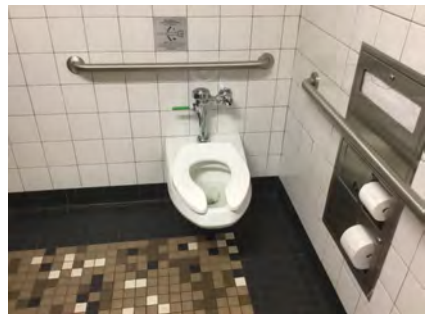
<input type="checkbox"/> Staff Only			
			Priority	Severity		
			3	4		
Water Closet						
968	<ul style="list-style-type: none">As-Built Description: Water closet not 16"-18" (CA: 17"-18") from near side wall to center line of water closet (2010 ADAAG: 16"-18").As-Built: 18.5" o.c.Proposed Solution: Relocate existing water closet and plumbing, remount with offset closet flange to provide 18" max. from side wall.	PCODE WB02C ADAAG 91 Fig. 28 ADA 2010 604.2 CBC 2007 1115B.4.1.1 CBC 2016 11B-604.2 Mitigated: <input type="radio"/> YES <input checked="" type="radio"/> NO	1	JOB	\$1,500	\$1,500

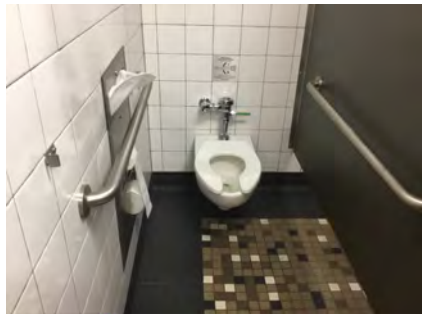
Item no., Rm no. and Name	Existing Architectural Barrier and Proposed Solution	Codes / Mitigation Info	Qty	Unit	Cost	Total
964	<ul style="list-style-type: none"> As-Built Description: Height of water closet seat less than 17" or more than 19" from floor. As-Built: 16.5" high in the ambulatory compartment Proposed Solution: Provide new accessible water closet. 	PCODE WB08 ADAAG 91 4.16.3 ADA 2010 604.4 CBC 2007 1115B.4.1.4 CBC 2016 11B-604.4 Mitigated: <input type="radio"/> YES <input checked="" type="radio"/> NO	1	JOB	\$4,200	\$4,200

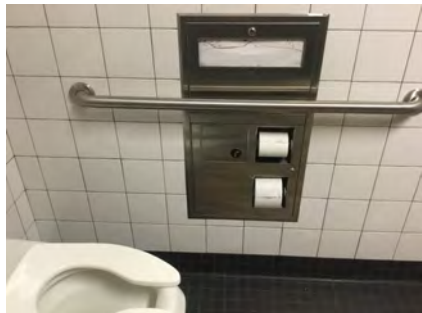
970	<ul style="list-style-type: none"> As-Built Description: Toilet paper dispenser less than 15" (CA: 19") or more than 48" above floor or not within 7" to 9" from front of water closet (Note: CA pre-2010 is allowed within 12" from front of water closet). As-Built: 6.75" from the front of the water closet to the CL of the steel enclosure. 10.5" to the CL of the toilet paper rolls. Proposed Solution: Relocate or provide new toilet paper dispenser. 	PCODE WG02 ADAAG 91 4.16.6 ADA 2010 604.7 CBC 2007 1115B.8.4 CBC 2016 11B-604.7 Mitigated: <input type="radio"/> YES <input checked="" type="radio"/> NO	1	JOB	\$225	\$225

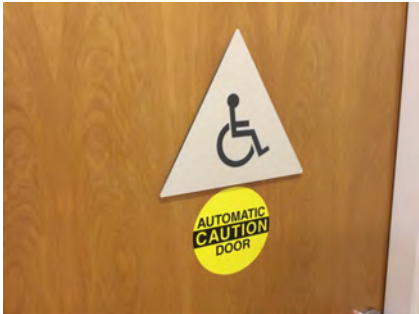
Item no., Rm no. and Name	Existing Architectural Barrier and Proposed Solution	Codes / Mitigation Info	Qty	Unit	Cost	Total
Signage						
974	<ul style="list-style-type: none">• <i>As-Built Description:</i> Required in CA only: identification symbol centered 58" to 60" high on sanitary facility door that contrasts with the door not provided (women: 12" ø circle, men: 12" triangle, unisex: combined symbol).• <i>As-Built:</i> Edges not beveled/eased• <i>Proposed Solution:</i> Provide properly mounted sanitary facility symbol when altering area. If wheelchair accessible, include International Symbol of Accessibility on sign.	<p>PCODE SA15</p> <p>CBC 2007 1115B.6</p> <p>CBC 2016 11B-703.7.2.6</p> <p>Mitigated:</p> <p><input type="radio"/> YES</p> <p><input checked="" type="radio"/> NO</p>	1	JOB	\$270	\$270

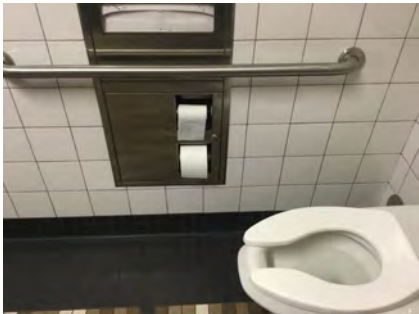
979	<ul style="list-style-type: none">• <i>As-Built Description:</i> Toilet paper dispenser less than 15" (CA: 19") or more than 48" above floor or not within 7" to 9" from front of water closet (Note: CA pre-2010 is allowed within 12" from front of water closet).• <i>As-Built:</i> 5" to the centerline of the toilet paper rolls• <i>Proposed Solution:</i> Relocate or provide new toilet paper dispenser.	<p>PCODE WG02</p> <p>ADAAG 91 4.16.6</p> <p>ADA 2010 604.7</p> <p>CBC 2007 1115B.8.4</p> <p>CBC 2016 11B-604.7</p> <p>Mitigated:</p> <p><input type="radio"/> YES</p> <p><input checked="" type="radio"/> NO</p>	1	JOB	\$225	\$225

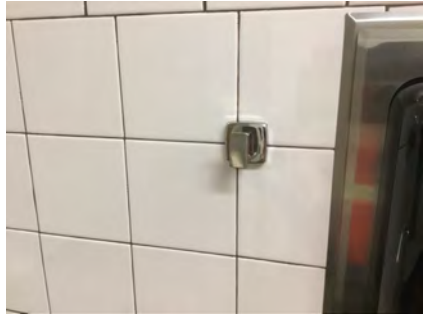
Item no., Rm no. and Name	Existing Architectural Barrier and Proposed Solution	Codes / Mitigation Info	Qty	Unit	Cost	Total
Coat Hook						
977	<ul style="list-style-type: none"> As-Built Description: Accessible coat hook not within reach range. As-Built: 54.4" high Proposed Solution: Adjust existing or provide new coat hook at maximum 48" height. 	PCODE WG03A ADAAG 91 4.2.5 ADA 2010 603.4 CBC 2007 1118B.5 CBC 2016 11B-603.4 Mitigated: <input type="radio"/> YES <input checked="" type="radio"/> NO	1	JOB	\$150	\$150

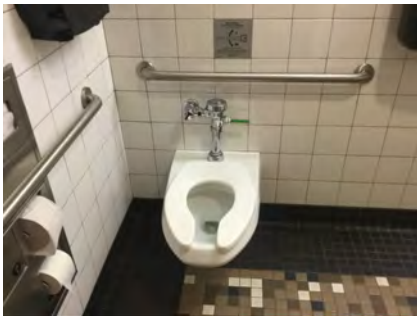
Item no., Rm no. and Name	Existing Architectural Barrier and Proposed Solution	Codes / Mitigation Info	Qty	Unit	Cost	Total
Water Closet						
2328	<ul style="list-style-type: none">• <i>As-Built Description:</i> Water closet not 16"-18" (CA: 17"-18") from near side wall to center line of water closet (2010 ADAAG: 16"-18").• <i>As-Built:</i> 18.5" o.c.• <i>Proposed Solution:</i> Relocate existing water closet and plumbing, remount with offset closet flange to provide 18" max. from side wall.	<p>PCODE WB02C ADAAG 91 Fig. 28 ADA 2010 604.2 CBC 2007 1115B.4.1.1 CBC 2016 11B-604.2</p> <p>Mitigated: <input type="radio"/> YES <input checked="" type="radio"/> NO</p>	1	JOB	\$1,500	\$1,500

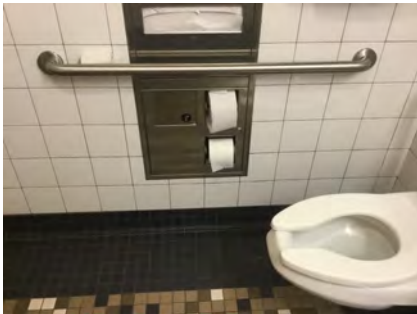
<input type="checkbox"/> Staff Only			
			Priority		Severity	
			3		4	
Accessories						
2341	<ul style="list-style-type: none">• <i>As-Built Description:</i> Toilet paper dispenser less than 15" (CA: 19") or more than 48" above floor or not within 7" to 9" from front of water closet (Note: CA pre-2010 is allowed within 12" from front of water closet).• <i>As-Built:</i> 5" to the centerline of the toilet paper rolls• <i>Proposed Solution:</i> Relocate or provide new toilet paper dispenser.	<p>PCODE WG02 ADAAG 91 4.16.6 ADA 2010 604.7 CBC 2007 1115B.8.4 CBC 2016 11B-604.7</p> <p>Mitigated: <input type="radio"/> YES <input checked="" type="radio"/> NO</p>	1	JOB	\$225	\$225

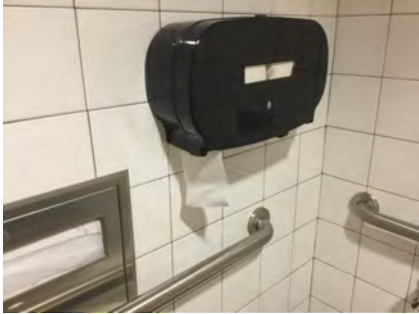
Item no., Rm no. and Name	Existing Architectural Barrier and Proposed Solution	Codes / Mitigation Info	Qty	Unit	Cost	Total
Grab Bars						
2337	<ul style="list-style-type: none">• <i>As-Built Description:</i> Accessories/dispensers in accessible stall located closer than 1-1/2" below or 12" above grab bar impedes its use.• <i>As-Built:</i> 10" above grab bar• <i>Proposed Solution:</i> Relocate accessories/dispensers to be no closer than 1-1/2" below and 12" above grab bars (except if accessories are recessed, flush with wall, and have no sharp edges).	<p>PCODE WB071</p> <p>ADAAG 91 4.26.2</p> <p>ADA 2010 609.3</p> <p>CBC 2007 1133B.4.2.5</p> <p>CBC 2016 11B-609.3</p> <p>Mitigated:</p> <p><input type="radio"/> YES</p> <p><input checked="" type="radio"/> NO</p>	1	JOB	\$225	\$225

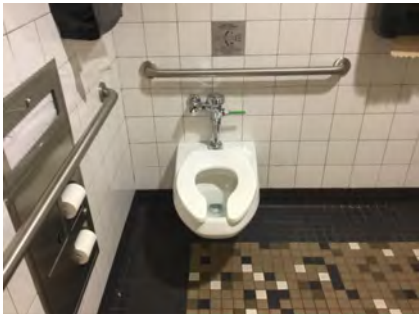
Water Closet						
2336	<ul style="list-style-type: none">• <i>As-Built Description:</i> Water closet not 16"-18" (CA: 17"-18") from near side wall to center line of water closet (2010 ADAAG: 16"-18").• <i>As-Built:</i> 18.5" o.c.• <i>Proposed Solution:</i> Relocate existing water closet and plumbing, remount with offset closet flange to provide 18" max. from side wall.	<p>PCODE WB02C</p> <p>ADAAG 91 Fig. 28</p> <p>ADA 2010 604.2</p> <p>CBC 2007 1115B.4.1.1</p> <p>CBC 2016 11B-604.2</p> <p>Mitigated:</p> <p><input type="radio"/> YES</p> <p><input checked="" type="radio"/> NO</p>	1	JOB	\$1,500	\$1,500

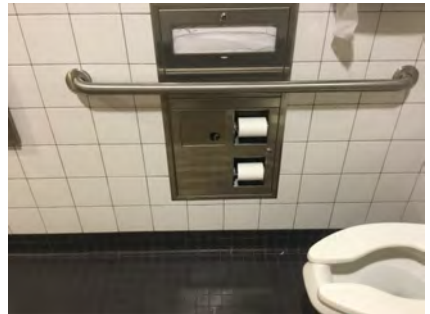
Item no., Rm no. and Name	Existing Architectural Barrier and Proposed Solution	Codes / Mitigation Info	Qty	Unit	Cost	Total
<u>Accessories</u>						
2338	<ul style="list-style-type: none">• <i>As-Built Description:</i> Toilet paper dispenser less than 15" (CA: 19") or more than 48" above floor or not within 7" to 9" from front of water closet (Note: CA pre-2010 is allowed within 12" from front of water closet).• <i>As-Built:</i> 5.5" to the centerline of the toilet paper rolls• <i>Proposed Solution:</i> Relocate or provide new toilet paper dispenser.	<p>PCODE WG02</p> <p>ADAAG 91 4.16.6</p> <p>ADA 2010 604.7</p> <p>CBC 2007 1115B.8.4</p> <p>CBC 2016 11B-604.7</p> <p>Mitigated:</p> <p><input type="radio"/> YES</p> <p><input checked="" type="radio"/> NO</p>	1	JOB	\$225	\$225

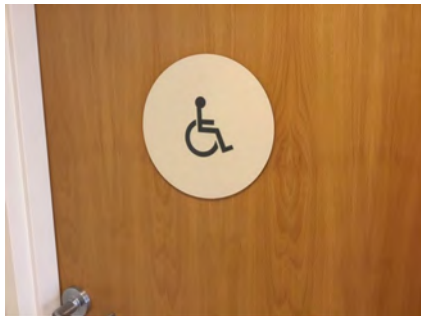
Item no., Rm no. and Name	Existing Architectural Barrier and Proposed Solution	Codes / Mitigation Info	Qty	Unit	Cost	Total
Signage						
1085	<ul style="list-style-type: none">As-Built Description: Required in CA only: identification symbol centered 58" to 60" high on sanitary facility door that contrasts with the door not provided (women: 12" ø circle, men: 12" triangle, unisex: combined symbol).As-Built: Not easedProposed Solution: Provide properly mounted sanitary facility symbol when altering area. If wheelchair accessible, include International Symbol of Accessibility on sign.	PCODE SA15 CBC 2007 1115B.6 CBC 2016 11B-703.7.2.6 Mitigated: <input type="radio"/> YES <input checked="" type="radio"/> NO	1	JOB	\$270	\$270

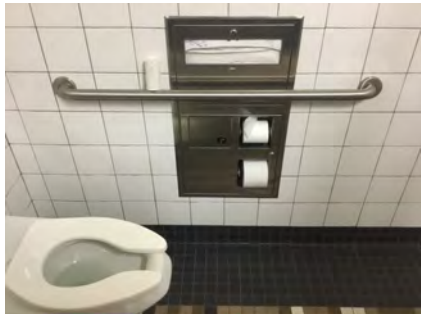
<input type="checkbox"/> Staff Only			
			Priority		Severity	
			3		3	
Grab Bars						
1088	<ul style="list-style-type: none">As-Built Description: Side grab bar less than 42" long, or located more than 12 inches max. from the rear wall, or extending less than 54" from rear wall (CA only: front end min. 24" in front of water closet).As-Built: Side grab bar extends 53" from the rear wallProposed Solution: Provide or relocate accessible side grab bar.	PCODE WB07A ADAAG 91 Fig. 29(b) ADA 2010 604.5.1 CBC 2007 1115B.4.1.3.1 CBC 2016 11B-604.5.1 Mitigated: <input type="radio"/> YES <input checked="" type="radio"/> NO	1	JOB	\$780	\$780

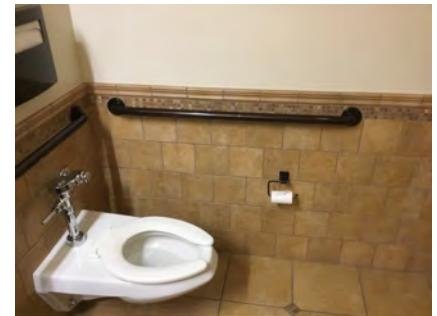
1109

The restroom appears to have been remodeled recently. If not, this condition may qualify for Safeharbor. Verify before making alterations.

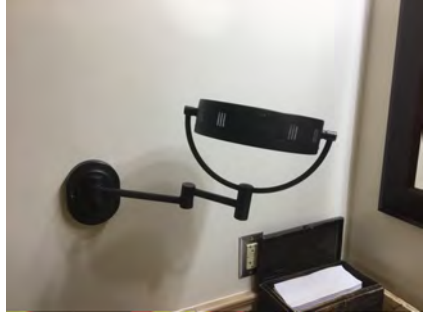
<input type="checkbox"/> Staff Only						
Priority 3 Severity 2						
1108	<ul style="list-style-type: none"> • <i>As-Built Description:</i> Bottom of mirror located above lavatories or countertops more than 40" above floor. • <i>As-Built:</i> 50" high • <i>Proposed Solution:</i> Relocate or provide new accessible mirror. 	PCODE WG03 ADAAG 91 4.19.6 ADA 2010 603.3 CBC 2007 1115B.8.1 CBC 2016 11B-603.3 Mitigated: <input type="radio"/> YES <input checked="" type="radio"/> NO	1	JOB	\$450	\$450

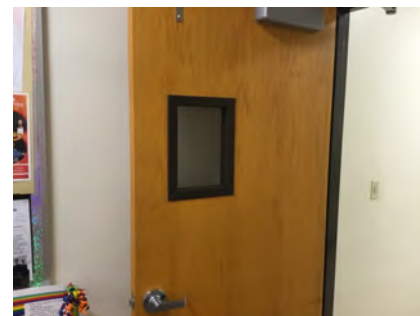
Item no., Rm no. and Name	Existing Architectural Barrier and Proposed Solution	Codes / Mitigation Info	Qty	Unit	Cost	Total
<u>Door Closer</u>						
30	<ul style="list-style-type: none">As-Built Description: Excessive force required to open door and/or door closing time of less than 5 seconds.As-Built: 2.5 secondsProposed Solution: Provide new door closer adjusted to accessible standards.	PCODE ID03A ADAAG 91 4.13.10 &11 ADA 2010 404.2.8 & CBC 2007 1133B.2.5.1 CBC 2016 11B-404.2.9 Mitigated: <input type="radio"/> YES <input checked="" type="radio"/> NO	1	JOB	\$1,125	\$1,125

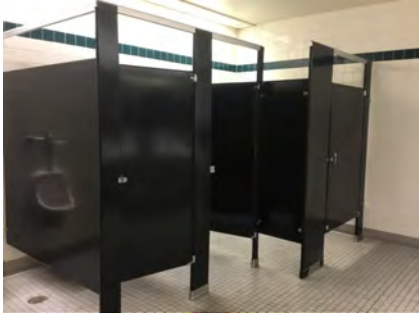
9	<ul style="list-style-type: none">• <i>As-Built Description:</i> Side grab bar less than 42" long, or located more than 12 inches max. from the rear wall, or extending less than 54" from rear wall (CA only: front end min. 24" in front of water closet).• <i>As-Built:</i> 52" from rear wall• <i>Proposed Solution:</i> Provide or relocate accessible side grab bar.	<p>PCODE WB07A ADAAG 91 Fig. 29(b) ADA 2010 604.5.1 CBC 2007 1115B.4.1.3.1 CBC 2016 11B-604.5.1</p> <p>Mitigated: <input type="radio"/> YES <input checked="" type="radio"/> NO</p>	1	JOB	\$780	\$780

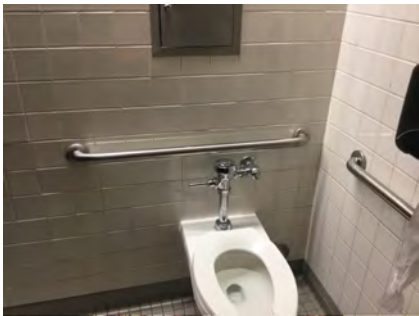
Item no., Rm no. and Name	Existing Architectural Barrier and Proposed Solution	Codes / Mitigation Info	Qty	Unit	Cost	Total
10	<ul style="list-style-type: none">As-Built Description: The rear wall grab is less than 36" min. or does not extend from the centerline of the water closet 12" min. on one side and 24" min. on the other side.As-Built: 22" on the wild sideProposed Solution: Provide or relocate accessible rear grab bar.	<p>PCODE WB07B</p> <p>ADAAG 91 4.17.6</p> <p>ADA 2010 604.5.2</p> <p>CBC 2007 1115B.4.1.3.2</p> <p>CBC 2016 11B-604.5.2</p> <p>Mitigated:</p> <p><input type="radio"/> YES</p> <p><input checked="" type="radio"/> NO</p>	1	JOB	\$1,020	\$1,020

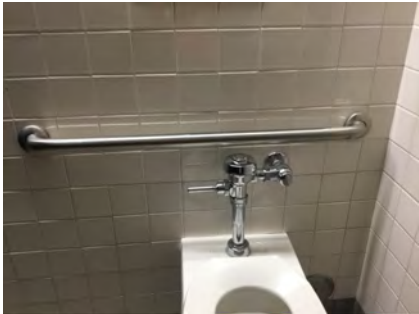
<input type="checkbox"/> Staff Only			
			<div>Priority 3Severity 4</div>			
11	<ul style="list-style-type: none">As-Built Description: Accessories/dispensers in accessible stall located closer than 1-1/2" below or 12" above grab bar impedes its use.As-Built: 1" belowProposed Solution: Raise the grab bar.	<p>PCODE WB071</p> <p>ADAAG 91 4.26.2</p> <p>ADA 2010 609.3</p> <p>CBC 2007 1133B.4.2.5</p> <p>CBC 2016 11B-609.3</p> <p>Mitigated:</p> <p><input type="radio"/> YES</p> <p><input checked="" type="radio"/> NO</p>	1	JOB	\$225	\$225

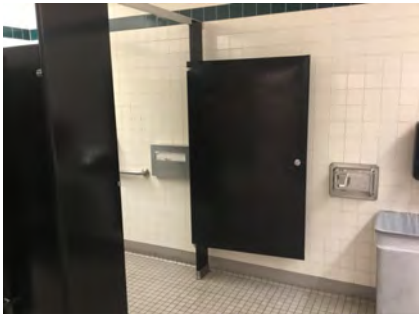
<input type="checkbox"/> Staff Only			
			<div>Priority 3Severity 4</div>			
<u>Stall Door</u>						
13	<ul style="list-style-type: none">As-Built Description: Stall door to accessible compartment not self closing.Proposed Solution: Adjust closer.	<p>PCODE WB05B</p> <p>ADAAG 91 4.22.4</p> <p>ADA 2010 604.8.1.2</p> <p>CBC 2007 1115B.3.1.4.4</p> <p>CBC 2016 11B-604.8.1.2</p> <p>Mitigated:</p> <p><input type="radio"/> YES</p> <p><input checked="" type="radio"/> NO</p>	1	JOB	\$75	\$75

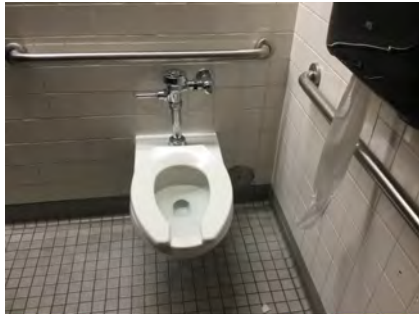
Item no., Rm no. and Name	Existing Architectural Barrier and Proposed Solution	Codes / Mitigation Info	Qty	Unit	Cost	Total
<u>Water Closet</u>						
12	<ul style="list-style-type: none">• <i>As-Built Description:</i> Water closet not 16"-18" (CA: 17"-18") from near side wall to center line of water closet (2010 ADAAG: 16"-18").• <i>As-Built:</i> 19" o.c.• <i>Proposed Solution:</i> Relocate existing water closet and plumbing, remount with offset closet flange to provide 18" max. from side wall.	<p>PCODE WB02C ADAAG 91 Fig. 28 ADA 2010 604.2 CBC 2007 1115B.4.1.1 CBC 2016 11B-604.2</p> <p>Mitigated: <input type="radio"/> YES <input checked="" type="radio"/> NO</p>	1	JOB	\$1,500	\$1,500

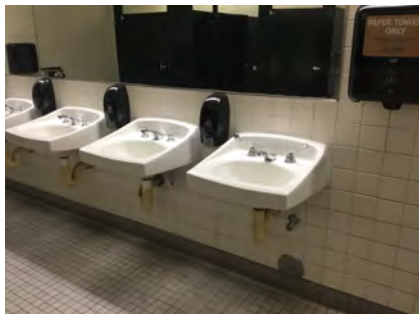
<input type="checkbox"/> Staff Only			
			Priority		Severity	
			3		4	
<u>Lavatory</u>						
6	<ul style="list-style-type: none">• <i>As-Built Description:</i> Knee clearance 27" min. high starting 8" back from the front edge of the lavatory towards the wall is not provided.• <i>As-Built:</i> 25.5" above finished floor• <i>Proposed Solution:</i> Remount compliant fixture to accessible height.	<p>PCODE WD04A ADAAG 91 Fig. 31 ADA 2010 306.3.3 CBC 2007 1115B.4.3 CBC 2016 11B-306.3.3</p> <p>Mitigated: <input type="radio"/> YES <input checked="" type="radio"/> NO</p>	1	JOB	\$4,500	\$4,500

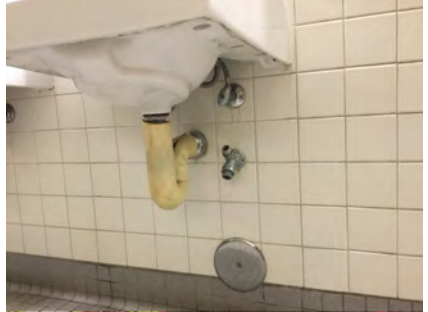
Item no., Rm no. and Name	Existing Architectural Barrier and Proposed Solution	Codes / Mitigation Info	Qty	Unit	Cost	Total
7	<ul style="list-style-type: none"> • <i>As-Built Description:</i> Hot or sharp-surfaced water/drain pipe not insulated or covered. • <i>Proposed Solution:</i> Insulate or cover water/drain pipe. 	PCODE WD05REF ADAAG 91 4.19.4 ADA 2010 606.5 CBC 2007 1115B.4.3.4 CBC 2016 11B-606.5 Mitigated: <input type="radio"/> YES <input checked="" type="radio"/> NO		REF

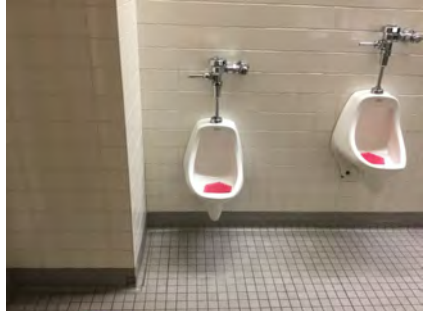
Urinal

3	<ul style="list-style-type: none"> • <i>As-Built Description:</i> Fixture mounted with rim more than 17" above floor. • <i>As-Built:</i> 18" above finished floor • <i>Proposed Solution:</i> Provide accessible urinal. Remodel restroom as needed. 	PCODE WE02 ADAAG 91 4.18.2 ADA 2010 605.2 CBC 2007 1115B.4.2.1 CBC 2016 11B-605.2 Mitigated: <input type="radio"/> YES <input checked="" type="radio"/> NO	1	JOB	\$7,200	\$7,200

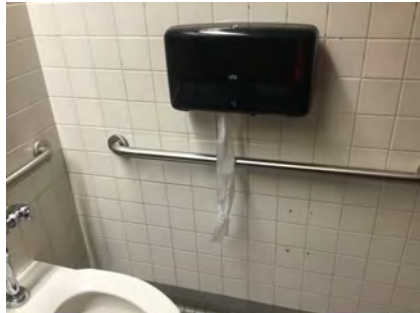
Item no., Rm no. and Name	Existing Architectural Barrier and Proposed Solution	Codes / Mitigation Info	Qty	Unit	Cost	Total
Accessories						
8	<ul style="list-style-type: none"> As-Built Description: Toilet paper dispenser less than 15" (CA: 19") or more than 48" above floor or not within 7" to 9" from front of water closet (Note: CA pre-2010 is allowed within 12" from front of water closet). As-Built: Above the grab bar Proposed Solution: Relocate or provide new toilet paper dispenser. 	PCODE WG02 ADAAG 91 4.16.6 ADA 2010 604.7 CBC 2007 1115B.8.4 CBC 2016 11B-604.7 Mitigated: <input type="radio"/> YES <input checked="" type="radio"/> NO	1	JOB	\$225	\$225

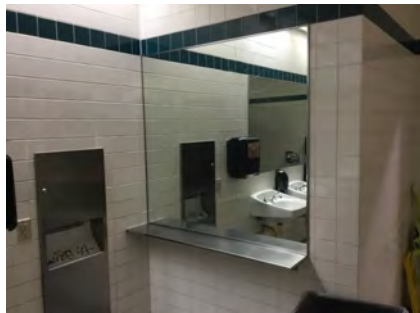
<input type="checkbox"/> Staff Only Priority 3 Severity 1			
4	<ul style="list-style-type: none"> As-Built Description: Bottom of mirror located above lavatories or countertops more than 40" above floor. Mirrors are not located above the lavatory, 35" high is required. As-Built: 36.25" above finished floor Proposed Solution: Relocate or provide new accessible mirror. 	PCODE WG03 ADAAG 91 4.19.6 ADA 2010 603.3 CBC 2007 1115B.8.1 CBC 2016 11B-603.3 Mitigated: <input type="radio"/> YES <input checked="" type="radio"/> NO	1	JOB	\$450	\$450

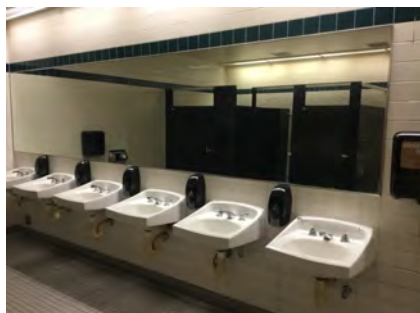
<input type="checkbox"/> Staff Only Priority 3 Severity 4			
5	<ul style="list-style-type: none"> As-Built Description: Bottom of mirror located above lavatories or countertops more than 40" above floor. As-Built: 43.75" above finished floor Proposed Solution: Relocate or provide new accessible mirror. 	PCODE WG03 ADAAG 91 4.19.6 ADA 2010 603.3 CBC 2007 1115B.8.1 CBC 2016 11B-603.3 Mitigated: <input type="radio"/> YES <input checked="" type="radio"/> NO	1	JOB	\$450	\$450

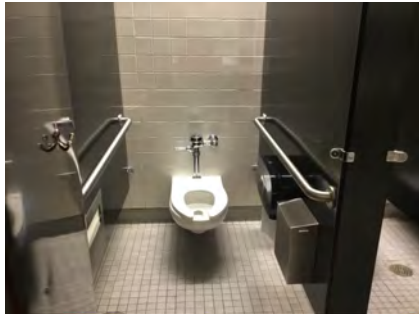
Item no., Rm no. and Name	Existing Architectural Barrier and Proposed Solution	Codes / Mitigation Info	Qty	Unit	Cost	Total
<u>Semi-Ambulant Stall</u>						
15	<ul style="list-style-type: none">• <i>As-Built Description:</i> Semi-Ambulant stall with 35-37" width, minimum 60" depth, parallel grab bars, and out-swinging door not provided (one required where 6 or more exist).• <i>As-Built:</i> 59" deep• <i>Proposed Solution:</i> Provide 36" wide stall with out-swinging door and two side grab bars. Remodel restroom as needed.	<p>PCODE WB06A ADAAG 91 4.22.4 ADA 2010 213.3.1 & CBC 2007 1115B.3.1.5 CBC 2016 11B-213.3.1 & 11B-604.8.2</p> <p>Mitigated: <input type="radio"/> YES <input checked="" type="radio"/> NO</p>	1	JOB	\$5,700	\$5,700

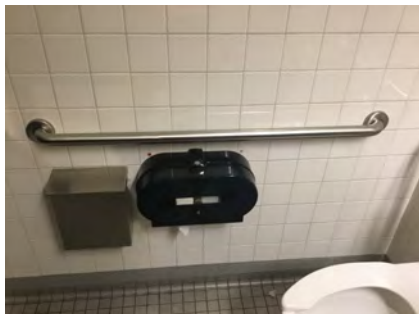
19	<ul style="list-style-type: none">• <i>As-Built Description:</i> Side grab bar less than 42" long, or located more than 12 inches max. from the rear wall, or extending less than 54" from rear wall (CA only: front end min. 24" in front of water closet).• <i>As-Built:</i> 52" from rear wall• <i>Proposed Solution:</i> Provide or relocate accessible side grab bar.	<p>PCODE WB07A ADAAG 91 Fig. 29(b) ADA 2010 604.5.1 CBC 2007 1115B.4.1.3.1 CBC 2016 11B-604.5.1</p> <p>Mitigated: <input type="radio"/> YES <input checked="" type="radio"/> NO</p>	1	JOB	\$780	\$780

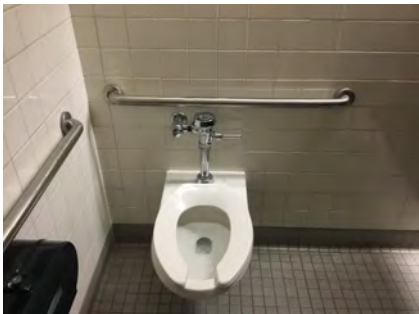
Item no., Rm no. and Name	Existing Architectural Barrier and Proposed Solution	Codes / Mitigation Info	Qty	Unit	Cost	Total
20	<ul style="list-style-type: none">As-Built Description: The rear wall grab is less than 36" min. or does not extend from the centerline of the water closet 12" min. on one side and 24" min. on the other side.As-Built: 21.5" from the wide sideProposed Solution: Provide or relocate accessible rear grab bar.	PCODE WB07B ADAAG 91 4.17.6 ADA 2010 604.5.2 CBC 2007 1115B.4.1.3.2 CBC 2016 11B-604.5.2 Mitigated: <input type="radio"/> YES <input checked="" type="radio"/> NO	1	JOB	\$1,020	\$1,020

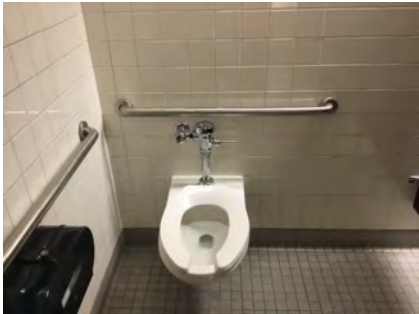
<input type="checkbox"/> Staff Only			
			Priority 3 Severity 3			
18	<ul style="list-style-type: none">As-Built Description: Accessories/dispensers in accessible stall located closer than 1-1/2" below or 12" above grab bar impedes its use.As-Built: 1" below grab barProposed Solution: Raise the grab bar.	PCODE WB071 ADAAG 91 4.26.2 ADA 2010 609.3 CBC 2007 1133B.4.2.5 CBC 2016 11B-609.3 Mitigated: <input type="radio"/> YES <input checked="" type="radio"/> NO	1	JOB	\$225	\$225

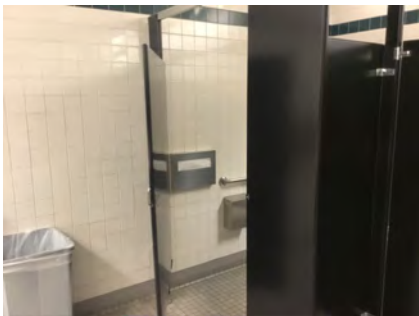
<input type="checkbox"/> Staff Only			
			Priority 3 Severity 4			
<u>Stall Door</u>						
16	<ul style="list-style-type: none">As-Built Description: Stall door to accessible compartment not self closing.Proposed Solution: Adjust closer.	PCODE WB05B ADAAG 91 4.22.4 ADA 2010 604.8.1.2 CBC 2007 1115B.3.1.4.4 CBC 2016 11B-604.8.1.2 Mitigated: <input type="radio"/> YES <input checked="" type="radio"/> NO	1	JOB	\$75	\$75

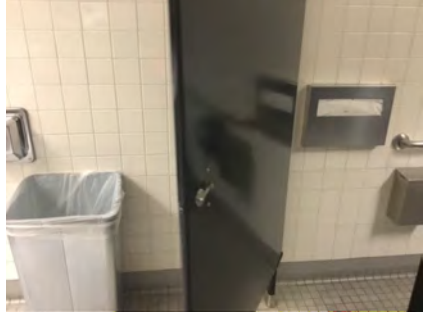
Item no., Rm no. and Name	Existing Architectural Barrier and Proposed Solution	Codes / Mitigation Info	Qty	Unit	Cost	Total
17	<ul style="list-style-type: none"> As-Built Description: Stall door does not have accessible operating hardware (U-pulls on both sides, flip-over or sliding lock). Proposed Solution: Provide new accessible locking hardware that does not require grasping, pinching, or twisting and U-pulls on both sides. 	PCODE WB05C ADAAG 91 4.17.5 ADA 2010 604.8.1.2 CBC 2007 1115B.3.1.4.5 CBC 2016 11B-604.8.1.2 Mitigated: <input type="radio"/> YES <input checked="" type="radio"/> NO	1	JOB	\$300	\$300

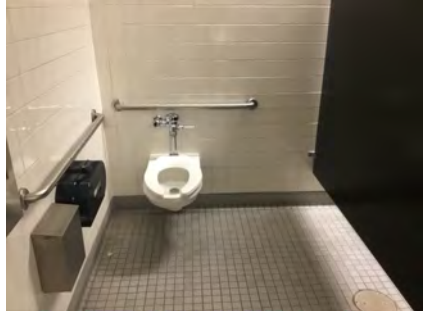
Toilet Stall

22	<ul style="list-style-type: none"> As-Built Description: Toilet stall less than 60" wide. As-Built: 58" wide Proposed Solution: Provide new accessible stall. 	PCODE WB06 ADAAG 91 4.17.3 ADA 2010 604.8.1.1 CBC 2007 1115B.3.1.4.1 CBC 2016 11B-604.8.1.1 Mitigated: <input type="radio"/> YES <input checked="" type="radio"/> NO	1	JOB	\$4,500	\$4,500

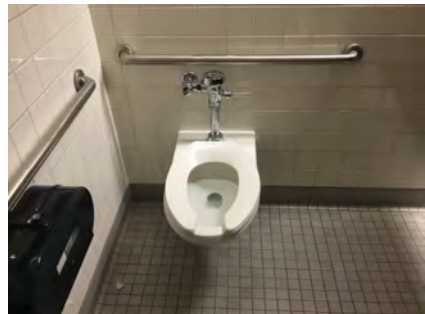
Item no., Rm no. and Name	Existing Architectural Barrier and Proposed Solution	Codes / Mitigation Info	Qty	Unit	Cost	Total
<u>Water Closet</u>						
21	<ul style="list-style-type: none">• <i>As-Built Description:</i> Water closet not 16"-18" (CA: 17"-18") from near side wall to center line of water closet (2010 ADAAG: 16"-18").• <i>As-Built:</i> 19" o.c.• <i>Proposed Solution:</i> Relocate existing water closet and plumbing, remount with offset closet flange to provide 18" max. from side wall.	<p>PCODE WB02C ADAAG 91 Fig. 28 ADA 2010 604.2 CBC 2007 1115B.4.1.1 CBC 2016 11B-604.2</p> <p>Mitigated: <input type="radio"/> YES <input checked="" type="radio"/> NO</p>	1	JOB	\$1,500	\$1,500

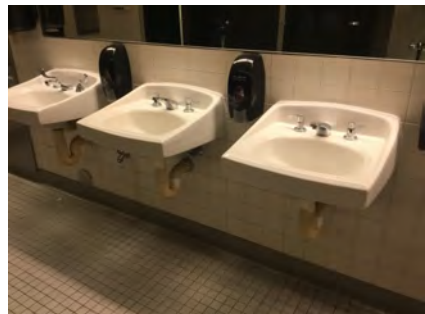
<input type="checkbox"/> Staff Only			
			Priority <input checked="" type="radio"/> 3	Severity <input checked="" type="radio"/> 4		
<u>Lavatory</u>						
23	<ul style="list-style-type: none">• <i>As-Built Description:</i> Knee clearance 27" min. high starting 8" back from the front edge of the lavatory towards the wall is not provided.• <i>As-Built:</i> 26" above finished floor• <i>Proposed Solution:</i> Remount compliant fixture to accessible height.	<p>PCODE WD04A ADAAG 91 Fig. 31 ADA 2010 306.3.3 CBC 2007 1115B.4.3 CBC 2016 11B-306.3.3</p> <p>Mitigated: <input type="radio"/> YES <input checked="" type="radio"/> NO</p>	1	JOB	\$4,500	\$4,500

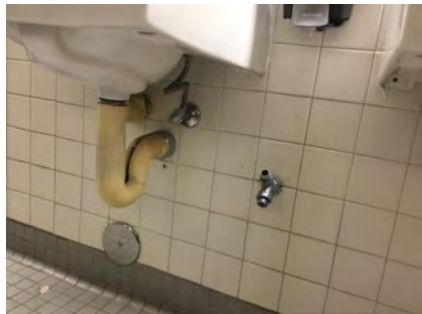
Item no., Rm no. and Name	Existing Architectural Barrier and Proposed Solution	Codes / Mitigation Info	Qty	Unit	Cost	Total
24	<ul style="list-style-type: none"> As-Built Description: Hot or sharp-surfaced water/drain pipe not insulated or covered. Proposed Solution: Insulate or cover water/drain pipe. 	PCODE WD05REF ADAAG 91 4.19.4 ADA 2010 606.5 CBC 2007 1115B.4.3.4 CBC 2016 11B-606.5 Mitigated: <input type="radio"/> YES <input checked="" type="radio"/> NO	REF

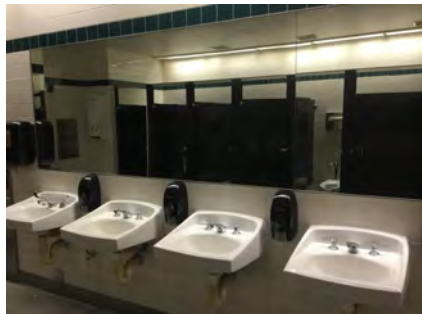
25	<ul style="list-style-type: none"> As-Built Description: Bottom of mirror located above lavatories or countertops more than 40" above floor. As-Built: 44" above finished floor Proposed Solution: Relocate or provide new accessible mirror. 	PCODE WG03 ADAAG 91 4.19.6 ADA 2010 603.3 CBC 2007 1115B.8.1 CBC 2016 11B-603.3 Mitigated: <input type="radio"/> YES <input checked="" type="radio"/> NO	1	JOB	\$450	\$450

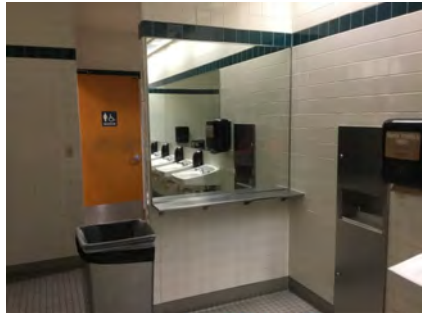
<input type="checkbox"/> Staff Only Priority 3 Severity 4						
26	<ul style="list-style-type: none"> As-Built Description: Bottom of mirror located above lavatories or countertops more than 40" above floor. Mirrors not located above the lavatory required 35" high above the floor. As-Built: 36.5" above finished floor Proposed Solution: Relocate or provide new accessible mirror. 	PCODE WG03 ADAAG 91 4.19.6 ADA 2010 603.3 CBC 2007 1115B.8.1 CBC 2016 11B-603.3 Mitigated: <input type="radio"/> YES <input checked="" type="radio"/> NO	1	JOB	\$450	\$450

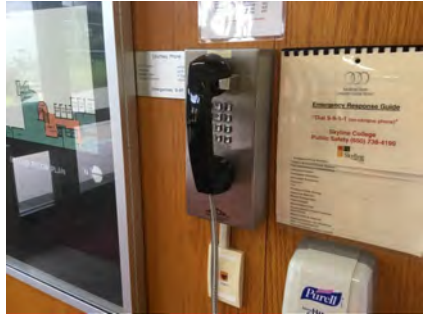
Item no., Rm no. and Name	Existing Architectural Barrier and Proposed Solution	Codes / Mitigation Info	Qty	Unit	Cost	Total
Reach Range						
36	<ul style="list-style-type: none"> As-Built Description: Reach height to control or access point, where side approach is available, exceeds 48" or is less than 15" in height, or exceeds 10" in depth. As-Built: 56.25" above finished floor Proposed Solution: Modify equipment or mounting. 	PCODE IE02 ADAAG 91 4.2.6 ADA 2010 308.3.1 CBC 2007 1118B.6 CBC 2016 11B-308.3 Mitigated: <input type="radio"/> YES <input checked="" type="radio"/> NO	1	JOB	\$300	\$300

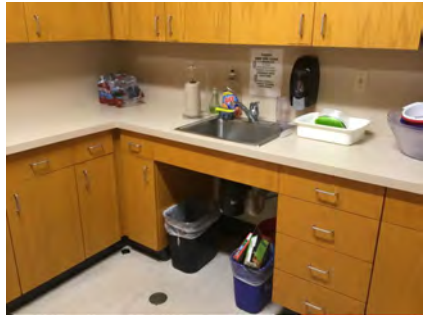
Item no., Rm no. and Name	Existing Architectural Barrier and Proposed Solution	Codes / Mitigation Info	Qty	Unit	Cost	Total
Sink						
44	<ul style="list-style-type: none"> As-Built Description: Sink rim higher than 34" above floor. As-Built: 37" above finished floor Proposed Solution: Remodel sink cabinet to lower sink. 	PCODE IN06 ADAAG 91 4.24.2 ADA 2010 606.3 CBC 2007 1115B.4.7.1 CBC 2016 11B-606.3 Mitigated: <input type="radio"/> YES <input checked="" type="radio"/> NO	1	JOB	\$5,250	\$5,250

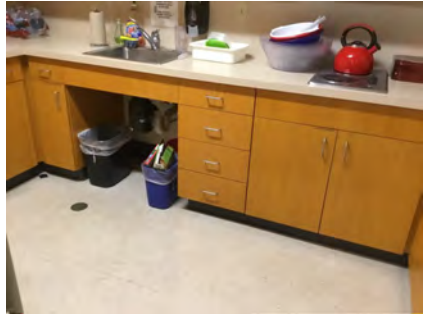
<input type="checkbox"/> Staff Only Priority 4 Severity 4			
43	<ul style="list-style-type: none"> As-Built Description: Sink does not have knee space min. 27" high x 19" deep x 30" wide. As-Built: Obstructed by disposal and pipes Proposed Solution: Remodel sink cabinet. 	PCODE IN06A ADAAG 91 4.24.3 ADA 2010 606.2 CBC 2007 1115B.4.7.1 CBC 2016 11B-606.2 Mitigated: <input type="radio"/> YES <input checked="" type="radio"/> NO	1	JOB	\$5,250	\$5,250

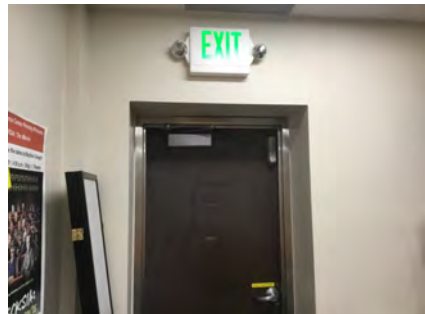
Item no., Rm no. and Name	Existing Architectural Barrier and Proposed Solution	Codes / Mitigation Info	Qty	Unit	Cost	Total
Door Swing						
53	<ul style="list-style-type: none">As-Built Description: Front approach: At push side, door does not have clear and level maneuvering space measuring door width x 48" (door width plus 12" if door has both, latch and closer).As-Built: 18" deep alcoveProposed Solution: Provide relocated new door and frame; remodel walls as needed.	<p>PCODE ID24B</p> <p>ADAAG 91 Fig. 25(a)</p> <p>ADA 2010 404.2.4</p> <p>CBC 2007 11B-26A(a)</p> <p>CBC 2016 11B-404.2.4</p> <p>Mitigated:</p> <p><input type="radio"/> YES</p> <p><input checked="" type="radio"/> NO</p>	1	JOB	\$7,800	\$7,800

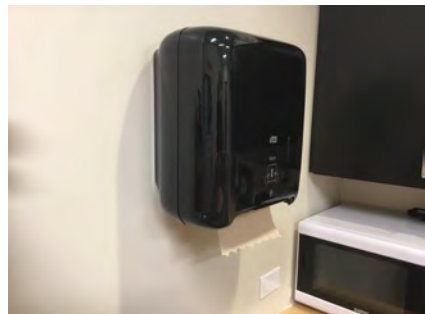
<input type="checkbox"/> Staff Only			
			Priority	Severity		
			2	2		
Reach Range						
52	<ul style="list-style-type: none">As-Built Description: Reach height to control or access point, where side approach is available, exceeds 48" or is less than 15" in height, or exceeds 10" in depth.As-Built: 52" above finished floorProposed Solution: Modify equipment or mounting.	<p>PCODE IE02</p> <p>ADAAG 91 4.2.6</p> <p>ADA 2010 308.3.1</p> <p>CBC 2007 1118B.6</p> <p>CBC 2016 11B-308.3</p> <p>Mitigated:</p> <p><input type="radio"/> YES</p> <p><input checked="" type="radio"/> NO</p>	1	JOB	\$300	\$300

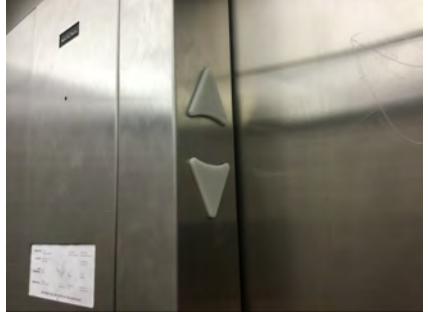
Item no., Rm no. and Name	Existing Architectural Barrier and Proposed Solution	Codes / Mitigation Info	Qty	Unit	Cost	Total
58	<ul style="list-style-type: none"> As-Built Description: Visual hall lantern, minimum 2-1/2" x 2-1/2", not provided, or installed less than 72" above floor. As-Built: Lanterns do not provide illumination Proposed Solution: Provide or raise proper visual hall lantern for elevator. 	PCODE IK10A ADAAG 91 4.10.4(1) ADA 2010 407.2.2.2 CBC 2007 1116B.1.13 CBC 2016 11B-407.2.2.2 Mitigated: <input type="radio"/> YES <input checked="" type="radio"/> NO	1	JOB	\$4,650	\$4,650

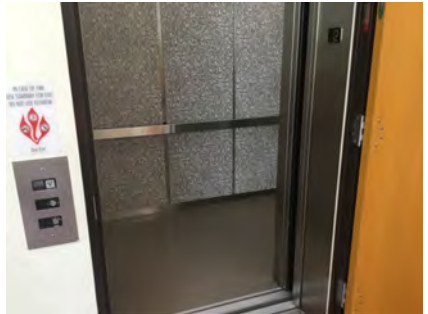
<input type="checkbox"/> Staff Only Priority 2 Severity 3						
59	<ul style="list-style-type: none"> As-Built Description: Door reopening device does not remain effective for at least 20 seconds. Proposed Solution: Adjust timing. Notes: Door requires contact to reopen. 	PCODE IK14 ADAAG 91 4.10.6 ADA 2010 407.3.3.3 CBC 2007 1116B.1.5 CBC 2016 11B-407.3.3.3 Mitigated: <input type="radio"/> YES <input checked="" type="radio"/> NO	1	JOB	\$150	\$150

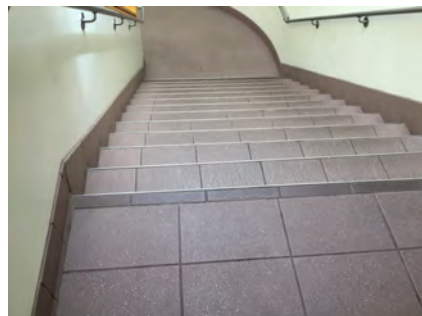
Item no., Rm no. and Name	Existing Architectural Barrier and Proposed Solution	Codes / Mitigation Info	Qty	Unit	Cost	Total
Stairway						
61	<ul style="list-style-type: none">• <i>As-Built Description:</i> The leading 2" of the tread does not have visual contrast of dark-on-light or light-on-dark from the remainder of the tread.• <i>Proposed Solution:</i> Provide 2" min., 4" max. wide contrasting color strip 1" max. from nosing on top & bottom treads when altering area.	PCODE II02B ADA 2010 504.4 CBC 2007 1133B.4.4 CBC 2016 11B-504.4.1 Mitigated: <input type="radio"/> YES <input checked="" type="radio"/> NO	24	LF	\$42	\$1,008

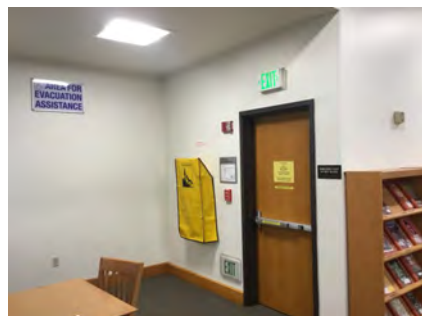
<input type="checkbox"/> Staff Only			
			Priority	Severity		
			2	3		
Signage						
149	<ul style="list-style-type: none">• <i>As-Built Description:</i> At door leading into exit stairway: Where required exit signs are installed, signs to provide exiting information for people with vision impairment are not provided.• <i>Proposed Solution:</i> Provide raised letter/Braille "EXIT STAIR UP/DOWN" sign at door.	PCODE SA10B ADAAG 91 4.1.3(16) ADA 2010 216.4.1 CBC 2007 1011.3 CBC 2016 11B-216.4.1 Mitigated: <input type="radio"/> YES <input checked="" type="radio"/> NO	1	JOB	\$270	\$270

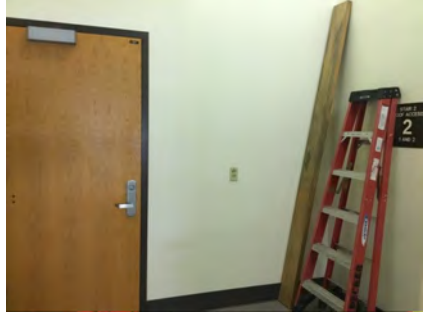
Item no., Rm no. and Name	Existing Architectural Barrier and Proposed Solution	Codes / Mitigation Info	Qty	Unit	Cost	Total
143	<ul style="list-style-type: none"> • <i>As-Built Description:</i> At enclosed stairwells in buildings: Floor level information sign in stairwell not provided for people with vision impairment. • <i>Proposed Solution:</i> Provide additional floor level with tactile and Braille located on the latch side of the door. 	PCODE SA10F ADAAG 91 4.1.3(16) CBC 2007 1020.1.6 CBC 2016 11B-504.8 Mitigated: <input type="radio"/> YES <input checked="" type="radio"/> NO	2	JOB	\$450	\$900

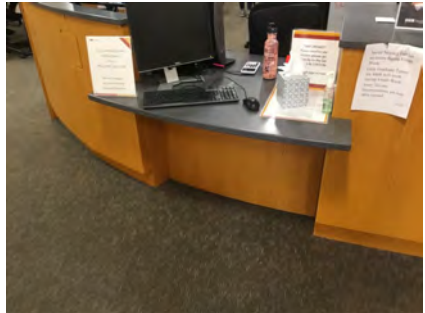
Item no., Rm no. and Name	Existing Architectural Barrier and Proposed Solution	Codes / Mitigation Info	Qty	Unit	Cost	Total
Non-Fixed Desk						
63	<ul style="list-style-type: none"> As-Built Description: Accessible non-fixed table or desk (top 28" to 34" high; knee space at least 27" high x 19" deep x 30" wide) not provided. As-Built: 18" deep Proposed Solution: Provide table or desk with accessible dimensions when purchasing new furniture. 	PCODE IN02A ADAAG 91 4.32.3 & .4 ADA 2010 306.1 CBC 2007 1122B.3 & 4 CBC 2016 11B-306.1 & 11B-902.3 Mitigated: <input type="radio"/> YES <input checked="" type="radio"/> NO	1	JOB	\$4,800	\$4,800

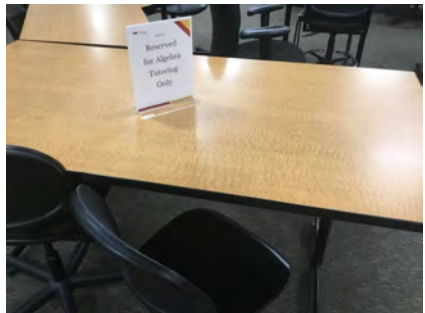
<input type="checkbox"/> Staff Only Priority 2 Severity 2			
64	<ul style="list-style-type: none"> As-Built Description: Accessible non-fixed table or desk (top 28" to 34" high; knee space at least 27" high x 19" deep x 30" wide) not provided. As-Built: 14" deep Proposed Solution: Provide table or desk with accessible dimensions when purchasing new furniture. Notes: 10 tables provided, no accessible 	PCODE IN02A ADAAG 91 4.32.3 & .4 ADA 2010 306.1 CBC 2007 1122B.3 & 4 CBC 2016 11B-306.1 & 11B-902.3 Mitigated: <input type="radio"/> YES <input checked="" type="radio"/> NO	1	JOB	\$4,800	\$4,800

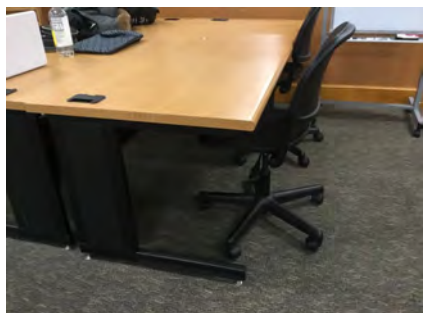
<input type="checkbox"/> Staff Only Priority 2 Severity 2			
65	<ul style="list-style-type: none"> As-Built Description: Accessible non-fixed table or desk (top 28" to 34" high; knee space at least 27" high x 19" deep x 30" wide) not provided. As-Built: 26" knee clearance Proposed Solution: Provide table or desk with accessible dimensions when purchasing new furniture. Notes: 12 seats. 0 accessible. 	PCODE IN02A ADAAG 91 4.32.3 & .4 ADA 2010 306.1 CBC 2007 1122B.3 & 4 CBC 2016 11B-306.1 & 11B-902.3 Mitigated: <input type="radio"/> YES <input checked="" type="radio"/> NO	1	JOB	\$4,800	\$4,800

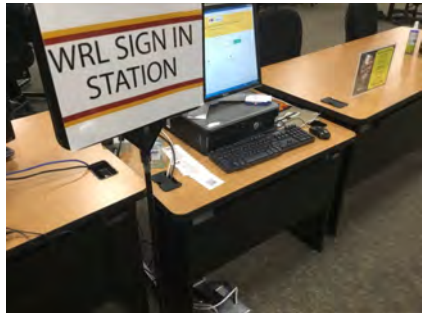
Item no., Rm no. and Name	Existing Architectural Barrier and Proposed Solution	Codes / Mitigation Info	Qty	Unit	Cost	Total
66	<ul style="list-style-type: none"> As-Built Description: Accessible non-fixed table or desk (top 28" to 34" high; knee space at least 27" high x 19" deep x 30" wide) not provided. As-Built: 26" knee clearance Proposed Solution: Provide table or desk with accessible dimensions when purchasing new furniture. Notes: Check in station 	PCODE IN02A ADAAG 91 4.32.3 & .4 ADA 2010 306.1 CBC 2007 1122B.3 & 4 CBC 2016 11B-306.1 & 11B-902.3 Mitigated: <input type="radio"/> YES <input checked="" type="radio"/> NO	1	JOB	\$4,800	\$4,800

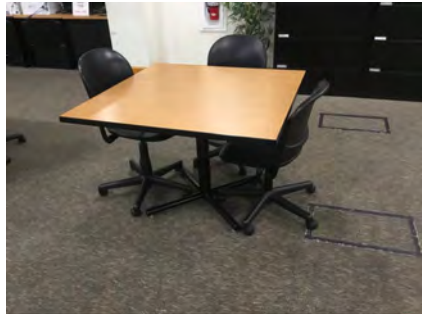
<input type="checkbox"/> Staff Only						
Priority 2 Severity 2						
67	<ul style="list-style-type: none"> As-Built Description: Accessible non-fixed table or desk (top 28" to 34" high; knee space at least 27" high x 19" deep x 30" wide) not provided. Proposed Solution: Provide table or desk with accessible dimensions when purchasing new furniture. Notes: 20 seats, no accessible provided. 	PCODE IN02A ADAAG 91 4.32.3 & .4 ADA 2010 306.1 CBC 2007 1122B.3 & 4 CBC 2016 11B-306.1 & 11B-902.3 Mitigated: <input type="radio"/> YES <input checked="" type="radio"/> NO	1	JOB	\$4,800	\$4,800

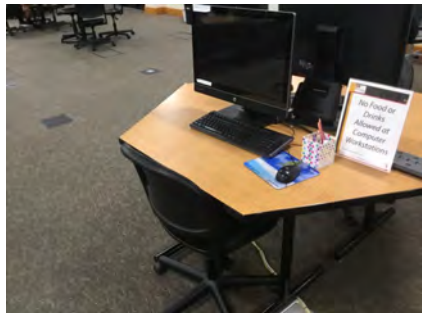
<input type="checkbox"/> Staff Only						
Priority 2 Severity 2						
68	<ul style="list-style-type: none"> As-Built Description: Accessible non-fixed table or desk (top 28" to 34" high; knee space at least 27" high x 19" deep x 30" wide) not provided. As-Built: 21" wide Proposed Solution: Provide table or desk with accessible dimensions when purchasing new furniture. Notes: 2 seats, 0 accessible 	PCODE IN02A ADAAG 91 4.32.3 & .4 ADA 2010 306.1 CBC 2007 1122B.3 & 4 CBC 2016 11B-306.1 & 11B-902.3 Mitigated: <input type="radio"/> YES <input checked="" type="radio"/> NO	1	JOB	\$4,800	\$4,800

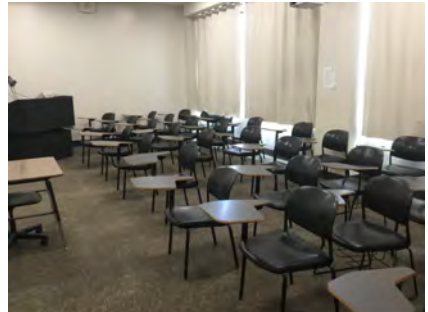
Item no., Rm no. and Name	Existing Architectural Barrier and Proposed Solution	Codes / Mitigation Info	Qty	Unit	Cost	Total
70	<ul style="list-style-type: none">• As-Built Description: Accessible non-fixed table or desk (top 28" to 34" high; knee space at least 27" high x 19" deep x 30" wide) not provided.• Proposed Solution: Provide table or desk with accessible dimensions when purchasing new furniture.• Notes: 34 seats, no accessible provided	<p>PCODE IN02A</p> <p>ADAAG 91 4.32.3 & .4</p> <p>ADA 2010 306.1</p> <p>CBC 2007 1122B.3 & 4</p> <p>CBC 2016 11B-306.1 & 11B-902.3</p> <p>Mitigated:</p> <p><input type="radio"/> YES</p> <p><input checked="" type="radio"/> NO</p>	1	JOB	\$4,800	\$4,800

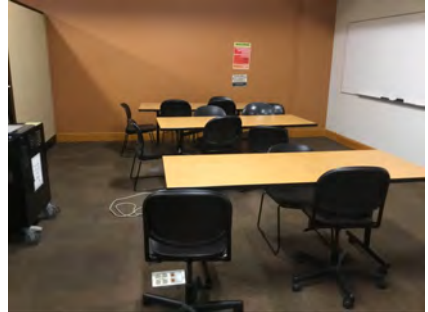
<div><input type="checkbox"/> Staff Only</div> <div><div>Priority</div><div>2</div><div>Severity</div><div>2</div></div>			
72	<ul style="list-style-type: none">• As-Built Description: Accessible non-fixed table or desk (top 28" to 34" high; knee space at least 27" high x 19" deep x 30" wide) not provided.• Proposed Solution: Provide table or desk with accessible dimensions when purchasing new furniture.• Notes: 42 seats, no accessible table provided	<p>PCODE IN02A</p> <p>ADAAG 91 4.32.3 & .4</p> <p>ADA 2010 306.1</p> <p>CBC 2007 1122B.3 & 4</p> <p>CBC 2016 11B-306.1 & 11B-902.3</p> <p>Mitigated:</p> <p><input type="radio"/> YES</p> <p><input checked="" type="radio"/> NO</p>	1	JOB	\$4,800	\$4,800

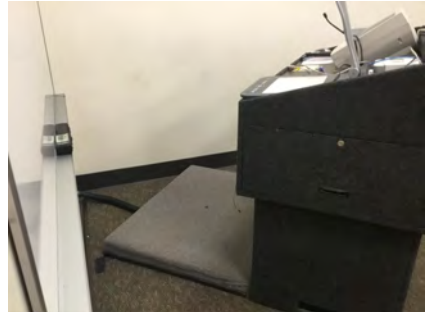
<div><input type="checkbox"/> Staff Only</div> <div><div>Priority</div><div>2</div><div>Severity</div><div>2</div></div>			
<u>Public Participation Counter</u>						
71	<ul style="list-style-type: none">• As-Built Description: Speaker podium is not accessible. Upper edge of podium is more than 34" above the finished floor, and knee space is less than 27" high, 30" wide, and 19" deep.• As-Built: 42" above finished floor• Proposed Solution: Provide additional, integrated, and accessible speaker podium.• Notes: Obstructed by platform.	<p>PCODE GB02A</p> <p>ADAAG 91 4.32.3</p> <p>ADA 2010 902.3</p> <p>CBC 2007 1122B.3</p> <p>CBC 2016 11B-902.3</p> <p>Mitigated:</p> <p><input type="radio"/> YES</p> <p><input checked="" type="radio"/> NO</p>	1	JOB	\$6,000	\$6,000
