SAN MATEO COUNTY
COMMUNITY
COLLEGE DISTRICT

San Mateo County Community College District Americans with Disabilities Act Self-Evaluation and Transition Plan

Report Prepared by:

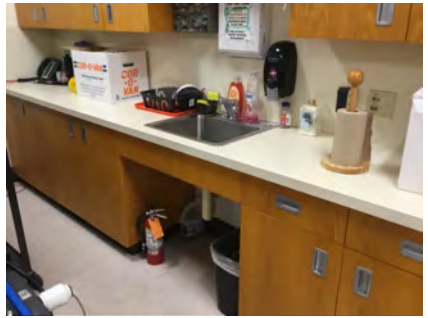
Item no., Rm no. and Name	Existing Architectural Barrier and Proposed Solution	Codes / Mitigation Info	Qty	Unit	Cost	Total
Sink						
75	<ul style="list-style-type: none"> As-Built Description: Sink rim higher than 34" above floor. As-Built: 37" above finished floor Proposed Solution: Remodel sink cabinet to lower sink. 	PCODE IN06 ADAAG 91 4.24.2 ADA 2010 606.3 CBC 2007 1115B.4.7.1 CBC 2016 11B-606.3 Mitigated: <input type="radio"/> YES <input checked="" type="radio"/> NO	1	JOB	\$5,250	\$5,250

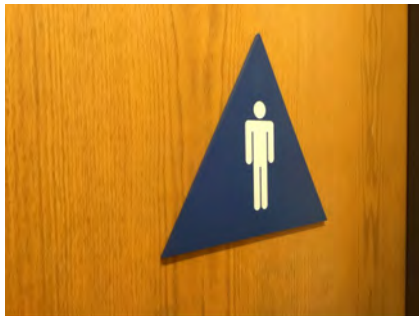
Item no., Rm no. and Name	Existing Architectural Barrier and Proposed Solution	Codes / Mitigation Info	Qty	Unit	Cost	Total
Signage						
85	<ul style="list-style-type: none">As-Built Description: Required in CA only: identification symbol centered 58" to 60" high on sanitary facility door that contrasts with the door not provided (women: 12" ø circle, men: 12" triangle, unisex: combined symbol).As-Built: Edges are not easedProposed Solution: Provide properly mounted sanitary facility symbol when altering area. If wheelchair accessible, include International Symbol of Accessibility on sign.	PCODE SA15 CBC 2007 1115B.6 CBC 2016 11B-703.7.2.6 Mitigated: <input type="radio"/> YES <input checked="" type="radio"/> NO	1	JOB	\$270	\$270

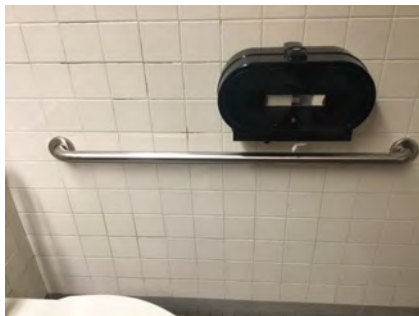
<input type="checkbox"/> Staff Only			
			Priority		Severity	
			3		3	
Grab Bars						
92	<ul style="list-style-type: none">As-Built Description: Side grab bar less than 42" long, or located more than 12 inches max. from the rear wall, or extending less than 54" from rear wall (CA only: front end min. 24" in front of water closet).As-Built: 51" from rear wallProposed Solution: Provide or relocate accessible side grab bar.	PCODE WB07A ADAAG 91 Fig. 29(b) ADA 2010 604.5.1 CBC 2007 1115B.4.1.3.1 CBC 2016 11B-604.5.1 Mitigated: <input type="radio"/> YES <input checked="" type="radio"/> NO	1	JOB	\$780	\$780

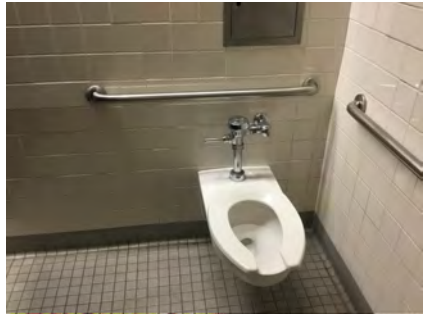
Item no., Rm no. and Name	Existing Architectural Barrier and Proposed Solution	Codes / Mitigation Info	Qty	Unit	Cost	Total
93	<ul style="list-style-type: none"> As-Built Description: The rear wall grab is less than 36" min. or does not extend from the centerline of the water closet 12" min. on one side and 24" min. on the other side. As-Built: 23" on the wide side Proposed Solution: Provide or relocate accessible rear grab bar. 	PCODE WB07B ADAAG 91 4.17.6 ADA 2010 604.5.2 CBC 2007 1115B.4.1.3.2 CBC 2016 11B-604.5.2 Mitigated: <input type="radio"/> YES <input checked="" type="radio"/> NO	1	JOB	\$1,020	\$1,020

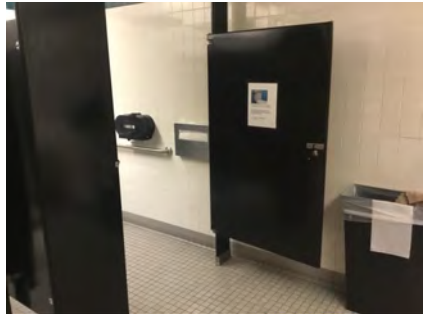
90	<ul style="list-style-type: none"> As-Built Description: Stall door to accessible compartment not self closing. Proposed Solution: Adjust closer. 	PCODE WB05B ADAAG 91 4.22.4 ADA 2010 604.8.1.2 CBC 2007 1115B.3.1.4.4 CBC 2016 11B-604.8.1.2 Mitigated: <input type="radio"/> YES <input checked="" type="radio"/> NO	1	JOB	\$75	\$75

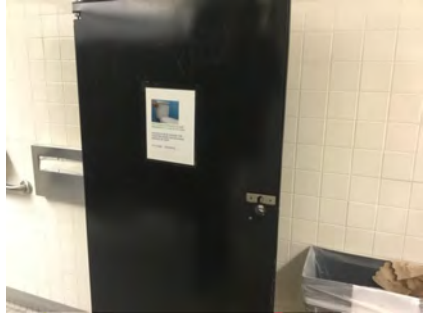
<input type="checkbox"/> Staff Only						
Priority 3 Severity 4						
91	<ul style="list-style-type: none"> As-Built Description: Stall door does not have accessible operating hardware (U-pulls on both sides, flip-over or sliding lock). Proposed Solution: Provide new accessible locking hardware that does not require grasping, pinching, or twisting and U-pulls on both sides. 	PCODE WB05C ADAAG 91 4.17.5 ADA 2010 604.8.1.2 CBC 2007 1115B.3.1.4.5 CBC 2016 11B-604.8.1.2 Mitigated: <input type="radio"/> YES <input checked="" type="radio"/> NO	1	JOB	\$300	\$300

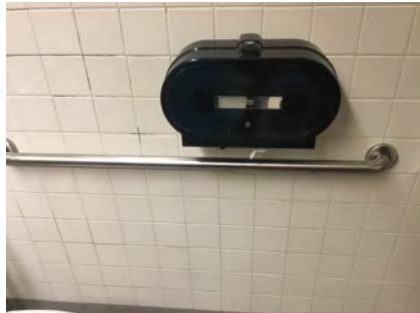
Item no., Rm no. and Name	Existing Architectural Barrier and Proposed Solution	Codes / Mitigation Info	Qty	Unit	Cost	Total
Accessories						
94	<ul style="list-style-type: none"> As-Built Description: Toilet paper dispenser less than 15" (CA: 19") or more than 48" above floor or not within 7" to 9" from front of water closet (Note: CA pre-2010 is allowed within 12" from front of water closet). As-Built: Above the side grab bar Proposed Solution: Relocate or provide new toilet paper dispenser. 	PCODE WG02 ADAAG 91 4.16.6 ADA 2010 604.7 CBC 2007 1115B.8.4 CBC 2016 11B-604.7 Mitigated: <input type="radio"/> YES <input checked="" type="radio"/> NO	1	JOB	\$225	\$225

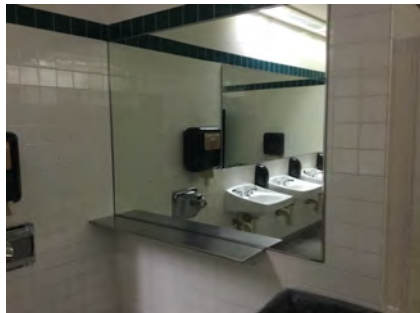
<input type="checkbox"/> Staff Only Priority 3 Severity 1			
86	<ul style="list-style-type: none"> As-Built Description: Bottom of mirror located above lavatories or countertops more than 40" above floor. Mirror not located above lavatory required 35" high. As-Built: 36.5" above finished floor Proposed Solution: Relocate or provide new accessible mirror. 	PCODE WG03 ADAAG 91 4.19.6 ADA 2010 603.3 CBC 2007 1115B.8.1 CBC 2016 11B-603.3 Mitigated: <input type="radio"/> YES <input checked="" type="radio"/> NO	1	JOB	\$450	\$450

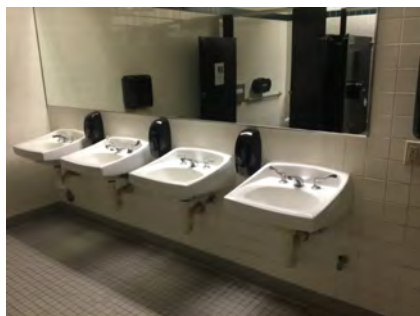
<input type="checkbox"/> Staff Only Priority 3 Severity 4			
87	<ul style="list-style-type: none"> As-Built Description: Bottom of mirror located above lavatories or countertops more than 40" above floor. As-Built: 44" above finished floor Proposed Solution: Relocate or provide new accessible mirror. 	PCODE WG03 ADAAG 91 4.19.6 ADA 2010 603.3 CBC 2007 1115B.8.1 CBC 2016 11B-603.3 Mitigated: <input type="radio"/> YES <input checked="" type="radio"/> NO	1	JOB	\$450	\$450

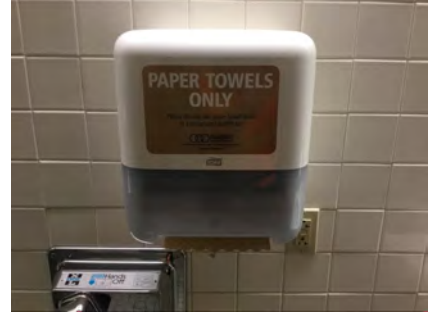
Item no., Rm no. and Name	Existing Architectural Barrier and Proposed Solution	Codes / Mitigation Info	Qty	Unit	Cost	Total
100	<ul style="list-style-type: none"> As-Built Description: Protruding objects more than 4" from wall, when bottom of object more than 27" or less than 80" above finished floor. As-Built: Paper towel dispenser 8" protrusion at 45" high. Proposed Solution: Remove/relocate protruding object. Patch existing surface. Notes: Occurs in all 4 multi user restrooms in the building. 	PCODE EG04 ADAAG 91 4.4.1 ADA 2010 307.2 CBC 2007 1133B.8.6.1 CBC 2016 11B-307.2 Mitigated: <input type="radio"/> YES <input checked="" type="radio"/> NO	8	JOB	\$300	\$2,400

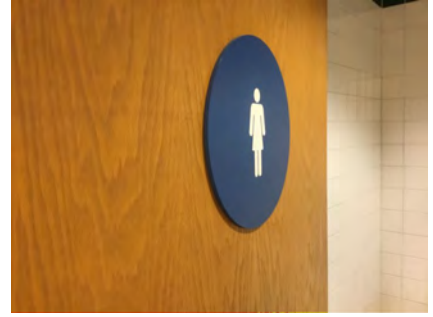
110	<ul style="list-style-type: none"> As-Built Description: Required in CA only: identification symbol centered 58" to 60" high on sanitary facility door that contrasts with the door not provided (women: 12" ø circle, men: 12" triangle, unisex: combined symbol). As-Built: The edges are not eased Proposed Solution: Provide properly mounted sanitary facility symbol when altering area. If wheelchair accessible, include International Symbol of Accessibility on sign. 	PCODE SA15 CBC 2007 1115B.6 CBC 2016 11B-703.7.2.6 Mitigated: <input type="radio"/> YES <input checked="" type="radio"/> NO	1	JOB	\$270	\$270

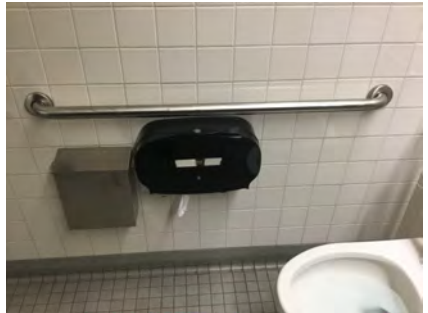
Item no., Rm no. and Name	Existing Architectural Barrier and Proposed Solution	Codes / Mitigation Info	Qty	Unit	Cost	Total
Grab Bars						
107	<ul style="list-style-type: none"> As-Built Description: Side grab bar less than 42" long, or located more than 12 inches max. from the rear wall, or extending less than 54" from rear wall (CA only: front end min. 24" in front of water closet). As-Built: 52" from rear wall Proposed Solution: Provide or relocate accessible side grab bar. 	PCODE WB07A ADAAG 91 Fig. 29(b) ADA 2010 604.5.1 CBC 2007 1115B.4.1.3.1 CBC 2016 11B-604.5.1 Mitigated: <input type="radio"/> YES <input checked="" type="radio"/> NO	1	JOB	\$780	\$780

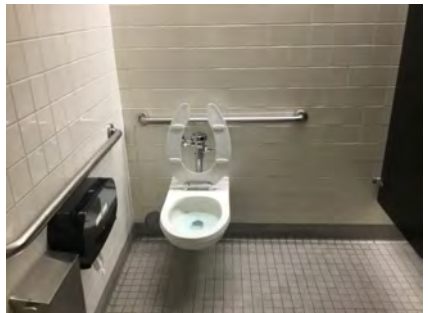
<input type="checkbox"/> Staff Only			
			Priority	Severity		
			3	4		
106	<ul style="list-style-type: none"> As-Built Description: The rear wall grab is less than 36" min. or does not extend from the centerline of the water closet 12" min. on one side and 24" min. on the other side. As-Built: 22.5" on the wide side Proposed Solution: Provide or relocate accessible rear grab bar. 	PCODE WB07B ADAAG 91 4.17.6 ADA 2010 604.5.2 CBC 2007 1115B.4.1.3.2 CBC 2016 11B-604.5.2 Mitigated: <input type="radio"/> YES <input checked="" type="radio"/> NO	1	JOB	\$1,020	\$1,020

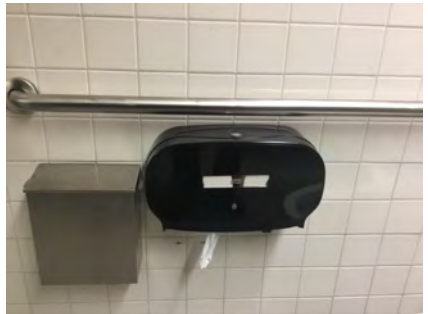
<input type="checkbox"/> Staff Only			
			Priority	Severity		
			3	4		
109	<ul style="list-style-type: none"> As-Built Description: Accessories/dispensers in accessible stall located closer than 1-1/2" below or 12" above grab bar impedes its use. As-Built: 1.25" below grab bar Proposed Solution: Relocate accessories/dispensers to be no closer than 1-1/2" below and 12" above grab bars (except if accessories are recessed, flush with wall, and have no sharp edges). 	PCODE WB07I ADAAG 91 4.26.2 ADA 2010 609.3 CBC 2007 1133B.4.2.5 CBC 2016 11B-609.3 Mitigated: <input type="radio"/> YES <input checked="" type="radio"/> NO	1	JOB	\$225	\$225

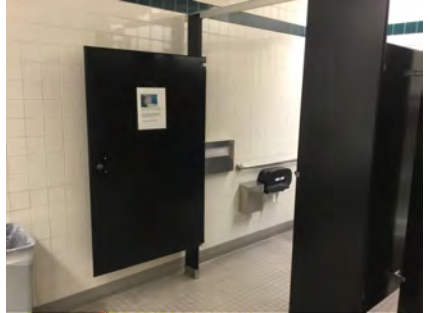
Item no., Rm no. and Name	Existing Architectural Barrier and Proposed Solution	Codes / Mitigation Info	Qty	Unit	Cost	Total
<u>Stall Door</u>						
104	<ul style="list-style-type: none"> • <i>As-Built Description:</i> Stall door to accessible compartment not self closing. • <i>Proposed Solution:</i> Adjust closer. 	PCODE WB05B ADAAG 91 4.22.4 ADA 2010 604.8.1.2 CBC 2007 1115B.3.1.4.4 CBC 2016 11B-604.8.1.2 Mitigated: <input type="radio"/> YES <input checked="" type="radio"/> NO	1	JOB	\$75	\$75

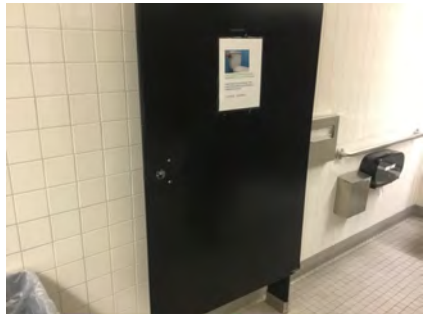
<input type="checkbox"/> Staff Only			
			Priority		Severity	
			3		4	
105	<ul style="list-style-type: none"> • <i>As-Built Description:</i> Stall door does not have accessible operating hardware (U-pulls on both sides, flip-over or sliding lock). • <i>Proposed Solution:</i> Provide new accessible locking hardware that does not require grasping, pinching, or twisting and U-pulls on both sides. 	PCODE WB05C ADAAG 91 4.17.5 ADA 2010 604.8.1.2 CBC 2007 1115B.3.1.4.5 CBC 2016 11B-604.8.1.2 Mitigated: <input type="radio"/> YES <input checked="" type="radio"/> NO	1	JOB	\$300	\$300

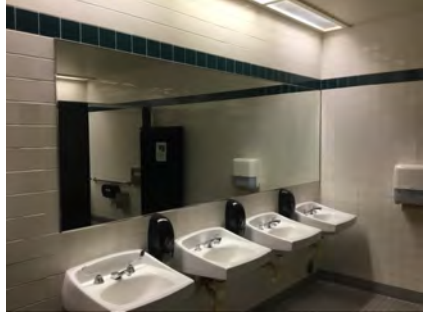
Item no., Rm no. and Name	Existing Architectural Barrier and Proposed Solution	Codes / Mitigation Info	Qty	Unit	Cost	Total
102	<ul style="list-style-type: none"> As-Built Description: Bottom of mirror located above lavatories or countertops more than 40" above floor. As-Built: 44" high Proposed Solution: Relocate or provide new accessible mirror. 	PCODE WG03 ADAAG 91 4.19.6 ADA 2010 603.3 CBC 2007 1115B.8.1 CBC 2016 11B-603.3 Mitigated: <input type="radio"/> YES <input checked="" type="radio"/> NO	1	JOB	\$450	\$450

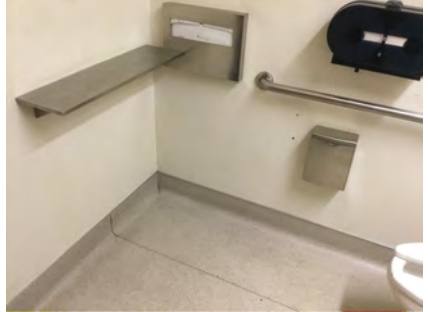
Item no., Rm no. and Name	Existing Architectural Barrier and Proposed Solution	Codes / Mitigation Info	Qty	Unit	Cost	Total
119	<ul style="list-style-type: none"> As-Built Description: Protruding objects more than 4" from wall, when bottom of object more than 27" or less than 80" above finished floor. As-Built: Shelf protrudes 6" at 42" high. Proposed Solution: Remove/relocate protruding object. Patch existing surface. 	PCODE EG04 ADAAG 91 4.4.1 ADA 2010 307.2 CBC 2007 1133B.8.6.1 CBC 2016 11B-307.2 Mitigated: <input type="radio"/> YES <input checked="" type="radio"/> NO	1	JOB	\$300	\$300

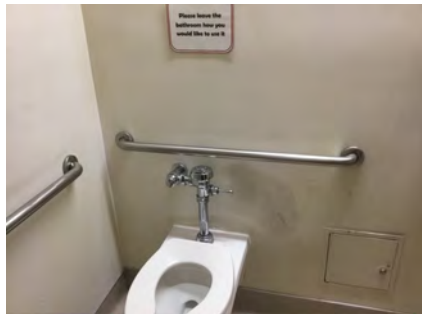
Item no., Rm no. and Name	Existing Architectural Barrier and Proposed Solution	Codes / Mitigation Info	Qty	Unit	Cost	Total
122	<ul style="list-style-type: none"> As-Built Description: The rear wall grab is less than 36" min. or does not extend from the centerline of the water closet 12" min. on one side and 24" min. on the other side. As-Built: 22" on the wide side Proposed Solution: Provide accessible rear grab bar. 	PCODE WB07BREF ADAAG 91 4.17.6 ADA 2010 604.5.2 CBC 2007 1115B.4.1.3.2 CBC 2016 11B-604.5.2 Mitigated: <input type="radio"/> YES <input checked="" type="radio"/> NO	REF

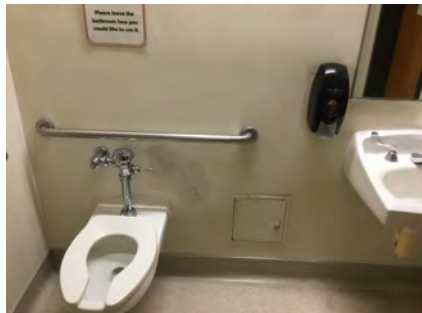
115	<ul style="list-style-type: none"> As-Built Description: 60" min. clearance around a water closet measured perpendicular from the side wall not provided (Fixtures are not allowed to overlap this clearance). As-Built: 57.5" from edge of lavatory to wall Proposed Solution: Remove adjacent fixture and provide new enclosure at accessible water closet. 	PCODE WB01A ADA 2010 604.3.1; 604.3.2 CBC 2007 1115B.7.1.3 CBC 2016 11B-604.3.1; 11B-604.3.2 Mitigated: <input type="radio"/> YES <input checked="" type="radio"/> NO	1	JOB	\$6,000	\$6,000

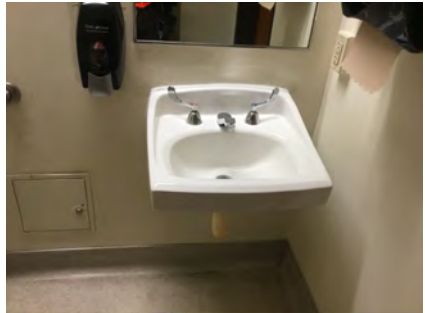
Item no., Rm no. and Name	Existing Architectural Barrier and Proposed Solution	Codes / Mitigation Info	Qty	Unit	Cost	Total
Lavatory						
116	<ul style="list-style-type: none"> • <i>As-Built Description:</i> Clear floor space, 30" x 48" in front of fixture, extending 19" max. under the lavatory, not provided (CA only: Less than 18" from side wall to centerline of lavatory). • <i>As-Built:</i> 15.25" o.c. • <i>Proposed Solution:</i> Provide new accessible lavatory. Remodel restroom as needed. 	PCODE WD01 ADAAG 91 4.19.3 ADA 2010 606.2 CBC 2007 1115B.4.3 CBC 2016 11B-606.2, 11B-606.6 Mitigated: <input type="radio"/> YES <input checked="" type="radio"/> NO	1	JOB	\$10,200	\$10,200

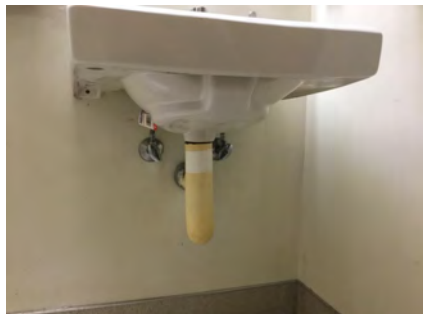
<input type="checkbox"/> Staff Only Priority 3 Severity 2			
126	<ul style="list-style-type: none"> • <i>As-Built Description:</i> Knee clearance 27" min. high starting 8" back from the front edge of the lavatory towards the wall is not provided. • <i>As-Built:</i> 25" above finished floor • <i>Proposed Solution:</i> Remount compliant fixture to accessible height. 	PCODE WD04A ADAAG 91 Fig. 31 ADA 2010 306.3.3 CBC 2007 1115B.4.3 CBC 2016 11B-306.3.3 Mitigated: <input type="radio"/> YES <input checked="" type="radio"/> NO	1	JOB	\$4,500	\$4,500

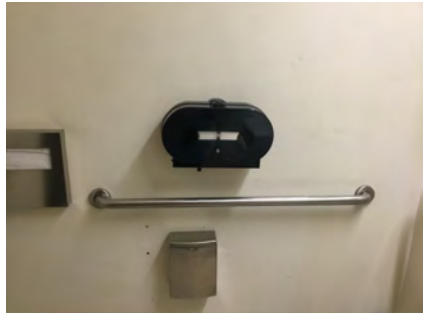
Item no., Rm no. and Name	Existing Architectural Barrier and Proposed Solution	Codes / Mitigation Info	Qty	Unit	Cost	Total
Accessories						
120	<ul style="list-style-type: none"> • <i>As-Built Description:</i> Toilet paper dispenser less than 15" (CA: 19") or more than 48" above floor or not within 7" to 9" from front of water closet (Note: CA pre-2010 is allowed within 12" from front of water closet). • <i>As-Built:</i> The toilet paper dispenser is 5" above the side grab bar • <i>Proposed Solution:</i> Relocate or provide new toilet paper dispenser. 	PCODE WG02 ADAAG 91 4.16.6 ADA 2010 604.7 CBC 2007 1115B.8.4 CBC 2016 11B-604.7 Mitigated: <input type="radio"/> YES <input checked="" type="radio"/> NO	1	JOB	\$225	\$225

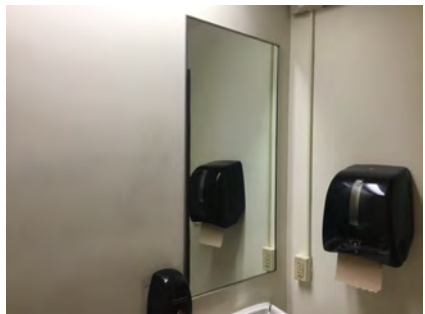
<input type="checkbox"/> Staff Only			
			Priority	Severity		
			3	1		
117	<ul style="list-style-type: none"> • <i>As-Built Description:</i> Bottom of mirror located above lavatories or countertops more than 40" above floor. • <i>As-Built:</i> 41.25" above finished floor • <i>Proposed Solution:</i> Relocate or provide new accessible mirror. 	PCODE WG03 ADAAG 91 4.19.6 ADA 2010 603.3 CBC 2007 1115B.8.1 CBC 2016 11B-603.3 Mitigated: <input type="radio"/> YES <input checked="" type="radio"/> NO	1	JOB	\$450	\$450

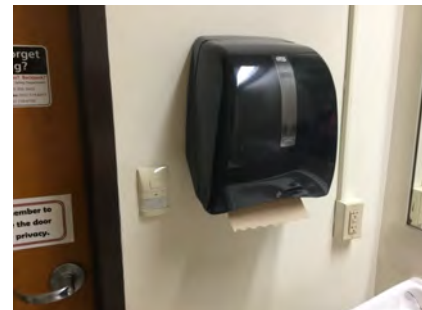
Item no., Rm no. and Name	Existing Architectural Barrier and Proposed Solution	Codes / Mitigation Info	Qty	Unit	Cost	Total
125	<ul style="list-style-type: none"> As-Built Description: Protruding objects more than 4" from wall, when bottom of object more than 27" or less than 80" above finished floor. As-Built: Paper towel dispenser protrudes 8" at 55" high. Proposed Solution: Remove/relocate protruding object. Patch existing surface. Notes: Above lavatory 	PCODE EG04REF ADAAG 91 4.4.1 ADA 2010 307.2 CBC 2007 1133B.8.6.1 CBC 2016 11B-307.2 Mitigated: <input type="radio"/> YES <input checked="" type="radio"/> NO		REF		
<div style="text-align: right;"> <input type="checkbox"/> Staff Only Priority 3 Severity 3 </div>

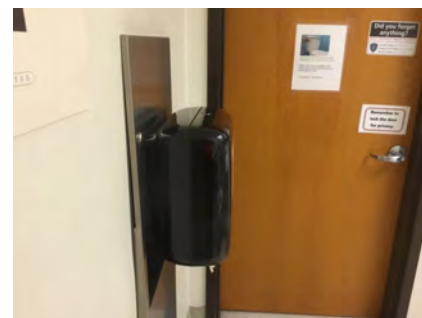
160	<ul style="list-style-type: none"> As-Built Description: Front approach: At push side, door does not have clear and level maneuvering space measuring door width x 48" (door width plus 12" if door has both, latch and closer). Proposed Solution: Remove or relocate furniture or storage items. Notes: Paper towel dispenser obstructs door landing. 	PCODE ID24A ADAAG 91 Fig. 25(a) ADA 2010 404.2.4 CBC 2007 11B-26A(a) CBC 2016 11B-404.2.4 Mitigated: <input type="radio"/> YES <input checked="" type="radio"/> NO	1	JOB	\$150	\$150
<div style="text-align: right;"> <input type="checkbox"/> Staff Only Priority 3 Severity 3 </div>

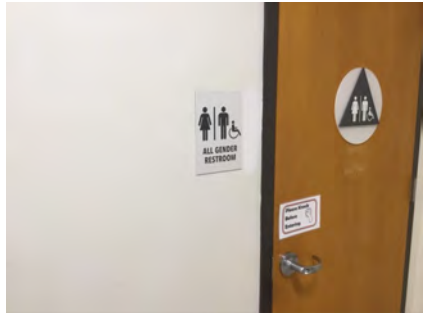
Item no., Rm no. and Name	Existing Architectural Barrier and Proposed Solution	Codes / Mitigation Info	Qty	Unit	Cost	Total
Signage						
124	<ul style="list-style-type: none"> As-Built Description: Signs containing tactile characters is not located so that a clear floor space of 18" min x 18" min., centered on the tactile characters, is provided beyond the arc of any door swing between the closed position and 45 degree open position. As-Built: The centerline of the sign is 8.5" from the swing of the door Proposed Solution: Relocate compliant signage on latch side of door located at compliant height with a clear floor space. 	PCODE SA07B ADA 2010 703.4.2 CBC 2016 11B-703.4.2 Mitigated: <input type="radio"/> YES <input checked="" type="radio"/> NO	1	JOB	\$150	\$150

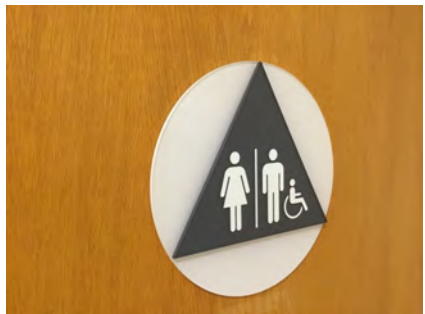
<input type="checkbox"/> Staff Only Priority 3 Severity 4			
123	<ul style="list-style-type: none"> As-Built Description: Required in CA only: identification symbol centered 58" to 60" high on sanitary facility door that contrasts with the door not provided (women: 12" ø circle, men: 12" triangle, unisex: combined symbol). As-Built: Edges are not eased Proposed Solution: Provide properly mounted sanitary facility symbol when altering area. If wheelchair accessible, include International Symbol of Accessibility on sign. 	PCODE SA15 CBC 2007 1115B.6 CBC 2016 11B-703.7.2.6 Mitigated: <input type="radio"/> YES <input checked="" type="radio"/> NO	1	JOB	\$270	\$270

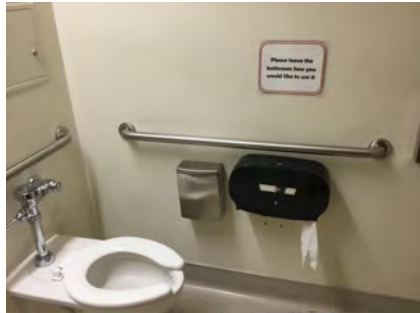
Item no., Rm no. and Name	Existing Architectural Barrier and Proposed Solution	Codes / Mitigation Info	Qty	Unit	Cost	Total
Grab Bars						
153	<ul style="list-style-type: none"> • <i>As-Built Description:</i> Side grab bar less than 42" long, or located more than 12 inches max. from the rear wall, or extending less than 54" from rear wall (CA only: front end min. 24" in front of water closet). • <i>As-Built:</i> Side grab bar extends 52" from the rear wall • <i>Proposed Solution:</i> Provide or relocate accessible side grab bar. 	PCODE WB07A ADAAG 91 Fig. 29(b) ADA 2010 604.5.1 CBC 2007 1115B.4.1.3.1 CBC 2016 11B-604.5.1 Mitigated: <input type="radio"/> YES <input checked="" type="radio"/> NO	1	JOB	\$780	\$780

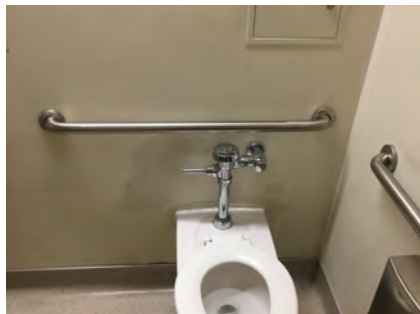
<input type="checkbox"/> Staff Only			
			Priority		Severity	
			3		4	
154	<ul style="list-style-type: none"> • <i>As-Built Description:</i> The rear wall grab is less than 36" min. or does not extend from the centerline of the water closet 12" min. on one side and 24" min. on the other side. • <i>As-Built:</i> 22" on the wide side • <i>Proposed Solution:</i> Provide or relocate accessible rear grab bar. 	PCODE WB07B ADAAG 91 4.17.6 ADA 2010 604.5.2 CBC 2007 1115B.4.1.3.2 CBC 2016 11B-604.5.2 Mitigated: <input type="radio"/> YES <input checked="" type="radio"/> NO	1	JOB	\$1,020	\$1,020

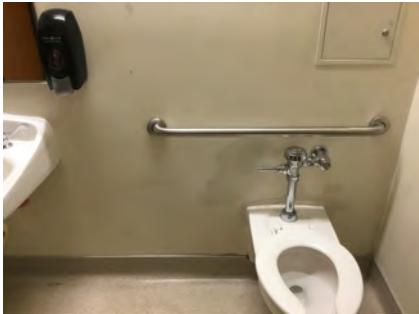
Item no., Rm no. and Name	Existing Architectural Barrier and Proposed Solution	Codes / Mitigation Info	Qty	Unit	Cost	Total
<u>Toilet Stall</u>						
159	<ul style="list-style-type: none">• <i>As-Built Description:</i> 60" min. clearance around a water closet measured perpendicular from the side wall not provided (Fixtures are not allowed to overlap this clearance).• <i>As-Built:</i> 57" from the edge of the lavatory to the wall• <i>Proposed Solution:</i> Remove adjacent fixture and provide new enclosure at accessible water closet.	<p>PCODE WB01A</p> <p>ADA 2010 604.3.1; 604.3.2</p> <p>CBC 2007 1115B.7.1.3</p> <p>CBC 2016 11B-604.3.1; 11B-604.3.2</p> <p>Mitigated:</p> <p><input type="radio"/> YES</p> <p><input checked="" type="radio"/> NO</p>	1	JOB	\$6,000	\$6,000

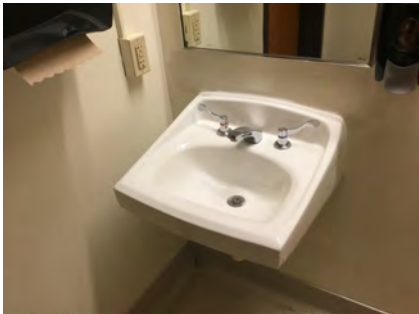
<input type="checkbox"/> Staff Only			
			<div>Priority 3 Severity 4</div>			
<u>Lavatory</u>						
158	<ul style="list-style-type: none">• <i>As-Built Description:</i> Clear floor space, 30" x 48" in front of fixture, extending 19" max. under the lavatory, not provided (CA only: Less than 18" from side wall to centerline of lavatory).• <i>As-Built:</i> 14.75" o.c.• <i>Proposed Solution:</i> Provide new accessible lavatory. Remodel restroom as needed.	<p>PCODE WD01</p> <p>ADAAG 91 4.19.3</p> <p>ADA 2010 606.2</p> <p>CBC 2007 1115B.4.3</p> <p>CBC 2016 11B-606.2, 11B -606.6</p> <p>Mitigated:</p> <p><input type="radio"/> YES</p> <p><input checked="" type="radio"/> NO</p>	1	JOB	\$10,200	\$10,200

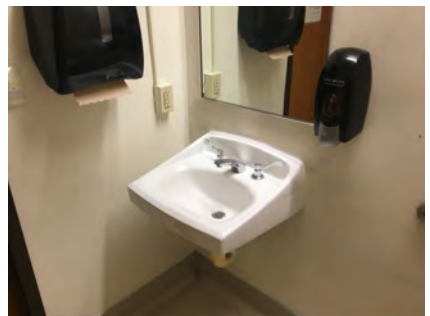
Item no., Rm no. and Name	Existing Architectural Barrier and Proposed Solution	Codes / Mitigation Info	Qty	Unit	Cost	Total
157	<ul style="list-style-type: none">As-Built Description: Knee clearance 27" min. high starting 8" back from the front edge of the lavatory towards the wall is not provided.As-Built: 25.5" above finished floorProposed Solution: Remount compliant fixture to accessible height.	PCODE WD04A ADAAG 91 Fig. 31 ADA 2010 306.3.3 CBC 2007 1115B.4.3 CBC 2016 11B-306.3.3 Mitigated: <input type="radio"/> YES <input checked="" type="radio"/> NO	1	JOB	\$4,500	\$4,500

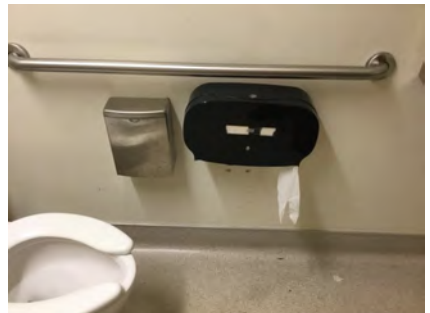
<input type="checkbox"/> Staff Only Priority 3 Severity 2			
Accessories						
151	<ul style="list-style-type: none">As-Built Description: Toilet paper dispenser less than 15" (CA: 19") or more than 48" above floor or not within 7" to 9" from front of water closet (Note: CA pre-2010 is allowed within 12" from front of water closet).As-Built: 12" in front of the water closetProposed Solution: Relocate or provide new toilet paper dispenser.	PCODE WG02 ADAAG 91 4.16.6 ADA 2010 604.7 CBC 2007 1115B.8.4 CBC 2016 11B-604.7 Mitigated: <input type="radio"/> YES <input checked="" type="radio"/> NO	1	JOB	\$225	\$225

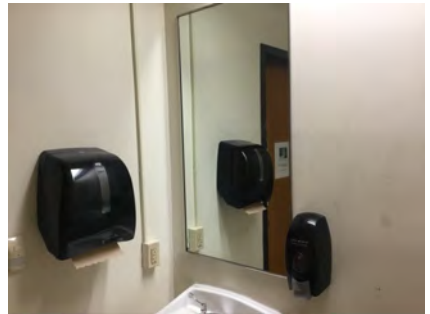
<input type="checkbox"/> Staff Only Priority 3 Severity 3			
156	<ul style="list-style-type: none">As-Built Description: Bottom of mirror located above lavatories or countertops more than 40" above floor.As-Built: 41.5" above finished floorProposed Solution: Relocate or provide new accessible mirror.	PCODE WG03 ADAAG 91 4.19.6 ADA 2010 603.3 CBC 2007 1115B.8.1 CBC 2016 11B-603.3 Mitigated: <input type="radio"/> YES <input checked="" type="radio"/> NO	1	JOB	\$450	\$450

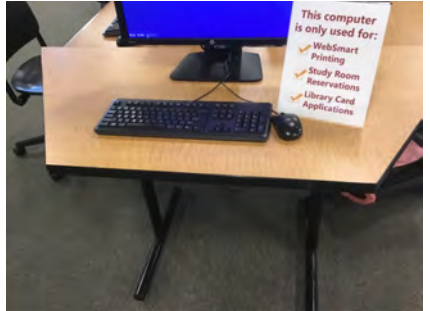
Item no., Rm no. and Name	Existing Architectural Barrier and Proposed Solution	Codes / Mitigation Info	Qty	Unit	Cost	Total
130	<ul style="list-style-type: none"> As-Built Description: Accessible non-fixed table or desk (top 28" to 34" high; knee space at least 27" high x 19" deep x 30" wide) not provided. As-Built: 22" wide Proposed Solution: Provide table or desk with accessible dimensions when purchasing new furniture. Notes: Printing desk 	PCODE IN02A ADAAG 91 4.32.3 & .4 ADA 2010 306.1 CBC 2007 1122B.3 & 4 CBC 2016 11B-306.1 & 11B-902.3 Mitigated: <input type="radio"/> YES <input checked="" type="radio"/> NO	1	JOB	\$4,800	\$4,800

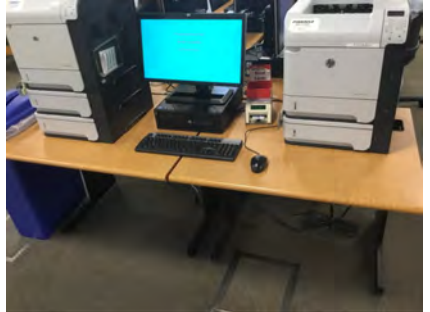
<input type="checkbox"/> Staff Only Priority 2 Severity 2						
131	<ul style="list-style-type: none"> As-Built Description: Accessible non-fixed table or desk (top 28" to 34" high; knee space at least 27" high x 19" deep x 30" wide) not provided. As-Built: 25.5" knee clearance. 29.5" wide. Proposed Solution: Provide table or desk with accessible dimensions when purchasing new furniture. 	PCODE IN02A ADAAG 91 4.32.3 & .4 ADA 2010 306.1 CBC 2007 1122B.3 & 4 CBC 2016 11B-306.1 & 11B-902.3 Mitigated: <input type="radio"/> YES <input checked="" type="radio"/> NO	1	JOB	\$4,800	\$4,800

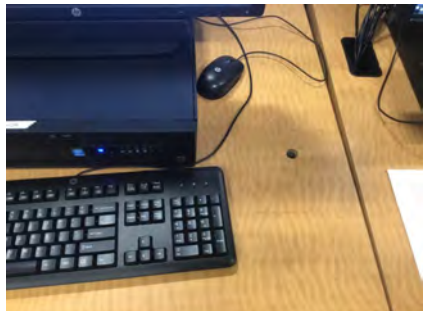
<input type="checkbox"/> Staff Only Priority 2 Severity 2						
133	<ul style="list-style-type: none"> As-Built Description: Accessible non-fixed table or desk (top 28" to 34" high; knee space at least 27" high x 19" deep x 30" wide) not provided. Proposed Solution: Provide table or desk with accessible dimensions when purchasing new furniture. Notes: 80 desks. 6 adjustable provided. However the appears to be only 1 crank provided which adjusts the tables and it is removable and may be difficult to find or it may get misplaced. Consider permanently installing adjusters at accessible tables. 	PCODE IN02A ADAAG 91 4.32.3 & .4 ADA 2010 306.1 CBC 2007 1122B.3 & 4 CBC 2016 11B-306.1 & 11B-902.3 Mitigated: <input type="radio"/> YES <input checked="" type="radio"/> NO	4	JOB	\$300	\$1,200

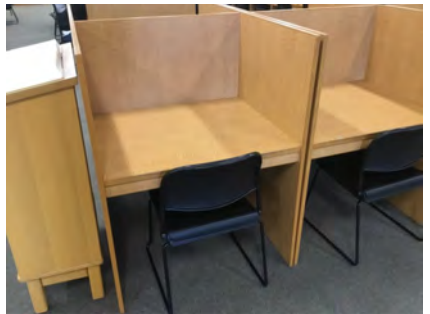
Item no., Rm no. and Name	Existing Architectural Barrier and Proposed Solution	Codes / Mitigation Info	Qty	Unit	Cost	Total
134	<ul style="list-style-type: none"> As-Built Description: Accessible non-fixed table or desk (top 28" to 34" high; knee space at least 27" high x 19" deep x 30" wide) not provided. As-Built: 25" high knee clearance Proposed Solution: Provide table or desk with accessible dimensions when purchasing new furniture. Notes: 52 desks provided at Quiet Study Area. No accessible provided 	PCODE IN02A ADAAG 91 4.32.3 & .4 ADA 2010 306.1 CBC 2007 112B.3 & 4 CBC 2016 11B-306.1 & 11B-902.3 Mitigated: <input type="radio"/> YES <input checked="" type="radio"/> NO	1	JOB	\$4,800	\$4,800

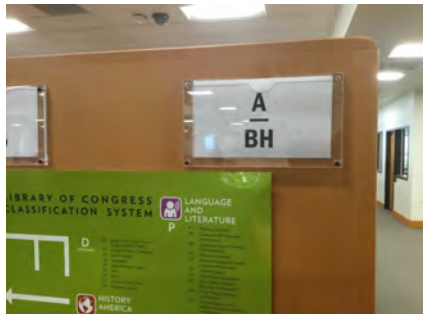
128	<ul style="list-style-type: none"> As-Built Description: Sign does not have non-glare finish and/or good color contrast (dark on light or light on dark). Proposed Solution: Provide compliant signage. 	PCODE SA03 ADAAG 91 4.30.5 ADA 2010 703.5.1 CBC 2007 1117B.5.5 CBC 2016 11B-403.5.1 Mitigated: <input type="radio"/> YES <input checked="" type="radio"/> NO	22	JOB	\$270	\$5,940

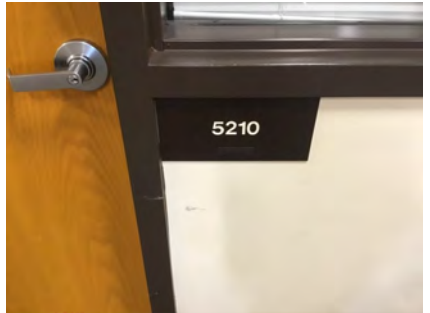
<input type="checkbox"/> Staff Only						
Priority 2 Severity 4						
135	<ul style="list-style-type: none"> As-Built Description: Signs containing tactile characters is not located so that a clear floor space of 18" min x 18" min., centered on the tactile characters, is provided beyond the arc of any door swing between the closed position and 45 degree open position. As-Built: 33.5" to bottom of lowest tactile character Proposed Solution: Relocate compliant signage on latch side of door located at compliant height with a clear floor space. 	PCODE SA07B ADA 2010 703.4.2 CBC 2016 11B-703.4.2 Mitigated: <input type="radio"/> YES <input checked="" type="radio"/> NO	3	JOB	\$150	\$450

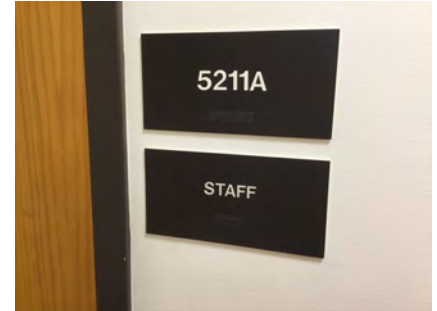
Item no., Rm no. and Name	Existing Architectural Barrier and Proposed Solution	Codes / Mitigation Info	Qty	Unit	Cost	Total
136	<ul style="list-style-type: none"> • <i>As-Built Description:</i> Braille symbols: dots are not 1/10" on centers in each cell with 2/10" space between cells. • <i>As-Built:</i> 1.125" space between braille and tactile • <i>Proposed Solution:</i> CA only - Provide new compliant signage including Contracted Grade 2 Braille with Title 24 spacing requirements - 1/10" on center dots with 2/10" space between cells. 	PCODE SA07C CBC 2007 1117B.5.6 CBC 2016 11B-703.3 Mitigated: <input type="radio"/> YES <input checked="" type="radio"/> NO	15	JOB	\$450	\$6,750

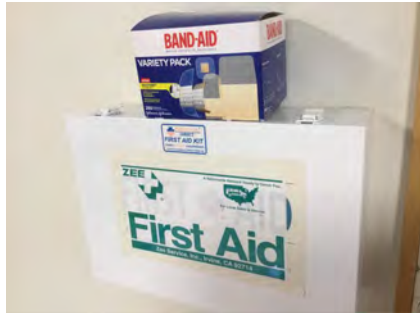
Item no., Rm no. and Name	Existing Architectural Barrier and Proposed Solution	Codes / Mitigation Info	Qty	Unit	Cost	Total
Reach Range						
138	<ul style="list-style-type: none"> As-Built Description: Reach height to control or access point, where side approach is available, exceeds 48" or is less than 15" in height, or exceeds 10" in depth. As-Built: 67" above finished floor Proposed Solution: Modify equipment or mounting. 	PCODE IE02 ADAAG 91 4.2.6 ADA 2010 308.3.1 CBC 2007 1118B.6 CBC 2016 11B-308.3 Mitigated: <input type="radio"/> YES <input checked="" type="radio"/> NO	1	JOB	\$300	\$300

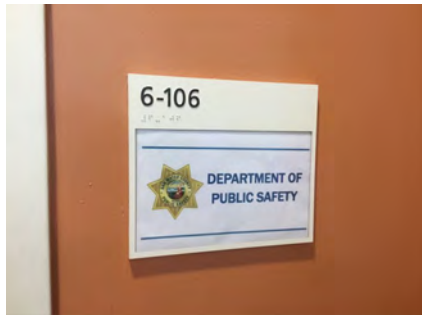
Item no., Rm no. and Name	Existing Architectural Barrier and Proposed Solution	Codes / Mitigation Info	Qty	Unit	Cost	Total
Signage						
188	<ul style="list-style-type: none"> As-Built Description: Signs containing tactile characters is not located so that a clear floor space of 18" min x 18" min., centered on the tactile characters, is provided beyond the arc of any door swing between the closed position and 45 degree open position. As-Built: 62.5" to the bottom of the highest tactile character Proposed Solution: Relocate compliant signage on latch side of door located at compliant height with a clear floor space. Notes: 60" to the center of the sign. 	PCODE SA07BREF ADAAG 91 4.30.6 ADA 2010 703.4.2 CBC 2007 1117B.5.7 CBC 2016 11B-703.4.2 Mitigated: <input type="radio"/> YES <input checked="" type="radio"/> NO				
			REF

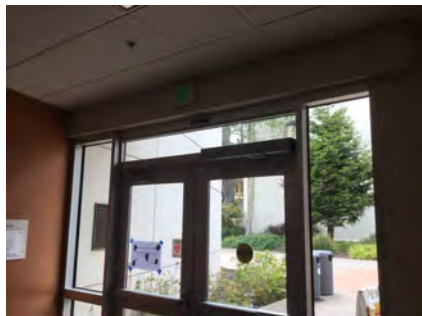
2		4	
163	<ul style="list-style-type: none"> As-Built Description: At final exit door to exterior: Where required exit signs are installed, signs to provide exiting information for people with vision impairment are not provided. Proposed Solution: Provide raised letter/Braille "EXIT" sign at door. 	PCODE SA10A ADAAG 91 4.1.3(16) ADA 2010 216.4.1 CBC 2007 1011.3 CBC 2016 11B-216.4.1 Mitigated: <input type="radio"/> YES <input checked="" type="radio"/> NO				
			6 JOB \$270 \$1,620

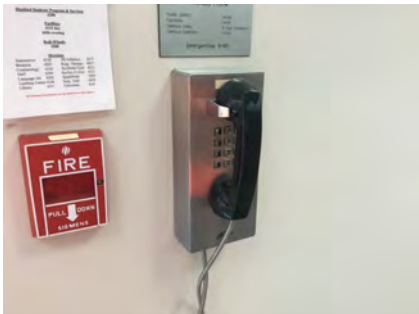
Item no., Rm no. and Name	Existing Architectural Barrier and Proposed Solution	Codes / Mitigation Info	Qty	Unit	Cost	Total
TTY						
166	<ul style="list-style-type: none">• <i>As-Built Description:</i> Interior public text telephone (TTY) not provided at type of facility required to have a public text telephone.• <i>Proposed Solution:</i> Provide text telephone.• <i>Notes:</i> No TTY	<p>PCODE IB10</p> <p>ADAAG 91 4.1.3(17)(c)</p> <p>ADA 2010 216.9</p> <p>CBC 2007 1117B.2.9.1</p> <p>CBC 2016 11B-216.9</p> <p>Mitigated:</p> <p><input type="radio"/> YES</p> <p><input checked="" type="radio"/> NO</p>	1	JOB	\$3,450	\$3,450

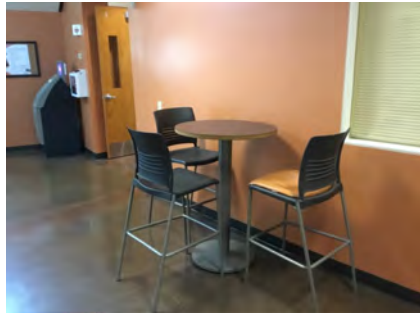
Item no., Rm no. and Name	Existing Architectural Barrier and Proposed Solution	Codes / Mitigation Info	Qty	Unit	Cost	Total
Non-Fixed Desk						
167	<ul style="list-style-type: none"> As-Built Description: Accessible non-fixed table or desk (top 28" to 34" high; knee space at least 27" high x 19" deep x 30" wide) not provided. As-Built: 42" to top. Five separate dining areas with high tables. Five accessible tables required. Proposed Solution: Provide table or desk with accessible dimensions when purchasing new furniture. 	PCODE IN02A ADAAG 91 4.32.3 & .4 ADA 2010 306.1 CBC 2007 1122B.3 & 4 CBC 2016 11B-306.1 & 11B-902.3 Mitigated: <input type="radio"/> YES <input checked="" type="radio"/> NO	5	JOB	\$4,800	\$24,000

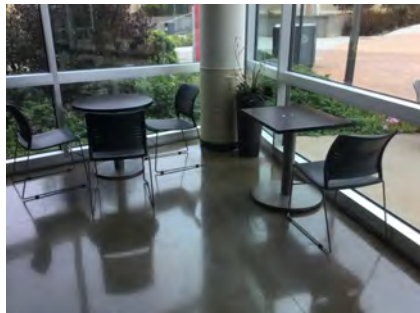
<input type="checkbox"/> Staff Only Priority 2 Severity 2			
168	<ul style="list-style-type: none"> As-Built Description: Accessible non-fixed table or desk (top 28" to 34" high; knee space at least 27" high x 19" deep x 30" wide) not provided. As-Built: 120 seats 0 accessible Proposed Solution: Provide table or desk with accessible dimensions when purchasing new furniture. Notes: Occurs in south dining area 	PCODE IN02A ADAAG 91 4.32.3 & .4 ADA 2010 306.1 CBC 2007 1122B.3 & 4 CBC 2016 11B-306.1 & 11B-902.3 Mitigated: <input type="radio"/> YES <input checked="" type="radio"/> NO	1	JOB	\$4,800	\$4,800

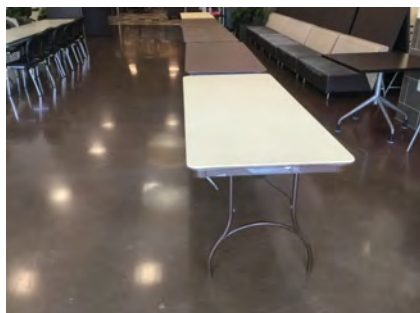
<input type="checkbox"/> Staff Only Priority 2 Severity 2			
169	<ul style="list-style-type: none"> As-Built Description: Accessible non-fixed table or desk (top 28" to 34" high; knee space at least 27" high x 19" deep x 30" wide) not provided. As-Built: 112 seats at portable tables. 0 accessible. 26.5" knee clearance. Proposed Solution: Provide table or desk with accessible dimensions when purchasing new furniture. 	PCODE IN02A ADAAG 91 4.32.3 & .4 ADA 2010 306.1 CBC 2007 1122B.3 & 4 CBC 2016 11B-306.1 & 11B-902.3 Mitigated: <input type="radio"/> YES <input checked="" type="radio"/> NO	1	JOB	\$4,800	\$4,800

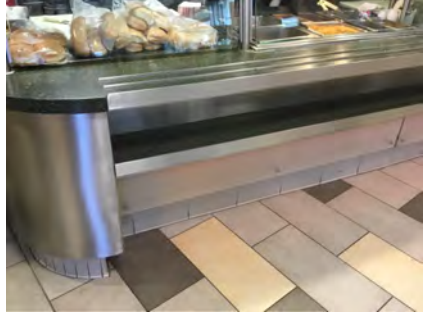
Item no., Rm no. and Name	Existing Architectural Barrier and Proposed Solution	Codes / Mitigation Info	Qty	Unit	Cost	Total
173	<ul style="list-style-type: none"> As-Built Description: Counters, shelves, equipment are not accessible to disabled persons (required: tray slides 34" high maximum; at least 50% of shelves less than 48" high). As-Built: Tray slide 36" AFF Proposed Solution: Provide new counter and shelves. 	PCODE FB02 ADAAG 91 5.5 ADA 2010 227.4 CBC 2007 1104B.5.5 CBC 2016 11B-227.4 Mitigated: <input type="radio"/> YES <input checked="" type="radio"/> NO	50	LF	\$1,200	\$60,000

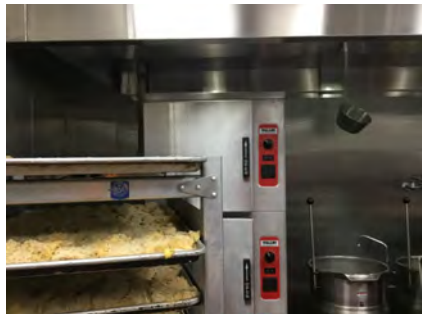
Item no., Rm no. and Name	Existing Architectural Barrier and Proposed Solution	Codes / Mitigation Info	Qty	Unit	Cost	Total
179	<ul style="list-style-type: none"> As-Built Description: Reach height to control or access point, where side approach is available, exceeds 48" or is less than 15" in height, or exceeds 10" in depth. As-Built: 66" high, varies Proposed Solution: Modify equipment or mounting. Notes: Occurs throughout at specialty equipment. 	PCODE IE02 ADAAG 91 4.2.6 ADA 2010 308.3.1 CBC 2007 1118B.6 CBC 2016 11B-308.3 Mitigated: <input type="radio"/> YES <input checked="" type="radio"/> NO	1	JOB	\$300	\$300

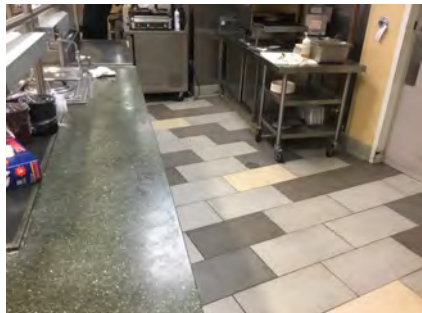
177	<ul style="list-style-type: none"> As-Built Description: Accessible fixed table or desk (top 28" to 34" high; knee space at least 27" high x 19" deep x 30" wide) not provided. As-Built: 36" to top. No knee clearance. Proposed Solution: Provide new fixed accessible table or desk. Notes: Occurs at multiple work surfaces, food prep areas, serving areas and washing areas. 	PCODE IN02 ADAAG 91 4.32.3 & .4 ADA 2010 306.1 & 902.3 CBC 2007 1122B.3 & 4 CBC 2016 11B-306.1 & 11B-902.3 Mitigated: <input type="radio"/> YES <input checked="" type="radio"/> NO	12	JOB	\$7,500	\$90,000

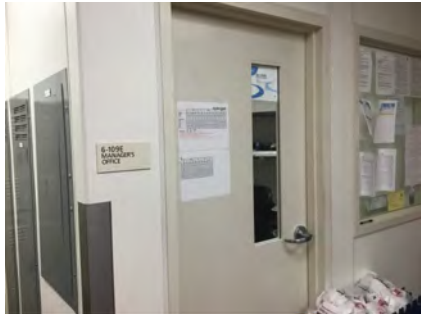
Item no., Rm no. and Name	Existing Architectural Barrier and Proposed Solution	Codes / Mitigation Info	Qty	Unit	Cost	Total
Signage						
189	<ul style="list-style-type: none">• <i>As-Built Description:</i> Sign not located on latch side of door and/or not located at 48" min. above to baseline of the lowest Braille cells and 60" max. to baseline of the highest line of raised characters.• <i>Proposed Solution:</i> Provide compliant signage including tactile characters and Grade II Braille on latch side of door located at compliant height.	<p>PCODE SA07 ADAAG 91 4.30.6 ADA 2010 703.4.1 CBC 2007 1117B.5.7 CBC 2016 11B-703.4.1</p> <p>Mitigated: <input type="radio"/> YES <input checked="" type="radio"/> NO</p>	1	JOB	\$150	\$150

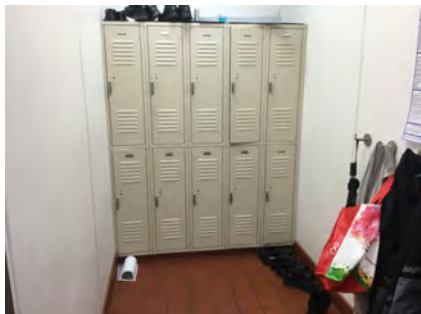
<input type="checkbox"/> Staff Only			
			Priority 2 Severity 3			
Locker Facilities						
180	<ul style="list-style-type: none">• <i>As-Built Description:</i> No section of bench provided adjacent to designated accessible locker, measuring minimum 20-24" deep, 48" wide, and 17-19" high, and fixed to a wall along the longer dimension.• <i>Proposed Solution:</i> Provide a new bench, fixed to a wall along the longer dimension, close to the accessible locker.• Notes: No accessible benches at lockers.	<p>PCODE GG03 ADAAG 91 4.35.4 ADA 2010 803.4 CBC 2007 1117B.8 CBC 2016 11B-803.4</p> <p>Mitigated: <input type="radio"/> YES <input checked="" type="radio"/> NO</p>	1	JOB	\$2,250	\$2,250

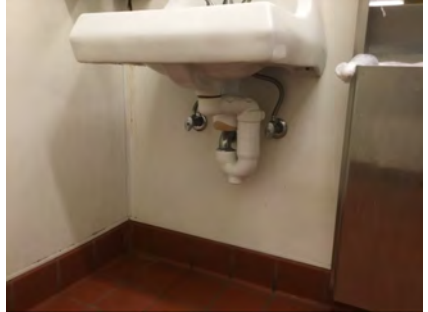
Item no., Rm no. and Name	Existing Architectural Barrier and Proposed Solution	Codes / Mitigation Info	Qty	Unit	Cost	Total
182	<ul style="list-style-type: none"> • <i>As-Built Description:</i> Hot or sharp-surfaced water/drain pipe not insulated or covered. • <i>Proposed Solution:</i> Insulate or cover water/drain pipe. 	PCODE WD05REF ADAAG 91 4.19.4 ADA 2010 606.5 CBC 2007 1115B.4.3.4 CBC 2016 11B-606.5 Mitigated: <input type="radio"/> YES <input checked="" type="radio"/> NO	REF

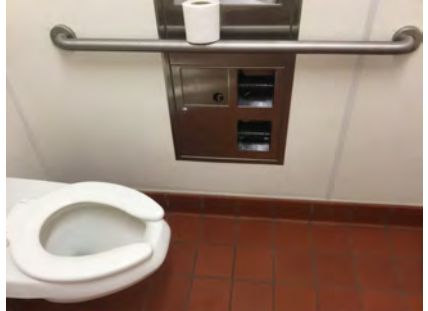
186	<ul style="list-style-type: none"> • <i>As-Built Description:</i> Toilet paper dispenser less than 15" (CA: 19") or more than 48" above floor or not within 7" to 9" from front of water closet (Note: CA pre-2010 is allowed within 12" from front of water closet). • <i>As-Built:</i> 10" from the front of the water closet • <i>Proposed Solution:</i> Relocate or provide new toilet paper dispenser. 	PCODE WG02 ADAAG 91 4.16.6 ADA 2010 604.7 CBC 2007 1115B.8.4 CBC 2016 11B-604.7 Mitigated: <input type="radio"/> YES <input checked="" type="radio"/> NO	1	JOB	\$225	\$225

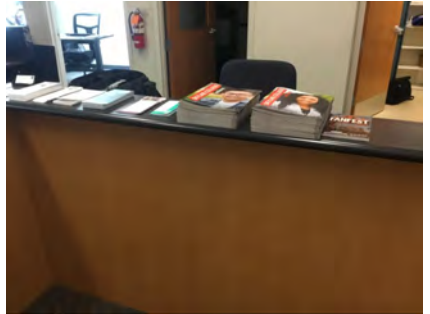
Item no., Rm no. and Name	Existing Architectural Barrier and Proposed Solution	Codes / Mitigation Info	Qty	Unit	Cost	Total
Public Counter						
191	<ul style="list-style-type: none"> • <i>As-Built Description:</i> Service counter (stand-up): Accessible section min. 36" length and 36" max. height (in CA: 28" to 34" high) not provided. • <i>As-Built:</i> 42" • <i>Proposed Solution:</i> Retrofit existing counter to provide accessible section. Interim solution: Provide auxiliary counter, table, or clipboard. 	PCODE IN03 ADAAG 91 7.2(2) ADA 2010 904.4 CBC 2007 1122B.4 CBC 2016 11B-904.4 Mitigated: <input type="radio"/> YES <input checked="" type="radio"/> NO	1	JOB	\$6,000	\$6,000

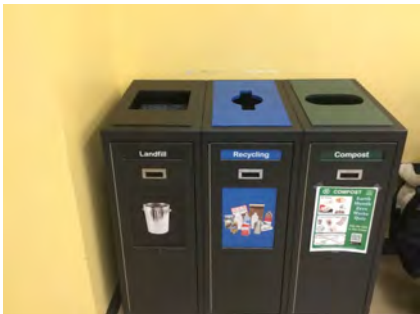
Item no., Rm no. and Name	Existing Architectural Barrier and Proposed Solution	Codes / Mitigation Info	Qty	Unit	Cost	Total
<u>Reach Range</u>						
196	<ul style="list-style-type: none">As-Built Description: Reach height to control or access point, where side approach is available, exceeds 48" or is less than 15" in height, or exceeds 10" in depth.As-Built: 37.5" high obstructionProposed Solution: Modify equipment or mounting.	PCODE IE02 ADAAG 91 4.2.6 ADA 2010 308.3.1 CBC 2007 1118B.6 CBC 2016 11B-308.3 Mitigated: <input type="radio"/> YES <input checked="" type="radio"/> NO	1	JOB	\$300	\$300

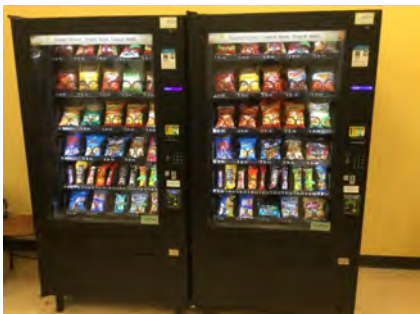
<input type="checkbox"/> Staff Only			
			Priority	Severity		
			2	4		
<u>Vending Machine</u>						
197	<ul style="list-style-type: none">As-Built Description: Vending machine coin slot or dispensing outlet, for forward reach, more than 48" above the floor.As-Built: 11" to the bottom of the dispensing trayProposed Solution: Advise vendor/leasing company to provide accessible vending machine.	PCODE IL02REF ADAAG 91 4.2.5 ADA 2010 308.2.1 CBC 2007 1126B CBC 2016 11B-308.2.1 Mitigated: <input type="radio"/> YES <input checked="" type="radio"/> NO	2	REF

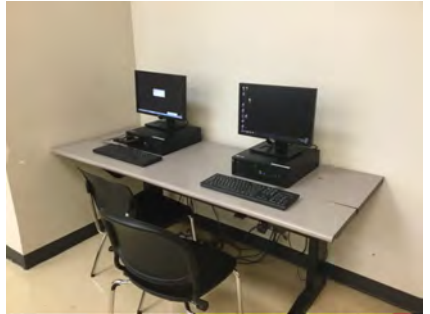
Item no., Rm no. and Name	Existing Architectural Barrier and Proposed Solution	Codes / Mitigation Info	Qty	Unit	Cost	Total
Non-Fixed Desk						
195	<ul style="list-style-type: none"> • <i>As-Built Description:</i> Accessible non-fixed table or desk (top 28" to 34" high; knee space at least 27" high x 19" deep x 30" wide) not provided. • <i>As-Built:</i> 15" deep • <i>Proposed Solution:</i> Provide table or desk with accessible dimensions when purchasing new furniture. 	PCODE IN02A ADAAG 91 4.32.3 & .4 ADA 2010 306.1 CBC 2007 1122B.3 & 4 CBC 2016 11B-306.1 & 11B-902.3	1	JOB	\$4,800	\$4,800
Mitigated: <input type="radio"/> YES <input checked="" type="radio"/> NO

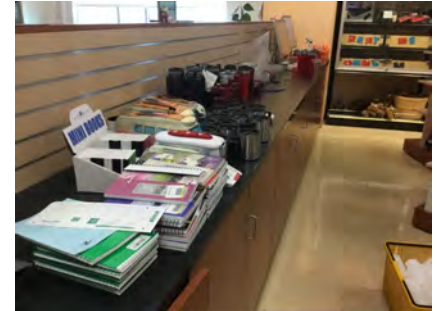
Item no., Rm no. and Name	Existing Architectural Barrier and Proposed Solution	Codes / Mitigation Info	Qty	Unit	Cost	Total
202	<ul style="list-style-type: none"> • <i>As-Built Description:</i> Service counter (stand-up): Accessible section min. 36" length and 36" max. height (in CA: 28" to 34" high) not provided. • <i>As-Built:</i> 36" • <i>Proposed Solution:</i> Retrofit existing counter to provide accessible section. Interim solution: Provide auxiliary counter, table, or clipboard. 	PCODE IN03 ADAAG 91 7.2(2) ADA 2010 904.4 CBC 2007 1122B.4 CBC 2016 11B-904.4 Mitigated: <input type="radio"/> YES <input checked="" type="radio"/> NO	1	JOB	\$6,000	\$6,000

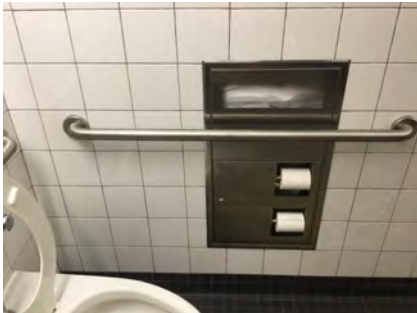
Item no., Rm no. and Name	Existing Architectural Barrier and Proposed Solution	Codes / Mitigation Info	Qty	Unit	Cost	Total
Grab Bars						
215	<ul style="list-style-type: none">As-Built Description: Side grab bar less than 42" long, or located more than 12 inches max. from the rear wall, or extending less than 54" from rear wall (CA only: front end min. 24" in front of water closet).As-Built: Side grab bar extend 51.5" from rewardsProposed Solution: Provide or relocate accessible side grab bar.	PCODE WB07A ADAAG 91 Fig. 29(b) ADA 2010 604.5.1 CBC 2007 1115B.4.1.3.1 CBC 2016 11B-604.5.1 Mitigated: <input type="radio"/> YES <input checked="" type="radio"/> NO	1	JOB	\$780	\$780

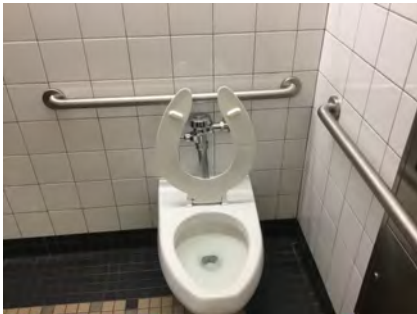
<input type="checkbox"/> Staff Only			
			Priority	Severity		
			3	3		
217	<ul style="list-style-type: none">As-Built Description: The rear wall grab is less than 36" min. or does not extend from the centerline of the water closet 12" min. on one side and 24" min. on the other side.As-Built: 21.5" on the wide sideProposed Solution: Provide accessible rear grab bar.Notes: 3.25" from the side wall.	PCODE WB07BREF ADAAG 91 4.17.6 ADA 2010 604.5.2 CBC 2007 1115B.4.1.3.2 CBC 2016 11B-604.5.2 Mitigated: <input type="radio"/> YES <input checked="" type="radio"/> NO		REF

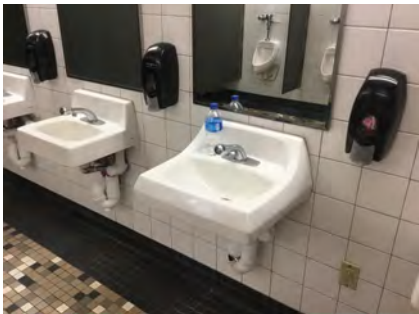
Item no., Rm no. and Name	Existing Architectural Barrier and Proposed Solution	Codes / Mitigation Info	Qty	Unit	Cost	Total
212	<ul style="list-style-type: none">As-Built Description: Lavatory: Self-closing faucet at accessible lavatory does not remain open for at least 10 seconds.As-Built: Automatic faucet remains open for 3 secondsProposed Solution: Adjust self-closing faucet at accessible lavatory.	PCODE WD07 ADAAG 91 4.19.5 ADA 2010 606.4 CBC 2007 1115B.4.3 CBC 2016 11B-606.4 Mitigated: <div><input type="radio"/> YES</div> <div><input checked="" type="radio"/> NO</div>	1	JOB	\$150	\$150

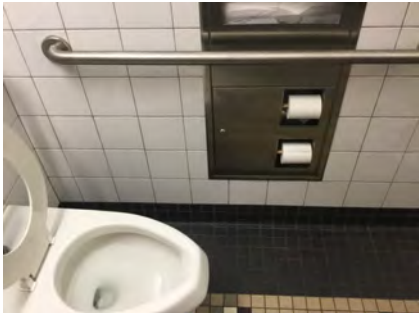
<div><input type="checkbox"/> Staff Only</div>			
			<div>Priority<div>3</div>Severity<div>3</div></div>			
Accessories						
216	<ul style="list-style-type: none">As-Built Description: Toilet paper dispenser less than 15" (CA: 19") or more than 48" above floor or not within 7" to 9" from front of water closet (Note: CA pre-2010 is allowed within 12" from front of water closet).As-Built: 12" from the front of the water closetProposed Solution: Relocate or provide new toilet paper dispenser.	PCODE WG02 ADAAG 91 4.16.6 ADA 2010 604.7 CBC 2007 1115B.8.4 CBC 2016 11B-604.7 Mitigated: <div><input type="radio"/> YES</div> <div><input checked="" type="radio"/> NO</div>	1	JOB	\$225	\$225

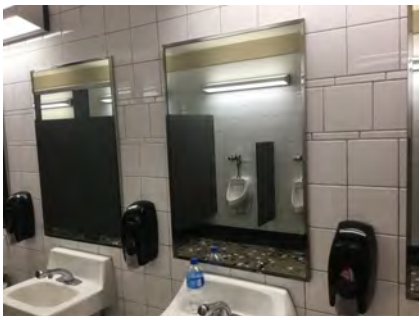
<div><input type="checkbox"/> Staff Only</div>			
			<div>Priority<div>3</div>Severity<div>3</div></div>			
211	<ul style="list-style-type: none">As-Built Description: Bottom of mirror located above lavatories or countertops more than 40" above floor.As-Built: 40.25"Proposed Solution: Relocate or provide new accessible mirror.	PCODE WG03 ADAAG 91 4.19.6 ADA 2010 603.3 CBC 2007 1115B.8.1 CBC 2016 11B-603.3 Mitigated: <div><input type="radio"/> YES</div> <div><input checked="" type="radio"/> NO</div>	1	JOB	\$450	\$450

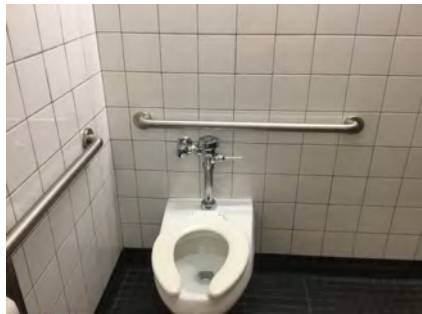
Item no., Rm no. and Name	Existing Architectural Barrier and Proposed Solution	Codes / Mitigation Info	Qty	Unit	Cost	Total
228	<ul style="list-style-type: none"> As-Built Description: Accessories/dispensers in accessible stall located closer than 1-1/2" below or 12" above grab bar impedes its use. As-Built: 1.25" below the rear grab bar Proposed Solution: Raise the grab bar. 	PCODE WB07I ADAAG 91 4.26.2 ADA 2010 609.3 CBC 2007 1133B.4.2.5 CBC 2016 11B-609.3 Mitigated: <input type="radio"/> YES <input checked="" type="radio"/> NO	1	JOB	\$225	\$225

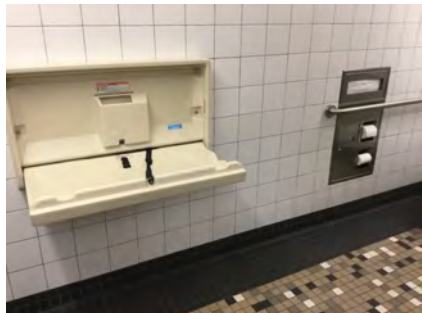
225	<ul style="list-style-type: none"> As-Built Description: Baby changing tables shall not be located in accessible toilet compartments. As-Built: Changing table is 59" from the compartment door Proposed Solution: Relocate baby changing table outside of accessible toilet compartment. 	PCODE WB01C CBC 2016 11B-226.4 Mitigated: <input type="radio"/> YES <input checked="" type="radio"/> NO	1	JOB	\$300	\$300

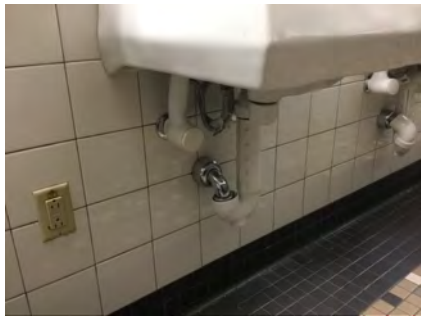
Item no., Rm no. and Name	Existing Architectural Barrier and Proposed Solution	Codes / Mitigation Info	Qty	Unit	Cost	Total
220	<ul style="list-style-type: none">• <i>As-Built Description:</i> Hot or sharp-surfaced water/drain pipe not insulated or covered.• <i>Proposed Solution:</i> Insulate or cover water/drain pipe.	<p>PCODE WD05REF</p> <p>ADAAG 91 4.19.4</p> <p>ADA 2010 606.5</p> <p>CBC 2007 1115B.4.3.4</p> <p>CBC 2016 11B-606.5</p> <p>Mitigated:</p> <p><input type="radio"/> YES</p> <p><input checked="" type="radio"/> NO</p>

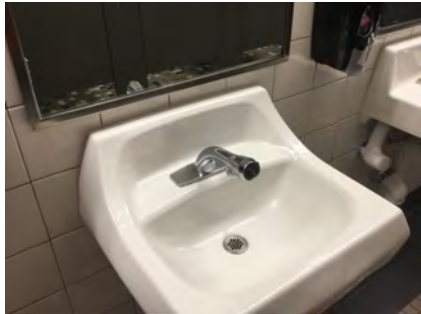
<input type="checkbox"/> Staff Only			
			Priority	Severity		
			<input checked="" type="radio"/> 3	<input checked="" type="radio"/> 3		
222	<ul style="list-style-type: none">• <i>As-Built Description:</i> Lavatory: Self-closing faucet at accessible lavatory does not remain open for at least 10 seconds.• <i>As-Built:</i> 5 seconds• <i>Proposed Solution:</i> Adjust self-closing faucet at accessible lavatory.	<p>PCODE WD07</p> <p>ADAAG 91 4.19.5</p> <p>ADA 2010 606.4</p> <p>CBC 2007 1115B.4.3</p> <p>CBC 2016 11B-606.4</p> <p>Mitigated:</p> <p><input type="radio"/> YES</p> <p><input checked="" type="radio"/> NO</p>	1	JOB	\$150	\$150

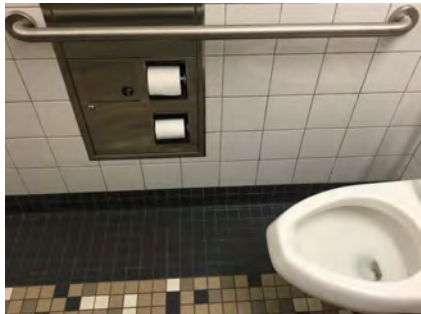
<input type="checkbox"/> Staff Only			
			Priority	Severity		
			<input checked="" type="radio"/> 3	<input checked="" type="radio"/> 3		
Accessories						
226	<ul style="list-style-type: none">• <i>As-Built Description:</i> Toilet paper dispenser less than 15" (CA: 19") or more than 48" above floor or not within 7" to 9" from front of water closet (Note: CA pre-2010 is allowed within 12" from front of water closet).• <i>As-Built:</i> 11" from the front of the water closet• <i>Proposed Solution:</i> Relocate or provide new toilet paper dispenser.	<p>PCODE WG02</p> <p>ADAAG 91 4.16.6</p> <p>ADA 2010 604.7</p> <p>CBC 2007 1115B.8.4</p> <p>CBC 2016 11B-604.7</p> <p>Mitigated:</p> <p><input type="radio"/> YES</p> <p><input checked="" type="radio"/> NO</p>	1	JOB	\$225	\$225
