SAN MATEO COUNTY
COMMUNITY
COLLEGE DISTRICT

San Mateo County Community College District Americans with Disabilities Act Self-Evaluation and Transition Plan

Report Prepared by:

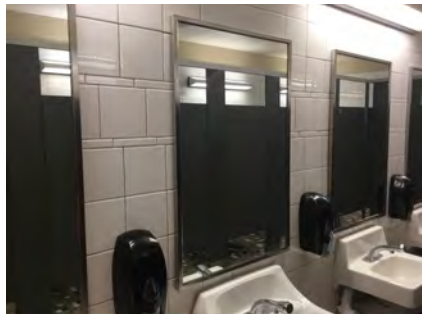
Item no., Rm no. and Name	Existing Architectural Barrier and Proposed Solution	Codes / Mitigation Info	Qty	Unit	Cost	Total
221	<ul style="list-style-type: none"> • <i>As-Built Description:</i> Bottom of mirror located above lavatories or countertops more than 40" above floor. • <i>As-Built:</i> 40.5" • <i>Proposed Solution:</i> Relocate or provide new accessible mirror. 	PCODE WG03 ADAAG 91 4.19.6 ADA 2010 603.3 CBC 2007 1115B.8.1 CBC 2016 11B-603.3 Mitigated: <input type="radio"/> YES <input checked="" type="radio"/> NO	1	JOB	\$450	\$450

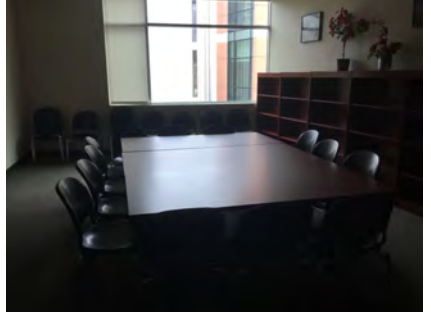
Item no., Rm no. and Name	Existing Architectural Barrier and Proposed Solution	Codes / Mitigation Info	Qty	Unit	Cost	Total
235	<ul style="list-style-type: none"> • <i>As-Built Description:</i> No signs at the building or assembly area entrance to notify patrons that an assistive listening system is available. • <i>Proposed Solution:</i> Provide assistive listening signage. 	PCODE GI02 ADAAG 91 4.1.3(19)(b) ADA 2010 703.7.2.4 CBC 2007 1104B.2.4 CBC 2016 11B-703.7.2.4 Mitigated: <input type="radio"/> YES <input checked="" type="radio"/> NO	1	JOB	\$300	\$300

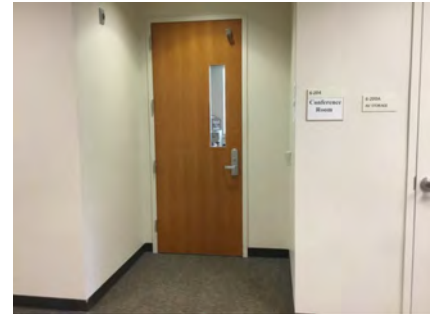
Provide assistive listening signage.

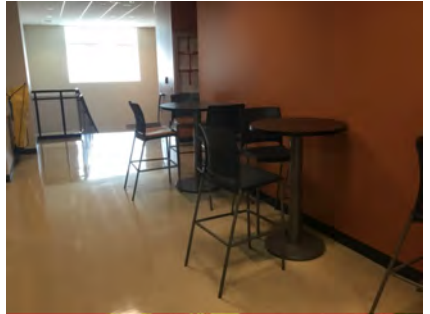
Item no., Rm no. and Name	Existing Architectural Barrier and Proposed Solution	Codes / Mitigation Info	Qty	Unit	Cost	Total
Non-Fixed Desk						
272	<ul style="list-style-type: none"> • <i>As-Built Description:</i> Accessible non-fixed table or desk (top 28" to 34" high; knee space at least 27" high x 19" deep x 30" wide) not provided. • <i>As-Built:</i> 42" to top. 9 seats 0 accessible. • <i>Proposed Solution:</i> Provide table or desk with accessible dimensions when purchasing new furniture. 	PCODE IN02A ADAAG 91 4.32.3 & .4 ADA 2010 306.1 CBC 2007 1122B.3 & 4 CBC 2016 11B-306.1 & 11B-902.3	1	JOB	\$4,800	\$4,800
Mitigated: <input type="radio"/> YES <input checked="" type="radio"/> NO

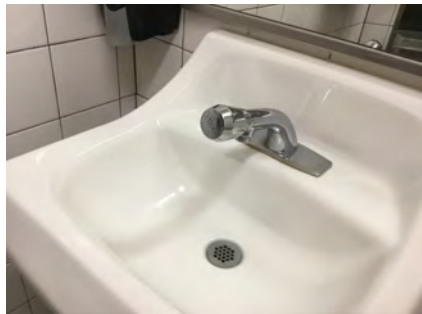
Item no., Rm no. and Name	Existing Architectural Barrier and Proposed Solution	Codes / Mitigation Info	Qty	Unit	Cost	Total
255	<ul style="list-style-type: none"> As-Built Description: Lavatory: Self-closing faucet at accessible lavatory does not remain open for at least 10 seconds. As-Built: 2 seconds Proposed Solution: Adjust self-closing faucet at accessible lavatory. 	PCODE WD07 ADAAG 91 4.19.5 ADA 2010 606.4 CBC 2007 1115B.4.3 CBC 2016 11B-606.4 Mitigated: <input type="radio"/> YES <input checked="" type="radio"/> NO	1	JOB	\$150	\$150

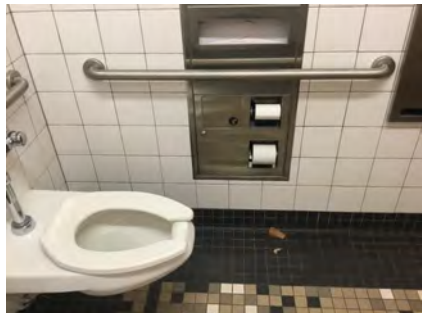
250	<ul style="list-style-type: none"> As-Built Description: Toilet paper dispenser less than 15" (CA: 19") or more than 48" above floor or not within 7" to 9" from front of water closet (Note: CA pre-2010 is allowed within 12" from front of water closet). As-Built: 10" from the front of the water closet Proposed Solution: Relocate or provide new toilet paper dispenser. 	PCODE WG02 ADAAG 91 4.16.6 ADA 2010 604.7 CBC 2007 1115B.8.4 CBC 2016 11B-604.7 Mitigated: <input type="radio"/> YES <input checked="" type="radio"/> NO	1	JOB	\$225	\$225

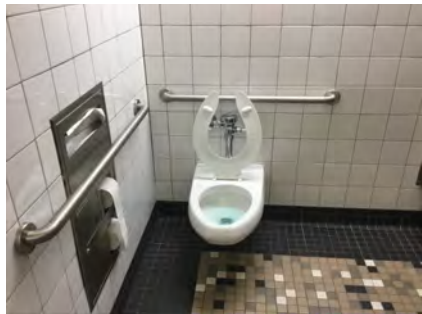
Item no., Rm no. and Name	Existing Architectural Barrier and Proposed Solution	Codes / Mitigation Info	Qty	Unit	Cost	Total
261	<ul style="list-style-type: none"> As-Built Description: The rear wall grab is less than 36" min. or does not extend from the centerline of the water closet 12" min. on one side and 24" min. on the other side. As-Built: 22" on the wide side Proposed Solution: Provide accessible rear grab bar. 	PCODE WB07BREF ADAAG 91 4.17.6 ADA 2010 604.5.2 CBC 2007 1115B.4.1.3.2 CBC 2016 11B-604.5.2 Mitigated: <input type="radio"/> YES <input checked="" type="radio"/> NO	REF

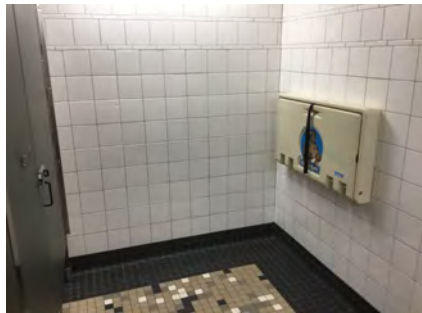
260	<ul style="list-style-type: none"> As-Built Description: Baby changing tables shall not be located in accessible toilet compartments. Proposed Solution: Relocate baby changing table outside of accessible toilet compartment. Notes: Baby changing table is also 59" from the door on the pull side. 	PCODE WB01C CBC 2016 11B-226.4 Mitigated: <input type="radio"/> YES <input checked="" type="radio"/> NO	1	JOB	\$300	\$300

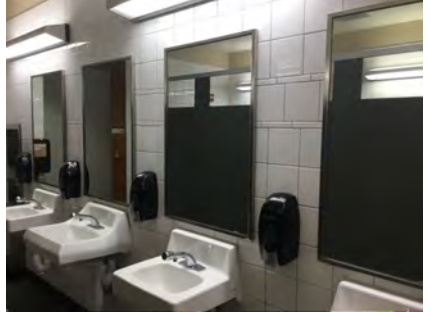
Item no., Rm no. and Name	Existing Architectural Barrier and Proposed Solution	Codes / Mitigation Info	Qty	Unit	Cost	Total
257	<ul style="list-style-type: none"> • <i>As-Built Description:</i> Bottom of mirror located above lavatories or countertops more than 40" above floor. • <i>As-Built:</i> 40.25" • <i>Proposed Solution:</i> Relocate or provide new accessible mirror. 	PCODE WG03 ADAAG 91 4.19.6 ADA 2010 603.3 CBC 2007 1115B.8.1 CBC 2016 11B-603.3 Mitigated: <input type="radio"/> YES <input checked="" type="radio"/> NO	1	JOB	\$450	\$450

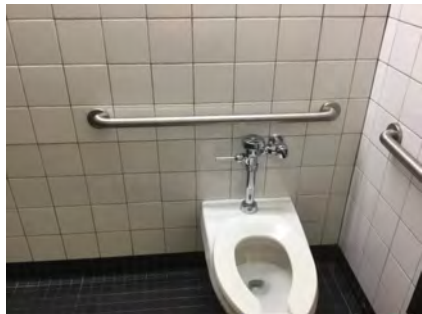
Item no., Rm no. and Name	Existing Architectural Barrier and Proposed Solution	Codes / Mitigation Info	Qty	Unit	Cost	Total
270	<ul style="list-style-type: none"> As-Built Description: The rear wall grab is less than 36" min. or does not extend from the centerline of the water closet 12" min. on one side and 24" min. on the other side. As-Built: 23.5" on the wide side Proposed Solution: Provide accessible rear grab bar. Notes: If the water closet is relocated closer to the side wall the rear grab bar may then meet current requirements. 	PCODE WB07BREF ADAAG 91 4.17.6 ADA 2010 604.5.2 CBC 2007 1115B.4.1.3.2 CBC 2016 11B-604.5.2 Mitigated: <input type="radio"/> YES <input checked="" type="radio"/> NO		REF		
<div style="text-align: right;">

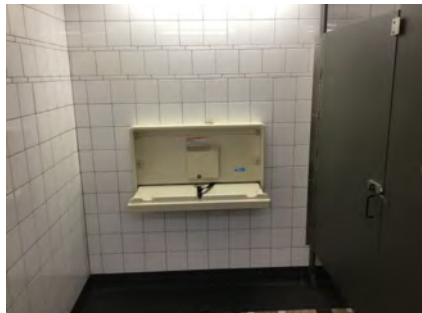
267	<ul style="list-style-type: none"> As-Built Description: Baby changing tables shall not be located in accessible toilet compartments. Proposed Solution: Relocate baby changing table outside of accessible toilet compartment. 	PCODE WB01C CBC 2016 11B-226.4 Mitigated: <input type="radio"/> YES <input checked="" type="radio"/> NO	1	JOB	\$300	\$300
<div style="text-align: right;">

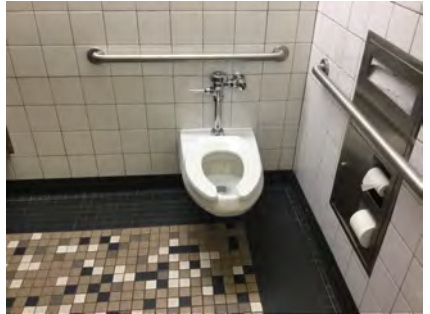
Item no., Rm no. and Name	Existing Architectural Barrier and Proposed Solution	Codes / Mitigation Info	Qty	Unit	Cost	Total
Water Closet						
269	<ul style="list-style-type: none"> • <i>As-Built Description:</i> Water closet not 16"-18" (CA: 17"-18") from near side wall to center line of water closet (2010 ADAAG: 16"-18"). • <i>As-Built:</i> 18.5" • <i>Proposed Solution:</i> Relocate existing water closet and plumbing, remount with offset closet flange to provide 18" max. from side wall. 	PCODE WB02C ADAAG 91 Fig. 28 ADA 2010 604.2 CBC 2007 1115B.4.1.1 CBC 2016 11B-604.2 Mitigated: <input type="radio"/> YES <input checked="" type="radio"/> NO	1	JOB	\$1,500	\$1,500

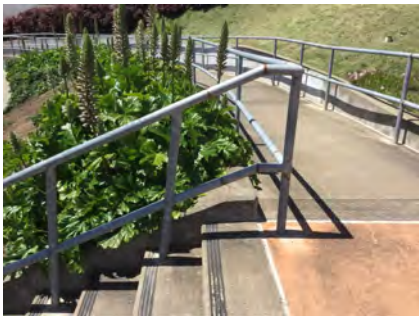
Item no., Rm no. and Name	Existing Architectural Barrier and Proposed Solution	Codes / Mitigation Info	Qty	Unit	Cost	Total
Top & Bottom Extension at Stairs						
928	<ul style="list-style-type: none">• <i>As-Built Description:</i> Stair handrail does not extend horizontally 12" minimum beyond top nosing, and one tread width sloped, plus 12" minimum horizontally beyond the bottom nosing.• <i>Proposed Solution:</i> Extend stair handrail at top and bottom (cost for each extension piece).• <i>Notes:</i> The handrail extension at the top step is not parallel to the landing. And/or at inconsistent height.	<p>PCODE ED06</p> <p>ADAAG 91 4.9.4(2)</p> <p>ADA 2010 505.10.2;</p> <p>CBC 2007 1133B.4.2.2</p> <p>CBC 2016 11B-505.10.2; 11B-505.10.3</p> <p>Mitigated:</p> <p><input type="radio"/> YES</p> <p><input checked="" type="radio"/> NO</p>	4	JOB	\$510	\$2,040

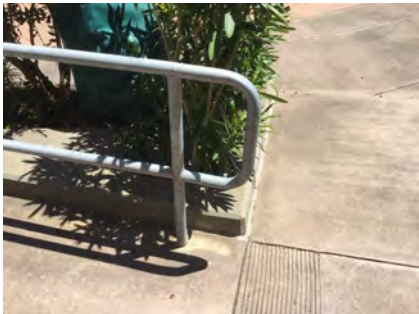
Priority		Severity	
			<input checked="" type="radio"/> 1		<input checked="" type="radio"/> 2	
Top and Bottom Extension at Ramps						
926	<ul style="list-style-type: none">• <i>As-Built Description:</i> Ramp handrail does not extend horizontally 12" past top and / or bottom of ramp.• <i>As-Built:</i> 0" extension• <i>Proposed Solution:</i> Provide ramp handrail extension (cost for each extension piece).	<p>PCODE ED05</p> <p>ADAAG 91 4.8.5(2)</p> <p>ADA 2010 505.10.1</p> <p>CBC 2007 1133B.4.2.2 &</p> <p>CBC 2016 1133B.5.5.1 11B-505.10.1</p> <p>Mitigated:</p> <p><input type="radio"/> YES</p> <p><input checked="" type="radio"/> NO</p>	8	JOB	\$510	\$4,080

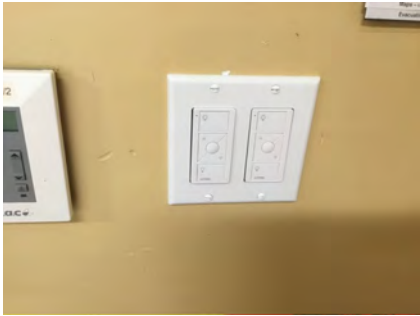
Item no., Rm no. and Name	Existing Architectural Barrier and Proposed Solution	Codes / Mitigation Info	Qty	Unit	Cost	Total
Electrical						
1558	<ul style="list-style-type: none">• <i>As-Built Description:</i> Electric switch or control mounted less than 15" measured to the bottom of the outlet box or greater than 48 inches measured to the top of the outlet box.• <i>As-Built:</i> 48.5" to switch. 49.75" to top of box.• <i>Proposed Solution:</i> Relocate light switches or control to between 15" and 48" height.	<p>PCODE IC01</p> <p>ADAAG 91 4.2.5 & 6</p> <p>ADA 2010 308.2.1 &</p> <p>CBC 2007 1117B.6.3</p> <p>CBC 2016 11B-308.2.1 & 11B-308.2.2</p> <p>Mitigated:</p> <p><input type="radio"/> YES</p> <p><input checked="" type="radio"/> NO</p>	80	JOB	\$900	\$72,000

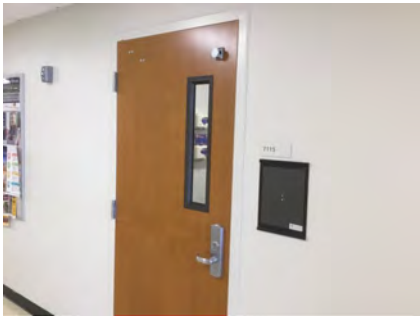
<input type="checkbox"/> Staff Only			
			Priority		Severity	
			2		4	
Door						
1479	<ul style="list-style-type: none">• <i>As-Built Description:</i> Vision Light at door that permits viewing, does not have bottom of at least one glazed panel located 43 inches maximum above the finish floor. (Exception: More than 66" above finished floor.)• <i>As-Built:</i> 47.5" high• <i>Proposed Solution:</i> Provide new door with vision panel at 43" max.	<p>PCODE Id06c</p> <p>ADA 2010 404.2.11</p> <p>CBC 2016 11B-404.2.11</p> <p>Mitigated:</p> <p><input type="radio"/> YES</p> <p><input checked="" type="radio"/> NO</p>	1	JOB	\$7,500	\$7,500

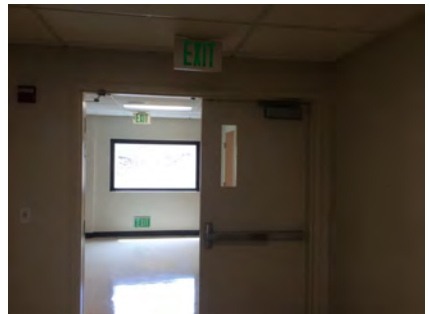
Item no., Rm no. and Name	Existing Architectural Barrier and Proposed Solution	Codes / Mitigation Info	Qty	Unit	Cost	Total
1507	<ul style="list-style-type: none">As-Built Description: Vision Light at door that permits viewing, does not have bottom of at least one glazed panel located 43 inches maximum above the finish floor. (Exception: More than 66" above finished floor.)As-Built: 55.5" highProposed Solution: Provide new door with vision panel at 43" max.	PCODE ID06C ADA 2010 404.2.11 CBC 2016 11B-404.2.11 Mitigated: <div><input type="radio"/> YES</div> <div><input checked="" type="radio"/> NO</div>	1	JOB	\$7,500	\$7,500

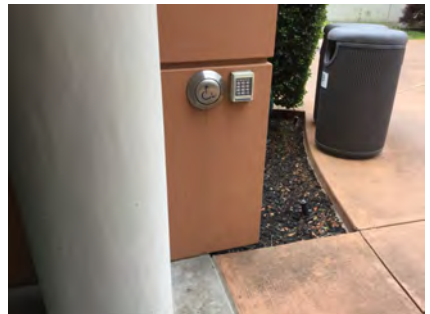
<div><input type="checkbox"/> Staff Only</div>			
			Priority <div><div>2</div></div> Severity <div><div>2</div></div>			
1256	<ul style="list-style-type: none">As-Built Description: Lower push plate located at 7" minimum and 8" maximum above the floor or ground surface not provided.Proposed Solution: Provide lower push plate.	PCODE Id13b CBC 2007 1133B.2.3.2 CBC 2016 11B-404.2.9 2.C Mitigated: <div><input type="radio"/> YES</div> <div><input checked="" type="radio"/> NO</div>	1	JOB	\$1,500	\$1,500

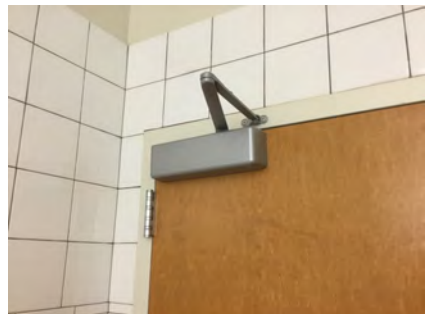
<div><input type="checkbox"/> Staff Only</div>			
			Priority <div><div>2</div></div> Severity <div><div>2</div></div>			
<u>Door Closer</u>						
1651	<ul style="list-style-type: none">As-Built Description: Excessive force required to open door and/or door closing time of less than 5 seconds.As-Built: 1 secondProposed Solution: Provide new door closer adjusted to accessible standards.	PCODE ID03A ADAAG 91 4.13.10 & 11 ADA 2010 404.2.8 & CBC 2007 1133B.2.5.1 CBC 2016 11B-404.2.9 Mitigated: <div><input type="radio"/> YES</div> <div><input checked="" type="radio"/> NO</div>	1	JOB	\$1,125	\$1,125

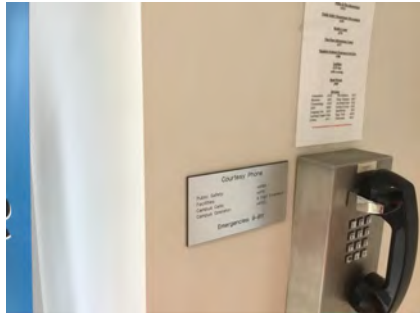
Item no., Rm no. and Name	Existing Architectural Barrier and Proposed Solution	Codes / Mitigation Info	Qty	Unit	Cost	Total
Signage						
1264	<ul style="list-style-type: none"> As-Built Description: Sign characters not readable because they are not sized for viewing distance. As-Built: 0.125" high characters and glare Proposed Solution: Provide compliant signage. 	PCODE SA02A ADAAG 91 4.30.3 ADA 2010 703.5.5 CBC 2007 1117B.5.4 CBC 2016 11B-703.4.2 Mitigated: <input type="radio"/> YES <input checked="" type="radio"/> NO	6	JOB	\$270	\$1,620

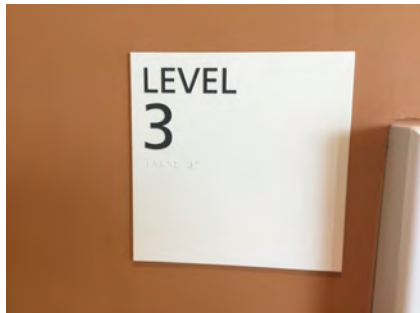
<input type="checkbox"/> Staff Only Priority 2 Severity 4			
1261	<ul style="list-style-type: none"> As-Built Description: Signs containing tactile characters is not located so that a clear floor space of 18" min x 18" min., centered on the tactile characters, is provided beyond the arc of any door swing between the closed position and 45 degree open position. As-Built: 62.75" to bottom of highest tactile character. 60" to center of sign. Proposed Solution: Relocate compliant signage on latch side of door located at compliant height with a clear floor space. 	PCODE SA07B ADA 2010 703.4.2 CBC 2016 11B-703.4.2 Mitigated: <input type="radio"/> YES <input checked="" type="radio"/> NO	1	JOB	\$150	\$150

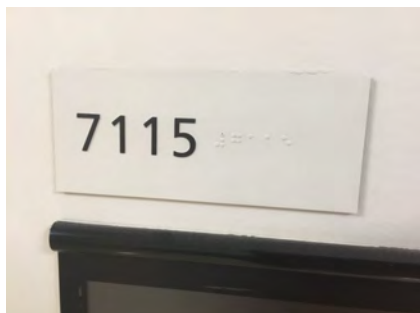
<input type="checkbox"/> Staff Only Priority 2 Severity 4			
1480	<ul style="list-style-type: none"> As-Built Description: Braille symbols: dots are not 1/10" on centers in each cell with 2/10" space between cells. Proposed Solution: CA only - Provide new compliant signage including Contracted Grade 2 Braille with Title 24 spacing requirements - 1/10" on center dots with 2/10" space between cells. Notes: Braille not below. 	PCODE SA07C CBC 2007 1117B.5.6 CBC 2016 11B-703.3 Mitigated: <input type="radio"/> YES <input checked="" type="radio"/> NO	1	JOB	\$450	\$450

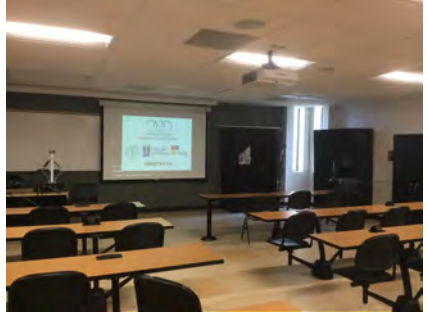
Item no., Rm no. and Name	Existing Architectural Barrier and Proposed Solution	Codes / Mitigation Info	Qty	Unit	Cost	Total
1499	<ul style="list-style-type: none"> As-Built Description: No signs at the building or assembly area entrance to notify patrons that an assistive listening system is available. Proposed Solution: Provide assistive listening signage. 	PCODE GI02 ADAAG 91 4.1.3(19)(b) ADA 2010 703.7.2.4 CBC 2007 1104B.2.4 CBC 2016 11B-703.7.2.4 Mitigated: <input type="radio"/> YES <input checked="" type="radio"/> NO	4	JOB	\$300	\$1,200

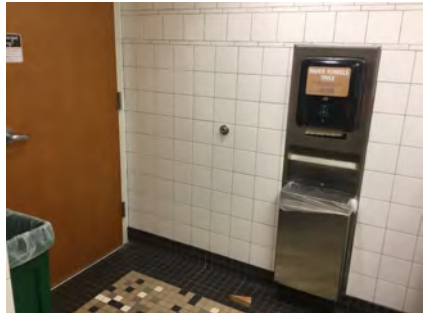
Item no., Rm no. and Name	Existing Architectural Barrier and Proposed Solution	Codes / Mitigation Info	Qty	Unit	Cost	Total
Door Swing						
904	<ul style="list-style-type: none"> • <i>As-Built Description:</i> Front approach: At pull side, door does not have clear and level maneuvering space measuring door width plus 18" x 60". (24" x 60" at exterior doors). • <i>As-Built:</i> Trashcan 48.5" from the face of the door • <i>Proposed Solution:</i> Remove or relocate furniture or storage items. • <i>Notes:</i> The trash can encroaches approximately 1.5" into the door maneuvering clearance at the hinge side. 	PCODE ID23A ADAAG 91 Fig. 25(a) ADA 2010 404.2.4 CBC 2007 11B-26A(a) CBC 2016 11B-404.2.4 Mitigated: <input type="radio"/> YES <input checked="" type="radio"/> NO	1	JOB	\$150	\$150

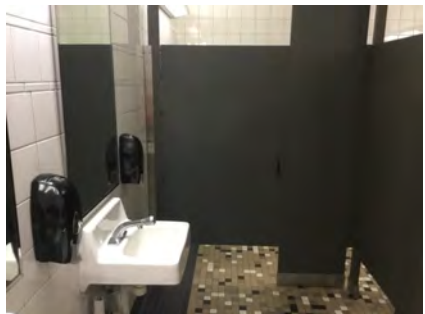
<input type="checkbox"/> Staff Only			
			Priority		Severity	
			3		3	
908	<ul style="list-style-type: none"> • <i>As-Built Description:</i> Front approach: At push side, door does not have clear and level maneuvering space measuring door width x 48" (door width plus 12" if door has both, latch and closer). • <i>As-Built:</i> 34.5" to the lavatory • <i>Proposed Solution:</i> Remove the lavatory. 	PCODE ID24 ADAAG 91 Fig. 25(a) ADA 2010 404.2.4 CBC 2007 11B-26A(a) CBC 2016 11B-404.2.4 Mitigated: <input type="radio"/> YES <input checked="" type="radio"/> NO	1	JOB	\$1,500	\$1,500

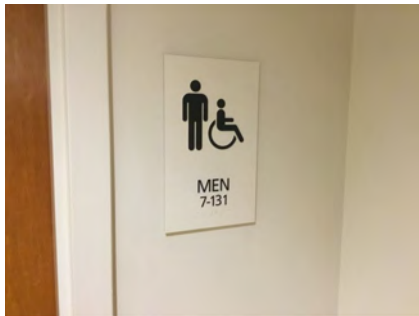
Item no., Rm no. and Name	Existing Architectural Barrier and Proposed Solution	Codes / Mitigation Info	Qty	Unit	Cost	Total
<u>Signage</u>						
903	<ul style="list-style-type: none">As-Built Description: Braille symbols: dots are not 1/10" on centers in each cell with 2/10" space between cells.As-Built: Braille 0.25" from tactile charactersProposed Solution: CA only - Provide new compliant signage including Contracted Grade 2 Braille with Title 24 spacing requirements - 1/10" on center dots with 2/10" space between cells.	PCODE SA07C CBC 2007 1117B.5.6 CBC 2016 11B-703.3 Mitigated: <input type="radio"/> YES <input checked="" type="radio"/> NO	1	JOB	\$450	\$450

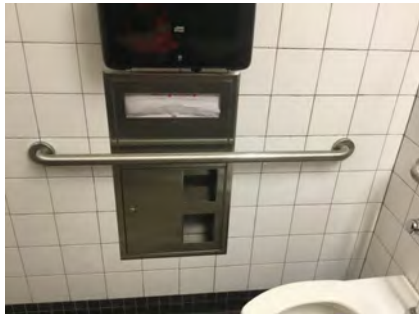
<input type="checkbox"/> Staff Only			
			Priority		Severity	
			3		3	
<u>Grab Bars</u>						
910	<ul style="list-style-type: none">As-Built Description: Side grab bar less than 42" long, or located more than 12 inches max. from the rear wall, or extending less than 54" from rear wall (CA only: front end min. 24" in front of water closet).As-Built: Side grab bar extends 51" from the rear wallProposed Solution: Provide or relocate accessible side grab bar.	PCODE WB07A ADAAG 91 Fig. 29(b) ADA 2010 604.5.1 CBC 2007 1115B.4.1.3.1 CBC 2016 11B-604.5.1 Mitigated: <input type="radio"/> YES <input checked="" type="radio"/> NO	1	JOB	\$780	\$780

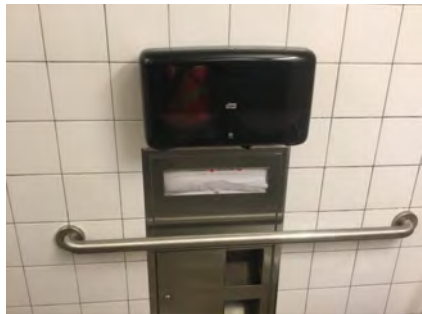
Item no., Rm no. and Name	Existing Architectural Barrier and Proposed Solution	Codes / Mitigation Info	Qty	Unit	Cost	Total
911	<ul style="list-style-type: none"> As-Built Description: Accessories/dispensers in accessible stall located closer than 1-1/2" below or 12" above grab bar impedes its use. As-Built: 11" above the grab bar Proposed Solution: Relocate accessories/dispensers to be no closer than 1-1/2" below and 12" above grab bars (except if accessories are recessed, flush with wall, and have no sharp edges). 	PCODE WB071 ADAAG 91 4.26.2 ADA 2010 609.3 CBC 2007 1133B.4.2.5 CBC 2016 11B-609.3 Mitigated: <input type="radio"/> YES <input checked="" type="radio"/> NO	1	JOB	\$225	\$225

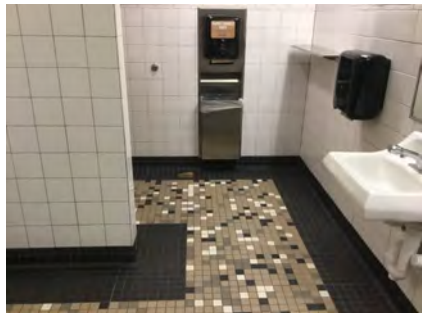
907	<ul style="list-style-type: none"> As-Built Description: Clear passage width (except doorways) from rest room entry to accessible water closet compartment less than 36" (CA only: 44" wide). As-Built: 42" between wall and lavatory Proposed Solution: Modify facility passage to be min. 44" wide. Demolish existing partition and replace. 	PCODE WC02A ADAAG 91 4.3.3 ADA 2010 403.5.1 CBC 2007 1115B.3.2.4 CBC 2016 11B-403.5.1 Mitigated: <input type="radio"/> YES <input checked="" type="radio"/> NO	1	LF	\$510	\$510

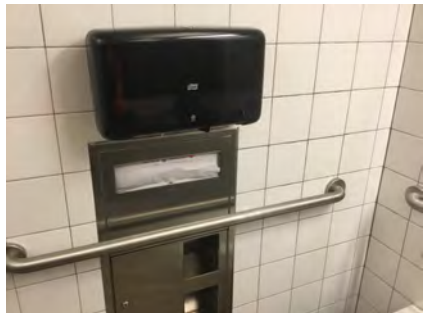
<input type="checkbox"/> Staff Only Priority 3 Severity 3			
914	<ul style="list-style-type: none"> • <i>As-Built Description:</i> Toilet paper dispenser less than 15" (CA: 19") or more than 48" above floor or not within 7" to 9" from front of water closet (Note: CA pre-2010 is allowed within 12" from front of water closet). • <i>Proposed Solution:</i> Relocate or provide new toilet paper dispenser. • <i>Notes:</i> Toilet paper dispenser is above the grab bar. 	PCODE WG02REF ADAAG 91 4.16.6 ADA 2010 604.7 CBC 2007 1115B.8.4 CBC 2016 11B-604.7 Mitigated: <input type="radio"/> YES <input checked="" type="radio"/> NO	REF

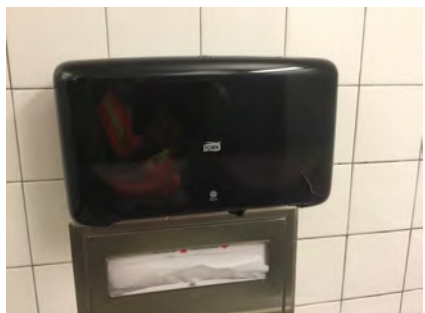
<input type="checkbox"/> Staff Only Priority 3 Severity 1			
913	<ul style="list-style-type: none"> • <i>As-Built Description:</i> Accessories in sanitary facilities not accessible, hardware requires tight grasping, pinching, or twisting of the wrist. • <i>Proposed Solution:</i> Provide accessories with accessible operating mechanism. 	PCODE WG05 ADAAG 91 4.27.4 ADA 2010 309.4 CBC 2007 1117B.6 CBC 2016 11B-309.4 Mitigated: <input type="radio"/> YES <input checked="" type="radio"/> NO	1	JOB	\$1,200	\$1,200

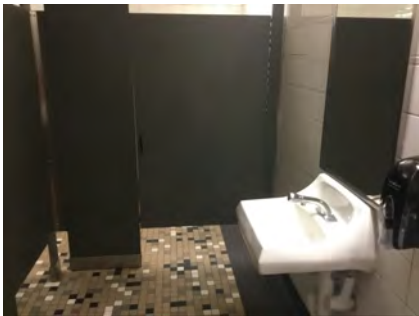
Item no., Rm no. and Name	Existing Architectural Barrier and Proposed Solution	Codes / Mitigation Info	Qty	Unit	Cost	Total
<div>Door Swing</div>						
918	<div><div>As-Built Description:</div><div>Front approach: At push side, door does not have clear and level maneuvering space measuring door width x 48" (door width plus 12" if door has both, latch and closer).</div><div>As-Built: 33" to the lavatory</div><div>Proposed Solution:</div><div>Remove the lavatory.</div></div>	<div>PCODE ID24</div> <div>ADAAG 91 Fig. 25(a)</div> <div>ADA 2010 404.2.4</div> <div>CBC 2007 11B-26A(a)</div> <div>CBC 2016 11B-404.2.4</div> <div>Mitigated:</div> <div><div><input type="radio"/> YES</div><div><input checked="" type="radio"/> NO</div></div>	1	JOB	\$1,500	\$1,500
			<div>

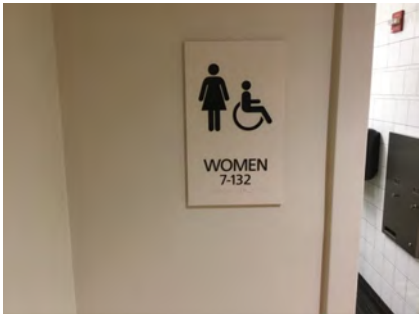
<div>Signage</div>						
915	<div><div>As-Built Description:</div><div>Braille symbols: dots are not 1/10" on centers in each cell with 2/10" space between cells.</div><div>As-Built: Braille 0.3" from tactile characters</div><div>Proposed Solution:</div><div>CA only - Provide new compliant signage including Contracted Grade 2 Braille with Title 24 spacing requirements - 1/10" on center dots with 2/10" space between cells.</div></div>	<div>PCODE SA07C</div> <div>CBC 2007 1117B.5.6</div> <div>CBC 2016 11B-703.3</div> <div>Mitigated:</div> <div><div><input type="radio"/> YES</div><div><input checked="" type="radio"/> NO</div></div>	1	JOB	\$450	\$450
			<div>

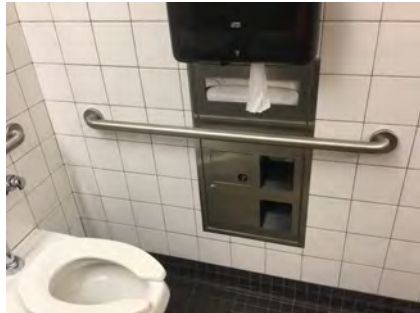
Item no., Rm no. and Name	Existing Architectural Barrier and Proposed Solution	Codes / Mitigation Info	Qty	Unit	Cost	Total
Grab Bars						
922	<ul style="list-style-type: none"> As-Built Description: Side grab bar less than 42" long, or located more than 12 inches max. from the rear wall, or extending less than 54" from rear wall (CA only: front end min. 24" in front of water closet). As-Built: Side grab bar extends 50.5" from the rear wall Proposed Solution: Provide or relocate accessible side grab bar. 	PCODE WB07A ADAAG 91 Fig. 29(b) ADA 2010 604.5.1 CBC 2007 1115B.4.1.3.1 CBC 2016 11B-604.5.1 Mitigated: <input type="radio"/> YES <input checked="" type="radio"/> NO	1	JOB	\$780	\$780

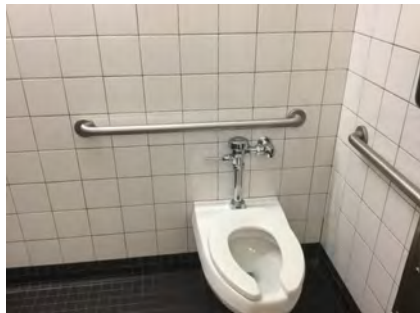
<input type="checkbox"/> Staff Only			
			Priority 3 Severity 3			
920	<ul style="list-style-type: none"> As-Built Description: The rear wall grab is less than 36" min. or does not extend from the centerline of the water closet 12" min. on one side and 24" min. on the other side. As-Built: 10.5" on the narrow side Proposed Solution: Provide or relocate accessible rear grab bar. 	PCODE WB07B ADAAG 91 4.17.6 ADA 2010 604.5.2 CBC 2007 1115B.4.1.3.2 CBC 2016 11B-604.5.2 Mitigated: <input type="radio"/> YES <input checked="" type="radio"/> NO	1	JOB	\$1,020	\$1,020

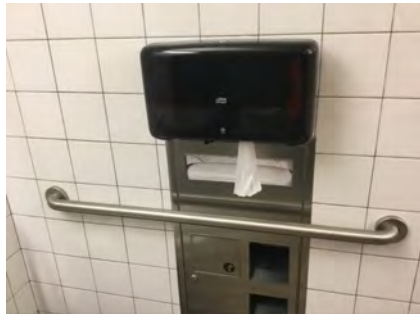
<input type="checkbox"/> Staff Only			
			Priority 3 Severity 4			
923	<ul style="list-style-type: none"> As-Built Description: Accessories/dispensers in accessible stall located closer than 1-1/2" below or 12" above grab bar impedes its use. As-Built: 9.75" above the side grab bar Proposed Solution: Relocate accessories/dispensers to be no closer than 1-1/2" below and 12" above grab bars (except if accessories are recessed, flush with wall, and have no sharp edges). 	PCODE WB07I ADAAG 91 4.26.2 ADA 2010 609.3 CBC 2007 1133B.4.2.5 CBC 2016 11B-609.3 Mitigated: <input type="radio"/> YES <input checked="" type="radio"/> NO	1	JOB	\$225	\$225

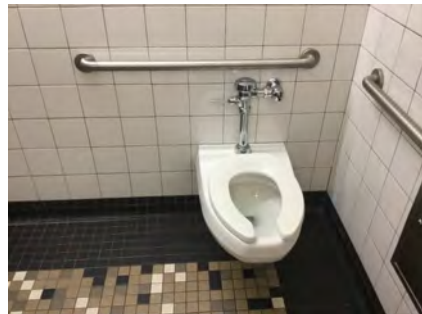
Item no., Rm no. and Name	Existing Architectural Barrier and Proposed Solution	Codes / Mitigation Info	Qty	Unit	Cost	Total
Water Closet						
921	<ul style="list-style-type: none">• <i>As-Built Description:</i> Water closet not 16"-18" (CA: 17"-18") from near side wall to center line of water closet (2010 ADAAG: 16"-18").• <i>As-Built:</i> 18.5" o.c.• <i>Proposed Solution:</i> Relocate existing water closet and plumbing, remount with offset closet flange to provide 18" max. from side wall.	<p>PCODE WB02C</p> <p>ADAAG 91 Fig. 28</p> <p>ADA 2010 604.2</p> <p>CBC 2007 1115B.4.1.1</p> <p>CBC 2016 11B-604.2</p> <p>Mitigated:</p> <p><input type="radio"/> YES</p> <p><input checked="" type="radio"/> NO</p>	1	JOB	\$1,500	\$1,500

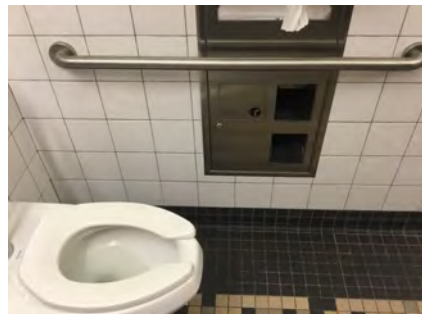
<input type="checkbox"/> Staff Only			
			Priority		Severity	
			3		4	
Accessories						
919	<ul style="list-style-type: none">• <i>As-Built Description:</i> Toilet paper dispenser less than 15" (CA: 19") or more than 48" above floor or not within 7" to 9" from front of water closet (Note: CA pre-2010 is allowed within 12" from front of water closet).• <i>As-Built:</i> 11" to the centerline of the toilet paper roll from the front of the water closet• <i>Proposed Solution:</i> Relocate or provide new toilet paper dispenser.	<p>PCODE WG02</p> <p>ADAAG 91 4.16.6</p> <p>ADA 2010 604.7</p> <p>CBC 2007 1115B.8.4</p> <p>CBC 2016 11B-604.7</p> <p>Mitigated:</p> <p><input type="radio"/> YES</p> <p><input checked="" type="radio"/> NO</p>	1	JOB	\$225	\$225

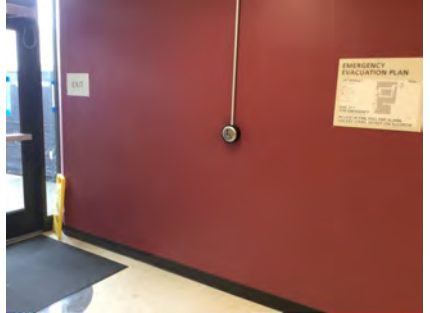
Item no., Rm no. and Name	Existing Architectural Barrier and Proposed Solution	Codes / Mitigation Info	Qty	Unit	Cost	Total
Door						
6	<ul style="list-style-type: none"> • <i>As-Built Description:</i> Lower push plate located at 7" minimum and 8" maximum above the floor or ground surface not provided. • <i>Proposed Solution:</i> Provide lower push plate. 	PCODE ID13B CBC 2007 1133B.2.3.2 CBC 2016 11B-404.2.9 2.C Mitigated: <input type="radio"/> YES <input checked="" type="radio"/> NO	2	JOB	\$1,500	\$3,000

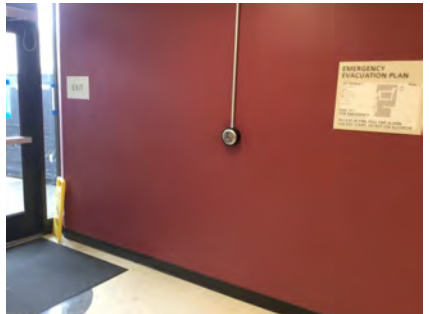
<input type="checkbox"/> Staff Only			
			Priority		Severity	
			2		2	
1269	<ul style="list-style-type: none"> • <i>As-Built Description:</i> High push plate located at 30" minimum and 44" maximum above the floor or ground surface not provided. • <i>As-Built:</i> Push plate 48" to center • <i>Proposed Solution:</i> Provide higher push plate. 	PCODE ID13E CBC 2007 1133B.2.3.2 CBC 2016 11B-404.2.9 2.C Mitigated: <input type="radio"/> YES <input checked="" type="radio"/> NO	2	JOB	\$1,500	\$3,000

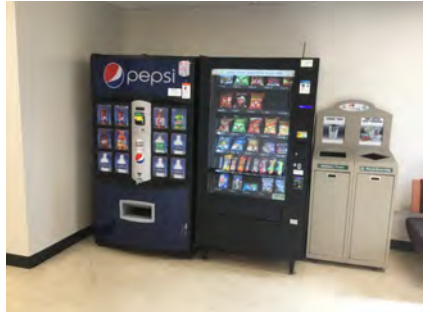
Item no., Rm no. and Name	Existing Architectural Barrier and Proposed Solution	Codes / Mitigation Info	Qty	Unit	Cost	Total
<u>Vending Machine</u>						
1482	<ul style="list-style-type: none"> • <i>As-Built Description:</i> Vending machine coin slot or dispensing outlet, more than 48" above the floor. • <i>As-Built:</i> 9" to the bottom of the dispensing tray 53.5" to the top of the card reader • <i>Proposed Solution:</i> Advise vendor/leasing company to provide accessible vending machine with highest operable part at 48" max. 	PCODE IL02 ADAAG 91 4.2.5 ADA 2010 308.2.1 CBC 2007 1126B CBC 2016 11B-308.2.1 Mitigated: <input type="radio"/> YES <input checked="" type="radio"/> NO	2	REF

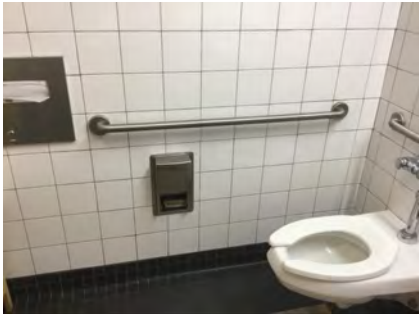
Item no., Rm no. and Name	Existing Architectural Barrier and Proposed Solution	Codes / Mitigation Info	Qty	Unit	Cost	Total
Grab Bars						
1495	<ul style="list-style-type: none">As-Built Description: Side grab bar less than 42" long, or located more than 12 inches max. from the rear wall, or extending less than 54" from rear wall (CA only: front end min. 24" in front of water closet).As-Built: Side grab bar extends 50" from rear wallProposed Solution: Provide or relocate accessible side grab bar.	<p>PCODE WB07A</p> <p>ADAAG 91 Fig. 29(b)</p> <p>ADA 2010 604.5.1</p> <p>CBC 2007 1115B.4.1.3.1</p> <p>CBC 2016 11B-604.5.1</p> <p>Mitigated:</p> <p><input type="radio"/> YES</p> <p><input checked="" type="radio"/> NO</p>	1	JOB	\$780	\$780

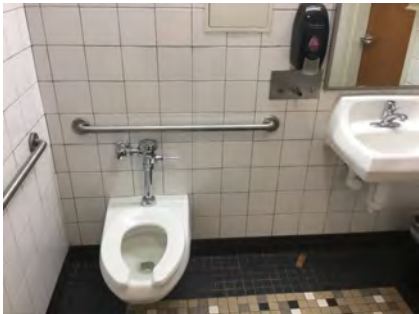
<input type="checkbox"/> Staff Only			
			Priority 3 Severity 3			
Toilet Stall						
1493	<ul style="list-style-type: none">As-Built Description: 60" min. clearance around a water closet measured perpendicular from the side wall not provided (Fixtures are not allowed to overlap this clearance).As-Built: 53" to edge of lavatoryProposed Solution: Remove adjacent fixture and provide new enclosure at accessible water closet.	<p>PCODE WB01A</p> <p>ADA 2010 604.3.1; 604.3.2</p> <p>CBC 2007 1115B.7.1.3</p> <p>CBC 2016 11B-604.3.1; 11B-604.3.2</p> <p>Mitigated:</p> <p><input type="radio"/> YES</p> <p><input checked="" type="radio"/> NO</p>	1	JOB	\$6,000	\$6,000

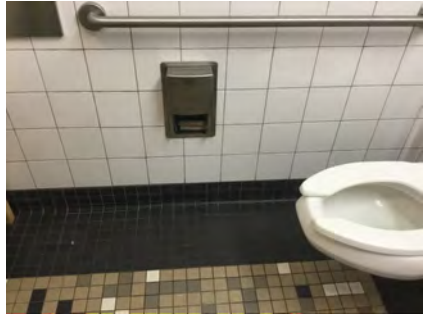
Item no., Rm no. and Name	Existing Architectural Barrier and Proposed Solution	Codes / Mitigation Info	Qty	Unit	Cost	Total
<u>Accessories</u>						
1497	<ul style="list-style-type: none"> • <i>As-Built Description:</i> Toilet paper dispenser less than 15" (CA: 19") or more than 48" above floor or not within 7" to 9" from front of water closet (Note: CA pre-2010 is allowed within 12" from front of water closet). • <i>As-Built:</i> 12.5" from the front of the water closet • <i>Proposed Solution:</i> Relocate or provide new toilet paper dispenser. 	PCODE WG02 ADAAG 91 4.16.6 ADA 2010 604.7 CBC 2007 1115B.8.4 CBC 2016 11B-604.7 Mitigated: <input type="radio"/> YES <input checked="" type="radio"/> NO	1	JOB	\$225	\$225

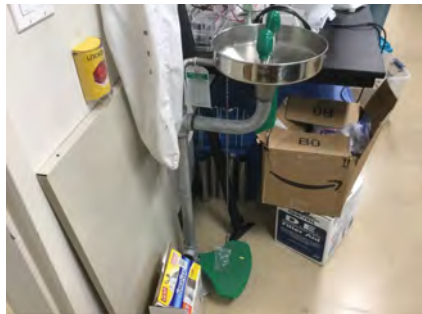
Item no., Rm no. and Name	Existing Architectural Barrier and Proposed Solution	Codes / Mitigation Info	Qty	Unit	Cost	Total
1512	<ul style="list-style-type: none"> As-Built Description: Minimum of at least one of each type of sink and other specialized equipment such as fume hoods, microscopes, emergency eyewash and showers, etc, associated with the special use activity is not accessible. (CA Only) As-Built: Toe clearance 7" deep Proposed Solution: Remodel existing cabinet/counter to make specialized equipment accessible to disabled persons. 	PCODE LB01B CBC 2007 1106B.2 CBC 2016 11B-805.7 Mitigated: <input type="radio"/> YES <input checked="" type="radio"/> NO	1	JOB	\$5,400	\$5,400

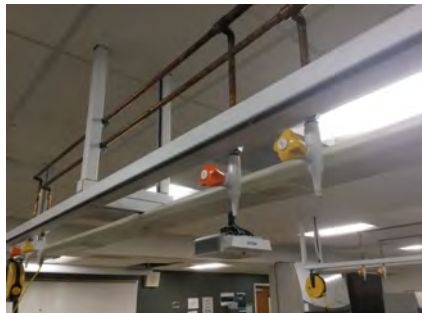
1509	<ul style="list-style-type: none"> As-Built Description: Operable part(s) require tight grasping, pinching, or twisting of the wrist with one hand. Proposed Solution: Modify or replace the operable part(s) to not require tight grasping, pinching, or twisting of the wrist with one hand. Notes: Occurs at multiple tools. 	PCODE IC02 ADAAG 91 4.27.4 ADA 2010 309.4 CBC 2007 1117B.6.4 CBC 2016 11B-309.4 Mitigated: <input type="radio"/> YES <input checked="" type="radio"/> NO	1	JOB	\$900	\$900

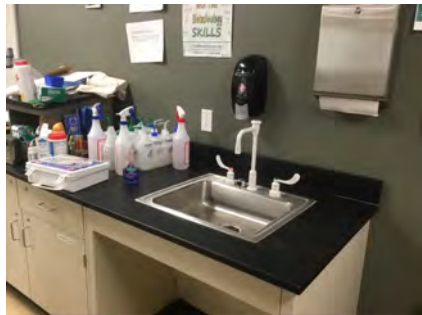
Item no., Rm no. and Name	Existing Architectural Barrier and Proposed Solution	Codes / Mitigation Info	Qty	Unit	Cost	Total
Reach Range						
1510	<ul style="list-style-type: none"> As-Built Description: Reach height to control or access point, exceeds 48" or is less than 15". As-Built: Soap 26" deep 46" high Proposed Solution: Modify equipment or mounting. 	PCODE IE01 ADAAG 91 4.2.5 ADA 2010 308.2.1 CBC 2007 1118B.5 CBC 2016 11B-308.2.1 Mitigated: <input type="radio"/> YES <input checked="" type="radio"/> NO	1	JOB	\$300	\$300

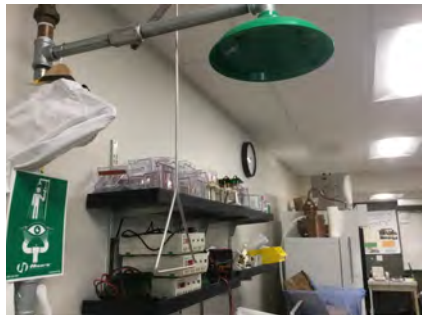
<input type="checkbox"/> Staff Only Priority 2 Severity 4			
1513	<ul style="list-style-type: none"> As-Built Description: Reach height to control or access point, where side approach is available, exceeds 48" or is less than 15" in height, or exceeds 10" in depth. As-Built: Shower handle 65" Proposed Solution: Modify equipment or mounting. 	PCODE IE02 ADAAG 91 4.2.6 ADA 2010 308.3.1 CBC 2007 1118B.6 CBC 2016 11B-308.3 Mitigated: <input type="radio"/> YES <input checked="" type="radio"/> NO	1	JOB	\$300	\$300

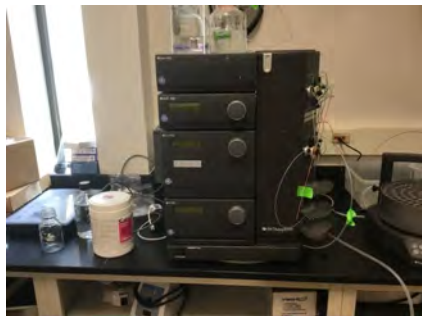
<input type="checkbox"/> Staff Only Priority 2 Severity 2			
1514	<ul style="list-style-type: none"> As-Built Description: Reach height to control or access point, where side approach is available, exceeds 48" or is less than 15" in height, or exceeds 10" in depth. As-Built: 53" high Proposed Solution: Modify equipment or mounting. 	PCODE IE02 ADAAG 91 4.2.6 ADA 2010 308.3.1 CBC 2007 1118B.6 CBC 2016 11B-308.3 Mitigated: <input type="radio"/> YES <input checked="" type="radio"/> NO	2	JOB	\$300	\$600

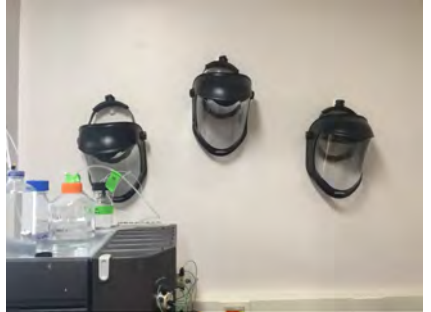
Item no., Rm no. and Name	Existing Architectural Barrier and Proposed Solution	Codes / Mitigation Info	Qty	Unit	Cost	Total
1515	<ul style="list-style-type: none"> • <i>As-Built Description:</i> Reach height to control or access point, where side approach is available, exceeds 48" or is less than 15" in height, or exceeds 10" in depth. • <i>As-Built:</i> Storage 65" high • <i>Proposed Solution:</i> Modify equipment or mounting. 	PCODE IE02 ADAAG 91 4.2.6 ADA 2010 308.3.1 CBC 2007 1118B.6 CBC 2016 11B-308.3 Mitigated: <input type="radio"/> YES <input checked="" type="radio"/> NO	1	JOB	\$300	\$300

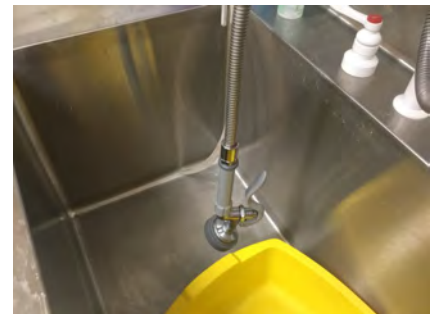
Item no., Rm no. and Name	Existing Architectural Barrier and Proposed Solution	Codes / Mitigation Info	Qty	Unit	Cost	Total
1528	<ul style="list-style-type: none">• <i>As-Built Description:</i> Operable part(s) require tight grasping, pinching, or twisting of the wrist with one hand.• <i>Proposed Solution:</i> Modify or replace the operable part(s) to not require tight grasping, pinching, or twisting of the wrist with one hand.	<div>PCODE IC02</div> <div>ADAAG 91 4.27.4</div> <div>ADA 2010 309.4</div> <div>CBC 2007 1117B.6.4</div> <div>CBC 2016 11B-309.4</div> <div>Mitigated:</div> <div><div><input type="radio"/> YES</div><div><input checked="" type="radio"/> NO</div></div>	1	JOB	\$900	\$900

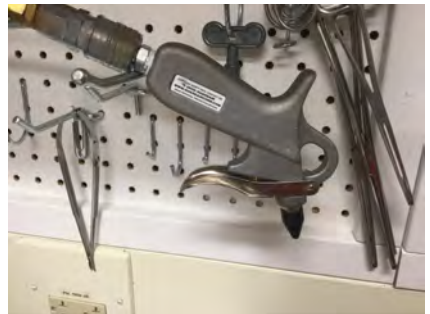
<div><input type="checkbox"/> Staff Only</div> <div><div>Priority</div><div>2</div><div>Severity</div><div>2</div></div>			
1529	<ul style="list-style-type: none">• <i>As-Built Description:</i> Operable part(s) require tight grasping, pinching, or twisting of the wrist with one hand.• <i>Proposed Solution:</i> Modify or replace the operable part(s) to not require tight grasping, pinching, or twisting of the wrist with one hand.	<div>PCODE IC02</div> <div>ADAAG 91 4.27.4</div> <div>ADA 2010 309.4</div> <div>CBC 2007 1117B.6.4</div> <div>CBC 2016 11B-309.4</div> <div>Mitigated:</div> <div><div><input type="radio"/> YES</div><div><input checked="" type="radio"/> NO</div></div>	1	JOB	\$900	\$900

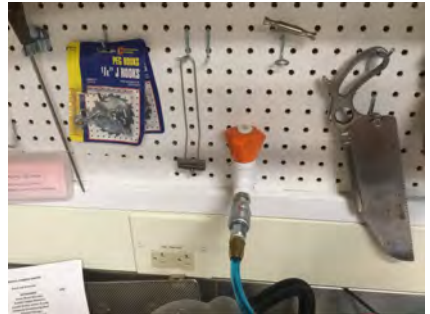
<div><input type="checkbox"/> Staff Only</div> <div><div>Priority</div><div>2</div><div>Severity</div><div>2</div></div>			
<div>Reach Range</div>						
1516	<ul style="list-style-type: none">• <i>As-Built Description:</i> Reach height to control or access point, where side approach is available, exceeds 48" or is less than 15" in height, or exceeds 10" in depth.• <i>As-Built:</i> 51" high• <i>Proposed Solution:</i> Modify equipment or mounting.	<div>PCODE IE02</div> <div>ADAAG 91 4.2.6</div> <div>ADA 2010 308.3.1</div> <div>CBC 2007 1118B.6</div> <div>CBC 2016 11B-308.3</div> <div>Mitigated:</div> <div><div><input type="radio"/> YES</div><div><input checked="" type="radio"/> NO</div></div>	1	JOB	\$300	\$300

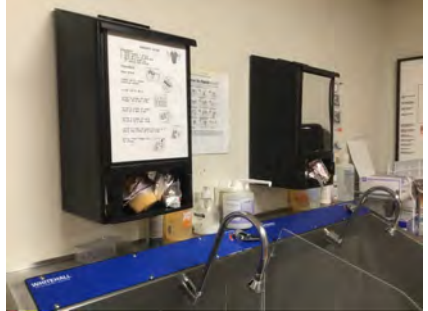
Item no., Rm no. and Name	Existing Architectural Barrier and Proposed Solution	Codes / Mitigation Info	Qty	Unit	Cost	Total
1518	<ul style="list-style-type: none"> As-Built Description: Reach height to control or access point, where side approach is available, exceeds 48" or is less than 15" in height, or exceeds 10" in depth. As-Built: Sponges 57" high Proposed Solution: Modify equipment or mounting. 	PCODE IE02 ADAAG 91 4.2.6 ADA 2010 308.3.1 CBC 2007 1118B.6 CBC 2016 11B-308.3 Mitigated: <input type="radio"/> YES <input checked="" type="radio"/> NO	1	JOB	\$300	\$300

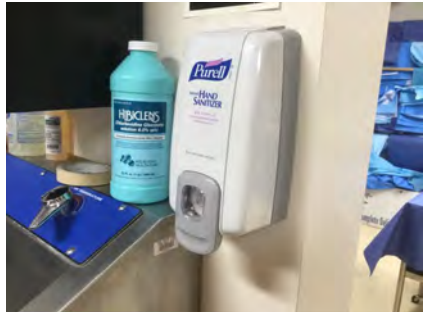
<input type="checkbox"/> Staff Only Priority 2 Severity 3						
1519	<ul style="list-style-type: none"> As-Built Description: Reach height to control or access point, where side approach is available, exceeds 48" or is less than 15" in height, or exceeds 10" in depth. As-Built: 51.5" high Proposed Solution: Modify equipment or mounting. 	PCODE IE02 ADAAG 91 4.2.6 ADA 2010 308.3.1 CBC 2007 1118B.6 CBC 2016 11B-308.3 Mitigated: <input type="radio"/> YES <input checked="" type="radio"/> NO	1	JOB	\$300	\$300

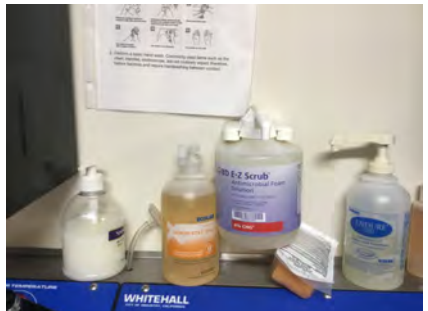
<input type="checkbox"/> Staff Only Priority 2 Severity 4						
1520	<ul style="list-style-type: none"> As-Built Description: Reach height to control or access point, where side approach is available, exceeds 48" or is less than 15" in height, or exceeds 10" in depth. As-Built: 60" high. Over a 40" high obstruction. Proposed Solution: Modify equipment or mounting. 	PCODE IE02 ADAAG 91 4.2.6 ADA 2010 308.3.1 CBC 2007 1118B.6 CBC 2016 11B-308.3 Mitigated: <input type="radio"/> YES <input checked="" type="radio"/> NO	1	JOB	\$300	\$300

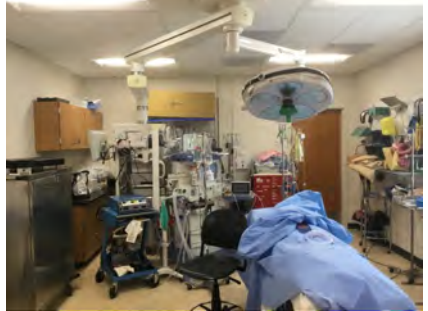
Item no., Rm no. and Name	Existing Architectural Barrier and Proposed Solution	Codes / Mitigation Info	Qty	Unit	Cost	Total
1524	<ul style="list-style-type: none"> As-Built Description: Reach height to control or access point, where side approach is available, exceeds 48" or is less than 15" in height, or exceeds 10" in depth. As-Built: The reach to multiple specialized equipment up to 80" high Proposed Solution: Modify equipment or mounting. 	PCODE IE02 ADAAG 91 4.2.6 ADA 2010 308.3.1 CBC 2007 1118B.6 CBC 2016 11B-308.3 Mitigated: <input type="radio"/> YES <input checked="" type="radio"/> NO	6	JOB	\$300	\$1,800

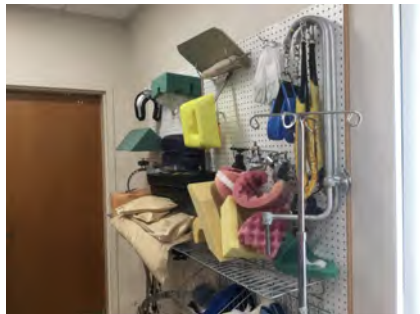
<input type="checkbox"/> Staff Only			
			Priority 2 Severity 1			
1525	<ul style="list-style-type: none"> As-Built Description: Reach height to control or access point, where side approach is available, exceeds 48" or is less than 15" in height, or exceeds 10" in depth. As-Built: Various storage items up to 80" high Proposed Solution: Modify equipment or mounting. 	PCODE IE02 ADAAG 91 4.2.6 ADA 2010 308.3.1 CBC 2007 1118B.6 CBC 2016 11B-308.3 Mitigated: <input type="radio"/> YES <input checked="" type="radio"/> NO	1	JOB	\$300	\$300

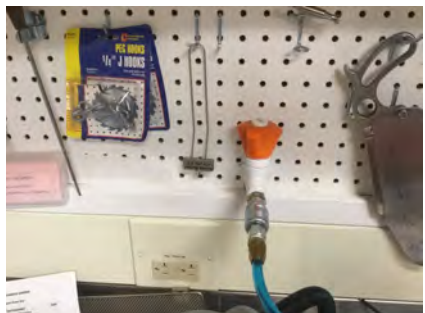
<input type="checkbox"/> Staff Only			
			Priority 2 Severity 1			
1530	<ul style="list-style-type: none"> As-Built Description: Reach height to control or access point, where side approach is available, exceeds 48" or is less than 15" in height, or exceeds 10" in depth. As-Built: 51" high at 24" deep Proposed Solution: Modify equipment or mounting. 	PCODE IE02 ADAAG 91 4.2.6 ADA 2010 308.3.1 CBC 2007 1118B.6 CBC 2016 11B-308.3 Mitigated: <input type="radio"/> YES <input checked="" type="radio"/> NO	1	JOB	\$300	\$300

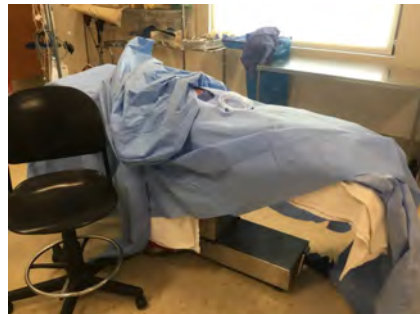
Item no., Rm no. and Name	Existing Architectural Barrier and Proposed Solution	Codes / Mitigation Info	Qty	Unit	Cost	Total
<u>Non-Fixed Desk</u>						
1523	<ul style="list-style-type: none">• <i>As-Built Description:</i> Accessible non-fixed table or desk (top 28" to 34" high; knee space at least 27" high x 19" deep x 30" wide) not provided.• <i>Proposed Solution:</i> Provide table or desk with accessible dimensions when purchasing new furniture.• <i>Notes:</i> No toe clearance or knee clearance at exam table.	<p>PCODE IN02A</p> <p>ADAAG 91 4.32.3 & .4</p> <p>ADA 2010 306.1</p> <p>CBC 2007 1122B.3 & 4</p> <p>CBC 2016 11B-306.1 & 11B-902.3</p> <p>Mitigated:</p> <p><input type="radio"/> YES</p> <p><input checked="" type="radio"/> NO</p>	1	JOB	\$4,800	\$4,800

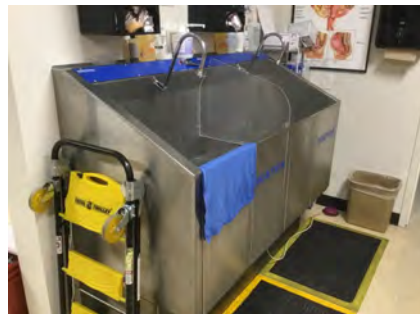
<input type="checkbox"/> Staff Only			
			Priority 2 Severity 2			
<u>Sink</u>						
1517	<ul style="list-style-type: none">• <i>As-Built Description:</i> Sink rim higher than 34" above floor.• <i>As-Built:</i> 40" high• <i>Proposed Solution:</i> Remodel sink cabinet to lower sink.• <i>Notes:</i> Consider exception ADA Chapter 8: Special Rooms, Spaces and Elements	<p>PCODE IN06</p> <p>ADAAG 91 4.24.2</p> <p>ADA 2010 606.3</p> <p>CBC 2007 1115B.4.7.1</p> <p>CBC 2016 11B-606.3</p> <p>Mitigated:</p> <p><input type="radio"/> YES</p> <p><input checked="" type="radio"/> NO</p>	1	JOB	\$5,250	\$5,250

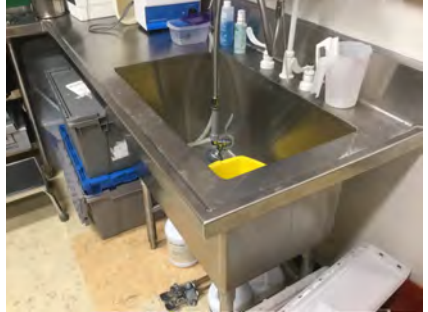
Item no., Rm no. and Name	Existing Architectural Barrier and Proposed Solution	Codes / Mitigation Info	Qty	Unit	Cost	Total
1526	<ul style="list-style-type: none"> As-Built Description: Sink rim higher than 34" above floor. As-Built: 34.75" high Proposed Solution: Remodel sink cabinet to lower sink. 	PCODE IN06 ADAAG 91 4.24.2 ADA 2010 606.3 CBC 2007 1115B.4.7.1 CBC 2016 11B-606.3 Mitigated: <input type="radio"/> YES <input checked="" type="radio"/> NO	1	JOB	\$5,250	\$5,250

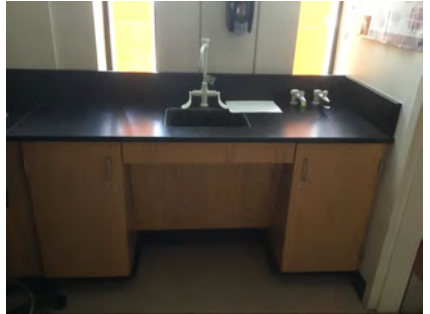
Item no., Rm no. and Name	Existing Architectural Barrier and Proposed Solution	Codes / Mitigation Info	Qty	Unit	Cost	Total
Sink						
1533	<ul style="list-style-type: none"> As-Built Description: Toe clearance less than 9" high x 17" deep from front edge of sink. As-Built: Toe clearance 9.5" deep Proposed Solution: Reconfigure casework at sink. 	PCODE CF04 ADAAG 91 4.24.2; 4.24.4; ADA 2010 Fig. 31 606.3 CBC 2016 11B-606.3	1	JOB	\$4,500	\$4,500
Mitigated: <input type="radio"/> YES <input checked="" type="radio"/> NO

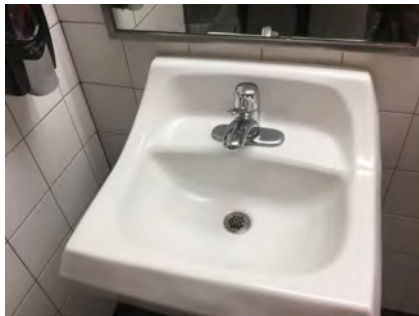
Item no., Rm no. and Name	Existing Architectural Barrier and Proposed Solution	Codes / Mitigation Info	Qty	Unit	Cost	Total
Lavatory						
1542	<ul style="list-style-type: none">As-Built Description: Clear floor space, 30" x 48" in front of fixture, extending 19" max. under the lavatory, not provided (CA only: Less than 18" from side wall to centerline of lavatory).As-Built: 17.5 o.c.Proposed Solution: Provide new accessible lavatory. Remodel restroom as needed.	<p>PCODE WD01 ADAAG 91 4.19.3 ADA 2010 606.2 CBC 2007 1115B.4.3 CBC 2016 11B-606.2, 11B-606.6</p> <p>Mitigated: <input type="radio"/> YES <input checked="" type="radio"/> NO</p>	1	JOB	\$10,200	\$10,200

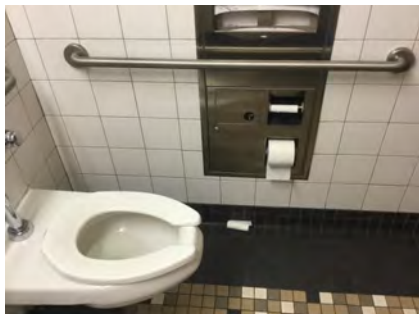
<input type="checkbox"/> Staff Only			
			Priority		Severity	
			3		2	
Accessories						
1539	<ul style="list-style-type: none">As-Built Description: Toilet paper dispenser less than 15" (CA: 19") or more than 48" above floor or not within 7" to 9" from front of water closet (Note: CA pre-2010 is allowed within 12" from front of water closet).As-Built: 10.5" to the centerline of the toilet paper rollProposed Solution: Relocate or provide new toilet paper dispenser.	<p>PCODE WG02 ADAAG 91 4.16.6 ADA 2010 604.7 CBC 2007 1115B.8.4 CBC 2016 11B-604.7</p> <p>Mitigated: <input type="radio"/> YES <input checked="" type="radio"/> NO</p>	1	JOB	\$225	\$225

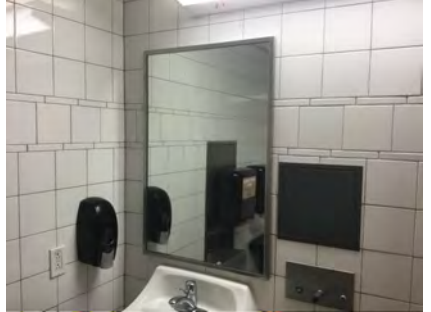
Item no., Rm no. and Name	Existing Architectural Barrier and Proposed Solution	Codes / Mitigation Info	Qty	Unit	Cost	Total
1543	<ul style="list-style-type: none"> • <i>As-Built Description:</i> Bottom of mirror located above lavatories or countertops more than 40" above floor. • <i>As-Built:</i> 41.25" high • <i>Proposed Solution:</i> Relocate or provide new accessible mirror. 	PCODE WG03 ADAAG 91 4.19.6 ADA 2010 603.3 CBC 2007 1115B.8.1 CBC 2016 11B-603.3 Mitigated: <input type="radio"/> YES <input checked="" type="radio"/> NO	1	JOB	\$450	\$450

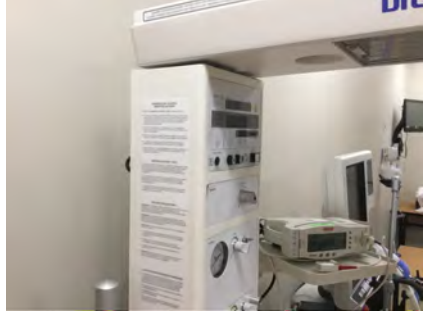
Item no., Rm no. and Name	Existing Architectural Barrier and Proposed Solution	Codes / Mitigation Info	Qty	Unit	Cost	Total
1548	<ul style="list-style-type: none"> As-Built Description: Reach height to control or access point, where side approach is available, exceeds 48" or is less than 15" in height, or exceeds 10" in depth. As-Built: 64" high Proposed Solution: Modify equipment or mounting. 	PCODE IE02 ADAAG 91 4.2.6 ADA 2010 308.3.1 CBC 2007 1118B.6 CBC 2016 11B-308.3 Mitigated: <input type="radio"/> YES <input checked="" type="radio"/> NO	1	JOB	\$300	\$300

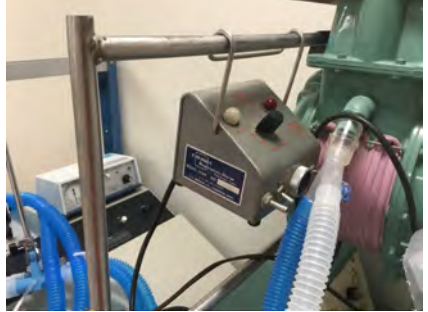
<input type="checkbox"/> Staff Only						
Priority 2 Severity 2						
1552	<ul style="list-style-type: none"> As-Built Description: Reach height to control or access point, where side approach is available, exceeds 48" or is less than 15" in height, or exceeds 10" in depth. As-Built: 56" high Proposed Solution: Modify equipment or mounting. 	PCODE IE02 ADAAG 91 4.2.6 ADA 2010 308.3.1 CBC 2007 1118B.6 CBC 2016 11B-308.3 Mitigated: <input type="radio"/> YES <input checked="" type="radio"/> NO	1	JOB	\$300	\$300

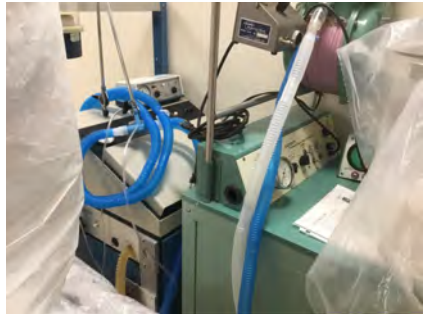
<input type="checkbox"/> Staff Only						
Priority 2 Severity 3						
1553	<ul style="list-style-type: none"> As-Built Description: Reach height to control or access point, where side approach is available, exceeds 48" or is less than 15" in height, or exceeds 10" in depth. As-Built: The reach to the controls is over a 41" high obstruction Proposed Solution: Modify equipment or mounting. 	PCODE IE02 ADAAG 91 4.2.6 ADA 2010 308.3.1 CBC 2007 1118B.6 CBC 2016 11B-308.3 Mitigated: <input type="radio"/> YES <input checked="" type="radio"/> NO	2	JOB	\$300	\$600

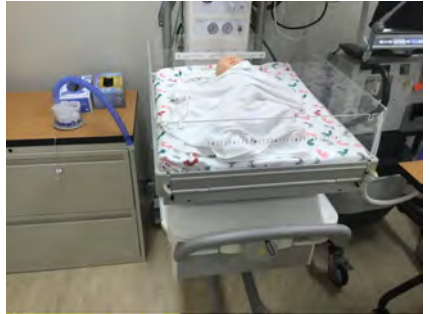
Item no., Rm no. and Name	Existing Architectural Barrier and Proposed Solution	Codes / Mitigation Info	Qty	Unit	Cost	Total
Desk						
1551	<ul style="list-style-type: none"> As-Built Description: Accessible fixed table or desk (top 28" to 34" high; knee space at least 27" high x 19" deep x 30" wide) not provided." As-Built: 37" to top Proposed Solution: Provide new fixed accessible table or desk. 	PCODE IN02REF ADAAG 91 4.32.3 & .4 ADA 2010 306.1 & 902.3 CBC 2007 1122B.3 & 4 CBC 2016 11B-306.1 & 11B-902.3				
		Mitigated: <input type="radio"/> YES <input checked="" type="radio"/> NO	REF

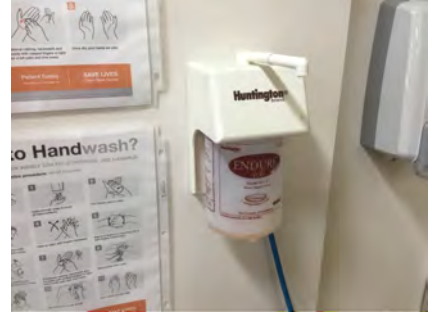
Item no., Rm no. and Name	Existing Architectural Barrier and Proposed Solution	Codes / Mitigation Info	Qty	Unit	Cost	Total
1556	<ul style="list-style-type: none"> As-Built Description: Reach height to control or access point, where side approach is available, exceeds 48" or is less than 15" in height, or exceeds 10" in depth. As-Built: 55" high Proposed Solution: Modify equipment or mounting. 	PCODE IE02 ADAAG 91 4.2.6 ADA 2010 308.3.1 CBC 2007 1118B.6 CBC 2016 11B-308.3 Mitigated: <input type="radio"/> YES <input checked="" type="radio"/> NO	1	JOB	\$300	\$300

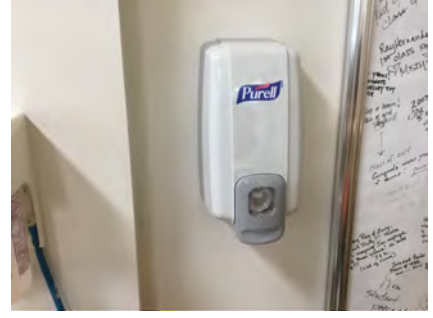
<input type="checkbox"/> Staff Only						
Priority 2 Severity 3						
1557	<ul style="list-style-type: none"> As-Built Description: Reach height to control or access point, where side approach is available, exceeds 48" or is less than 15" in height, or exceeds 10" in depth. As-Built: 49" high Proposed Solution: Modify equipment or mounting. 	PCODE IE02 ADAAG 91 4.2.6 ADA 2010 308.3.1 CBC 2007 1118B.6 CBC 2016 11B-308.3 Mitigated: <input type="radio"/> YES <input checked="" type="radio"/> NO	1	JOB	\$300	\$300
