SAN MATEO COUNTY
COMMUNITY
COLLEGE DISTRICT

San Mateo County Community College District Americans with Disabilities Act Self-Evaluation and Transition Plan

Report Prepared by:

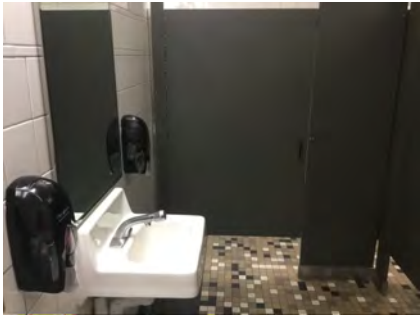
Item no., Rm no. and Name	Existing Architectural Barrier and Proposed Solution	Codes / Mitigation Info	Qty	Unit	Cost	Total
Door Swing						
1575	<ul style="list-style-type: none">As-Built Description: Front approach: At push side, door does not have clear and level maneuvering space measuring door width x 48" (door width plus 12" if door has both, latch and closer).As-Built: Lavatory 35" from the push side of the accessible compartment doorProposed Solution: Remove or relocate furniture or storage items.	<p>PCODE ID24A ADAAG 91 Fig. 25(a) ADA 2010 404.2.4 CBC 2007 11B-26A(a) CBC 2016 11B-404.2.4</p> <p>Mitigated: <input type="radio"/> YES <input checked="" type="radio"/> NO</p>	1	JOB	\$150	\$150

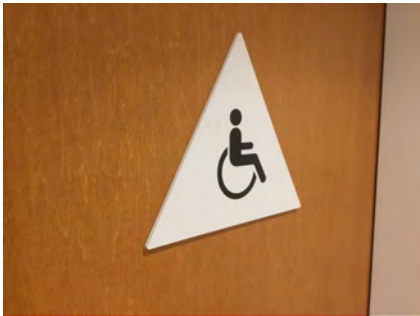
<input type="checkbox"/> Staff Only			
			Priority	Severity		
			3	2		
Signage						
1559	<ul style="list-style-type: none">As-Built Description: Required in CA only: identification symbol centered 58" to 60" high on sanitary facility door that contrasts with the door not provided (women: 12" ø circle, men: 12" triangle, unisex: combined symbol).As-Built: Not easedProposed Solution: Provide properly mounted sanitary facility symbol when altering area. If wheelchair accessible, include International Symbol of Accessibility on sign.	<p>PCODE SA15 CBC 2007 1115B.6 CBC 2016 11B-703.7.2.6</p> <p>Mitigated: <input type="radio"/> YES <input checked="" type="radio"/> NO</p>	1	JOB	\$270	\$270

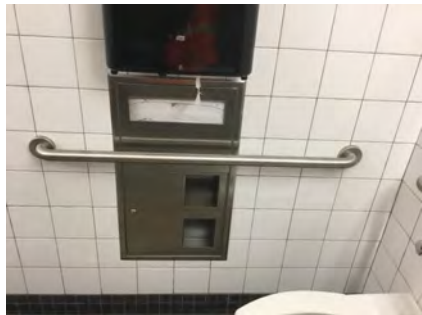
Item no., Rm no. and Name	Existing Architectural Barrier and Proposed Solution	Codes / Mitigation Info	Qty	Unit	Cost	Total
Grab Bars						
1576	<ul style="list-style-type: none"> • <i>As-Built Description:</i> Side grab bar less than 42" long, or located more than 12 inches max. from the rear wall, or extending less than 54" from rear wall (CA only: front end min. 24" in front of water closet). • <i>As-Built:</i> 42" side grab bar extends 51" from rear wall • <i>Proposed Solution:</i> Provide or relocate accessible side grab bar. 	PCODE WB07A ADAAG 91 Fig. 29(b) ADA 2010 604.5.1 CBC 2007 1115B.4.1.3.1 CBC 2016 11B-604.5.1 Mitigated: <input type="radio"/> YES <input checked="" type="radio"/> NO	1	JOB	\$780	\$780

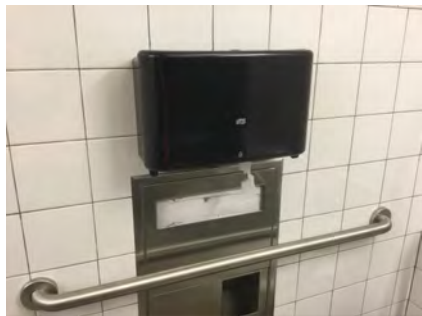
<input type="checkbox"/> Staff Only			
			Priority	Severity		
			3	3		
1577	<ul style="list-style-type: none"> • <i>As-Built Description:</i> Accessories/dispensers in accessible stall located closer than 1-1/2" below or 12" above grab bar impedes its use. • <i>As-Built:</i> 10.5" above • <i>Proposed Solution:</i> Relocate accessories/dispensers to be no closer than 1-1/2" below and 12" above grab bars (except if accessories are recessed, flush with wall, and have no sharp edges). 	PCODE WB07I ADAAG 91 4.26.2 ADA 2010 609.3 CBC 2007 1133B.4.2.5 CBC 2016 11B-609.3 Mitigated: <input type="radio"/> YES <input checked="" type="radio"/> NO	1	JOB	\$225	\$225

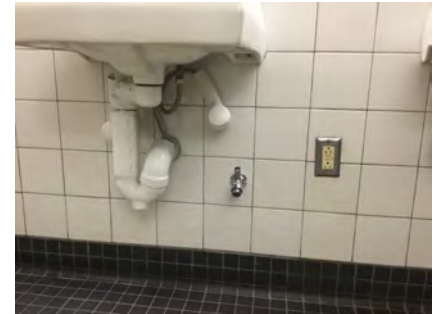
1574	<ul style="list-style-type: none"> • <i>As-Built Description:</i> Hot or sharp-surfaced water/drain pipe not insulated or covered. • <i>Proposed Solution:</i> Insulate or cover water/drain pipe. 	PCODE WD05 ADAAG 91 4.19.4 ADA 2010 606.5 CBC 2007 1115B.4.3.4 CBC 2016 11B-606.5	1	JOB	\$360	\$360
------	--	---	---	-----	-------	-------

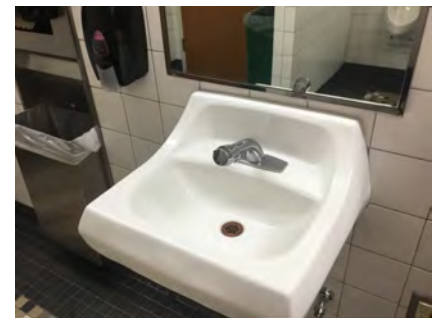
1573	<ul style="list-style-type: none"> • <i>As-Built Description:</i> Lavatory: Self-closing faucet at accessible lavatory does not remain open for at least 10 seconds. • <i>As-Built:</i> 4 seconds • <i>Proposed Solution:</i> Adjust self-closing faucet at accessible lavatory. 	PCODE WD07 ADAAG 91 4.19.5 ADA 2010 606.4 CBC 2007 1115B.4.3 CBC 2016 11B-606.4	1	JOB	\$150	\$150
------	--	---	---	-----	-------	-------

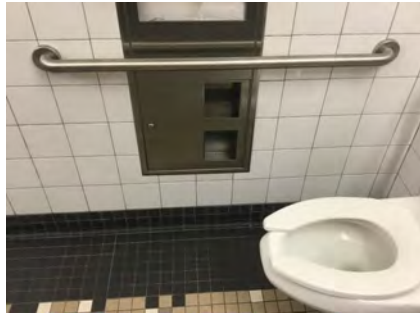
Item no., Rm no. and Name	Existing Architectural Barrier and Proposed Solution	Codes / Mitigation Info	Qty	Unit	Cost	Total
Accessories						
1579	<ul style="list-style-type: none"> • <i>As-Built Description:</i> Toilet paper dispenser less than 15" (CA: 19") or more than 48" above floor or not within 7" to 9" from front of water closet (Note: CA pre-2010 is allowed within 12" from front of water closet). • <i>As-Built:</i> 3.5" to the centerline of the toilet paper rolls • <i>Proposed Solution:</i> Relocate or provide new toilet paper dispenser. 	PCODE WG02 ADAAG 91 4.16.6 ADA 2010 604.7 CBC 2007 1115B.8.4 CBC 2016 11B-604.7 Mitigated: <input type="radio"/> YES <input checked="" type="radio"/> NO	1	JOB	\$225	\$225

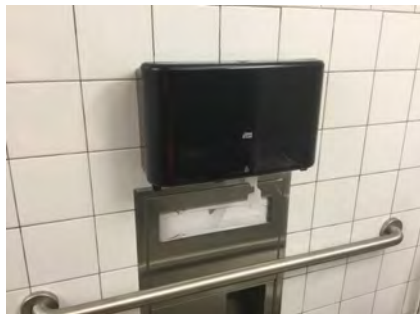
<input type="checkbox"/> Staff Only Priority 3 Severity 3			
1578	<ul style="list-style-type: none"> • <i>As-Built Description:</i> Toilet paper dispenser less than 15" (CA: 19") or more than 48" above floor or not within 7" to 9" from front of water closet (Note: CA pre-2010 is allowed within 12" from front of water closet). • <i>As-Built:</i> Above the side grab bar • <i>Proposed Solution:</i> Relocate or provide new toilet paper dispenser. 	PCODE WG02REF ADAAG 91 4.16.6 ADA 2010 604.7 CBC 2007 1115B.8.4 CBC 2016 11B-604.7 Mitigated: <input type="radio"/> YES <input checked="" type="radio"/> NO		REF

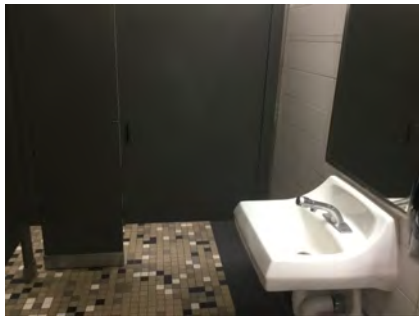
Item no., Rm no. and Name	Existing Architectural Barrier and Proposed Solution	Codes / Mitigation Info	Qty	Unit	Cost	Total
Door Swing						
1564	<ul style="list-style-type: none">As-Built Description: Front approach: At push side, door does not have clear and level maneuvering space measuring door width x 48" (door width plus 12" if door has both, latch and closer).As-Built: Lavatory 33" from push side of accessible compartment doorProposed Solution: Remove or relocate furniture or storage items.Notes: The lavatory is the only accessible lavatory in the room because the others are 16" deep.	PCODE ID24A ADAAG 91 Fig. 25(a) ADA 2010 404.2.4 CBC 2007 11B-26A(a) CBC 2016 11B-404.2.4 Mitigated: <input type="radio"/> YES <input checked="" type="radio"/> NO	1	JOB	\$150	\$150

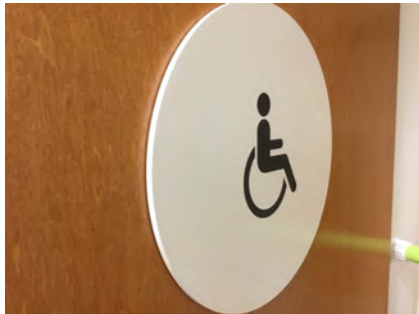
<input type="checkbox"/> Staff Only			
			Priority		Severity	
			3		2	
Signage						
1561	<ul style="list-style-type: none">As-Built Description: Required in CA only: identification symbol centered 58" to 60" high on sanitary facility door that contrasts with the door not provided (women: 12" ø circle, men: 12" triangle, unisex: combined symbol).As-Built: Not easedProposed Solution: Provide properly mounted sanitary facility symbol when altering area. If wheelchair accessible, include International Symbol of Accessibility on sign.	PCODE SA15 CBC 2007 1115B.6 CBC 2016 11B-703.7.2.6 Mitigated: <input type="radio"/> YES <input checked="" type="radio"/> NO	1	JOB	\$270	\$270

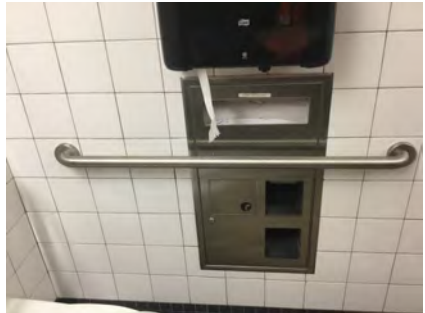
Item no., Rm no. and Name	Existing Architectural Barrier and Proposed Solution	Codes / Mitigation Info	Qty	Unit	Cost	Total
Grab Bars						
1569	<ul style="list-style-type: none"> • <i>As-Built Description:</i> Side grab bar less than 42" long, or located more than 12 inches max. from the rear wall, or extending less than 54" from rear wall (CA only: front end min. 24" in front of water closet). • <i>As-Built:</i> Side grab bar extend 51" from the rear wall • <i>Proposed Solution:</i> Provide or relocate accessible side grab bar. 	PCODE WB07A ADAAG 91 Fig. 29(b) ADA 2010 604.5.1 CBC 2007 1115B.4.1.3.1 CBC 2016 11B-604.5.1 Mitigated: <input type="radio"/> YES <input checked="" type="radio"/> NO	1	JOB	\$780	\$780

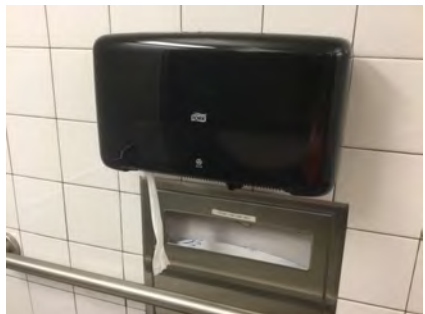
<input type="checkbox"/> Staff Only			
			Priority		Severity	
			3		3	
1567	<ul style="list-style-type: none"> • <i>As-Built Description:</i> Accessories/dispensers in accessible stall located closer than 1-1/2" below or 12" above grab bar impedes its use. • <i>As-Built:</i> 11" above the side grab bar • <i>Proposed Solution:</i> Relocate accessories/dispensers to be no closer than 1-1/2" below and 12" above grab bars (except if accessories are recessed, flush with wall, and have no sharp edges). 	PCODE WB07I ADAAG 91 4.26.2 ADA 2010 609.3 CBC 2007 1133B.4.2.5 CBC 2016 11B-609.3 Mitigated: <input type="radio"/> YES <input checked="" type="radio"/> NO	1	JOB	\$225	\$225

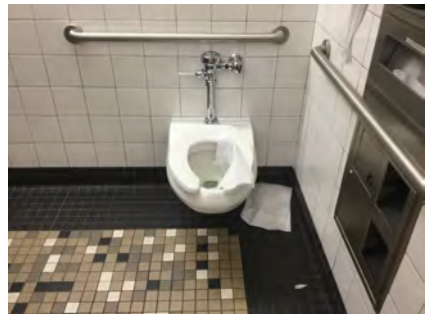
Item no., Rm no. and Name	Existing Architectural Barrier and Proposed Solution	Codes / Mitigation Info	Qty	Unit	Cost	Total
Water Closet						
1565	<ul style="list-style-type: none">• <i>As-Built Description:</i> Water closet not 16"-18" (CA: 17"-18") from near side wall to center line of water closet (2010 ADAAG: 16"-18").• <i>As-Built:</i> 18.25" o.c.• <i>Proposed Solution:</i> Relocate existing water closet and plumbing, remount with offset closet flange to provide 18" max. from side wall.	<p>PCODE WB02C ADAAG 91 Fig. 28 ADA 2010 604.2 CBC 2007 1115B.4.1.1 CBC 2016 11B-604.2</p> <p>Mitigated: <input type="radio"/> YES <input checked="" type="radio"/> NO</p>	1	JOB	\$1,500	\$1,500

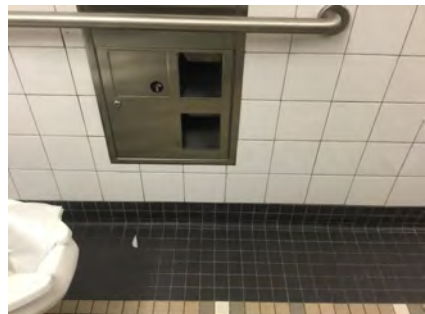
<input type="checkbox"/> Staff Only			
			Priority	Severity		
			3	4		
Accessories						
1568	<ul style="list-style-type: none">• <i>As-Built Description:</i> Toilet paper dispenser less than 15" (CA: 19") or more than 48" above floor or not within 7" to 9" from front of water closet (Note: CA pre-2010 is allowed within 12" from front of water closet).• <i>As-Built:</i> 11.5" to the centerline the toilet paper rolls• <i>Proposed Solution:</i> Relocate or provide new toilet paper dispenser.	<p>PCODE WG02 ADAAG 91 4.16.6 ADA 2010 604.7 CBC 2007 1115B.8.4 CBC 2016 11B-604.7</p> <p>Mitigated: <input type="radio"/> YES <input checked="" type="radio"/> NO</p>	1	JOB	\$225	\$225

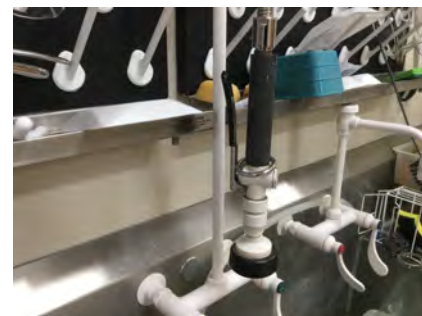
Item no., Rm no. and Name	Existing Architectural Barrier and Proposed Solution	Codes / Mitigation Info	Qty	Unit	Cost	Total
Reach Range						
1585	<ul style="list-style-type: none"> As-Built Description: Reach height to control or access point, exceeds 48" or is less than 15". As-Built: 26" to 28" deep Proposed Solution: Modify equipment or mounting. Notes: 25" toe clearance 	PCODE IE01 ADAAG 91 4.2.5 ADA 2010 308.2.1 CBC 2007 1118B.5 CBC 2016 11B-308.2.1 Mitigated: <input type="radio"/> YES <input checked="" type="radio"/> NO	2	JOB	\$300	\$600

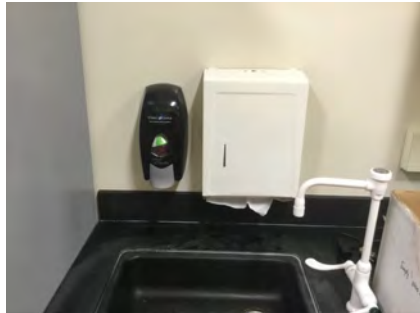
<input type="checkbox"/> Staff Only			
			Priority 2 Severity 4			
1586	<ul style="list-style-type: none"> As-Built Description: Reach height to control or access point, where side approach is available, exceeds 48" or is less than 15" in height, or exceeds 10" in depth. As-Built: Storage up to 67" high Proposed Solution: Modify equipment or mounting. 	PCODE IE02 ADAAG 91 4.2.6 ADA 2010 308.3.1 CBC 2007 1118B.6 CBC 2016 11B-308.3 Mitigated: <input type="radio"/> YES <input checked="" type="radio"/> NO	1	JOB	\$300	\$300

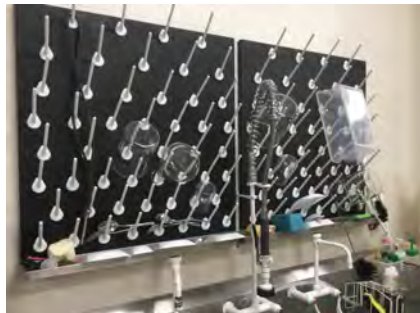
<input type="checkbox"/> Staff Only			
			Priority 2 Severity 1			
1589	<ul style="list-style-type: none"> As-Built Description: Reach height to control or access point, where side approach is available, exceeds 48" or is less than 15" in height, or exceeds 10" in depth. As-Built: 26" deep and 48" high over 36" high obstruction Proposed Solution: Modify equipment or mounting. 	PCODE IE02 ADAAG 91 4.2.6 ADA 2010 308.3.1 CBC 2007 1118B.6 CBC 2016 11B-308.3 Mitigated: <input type="radio"/> YES <input checked="" type="radio"/> NO	2	JOB	\$300	\$600

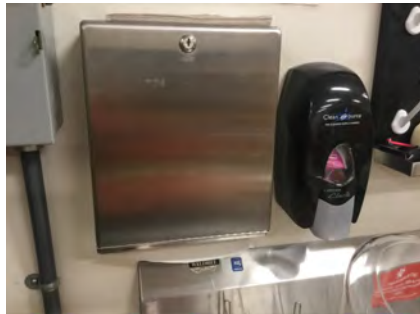
Item no., Rm no. and Name	Existing Architectural Barrier and Proposed Solution	Codes / Mitigation Info	Qty	Unit	Cost	Total
1590	<ul style="list-style-type: none"> As-Built Description: Reach height to control or access point, where side approach is available, exceeds 48" or is less than 15" in height, or exceeds 10" in depth. As-Built: Various tools and message boards are higher than 54" Proposed Solution: Modify equipment or mounting. 	PCODE IE02 ADAAG 91 4.2.6 ADA 2010 308.3.1 CBC 2007 1118B.6 CBC 2016 11B-308.3 Mitigated: <input type="radio"/> YES <input checked="" type="radio"/> NO	4	JOB	\$300	\$1,200

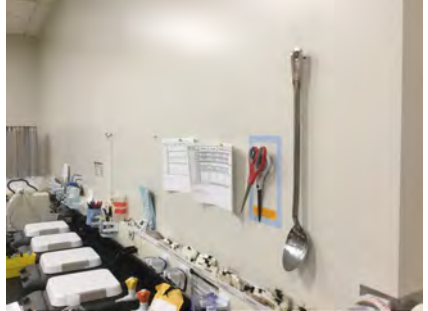
<input type="checkbox"/> Staff Only Priority 2 Severity 3			
1591	<ul style="list-style-type: none"> As-Built Description: Reach height to control or access point, where side approach is available, exceeds 48" or is less than 15" in height, or exceeds 10" in depth. As-Built: 63.5" high Proposed Solution: Modify equipment or mounting. 	PCODE IE02 ADAAG 91 4.2.6 ADA 2010 308.3.1 CBC 2007 1118B.6 CBC 2016 11B-308.3 Mitigated: <input type="radio"/> YES <input checked="" type="radio"/> NO	1	JOB	\$300	\$300

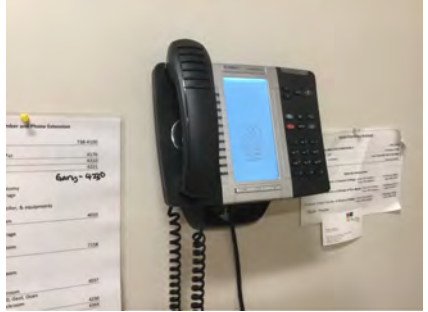
<input type="checkbox"/> Staff Only Priority 2 Severity 2			
1592	<ul style="list-style-type: none"> As-Built Description: Reach height to control or access point, where side approach is available, exceeds 48" or is less than 15" in height, or exceeds 10" in depth. As-Built: Specialty equipment 63" high Proposed Solution: Modify equipment or mounting. Notes: Multiple devices. 	PCODE IE02 ADAAG 91 4.2.6 ADA 2010 308.3.1 CBC 2007 1118B.6 CBC 2016 11B-308.3 Mitigated: <input type="radio"/> YES <input checked="" type="radio"/> NO	5	JOB	\$300	\$1,500

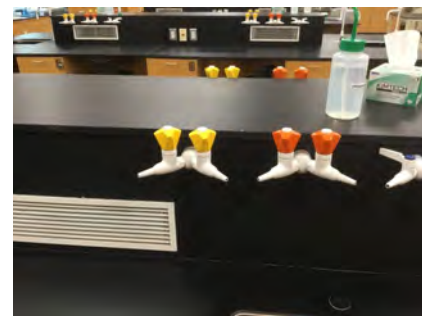
Item no., Rm no. and Name	Existing Architectural Barrier and Proposed Solution	Codes / Mitigation Info	Qty	Unit	Cost	Total
Reach Range						
1594	<ul style="list-style-type: none"> As-Built Description: Reach height to control or access point, exceeds 48" or is less than 15". As-Built: 47" high at 23" deep obstructed reach Proposed Solution: Modify equipment or mounting. 	PCODE IE01 ADAAG 91 4.2.5 ADA 2010 308.2.1 CBC 2007 1118B.5 CBC 2016 11B-308.2.1 Mitigated: <input type="radio"/> YES <input checked="" type="radio"/> NO	6	JOB	\$300	\$1,800

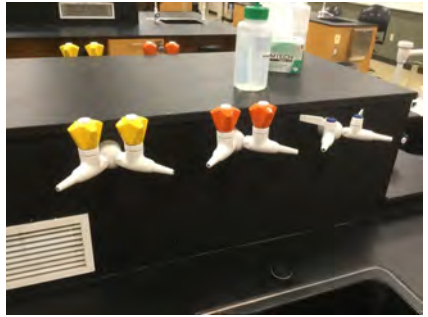
<input type="checkbox"/> Staff Only Priority 2 Severity 4			
1597	<ul style="list-style-type: none"> As-Built Description: Reach height to control or access point, where side approach is available, exceeds 48" or is less than 15" in height, or exceeds 10" in depth. As-Built: 26" deep at 36" high obstruction Proposed Solution: Modify equipment or mounting. 	PCODE IE02 ADAAG 91 4.2.6 ADA 2010 308.3.1 CBC 2007 1118B.6 CBC 2016 11B-308.3 Mitigated: <input type="radio"/> YES <input checked="" type="radio"/> NO	1	JOB	\$300	\$300

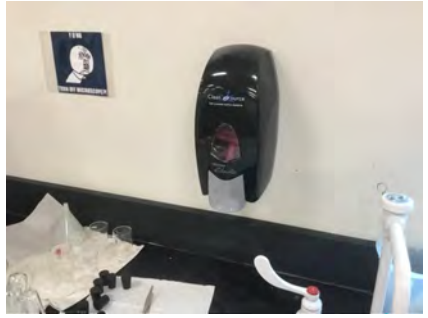
Item no., Rm no. and Name	Existing Architectural Barrier and Proposed Solution	Codes / Mitigation Info	Qty	Unit	Cost	Total
Sink						
1596	<ul style="list-style-type: none"> As-Built Description: Sink rim higher than 34" above floor. As-Built: 36" high Proposed Solution: Remodel sink cabinet to lower sink. 	PCODE IN06 ADAAG 91 4.24.2 ADA 2010 606.3 CBC 2007 1115B.4.7.1 CBC 2016 11B-606.3 Mitigated: <input type="radio"/> YES <input checked="" type="radio"/> NO	1	JOB	\$5,250	\$5,250

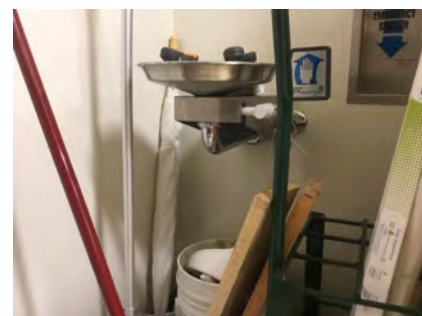
Item no., Rm no. and Name	Existing Architectural Barrier and Proposed Solution	Codes / Mitigation Info	Qty	Unit	Cost	Total
1605	<ul style="list-style-type: none">• <i>As-Built Description:</i> Minimum of at least one of each type of sink and other specialized equipment such as fume hoods, microscopes, emergency eyewash and showers, etc, associated with the special use activity is not accessible. (CA Only)• <i>Proposed Solution:</i> Remodel existing area to make specialized equipment accessible to disabled persons.• <i>Notes:</i> Clear floor space at eyewash station obstructed.	<p>PCODE LB01B</p> <p>CBC 2007 1106B.2</p> <p>CBC 2016 11B-805.7</p> <p>Mitigated:</p> <p><input type="radio"/> YES</p> <p><input checked="" type="radio"/> NO</p>	1	JOB	\$5,400	\$5,400

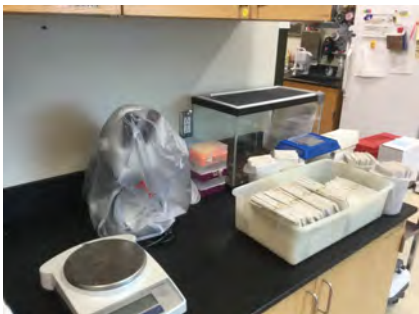
Item no., Rm no. and Name	Existing Architectural Barrier and Proposed Solution	Codes / Mitigation Info	Qty	Unit	Cost	Total
Reach Range						
1602	<ul style="list-style-type: none"> As-Built Description: Reach height to control or access point, exceeds 48" or is less than 15". As-Built: 28" deep obstructed Proposed Solution: Modify equipment or mounting. Notes: 25" of toe space 	PCODE IE01 ADAAG 91 4.2.5 ADA 2010 308.2.1 CBC 2007 1118B.5 CBC 2016 11B-308.2.1 Mitigated: <input type="radio"/> YES <input checked="" type="radio"/> NO	2	JOB	\$300	\$600

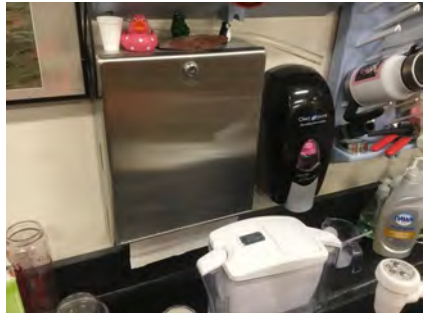
<input type="checkbox"/> Staff Only			
			Priority	Severity		
			2	4		
1598	<ul style="list-style-type: none"> As-Built Description: Reach height to control or access point, where side approach is available, exceeds 48" or is less than 15" in height, or exceeds 10" in depth. As-Built: 54.65" to 56" high Proposed Solution: Modify equipment or mounting. 	PCODE IE02 ADAAG 91 4.2.6 ADA 2010 308.3.1 CBC 2007 1118B.6 CBC 2016 11B-308.3 Mitigated: <input type="radio"/> YES <input checked="" type="radio"/> NO	2	JOB	\$300	\$600

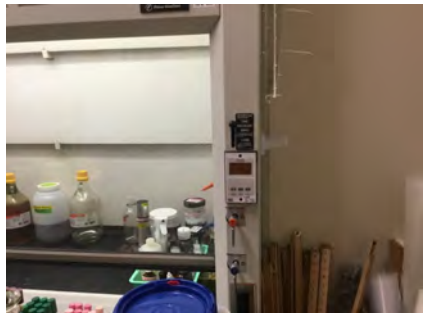
<input type="checkbox"/> Staff Only			
			Priority	Severity		
			2	3		
1599	<ul style="list-style-type: none"> As-Built Description: Reach height to control or access point, where side approach is available, exceeds 48" or is less than 15" in height, or exceeds 10" in depth. As-Built: Phone 28" deep and 54" high Proposed Solution: Modify equipment or mounting. 	PCODE IE02 ADAAG 91 4.2.6 ADA 2010 308.3.1 CBC 2007 1118B.6 CBC 2016 11B-308.3 Mitigated: <input type="radio"/> YES <input checked="" type="radio"/> NO	1	JOB	\$300	\$300

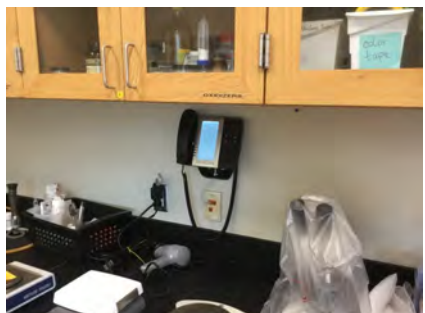
Item no., Rm no. and Name	Existing Architectural Barrier and Proposed Solution	Codes / Mitigation Info	Qty	Unit	Cost	Total
1601	<ul style="list-style-type: none"> • <i>As-Built Description:</i> Reach height to control or access point, where side approach is available, exceeds 48" or is less than 15" in height, or exceeds 10" in depth. • <i>As-Built:</i> 52" high • <i>Proposed Solution:</i> Modify equipment or mounting. 	PCODE IE02 ADAAG 91 4.2.6 ADA 2010 308.3.1 CBC 2007 1118B.6 CBC 2016 11B-308.3 Mitigated: <input type="radio"/> YES <input checked="" type="radio"/> NO	1	JOB	\$300	\$300

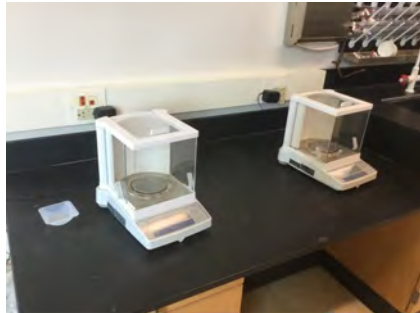
Item no., Rm no. and Name	Existing Architectural Barrier and Proposed Solution	Codes / Mitigation Info	Qty	Unit	Cost	Total
Electrical						
1621	<ul style="list-style-type: none"> • <i>As-Built Description:</i> Electric switch or control mounted less than 15" measured to the bottom of the outlet box or greater than 48 inches measured to the top of the outlet box. • <i>As-Built:</i> 27" deep obstructed forward reach • <i>Proposed Solution:</i> Relocate light switches or control to between 15" and 48" height. 	PCODE IC01 ADAAG 91 4.2.5 & 6 ADA 2010 308.2.1 & CBC 2007 1117B.6.3 CBC 2016 11B-308.2.1 & 11B-308.2.2 Mitigated: <input type="radio"/> YES <input checked="" type="radio"/> NO	3	JOB	\$900	\$2,700

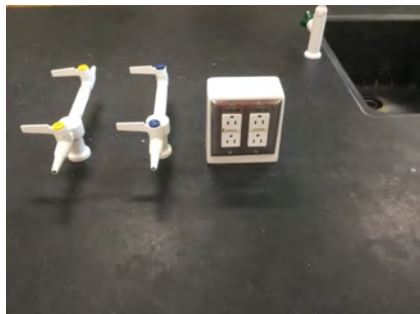
<input type="checkbox"/> Staff Only Priority 2 Severity 4			
1634	<ul style="list-style-type: none"> • <i>As-Built Description:</i> Electric switch or control mounted less than 15" measured to the bottom of the outlet box or greater than 48 inches measured to the top of the outlet box. • <i>As-Built:</i> 30" deep obstructed forward reach • <i>Proposed Solution:</i> Relocate light switches or control to between 15" and 48" height. 	PCODE IC01 ADAAG 91 4.2.5 & 6 ADA 2010 308.2.1 & CBC 2007 1117B.6.3 CBC 2016 11B-308.2.1 & 11B-308.2.2 Mitigated: <input type="radio"/> YES <input checked="" type="radio"/> NO	12	JOB	\$900	\$10,800

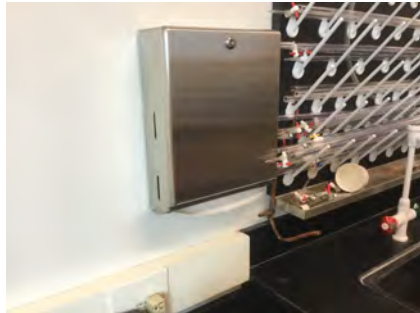
Item no., Rm no. and Name	Existing Architectural Barrier and Proposed Solution	Codes / Mitigation Info	Qty	Unit	Cost	Total
Reach Range						
1622	<ul style="list-style-type: none"> As-Built Description: Reach height to control or access point, exceeds 48" or is less than 15". As-Built: 28" deep obstructed forward reach Proposed Solution: Modify equipment or mounting. 	PCODE IE01 ADAAG 91 4.2.5 ADA 2010 308.2.1 CBC 2007 1118B.5 CBC 2016 11B-308.2.1 Mitigated: <input type="radio"/> YES <input checked="" type="radio"/> NO	1	JOB	\$300	\$300

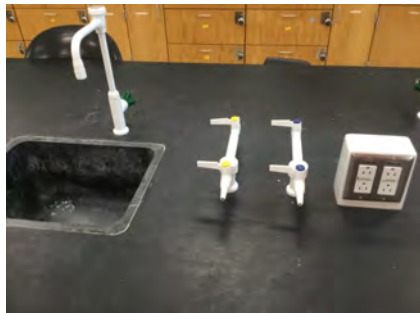
<input type="checkbox"/> Staff Only Priority 2 Severity 4			
1632	<ul style="list-style-type: none"> As-Built Description: Reach height to control or access point, exceeds 48" or is less than 15". As-Built: 30" deep obstructed forward reach Proposed Solution: Modify equipment or mounting. 	PCODE IE01 ADAAG 91 4.2.5 ADA 2010 308.2.1 CBC 2007 1118B.5 CBC 2016 11B-308.2.1 Mitigated: <input type="radio"/> YES <input checked="" type="radio"/> NO	24	JOB	\$300	\$7,200

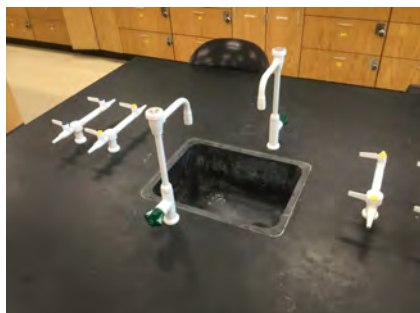
<input type="checkbox"/> Staff Only Priority 2 Severity 4			
1633	<ul style="list-style-type: none"> As-Built Description: Reach height to control or access point, exceeds 48" or is less than 15". As-Built: 30" deep obstructed forward reach to sink Proposed Solution: Modify equipment or mounting. 	PCODE IE01 ADAAG 91 4.2.5 ADA 2010 308.2.1 CBC 2007 1118B.5 CBC 2016 11B-308.2.1 Mitigated: <input type="radio"/> YES <input checked="" type="radio"/> NO	3	JOB	\$300	\$900

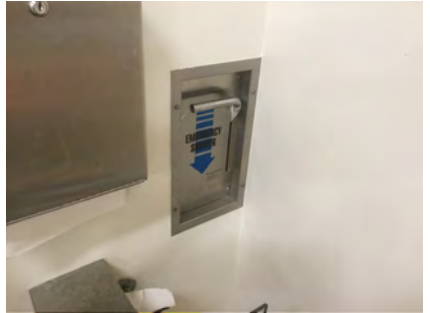
Item no., Rm no. and Name	Existing Architectural Barrier and Proposed Solution	Codes / Mitigation Info	Qty	Unit	Cost	Total
1644	<ul style="list-style-type: none"> As-Built Description: Reach height to control or access point, exceeds 48" or is less than 15". As-Built: The reach is over the toes approximately 1" Proposed Solution: Modify equipment or mounting. 	PCODE IE01 ADAAG 91 4.2.5 ADA 2010 308.2.1 CBC 2007 1118B.5 CBC 2016 11B-308.2.1 Mitigated: <input type="radio"/> YES <input checked="" type="radio"/> NO	1	JOB	\$300	\$300

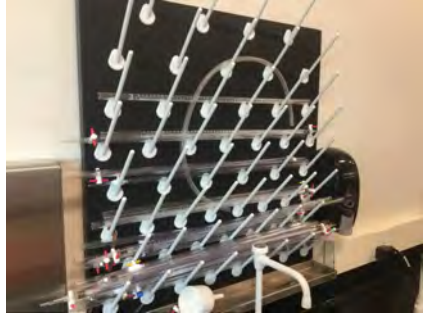
<input type="checkbox"/> Staff Only Priority 2 Severity 4			
1623	<ul style="list-style-type: none"> As-Built Description: Reach height to control or access point, where side approach is available, exceeds 48" or is less than 15" in height, or exceeds 10" in depth. As-Built: 28" deep obstructed side reach Proposed Solution: Modify equipment or mounting. 	PCODE IE02 ADAAG 91 4.2.6 ADA 2010 308.3.1 CBC 2007 1118B.6 CBC 2016 11B-308.3 Mitigated: <input type="radio"/> YES <input checked="" type="radio"/> NO	3	JOB	\$300	\$900

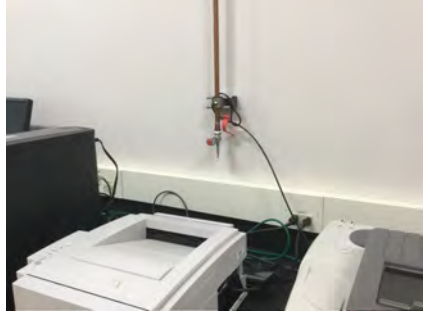
<input type="checkbox"/> Staff Only Priority 2 Severity 4			
1626	<ul style="list-style-type: none"> As-Built Description: Reach height to control or access point, where side approach is available, exceeds 48" or is less than 15" in height, or exceeds 10" in depth. As-Built: 26" deep and 50" high over a 36" high obstruction Proposed Solution: Modify equipment or mounting. 	PCODE IE02 ADAAG 91 4.2.6 ADA 2010 308.3.1 CBC 2007 1118B.6 CBC 2016 11B-308.3 Mitigated: <input type="radio"/> YES <input checked="" type="radio"/> NO	1	JOB	\$300	\$300

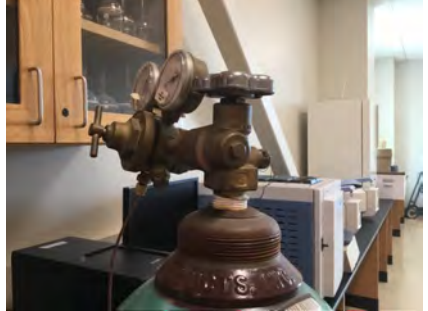
Item no., Rm no. and Name	Existing Architectural Barrier and Proposed Solution	Codes / Mitigation Info	Qty	Unit	Cost	Total
1628	<ul style="list-style-type: none"> As-Built Description: Reach height to control or access point, where side approach is available, exceeds 48" or is less than 15" in height, or exceeds 10" in depth. As-Built: 60" high Proposed Solution: Modify equipment or mounting. Notes: Unclear if operated by students or faculty only. 	PCODE IE02 ADAAG 91 4.2.6 ADA 2010 308.3.1 CBC 2007 1118B.6 CBC 2016 11B-308.3 Mitigated: <input type="radio"/> YES <input checked="" type="radio"/> NO	1	JOB	\$300	\$300

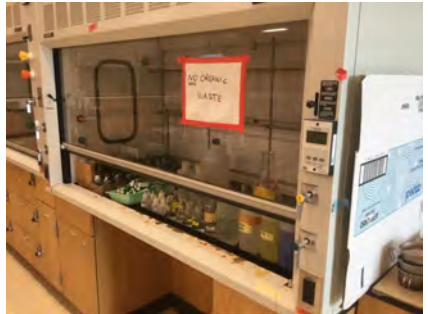
<input type="checkbox"/> Staff Only Priority 2 Severity 2			
1630	<ul style="list-style-type: none"> As-Built Description: Reach height to control or access point, where side approach is available, exceeds 48" or is less than 15" in height, or exceeds 10" in depth. As-Built: Up to 58" high at accessible stations Proposed Solution: Modify equipment or mounting. 	PCODE IE02 ADAAG 91 4.2.6 ADA 2010 308.3.1 CBC 2007 1118B.6 CBC 2016 11B-308.3 Mitigated: <input type="radio"/> YES <input checked="" type="radio"/> NO	9	JOB	\$300	\$2,700

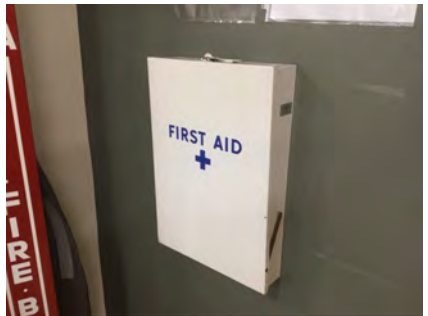
<input type="checkbox"/> Staff Only Priority 2 Severity 3			
1647	<ul style="list-style-type: none"> As-Built Description: Reach height to control or access point, where side approach is available, exceeds 48" or is less than 15" in height, or exceeds 10" in depth. As-Built: 57" high Proposed Solution: Modify equipment or mounting. 	PCODE IE02 ADAAG 91 4.2.6 ADA 2010 308.3.1 CBC 2007 1118B.6 CBC 2016 11B-308.3 Mitigated: <input type="radio"/> YES <input checked="" type="radio"/> NO	3	JOB	\$300	\$900

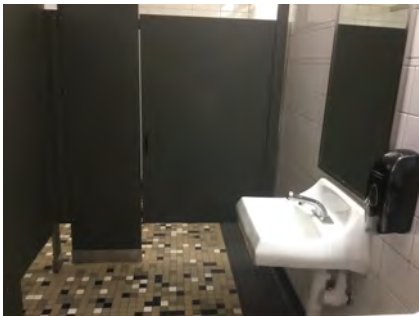
Item no., Rm no. and Name	Existing Architectural Barrier and Proposed Solution	Codes / Mitigation Info	Qty	Unit	Cost	Total
Door Swing						
1656	<ul style="list-style-type: none">As-Built Description: Front approach: At push side, door does not have clear and level maneuvering space measuring door width x 48" (door width plus 12" if door has both, latch and closer).As-Built: <i>The accessible laboratory is 34" from the accessible compartment door.</i>Proposed Solution: Remove or relocate furniture or storage items.Notes: This lavatory is the only accessible one in the room because the other lavatories are 16" deep.	<p>PCODE ID24A ADAAG 91 Fig. 25(a) ADA 2010 404.2.4 CBC 2007 11B-26A(a) CBC 2016 11B-404.2.4</p> <p>Mitigated: <input type="radio"/> YES <input checked="" type="radio"/> NO</p>	1	JOB	\$150	\$150

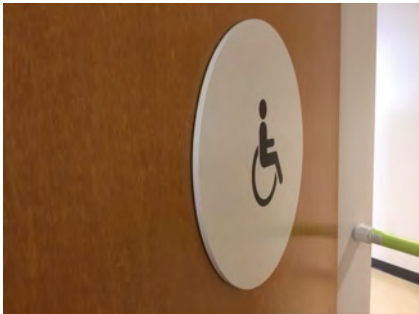
1650	<ul style="list-style-type: none">As-Built Description: Required in CA only: identification symbol centered 58" to 60" high on sanitary facility door that contrasts with the door not provided (women: 12" ø circle, men: 12" triangle, unisex: combined symbol).As-Built: Not easedProposed Solution: Provide properly mounted sanitary facility symbol when altering area. If wheelchair accessible, include International Symbol of Accessibility on sign.	<p>PCODE SA15 CBC 2007 1115B.6 CBC 2016 11B-703.7.2.6</p> <p>Mitigated: <input type="radio"/> YES <input checked="" type="radio"/> NO</p>	1	JOB	\$270	\$270

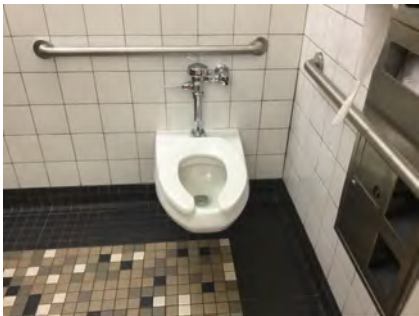
Item no., Rm no. and Name	Existing Architectural Barrier and Proposed Solution	Codes / Mitigation Info	Qty	Unit	Cost	Total
<u>Water Closet</u>						
1657	<ul style="list-style-type: none">• <i>As-Built Description:</i> Water closet not 16"-18" (CA: 17"-18") from near side wall to center line of water closet (2010 ADAAG: 16"-18").• <i>As-Built:</i> 18.5" o.c.• <i>Proposed Solution:</i> Relocate existing water closet and plumbing, remount with offset closet flange to provide 18" max. from side wall.	<p>PCODE WB02C ADAAG 91 Fig. 28 ADA 2010 604.2 CBC 2007 1115B.4.1.1 CBC 2016 11B-604.2</p> <p>Mitigated: <input type="radio"/> YES <input checked="" type="radio"/> NO</p>	1	JOB	\$1,500	\$1,500

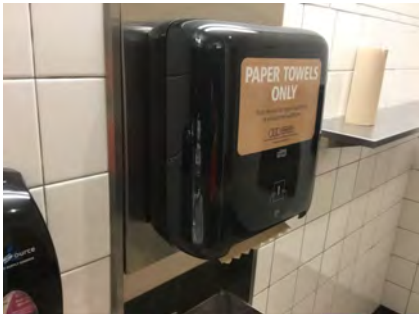
<input type="checkbox"/> Staff Only			
			Priority		Severity	
			3		4	
<u>Accessories</u>						
1655	<ul style="list-style-type: none">• <i>As-Built Description:</i> Dispensers in sanitary facilities, such as for towels, soap, sanitary napkins, seat covers, etc., and waste receptacles more than 48" (CA only: 40") from floor to highest operating slot or control.• <i>As-Built:</i> 42.5" high• <i>Proposed Solution:</i> Relocate existing restroom accessories.	<p>PCODE WG01A ADAAG 91 4.23.7 ADA 2010 308.2.1 CBC 2007 1115B.8.3 CBC 2016 11B-603.5</p> <p>Mitigated: <input type="radio"/> YES <input checked="" type="radio"/> NO</p>	1	JOB	\$300	\$300

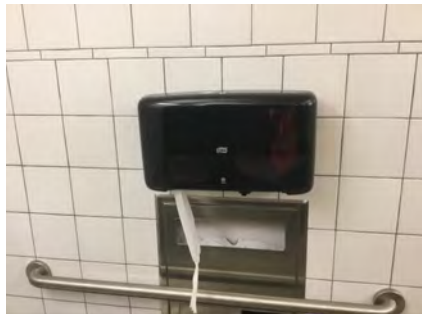
Item no., Rm no. and Name	Existing Architectural Barrier and Proposed Solution	Codes / Mitigation Info	Qty	Unit	Cost	Total
1661	<ul style="list-style-type: none"> • <i>As-Built Description:</i> Toilet paper dispenser less than 15" (CA: 19") or more than 48" above floor or not within 7" to 9" from front of water closet (Note: CA pre-2010 is allowed within 12" from front of water closet). • <i>As-Built:</i> Above the grab bar • <i>Proposed Solution:</i> Relocate or provide new toilet paper dispenser. 	PCODE WG02 ADAAG 91 4.16.6 ADA 2010 604.7 CBC 2007 1115B.8.4 CBC 2016 11B-604.7 Mitigated: <input type="radio"/> YES <input checked="" type="radio"/> NO	1	JOB	\$225	\$225

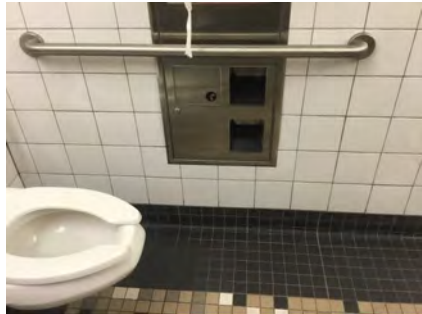
<input type="checkbox"/> Staff Only						
Priority 3 Severity 1						
1662	<ul style="list-style-type: none"> • <i>As-Built Description:</i> Toilet paper dispenser less than 15" (CA: 19") or more than 48" above floor or not within 7" to 9" from front of water closet (Note: CA pre-2010 is allowed within 12" from front of water closet). • <i>As-Built:</i> 12" to the centerline of the toilet paper rolls • <i>Proposed Solution:</i> Relocate or provide new toilet paper dispenser. 	PCODE WG02 ADAAG 91 4.16.6 ADA 2010 604.7 CBC 2007 1115B.8.4 CBC 2016 11B-604.7 Mitigated: <input type="radio"/> YES <input checked="" type="radio"/> NO	1	JOB	\$225	\$225

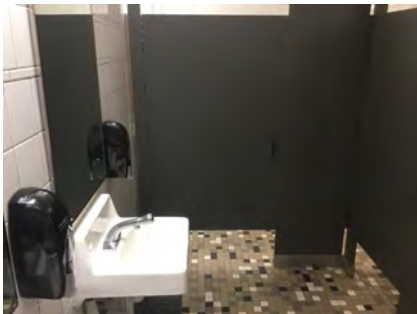
Item no., Rm no. and Name	Existing Architectural Barrier and Proposed Solution	Codes / Mitigation Info	Qty	Unit	Cost	Total
Door Swing						
1670	<ul style="list-style-type: none">As-Built Description: Front approach: At push side, door does not have clear and level maneuvering space measuring door width x 48" (door width plus 12" if door has both, latch and closer).As-Built: Lavatory 35" from the push side of the accessible compartment doorProposed Solution: Remove or relocate furniture or storage items.	PCODE ID24A ADAAG 91 Fig. 25(a) ADA 2010 404.2.4 CBC 2007 11B-26A(a) CBC 2016 11B-404.2.4 Mitigated: <input type="radio"/> YES <input checked="" type="radio"/> NO	1	JOB	\$150	\$150

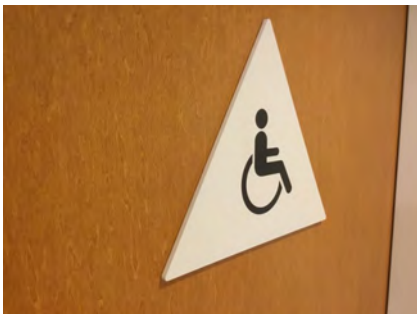
<input type="checkbox"/> Staff Only			
			Priority	Severity		
			3	2		
Signage						
1663	<ul style="list-style-type: none">As-Built Description: Required in CA only: identification symbol centered 58" to 60" high on sanitary facility door that contrasts with the door not provided (women: 12" ø circle, men: 12" triangle, unisex: combined symbol).As-Built: Edges not easedProposed Solution: Provide properly mounted sanitary facility symbol when altering area. If wheelchair accessible, include International Symbol of Accessibility on sign.	PCODE SA15 CBC 2007 1115B.6 CBC 2016 11B-703.7.2.6 Mitigated: <input type="radio"/> YES <input checked="" type="radio"/> NO	1	JOB	\$270	\$270

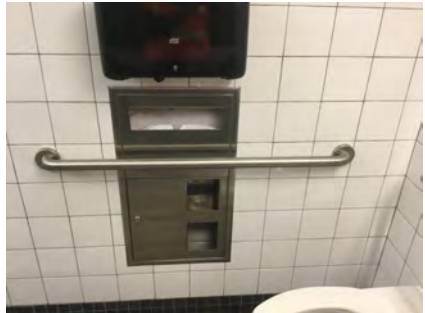
Item no., Rm no. and Name	Existing Architectural Barrier and Proposed Solution	Codes / Mitigation Info	Qty	Unit	Cost	Total
Grab Bars						
1671	<ul style="list-style-type: none"> • <i>As-Built Description:</i> Side grab bar less than 42" long, or located more than 12 inches max. from the rear wall, or extending less than 54" from rear wall (CA only: front end min. 24" in front of water closet). • <i>As-Built:</i> Side grab bar 52.75" from the rear wall. • <i>Proposed Solution:</i> Provide or relocate accessible side grab bar. 	PCODE WB07A ADAAG 91 Fig. 29(b) ADA 2010 604.5.1 CBC 2007 1115B.4.1.3.1 CBC 2016 11B-604.5.1 Mitigated: <input type="radio"/> YES <input checked="" type="radio"/> NO	1	JOB	\$780	\$780

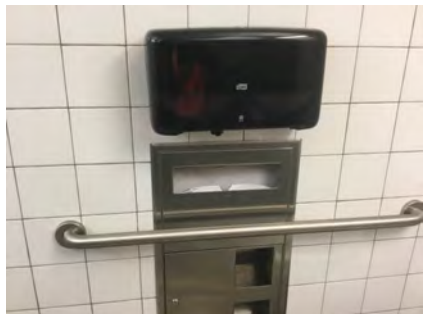
<input type="checkbox"/> Staff Only			
			Priority		Severity	
			3		4	
1673	<ul style="list-style-type: none"> • <i>As-Built Description:</i> Accessories/dispensers in accessible stall located closer than 1-1/2" below or 12" above grab bar impedes its use. • <i>As-Built:</i> Toilet paper dispenser 11.5" above the grab bar. • <i>Proposed Solution:</i> Relocate accessories/dispensers to be no closer than 1-1/2" below and 12" above grab bars (except if accessories are recessed, flush with wall, and have no sharp edges). 	PCODE WB07IREF ADAAG 91 4.26.2 ADA 2010 609.3 CBC 2007 1133B.4.2.5 CBC 2016 11B-609.3 Mitigated: <input type="radio"/> YES <input checked="" type="radio"/> NO		REF

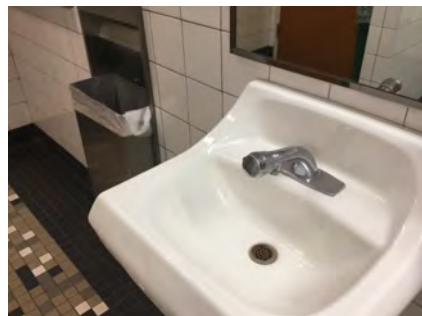
Item no., Rm no. and Name	Existing Architectural Barrier and Proposed Solution	Codes / Mitigation Info	Qty	Unit	Cost	Total
<u>Lavatory</u>						
1668	<ul style="list-style-type: none">As-Built Description: Lavatory: Self-closing faucet at accessible lavatory does not remain open for at least 10 seconds.As-Built: 2 secondsProposed Solution: Adjust self-closing faucet at accessible lavatory.	PCODE WD07 ADAAG 91 4.19.5 ADA 2010 606.4 CBC 2007 1115B.4.3 CBC 2016 11B-606.4 Mitigated: <input type="radio"/> YES <input checked="" type="radio"/> NO	1	JOB	\$150	\$150

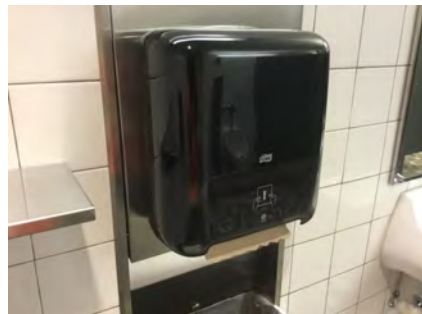
<input type="checkbox"/> Staff Only			
			Priority		Severity	
			3		3	
<u>Accessories</u>						
1665	<ul style="list-style-type: none">As-Built Description: Dispensers in sanitary facilities, such as for towels, soap, sanitary napkins, seat covers, etc., and waste receptacles more than 48" (CA only: 40") from floor to highest operating slot or control.As-Built: 42" highProposed Solution: Relocate existing restroom accessories.	PCODE WG01A ADAAG 91 4.23.7 ADA 2010 308.2.1 CBC 2007 1115B.8.3 CBC 2016 11B-603.5 Mitigated: <input type="radio"/> YES <input checked="" type="radio"/> NO	1	JOB	\$300	\$300

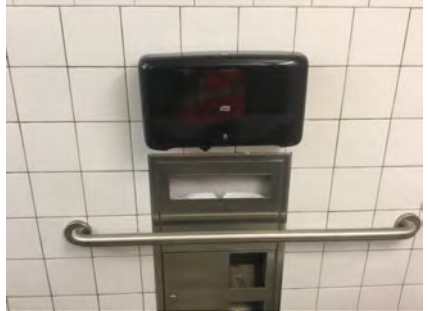
Item no., Rm no. and Name	Existing Architectural Barrier and Proposed Solution	Codes / Mitigation Info	Qty	Unit	Cost	Total
1672	<ul style="list-style-type: none"> As-Built Description: Toilet paper dispenser less than 15" (CA: 19") or more than 48" above floor or not within 7" to 9" from front of water closet (Note: CA pre-2010 is allowed within 12" from front of water closet). As-Built: Above the grab bar Proposed Solution: Relocate or provide new toilet paper dispenser. 	PCODE WG02 ADAAG 91 4.16.6 ADA 2010 604.7 CBC 2007 1115B.8.4 CBC 2016 11B-604.7 Mitigated: <input type="radio"/> YES <input checked="" type="radio"/> NO	1	JOB	\$225	\$225

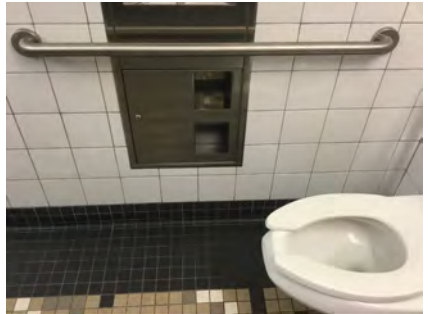
<input type="checkbox"/> Staff Only Priority 3 Severity 1				
1674	<ul style="list-style-type: none"> As-Built Description: Toilet paper dispenser less than 15" (CA: 19") or more than 48" above floor or not within 7" to 9" from front of water closet (Note: CA pre-2010 is allowed within 12" from front of water closet). As-Built: 5" to the centerline of the toilet paper rolls Proposed Solution: Relocate or provide new toilet paper dispenser. 	PCODE WG02 ADAAG 91 4.16.6 ADA 2010 604.7 CBC 2007 1115B.8.4 CBC 2016 11B-604.7 Mitigated: <input type="radio"/> YES <input checked="" type="radio"/> NO	1	JOB	\$225	\$225

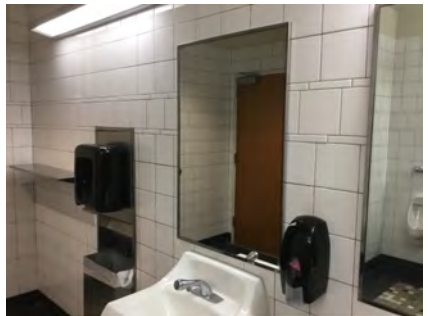
<input type="checkbox"/> Staff Only Priority 3 Severity 4				
1667	<ul style="list-style-type: none"> As-Built Description: Bottom of mirror located above lavatories or countertops more than 40" above floor. As-Built: 40.25" high Proposed Solution: Relocate or provide new accessible mirror. 	PCODE WG03 ADAAG 91 4.19.6 ADA 2010 603.3 CBC 2007 1115B.8.1 CBC 2016 11B-603.3 Mitigated: <input type="radio"/> YES <input checked="" type="radio"/> NO	1	JOB	\$450	\$450

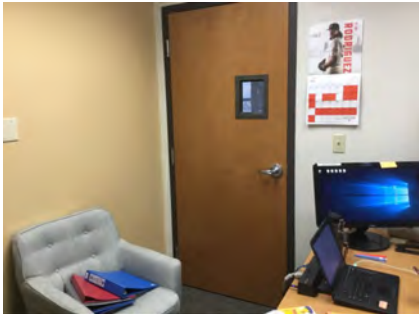
Item no., Rm no. and Name	Existing Architectural Barrier and Proposed Solution	Codes / Mitigation Info	Qty	Unit	Cost	Total
Door Swing						
761	<ul style="list-style-type: none">• <i>As-Built Description:</i> Front approach: At pull side, door does not have clear and level maneuvering space measuring door width plus 18" x 60". (24" x 60" at exterior doors).• <i>Proposed Solution:</i> Remove or relocate furniture or storage items.• <i>Notes:</i> Occurs in offices used by students and /or public throughout building.	<p>PCODE ID23A ADAAG 91 Fig. 25(a) ADA 2010 404.2.4 CBC 2007 11B-26A(a) CBC 2016 11B-404.2.4</p> <p>Mitigated: <input type="radio"/> YES <input checked="" type="radio"/> NO</p>	1	JOB	\$150	\$150

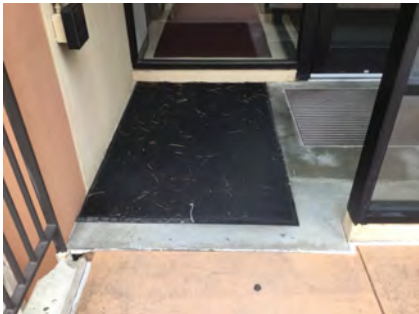
<input type="checkbox"/> Staff Only			
			Priority		Severity	
			2		2	
Doormat						
711	<ul style="list-style-type: none">• <i>As-Built Description:</i> Doormat hinders access to disabled persons.• <i>Proposed Solution:</i> Provide new doormat; recess or attach at edges.	<p>PCODE ID05 ADAAG 91 4.5.3 ADA 2010 302.2 CBC 2007 1124B.3 CBC 2016 11B-302.2</p> <p>Mitigated: <input type="radio"/> YES <input checked="" type="radio"/> NO</p>	20	JOB	\$1,500	\$30,000

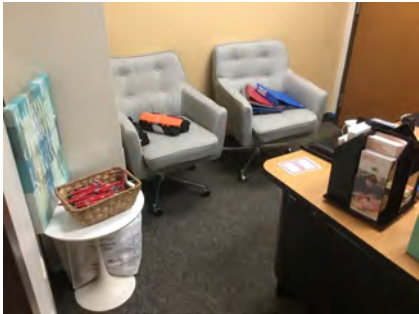
Item no., Rm no. and Name	Existing Architectural Barrier and Proposed Solution	Codes / Mitigation Info	Qty	Unit	Cost	Total
<u>Non-Fixed Desk</u>						
760	<ul style="list-style-type: none">As-Built Description: Accessible non-fixed table or desk (top 28" to 34" high; knee space at least 27" high x 19" deep x 30" wide) not provided.As-Built: No knee clearanceProposed Solution: Provide table or desk with accessible dimensions when purchasing new furniture.Notes: Verify writing is required. Consider providing clipboards. Occurs in offices used by students and /or public throughout building.	<p>PCODE IN02A</p> <p>ADAAG 91 4.32.3 & .4</p> <p>ADA 2010 306.1</p> <p>CBC 2007 1122B.3 & 4</p> <p>CBC 2016 11B-306.1 & 11B-902.3</p> <p>Mitigated:</p> <p><input type="radio"/> YES</p> <p><input checked="" type="radio"/> NO</p>	1	JOB	\$4,800	\$4,800

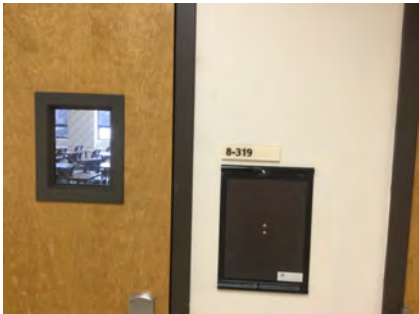
2	2		
<u>Signage</u>						
744	<ul style="list-style-type: none">As-Built Description: Signs containing tactile characters is not located so that a clear floor space of 18" min x 18" min., centered on the tactile characters, is provided beyond the arc of any door swing between the closed position and 45 degree open position.As-Built: Centerline of braille and tactile on signs is 8.5" from the swing of the doorProposed Solution: Relocate compliant signage on latch side of door located at compliant height with a clear floor space.	<p>PCODE SA07B</p> <p>ADA 2010 703.4.2</p> <p>CBC 2016 11B-703.4.2</p> <p>Mitigated:</p> <p><input type="radio"/> YES</p> <p><input checked="" type="radio"/> NO</p>	1	JOB	\$150	\$150

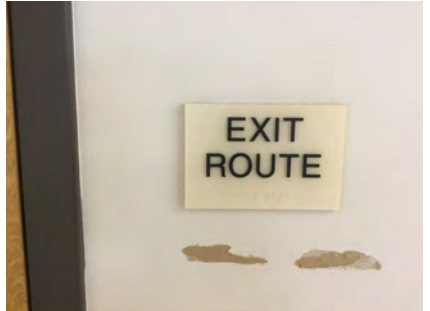
Item no., Rm no. and Name	Existing Architectural Barrier and Proposed Solution	Codes / Mitigation Info	Qty	Unit	Cost	Total
751	<ul style="list-style-type: none"> As-Built Description: Signs containing tactile characters is not located so that a clear floor space of 18" min x 18" min., centered on the tactile characters, is provided beyond the arc of any door swing between the closed position and 45 degree open position. As-Built: 60.5" to the bottom of the highest tactile character. 60" to the sign centerline Proposed Solution: Relocate compliant signage on latch side of door located at compliant height with a clear floor space. 	PCODE SA07B ADA 2010 703.4.2 CBC 2016 11B-703.4.2 Mitigated: <input type="radio"/> YES <input checked="" type="radio"/> NO	1	JOB	\$150	\$150

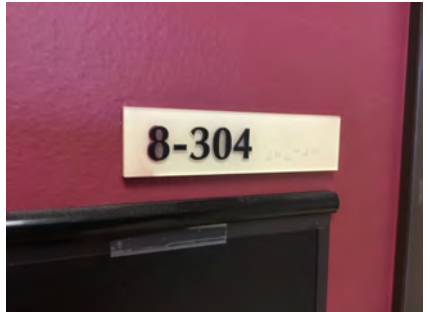
<input type="checkbox"/> Staff Only						
Priority 2 Severity 4						
713	<ul style="list-style-type: none"> As-Built Description: Braille symbols: dots are not 1/10" on centers in each cell with 2/10" space between cells. Proposed Solution: CA only - Provide new compliant signage including Contracted Grade 2 Braille with Title 24 spacing requirements - 1/10" on center dots with 2/10" space between cells. Notes: <i>Braille not below text</i> 	PCODE SA07C CBC 2007 1117B.5.6 CBC 2016 11B-703.3 Mitigated: <input type="radio"/> YES <input checked="" type="radio"/> NO	1	JOB	\$450	\$450

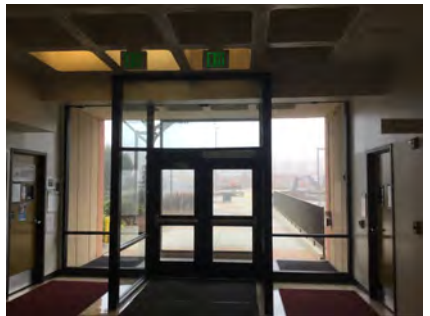
<input type="checkbox"/> Staff Only						
Priority 2 Severity 3						
716	<ul style="list-style-type: none"> As-Built Description: At final exit door to exterior: Where required exit signs are installed, signs to provide exiting information for people with vision impairment are not provided. Proposed Solution: Provide raised letter/Braille "EXIT" sign at door. 	PCODE SA10A ADAAG 91 4.1.3(16) ADA 2010 216.4.1 CBC 2007 1011.3 CBC 2016 11B-216.4.1 Mitigated: <input type="radio"/> YES <input checked="" type="radio"/> NO	2	JOB	\$270	\$540

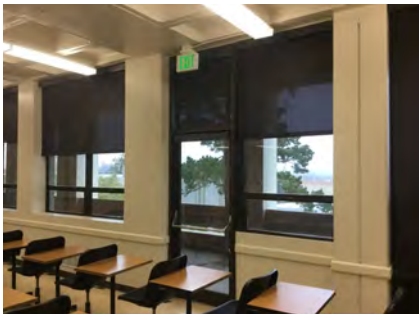
Item no., Rm no. and Name	Existing Architectural Barrier and Proposed Solution	Codes / Mitigation Info	Qty	Unit	Cost	Total
755	<ul style="list-style-type: none">• <i>As-Built Description:</i> At door leading into exit corridor: Where required exit signs are installed, signs to provide exiting information for people with vision impairment are not provided.• <i>Proposed Solution:</i> Provide raised letter/Braille "EXIT ROUTE" sign at door.	<div>PCODE SA10D</div> <div>ADAAG 91 4.1.3(16)</div> <div>ADA 2010 216.4.1</div> <div>CBC 2007 1011.3</div> <div>CBC 2016 11B-216.4.1</div> <div>Mitigated:</div> <div><div><input type="radio"/></div> YES</div> <div><div><input checked="" type="radio"/></div> NO</div>	10	JOB	\$270	\$2,700

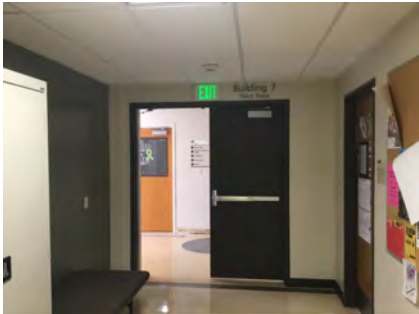
<div><input type="checkbox"/> Staff Only</div>			
			<div>Priority<div>2</div>Severity<div>3</div></div>			
776	<ul style="list-style-type: none">• <i>As-Built Description:</i> At door leading into exit corridor: Where required exit signs are installed, signs to provide exiting information for people with vision impairment are not provided.• <i>Proposed Solution:</i> Provide raised letter/Braille "EXIT ROUTE" sign at door.	<div>PCODE SA10D</div> <div>ADAAG 91 4.1.3(16)</div> <div>ADA 2010 216.4.1</div> <div>CBC 2007 1011.3</div> <div>CBC 2016 11B-216.4.1</div> <div>Mitigated:</div> <div><div><input type="radio"/></div> YES</div> <div><div><input checked="" type="radio"/></div> NO</div>	6	JOB	\$270	\$1,620

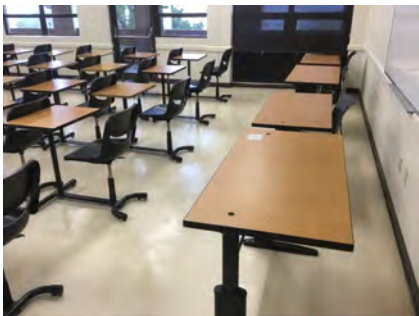
<div><input type="checkbox"/> Staff Only</div>			
			<div>Priority<div>2</div>Severity<div>3</div></div>			
<div>Fixed Seating</div>						
754	<ul style="list-style-type: none">• <i>As-Built Description:</i> Wheelchair locations not dispersed throughout seating area (n/a if floor slope greater than 1:20 or 5%).• <i>Proposed Solution:</i> Disperse accessible wheelchair space(s).• <i>Notes:</i> Accessible desks are located at the rear of the classroom.	<div>PCODE GE01C</div> <div>ADAAG 91 4.33.3</div> <div>ADA 2010 221.2.3</div> <div>CBC 2007 1104B.3.3</div> <div>CBC 2016 11B-221.2.3</div> <div>Mitigated:</div> <div><div><input type="radio"/></div> YES</div> <div><div><input checked="" type="radio"/></div> NO</div>	1	EA	\$1,800	\$1,800

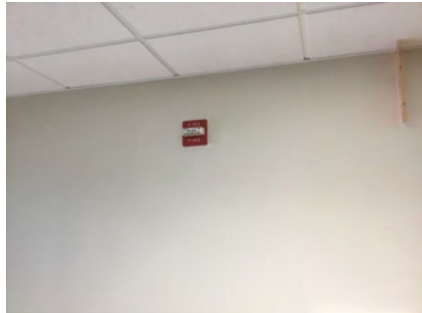
Item no., Rm no. and Name	Existing Architectural Barrier and Proposed Solution	Codes / Mitigation Info	Qty	Unit	Cost	Total
General Note						
723	<ul style="list-style-type: none"> As-Built Description: Refer to notes for observation and recommendation. Proposed Solution: Notes: Audible and visual alarms throughout 	PCODE GN01 CBC 2016 11B-216.4.1 Mitigated: <input type="radio"/> YES <input checked="" type="radio"/> NO				
						REF

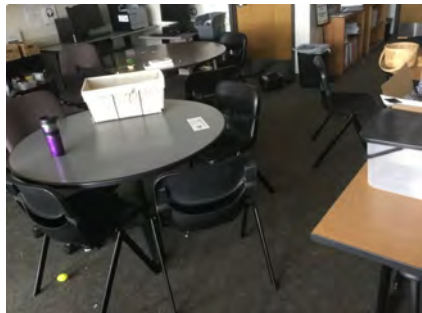
<input type="checkbox"/> Staff Only
						Priority 2 Severity 0
756	<ul style="list-style-type: none"> As-Built Description: Refer to notes for observation and recommendation. As-Built: Dimensions vary. 16" - 30" wide path of travel Proposed Solution: Maintain a 36" wide path of travel throughout seating areas. Notes: Condition occurs throughout facility. 	PCODE GN01 CBC 2016 11B-403.5.1 Mitigated: <input type="radio"/> YES <input checked="" type="radio"/> NO

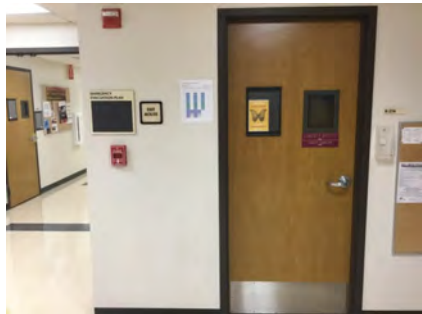
<input type="checkbox"/> Staff Only
						Priority 2 Severity 2
825	<ul style="list-style-type: none"> As-Built Description: Refer to notes for observation and recommendation. Proposed Solution: Notes: <i>Sign is potentially confusing to blind. Braille and tactile signs are only required at doors. The location of this exit route sign suggests that the door could be an exit route. There are many exit route signs installed randomly throughout this building.</i> 	PCODE GN01 CBC 2016 11B-604.5.2 Mitigated: <input type="radio"/> YES <input checked="" type="radio"/> NO				
						REF

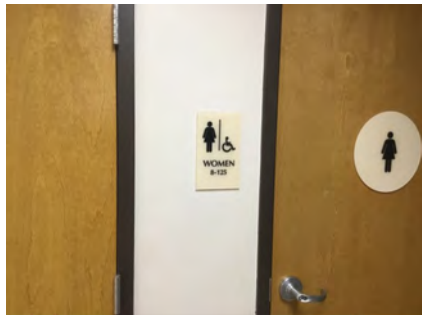
Item no., Rm no. and Name	Existing Architectural Barrier and Proposed Solution	Codes / Mitigation Info	Qty	Unit	Cost	Total
Signage						
848	<ul style="list-style-type: none"> As-Built Description: Signs containing tactile characters is not located so that a clear floor space of 18" min x 18" min., centered on the tactile characters, is provided beyond the arc of any door swing between the closed position and 45 degree open position. As-Built: Centerline of sign 8" from the door swing Proposed Solution: Relocate compliant signage on latch side of door located at compliant height with a clear floor space. 	PCODE SA07B ADA 2010 703.4.2 CBC 2016 11B-703.4.2 Mitigated: <input type="radio"/> YES <input checked="" type="radio"/> NO	1	JOB	\$150	\$150

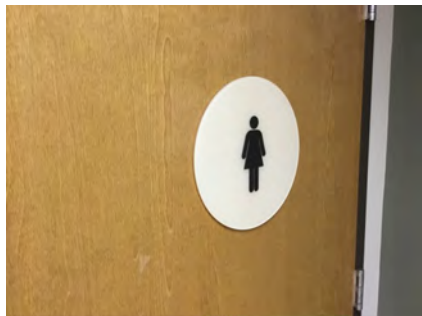
<input type="checkbox"/> Staff Only Priority 3 Severity 4			
849	<ul style="list-style-type: none"> As-Built Description: Required in CA only: identification symbol centered 58" to 60" high on sanitary facility door that contrasts with the door not provided (women: 12" ø circle, men: 12" triangle, unisex: combined symbol). As-Built: Edges are not eased Proposed Solution: Provide properly mounted sanitary facility symbol when altering area. If wheelchair accessible, include International Symbol of Accessibility on sign. 	PCODE SA15 CBC 2007 1115B.6 CBC 2016 11B-703.7.2.6 Mitigated: <input type="radio"/> YES <input checked="" type="radio"/> NO	1	JOB	\$270	\$270

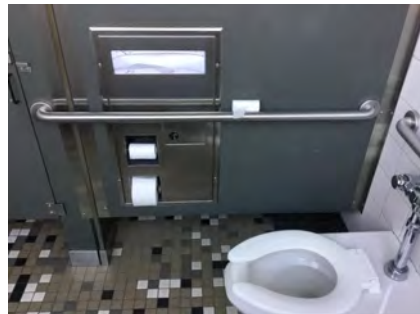
Item no., Rm no. and Name	Existing Architectural Barrier and Proposed Solution	Codes / Mitigation Info	Qty	Unit	Cost	Total
Grab Bars						
855	<ul style="list-style-type: none">As-Built Description: Side grab bar less than 42" long, or located more than 12 inches max. from the rear wall, or extending less than 54" from rear wall (CA only: front end min. 24" in front of water closet).As-Built: Side grab bar extends 51.5" from the rear wallProposed Solution: Provide or relocate accessible side grab bar.	<p>PCODE WB07A</p> <p>ADAAG 91 Fig. 29(b)</p> <p>ADA 2010 604.5.1</p> <p>CBC 2007 1115B.4.1.3.1</p> <p>CBC 2016 11B-604.5.1</p> <p>Mitigated:</p> <p><input type="radio"/> YES</p> <p><input checked="" type="radio"/> NO</p>	1	JOB	\$780	\$780

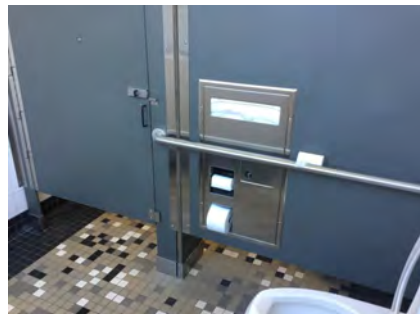
853	<ul style="list-style-type: none">As-Built Description: Less than 59" from back wall to front wall or door swing of toilet stall, or less than 56" if water closet is wall-hung.As-Built: 53.625" from the rear wall to the compartment door swingProposed Solution: Re-locate the door closer to the hinge side wall.	<p>PCODE WB03</p> <p>ADAAG 91 4.17.3</p> <p>ADA 2010 604.8.1.1</p> <p>CBC 2007 1115B.3.4.3</p> <p>CBC 2016 11B-604.8.1.1</p> <p>Mitigated:</p> <p><input type="radio"/> YES</p> <p><input checked="" type="radio"/> NO</p>	1	JOB	\$4,500	\$4,500
