SAN MATEO COUNTY
COMMUNITY
COLLEGE DISTRICT

San Mateo County Community College District Americans with Disabilities Act Self-Evaluation and Transition Plan

Report Prepared by:

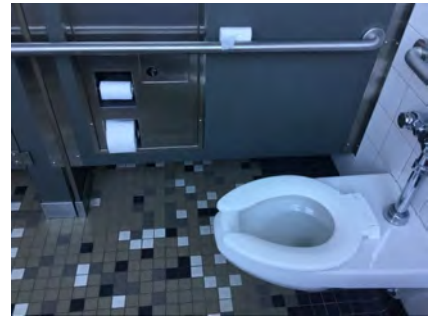
Item no., Rm no. and Name	Existing Architectural Barrier and Proposed Solution	Codes / Mitigation Info	Qty	Unit	Cost	Total
<u>Accessories</u>						
854	<ul style="list-style-type: none"> • <i>As-Built Description:</i> Toilet paper dispenser less than 15" (CA: 19") or more than 48" above floor or not within 7" to 9" from front of water closet (Note: CA pre-2010 is allowed within 12" from front of water closet). • <i>As-Built:</i> 12.5" from the front of the water closet • <i>Proposed Solution:</i> Relocate or provide new toilet paper dispenser. 	PCODE WG02 ADAAG 91 4.16.6 ADA 2010 604.7 CBC 2007 1115B.8.4 CBC 2016 11B-604.7 Mitigated: <input type="radio"/> YES <input checked="" type="radio"/> NO	1	JOB	\$225	\$225

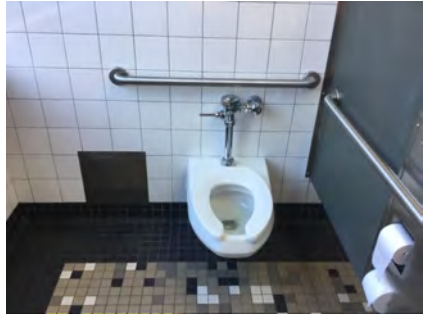
Item no., Rm no. and Name	Existing Architectural Barrier and Proposed Solution	Codes / Mitigation Info	Qty	Unit	Cost	Total
<u>Water Closet</u>						
859	<ul style="list-style-type: none"> • <i>As-Built Description:</i> Water closet not 16"-18" (CA: 17"-18") from near side wall to center line of water closet (2010 ADAAG: 16"-18"). • <i>As-Built:</i> 18.5" o.c. • <i>Proposed Solution:</i> Relocate existing water closet and plumbing, remount with offset closet flange to provide 18" max. from side wall. 	PCODE WB02C ADAAG 91 Fig. 28 ADA 2010 604.2 CBC 2007 1115B.4.1.1 CBC 2016 11B-604.2 Mitigated: <input type="radio"/> YES <input checked="" type="radio"/> NO	1	JOB	\$1,500	\$1,500

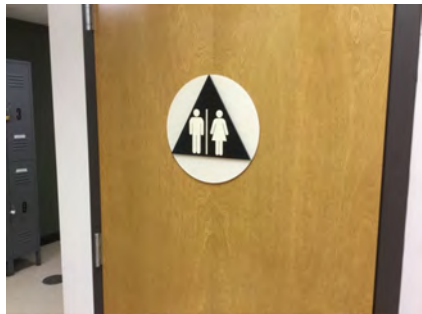
Item no., Rm no. and Name	Existing Architectural Barrier and Proposed Solution	Codes / Mitigation Info	Qty	Unit	Cost	Total
861	<ul style="list-style-type: none"> As-Built Description: Required in CA only: identification symbol centered 58" to 60" high on sanitary facility door that contrasts with the door not provided (women: 12" ø circle, men: 12" triangle, unisex: combined symbol). As-Built: Edges not eased. No radius. Proposed Solution: Provide properly mounted sanitary facility symbol when altering area. If wheelchair accessible, include International Symbol of Accessibility on sign. 	PCODE SA15 CBC 2007 1115B.6 CBC 2016 11B-703.7.2.6 Mitigated: <input type="radio"/> YES <input checked="" type="radio"/> NO	1	JOB	\$270	\$270

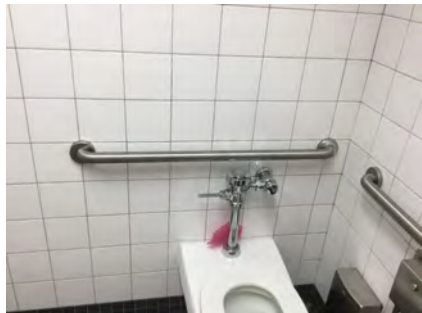
870	<ul style="list-style-type: none"> As-Built Description: The rear wall grab is less than 36" min. or does not extend from the centerline of the water closet 12" min. on one side and 24" min. on the other side. As-Built: 21.5" the wide side Proposed Solution: Provide or relocate accessible rear grab bar. 	PCODE WB07B ADAAG 91 4.17.6 ADA 2010 604.5.2 CBC 2007 1115B.4.1.3.2 CBC 2016 11B-604.5.2 Mitigated: <input type="radio"/> YES <input checked="" type="radio"/> NO	1	JOB	\$1,020	\$1,020

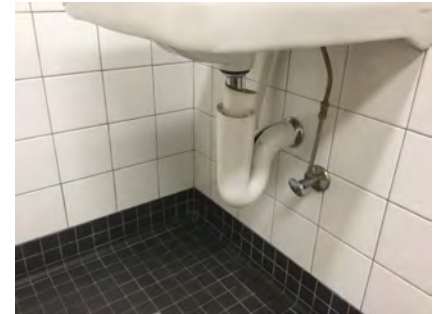
2299	<ul style="list-style-type: none"> • <i>As-Built Description:</i> Knee clearance 27" min. high starting 8" back from the front edge of the lavatory towards the wall is not provided. • <i>As-Built:</i> Drain pipes and or drain insulation 9" from the front of the lavatory at 16" AFF • <i>Proposed Solution:</i> Remount compliant fixture to accessible height. 	PCODE WD04A ADAAG 91 Fig. 31 ADA 2010 306.3.3 CBC 2007 1115B.4.3 CBC 2016 11B-306.3.3	1	JOB	\$4,500	\$4,500
------	---	---	---	-----	---------	---------

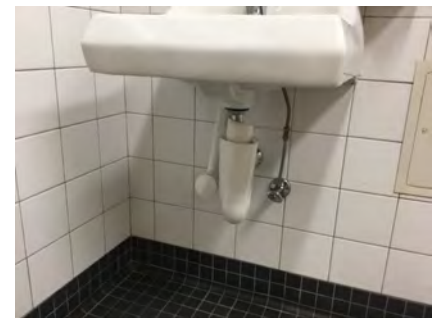
865	<ul style="list-style-type: none"> • <i>As-Built Description:</i> Hot or sharp-surfaced water/drain pipe not insulated or covered. • <i>Proposed Solution:</i> Insulate or cover water/drain pipe. 	PCODE WD05REF ADAAG 91 4.19.4 ADA 2010 606.5 CBC 2007 1115B.4.3.4 CBC 2016 11B-606.5				
-----	--	--	--	--	--	--

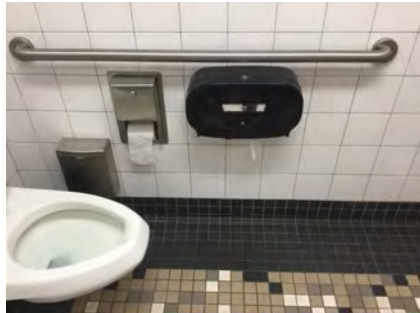
Item no., Rm no. and Name	Existing Architectural Barrier and Proposed Solution	Codes / Mitigation Info	Qty	Unit	Cost	Total
Accessories						
868	<ul style="list-style-type: none"> As-Built Description: Toilet paper dispenser less than 15" (CA: 19") or more than 48" above floor or not within 7" to 9" from front of water closet (Note: CA pre-2010 is allowed within 12" from front of water closet). As-Built: 12" from the front of the water closet Proposed Solution: Relocate or provide new toilet paper dispenser. 	PCODE WG02 ADAAG 91 4.16.6 ADA 2010 604.7 CBC 2007 1115B.8.4 CBC 2016 11B-604.7 Mitigated: <input type="radio"/> YES <input checked="" type="radio"/> NO	1	JOB	\$225	\$225

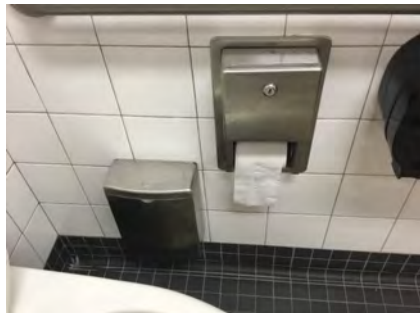
<input type="checkbox"/> Staff Only Priority 3 Severity 3			
869	<ul style="list-style-type: none"> As-Built Description: Toilet paper dispenser less than 15" (CA: 19") or more than 48" above floor or not within 7" to 9" from front of water closet (Note: CA pre-2010 is allowed within 12" from front of water closet). As-Built: Behind the front of the water closet Proposed Solution: Relocate or provide new toilet paper dispenser. 	PCODE WG02 ADAAG 91 4.16.6 ADA 2010 604.7 CBC 2007 1115B.8.4 CBC 2016 11B-604.7 Mitigated: <input type="radio"/> YES <input checked="" type="radio"/> NO	1	JOB	\$225	\$225

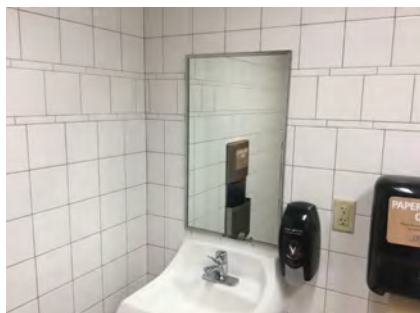
<input type="checkbox"/> Staff Only Priority 3 Severity 1			
864	<ul style="list-style-type: none"> As-Built Description: Bottom of mirror located above lavatories or countertops more than 40" above floor. As-Built: 40.7" high Proposed Solution: Relocate or provide new accessible mirror. 	PCODE WG03 ADAAG 91 4.19.6 ADA 2010 603.3 CBC 2007 1115B.8.1 CBC 2016 11B-603.3 Mitigated: <input type="radio"/> YES <input checked="" type="radio"/> NO	1	JOB	\$450	\$450

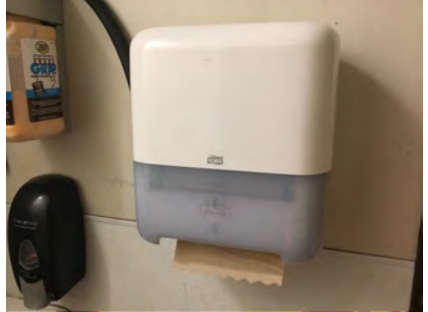
Item no., Rm no. and Name	Existing Architectural Barrier and Proposed Solution	Codes / Mitigation Info	Qty	Unit	Cost	Total
881	<ul style="list-style-type: none"> As-Built Description: Reach height to control or access point, where side approach is available, exceeds 48" or is less than 15" in height, or exceeds 10" in depth. As-Built: 50" high Proposed Solution: Modify equipment or mounting. 	PCODE IE02 ADAAG 91 4.2.6 ADA 2010 308.3.1 CBC 2007 1118B.6 CBC 2016 11B-308.3 Mitigated: <input type="radio"/> YES <input checked="" type="radio"/> NO	1	JOB	\$300	\$300

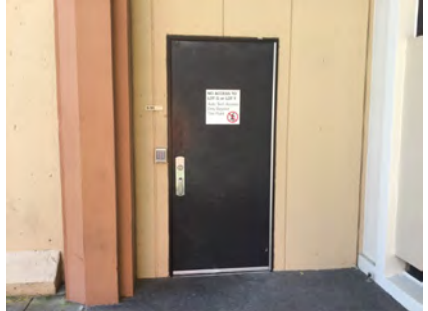
902	<ul style="list-style-type: none"> As-Built Description: Exterior signage at inaccessible entrances to provide direction to accessible entrances is missing or noncompliant. As-Built: 13" at strike side and 16" deep alcove Proposed Solution: Provide signage sufficient to guide persons to accessible entrances. 	PCODE SA01 ADAAG 91 4.1.2(7)(c) ADA 2010 216.6 CBC 2007 1117B.5.8.1.2 CBC 2016 11B-216.6 Mitigated: <input type="radio"/> YES <input checked="" type="radio"/> NO	1	JOB	\$690	\$690

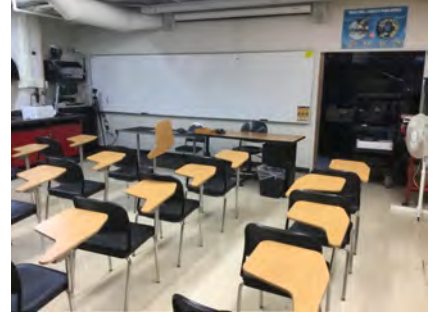
Item no., Rm no. and Name	Existing Architectural Barrier and Proposed Solution	Codes / Mitigation Info	Qty	Unit	Cost	Total
886	<ul style="list-style-type: none"> • As-Built Description: Recommended only: Accessible non-fixed table or desk (top 28" to 34" high; knee space at least 27" high x 19" deep x 30" wide) not provided. • Proposed Solution: Provide table or desk with accessible dimensions when purchasing new furniture. • Notes: There are 27 desks and there are 2 accessible desks but they are both being used by the teachers. 	PCODE IN02AREF ADAAG 91 4.32.3 & .4 ADA 2010 306.1 CBC 2007 1122B.3 & 4 CBC 2016 11B-306.1 & 11B-902.3 Mitigated: <input type="radio"/> YES <input checked="" type="radio"/> NO				
<div>REF</div> <div>

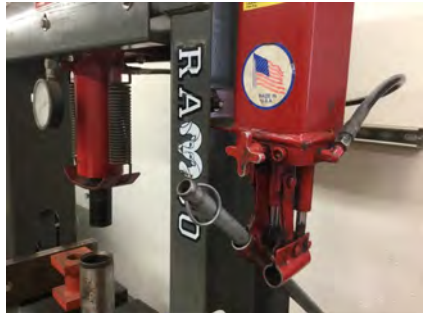
Item no., Rm no. and Name	Existing Architectural Barrier and Proposed Solution	Codes / Mitigation Info	Qty	Unit	Cost	Total
Reach Range						
894	<ul style="list-style-type: none"> As-Built Description: Reach height to control or access point, where side approach is available, exceeds 48" or is less than 15" in height, or exceeds 10" in depth. As-Built: 60" high Proposed Solution: Modify equipment or mounting. 	PCODE IE02 ADAAG 91 4.2.6 ADA 2010 308.3.1 CBC 2007 1118B.6 CBC 2016 11B-308.3 Mitigated: <input type="radio"/> YES <input checked="" type="radio"/> NO	1	JOB	\$300	\$300

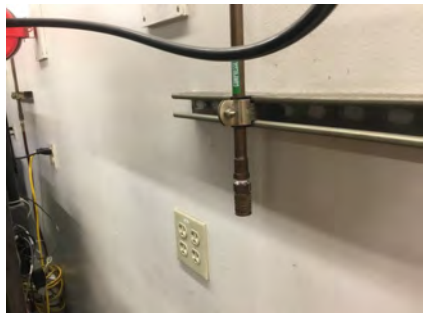
<input type="checkbox"/> Staff Only Priority 2 Severity 2			
896	<ul style="list-style-type: none"> As-Built Description: Reach height to control or access point, where side approach is available, exceeds 48" or is less than 15" in height, or exceeds 10" in depth. As-Built: 54" high Proposed Solution: Modify equipment or mounting. 	PCODE IE02 ADAAG 91 4.2.6 ADA 2010 308.3.1 CBC 2007 1118B.6 CBC 2016 11B-308.3 Mitigated: <input type="radio"/> YES <input checked="" type="radio"/> NO	1	JOB	\$300	\$300

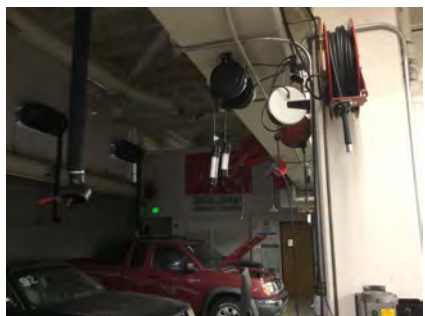
<input type="checkbox"/> Staff Only Priority 2 Severity 3			
897	<ul style="list-style-type: none"> As-Built Description: Reach height to control or access point, where side approach is available, exceeds 48" or is less than 15" in height, or exceeds 10" in depth. As-Built: Reach to lights, extension cords, air compressor hoses and other tools 80" AFF Proposed Solution: Modify equipment or mounting. 	PCODE IE02 ADAAG 91 4.2.6 ADA 2010 308.3.1 CBC 2007 1118B.6 CBC 2016 11B-308.3 Mitigated: <input type="radio"/> YES <input checked="" type="radio"/> NO	1	JOB	\$300	\$300

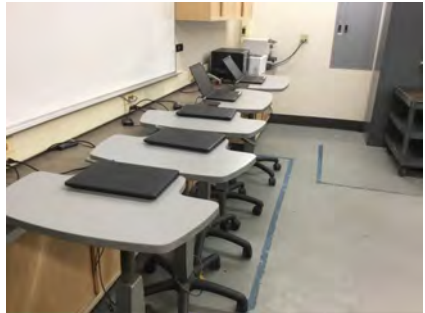
Item no., Rm no. and Name	Existing Architectural Barrier and Proposed Solution	Codes / Mitigation Info	Qty	Unit	Cost	Total
Non-Fixed Desk						
889	<ul style="list-style-type: none"> As-Built Description: Accessible non-fixed table or desk (top 28" to 34" high; knee space at least 27" high x 19" deep x 30" wide) not provided. As-Built: No knee clearance at portable computer stations. Proposed Solution: Provide table or desk with accessible dimensions when purchasing new furniture. Notes: 11 provided, 0 accessible. 	PCODE IN02A ADAAG 91 4.32.3 & .4 ADA 2010 306.1 CBC 2007 1122B.3 & 4 CBC 2016 11B-306.1 & 11B-902.3 Mitigated: <input type="radio"/> YES <input checked="" type="radio"/> NO	1	JOB	\$4,800	\$4,800

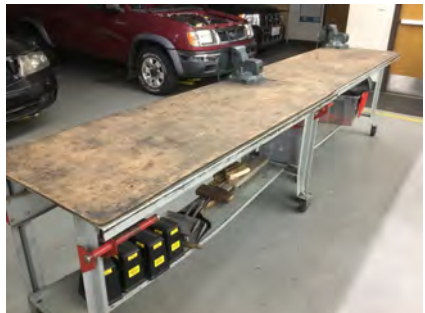
<input type="checkbox"/> Staff Only Priority 2 Severity 2			
890	<ul style="list-style-type: none"> As-Built Description: Accessible non-fixed table or desk (top 28" to 34" high; knee space at least 27" high x 19" deep x 30" wide) not provided. As-Built: 13" deep knee clearance top of work surface 35" AFF. Proposed Solution: Provide table or desk with accessible dimensions when purchasing new furniture. 	PCODE IN02A ADAAG 91 4.32.3 & .4 ADA 2010 306.1 CBC 2007 1122B.3 & 4 CBC 2016 11B-306.1 & 11B-902.3 Mitigated: <input type="radio"/> YES <input checked="" type="radio"/> NO	1	JOB	\$4,800	\$4,800

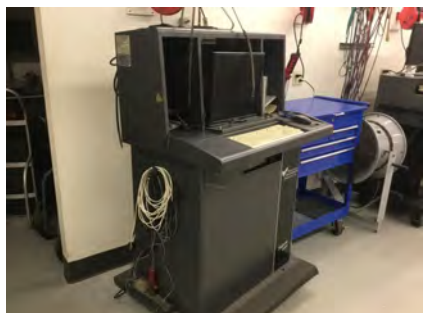
<input type="checkbox"/> Staff Only Priority 2 Severity 2			
891	<ul style="list-style-type: none"> As-Built Description: Accessible non-fixed table or desk (top 28" to 34" high; knee space at least 27" high x 19" deep x 30" wide) not provided. As-Built: Stand up work surfaces 43" to top. No knee clearance. 4 stations. Proposed Solution: Provide table or desk with accessible dimensions when purchasing new furniture. 	PCODE IN02A ADAAG 91 4.32.3 & .4 ADA 2010 306.1 CBC 2007 1122B.3 & 4 CBC 2016 11B-306.1 & 11B-902.3 Mitigated: <input type="radio"/> YES <input checked="" type="radio"/> NO	1	JOB	\$4,800	\$4,800

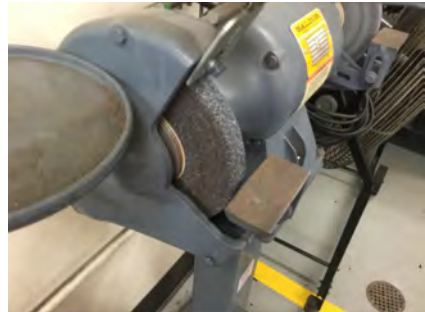
Item no., Rm no. and Name	Existing Architectural Barrier and Proposed Solution	Codes / Mitigation Info	Qty	Unit	Cost	Total
893	<ul style="list-style-type: none">As-Built Description: Accessible non-fixed table or desk (top 28" to 34" high; knee space at least 27" high x 19" deep x 30" wide) not provided.As-Built: Work surface 41.25" to topProposed Solution: Provide table or desk with accessible dimensions when purchasing new furniture.	<p>PCODE IN02A ADAAG 91 4.32.3 & .4 ADA 2010 306.1 CBC 2007 1122B.3 & 4 CBC 2016 11B-306.1 & 11B-902.3</p> <p>Mitigated: <input type="radio"/> YES <input checked="" type="radio"/> NO</p>	1	JOB	\$4,800	\$4,800

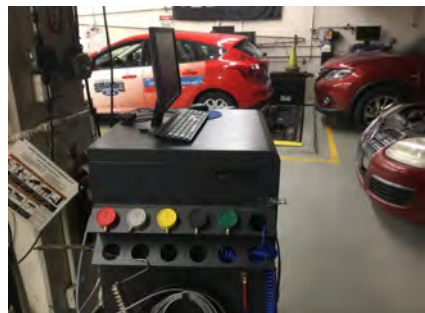
<input type="checkbox"/> Staff Only			
			Priority 2 Severity 2			
900	<ul style="list-style-type: none">As-Built Description: Accessible non-fixed table or desk (top 28" to 34" high; knee space at least 27" high x 19" deep x 30" wide) not provided.As-Built: Specialized equipment 45" AFF to computer keyboard. No knee clearance.Proposed Solution: Provide table or desk with accessible dimensions when purchasing new furniture.	<p>PCODE IN02A ADAAG 91 4.32.3 & .4 ADA 2010 306.1 CBC 2007 1122B.3 & 4 CBC 2016 11B-306.1 & 11B-902.3</p> <p>Mitigated: <input type="radio"/> YES <input checked="" type="radio"/> NO</p>	1	JOB	\$4,800	\$4,800

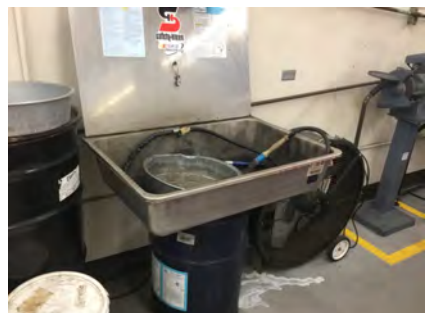
<input type="checkbox"/> Staff Only			
			Priority 2 Severity 2			
Sink						
892	<ul style="list-style-type: none">As-Built Description: Sink rim higher than 34" above floor.As-Built: 37" highProposed Solution: Remodel sink cabinet to lower sink.	<p>PCODE IN06 ADAAG 91 4.24.2 ADA 2010 606.3 CBC 2007 1115B.4.7.1 CBC 2016 11B-606.3</p> <p>Mitigated: <input type="radio"/> YES <input checked="" type="radio"/> NO</p>	1	JOB	\$5,250	\$5,250

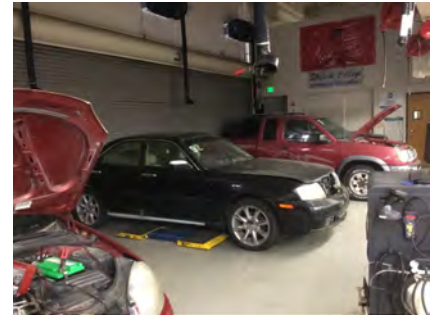
No car lift provided for people who use wheelchairs or who otherwise cannot crawl or slide under a car to work on vehicles.

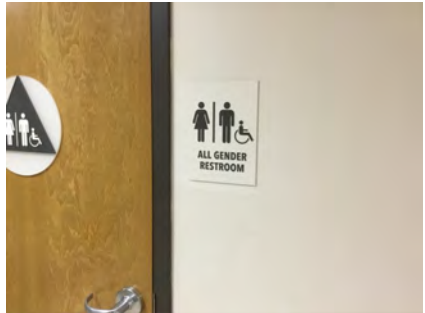
Item no., Rm no. and Name	Existing Architectural Barrier and Proposed Solution	Codes / Mitigation Info	Qty	Unit	Cost	Total
Signage						
788	<ul style="list-style-type: none"> As-Built Description: Signs containing tactile characters is not located so that a clear floor space of 18" min x 18" min., centered on the tactile characters, is provided beyond the arc of any door swing between the closed position and 45 degree open position. As-Built: 7.75" from the centerline of the sign to the door swing Proposed Solution: Relocate compliant signage on latch side of door located at compliant height with a clear floor space. 	PCODE SA07B ADA 2010 703.4.2 CBC 2016 11B-703.4.2 Mitigated: <input type="radio"/> YES <input checked="" type="radio"/> NO	1	JOB	\$150	\$150

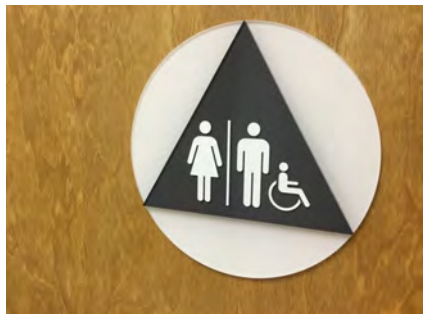
<input type="checkbox"/> Staff Only Priority 3 Severity 4			
777	<ul style="list-style-type: none"> As-Built Description: Required in CA only: identification symbol centered 58" to 60" high on sanitary facility door that contrasts with the door not provided (women: 12" ø circle, men: 12" triangle, unisex: combined symbol). As-Built: Not eased. No radius. Proposed Solution: Provide properly mounted sanitary facility symbol when altering area. If wheelchair accessible, include International Symbol of Accessibility on sign. 	PCODE SA15 CBC 2007 1115B.6 CBC 2016 11B-703.7.2.6 Mitigated: <input type="radio"/> YES <input checked="" type="radio"/> NO	1	JOB	\$270	\$270

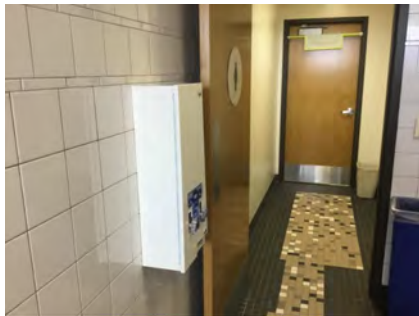
Item no., Rm no. and Name	Existing Architectural Barrier and Proposed Solution	Codes / Mitigation Info	Qty	Unit	Cost	Total
Door Swing						
789	<ul style="list-style-type: none">As-Built Description: Front approach: At pull side, door does not have clear and level maneuvering space measuring door width plus 18" x 60". (24" x 60" at exterior doors).As-Built: Sanitary napkin dispenser 44" from the face of the doorProposed Solution: Remove or relocate furniture or storage items.	PCODE ID23A ADAAG 91 Fig. 25(a) ADA 2010 404.2.4 CBC 2007 11B-26A(a) CBC 2016 11B-404.2.4 Mitigated: <input type="radio"/> YES <input checked="" type="radio"/> NO	1	JOB	\$150	\$150

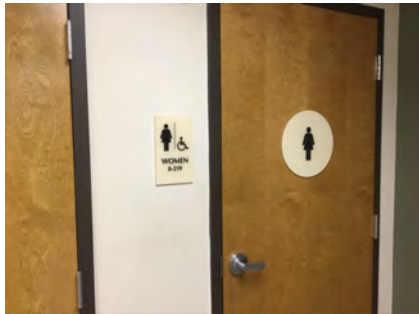
<input type="checkbox"/> Staff Only			
			Priority	Severity		
			3	3		
Signage						
787	<ul style="list-style-type: none">As-Built Description: Signs containing tactile characters is not located so that a clear floor space of 18" min x 18" min., centered on the tactile characters, is provided beyond the arc of any door swing between the closed position and 45 degree open position.As-Built: 8" from the centerline of the sign to the door swingProposed Solution: Relocate compliant signage on latch side of door located at compliant height with a clear floor space.	PCODE SA07B ADA 2010 703.4.2 CBC 2016 11B-703.4.2 Mitigated: <input type="radio"/> YES <input checked="" type="radio"/> NO	1	JOB	\$150	\$150

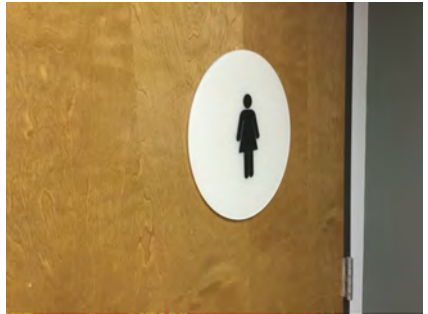
Item no., Rm no. and Name	Existing Architectural Barrier and Proposed Solution	Codes / Mitigation Info	Qty	Unit	Cost	Total
786	<ul style="list-style-type: none"> As-Built Description: Required in CA only: identification symbol centered 58" to 60" high on sanitary facility door that contrasts with the door not provided (women: 12" ø circle, men: 12" triangle, unisex: combined symbol). As-Built: Not eased Proposed Solution: Provide properly mounted sanitary facility symbol when altering area. If wheelchair accessible, include International Symbol of Accessibility on sign. 	PCODE SA15 CBC 2007 1115B.6 CBC 2016 11B-703.7.2.6 Mitigated: <input type="radio"/> YES <input checked="" type="radio"/> NO	2	JOB	\$270	\$540

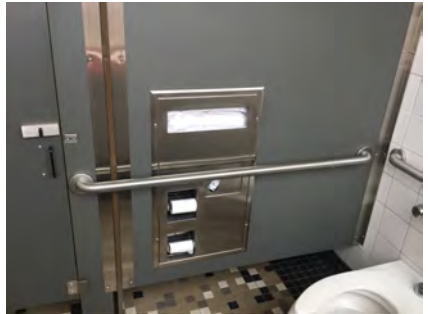
793	<ul style="list-style-type: none"> As-Built Description: Side grab bar less than 42" long, or located more than 12 inches max. from the rear wall, or extending less than 54" from rear wall (CA only: front end min. 24" in front of water closet). As-Built: Side grab bar extends 53" from the rear wall Proposed Solution: Provide or relocate accessible side grab bar. 	PCODE WB07A ADAAG 91 Fig. 29(b) ADA 2010 604.5.1 CBC 2007 1115B.4.1.3.1 CBC 2016 11B-604.5.1 Mitigated: <input type="radio"/> YES <input checked="" type="radio"/> NO	1	JOB	\$780	\$780

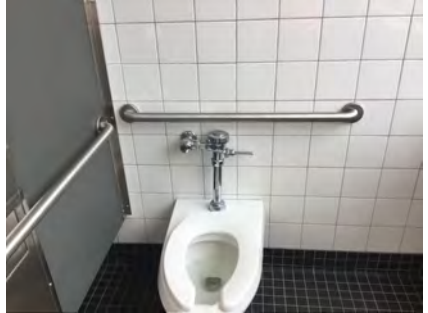
<input type="checkbox"/> Staff Only						
Priority 3 Severity 4						
795	<ul style="list-style-type: none"> As-Built Description: The rear wall grab is less than 36" min. or does not extend from the centerline of the water closet 12" min. on one side and 24" min. on the other side. As-Built: 21" on the wide side Proposed Solution: Provide or relocate accessible rear grab bar. 	PCODE WB07B ADAAG 91 4.17.6 ADA 2010 604.5.2 CBC 2007 1115B.4.1.3.2 CBC 2016 11B-604.5.2 Mitigated: <input type="radio"/> YES <input checked="" type="radio"/> NO	1	JOB	\$1,020	\$1,020

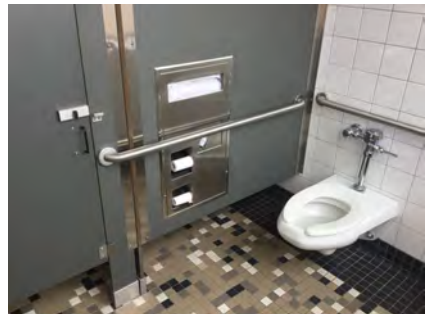
Item no., Rm no. and Name	Existing Architectural Barrier and Proposed Solution	Codes / Mitigation Info	Qty	Unit	Cost	Total
<u>Toilet Stall</u>						
792	<ul style="list-style-type: none">• <i>As-Built Description:</i> Less than 59" from back wall to front wall or door swing of toilet stall, or less than 56" if water closet is wall-hung.• <i>As-Built:</i> 54.5" from rear wall to compartment door• <i>Proposed Solution:</i> Provide new enclosure at existing water closet fixture.	<p>PCODE WB03</p> <p>ADAAG 91 4.17.3</p> <p>ADA 2010 604.8.1.1</p> <p>CBC 2007 1115B.3.4.3</p> <p>CBC 2016 11B-604.8.1.1</p> <p>Mitigated:</p> <p><input type="radio"/> YES</p> <p><input checked="" type="radio"/> NO</p>	1	JOB	\$4,500	\$4,500

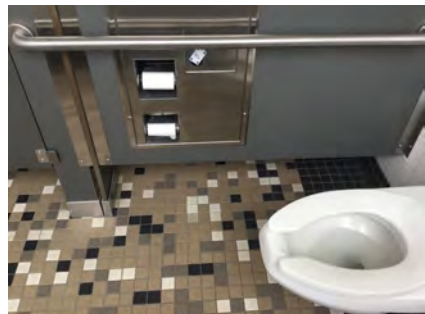
<input type="checkbox"/> Staff Only			
			Priority		Severity	
			3		4	
<u>Accessories</u>						
794	<ul style="list-style-type: none">• <i>As-Built Description:</i> Toilet paper dispenser less than 15" (CA: 19") or more than 48" above floor or not within 7" to 9" from front of water closet (Note: CA pre-2010 is allowed within 12" from front of water closet).• <i>As-Built:</i> 11.5" from the front of the water closet• <i>Proposed Solution:</i> Relocate or provide new toilet paper dispenser.	<p>PCODE WG02</p> <p>ADAAG 91 4.16.6</p> <p>ADA 2010 604.7</p> <p>CBC 2007 1115B.8.4</p> <p>CBC 2016 11B-604.7</p> <p>Mitigated:</p> <p><input type="radio"/> YES</p> <p><input checked="" type="radio"/> NO</p>	1	JOB	\$225	\$225

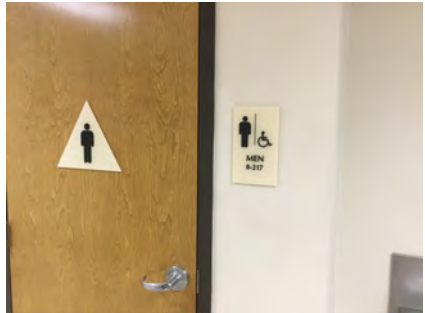
Item no., Rm no. and Name	Existing Architectural Barrier and Proposed Solution	Codes / Mitigation Info	Qty	Unit	Cost	Total
Signage						
796	<ul style="list-style-type: none"> As-Built Description: Signs containing tactile characters is not located so that a clear floor space of 18" min x 18" min., centered on the tactile characters, is provided beyond the arc of any door swing between the closed position and 45 degree open position. As-Built: 8" from centerline of sign to door swing Proposed Solution: Relocate compliant signage on latch side of door located at compliant height with a clear floor space. 	PCODE SA07B ADA 2010 703.4.2 CBC 2016 11B-703.4.2 Mitigated: <input type="radio"/> YES <input checked="" type="radio"/> NO	1	JOB	\$150	\$150

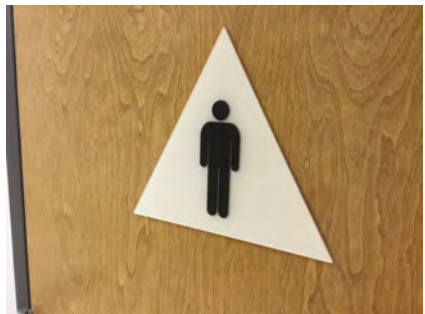
<input type="checkbox"/> Staff Only Priority 3 Severity 4			
797	<ul style="list-style-type: none"> As-Built Description: Required in CA only: identification symbol centered 58" to 60" high on sanitary facility door that contrasts with the door not provided (women: 12" ø circle, men: 12" triangle, unisex: combined symbol). As-Built: Edges not eased. No radius. Proposed Solution: Provide properly mounted sanitary facility symbol when altering area. If wheelchair accessible, include International Symbol of Accessibility on sign. 	PCODE SA15 CBC 2007 1115B.6 CBC 2016 11B-703.7.2.6 Mitigated: <input type="radio"/> YES <input checked="" type="radio"/> NO	2	JOB	\$270	\$540

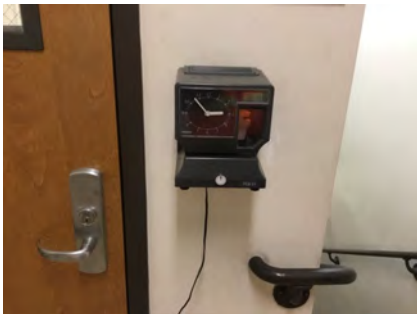
Item no., Rm no. and Name	Existing Architectural Barrier and Proposed Solution	Codes / Mitigation Info	Qty	Unit	Cost	Total
<u>Protrusion Limits</u>						
815	<ul style="list-style-type: none">• <i>As-Built Description:</i> Protruding objects more than 4" from wall, when bottom of object more than 27" or less than 80" above finished floor.• <i>As-Built:</i> Machine protrudes 6.25" deep at 44.75" high.• <i>Proposed Solution:</i> Remove/relocate protruding object. Patch existing surface.	<p>PCODE EG04 ADAAG 91 4.4.1 ADA 2010 307.2 CBC 2007 1133B.8.6.1 CBC 2016 11B-307.2</p> <p>Mitigated: <input type="radio"/> YES <input checked="" type="radio"/> NO</p>	1	JOB	\$300	\$300

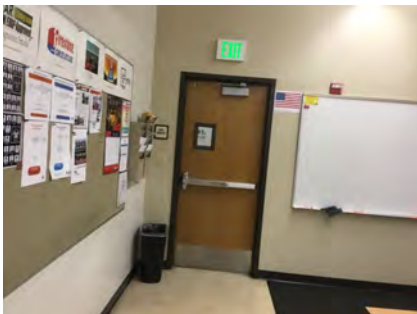
<input type="checkbox"/> Staff Only			
			<div>Priority 2Severity 3</div>			
<u>Signage</u>						
811	<ul style="list-style-type: none">• <i>As-Built Description:</i> At door leading into exit stairway: Where required exit signs are installed, signs to provide exiting information for people with vision impairment are not provided.• <i>Proposed Solution:</i> Provide raised letter/Braille "EXIT STAIR UP/DOWN" sign at door.	<p>PCODE SA10B ADAAG 91 4.1.3(16) ADA 2010 216.4.1 CBC 2007 1011.3 CBC 2016 11B-216.4.1</p> <p>Mitigated: <input type="radio"/> YES <input checked="" type="radio"/> NO</p>	1	JOB	\$270	\$270

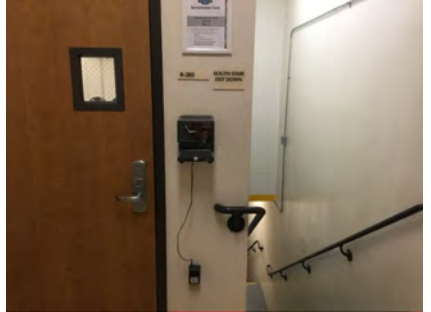
Item no., Rm no. and Name	Existing Architectural Barrier and Proposed Solution	Codes / Mitigation Info	Qty	Unit	Cost	Total
816	<ul style="list-style-type: none"> • <i>As-Built Description:</i> At enclosed stairwells in high-rise buildings: Floor level information sign in stairwell not provided for people with vision impairment. • <i>Proposed Solution:</i> Provide raised letter/Braille sign at door, indicating the floor level and other exiting information. 	PCODE SA10F ADAAG 91 4.1.3(16) CBC 2007 1020.1.6 CBC 2016 11B-504.8 Mitigated: <input type="radio"/> YES <input checked="" type="radio"/> NO	1	JOB	\$450	\$450

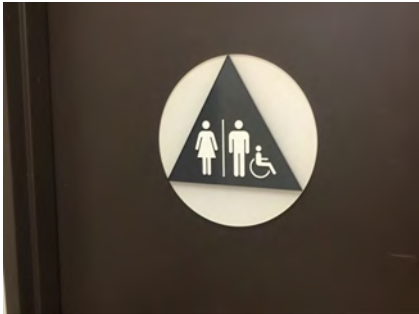
Item no., Rm no. and Name	Existing Architectural Barrier and Proposed Solution	Codes / Mitigation Info	Qty	Unit	Cost	Total
Signage						
817	<ul style="list-style-type: none">As-Built Description: Required in CA only: identification symbol centered 58" to 60" high on sanitary facility door that contrasts with the door not provided (women: 12" ø circle, men: 12" triangle, unisex: combined symbol).As-Built: Not eased. No radius.Proposed Solution: Provide properly mounted sanitary facility symbol when altering area. If wheelchair accessible, include International Symbol of Accessibility on sign.	PCODE SA15 CBC 2007 1115B.6 CBC 2016 11B-703.7.2.6 Mitigated: <input type="radio"/> YES <input checked="" type="radio"/> NO	1	JOB	\$270	\$270

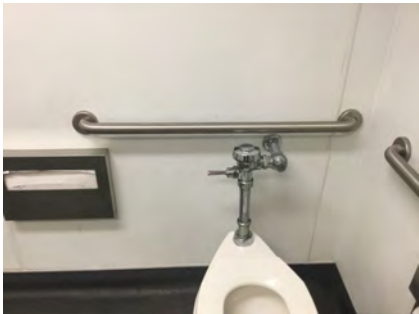
<input type="checkbox"/> Staff Only			
			Priority		Severity	
			3		3	
Grab Bars						
824	<ul style="list-style-type: none">As-Built Description: The rear wall grab is less than 36" min. or does not extend from the centerline of the water closet 12" min. on one side and 24" min. on the other side.As-Built: 21" on the wide sideProposed Solution: Provide or relocate accessible rear grab bar.	PCODE WB07B ADAAG 91 4.17.6 ADA 2010 604.5.2 CBC 2007 1115B.4.1.3.2 CBC 2016 11B-604.5.2 Mitigated: <input type="radio"/> YES <input checked="" type="radio"/> NO	1	JOB	\$1,020	\$1,020

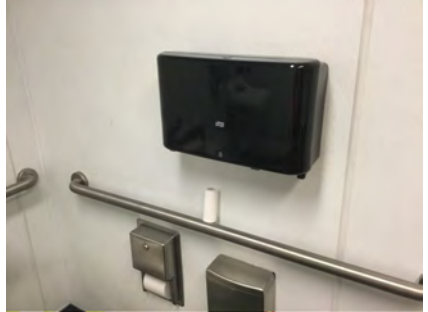
Item no., Rm no. and Name	Existing Architectural Barrier and Proposed Solution	Codes / Mitigation Info	Qty	Unit	Cost	Total
822	<ul style="list-style-type: none"> As-Built Description: Accessories/dispensers in accessible stall located closer than 1-1/2" below or 12" above grab bar impedes its use. As-Built: 8.5" above side grab bar Proposed Solution: Relocate accessories/dispensers to be no closer than 1-1/2" below and 12" above grab bars (except if accessories are recessed, flush with wall, and have no sharp edges). 	PCODE WB071 ADAAG 91 4.26.2 ADA 2010 609.3 CBC 2007 1133B.4.2.5 CBC 2016 11B-609.3 Mitigated: <input type="radio"/> YES <input checked="" type="radio"/> NO	1	JOB	\$225	\$225

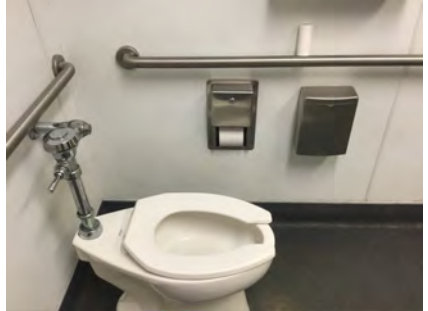
823	<ul style="list-style-type: none"> As-Built Description: Toilet paper dispenser less than 15" (CA: 19") or more than 48" above floor or not within 7" to 9" from front of water closet (Note: CA pre-2010 is allowed within 12" from front of water closet). As-Built: Behind the front of the water closet Proposed Solution: Relocate or provide new toilet paper dispenser. 	PCODE WG02 ADAAG 91 4.16.6 ADA 2010 604.7 CBC 2007 1115B.8.4 CBC 2016 11B-604.7 Mitigated: <input type="radio"/> YES <input checked="" type="radio"/> NO	1	JOB	\$225	\$225

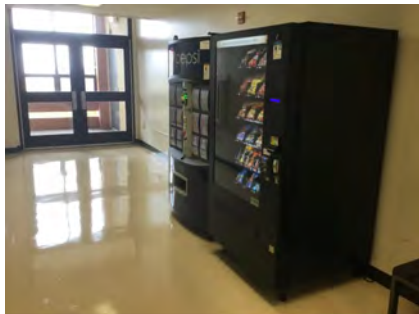
Item no., Rm no. and Name	Existing Architectural Barrier and Proposed Solution	Codes / Mitigation Info	Qty	Unit	Cost	Total
<u>Vending Machine</u>						
764	<ul style="list-style-type: none">• <i>As-Built Description:</i> Vending machine coin slot or dispensing outlet, more than 48" above the floor.• <i>As-Built:</i> 10" to the bottom of the dispensing tray 54" to the top of the card reader• <i>Proposed Solution:</i> Advise vendor/leasing company to provide accessible vending machine with highest operable part at 48" max.	<p>PCODE IL02 ADAAG 91 4.2.5 ADA 2010 308.2.1 CBC 2007 1126B CBC 2016 11B-308.2.1</p> <p>Mitigated: <input type="radio"/> YES <input checked="" type="radio"/> NO</p>	2	REF

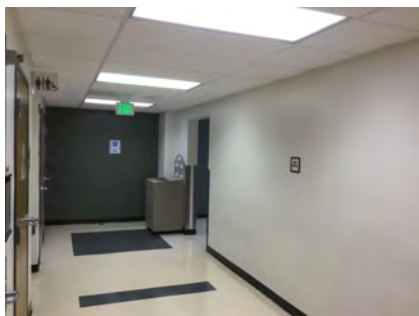
<input type="checkbox"/> Staff Only			
			Priority 2	Severity 3		
<u>Route Sign</u>						
717	<ul style="list-style-type: none">• <i>As-Built Description:</i> No sign by inaccessible route directing persons to an accessible route.• <i>Proposed Solution:</i> Provide directional sign.• <i>Notes:</i> No ISA directional signage to accessible exit. There are illuminated exit signs which direct people to an inaccessible exit due to stairs. Install directional signage at decision points.	<p>PCODE SA20 ADAAG 91 35.163(b) ADA 2010 216.3 CBC 2007 1127B.3 CBC 2016 11B-216.3</p> <p>Mitigated: <input type="radio"/> YES <input checked="" type="radio"/> NO</p>	1	JOB	\$510	\$510

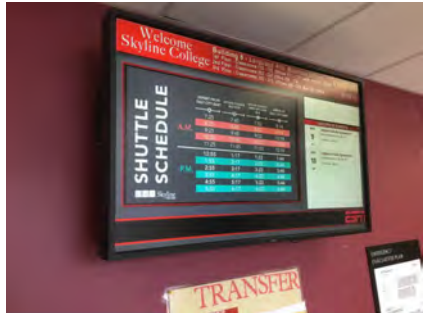
Item no., Rm no. and Name	Existing Architectural Barrier and Proposed Solution	Codes / Mitigation Info	Qty	Unit	Cost	Total
Signage						
766	<ul style="list-style-type: none"> As-Built Description: Sign characters not readable because they are not sized for viewing distance. As-Built: Character dimensions vary depending on the message being displayed Proposed Solution: Provide compliant signage. 	PCODE SA02A ADAAG 91 4.30.3 ADA 2010 703.5.5 CBC 2007 1117B.5.4 CBC 2016 11B-307.2 Mitigated: <input type="radio"/> YES <input checked="" type="radio"/> NO	1	JOB	\$270	\$270

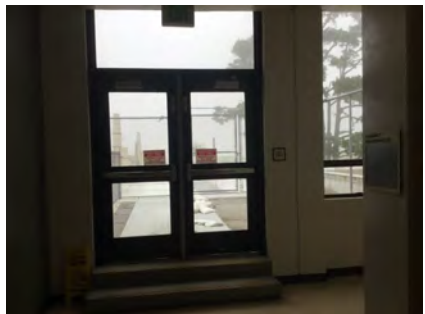
<input type="checkbox"/> Staff Only			
			Priority		Severity	
			2		4	
718	<ul style="list-style-type: none"> As-Built Description: At door leading into exit stairway: Where required exit signs are installed, signs to provide exiting information for people with vision impairment are not provided. Proposed Solution: Provide raised letter/Braille "EXIT STAIR UP/DOWN" sign at door. 	PCODE SA10B ADAAG 91 4.1.3(16) ADA 2010 216.4.1 CBC 2007 1011.3 CBC 2016 11B-216.4.1 Mitigated: <input type="radio"/> YES <input checked="" type="radio"/> NO	1	JOB	\$270	\$270

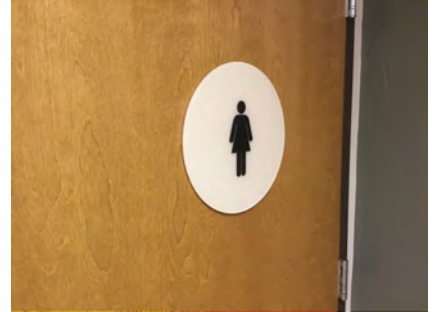
Item no., Rm no. and Name	Existing Architectural Barrier and Proposed Solution	Codes / Mitigation Info	Qty	Unit	Cost	Total
724	<ul style="list-style-type: none"> As-Built Description: Required in CA only: identification symbol centered 58" to 60" high on sanitary facility door that contrasts with the door not provided (women: 12" ø circle, men: 12" triangle, unisex: combined symbol). As-Built: Edges are not eased Proposed Solution: Provide properly mounted sanitary facility symbol when altering area. If wheelchair accessible, include International Symbol of Accessibility on sign. 	PCODE SA15 CBC 2007 1115B.6 CBC 2016 11B-703.7.2.6 Mitigated: <input type="radio"/> YES <input checked="" type="radio"/> NO	2	JOB	\$270	\$540

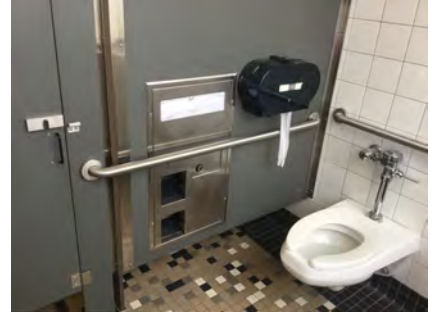
726	<ul style="list-style-type: none"> As-Built Description: Side grab bar less than 42" long, or located more than 12 inches max. from the rear wall, or extending less than 54" from rear wall (CA only: front end min. 24" in front of water closet). As-Built: Side grab bar extends 52" from the rear wall Proposed Solution: Provide or relocate accessible side grab bar. 	PCODE WB07A ADAAG 91 Fig. 29(b) ADA 2010 604.5.1 CBC 2007 1115B.4.1.3.1 CBC 2016 11B-604.5.1 Mitigated: <input type="radio"/> YES <input checked="" type="radio"/> NO	1	JOB	\$780	\$780

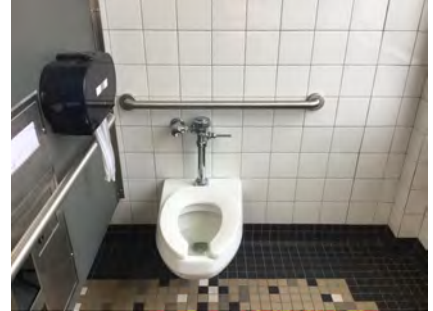
<input type="checkbox"/> Staff Only						
Priority 3 Severity 4						
727	<ul style="list-style-type: none"> As-Built Description: The rear wall grab is less than 36" min. or does not extend from the centerline of the water closet 12" min. on one side and 24" min. on the other side. As-Built: 22" on the widest side Proposed Solution: Provide or relocate accessible rear grab bar. 	PCODE WB07B ADAAG 91 4.17.6 ADA 2010 604.5.2 CBC 2007 1115B.4.1.3.2 CBC 2016 11B-604.5.2 Mitigated: <input type="radio"/> YES <input checked="" type="radio"/> NO	1	JOB	\$1,020	\$1,020

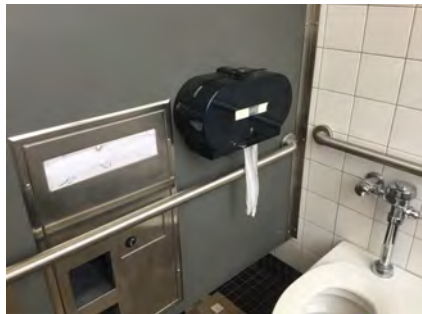
Item no., Rm no. and Name	Existing Architectural Barrier and Proposed Solution	Codes / Mitigation Info	Qty	Unit	Cost	Total
728	<ul style="list-style-type: none"> • <i>As-Built Description:</i> Accessories/dispensers in accessible stall located closer than 1-1/2" below or 12" above grab bar impedes its use. • <i>As-Built:</i> 3" above grab bar • <i>Proposed Solution:</i> Relocate accessories/dispensers to be no closer than 1-1/2" below and 12" above grab bars (except if accessories are recessed, flush with wall, and have no sharp edges). 	PCODE WB071 ADAAG 91 4.26.2 ADA 2010 609.3 CBC 2007 1133B.4.2.5 CBC 2016 11B-609.3 Mitigated: <input type="radio"/> YES <input checked="" type="radio"/> NO	1	JOB	\$225	\$225

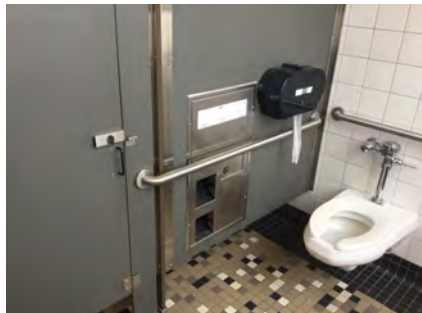
725	<ul style="list-style-type: none"> • <i>As-Built Description:</i> Less than 59" from back wall to front wall or door swing of toilet stall, or less than 56" if water closet is wall-hung. • <i>As-Built:</i> 55" to compartment door, wall mounted water closet • <i>Proposed Solution:</i> Provide new enclosure at existing water closet fixture. • <i>Notes:</i> Relocate the compartment door further from the water closet. There are approximately 4" available on the hinge side of the door. 	PCODE WB03 ADAAG 91 4.17.3 ADA 2010 604.8.1.1 CBC 2007 1115B.3.4.3 CBC 2016 11B-604.8.1.1 Mitigated: <input type="radio"/> YES <input checked="" type="radio"/> NO	1	JOB	\$4,500	\$4,500

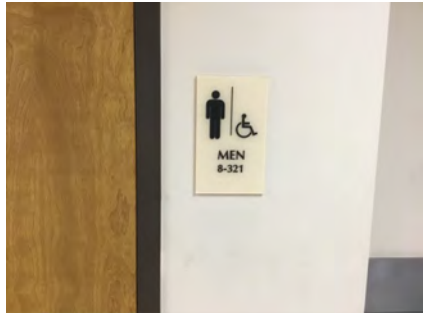
Item no., Rm no. and Name	Existing Architectural Barrier and Proposed Solution	Codes / Mitigation Info	Qty	Unit	Cost	Total
Signage						
732	<ul style="list-style-type: none"> As-Built Description: Signs containing tactile characters is not located so that a clear floor space of 18" min x 18" min., centered on the tactile characters, is provided beyond the arc of any door swing between the closed position and 45 degree open position. As-Built: Centerline of sign is 8" from the door swing Proposed Solution: Relocate compliant signage on latch side of door located at compliant height with a clear floor space. 	PCODE SA07B ADA 2010 703.4.2 CBC 2016 11B-703.4.2 Mitigated: <input type="radio"/> YES <input checked="" type="radio"/> NO	1	JOB	\$150	\$150

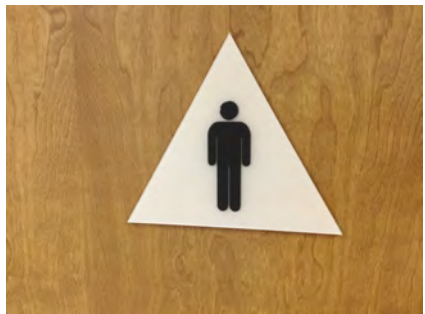
<input type="checkbox"/> Staff Only Priority 3 Severity 4			
733	<ul style="list-style-type: none"> As-Built Description: Required in CA only: identification symbol centered 58" to 60" high on sanitary facility door that contrasts with the door not provided (women: 12" ø circle, men: 12" triangle, unisex: combined symbol). As-Built: Edges not eased. No radius Proposed Solution: Provide properly mounted sanitary facility symbol when altering area. If wheelchair accessible, include International Symbol of Accessibility on sign. 	PCODE SA15 CBC 2007 1115B.6 CBC 2016 11B-703.7.2.6 Mitigated: <input type="radio"/> YES <input checked="" type="radio"/> NO	2	JOB	\$270	\$540

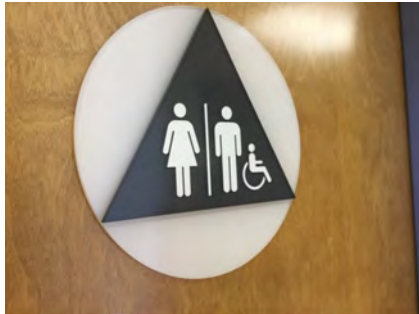
Item no., Rm no. and Name	Existing Architectural Barrier and Proposed Solution	Codes / Mitigation Info	Qty	Unit	Cost	Total
Signage						
2286	<ul style="list-style-type: none">As-Built Description: Required in CA only: identification symbol centered 58" to 60" high on sanitary facility door that contrasts with the door not provided (women: 12" ø circle, men: 12" triangle, unisex: combined symbol).As-Built: Not eased. No radius.Proposed Solution: Provide properly mounted sanitary facility symbol when altering area. If wheelchair accessible, include International Symbol of Accessibility on sign.	PCODE SA15 CBC 2007 1115B.6 CBC 2016 11B-703.7.2.6 Mitigated: <input type="radio"/> YES <input checked="" type="radio"/> NO	1	JOB	\$270	\$270

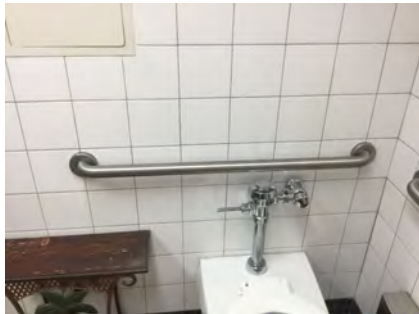
<input type="checkbox"/> Staff Only			
			Priority 3 Severity 3			
Grab Bars						
2292	<ul style="list-style-type: none">As-Built Description: The rear wall grab is less than 36" min. or does not extend from the centerline of the water closet 12" min. on one side and 24" min. on the other side.As-Built: 22" on the wide sideProposed Solution: Provide or relocate accessible rear grab bar.	PCODE WB07B ADAAG 91 4.17.6 ADA 2010 604.5.2 CBC 2007 1115B.4.1.3.2 CBC 2016 11B-604.5.2 Mitigated: <input type="radio"/> YES <input checked="" type="radio"/> NO	1	JOB	\$1,020	\$1,020

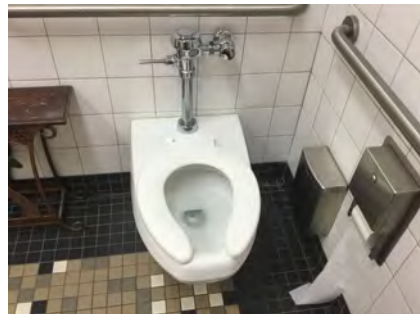
Item no., Rm no. and Name	Existing Architectural Barrier and Proposed Solution	Codes / Mitigation Info	Qty	Unit	Cost	Total
Water Closet						
2291	<ul style="list-style-type: none">• <i>As-Built Description:</i> Water closet not 16"-18" (CA: 17"-18") from near side wall to center line of water closet (2010 ADAAG: 16"-18").• <i>As-Built:</i> 18.5" o.c.• <i>Proposed Solution:</i> Relocate existing water closet and plumbing, remount with offset closet flange to provide 18" max. from side wall.	<p>PCODE WB02C ADAAG 91 Fig. 28 ADA 2010 604.2 CBC 2007 1115B.4.1.1 CBC 2016 11B-604.2</p> <p>Mitigated: <input type="radio"/> YES <input checked="" type="radio"/> NO</p>	1	JOB	\$1,500	\$1,500

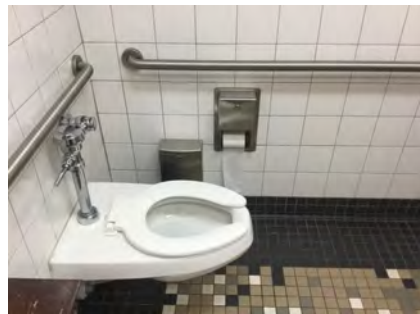
<input type="checkbox"/> Staff Only			
			Priority	Severity		
			3	4		
Accessories						
2293	<ul style="list-style-type: none">• <i>As-Built Description:</i> Toilet paper dispenser less than 15" (CA: 19") or more than 48" above floor or not within 7" to 9" from front of water closet (Note: CA pre-2010 is allowed within 12" from front of water closet).• <i>As-Built:</i> Behind the front of the water closet• <i>Proposed Solution:</i> Relocate or provide new toilet paper dispenser.	<p>PCODE WG02 ADAAG 91 4.16.6 ADA 2010 604.7 CBC 2007 1115B.8.4 CBC 2016 11B-604.7</p> <p>Mitigated: <input type="radio"/> YES <input checked="" type="radio"/> NO</p>	1	JOB	\$225	\$225

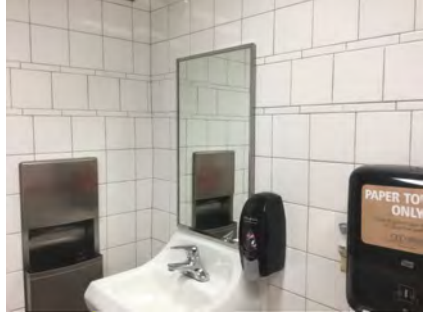
Item no., Rm no. and Name	Existing Architectural Barrier and Proposed Solution	Codes / Mitigation Info	Qty	Unit	Cost	Total
2288	<ul style="list-style-type: none"> As-Built Description: Bottom of mirror located above lavatories or countertops more than 40" above floor. As-Built: 40.25" high Proposed Solution: Relocate or provide new accessible mirror. 	PCODE WG03 ADAAG 91 4.19.6 ADA 2010 603.3 CBC 2007 1115B.8.1 CBC 2016 11B-603.3 Mitigated: <input type="radio"/> YES <input checked="" type="radio"/> NO	1	JOB	\$450	\$450

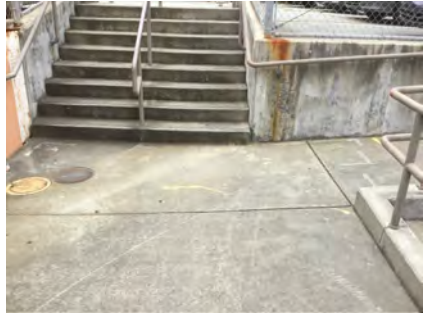
Item no., Rm no. and Name	Existing Architectural Barrier and Proposed Solution	Codes / Mitigation Info	Qty	Unit	Cost	Total
1724	<ul style="list-style-type: none"> As-Built Description: Level 2% max. landing for ramp not provided. As-Built: 5.4% Proposed Solution: Rebuild ramp to provide landings for each ramp run with slopes no greater than 2% 	PCODE EB05A ADAAG 91 4.8.4 ADA 2010 405.7.1 CBC 2007 1133B.5.4.1 CBC 2016 11B-405.7.1 Mitigated: <input type="radio"/> YES <input checked="" type="radio"/> NO	30	SF	\$300	\$9,000

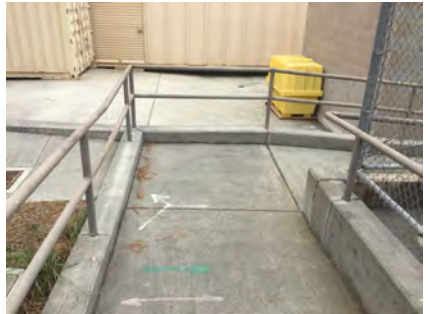
<input type="checkbox"/> Staff Only Priority 1 Severity 3			
1728	<ul style="list-style-type: none"> As-Built Description: Level 2% max. landing for ramp not provided. As-Built: 3.2% Proposed Solution: Grind the surface. 	PCODE EB05A ADAAG 91 4.8.4 ADA 2010 405.7.1 CBC 2007 1133B.5.4.1 CBC 2016 11B-405.7.1 Mitigated: <input type="radio"/> YES <input checked="" type="radio"/> NO	15	SF	\$300	\$4,500

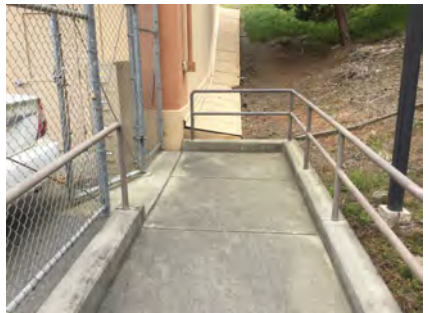
<input type="checkbox"/> Staff Only Priority 1 Severity 4			
1730	<ul style="list-style-type: none"> As-Built Description: Level 2% max. landing for ramp not provided. As-Built: 5.8% Proposed Solution: Modify top landing. 	PCODE EB05A ADAAG 91 4.8.4 ADA 2010 405.7.1 CBC 2007 1133B.5.4.1 CBC 2016 11B-405.7.1 Mitigated: <input type="radio"/> YES <input checked="" type="radio"/> NO	30	SF	\$300	\$9,000

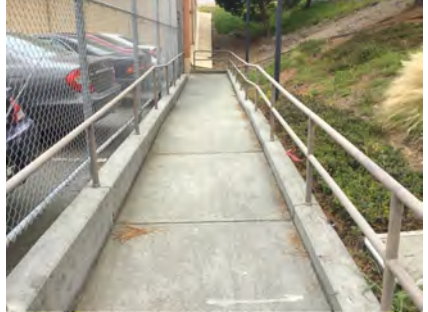
Item no., Rm no. and Name	Existing Architectural Barrier and Proposed Solution	Codes / Mitigation Info	Qty	Unit	Cost	Total
1727	<ul style="list-style-type: none"> As-Built Description: Cross slope more than 1":48" (2.083%). As-Built: Up to 3.6% Proposed Solution: Modify cross slope. 	PCODE EF07 ADAAG 91 4.3.7 ADA 2010 403.3 CBC 2007 1133B.7.1.3 CBC 2016 11B-403.3 Mitigated: <input type="radio"/> YES <input checked="" type="radio"/> NO	40	SF	\$75	\$3,000

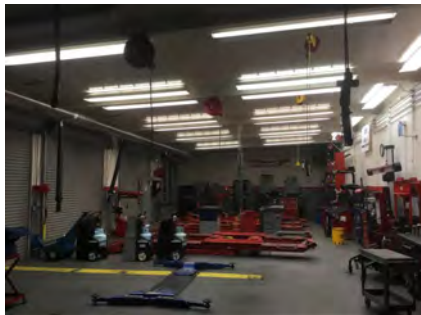
Item no., Rm no. and Name	Existing Architectural Barrier and Proposed Solution	Codes / Mitigation Info	Qty	Unit	Cost	Total
Vertical Clearance						
1690	<ul style="list-style-type: none"> As-Built Description: Overhead clearance less than 80" above finished floor. As-Built: Hanging cords and lights 27" - 80" high Proposed Solution: Modify overhead clearance. 	PCODE EG01 ADAAG 91 4.4.2 ADA 2010 307.4 CBC 2007 1133B.8.6.2 CBC 2016 11B-307.4 Mitigated: <input type="radio"/> YES <input checked="" type="radio"/> NO	1	JOB	\$300	\$300

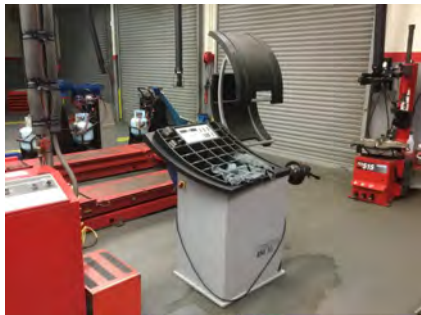
<input type="checkbox"/> Staff Only Priority 2 Severity 2			
1701	<ul style="list-style-type: none"> As-Built Description: Overhead clearance less than 80" above finished floor. As-Built: 69" high Proposed Solution: Modify overhead clearance. 	PCODE EG01 ADAAG 91 4.4.2 ADA 2010 307.4 CBC 2007 1133B.8.6.2 CBC 2016 11B-307.4 Mitigated: <input type="radio"/> YES <input checked="" type="radio"/> NO	1	JOB	\$300	\$300

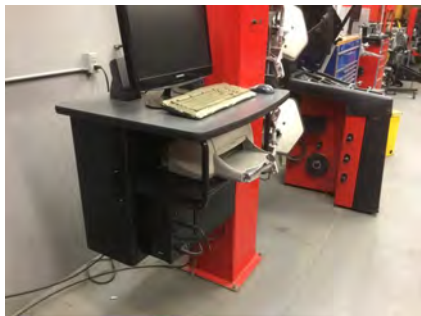
<input type="checkbox"/> Staff Only Priority 2 Severity 2			
1702	<ul style="list-style-type: none"> As-Built Description: Overhead clearance less than 80" above finished floor. As-Built: 43" high Proposed Solution: Modify overhead clearance. 	PCODE EG01 ADAAG 91 4.4.2 ADA 2010 307.4 CBC 2007 1133B.8.6.2 CBC 2016 11B-307.4 Mitigated: <input type="radio"/> YES <input checked="" type="radio"/> NO	1	JOB	\$300	\$300

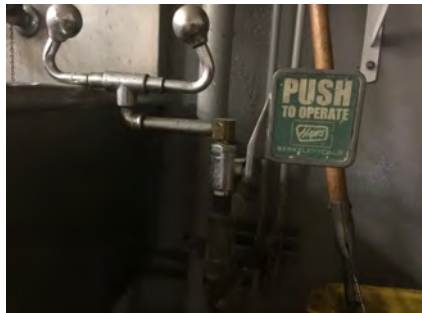
Item no., Rm no. and Name	Existing Architectural Barrier and Proposed Solution	Codes / Mitigation Info	Qty	Unit	Cost	Total
1704	<ul style="list-style-type: none"> As-Built Description: Overhead clearance less than 80" above finished floor. As-Built: 57" high Proposed Solution: Modify overhead clearance. 	PCODE EG01 ADAAG 91 4.4.2 ADA 2010 307.4 CBC 2007 1133B.8.6.2 CBC 2016 11B-307.4 Mitigated: <input type="radio"/> YES <input checked="" type="radio"/> NO	1	JOB	\$300	\$300

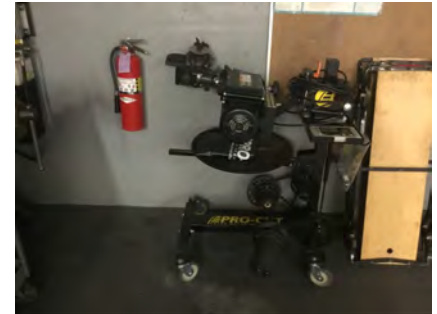
1695	<ul style="list-style-type: none"> As-Built Description: Minimum of one non-fixed station per lab not provided at specialized laboratory equipment (height between 28" and 34", with leg room 27" high x 30" wide x 19" deep). (CA Only) As-Built: 25.5" high Proposed Solution: Remodel existing cabinet/counter to provide lab/studio equipment for disabled person. 	PCODE LB01A CBC 2007 1106B.2 CBC 2016 11B-805.7 Mitigated: <input type="radio"/> YES <input checked="" type="radio"/> NO	1	JOB	\$3,600	\$3,600

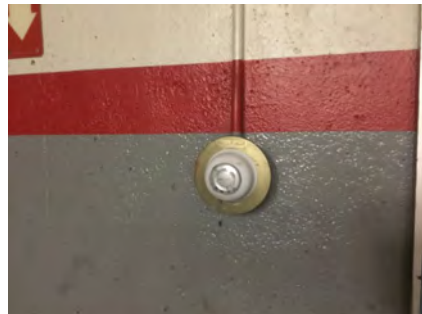
Item no., Rm no. and Name	Existing Architectural Barrier and Proposed Solution	Codes / Mitigation Info	Qty	Unit	Cost	Total
1687	<ul style="list-style-type: none">As-Built Description: Electric switch or control mounted less than 15" measured to the bottom of the outlet box or greater than 48 inches measured to the top of the outlet box.As-Built: 61.5" highProposed Solution: Relocate light switches or control to between 15" and 48" height.	PCODE IC01 ADAAG 91 4.2.5 & 6 ADA 2010 308.2.1 & CBC 2007 1117B.6.3 CBC 2016 11B-308.2.1 & 11B-308.2.2 Mitigated: <input type="radio"/> YES <input checked="" type="radio"/> NO	1	JOB	\$900	\$900

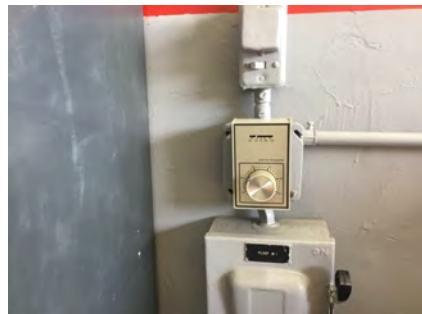
<input type="checkbox"/> Staff Only			
			Priority	Severity		
			2	2		
1700	<ul style="list-style-type: none">As-Built Description: Electric switch or control mounted less than 15" measured to the bottom of the outlet box or greater than 48 inches measured to the top of the outlet box.As-Built: 59" highProposed Solution: Relocate light switches or control to between 15" and 48" height.	PCODE IC01 ADAAG 91 4.2.5 & 6 ADA 2010 308.2.1 & CBC 2007 1117B.6.3 CBC 2016 11B-308.2.1 & 11B-308.2.2 Mitigated: <input type="radio"/> YES <input checked="" type="radio"/> NO	1	JOB	\$900	\$900

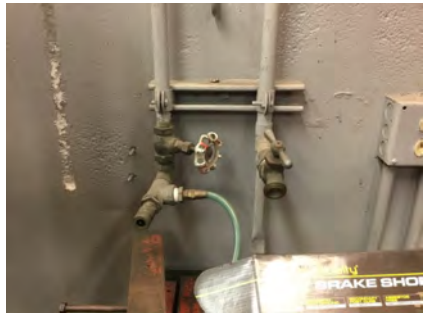
<input type="checkbox"/> Staff Only			
			Priority	Severity		
			2	3		
Operable Part						
1686	<ul style="list-style-type: none">As-Built Description: Operable part(s) require tight grasping, pinching, or twisting of the wrist with one hand.Proposed Solution: Modify or replace the operable part(s) to not require tight grasping, pinching, or twisting of the wrist with one hand.	PCODE IC02 ADAAG 91 4.27.4 ADA 2010 309.4 CBC 2007 1117B.6.4 CBC 2016 11B-309.4 Mitigated: <input type="radio"/> YES <input checked="" type="radio"/> NO	1	JOB	\$900	\$900

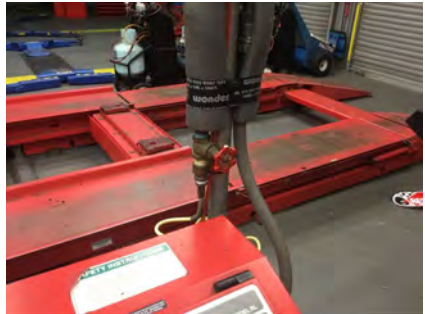
Item no., Rm no. and Name	Existing Architectural Barrier and Proposed Solution	Codes / Mitigation Info	Qty	Unit	Cost	Total
1698	<ul style="list-style-type: none"> As-Built Description: Operable part(s) require tight grasping, pinching, or twisting of the wrist with one hand. Proposed Solution: Modify or replace the operable part(s) to not require tight grasping, pinching, or twisting of the wrist with one hand. 	PCODE IC02 ADAAG 91 4.27.4 ADA 2010 309.4 CBC 2007 1117B.6.4 CBC 2016 11B-309.4 Mitigated: <input type="radio"/> YES <input checked="" type="radio"/> NO	2	JOB	\$900	\$1,800

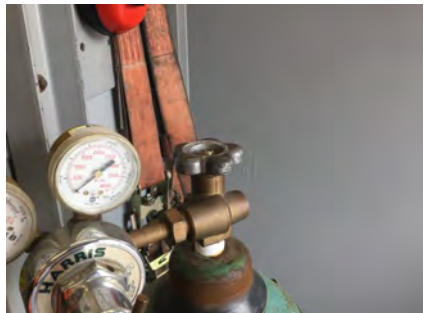
<input type="checkbox"/> Staff Only						
Priority 2 Severity 2						
1707	<ul style="list-style-type: none"> As-Built Description: Operable part(s) require tight grasping, pinching, or twisting of the wrist with one hand. Proposed Solution: Modify or replace the operable part(s) to not require tight grasping, pinching, or twisting of the wrist with one hand. 	PCODE IC02 ADAAG 91 4.27.4 ADA 2010 309.4 CBC 2007 1117B.6.4 CBC 2016 11B-309.4 Mitigated: <input type="radio"/> YES <input checked="" type="radio"/> NO	1	JOB	\$900	\$900

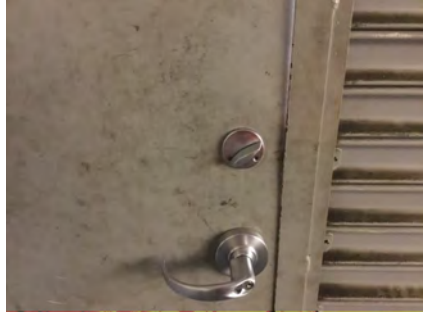
<input type="checkbox"/> Staff Only						
Priority 2 Severity 2						
1680	<ul style="list-style-type: none"> As-Built Description: Operable part(s) require tight grasping, pinching, or twisting of the wrist with one hand. Proposed Solution: Modify or replace the operable part(s) to not require tight grasping, pinching, or twisting of the wrist with one hand. Notes: Unclear if used by students or faculty only. 	PCODE IC02REF ADAAG 91 4.27.4 ADA 2010 309.4 CBC 2007 1117B.6.4 CBC 2016 11B-309.4 Mitigated: <input type="radio"/> YES <input checked="" type="radio"/> NO		REF

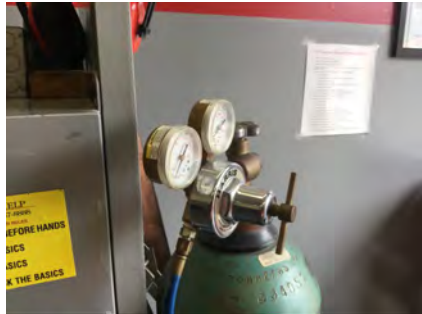
Item no., Rm no. and Name	Existing Architectural Barrier and Proposed Solution	Codes / Mitigation Info	Qty	Unit	Cost	Total
1679	<ul style="list-style-type: none"> As-Built Description: Reach height to control or access point, where side approach is available, exceeds 48" or is less than 15" in height, or exceeds 10" in depth. As-Built: 67" high Proposed Solution: Modify equipment or mounting. 	PCODE IE02 ADAAG 91 4.2.6 ADA 2010 308.3.1 CBC 2007 1118B.6 CBC 2016 11B-308.3 Mitigated: <input type="radio"/> YES <input checked="" type="radio"/> NO	1	JOB	\$300	\$300

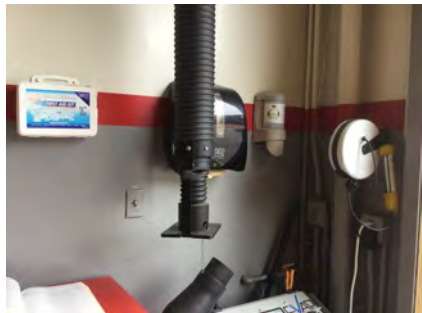
<input type="checkbox"/> Staff Only			
			Priority 2 Severity 1			
1681	<ul style="list-style-type: none"> As-Built Description: Reach height to control or access point, where side approach is available, exceeds 48" or is less than 15" in height, or exceeds 10" in depth. As-Built: 56" high Proposed Solution: Modify equipment or mounting. 	PCODE IE02 ADAAG 91 4.2.6 ADA 2010 308.3.1 CBC 2007 1118B.6 CBC 2016 11B-308.3 Mitigated: <input type="radio"/> YES <input checked="" type="radio"/> NO	1	JOB	\$300	\$300
