SAN MATEO COUNTY
COMMUNITY
COLLEGE DISTRICT

San Mateo County Community College District Americans with Disabilities Act Self-Evaluation and Transition Plan

Report Prepared by:

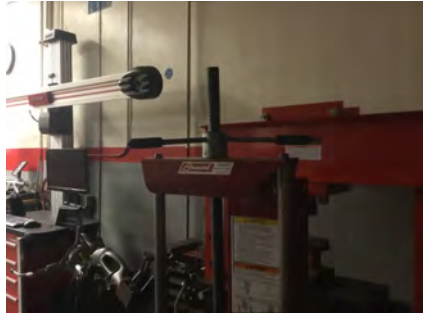
<input type="checkbox"/> Staff Only			
			Priority 2 Severity 3			
1682	<ul style="list-style-type: none"> As-Built Description: Reach height to control or access point, where side approach is available, exceeds 48" or is less than 15" in height, or exceeds 10" in depth. As-Built: Multiple items above 48" high Proposed Solution: Modify equipment or mounting. 	PCODE IE02 ADAAG 91 4.2.6 ADA 2010 308.3.1 CBC 2007 1118B.6 CBC 2016 11B-308.3 Mitigated: <input type="radio"/> YES <input checked="" type="radio"/> NO	10	JOB	\$300	\$3,000

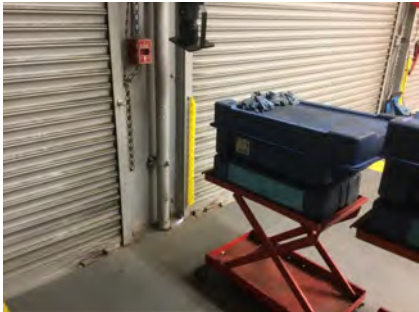
Item no., Rm no. and Name	Existing Architectural Barrier and Proposed Solution	Codes / Mitigation Info	Qty	Unit	Cost	Total
1710	<ul style="list-style-type: none"> As-Built Description: Refer to notes for observation and recommendation. Proposed Solution: Notes: Clear floor space at pull station blocked by carts 	<p>PCODE GN01</p> <p>CBC 2016 11B-403.5.1</p> <p>Mitigated:</p> <p><input type="radio"/> YES</p> <p><input checked="" type="radio"/> NO</p>

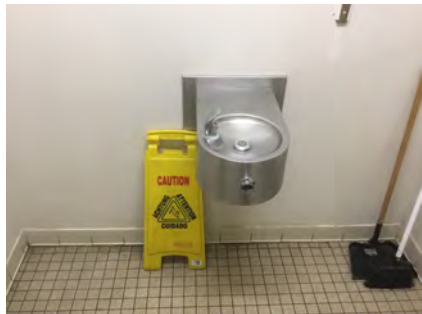
Item no., Rm no. and Name	Existing Architectural Barrier and Proposed Solution	Codes / Mitigation Info	Qty	Unit	Cost	Total
1716	<ul style="list-style-type: none"> As-Built Description: Wall- and post-mounted cantilevered units: Knee space not provided at drinking fountain (27" high, 8" deep, 30" wide from front of drinking fountain). As-Built: 25.75" high Proposed Solution: Provide new, accessible fountain. 	PCODE IA02REF ADAAG 91 4.15.5(1) ADA 2010 602.2 CBC 2007 1115B.4.6.2 CBC 2016 11B-602.2 Mitigated: <input type="radio"/> YES <input checked="" type="radio"/> NO	REF

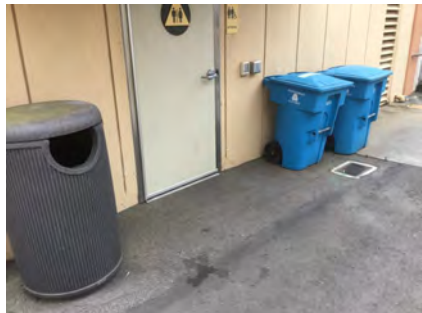
<input type="checkbox"/> Staff Only						
Priority 3 Severity 2						
<hr/>						
1719	<ul style="list-style-type: none"> As-Built Description: Surface of required maneuvering clearance at door slopes more than 1/4":12" (2.0%). As-Built: 4.7% Proposed Solution: Modify surface slope at door. 	PCODE ID11 ADAAG 91 4.13.6 ADA 2010 404.2.4.4 CBC 2007 1133B.2.4 CBC 2016 11B-404.2.4 Mitigated: <input type="radio"/> YES <input checked="" type="radio"/> NO	25	SF	\$120	\$3,000

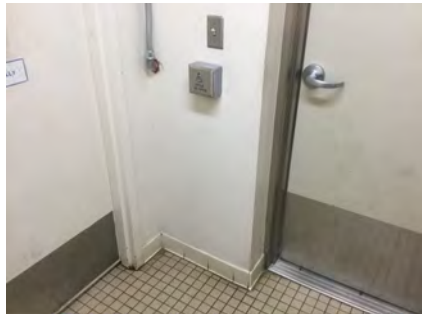
<input type="checkbox"/> Staff Only						
Priority 3 Severity 3						
<hr/>						
1718	<ul style="list-style-type: none"> As-Built Description: Lower push plate located at 7" minimum and 8" maximum above the floor or ground surface not provided. Proposed Solution: Provide lower push plate. 	PCODE ID13B CBC 2007 1133B.2.3.2 CBC 2016 11B-404.2.9 2.C Mitigated: <input type="radio"/> YES <input checked="" type="radio"/> NO	2	JOB	\$1,500	\$3,000

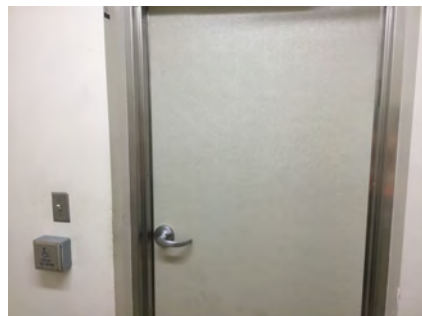
Item no., Rm no. and Name	Existing Architectural Barrier and Proposed Solution	Codes / Mitigation Info	Qty	Unit	Cost	Total
Door Swing						
1717	<ul style="list-style-type: none">As-Built Description: Front approach: At push side, door does not have clear and level maneuvering space measuring door width x 48" (door width plus 12" if door has both, latch and closer).As-Built: 10" deep alcoveProposed Solution: Provide door operator.Notes: The power door operator was not functioning at the time of the survey.	<p>PCODE ID24C</p> <p>ADAAG 91 Fig. 25(a)</p> <p>ADA 2010 404.2.4</p> <p>CBC 2007 11B-26A(a)</p> <p>CBC 2016 11B-404.2.4</p> <p>Mitigated:</p> <p><input type="radio"/> YES</p> <p><input checked="" type="radio"/> NO</p>	1	JOB	\$15,000	\$15,000

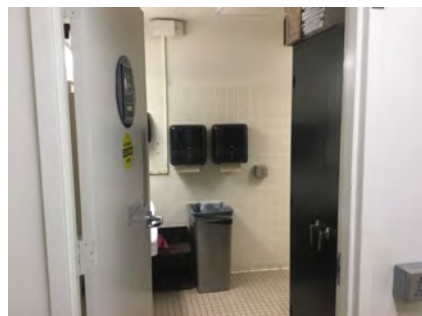
<input type="checkbox"/> Staff Only			
			Priority		Severity	
			3		2	
Restroom						
1714	<ul style="list-style-type: none">As-Built Description: Multiple accommodation restroom not accessible; multiple compliance violations.Proposed Solution: Remodel area to provide accessible restroom with one accessible stall, lavatory (and one urinal at Mens).	<p>PCODE WA01A</p> <p>ADAAG 91 4.22</p> <p>ADA 2010 603.1</p> <p>CBC 2007 1115B.3.1</p> <p>CBC 2016 11B-603.1</p> <p>Mitigated:</p> <p><input type="radio"/> YES</p> <p><input checked="" type="radio"/> NO</p>	2	JOB	? \$210,000

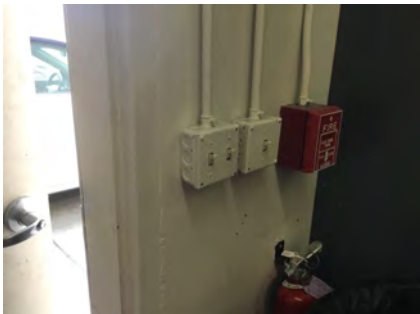
Item no., Rm no. and Name	Existing Architectural Barrier and Proposed Solution	Codes / Mitigation Info	Qty	Unit	Cost	Total
Electrical						
1731	<ul style="list-style-type: none">• <i>As-Built Description:</i> Electric switch or control mounted less than 15" measured to the bottom of the outlet box or greater than 48 inches measured to the top of the outlet box.• <i>As-Built:</i> 50" to top of box. 48.5" to top of switch.• <i>Proposed Solution:</i> Relocate light switches or control to between 15" and 48" height.	<p>PCODE IC01</p> <p>ADAAG 91 4.2.5 & 6</p> <p>ADA 2010 308.2.1 &</p> <p>CBC 2007 1117B.6.3</p> <p>CBC 2016 11B-308.2.1 & 11B-308.2.2</p> <p>Mitigated:</p> <p><input type="radio"/> YES</p> <p><input checked="" type="radio"/> NO</p>	1	JOB	\$900	\$900

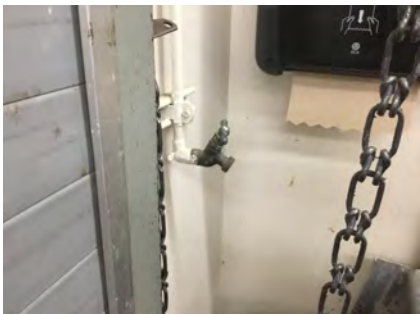
<input type="checkbox"/> Staff Only			
			Priority		Severity	
			2		4	
Operable Part						
1736	<ul style="list-style-type: none">• <i>As-Built Description:</i> Operable part(s) require tight grasping, pinching, or twisting of the wrist with one hand.• <i>Proposed Solution:</i> Modify or replace the operable part(s) to not require tight grasping, pinching, or twisting of the wrist with one hand.	<p>PCODE IC02</p> <p>ADAAG 91 4.27.4</p> <p>ADA 2010 309.4</p> <p>CBC 2007 1117B.6.4</p> <p>CBC 2016 11B-309.4</p> <p>Mitigated:</p> <p><input type="radio"/> YES</p> <p><input checked="" type="radio"/> NO</p>	1	JOB	\$900	\$900

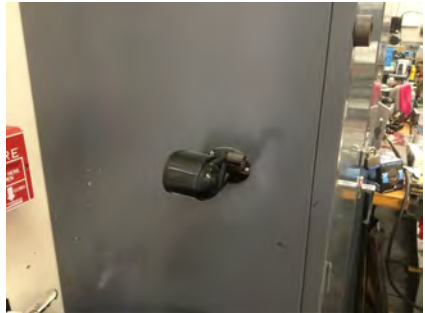
Item no., Rm no. and Name	Existing Architectural Barrier and Proposed Solution	Codes / Mitigation Info	Qty	Unit	Cost	Total
Reach Range						
1733	<ul style="list-style-type: none"> As-Built Description: Reach height to control or access point, where side approach is available, exceeds 48" or is less than 15" in height, or exceeds 10" in depth. As-Built: 50" high Proposed Solution: Modify equipment or mounting. 	PCODE IE02 ADAAG 91 4.2.6 ADA 2010 308.3.1 CBC 2007 1118B.6 CBC 2016 11B-308.3 Mitigated: <input type="radio"/> YES <input checked="" type="radio"/> NO	1	JOB	\$300	\$300

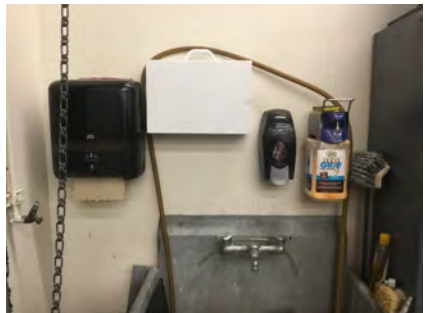
<input type="checkbox"/> Staff Only Priority 2 Severity 4			
1738	<ul style="list-style-type: none"> As-Built Description: Reach height to control or access point, where side approach is available, exceeds 48" or is less than 15" in height, or exceeds 10" in depth. As-Built: 53" - 63" high. 20" deep over 36" high obstruction. Proposed Solution: Modify equipment or mounting. 	PCODE IE02 ADAAG 91 4.2.6 ADA 2010 308.3.1 CBC 2007 1118B.6 CBC 2016 11B-308.3 Mitigated: <input type="radio"/> YES <input checked="" type="radio"/> NO	13	JOB	\$300	\$3,900

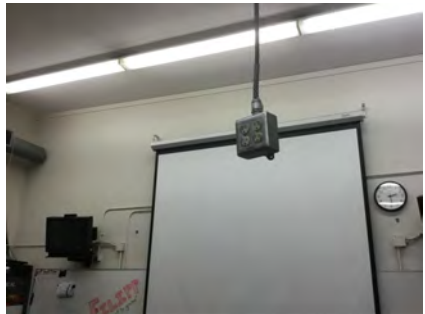
<input type="checkbox"/> Staff Only Priority 2 Severity 2			
1739	<ul style="list-style-type: none"> As-Built Description: Reach height to control or access point, where side approach is available, exceeds 48" or is less than 15" in height, or exceeds 10" in depth. As-Built: 90" high Proposed Solution: Modify equipment or mounting. 	PCODE IE02 ADAAG 91 4.2.6 ADA 2010 308.3.1 CBC 2007 1118B.6 CBC 2016 11B-308.3 Mitigated: <input type="radio"/> YES <input checked="" type="radio"/> NO	3	JOB	\$300	\$900

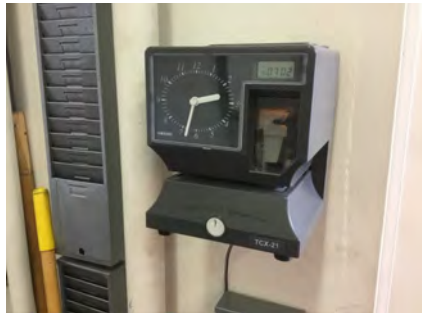
Item no., Rm no. and Name	Existing Architectural Barrier and Proposed Solution	Codes / Mitigation Info	Qty	Unit	Cost	Total
1741	<ul style="list-style-type: none"> As-Built Description: Reach height to control or access point, where side approach is available, exceeds 48" or is less than 15" in height, or exceeds 10" in depth. As-Built: 52" high Proposed Solution: Modify equipment or mounting. 	PCODE IE02 ADAAG 91 4.2.6 ADA 2010 308.3.1 CBC 2007 1118B.6 CBC 2016 11B-308.3 Mitigated: <input type="radio"/> YES <input checked="" type="radio"/> NO	2	JOB	\$300	\$600

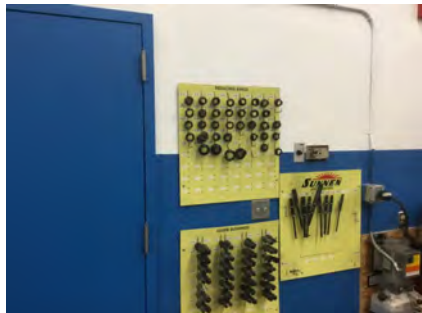
<input type="checkbox"/> Staff Only Priority 2 Severity 4				
1743	<ul style="list-style-type: none"> As-Built Description: Reach height to control or access point, where side approach is available, exceeds 48" or is less than 15" in height, or exceeds 10" in depth. As-Built: 10 pieces of specialized equipment controls up to 79" high Proposed Solution: Modify equipment or mounting. 	PCODE IE02 ADAAG 91 4.2.6 ADA 2010 308.3.1 CBC 2007 1118B.6 CBC 2016 11B-308.3 Mitigated: <input type="radio"/> YES <input checked="" type="radio"/> NO	10	JOB	\$9,000	\$90,000

<input type="checkbox"/> Staff Only Priority 2 Severity 1				
1746	<ul style="list-style-type: none"> As-Built Description: Reach height to control or access point, where side approach is available, exceeds 48" or is less than 15" in height, or exceeds 10" in depth. As-Built: Storage and tools 71" high Proposed Solution: Modify equipment or mounting. 	PCODE IE02 ADAAG 91 4.2.6 ADA 2010 308.3.1 CBC 2007 1118B.6 CBC 2016 11B-308.3 Mitigated: <input type="radio"/> YES <input checked="" type="radio"/> NO	1	JOB	\$300	\$300

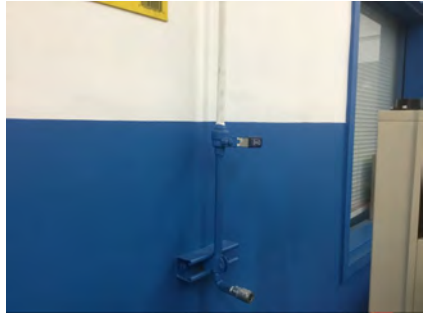
Item no., Rm no. and Name	Existing Architectural Barrier and Proposed Solution	Codes / Mitigation Info	Qty	Unit	Cost	Total
1747	<ul style="list-style-type: none"> As-Built Description: Reach height to control or access point, where side approach is available, exceeds 48" or is less than 15" in height, or exceeds 10" in depth. As-Built: 59" high Proposed Solution: Modify equipment or mounting. 	PCODE IE02 ADAAG 91 4.2.6 ADA 2010 308.3.1 CBC 2007 1118B.6 CBC 2016 11B-308.3 Mitigated: <input type="radio"/> YES <input checked="" type="radio"/> NO	2	JOB	\$300	\$600

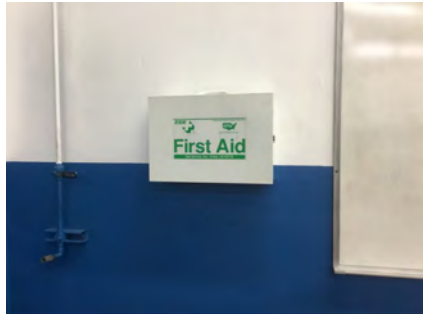
<input type="checkbox"/> Staff Only			
			Priority 2 Severity 3			
1748	<ul style="list-style-type: none"> As-Built Description: Reach height to control or access point, where side approach is available, exceeds 48" or is less than 15" in height, or exceeds 10" in depth. As-Built: 64" high Proposed Solution: Modify equipment or mounting. 	PCODE IE02 ADAAG 91 4.2.6 ADA 2010 308.3.1 CBC 2007 1118B.6 CBC 2016 11B-308.3 Mitigated: <input type="radio"/> YES <input checked="" type="radio"/> NO	1	JOB	\$300	\$300

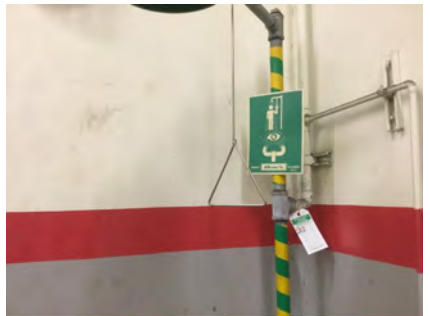
<input type="checkbox"/> Staff Only			
			Priority 2 Severity 2			
1755	<ul style="list-style-type: none"> As-Built Description: Reach height to control or access point, where side approach is available, exceeds 48" or is less than 15" in height, or exceeds 10" in depth. As-Built: Shower pull 66" AFF Proposed Solution: Modify equipment or mounting. Notes: Similar conditions exist at the shower on the exterior of the building. 	PCODE IE02 ADAAG 91 4.2.6 ADA 2010 308.3.1 CBC 2007 1118B.6 CBC 2016 11B-308.3 Mitigated: <input type="radio"/> YES <input checked="" type="radio"/> NO	3	JOB	\$300	\$900

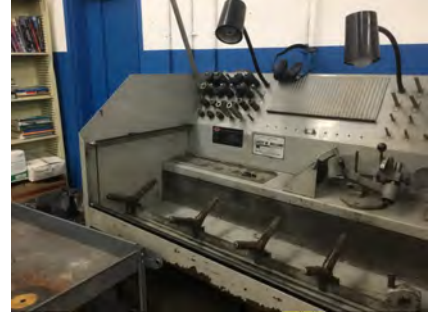
Item no., Rm no. and Name	Existing Architectural Barrier and Proposed Solution	Codes / Mitigation Info	Qty	Unit	Cost	Total
1744	<ul style="list-style-type: none"> As-Built Description: Reach height to control or access point, where side approach is available, exceeds 48" or is less than 15" in height, or exceeds 10" in depth. As-Built: 32" deep side reach Proposed Solution: Modify equipment or mounting. 	PCODE IE02REF ADAAG 91 4.2.6 ADA 2010 308.3.1 CBC 2007 1118B.6 CBC 2016 11B-308.3 Mitigated: <input type="radio"/> YES <input checked="" type="radio"/> NO				
<div>REF</div>

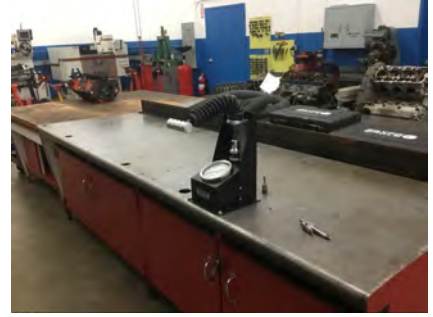
1745	<ul style="list-style-type: none"> As-Built Description: Accessible fixed table or desk (top 28" to 34" high; knee space at least 27" high x 19" deep x 30" wide) not provided. As-Built: Work surfaces 36" high and no knee clearance Proposed Solution: Provide new fixed accessible table or desk. 	PCODE IN02 ADAAG 91 4.32.3 & .4 ADA 2010 306.1 & 902.3 CBC 2007 1122B.3 & 4 CBC 2016 11B-306.1 & 11B-902.3 Mitigated: <input type="radio"/> YES <input checked="" type="radio"/> NO	1	JOB	\$7,500	\$7,500

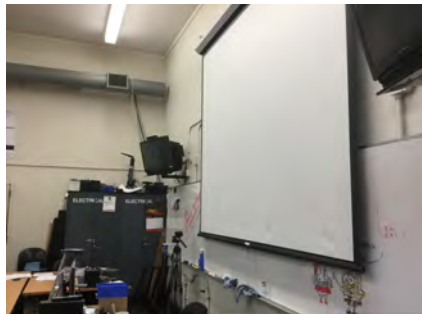
Item no., Rm no. and Name	Existing Architectural Barrier and Proposed Solution	Codes / Mitigation Info	Qty	Unit	Cost	Total
1735	<ul style="list-style-type: none"> As-Built Description: No signs at the building or assembly area entrance to notify patrons that an assistive listening system is available. Proposed Solution: Provide assistive listening signage. 	PCODE GI02 ADAAG 91 4.1.3(19)(b) ADA 2010 703.7.2.4 CBC 2007 1104B.2.4 CBC 2016 11B-703.7.2.4 Mitigated: <input type="radio"/> YES <input checked="" type="radio"/> NO	1	JOB	\$300	\$300

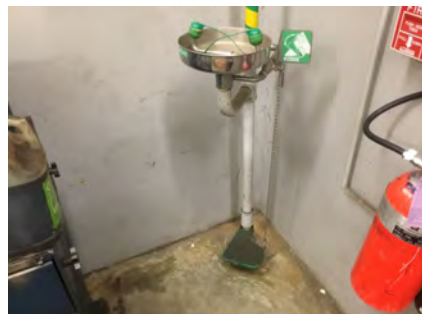
- As-Built Description:
Refer to notes for observation and recommendation.
- Proposed Solution:
- Notes:
Toe clearance at eye wash 6" deep. Obstructed by foot pedal. Occurs at the shower on the exterior of the building as well. 3 occurrences.

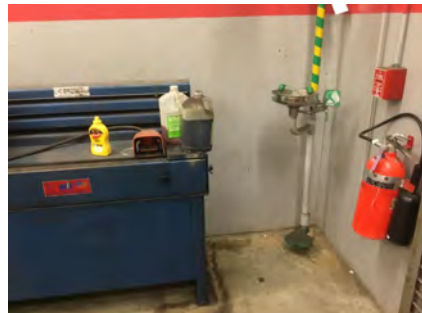
- As-Built Description:
Refer to notes for observation and recommendation.
- Proposed Solution:
- Notes:
Eye wash clear floor space obstructed by machinery.

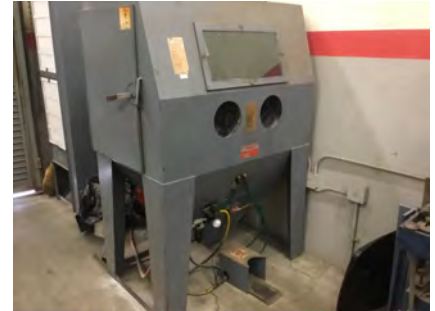
Item no., Rm no. and Name	Existing Architectural Barrier and Proposed Solution	Codes / Mitigation Info	Qty	Unit	Cost	Total
1757	<ul style="list-style-type: none"> • <i>As-Built Description:</i> Refer to notes for observation and recommendation. • <i>Proposed Solution:</i> • <i>Notes:</i> No knee clearance provided at equipment. 	PCODE GN01 CBC 2016 11B-308.3 Mitigated: <input type="radio"/> YES <input checked="" type="radio"/> NO		REF		
<div> <input type="checkbox"/> Staff Only </div> <div> Priority 2 Severity 2 </div>

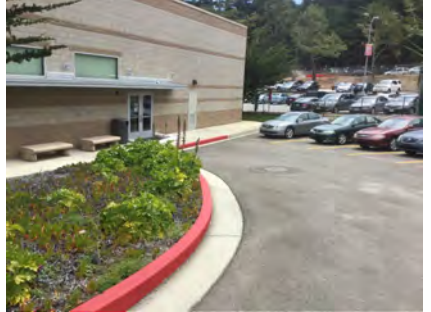
Item no., Rm no. and Name	Existing Architectural Barrier and Proposed Solution	Codes / Mitigation Info	Qty	Unit	Cost	Total
1828	<ul style="list-style-type: none"> As-Built Description: Accessible parking space(s) not located close to the nearest possible entrance on an accessible route. Proposed Solution: Relocate accessible parking space(s). Notes: There is an accessible parking spot approximately 100 feet from the entrance. 	PCODE EA06 ADAAG 91 4.6.2 ADA 2010 208.3 CBC 2007 1129B.1 CBC 2016 11B-208.3.1 Mitigated: <input type="radio"/> YES <input checked="" type="radio"/> NO	1	JOB	\$1,050	\$1,050

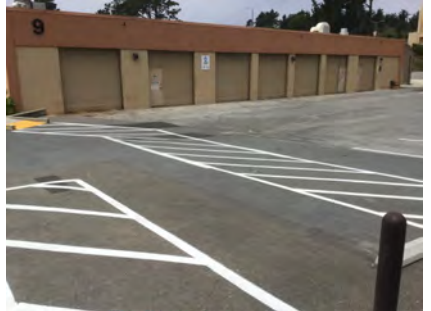
1837	<ul style="list-style-type: none"> As-Built Description: Cross slope more than 1":48" (2.083%). As-Built: 5.4% Proposed Solution: Modify cross slope. 	PCODE EF07 ADAAG 91 4.3.7 ADA 2010 403.3 CBC 2007 1133B.7.1.3 CBC 2016 11B-403.3 Mitigated: <input type="radio"/> YES <input checked="" type="radio"/> NO	160	SF	\$75	\$12,000

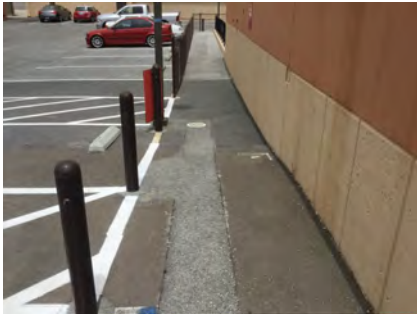
Item no., Rm no. and Name	Existing Architectural Barrier and Proposed Solution	Codes / Mitigation Info	Qty	Unit	Cost	Total
Walk						
1836	<ul style="list-style-type: none">As-Built Description: Walk: Slope greater than 1:20 (5.0%), and walk does not comply with requirements for ramps.As-Built: 11.5%Proposed Solution: Modify walk/sidewalk slope to 1:20 or less.	<p>PCODE EF01</p> <p>ADAAG 91 4.3.7</p> <p>ADA 2010 403.3</p> <p>CBC 2007 1133B.7.3</p> <p>CBC 2016 11B-403.3</p> <p>Mitigated:</p> <p><input type="radio"/> YES</p> <p><input checked="" type="radio"/> NO</p>	50	SF	\$75	\$3,750

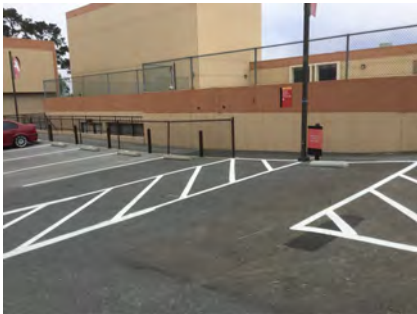
<input type="checkbox"/> Staff Only			
			Priority 1 Severity 3			
Detectable Warning						
1835	<ul style="list-style-type: none">As-Built Description: 36" wide band of truncated domes not provided at walkway or crossing adjoining a vehicular way, if surfaces are not separated by a curb, railing, or other element.Proposed Solution: Provide 36" wide, contrasting color, band of truncated domes between pedestrian and vehicular area.	<p>PCODE EG09</p> <p>ADAAG 91 4.29.5</p> <p>CBC 2007 1133B.8.5</p> <p>CBC 2016 11B-705.1.2.5</p> <p>Mitigated:</p> <p><input type="radio"/> YES</p> <p><input checked="" type="radio"/> NO</p>	5	LF	\$81	\$405

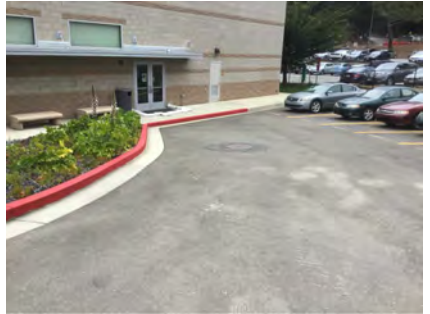
Item no., Rm no. and Name	Existing Architectural Barrier and Proposed Solution	Codes / Mitigation Info	Qty	Unit	Cost	Total
<u>Curb Ramp</u>						
1830	<ul style="list-style-type: none"> • <i>As-Built Description:</i> No curb ramp available where an accessible route crosses a curb. • <i>Proposed Solution:</i> Provide new curb ramp. 	PCODE EH01 ADAAG 91 4.7.1 ADA 2010 303.4 CBC 2007 1127B.5.1 CBC 2016 11B-402.2 Mitigated: <input type="radio"/> YES <input checked="" type="radio"/> NO	1	JOB	\$7,500	\$7,500

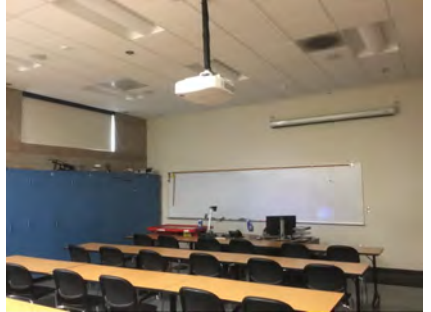
Item no., Rm no. and Name	Existing Architectural Barrier and Proposed Solution	Codes / Mitigation Info	Qty	Unit	Cost	Total
1805	<ul style="list-style-type: none"> • <i>As-Built Description:</i> No signs at the building or assembly area entrance to notify patrons that an assistive listening system is available. • <i>Proposed Solution:</i> Provide assistive listening signage. 	PCODE GI02 ADAAG 91 4.1.3(19)(b) ADA 2010 703.7.2.4 CBC 2007 1104B.2.4 CBC 2016 11B-703.7.2.4 Mitigated: <input type="radio"/> YES <input checked="" type="radio"/> NO	2	JOB	\$300	\$600

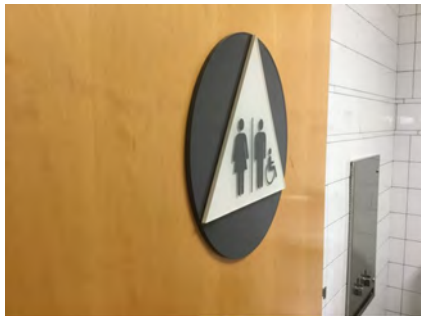
Item no., Rm no. and Name	Existing Architectural Barrier and Proposed Solution	Codes / Mitigation Info	Qty	Unit	Cost	Total
Signage						
1759	<ul style="list-style-type: none">As-Built Description: Required in CA only: identification symbol centered 58" to 60" high on sanitary facility door that contrasts with the door not provided (women: 12" ø circle, men: 12" triangle, unisex: combined symbol).As-Built: Edges not beveledProposed Solution: Provide properly mounted sanitary facility symbol when altering area. If wheelchair accessible, include International Symbol of Accessibility on sign.	PCODE SA15 CBC 2007 1115B.6 CBC 2016 11B-703.7.2.6 Mitigated: <input type="radio"/> YES <input checked="" type="radio"/> NO	1	JOB	\$270	\$270

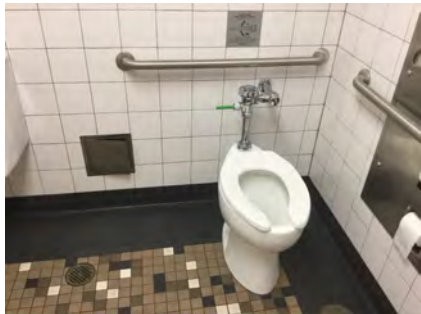
<input type="checkbox"/> Staff Only			
			Priority		Severity	
			<input checked="" type="radio"/> 3		<input checked="" type="radio"/> 3	
Grab Bars						
1766	<ul style="list-style-type: none">As-Built Description: The rear wall grab is less than 36" min. or does not extend from the centerline of the water closet 12" min. on one side and 24" min. on the other side.As-Built: 21.5" on the wide sideProposed Solution: Provide or relocate accessible rear grab bar.	PCODE WB07B ADAAG 91 4.17.6 ADA 2010 604.5.2 CBC 2007 1115B.4.1.3.2 CBC 2016 11B-604.5.2 Mitigated: <input type="radio"/> YES <input checked="" type="radio"/> NO	1	JOB	\$1,020	\$1,020

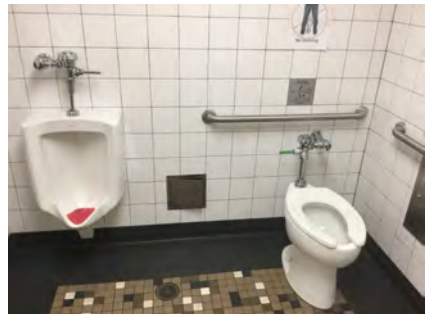
Item no., Rm no. and Name	Existing Architectural Barrier and Proposed Solution	Codes / Mitigation Info	Qty	Unit	Cost	Total
<u>Toilet Stall</u>						
1765	<ul style="list-style-type: none">• <i>As-Built Description:</i> 60" min. clearance around a water closet measured perpendicular from the side wall not provided (Fixtures are not allowed to overlap this clearance).• <i>As-Built:</i> 57.75" to the urinal• <i>Proposed Solution:</i> Remove adjacent fixture and provide new enclosure at accessible water closet.	<p>PCODE WB01A</p> <p>ADA 2010 604.3.1; 604.3.2</p> <p>CBC 2007 1115B.7.1.3</p> <p>CBC 2016 11B-604.3.1; 11B-604.3.2</p> <p>Mitigated:</p> <p><input type="radio"/> YES</p> <p><input checked="" type="radio"/> NO</p>	1	JOB	\$6,000	\$6,000

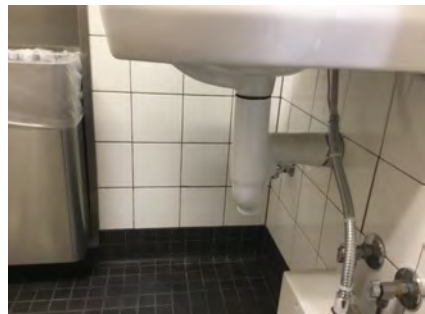
<input type="checkbox"/> Staff Only			
			Priority		Severity	
			3		4	
<u>Lavatory</u>						
1777	<ul style="list-style-type: none">• <i>As-Built Description:</i> Knee clearance 27" min. high starting 8" back from the front edge of the lavatory towards the wall is not provided.• <i>As-Built:</i> Drain pipe 8.75" from the front edge of the lavatory at 19" AFF• <i>Proposed Solution:</i> Remount compliant fixture to accessible height.	<p>PCODE WD04A</p> <p>ADAAG 91 Fig. 31</p> <p>ADA 2010 306.3.3</p> <p>CBC 2007 1115B.4.3</p> <p>CBC 2016 11B-306.3.3</p> <p>Mitigated:</p> <p><input type="radio"/> YES</p> <p><input checked="" type="radio"/> NO</p>	1	JOB	\$4,500	\$4,500

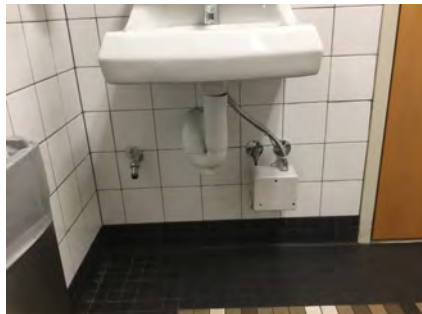
Item no., Rm no. and Name	Existing Architectural Barrier and Proposed Solution	Codes / Mitigation Info	Qty	Unit	Cost	Total
1762	<ul style="list-style-type: none"> • As-Built Description: Hot or sharp-surfaced water/drain pipe not insulated or covered. • Proposed Solution: Insulate or cover water/drain pipe. 	PCODE WD05 ADAAG 91 4.19.4 ADA 2010 606.5 CBC 2007 1115B.4.3.4 CBC 2016 11B-606.5 Mitigated: <input type="radio"/> YES <input checked="" type="radio"/> NO	1	JOB	\$360	\$360

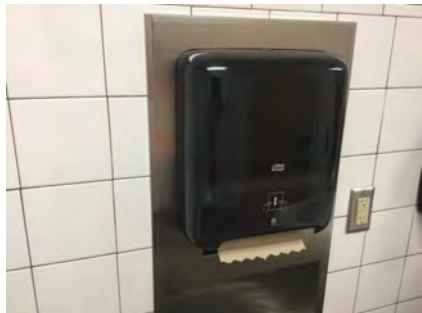
<input type="checkbox"/> Staff Only Priority 3 Severity 3						
Accessories						
1764	<ul style="list-style-type: none"> • As-Built Description: Dispensers in sanitary facilities, such as for towels, soap, sanitary napkins, seat covers, etc., and waste receptacles more than 48" (CA only: 40") from floor to highest operating slot or control. • As-Built: 42" high • Proposed Solution: Relocate existing restroom accessories. 	PCODE WG01A ADAAG 91 4.23.7 ADA 2010 308.2.1 CBC 2007 1115B.8.3 CBC 2016 11B-603.5 Mitigated: <input type="radio"/> YES <input checked="" type="radio"/> NO	1	JOB	\$300	\$300

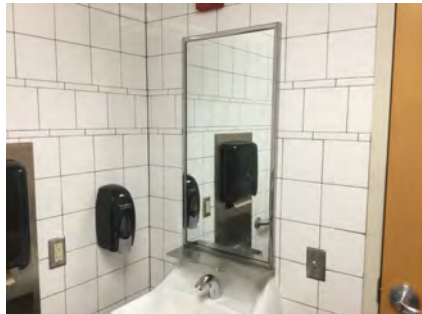
<input type="checkbox"/> Staff Only Priority 3 Severity 4						
1763	<ul style="list-style-type: none"> • As-Built Description: Bottom of mirror located above lavatories or countertops more than 40" above floor. • As-Built: 40.25" high • Proposed Solution: Relocate or provide new accessible mirror. 	PCODE WG03 ADAAG 91 4.19.6 ADA 2010 603.3 CBC 2007 1115B.8.1 CBC 2016 11B-603.3 Mitigated: <input type="radio"/> YES <input checked="" type="radio"/> NO	1	JOB	\$450	\$450

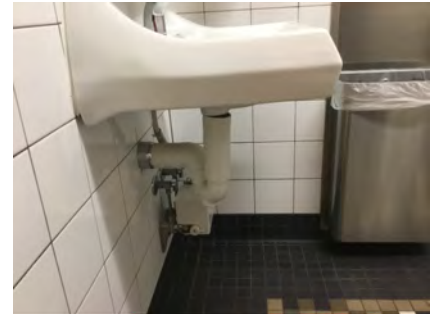
1774	<ul style="list-style-type: none"> • <i>As-Built Description:</i> Knee clearance 27" min. high starting 8" back from the front edge of the lavatory towards the wall is not provided. • <i>As-Built:</i> Pipes are 8" from the front edge of the lavatory at 18" AFF • <i>Proposed Solution:</i> Remount compliant fixture to accessible height. 	PCODE WD04A ADAAG 91 Fig. 31 ADA 2010 306.3.3 CBC 2007 1115B.4.3 CBC 2016 11B-306.3.3	1	JOB	\$4,500	\$4,500
------	--	---	---	-----	---------	----------------

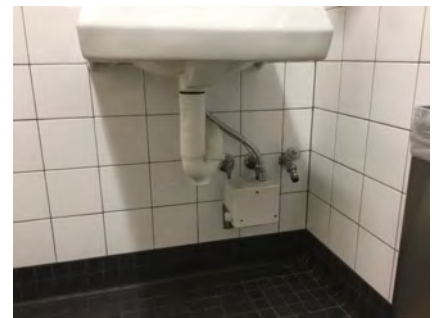
1773	<ul style="list-style-type: none"> • <i>As-Built Description:</i> Hot or sharp-surfaced water/drain pipe not insulated or covered. • <i>Proposed Solution:</i> Insulate or cover water/drain pipe. 	PCODE WD05 ADAAG 91 4.19.4 ADA 2010 606.5 CBC 2007 1115B.4.3.4 CBC 2016 11B-606.5	1	JOB	\$360	\$360
------	--	---	---	-----	-------	--------------

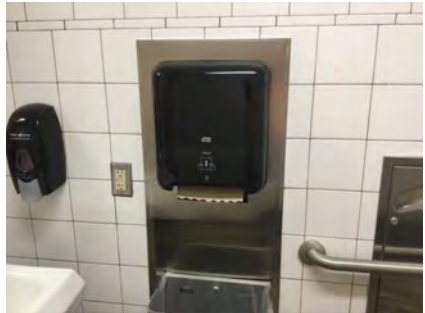
Item no., Rm no. and Name	Existing Architectural Barrier and Proposed Solution	Codes / Mitigation Info	Qty	Unit	Cost	Total
Accessories						
1775	<ul style="list-style-type: none"> • <i>As-Built Description:</i> Dispensers in sanitary facilities, such as for towels, soap, sanitary napkins, seat covers, etc., and waste receptacles more than 48" (CA only: 40") from floor to highest operating slot or control. • <i>As-Built:</i> 41.5" high • <i>Proposed Solution:</i> Relocate existing restroom accessories. 	PCODE WG01A ADAAG 91 4.23.7 ADA 2010 308.2.1 CBC 2007 1115B.8.3 CBC 2016 11B-603.5 Mitigated: <input type="radio"/> YES <input checked="" type="radio"/> NO	1	JOB	\$300	\$300

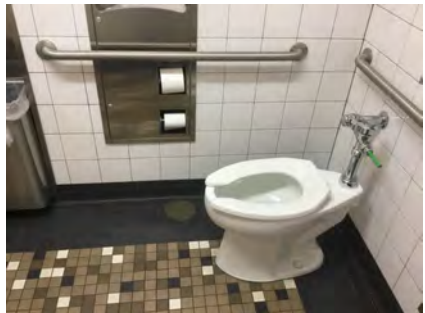
<input type="checkbox"/> Staff Only Priority 3 Severity 4			
1780	<ul style="list-style-type: none"> • <i>As-Built Description:</i> Toilet paper dispenser less than 15" (CA: 19") or more than 48" above floor or not within 7" to 9" from front of water closet (Note: CA pre-2010 is allowed within 12" from front of water closet). • <i>As-Built:</i> 4.5" to the centerline of the toilet paper rolls • <i>Proposed Solution:</i> Relocate or provide new toilet paper dispenser. 	PCODE WG02 ADAAG 91 4.16.6 ADA 2010 604.7 CBC 2007 1115B.8.4 CBC 2016 11B-604.7 Mitigated: <input type="radio"/> YES <input checked="" type="radio"/> NO	1	JOB	\$225	\$225

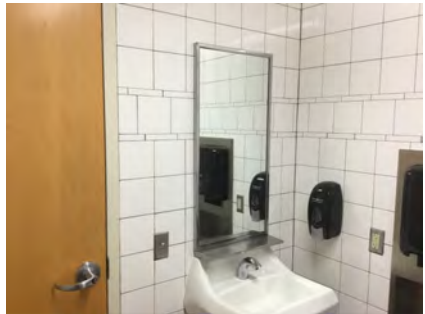
<input type="checkbox"/> Staff Only Priority 3 Severity 3			
1772	<ul style="list-style-type: none"> • <i>As-Built Description:</i> Bottom of mirror located above lavatories or countertops more than 40" above floor. • <i>As-Built:</i> 40.25" high • <i>Proposed Solution:</i> Relocate or provide new accessible mirror. 	PCODE WG03 ADAAG 91 4.19.6 ADA 2010 603.3 CBC 2007 1115B.8.1 CBC 2016 11B-603.3 Mitigated: <input type="radio"/> YES <input checked="" type="radio"/> NO	1	JOB	\$450	\$450

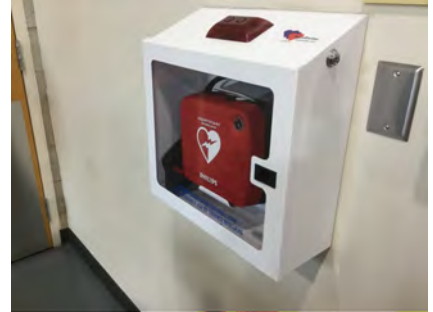
Item no., Rm no. and Name	Existing Architectural Barrier and Proposed Solution	Codes / Mitigation Info	Qty	Unit	Cost	Total
1824	<ul style="list-style-type: none"> As-Built Description: Protruding objects more than 4" from wall, when bottom of object more than 27" or less than 80" above finished floor. As-Built: AED protrudes 6" at 36" high. Proposed Solution: Provide cane-detectable railing to mark area of low clearance. 	PCODE EG04A ADAAG 91 4.4.1 ADA 2010 307.2 CBC 2007 1133B.8.6.1 CBC 2016 11B-307.2 Mitigated: <input type="radio"/> YES <input checked="" type="radio"/> NO	1	LF	\$300	\$300

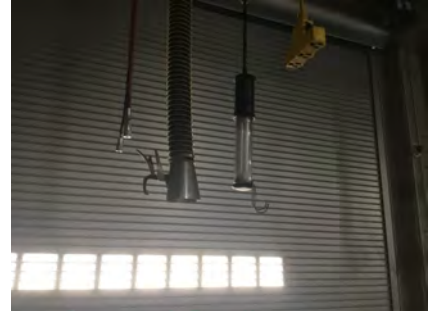
1789	<ul style="list-style-type: none"> As-Built Description: Overhead clearance less than 80" above finished floor. As-Built: Hanging lights and tools 71" AFF Proposed Solution: Modify overhead clearance. 	PCODE EG01 ADAAG 91 4.4.2 ADA 2010 307.4 CBC 2007 1133B.8.6.2 CBC 2016 11B-307.4 Mitigated: <input type="radio"/> YES <input checked="" type="radio"/> NO	1	JOB	\$300	\$300

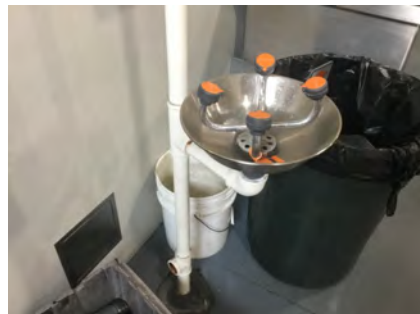
<input type="checkbox"/> Staff Only			
			Priority 2 Severity 4			
Eye Wash						
1821	<ul style="list-style-type: none">As-Built Description: Wall- and post-mounted cantilevered units: Knee space not provided at eye wash (27" high, 8" deep, 30" wide from front of eye wash).As-Built: 13" deep toe clearanceProposed Solution: Provide new, accessible eye wash.	<p>PCODE IA02NT</p> <p>ADAAG 91 4.15.5(1)</p> <p>ADA 2010 602.2</p> <p>CBC 2007 1115B.4.6.2</p> <p>CBC 2016 11B-602.2</p> <p>Mitigated:</p> <p><input type="radio"/> YES</p> <p><input checked="" type="radio"/> NO</p>	1	JOB	\$9,600	\$9,600

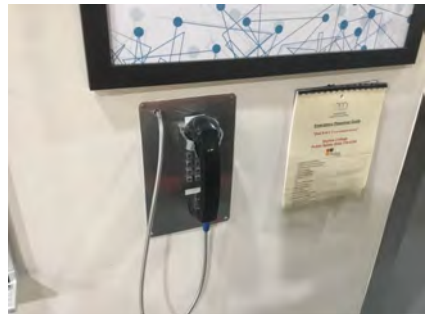
Item no., Rm no. and Name	Existing Architectural Barrier and Proposed Solution	Codes / Mitigation Info	Qty	Unit	Cost	Total
TTY						
1800	<ul style="list-style-type: none">• <i>As-Built Description:</i> Interior public text telephone (TTY) not provided at type of facility required to have a public text telephone.• <i>Proposed Solution:</i> Provide text telephone.• <i>Notes:</i> Telephone does not provide TTY capabilities. Provide TTY on each floor as best practice.	<p>PCODE IB10</p> <p>ADAAG 91 4.1.3(17)(c)</p> <p>ADA 2010 216.9</p> <p>CBC 2007 1117B.2.9.1</p> <p>CBC 2016 11B-216.9</p> <p>Mitigated:</p> <p><input type="radio"/> YES</p> <p><input checked="" type="radio"/> NO</p>	1	JOB	\$3,450	\$3,450

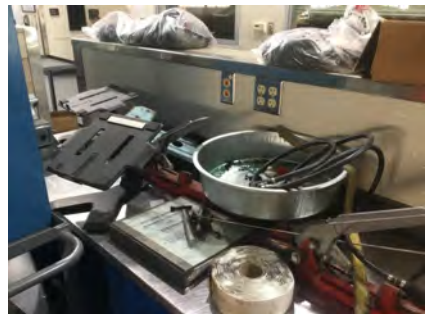
<input type="checkbox"/> Staff Only			
			Priority		Severity	
			2		3	
Electrical						
1787	<ul style="list-style-type: none">• <i>As-Built Description:</i> Electric switch or control mounted less than 15" measured to the bottom of the outlet box or greater than 48 inches measured to the top of the outlet box.• <i>As-Built:</i> 24" deep at 45.5" high• <i>Proposed Solution:</i> Relocate light switches or control to between 15" and 48" height.	<p>PCODE IC01</p> <p>ADAAG 91 4.2.5 & 6</p> <p>ADA 2010 308.2.1 &</p> <p>CBC 2007 1117B.6.3</p> <p>CBC 2016 11B-308.2.1 & 11B-308.2.2</p> <p>Mitigated:</p> <p><input type="radio"/> YES</p> <p><input checked="" type="radio"/> NO</p>	2	JOB	\$900	\$1,800

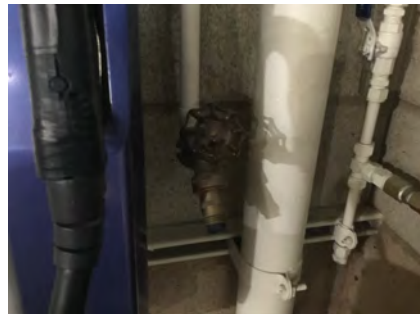
Item no., Rm no. and Name	Existing Architectural Barrier and Proposed Solution	Codes / Mitigation Info	Qty	Unit	Cost	Total
<u>Operable Part</u>						
1792	<ul style="list-style-type: none">• <i>As-Built Description:</i> Operable part(s) require tight grasping, pinching, or twisting of the wrist with one hand.• <i>Proposed Solution:</i> Modify or replace the operable part(s) to not require tight grasping, pinching, or twisting of the wrist with one hand.	<p>PCODE IC02</p> <p>ADAAG 91 4.27.4</p> <p>ADA 2010 309.4</p> <p>CBC 2007 1117B.6.4</p> <p>CBC 2016 11B-309.4</p> <p>Mitigated:</p> <p><input type="radio"/> YES</p> <p><input checked="" type="radio"/> NO</p>	1	JOB	\$900	\$900

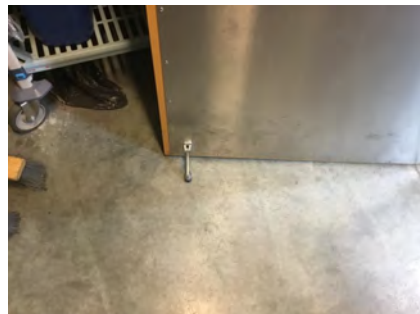
<input type="checkbox"/> Staff Only			
			<div><div>Priority</div><div>2</div></div> <div><div>Severity</div><div>2</div></div>			
<u>Door Stopper</u>						
1826	<ul style="list-style-type: none">• <i>As-Built Description:</i> At push side of door on accessible route, bottom 10" does not have a smooth, uninterrupted surface.• <i>Proposed Solution:</i> Remove door stopper when altering area. Provide rubber wedge.	<p>PCODE ID06A</p> <p>ADA 2010 404.2.10</p> <p>CBC 2007 1133B.2.6</p> <p>CBC 2016 11B-404.2.10</p> <p>Mitigated:</p> <p><input type="radio"/> YES</p> <p><input checked="" type="radio"/> NO</p>	1	JOB	\$75	\$75

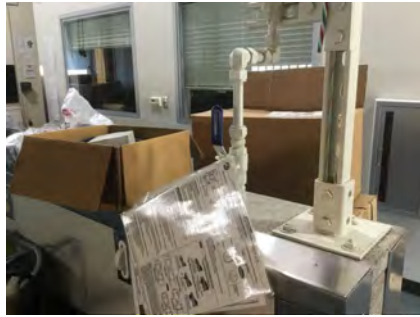
Item no., Rm no. and Name	Existing Architectural Barrier and Proposed Solution	Codes / Mitigation Info	Qty	Unit	Cost	Total
Reach Range						
1786	<ul style="list-style-type: none"> As-Built Description: Reach height to control or access point, where side approach is available, exceeds 48" or is less than 15" in height, or exceeds 10" in depth. As-Built: 60" high Proposed Solution: Modify equipment or mounting. 	PCODE IE02 ADAAG 91 4.2.6 ADA 2010 308.3.1 CBC 2007 1118B.6 CBC 2016 11B-308.3 Mitigated: <input type="radio"/> YES <input checked="" type="radio"/> NO	2	JOB	\$300	\$600

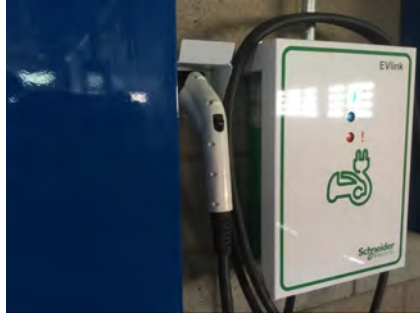
<input type="checkbox"/> Staff Only			
			Priority	Severity		
			2	2		
1790	<ul style="list-style-type: none"> As-Built Description: Reach height to control or access point, where side approach is available, exceeds 48" or is less than 15" in height, or exceeds 10" in depth. As-Built: 59" high Proposed Solution: Modify equipment or mounting. 	PCODE IE02 ADAAG 91 4.2.6 ADA 2010 308.3.1 CBC 2007 1118B.6 CBC 2016 11B-308.3 Mitigated: <input type="radio"/> YES <input checked="" type="radio"/> NO	1	JOB	\$300	\$300

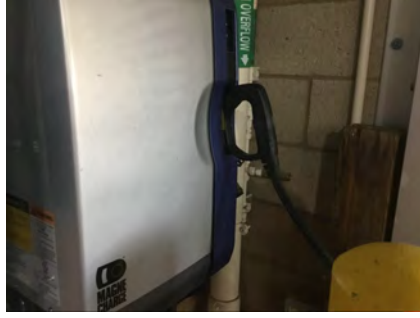
<input type="checkbox"/> Staff Only			
			Priority	Severity		
			2	3		
1791	<ul style="list-style-type: none"> As-Built Description: Reach height to control or access point, where side approach is available, exceeds 48" or is less than 15" in height, or exceeds 10" in depth. As-Built: 53" high Proposed Solution: Modify equipment or mounting. 	PCODE IE02 ADAAG 91 4.2.6 ADA 2010 308.3.1 CBC 2007 1118B.6 CBC 2016 11B-308.3 Mitigated: <input type="radio"/> YES <input checked="" type="radio"/> NO	1	JOB	\$300	\$300

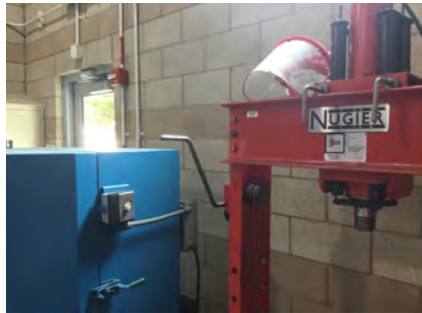
Item no., Rm no. and Name	Existing Architectural Barrier and Proposed Solution	Codes / Mitigation Info	Qty	Unit	Cost	Total
1797	<ul style="list-style-type: none"> As-Built Description: Reach height to control or access point, where side approach is available, exceeds 48" or is less than 15" in height, or exceeds 10" in depth. As-Built: Specialty tools to 64" high Proposed Solution: Modify equipment or mounting. 	PCODE IE02 ADAAG 91 4.2.6 ADA 2010 308.3.1 CBC 2007 1118B.6 CBC 2016 11B-308.3 Mitigated: <input type="radio"/> YES <input checked="" type="radio"/> NO	5	JOB	\$300	\$1,500

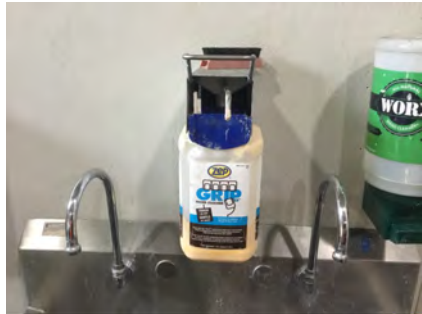
<input type="checkbox"/> Staff Only			
			Priority 2 Severity 2			
1819	<ul style="list-style-type: none"> As-Built Description: Reach height to control or access point, where side approach is available, exceeds 48" or is less than 15" in height, or exceeds 10" in depth. As-Built: 59" high, 17" deep Proposed Solution: Modify equipment or mounting. 	PCODE IE02 ADAAG 91 4.2.6 ADA 2010 308.3.1 CBC 2007 1118B.6 CBC 2016 11B-308.3 Mitigated: <input type="radio"/> YES <input checked="" type="radio"/> NO	1	JOB	\$300	\$300

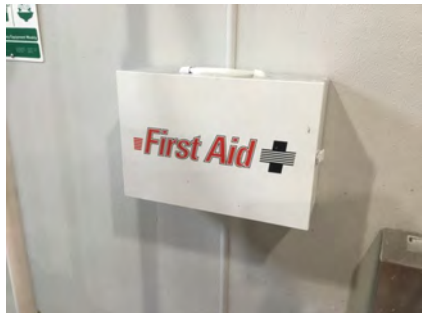
<input type="checkbox"/> Staff Only			
			Priority 2 Severity 3			
1820	<ul style="list-style-type: none"> As-Built Description: Reach height to control or access point, where side approach is available, exceeds 48" or is less than 15" in height, or exceeds 10" in depth. As-Built: 51" high Proposed Solution: Modify equipment or mounting. 	PCODE IE02 ADAAG 91 4.2.6 ADA 2010 308.3.1 CBC 2007 1118B.6 CBC 2016 11B-308.3 Mitigated: <input type="radio"/> YES <input checked="" type="radio"/> NO	1	JOB	\$300	\$300

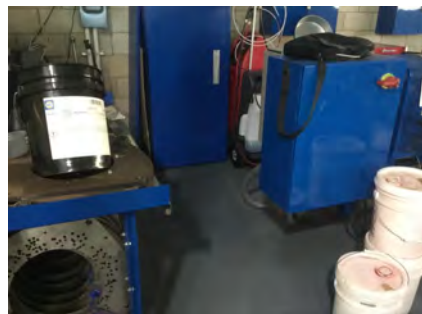
Item no., Rm no. and Name	Existing Architectural Barrier and Proposed Solution	Codes / Mitigation Info	Qty	Unit	Cost	Total
1795	<ul style="list-style-type: none">As-Built Description: Corridor, for occupant load less than 10, less than 36" wide.As-Built: 27" wideProposed Solution: Remove or relocate furniture and storage items.	PCODE IH03A ADAAG 91 4.3.3 ADA 2010 403.5.1 CBC 2007 1133B.3.1 CBC 2016 11B-403.5.1 Mitigated: <input type="radio"/> YES <input checked="" type="radio"/> NO	1	JOB	\$150	\$150

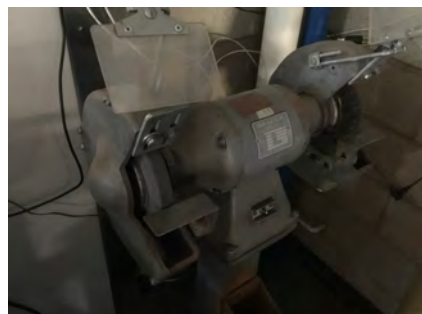
<input type="checkbox"/> Staff Only			
			Priority 2 Severity 2			
<hr/>						
Desk						
1793	<ul style="list-style-type: none">As-Built Description: Accessible fixed table or desk (top 28" to 34" high; knee space at least 27" high x 19" deep x 30" wide) not provided.As-Built: Work surface 41" highProposed Solution: Provide new fixed accessible table or desk.	PCODE IN02 ADAAG 91 4.32.3 & .4 ADA 2010 306.1 & 902.3 CBC 2007 1122B.3 & 4 CBC 2016 11B-306.1 & 11B-902.3 Mitigated: <input type="radio"/> YES <input checked="" type="radio"/> NO	1	JOB	\$7,500	\$7,500

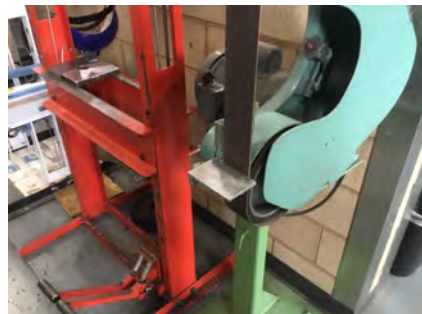
<input type="checkbox"/> Staff Only			
			Priority 2 Severity 3			
<hr/>						
Desk						
1799	<ul style="list-style-type: none">As-Built Description: Accessible fixed table or desk (top 28" to 34" high; knee space at least 27" high x 19" deep x 30" wide) not provided.As-Built: Worksurface 41.5"Proposed Solution: Provide new fixed accessible table or desk.	PCODE IN02 ADAAG 91 4.32.3 & .4 ADA 2010 306.1 & 902.3 CBC 2007 1122B.3 & 4 CBC 2016 11B-306.1 & 11B-902.3 Mitigated: <input type="radio"/> YES <input checked="" type="radio"/> NO	1	JOB	\$7,500	\$7,500

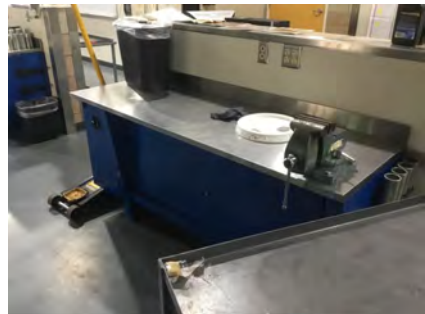
Item no., Rm no. and Name	Existing Architectural Barrier and Proposed Solution	Codes / Mitigation Info	Qty	Unit	Cost	Total
<u>Non-Fixed Desk</u>						
1784	<ul style="list-style-type: none">As-Built Description: Accessible non-fixed table or desk (top 28" to 34" high; knee space at least 27" high x 19" deep x 30" wide) not provided.As-Built: No knee clearanceProposed Solution: Provide table or desk with accessible dimensions when purchasing new furniture.Notes: 8 work surfaces	PCODE IN02A ADAAG 91 4.32.3 & .4 ADA 2010 306.1 CBC 2007 1122B.3 & 4 CBC 2016 11B-306.1 & 11B-902.3 Mitigated: <input type="radio"/> YES <input checked="" type="radio"/> NO	1	JOB	\$4,800	\$4,800

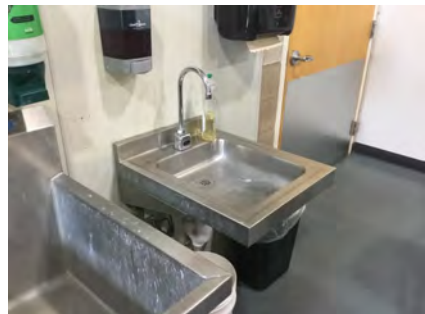
<input type="checkbox"/> Staff Only			
			Priority	Severity		
			2	2		
<u>Sink</u>						
1816	<ul style="list-style-type: none">As-Built Description: Sink rim higher than 34" above floor.As-Built: 34.25" highProposed Solution: Remodel sink cabinet to lower sink.	PCODE IN06 ADAAG 91 4.24.2 ADA 2010 606.3 CBC 2007 1115B.4.7.1 CBC 2016 11B-606.3 Mitigated: <input type="radio"/> YES <input checked="" type="radio"/> NO	1	JOB	\$5,250	\$5,250

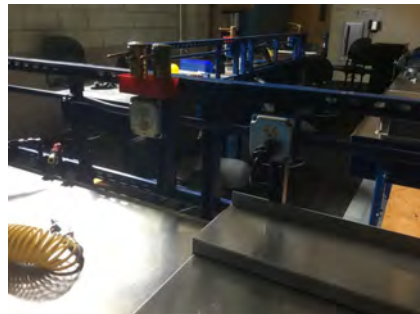
Item no., Rm no. and Name	Existing Architectural Barrier and Proposed Solution	Codes / Mitigation Info	Qty	Unit	Cost	Total
Electrical						
1809	<ul style="list-style-type: none">As-Built Description: Electric switch or control mounted less than 15" measured to the bottom of the outlet box or greater than 48 inches measured to the top of the outlet box.As-Built: 30" deep, 44.5" highProposed Solution: Relocate light switches or control to between 15" and 48" height.	<p>PCODE IC01</p> <p>ADAAG 91 4.2.5 & 6</p> <p>ADA 2010 308.2.1 &</p> <p>CBC 2007 1117B.6.3</p> <p>CBC 2016 11B-308.2.1 & 11B-308.2.2</p> <p>Mitigated:</p> <p><input type="radio"/> YES</p> <p><input checked="" type="radio"/> NO</p>	2	JOB	\$900	\$1,800

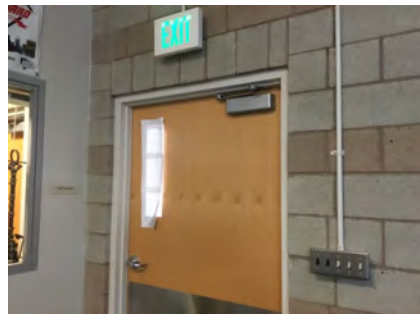
<input type="checkbox"/> Staff Only			
			Priority	Severity		
			<input checked="" type="radio"/> 2	<input checked="" type="radio"/> 4		
Door Swing						
1815	<ul style="list-style-type: none">As-Built Description: Front approach: At push side, door does not have clear and level maneuvering space measuring door width x 48" (door width plus 12" if door has both, latch and closer).As-Built: 11.625" strike side clearanceProposed Solution: Provide relocated new door and frame; remodel walls as needed.	<p>PCODE ID24B</p> <p>ADAAG 91 Fig. 25(a)</p> <p>ADA 2010 404.2.4</p> <p>CBC 2007 11B-26A(a)</p> <p>CBC 2016 11B-404.2.4</p> <p>Mitigated:</p> <p><input type="radio"/> YES</p> <p><input checked="" type="radio"/> NO</p>	1	JOB	\$7,800	\$7,800

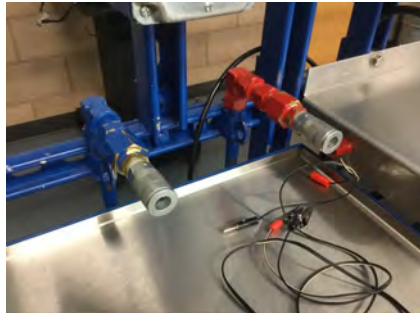
Item no., Rm no. and Name	Existing Architectural Barrier and Proposed Solution	Codes / Mitigation Info	Qty	Unit	Cost	Total
Reach Range						
1810	<ul style="list-style-type: none"> As-Built Description: Reach height to control or access point, exceeds 48" or is less than 15". As-Built: 28" deep over a 33" high obstruction Proposed Solution: Modify equipment or mounting. 	PCODE IE01 ADAAG 91 4.2.5 ADA 2010 308.2.1 CBC 2007 1118B.5 CBC 2016 11B-308.2.1 Mitigated: <input type="radio"/> YES <input checked="" type="radio"/> NO	4	JOB	\$300	\$1,200

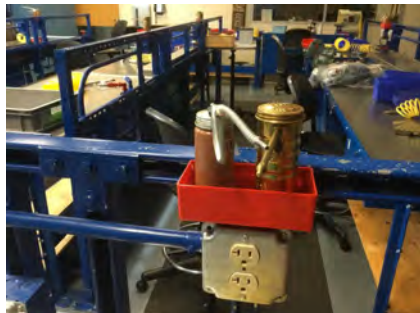
<input type="checkbox"/> Staff Only Priority 2 Severity 4			
1811	<ul style="list-style-type: none"> As-Built Description: Reach height to control or access point, exceeds 48" or is less than 15". As-Built: 28" deep 48" high over 33" high obstruction Proposed Solution: Modify equipment or mounting. 	PCODE IE01 ADAAG 91 4.2.5 ADA 2010 308.2.1 CBC 2007 1118B.5 CBC 2016 11B-308.2.1 Mitigated: <input type="radio"/> YES <input checked="" type="radio"/> NO	1	JOB	\$300	\$300

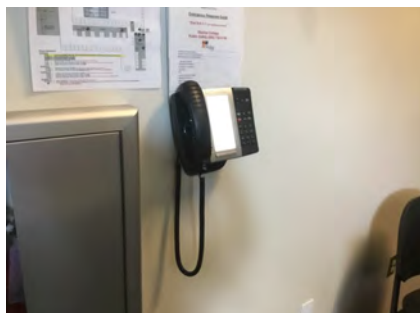
<input type="checkbox"/> Staff Only Priority 2 Severity 4			
1804	<ul style="list-style-type: none"> As-Built Description: Reach height to control or access point, where side approach is available, exceeds 48" or is less than 15" in height, or exceeds 10" in depth. As-Built: 52.5" high Proposed Solution: Modify equipment or mounting. 	PCODE IE02 ADAAG 91 4.2.6 ADA 2010 308.3.1 CBC 2007 1118B.6 CBC 2016 11B-308.3 Mitigated: <input type="radio"/> YES <input checked="" type="radio"/> NO	1	JOB	\$300	\$300

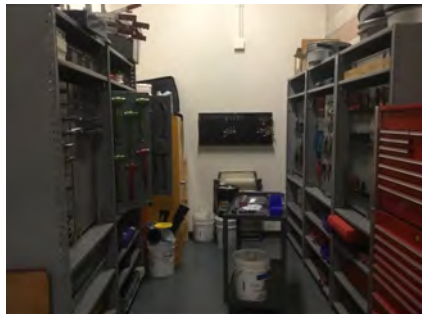
Item no., Rm no. and Name	Existing Architectural Barrier and Proposed Solution	Codes / Mitigation Info	Qty	Unit	Cost	Total
1813	<ul style="list-style-type: none"> As-Built Description: Reach height to control or access point, where side approach is available, exceeds 48" or is less than 15" in height, or exceeds 10" in depth. As-Built: Tools 70" high Proposed Solution: Modify equipment or mounting. 	PCODE IE02 ADAAG 91 4.2.6 ADA 2010 308.3.1 CBC 2007 1118B.6 CBC 2016 11B-308.3 Mitigated: <input type="radio"/> YES <input checked="" type="radio"/> NO	1	JOB	\$300	\$300

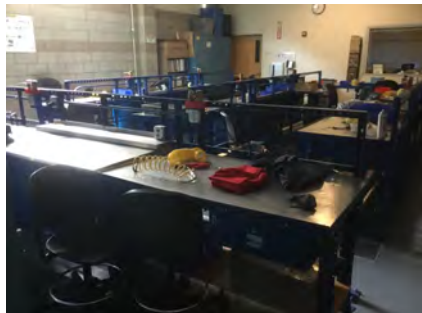
1808	<ul style="list-style-type: none"> As-Built Description: Accessible non-fixed table or desk (top 28" to 34" high; knee space at least 27" high x 19" deep x 30" wide) not provided. As-Built: Knee and toe clearance 7" deep Proposed Solution: Provide table or desk with accessible dimensions when purchasing new furniture. Notes: 12 workstations. 2 different varieties of workstations 	PCODE IN02A ADAAG 91 4.32.3 & .4 ADA 2010 306.1 CBC 2007 1122B.3 & 4 CBC 2016 11B-306.1 & 11B-902.3 Mitigated: <input type="radio"/> YES <input checked="" type="radio"/> NO	1	JOB	\$4,800	\$4,800

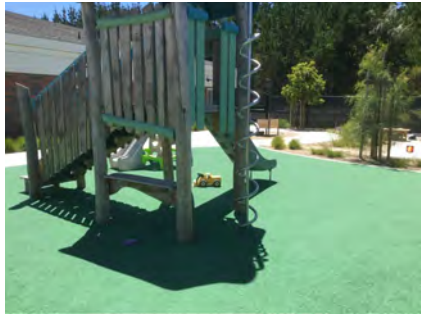
Item no., Rm no. and Name	Existing Architectural Barrier and Proposed Solution	Codes / Mitigation Info	Qty	Unit	Cost	Total
2366	<ul style="list-style-type: none"> As-Built Description: Accessible versions of each type of play activity provided on the structure are not provided. Proposed Solution: Provide accessible play area(s) at structure. Notes: There is a lack of ground style play structures. 	<p>PCODE OC06REF</p> <p>ADAAG 91 36 CFR Part</p> <p>ADA 2010 1191</p> <p>240.2.1.1</p> <p>CBC 2007 DSA 99-02</p> <p>CBC 2016 11B-240.2.1.1</p> <p>Mitigated:</p> <p><input type="radio"/> YES</p> <p><input checked="" type="radio"/> NO</p>				
			<p>REF</p>

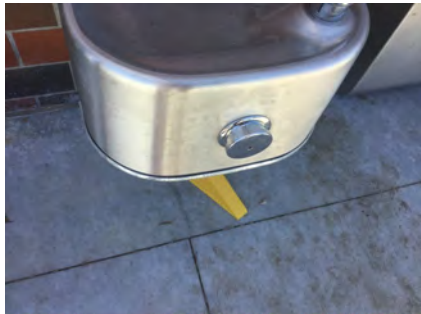
<p><input type="checkbox"/> Staff Only</p> <p>Priority Severity</p> <p>1 3</p>			
<hr/>						
<u>Drinking Fountain</u>						
2360	<ul style="list-style-type: none"> As-Built Description: Fountain bubbler not easily activated by lever, push bar, or other accessible control. As-Built: 7 lbs. Proposed Solution: Provide new, accessible fountain. 	<p>PCODE IA03</p> <p>ADAAG 91 4.15.4</p> <p>ADA 2010 602.3</p> <p>CBC 2007 1115B.4.6.4</p> <p>CBC 2016 11B-602.3</p> <p>Mitigated:</p> <p><input type="radio"/> YES</p> <p><input checked="" type="radio"/> NO</p>	1	JOB	\$9,600	\$9,600

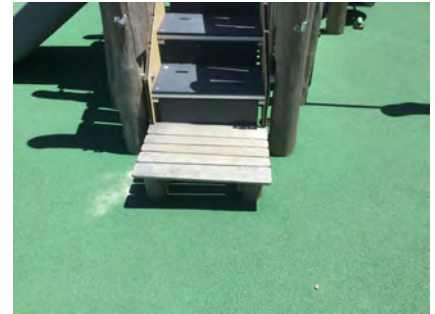
• *Notes:***No transfer supports per ADA 1008.3.2.3.****Mitigated:**☐ YES☒ NO

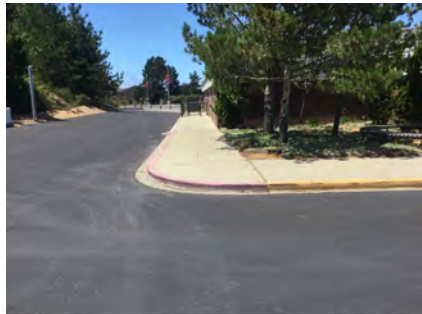
Item no., Rm no. and Name	Existing Architectural Barrier and Proposed Solution	Codes / Mitigation Info	Qty	Unit	Cost	Total
2372	<ul style="list-style-type: none"> As-Built Description: Exterior signage at inaccessible entrances to provide direction to accessible entrances is missing or noncompliant. Proposed Solution: Provide signage sufficient to guide persons to accessible entrances. Notes: There are clear all slopes on this route in excess of 3% and slopes at the door in excess of 9%. Consider placing a sign at decision point. 	PCODE SA01 ADAAG 91 4.1.2(7)(c) ADA 2010 216.6 CBC 2007 1117B.5.8.1.2 CBC 2016 11B-216.6 Mitigated: <input type="radio"/> YES <input checked="" type="radio"/> NO	1	JOB	\$690	\$690

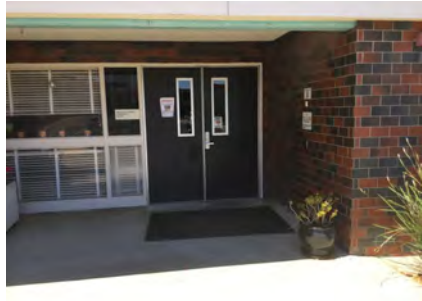
<input type="checkbox"/> Staff Only						
Priority 1 Severity 3						
2373	<ul style="list-style-type: none"> As-Built Description: Sign showing the International Symbol of Accessibility (ISA) not provided at accessible building entrances. Proposed Solution: Provide building entrance signage with ISA signage at accessible entrance. 	PCODE SA12A ADAAG 91 28 CFR 35.163 ADA 2010 (b) 216.6 CBC 2007 1127B.3 CBC 2016 11B-216.6 Mitigated: <input type="radio"/> YES <input checked="" type="radio"/> NO	1	JOB	\$150	\$150

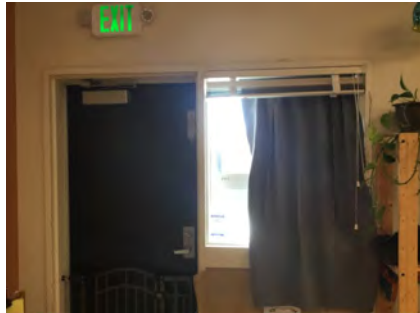
Item no., Rm no. and Name	Existing Architectural Barrier and Proposed Solution	Codes / Mitigation Info	Qty	Unit	Cost	Total
Signage						
2065	<ul style="list-style-type: none"> As-Built Description: Signs containing tactile characters is not located so that a clear floor space of 18" min x 18" min., centered on the tactile characters, is provided beyond the arc of any door swing between the closed position and 45 degree open position. As-Built: <i>CL of Braille and tactile characters are 3.5" from the mullions. The mullions are 6.5" deep.</i> Proposed Solution: Relocate compliant signage on latch side of door located at compliant height with a clear floor space. Notes: <i>The blinds block the sign when they are closed. Consider placing the signs on the push side of the exit doors.</i> 	PCODE SA07B ADA 2010 703.4.2 CBC 2016 11B-703.4.2 Mitigated: <input type="radio"/> YES <input checked="" type="radio"/> NO	4	JOB	\$150	\$600

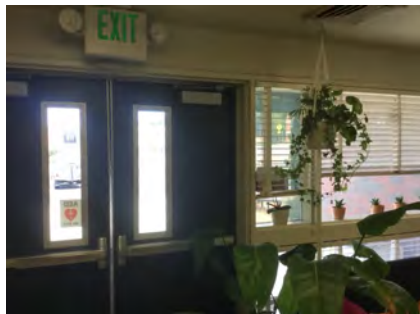
<input type="checkbox"/> Staff Only Priority 2 Severity 4			
2031	<ul style="list-style-type: none"> As-Built Description: At final exit door to exterior: Where required exit signs are installed, signs to provide exiting information for people with vision impairment are not provided. As-Built: <i>Exit sign is blocked by plant and blinds.</i> Proposed Solution: Relocate "EXIT" sign at door. Notes: <i>In addition the mullion at the sign is 6.5" deep. Consider placing the sign on the door if the doors cannot be propped open.</i> 	PCODE SA10A ADAAG 91 4.1.3(16) ADA 2010 216.4.1 CBC 2007 1011.3 CBC 2016 11B-216.4.1 Mitigated: <input type="radio"/> YES <input checked="" type="radio"/> NO	1	JOB	\$270	\$270

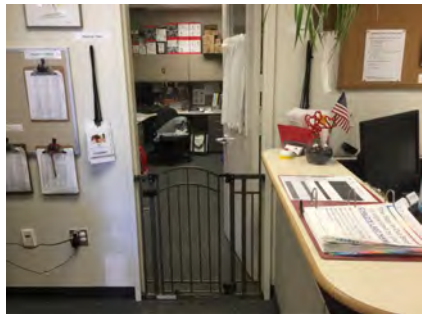
Item no., Rm no. and Name	Existing Architectural Barrier and Proposed Solution	Codes / Mitigation Info	Qty	Unit	Cost	Total
1227	<ul style="list-style-type: none"> • As-Built Description: Front approach: At push side, door does not have clear and level maneuvering space measuring door width x 48" (door width plus 12" if door has both, latch and closer). • As-Built: 9" wide • Proposed Solution: Remove or relocate furniture or storage items. 	PCODE ID24AREF ADAAG 91 Fig. 25(a) ADA 2010 404.2.4 CBC 2007 11B-26A(a) CBC 2016 11B-404.2.4 Mitigated: <input type="radio"/> YES <input checked="" type="radio"/> NO				
REF

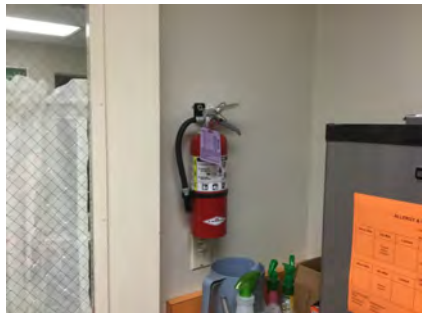
<input type="checkbox"/> Staff Only						
Priority 2 Severity 4						
<hr/>						
Reach Range						
2059	<ul style="list-style-type: none"> • As-Built Description: Reach height to control or access point, where side approach is available, exceeds 48" or is less than 15" in height, or exceeds 10" in depth. • As-Built: 65" high • Proposed Solution: Modify equipment or mounting. 	PCODE IE02 ADAAG 91 4.2.6 ADA 2010 308.3.1 CBC 2007 1118B.6 CBC 2016 11B-308.3 Mitigated: <input type="radio"/> YES <input checked="" type="radio"/> NO	1	JOB	\$300	\$300
