SAN MATEO COUNTY
COMMUNITY
COLLEGE DISTRICT

San Mateo County Community College District Americans with Disabilities Act Self-Evaluation and Transition Plan

Report Prepared by:

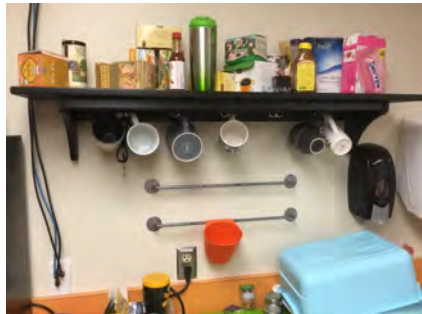
<input type="checkbox"/> Staff Only						
Priority 2 Severity 2						
<hr/>						
2062	<ul style="list-style-type: none"> • As-Built Description: Reach height to control or access point, where side approach is available, exceeds 48" or is less than 15" in height, or exceeds 10" in depth. • As-Built: Storage 52" to 67" high • Proposed Solution: Modify equipment or mounting. 	PCODE IE02 ADAAG 91 4.2.6 ADA 2010 308.3.1 CBC 2007 1118B.6 CBC 2016 11B-308.3 Mitigated: <input type="radio"/> YES <input checked="" type="radio"/> NO	1	JOB	\$300	\$300

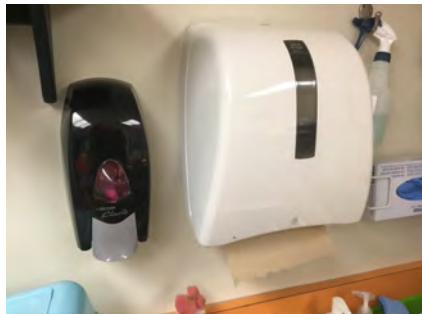
Item no., Rm no. and Name	Existing Architectural Barrier and Proposed Solution	Codes / Mitigation Info	Qty	Unit	Cost	Total
2061	<ul style="list-style-type: none"> As-Built Description: Reach height to control or access point, where side approach is available, exceeds 48" or is less than 15" in height, or exceeds 10" in depth. As-Built: 52" high Proposed Solution: Modify equipment or mounting. 	PCODE IE02REF ADAAG 91 4.2.6 ADA 2010 308.3.1 CBC 2007 1118B.6 CBC 2016 11B-308.3 Mitigated: <input type="radio"/> YES <input checked="" type="radio"/> NO		REF

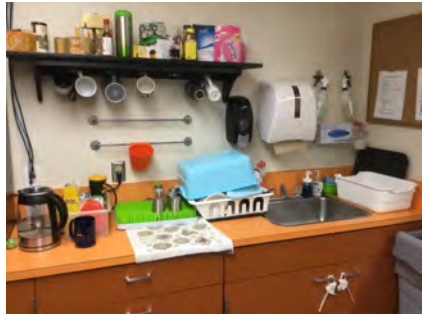
<input checked="" type="checkbox"/> Staff Only		
			Priority	Severity		
			4	4		
2063	<ul style="list-style-type: none"> As-Built Description: Reach height to control or access point, where side approach is available, exceeds 48" or is less than 15" in height, or exceeds 10" in depth. As-Built: The reach to controls and storage is obstructed because the counters 36.5" high. Proposed Solution: Modify equipment or mounting. Notes: Lower the counter to 34" AFF. 	PCODE IE02REF ADAAG 91 4.2.6 ADA 2010 308.3.1 CBC 2007 1118B.6 CBC 2016 11B-308.3 Mitigated: <input type="radio"/> YES <input checked="" type="radio"/> NO		REF

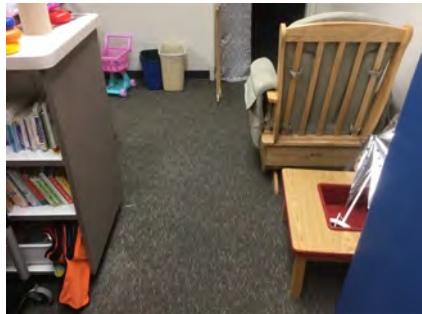
<input checked="" type="checkbox"/> Staff Only		
			Priority	Severity		
			4	4		
Corridor						
2064	<ul style="list-style-type: none"> As-Built Description: Corridor, for occupant load less than 10, less than 36" wide. As-Built: 22" to 34" for a distance that is greater than 24" long Proposed Solution: Remove or relocate furniture and storage items. 	PCODE IH03A ADAAG 91 4.3.3 ADA 2010 403.5.1 CBC 2007 1133B.3.1 CBC 2016 11B-403.5.1 Mitigated: <input type="radio"/> YES <input checked="" type="radio"/> NO		1 JOB	\$150	\$150

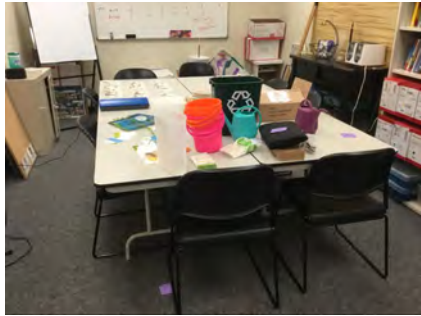
Item no., Rm no. and Name	Existing Architectural Barrier and Proposed Solution	Codes / Mitigation Info	Qty	Unit	Cost	Total
<u>Non-Fixed Desk</u>						
1228	<ul style="list-style-type: none">• <i>As-Built Description:</i> Accessible non-fixed table or desk (top 28" to 34" high; knee space at least 27" high x 19" deep x 30" wide) not provided.• <i>As-Built:</i> 26.25" high knee clearance• <i>Proposed Solution:</i> Provide table or desk with accessible dimensions when purchasing new furniture.• <i>Notes:</i> Appears to be children's use. No specific age group.	<p>PCODE IN02A</p> <p>ADAAG 91 4.32.3 & .4</p> <p>ADA 2010 306.1</p> <p>CBC 2007 1122B.3 & 4</p> <p>CBC 2016 11B-306.1 & 11B-902.3</p> <p>Mitigated:</p> <p><input type="radio"/> YES</p> <p><input checked="" type="radio"/> NO</p>	1	JOB	\$4,800	\$4,800

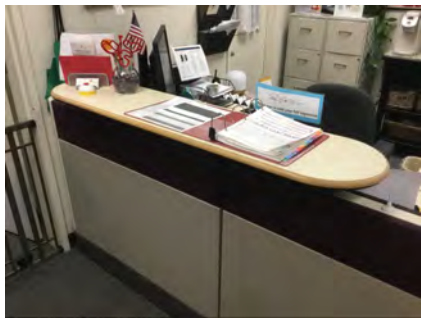
<u>Public Counter</u>						
1225	<ul style="list-style-type: none">• <i>As-Built Description:</i> Sales and service counter: Accessible section not provided (knee space min. 27" high x 19" deep x 30" wide)• <i>As-Built:</i> 42.5" high• <i>Proposed Solution:</i> Retrofit existing counter to provide accessible seating section. Interim solution: Provide auxiliary counter, table, or clipboard.	<p>PCODE IN03A</p> <p>ADAAG 91 4.32.3 & 4</p> <p>ADA 2010 306.3; 904.4</p> <p>CBC 2007 1122B.3 & 4</p> <p>CBC 2016 11B-306.3; 11B-904.4</p> <p>Mitigated:</p> <p><input type="radio"/> YES</p> <p><input checked="" type="radio"/> NO</p>	1	JOB	\$6,000	\$6,000

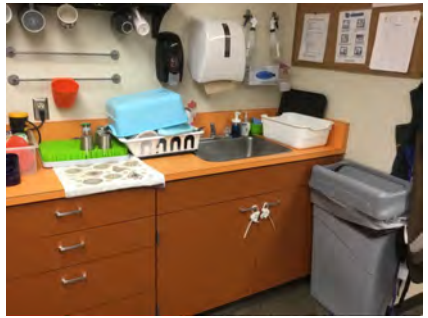
Item no., Rm no. and Name	Existing Architectural Barrier and Proposed Solution	Codes / Mitigation Info	Qty	Unit	Cost	Total
Sink						
2060	<ul style="list-style-type: none"> As-Built Description: Sink rim higher than 34" above floor. As-Built: 36.5" high Proposed Solution: Remodel sink cabinet to lower sink. 	PCODE IN06 ADAAG 91 4.24.2 ADA 2010 606.3 CBC 2007 1115B.4.7.1 CBC 2016 11B-606.3 Mitigated: <input type="radio"/> YES <input checked="" type="radio"/> NO	1	JOB	\$5,250	\$5,250

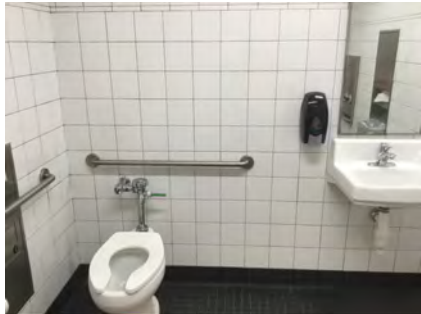
<input type="checkbox"/> Staff Only			
			Priority	Severity		
			3	3		
<u>Lavatory</u>						
2005	<ul style="list-style-type: none">As-Built Description: Knee clearance 27" min. high starting 8" back from the front edge of the lavatory towards the wall is not provided.As-Built: Lavatory insulation on page 8.75" from the front of the lavatory at 18" AFF.Proposed Solution: Remount compliant fixture to accessible height.	<p>PCODE WD04A</p> <p>ADAAG 91 Fig. 31</p> <p>ADA 2010 306.3.3</p> <p>CBC 2007 1115B.4.3</p> <p>CBC 2016 11B-306.3.3</p> <p>Mitigated:</p> <p><input type="radio"/> YES</p> <p><input checked="" type="radio"/> NO</p>	1	JOB	\$4,500	\$4,500

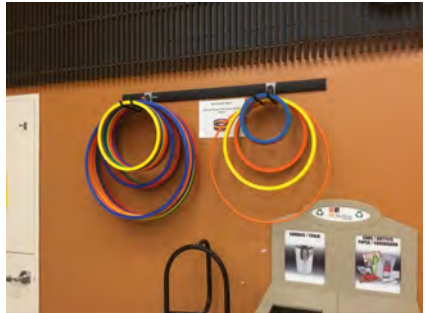
<input type="checkbox"/> Staff Only Priority 2 Severity 1			
2020	<ul style="list-style-type: none"> As-Built Description: Reach height to control or access point, where side approach is available, exceeds 48" or is less than 15" in height, or exceeds 10" in depth. As-Built: 52.5" high Proposed Solution: Modify equipment or mounting. 	PCODE IE02 ADAAG 91 4.2.6 ADA 2010 308.3.1 CBC 2007 1118B.6 CBC 2016 11B-308.3 Mitigated: <input type="radio"/> YES <input checked="" type="radio"/> NO	1	JOB	\$300	\$300

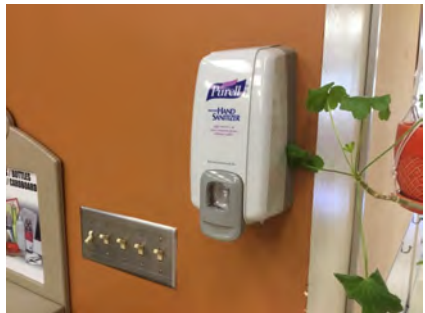
<input type="checkbox"/> Staff Only Priority 2 Severity 4			
2022	<ul style="list-style-type: none"> As-Built Description: Reach height to control or access point, where side approach is available, exceeds 48" or is less than 15" in height, or exceeds 10" in depth. As-Built: 79" high Proposed Solution: Modify equipment or mounting. 	PCODE IE02 ADAAG 91 4.2.6 ADA 2010 308.3.1 CBC 2007 1118B.6 CBC 2016 11B-308.3 Mitigated: <input type="radio"/> YES <input checked="" type="radio"/> NO	1	JOB	\$300	\$300

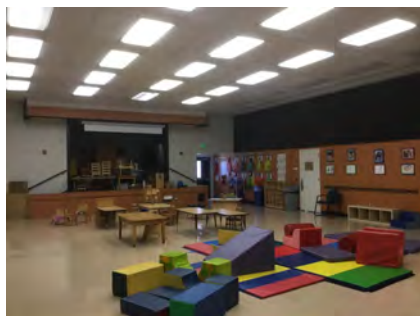
Item no., Rm no. and Name	Existing Architectural Barrier and Proposed Solution	Codes / Mitigation Info	Qty	Unit	Cost	Total
2044	<ul style="list-style-type: none"> • <i>As-Built Description:</i> No signs at the building or assembly area entrance to notify patrons that an assistive listening system is available. • <i>Proposed Solution:</i> Provide assistive listening signage. 	PCODE GI02 ADAAG 91 4.1.3(19)(b) ADA 2010 703.7.2.4 CBC 2007 1104B.2.4 CBC 2016 11B-703.7.2.4 Mitigated: <input type="radio"/> YES <input checked="" type="radio"/> NO	2	JOB	\$300	\$600

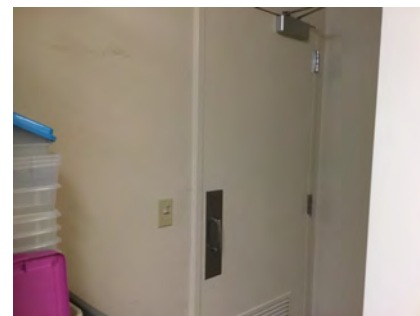
Item no., Rm no. and Name	Existing Architectural Barrier and Proposed Solution	Codes / Mitigation Info	Qty	Unit	Cost	Total
Door Swing						
2025	<ul style="list-style-type: none"> • <i>As-Built Description:</i> Front approach: At pull side, door does not have clear and level maneuvering space measuring door width plus 18" x 60". (24" x 60" at exterior doors). • <i>As-Built:</i> 4" wide • <i>Proposed Solution:</i> Provide relocated new door and frame; remodel walls as needed. 	PCODE ID23B ADAAG 91 Fig. 25(a) ADA 2010 404.2.4 CBC 2007 11B-26A(a) CBC 2016 11B-404.2.4 Mitigated: <input type="radio"/> YES <input checked="" type="radio"/> NO	1	JOB	\$7,800	\$7,800

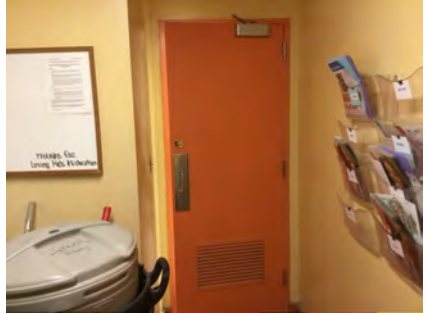
<input checked="" type="checkbox"/> Staff Only Priority Severity <input checked="" type="radio"/> 4 <input checked="" type="radio"/> 2			
2026	<ul style="list-style-type: none"> • <i>As-Built Description:</i> Front approach: At pull side, door does not have clear and level maneuvering space measuring door width plus 18" x 60". (24" x 60" at exterior doors). • <i>As-Built:</i> 34" wide • <i>Proposed Solution:</i> Provide relocated new door and frame; remodel walls as needed. 	PCODE ID23B ADAAG 91 Fig. 25(a) ADA 2010 404.2.4 CBC 2007 11B-26A(a) CBC 2016 11B-404.2.4 Mitigated: <input type="radio"/> YES <input checked="" type="radio"/> NO	1	JOB	\$7,800	\$7,800

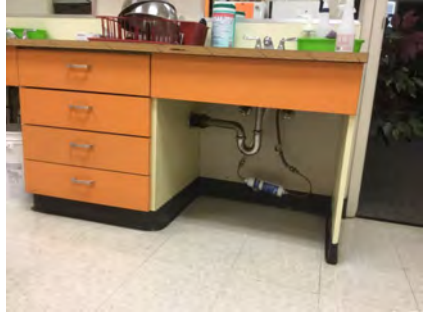
Item no., Rm no. and Name	Existing Architectural Barrier and Proposed Solution	Codes / Mitigation Info	Qty	Unit	Cost	Total
2037	<ul style="list-style-type: none"> • <i>As-Built Description:</i> Knee clearance 27" min. high starting 8" back from the front edge of the lavatory towards the wall is not provided. • <i>As-Built:</i> 28" wide by 25.5" high • <i>Proposed Solution:</i> Remount compliant fixture to accessible height. • <i>Notes:</i> Staff Only? 	PCODE WD04AREF ADAAG 91 Fig. 31 ADA 2010 306.3.3 CBC 2007 1115B.4.3 CBC 2016 11B-306.3.3 Mitigated: <input type="radio"/> YES <input checked="" type="radio"/> NO				
REF

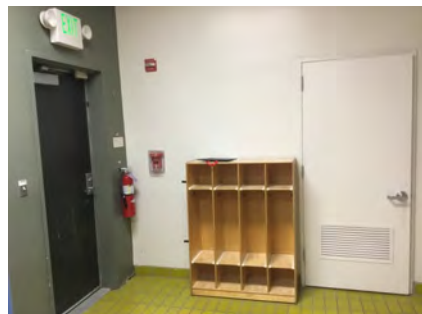
Item no., Rm no. and Name	Existing Architectural Barrier and Proposed Solution	Codes / Mitigation Info	Qty	Unit	Cost	Total
2048	<ul style="list-style-type: none">• As-Built Description: Front approach: At push side, door does not have clear and level maneuvering space measuring door width x 48" (door width plus 12" if door has both, latch and closer).• Proposed Solution: Remove or relocate furniture or storage items.	<p>PCODE ID24A</p> <p>ADAAG 91 Fig. 25(a)</p> <p>ADA 2010 404.2.4</p> <p>CBC 2007 11B-26A(a)</p> <p>CBC 2016 11B-404.2.4</p> <p>Mitigated:</p> <p><input type="radio"/> YES</p> <p><input checked="" type="radio"/> NO</p>	1	JOB	\$150	\$150

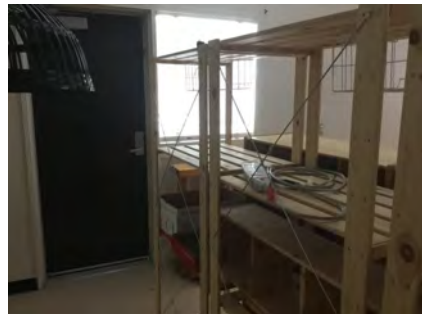
<input type="checkbox"/> Staff Only			
			Priority		Severity	
			2		3	
2052	<ul style="list-style-type: none">• As-Built Description: Front approach: At push side, door does not have clear and level maneuvering space measuring door width x 48" (door width plus 12" if door has both, latch and closer).• Proposed Solution: Remove or relocate furniture or storage items.	<p>PCODE ID24A</p> <p>ADAAG 91 Fig. 25(a)</p> <p>ADA 2010 404.2.4</p> <p>CBC 2007 11B-26A(a)</p> <p>CBC 2016 11B-404.2.4</p> <p>Mitigated:</p> <p><input type="radio"/> YES</p> <p><input checked="" type="radio"/> NO</p>	1	JOB	\$150	\$150

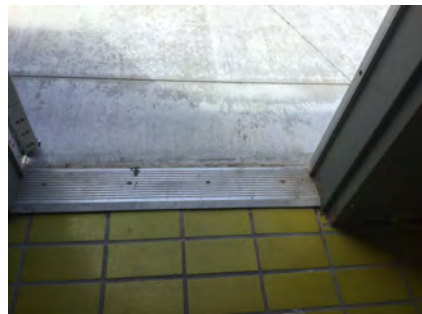
<input type="checkbox"/> Staff Only			
			Priority		Severity	
			2		3	
<u>Door Threshold</u>						
2053	<ul style="list-style-type: none">• As-Built Description: Existing threshold at door is 1/2" high or less but without a beveled edge on both sides.• As-Built: 0.75" high• Proposed Solution: Replace threshold.	<p>PCODE ID02</p> <p>ADAAG 91 4.1.6(3)(d)(ii)</p> <p>ADA 2010 404.2.5</p> <p>CBC 2007 1133B.2.4.1</p> <p>CBC 2016 11B-404.2.5</p> <p>Mitigated:</p> <p><input type="radio"/> YES</p> <p><input checked="" type="radio"/> NO</p>	1	JOB	\$750	\$750

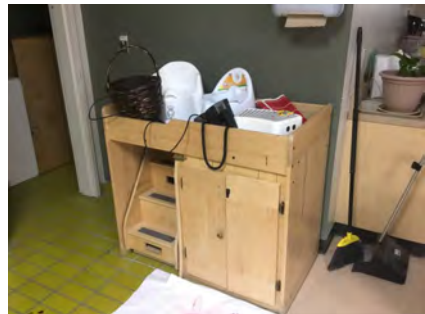
Item no., Rm no. and Name	Existing Architectural Barrier and Proposed Solution	Codes / Mitigation Info	Qty	Unit	Cost	Total
<u>Non-Fixed Desk</u>						
2049	<ul style="list-style-type: none">As-Built Description: Accessible non-fixed table or desk (top 28" to 34" high; knee space at least 27" high x 19" deep x 30" wide) not provided.As-Built: No knee clearance provided at baby changing table. 16.5" wide where the movable steps are located.Proposed Solution: Provide table or desk with accessible dimensions when purchasing new furniture.	PCODE IN02A ADAAG 91 4.32.3 & .4 ADA 2010 306.1 CBC 2007 1122B.3 & 4 CBC 2016 11B-306.1 & 11B-902.3 Mitigated: <input type="radio"/> YES <input checked="" type="radio"/> NO	1	JOB	\$4,800	\$4,800

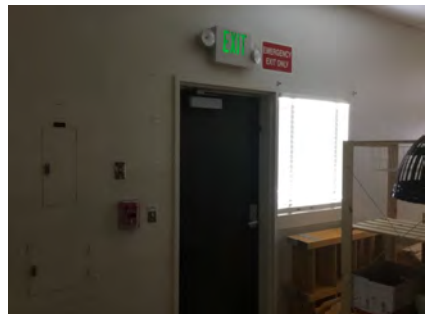
2050	<ul style="list-style-type: none">As-Built Description: At final exit door to exterior: Where required exit signs are installed, signs to provide exiting information for people with vision impairment are not provided.Proposed Solution: Provide raised letter/Braille "EXIT" sign at door.	PCODE SA10A ADAAG 91 4.1.3(16) ADA 2010 216.4.1 CBC 2007 1011.3 CBC 2016 11B-216.4.1 Mitigated: <input type="radio"/> YES <input checked="" type="radio"/> NO	1	JOB	\$270	\$270

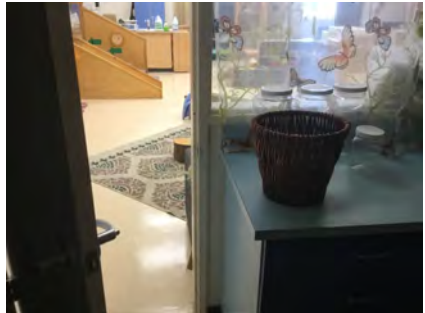
Item no., Rm no. and Name	Existing Architectural Barrier and Proposed Solution	Codes / Mitigation Info	Qty	Unit	Cost	Total
Door Swing						
2076	<ul style="list-style-type: none"> • <i>As-Built Description:</i> Front approach: At pull side, door does not have clear and level maneuvering space measuring door width plus 18" x 60". (24" x 60" at exterior doors). • <i>As-Built:</i> 3.5" to 15" wide obstructed by the counters. • <i>Proposed Solution:</i> Remove or relocate furniture or storage items. 	PCODE ID23A ADAAG 91 Fig. 25(a) ADA 2010 404.2.4 CBC 2007 11B-26A(a) CBC 2016 11B-404.2.4 Mitigated: <input type="radio"/> YES <input checked="" type="radio"/> NO	2	JOB	\$300	\$600

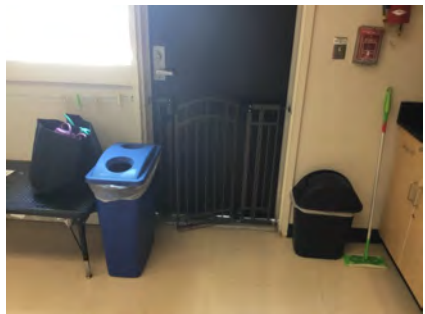
<input type="checkbox"/> Staff Only			
			Priority	Severity		
			2	2		
2074	<ul style="list-style-type: none"> • <i>As-Built Description:</i> Front approach: At push side, door does not have clear and level maneuvering space measuring door width x 48" (door width plus 12" if door has both, latch and closer). • <i>Proposed Solution:</i> Remove or relocate furniture or storage items. • Notes: These doors are emergency exit doors. 	PCODE ID24A ADAAG 91 Fig. 25(a) ADA 2010 404.2.4 CBC 2007 11B-26A(a) CBC 2016 11B-404.2.4 Mitigated: <input type="radio"/> YES <input checked="" type="radio"/> NO	3	JOB	\$150	\$450

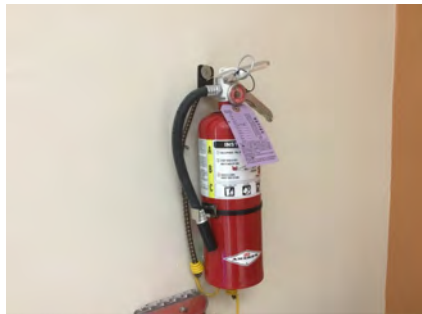
Item no., Rm no. and Name	Existing Architectural Barrier and Proposed Solution	Codes / Mitigation Info	Qty	Unit	Cost	Total
2085	<ul style="list-style-type: none"> As-Built Description: Reach height to control or access point, where side approach is available, exceeds 48" or is less than 15" in height, or exceeds 10" in depth. As-Built: 70" high Proposed Solution: Modify equipment or mounting. 	PCODE IE02 ADAAG 91 4.2.6 ADA 2010 308.3.1 CBC 2007 1118B.6 CBC 2016 11B-308.3 Mitigated: <input type="radio"/> YES <input checked="" type="radio"/> NO	4	JOB	\$300	\$1,200

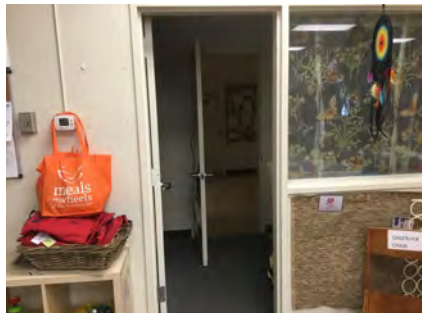
2072	<ul style="list-style-type: none"> As-Built Description: Room length in direction of travel less than width (es) of door(s) swinging into room, plus 48". As-Built: Approximately 5" between open doors Proposed Solution: At room with standard pairs of doors, remodel area to provide required length. 	PCODE IF02ANT ADAAG 91 4.13.7 ADA 2010 404.2.6 CBC 2007 1133B.2.4.4 CBC 2016 11B-404.2.6 Mitigated: <input type="radio"/> YES <input checked="" type="radio"/> NO	2	JOB	\$15,000	\$30,000

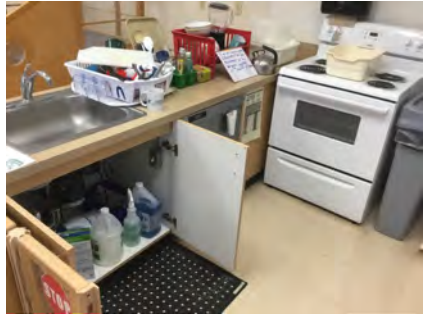
Item no., Rm no. and Name	Existing Architectural Barrier and Proposed Solution	Codes / Mitigation Info	Qty	Unit	Cost	Total
Sink						
2078	<ul style="list-style-type: none"> • <i>As-Built Description:</i> Sink does not have knee space min. 27" high x 19" deep x 30" wide. • <i>Proposed Solution:</i> Remodel sink cabinet. 	PCODE IN06A ADAAG 91 4.24.3 ADA 2010 606.2 CBC 2007 1115B.4.7.1 CBC 2016 11B-606.2 Mitigated: <input type="radio"/> YES <input checked="" type="radio"/> NO	1	JOB	\$5,250	\$5,250

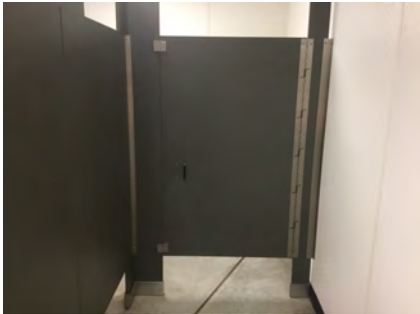
Item no., Rm no. and Name	Existing Architectural Barrier and Proposed Solution	Codes / Mitigation Info	Qty	Unit	Cost	Total
Door Swing						
1922	<ul style="list-style-type: none">As-Built Description: Front approach: At pull side, door does not have clear and level maneuvering space measuring door width plus 18" x 60". (24" x 60" at exterior doors).As-Built: 8"Proposed Solution: Change door swing.	<p>PCODE ID23 ADAAG 91 Fig. 25(a) ADA 2010 404.2.4 CBC 2007 11B-26A(a) CBC 2016 11B-404.2.4</p> <p>Mitigated: <input type="radio"/> YES <input checked="" type="radio"/> NO</p>	1	JOB	\$1,500	\$1,500

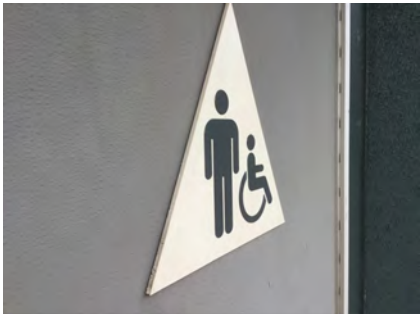
<input type="checkbox"/> Staff Only			
			Priority	Severity		
			3	3		
Signage						
1914	<ul style="list-style-type: none">As-Built Description: Required in CA only: identification symbol centered 58" to 60" high on sanitary facility door that contrasts with the door not provided (women: 12" ø circle, men: 12" triangle, unisex: combined symbol).As-Built: Not eased. No radius.Proposed Solution: Provide properly mounted sanitary facility symbol when altering area. If wheelchair accessible, include International Symbol of Accessibility on sign.	<p>PCODE SA15 CBC 2007 1115B.6 CBC 2016 11B-703.7.2.6</p> <p>Mitigated: <input type="radio"/> YES <input checked="" type="radio"/> NO</p>	1	JOB	\$270	\$270

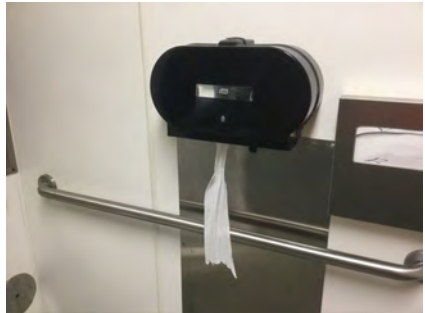
Item no., Rm no. and Name	Existing Architectural Barrier and Proposed Solution	Codes / Mitigation Info	Qty	Unit	Cost	Total
Grab Bars						
1924	<ul style="list-style-type: none"> • <i>As-Built Description:</i> Accessories/dispensers in accessible stall located closer than 1-1/2" below or 12" above grab bar impedes its use. • <i>As-Built:</i> Toilet paper dispenser 9.5" above the grab bar • <i>Proposed Solution:</i> Relocate accessories/dispensers to be no closer than 1-1/2" below and 12" above grab bars (except if accessories are recessed, flush with wall, and have no sharp edges). 	PCODE WB071 ADAAG 91 4.26.2 ADA 2010 609.3 CBC 2007 1133B.4.2.5 CBC 2016 11B-609.3 Mitigated: <input type="radio"/> YES <input checked="" type="radio"/> NO	1	JOB	\$225	\$225

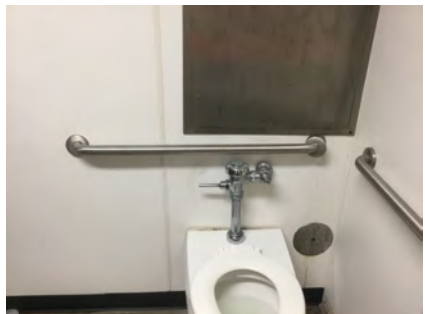
<input type="checkbox"/> Staff Only Priority 3 Severity 3			
1925	<ul style="list-style-type: none"> • <i>As-Built Description:</i> Accessories/dispensers in accessible stall located closer than 1-1/2" below or 12" above grab bar impedes its use. • <i>As-Built:</i> Plumbing 1.25" below the grab bar • <i>Proposed Solution:</i> Raise the grab bar. 	PCODE WB071 ADAAG 91 4.26.2 ADA 2010 609.3 CBC 2007 1133B.4.2.5 CBC 2016 11B-609.3 Mitigated: <input type="radio"/> YES <input checked="" type="radio"/> NO	1	JOB	\$225	\$225

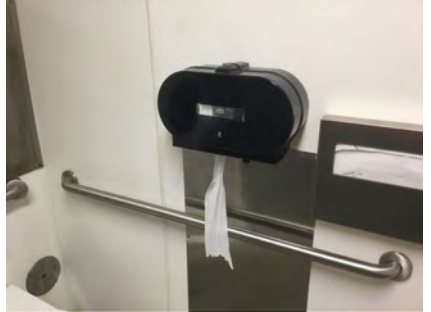
Item no., Rm no. and Name	Existing Architectural Barrier and Proposed Solution	Codes / Mitigation Info	Qty	Unit	Cost	Total
1923	<ul style="list-style-type: none"> • <i>As-Built Description:</i> Toilet paper dispenser less than 15" (CA: 19") or more than 48" above floor or not within 7" to 9" from front of water closet (Note: CA pre-2010 is allowed within 12" from front of water closet). • <i>As-Built:</i> Above the grab bar • <i>Proposed Solution:</i> Relocate or provide new toilet paper dispenser. 	PCODE WG02REF ADAAG 91 4.16.6 ADA 2010 604.7 CBC 2007 1115B.8.4 CBC 2016 11B-604.7 Mitigated: <input type="radio"/> YES <input checked="" type="radio"/> NO				
REF

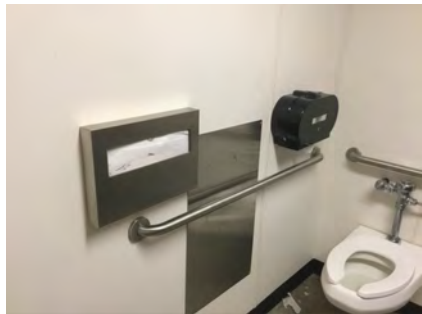
Item no., Rm no. and Name	Existing Architectural Barrier and Proposed Solution	Codes / Mitigation Info	Qty	Unit	Cost	Total
1934	<ul style="list-style-type: none"> As-Built Description: Accessories/dispensers in accessible stall located closer than 1-1/2" below or 12" above grab bar impedes its use. As-Built: Grab bar obstructed by seat cover dispenser and toilet paper dispenser at 3" and 4" above the Proposed Solution: Relocate accessories/dispensers to be no closer than 1-1/2" below and 12" above grab bars (except if accessories are recessed, flush with wall, and have no sharp edges). 	PCODE WB071 ADAAG 91 4.26.2 ADA 2010 609.3 CBC 2007 1133B.4.2.5 CBC 2016 11B-609.3 Mitigated: <input type="radio"/> YES <input checked="" type="radio"/> NO	2	JOB	\$225	\$450

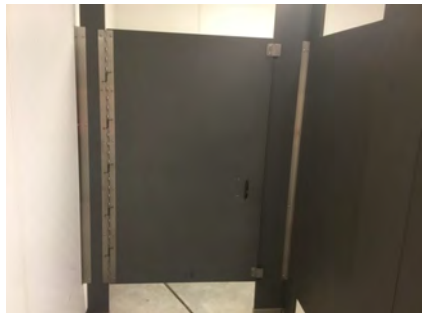
Stall Door

1931	<ul style="list-style-type: none"> As-Built Description: Stall door to accessible compartment not self closing. Proposed Solution: Adjust closer. 	PCODE WB05B ADAAG 91 4.22.4 ADA 2010 604.8.1.2 CBC 2007 1115B.3.1.4.4 CBC 2016 11B-604.8.1.2 Mitigated: <input type="radio"/> YES <input checked="" type="radio"/> NO	1	JOB	\$75	\$75

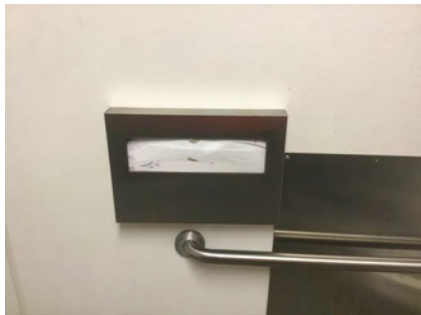
Item no., Rm no. and Name	Existing Architectural Barrier and Proposed Solution	Codes / Mitigation Info	Qty	Unit	Cost	Total
Accessories						
1937	<ul style="list-style-type: none">As-Built Description: Dispensers in sanitary facilities, such as for towels, soap, sanitary napkins, seat covers, etc., and waste receptacles more than 48" (CA only: 40") from floor to highest operating slot or control.As-Built: 43" highProposed Solution: Relocate existing restroom accessories.	<p>PCODE WG01AREF</p> <p>ADAAG 91 4.23.7</p> <p>ADA 2010 308.2.1</p> <p>CBC 2007 1115B.8.3</p> <p>CBC 2016 11B-603.5</p> <p>Mitigated:</p> <p><input type="radio"/> YES</p> <p><input checked="" type="radio"/> NO</p>			REF

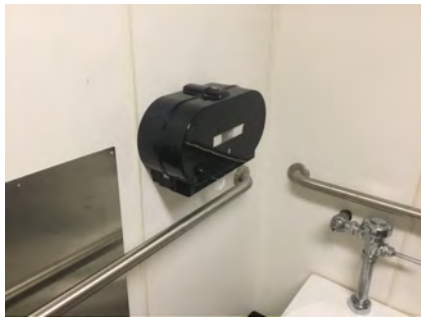
<input type="checkbox"/> Staff Only			
			Priority		Severity	
			<input checked="" type="radio"/> 3		<input checked="" type="radio"/> 4	
1935	<ul style="list-style-type: none">As-Built Description: Toilet paper dispenser less than 15" (CA: 19") or more than 48" above floor or not within 7" to 9" from front of water closet (Note: CA pre-2010 is allowed within 12" from front of water closet).As-Built: Above the grab barProposed Solution: Relocate or provide new toilet paper dispenser.	<p>PCODE WG02REF</p> <p>ADAAG 91 4.16.6</p> <p>ADA 2010 604.7</p> <p>CBC 2007 1115B.8.4</p> <p>CBC 2016 11B-604.7</p> <p>Mitigated:</p> <p><input type="radio"/> YES</p> <p><input checked="" type="radio"/> NO</p>			REF

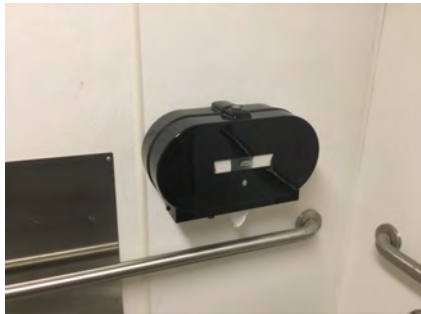
<input type="checkbox"/> Staff Only			
			Priority		Severity	
			<input checked="" type="radio"/> 3		<input checked="" type="radio"/> 1	
1936	<ul style="list-style-type: none">As-Built Description: Accessories in sanitary facilities not accessible, hardware requires tight grasping, pinching, or twisting of the wrist.Proposed Solution: Provide accessories with accessible operating mechanism.Notes: Same dispenser provided in men's restroom.	<p>PCODE WG05</p> <p>ADAAG 91 4.27.4</p> <p>ADA 2010 309.4</p> <p>CBC 2007 1117B.6</p> <p>CBC 2016 11B-309.4</p> <p>Mitigated:</p> <p><input type="radio"/> YES</p> <p><input checked="" type="radio"/> NO</p>	2	JOB	\$1,200	\$2,400

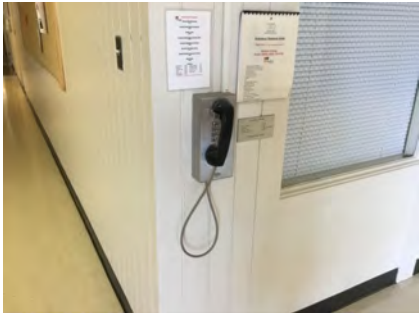
Item no., Rm no. and Name	Existing Architectural Barrier and Proposed Solution	Codes / Mitigation Info	Qty	Unit	Cost	Total
TTY						
1440	<ul style="list-style-type: none">• <i>As-Built Description:</i> Interior public text telephone (TTY) not provided at type of facility required to have a public text telephone.• <i>Proposed Solution:</i> Provide text telephone.• <i>Notes:</i> No TTY. Technically not required because this is not a payphone. Best practice would be providing a one TTY on this floor.	<p>PCODE IB10</p> <p>ADAAG 91 4.1.3(17)(c)</p> <p>ADA 2010 216.9</p> <p>CBC 2007 1117B.2.9.1</p> <p>CBC 2016 11B-216.9</p> <p>Project: SKYB19 Swing Space</p> <p>Year to be Completed: 2020/2021</p> <p>Mitigated:</p> <p><input type="radio"/> YES</p> <p><input checked="" type="radio"/> NO</p>	1	JOB	\$3,450	\$3,450

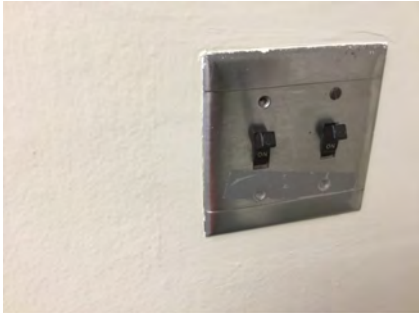
1382	<ul style="list-style-type: none">• <i>As-Built Description:</i> Electric switch or control mounted less than 15" measured to the bottom of the outlet box or greater than 48 inches measured to the top of the outlet box.• <i>As-Built:</i> 53.5" to the top of the electrical box. 52.5" to the top of the switch.• <i>Proposed Solution:</i> Relocate light switches or control to between 15" and 48" height.	<p>PCODE IC01</p> <p>ADAAG 91 4.2.5 & 6</p> <p>ADA 2010 308.2.1 &</p> <p>CBC 2007 1117B.6.3</p> <p>CBC 2016 11B-308.2.1 & 11B-308.2.2</p> <p>Project: SKYB19 Swing Space</p> <p>Year to be Completed: 2020/2021</p> <p>Mitigated:</p> <p><input type="radio"/> YES</p> <p><input checked="" type="radio"/> NO</p>	20	JOB	\$900	\$18,000

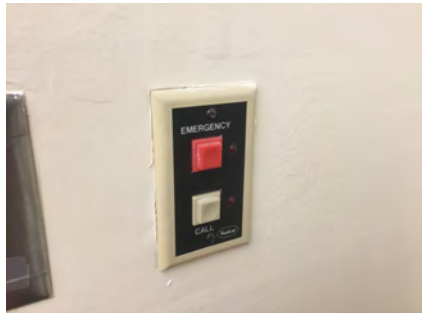
Item no., Rm no. and Name	Existing Architectural Barrier and Proposed Solution	Codes / Mitigation Info	Qty	Unit	Cost	Total
1383	<ul style="list-style-type: none"> • <i>As-Built Description:</i> Electric switch or control mounted less than 15" measured to the bottom of the outlet box or greater than 48 inches measured to the top of the outlet box. • <i>As-Built:</i> 52.5" • <i>Proposed Solution:</i> Relocate light switches or control to between 15" and 48" height. 	PCODE IC01 ADAAG 91 4.2.5 & 6 ADA 2010 308.2.1 & CBC 2007 1117B.6.3 CBC 2016 11B-308.2.1 & 11B-308.2.2 Project: SKYB19 Swing Space Year to be Completed: 2020/2021 Mitigated: <input type="radio"/> YES <input checked="" type="radio"/> NO	16	JOB	\$900	\$14,400

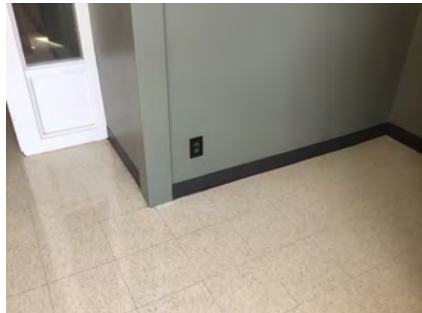
<input type="checkbox"/> Staff Only Priority 2 Severity 4						
1396	<ul style="list-style-type: none"> • <i>As-Built Description:</i> Electric switch or control mounted less than 15" measured to the bottom of the outlet box or greater than 48 inches measured to the top of the outlet box. • <i>As-Built:</i> 10.5" to the bottom of the electrical box. 13" to the top electrical outlet. • <i>Proposed Solution:</i> Relocate light switches or control to between 15" and 48" height. 	PCODE IC01 ADAAG 91 4.2.5 & 6 ADA 2010 308.2.1 & CBC 2007 1117B.6.3 CBC 2016 11B-308.2.1 & 11B-308.2.2 Project: SKYB19 Swing Space Year to be Completed: 2020/2021 Mitigated: <input type="radio"/> YES <input checked="" type="radio"/> NO	1	JOB	\$900	\$900

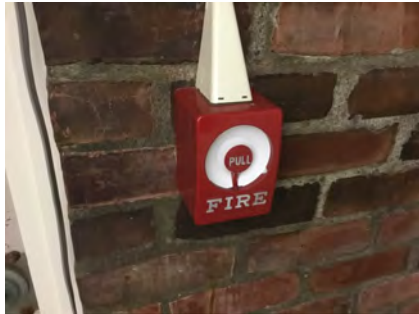
Item no., Rm no. and Name	Existing Architectural Barrier and Proposed Solution	Codes / Mitigation Info	Qty	Unit	Cost	Total
<u>Fire Alarm</u>						
1380	<ul style="list-style-type: none">As-Built Description: Fire alarm pull stations not 42"-48" from floor to center. Note: Required only at new construction, or where mounting location was or is to be remodeled.As-Built: 49" highProposed Solution: Remount fire alarm station to be 42" min., and 48" max. from floor to center.	<p>PCODE IC03</p> <p>ADAAG 91 4.2.5</p> <p>ADA 2010 308.2.1</p> <p>CBC 2007 907.4.2</p> <p>CBC 2016 907.4.2.2</p> <p>Project: SKYB19 Swing Space</p> <p>Year to be Completed: 2020/2021</p> <p>Mitigated:</p> <p><input type="radio"/> YES</p> <p><input checked="" type="radio"/> NO</p>	20	JOB	\$825	\$16,500

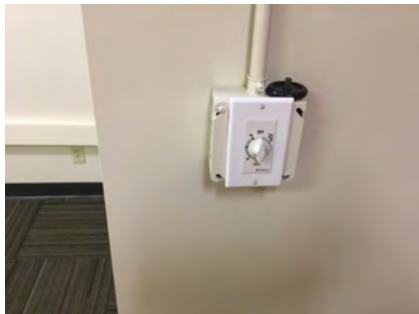
<u>Operable Part</u>						
1387	<ul style="list-style-type: none">As-Built Description: Operable part(s) require tight grasping, pinching, or twisting of the wrist with one hand.Proposed Solution: Modify or replace the operable part(s) to not require tight grasping, pinching, or twisting of the wrist with one hand.	<p>PCODE IC02</p> <p>ADAAG 91 4.27.4</p> <p>ADA 2010 309.4</p> <p>CBC 2007 1117B.6.4</p> <p>CBC 2016 11B-309.4</p> <p>Project: SKYB19 Swing Space</p> <p>Year to be Completed: 2020/2021</p> <p>Mitigated:</p> <p><input type="radio"/> YES</p> <p><input checked="" type="radio"/> NO</p>	15	JOB	\$900	\$13,500

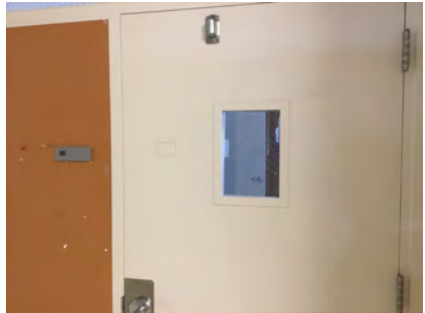
Item no., Rm no. and Name	Existing Architectural Barrier and Proposed Solution	Codes / Mitigation Info	Qty	Unit	Cost	Total
Door						
1369	<ul style="list-style-type: none"> • <i>As-Built Description:</i> Vision Light at door that permits viewing, does not have bottom of at least one glazed panel located 43 inches maximum above the finish floor. (Exception: More than 66" above finished floor.) • <i>As-Built:</i> 47.5" - 54.5" high • <i>Proposed Solution:</i> Provide new door with vision panel at 43" max. 	PCODE ID06C ADA 2010 404.2.11 CBC 2016 11B-404.2.11 Project: SKYB19 Swing Space Year to be Completed: 2020/2021 Mitigated: <input type="radio"/> YES <input checked="" type="radio"/> NO	1	JOB	\$7,500	\$7,500

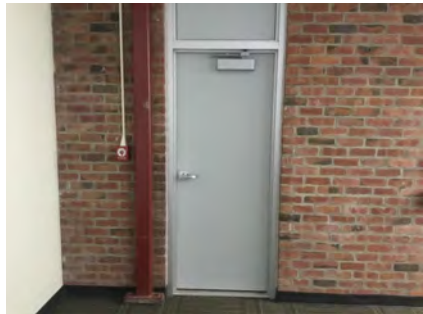
Door Clearance						
1386	<ul style="list-style-type: none"> • <i>As-Built Description:</i> Door on accessible route has less than 32" clear and 80" (78" min. to closer if provided) opening width when 90° open. • <i>As-Built:</i> 29" wide, 79.87" high • <i>Proposed Solution:</i> Provide new, larger door and frame with new accessible hardware. • <i>Notes:</i> Occurs at doors on south side of building. 	PCODE ID01 ADAAG 91 4.13.5 ADA 2010 404.2.3 CBC 2007 1133B.1.1.1.1 CBC 2016 11B-404.2.3 Project: SKYB19 Swing Space Year to be Completed: 2020/2021 Mitigated: <input type="radio"/> YES <input checked="" type="radio"/> NO	5	JOB	\$7,800	\$39,000

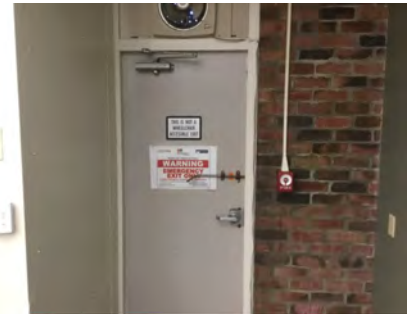
Item no., Rm no. and Name	Existing Architectural Barrier and Proposed Solution	Codes / Mitigation Info	Qty	Unit	Cost	Total
1379	<ul style="list-style-type: none"> As-Built Description: Door on accessible route has less than 32" clear and 80" (78" min. to closer if provided) opening width when 90° open. As-Built: 29.25" clear width. 76.5" high closer. 78.5" high doorway. Proposed Solution: Install off-set hinges to increase door opening to clear frame width (32" min.). Notes: Occurs at old exit doors from rooms throughout. 	PCODE ID01A ADAAG 91 4.13.5 ADA 2010 404.2.3 CBC 2007 1133B.1.1.1.1 CBC 2016 11B-404.2.3 Project: SKYB19 Swing Space Year to be Completed: 2020/2021 Mitigated: <input type="radio"/> YES <input checked="" type="radio"/> NO	18	JOB	\$1,500	\$27,000

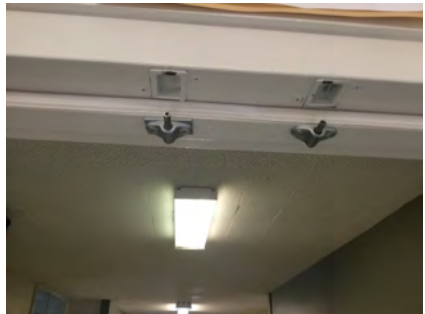
<input type="checkbox"/> Staff Only Priority 2 Severity 3			
1433	<ul style="list-style-type: none"> As-Built Description: Door on accessible route has less than 32" clear and 80" (78" min. to closer if provided) opening width when 90° open. Proposed Solution: Remove/relocate the mechanisms. 	PCODE ID01REF ADAAG 91 4.13.5 ADA 2010 404.2.3 CBC 2007 1133B.1.1.1.1 CBC 2016 11B-404.2.3 Project: SKYB19 Swing Space Year to be Completed: 2020/2021 Mitigated: <input type="radio"/> YES <input checked="" type="radio"/> NO	REF

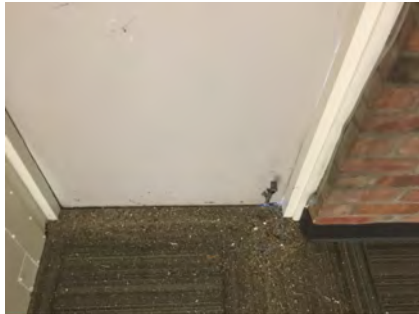
Item no., Rm no. and Name	Existing Architectural Barrier and Proposed Solution	Codes / Mitigation Info	Qty	Unit	Cost	Total
<u>Door Stopper</u>						
1381	<ul style="list-style-type: none">• <i>As-Built Description:</i> At push side of door on accessible route, bottom 10" does not have a smooth, uninterrupted surface.• <i>Proposed Solution:</i> Remove door stopper when altering area. Provide rubber wedge.	<p>PCODE ID06A</p> <p>ADA 2010 404.2.10</p> <p>CBC 2007 1133B.2.6</p> <p>CBC 2016 11B-404.2.10</p> <p>Project: SKYB19 Swing Space</p> <p>Year to be Completed: 2020/2021</p> <p>Mitigated: <input type="radio"/> YES <input checked="" type="radio"/> NO</p>	20	JOB	\$75	\$1,500

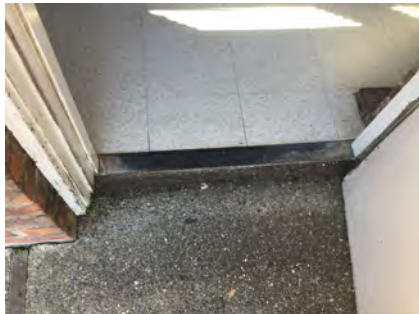
<input type="checkbox"/> Staff Only			
			Priority 2 Severity 3			
<u>Door Threshold</u>						
1392	<ul style="list-style-type: none">• <i>As-Built Description:</i> Door inaccessible due to threshold or step at door exceeding 1/2".• <i>As-Built:</i> 1" high• <i>Proposed Solution:</i> Modify threshold to be no more than 1/2" by removing existing paving at door and providing landing with edge ramping (slope 1:20 max).• <i>Notes:</i> Occurs at old exit doors from rooms throughout.	<p>PCODE ID02A</p> <p>ADAAG 91 4.13.8</p> <p>ADA 2010 404.2.5</p> <p>CBC 2007 1133B.2.4.1</p> <p>CBC 2016 11B-404.2.5</p> <p>Project: SKYB19 Swing Space</p> <p>Year to be Completed: 2020/2021</p> <p>Mitigated: <input type="radio"/> YES <input checked="" type="radio"/> NO</p>	18	JOB	\$1,200	\$21,600

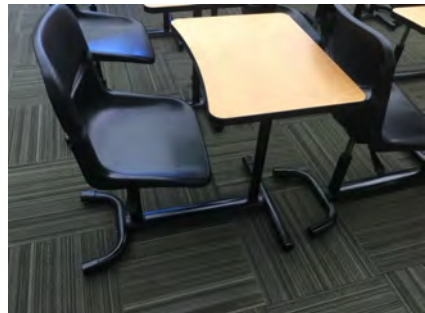
Item no., Rm no. and Name	Existing Architectural Barrier and Proposed Solution	Codes / Mitigation Info	Qty	Unit	Cost	Total
Non-Fixed Desk						
1374	<ul style="list-style-type: none">• <i>As-Built Description:</i> Accessible non-fixed table or desk (top 28" to 34" high; knee space at least 27" high x 19" deep x 30" wide) not provided.• <i>Proposed Solution:</i> Provide table or desk with accessible dimensions when purchasing new furniture.• <i>Notes:</i> Accessible desks are not provided in the correct number throughout all the classrooms.	<p>PCODE IN02A</p> <p>ADAAG 91 4.32.3 & .4</p> <p>ADA 2010 306.1</p> <p>CBC 2007 1122B.3 & 4</p> <p>CBC 2016 11B-306.1 & 11B-902.3</p> <p>Project: SKYB19 Swing Space</p> <p>Year to be Completed: 2020/2021</p> <p>Mitigated:</p> <p><input type="radio"/> YES</p> <p><input checked="" type="radio"/> NO</p>	4	JOB	\$4,800	\$19,200

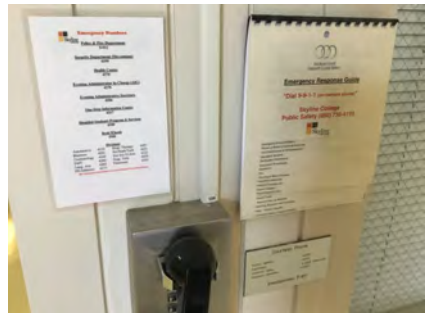
<div><div>Priority</div><div>2</div></div> <div><div>Severity</div><div>2</div></div>			
Signage						
1441	<ul style="list-style-type: none">• <i>As-Built Description:</i> Sign characters not readable because they are not sized for viewing distance.• <i>As-Built:</i> 0.125"• <i>Proposed Solution:</i> Provide compliant signage.	<p>PCODE SA02A</p> <p>ADAAG 91 4.30.3</p> <p>ADA 2010 703.5.5</p> <p>CBC 2007 1117B.5.4</p> <p>CBC 2016 11B-216.4.1</p> <p>Project: SKYB19 Swing Space</p> <p>Year to be Completed: 2020/2021</p> <p>Mitigated:</p> <p><input type="radio"/> YES</p> <p><input checked="" type="radio"/> NO</p>	1	JOB	\$270	\$270

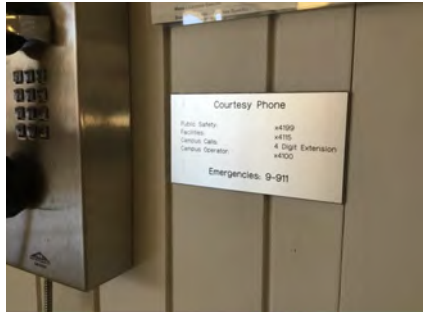
Item no., Rm no. and Name	Existing Architectural Barrier and Proposed Solution	Codes / Mitigation Info	Qty	Unit	Cost	Total
1442	<ul style="list-style-type: none"> As-Built Description: Sign does not have non-glare finish and/or good color contrast (dark on light or light on dark). As-Built: Glare Proposed Solution: Provide compliant signage. 	PCODE SA03 ADAAG 91 4.30.5 ADA 2010 703.5.1 CBC 2007 1117B.5.5 CBC 2016 11B-216.4.1 Project: SKYB19 Swing Space Year to be Completed: 2020/2021 Mitigated: <input type="radio"/> YES <input checked="" type="radio"/> NO	1	JOB	\$270	\$270

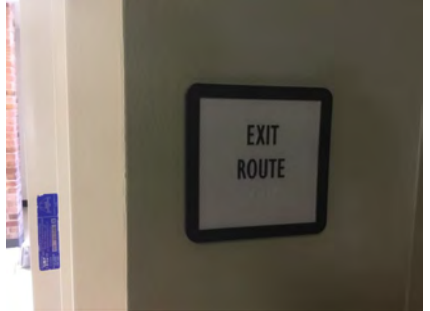
<input type="checkbox"/> Staff Only Priority 2 Severity 4				
1368	<ul style="list-style-type: none"> As-Built Description: Signs containing tactile characters is not located so that a clear floor space of 18" min x 18" min., centered on the tactile characters, is provided beyond the arc of any door swing between the closed position and 45 degree open position. As-Built: 60.875" to the bottom of the highest tactile character. 60" to the centerline of the signs. Proposed Solution: Relocate compliant signage on latch side of door located at compliant height with a clear floor space. 	PCODE SA07B ADA 2010 703.4.2 CBC 2016 11B-703.4.2 Project: SKYB19 Swing Space Year to be Completed: 2020/2021 Mitigated: <input type="radio"/> YES <input checked="" type="radio"/> NO	1	JOB	\$150	\$150

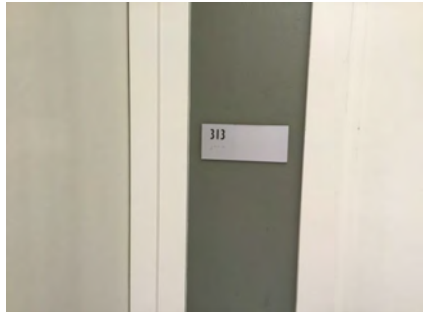
<input type="checkbox"/> Staff Only Priority 2 Severity 4				
1373	<ul style="list-style-type: none"> As-Built Description: Signs containing tactile characters is not located so that a clear floor space of 18" min x 18" min., centered on the tactile characters, is provided beyond the arc of any door swing between the closed position and 45 degree open position. As-Built: 18 x 18" sign clear floor space is obstructed. Centerline of braille and tactile 6" from obstruction. Proposed Solution: Relocate compliant signage on latch side of door located at compliant height with a clear floor space. 	PCODE SA07B ADA 2010 703.4.2 CBC 2016 11B-703.4.2 Project: SKYB19 Swing Space Year to be Completed: 2020/2021 Mitigated: <input type="radio"/> YES <input checked="" type="radio"/> NO	1	JOB	\$150	\$150

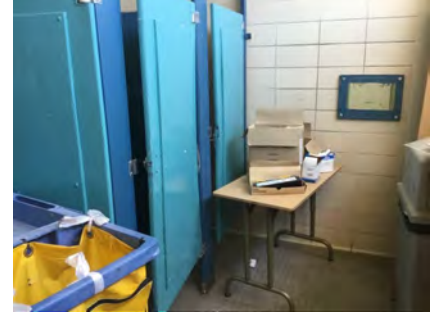
Multiple accommodation restroom not accessible;
multiple compliance violations.

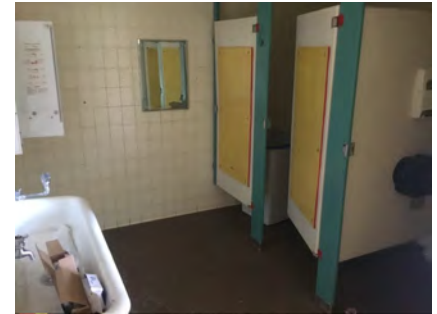
Multiple accommodation restroom not accessible;
multiple compliance violations.

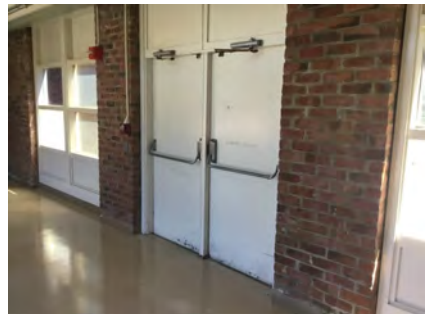
Item no., Rm no. and Name	Existing Architectural Barrier and Proposed Solution	Codes / Mitigation Info	Qty	Unit	Cost	Total
Door Clearance						
1446	<ul style="list-style-type: none">• <i>As-Built Description:</i> Door on accessible route has less than 32" clear and 80" (78" min. to closer if provided) opening width when 90° open.• <i>As-Built:</i> 78.75" clear height. 76.25" high to the closer• <i>Proposed Solution:</i> Provide new, larger door and frame with new accessible hardware.	<p>PCODE ID01</p> <p>ADAAG 91 4.13.5</p> <p>ADA 2010 404.2.3</p> <p>CBC 2007 1133B.1.1.1.1</p> <p>CBC 2016 11B-404.2.3</p> <p>Project: SKYB19 Swing Space</p> <p>Year to be Completed: 2020/2021</p> <p>Mitigated:</p> <p><input type="radio"/> YES</p> <p><input checked="" type="radio"/> NO</p>	1	JOB	\$7,800	\$7,800

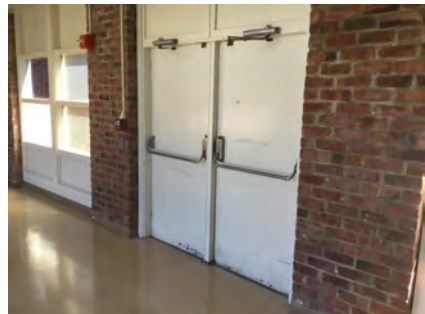
<input type="checkbox"/> Staff Only			
			Priority 2 Severity 4			
Door Threshold						
1445	<ul style="list-style-type: none">• <i>As-Built Description:</i> Door inaccessible due to threshold or step at door exceeding 1/2".• <i>As-Built:</i> 1" high• <i>Proposed Solution:</i> Modify threshold to be no more than 1/2" by removing existing paving at door and providing landing with edge ramping (slope 1:20 max).	<p>PCODE ID02A</p> <p>ADAAG 91 4.13.8</p> <p>ADA 2010 404.2.5</p> <p>CBC 2007 1133B.2.4.1</p> <p>CBC 2016 11B-404.2.5</p> <p>Project: SKYB19 Swing Space</p> <p>Year to be Completed: 2020/2021</p> <p>Mitigated:</p> <p><input type="radio"/> YES</p> <p><input checked="" type="radio"/> NO</p>	1	JOB	\$1,200	\$1,200

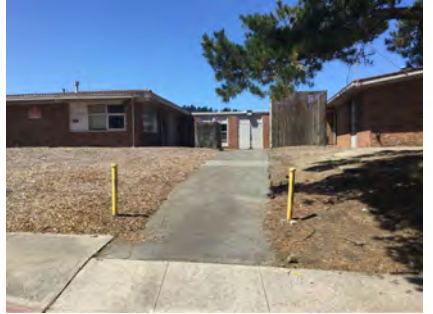
Item no., Rm no. and Name	Existing Architectural Barrier and Proposed Solution	Codes / Mitigation Info	Qty	Unit	Cost	Total
Signage						
1444	<ul style="list-style-type: none"> • <i>As-Built Description:</i> Exterior signage at inaccessible entrances to provide direction to accessible entrances is missing or noncompliant. • <i>Proposed Solution:</i> Provide signage sufficient to guide persons to accessible entrances. • <i>Notes:</i> Install an ISA directional sign at decision points outside. The slope of the ramp is 13%. There is a high threshold at the door. 	PCODE SA01 ADAAG 91 4.1.2(7)(c) ADA 2010 216.6 CBC 2007 1117B.5.8.1.2 CBC 2016 11B-216.6 Project: SKYB19 Swing Space Year to be Completed: 2020/2021 Mitigated: <input type="radio"/> YES <input checked="" type="radio"/> NO	1	JOB	\$690	\$690

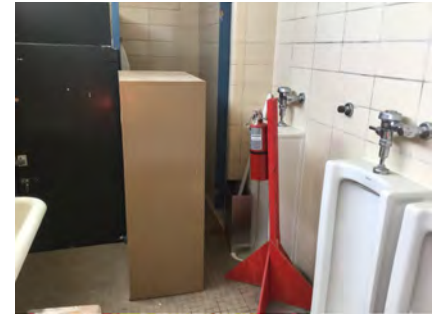
Multiple accommodation restroom not accessible;
multiple compliance violations.

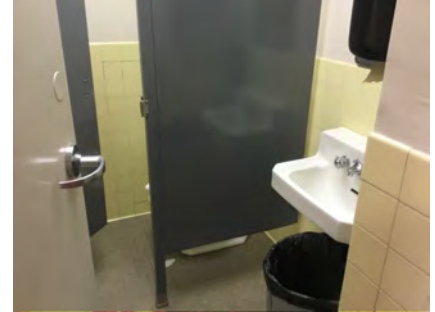
Single accommodation restroom not accessible;
multiple compliance violations.

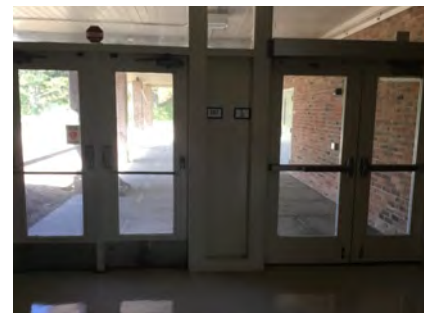
Exterior signage at inaccessible entrances to provide direction to accessible entrances is missing or noncompliant.

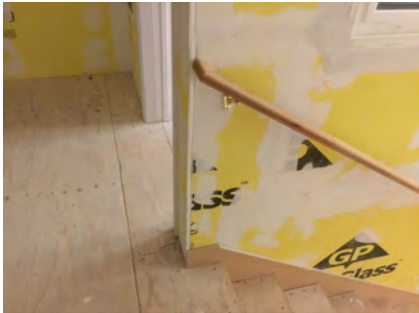
Item no., Rm no. and Name	Existing Architectural Barrier and Proposed Solution	Codes / Mitigation Info	Qty	Unit	Cost	Total
<u>Top & Bottom Extension at Stairs</u>						
1420	<ul style="list-style-type: none">• <i>As-Built Description:</i> Stair handrail does not extend horizontally 12" minimum beyond top nosing, and one tread width sloped, plus 12" minimum horizontally beyond the bottom nosing.• <i>Proposed Solution:</i> Extend stair handrail at top and bottom (cost for each extension piece).	<p>PCODE ED06</p> <p>ADAAG 91 4.9.4(2)</p> <p>ADA 2010 505.10.2;</p> <p>CBC 2007 1133B.4.2.2</p> <p>CBC 2016 11B-505.10.2; 11B-505.10.3</p> <p>Project: SKYB19 Swing Space</p> <p>Year to be Completed: 2020/2021</p> <p>Mitigated:</p> <p><input type="radio"/> YES</p> <p><input checked="" type="radio"/> NO</p>	5	JOB	\$510	\$2,550

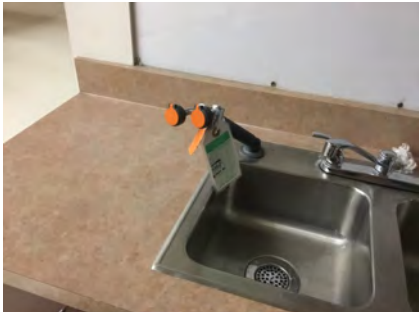
<u>Operable Part</u>						
1410	<ul style="list-style-type: none">• <i>As-Built Description:</i> Operable part(s) require tight grasping, pinching, or twisting of the wrist with one hand.• <i>Proposed Solution:</i> Modify or replace the operable part(s) to not require tight grasping, pinching, or twisting of the wrist with one hand.• <i>Notes:</i> Eye wash station requires grasping and/or possibly two hands to operate.	<p>PCODE IC02</p> <p>ADAAG 91 4.27.4</p> <p>ADA 2010 309.4</p> <p>CBC 2007 1117B.6.4</p> <p>CBC 2016 11B-309.4</p> <p>Project: SKYB19 Swing Space</p> <p>Year to be Completed: 2020/2021</p> <p>Mitigated:</p> <p><input type="radio"/> YES</p> <p><input checked="" type="radio"/> NO</p>	1	JOB	\$900	\$900

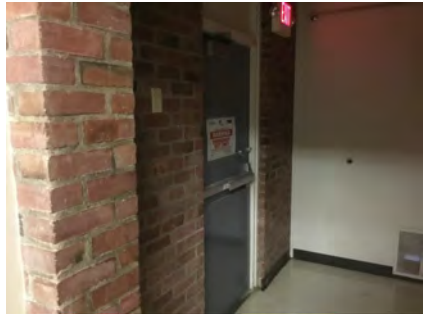
Item no., Rm no. and Name	Existing Architectural Barrier and Proposed Solution	Codes / Mitigation Info	Qty	Unit	Cost	Total
Door Clearance						
1406	<ul style="list-style-type: none"> As-Built Description: Door on accessible route has less than 32" clear and 80" (78" min. to closer if provided) opening width when 90° open. As-Built: 79" clear height Proposed Solution: Provide new, larger door and frame with new accessible hardware. 	PCODE ID01 ADAAG 91 4.13.5 ADA 2010 404.2.3 CBC 2007 1133B.1.1.1.1 CBC 2016 11B-404.2.3 Project: SKYB19 Swing Space Year to be Completed: 2020/2021 Mitigated: <input type="radio"/> YES <input checked="" type="radio"/> NO	1	JOB	\$7,800	\$7,800

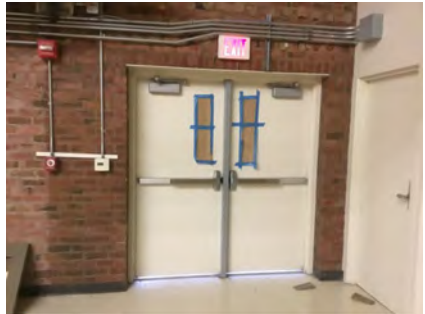
<input type="checkbox"/> Staff Only Priority 2 Severity 4			
1408	<ul style="list-style-type: none"> As-Built Description: Door on accessible route has less than 32" clear and 80" (78" min. to closer if provided) opening width when 90° open. As-Built: 79.75" clear height Proposed Solution: Provide new, larger door and frame with new accessible hardware. 	PCODE ID01 ADAAG 91 4.13.5 ADA 2010 404.2.3 CBC 2007 1133B.1.1.1.1 CBC 2016 11B-404.2.3 Project: SKYB19 Swing Space Year to be Completed: 2020/2021 Mitigated: <input type="radio"/> YES <input checked="" type="radio"/> NO	1	JOB	\$7,800	\$7,800

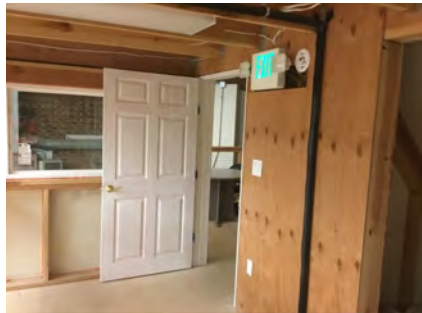
Item no., Rm no. and Name	Existing Architectural Barrier and Proposed Solution	Codes / Mitigation Info	Qty	Unit	Cost	Total
1416	<ul style="list-style-type: none"> As-Built Description: Door on accessible route has less than 32" clear and 80" (78" min. to closer if provided) opening width when 90° open. As-Built: 76.75" clear height Proposed Solution: Provide new, larger door and frame with new accessible hardware. 	PCODE ID01 ADAAG 91 4.13.5 ADA 2010 404.2.3 CBC 2007 1133B.1.1.1.1 CBC 2016 11B-404.2.3 Project: SKYB19 Swing Space Year to be Completed: 2020/2021 Mitigated: <input type="radio"/> YES <input checked="" type="radio"/> NO	2	JOB	\$7,800	\$15,600

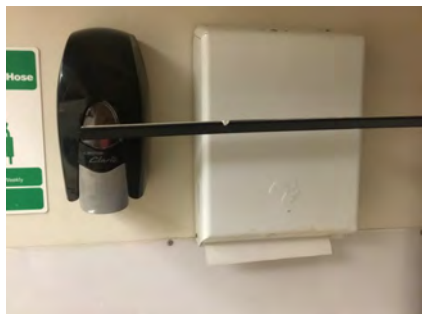
<input type="checkbox"/> Staff Only Priority 2 Severity 4						
<hr/>						
1412	Reach Range <ul style="list-style-type: none"> As-Built Description: Reach height to control or access point, where side approach is available, exceeds 48" or is less than 15" in height, or exceeds 10" in depth. As-Built: Paper towel dispenser and soap dispenser 51" and 54" high Proposed Solution: Modify equipment or mounting. 	PCODE IE02 ADAAG 91 4.2.6 ADA 2010 308.3.1 CBC 2007 1118B.6 CBC 2016 11B-308.3 Project: SKYB19 Swing Space Year to be Completed: 2020/2021 Mitigated: <input type="radio"/> YES <input checked="" type="radio"/> NO	2	JOB	\$300	\$600

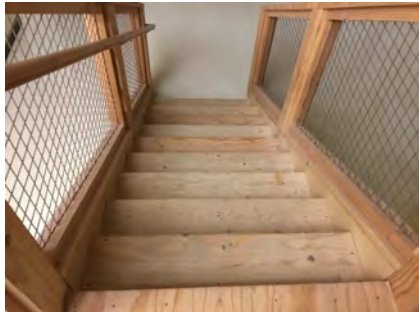
Item no., Rm no. and Name	Existing Architectural Barrier and Proposed Solution	Codes / Mitigation Info	Qty	Unit	Cost	Total
<u>Stairway</u>						
1421	<ul style="list-style-type: none">• <i>As-Built Description:</i> The leading 2" of the tread does not have visual contrast of dark-on-light or light-on-dark from the remainder of the tread.• <i>Proposed Solution:</i> Provide 2" min., 4" max. wide contrasting color strip 1" max. from nosing on top & bottom treads when altering area.	<p>PCODE II02B</p> <p>ADA 2010 504.4</p> <p>CBC 2007 1133B.4.4</p> <p>CBC 2016 11B-504.4.1</p> <p>Project: SKYB19 Swing Space</p> <p>Year to be Completed: 2020/2021</p> <p>Mitigated:</p> <p><input type="radio"/> YES</p> <p><input checked="" type="radio"/> NO</p>	16	LF	\$42	\$672

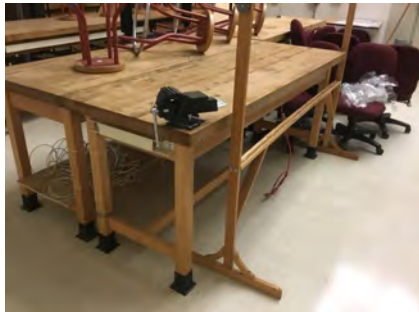
<input type="checkbox"/> Staff Only			
			Priority 2 Severity 3			
<u>Non-Fixed Desk</u>						
1409	<ul style="list-style-type: none">• <i>As-Built Description:</i> Accessible non-fixed table or desk (top 28" to 34" high; knee space at least 27" high x 19" deep x 30" wide) not provided.• <i>As-Built:</i> 36" high to the top, 14.5" deep• <i>Proposed Solution:</i> Provide table or desk with accessible dimensions when purchasing new furniture.• Notes: 14 desks, 0 accessible.	<p>PCODE IN02A</p> <p>ADAAG 91 4.32.3 & .4</p> <p>ADA 2010 306.1</p> <p>CBC 2007 1122B.3 & 4</p> <p>CBC 2016 11B-306.1 & 11B-902.3</p> <p>Project: SKYB19 Swing Space</p> <p>Year to be Completed: 2020/2021</p> <p>Mitigated:</p> <p><input type="radio"/> YES</p> <p><input checked="" type="radio"/> NO</p>	1	JOB	\$4,800	\$4,800

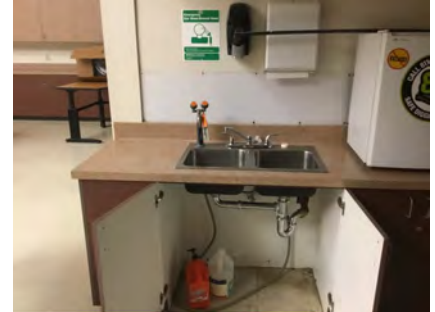
1411	<ul style="list-style-type: none"> As-Built Description: Sink does not have knee space min. 27" high x 19" deep x 30" wide. As-Built: knee clearance 16" high and 10" deep Proposed Solution: Remodel sink cabinet. 	PCODE IN06A ADAAG 91 4.24.3 ADA 2010 606.2 CBC 2007 1115B.4.7.1 CBC 2016 11B-606.2 Project: SKYB19 Swing Space Year to be Completed: 2020/2021 Mitigated: <input type="radio"/> YES <input checked="" type="radio"/> NO	1	JOB	\$5,250	\$5,250
------	---	---	---	-----	---------	---------

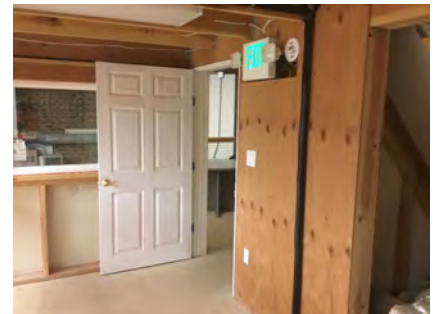
1417	<ul style="list-style-type: none"> As-Built Description: At door leading into exit stairway: Where required exit signs are installed, signs to provide exiting information for people with vision impairment are not provided. Proposed Solution: Provide raised letter/Braille "EXIT STAIR UP/DOWN" sign at door. 	PCODE SA10B ADAAG 91 4.1.3(16) ADA 2010 216.4.1 CBC 2007 1011.3 CBC 2016 11B-216.4.1 Project: SKYB19 Swing Space Year to be Completed: 2020/2021 Mitigated: <input type="radio"/> YES <input checked="" type="radio"/> NO	2	JOB	\$270	\$540
------	--	---	---	-----	-------	-------

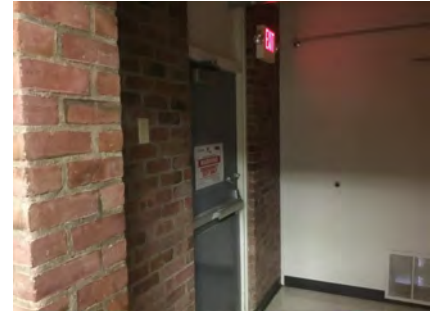
Item no., Rm no. and Name	Existing Architectural Barrier and Proposed Solution	Codes / Mitigation Info	Qty	Unit	Cost	Total
1407	<ul style="list-style-type: none"> As-Built Description: At door leading into exit corridor: Where required exit signs are installed, signs to provide exiting information for people with vision impairment are not provided. Proposed Solution: Provide raised letter/Braille "EXIT ROUTE" sign at door. 	PCODE SA10D ADAAG 91 4.1.3(16) ADA 2010 216.4.1 CBC 2007 1011.3 CBC 2016 11B-216.4.1 Project: SKYB19 Swing Space Year to be Completed: 2020/2021 Mitigated: <input type="radio"/> YES <input checked="" type="radio"/> NO	2	JOB	\$270	\$540

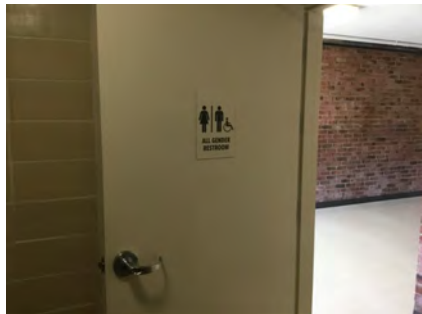
Item no., Rm no. and Name	Existing Architectural Barrier and Proposed Solution	Codes / Mitigation Info	Qty	Unit	Cost	Total
1422	<ul style="list-style-type: none"> As-Built Description: Required in CA only: identification symbol centered 58" to 60" high on sanitary facility door that contrasts with the door not provided (women: 12" ø circle, men: 12" triangle, unisex: combined symbol). Proposed Solution: Provide properly mounted sanitary facility symbol when altering area. If wheelchair accessible, include International Symbol of Accessibility on sign. 	PCODE SA15 CBC 2007 1115B.6 CBC 2016 11B-703.7.2.6 Project: SKYB19 Swing Space Year to be Completed: 2020/2021 Mitigated: <input type="radio"/> YES <input checked="" type="radio"/> NO	1	JOB	\$270	\$270
