SAN MATEO COUNTY
COMMUNITY
COLLEGE DISTRICT

San Mateo County Community College District Americans with Disabilities Act Self-Evaluation and Transition Plan

Report Prepared by:

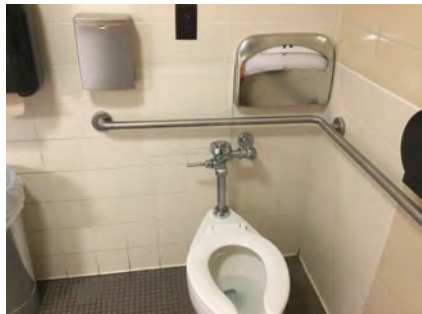
Grab Bars

1429	<ul style="list-style-type: none"> As-Built Description: The rear wall grab is less than 36" min. or does not extend from the centerline of the water closet 12" min. on one side and 24" min. on the other side. As-Built: 19" on the wide side Proposed Solution: Provide or relocate accessible rear grab bar. 	PCODE WB07B ADAAG 91 4.17.6 ADA 2010 604.5.2 CBC 2007 1115B.4.1.3.2 CBC 2016 11B-604.5.2 Project: SKYB19 Swing Space Year to be Completed: 2020/2021 Mitigated: <input type="radio"/> YES <input checked="" type="radio"/> NO	1	JOB	\$1,020	\$1,020

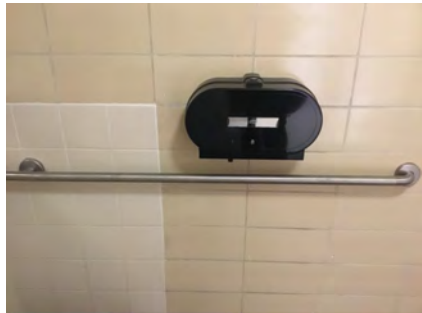
Item no., Rm no. and Name	Existing Architectural Barrier and Proposed Solution	Codes / Mitigation Info	Qty	Unit	Cost	Total
1431	<ul style="list-style-type: none"> • As-Built Description: Accessories/dispensers in accessible stall located closer than 1-1/2" below or 12" above grab bar impedes its use. • As-Built: Toilet paper dispenser 3" above the side grab bar • Proposed Solution: Relocate accessories/dispensers to be no closer than 1-1/2" below and 12" above grab bars (except if accessories are recessed, flush with wall, and have no sharp edges). 	PCODE WB07I ADAAG 91 4.26.2 ADA 2010 609.3 CBC 2007 1133B.4.2.5 CBC 2016 11B-609.3 Project: SKYB19 Swing Space Year to be Completed: 2020/2021 Mitigated: <input type="radio"/> YES <input checked="" type="radio"/> NO	1	JOB	\$225	\$225

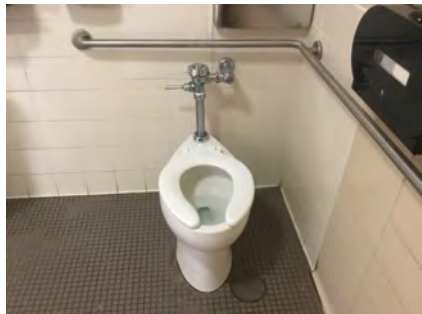
<input type="checkbox"/> Staff Only Priority 3 Severity 2						
<hr/>						
<u>Water Closet</u>						
1430	<ul style="list-style-type: none"> • As-Built Description: Water closet not 16"-18" (CA: 17"-18") from near side wall to center line of water closet (2010 ADAAG: 16"-18"). • As-Built: 19" o.c. • Proposed Solution: Relocate existing water closet and plumbing, remount with offset closet flange to provide 18" max. from side wall. 	PCODE WB02C ADAAG 91 Fig. 28 ADA 2010 604.2 CBC 2007 1115B.4.1.1 CBC 2016 11B-604.2 Project: SKYB19 Swing Space Year to be Completed: 2020/2021 Mitigated: <input type="radio"/> YES <input checked="" type="radio"/> NO	1	JOB	\$1,500	\$1,500

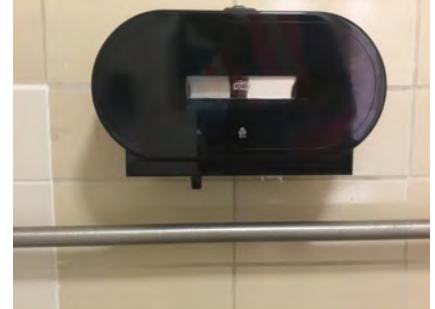
Item no., Rm no. and Name	Existing Architectural Barrier and Proposed Solution	Codes / Mitigation Info	Qty	Unit	Cost	Total
1432	<ul style="list-style-type: none"> As-Built Description: Accessories in sanitary facilities not accessible, hardware requires tight grasping, pinching, or twisting of the wrist. Proposed Solution: Provide accessories with accessible operating mechanism. 	PCODE WG05REF ADAAG 91 4.27.4 ADA 2010 309.4 CBC 2007 1117B.6 CBC 2016 11B-309.4 Project: SKYB19 Swing Space Year to be Completed: 2020/2021 Mitigated: <input type="radio"/> YES <input checked="" type="radio"/> NO

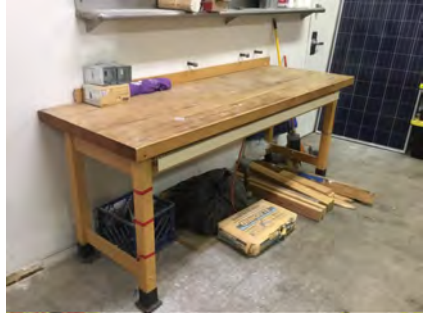
Item no., Rm no. and Name	Existing Architectural Barrier and Proposed Solution	Codes / Mitigation Info	Qty	Unit	Cost	Total
Non-Fixed Desk						
1435	<ul style="list-style-type: none"> • <i>As-Built Description:</i> Accessible non-fixed table or desk (top 28" to 34" high; knee space at least 27" high x 19" deep x 30" wide) not provided. • <i>As-Built:</i> 36" to the top • <i>Proposed Solution:</i> Provide table or desk with accessible dimensions when purchasing new furniture. • <i>Notes:</i> This room may be used by students. 	PCODE IN02A ADAAG 91 4.32.3 & .4 ADA 2010 306.1 CBC 2007 1122B.3 & 4 CBC 2016 11B-306.1 & 11B-902.3 Project: SKYB19 Swing Space Year to be Completed: 2020/2021 Mitigated: <input type="radio"/> YES <input checked="" type="radio"/> NO	1	JOB	\$4,800	\$4,800

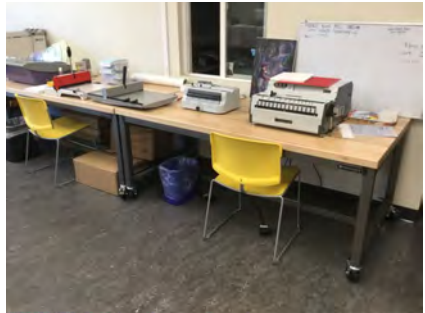
Item no., Rm no. and Name	Existing Architectural Barrier and Proposed Solution	Codes / Mitigation Info	Qty	Unit	Cost	Total
Non-Fixed Desk						
1448	<ul style="list-style-type: none"> As-Built Description: Accessible non-fixed table or desk (top 28" to 34" high; knee space at least 27" high x 19" deep x 30" wide) not provided. As-Built: 26.3" high knee clearance. 17.5" deep toe clearance Proposed Solution: Provide table or desk with accessible dimensions when purchasing new furniture. 	PCODE IN02A ADAAG 91 4.32.3 & .4 ADA 2010 306.1 CBC 2007 1122B.3 & 4 CBC 2016 11B-306.1 & 11B-902.3 Project: SKYB19 Swing Space Year to be Completed: 2020/2021 Mitigated: <input type="radio"/> YES <input checked="" type="radio"/> NO	2	JOB	\$4,800	\$9,600

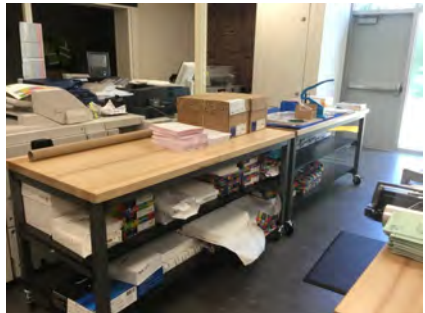
<input type="checkbox"/> Staff Only Priority Severity <input checked="" type="radio"/> 2 <input checked="" type="radio"/> 2			
1449	<ul style="list-style-type: none"> As-Built Description: Accessible non-fixed table or desk (top 28" to 34" high; knee space at least 27" high x 19" deep x 30" wide) not provided. As-Built: 36" high to the top. 3.25" deep knee and toe clearance Proposed Solution: Provide table or desk with accessible dimensions when purchasing new furniture. 	PCODE IN02A ADAAG 91 4.32.3 & .4 ADA 2010 306.1 CBC 2007 1122B.3 & 4 CBC 2016 11B-306.1 & 11B-902.3 Project: SKYB19 Swing Space Year to be Completed: 2020/2021 Mitigated: <input type="radio"/> YES <input checked="" type="radio"/> NO	1	JOB	\$4,800	\$4,800

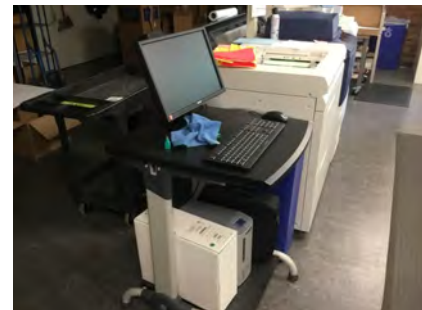
Item no., Rm no. and Name	Existing Architectural Barrier and Proposed Solution	Codes / Mitigation Info	Qty	Unit	Cost	Total
1455	<ul style="list-style-type: none"> As-Built Description: Accessible non-fixed table or desk (top 28" to 34" high; knee space at least 27" high x 19" deep x 30" wide) not provided. As-Built: No knee clearance Proposed Solution: Provide table or desk with accessible dimensions when purchasing new furniture. 	PCODE IN02A ADAAG 91 4.32.3 & .4 ADA 2010 306.1 CBC 2007 1122B.3 & 4 CBC 2016 11B-306.1 & 11B-902.3 Project: SKYB19 Swing Space Year to be Completed: 2020/2021 Mitigated: <input type="radio"/> YES <input checked="" type="radio"/> NO	1	JOB	\$4,800	\$4,800

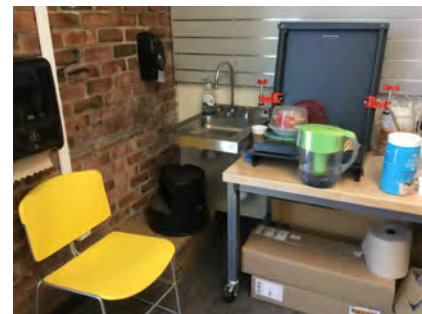
1454	<ul style="list-style-type: none"> As-Built Description: No min. 30" x 48" clear floor or ground space for forward or parallel approach. Proposed Solution: Relocate object to provide path to sink Notes: Clear floor space at sink is obstructed. Relocate desk. 	PCODE IN06E ADAAG 91 4.24.5 ADA 2010 606.2 CBC 2007 1115B.4.7.1 CBC 2016 11B-606.2 Project: SKYB19 Swing Space Year to be Completed: 2020/2021 Mitigated: <input type="radio"/> YES <input checked="" type="radio"/> NO	1	JOB	\$150	\$150
------	---	---	---	-----	-------	--------------

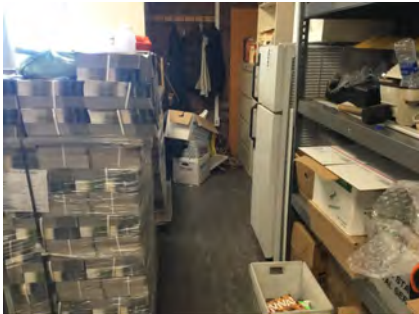
Item no., Rm no. and Name	Existing Architectural Barrier and Proposed Solution	Codes / Mitigation Info	Qty	Unit	Cost	Total
<u>Corridor</u>						
1458	<ul style="list-style-type: none">• <i>As-Built Description:</i> Corridor, for occupant load less than 10, less than 36" wide.• <i>As-Built:</i> 28"• <i>Proposed Solution:</i> Remove or relocate furniture and storage items.	<p>PCODE IH03A ADAAG 91 4.3.3 ADA 2010 403.5.1 CBC 2007 1133B.3.1 CBC 2016 11B-403.5.1</p> <p>Project: SKYB19 Swing Space</p> <p>Year to be Completed: 2020/2021</p> <p>Mitigated: <input type="radio"/> YES <input checked="" type="radio"/> NO</p>	1	JOB	\$150	\$150

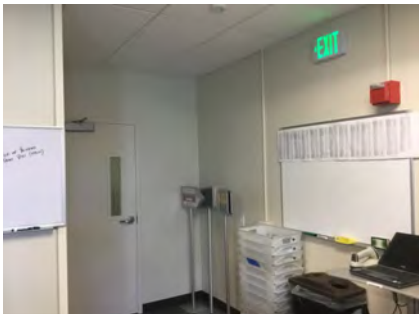
<input type="checkbox"/> Staff Only			
			Priority Severity <input checked="" type="radio"/> 4 <input checked="" type="radio"/> 2			
<u>Signage</u>						
1456	<ul style="list-style-type: none">• <i>As-Built Description:</i> At door leading into exit corridor: Where required exit signs are installed, signs to provide exiting information for people with vision impairment are not provided.• <i>Proposed Solution:</i> Provide raised letter/Braille "EXIT ROUTE" sign at door.	<p>PCODE SA10D ADAAG 91 4.1.3(16) ADA 2010 216.4.1 CBC 2007 1011.3 CBC 2016 11B-216.4.1</p> <p>Project: SKYB19 Swing Space</p> <p>Year to be Completed: 2020/2021</p> <p>Mitigated: <input type="radio"/> YES <input checked="" type="radio"/> NO</p>	5	JOB	\$270	\$1,350

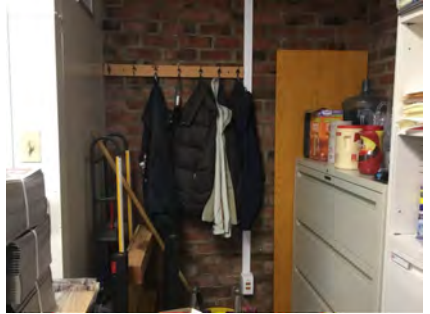
Item no., Rm no. and Name	Existing Architectural Barrier and Proposed Solution	Codes / Mitigation Info	Qty	Unit	Cost	Total
Coat Hook						
1460	<ul style="list-style-type: none"> As-Built Description: Accessible coat hook not within reach range. As-Built: 76" high Proposed Solution: Adjust existing or provide new coat hook at maximum 48" height. 	PCODE WG03A ADAAG 91 4.2.5 ADA 2010 603.4 CBC 2007 1118B.5 CBC 2016 11B-603.4 Project: SKYB19 Swing Space Year to be Completed: 2020/2021 Mitigated: <input type="radio"/> YES <input checked="" type="radio"/> NO	1	JOB	\$150	\$150

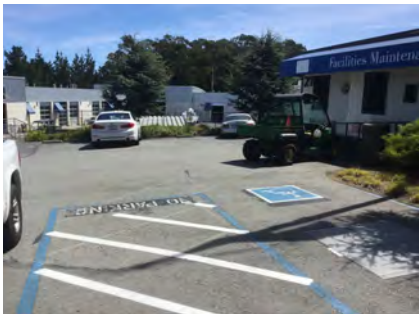
Item no., Rm no. and Name	Existing Architectural Barrier and Proposed Solution	Codes / Mitigation Info	Qty	Unit	Cost	Total
2188	<ul style="list-style-type: none">• <i>As-Built Description:</i> Disabled persons must wheel or walk behind parked car(s) other than their own.• <i>Proposed Solution:</i> Relocate parking and provide curb ramp to accessible route.	<div>PCODE EA03</div> <div>ADAAG 91 Fig.9</div> <div>ADA 2010 502.3</div> <div>CBC 2007 1129B.3.1</div> <div>CBC 2016 11B-502.7.1</div> <div>Mitigated:</div> <div><div><input type="radio"/></div> YES</div> <div><div><input checked="" type="radio"/></div> NO</div>	1	JOB	\$2,190	\$2,190

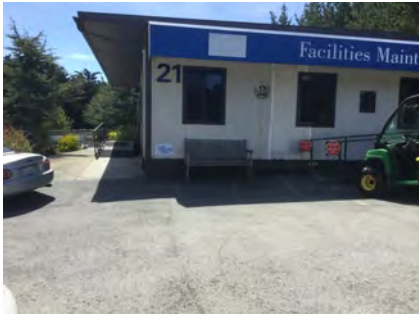
<div><input type="checkbox"/> Staff Only</div> <div><div>Priority</div><div>1</div><div>Severity</div><div>3</div></div>			
2189	<ul style="list-style-type: none">• <i>As-Built Description:</i> Accessible parking space(s) not located close to the nearest possible entrance on an accessible route.• <i>Proposed Solution:</i> Relocate accessible parking space(s).	<div>PCODE EA06REF</div> <div>ADAAG 91 4.6.2</div> <div>ADA 2010 208.3</div> <div>CBC 2007 1129B.1</div> <div>CBC 2016 11B-208.3.1</div> <div>Mitigated:</div> <div><div><input type="radio"/></div> YES</div> <div><div><input checked="" type="radio"/></div> NO</div>		REF

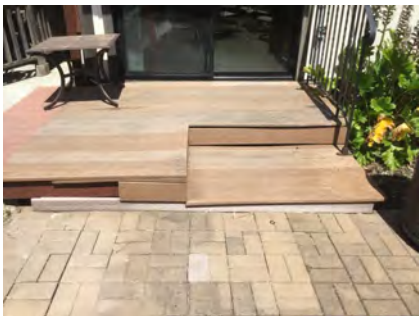
<div><input type="checkbox"/> Staff Only</div> <div><div>Priority</div><div>1</div><div>Severity</div><div>3</div></div>			
<u>Treads and Risers</u>						
2196	<ul style="list-style-type: none">• <i>As-Built Description:</i> Steps do not have uniform riser height.• <i>As-Built:</i> 3"-7.5"• <i>Proposed Solution:</i> Remodel stairs as needed.	<div>PCODE EC07A</div> <div>ADA 2010 504.2</div> <div>CBC 2007 1133B.4.5.3</div> <div>CBC 2016 11B-504.2</div> <div>Mitigated:</div> <div><div><input type="radio"/></div> YES</div> <div><div><input checked="" type="radio"/></div> NO</div>	8	LF	\$225	\$1,800

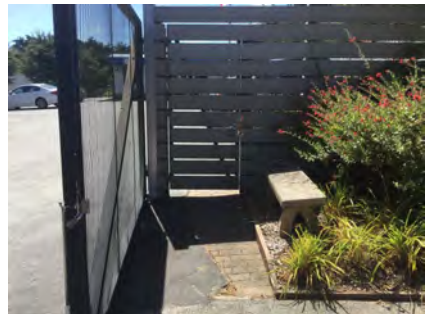
Item no., Rm no. and Name	Existing Architectural Barrier and Proposed Solution	Codes / Mitigation Info	Qty	Unit	Cost	Total
Door Swing						
2183	<ul style="list-style-type: none">• <i>As-Built Description:</i> Front approach: At pull side, door does not have clear and level maneuvering space measuring door width plus 18" x 60". (24" x 60" at exterior doors).• <i>As-Built:</i> 2" wide• <i>Proposed Solution:</i> Remove or relocate landscape.	<p>PCODE ID23A</p> <p>ADAAG 91 Fig. 25(a)</p> <p>ADA 2010 404.2.4</p> <p>CBC 2007 11B-26A(a)</p> <p>CBC 2016 11B-404.2.4</p> <p>Mitigated:</p> <p><input type="radio"/> YES</p> <p><input checked="" type="radio"/> NO</p>	1	JOB	\$150	\$150

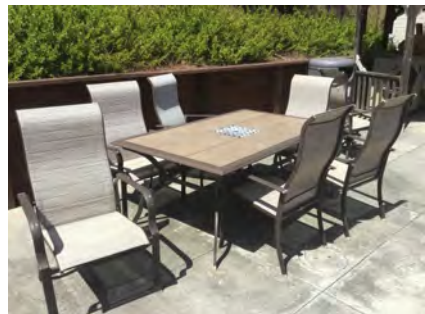
<input type="checkbox"/> Staff Only			
			Priority		Severity	
			1		2	
Non-Fixed Desk						
2193	<ul style="list-style-type: none">• <i>As-Built Description:</i> Accessible non-fixed table or desk (top 28" to 34" high; knee space at least 27" high x 19" deep x 30" wide) not provided.• <i>Proposed Solution:</i> Provide table or desk with accessible dimensions when purchasing new furniture.• <i>Notes:</i> 14 seats 0 accessible	<p>PCODE IN02A</p> <p>ADAAG 91 4.32.3 & .4</p> <p>ADA 2010 306.1</p> <p>CBC 2007 1122B.3 & 4</p> <p>CBC 2016 11B-306.1 & 11B-902.3</p> <p>Mitigated:</p> <p><input type="radio"/> YES</p> <p><input checked="" type="radio"/> NO</p>	1	JOB	\$4,800	\$4,800

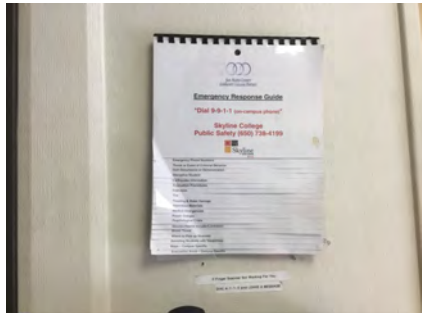
Item no., Rm no. and Name	Existing Architectural Barrier and Proposed Solution	Codes / Mitigation Info	Qty	Unit	Cost	Total
2214	<ul style="list-style-type: none"> As-Built Description: Reach height to control or access point, where side approach is available, exceeds 48" or is less than 15" in height, or exceeds 10" in depth. As-Built: 65" high Proposed Solution: Modify equipment or mounting. 	PCODE IE02 ADAAG 91 4.2.6 ADA 2010 308.3.1 CBC 2007 1118B.6 CBC 2016 11B-308.3 Mitigated: <input type="radio"/> YES <input checked="" type="radio"/> NO	1	JOB	\$300	\$300

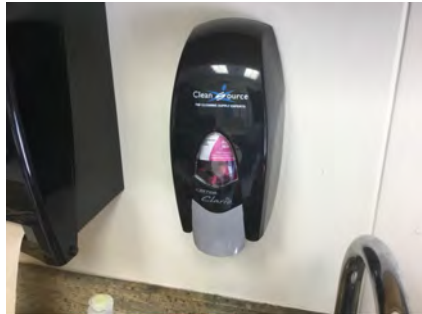
<input type="checkbox"/> Staff Only Priority 4 Severity 2						
2217	<ul style="list-style-type: none"> As-Built Description: Reach height to control or access point, where side approach is available, exceeds 48" or is less than 15" in height, or exceeds 10" in depth. As-Built: 21" deep, 47" high Proposed Solution: Modify equipment or mounting. 	PCODE IE02 ADAAG 91 4.2.6 ADA 2010 308.3.1 CBC 2007 1118B.6 CBC 2016 11B-308.3 Mitigated: <input type="radio"/> YES <input checked="" type="radio"/> NO	1	JOB	\$300	\$300

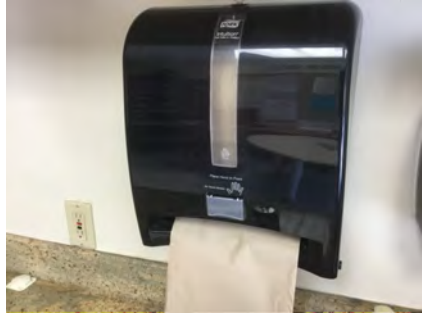
<input checked="" type="checkbox"/> Staff Only Priority 4 Severity 4						
2218	<ul style="list-style-type: none"> As-Built Description: Reach height to control or access point, where side approach is available, exceeds 48" or is less than 15" in height, or exceeds 10" in depth. As-Built: 50" high Proposed Solution: Modify equipment or mounting. 	PCODE IE02 ADAAG 91 4.2.6 ADA 2010 308.3.1 CBC 2007 1118B.6 CBC 2016 11B-308.3 Mitigated: <input type="radio"/> YES <input checked="" type="radio"/> NO	1	JOB	\$300	\$300

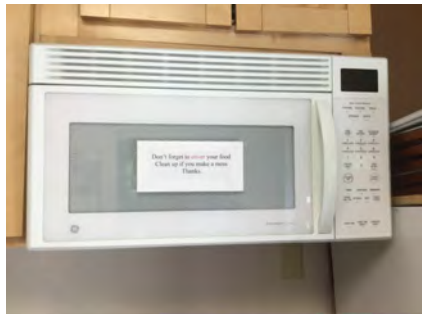
Item no., Rm no. and Name	Existing Architectural Barrier and Proposed Solution	Codes / Mitigation Info	Qty	Unit	Cost	Total
2252	<ul style="list-style-type: none"> As-Built Description: Reach height to control or access point, where side approach is available, exceeds 48" or is less than 15" in height, or exceeds 10" in depth. As-Built: 75" high Proposed Solution: Modify equipment or mounting. 	PCODE IE02 ADAAG 91 4.2.6 ADA 2010 308.3.1 CBC 2007 1118B.6 CBC 2016 11B-308.3 Mitigated: <input type="radio"/> YES <input checked="" type="radio"/> NO	1	JOB	\$300	\$300

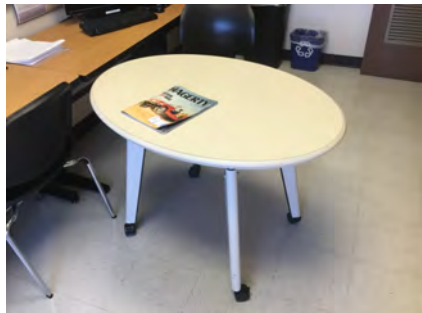
Non-Fixed Desk

2219	<ul style="list-style-type: none"> As-Built Description: Accessible non-fixed table or desk (top 28" to 34" high; knee space at least 27" high x 19" deep x 30" wide) not provided. As-Built: 2 seats 0 accessible Proposed Solution: Provide table or desk with accessible dimensions when purchasing new furniture. 	PCODE IN02A ADAAG 91 4.32.3 & .4 ADA 2010 306.1 CBC 2007 1122B.3 & 4 CBC 2016 11B-306.1 & 11B-902.3 Mitigated: <input type="radio"/> YES <input checked="" type="radio"/> NO	1	JOB	\$4,800	\$4,800

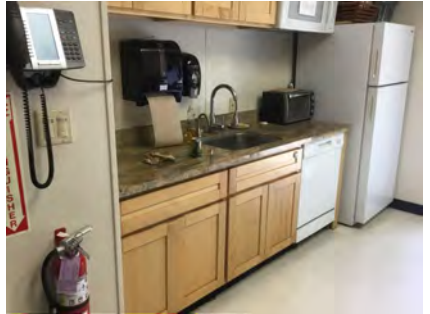
Item no., Rm no. and Name	Existing Architectural Barrier and Proposed Solution	Codes / Mitigation Info	Qty	Unit	Cost	Total
Sink						
2216	<ul style="list-style-type: none"> As-Built Description: Sink rim higher than 34" above floor. As-Built: 36" high Proposed Solution: Remodel sink cabinet to lower sink. 	PCODE IN06 ADAAG 91 4.24.2 ADA 2010 606.3 CBC 2007 1115B.4.7.1 CBC 2016 11B-606.3 Mitigated: <input type="radio"/> YES <input checked="" type="radio"/> NO	1	JOB	\$5,250	\$5,250

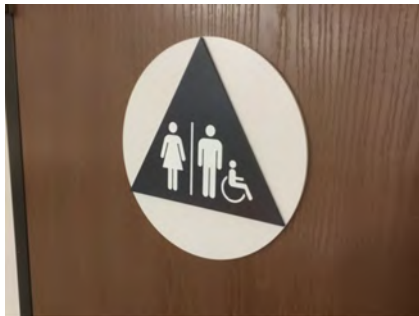
Item no., Rm no. and Name	Existing Architectural Barrier and Proposed Solution	Codes / Mitigation Info	Qty	Unit	Cost	Total
Signage						
2221	<ul style="list-style-type: none">As-Built Description: Required in CA only: identification symbol centered 58" to 60" high on sanitary facility door that contrasts with the door not provided (women: 12" ø circle, men: 12" triangle, unisex: combined symbol).As-Built: Not easedProposed Solution: Provide properly mounted sanitary facility symbol when altering area. If wheelchair accessible, include International Symbol of Accessibility on sign.	PCODE SA15 CBC 2007 1115B.6 CBC 2016 11B-703.7.2.6 Mitigated: <input type="radio"/> YES <input checked="" type="radio"/> NO	1	JOB	\$270	\$270

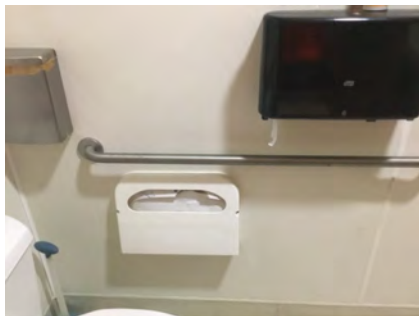
<input type="checkbox"/> Staff Only			
			Priority 3 Severity 3			
Grab Bars						
2234	<ul style="list-style-type: none">As-Built Description: Side grab bar less than 42" long, or located more than 12 inches max. from the rear wall, or extending less than 54" from rear wall (CA only: front end min. 24" in front of water closet).As-Built: Side ground bar extends 53" from rear wallProposed Solution: Provide or relocate accessible side grab bar.	PCODE WB07A ADAAG 91 Fig. 29(b) ADA 2010 604.5.1 CBC 2007 1115B.4.1.3.1 CBC 2016 11B-604.5.1 Mitigated: <input type="radio"/> YES <input checked="" type="radio"/> NO	1	JOB	\$780	\$780

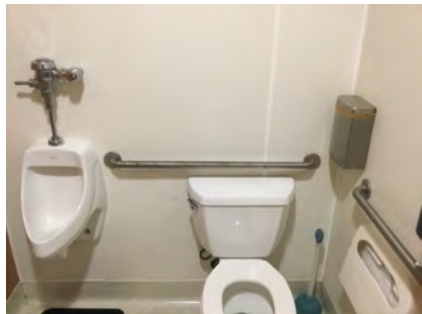
Item no., Rm no. and Name	Existing Architectural Barrier and Proposed Solution	Codes / Mitigation Info	Qty	Unit	Cost	Total
2233	<ul style="list-style-type: none"> • As-Built Description: The rear wall grab is less than 36" min. or does not extend from the centerline of the water closet 12" min. on one side and 24" min. on the other side. • As-Built: 23" on wide side • Proposed Solution: Provide or relocate accessible rear grab bar. 	PCODE WB07B ADAAG 91 4.17.6 ADA 2010 604.5.2 CBC 2007 1115B.4.1.3.2 CBC 2016 11B-604.5.2 Mitigated: <input type="radio"/> YES <input checked="" type="radio"/> NO	1	JOB	\$1,020	\$1,020

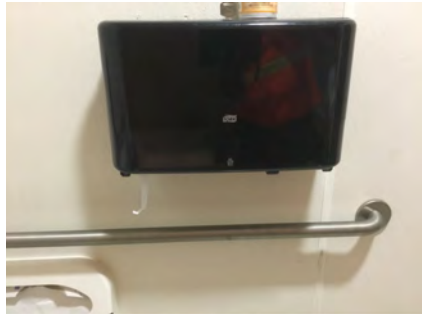
<input type="checkbox"/> Staff Only						
Priority 3 Severity 4						
2235	<ul style="list-style-type: none"> • As-Built Description: Accessories/dispensers in accessible stall located closer than 1-1/2" below or 12" above grab bar impedes its use. • As-Built: 5" above • Proposed Solution: Relocate accessories/dispensers to be no closer than 1-1/2" below and 12" above grab bars (except if accessories are recessed, flush with wall, and have no sharp edges). 	PCODE WB07I ADAAG 91 4.26.2 ADA 2010 609.3 CBC 2007 1133B.4.2.5 CBC 2016 11B-609.3 Mitigated: <input type="radio"/> YES <input checked="" type="radio"/> NO	1	JOB	\$225	\$225

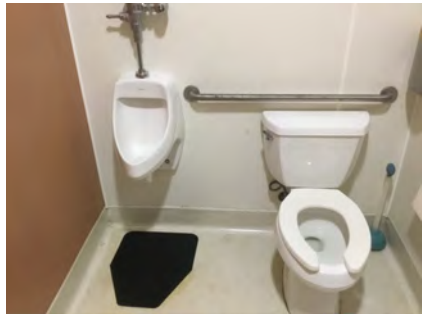
<input type="checkbox"/> Staff Only						
Priority 3 Severity 2						
<u>Toilet Stall</u>						
2222	<ul style="list-style-type: none"> • As-Built Description: 60" min. clearance around a water closet measured perpendicular from the side wall not provided (Fixtures are not allowed to overlap this clearance). • As-Built: 43" • Proposed Solution: Remove adjacent fixture. 	PCODE WB01A ADA 2010 604.3.1; 604.3.2 CBC 2007 1115B.7.1.3 CBC 2016 11B-604.3.1; 11B-604.3.2 Mitigated: <input type="radio"/> YES <input checked="" type="radio"/> NO	1	JOB	\$6,000	\$6,000

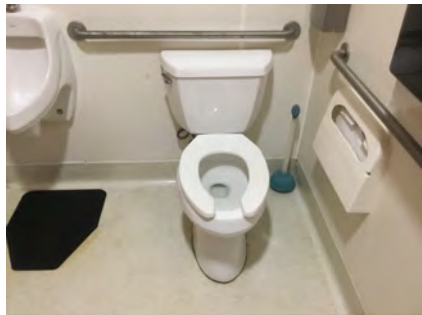
Item no., Rm no. and Name	Existing Architectural Barrier and Proposed Solution	Codes / Mitigation Info	Qty	Unit	Cost	Total
Water Closet						
2232	<ul style="list-style-type: none"> • <i>As-Built Description:</i> Water closet not 16"-18" (CA: 17"-18") from near side wall to center line of water closet (2010 ADAAG: 16"-18"). • <i>As-Built:</i> 18.5" o.c. • <i>Proposed Solution:</i> Relocate existing water closet and plumbing, remount with offset closet flange to provide 18" max. from side wall. 	PCODE WB02C ADAAG 91 Fig. 28 ADA 2010 604.2 CBC 2007 1115B.4.1.1 CBC 2016 11B-604.2 Mitigated: <input type="radio"/> YES <input checked="" type="radio"/> NO	1	JOB	\$1,500	\$1,500

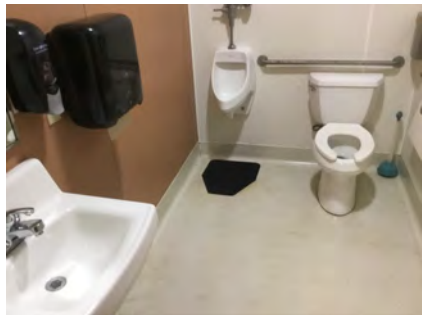
<input type="checkbox"/> Staff Only Priority 3 Severity 4			
2223	<ul style="list-style-type: none"> • <i>As-Built Description:</i> CA only: In single-accommodation restroom less than 48" in front of water closet provided. • <i>As-Built:</i> 44" to lavatory • <i>Proposed Solution:</i> Install shallow water closet. 	PCODE WB03A CBC 2007 1115B.3.2.1 CBC 2016 11B-604.3.1 Mitigated: <input type="radio"/> YES <input checked="" type="radio"/> NO	1	JOB	\$15,000	\$15,000

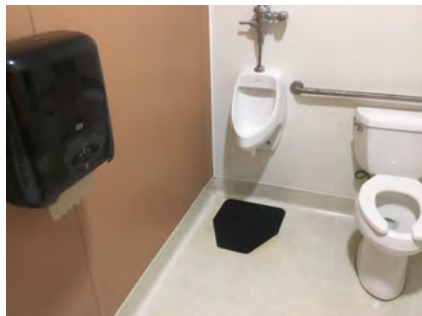
<input type="checkbox"/> Staff Only Priority 3 Severity 4			
2224	<ul style="list-style-type: none"> • <i>As-Built Description:</i> CA only: In single-accommodation restroom less than 48" in front of water closet provided. • <i>As-Built:</i> 23" to PTD • <i>Proposed Solution:</i> Relocate paper towel dispenser. 	PCODE WB03A CBC 2007 1115B.3.2.1 CBC 2016 11B-604.3.1 Mitigated: <input type="radio"/> YES <input checked="" type="radio"/> NO	1	JOB	\$150	\$150

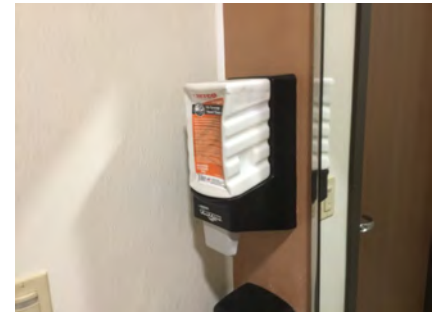
- 2227
- *As-Built Description:*
Dispensers in sanitary facilities, such as for towels, soap, sanitary napkins, seat covers, etc., and waste receptacles more than 48" (CA only: 40") from floor to highest operating slot or control.
 - *As-Built:* **52" high**
 - *Proposed Solution:*
Relocate existing restroom accessories.

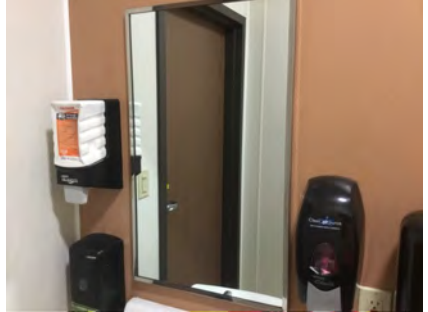
Item no., Rm no. and Name	Existing Architectural Barrier and Proposed Solution	Codes / Mitigation Info	Qty	Unit	Cost	Total
2228	<ul style="list-style-type: none"> As-Built Description: Bottom of mirror located above lavatories or countertops more than 40" above floor. As-Built: 41" high Proposed Solution: Relocate or provide new accessible mirror. 	PCODE WG03 ADAAG 91 4.19.6 ADA 2010 603.3 CBC 2007 1115B.8.1 CBC 2016 11B-603.3 Mitigated: <input type="radio"/> YES <input checked="" type="radio"/> NO	1	JOB	\$450	\$450

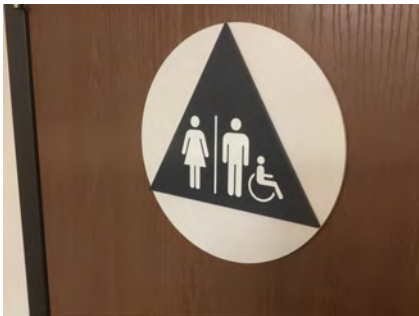
Item no., Rm no. and Name	Existing Architectural Barrier and Proposed Solution	Codes / Mitigation Info	Qty	Unit	Cost	Total
Signage						
2239	<ul style="list-style-type: none">As-Built Description: Required in CA only: identification symbol centered 58" to 60" high on sanitary facility door that contrasts with the door not provided (women: 12" ø circle, men: 12" triangle, unisex: combined symbol).As-Built: Not leveled properly. Radius.Proposed Solution: Provide properly mounted sanitary facility symbol when altering area. If wheelchair accessible, include International Symbol of Accessibility on sign.	PCODE SA15 CBC 2007 1115B.6 CBC 2016 11B-703.7.2.6 Mitigated: <input type="radio"/> YES <input checked="" type="radio"/> NO	1	JOB	\$270	\$270

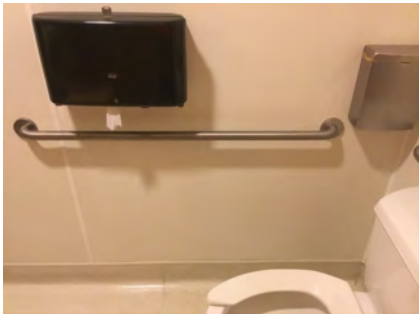
<input type="checkbox"/> Staff Only			
			Priority		Severity	
			3		3	
Grab Bars						
2248	<ul style="list-style-type: none">As-Built Description: Side grab bar less than 42" long, or located more than 12 inches max. from the rear wall, or extending less than 54" from rear wall (CA only: front end min. 24" in front of water closet).As-Built: Side grab bar extends 53" from the rear wallProposed Solution: Provide or relocate accessible side grab bar.	PCODE WB07A ADAAG 91 Fig. 29(b) ADA 2010 604.5.1 CBC 2007 1115B.4.1.3.1 CBC 2016 11B-604.5.1 Mitigated: <input type="radio"/> YES <input checked="" type="radio"/> NO	1	JOB	\$780	\$780

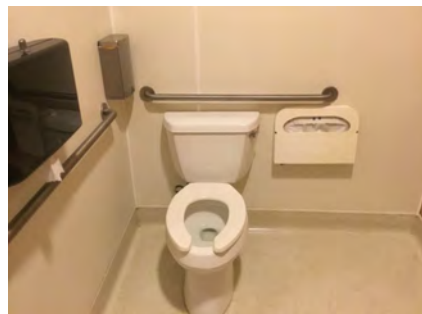
Item no., Rm no. and Name	Existing Architectural Barrier and Proposed Solution	Codes / Mitigation Info	Qty	Unit	Cost	Total
2247	<ul style="list-style-type: none">As-Built Description: The rear wall grab is less than 36" min. or does not extend from the centerline of the water closet 12" min. on one side and 24" min. on the other side.As-Built: 23" on the wide sideProposed Solution: Provide or relocate accessible rear grab bar.	PCODE WB07B ADAAG 91 4.17.6 ADA 2010 604.5.2 CBC 2007 1115B.4.1.3.2 CBC 2016 11B-604.5.2 Mitigated: <input type="radio"/> YES <input checked="" type="radio"/> NO	1	JOB	\$1,020	\$1,020

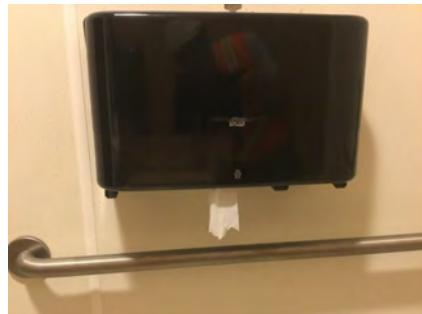
<input type="checkbox"/> Staff Only			
			Priority 3 Severity 4			
2249	<ul style="list-style-type: none">As-Built Description: Accessories/dispensers in accessible stall located closer than 1-1/2" below or 12" above grab bar impedes its use.As-Built: 4" aboveProposed Solution: Relocate accessories/dispensers to be no closer than 1-1/2" below and 12" above grab bars (except if accessories are recessed, flush with wall, and have no sharp edges).	PCODE WB071 ADAAG 91 4.26.2 ADA 2010 609.3 CBC 2007 1133B.4.2.5 CBC 2016 11B-609.3 Mitigated: <input type="radio"/> YES <input checked="" type="radio"/> NO	1	JOB	\$225	\$225

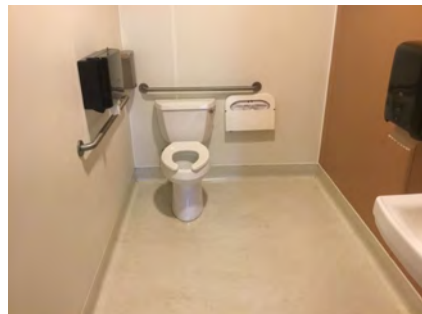
<input type="checkbox"/> Staff Only			
			Priority 3 Severity 2			
<u>Water Closet</u>						
2244	<ul style="list-style-type: none">As-Built Description: CA only: In single-accommodation restroom less than 48" in front of water closet provided.As-Built: 44" to lavatoryProposed Solution: Install lower profile water closet.	PCODE WB03A CBC 2007 1115B.3.2.1 CBC 2016 11B-604.3.1 Mitigated: <input type="radio"/> YES <input checked="" type="radio"/> NO	1	JOB	\$1,500	\$1,500

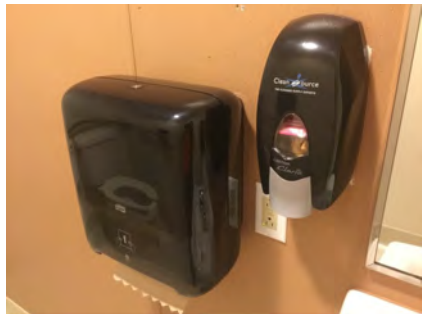
Item no., Rm no. and Name	Existing Architectural Barrier and Proposed Solution	Codes / Mitigation Info	Qty	Unit	Cost	Total
2245	<ul style="list-style-type: none"> As-Built Description: CA only: In single-accommodation restroom less than 48" in front of water closet provided. As-Built: Dispensers are less than 48" from the front of the water closet Proposed Solution: Relocate the dispensers or install lower profile dispensers. 	PCODE WB03AREF CBC 2007 1115B.3.2.1 CBC 2016 11B-604.3.1 Mitigated: <input type="radio"/> YES <input checked="" type="radio"/> NO		REF

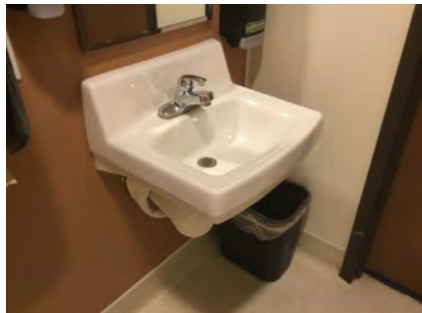
<input type="checkbox"/> Staff Only						
Priority 3 Severity 4						
<hr/>						
2240	Lavatory <ul style="list-style-type: none"> As-Built Description: Wheelchair clearance under lavatory apron or lavatory counter front edge less than 29" high. As-Built: 28.75" high Proposed Solution: Raise lavatory. 	PCODE WD03 ADAAG 91 4.19.2 ADA 2010 606.3 CBC 2007 1115B.4.3.3 CBC 2016 11B-306.3.1 Mitigated: <input type="radio"/> YES <input checked="" type="radio"/> NO		1 JOB	\$10,200	\$10,200

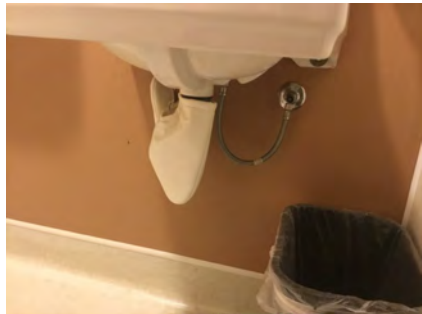
<input type="checkbox"/> Staff Only						
Priority 3 Severity 2						
<hr/>						
2241	<ul style="list-style-type: none"> As-Built Description: Hot or sharp-surfaced water/drain pipe not insulated or covered. Proposed Solution: Insulate or cover water/drain pipe. 	PCODE WD05 ADAAG 91 4.19.4 ADA 2010 606.5 CBC 2007 1115B.4.3.4 CBC 2016 11B-606.5 Mitigated: <input type="radio"/> YES <input checked="" type="radio"/> NO		1 JOB	\$360	\$360

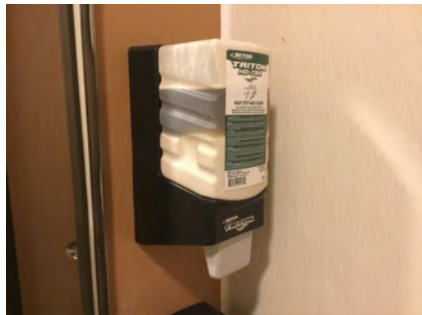
Item no., Rm no. and Name	Existing Architectural Barrier and Proposed Solution	Codes / Mitigation Info	Qty	Unit	Cost	Total
Accessories						
2243	<ul style="list-style-type: none"> • <i>As-Built Description:</i> Dispensers in sanitary facilities, such as for towels, soap, sanitary napkins, seat covers, etc., and waste receptacles more than 48" (CA only: 40") from floor to highest operating slot or control. • <i>As-Built:</i> 52" • <i>Proposed Solution:</i> Relocate existing restroom accessories. 	PCODE WG01A ADAAG 91 4.23.7 ADA 2010 308.2.1 CBC 2007 1115B.8.3 CBC 2016 11B-603.5 Mitigated: <input type="radio"/> YES <input checked="" type="radio"/> NO	1	JOB	\$300	\$300

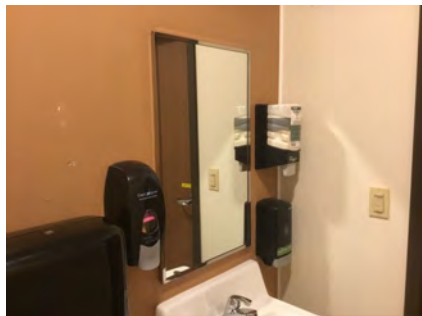
<input type="checkbox"/> Staff Only			
			Priority	Severity		
			3	2		
2242	<ul style="list-style-type: none"> • <i>As-Built Description:</i> Bottom of mirror located above lavatories or countertops more than 40" above floor. • <i>As-Built:</i> 42" high • <i>Proposed Solution:</i> Relocate or provide new accessible mirror. 	PCODE WG03 ADAAG 91 4.19.6 ADA 2010 603.3 CBC 2007 1115B.8.1 CBC 2016 11B-603.3 Mitigated: <input type="radio"/> YES <input checked="" type="radio"/> NO	1	JOB	\$450	\$450

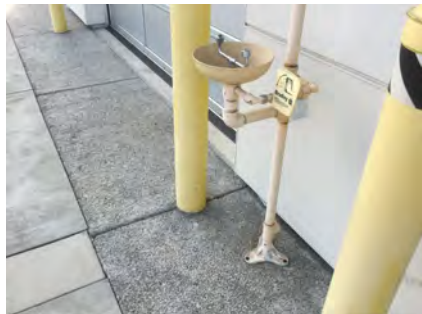
Item no., Rm no. and Name	Existing Architectural Barrier and Proposed Solution	Codes / Mitigation Info	Qty	Unit	Cost	Total
2152	<ul style="list-style-type: none"> • <i>As-Built Description:</i> Minimum of at least one of each type of sink and other specialized equipment such as fume hoods, microscopes, emergency eyewash and showers, etc, associated with the special use activity is not accessible. (CA Only) • <i>As-Built:</i> 10" deep toe clearance • <i>Proposed Solution:</i> Remodel existing cabinet/counter to make specialized equipment accessible to disabled persons. 	PCODE LB01B CBC 2007 1106B.2 CBC 2016 11B-805.7 Mitigated: <input type="radio"/> YES <input checked="" type="radio"/> NO	1	JOB	\$5,400	\$5,400

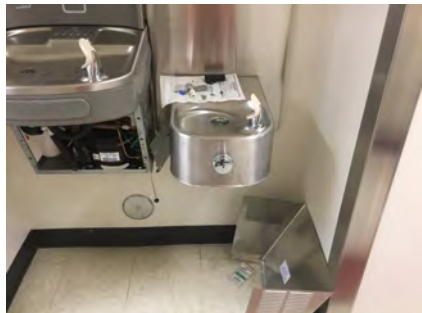
2096	<ul style="list-style-type: none"> • <i>As-Built Description:</i> Wall- and post-mounted cantilevered units: Knee space not provided at drinking fountain (27" high, 8" deep, 30" wide from front of drinking fountain). • <i>As-Built:</i> 26.7" high • <i>Proposed Solution:</i> Provide new, accessible fountain. 	PCODE IA02 ADAAG 91 4.15.5(1) ADA 2010 602.2 CBC 2007 1115B.4.6.2 CBC 2016 11B-602.2 Mitigated: <input type="radio"/> YES <input checked="" type="radio"/> NO	1	JOB	\$9,600	\$9,600

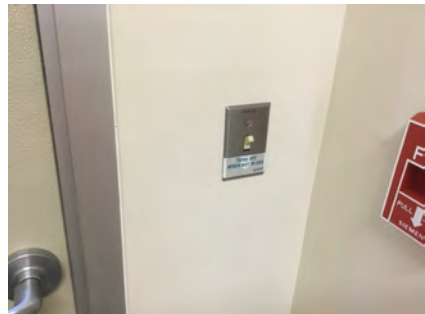
Item no., Rm no. and Name	Existing Architectural Barrier and Proposed Solution	Codes / Mitigation Info	Qty	Unit	Cost	Total
Electrical						
2093	<ul style="list-style-type: none">As-Built Description: Electric switch or control mounted less than 15" measured to the bottom of the outlet box or greater than 48 inches measured to the top of the outlet box.As-Built: 48.5" to the top of the switchProposed Solution: Relocate light switches or control to between 15" and 48" height.	<p>PCODE IC01</p> <p>ADAAG 91 4.2.5 & 6</p> <p>ADA 2010 308.2.1 &</p> <p>CBC 2007 1117B.6.3</p> <p>CBC 2016 11B-308.2.1 & 11B-308.2.2</p> <p>Mitigated:</p> <p><input type="radio"/> YES</p> <p><input checked="" type="radio"/> NO</p>	1	JOB	\$900	\$900

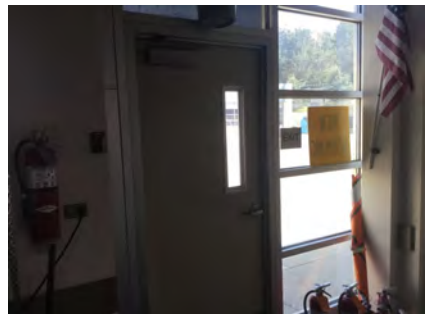
<input type="checkbox"/> Staff Only			
			<div>Priority<div>2</div></div> <div>Severity<div>4</div></div>			
Door						
2138	<ul style="list-style-type: none">As-Built Description: Vision Light at door that permits viewing, does not have bottom of at least one glazed panel located 43 inches maximum above the finish floor. (Exception: More than 66" above finished floor.)As-Built: 48" highProposed Solution: Provide new door with vision panel at 43" max.	<p>PCODE ID06C</p> <p>ADA 2010 404.2.11</p> <p>CBC 2016 11B-404.2.11</p> <p>Mitigated:</p> <p><input type="radio"/> YES</p> <p><input checked="" type="radio"/> NO</p>	1	JOB	\$7,500	\$7,500

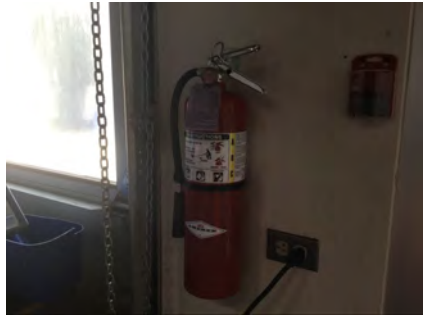
Item no., Rm no. and Name	Existing Architectural Barrier and Proposed Solution	Codes / Mitigation Info	Qty	Unit	Cost	Total
Reach Range						
2139	<ul style="list-style-type: none"> As-Built Description: Reach height to control or access point, where side approach is available, exceeds 48" or is less than 15" in height, or exceeds 10" in depth. As-Built: 64" high Proposed Solution: Modify equipment or mounting. 	PCODE IE02 ADAAG 91 4.2.6 ADA 2010 308.3.1 CBC 2007 1118B.6 CBC 2016 11B-308.3 Mitigated: <input type="radio"/> YES <input checked="" type="radio"/> NO	4	JOB	\$300	\$1,200

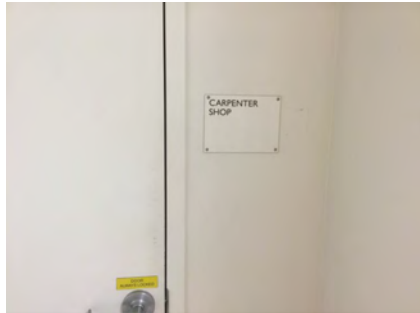
<input type="checkbox"/> Staff Only Priority 2 Severity 4			
2098	<ul style="list-style-type: none"> As-Built Description: Signs containing tactile characters is not located so that a clear floor space of 18" min x 18" min., centered on the tactile characters, is provided beyond the arc of any door swing between the closed position and 45 degree open position. As-Built: Centerline of Braille and tactile 6" from the swing of the door Proposed Solution: Relocate compliant signage on latch side of door located at compliant height with a clear floor space. 	PCODE SA07B ADA 2010 703.4.2 CBC 2016 11B-703.4.2 Mitigated: <input type="radio"/> YES <input checked="" type="radio"/> NO	1	JOB	\$150	\$150

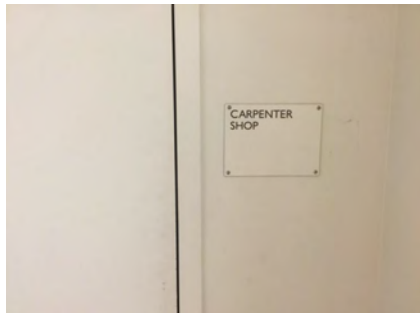
<input type="checkbox"/> Staff Only Priority 2 Severity 4			
2094	<ul style="list-style-type: none"> As-Built Description: Braille symbols: dots are not 1/10" on centers in each cell with 2/10" space between cells. As-Built: More than 0.5" between the Braille and the tactile characters Proposed Solution: CA only - Provide new compliant signage including Contracted Grade 2 Braille with Title 24 spacing requirements - 1/10" on center dots with 2/10" space between cells. 	PCODE SA07C CBC 2007 1117B.5.6 CBC 2016 11B-703.3 Mitigated: <input type="radio"/> YES <input checked="" type="radio"/> NO	1	JOB	\$450	\$450

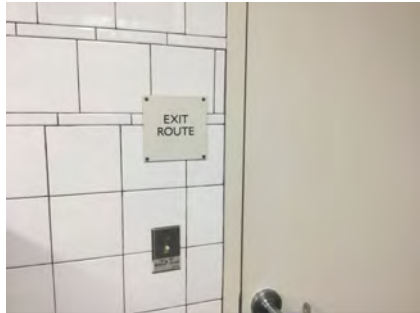
<input type="checkbox"/> Staff Only Priority 3 Severity 4			
2099	<ul style="list-style-type: none"> As-Built Description: Required in CA only: identification symbol centered 58" to 60" high on sanitary facility door that contrasts with the door not provided (women: 12" ø circle, men: 12" triangle, unisex: combined symbol). As-Built: Edges are not eased. No radius. Glare. Proposed Solution: Provide properly mounted sanitary facility symbol when altering area. If wheelchair accessible, include International Symbol of Accessibility on sign. 	PCODE SA15 CBC 2007 1115B.6 CBC 2016 11B-703.7.2.6 Mitigated: <input type="radio"/> YES <input checked="" type="radio"/> NO	1	JOB	\$270	\$270

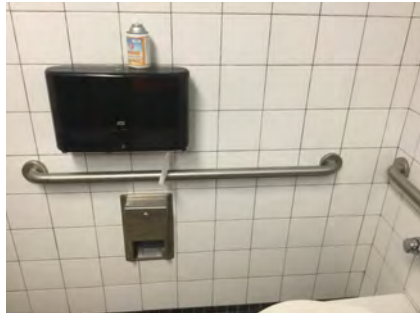
<input type="checkbox"/> Staff Only			
			Priority 3 Severity 4			
2107	<ul style="list-style-type: none"> • <i>As-Built Description:</i> The rear wall grab is less than 36" min. or does not extend from the centerline of the water closet 12" min. on one side and 24" min. on the other side. • <i>As-Built:</i> 20" on the wide side • <i>Proposed Solution:</i> Provide or relocate accessible rear grab bar. 	PCODE WB07B ADAAG 91 4.17.6 ADA 2010 604.5.2 CBC 2007 1115B.4.1.3.2 CBC 2016 11B-604.5.2 Mitigated: <input type="radio"/> YES <input checked="" type="radio"/> NO	1	JOB	\$1,020	\$1,020

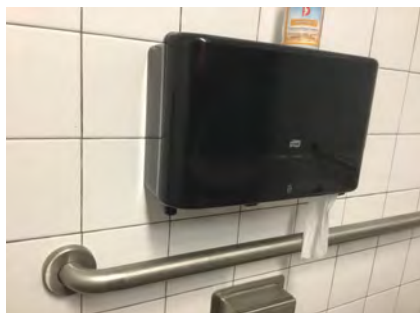
<input type="checkbox"/> Staff Only			
			Priority 3 Severity 3			
2109	<ul style="list-style-type: none"> • <i>As-Built Description:</i> Accessories/dispensers in accessible stall located closer than 1-1/2" below or 12" above grab bar impedes its use. • <i>As-Built:</i> 3" above the side grab bar • <i>Proposed Solution:</i> Relocate accessories/dispensers to be no closer than 1-1/2" below and 12" above grab bars (except if accessories are recessed, flush with wall, and have no sharp edges). 	PCODE WB07I ADAAG 91 4.26.2 ADA 2010 609.3 CBC 2007 1133B.4.2.5 CBC 2016 11B-609.3 Mitigated: <input type="radio"/> YES <input checked="" type="radio"/> NO	1	JOB	\$225	\$225

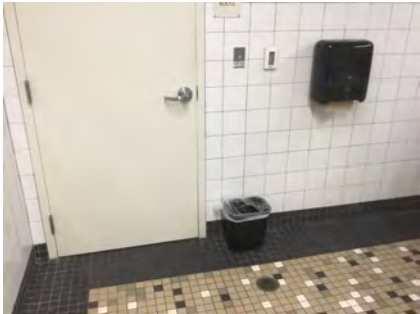
<input type="checkbox"/> Staff Only			
			Priority	Severity		
			3	4		
Signage						
2120	<ul style="list-style-type: none">As-Built Description: Signs containing tactile characters is not located so that a clear floor space of 18" min x 18" min., centered on the tactile characters, is provided beyond the arc of any door swing between the closed position and 45 degree open position.As-Built: 7" from the center of the Braille and tactile to the door swingProposed Solution: Relocate compliant signage on latch side of door located at compliant height with a clear floor space.	PCODE SA07B ADA 2010 703.4.2 CBC 2016 11B-703.4.2 Mitigated: <input type="radio"/> YES <input checked="" type="radio"/> NO	1	JOB	\$150	\$150

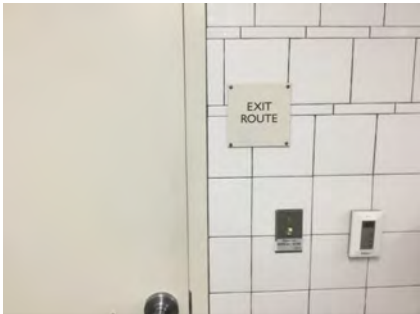
Item no., Rm no. and Name	Existing Architectural Barrier and Proposed Solution	Codes / Mitigation Info	Qty	Unit	Cost	Total
2117	<ul style="list-style-type: none"> As-Built Description: Required in CA only: identification symbol centered 58" to 60" high on sanitary facility door that contrasts with the door not provided (women: 12" ø circle, men: 12" triangle, unisex: combined symbol). As-Built: Edges not eased. Glare. Proposed Solution: Provide properly mounted sanitary facility symbol when altering area. If wheelchair accessible, include International Symbol of Accessibility on sign. 	PCODE SA15 CBC 2007 1115B.6 CBC 2016 11B-703.7.2.6 Mitigated: <input type="radio"/> YES <input checked="" type="radio"/> NO	1	JOB	\$270	\$270

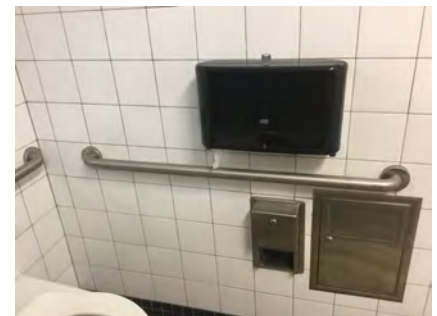
2125	<ul style="list-style-type: none"> As-Built Description: The rear wall grab is less than 36" min. or does not extend from the centerline of the water closet 12" min. on one side and 24" min. on the other side. As-Built: 20" on the wide side Proposed Solution: Provide or relocate accessible rear grab bar. 	PCODE WB07B ADAAG 91 4.17.6 ADA 2010 604.5.2 CBC 2007 1115B.4.1.3.2 CBC 2016 11B-604.5.2 Mitigated: <input type="radio"/> YES <input checked="" type="radio"/> NO	1	JOB	\$1,020	\$1,020
------	---	---	---	-----	---------	---------

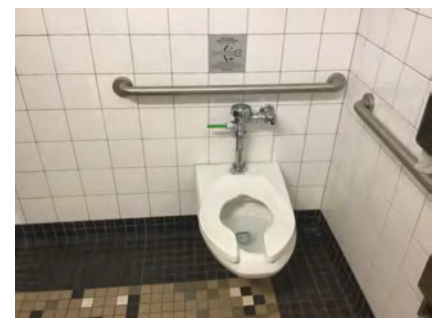
Item no., Rm no. and Name	Existing Architectural Barrier and Proposed Solution	Codes / Mitigation Info	Qty	Unit	Cost	Total
2128	<ul style="list-style-type: none"> As-Built Description: Accessories/dispensers in accessible stall located closer than 1-1/2" below or 12" above grab bar impedes its use. As-Built: 3" above the side grab bar Proposed Solution: Relocate accessories/dispensers to be no closer than 1-1/2" below and 12" above grab bars (except if accessories are recessed, flush with wall, and have no sharp edges). 	PCODE WB071 ADAAG 91 4.26.2 ADA 2010 609.3 CBC 2007 1133B.4.2.5 CBC 2016 11B-609.3 Mitigated: <input type="radio"/> YES <input checked="" type="radio"/> NO	1	JOB	\$225	\$225

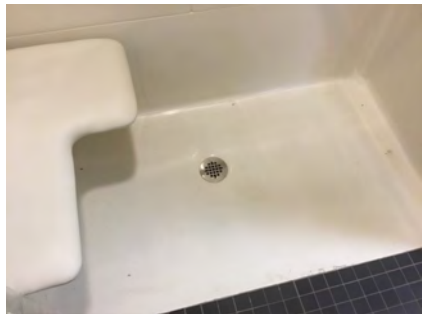
Item no., Rm no. and Name	Existing Architectural Barrier and Proposed Solution	Codes / Mitigation Info	Qty	Unit	Cost	Total
2136	<ul style="list-style-type: none"> • As-Built Description: Floor surface sloped greater than 2.0% (1:48) due to drain. • As-Built: 5% • Proposed Solution: Remodel floor surface to compliance. 	PCODE WF06A ADA 2010 608.9 CBC 2016 11B-608.9 Mitigated: <input type="radio"/> YES <input checked="" type="radio"/> NO	1	JOB	\$1,500	\$1,500

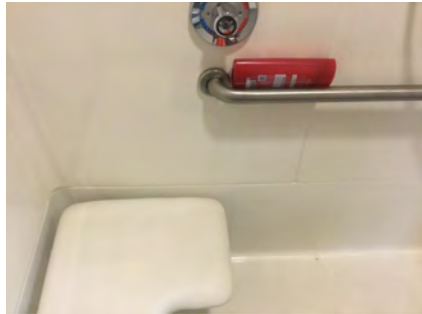
<input type="checkbox"/> Staff Only Priority 3 Severity 3						
2134	<ul style="list-style-type: none"> • As-Built Description: In a standard roll-in type shower, grab bars are not provided on the back wall and side wall opposite the seat. Grab bars shall not be provided above the seat. • Proposed Solution: Relocate grab bars in shower. • Notes: Grab bar is above the shower bench. 	PCODE WF08C ADA 2010 608.3.2 CBC 2016 11B-608.3.2 Mitigated: <input type="radio"/> YES <input checked="" type="radio"/> NO	1	JOB	\$1,500	\$1,500

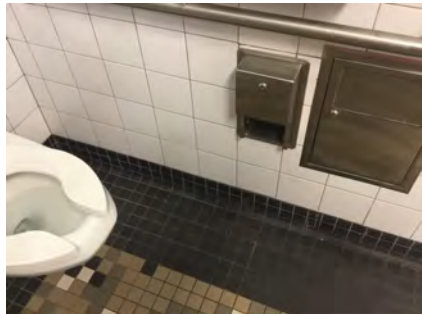
<input type="checkbox"/> Staff Only Priority 3 Severity 3						
Accessories						
2127	<ul style="list-style-type: none"> • As-Built Description: Toilet paper dispenser less than 15" (CA: 19") or more than 48" above floor or not within 7" to 9" from front of water closet (Note: CA pre-2010 is allowed within 12" from front of water closet). • As-Built: 11" from the front of the water closet • Proposed Solution: Relocate or provide new toilet paper dispenser. 	PCODE WG02 ADAAG 91 4.16.6 ADA 2010 604.7 CBC 2007 1115B.8.4 CBC 2016 11B-604.7 Mitigated: <input type="radio"/> YES <input checked="" type="radio"/> NO	1	JOB	\$225	\$225

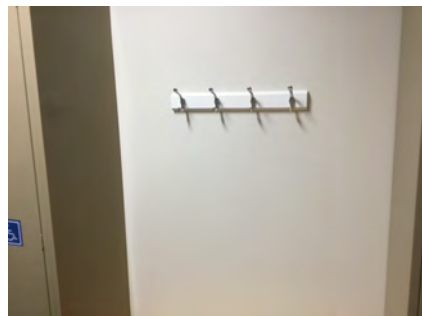
Item no., Rm no. and Name	Existing Architectural Barrier and Proposed Solution	Codes / Mitigation Info	Qty	Unit	Cost	Total
<u>Coat Hook</u>						
2132	<ul style="list-style-type: none">• <i>As-Built Description:</i> Accessible coat hook not within reach range.• <i>As-Built:</i> 60" high• <i>Proposed Solution:</i> Adjust existing or provide new coat hook at maximum 48" height.	<p>PCODE WG03A</p> <p>ADAAG 91 4.2.5</p> <p>ADA 2010 603.4</p> <p>CBC 2007 1118B.5</p> <p>CBC 2016 11B-603.4</p> <p>Mitigated:</p> <p><input type="radio"/> YES</p> <p><input checked="" type="radio"/> NO</p>	1	JOB	\$150	\$150

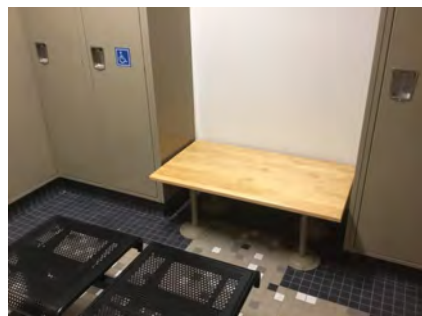
<input type="checkbox"/> Staff Only			
			Priority		Severity	
			3		2	
<u>Locker Facilities</u>						
2129	<ul style="list-style-type: none">• <i>As-Built Description:</i> 60" square min clear space in front of the accessible bench section, to allow a person using a wheelchair to make a parallel transfer onto the bench not provided.• <i>Proposed Solution:</i> Remove and relocate bench and patch floor to provide adequate 60" square wheelchair space between locker and bench.• Notes: No clear floor space at the end of the accessible bench.	<p>PCODE GG01</p> <p>ADAAG 91 4.35.2</p> <p>ADA 2010 803.2</p> <p>CBC 2007 1117B.8</p> <p>CBC 2016 11B-803.2</p> <p>Mitigated:</p> <p><input type="radio"/> YES</p> <p><input checked="" type="radio"/> NO</p>	1	JOB	\$450	\$450

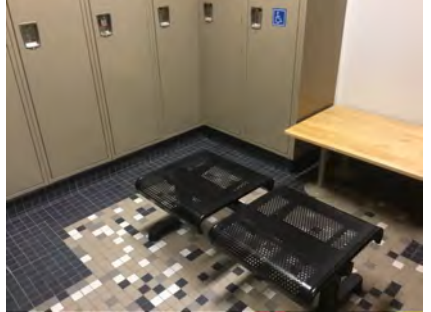
Item no., Rm no. and Name	Existing Architectural Barrier and Proposed Solution	Codes / Mitigation Info	Qty	Unit	Cost	Total
2130	<ul style="list-style-type: none"> • As-Built Description: 60" square min clear space in front of the accessible bench section, to allow a person using a wheelchair to make a parallel transfer onto the bench not provided. • Proposed Solution: Remove and relocate bench and patch floor to provide adequate 60" square wheelchair space between locker and bench. • Notes: Clear floor space at accessible locker and route to accessible locker obstructed by movable bench. 	PCODE GG01 ADAAG 91 4.35.2 ADA 2010 803.2 CBC 2007 1117B.8 CBC 2016 11B-803.2 Mitigated: <input type="radio"/> YES <input checked="" type="radio"/> NO	1	JOB	\$450	\$450

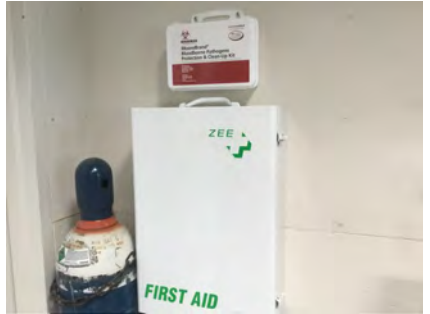
Item no., Rm no. and Name	Existing Architectural Barrier and Proposed Solution	Codes / Mitigation Info	Qty	Unit	Cost	Total
Reach Range						
2146	<ul style="list-style-type: none"> As-Built Description: Reach height to control or access point, where side approach is available, exceeds 48" or is less than 15" in height, or exceeds 10" in depth. As-Built: 60" and 72" to first aid and pathogen cleanup kit Proposed Solution: Modify equipment or mounting. 	PCODE IE02 ADAAG 91 4.2.6 ADA 2010 308.3.1 CBC 2007 1118B.6 CBC 2016 11B-308.3 Mitigated: <input type="radio"/> YES <input checked="" type="radio"/> NO	3	JOB	\$300	\$900

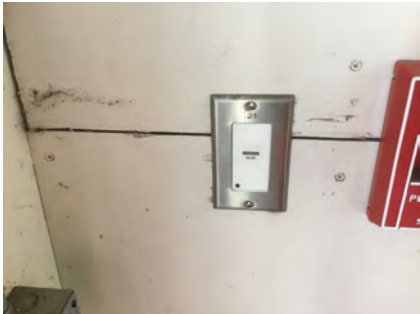
Item no., Rm no. and Name	Existing Architectural Barrier and Proposed Solution	Codes / Mitigation Info	Qty	Unit	Cost	Total
Electrical						
2166	<ul style="list-style-type: none">• <i>As-Built Description:</i> Electric switch or control mounted less than 15" measured to the bottom of the outlet box or greater than 48 inches measured to the top of the outlet box.• <i>As-Built:</i> 48.25" to the top of the switch 50" to the top of the box• <i>Proposed Solution:</i> Relocate light switches or control to between 15" and 48" height.	<p>PCODE IC01</p> <p>ADAAG 91 4.2.5 & 6</p> <p>ADA 2010 308.2.1 &</p> <p>CBC 2007 1117B.6.3</p> <p>CBC 2016 11B-308.2.1 & 11B-308.2.2</p> <p>Mitigated:</p> <p><input type="radio"/> YES</p> <p><input checked="" type="radio"/> NO</p>	1	JOB	\$900	\$900

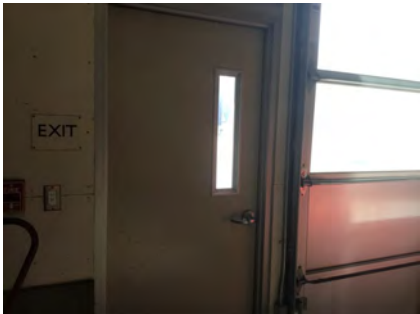
<input type="checkbox"/> Staff Only			
			<div>Priority 2Severity 4</div>			
Door						
2155	<ul style="list-style-type: none">• <i>As-Built Description:</i> Vision Light at door that permits viewing, does not have bottom of at least one glazed panel located 43 inches maximum above the finish floor. (Exception: More than 66" above finished floor.)• <i>As-Built:</i> 48" high• <i>Proposed Solution:</i> Provide new door with vision panel at 43" max.	<p>PCODE ID06C</p> <p>ADA 2010 404.2.11</p> <p>CBC 2016 11B-404.2.11</p> <p>Mitigated:</p> <p><input type="radio"/> YES</p> <p><input checked="" type="radio"/> NO</p>	1	JOB	\$7,500	\$7,500

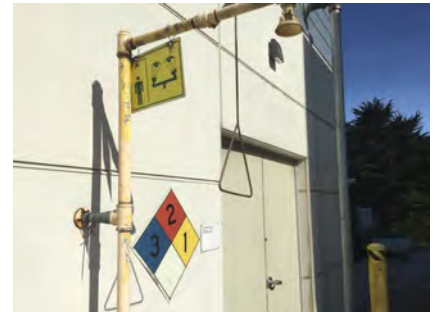
- 2165
- *As-Built Description:*
Reach height to control or access point, where side approach is available, exceeds 48" or is less than 15" in height, or exceeds 10" in depth.
 - *As-Built:* **68" high**
 - *Proposed Solution:*
Modify equipment or mounting.

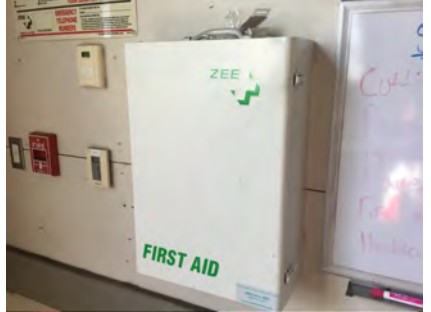
Item no., Rm no. and Name	Existing Architectural Barrier and Proposed Solution	Codes / Mitigation Info	Qty	Unit	Cost	Total
2159	<ul style="list-style-type: none"> • <i>As-Built Description:</i> Reach height to control or access point, where side approach is available, exceeds 48" or is less than 15" in height, or exceeds 10" in depth. • <i>As-Built:</i> 59" high • <i>Proposed Solution:</i> Modify equipment or mounting. 	PCODE IE02 ADAAG 91 4.2.6 ADA 2010 308.3.1 CBC 2007 1118B.6 CBC 2016 11B-308.3 Mitigated: <input type="radio"/> YES <input checked="" type="radio"/> NO	1	JOB	\$300	\$300

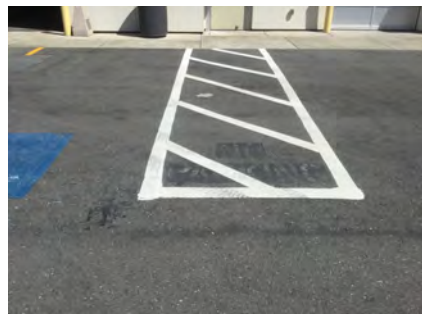
Item no., Rm no. and Name	Existing Architectural Barrier and Proposed Solution	Codes / Mitigation Info	Qty	Unit	Cost	Total
2177	<ul style="list-style-type: none">• As-Built Description: The words "NO PARKING" not painted on the ground within loading and unloading access aisle (12" min high white letters), located so that it is visible to traffic enforcement officials (required in CA only).• Proposed Solution: Provide the words "NO PARKING" in each access aisle, painted in 12" high letters, when altering area.• Notes: No blue contrast	<p>PCODE EA04D</p> <p>CBC 2007 1129B.3.1</p> <p>CBC 2016 11B-502.3.3</p> <p>Mitigated:</p> <p><input type="radio"/> YES</p> <p><input checked="" type="radio"/> NO</p>	1	JOB	\$300	\$300

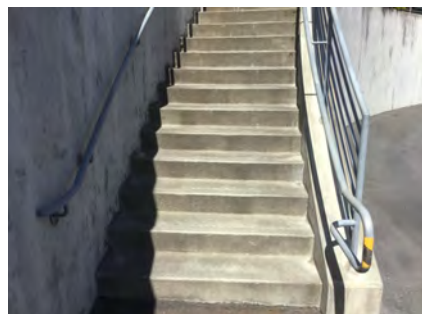
<div><input type="checkbox"/> Staff Only</div> <div><div>Priority</div><div>1</div><div>Severity</div><div>4</div></div>			
<u>Tread Surface</u>						
2180	<ul style="list-style-type: none">• As-Built Description: The leading 2" of the tread does not have visual contrast of dark-on-light or light-on-dark from the remainder of the tread.• Proposed Solution: Provide contrasting color strips at all exterior stair treads.	<p>PCODE EC02</p> <p>ADA 2010 504.4</p> <p>CBC 2007 1133B.4.4</p> <p>CBC 2016 11B-504.4.1</p> <p>Mitigated:</p> <p><input type="radio"/> YES</p> <p><input checked="" type="radio"/> NO</p>	60	LF	\$27	\$1,620

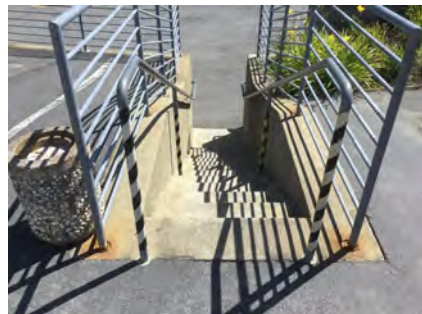
<div><input type="checkbox"/> Staff Only</div> <div><div>Priority</div><div>1</div><div>Severity</div><div>4</div></div>			
2181	<ul style="list-style-type: none">• As-Built Description: The leading 2" of the tread does not have visual contrast of dark-on-light or light-on-dark from the remainder of the tread.• Proposed Solution: Provide contrasting color strips at all exterior stair treads.	<p>PCODE EC02</p> <p>ADA 2010 504.4</p> <p>CBC 2007 1133B.4.4</p> <p>CBC 2016 11B-504.4.1</p> <p>Mitigated:</p> <p><input type="radio"/> YES</p> <p><input checked="" type="radio"/> NO</p>	50	LF	\$27	\$1,350

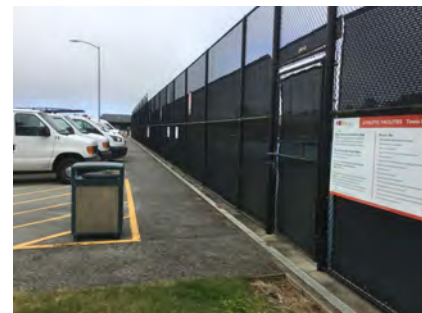
Exterior signage at inaccessible entrances to provide direction to accessible entrances is missing or noncompliant.

There are 20% slopes at the gates at the north end of the tennis courts caused by the drain swale. At the north east end the route to the northern tennis court entrances is reduced to less than 32" by bollards and or parked cars.
