SAN MATEO COUNTY
COMMUNITY
COLLEGE DISTRICT

San Mateo County Community College District Americans with Disabilities Act Self-Evaluation and Transition Plan

Report Prepared by:

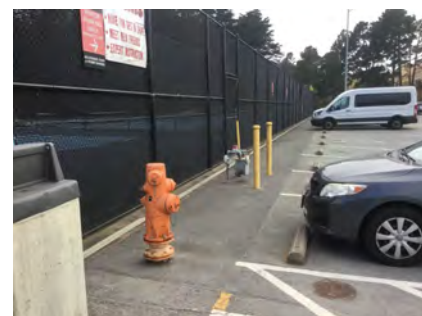
Exterior signage at inaccessible entrances to provide direction to accessible entrances is missing or noncompliant.

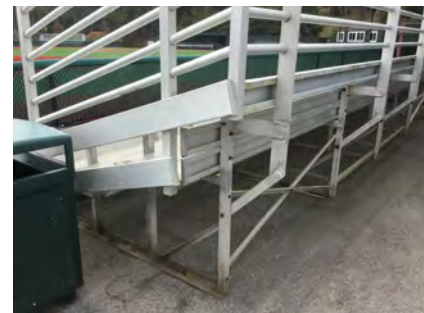
Occurs at all bleachers. The backside of the entire bleacher length shown in the right of this photo is also protruding. The corner in the center appears to be particularly hazardous.

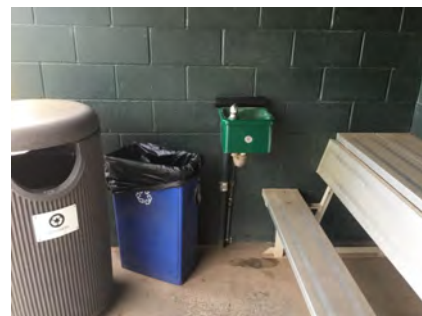
The drinking fountains here appear to be a compliant high drinking fountains. The condition occurs at both the east and west dugouts.

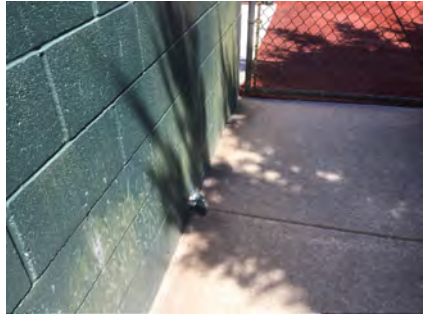
Item no., Rm no. and Name	Existing Architectural Barrier and Proposed Solution	Codes / Mitigation Info	Qty	Unit	Cost	Total
Door Swing						
1988	<ul style="list-style-type: none"> As-Built Description: Front approach: At push side, door does not have clear and level maneuvering space measuring door width x 48" (door width plus 12" if door has both, latch and closer). As-Built: Plumbing protrudes into the door maneuvering clearance 2.5" at 45" from the face of the gate. Proposed Solution: Remove or relocate furniture or storage items. Notes: The latch edge of the gate itself is approximately 2" from the cinderblock wall. 	PCODE ID24A ADAAG 91 Fig. 25(a) ADA 2010 404.2.4 CBC 2007 11B-26A(a) CBC 2016 11B-404.2.4 Mitigated: <input type="radio"/> YES <input checked="" type="radio"/> NO	1	JOB	\$150	\$150

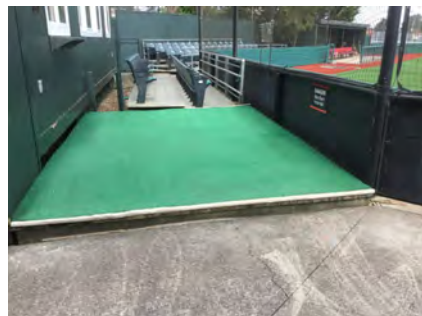
Item no., Rm no. and Name	Existing Architectural Barrier and Proposed Solution	Codes / Mitigation Info	Qty	Unit	Cost	Total
<u>Accessible Route</u>						
1962	<ul style="list-style-type: none">• <i>As-Built Description:</i> No walk / sidewalk provided to connect accessible facilities or elements that are on the same site.• <i>Proposed Solution:</i> Provide new 48" wide walk / sidewalk.• <i>Notes:</i> No accessible route to the seating directly behind homeplate.	PCODE EF13 ADAAG 91 4.3.2 ADA 2010 206.1 CBC 2007 1114B.1.2 CBC 2016 11B-206.1	30	LF	\$135	\$4,050

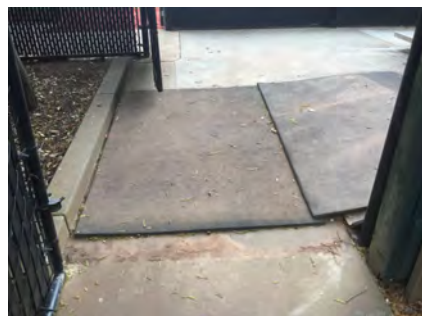
<input type="checkbox"/> Staff Only			
			Priority <div>1</div>		Severity <div>3</div>	
<u>Changes in Level</u>						
1966	<ul style="list-style-type: none">• <i>As-Built Description:</i> Walk: Pavement dislocation creates abrupt change in level exceeding 1/2" in accessible route.• <i>As-Built:</i> 0.5" not beveled• <i>Proposed Solution:</i> Remove, replace or repair area of pavement sufficient to correct abrupt change in level.• <i>Notes:</i> The mats that are stacked have level changes in excess of 1 inch.	PCODE EF03 ADAAG 91 4.3.8 ADA 2010 403.4 CBC 2007 1133B.7.4 CBC 2016 11B-403.4	25	SF	\$63	\$1,575

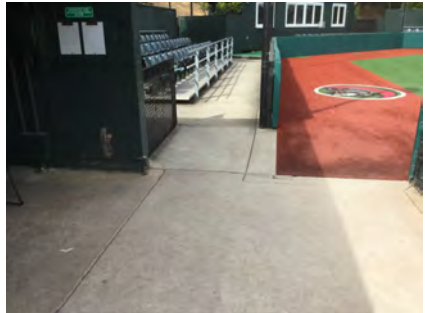
Item no., Rm no. and Name	Existing Architectural Barrier and Proposed Solution	Codes / Mitigation Info	Qty	Unit	Cost	Total
Walk						
1955	<ul style="list-style-type: none"> As-Built Description: Walk: Slope greater than 1:20 (5.0%), and walk does not comply with requirements for ramps. As-Built: 6.9% Proposed Solution: Modify walk/sidewalk slope to 1:20 or less. Notes: The ramp is approximately 67" long. 	PCODE EF01 ADAAG 91 4.3.7 ADA 2010 403.3 CBC 2007 1133B.7.3 CBC 2016 11B-403.3 Mitigated: <input type="radio"/> YES <input checked="" type="radio"/> NO	22	SF	\$75	\$1,650

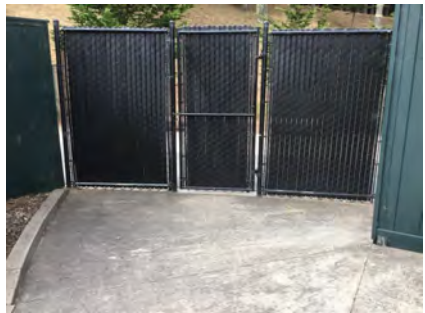
<input type="checkbox"/> Staff Only			
			Priority 1 Severity 3			
1964	<ul style="list-style-type: none"> As-Built Description: Walk: Slope greater than 1:20 (5.0%), and walk does not comply with requirements for ramps. As-Built: 12.2% Proposed Solution: Modify walk/sidewalk slope to 1:20 or less. Notes: Occurs at the entrance at the Western seating area behind home plate. 	PCODE EF01 ADAAG 91 4.3.7 ADA 2010 403.3 CBC 2007 1133B.7.3 CBC 2016 11B-403.3 Mitigated: <input type="radio"/> YES <input checked="" type="radio"/> NO	80	SF	\$75	\$6,000

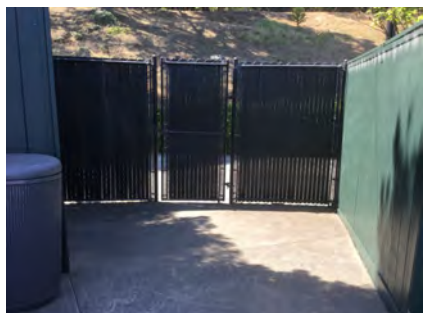
<input type="checkbox"/> Staff Only			
			Priority 1 Severity 3			
1985	<ul style="list-style-type: none"> As-Built Description: Walk: Slope greater than 1:20 (5.0%), and walk does not comply with requirements for ramps. As-Built: 7.3% Proposed Solution: Modify walk/sidewalk slope to 1:20 or less. Notes: Western side of pressbox 	PCODE EF01 ADAAG 91 4.3.7 ADA 2010 403.3 CBC 2007 1133B.7.3 CBC 2016 11B-403.3 Mitigated: <input type="radio"/> YES <input checked="" type="radio"/> NO	40	SF	\$75	\$3,000

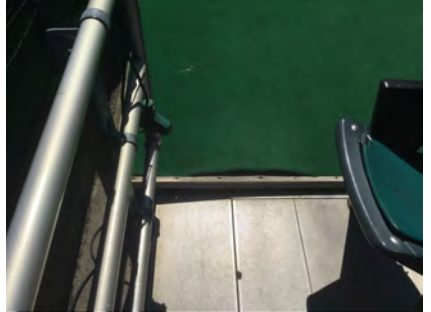
Item no., Rm no. and Name	Existing Architectural Barrier and Proposed Solution	Codes / Mitigation Info	Qty	Unit	Cost	Total
1986	<ul style="list-style-type: none"> As-Built Description: Walk: Irregular surface along pathway. Proposed Solution: Maintain pathway to be even and smooth, provide firm, stable, and slip resistant surface. Notes: Not stable or firm. The stripping and the AstroTurf is loose. 	PCODE EF10CNT ADAAG 91 4.5.2 ADA 2010 303.1; 302.1 CBC 2007 1133B.7.1 CBC 2016 11B-303.1; 11B-302.1 Mitigated: <input type="radio"/> YES <input checked="" type="radio"/> NO	50	SF	\$12	\$600

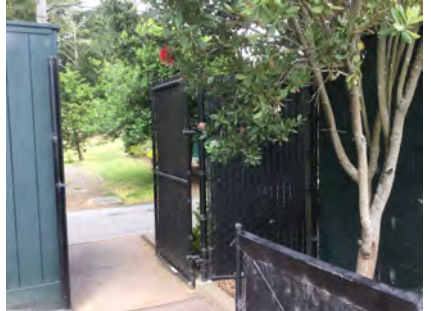
Vertical Clearance

1967	<ul style="list-style-type: none"> As-Built Description: Overhead clearance less than 80" above finished floor. Proposed Solution: Modify overhead clearance. 	PCODE EG01 ADAAG 91 4.4.2 ADA 2010 307.4 CBC 2007 1133B.8.6.2 CBC 2016 11B-307.4 Mitigated: <input type="radio"/> YES <input checked="" type="radio"/> NO	1	JOB	\$300	\$300

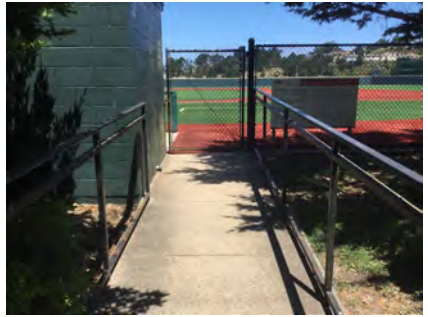
Item no., Rm no. and Name	Existing Architectural Barrier and Proposed Solution	Codes / Mitigation Info	Qty	Unit	Cost	Total
Door						
1997	<ul style="list-style-type: none"> As-Built Description: Surface of required maneuvering clearance at door slopes more than 1/4":12" (2.0%). As-Built: 2.6% Proposed Solution: Modify surface slope at door. Notes: Because of the location in proximity to the field it seems unlikely that the gate would be held open during play. 	PCODE ID11 ADAAG 91 4.13.6 ADA 2010 404.2.4.4 CBC 2007 1133B.2.4 CBC 2016 11B-404.2.4 Mitigated: <input type="radio"/> YES <input checked="" type="radio"/> NO	20	SF	\$120	\$2,400

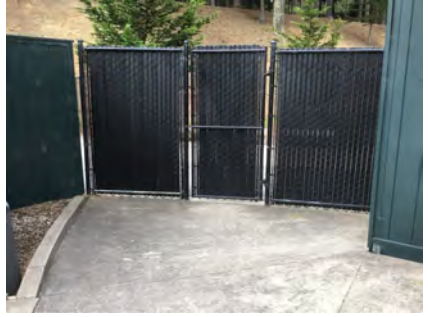
<input type="checkbox"/> Staff Only Priority 1 Severity 4			
1973	<ul style="list-style-type: none"> As-Built Description: Surface of required maneuvering clearance at door slopes more than 1/4":12" (2.0%). As-Built: 12% Proposed Solution: Modify surface slope at door. Notes: Occurs at both doors to the westernmost seating area behind home plate. 	PCODE ID11REF ADAAG 91 4.13.6 ADA 2010 404.2.4.4 CBC 2007 1133B.2.4 CBC 2016 11B-404.2.4 Mitigated: <input type="radio"/> YES <input checked="" type="radio"/> NO	REF

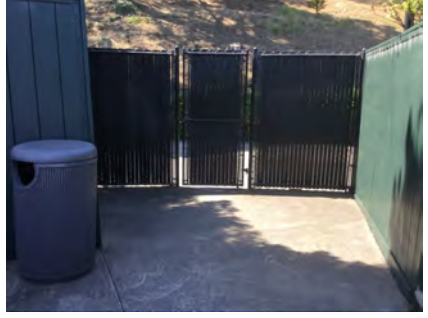
<input type="checkbox"/> Staff Only Priority 1 Severity 1			
1984	<ul style="list-style-type: none"> As-Built Description: Surface of required maneuvering clearance at door slopes more than 1/4":12" (2.0%). As-Built: 7.3% Proposed Solution: Modify surface slope at door. Notes: Occurs at the western side of the press box. 	PCODE ID11REF ADAAG 91 4.13.6 ADA 2010 404.2.4.4 CBC 2007 1133B.2.4 CBC 2016 11B-404.2.4 Mitigated: <input type="radio"/> YES <input checked="" type="radio"/> NO	REF

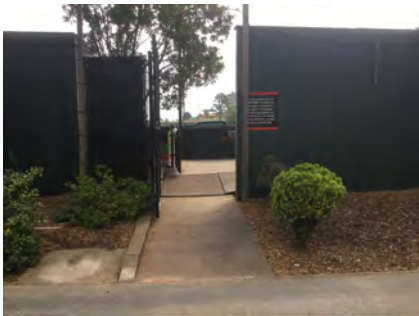
Item no., Rm no. and Name	Existing Architectural Barrier and Proposed Solution	Codes / Mitigation Info	Qty	Unit	Cost	Total
Signage						
1965	<ul style="list-style-type: none">• <i>As-Built Description:</i> Exterior signage at inaccessible entrances to provide direction to accessible entrances is missing or noncompliant.• <i>Proposed Solution:</i> Provide signage sufficient to guide persons to accessible entrances.• <i>Notes:</i> At the time of the survey there was no accessible route into this western seating area behind home plate. Both of the doors into this area have slopes in excess of 10.4%.	<p>PCODE SA01</p> <p>ADAAG 91 4.1.2(7)(c)</p> <p>ADA 2010 216.6</p> <p>CBC 2007 1117B.5.8.1.2</p> <p>CBC 2016 11B-216.6</p> <p>Mitigated:</p> <p><input type="radio"/> YES</p> <p><input checked="" type="radio"/> NO</p>	1	JOB	\$690	\$690

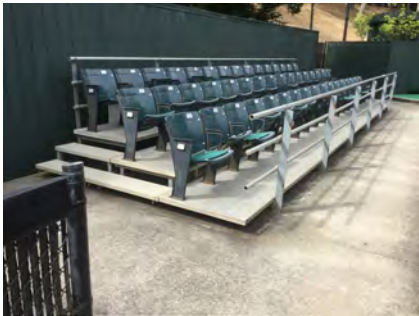
1		3	
Disabled Seating						
1958	<ul style="list-style-type: none">• <i>As-Built Description:</i> Wheelchair space (33"x48") not provided at fixed seating with forward or rear approach. (NOTE: Space must be adjacent to regular seating; can provide easily removable fixed seat).• <i>Proposed Solution:</i> Remove fixed seating and provide wheelchair space plus necessary maneuvering clearance.	<p>PCODE GB01A</p> <p>ADAAG 91 4.1.3(19)(a)</p> <p>ADA 2010 221.2</p> <p>CBC 2007 1104B.3.6</p> <p>CBC 2016 11B-221.2</p> <p>Mitigated:</p> <p><input type="radio"/> YES</p> <p><input checked="" type="radio"/> NO</p>	1	JOB	\$1,350	\$1,350

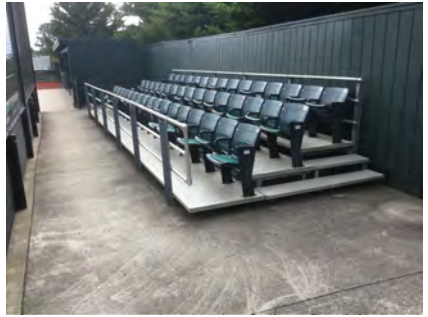
Item no., Rm no. and Name	Existing Architectural Barrier and Proposed Solution	Codes / Mitigation Info	Qty	Unit	Cost	Total
Fixed Seating						
1960	<ul style="list-style-type: none"> As-Built Description: At least one fixed companion seat next to each wheelchair seating area is not provided. As-Built: No companion seats Proposed Solution: Provide one companion seat next to each accessible wheelchair space(s). 	PCODE GE01B ADAAG 91 4.33.3 ADA 2010 221.3 CBC 2007 1104B.3.5 CBC 2016 11B-221.3 Mitigated: <input type="radio"/> YES <input checked="" type="radio"/> NO	1	EA	\$1,050	\$1,050

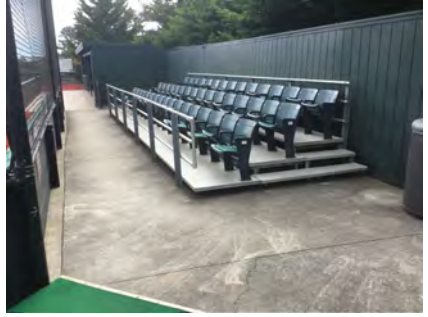
<input type="checkbox"/> Staff Only			
			Priority	Severity		
			1	2		
1959	<ul style="list-style-type: none"> As-Built Description: Wheelchair locations not dispersed throughout seating area (n/a if floor slope greater than 1:20 or 5%). Proposed Solution: Disperse accessible wheelchair space(s). Notes: Wheelchair seating is not disbursed and or integrated. 	PCODE GE01C ADAAG 91 4.33.3 ADA 2010 221.2.3 CBC 2007 1104B.3.3 CBC 2016 11B-221.2.3 Mitigated: <input type="radio"/> YES <input checked="" type="radio"/> NO	1	EA	\$1,800	\$1,800

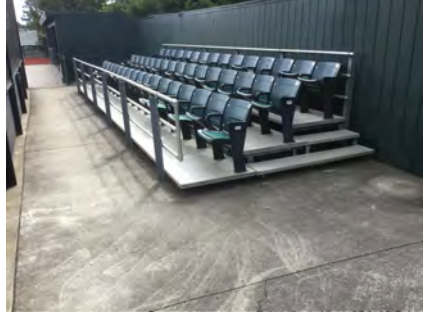
<input type="checkbox"/> Staff Only			
			Priority	Severity		
			1	2		
1961	<ul style="list-style-type: none"> As-Built Description: CA only: Less than one percent of total seats have at least 24" clear leg space between the front of the seat and any obstruction to accommodate semi-ambulant individuals. As-Built: No semi ambulatory seating with removable armrest Proposed Solution: Relocate seats to provide 24" clear leg room for semi-ambulant individuals. 	PCODE GE01D CBC 2007 1104B.3.8 CBC 2016 11B-221.6 Mitigated: <input type="radio"/> YES <input checked="" type="radio"/> NO	1	EA	\$1,050	\$1,050

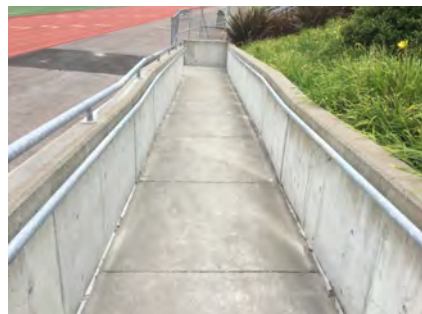
Item no., Rm no. and Name	Existing Architectural Barrier and Proposed Solution	Codes / Mitigation Info	Qty	Unit	Cost	Total
1903	<ul style="list-style-type: none">As-Built Description: Level 2% max. landing for ramp not provided.As-Built: 3.4%Proposed Solution: Rebuild ramp to provide landings for each ramp run with slopes no greater than 2%Notes: First intermediate landing from the bottom landing.	PCODE EB05A ADAAG 91 4.8.4 ADA 2010 405.7.1 CBC 2007 1133B.5.4.1 CBC 2016 11B-405.7.1 <div>Mitigated: <div><input type="radio"/> YES</div><div><input checked="" type="radio"/> NO</div></div>	30	SF	\$300	\$9,000

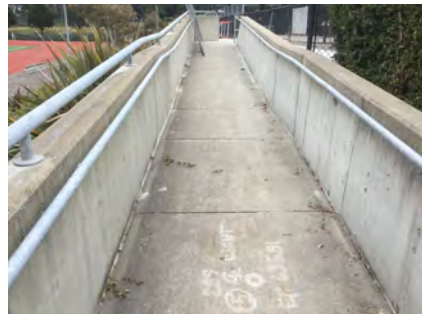
<div><input type="checkbox"/> Staff Only</div> <div><div>Priority</div><div>1</div><div>Severity</div><div>4</div></div>			
1905	<ul style="list-style-type: none">As-Built Description: Level 2% max. landing for ramp not provided.As-Built: 2.5%Proposed Solution: Rebuild ramp to provide landings for each ramp run with slopes no greater than 2%Notes: Intermediate landing first from the top landing.	PCODE EB05A ADAAG 91 4.8.4 ADA 2010 405.7.1 CBC 2007 1133B.5.4.1 CBC 2016 11B-405.7.1 <div>Mitigated: <div><input type="radio"/> YES</div><div><input checked="" type="radio"/> NO</div></div>	4	SF	\$300	\$1,200

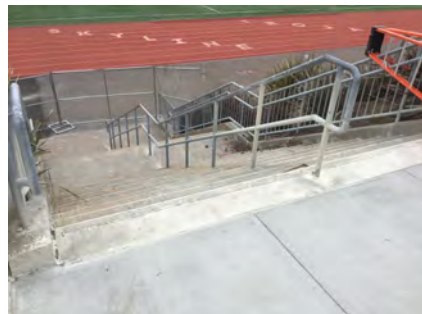
<div><input type="checkbox"/> Staff Only</div> <div><div>Priority</div><div>1</div><div>Severity</div><div>4</div></div>			
<u>Tread Surface</u>						
1906	<ul style="list-style-type: none">As-Built Description: The leading 2" of the tread does not have visual contrast of dark-on-light or light-on-dark from the remainder of the tread.Proposed Solution: Provide contrasting color strips at all exterior stair treads.	PCODE EC02 ADA 2010 504.4 CBC 2007 1133B.4.4 CBC 2016 11B-504.4.1 <div>Mitigated: <div><input type="radio"/> YES</div><div><input checked="" type="radio"/> NO</div></div>	300	LF	\$27	\$8,100

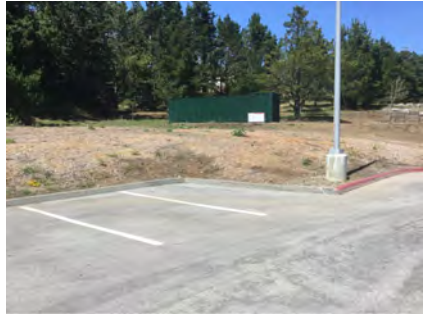
Item no., Rm no. and Name	Existing Architectural Barrier and Proposed Solution	Codes / Mitigation Info	Qty	Unit	Cost	Total
<u>Curb Ramp</u>						
2272	<ul style="list-style-type: none"> • <i>As-Built Description:</i> No curb ramp available where an accessible route crosses a curb. • <i>Proposed Solution:</i> Provide new curb ramp. 	PCODE EH01 ADAAG 91 4.7.1 ADA 2010 303.4 CBC 2007 1127B.5.1 CBC 2016 11B-402.2 Mitigated: <input type="radio"/> YES <input checked="" type="radio"/> NO	1	JOB	\$7,500	\$7,500

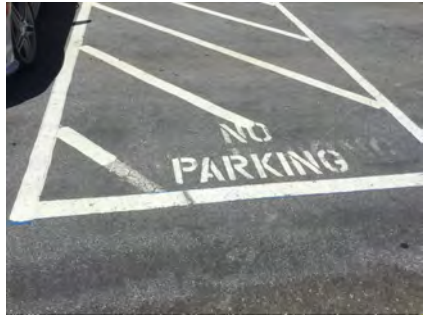
2261	<ul style="list-style-type: none"> As-Built Description: The words "NO PARKING" not painted on the ground within loading and unloading access aisle (12" min high white letters), located so that it is visible to traffic enforcement officials (required in CA only). As-Built: 9" letters Proposed Solution: Provide the words "NO PARKING" in each access aisle, painted in 12" high letters, when altering area. 	PCODE EA04D CBC 2007 1129B.3.1 CBC 2016 11B-502.3.3 Mitigated: <input type="radio"/> YES <input checked="" type="radio"/> NO	2	JOB	\$300	\$600

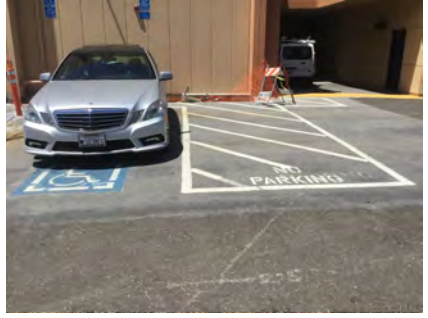
<input type="checkbox"/> Staff Only						
Priority 1 Severity 4						
2260	<ul style="list-style-type: none"> As-Built Description: An accessible parking space shall be outlined or painted blue (required in CA only). As-Built: No contrasting blue outline for three access aisles Proposed Solution: Identify accessible parking space using blue markings. 	PCODE EA04K CBC 2016 11B-502.6 Mitigated: <input type="radio"/> YES <input checked="" type="radio"/> NO	1	JOB	\$360	\$360

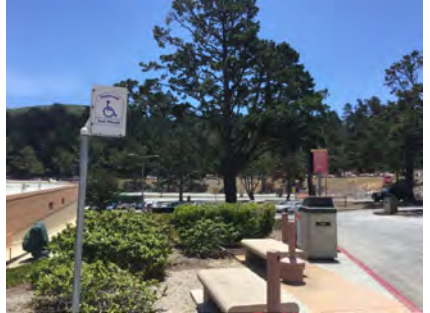
Item no., Rm no. and Name	Existing Architectural Barrier and Proposed Solution	Codes / Mitigation Info	Qty	Unit	Cost	Total
Signage						
637	<ul style="list-style-type: none"> • <i>As-Built Description:</i> Sign characters not readable because they are not sized for viewing distance. • <i>As-Built:</i> 98" high with 1" characters • <i>Proposed Solution:</i> Provide compliant signage. • <i>Notes:</i> 3" high minimum per CBC 11B-703.8.4 	PCODE SA02A ADAAG 91 4.30.3 ADA 2010 703.5.5 CBC 2007 1117B.5.4 CBC 2016 11B-505.10.1 Mitigated: <input type="radio"/> YES <input checked="" type="radio"/> NO	2	JOB	\$270	\$540

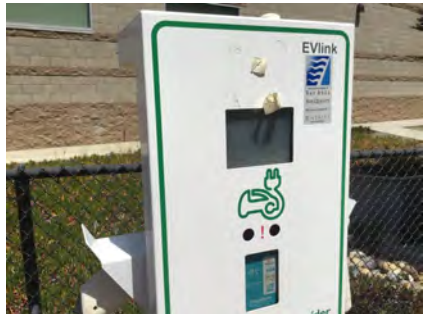
<input type="checkbox"/> Staff Only			
			Priority		Severity	
			1		4	
619	<ul style="list-style-type: none"> • <i>As-Built Description:</i> Sign does not have non-glare finish and/or good color contrast (dark on light or light on dark). • <i>Proposed Solution:</i> Provide compliant signage. 	PCODE SA03 ADAAG 91 4.30.5 ADA 2010 703.5.1 CBC 2007 1117B.5.5 CBC 2016 11B-502.4 Mitigated: <input type="radio"/> YES <input checked="" type="radio"/> NO	1	JOB	\$270	\$270

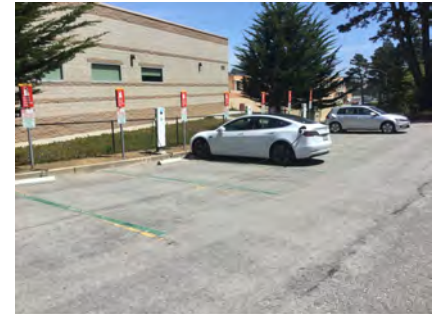
• **Notes:****No compliant marking.****Mitigated:**☐ YES☒ NO

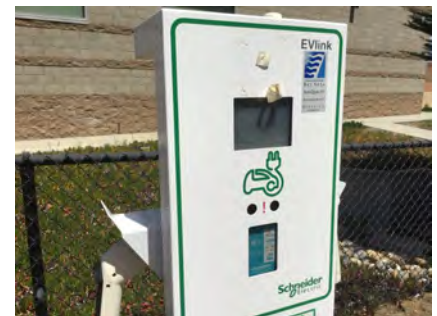
• **Notes:****ADA 707.3. No clear or correct button and not differentiated by sound or touch****Mitigated:**☐ YES☒ NO

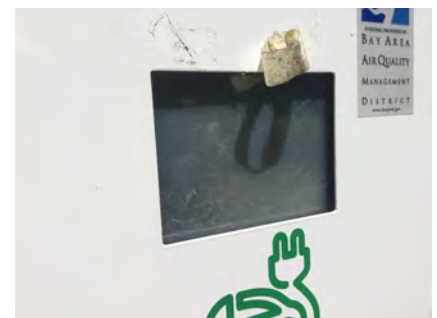
• **Notes:****ADA 707.7.2. Characters are approximately 0.14" high.****Mitigated:**☐ YES☒ NO

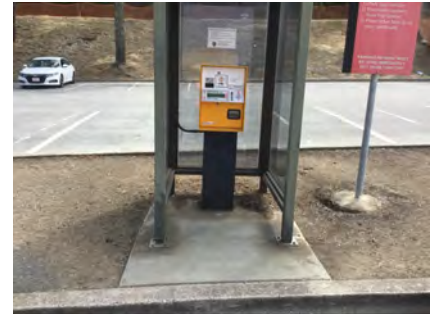
• *Notes:****Fare Machine does not comply with ADA 707.4 through 707.6 and 707.8.*****Mitigated:**☐ YES☒ NO

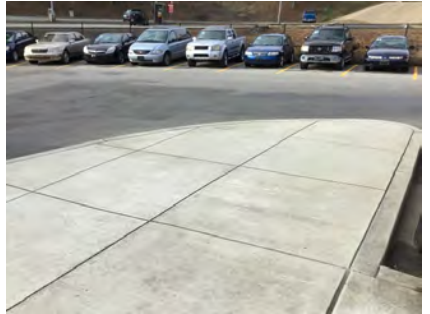
Item no., Rm no. and Name	Existing Architectural Barrier and Proposed Solution	Codes / Mitigation Info	Qty	Unit	Cost	Total
Curb Ramp						
2	<ul style="list-style-type: none"> • <i>As-Built Description:</i> No curb ramp available where an accessible route crosses a curb. • <i>Proposed Solution:</i> Provide new curb ramp. 	PCODE EH01 ADAAG 91 4.7.1 ADA 2010 303.4 CBC 2007 1127B.5.1 CBC 2016 11B-402.2 Mitigated: <input type="radio"/> YES <input checked="" type="radio"/> NO	1	JOB	\$7,500	\$7,500

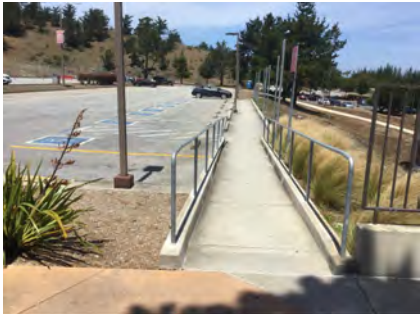
Item no., Rm no. and Name	Existing Architectural Barrier and Proposed Solution	Codes / Mitigation Info	Qty	Unit	Cost	Total
Top and Bottom Extension at Ramps						
629	<ul style="list-style-type: none">As-Built Description: Ramp handrail does not extend horizontally 12" past top and / or bottom of ramp.As-Built: 0"-10"Proposed Solution: Provide ramp handrail extension (cost for each extension piece).Notes: The bottom handrail extensions are over the sloped portion of the ramp.	<p>PCODE ED05</p> <p>ADAAG 91 4.8.5(2)</p> <p>ADA 2010 505.10.1</p> <p>CBC 2007 1133B.4.2.2 &</p> <p>CBC 2016 1133B.5.5.1</p> <p>11B-505.10.1</p> <p>Mitigated:</p> <p><input type="radio"/> YES</p> <p><input checked="" type="radio"/> NO</p>	1	JOB	\$510	\$510

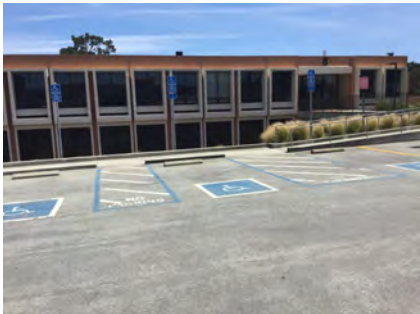
<input type="checkbox"/> Staff Only			
			Priority		Severity	
			1		2	
Detectable Warning						
628	<ul style="list-style-type: none">As-Built Description: 36" wide band of truncated domes not provided at walkway or crossing adjoining a vehicular way, if surfaces are not separated by a curb, railing, or other element.Proposed Solution: Provide 36" wide, contrasting color, band of truncated domes between pedestrian and vehicular area.	<p>PCODE EG09</p> <p>ADAAG 91 4.29.5</p> <p>CBC 2007 1133B.8.5</p> <p>CBC 2016 11B-705.1.2.5</p> <p>Mitigated:</p> <p><input type="radio"/> YES</p> <p><input checked="" type="radio"/> NO</p>	30	LF	\$81	\$2,430

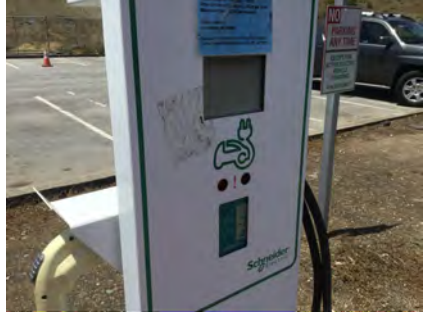
Item no., Rm no. and Name	Existing Architectural Barrier and Proposed Solution	Codes / Mitigation Info	Qty	Unit	Cost	Total
635	<ul style="list-style-type: none"> As-Built Description: Refer to notes for observation and recommendation. Proposed Solution: Notes: No raised, no correct key not differentiated by sound or touch 	PCODE GN01 CBC 2016 11B-308.3 Mitigated: <input type="radio"/> YES <input checked="" type="radio"/> NO				
						REF

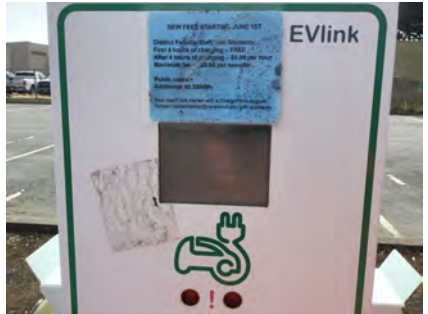
<input type="checkbox"/> Staff Only
						Priority <input checked="" type="radio"/> 1
						Severity <input checked="" type="radio"/> 3
844	<ul style="list-style-type: none"> As-Built Description: Refer to notes for observation and recommendation. Proposed Solution: Notes: Per ADA 707.3 and CBC 11B-707.9. The buttons are not discernible by touch or sound. There is no clear or correct button. 	PCODE GN01 CBC 2016 11B-308.3 Mitigated: <input type="radio"/> YES <input checked="" type="radio"/> NO

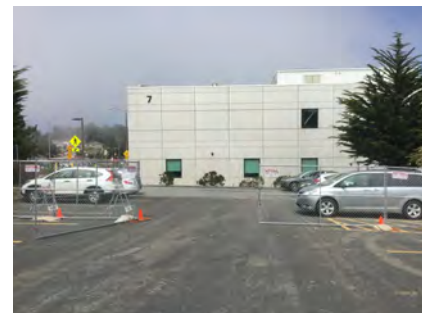
No accessible routes from this parking lot to any buildings, walks, or accessible elements on site. The pathways and driveway from this lot slope from 16% to 25%. The spaces in the lot slope 6%. There are spaces which appear to have been marked as accessible, they slope 6%, have no vehicle signage and the pavement markings are incorrect or nonexistent.

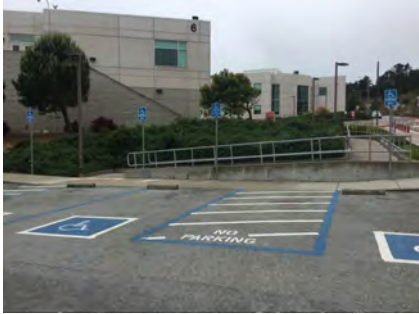
Item no., Rm no. and Name	Existing Architectural Barrier and Proposed Solution	Codes / Mitigation Info	Qty	Unit	Cost	Total
<u>Parking Signage</u>						
283	<ul style="list-style-type: none">• <i>As-Built Description:</i> CA only: Additional Sign or additional language below the symbol of accessibility stating “Minimum Fine \$250” not provided.• <i>Proposed Solution:</i> Provide compliant parking signage that includes fine information.	<p>PCODE EA04G</p> <p>CBC 2007 1129B.4</p> <p>CBC 2016 11B-502.6.2</p> <p>Mitigated:</p> <p><input type="radio"/> YES</p> <p><input checked="" type="radio"/> NO</p>	4	JOB	\$300	\$1,200

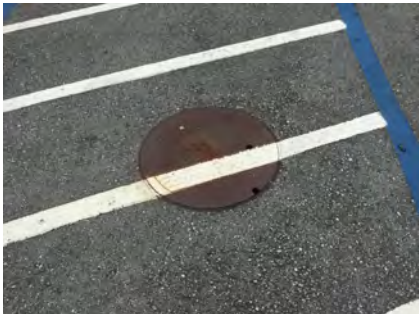
<input type="checkbox"/> Staff Only			
			Priority		Severity	
			1		4	
<u>Floor or Ground Surface</u>						
282	<ul style="list-style-type: none">• <i>As-Built Description:</i> Walk: Grating has grid openings greater than 1/2" along the line of traffic flow.• <i>As-Built:</i> 1” x 1”• <i>Proposed Solution:</i> Provide new grating, with grid openings 1/2" max. along the line of traffic flow.	<p>PCODE EF04</p> <p>ADAAG 91 4.3.6; 4.5.4</p> <p>ADA 2010 403.2; 302.3</p> <p>CBC 2007 1133B.7.2</p> <p>CBC 2016 11B-403.2; 11B-302.3</p> <p>Mitigated:</p> <p><input type="radio"/> YES</p> <p><input checked="" type="radio"/> NO</p>	1	SF	\$240	\$240

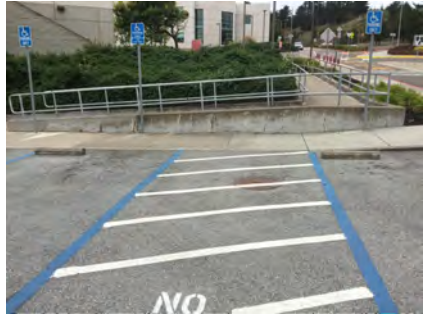
Item no., Rm no. and Name	Existing Architectural Barrier and Proposed Solution	Codes / Mitigation Info	Qty	Unit	Cost	Total
Detectable Warning						
284	<ul style="list-style-type: none"> As-Built Description: 36" wide band of truncated domes not provided at walkway or crossing adjoining a vehicular way, if surfaces are not separated by a curb, railing, or other element. Proposed Solution: Provide 36" wide, contrasting color, band of truncated domes between pedestrian and vehicular area. 	PCODE EG09 ADAAG 91 4.29.5 CBC 2007 1133B.8.5 CBC 2016 11B-705.1.2.5 Mitigated: <input type="radio"/> YES <input checked="" type="radio"/> NO	20	LF	\$81	\$1,620

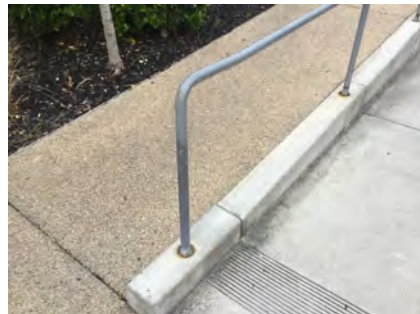
Item no., Rm no. and Name	Existing Architectural Barrier and Proposed Solution	Codes / Mitigation Info	Qty	Unit	Cost	Total
<u>Top and Bottom Extension at Ramps</u>						
294	<ul style="list-style-type: none">As-Built Description: Ramp handrail does not extend horizontally 12" past top and / or bottom of ramp.As-Built: 9"Proposed Solution: Provide ramp handrail extension (cost for each extension piece).	PCODE ED05 ADAAG 91 4.8.5(2) ADA 2010 505.10.1 CBC 2007 1133B.4.2.2 & CBC 2016 1133B.5.5.1 11B-505.10.1	4	JOB	\$510	\$2,040
		Mitigated: <input type="radio"/> YES <input checked="" type="radio"/> NO

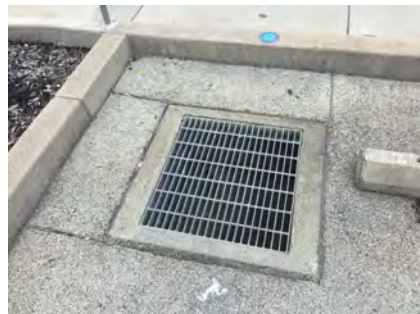
<input type="checkbox"/> Staff Only				
		Priority 1		Severity 3		
<u>Floor or Ground Surface</u>						
292	<ul style="list-style-type: none">As-Built Description: Walk: Grating has grid openings greater than 1/2" along the line of traffic flow.As-Built: 1" x 3.5"Proposed Solution: Provide new grating, with grid openings 1/2" max. along the line of traffic flow.	PCODE EF04 ADAAG 91 4.3.6; 4.5.4 ADA 2010 403.2; 302.3 CBC 2007 1133B.7.2 CBC 2016 11B-403.2; 11B-302.3	4	SF	\$240	\$960

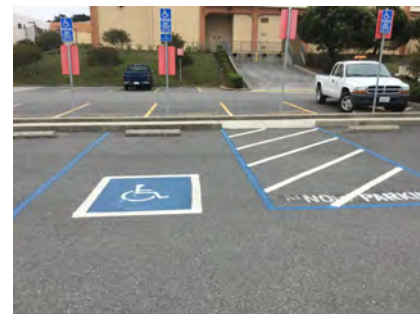
289	<ul style="list-style-type: none"> • <i>As-Built Description:</i> 36" wide band of truncated domes not provided at walkway or crossing adjoining a vehicular way, if surfaces are not separated by a curb, railing, or other element. • <i>Proposed Solution:</i> Provide 36" wide, contrasting color, band of truncated domes between pedestrian and vehicular area. 	PCODE EG09 ADAAG 91 4.29.5 CBC 2007 1133B.8.5 CBC 2016 11B-705.1.2.5	16	LF	\$81	\$1,296
<div> <div>Mitigated:</div> <div> <input type="radio"/> YES <input checked="" type="radio"/> NO </div> </div> <div> <input type="checkbox"/> Staff Only </div> <div> <div>Priority</div> <div>1</div> </div> <div> <div>Severity</div> <div>3</div> </div>

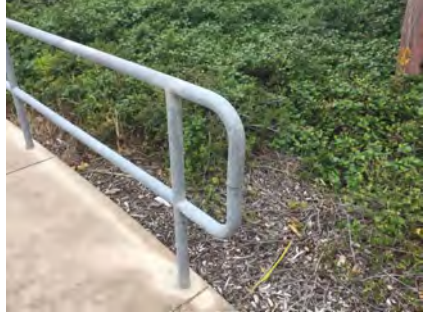
Item no., Rm no. and Name	Existing Architectural Barrier and Proposed Solution	Codes / Mitigation Info	Qty	Unit	Cost	Total
288	<ul style="list-style-type: none"> As-Built Description: Ramp handrail does not extend horizontally 12" past top and / or bottom of ramp. As-Built: 8" Proposed Solution: Provide ramp handrail extension (cost for each extension piece). 	PCODE ED05 ADAAG 91 4.8.5(2) ADA 2010 505.10.1 CBC 2007 1133B.4.2.2 & CBC 2016 1133B.5.5.1 11B-505.10.1 Mitigated: <input type="radio"/> YES <input checked="" type="radio"/> NO	2	JOB	\$510	\$1,020

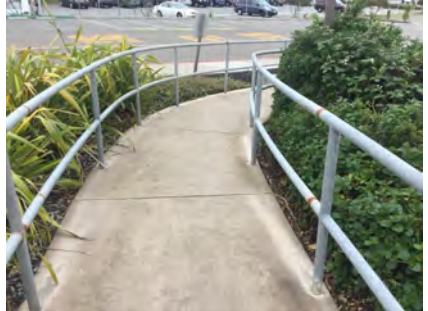
287	<ul style="list-style-type: none"> As-Built Description: Ramp landing(s): Change of direction less than 60" long. (CA Only: 72" long.) Proposed Solution: Modify ramp bottom landing to 60" length. (Ca Only: 72' length.) 	PCODE IJ05D ADA 2010 405.7.4 CBC 2007 1133B.5.4.6 CBC 2016 11B-405.7.4 Mitigated: <input type="radio"/> YES <input checked="" type="radio"/> NO	60	SF	\$162	\$9,720

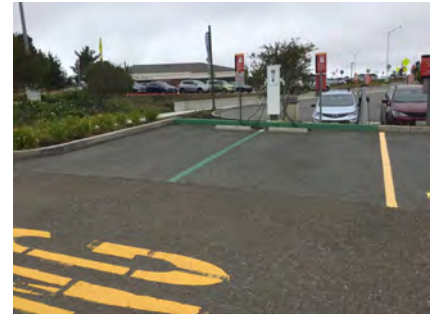
• **Notes:****No markings.****Mitigated:**☐ YES☒ NO

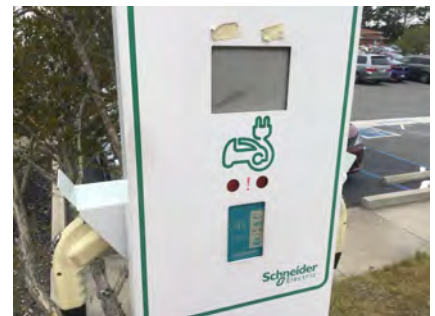
• **Notes:****Tactile keypad and keypads with contrast are required and earphone jacks.****Mitigated:**☐ YES☒ NO

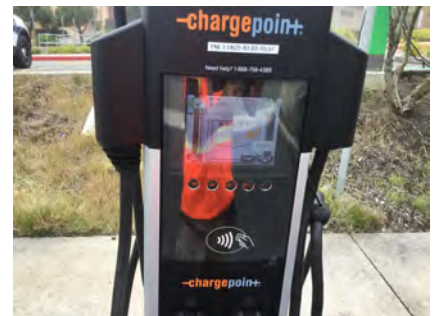
• **Notes:****Tactile keypad and keypads with contrast are required and earphone jacks.****Mitigated:**☐ YES☒ NO

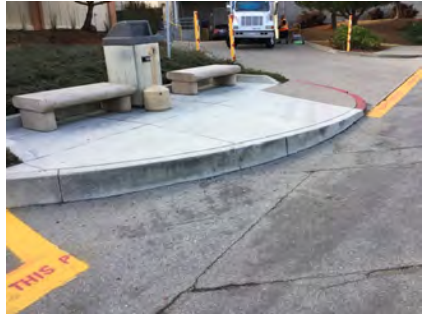
Item no., Rm no. and Name	Existing Architectural Barrier and Proposed Solution	Codes / Mitigation Info	Qty	Unit	Cost	Total
Curb Ramp						
14	<ul style="list-style-type: none"> • <i>As-Built Description:</i> No curb ramp available where an accessible route crosses a curb. • <i>Proposed Solution:</i> Provide new curb ramp. 	PCODE EH01 ADAAG 91 4.7.1 ADA 2010 303.4 CBC 2007 1127B.5.1 CBC 2016 11B-402.2 Mitigated: <input type="radio"/> YES <input checked="" type="radio"/> NO	1	JOB	\$7,500	\$7,500

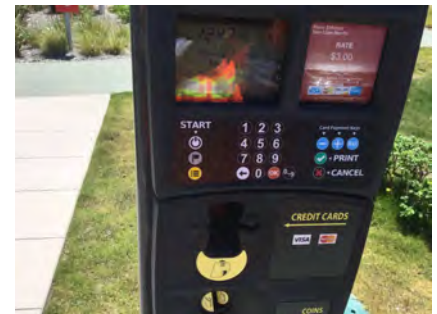
- 1222
- **As-Built Description:**
Refer to notes for observation and recommendation.
 - **Proposed Solution:**
 - **Notes:**
Keypad not differentiated by sound or touch.
Verify arrow functions as clear or correct key.

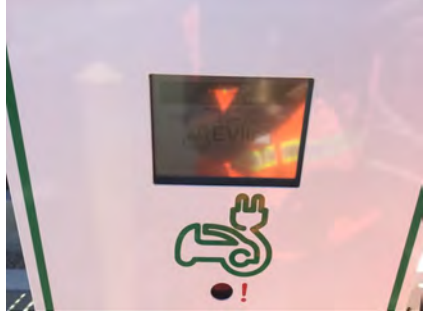
Item no., Rm no. and Name	Existing Architectural Barrier and Proposed Solution	Codes / Mitigation Info	Qty	Unit	Cost	Total
1463	<ul style="list-style-type: none"> • <i>As-Built Description:</i> Refer to notes for observation and recommendation. • <i>Proposed Solution:</i> • <i>Notes:</i> Per ADA 707.3 and CBC 11B-707.9. The buttons are not discernible by touch or sound. There is no clear or correct button. 	PCODE GN01 CBC 2016 11B-603.4 Mitigated: <input type="radio"/> YES <input checked="" type="radio"/> NO				REF

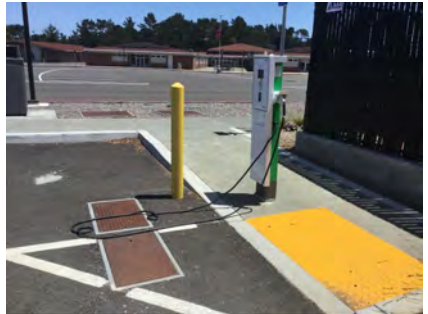
<input type="checkbox"/> Staff Only Priority 1 Severity 3
1465	<ul style="list-style-type: none"> • <i>As-Built Description:</i> Refer to notes for observation and recommendation. • <i>Proposed Solution:</i> • <i>Notes:</i> The clear floor space is obstructed by the vehicle space 	PCODE GN01 CBC 2016 11B-603.4 Mitigated: <input type="radio"/> YES <input checked="" type="radio"/> NO				REF

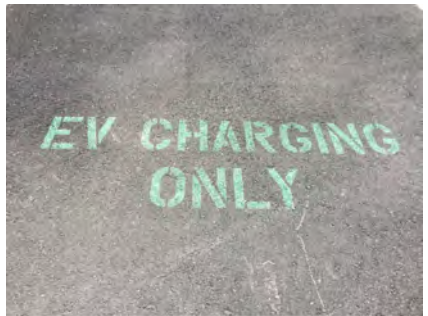
<input type="checkbox"/> Staff Only Priority 1 Severity 2
1466	<ul style="list-style-type: none"> • <i>As-Built Description:</i> Refer to notes for observation and recommendation. • <i>Proposed Solution:</i> • <i>Notes:</i> 10" high surface marking 	PCODE GN01 CBC 2016 11B-603.4 Mitigated: <input type="radio"/> YES <input checked="" type="radio"/> NO				REF

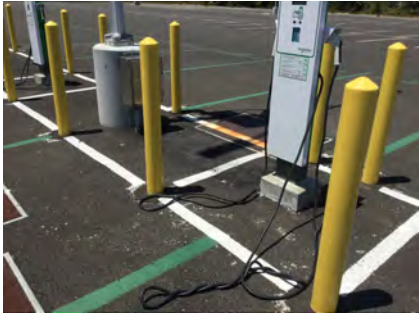
Item no., Rm no. and Name	Existing Architectural Barrier and Proposed Solution	Codes / Mitigation Info	Qty	Unit	Cost	Total
1467	<ul style="list-style-type: none">As-Built Description: Refer to notes for observation and recommendation.Proposed Solution:Notes: The route to the charger is obstructed by bollards and parked vehicles. The which of the obstruction varies. 35" wide shown at this one. The clear floor space is 27" wide obstructed by the parked vehicle .	PCODE GN01 CBC 2016 11B-603.4 Mitigated: <div><input type="radio"/> YES</div> <div><input checked="" type="radio"/> NO</div>				
			REF

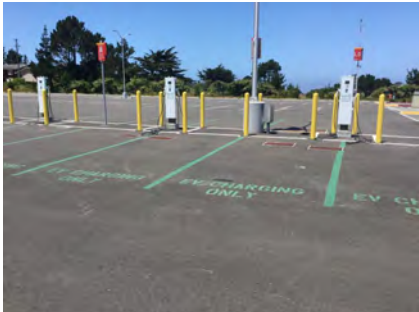
<div><input type="checkbox"/> Staff Only</div>			
			Priority <div>1</div> Severity <div>2</div>			
1468	<ul style="list-style-type: none">As-Built Description: Refer to notes for observation and recommendation.Proposed Solution:Notes: No access aisle markings at standard spaces.	PCODE GN01 CBC 2016 11B-603.4 Mitigated: <div><input type="radio"/> YES</div> <div><input checked="" type="radio"/> NO</div>

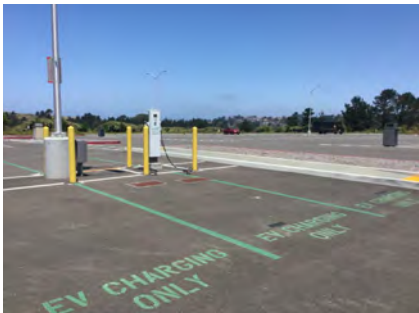
<div><input type="checkbox"/> Staff Only</div>			
			Priority <div>1</div> Severity <div>3</div>			
1469	<ul style="list-style-type: none">As-Built Description: Refer to notes for observation and recommendation.Proposed Solution:Notes: The route from the chargers to the facilities they serve is obstructed by charging station vehicle spaces. It may be possible to remediate this condition by placing and access aisle adjacent to the accessible route.	PCODE GN01 CBC 2016 11B-603.4 Mitigated: <div><input type="radio"/> YES</div> <div><input checked="" type="radio"/> NO</div>				
			REF

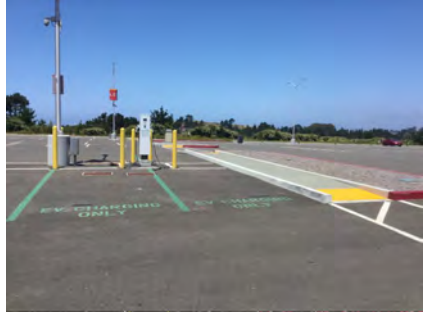
Item no., Rm no. and Name	Existing Architectural Barrier and Proposed Solution	Codes / Mitigation Info	Qty	Unit	Cost	Total
1470	<ul style="list-style-type: none"> • As-Built Description: Refer to notes for observation and recommendation. • Proposed Solution: • Notes: Some of the electric vehicle spaces slope more than 2.08%. The spaces on the north side have generally compliant slopes. However the spaces with compliant slopes are also further from the facility. 	PCODE GN01 CBC 2016 11B-603.4 Mitigated: <input type="radio"/> YES <input checked="" type="radio"/> NO		REF

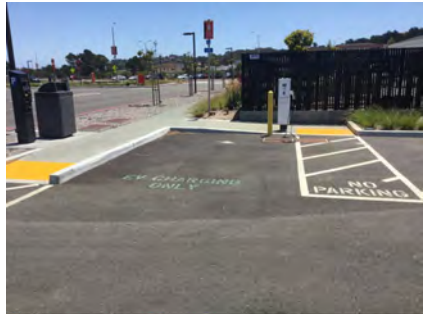
<input type="checkbox"/> Staff Only		
			Priority	Severity		
			1	4		
1473	<ul style="list-style-type: none"> • As-Built Description: Refer to notes for observation and recommendation. • Proposed Solution: • Notes: Van accessible charging station space 143" wide. 	PCODE GN01 CBC 2016 11B-502.4 Mitigated: <input type="radio"/> YES <input checked="" type="radio"/> NO		REF

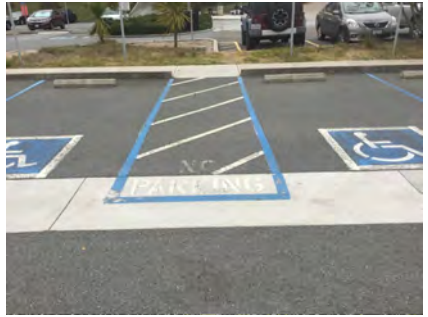
Item no., Rm no. and Name	Existing Architectural Barrier and Proposed Solution	Codes / Mitigation Info	Qty	Unit	Cost	Total
Parking						
310	<ul style="list-style-type: none"> • <i>As-Built Description:</i> Accessible parking space does not have 5' wide access aisle; 8' wide for van accessible aisle. • <i>As-Built:</i> 58" • <i>Proposed Solution:</i> Modify parking aisle(s) to create accessible space by restriping. 	PCODE EA02B ADAAG 91 4.6.3 ADA 2010 502.3 CBC 2007 1129B.3.1 CBC 2016 11B-502.2; 11B-502.3.1 Mitigated: <input type="radio"/> YES <input checked="" type="radio"/> NO	1	JOB	\$600	\$600

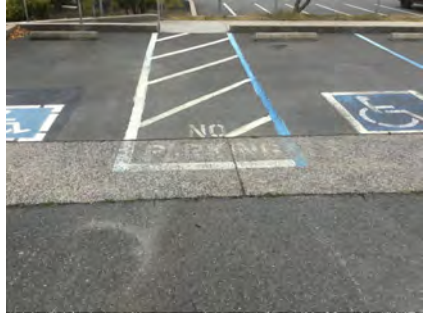
<input type="checkbox"/> Staff Only Priority 1 Severity 4			
306	<ul style="list-style-type: none"> • <i>As-Built Description:</i> The words "NO PARKING" not painted on the ground within loading and unloading access aisle (12" min high white letters), located so that it is visible to traffic enforcement officials (required in CA only). • <i>Proposed Solution:</i> Provide the words "NO PARKING" in each access aisle, painted in 12" high letters, when altering area. • <i>Notes:</i> No contrast 	PCODE EA04D CBC 2007 1129B.3.1 CBC 2016 11B-502.3.3 Mitigated: <input type="radio"/> YES <input checked="" type="radio"/> NO	9	JOB	\$300	\$2,700

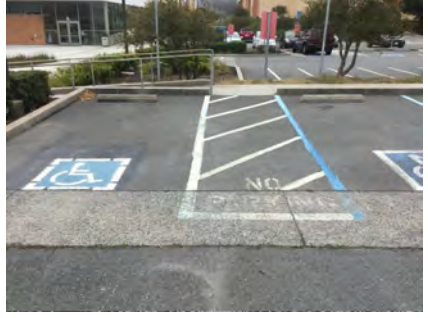
<input type="checkbox"/> Staff Only Priority 1 Severity 4			
305	<ul style="list-style-type: none"> • <i>As-Built Description:</i> CA only: The area within the blue borderlines not marked with hatched lines a maximum of 36" on center. • <i>Proposed Solution:</i> Restripe to provide hatched lines at 36" on center within access aisle. 	PCODE EA04I CBC 2007 1129B.3.1 CBC 2016 11B-502.3.3 Mitigated: <input type="radio"/> YES <input checked="" type="radio"/> NO	1	JOB	\$300	\$300

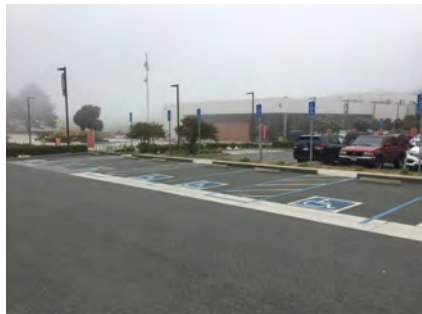
Item no., Rm no. and Name	Existing Architectural Barrier and Proposed Solution	Codes / Mitigation Info	Qty	Unit	Cost	Total
313	<ul style="list-style-type: none"> As-Built Description: No van parking provided (one in every 6 or fraction of 6 accessible spaces, but not less than one). As-Built: 16 spaces no van parking Proposed Solution: Provide van parking space(s) by restriping; provide van sign. 	PCODE EA07 ADAAG 91 4.1.2(5)(b) ADA 2010 208.2; 502.1 CBC 2007 1129B.3.2 CBC 2016 11B-208.2.4 Mitigated: <input type="radio"/> YES <input checked="" type="radio"/> NO	3	JOB	\$1,050	\$3,150

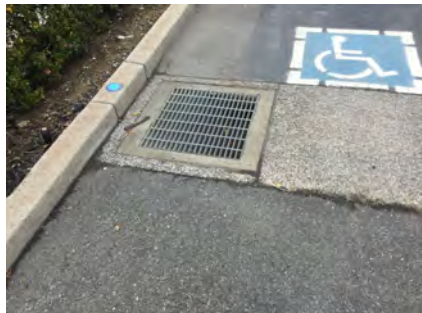
307	<ul style="list-style-type: none"> As-Built Description: Walk: Grating has grid openings greater than 1/2" along the line of traffic flow. As-Built: 1" x 3.5" Proposed Solution: Provide new grating, with grid openings 1/2" max. along the line of traffic flow. 	PCODE EF04 ADAAG 91 4.3.6; 4.5.4 ADA 2010 403.2; 302.3 CBC 2007 1133B.7.2 CBC 2016 11B-403.2; 11B-302.3 Mitigated: <input type="radio"/> YES <input checked="" type="radio"/> NO	4	SF	\$240	\$960

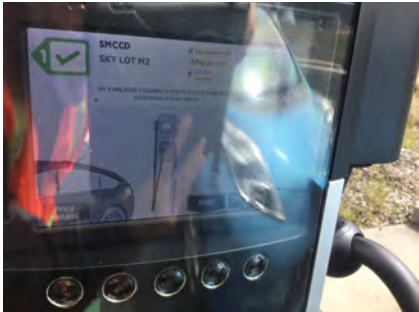
Item no., Rm no. and Name	Existing Architectural Barrier and Proposed Solution	Codes / Mitigation Info	Qty	Unit	Cost	Total
839	<ul style="list-style-type: none"> As-Built Description: Refer to notes for observation and recommendation. Proposed Solution: Notes: Characters at EV pay station 0.07"-0.125" high. 	<p>PCODE GN01</p> <p>CBC 2016 11B-502.4</p> <p>Mitigated:</p> <p><input type="radio"/> YES</p> <p><input checked="" type="radio"/> NO</p>				<p>REF</p>

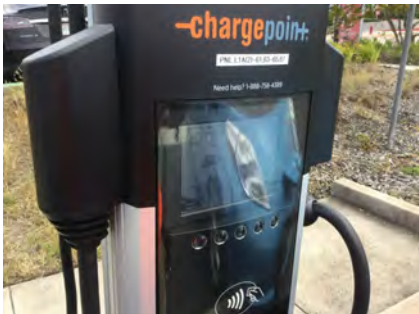
<p><input type="checkbox"/> Staff Only</p> <p>Priority 1 Severity 3</p>
841	<ul style="list-style-type: none"> As-Built Description: Refer to notes for observation and recommendation. Proposed Solution: Notes: Per CBC 11B-707.9. No tactilely discernible buttons and no other technology to guide a person with vision impairment through the process of paying. 	<p>PCODE GN01</p> <p>CBC 2016 11B-502.4</p> <p>Mitigated:</p> <p><input type="radio"/> YES</p> <p><input checked="" type="radio"/> NO</p>				<p>REF</p>

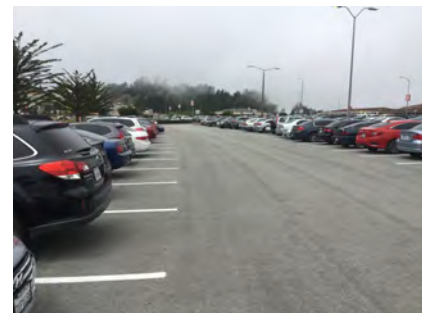
Verify the number of parking spaces provided before installing accessible spaces.

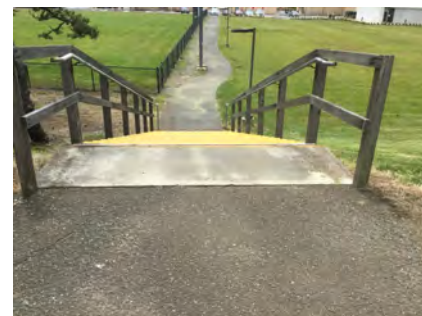
The top step vertical riser is loose and may pose a hazard. In addition there is a gap between the wooden piece and the concrete and the top of the wooden piece is offset from the top of the concrete. There appears to be an accessible route connecting the levels that the stairs serve.

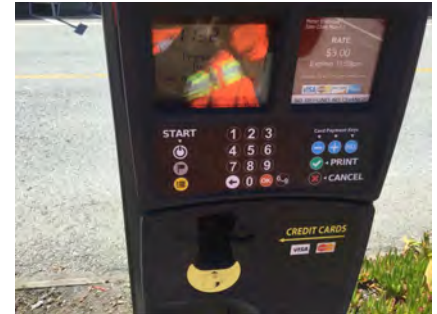
- 1211
- **As-Built Description:**
Refer to notes for observation and recommendation.
 - **Proposed Solution:**
 - **Notes:**
Buttons not differentiated by sound or touch. Verify clear or correct button functions.

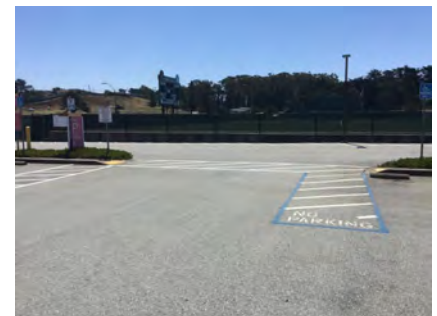
- 1215
- **As-Built Description:**
Refer to notes for observation and recommendation.
 - **Proposed Solution:**
 - **Notes:**
Access aisle appears to be within the vehicular way. Reconfigure access aisle where it is not located within the drive aisle.

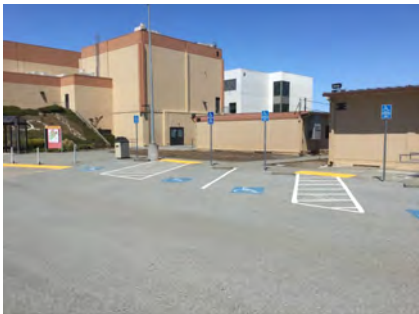
Item no., Rm no. and Name	Existing Architectural Barrier and Proposed Solution	Codes / Mitigation Info	Qty	Unit	Cost	Total
1991	<ul style="list-style-type: none">As-Built Description: Accessible parking space does not have 5' wide access aisle; 8' wide for van accessible aisle.As-Built: 93" and 57" wideProposed Solution: Modify parking aisle(s) to create accessible space by restriping.	PCODE EA02B ADAAG 91 4.6.3 ADA 2010 502.3 CBC 2007 1129B.3.1 CBC 2016 11B-502.2; 11B-502.3.1 Mitigated: <input type="radio"/> YES <input checked="" type="radio"/> NO	3	JOB	\$600	\$1,800

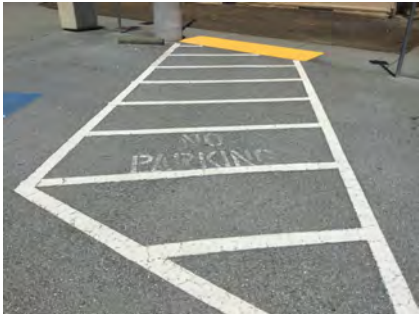
<input type="checkbox"/> Staff Only			
			Priority 1 Severity 4			
1994	<ul style="list-style-type: none">As-Built Description: The words "NO PARKING" not painted on the ground within loading and unloading access aisle (12" min high white letters), located so that it is visible to traffic enforcement officials (required in CA only).As-Built: FadedProposed Solution: Provide the words "NO PARKING" in each access aisle, painted in 12" high letters, when altering area.Notes: Also striping must be blue	PCODE EA04DREF CBC 2007 1129B.3.1 CBC 2016 11B-502.3.3 Mitigated: <input type="radio"/> YES <input checked="" type="radio"/> NO	REF

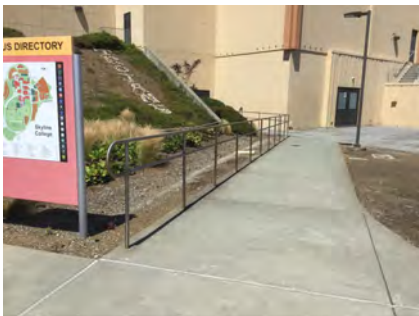
<input type="checkbox"/> Staff Only			
			Priority 1 Severity 4			
Height						
1993	<ul style="list-style-type: none">As-Built Description: Handrail gripping surface top not mounted between 34" and 38" above ramp surface or stair nosings.As-Built: Handrail at walking surface 30.5" and 43"Proposed Solution: Remove existing and provide new handrail.	PCODE ED02 ADAAG 91 4.9.4(5) ADA 2010 505.4 CBC 2007 1133B.4.2.1 & B.5.5.1 CBC 2016 11B-505.4 Mitigated: <input type="radio"/> YES <input checked="" type="radio"/> NO	30	LF	\$225	\$6,750

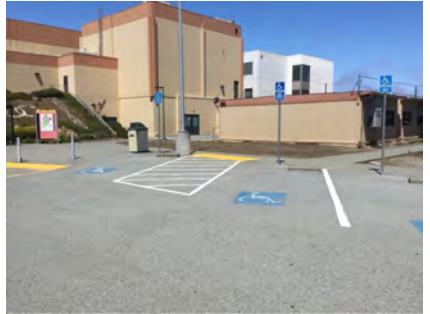
Item no., Rm no. and Name	Existing Architectural Barrier and Proposed Solution	Codes / Mitigation Info	Qty	Unit	Cost	Total
Detectable Warning						
1992	<ul style="list-style-type: none"> As-Built Description: 36" wide band of truncated domes not provided at walkway or crossing adjoining a vehicular way, if surfaces are not separated by a curb, railing, or other element. Proposed Solution: Provide 36" wide, contrasting color, band of truncated domes between pedestrian and vehicular area. 	PCODE EG09 ADAAG 91 4.29.5 CBC 2007 1133B.8.5 CBC 2016 11B-705.1.2.5 Mitigated: <input type="radio"/> YES <input checked="" type="radio"/> NO	80	LF	\$81	\$6,480

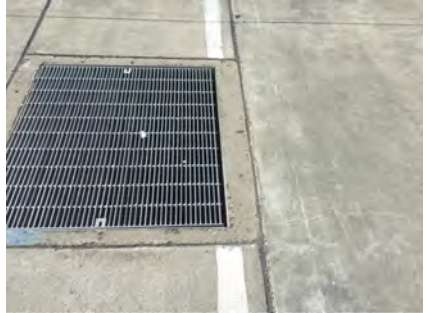
Item no., Rm no. and Name	Existing Architectural Barrier and Proposed Solution	Codes / Mitigation Info	Qty	Unit	Cost	Total
Floor or Ground Surface						
693	<ul style="list-style-type: none"> • <i>As-Built Description:</i> Walk: Grating has grid openings greater than 1/2" along the line of traffic flow. • <i>As-Built:</i> 1" x 40.5" • <i>Proposed Solution:</i> Provide new grating, with grid openings 1/2" max. along the line of traffic flow. 	PCODE EF04 ADAAG 91 4.3.6; 4.5.4 ADA 2010 403.2; 302.3 CBC 2007 1133B.7.2 CBC 2016 11B-403.2; 11B-302.3	8	SF	\$240	\$1,920
Mitigated: <input type="radio"/> YES <input checked="" type="radio"/> NO

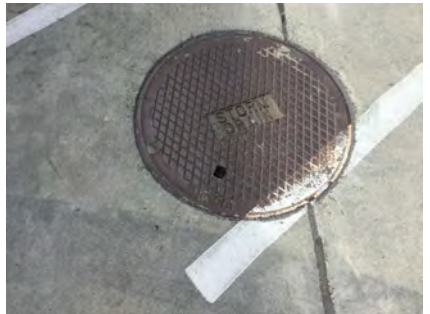
<input type="checkbox"/> Staff Only			
			Priority 1 Severity 2			
694	<ul style="list-style-type: none"> • <i>As-Built Description:</i> Walk: Grating has grid openings greater than 1/2" along the line of traffic flow. • <i>As-Built:</i> 1.25" x 1.25" • <i>Proposed Solution:</i> Provide new grating, with grid openings 1/2" max. along the line of traffic flow. 	PCODE EF04 ADAAG 91 4.3.6; 4.5.4 ADA 2010 403.2; 302.3 CBC 2007 1133B.7.2 CBC 2016 11B-403.2; 11B-302.3	4	SF	\$240	\$960

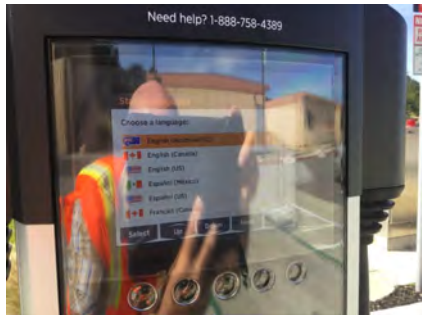
Item no., Rm no. and Name	Existing Architectural Barrier and Proposed Solution	Codes / Mitigation Info	Qty	Unit	Cost	Total
General Note						
696	<ul style="list-style-type: none"> • As-Built Description: Refer to notes for observation and recommendation. • Proposed Solution: • Notes: Characters approximately 0.1" high, character height should be 3/16" per CBC-11B-707.7.2. See Lot F for code citations. 	PCODE GN01 CBC 2016 11B-502.4 Mitigated: <input type="radio"/> YES <input checked="" type="radio"/> NO				
						REF

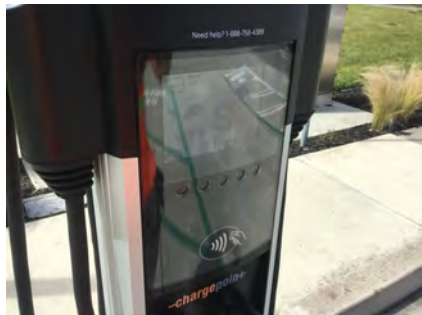
<input type="checkbox"/> Staff Only Priority Severity 1 3
697	<ul style="list-style-type: none"> • As-Built Description: Refer to notes for observation and recommendation. • Proposed Solution: • Notes: No raised dot. 	PCODE GN01 CBC 2016 11B-502.4 Mitigated: <input type="radio"/> YES <input checked="" type="radio"/> NO				
						REF

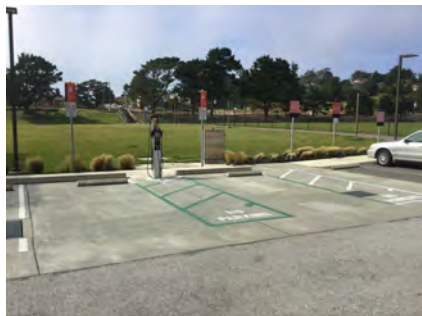
701	<ul style="list-style-type: none"> • As-Built Description: Refer to notes for observation and recommendation. • Proposed Solution: • Notes: The placement of the access aisle requires a user to travel behind vehicles. 	PCODE GN01 CBC 2016 11B-309.4 Mitigated: <input type="radio"/> YES <input checked="" type="radio"/> NO				
						REF

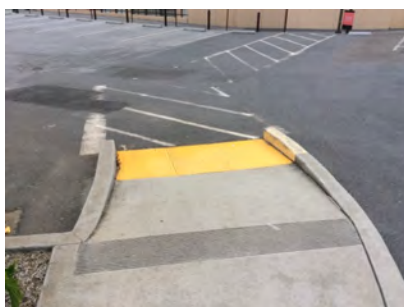
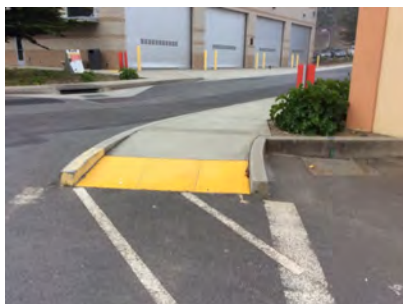
Width of Ramp / Pad	(in)	72.0
Length of Ramp / Pad	(in)	82.0
Slope of the Ramp / Pad	(%)	11.6
X Slope of the Ramp / Pad	(%)	1.9
Top Landing Length	(in)	48.0
Top Landing Slope	(%)	1.9
Top Landing X Slope	(%)	0.4

Demolish existing and provide new, perpendicular curb ramp, including detectable warning surfaces, and top and bottom landings as required.

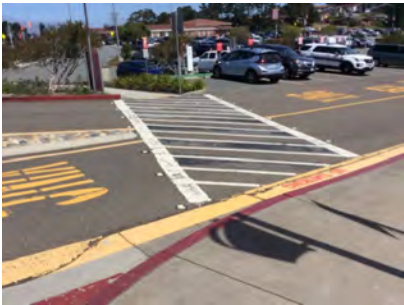
56 Compliant Curb Ramp

- As-Built Description:
Curb ramp, blended transition, island cut-through, island perpendicular, or pedestrian pad surveyed for the following items are in compliance with the ADA and applicable building codes.
- Proposed Solution:
Provide routine inspection and maintenance to maintain accessible access route.

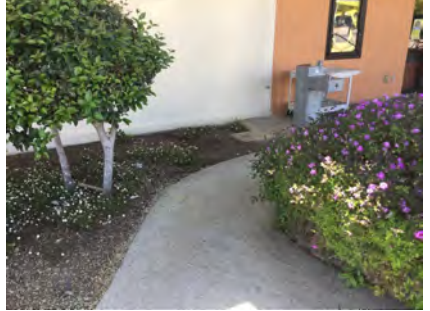
10990	<ul style="list-style-type: none"> As-Built Description: Walk more than 36" but less than 48" wide (required in CA only). As-Built: 30" wide obstructed by vegetation. Proposed Solution: Trim vegetation. 	PCODE EF08 CBC 2007 1133B.7.1 CBC 2016 11B-403.5.1.3 Mitigated: <input type="radio"/> YES <input checked="" type="radio"/> NO	2	JOB	\$135	\$270

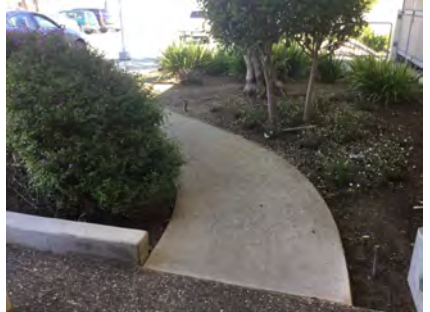
<input type="checkbox"/> Staff Only						
Priority 1 Severity 3						
10991	<ul style="list-style-type: none"> As-Built Description: Walk more than 36" but less than 48" wide (required in CA only). As-Built: 46" Proposed Solution: Enlarge width of walk to 48". 	PCODE EF08REF ADA 2010 403.5 CBC 2007 1133B.7.1 CBC 2016 11B-403.5.1.3 Mitigated: <input type="radio"/> YES <input checked="" type="radio"/> NO		REF

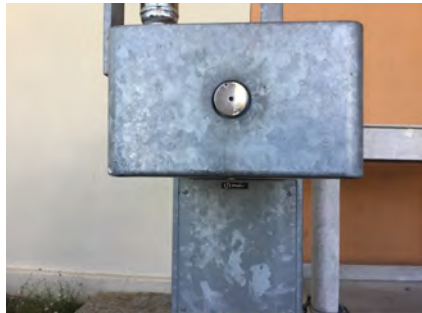
Item no., Rm no. and Name	Existing Architectural Barrier and Proposed Solution	Codes / Mitigation Info	Qty	Unit	Cost	Total
Drinking Fountain						
10993	<ul style="list-style-type: none"> As-Built Description: Wall- and post-mounted cantilevered units: Knee space not provided at drinking fountain (27" high, 8" deep, 30" wide from front of drinking fountain). As-Built: 26.75" high Proposed Solution: Provide new, accessible fountain. 	PCODE IA02 ADAAG 91 4.15.5(1) ADA 2010 602.2 CBC 2007 1115B.4.6.2 CBC 2016 11B-602.2 Mitigated: <input type="radio"/> YES <input checked="" type="radio"/> NO	1	JOB	\$9,600	\$9,600
