SAN MATEO COUNTY
COMMUNITY
COLLEGE DISTRICT

San Mateo County Community College District Americans with Disabilities Act Self-Evaluation and Transition Plan

Report Prepared by:

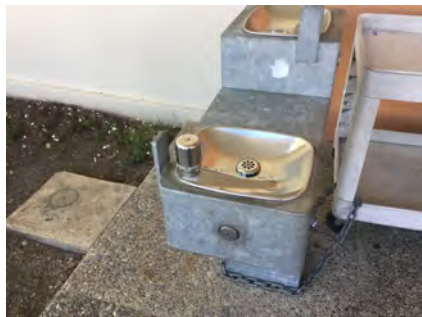
<input type="checkbox"/> Staff Only Priority 3 Severity 2			
10994	<ul style="list-style-type: none"> As-Built Description: Drinking fountain water flow less than 4" high; unit in good condition. As-Built: 1.5" high Proposed Solution: Adjust water flow. 	PCODE IA03D ADAAG 91 4.15.3 ADA 2010 602.6 CBC 2007 1115B.4.6.5 CBC 2016 11B-602.6 Mitigated: <input type="radio"/> YES <input checked="" type="radio"/> NO	1	JOB	\$225	\$225

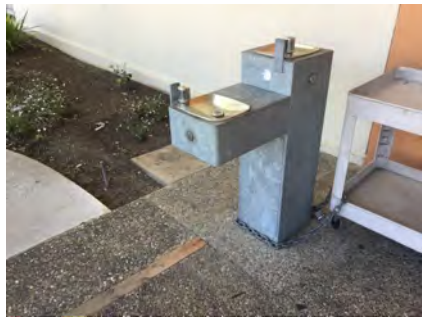
<input type="checkbox"/> Staff Only Priority 3 Severity 3			
10995	<ul style="list-style-type: none"> As-Built Description: Drinking fountain lacks protection for visually impaired persons. Proposed Solution: Provide cane-detectable rails. 	PCODE IA05C ADAAG 91 4.4.1 ADA 2010 307.2 CBC 2007 1115B.4.6.3 CBC 2016 11B-307.2 Mitigated: <input type="radio"/> YES <input checked="" type="radio"/> NO	1	JOB	\$1,500	\$1,500

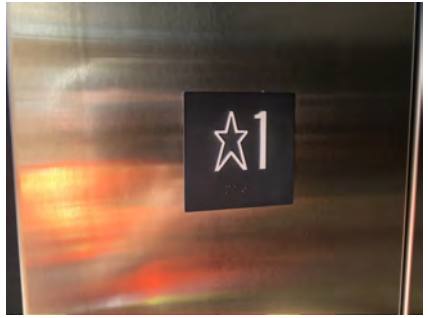
Item no., Rm no. and Name	Existing Architectural Barrier and Proposed Solution	Codes / Mitigation Info	Qty	Unit	Cost	Total
11009	<ul style="list-style-type: none"> • As-Built Description: Braille and raised floor numbers on entrance incorrect. • Proposed Solution: Relocate Braille and raised floor numbers on entrance jambs to 5' above floor. • Notes: Star 1.25" wide. 2" minimum required. 	PCODE IK11C ADAAG 91 4.10.5 ADA 2010 703.4.1 CBC 2007 1116B.1.14 CBC 2016 11B-703.4.1 Mitigated: <input type="radio"/> YES <input checked="" type="radio"/> NO	2	JOB	\$360	\$720

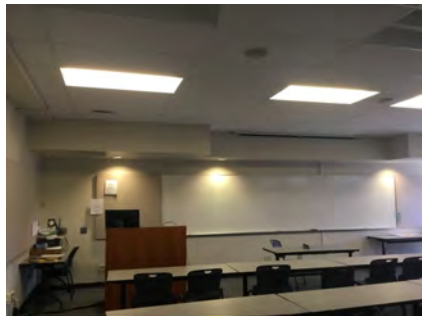
Item no., Rm no. and Name	Existing Architectural Barrier and Proposed Solution	Codes / Mitigation Info	Qty	Unit	Cost	Total
11013	<ul style="list-style-type: none"> • <i>As-Built Description:</i> No signs at the building or assembly area entrance to notify patrons that an assistive listening system is available. • <i>Proposed Solution:</i> Provide assistive listening signage. 	PCODE GI02 ADAAG 91 4.1.3(19)(b) ADA 2010 703.7.2.4 CBC 2007 1104B.2.4 CBC 2016 11B-703.7.2.4 Mitigated: <input type="radio"/> YES <input checked="" type="radio"/> NO	1	JOB	\$300	\$300

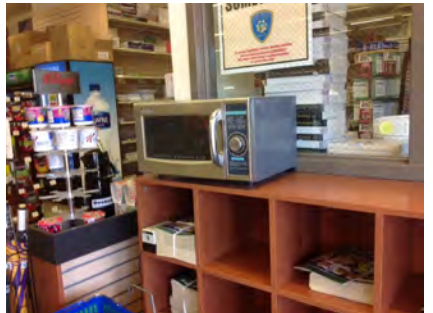
220	<ul style="list-style-type: none"> • <i>As-Built Description:</i> Microwave door does not have accessible operating hardware. • <i>Proposed Solution:</i> Provide accessible microwave with lever handle or other accessible hardware. 	PCODE ID07NT ADAAG 91 4.13.9 ADA 2010 404.2.7 CBC 2007 1133B.2.5.2 CBC 2016 11B-404.2.7 Mitigated: <input type="radio"/> YES <input checked="" type="radio"/> NO	1	JOB	\$750	\$750

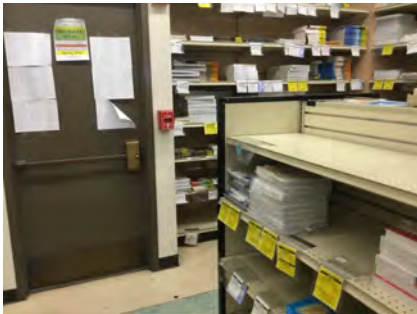
Item no., Rm no. and Name	Existing Architectural Barrier and Proposed Solution	Codes / Mitigation Info	Qty	Unit	Cost	Total
<div>Door Swing</div>						
11005	<div><div>As-Built Description:</div><div>Front approach: At push side, door does not have clear and level maneuvering space measuring door width x 48" (door width plus 12" if door has both, latch and closer).</div><div>As-Built: Display shelf 38" from door. 5" from the strike side.</div><div>Proposed Solution:</div><div>Remove or relocate furniture or storage items.</div></div>	<div>PCODE ID24A</div> <div>ADAAG 91 Fig. 25(a)</div> <div>ADA 2010 404.2.4</div> <div>CBC 2007 11B-26A(a)</div> <div>CBC 2016 11B-404.2.4</div> <div>Mitigated:</div> <div><div><input type="radio"/> YES</div><div><input checked="" type="radio"/> NO</div></div>	1	JOB	\$150	\$150
			<div>

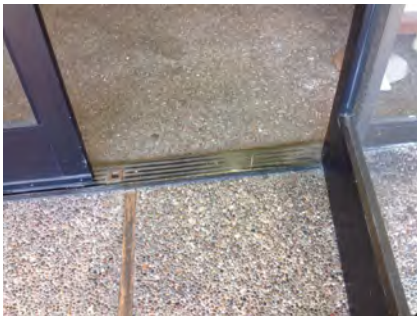
<div><div>2</div></div>	<div><div>2</div></div>		
<div>Door Threshold</div>						
215	<div><div>As-Built Description:</div><div>Door inaccessible due to threshold or step at door exceeding 1/2".</div><div>As-Built: 0.75"</div><div>Proposed Solution:</div><div>Modify threshold to be no more than 1/2" by removing existing paving at door and providing landing with edge ramping (slope 1:20 max).</div></div>	<div>PCODE ID02A</div> <div>ADAAG 91 4.13.8</div> <div>ADA 2010 404.2.5</div> <div>CBC 2007 1133B.2.4.1</div> <div>CBC 2016 11B-404.2.5</div> <div>Mitigated:</div> <div><div><input type="radio"/> YES</div><div><input checked="" type="radio"/> NO</div></div>	1	JOB	\$1,200	\$1,200
			<div>

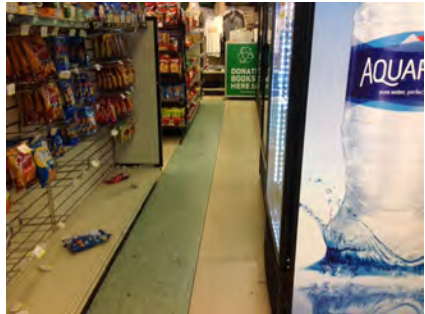
Item no., Rm no. and Name	Existing Architectural Barrier and Proposed Solution	Codes / Mitigation Info	Qty	Unit	Cost	Total
222	<ul style="list-style-type: none"> As-Built Description: Corridor less than 44" wide. As-Built: 36" wide serving both sides Proposed Solution: Enlarge corridor to 44" wide; relocate stud wall. Notes: Several rows 	PCODE IH03 ADAAG 91 4.3.3 ADA 2010 403.5.1 CBC 2007 1133B.3.1 CBC 2016 11B-403.5.1 Mitigated: <input type="radio"/> YES <input checked="" type="radio"/> NO		LF	\$420

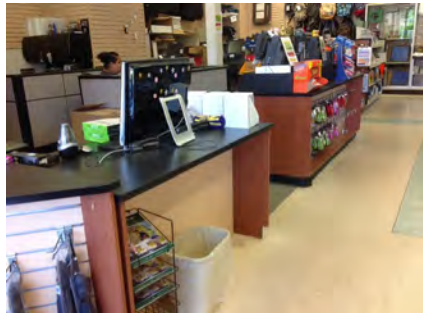
223	<ul style="list-style-type: none"> As-Built Description: Service counter (stand-up): Accessible section min. 36" length and 36" max. height (in CA: 28" to 34" high) not provided. Proposed Solution: Retrofit existing counter to provide accessible section. Interim solution: Provide auxiliary counter, table, or clipboard. Notes: Ensure both registers provide same services. The lowered counter must be operational at all times. 	PCODE IN03 ADAAG 91 7.2(2) ADA 2010 904.4 CBC 2007 1122B.4 CBC 2016 11B-904.4 Mitigated: <input type="radio"/> YES <input checked="" type="radio"/> NO	1	JOB	\$6,000	\$6,000

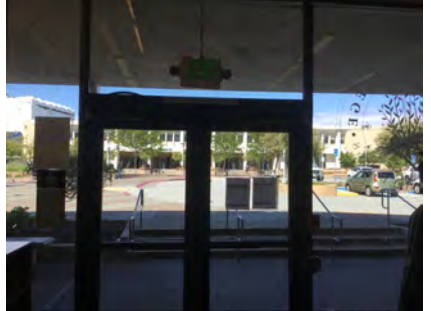
Item no., Rm no. and Name	Existing Architectural Barrier and Proposed Solution	Codes / Mitigation Info	Qty	Unit	Cost	Total
Signage						
11002	<ul style="list-style-type: none"> As-Built Description: At final exit door to exterior: Where required exit signs are installed, signs to provide exiting information for people with vision impairment are not provided. Proposed Solution: Provide raised letter/Braille "EXIT" sign at door. 	PCODE SA10A ADAAG 91 4.1.3(16) ADA 2010 216.4.1 CBC 2007 1011.3 CBC 2016 11B-216.4.1 Mitigated: <input type="radio"/> YES <input checked="" type="radio"/> NO	2	JOB	\$270	\$540

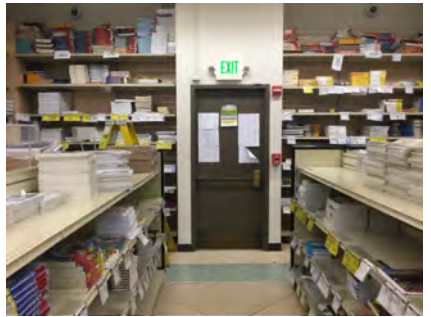
<input type="checkbox"/> Staff Only Priority 2 Severity 3			
11004	<ul style="list-style-type: none"> As-Built Description: At final exit door to exterior: Where required exit signs are installed, signs to provide exiting information for people with vision impairment are not provided. Proposed Solution: Provide raised letter/Braille "EXIT" sign at door. 	PCODE SA10A ADAAG 91 4.1.3(16) ADA 2010 216.4.1 CBC 2007 1011.3 CBC 2016 11B-216.4.1 Mitigated: <input type="radio"/> YES <input checked="" type="radio"/> NO	1	JOB	\$270	\$270

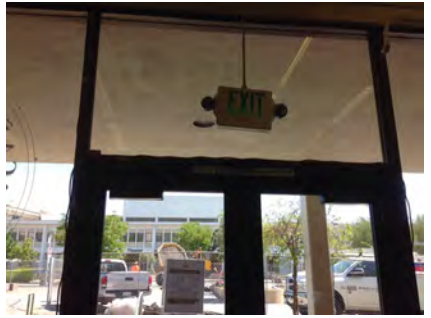
<input type="checkbox"/> Staff Only Priority 2 Severity 3			
216	<ul style="list-style-type: none"> As-Built Description: At final exit door to exterior: Where required exit signs are installed, signs to provide exiting information for people with vision impairment are not provided. Proposed Solution: Provide raised letter/Braille "EXIT" sign at door. 	PCODE SA10A ADAAG 91 4.1.3(16) ADA 2010 216.4.1 CBC 2007 1011.3 CBC 2016 11B-216.4.1 Mitigated: <input type="radio"/> YES <input checked="" type="radio"/> NO	2	JOB	\$270	\$540

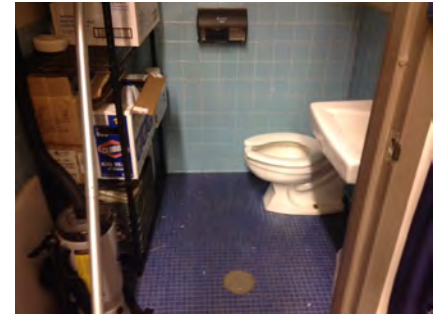
Single accommodation restroom not accessible;
multiple compliance violations.

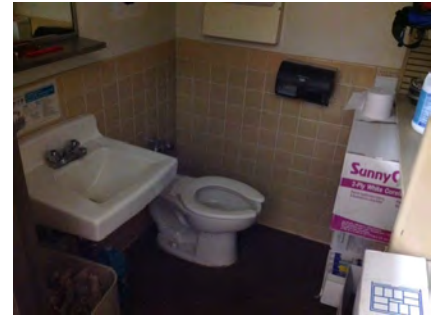
Single accommodation restroom not accessible;
multiple compliance violations.

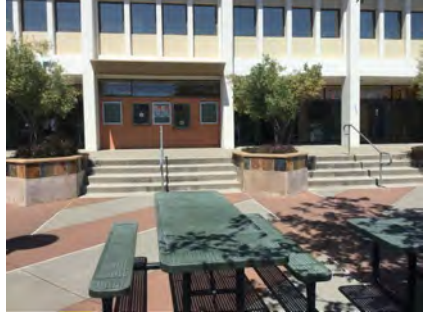
Item no., Rm no. and Name	Existing Architectural Barrier and Proposed Solution	Codes / Mitigation Info	Qty	Unit	Cost	Total
<u>Signage</u>						
10973	<ul style="list-style-type: none"> • <i>As-Built Description:</i> Exterior signage at inaccessible entrances to provide direction to accessible entrances is missing or noncompliant. • <i>Proposed Solution:</i> Provide signage sufficient to guide persons to accessible entrances. 	PCODE SA01 ADAAG 91 4.1.2(7)(c) ADA 2010 216.6 CBC 2007 1117B.5.8.1.2 CBC 2016 11B-216.6 Mitigated: <input type="radio"/> YES <input checked="" type="radio"/> NO	1	JOB	\$690	\$690

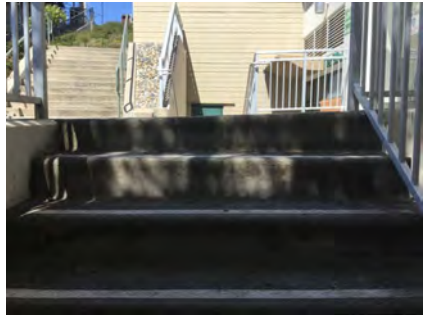
Item no., Rm no. and Name	Existing Architectural Barrier and Proposed Solution	Codes / Mitigation Info	Qty	Unit	Cost	Total
10983	<ul style="list-style-type: none"> As-Built Description: Steps do not have uniform riser height. As-Built: 6" - 8" high Proposed Solution: Remodel stairs as needed. 	PCODE EC07A ADA 2010 504.2 CBC 2007 1133B.4.5.3 CBC 2016 11B-504.2 Mitigated: <input type="radio"/> YES <input checked="" type="radio"/> NO	10	LF	\$225	\$2,250

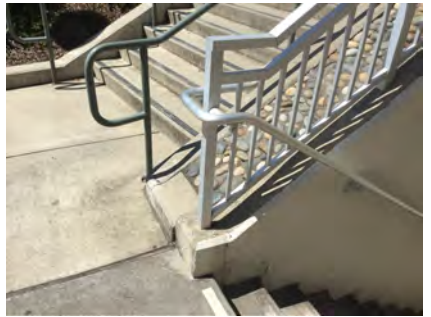
10979	<ul style="list-style-type: none"> As-Built Description: Stair handrail does not extend horizontally 12" minimum beyond top nosing, and one tread width sloped, plus 12" minimum horizontally beyond the bottom nosing. As-Built: 6" - 9" long Proposed Solution: Extend stair handrail at top and bottom (cost for each extension piece). 	PCODE ED06 ADAAG 91 4.9.4(2) ADA 2010 505.10.2; CBC 2007 1133B.4.2.2 CBC 2016 11B-505.10.2; 11B-505.10.3 Mitigated: <input type="radio"/> YES <input checked="" type="radio"/> NO	6	JOB	\$510	\$3,060

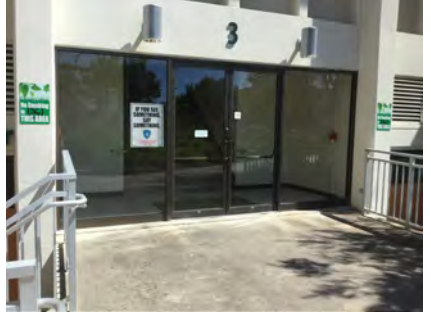
Item no., Rm no. and Name	Existing Architectural Barrier and Proposed Solution	Codes / Mitigation Info	Qty	Unit	Cost	Total
Route Sign						
10984	<ul style="list-style-type: none"> • <i>As-Built Description:</i> No sign by inaccessible route directing persons to an accessible route. • <i>Proposed Solution:</i> Provide directional sign. • <i>Notes:</i> Only accessed by stairs. Provide directional signage at the bottom of the stairs. 	PCODE SA20 ADAAG 91 35.163(b) ADA 2010 216.3 CBC 2007 1127B.3 CBC 2016 11B-216.3 Mitigated: <input type="radio"/> YES <input checked="" type="radio"/> NO	1	JOB	\$510	\$510

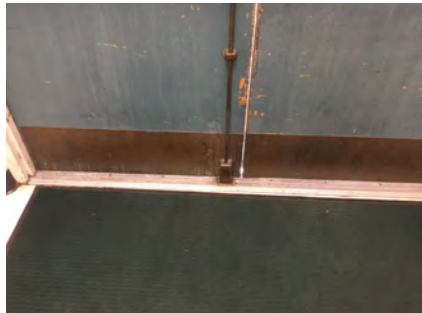
Item no., Rm no. and Name	Existing Architectural Barrier and Proposed Solution	Codes / Mitigation Info	Qty	Unit	Cost	Total
Door						
10939	<ul style="list-style-type: none"> As-Built Description: At push side of door on accessible route, bottom 10" does not have a smooth, uninterrupted surface. Proposed Solution: Provide 10" min. "kick plate" covering width of door when altering area. 	PCODE ID06 ADA 2010 404.2.10 CBC 2007 1133B.2.6 CBC 2016 11B-404.2.10 Mitigated: <input type="radio"/> YES <input checked="" type="radio"/> NO	1	JOB	\$300	\$300

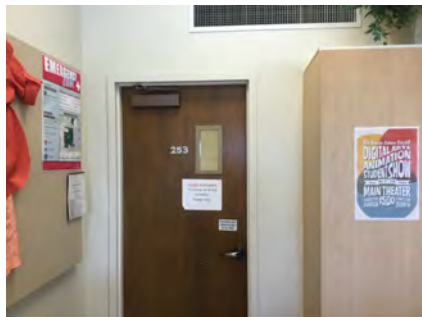
<input type="checkbox"/> Staff Only Priority 2 Severity 3			
10813	<ul style="list-style-type: none"> As-Built Description: Vision Light at door that permits viewing, does not have bottom of at least one glazed panel located 43 inches maximum above the finish floor. (Exception: More than 66" above finished floor.) As-Built: 60" AFF Proposed Solution: Provide new door with vision panel at 43" max. 	PCODE ID06C ADA 2010 404.2.11 CBC 2016 11B-404.2.11 Mitigated: <input type="radio"/> YES <input checked="" type="radio"/> NO	1	JOB	\$7,500	\$7,500

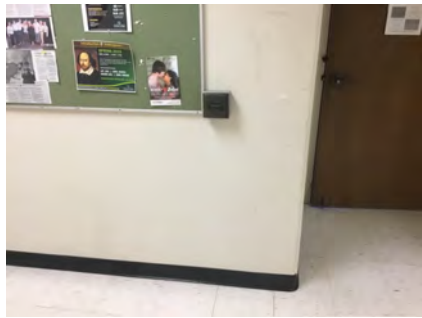
<input type="checkbox"/> Staff Only Priority 2 Severity 1			
10748	<ul style="list-style-type: none"> As-Built Description: Push plate to operate automatic door not a minimum 4" in diameter or a minimum of 4" x 4" square. Proposed Solution: Provide compliant push plate. Notes: No ISA is provided. 	PCODE ID13C CBC 2016 11B-404.2.9 2.C Mitigated: <input type="radio"/> YES <input checked="" type="radio"/> NO	20	JOB	\$1,500	\$30,000

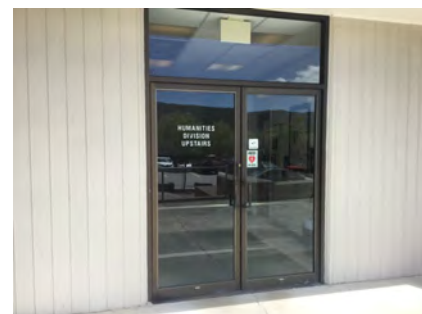
10814

Exterior signage at inaccessible entrances to provide direction to accessible entrances is missing or noncompliant.

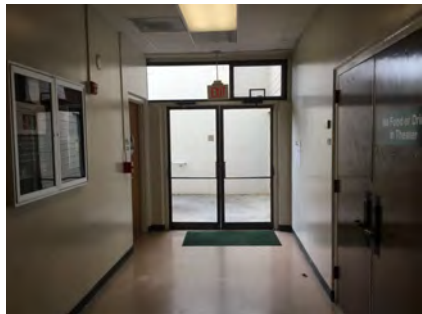
Item no., Rm no. and Name	Existing Architectural Barrier and Proposed Solution	Codes / Mitigation Info	Qty	Unit	Cost	Total
10869	<ul style="list-style-type: none"> As-Built Description: At final exit door to exterior: Where required exit signs are installed, signs to provide exiting information for people with vision impairment are not provided. Proposed Solution: Provide raised letter/Braille "EXIT" sign at door. 	PCODE SA10A ADAAG 91 4.1.3(16) ADA 2010 216.4.1 CBC 2007 1011.3 CBC 2016 11B-216.4.1 Mitigated: <input type="radio"/> YES <input checked="" type="radio"/> NO	10	JOB	\$270	\$2,700

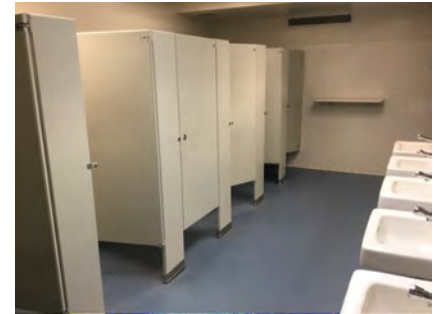
Multiple accommodation restroom not accessible;
multiple compliance violations.

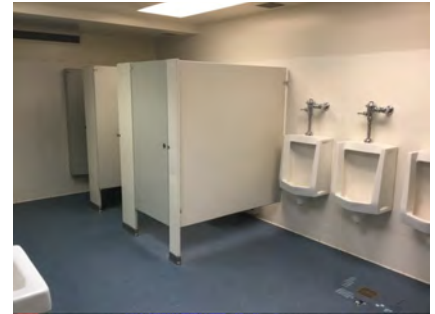
Multiple accommodation restroom not accessible;
multiple compliance violations.

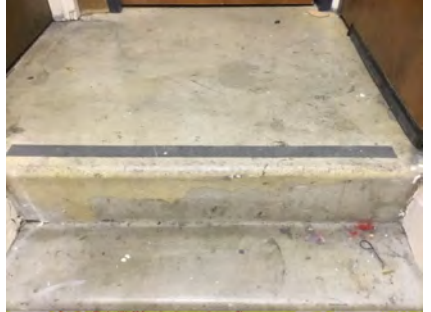
Item no., Rm no. and Name	Existing Architectural Barrier and Proposed Solution	Codes / Mitigation Info	Qty	Unit	Cost	Total
<u>Stairway</u>						
10963	<ul style="list-style-type: none"> • <i>As-Built Description:</i> The leading 2" of the tread does not have visual contrast of dark-on-light or light-on-dark from the remainder of the tread. • <i>As-Built:</i> 2" from nosing • <i>Proposed Solution:</i> Provide 2" min., 4" max. wide contrasting color strip 1" max. from nosing on top & bottom treads when altering area. 	PCODE II02B ADA 2010 504.4 CBC 2007 1133B.4.4 CBC 2016 11B-504.4.1 Mitigated: <input type="radio"/> YES <input checked="" type="radio"/> NO	8	LF	\$42	\$336

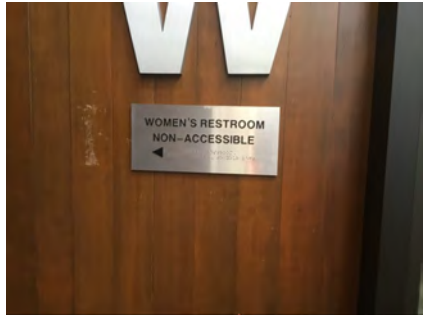
Item no., Rm no. and Name	Existing Architectural Barrier and Proposed Solution	Codes / Mitigation Info	Qty	Unit	Cost	Total
10834	<ul style="list-style-type: none"> As-Built Description: No sign by inaccessible route directing persons to an accessible route. Proposed Solution: Provide directional sign. Notes: <i>Provide directional sign to accessible restroom.</i> 	PCODE SA20 ADAAG 91 35.163(b) ADA 2010 216.3 CBC 2007 1127B.3 CBC 2016 11B-216.3 Mitigated: <input type="radio"/> YES <input checked="" type="radio"/> NO	1	JOB	\$510	\$510

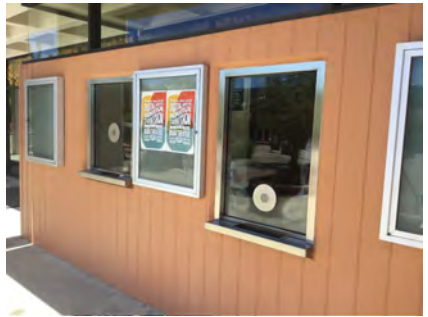
10836	<ul style="list-style-type: none"> As-Built Description: No signs at the building or assembly area entrance to notify patrons that an assistive listening system is available. Proposed Solution: Provide assistive listening signage. 	PCODE GI02 ADAAG 91 4.1.3(19)(b) ADA 2010 703.7.2.4 CBC 2007 1104B.2.4 CBC 2016 11B-703.7.2.4 Mitigated: <input type="radio"/> YES <input checked="" type="radio"/> NO	1	JOB	\$300	\$300

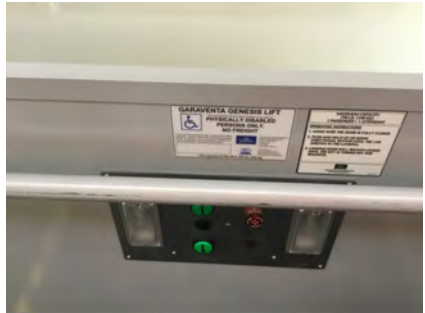
Item no., Rm no. and Name	Existing Architectural Barrier and Proposed Solution	Codes / Mitigation Info	Qty	Unit	Cost	Total
General Note						
10818	<ul style="list-style-type: none"> As-Built Description: Refer to notes for observation and recommendation. Proposed Solution: Notes: Incorrect/insensitive terminology at lift notes. 	PCODE GN01 CBC 2016 11B-404.2.5 Mitigated: <input type="radio"/> YES <input checked="" type="radio"/> NO				
			REF

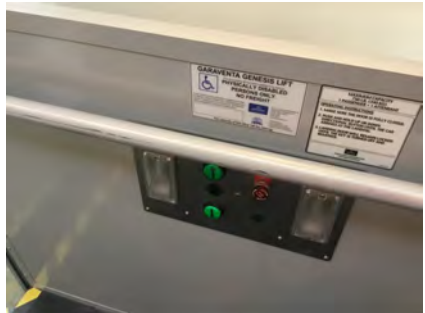
<input type="checkbox"/> Staff Only			
			Priority 1 Severity 3			
10819	<ul style="list-style-type: none"> As-Built Description: Refer to notes for observation and recommendation. Proposed Solution: Notes: Ensure the lift is provided with standby power for egress. 	PCODE GN01 CBC 2016 11B-404.2.5 Mitigated: <input type="radio"/> YES <input checked="" type="radio"/> NO				
			REF

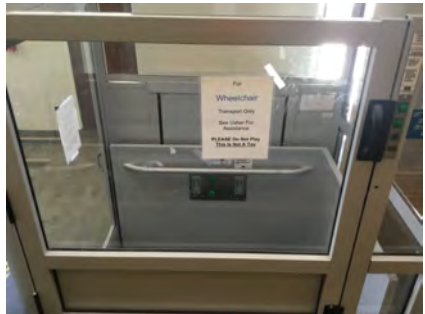
10837	<ul style="list-style-type: none"> As-Built Description: Refer to notes for observation and recommendation. Proposed Solution: Notes: The surveyor was able to use the lift without assistance per requirements. However the sign indicates that assistance is needed. Inform staff that unassisted use is a requirement. 	PCODE GN01 CBC 2016 11B-703.7.2.4 Mitigated: <input type="radio"/> YES <input checked="" type="radio"/> NO				
			REF

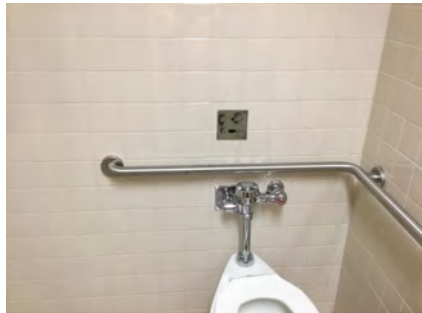
Item no., Rm no. and Name	Existing Architectural Barrier and Proposed Solution	Codes / Mitigation Info	Qty	Unit	Cost	Total
Grab Bars						
10824	<ul style="list-style-type: none"> As-Built Description: The rear wall grab is less than 36" min. or does not extend from the centerline of the water closet 12" min. on one side and 24" min. on the other side. As-Built: 20" on the wide side Proposed Solution: Provide or relocate accessible rear grab bar. 	PCODE WB07B ADAAG 91 4.17.6 ADA 2010 604.5.2 CBC 2007 1115B.4.1.3.2 CBC 2016 11B-604.5.2 Mitigated: <input type="radio"/> YES <input checked="" type="radio"/> NO	1	JOB	\$1,020	\$1,020

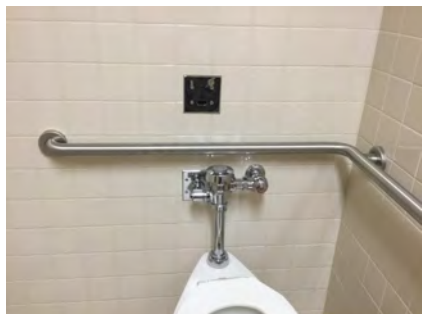
<input type="checkbox"/> Staff Only			
			Priority		Severity	
			3		3	
10823	<ul style="list-style-type: none"> As-Built Description: Accessories/dispensers in accessible stall located closer than 1-1/2" below or 12" above grab bar impedes its use. As-Built: 1.25" between grab bar and flush valve Proposed Solution: Relocate accessories/dispensers to be no closer than 1-1/2" below and 12" above grab bars (except if accessories are recessed, flush with wall, and have no sharp edges). 	PCODE WB071 ADAAG 91 4.26.2 ADA 2010 609.3 CBC 2007 1133B.4.2.5 CBC 2016 11B-609.3 Mitigated: <input type="radio"/> YES <input checked="" type="radio"/> NO	1	JOB	\$225	\$225

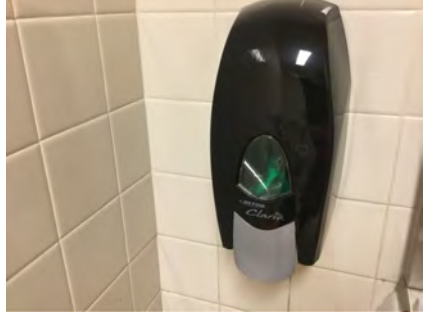
Item no., Rm no. and Name	Existing Architectural Barrier and Proposed Solution	Codes / Mitigation Info	Qty	Unit	Cost	Total
<u>Accessories</u>						
10825	<ul style="list-style-type: none"> • <i>As-Built Description:</i> Dispensers in sanitary facilities, such as for towels, soap, sanitary napkins, seat covers, etc., and waste receptacles more than 48" (CA only: 40") from floor to highest operating slot or control. • <i>As-Built:</i> 41" AFF • <i>Proposed Solution:</i> Relocate existing restroom accessories. 	PCODE WG01A ADAAG 91 4.23.7 ADA 2010 308.2.1 CBC 2007 1115B.8.3 CBC 2016 11B-603.5 Mitigated: <input type="radio"/> YES <input checked="" type="radio"/> NO	1	JOB	\$300	\$300

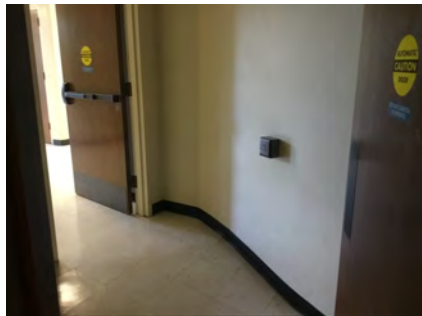
Item no., Rm no. and Name	Existing Architectural Barrier and Proposed Solution	Codes / Mitigation Info	Qty	Unit	Cost	Total
10853	<ul style="list-style-type: none"> As-Built Description: Cross slope more than 1":48" (2.083%). As-Built: 13% Proposed Solution: Modify cross slope. Notes: <i>Clear floor space slopes 13% at automatic door openers.</i> 	PCODE EF07 ADAAG 91 4.3.7 ADA 2010 403.3 CBC 2007 1133B.7.1.3 CBC 2016 11B-403.3 Mitigated: <input type="radio"/> YES <input checked="" type="radio"/> NO	24	SF	\$75	\$1,800

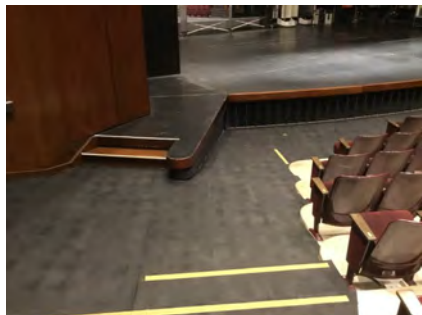
10839	<ul style="list-style-type: none"> As-Built Description: Walk: Slope greater than 1:20 (5.0%), and walk does not comply with requirements for ramps. As-Built: 22.2% Proposed Solution: Modify walk/sidewalk slope to 1:20 or less. Notes: <i>There are coinciding cross slopes of 11%. This condition occurs at the exit/entrance is nearest the stage. These routes appear to serve the wheelchair seating areas nearest the stage.</i> 	PCODE EF01 ADAAG 91 4.3.7 ADA 2010 403.3 CBC 2007 1133B.7.3 CBC 2016 11B-403.3 Mitigated: <input type="radio"/> YES <input checked="" type="radio"/> NO	150	SF	\$75	\$11,250

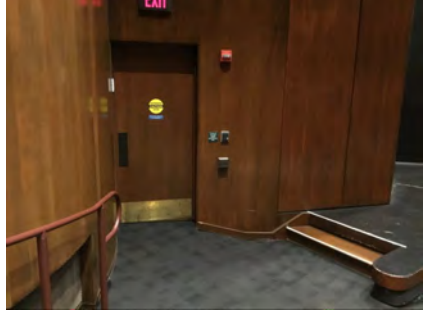
10842	<ul style="list-style-type: none"> • <i>As-Built Description:</i> Surface of required maneuvering clearance at door slopes more than 1/4":12" (2.0%). • <i>As-Built:</i> 13% • <i>Proposed Solution:</i> Modify surface slope at door. 	PCODE ID11 ADAAG 91 4.13.6 ADA 2010 404.2.4.4 CBC 2007 1133B.2.4 CBC 2016 11B-404.2.4 Mitigated: <input type="radio"/> YES <input checked="" type="radio"/> NO	50	SF	\$120	\$6,000

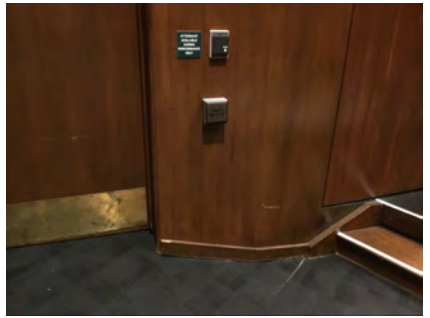
<input type="checkbox"/> Staff Only						
Priority 2 Severity 1						
10841	<ul style="list-style-type: none"> • <i>As-Built Description:</i> Push plate to operate automatic door not a minimum 4" in diameter or a minimum of 4" x 4" square. • <i>Proposed Solution:</i> Provide compliant push plate. 	PCODE ID13C CBC 2016 11B-404.2.9 2.C Mitigated: <input type="radio"/> YES <input checked="" type="radio"/> NO	4	JOB	\$1,500	\$6,000

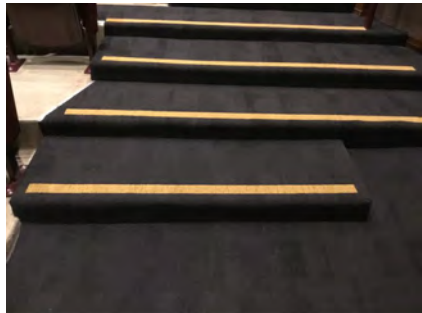
Item no., Rm no. and Name	Existing Architectural Barrier and Proposed Solution	Codes / Mitigation Info	Qty	Unit	Cost	Total
Stairway						
10844	<ul style="list-style-type: none"> • <i>As-Built Description:</i> The leading 2" of the tread does not have visual contrast of dark-on-light or light-on-dark from the remainder of the tread. • <i>As-Built:</i> 2" from nosing • <i>Proposed Solution:</i> Provide 2" min., 4" max. wide contrasting color strip 1" max. from nosing on top & bottom treads when altering area. 	PCODE II02B ADA 2010 504.4 CBC 2007 1133B.4.4 CBC 2016 11B-504.4.1 Mitigated: <input type="radio"/> YES <input checked="" type="radio"/> NO	30	LF	\$42	\$1,260

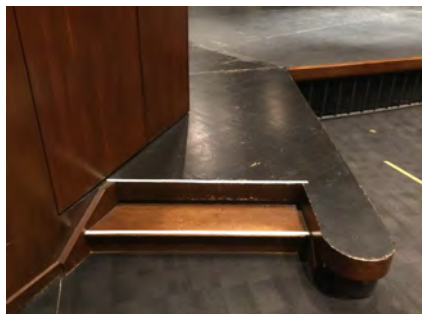
<input type="checkbox"/> Staff Only Priority 2 Severity 3			
10845	<ul style="list-style-type: none"> • <i>As-Built Description:</i> The leading 2" of the tread does not have visual contrast of dark-on-light or light-on-dark from the remainder of the tread. • <i>As-Built:</i> 1" wide • <i>Proposed Solution:</i> Provide 2" min., 4" max. wide contrasting color strip 1" max. from nosing on top & bottom treads when altering area. 	PCODE II02B ADA 2010 504.4 CBC 2007 1133B.4.4 CBC 2016 11B-504.4.1 Mitigated: <input type="radio"/> YES <input checked="" type="radio"/> NO	20	LF	\$42	\$840

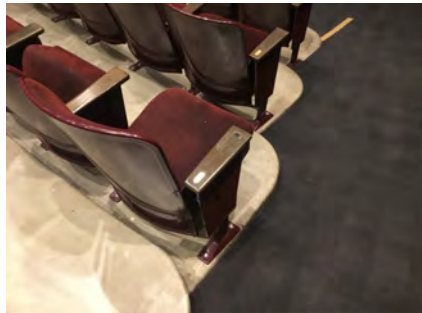
Item no., Rm no. and Name	Existing Architectural Barrier and Proposed Solution	Codes / Mitigation Info	Qty	Unit	Cost	Total
Fixed Seating						
10838	<ul style="list-style-type: none"> As-Built Description: Less than five percent of the total number of aisle seats are accessible. Proposed Solution: Provide aisle seats with no or removable armrest and post availability at ticket office. Notes: 509 seats, 4 designated aisle seats provided. There are no ISA's on the aisle seats. 	PCODE GE01ANT ADAAG 91 4.1.2(19)a ADA 2010 221.4 CBC 2007 1104B.3.4 CBC 2016 11B-221.4 Mitigated: <input type="radio"/> YES <input checked="" type="radio"/> NO	1	EA	\$1,050	\$1,050

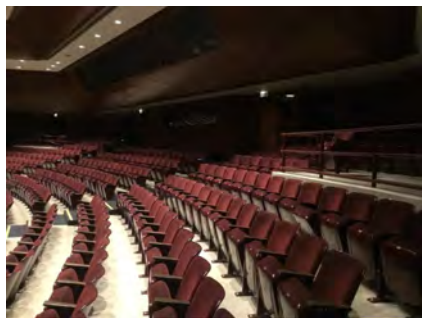
<input type="checkbox"/> Staff Only			
			Priority		Severity	
			2		3	
10843	<ul style="list-style-type: none"> As-Built Description: Wheelchair locations not dispersed throughout seating area (n/a if floor slope greater than 1:20 or 5%). Proposed Solution: Disperse accessible wheelchair space(s). Notes: There does not appear to be horizontal or vertical dispersion at the wheelchair seating spaces. The wheelchair spaces are at the outside edges of the theater. 	PCODE GE01C ADAAG 91 4.33.3 ADA 2010 221.2.3 CBC 2007 1104B.3.3 CBC 2016 11B-221.2.3 Mitigated: <input type="radio"/> YES <input checked="" type="radio"/> NO	1	EA	\$1,800	\$1,800

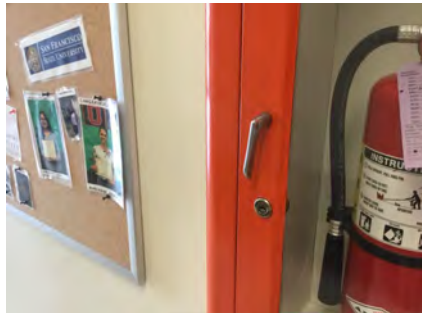
Item no., Rm no. and Name	Existing Architectural Barrier and Proposed Solution	Codes / Mitigation Info	Qty	Unit	Cost	Total
Reach Range						
10859	<ul style="list-style-type: none"> • <i>As-Built Description:</i> Reach height to control or access point, where side approach is available, exceeds 48" or is less than 15" in height, or exceeds 10" in depth. • <i>As-Built:</i> 51" above finished floor • <i>Proposed Solution:</i> Modify equipment or mounting. 	PCODE IE02 ADAAG 91 4.2.6 ADA 2010 308.3.1 CBC 2007 1118B.6 CBC 2016 11B-308.3 Mitigated: <input type="radio"/> YES <input checked="" type="radio"/> NO	1	JOB	\$300	\$300

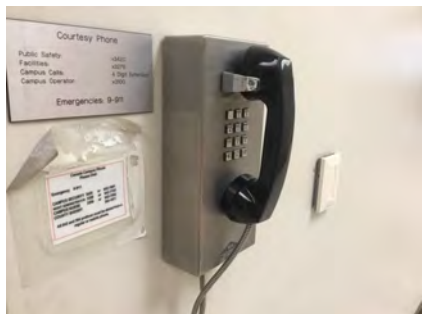
<input type="checkbox"/> Staff Only			
			Priority		Severity	
			2		4	
10866	<ul style="list-style-type: none"> • <i>As-Built Description:</i> Reach height to control or access point, where side approach is available, exceeds 48" or is less than 15" in height, or exceeds 10" in depth. • <i>As-Built:</i> 55.25" above finished floor • <i>Proposed Solution:</i> Modify equipment or mounting. 	PCODE IE02 ADAAG 91 4.2.6 ADA 2010 308.3.1 CBC 2007 1118B.6 CBC 2016 11B-308.3 Mitigated: <input type="radio"/> YES <input checked="" type="radio"/> NO	1	JOB	\$300	\$300

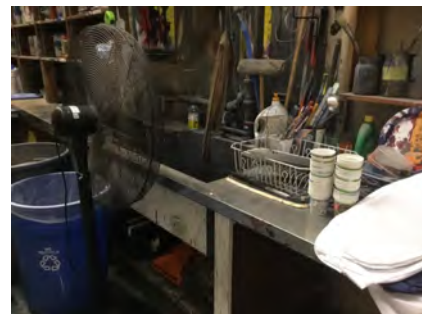
Item no., Rm no. and Name	Existing Architectural Barrier and Proposed Solution	Codes / Mitigation Info	Qty	Unit	Cost	Total
2	<ul style="list-style-type: none"> As-Built Description: Sink does not have knee space min. 27" high x 19" deep x 30" wide. As-Built: No knee clearance provided Proposed Solution: Remodel sink cabinet. 	PCODE IN06A ADAAG 91 4.24.3 ADA 2010 606.2 CBC 2007 1115B.4.7.1 CBC 2016 11B-606.2 Mitigated: <input type="radio"/> YES <input checked="" type="radio"/> NO	1	JOB	\$5,250	\$5,250

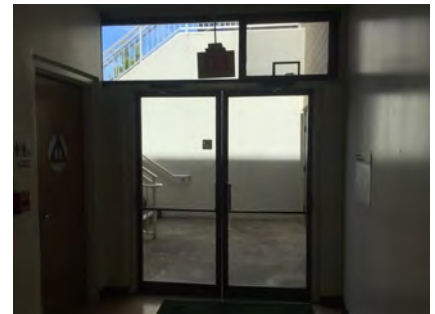
Item no., Rm no. and Name	Existing Architectural Barrier and Proposed Solution	Codes / Mitigation Info	Qty	Unit	Cost	Total
10881	<ul style="list-style-type: none"> As-Built Description: At door leading into exit corridor: Where required exit signs are installed, signs to provide exiting information for people with vision impairment are not provided. Proposed Solution: Provide raised letter/Braille "EXIT ROUTE" sign at door. 	PCODE SA10D ADAAG 91 4.1.3(16) ADA 2010 216.4.1 CBC 2007 1011.3 CBC 2016 11B-216.4.1 Mitigated: <input type="radio"/> YES <input checked="" type="radio"/> NO	2	JOB	\$270	\$540

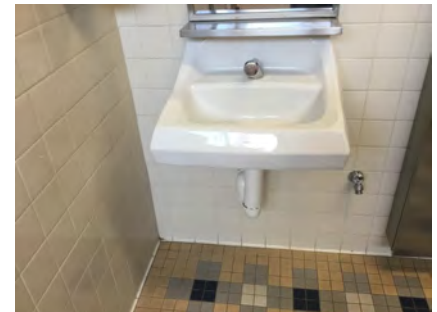
Item no., Rm no. and Name	Existing Architectural Barrier and Proposed Solution	Codes / Mitigation Info	Qty	Unit	Cost	Total
10889	<ul style="list-style-type: none"> As-Built Description: Hot or sharp-surfaced water/drain pipe not insulated or covered. Proposed Solution: Insulate or cover water/drain pipe. 	PCODE WD05REF ADAAG 91 4.19.4 ADA 2010 606.5 CBC 2007 1115B.4.3.4 CBC 2016 11B-606.5 Mitigated: <input type="radio"/> YES <input checked="" type="radio"/> NO	REF

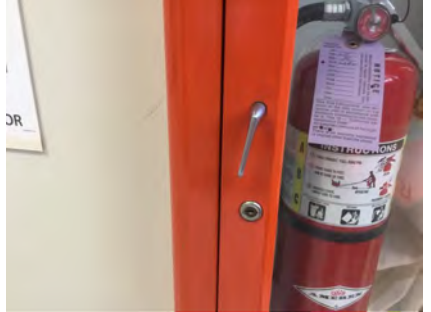
Item no., Rm no. and Name	Existing Architectural Barrier and Proposed Solution	Codes / Mitigation Info	Qty	Unit	Cost	Total
Reach Range						
10907	<ul style="list-style-type: none"> As-Built Description: Reach height to control or access point, where side approach is available, exceeds 48" or is less than 15" in height, or exceeds 10" in depth. As-Built: 51" above finished floor Proposed Solution: Modify equipment or mounting. 	PCODE IE02 ADAAG 91 4.2.6 ADA 2010 308.3.1 CBC 2007 1118B.6 CBC 2016 11B-308.3 Mitigated: <input type="radio"/> YES <input checked="" type="radio"/> NO	1	JOB	\$300	\$300

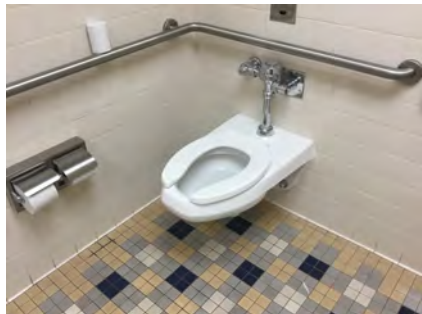
Item no., Rm no. and Name	Existing Architectural Barrier and Proposed Solution	Codes / Mitigation Info	Qty	Unit	Cost	Total
10938	<ul style="list-style-type: none"> As-Built Description: Height of water closet seat less than 17" or more than 19" from floor. As-Built: 19.25" above finished floor Proposed Solution: Provide new accessible water closet. 	PCODE WB08 ADAAG 91 4.16.3 ADA 2010 604.4 CBC 2007 1115B.4.1.4 CBC 2016 11B-604.4 Mitigated: <input type="radio"/> YES <input checked="" type="radio"/> NO	1	JOB	\$4,200	\$4,200

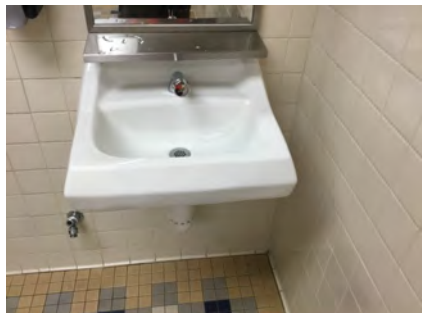
<input type="checkbox"/> Staff Only Priority 3 Severity 4						
Lavatory						
10917	<ul style="list-style-type: none"> As-Built Description: Clear floor space, 30" x 48" in front of fixture, extending 19" max. under the lavatory, not provided (CA only: Less than 18" from side wall to centerline of lavatory). As-Built: 16.5" o.c. Proposed Solution: Provide new accessible lavatory. Remodel restroom as needed. 	PCODE WD01 ADAAG 91 4.19.3 ADA 2010 606.2 CBC 2007 1115B.4.3 CBC 2016 11B-606.2, 11B-606.6 Mitigated: <input type="radio"/> YES <input checked="" type="radio"/> NO	1	JOB	\$10,200	\$10,200

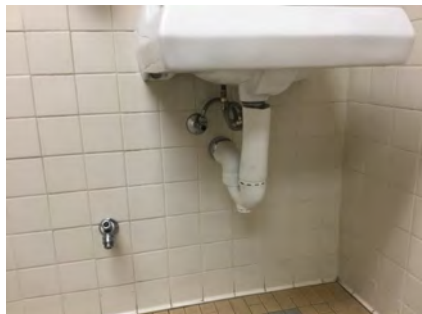
<input type="checkbox"/> Staff Only Priority 3 Severity 2						
10919	<ul style="list-style-type: none"> As-Built Description: Hot or sharp-surfaced water/drain pipe not insulated or covered. Proposed Solution: Insulate or cover water/drain pipe. 	PCODE WD05REF ADAAG 91 4.19.4 ADA 2010 606.5 CBC 2007 1115B.4.3.4 CBC 2016 11B-606.5 Mitigated: <input type="radio"/> YES <input checked="" type="radio"/> NO	REF

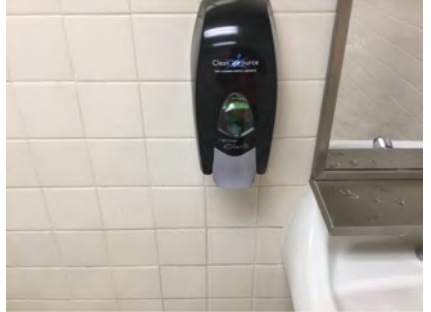
Item no., Rm no. and Name	Existing Architectural Barrier and Proposed Solution	Codes / Mitigation Info	Qty	Unit	Cost	Total
<u>Accessories</u>						
10918	<ul style="list-style-type: none"> • <i>As-Built Description:</i> Dispensers in sanitary facilities, such as for towels, soap, sanitary napkins, seat covers, etc., and waste receptacles more than 48" (CA only: 40") from floor to highest operating slot or control. • <i>As-Built:</i> 41.5" above finished floor • <i>Proposed Solution:</i> Relocate existing restroom accessories. 	PCODE WG01A ADAAG 91 4.23.7 ADA 2010 308.2.1 CBC 2007 1115B.8.3 CBC 2016 11B-603.5 Mitigated: <input type="radio"/> YES <input checked="" type="radio"/> NO	1	JOB	\$300	\$300

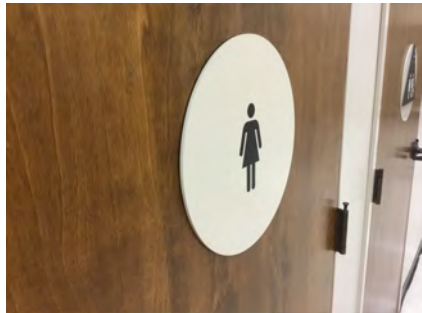
Item no., Rm no. and Name	Existing Architectural Barrier and Proposed Solution	Codes / Mitigation Info	Qty	Unit	Cost	Total
Signage						
10922	<ul style="list-style-type: none"> As-Built Description: Required in CA only: identification symbol centered 58" to 60" high on sanitary facility door that contrasts with the door not provided (women: 12" ø circle, men: 12" triangle, unisex: combined symbol). As-Built: Not eased Proposed Solution: Provide properly mounted sanitary facility symbol when altering area. If wheelchair accessible, include International Symbol of Accessibility on sign. 	PCODE SA15 CBC 2007 1115B.6 CBC 2016 11B-703.7.2.6 Mitigated: <input type="radio"/> YES <input checked="" type="radio"/> NO	1	JOB	\$270	\$270

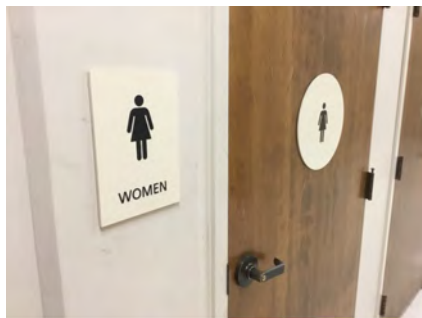
<input type="checkbox"/> Staff Only Priority 3 Severity 3			
10923	<ul style="list-style-type: none"> As-Built Description: Required in CA only: identification symbol centered 58" to 60" high on sanitary facility door that contrasts with the door not provided (women: 12" ø circle, men: 12" triangle, unisex: combined symbol). Proposed Solution: Provide properly mounted sanitary facility symbol when altering area. If wheelchair accessible, include International Symbol of Accessibility on sign. Notes: No ISA provided. Where there are non-accessible restrooms within the building, an ISA must identify the accessible restrooms. 	PCODE SA15 CBC 2007 1115B.6 CBC 2016 11B-703.7.2.6 Mitigated: <input type="radio"/> YES <input checked="" type="radio"/> NO	1	JOB	\$270	\$270

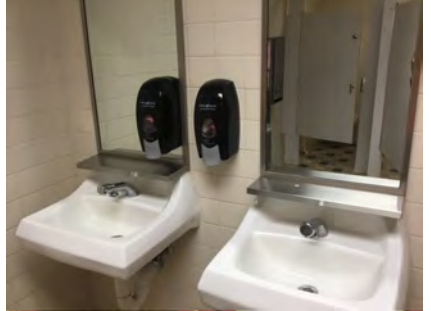
Item no., Rm no. and Name	Existing Architectural Barrier and Proposed Solution	Codes / Mitigation Info	Qty	Unit	Cost	Total
Accessories						
10926	<ul style="list-style-type: none"> • <i>As-Built Description:</i> Dispensers in sanitary facilities, such as for towels, soap, sanitary napkins, seat covers, etc., and waste receptacles more than 48" (CA only: 40") from floor to highest operating slot or control. • <i>As-Built:</i> 41.5" above finished floor • <i>Proposed Solution:</i> Relocate existing restroom accessories. 	PCODE WG01A ADAAG 91 4.23.7 ADA 2010 308.2.1 CBC 2007 1115B.8.3 CBC 2016 11B-603.5 Mitigated: <input type="radio"/> YES <input checked="" type="radio"/> NO	1	JOB	\$300	\$300

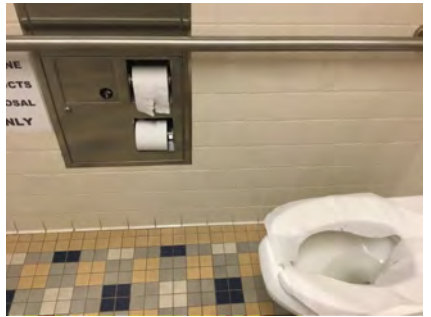
<input type="checkbox"/> Staff Only Priority 3 Severity 4			
10933	<ul style="list-style-type: none"> • <i>As-Built Description:</i> Toilet paper dispenser less than 15" (CA: 19") or more than 48" above floor or not within 7" to 9" from front of water closet (Note: CA pre-2010 is allowed within 12" from front of water closet). • <i>As-Built:</i> 11.5" in front of the water closet • <i>Proposed Solution:</i> Relocate or provide new toilet paper dispenser. 	PCODE WG02 ADAAG 91 4.16.6 ADA 2010 604.7 CBC 2007 1115B.8.4 CBC 2016 11B-604.7 Mitigated: <input type="radio"/> YES <input checked="" type="radio"/> NO	1	JOB	\$225	\$225

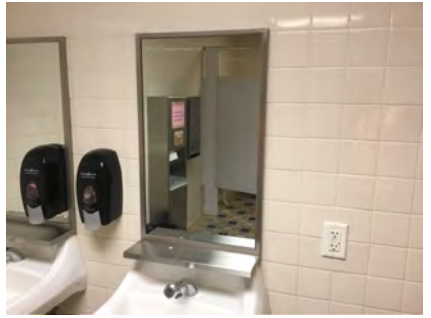
<input type="checkbox"/> Staff Only Priority 3 Severity 3			
10935	<ul style="list-style-type: none"> • <i>As-Built Description:</i> Bottom of mirror located above lavatories or countertops more than 40" above floor. • <i>As-Built:</i> 40.25" above finished floor • <i>Proposed Solution:</i> Relocate or provide new accessible mirror. 	PCODE WG03 ADAAG 91 4.19.6 ADA 2010 603.3 CBC 2007 1115B.8.1 CBC 2016 11B-603.3 Mitigated: <input type="radio"/> YES <input checked="" type="radio"/> NO	1	JOB	\$450	\$450

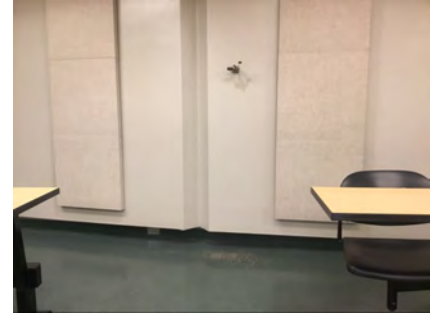
• *Proposed Solution:*CBC 2016 11B-306.1 & 11B
-902.3• **Notes:***Due to steps no accessible route to pencil sharpener provided. Provide pencil sharpener at accessible level.***Mitigated:**☐ YES☒ NO

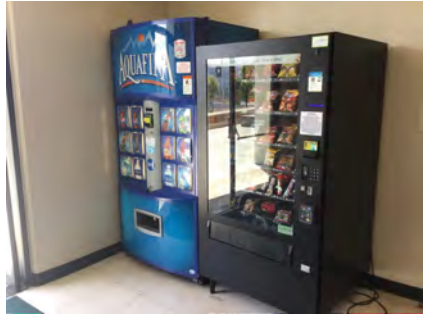
Item no., Rm no. and Name	Existing Architectural Barrier and Proposed Solution	Codes / Mitigation Info	Qty	Unit	Cost	Total
<u>Vending Machine</u>						
10947	<ul style="list-style-type: none"> As-Built Description: Vending machine coin slot or dispensing outlet, more than 48" above or less than 15" above the floor. As-Built: 8"-11" to the bottom of the dispensing trays. 53" to the top of the card reader. Proposed Solution: Advise vendor/leasing company to provide accessible vending machine with operable parts between 15" min. and 48" max. 	PCODE IL02 ADAAG 91 4.2.5 ADA 2010 308.2.1 CBC 2007 1126B CBC 2016 11B-308.2.1 Mitigated: <input type="radio"/> YES <input checked="" type="radio"/> NO				
			REF

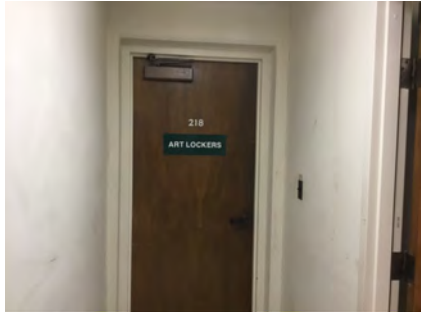
Item no., Rm no. and Name	Existing Architectural Barrier and Proposed Solution	Codes / Mitigation Info	Qty	Unit	Cost	Total
Door Swing						
10730	<ul style="list-style-type: none">As-Built Description: Front approach: At push side, door does not have clear and level maneuvering space measuring door width x 48" (door width plus 12" if door has both, latch and closer).As-Built: 3" strike side clearanceProposed Solution: Remove the closer and or latch.	PCODE ID24A ADAAG 91 Fig. 25(a) ADA 2010 404.2.4 CBC 2007 11B-26A(a) CBC 2016 11B-404.2.4 Mitigated: <div><input type="radio"/> YES</div> <div><input checked="" type="radio"/> NO</div>	2	JOB	\$150	\$300

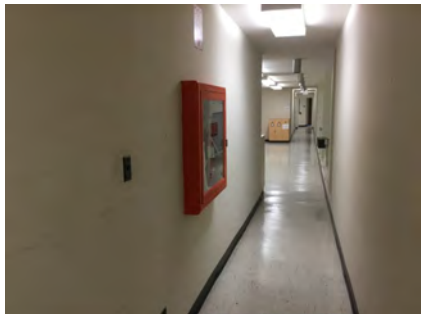
<input type="checkbox"/> Staff Only			
			Priority	Severity		
			<div>3</div>	<div>2</div>		
Corridor						
10729	<ul style="list-style-type: none">As-Built Description: Corridor less than 44" wide.As-Built: 40" wide at fire hose cabinetProposed Solution: Install a lower profile fire extinguisher cabinet.	PCODE IH03 ADAAG 91 4.3.3 ADA 2010 403.5.1 CBC 2007 1133B.3.1 CBC 2016 11B-403.5.1 Mitigated: <div><input type="radio"/> YES</div> <div><input checked="" type="radio"/> NO</div>	3	LF	\$420	\$1,260

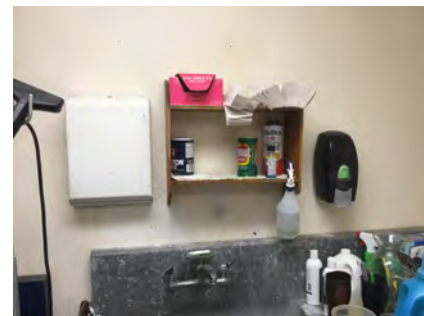
Item no., Rm no. and Name	Existing Architectural Barrier and Proposed Solution	Codes / Mitigation Info	Qty	Unit	Cost	Total
Sink						
10751	<ul style="list-style-type: none"> As-Built Description: Sink rim higher than 34" above floor. As-Built: 37" AFF Proposed Solution: Remodel sink cabinet to lower sink. 	PCODE IN06 ADAAG 91 4.24.2 ADA 2010 606.3 CBC 2007 1115B.4.7.1 CBC 2016 11B-606.3 Mitigated: <input type="radio"/> YES <input checked="" type="radio"/> NO	1	JOB	\$5,250	\$5,250

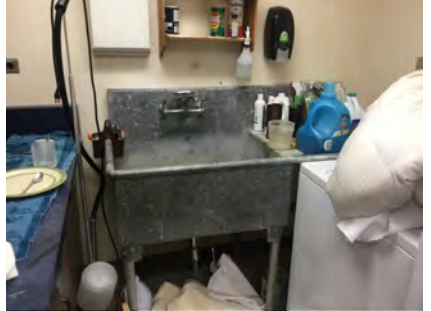
<input type="checkbox"/> Staff Only Priority 2 Severity 4			
10752	<ul style="list-style-type: none"> As-Built Description: Sink does not have knee space min. 27" high x 19" deep x 30" wide. Proposed Solution: Remodel sink cabinet. 	PCODE IN06A ADAAG 91 4.24.3 ADA 2010 606.2 CBC 2007 1115B.4.7.1 CBC 2016 11B-606.2 Mitigated: <input type="radio"/> YES <input checked="" type="radio"/> NO	1	JOB	\$5,250	\$5,250

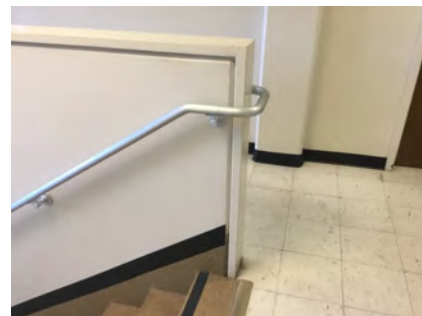
Item no., Rm no. and Name	Existing Architectural Barrier and Proposed Solution	Codes / Mitigation Info	Qty	Unit	Cost	Total
10783	<ul style="list-style-type: none"> As-Built Description: Stair handrail does not extend horizontally 12" minimum beyond top nosing, and one tread width sloped, plus 12" minimum horizontally beyond the bottom nosing. As-Built: 0"-10" Proposed Solution: Extend stair handrail at top and bottom (cost for each extension piece). Notes: Occurs at all open stairs. 	PCODE ED06 ADAAG 91 4.9.4(2) ADA 2010 505.10.2; CBC 2007 1133B.4.2.2 CBC 2016 11B-505.10.2; 11B-505.10.3 Mitigated: <input type="radio"/> YES <input checked="" type="radio"/> NO	4	JOB	\$510	\$2,040

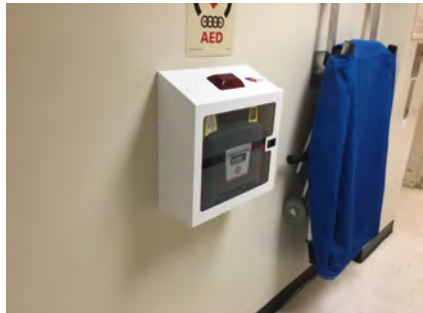
Item no., Rm no. and Name	Existing Architectural Barrier and Proposed Solution	Codes / Mitigation Info	Qty	Unit	Cost	Total
Reach Range						
10774	<ul style="list-style-type: none"> As-Built Description: Reach height to control or access point, where side approach is available, exceeds 48" or is less than 15" in height, or exceeds 10" in depth. As-Built: 51" AFF Proposed Solution: Modify equipment or mounting. 	PCODE IE02 ADAAG 91 4.2.6 ADA 2010 308.3.1 CBC 2007 1118B.6 CBC 2016 11B-308.3 Mitigated: <input type="radio"/> YES <input checked="" type="radio"/> NO	1	JOB	\$300	\$300

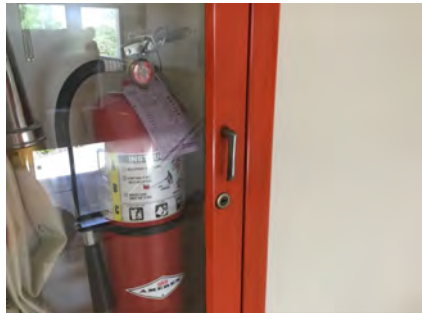
<input type="checkbox"/> Staff Only Priority Severity <input checked="" type="radio"/> 2 <input checked="" type="radio"/> 4			
10785	<ul style="list-style-type: none"> As-Built Description: Reach height to control or access point, where side approach is available, exceeds 48" or is less than 15" in height, or exceeds 10" in depth. As-Built: 55.25" AFF Proposed Solution: Modify equipment or mounting. 	PCODE IE02 ADAAG 91 4.2.6 ADA 2010 308.3.1 CBC 2007 1118B.6 CBC 2016 11B-308.3 Mitigated: <input type="radio"/> YES <input checked="" type="radio"/> NO	1	JOB	\$300	\$300

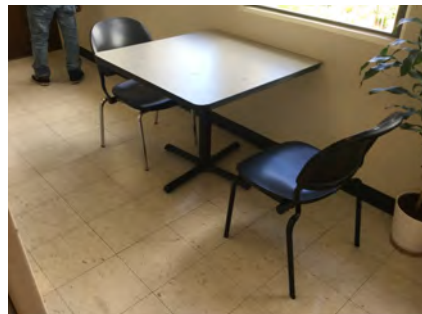
Item no., Rm no. and Name	Existing Architectural Barrier and Proposed Solution	Codes / Mitigation Info	Qty	Unit	Cost	Total
<u>Non-Fixed Desk</u>						
10777	<ul style="list-style-type: none">As-Built Description: Accessible non-fixed table or desk (top 28" to 34" high; knee space at least 27" high x 19" deep x 30" wide) not provided.As-Built: 2 seats, 0 accessibleProposed Solution: Provide table or desk with accessible dimensions when purchasing new furniture.	<p>PCODE IN02A</p> <p>ADAAG 91 4.32.3 & .4</p> <p>ADA 2010 306.1</p> <p>CBC 2007 1122B.3 & 4</p> <p>CBC 2016 11B-306.1 & 11B-902.3</p> <p>Mitigated:</p> <p><input type="radio"/> YES</p> <p><input checked="" type="radio"/> NO</p>	1	JOB	\$4,800	\$4,800

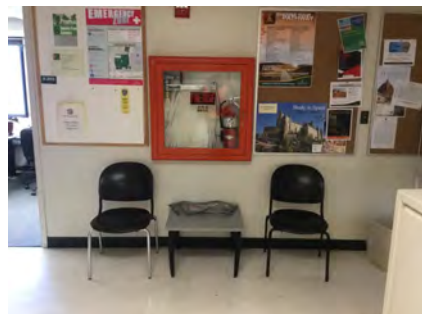
<input type="checkbox"/> Staff Only			
			Priority		Severity	
			2		2	
<u>Sink</u>						
10780	<ul style="list-style-type: none">As-Built Description: No min. 30" x 48" clear floor or ground space for forward or parallel approach.Proposed Solution: Relocate object to provide path to sinkNotes: Relocate chairs to provide a front approach to fire extinguisher.	<p>PCODE IN06E</p> <p>ADAAG 91 4.24.5</p> <p>ADA 2010 606.2</p> <p>CBC 2007 1115B.4.7.1</p> <p>CBC 2016 11B-606.2</p> <p>Mitigated:</p> <p><input type="radio"/> YES</p> <p><input checked="" type="radio"/> NO</p>	1	JOB	\$150	\$150

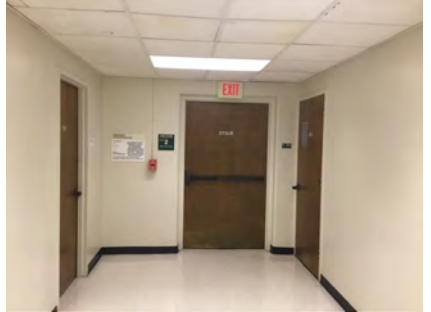
Item no., Rm no. and Name	Existing Architectural Barrier and Proposed Solution	Codes / Mitigation Info	Qty	Unit	Cost	Total
<u>Signage</u>						
10789	<ul style="list-style-type: none"> • <i>As-Built Description:</i> At door leading into exit stairway: Where required exit signs are installed, signs to provide exiting information for people with vision impairment are not provided. • <i>Proposed Solution:</i> Provide raised letter/Braille "EXIT STAIR UP/DOWN" sign at door. 	PCODE SA10B ADAAG 91 4.1.3(16) ADA 2010 216.4.1 CBC 2007 1011.3 CBC 2016 11B-216.4.1 Mitigated: <input type="radio"/> YES <input checked="" type="radio"/> NO	1	JOB	\$270	\$270

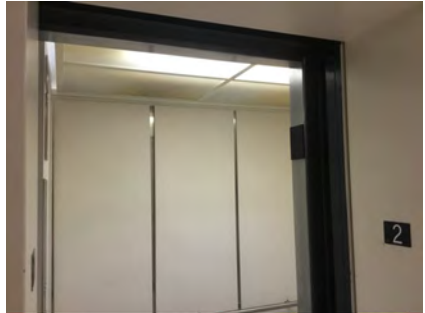
Item no., Rm no. and Name	Existing Architectural Barrier and Proposed Solution	Codes / Mitigation Info	Qty	Unit	Cost	Total
10796	<ul style="list-style-type: none"> As-Built Description: Visual hall lantern, minimum 2-1/2" x 2-1/2", not provided, or installed less than 72" above floor. Proposed Solution: Provide or raise proper visual hall lantern for elevator. 	PCODE IK10A ADAAG 91 4.10.4(1) ADA 2010 407.2.2.2 CBC 2007 1116B.1.13 CBC 2016 11B-407.2.2.2 Mitigated: <input type="radio"/> YES <input checked="" type="radio"/> NO	1	JOB	\$4,650	\$4,650

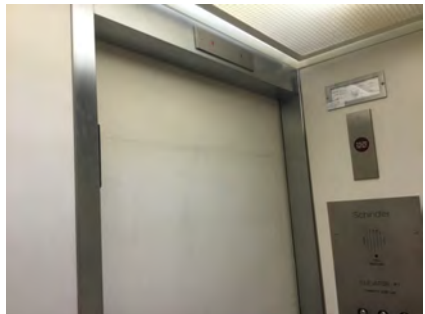
<input type="checkbox"/> Staff Only Priority 2 Severity 3						
10797	<ul style="list-style-type: none"> As-Built Description: Audible signal not provided (one for up, two for down). Proposed Solution: Provide proper audible hall signal for elevator. 	PCODE IK10B ADAAG 91 4.10.4 ADA 2010 407.2.2.3 CBC 2007 1116B.1.13 CBC 2016 11B-407.2.2.3 Mitigated: <input type="radio"/> YES <input checked="" type="radio"/> NO	1	JOB	\$4,650	\$4,650

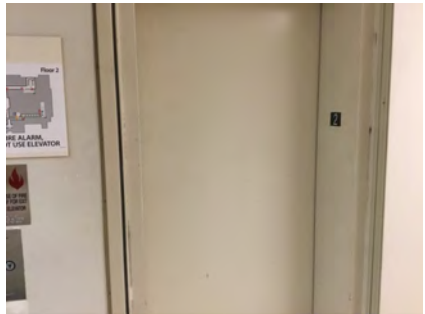
<input type="checkbox"/> Staff Only Priority 2 Severity 3						
10795	<ul style="list-style-type: none"> As-Built Description: Door reopening device does not remain effective for at least 20 seconds. As-Built: Door requires contact to re-open. Proposed Solution: Adjust timing. 	PCODE IK14 ADAAG 91 4.10.6 ADA 2010 407.3.3.3 CBC 2007 1116B.1.5 CBC 2016 11B-407.3.3.3 Mitigated: <input type="radio"/> YES <input checked="" type="radio"/> NO	1	JOB	\$150	\$150

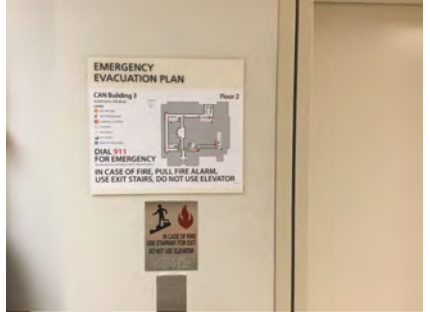
Item no., Rm no. and Name	Existing Architectural Barrier and Proposed Solution	Codes / Mitigation Info	Qty	Unit	Cost	Total
Signage						
10792	<ul style="list-style-type: none"> As-Built Description: At door leading to horizontal exit: Where required exit signs are installed, signs to provide exiting information for people with vision impairment are not provided. Proposed Solution: Provide raised letter/Braille "TO EXIT" sign at door. Notes: <i>There is no sign indicating which means of egress are accessible. The evacuation sign seems to indicate that the elevator is accessible during emergencies however there is a sign instructing people to use stairs in case of emergency.</i> 	PCODE SA10E ADAAG 91 4.1.3(16) ADA 2010 216.4.1 CBC 2007 1011.3 CBC 2016 11B-216.4.1 Mitigated: <input type="radio"/> YES <input checked="" type="radio"/> NO	1	JOB	\$270	\$270

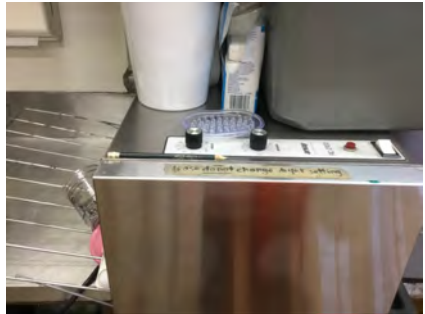
Item no., Rm no. and Name	Existing Architectural Barrier and Proposed Solution	Codes / Mitigation Info	Qty	Unit	Cost	Total
10807	<ul style="list-style-type: none"> • As-Built Description: Operable part(s) require tight grasping, pinching, or twisting of the wrist with one hand. • Proposed Solution: Modify or replace the operable part(s) to not require tight grasping, pinching, or twisting of the wrist with one hand. 	PCODE IC02 ADAAG 91 4.27.4 ADA 2010 309.4 CBC 2007 1117B.6.4 CBC 2016 11B-309.4 Mitigated: <input type="radio"/> YES <input checked="" type="radio"/> NO	1	JOB	\$900	\$900

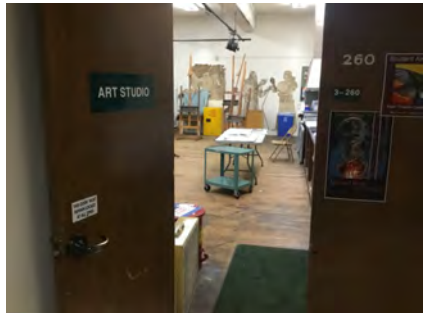
10800	<ul style="list-style-type: none"> • As-Built Description: Pair of doors on accessible route has less than 32" clear opening width with one leaf open 90°. • As-Built: 28" wide • Proposed Solution: Provide new door leaves, unequal in width, to existing frame for pair of doors. 	PCODE ID08A ADAAG 91 4.13.4 ADA 2010 404.2.2 CBC 2007 1133B.2.3.1 CBC 2016 11B-404.2.2 Mitigated: <input type="radio"/> YES <input checked="" type="radio"/> NO	1	JOB	\$4,500	\$4,500

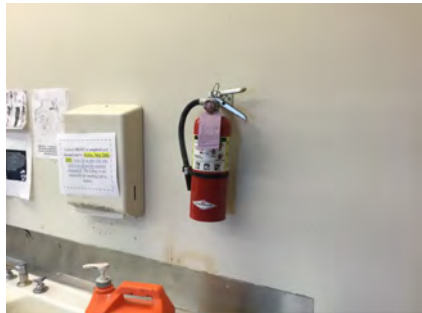
Item no., Rm no. and Name	Existing Architectural Barrier and Proposed Solution	Codes / Mitigation Info	Qty	Unit	Cost	Total
Reach Range						
10803	<ul style="list-style-type: none"> As-Built Description: Reach height to control or access point, where side approach is available, exceeds 48" or is less than 15" in height, or exceeds 10" in depth. As-Built: 65" AFF Proposed Solution: Modify equipment or mounting. 	PCODE IE02 ADAAG 91 4.2.6 ADA 2010 308.3.1 CBC 2007 1118B.6 CBC 2016 11B-308.3 Mitigated: <input type="radio"/> YES <input checked="" type="radio"/> NO	1	JOB	\$300	\$300

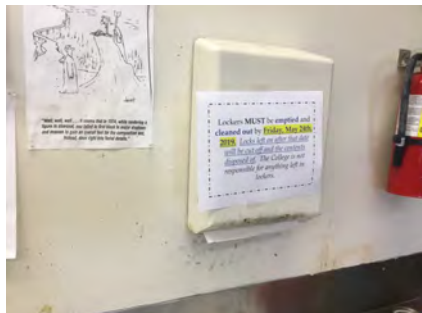
<input type="checkbox"/> Staff Only			
			Priority 2 Severity 2			
10805	<ul style="list-style-type: none"> As-Built Description: Reach height to control or access point, where side approach is available, exceeds 48" or is less than 15" in height, or exceeds 10" in depth. As-Built: 21" deep 50" AFF Proposed Solution: Modify equipment or mounting. 	PCODE IE02 ADAAG 91 4.2.6 ADA 2010 308.3.1 CBC 2007 1118B.6 CBC 2016 11B-308.3 Mitigated: <input type="radio"/> YES <input checked="" type="radio"/> NO	1	JOB	\$300	\$300
