SAN MATEO COUNTY
COMMUNITY
COLLEGE DISTRICT

San Mateo County Community College District Americans with Disabilities Act Self-Evaluation and Transition Plan

Report Prepared by:

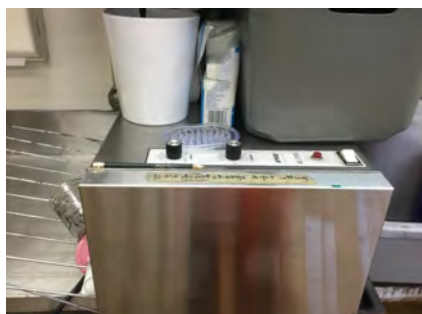
<input type="checkbox"/> Staff Only			
			Priority 2 Severity 4			
10806	<ul style="list-style-type: none"> As-Built Description: Reach height to control or access point, where side approach is available, exceeds 48" or is less than 15" in height, or exceeds 10" in depth. As-Built: 49" AFF Proposed Solution: Modify equipment or mounting. 	PCODE IE02 ADAAG 91 4.2.6 ADA 2010 308.3.1 CBC 2007 1118B.6 CBC 2016 11B-308.3 Mitigated: <input type="radio"/> YES <input checked="" type="radio"/> NO	1	JOB	\$300	\$300

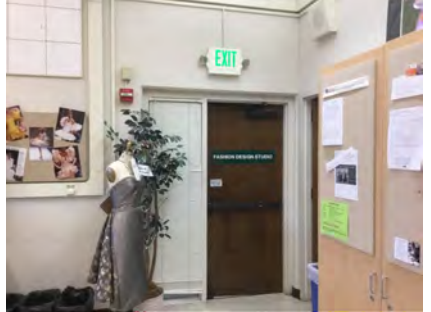
Item no., Rm no. and Name	Existing Architectural Barrier and Proposed Solution	Codes / Mitigation Info	Qty	Unit	Cost	Total
Signage						
10810	<ul style="list-style-type: none"> • <i>As-Built Description:</i> At door leading into exit corridor: Where required exit signs are installed, signs to provide exiting information for people with vision impairment are not provided. • <i>Proposed Solution:</i> Provide raised letter/Braille "EXIT ROUTE" sign at door. 	PCODE SA10D ADAAG 91 4.1.3(16) ADA 2010 216.4.1 CBC 2007 1011.3 CBC 2016 11B-216.4.1 Mitigated: <input type="radio"/> YES <input checked="" type="radio"/> NO	2	JOB	\$270	\$540

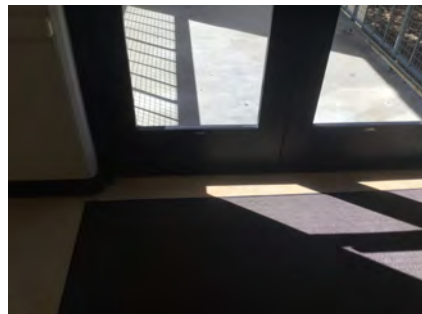
Item no., Rm no. and Name	Existing Architectural Barrier and Proposed Solution	Codes / Mitigation Info	Qty	Unit	Cost	Total
<u>Door Threshold</u>						
11056	<ul style="list-style-type: none">As-Built Description: Door inaccessible due to threshold or step at door exceeding 1/2".As-Built: 1" highProposed Solution: Modify threshold.	PCODE ID02A ADAAG 91 4.13.8 ADA 2010 404.2.5 CBC 2007 1133B.2.4.1 CBC 2016 11B-404.2.5 Mitigated: <input type="radio"/> YES <input checked="" type="radio"/> NO	4	JOB	\$1,200	\$4,800

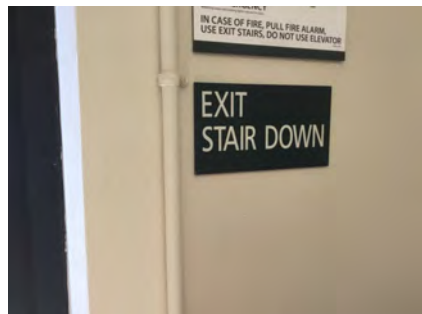
<input type="checkbox"/> Staff Only			
			Priority		Severity	
			2		4	
<u>Signage</u>						
11058	<ul style="list-style-type: none">As-Built Description: Signs containing tactile characters is not located so that a clear floor space of 18" min x 18" min., centered on the tactile characters, is provided beyond the arc of any door swing between the closed position and 45 degree open position.As-Built: 61" to the bottom of the highest tactile characterProposed Solution: Relocate compliant signage on latch side of door located at compliant height with a clear floor space.Notes: Tactile should be 60" high maximum to the bottom of the highest tactile character.	PCODE SA07B ADA 2010 703.4.2 CBC 2016 11B-703.4.2 Mitigated: <input type="radio"/> YES <input checked="" type="radio"/> NO	1	JOB	\$150	\$150

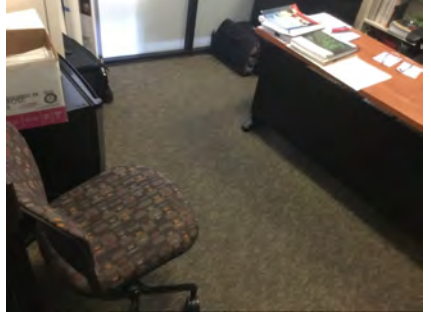
Item no., Rm no. and Name	Existing Architectural Barrier and Proposed Solution	Codes / Mitigation Info	Qty	Unit	Cost	Total
Disabled Seating						
11035	<ul style="list-style-type: none"> As-Built Description: Wheelchair space (33"x48") not provided at fixed seating with forward or rear approach. (NOTE: Space must be adjacent to regular seating; can provide easily removable fixed seat). Proposed Solution: Remove seating and provide wheelchair space plus necessary maneuvering clearance. 	PCODE GB01A ADAAG 91 4.1.3(19)(a) ADA 2010 221.2 CBC 2007 1104B.3.6 CBC 2016 11B-221.2 Mitigated: <input type="radio"/> YES <input checked="" type="radio"/> NO	1	JOB	\$1,350	\$1,350

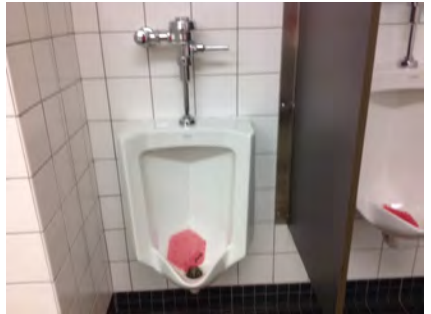
Item no., Rm no. and Name	Existing Architectural Barrier and Proposed Solution	Codes / Mitigation Info	Qty	Unit	Cost	Total
702	<ul style="list-style-type: none"> • <i>As-Built Description:</i> Flush Control: Operating handle mounted more than 44" above floor. • <i>As-Built:</i> 46" • <i>Proposed Solution:</i> Replace flush control with properly mounted accessible type, or install sensor flush. 	PCODE WB10A ADAAG 91 4.16.5 ADA 2010 604.6 CBC 2007 1115B.4.1.5 CBC 2016 11B-604.6 Mitigated: <input type="radio"/> YES <input checked="" type="radio"/> NO	1	JOB	\$1,500	\$1,500

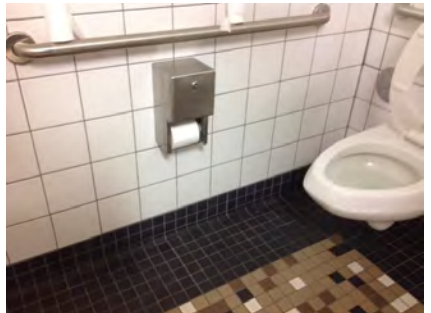
704	<ul style="list-style-type: none"> • <i>As-Built Description:</i> Toilet paper dispenser less than 15" (CA: 19") or more than 48" above floor or not within 7" to 9" from front of water closet (Note: CA pre-2010 is allowed within 12" from front of water closet). • <i>As-Built:</i> 12" o.c. • <i>Proposed Solution:</i> Relocate or provide new toilet paper dispenser. 	PCODE WG02 ADAAG 91 4.16.6 ADA 2010 604.7 CBC 2007 1115B.8.4 Mitigated: <input type="radio"/> YES <input checked="" type="radio"/> NO	1	JOB	\$225	\$225

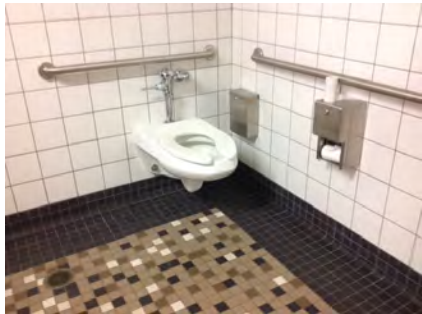
Item no., Rm no. and Name	Existing Architectural Barrier and Proposed Solution	Codes / Mitigation Info	Qty	Unit	Cost	Total
Water Closet						
707	<ul style="list-style-type: none">• <i>As-Built Description:</i> Water closet not 16"-18" (CA: 17"-18") from near side wall to center line of water closet (2010 ADAAG: 16"-18").• <i>As-Built:</i> 18.5" o.c.• <i>Proposed Solution:</i> Relocate existing water closet and plumbing, remount with offset closet flange to provide 18" max. from side wall.	<p>PCODE WB02C</p> <p>ADAAG 91 Fig. 28</p> <p>ADA 2010 604.2</p> <p>CBC 2007 1115B.4.1.1</p> <p>CBC 2016 11B-604.2</p> <p>Mitigated:</p> <p><input type="radio"/> YES</p> <p><input checked="" type="radio"/> NO</p>	1	JOB	\$1,500	\$1,500

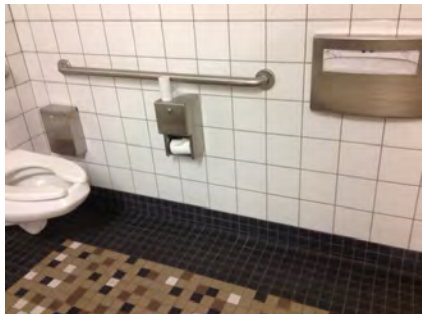
Accessories						
708	<ul style="list-style-type: none">• <i>As-Built Description:</i> Toilet paper dispenser less than 15" (CA: 19") or more than 48" above floor or not within 7" to 9" from front of water closet (Note: CA pre-2010 is allowed within 12" from front of water closet).• <i>As-Built:</i> 12"• <i>Proposed Solution:</i> Relocate or provide new toilet paper dispenser.	<p>PCODE WG02</p> <p>ADAAG 91 4.16.6</p> <p>ADA 2010 604.7</p> <p>CBC 2007 1115B.8.4</p> <p>CBC 2016 11B-604.7</p> <p>Mitigated:</p> <p><input type="radio"/> YES</p> <p><input checked="" type="radio"/> NO</p>	1	JOB	\$225	\$225

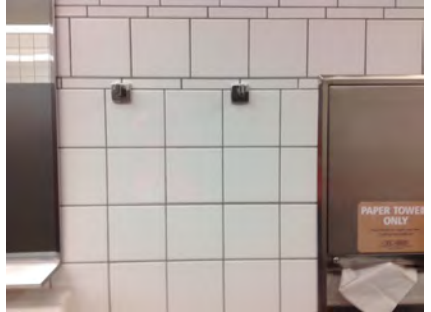
Item no., Rm no. and Name	Existing Architectural Barrier and Proposed Solution	Codes / Mitigation Info	Qty	Unit	Cost	Total
Coat Hook						
709	<ul style="list-style-type: none"> As-Built Description: Accessible coat hook not within reach range. As-Built: 60" high Proposed Solution: Adjust existing or provide new coat hook at maximum 48" height. 	PCODE WG03A ADAAG 91 4.2.5 ADA 2010 603.4 CBC 2007 1118B.5 CBC 2016 11B-603.4 Mitigated: <input type="radio"/> YES <input checked="" type="radio"/> NO	1	JOB	\$150	\$150

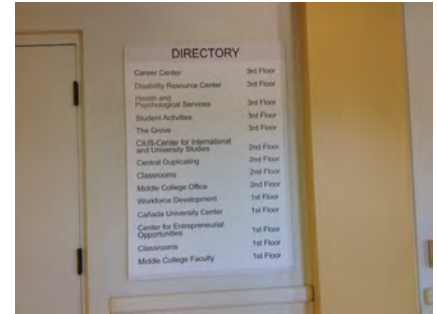
• **Notes:****No restroom on directory.****Mitigated:**☐ YES☒ NO

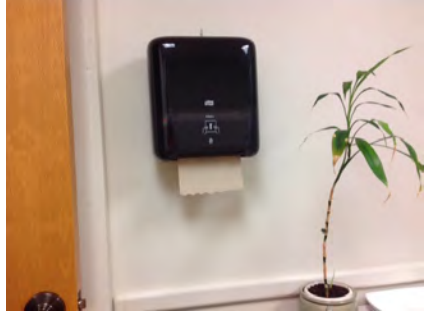
Item no., Rm no. and Name	Existing Architectural Barrier and Proposed Solution	Codes / Mitigation Info	Qty	Unit	Cost	Total
Reach Range						
664	<ul style="list-style-type: none"> • <i>As-Built Description:</i> Reach height to control or access point, exceeds 48" or is less than 15". • <i>As-Built:</i> 54" high • <i>Proposed Solution:</i> Modify equipment or mounting. • <i>Notes:</i> Break Room 	PCODE IE01 ADAAG 91 4.2.5 ADA 2010 308.2.1 CBC 2007 1118B.5 CBC 2016 11B-308.2.1 Mitigated: <input type="radio"/> YES <input checked="" type="radio"/> NO	1	JOB	\$300	\$300

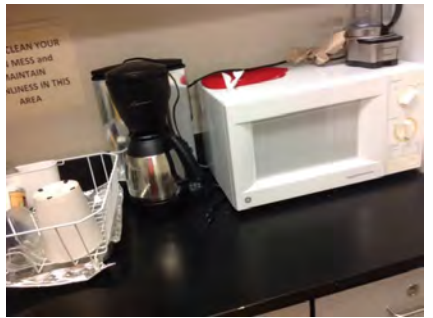
<input type="checkbox"/> Staff Only			
			Priority		Severity	
			2		3	
666	<ul style="list-style-type: none"> • <i>As-Built Description:</i> Reach height to control or access point, exceeds 48" or is less than 15". • <i>As-Built:</i> 26" deep to outlet • <i>Proposed Solution:</i> Modify equipment or mounting. • <i>Notes:</i> Break Room 	PCODE IE01 ADAAG 91 4.2.5 ADA 2010 308.2.1 CBC 2007 1118B.5 CBC 2016 11B-308.2.1 Mitigated: <input type="radio"/> YES <input checked="" type="radio"/> NO	1	JOB	\$300	\$300

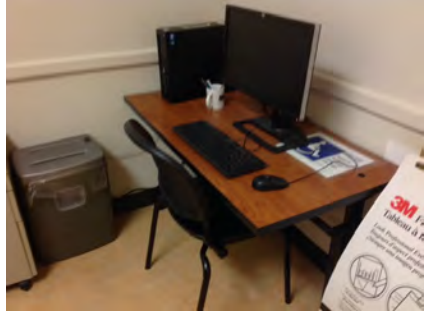
Item no., Rm no. and Name	Existing Architectural Barrier and Proposed Solution	Codes / Mitigation Info	Qty	Unit	Cost	Total
Non-Fixed Desk						
667	<ul style="list-style-type: none"> • <i>As-Built Description:</i> Accessible non-fixed table or desk (top 28" to 34" high; knee space at least 27" high x 19" deep x 30" wide) not provided. • <i>As-Built:</i> 25" knee height • <i>Proposed Solution:</i> Provide table or desk with accessible dimensions when purchasing new furniture. • <i>Notes:</i> Break Room 	PCODE IN02A ADAAG 91 4.32.3 & .4 ADA 2010 306.1 CBC 2007 1122B.3 & 4 CBC 2016 11B-306.1 & 11B-902.3 Mitigated: <input type="radio"/> YES <input checked="" type="radio"/> NO	1	JOB	\$4,800	\$4,800

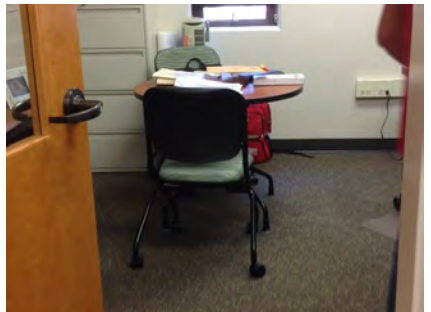
<input type="checkbox"/> Staff Only Priority 2 Severity 2			
668	<ul style="list-style-type: none"> • <i>As-Built Description:</i> Accessible non-fixed table or desk (top 28" to 34" high; knee space at least 27" high x 19" deep x 30" wide) not provided. • <i>Proposed Solution:</i> Provide table or desk with accessible dimensions when purchasing new furniture. 	PCODE IN02A ADAAG 91 4.32.3 & .4 ADA 2010 306.1 CBC 2007 1122B.3 & 4 CBC 2016 11B-306.1 & 11B-902.3 Mitigated: <input type="radio"/> YES <input checked="" type="radio"/> NO	1	JOB	\$4,800	\$4,800

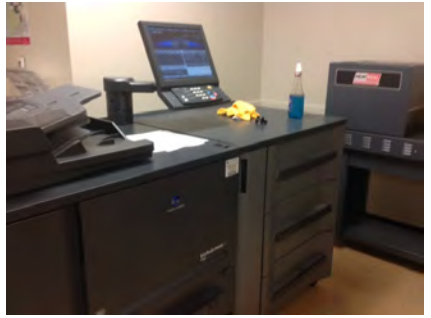
Item no., Rm no. and Name	Existing Architectural Barrier and Proposed Solution	Codes / Mitigation Info	Qty	Unit	Cost	Total
671	<ul style="list-style-type: none"> • <i>As-Built Description:</i> Reach height to control or access point, exceeds 48" or is less than 15". • <i>As-Built:</i> 60" high to equipment • <i>Proposed Solution:</i> Modify equipment or mounting. • <i>Notes:</i> Faculty area 	PCODE IE01 ADAAG 91 4.2.5 ADA 2010 308.2.1 CBC 2007 1118B.5 CBC 2016 11B-308.2.1 Mitigated: <input type="radio"/> YES <input checked="" type="radio"/> NO	1	JOB	\$300	\$300

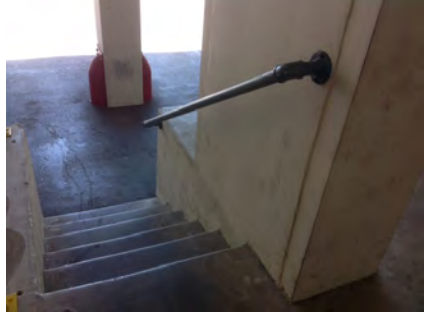
Item no., Rm no. and Name	Existing Architectural Barrier and Proposed Solution	Codes / Mitigation Info	Qty	Unit	Cost	Total
Top & Bottom Extension at Stairs						
678	<ul style="list-style-type: none"> <i>As-Built Description:</i> Stair handrail does not extend horizontally 12" minimum beyond top nosing, and one tread width sloped, plus 12" minimum horizontally beyond the bottom nosing. <i>Proposed Solution:</i> Extend stair handrail at top and bottom (cost for each extension piece). 	PCODE ED06 ADAAG 91 4.9.4(2) ADA 2010 505.10.2; CBC 2007 1133B.4.2.2 CBC 2016 11B-505.10.2; 11B-505.10.3 Mitigated: <input type="radio"/> YES <input checked="" type="radio"/> NO	2	JOB	\$510	\$1,020

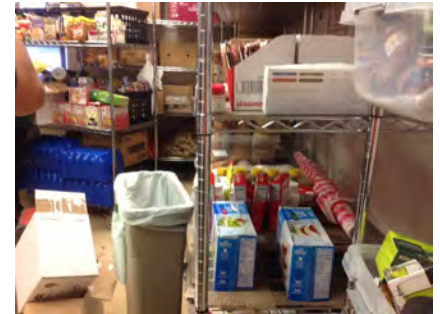
• **Notes:****Pantry is self service but employee on duty during open hours to assist.****Mitigated:**☐ YES☒ NO

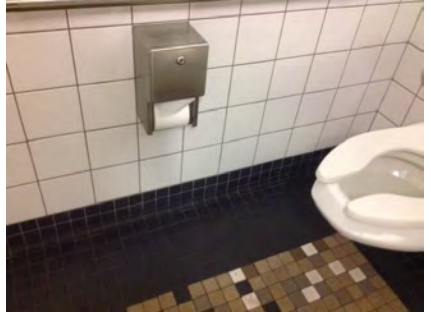
Item no., Rm no. and Name	Existing Architectural Barrier and Proposed Solution	Codes / Mitigation Info	Qty	Unit	Cost	Total
<u>Accessories</u>						
688	<ul style="list-style-type: none"> • <i>As-Built Description:</i> Toilet paper dispenser less than 15" (CA: 19") or more than 48" above floor or not within 7" to 9" from front of water closet (Note: CA pre-2010 is allowed within 12" from front of water closet). • <i>As-Built:</i> 12" o.c. • <i>Proposed Solution:</i> Relocate or provide new toilet paper dispenser. 	PCODE WG02 ADAAG 91 4.16.6 ADA 2010 604.7 CBC 2007 1115B.8.4 CBC 2016 11B-604.7 Mitigated: <input type="radio"/> YES <input checked="" type="radio"/> NO	1	JOB	\$225	\$225

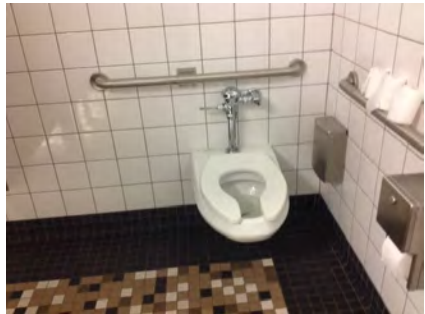
Item no., Rm no. and Name	Existing Architectural Barrier and Proposed Solution	Codes / Mitigation Info	Qty	Unit	Cost	Total
Water Closet						
692	<ul style="list-style-type: none"> • <i>As-Built Description:</i> Water closet not 16"-18" (CA: 17"-18") from near side wall to center line of water closet (2010 ADAAG: 16"-18"). • <i>As-Built:</i> 18.5" o.c. • <i>Proposed Solution:</i> Relocate existing water closet and plumbing, remount with offset closet flange to provide 18" max. from side wall. 	PCODE WB02C ADAAG 91 Fig. 28 ADA 2010 604.2 CBC 2007 1115B.4.1.1 CBC 2016 11B-604.2 Mitigated: <input type="radio"/> YES <input checked="" type="radio"/> NO	1	JOB	\$1,500	\$1,500

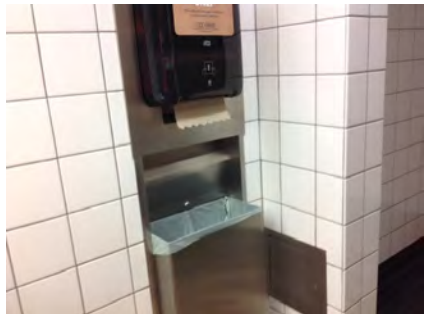
<input type="checkbox"/> Staff Only			
			Priority		Severity	
			3		4	
Accessories						
690	<ul style="list-style-type: none"> • <i>As-Built Description:</i> Dispensers in sanitary facilities, such as for towels, soap, sanitary napkins, seat covers, etc., and waste receptacles more than 48" (CA only: 40") from floor to highest operating slot or control. • <i>As-Built:</i> 45" high • <i>Proposed Solution:</i> Relocate existing restroom accessories. 	PCODE WG01A ADAAG 91 4.23.7 ADA 2010 308.2.1 CBC 2007 1115B.8.3 CBC 2016 11B-603.5 Mitigated: <input type="radio"/> YES <input checked="" type="radio"/> NO	1	JOB	\$300	\$300

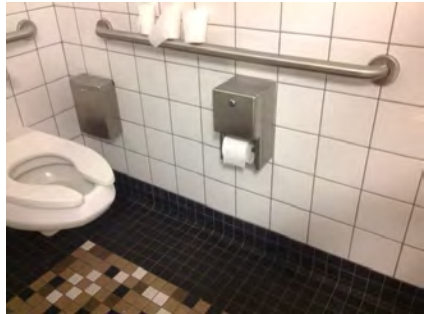
Item no., Rm no. and Name	Existing Architectural Barrier and Proposed Solution	Codes / Mitigation Info	Qty	Unit	Cost	Total
694	<ul style="list-style-type: none"> • <i>As-Built Description:</i> Toilet paper dispenser less than 15" (CA: 19") or more than 48" above floor or not within 7" to 9" from front of water closet (Note: CA pre-2010 is allowed within 12" from front of water closet). • <i>As-Built:</i> 12" o.c. • <i>Proposed Solution:</i> Relocate or provide new toilet paper dispenser. 	PCODE WG02 ADAAG 91 4.16.6 ADA 2010 604.7 CBC 2007 1115B.8.4 CBC 2016 11B-604.7 Mitigated: <input type="radio"/> YES <input checked="" type="radio"/> NO	1	JOB	\$225	\$225

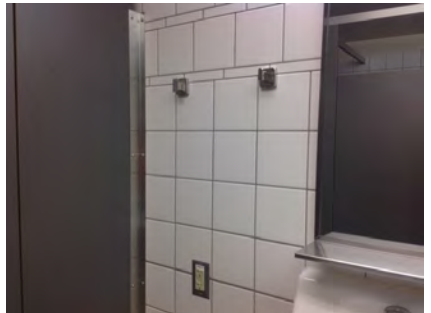
691	<ul style="list-style-type: none"> • <i>As-Built Description:</i> Accessible coat hook not within reach range. • <i>As-Built:</i> 65" • <i>Proposed Solution:</i> Adjust existing or provide new coat hook at maximum 48" height. 	PCODE WG03A ADAAG 91 4.2.5 ADA 2010 603.4 CBC 2007 1118B.5 CBC 2016 11B-603.4 Mitigated: <input type="radio"/> YES <input checked="" type="radio"/> NO	1	JOB	\$150	\$150

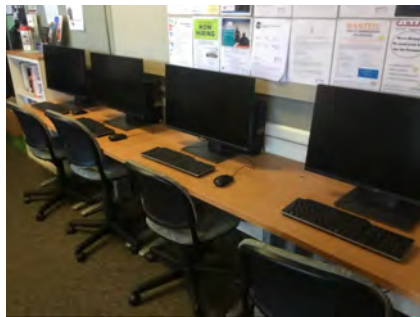
Item no., Rm no. and Name	Existing Architectural Barrier and Proposed Solution	Codes / Mitigation Info	Qty	Unit	Cost	Total
Non-Fixed Desk						
11031	<ul style="list-style-type: none"> • <i>As-Built Description:</i> Accessible non-fixed table or desk (top 28" to 34" high; knee space at least 27" high x 19" deep x 30" wide) not provided. • <i>As-Built:</i> 28" wide and 16.5" deep • <i>Proposed Solution:</i> Provide table or desk with accessible dimensions when purchasing new furniture. 	PCODE IN02A ADAAG 91 4.32.3 & .4 ADA 2010 306.1 CBC 2007 1122B.3 & 4 CBC 2016 11B-306.1 & 11B-902.3 Mitigated: <input type="radio"/> YES <input checked="" type="radio"/> NO	1	JOB	\$4,800	\$4,800

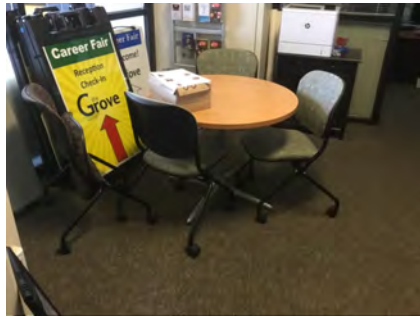
<input type="checkbox"/> Staff Only Priority 2 Severity 2			
11032	<ul style="list-style-type: none"> • <i>As-Built Description:</i> Accessible non-fixed table or desk (top 28" to 34" high; knee space at least 27" high x 19" deep x 30" wide) not provided. • <i>Proposed Solution:</i> Provide table or desk with accessible dimensions when purchasing new furniture. 	PCODE IN02A ADAAG 91 4.32.3 & .4 ADA 2010 306.1 CBC 2007 1122B.3 & 4 CBC 2016 11B-306.1 & 11B-902.3 Mitigated: <input type="radio"/> YES <input checked="" type="radio"/> NO	1	JOB	\$4,800	\$4,800

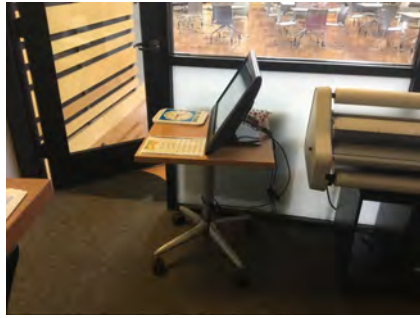
<input type="checkbox"/> Staff Only Priority 2 Severity 2			
11033	<ul style="list-style-type: none"> • <i>As-Built Description:</i> Accessible non-fixed table or desk (top 28" to 34" high; knee space at least 27" high x 19" deep x 30" wide) not provided. • <i>Proposed Solution:</i> Provide table or desk with accessible dimensions when purchasing new furniture. 	PCODE IN02A ADAAG 91 4.32.3 & .4 ADA 2010 306.1 CBC 2007 1122B.3 & 4 CBC 2016 11B-306.1 & 11B-902.3 Mitigated: <input type="radio"/> YES <input checked="" type="radio"/> NO	1	JOB	\$4,800	\$4,800

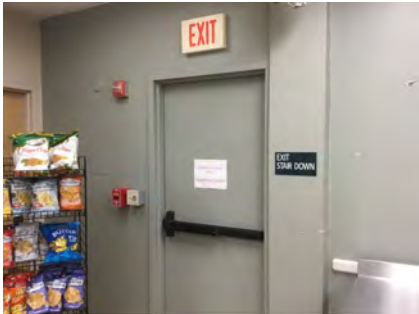
<input type="checkbox"/> Staff Only			
			<div>Priority 2 Severity 4</div>			
Signage						
11041	<ul style="list-style-type: none">As-Built Description: Sign not located on latch side of door and/or not located at 48" min. above to baseline of the lowest Braille cells and 60" max. to baseline of the highest line of raised characters.As-Built: 60.5" to the bottom of the highest tactile characterProposed Solution: Provide compliant signage including tactile characters and Grade II Braille on latch side of door located at compliant height.	<p>PCODE SA07</p> <p>ADAAG 91 4.30.6</p> <p>ADA 2010 703.4.1</p> <p>CBC 2007 1117B.5.7</p> <p>CBC 2016 11B-703.4.1</p> <p>Mitigated:</p> <p><input type="radio"/> YES</p> <p><input checked="" type="radio"/> NO</p>	1	JOB	\$150	\$150

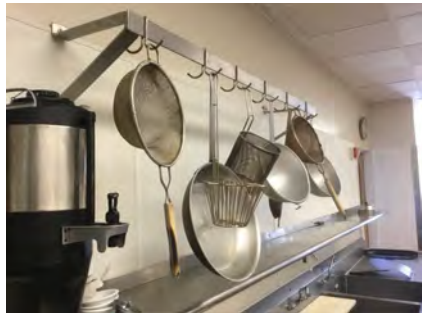
Item no., Rm no. and Name	Existing Architectural Barrier and Proposed Solution	Codes / Mitigation Info	Qty	Unit	Cost	Total
Reach Range						
11047	<ul style="list-style-type: none"> As-Built Description: Reach height to control or access point, where side approach is available, exceeds 48" or is less than 15" in height, or exceeds 10" in depth. As-Built: Pots and pans storage 84" AFF Proposed Solution: Modify equipment or mounting. Notes: Staff only 	PCODE IE02 ADAAG 91 4.2.6 ADA 2010 308.3.1 CBC 2007 1118B.6 CBC 2016 11B-308.3 Mitigated: <input type="radio"/> YES <input checked="" type="radio"/> NO	1	JOB	\$300	\$300

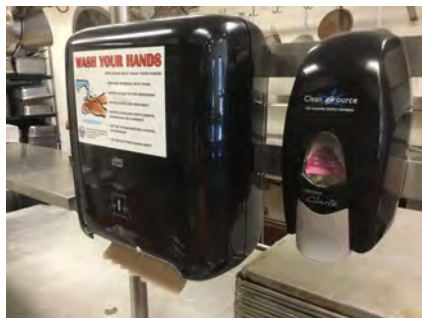
<input checked="" type="checkbox"/> Staff Only			
			Priority		Severity	
			4		1	
11049	<ul style="list-style-type: none"> As-Built Description: Reach height to control or access point, where side approach is available, exceeds 48" or is less than 15" in height, or exceeds 10" in depth. As-Built: 22" deep 52" to 54" AFF Proposed Solution: Modify equipment or mounting. 	PCODE IE02 ADAAG 91 4.2.6 ADA 2010 308.3.1 CBC 2007 1118B.6 CBC 2016 11B-308.3 Mitigated: <input type="radio"/> YES <input checked="" type="radio"/> NO	1	JOB	\$300	\$300

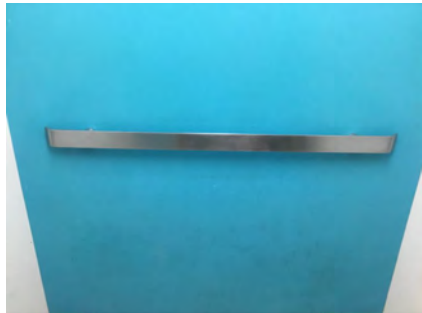
Item no., Rm no. and Name	Existing Architectural Barrier and Proposed Solution	Codes / Mitigation Info	Qty	Unit	Cost	Total
Elevator						
11054	<ul style="list-style-type: none"> • <i>As-Built Description:</i> Handrail not mounted with top 32", plus or minus one inch, above the floor of car. (CA Only) • <i>As-Built:</i> 39.3" high • <i>Proposed Solution:</i> Remount handrail at 32" above floor. 	PCODE IK08A CBC 2007 1116B.1.11 CBC 2016 11B-407.4.10 Mitigated: <input type="radio"/> YES <input checked="" type="radio"/> NO	1	JOB	\$1,080	\$1,080

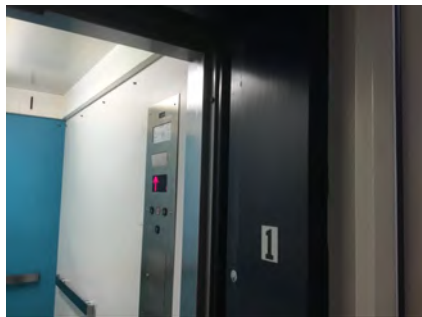
<input type="checkbox"/> Staff Only Priority Severity <input checked="" type="radio"/> 4 <input checked="" type="radio"/> 2			
11051	<ul style="list-style-type: none"> • <i>As-Built Description:</i> Visual hall lantern, minimum 2-1/2" x 2-1/2", not provided, or installed less than 72" above floor. • <i>Proposed Solution:</i> Provide or raise proper visual hall lantern for elevator. 	PCODE IK10A ADAAG 91 4.10.4(1) ADA 2010 407.2.2.2 CBC 2007 1116B.1.13 CBC 2016 11B-407.2.2.2 Mitigated: <input type="radio"/> YES <input checked="" type="radio"/> NO	1	JOB	\$4,650	\$4,650

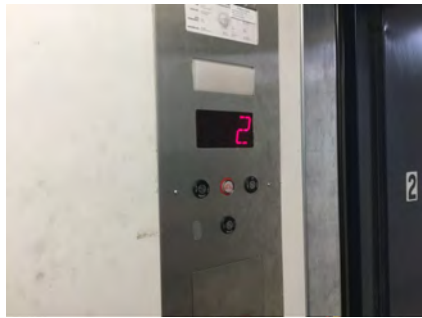
<input type="checkbox"/> Staff Only Priority Severity <input checked="" type="radio"/> 4 <input checked="" type="radio"/> 3			
11053	<ul style="list-style-type: none"> • <i>As-Built Description:</i> Audible signal not provided (one for up, two for down). • <i>Proposed Solution:</i> Provide proper audible hall signal for elevator. 	PCODE IK10B ADAAG 91 4.10.4 ADA 2010 407.2.2.3 CBC 2007 1116B.1.13 CBC 2016 11B-407.2.2.3 Mitigated: <input type="radio"/> YES <input checked="" type="radio"/> NO	1	JOB	\$4,650	\$4,650

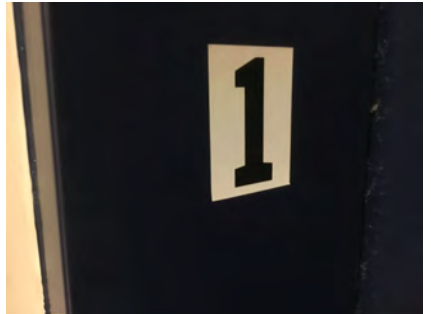
Item no., Rm no. and Name	Existing Architectural Barrier and Proposed Solution	Codes / Mitigation Info	Qty	Unit	Cost	Total
11052	<ul style="list-style-type: none"> As-Built Description: Braille and raised floor numbers on entrance jambs located more or less than 5' above floor. Proposed Solution: Relocate Braille and raised floor numbers on entrance jambs to 5' above floor. Notes: Not Braille and tactile 	PCODE IK11C ADAAG 91 4.10.5 ADA 2010 703.4.1 CBC 2007 1116B.1.14 CBC 2016 11B-703.4.1 Mitigated: <input type="radio"/> YES <input checked="" type="radio"/> NO	6	JOB	\$360	\$2,160

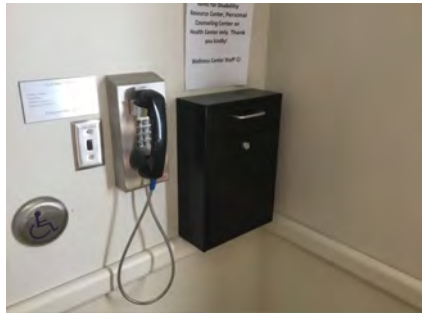
Item no., Rm no. and Name	Existing Architectural Barrier and Proposed Solution	Codes / Mitigation Info	Qty	Unit	Cost	Total
Reach Range						
11061	<ul style="list-style-type: none"> As-Built Description: Reach height to control or access point, where side approach is available, exceeds 48" or is less than 15" in height, or exceeds 10" in depth. As-Built: 50" high Proposed Solution: Modify equipment or mounting. 	PCODE IE02 ADAAG 91 4.2.6 ADA 2010 308.3.1 CBC 2007 1118B.6 CBC 2016 11B-308.3 Mitigated: <input type="radio"/> YES <input checked="" type="radio"/> NO	1	JOB	\$300	\$300

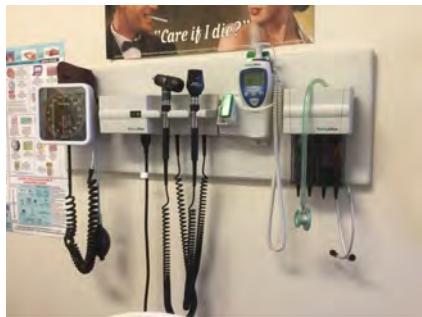
<input type="checkbox"/> Staff Only Priority 2 Severity 4			
11068	<ul style="list-style-type: none"> As-Built Description: Reach height to control or access point, where side approach is available, exceeds 48" or is less than 15" in height, or exceeds 10" in depth. As-Built: 62" AFF Proposed Solution: Modify equipment or mounting. Notes: Staff only 	PCODE IE02 ADAAG 91 4.2.6 ADA 2010 308.3.1 CBC 2007 1118B.6 CBC 2016 11B-308.3 Mitigated: <input type="radio"/> YES <input checked="" type="radio"/> NO	1	JOB	\$300	\$300

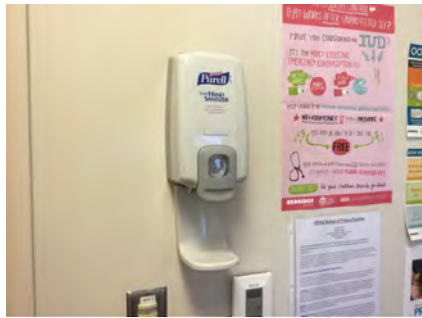
<input checked="" type="checkbox"/> Staff Only Priority 2 Severity 2			
11069	<ul style="list-style-type: none"> As-Built Description: Reach height to control or access point, where side approach is available, exceeds 48" or is less than 15" in height, or exceeds 10" in depth. As-Built: 57" high Proposed Solution: Modify equipment or mounting. 	PCODE IE02 ADAAG 91 4.2.6 ADA 2010 308.3.1 CBC 2007 1118B.6 CBC 2016 11B-308.3 Mitigated: <input type="radio"/> YES <input checked="" type="radio"/> NO	4	JOB	\$300	\$1,200

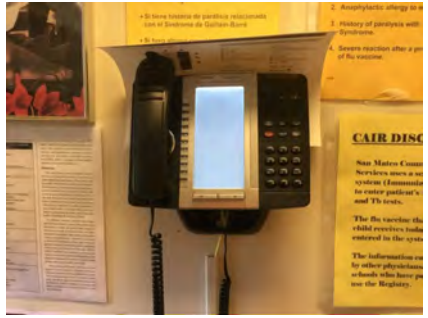
Item no., Rm no. and Name	Existing Architectural Barrier and Proposed Solution	Codes / Mitigation Info	Qty	Unit	Cost	Total
11071	<ul style="list-style-type: none"> As-Built Description: Reach height to control or access point, where side approach is available, exceeds 48" or is less than 15" in height, or exceeds 10" in depth. As-Built: 58" high Proposed Solution: Modify equipment or mounting. 	PCODE IE02 ADAAG 91 4.2.6 ADA 2010 308.3.1 CBC 2007 1118B.6 CBC 2016 11B-308.3 Mitigated: <input type="radio"/> YES <input checked="" type="radio"/> NO	1	JOB	\$300	\$300

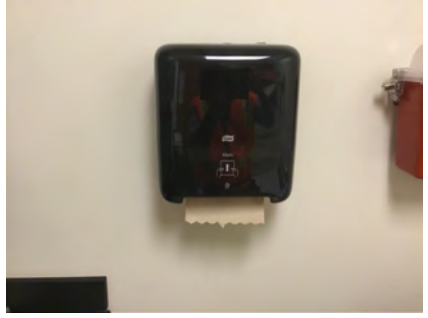
<input type="checkbox"/> Staff Only Priority 2 Severity 3						
11076	<ul style="list-style-type: none"> As-Built Description: Reach height to control or access point, where side approach is available, exceeds 48" or is less than 15" in height, or exceeds 10" in depth. As-Built: 50" AFF Proposed Solution: Modify equipment or mounting. 	PCODE IE02 ADAAG 91 4.2.6 ADA 2010 308.3.1 CBC 2007 1118B.6 CBC 2016 11B-308.3 Mitigated: <input type="radio"/> YES <input checked="" type="radio"/> NO	1	JOB	\$300	\$300

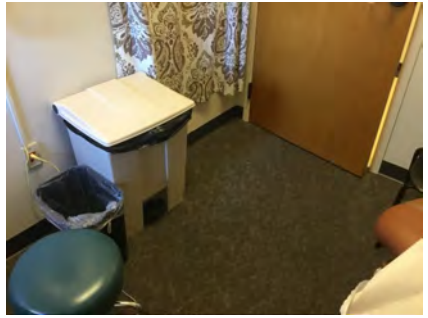
<input type="checkbox"/> Staff Only Priority 2 Severity 4						
Turning Space						
11065	<ul style="list-style-type: none"> As-Built Description: The area does not provide a minimum 60" diameter turning space within to allow maneuvering through the space. Proposed Solution: Modify area to provide sufficient maneuvering space. Notes: A trash can obstructs the turning space in exam room one. 	PCODE IH05 ADA 2010 304.3 CBC 2016 11B-304.3 Mitigated: <input type="radio"/> YES <input checked="" type="radio"/> NO	1	JOB	\$1,500	\$1,500

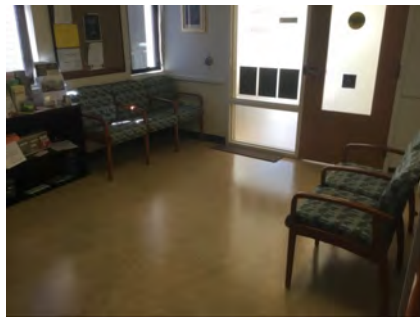
Item no., Rm no. and Name	Existing Architectural Barrier and Proposed Solution	Codes / Mitigation Info	Qty	Unit	Cost	Total
Disabled Seating						
11062	<ul style="list-style-type: none"> As-Built Description: Wheelchair space (33"x48") not provided at fixed seating with forward or rear approach. (NOTE: Space must be adjacent to regular seating; can provide easily removable fixed seat). Proposed Solution: Remove fixed seating and provide wheelchair space plus necessary maneuvering clearance. 	PCODE GB01A ADAAG 91 4.1.3(19)(a) ADA 2010 221.2 CBC 2007 1104B.3.6 CBC 2016 11B-221.2 Mitigated: <input type="radio"/> YES <input checked="" type="radio"/> NO	1	JOB	\$1,350	\$1,350

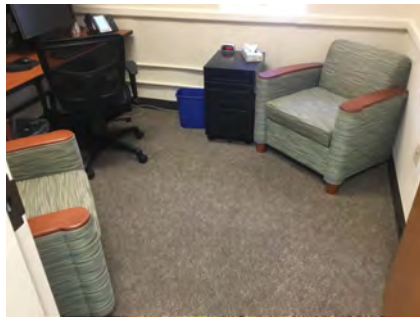
<input type="checkbox"/> Staff Only Priority 2 Severity 3			
11063	<ul style="list-style-type: none"> As-Built Description: Wheelchair space (33"x48") not provided at fixed seating with forward or rear approach. (NOTE: Space must be adjacent to regular seating; can provide easily removable fixed seat). Proposed Solution: Remove fixed seating and provide wheelchair space plus necessary maneuvering clearance. Notes: <i>No wheelchair space in counseling offices. Consider using office is 306 and 307 for people in wheelchairs or people who need more space. The rooms are larger than others.</i> 	PCODE GB01A ADAAG 91 4.1.3(19)(a) ADA 2010 221.2 CBC 2007 1104B.3.6 CBC 2016 11B-221.2 Mitigated: <input type="radio"/> YES <input checked="" type="radio"/> NO	1	JOB	\$1,350	\$1,350

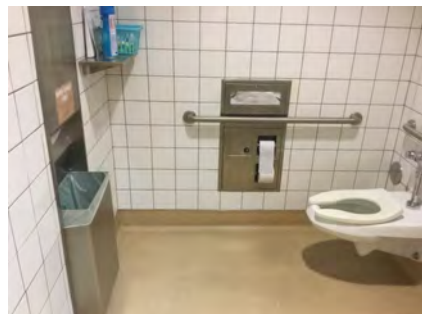
Item no., Rm no. and Name	Existing Architectural Barrier and Proposed Solution	Codes / Mitigation Info	Qty	Unit	Cost	Total
11092	<ul style="list-style-type: none">As-Built Description: CA only: In single-accommodation restroom less than 48" in front of water closet provided.As-Built: 47" to the tile wallProposed Solution: Install a shallow water closet.	PCODE WB03A CBC 2007 1115B.3.2.1 CBC 2016 11B-604.3.1 Mitigated: <div><input type="radio"/> YES</div> <div><input checked="" type="radio"/> NO</div>	1	JOB	\$3,000	\$3,000

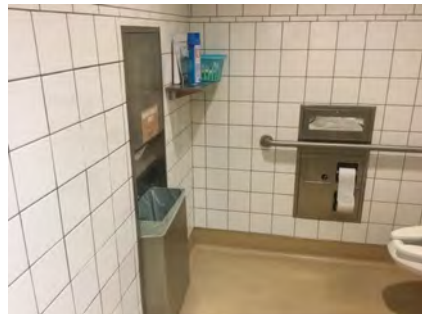
<div><input type="checkbox"/> Staff Only</div> <div>Priority <div>3</div>Severity <div>3</div></div>			
11093	<ul style="list-style-type: none">As-Built Description: CA only: In single-accommodation restroom less than 48" in front of water closet provided.As-Built: 39" and 43" to the shelf and the wall-mounted trash canProposed Solution: Remove the shelf and relocate the trash can.Notes: The shelf is a protruding object.	PCODE WB03A CBC 2007 1115B.3.2.1 CBC 2016 11B-604.3.1 Mitigated: <div><input type="radio"/> YES</div> <div><input checked="" type="radio"/> NO</div>	1	JOB	\$15,000	\$15,000

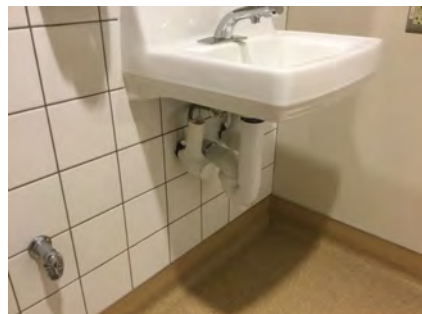
<div><input type="checkbox"/> Staff Only</div> <div>Priority <div>3</div>Severity <div>3</div></div>			
<u>Lavatory</u>						
11086	<ul style="list-style-type: none">As-Built Description: Knee clearance 27" min. high starting 8" back from the front edge of the lavatory towards the wall is not provided.As-Built: Drain pipes 9" from the front of the lavatory at 17" AFFProposed Solution: Remount compliant fixture to accessible height.	PCODE WD04A ADAAG 91 Fig. 31 ADA 2010 306.3.3 CBC 2007 1115B.4.3 CBC 2016 11B-306.3.3 Mitigated: <div><input type="radio"/> YES</div> <div><input checked="" type="radio"/> NO</div>	1	JOB	\$4,500	\$4,500

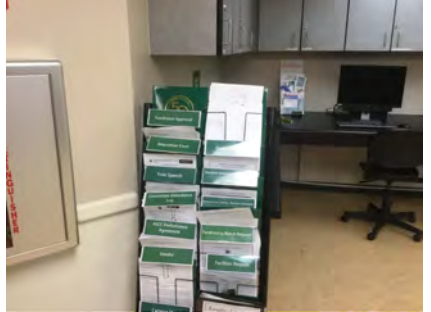
Item no., Rm no. and Name	Existing Architectural Barrier and Proposed Solution	Codes / Mitigation Info	Qty	Unit	Cost	Total
Brochure Bins						
11094	<ul style="list-style-type: none"> • <i>As-Built Description:</i> Information brochure bins mounted above accessible height of 48". • <i>As-Built:</i> 52" high • <i>Proposed Solution:</i> Relocate/remount bins at accessible height. 	PCODE IN08 ADAAG 91 4.2.5 & 6 ADA 2010 308.2.1 CBC 2007 1118B.5 CBC 2016 11B-308.2.1 Mitigated: <input type="radio"/> YES <input checked="" type="radio"/> NO	1	JOB	\$300	\$300

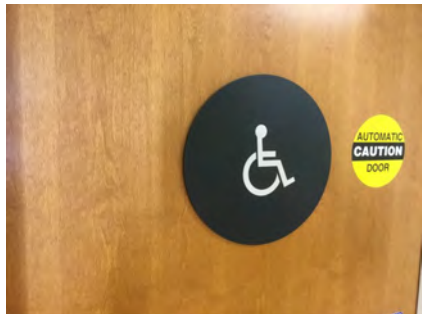
Item no., Rm no. and Name	Existing Architectural Barrier and Proposed Solution	Codes / Mitigation Info	Qty	Unit	Cost	Total
11099	<ul style="list-style-type: none"> As-Built Description: Required in CA only: identification symbol centered 58" to 60" high on sanitary facility door that contrasts with the door not provided (women: 12" ø circle, men: 12" triangle, unisex: combined symbol). As-Built: Edges not eased Proposed Solution: Provide properly mounted sanitary facility symbol when altering area. If wheelchair accessible, include International Symbol of Accessibility on sign. 	PCODE SA15 CBC 2007 1115B.6 CBC 2016 11B-703.7.2.6 Mitigated: <input type="radio"/> YES <input checked="" type="radio"/> NO	1	JOB	\$270	\$270

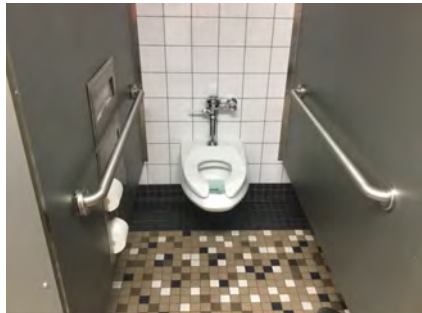
11102	<ul style="list-style-type: none"> As-Built Description: Side grab bar less than 42" long, or located more than 12 inches max. from the rear wall, or extending less than 54" from rear wall (CA only: front end min. 24" in front of water closet). As-Built: Side grab bars extend 52" from the rear wall. Proposed Solution: Provide or relocate accessible side grab bar. 	PCODE WB07A ADAAG 91 Fig. 29(b) ADA 2010 604.5.1 CBC 2007 1115B.4.1.3.1 CBC 2016 11B-604.5.1 Mitigated: <input type="radio"/> YES <input checked="" type="radio"/> NO	2	JOB	\$780	\$1,560

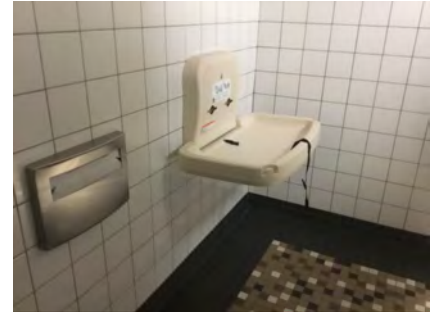
11103	<ul style="list-style-type: none"> As-Built Description: Baby changing tables shall not be located in accessible toilet compartments. Proposed Solution: Relocate baby changing table outside of accessible toilet compartment. 	PCODE WB01C CBC 2016 11B-226.4 Mitigated: <input type="radio"/> YES <input checked="" type="radio"/> NO	1	JOB	\$300	\$300
-------	---	--	---	-----	-------	--------------

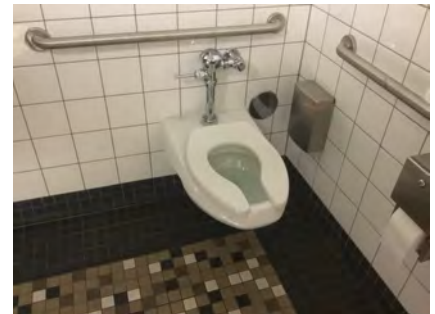
11105	<ul style="list-style-type: none"> As-Built Description: Height of water closet seat less than 17" or more than 19" from floor. As-Built: 19.25" high Proposed Solution: Provide new accessible water closet. 	PCODE WB08 ADAAG 91 4.16.3 ADA 2010 604.4 CBC 2007 1115B.4.1.4 CBC 2016 11B-604.4 Mitigated: <input type="radio"/> YES <input checked="" type="radio"/> NO	1	JOB	\$4,200	\$4,200
-------	--	--	---	-----	---------	----------------

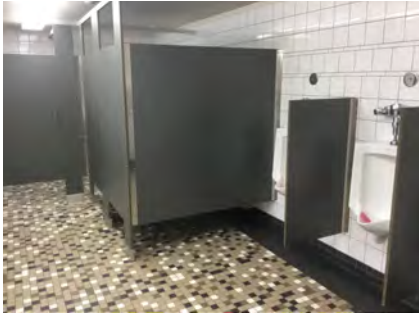
Item no., Rm no. and Name	Existing Architectural Barrier and Proposed Solution	Codes / Mitigation Info	Qty	Unit	Cost	Total
<u>Semi-Ambulant Stall</u>						
11110	<ul style="list-style-type: none">• <i>As-Built Description:</i> Semi-Ambulant stall with 35-37" width, minimum 60" depth, parallel grab bars, and out-swinging door not provided (one required where 6 or more exist).• <i>As-Built:</i> 3 compartments and 4 urinals, 0 ambulatory provided• <i>Proposed Solution:</i> Provide 36" wide stall with out-swinging door and two side grab bars. Remodel restroom as needed.	<p>PCODE WB06A</p> <p>ADAAG 91 4.22.4</p> <p>ADA 2010 213.3.1 & 604.8.2</p> <p>CBC 2007 1115B.3.1.5</p> <p>CBC 2016 11B-213.3.1 & 11B-604.8.2</p> <p>Mitigated:</p> <p><input type="radio"/> YES</p> <p><input checked="" type="radio"/> NO</p>	1	JOB	\$5,700	\$5,700

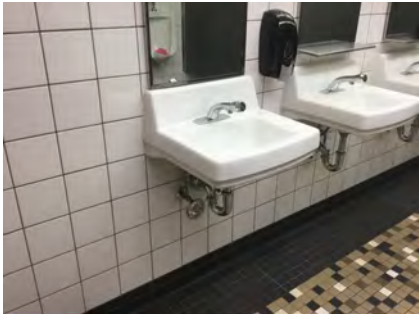
<u>Lavatory</u>						
11108	<ul style="list-style-type: none">• <i>As-Built Description:</i> Lavatory: Fixture rim or counter height more than 34" above floor.• <i>As-Built:</i> 34.3" high• <i>Proposed Solution:</i> Remount compliant fixture at accessible height.	<p>PCODE WD02A</p> <p>ADAAG 91 4.19.2</p> <p>ADA 2010 606.3</p> <p>CBC 2007 1115B.4.3</p> <p>CBC 2016 11B-606.3</p> <p>Mitigated:</p> <p><input type="radio"/> YES</p> <p><input checked="" type="radio"/> NO</p>	1	JOB	\$2,700	\$2,700

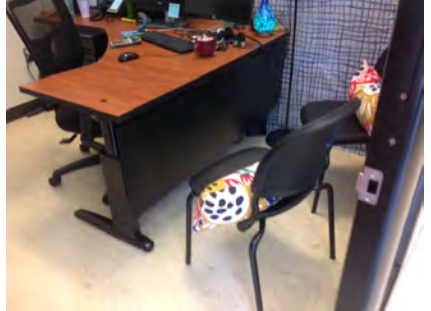
Item no., Rm no. and Name	Existing Architectural Barrier and Proposed Solution	Codes / Mitigation Info	Qty	Unit	Cost	Total
Non-Fixed Desk						
725	<ul style="list-style-type: none"> • <i>As-Built Description:</i> Accessible non-fixed table or desk (top 28" to 34" high; knee space at least 27" high x 19" deep x 30" wide) not provided. • <i>As-Built:</i> No knee clearance for student side if used as work surface. • <i>Proposed Solution:</i> Provide table or desk with accessible dimensions when purchasing new furniture. 	PCODE IN02A ADAAG 91 4.32.3 & .4 ADA 2010 306.1 CBC 2007 1122B.3 & 4 CBC 2016 11B-306.1 & 11B-902.3 Mitigated: <input type="radio"/> YES <input checked="" type="radio"/> NO	1	JOB	\$4,800	\$4,800

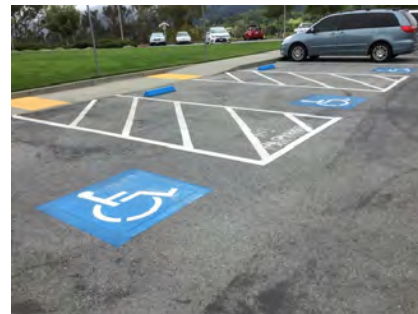
- 6
- *As-Built Description:*
Accessible parking space has slope greater than 1/4":12" (2%).
>2%
 - *Proposed Solution:*
Modify slope at accessible parking space.
- PCODE EA05
ADAAG 91 4.6.3
ADA 2010 502.4
CBC 2007 1129B.3.3
CBC 2016 11B-502.4
- Mitigated:
- ☐ YES
☒ NO

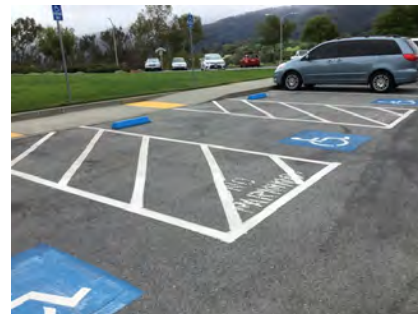
- 7
- *As-Built Description:*
Access aisle at accessible parking space has slope greater than 1/4":12" (2%).
>2%
 - *Proposed Solution:*
Modify slope at accessible parking space aisle.
- PCODE EA05B
ADAAG 91 4.6.3
ADA 2010 502.4
CBC 2007 1129B.3.3
CBC 2016 11B-502.4
- Mitigated:
- ☐ YES
☒ NO

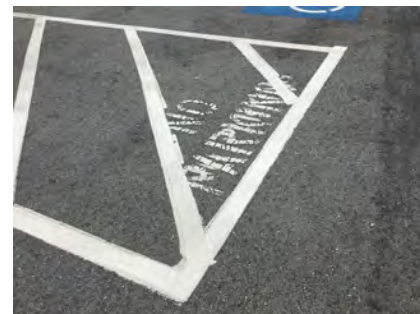
- 8
- **As-Built Description:**
The words "NO PARKING" not painted on the ground within loading and unloading access aisle (12" min high white letters), located so that it is visible to traffic enforcement officials (required in CA only).
 - **Proposed Solution:**
Provide the words "NO PARKING" in each access aisle, painted in 12" high letters, when altering area.
 - **Notes:**
Faded
- PCODE EA04D
CBC 2007 1129B.3.1
CBC 2016 11B-502.3.3

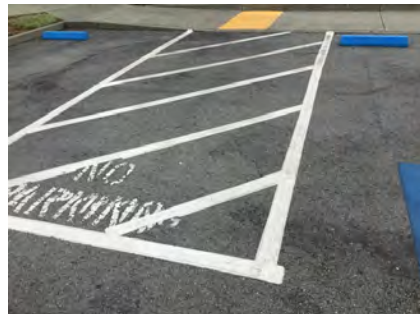
Item no., Rm no. and Name	Existing Architectural Barrier and Proposed Solution	Codes / Mitigation Info	Qty	Unit	Cost	Total
5	<ul style="list-style-type: none">• <i>As-Built Description:</i> CA only: The area within the blue borderlines not marked with hatched lines a maximum of 36" on center.• <i>Proposed Solution:</i> Restripe to provide hatched lines at 36" on center within access aisle.• <i>Notes:</i> No blue contrast	<p>PCODE EA04I</p> <p>CBC 2007 1129B.3.1</p> <p>CBC 2016 11B-502.3.3</p> <p>Mitigated:</p> <p><input type="radio"/> YES</p> <p><input checked="" type="radio"/> NO</p>	2	JOB	\$300	\$600

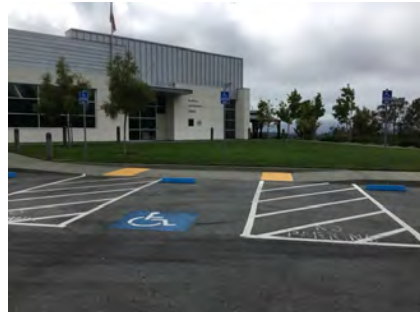
<div><input type="checkbox"/> Staff Only</div> <div><div>Priority</div><div>1</div><div>Severity</div><div>4</div></div>			
4	<ul style="list-style-type: none">• <i>As-Built Description:</i> No van parking provided (one in every 6 or fraction of 6 accessible spaces, but not less than one).• <i>Proposed Solution:</i> Provide van parking space(s) by restriping; provide van sign.• <i>Notes:</i> No signs	<p>PCODE EA07</p> <p>ADAAG 91 4.1.2(5)(b)</p> <p>ADA 2010 208.2; 502.1</p> <p>CBC 2007 1129B.3.2</p> <p>CBC 2016 11B-208.2.4</p> <p>Mitigated:</p> <p><input type="radio"/> YES</p> <p><input checked="" type="radio"/> NO</p>	1	JOB	\$1,050	\$1,050

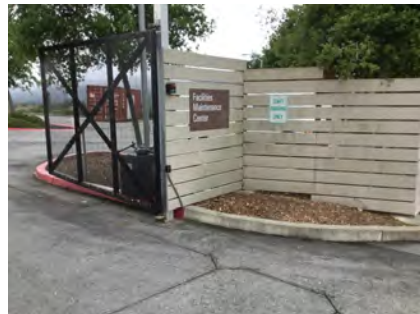
<div><input type="checkbox"/> Staff Only</div> <div><div>Priority</div><div>1</div><div>Severity</div><div>2</div></div>			
<u>Parking Signage</u>						
1	<ul style="list-style-type: none">• <i>As-Built Description:</i> No "Tow Away" sign at parking lot entrance (required in CA only).• <i>Proposed Solution:</i> Provide "Tow Away" sign at parking lot entrance when altering area.	<p>PCODE EA04C</p> <p>CBC 2007 1129B.4</p> <p>CBC 2016 11B-502.8.2</p> <p>Mitigated:</p> <p><input type="radio"/> YES</p> <p><input checked="" type="radio"/> NO</p>	1	JOB	\$975	\$975

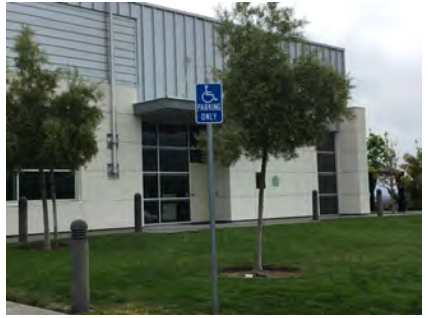
Item no., Rm no. and Name	Existing Architectural Barrier and Proposed Solution	Codes / Mitigation Info	Qty	Unit	Cost	Total
9	<ul style="list-style-type: none"> As-Built Description: CA only: Additional Sign or additional language below the symbol of accessibility stating "Minimum Fine \$250" not provided. Proposed Solution: Provide compliant parking signage that includes fine information. 	PCODE EA04G CBC 2007 1129B.4 CBC 2016 11B-502.6.2 Mitigated: <input type="radio"/> YES <input checked="" type="radio"/> NO	3	JOB	\$300	\$900

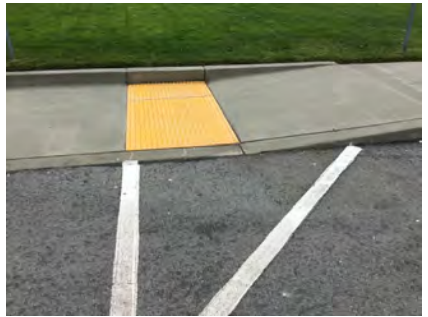
10	<ul style="list-style-type: none"> As-Built Description: Walk more than 36" but less than 48" wide (required in CA only). Proposed Solution: Enlarge width of walk to 48". Notes: 36" wide to access aisle - requires moving curb ramp. 	PCODE EF08 CBC 2007 1133B.7.1 CBC 2016 11B-403.5.1.3 Mitigated: <input type="radio"/> YES <input checked="" type="radio"/> NO	20	SF	\$135	\$2,700

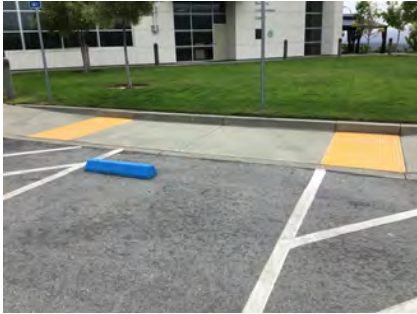
Item no., Rm no. and Name	Existing Architectural Barrier and Proposed Solution	Codes / Mitigation Info	Qty	Unit	Cost	Total
<u>Detectable Warning</u>						
11	<ul style="list-style-type: none">• <i>As-Built Description:</i> 36" wide band of truncated domes not provided at walkway or crossing adjoining a vehicular way, if surfaces are not separated by a curb, railing, or other element.• <i>Proposed Solution:</i> Provide 36" wide, contrasting color, band of truncated domes between pedestrian and vehicular area.	<p>PCODE EG09 ADAAG 91 4.29.5 CBC 2007 1133B.8.5 CBC 2016 11B-705.1.2.5</p> <p>Mitigated:</p> <p><input type="radio"/> YES <input checked="" type="radio"/> NO</p>	20	LF	\$81	\$1,620

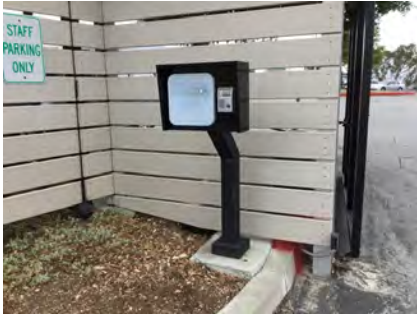
<input type="checkbox"/> Staff Only			
			Priority		Severity	
			1		3	
<u>Reach Range</u>						
2	<ul style="list-style-type: none">• <i>As-Built Description:</i> Reach height to control or access point, where side approach is available, exceeds 48" or is less than 15" in height, or exceeds 10" in depth.• <i>Proposed Solution:</i> Modify equipment or mounting.• <i>Notes:</i> Staff only, difficult to reach from car	<p>PCODE IE02REF ADAAG 91 4.2.6 ADA 2010 308.3.1 CBC 2007 1118B.6 CBC 2016 11B-308.3</p> <p>Mitigated:</p> <p><input type="radio"/> YES <input checked="" type="radio"/> NO</p>

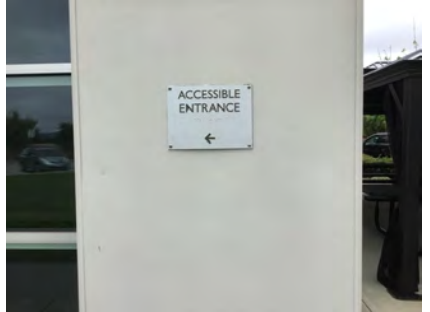
Item no., Rm no. and Name	Existing Architectural Barrier and Proposed Solution	Codes / Mitigation Info	Qty	Unit	Cost	Total
Route Sign						
15	<ul style="list-style-type: none"> • <i>As-Built Description:</i> No sign by inaccessible route directing persons to an accessible route. • <i>Proposed Solution:</i> Provide directional sign. • <i>Notes:</i> Provide directional sign with International Symbol of Accessibility. Braille cells are not required. 	PCODE SA20 ADAAG 91 35.163(b) ADA 2010 216.3 CBC 2007 1127B.3 CBC 2016 11B-216.3 Mitigated: <input type="radio"/> YES <input checked="" type="radio"/> NO	1	JOB	\$510	\$510

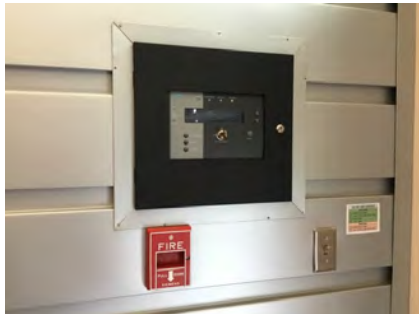
Item no., Rm no. and Name	Existing Architectural Barrier and Proposed Solution	Codes / Mitigation Info	Qty	Unit	Cost	Total
<u>Reach Range</u>						
22	<ul style="list-style-type: none">• <i>As-Built Description:</i> Reach height to control or access point, exceeds 48" or is less than 15".• <i>As-Built:</i> 60" high• <i>Proposed Solution:</i> Modify equipment or mounting.• <i>Notes:</i> Staff only	<p>PCODE IE01</p> <p>ADAAG 91 4.2.5</p> <p>ADA 2010 308.2.1</p> <p>CBC 2007 1118B.5</p> <p>CBC 2016 11B-308.2.1</p> <p>Mitigated:</p> <p><input type="radio"/> YES</p> <p><input checked="" type="radio"/> NO</p>	1	JOB	\$300	\$300

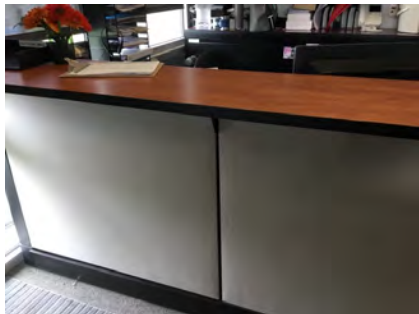
<input checked="" type="checkbox"/> Staff Only			
			Priority		Severity	
			1		2	
<u>Public Counter</u>						
21	<ul style="list-style-type: none">• <i>As-Built Description:</i> Service counter (stand-up): Accessible section min. 36" length and 36" max. height (in CA: 28" to 34" high) not provided.• <i>As-Built:</i> 45"• <i>Proposed Solution:</i> Retrofit existing counter to provide accessible section. Interim solution: Provide auxiliary counter, table, or clipboard.	<p>PCODE IN03</p> <p>ADAAG 91 7.2(2)</p> <p>ADA 2010 904.4</p> <p>CBC 2007 1122B.4</p> <p>CBC 2016 11B-904.4</p> <p>Mitigated:</p> <p><input type="radio"/> YES</p> <p><input checked="" type="radio"/> NO</p>	1	JOB	\$6,000	\$6,000

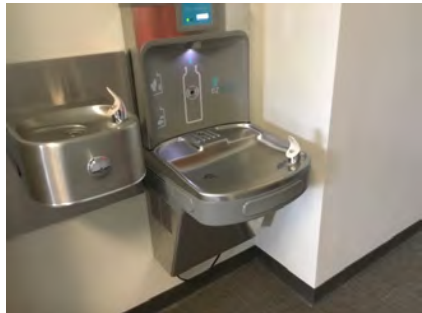
Item no., Rm no. and Name	Existing Architectural Barrier and Proposed Solution	Codes / Mitigation Info	Qty	Unit	Cost	Total
Drinking Fountain						
29	<ul style="list-style-type: none"> • <i>As-Built Description:</i> Wall- and post-mounted cantilevered units: Knee space not provided at drinking fountain (27" high, 8" deep, 30" wide from front of drinking fountain). • <i>As-Built:</i> 26.75" • <i>Proposed Solution:</i> Provide new, accessible fountain. 	PCODE IA02 ADAAG 91 4.15.5(1) ADA 2010 602.2 CBC 2007 1115B.4.6.2 CBC 2016 11B-602.2 Mitigated: <input type="radio"/> YES <input checked="" type="radio"/> NO	1	JOB	\$9,600	\$9,600

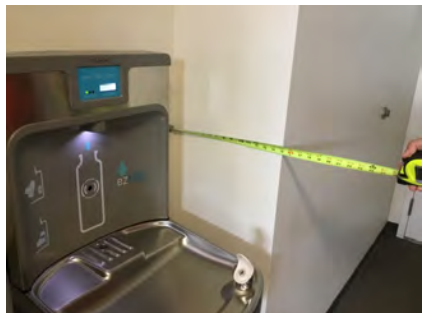
<input type="checkbox"/> Staff Only Priority 3 Severity 2			
30	<ul style="list-style-type: none"> • <i>As-Built Description:</i> CA only: Drinking fountain not located in an alcove (min. 32" wide x 18" deep) or otherwise encroaches into pedestrian way. • <i>As-Built:</i> 15" deep • <i>Proposed Solution:</i> Provide new alcove for drinking fountain, or, if unreasonable hardship is determined, provide wing walls or cane-detectable railings on each side of the drinking fountain. 	PCODE IA04 CBC 2007 1115B.4.6.3; Fig. 11B-3A(b) CBC 2016 11B-602.9 Mitigated: <input type="radio"/> YES <input checked="" type="radio"/> NO	1	JOB	\$9,000	\$9,000

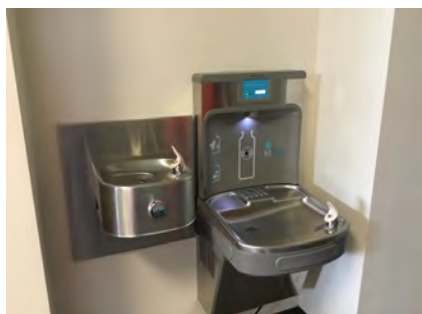
<input type="checkbox"/> Staff Only Priority 3 Severity 2			
31	<ul style="list-style-type: none"> • <i>As-Built Description:</i> 30" wide x 48" long clear floor space not provided at drinking fountain. • <i>As-Built:</i> 13.5" o.c. • <i>Proposed Solution:</i> Provide clear floor space at drinking fountain. 	PCODE IA06 ADAAG 91 4.15.5(1)* ADA 2010 602.2 CBC 2007 1115B.4.6.2 CBC 2016 11B-602.2 Mitigated: <input type="radio"/> YES <input checked="" type="radio"/> NO	1	JOB	\$6,660	\$6,660

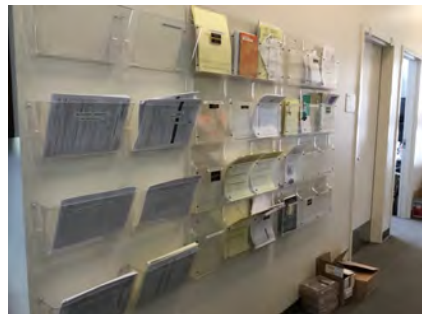
Item no., Rm no. and Name	Existing Architectural Barrier and Proposed Solution	Codes / Mitigation Info	Qty	Unit	Cost	Total
Brochure Bins						
24	<ul style="list-style-type: none">As-Built Description: Information brochure bins mounted above accessible height of 48".As-Built: 60"- 74" highProposed Solution: Relocate/remount bins at accessible height.	PCODE IN08 ADAAG 91 4.2.5 & 6 ADA 2010 308.2.1 CBC 2007 1118B.5 CBC 2016 11B-308.2.1 Mitigated: <input type="radio"/> YES <input checked="" type="radio"/> NO	1	JOB	\$300	\$300

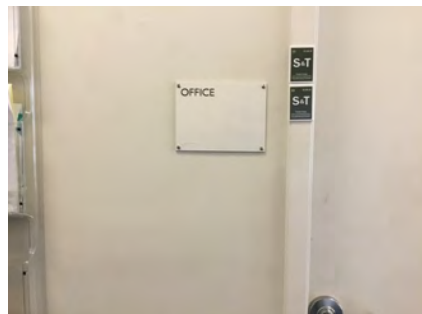
<input type="checkbox"/> Staff Only			
			Priority		Severity	
			2		1	
Signage						
25	<ul style="list-style-type: none">As-Built Description: Sign not located on latch side of door and/or not located at 48" min. above to baseline of the lowest Braille cells and 60" max. to baseline of the highest line of raised characters.As-Built: 61.5" highProposed Solution: Provide compliant signage including tactile characters and Grade II Braille on latch side of door located at compliant height.	PCODE SA07 ADAAG 91 4.30.6 ADA 2010 703.4.1 CBC 2007 1117B.5.7 Mitigated: <input type="radio"/> YES <input checked="" type="radio"/> NO	13	JOB	\$150	\$1,950

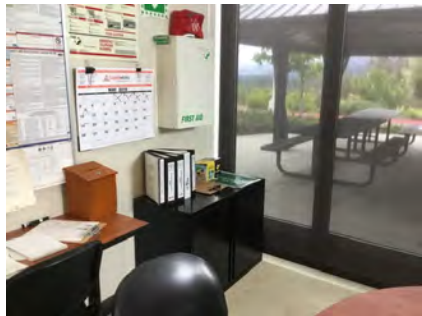
Item no., Rm no. and Name	Existing Architectural Barrier and Proposed Solution	Codes / Mitigation Info	Qty	Unit	Cost	Total
39	<ul style="list-style-type: none"> As-Built Description: Reach height to control or access point, exceeds 48" or is less than 15". As-Built: 63" high to First Aid Proposed Solution: Modify equipment or mounting. 	PCODE IE01 ADAAG 91 4.2.5 ADA 2010 308.2.1 CBC 2007 1118B.5 CBC 2016 11B-308.2.1 Mitigated: <input type="radio"/> YES <input checked="" type="radio"/> NO	1	JOB	\$300	\$300

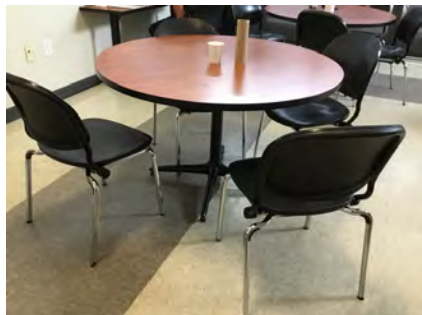
Non-Fixed Desk

42	<ul style="list-style-type: none"> As-Built Description: Accessible non-fixed table or desk (top 28" to 34" high; knee space at least 27" high x 19" deep x 30" wide) not provided. Proposed Solution: Provide table or desk with accessible dimensions when purchasing new furniture. Notes: 4 tables, 0 accessible 	PCODE IN02A ADAAG 91 4.32.3 & .4 ADA 2010 306.1 CBC 2007 1122B.3 & 4 CBC 2016 11B-306.1 & 11B-902.3 Mitigated: <input type="radio"/> YES <input checked="" type="radio"/> NO	1	JOB	\$4,800	\$4,800

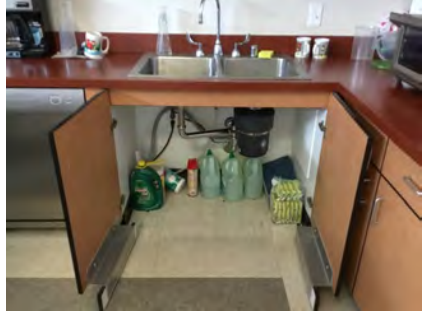
Item no., Rm no. and Name	Existing Architectural Barrier and Proposed Solution	Codes / Mitigation Info	Qty	Unit	Cost	Total
Sink						
41	<ul style="list-style-type: none"> • <i>As-Built Description:</i> Sink does not have knee space min. 27" high x 19" deep x 30" wide. • <i>Proposed Solution:</i> Remodel sink cabinet. 	PCODE IN06A ADAAG 91 4.24.3 ADA 2010 606.2 CBC 2007 1115B.4.7.1 CBC 2016 11B-606.2 Mitigated: <input type="radio"/> YES <input checked="" type="radio"/> NO	1	JOB	\$5,250	\$5,250

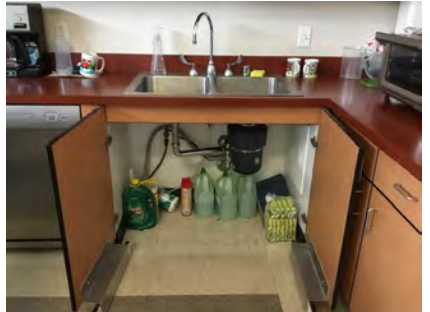
<input type="checkbox"/> Staff Only Priority Severity <input checked="" type="radio"/> 4 <input checked="" type="radio"/> 2			
40	<ul style="list-style-type: none"> • <i>As-Built Description:</i> Sink rim higher than 34" above floor. • <i>As-Built:</i> 34.25" high • <i>Proposed Solution:</i> Remodel sink cabinet to lower sink. 	PCODE IN06REF ADAAG 91 4.24.2 ADA 2010 606.3 CBC 2007 1115B.4.7.1 CBC 2016 11B-606.3 Mitigated: <input type="radio"/> YES <input checked="" type="radio"/> NO	REF

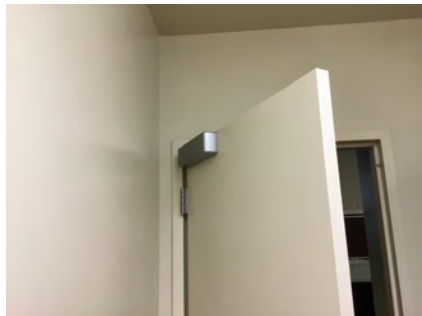
Item no., Rm no. and Name	Existing Architectural Barrier and Proposed Solution	Codes / Mitigation Info	Qty	Unit	Cost	Total
51	<ul style="list-style-type: none"> As-Built Description: Excessive force required to open door. As-Built: 11 lbs. Proposed Solution: Adjust regular door closer to accessible standards (5 lbs. max). 	PCODE ID03 ADAAG 91 4.13.11 ADA 2010 404.2.9 CBC 2007 113B.2.5 CBC 2016 11B-404.2.9 Mitigated: <input type="radio"/> YES <input checked="" type="radio"/> NO	1	JOB	\$75	\$75
