SAN MATEO COUNTY
COMMUNITY
COLLEGE DISTRICT

San Mateo County Community College District Americans with Disabilities Act Self-Evaluation and Transition Plan

Report Prepared by:

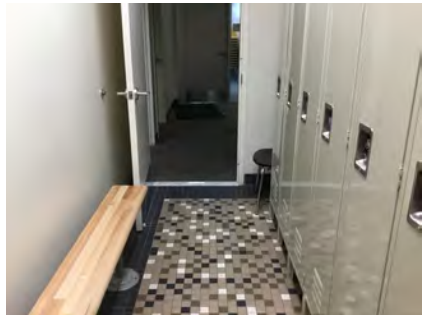
Door Swing

50	<ul style="list-style-type: none"> As-Built Description: Front approach: At pull side, door does not have clear and level maneuvering space measuring door width plus 18" x 60". (24" x 60" at exterior doors). As-Built: 42" to bench and 27" to locker Proposed Solution: Remove or relocate furniture or storage items. 	PCODE ID23A ADAAG 91 Fig. 25(a) ADA 2010 404.2.4 CBC 2007 11B-26A(a) CBC 2016 11B-404.2.4 Mitigated: <input type="radio"/> YES <input checked="" type="radio"/> NO	1	JOB	\$150	\$150

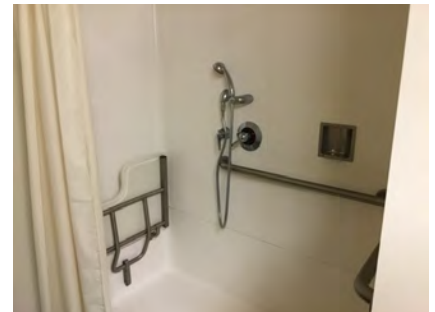
Shower not accessible; multiple compliance violations.

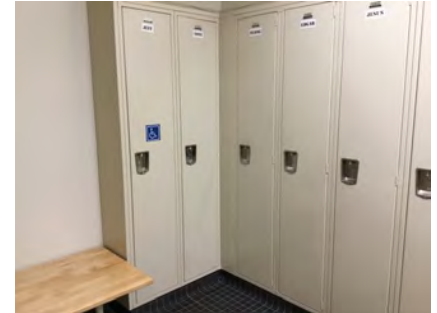
Item no., Rm no. and Name	Existing Architectural Barrier and Proposed Solution	Codes / Mitigation Info	Qty	Unit	Cost	Total
47	<ul style="list-style-type: none"> As-Built Description: Accessible locker(s) in dressing room not provided (5% of lockers; not less than one). Proposed Solution: Provide new locker(s) with accessible locking hardware that is operable with one hand and does not require grasping, pinching or twisting. Notes: 29 lockers, 1 accessible, need to provide 1 more accessible locker 	PCODE GG04 ADAAG 91 4.1.3(12)(a) ADA 2010 222.1 CBC 2007 1115B.8.5 CBC 2016 11B-222.1 Mitigated: <input type="radio"/> YES <input checked="" type="radio"/> NO	1	JOB	\$2,250	\$2,250

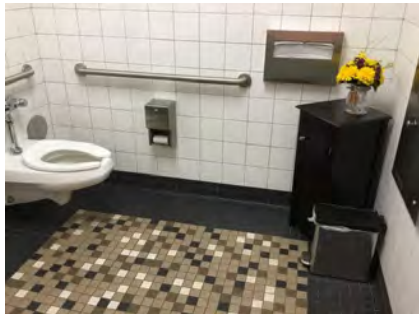
Item no., Rm no. and Name	Existing Architectural Barrier and Proposed Solution	Codes / Mitigation Info	Qty	Unit	Cost	Total
Water Closet						
56	<ul style="list-style-type: none">As-Built Description: CA only: In single-accommodation restroom less than 48" in front of water closet provided.As-Built: 39" to furnitureProposed Solution: Remodel restroom to provide at least 48" in front of water closet.Notes: Relocate furniture	<p>PCODE WB03A</p> <p>CBC 2007 1115B.3.2.1</p> <p>CBC 2016 11B-604.3.1</p> <p>Mitigated:</p> <p><input type="radio"/> YES</p> <p><input checked="" type="radio"/> NO</p>	1	JOB	\$15,000	\$15,000

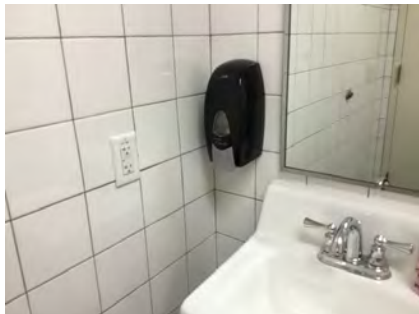
<input type="checkbox"/> Staff Only			
			Priority	Severity		
			3	3		
Accessories						
55	<ul style="list-style-type: none">As-Built Description: Dispensers in sanitary facilities, such as for towels, soap, sanitary napkins, seat covers, etc., and waste receptacles more than 48" (CA only: 40") from floor to highest operating slot or control.As-Built: 41" AFFProposed Solution: Relocate existing restroom accessories.	<p>PCODE WG01A</p> <p>ADAAG 91 4.23.7</p> <p>ADA 2010 308.2.1</p> <p>CBC 2007 1115B.8.3</p> <p>CBC 2016 11B-603.5</p> <p>Mitigated:</p> <p><input type="radio"/> YES</p> <p><input checked="" type="radio"/> NO</p>	1	JOB	\$300	\$300

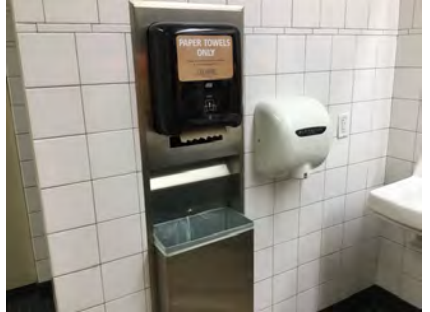
Item no., Rm no. and Name	Existing Architectural Barrier and Proposed Solution	Codes / Mitigation Info	Qty	Unit	Cost	Total
Accessories						
61	<ul style="list-style-type: none"> • <i>As-Built Description:</i> Dispensers in sanitary facilities, such as for towels, soap, sanitary napkins, seat covers, etc., and waste receptacles more than 48" (CA only: 40") from floor to highest operating slot or control. • <i>As-Built:</i> 46" ptd • <i>Proposed Solution:</i> Relocate existing restroom accessories. 	PCODE WG01A ADAAG 91 4.23.7 ADA 2010 308.2.1 CBC 2007 1115B.8.3 CBC 2016 11B-603.5 Mitigated: <input type="radio"/> YES <input checked="" type="radio"/> NO	1	JOB	\$300	\$300

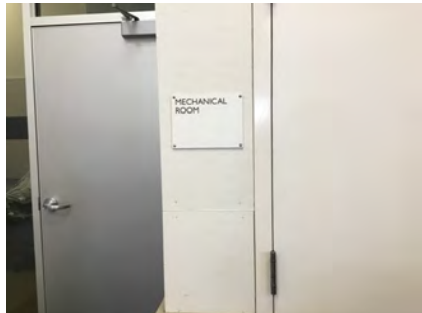
Item no., Rm no. and Name	Existing Architectural Barrier and Proposed Solution	Codes / Mitigation Info	Qty	Unit	Cost	Total
Signage						
69	<ul style="list-style-type: none"> As-Built Description: Sign not located on latch side of door and/or not located at 48" min. above to baseline of the lowest Braille cells and 60" max. to baseline of the highest line of raised characters. As-Built: 61.5" Proposed Solution: Provide compliant signage including tactile characters and Grade II Braille on latch side of door located at compliant height. Notes: Relocate to latch side of the door. 	PCODE SA07 ADAAG 91 4.30.6 ADA 2010 703.4.1 CBC 2007 1117B.5.7 CBC 2016 11B-703.4.1 Mitigated: <input type="radio"/> YES <input checked="" type="radio"/> NO	1	JOB	\$150	\$150

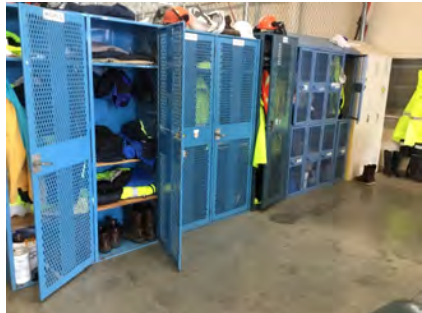
70	<ul style="list-style-type: none"> As-Built Description: Accessible locker(s) in dressing room not provided (1% of lockers; not less than one). Proposed Solution: Provide new locker(s) with accessible locking hardware that is operable with one hand and does not require grasping, pinching or twisting. Notes: 5 big, 8 small, 0 accessible 	PCODE GG04REF ADAAG 91 4.1.3(12)(a) ADA 2010 222.1 CBC 2007 1115B.8.5 CBC 2016 11B-222.1 Mitigated: <input type="radio"/> YES <input checked="" type="radio"/> NO	REF

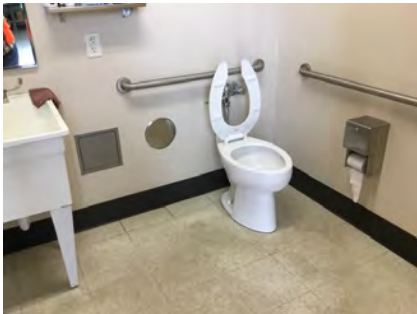
Item no., Rm no. and Name	Existing Architectural Barrier and Proposed Solution	Codes / Mitigation Info	Qty	Unit	Cost	Total
<u>Toilet Stall</u>						
75	<ul style="list-style-type: none">• <i>As-Built Description:</i> 60" min. clearance around a water closet measured perpendicular from the side wall not provided (Fixtures are not allowed to overlap this clearance).• <i>As-Built:</i> 58"• <i>Proposed Solution:</i> Remove adjacent fixture and provide new enclosure at accessible water closet.	<p>PCODE WB01A</p> <p>ADA 2010 604.3.1; 604.3.2</p> <p>CBC 2007 1115B.7.1.3</p> <p>CBC 2016 11B-604.3.1; 11B-604.3.2</p> <p>Mitigated:</p> <p><input type="radio"/> YES</p> <p><input checked="" type="radio"/> NO</p>	1	JOB	\$6,000	\$6,000

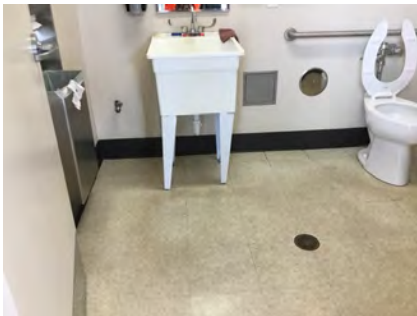
<input type="checkbox"/> Staff Only			
			<div><div>Priority</div><div>4</div></div> <div><div>Severity</div><div>4</div></div>			
<u>Lavatory</u>						
72	<ul style="list-style-type: none">• <i>As-Built Description:</i> Knee clearance 27" min. high starting 8" back from the front edge of the lavatory towards the wall is not provided.• <i>Proposed Solution:</i> Provide new accessible lavatory. Remodel restroom as needed.	<p>PCODE WD04</p> <p>ADAAG 91 Fig. 31</p> <p>ADA 2010 306.3.3</p> <p>CBC 2007 1115B.4.3</p> <p>CBC 2016 11B-306.3.3</p> <p>Mitigated:</p> <p><input type="radio"/> YES</p> <p><input checked="" type="radio"/> NO</p>	1	JOB	\$10,200	\$10,200

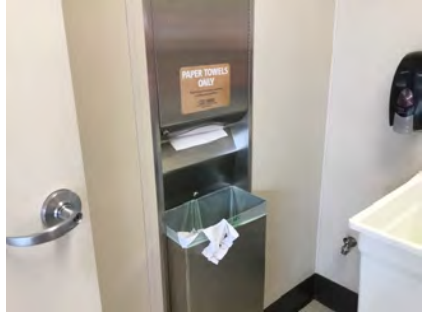
Item no., Rm no. and Name	Existing Architectural Barrier and Proposed Solution	Codes / Mitigation Info	Qty	Unit	Cost	Total
<u>Accessories</u>						
73	<ul style="list-style-type: none"> • <i>As-Built Description:</i> Dispensers in sanitary facilities, such as for towels, soap, sanitary napkins, seat covers, etc., and waste receptacles more than 48" (CA only: 40") from floor to highest operating slot or control. • <i>As-Built:</i> 41" ptd • <i>Proposed Solution:</i> Relocate existing restroom accessories. 	PCODE WG01A ADAAG 91 4.23.7 ADA 2010 308.2.1 CBC 2007 1115B.8.3 CBC 2016 11B-603.5 Mitigated: <input type="radio"/> YES <input checked="" type="radio"/> NO	1	JOB	\$300	\$300

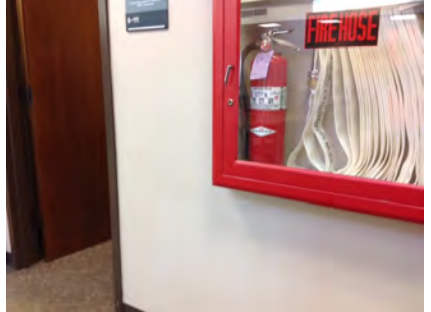
Item no., Rm no. and Name	Existing Architectural Barrier and Proposed Solution	Codes / Mitigation Info	Qty	Unit	Cost	Total
Reach Range						
257	<ul style="list-style-type: none"> As-Built Description: Reach height to control or access point, exceeds 48" or is less than 15". As-Built: 49" high Proposed Solution: Modify equipment or mounting. 	PCODE IE01 ADAAG 91 4.2.5 ADA 2010 308.2.1 CBC 2007 1118B.5 CBC 2016 11B-308.2.1 Mitigated: <input type="radio"/> YES <input checked="" type="radio"/> NO	1	JOB	\$300	\$300

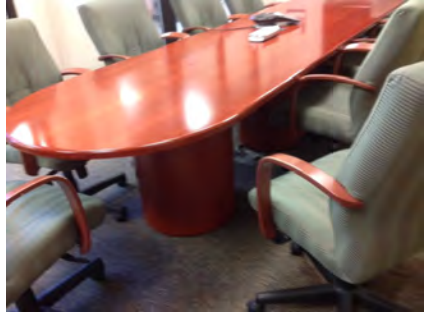
Item no., Rm no. and Name	Existing Architectural Barrier and Proposed Solution	Codes / Mitigation Info	Qty	Unit	Cost	Total
Non-Fixed Desk						
260	<ul style="list-style-type: none"> • <i>As-Built Description:</i> Accessible non-fixed table or desk (top 28" to 34" high; knee space at least 27" high x 19" deep x 30" wide) not provided. • <i>As-Built:</i> 17" deep • <i>Proposed Solution:</i> Provide table or desk with accessible dimensions when purchasing new furniture. 	PCODE IN02A ADAAG 91 4.32.3 & .4 ADA 2010 306.1 CBC 2007 1122B.3 & 4 CBC 2016 11B-306.1 & 11B-902.3 Mitigated: <input type="radio"/> YES <input checked="" type="radio"/> NO	2	JOB	\$4,800	\$9,600

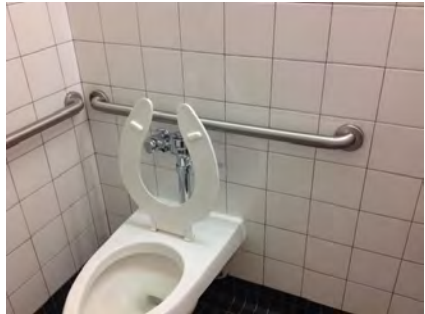
Item no., Rm no. and Name	Existing Architectural Barrier and Proposed Solution	Codes / Mitigation Info	Qty	Unit	Cost	Total
243	<ul style="list-style-type: none"> As-Built Description: The rear wall grab is less than 36" min. or does not extend from the centerline of the water closet 12" min. on one side and 24" min. on the other side. As-Built: 21" Proposed Solution: Provide or relocate accessible rear grab bar. 	PCODE WB07B ADAAG 91 4.17.6 ADA 2010 604.5.2 CBC 2007 1115B.4.1.3.2 CBC 2016 11B-604.5.2 Mitigated: <input type="radio"/> YES <input checked="" type="radio"/> NO	1	JOB	\$1,020	\$1,020

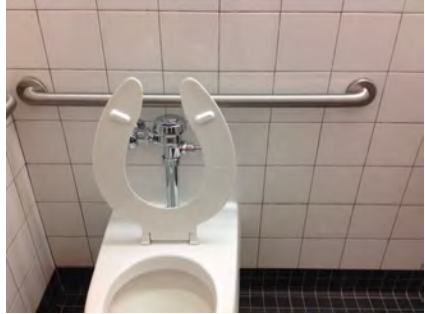
<input type="checkbox"/> Staff Only Priority 3 Severity 3						
244	<ul style="list-style-type: none"> As-Built Description: Accessories/dispensers in accessible stall located closer than 1-1/2" below or 12" above grab bar impedes its use. As-Built: 1" below Proposed Solution: Relocate accessories/dispensers to be no closer than 1-1/2" below and 12" above grab bars (except if accessories are recessed, flush with wall, and have no sharp edges). 	PCODE WB071 ADAAG 91 4.26.2 ADA 2010 609.3 CBC 2007 1133B.4.2.5 CBC 2016 11B-609.3 Mitigated: <input type="radio"/> YES <input checked="" type="radio"/> NO	1	JOB	\$225	\$225

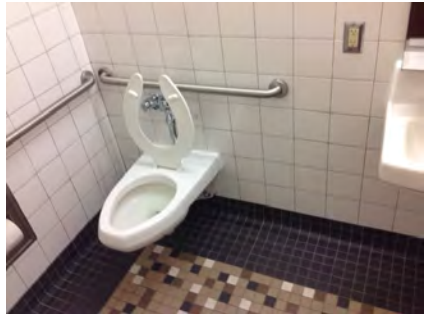
<input type="checkbox"/> Staff Only Priority 3 Severity 4						
<u>Toilet Stall</u>						
241	<ul style="list-style-type: none"> As-Built Description: Toilet stall less than 60" wide. As-Built: 56" Proposed Solution: Provide new accessible stall. Notes: 28" between WC and lavatory 	PCODE WB06 ADAAG 91 4.17.3 ADA 2010 604.8.1.1 CBC 2007 1115B.3.1.4.1 CBC 2016 11B-604.8.1.1 Mitigated: <input type="radio"/> YES <input checked="" type="radio"/> NO	1	JOB	\$4,500	\$4,500

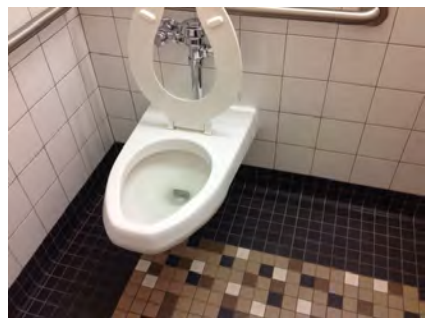
Item no., Rm no. and Name	Existing Architectural Barrier and Proposed Solution	Codes / Mitigation Info	Qty	Unit	Cost	Total
<u>Water Closet</u>						
242	<ul style="list-style-type: none">• <i>As-Built Description:</i> Water closet not 16"-18" (CA: 17"-18") from near side wall to center line of water closet (2010 ADAAG: 16"-18").• <i>As-Built:</i> 18.5" o.c.• <i>Proposed Solution:</i> Relocate existing water closet and plumbing, remount with offset closet flange to provide 18" max. from side wall.	<p>PCODE WB02C</p> <p>ADAAG 91 Fig. 28</p> <p>ADA 2010 604.2</p> <p>CBC 2007 1115B.4.1.1</p> <p>CBC 2016 11B-604.2</p> <p>Mitigated:</p> <p><input type="radio"/> YES</p> <p><input checked="" type="radio"/> NO</p>	1	JOB	\$1,500	\$1,500

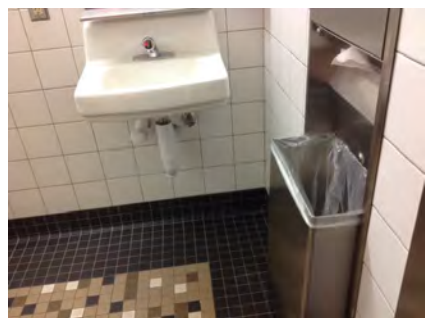
<input type="checkbox"/> Staff Only			
			Priority 3 Severity 4			
<u>Lavatory</u>						
238	<ul style="list-style-type: none">• <i>As-Built Description:</i> Clear floor space, 30" x 48" in front of fixture, extending 19" max. under the lavatory, not provided (CA only: Less than 18" from side wall to centerline of lavatory).• <i>As-Built:</i> 17.5" o.c.• <i>Proposed Solution:</i> Provide new accessible lavatory. Remodel restroom as needed.• <i>Notes:</i> Trash can obstructs clear approach.	<p>PCODE WD01</p> <p>ADAAG 91 4.19.3</p> <p>ADA 2010 606.2</p> <p>CBC 2007 1115B.4.3</p> <p>CBC 2016 11B-606.2, 11B-606.6</p> <p>Mitigated:</p> <p><input type="radio"/> YES</p> <p><input checked="" type="radio"/> NO</p>	1	JOB	\$10,200	\$10,200

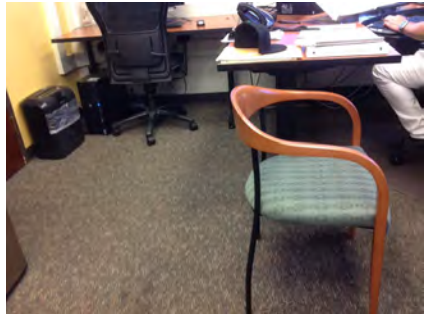
Item no., Rm no. and Name	Existing Architectural Barrier and Proposed Solution	Codes / Mitigation Info	Qty	Unit	Cost	Total
248	<ul style="list-style-type: none"> As-Built Description: Accessible non-fixed table or desk (top 28" to 34" high; knee space at least 27" high x 19" deep x 30" wide) not provided. As-Built: Knee space required if used as work surface for public. Proposed Solution: Provide table or desk with accessible dimensions when purchasing new furniture. 	PCODE IN02A ADAAG 91 4.32.3 & .4 ADA 2010 306.1 CBC 2007 1122B.3 & 4 CBC 2016 11B-306.1 & 11B-902.3 Mitigated: <input type="radio"/> YES <input checked="" type="radio"/> NO	1	JOB	\$4,800	\$4,800

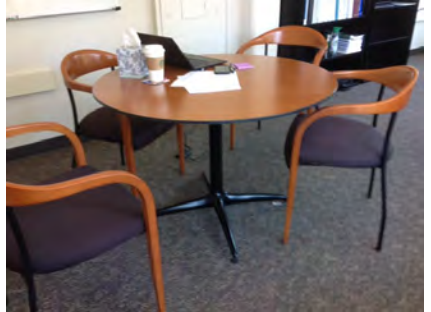
Item no., Rm no. and Name	Existing Architectural Barrier and Proposed Solution	Codes / Mitigation Info	Qty	Unit	Cost	Total
Non-Fixed Desk						
252	<ul style="list-style-type: none"> • <i>As-Built Description:</i> Accessible non-fixed table or desk (top 28" to 34" high; knee space at least 27" high x 19" deep x 30" wide) not provided. • <i>Proposed Solution:</i> Provide table or desk with accessible dimensions when purchasing new furniture. 	PCODE IN02A ADAAG 91 4.32.3 & .4 ADA 2010 306.1 CBC 2007 1122B.3 & 4 CBC 2016 11B-306.1 & 11B-902.3	1	JOB	\$4,800	\$4,800
		Mitigated: <input type="radio"/> YES <input checked="" type="radio"/> NO

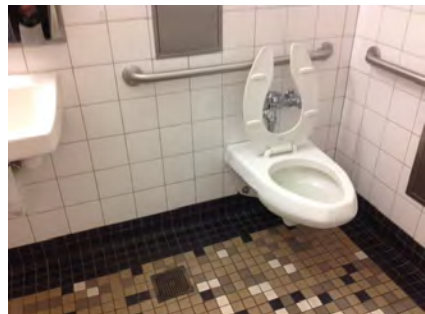
Item no., Rm no. and Name	Existing Architectural Barrier and Proposed Solution	Codes / Mitigation Info	Qty	Unit	Cost	Total
<u>Toilet Stall</u>						
761	<ul style="list-style-type: none">As-Built Description: Toilet stall less than 60" wide.As-Built: 54" wideProposed Solution: Provide new accessible stall.Notes: 28" between lavatory and toilet	PCODE WB06 ADAAG 91 4.17.3 ADA 2010 604.8.1.1 CBC 2007 1115B.3.1.4.1 CBC 2016 11B-604.8.1.1 Mitigated: <input type="radio"/> YES <input checked="" type="radio"/> NO	1	JOB	\$4,500	\$4,500

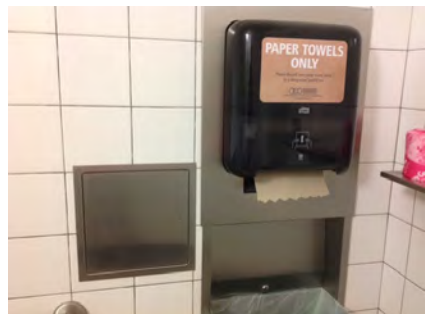
<input type="checkbox"/> Staff Only			
			Priority 3 Severity 3			
<u>Accessories</u>						
760	<ul style="list-style-type: none">As-Built Description: Dispensers in sanitary facilities, such as for towels, soap, sanitary napkins, seat covers, etc., and waste receptacles more than 48" (CA only: 40") from floor to highest operating slot or control.As-Built: Soap dispenser 41" high, paper towel 47" high.Proposed Solution: Relocate existing restroom accessories.	PCODE WG01A ADAAG 91 4.23.7 ADA 2010 308.2.1 CBC 2007 1115B.8.3 CBC 2016 11B-603.5 Mitigated: <input type="radio"/> YES <input checked="" type="radio"/> NO	1	JOB	\$300	\$300

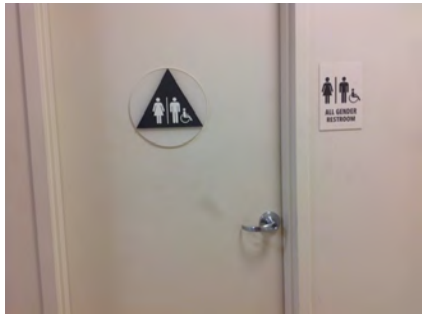
Item no., Rm no. and Name	Existing Architectural Barrier and Proposed Solution	Codes / Mitigation Info	Qty	Unit	Cost	Total
<u>Signage</u>						
762	<ul style="list-style-type: none">• <i>As-Built Description:</i> Required in CA only: identification symbol centered 58" to 60" high on sanitary facility door that contrasts with the door not provided (women: 12" ø circle, men: 12" triangle, unisex: combined symbol).• <i>Proposed Solution:</i> Provide properly mounted sanitary facility symbol when altering area. If wheelchair accessible, include International Symbol of Accessibility on sign.• <i>Notes:</i> No contrast between circle sign surface and door surface	<p>PCODE SA15</p> <p>CBC 2007 1115B.6</p> <p>CBC 2016 11B-703.7.2.6</p> <p>Mitigated:</p> <p><input type="radio"/> YES</p> <p><input checked="" type="radio"/> NO</p>	1	JOB	\$270	\$270

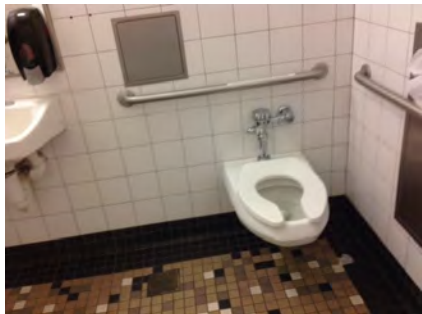
<u>Toilet Stall</u>						
767	<ul style="list-style-type: none">• <i>As-Built Description:</i> Toilet stall less than 60" wide.• <i>As-Built:</i> 54" wide• <i>Proposed Solution:</i> Provide new accessible stall.• <i>Notes:</i> 28" between toilet and lavatory	<p>PCODE WB06</p> <p>ADAAG 91 4.17.3</p> <p>ADA 2010 604.8.1.1</p> <p>CBC 2007 1115B.3.1.4.1</p> <p>CBC 2016 11B-604.8.1.1</p> <p>Mitigated:</p> <p><input type="radio"/> YES</p> <p><input checked="" type="radio"/> NO</p>	1	JOB	\$4,500	\$4,500

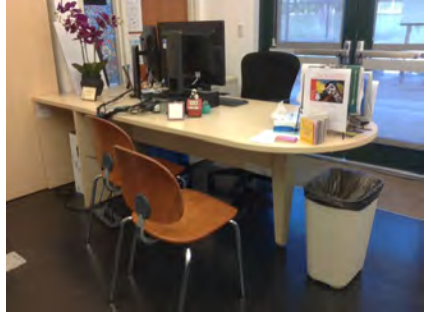
Item no., Rm no. and Name	Existing Architectural Barrier and Proposed Solution	Codes / Mitigation Info	Qty	Unit	Cost	Total
Non-Fixed Desk						
772	<ul style="list-style-type: none"> • <i>As-Built Description:</i> Accessible non-fixed table or desk (top 28" to 34" high; knee space at least 27" high x 19" deep x 30" wide) not provided. • <i>As-Built:</i> 18" deep knee • <i>Proposed Solution:</i> Provide table or desk with accessible dimensions when purchasing new furniture. • <i>Notes:</i> If used as work surface for students 	PCODE IN02A ADAAG 91 4.32.3 & .4 ADA 2010 306.1 CBC 2007 1122B.3 & 4 CBC 2016 11B-306.1 & 11B-902.3 Mitigated: <input type="radio"/> YES <input checked="" type="radio"/> NO	1	JOB	\$4,800	\$4,800

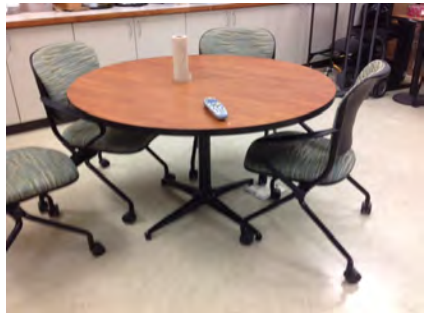
Item no., Rm no. and Name	Existing Architectural Barrier and Proposed Solution	Codes / Mitigation Info	Qty	Unit	Cost	Total
Non-Fixed Desk						
783	<ul style="list-style-type: none"> • <i>As-Built Description:</i> Accessible non-fixed table or desk (top 28" to 34" high; knee space at least 27" high x 19" deep x 30" wide) not provided. • <i>Proposed Solution:</i> Provide table or desk with accessible dimensions when purchasing new furniture. 	PCODE IN02A ADAAG 91 4.32.3 & .4 ADA 2010 306.1 CBC 2007 1122B.3 & 4 CBC 2016 11B-306.1 & 11B-902.3 Mitigated: <input type="radio"/> YES <input checked="" type="radio"/> NO	1	JOB	\$4,800	\$4,800

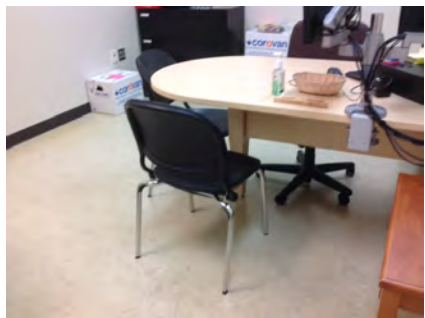
<input type="checkbox"/> Staff Only Priority 4 Severity 2			
784	<ul style="list-style-type: none"> • <i>As-Built Description:</i> Accessible non-fixed table or desk (top 28" to 34" high; knee space at least 27" high x 19" deep x 30" wide) not provided. • <i>As-Built:</i> 18" deep knee clearance if used as writing surface. • <i>Proposed Solution:</i> Provide table or desk with accessible dimensions when purchasing new furniture. 	PCODE IN02A ADAAG 91 4.32.3 & .4 ADA 2010 306.1 CBC 2007 1122B.3 & 4 CBC 2016 11B-306.1 & 11B-902.3 Mitigated: <input type="radio"/> YES <input checked="" type="radio"/> NO	1	JOB	\$4,800	\$4,800

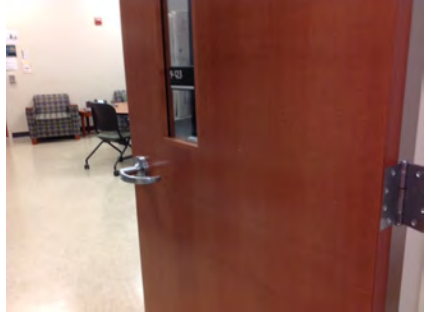
Item no., Rm no. and Name	Existing Architectural Barrier and Proposed Solution	Codes / Mitigation Info	Qty	Unit	Cost	Total
Signage						
781	<ul style="list-style-type: none"> • <i>As-Built Description:</i> Sign not located on latch side of door and/or not located at 48" min. above to baseline of the lowest Braille cells and 60" max. to baseline of the highest line of raised characters. • <i>Proposed Solution:</i> Provide compliant signage including tactile characters and Grade II Braille on latch side of door located at compliant height. 	PCODE SA07 ADAAG 91 4.30.6 ADA 2010 703.4.1 CBC 2007 1117B.5.7 CBC 2016 11B-703.4.1 Mitigated: <input type="radio"/> YES <input checked="" type="radio"/> NO	1	JOB	\$150	\$150

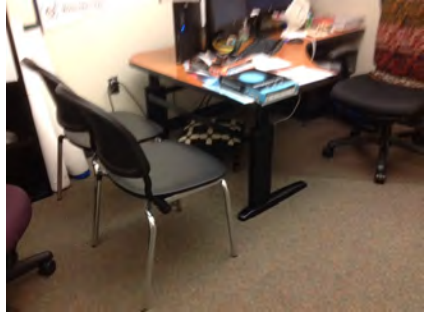
Item no., Rm no. and Name	Existing Architectural Barrier and Proposed Solution	Codes / Mitigation Info	Qty	Unit	Cost	Total
<u>Non-Fixed Desk</u>						
785	<ul style="list-style-type: none"> • <i>As-Built Description:</i> Accessible non-fixed table or desk (top 28" to 34" high; knee space at least 27" high x 19" deep x 30" wide) not provided. • <i>As-Built:</i> No knee clearance on the student side if used as writing surface. • <i>Proposed Solution:</i> Provide table or desk with accessible dimensions when purchasing new furniture. 	PCODE IN02A ADAAG 91 4.32.3 & .4 ADA 2010 306.1 CBC 2007 1122B.3 & 4 CBC 2016 11B-306.1 & 11B-902.3 Mitigated: <input type="radio"/> YES <input checked="" type="radio"/> NO	1	JOB	\$4,800	\$4,800

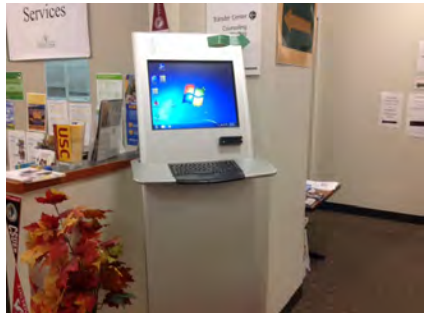
Item no., Rm no. and Name	Existing Architectural Barrier and Proposed Solution	Codes / Mitigation Info	Qty	Unit	Cost	Total
Non-Fixed Desk						
790	<ul style="list-style-type: none"> As-Built Description: Accessible non-fixed table or desk (top 28" to 34" high; knee space at least 27" high x 19" deep x 30" wide) not provided. As-Built: No knee space for check in computer Proposed Solution: Provide table or desk with accessible dimensions when purchasing new furniture. 	PCODE IN02A ADAAG 91 4.32.3 & .4 ADA 2010 306.1 CBC 2007 1122B.3 & 4 CBC 2016 11B-306.1 & 11B-902.3 Mitigated: <input type="radio"/> YES <input checked="" type="radio"/> NO	1	JOB	\$4,800	\$4,800

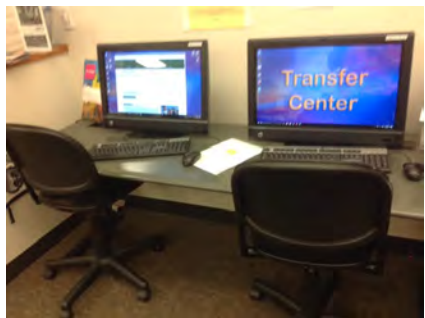
<input type="checkbox"/> Staff Only Priority 2 Severity 2			
791	<ul style="list-style-type: none"> As-Built Description: Accessible non-fixed table or desk (top 28" to 34" high; knee space at least 27" high x 19" deep x 30" wide) not provided. As-Built: 17" deep knee clearance Proposed Solution: Provide table or desk with accessible dimensions when purchasing new furniture. Notes: Transfer Center Room 118 	PCODE IN02A ADAAG 91 4.32.3 & .4 ADA 2010 306.1 CBC 2007 1122B.3 & 4 CBC 2016 11B-306.1 & 11B-902.3 Mitigated: <input type="radio"/> YES <input checked="" type="radio"/> NO	1	JOB	\$4,800	\$4,800

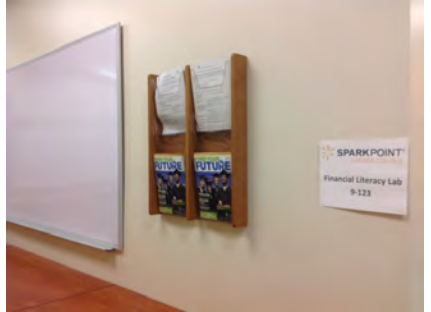
Item no., Rm no. and Name	Existing Architectural Barrier and Proposed Solution	Codes / Mitigation Info	Qty	Unit	Cost	Total
Brochure Bins						
794	<ul style="list-style-type: none"> • <i>As-Built Description:</i> Information brochure bins mounted above accessible height of 48". • <i>As-Built:</i> 60" high • <i>Proposed Solution:</i> Relocate/remount bins at accessible height. 	PCODE IN08 ADAAG 91 4.2.5 & 6 ADA 2010 308.2.1 CBC 2007 1118B.5 CBC 2016 11B-308.2.1 Mitigated: <input type="radio"/> YES <input checked="" type="radio"/> NO	1	JOB	\$300	\$300

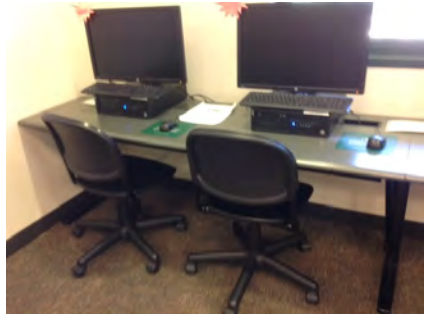
Item no., Rm no. and Name	Existing Architectural Barrier and Proposed Solution	Codes / Mitigation Info	Qty	Unit	Cost	Total
799	<ul style="list-style-type: none"> • <i>As-Built Description:</i> Accessible non-fixed table or desk (top 28" to 34" high; knee space at least 27" high x 19" deep x 30" wide) not provided. • <i>As-Built:</i> 26" high knee clearance • <i>Proposed Solution:</i> Provide table or desk with accessible dimensions when purchasing new furniture. 	PCODE IN02A ADAAG 91 4.32.3 & .4 ADA 2010 306.1 CBC 2007 1122B.3 & 4 CBC 2016 11B-306.1 & 11B-902.3 Mitigated: <input type="radio"/> YES <input checked="" type="radio"/> NO	1	JOB	\$4,800	\$4,800

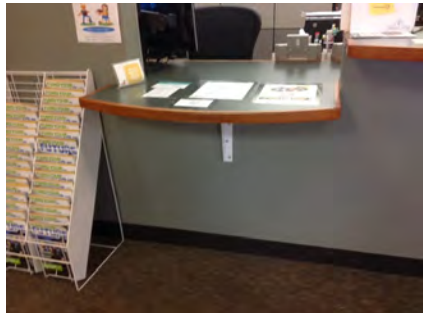
Public Counter

798	<ul style="list-style-type: none"> • <i>As-Built Description:</i> Service counter (stand-up): Accessible section min. 36" length and 36" max. height (in CA: 28" to 34" high) not provided. • <i>As-Built:</i> 34.5" high • <i>Proposed Solution:</i> Retrofit existing counter to provide accessible section. Interim solution: Provide auxiliary counter, table, or clipboard. 	PCODE IN03 ADAAG 91 7.2(2) ADA 2010 904.4 CBC 2007 1122B.4 CBC 2016 11B-904.4 Mitigated: <input type="radio"/> YES <input checked="" type="radio"/> NO	1	JOB	\$6,000	\$6,000

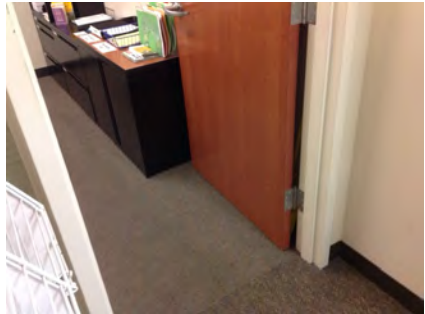
Item no., Rm no. and Name	Existing Architectural Barrier and Proposed Solution	Codes / Mitigation Info	Qty	Unit	Cost	Total
805	<ul style="list-style-type: none"> As-Built Description: Front approach: At pull side, door does not have clear and level maneuvering space measuring door width plus 18" x 60". (24" x 60" at exterior doors). Proposed Solution: Remove or relocate furniture or storage items. 	PCODE ID23A ADAAG 91 Fig. 25(a) ADA 2010 404.2.4 CBC 2007 11B-26A(a) CBC 2016 11B-404.2.4 Mitigated: <input type="radio"/> YES <input checked="" type="radio"/> NO	1	JOB	\$150	\$150

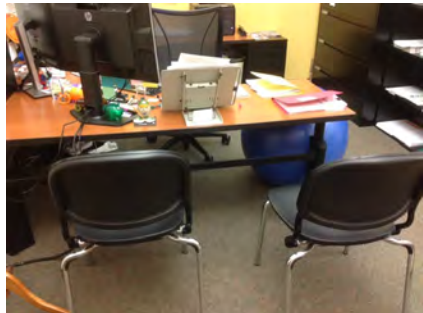
Non-Fixed Desk

803	<ul style="list-style-type: none"> As-Built Description: Accessible non-fixed table or desk (top 28" to 34" high; knee space at least 27" high x 19" deep x 30" wide) not provided. As-Built: No knee clearance if used as writing surface for public. Proposed Solution: Provide table or desk with accessible dimensions when purchasing new furniture. 	PCODE IN02A ADAAG 91 4.32.3 & .4 ADA 2010 306.1 CBC 2007 1122B.3 & 4 CBC 2016 11B-306.1 & 11B-902.3 Mitigated: <input type="radio"/> YES <input checked="" type="radio"/> NO	4	JOB	\$4,800	\$19,200

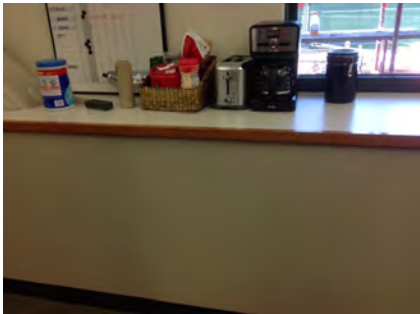
Item no., Rm no. and Name	Existing Architectural Barrier and Proposed Solution	Codes / Mitigation Info	Qty	Unit	Cost	Total
Public Counter						
807	<ul style="list-style-type: none">As-Built Description: Service counter (stand-up): Accessible section min. 36" length and 36" max. height (in CA: 28" to 34" high) not provided.As-Built: 37" high counterProposed Solution: Retrofit existing counter to provide accessible section. Interim solution: Provide auxiliary counter, table, or clipboard.	PCODE IN03 ADAAG 91 7.2(2) ADA 2010 904.4 CBC 2007 1122B.4 CBC 2016 11B-904.4 Mitigated: <input type="radio"/> YES <input checked="" type="radio"/> NO	1	JOB	\$6,000	\$6,000

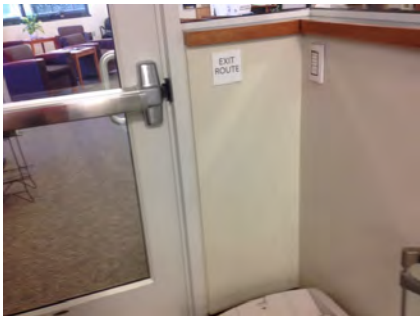
<input type="checkbox"/> Staff Only			
			Priority Severity <input checked="" type="radio"/> 4 <input checked="" type="radio"/> 4			
Signage						
806	<ul style="list-style-type: none">As-Built Description: Signs containing tactile characters is not located so that a clear floor space of 18" min x 18" min., centered on the tactile characters, is provided beyond the arc of any door swing between the closed position and 45 degree open position.As-Built: 42" highProposed Solution: Relocate compliant signage on latch side of door located at compliant height with a clear floor space.	PCODE SA07B ADA 2010 703.4.2 CBC 2016 11B-703.4.2 Mitigated: <input type="radio"/> YES <input checked="" type="radio"/> NO	1	JOB	\$150	\$150

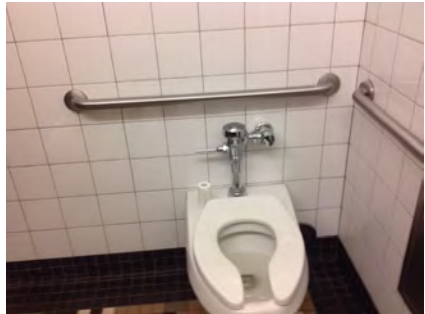
Item no., Rm no. and Name	Existing Architectural Barrier and Proposed Solution	Codes / Mitigation Info	Qty	Unit	Cost	Total
815	<ul style="list-style-type: none"> As-Built Description: The rear wall grab is less than 36" min. or does not extend from the centerline of the water closet 12" min. on one side and 24" min. on the other side. As-Built: 23" from the centerline of the toilet Proposed Solution: Provide or relocate accessible rear grab bar. 	PCODE WB07B ADAAG 91 4.17.6 ADA 2010 604.5.2 CBC 2007 1115B.4.1.3.2 CBC 2016 11B-604.5.2 Mitigated: <input type="radio"/> YES <input checked="" type="radio"/> NO	1	JOB	\$1,020	\$1,020

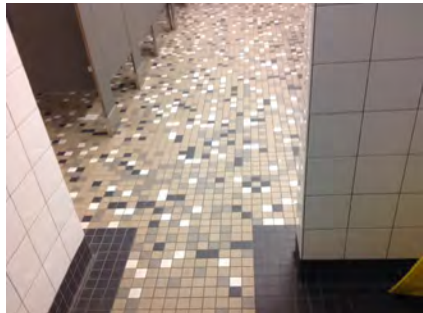
Wheelchair Clearance

812	<ul style="list-style-type: none"> As-Built Description: Clear passage width (except doorways) from rest room entry to accessible water closet compartment less than 36" (CA only: 44" wide). As-Built: 36" wide Proposed Solution: Modify facility passage to be min. 44" wide. Demolish existing partition and replace. 	PCODE WC02A ADAAG 91 4.3.3 ADA 2010 403.5.1 CBC 2007 1115B.3.2.4 CBC 2016 11B-403.5.1 Mitigated: <input type="radio"/> YES <input checked="" type="radio"/> NO	2	LF	\$510	\$1,020

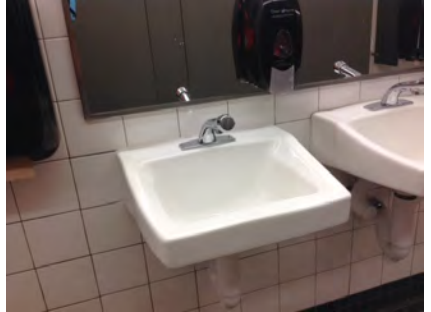
Item no., Rm no. and Name	Existing Architectural Barrier and Proposed Solution	Codes / Mitigation Info	Qty	Unit	Cost	Total
<u>Accessories</u>						
813	<ul style="list-style-type: none"> • <i>As-Built Description:</i> Dispensers in sanitary facilities, such as for towels, soap, sanitary napkins, seat covers, etc., and waste receptacles more than 48" (CA only: 40") from floor to highest operating slot or control. • <i>As-Built:</i> Soap dispenser 40.5" high • <i>Proposed Solution:</i> Relocate existing restroom accessories. 	PCODE WG01A ADAAG 91 4.23.7 ADA 2010 308.2.1 CBC 2007 1115B.8.3 CBC 2016 11B-603.5 Mitigated: <input type="radio"/> YES <input checked="" type="radio"/> NO	1	JOB	\$300	\$300

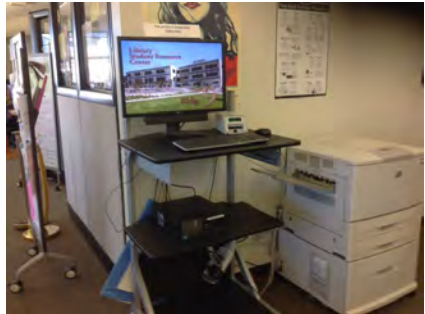
Item no., Rm no. and Name	Existing Architectural Barrier and Proposed Solution	Codes / Mitigation Info	Qty	Unit	Cost	Total
5	<ul style="list-style-type: none"> As-Built Description: Accessible non-fixed table or desk (top 28" to 34" high; knee space at least 27" high x 19" deep x 30" wide) not provided. Proposed Solution: Provide table or desk with accessible dimensions when purchasing new furniture. Notes: Printer computer not accessible 	PCODE IN02A ADAAG 91 4.32.3 & .4 ADA 2010 306.1 CBC 2007 1122B.3 & 4 CBC 2016 11B-306.1 & 11B-902.3 Mitigated: <input type="radio"/> YES <input checked="" type="radio"/> NO	1	JOB	\$4,800	\$4,800

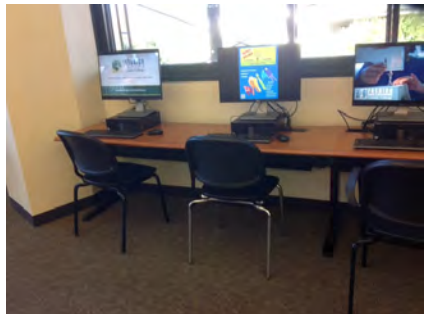
<input type="checkbox"/> Staff Only			
			Priority 2 Severity 2			
831	<ul style="list-style-type: none"> As-Built Description: Accessible non-fixed table or desk (top 28" to 34" high; knee space at least 27" high x 19" deep x 30" wide) not provided. As-Built: 26" high, 15" deep Proposed Solution: Provide table or desk with accessible dimensions when purchasing new furniture. Notes: Approximately 56 computer stations, no accessible stations 	PCODE IN02A ADAAG 91 4.32.3 & .4 ADA 2010 306.1 CBC 2007 1122B.3 & 4 CBC 2016 11B-306.1 & 11B-902.3 Mitigated: <input type="radio"/> YES <input checked="" type="radio"/> NO	1	JOB	\$4,800	\$4,800

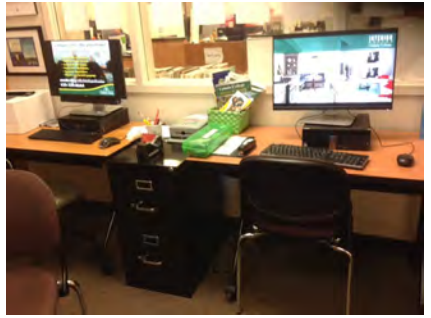
Item no., Rm no. and Name	Existing Architectural Barrier and Proposed Solution	Codes / Mitigation Info	Qty	Unit	Cost	Total
8	<ul style="list-style-type: none"> As-Built Description: Accessible non-fixed table or desk (top 28" to 34" high; knee space at least 27" high x 19" deep x 30" wide) not provided. As-Built: 24" knee space Proposed Solution: Provide table or desk with accessible dimensions when purchasing new furniture. 	PCODE IN02A ADAAG 91 4.32.3 & .4 ADA 2010 306.1 CBC 2007 1122B.3 & 4 CBC 2016 11B-306.1 & 11B-902.3 Mitigated: <input type="radio"/> YES <input checked="" type="radio"/> NO	1	JOB	\$4,800	\$4,800

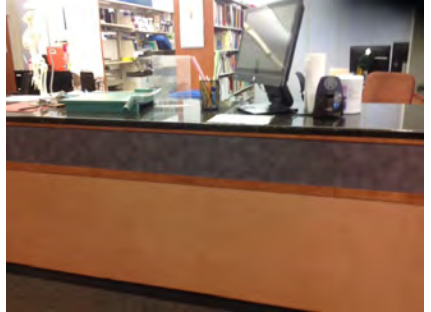
Item no., Rm no. and Name	Existing Architectural Barrier and Proposed Solution	Codes / Mitigation Info	Qty	Unit	Cost	Total
Public Counter						
9	<ul style="list-style-type: none"> • <i>As-Built Description:</i> Service counter (stand-up): Accessible section min. 36" length and 36" max. height (in CA: 28" to 34" high) not provided. • <i>As-Built:</i> 41" high • <i>Proposed Solution:</i> Retrofit existing counter to provide accessible section. Interim solution: Provide auxiliary counter, table, or clipboard. • <i>Notes:</i> Relocate computer to lowered counter 	PCODE IN03 ADAAG 91 7.2(2) ADA 2010 904.4 CBC 2007 1122B.4 CBC 2016 11B-904.4 Mitigated: <input type="radio"/> YES <input checked="" type="radio"/> NO	1	JOB	\$6,000	\$6,000

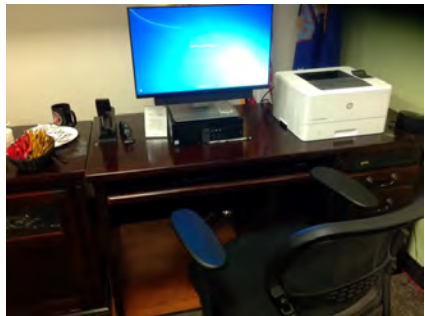
Item no., Rm no. and Name	Existing Architectural Barrier and Proposed Solution	Codes / Mitigation Info	Qty	Unit	Cost	Total
15	<ul style="list-style-type: none"> As-Built Description: Accessible non-fixed table or desk (top 28" to 34" high; knee space at least 27" high x 19" deep x 30" wide) not provided. As-Built: 25" knee height Proposed Solution: Provide table or desk with accessible dimensions when purchasing new furniture. 	PCODE IN02A ADAAG 91 4.32.3 & .4 ADA 2010 306.1 CBC 2007 112B.3 & 4 CBC 2016 11B-306.1 & 11B-902.3 Mitigated: <input type="radio"/> YES <input checked="" type="radio"/> NO	1	JOB	\$4,800	\$4,800

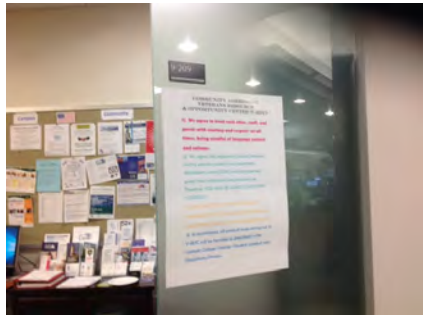
12	<ul style="list-style-type: none"> As-Built Description: Signs containing tactile characters is not located so that a clear floor space of 18" min x 18" min., centered on the tactile characters, is provided beyond the arc of any door swing between the closed position and 45 degree open position. As-Built: 72" high Proposed Solution: Relocate compliant signage on latch side of door located at compliant height with a clear floor space. 	PCODE SA07B ADA 2010 703.4.2 CBC 2016 11B-703.4.2 Mitigated: <input type="radio"/> YES <input checked="" type="radio"/> NO	1	JOB	\$150	\$150

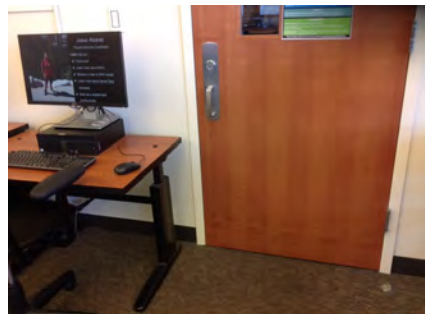
Item no., Rm no. and Name	Existing Architectural Barrier and Proposed Solution	Codes / Mitigation Info	Qty	Unit	Cost	Total
<u>Door Swing</u>						
23	<ul style="list-style-type: none">• <i>As-Built Description:</i> Front approach: At pull side, door does not have clear and level maneuvering space measuring door width plus 18" x 60". (24" x 60" at exterior doors).• <i>Proposed Solution:</i> Remove or relocate furniture or storage items.	<p>PCODE ID23A</p> <p>ADAAG 91 Fig. 25(a)</p> <p>ADA 2010 404.2.4</p> <p>CBC 2007 11B-26A(a)</p> <p>CBC 2016 11B-404.2.4</p> <p>Mitigated:</p> <p><input type="radio"/> YES</p> <p><input checked="" type="radio"/> NO</p>	1	JOB	\$150	\$150

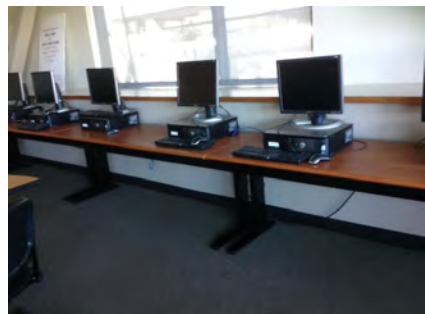
<input type="checkbox"/> Staff Only			
			<div><div>Priority</div><div>2</div></div> <div><div>Severity</div><div>2</div></div>			
<u>Non-Fixed Desk</u>						
24	<ul style="list-style-type: none">• <i>As-Built Description:</i> Accessible non-fixed table or desk (top 28" to 34" high; knee space at least 27" high x 19" deep x 30" wide) not provided.• <i>As-Built:</i> 26" knee space• <i>Proposed Solution:</i> Provide table or desk with accessible dimensions when purchasing new furniture.	<p>PCODE IN02A</p> <p>ADAAG 91 4.32.3 & .4</p> <p>ADA 2010 306.1</p> <p>CBC 2007 1122B.3 & 4</p> <p>CBC 2016 11B-306.1 & 11B-902.3</p> <p>Mitigated:</p> <p><input type="radio"/> YES</p> <p><input checked="" type="radio"/> NO</p>	1	JOB	\$4,800	\$4,800

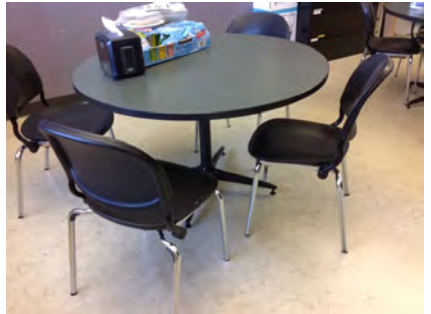
Item no., Rm no. and Name	Existing Architectural Barrier and Proposed Solution	Codes / Mitigation Info	Qty	Unit	Cost	Total
26	<ul style="list-style-type: none"> • <i>As-Built Description:</i> Accessible non-fixed table or desk (top 28" to 34" high; knee space at least 27" high x 19" deep x 30" wide) not provided. • <i>Proposed Solution:</i> Provide table or desk with accessible dimensions when purchasing new furniture. 	PCODE IN02A ADAAG 91 4.32.3 & .4 ADA 2010 306.1 CBC 2007 1122B.3 & 4 CBC 2016 11B-306.1 & 11B-902.3 Mitigated: <input type="radio"/> YES <input checked="" type="radio"/> NO	1	JOB	\$4,800	\$4,800

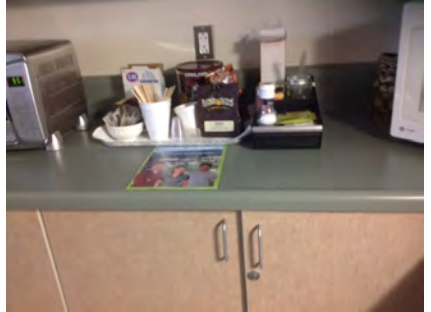
Item no., Rm no. and Name	Existing Architectural Barrier and Proposed Solution	Codes / Mitigation Info	Qty	Unit	Cost	Total
Reach Range						
30	<ul style="list-style-type: none"> • <i>As-Built Description:</i> Reach height to control or access point, exceeds 48" or is less than 15". • <i>As-Built:</i> 26" deep • <i>Proposed Solution:</i> Modify equipment or mounting. 	PCODE IE01 ADAAG 91 4.2.5 ADA 2010 308.2.1 CBC 2007 1118B.5 CBC 2016 11B-308.2.1 Mitigated: <input type="radio"/> YES <input checked="" type="radio"/> NO	1	JOB	\$300	\$300

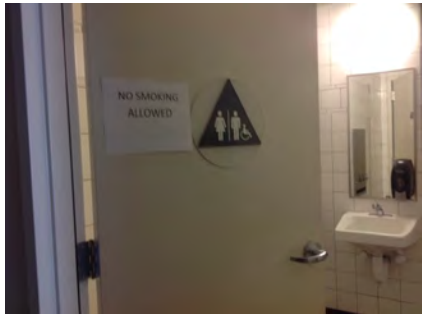
Item no., Rm no. and Name	Existing Architectural Barrier and Proposed Solution	Codes / Mitigation Info	Qty	Unit	Cost	Total
Signage						
31	<ul style="list-style-type: none">As-Built Description: Required in CA only: identification symbol centered 58" to 60" high on sanitary facility door that contrasts with the door not provided (women: 12" ø circle, men: 12" triangle, unisex: combined symbol).As-Built: No contrastProposed Solution: Provide properly mounted sanitary facility symbol when altering area. If wheelchair accessible, include International Symbol of Accessibility on sign.	<p>PCODE SA15</p> <p>CBC 2007 1115B.6</p> <p>CBC 2016 11B-703.7.2.6</p> <p>Mitigated:</p> <p><input type="radio"/> YES</p> <p><input checked="" type="radio"/> NO</p>	1	JOB	\$270	\$270

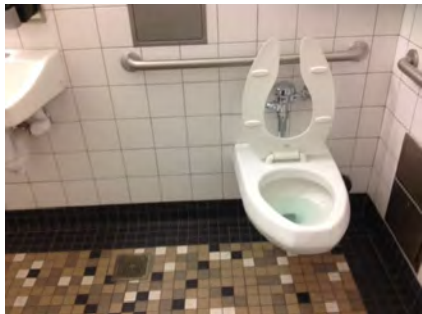
<input type="checkbox"/> Staff Only			
			Priority		Severity	
			3		3	
Toilet Stall						
34	<ul style="list-style-type: none">As-Built Description: Toilet stall less than 60" wide.As-Built: 55" wideProposed Solution: Provide new accessible stall.Notes: 28" between WC and lavatory	<p>PCODE WB06</p> <p>ADAAG 91 4.17.3</p> <p>ADA 2010 604.8.1.1</p> <p>CBC 2007 1115B.3.1.4.1</p> <p>CBC 2016 11B-604.8.1.1</p> <p>Mitigated:</p> <p><input type="radio"/> YES</p> <p><input checked="" type="radio"/> NO</p>	1	JOB	\$4,500	\$4,500

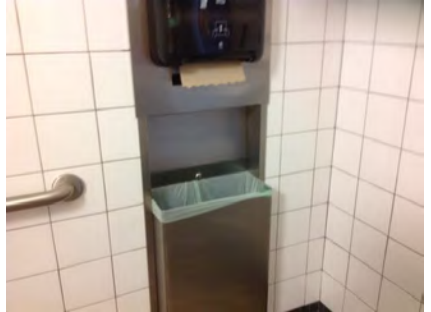
Item no., Rm no. and Name	Existing Architectural Barrier and Proposed Solution	Codes / Mitigation Info	Qty	Unit	Cost	Total
Accessories						
33	<ul style="list-style-type: none"> • <i>As-Built Description:</i> Dispensers in sanitary facilities, such as for towels, soap, sanitary napkins, seat covers, etc., and waste receptacles more than 48" (CA only: 40") from floor to highest operating slot or control. • <i>As-Built:</i> 45" high • <i>Proposed Solution:</i> Relocate existing restroom accessories. 	PCODE WG01A ADAAG 91 4.23.7 ADA 2010 308.2.1 CBC 2007 1115B.8.3 CBC 2016 11B-603.5 Mitigated: <input type="radio"/> YES <input checked="" type="radio"/> NO	1	JOB	\$300	\$300

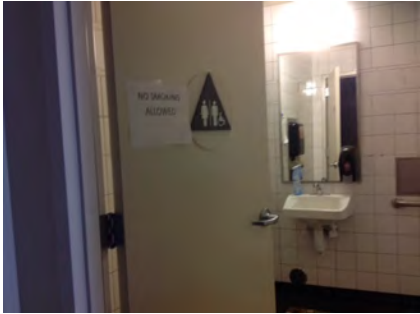
Item no., Rm no. and Name	Existing Architectural Barrier and Proposed Solution	Codes / Mitigation Info	Qty	Unit	Cost	Total
Signage						
36	<ul style="list-style-type: none">As-Built Description: Required in CA only: identification symbol centered 58" to 60" high on sanitary facility door that contrasts with the door not provided (women: 12" ø circle, men: 12" triangle, unisex: combined symbol).As-Built: No contrastProposed Solution: Provide properly mounted sanitary facility symbol when altering area. If wheelchair accessible, include International Symbol of Accessibility on sign.	<p>PCODE SA15</p> <p>CBC 2007 1115B.6</p> <p>CBC 2016 11B-703.7.2.6</p> <p>Mitigated:</p> <p><input type="radio"/> YES</p> <p><input checked="" type="radio"/> NO</p>	1	JOB	\$270	\$270

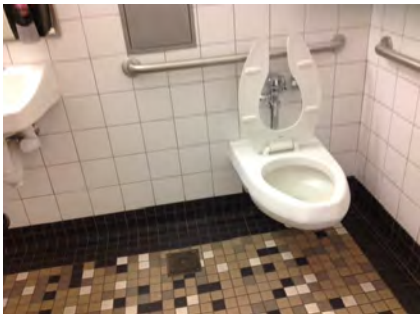
<input type="checkbox"/> Staff Only			
			<div>Priority 3 Severity 3</div>			
Toilet Stall						
40	<ul style="list-style-type: none">As-Built Description: Toilet stall less than 60" wide.As-Built: 55" wideProposed Solution: Provide new accessible stall.Notes: 28" between WC and lavatory	<p>PCODE WB06</p> <p>ADAAG 91 4.17.3</p> <p>ADA 2010 604.8.1.1</p> <p>CBC 2007 1115B.3.1.4.1</p> <p>CBC 2016 11B-604.8.1.1</p> <p>Mitigated:</p> <p><input type="radio"/> YES</p> <p><input checked="" type="radio"/> NO</p>	1	JOB	\$4,500	\$4,500

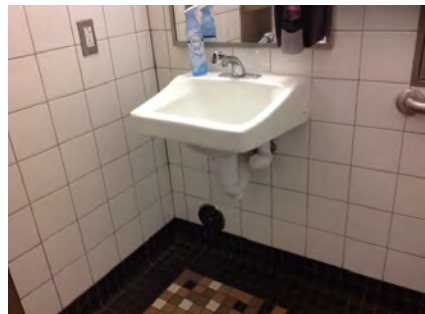
Item no., Rm no. and Name	Existing Architectural Barrier and Proposed Solution	Codes / Mitigation Info	Qty	Unit	Cost	Total
<u>Lavatory</u>						
38	<ul style="list-style-type: none">As-Built Description: Clear floor space, 30" x 48" in front of fixture, extending 19" max. under the lavatory, not provided (CA only: Less than 18" from side wall to centerline of lavatory).As-Built: 17.5" o.c.Proposed Solution: Provide new accessible lavatory. Remodel restroom as needed.	<p>PCODE WD01</p> <p>ADAAG 91 4.19.3</p> <p>ADA 2010 606.2</p> <p>CBC 2007 1115B.4.3</p> <p>CBC 2016 11B-606.2, 11B-606.6</p> <p>Mitigated:</p> <p><input type="radio"/> YES</p> <p><input checked="" type="radio"/> NO</p>	1	JOB	\$10,200	\$10,200

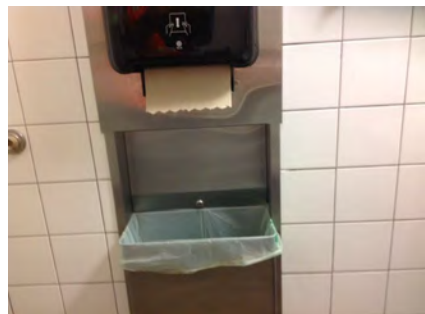
<input type="checkbox"/> Staff Only			
			Priority 3 Severity 2			
<u>Accessories</u>						
39	<ul style="list-style-type: none">As-Built Description: Dispensers in sanitary facilities, such as for towels, soap, sanitary napkins, seat covers, etc., and waste receptacles more than 48" (CA only: 40") from floor to highest operating slot or control.As-Built: 45" highProposed Solution: Relocate existing restroom accessories.	<p>PCODE WG01A</p> <p>ADAAG 91 4.23.7</p> <p>ADA 2010 308.2.1</p> <p>CBC 2007 1115B.8.3</p> <p>CBC 2016 11B-603.5</p> <p>Mitigated:</p> <p><input type="radio"/> YES</p> <p><input checked="" type="radio"/> NO</p>	1	JOB	\$300	\$300

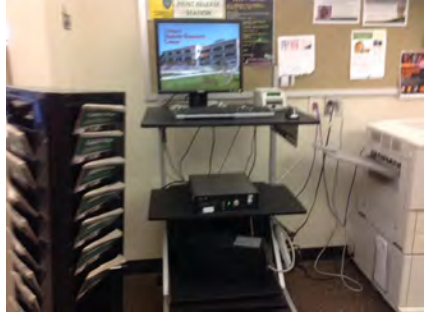
Item no., Rm no. and Name	Existing Architectural Barrier and Proposed Solution	Codes / Mitigation Info	Qty	Unit	Cost	Total
Non-Fixed Desk						
47	<ul style="list-style-type: none"> • <i>As-Built Description:</i> Accessible non-fixed table or desk (top 28" to 34" high; knee space at least 27" high x 19" deep x 30" wide) not provided. • <i>Proposed Solution:</i> Provide table or desk with accessible dimensions when purchasing new furniture. 	PCODE IN02A ADAAG 91 4.32.3 & .4 ADA 2010 306.1 CBC 2007 1122B.3 & 4 CBC 2016 11B-306.1 & 11B-902.3	1	JOB	\$4,800	\$4,800
Mitigated: <input type="radio"/> YES <input checked="" type="radio"/> NO

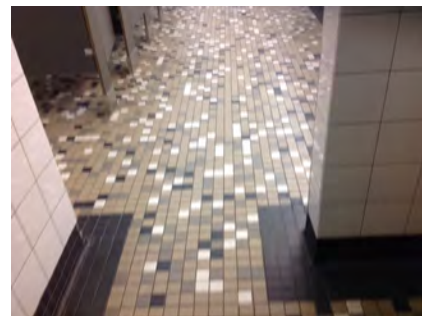
52

• *As-Built Description:*Clear passage width (except doorways) from rest
room entry to accessible water closet compartment
less than 36" (CA only: 44" wide).• *As-Built:* **36" wide**• *Proposed Solution:*Modify facility passage to be min. 44" wide.
Demolish existing partition and replace.

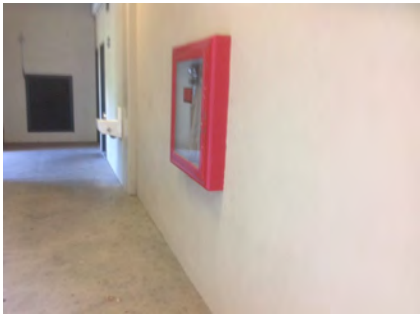
Item no., Rm no. and Name	Existing Architectural Barrier and Proposed Solution	Codes / Mitigation Info	Qty	Unit	Cost	Total
<u>Protrusion Limits</u>						
5	<ul style="list-style-type: none">• <i>As-Built Description:</i> Protruding objects more than 4" from wall, when bottom of object more than 27" or less than 80" above finished floor.• <i>As-Built:</i> Fire hose compartment 5" protrusion at 40" high.• <i>Proposed Solution:</i> Provide cane-detectable railing to mark area of low clearance.	<p>PCODE EG04A</p> <p>ADAAG 91 4.4.1</p> <p>ADA 2010 307.2</p> <p>CBC 2007 1133B.8.6.1</p> <p>CBC 2016 11B-307.2</p> <p>Mitigated:</p> <p><input type="radio"/> YES</p> <p><input checked="" type="radio"/> NO</p>	5	LF	\$300	\$1,500

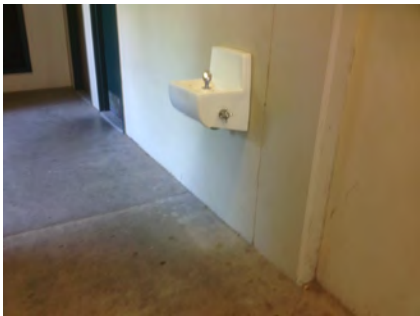
<input type="checkbox"/> Staff Only			
			Priority	Severity		
			2	4		
<u>Drinking Fountain</u>						
6	<ul style="list-style-type: none">• <i>As-Built Description:</i> Where only one drinking fountain is provided per floor: Fountain is not accessible to individuals who use wheelchairs, or to those who have difficulty bending or stooping.• <i>Proposed Solution:</i> Provide additional fountain or hi-lo combination fountain.	<p>PCODE IA01A</p> <p>ADAAG 91 4.1.3(10)(a)</p> <p>ADA 2010 211.1</p> <p>CBC 2007 1115B.4.6.1</p> <p>CBC 2016 11B-211.1</p> <p>Mitigated:</p> <p><input type="radio"/> YES</p> <p><input checked="" type="radio"/> NO</p>	1	JOB	\$6,000	\$6,000

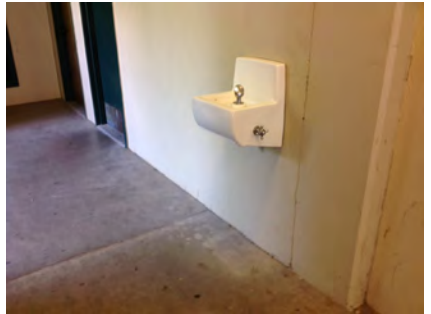
Item no., Rm no. and Name	Existing Architectural Barrier and Proposed Solution	Codes / Mitigation Info	Qty	Unit	Cost	Total
7	<ul style="list-style-type: none"> • <i>As-Built Description:</i> Drinking fountain lacks protection for visually impaired persons. • <i>Proposed Solution:</i> Provide cane-detectable rails. 	PCODE IA05C ADAAG 91 4.4.1 ADA 2010 307.2 CBC 2007 1115B.4.6.3 CBC 2016 11B-307.2 Mitigated: <input type="radio"/> YES <input checked="" type="radio"/> NO	1	JOB	\$1,500	\$1,500

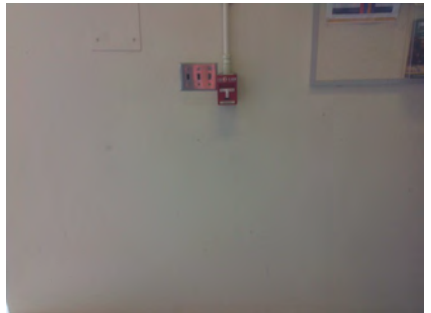
4	<ul style="list-style-type: none"> • <i>As-Built Description:</i> Reach height to control or access point, exceeds 48" or is less than 15". • <i>As-Built:</i> 48.5" AFF • <i>Proposed Solution:</i> Modify equipment or mounting. • <i>Notes:</i> Fire alarm pull 	PCODE IE01 ADAAG 91 4.2.5 ADA 2010 308.2.1 CBC 2007 1118B.5 CBC 2016 11B-308.2.1 Mitigated: <input type="radio"/> YES <input checked="" type="radio"/> NO	2	JOB	\$300	\$600

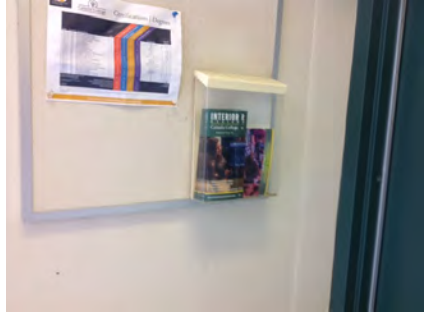
Item no., Rm no. and Name	Existing Architectural Barrier and Proposed Solution	Codes / Mitigation Info	Qty	Unit	Cost	Total
Brochure Bins						
8	<ul style="list-style-type: none"> • <i>As-Built Description:</i> Information brochure bins mounted above accessible height of 48". • <i>As-Built:</i> 60" AFF • <i>Proposed Solution:</i> Relocate/remount bins at accessible height. 	PCODE IN08 ADAAG 91 4.2.5 & 6 ADA 2010 308.2.1 CBC 2007 1118B.5 CBC 2016 11B-308.2.1 Mitigated: <input type="radio"/> YES <input checked="" type="radio"/> NO	1	JOB	\$300	\$300

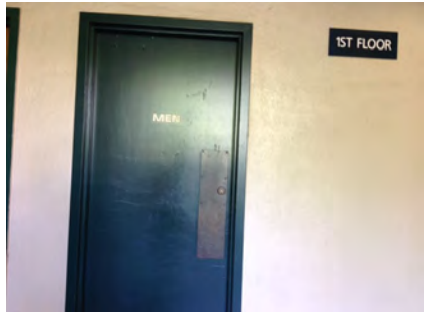
Item no., Rm no. and Name	Existing Architectural Barrier and Proposed Solution	Codes / Mitigation Info	Qty	Unit	Cost	Total
10	<ul style="list-style-type: none"> As-Built Description: Required in CA only: identification symbol centered 58" to 60" high on sanitary facility door that contrasts with the door not provided (women: 12" ø circle, men: 12" triangle, unisex: combined symbol). Proposed Solution: Provide properly mounted sanitary facility symbol when altering area. If wheelchair accessible, include International Symbol of Accessibility on sign. 	PCODE SA15REF CBC 2007 1115B.6 CBC 2016 11B-703.7.2.6 Mitigated: <input type="radio"/> YES <input checked="" type="radio"/> NO				
<div>REF</div> <div>

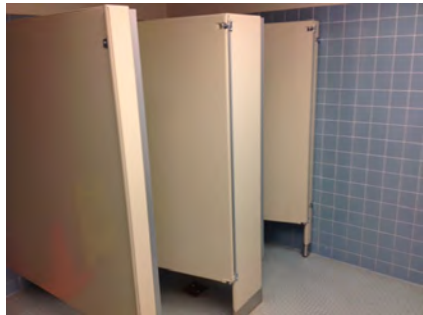
12	<ul style="list-style-type: none"> As-Built Description: Multiple accommodation restroom not accessible; multiple compliance violations. Proposed Solution: Remodel area to provide accessible restroom with one accessible stall, lavatory (and one urinal at Mens). 	PCODE WA01A ADAAG 91 4.22 ADA 2010 603.1 CBC 2007 1115B.3.1 CBC 2016 11B-603.1 Mitigated: <input type="radio"/> YES <input checked="" type="radio"/> NO	1	JOB	\$105,000	\$105,000
<div>

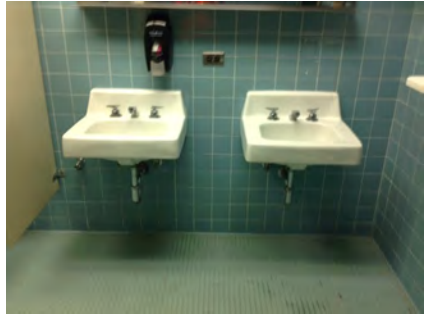
Item no., Rm no. and Name	Existing Architectural Barrier and Proposed Solution	Codes / Mitigation Info	Qty	Unit	Cost	Total
<u>Lavatory</u>						
13	<ul style="list-style-type: none"> • <i>As-Built Description:</i> Wheelchair clearance under lavatory apron or lavatory counter front edge less than 29" high. • <i>As-Built:</i> 27" knee height • <i>Proposed Solution:</i> Provide new accessible lavatory. Remodel restroom as needed. 	PCODE WD03REF ADAAG 91 4.19.2 ADA 2010 606.3 CBC 2007 1115B.4.3.3 CBC 2016 11B-306.3.1 Mitigated: <input type="radio"/> YES <input checked="" type="radio"/> NO				
			REF

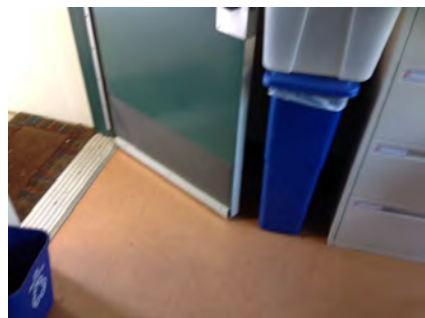
Item no., Rm no. and Name	Existing Architectural Barrier and Proposed Solution	Codes / Mitigation Info	Qty	Unit	Cost	Total
Door Swing						
16	<ul style="list-style-type: none">• <i>As-Built Description:</i> Front approach: At pull side, door does not have clear and level maneuvering space measuring door width plus 18" x 60". (24" x 60" at exterior doors).• <i>Proposed Solution:</i> Remove or relocate furniture or storage items.	PCODE ID23A ADAAG 91 Fig. 25(a) ADA 2010 404.2.4 CBC 2007 11B-26A(a) CBC 2016 11B-404.2.4 Mitigated: <div><input type="radio"/> YES</div> <div><input checked="" type="radio"/> NO</div>	2	JOB	\$150	\$300

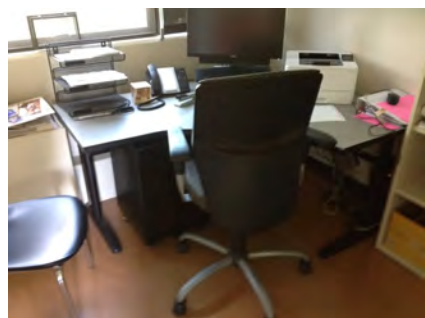
<div><input type="checkbox"/> Staff Only</div> <div><div>Priority</div><div>2</div><div>Severity</div><div>2</div></div>			
Non-Fixed Desk						
17	<ul style="list-style-type: none">• <i>As-Built Description:</i> Accessible non-fixed table or desk (top 28" to 34" high; knee space at least 27" high x 19" deep x 30" wide) not provided.• <i>As-Built:</i> 25"• <i>Proposed Solution:</i> Provide table or desk with accessible dimensions when purchasing new furniture.• <i>Notes:</i> Adjustable desk used by staff.	PCODE IN02A ADAAG 91 4.32.3 & .4 ADA 2010 306.1 CBC 2007 1122B.3 & 4 CBC 2016 11B-306.1 & 11B-902.3 Mitigated: <div><input type="radio"/> YES</div> <div><input checked="" type="radio"/> NO</div>	3	JOB	\$4,800	\$14,400

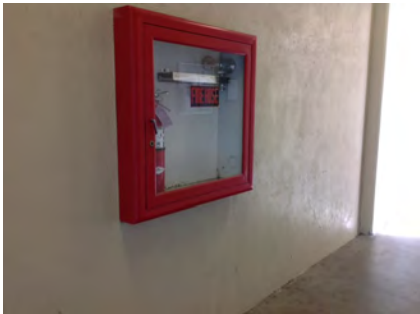
Item no., Rm no. and Name	Existing Architectural Barrier and Proposed Solution	Codes / Mitigation Info	Qty	Unit	Cost	Total
Protrusion Limits						
22	<ul style="list-style-type: none">As-Built Description: Protruding objects more than 4" from wall, when bottom of object more than 27" or less than 80" above finished floor.As-Built: Fire hose compartment 5" protrusion at 40" high.Proposed Solution: Provide cane-detectable railing to mark area of low clearance.	<p>PCODE EG04A</p> <p>ADAAG 91 4.4.1</p> <p>ADA 2010 307.2</p> <p>CBC 2007 1133B.8.6.1</p> <p>CBC 2016 11B-307.2</p> <p>Mitigated:</p> <p><input type="radio"/> YES</p> <p><input checked="" type="radio"/> NO</p>	6	LF	\$300	\$1,800
