SAN MATEO COUNTY
COMMUNITY
COLLEGE DISTRICT

San Mateo County Community College District Americans with Disabilities Act Self-Evaluation and Transition Plan

Report Prepared by:

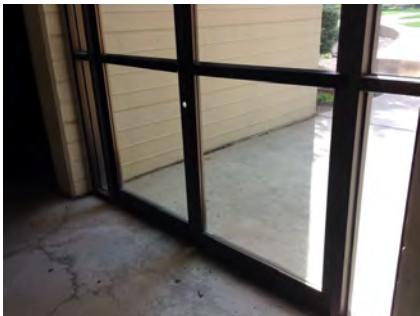
<input type="checkbox"/> Staff Only			
			Priority		Severity	
			2		4	
Door						
25	<ul style="list-style-type: none">As-Built Description: At push side of door on accessible route, bottom 10" does not have a smooth, uninterrupted surface.As-Built: 3" high kick plateProposed Solution: Provide 10" min. "kick plate" covering width of door when altering area.	<p>PCODE ID06</p> <p>ADA 2010 404.2.10</p> <p>CBC 2007 1133B.2.6</p> <p>CBC 2016 11B-404.2.10</p> <p>Mitigated:</p> <p><input type="radio"/> YES</p> <p><input checked="" type="radio"/> NO</p>	1	JOB	\$300	\$300

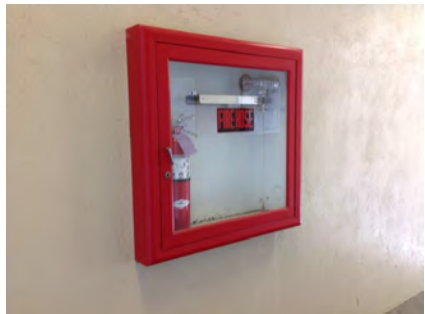
Item no., Rm no. and Name	Existing Architectural Barrier and Proposed Solution	Codes / Mitigation Info	Qty	Unit	Cost	Total
23	<ul style="list-style-type: none"> As-Built Description: Reach height to control or access point, exceeds 48" or is less than 15". As-Built: 50" AFF Proposed Solution: Modify equipment or mounting. Notes: Latch to open fire extinguisher cabinet 	PCODE IE01 ADAAG 91 4.2.5 ADA 2010 308.2.1 CBC 2007 1118B.5 CBC 2016 11B-308.2.1 Mitigated: <input type="radio"/> YES <input checked="" type="radio"/> NO	1	JOB	\$300	\$300

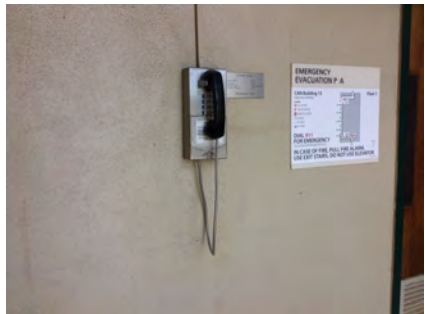
<input type="checkbox"/> Staff Only Priority 2 Severity 4						
24	<ul style="list-style-type: none"> As-Built Description: Reach height to control or access point, exceeds 48" or is less than 15". As-Built: 60" AFF Proposed Solution: Modify equipment or mounting. 	PCODE IE01 ADAAG 91 4.2.5 ADA 2010 308.2.1 CBC 2007 1118B.5 CBC 2016 11B-308.2.1 Mitigated: <input type="radio"/> YES <input checked="" type="radio"/> NO	1	JOB	\$300	\$300

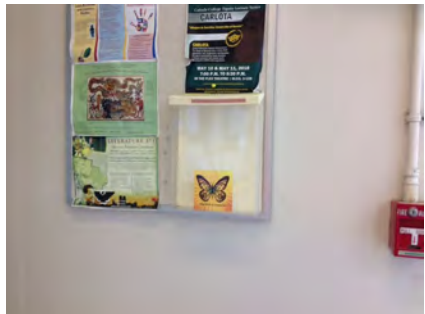
<input type="checkbox"/> Staff Only Priority 2 Severity 2						
Brochure Bins						
21	<ul style="list-style-type: none"> As-Built Description: Information brochure bins mounted above accessible height of 48". As-Built: 60" AFF Proposed Solution: Relocate/remount bins at accessible height. 	PCODE IN08 ADAAG 91 4.2.5 & 6 ADA 2010 308.2.1 CBC 2007 1118B.5 CBC 2016 11B-308.2.1 Mitigated: <input type="radio"/> YES <input checked="" type="radio"/> NO	1	JOB	\$300	\$300

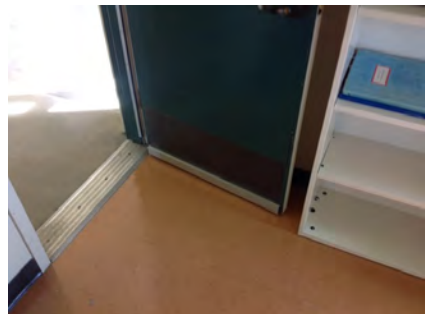
Item no., Rm no. and Name	Existing Architectural Barrier and Proposed Solution	Codes / Mitigation Info	Qty	Unit	Cost	Total
Door Swing						
30	<ul style="list-style-type: none">• <i>As-Built Description:</i> Front approach: At pull side, door does not have clear and level maneuvering space measuring door width plus 18" x 60". (24" x 60" at exterior doors).• <i>Proposed Solution:</i> Remove or relocate furniture or storage items.	<p>PCODE ID23A</p> <p>ADAAG 91 Fig. 25(a)</p> <p>ADA 2010 404.2.4</p> <p>CBC 2007 11B-26A(a)</p> <p>CBC 2016 11B-404.2.4</p> <p>Mitigated:</p> <p><input type="radio"/> YES</p> <p><input checked="" type="radio"/> NO</p>	1	JOB	\$150	\$150

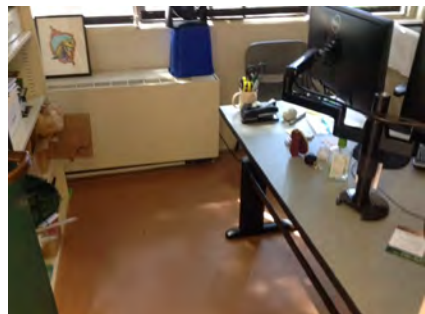
<input type="checkbox"/> Staff Only			
			Priority		Severity	
			2		3	
Turn Space						
32	<ul style="list-style-type: none">• <i>As-Built Description:</i> Less than 60" diameter or T-shaped space provided for wheelchair turns.• <i>Proposed Solution:</i> Retrofit space to provide 60" diameter or T-turn.• Notes: No 60" turning space is provided. If no students or public visit offices for office hours, a 60" circle does not need to be maintained.	<p>PCODE IN04</p> <p>ADAAG 91 4.2.3</p> <p>ADA 2010 304.1</p> <p>CBC 2007 1118B.3</p> <p>CBC 2016 11B-304.1</p> <p>Mitigated:</p> <p><input type="radio"/> YES</p> <p><input checked="" type="radio"/> NO</p>	1	JOB	\$2,775	\$2,775

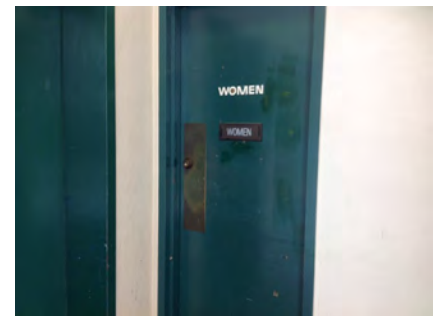
Item no., Rm no. and Name	Existing Architectural Barrier and Proposed Solution	Codes / Mitigation Info	Qty	Unit	Cost	Total
<u>Restroom</u>						
51	<ul style="list-style-type: none">• <i>As-Built Description:</i> Multiple accommodation restroom not accessible; multiple compliance violations.• <i>Proposed Solution:</i> Remodel area to provide accessible restroom with one accessible stall, lavatory (and one urinal at Mens).	<p>PCODE WA01A</p> <p>ADAAG 91 4.22</p> <p>ADA 2010 603.1</p> <p>CBC 2007 1115B.3.1</p> <p>CBC 2016 11B-603.1</p> <p>Mitigated:</p> <p><input type="radio"/> YES</p> <p><input checked="" type="radio"/> NO</p>	1	JOB	\$105,000	\$105,000

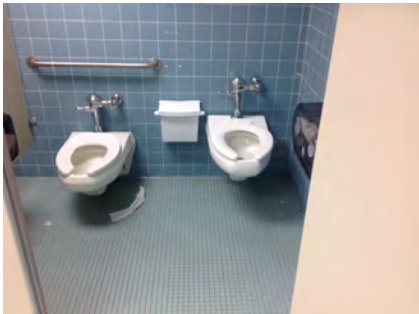
<input type="checkbox"/> Staff Only			
			Priority		Severity	
			3		1	
<u>Wheelchair Clearance</u>						
53	<ul style="list-style-type: none">• <i>As-Built Description:</i> Clear passage width (except doorways) from rest room entry to accessible water closet compartment less than 36" (CA only: 44" wide).• <i>As-Built:</i> 37" wide• <i>Proposed Solution:</i> Modify facility passage to be min. 44" wide. Demolish existing partition and replace.	<p>PCODE WC02AREF</p> <p>ADAAG 91 4.3.3</p> <p>ADA 2010 403.5.1</p> <p>CBC 2007 1115B.3.2.4</p> <p>CBC 2016 11B-403.5.1</p> <p>Mitigated:</p> <p><input type="radio"/> YES</p> <p><input checked="" type="radio"/> NO</p>		REF

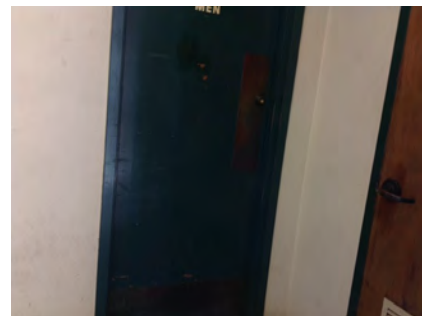
Item no., Rm no. and Name	Existing Architectural Barrier and Proposed Solution	Codes / Mitigation Info	Qty	Unit	Cost	Total
Door Swing						
39	<ul style="list-style-type: none"> • <i>As-Built Description:</i> Front approach: At pull side, door does not have clear and level maneuvering space measuring door width plus 18" x 60". (24" x 60" at exterior doors). • <i>As-Built:</i> 6" • <i>Proposed Solution:</i> Provide power door operator. 	PCODE ID23C ADAAG 91 Fig. 25(a) ADA 2010 404.2.4 CBC 2007 11B-26A(a) CBC 2016 11B-404.2.4 Mitigated: <input type="radio"/> YES <input checked="" type="radio"/> NO	1	JOB	\$15,000	\$15,000

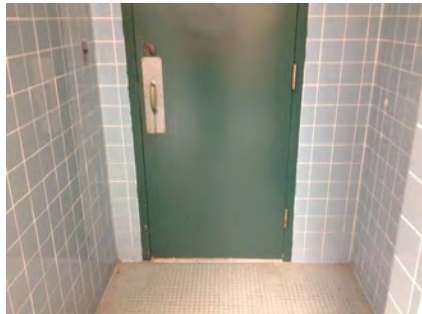
<input type="checkbox"/> Staff Only			
			Priority		Severity	
			3		3	
Signage						
36	<ul style="list-style-type: none"> • <i>As-Built Description:</i> Entrance to toilet or bathing facility not identified with ADAAG compliant signage. • <i>Proposed Solution:</i> Provide ADA compliant sign mounted at 48" min. above to baseline of the lowest Braille cells and 60" max. to baseline of the highest line of raised characters on nearest adjacent wall, on latch side of a single door (located not to cause a Braille reader to stand within the door swing). 	PCODE SA11A ADAAG 91 4.1.3(16)(a) ADA 2010 216.8 CBC 2016 11B-216.8 Mitigated: <input type="radio"/> YES <input checked="" type="radio"/> NO	1	JOB	\$270	\$270

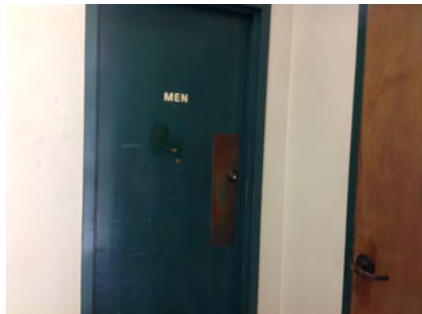
Item no., Rm no. and Name	Existing Architectural Barrier and Proposed Solution	Codes / Mitigation Info	Qty	Unit	Cost	Total
37	<ul style="list-style-type: none"> As-Built Description: Required in CA only: identification symbol centered 58" to 60" high on sanitary facility door that contrasts with the door not provided (women: 12" ø circle, men: 12" triangle, unisex: combined symbol). Proposed Solution: Provide properly mounted sanitary facility symbol when altering area. If wheelchair accessible, include International Symbol of Accessibility on sign. 	PCODE SA15 CBC 2007 1115B.6 CBC 2016 11B-703.7.2.6 Mitigated: <input type="radio"/> YES <input checked="" type="radio"/> NO	1	JOB	\$270	\$270

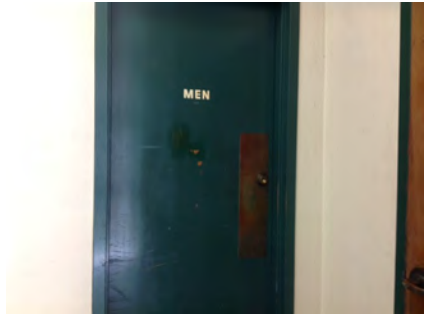
48	<ul style="list-style-type: none"> As-Built Description: Grab bars not provided or are not code compliant. Proposed Solution: Provide accessible grab bars. 	PCODE WB07 ADAAG 91 4.17.6 ADA 2010 604.5 CBC 2007 1115B.4.1.3 CBC 2016 11B-604.5 Mitigated: <input type="radio"/> YES <input checked="" type="radio"/> NO	1	JOB	\$1,500	\$1,500

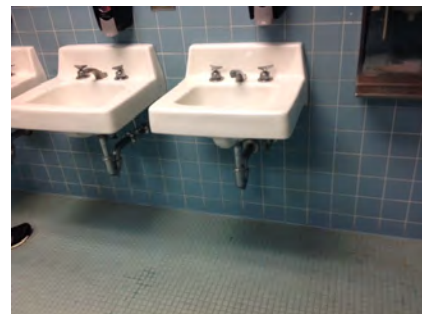
Item no., Rm no. and Name	Existing Architectural Barrier and Proposed Solution	Codes / Mitigation Info	Qty	Unit	Cost	Total
44	<ul style="list-style-type: none"> • <i>As-Built Description:</i> Hot or sharp-surfaced water/drain pipe not insulated or covered. • <i>Proposed Solution:</i> Insulate or cover water/drain pipe. 	PCODE WD05 ADAAG 91 4.19.4 ADA 2010 606.5 CBC 2007 1115B.4.3.4 CBC 2016 11B-606.5 Mitigated: <input type="radio"/> YES <input checked="" type="radio"/> NO	1	JOB	\$360	\$360

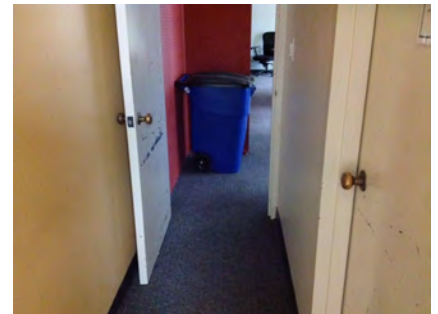
Item no., Rm no. and Name	Existing Architectural Barrier and Proposed Solution	Codes / Mitigation Info	Qty	Unit	Cost	Total
56	<ul style="list-style-type: none"> As-Built Description: Front approach: At push side, door does not have clear and level maneuvering space measuring door width x 48" (door width plus 12" if door has both, latch and closer). As-Built: 10" Proposed Solution: Provide door operator. Notes: Or remove closer or latch 	PCODE ID24C ADAAG 91 Fig. 25(a) ADA 2010 404.2.4 CBC 2007 11B-26A(a) CBC 2016 11B-404.2.4 Mitigated: <input type="radio"/> YES <input checked="" type="radio"/> NO	1	JOB	\$15,000	\$15,000

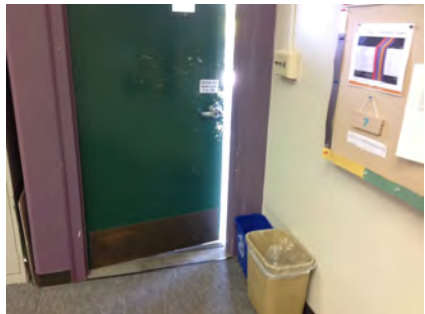
55	<ul style="list-style-type: none"> As-Built Description: Door inaccessible due to threshold or step at door exceeding 1/2". As-Built: 0.75" Proposed Solution: Modify threshold to be no more than 1/2" by removing existing paving at door and providing landing with edge ramping (slope 1:20 max). 	PCODE ID02A ADAAG 91 4.13.8 ADA 2010 404.2.5 CBC 2007 1133B.2.4.1 CBC 2016 11B-404.2.5 Mitigated: <input type="radio"/> YES <input checked="" type="radio"/> NO	2	JOB	\$1,200	\$2,400

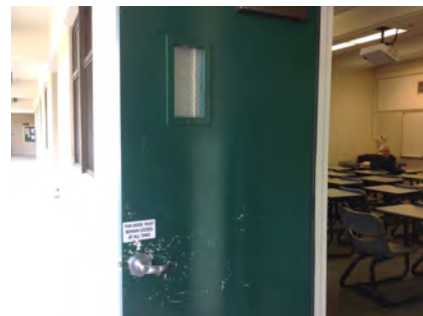
Item no., Rm no. and Name	Existing Architectural Barrier and Proposed Solution	Codes / Mitigation Info	Qty	Unit	Cost	Total
Door Swing						
65	<ul style="list-style-type: none">As-Built Description: Front approach: At push side, door does not have clear and level maneuvering space measuring door width x 48" (door width plus 12" if door has both, latch and closer).As-Built: 9"Proposed Solution: Provide door operator.	<p>PCODE ID24C</p> <p>ADAAG 91 Fig. 25(a)</p> <p>ADA 2010 404.2.4</p> <p>CBC 2007 11B-26A(a)</p> <p>CBC 2016 11B-404.2.4</p> <p>Mitigated:</p> <p><input type="radio"/> YES</p> <p><input checked="" type="radio"/> NO</p>	2	JOB	\$15,000	\$30,000

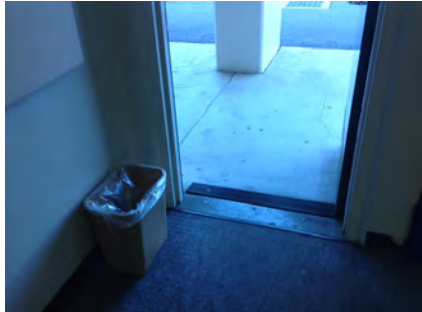
<input type="checkbox"/> Staff Only			
			Priority	Severity		
			2	4		
Door Threshold						
63	<ul style="list-style-type: none">As-Built Description: Door inaccessible due to threshold or step at door exceeding 1/2".As-Built: 1" AFFProposed Solution: Modify threshold to be no more than 1/2" by removing existing paving at door and providing landing with edge ramping (slope 1:20 max).	<p>PCODE ID02A</p> <p>ADAAG 91 4.13.8</p> <p>ADA 2010 404.2.5</p> <p>CBC 2007 1133B.2.4.1</p> <p>CBC 2016 11B-404.2.5</p> <p>Mitigated:</p> <p><input type="radio"/> YES</p> <p><input checked="" type="radio"/> NO</p>	2	JOB	\$1,200	\$2,400

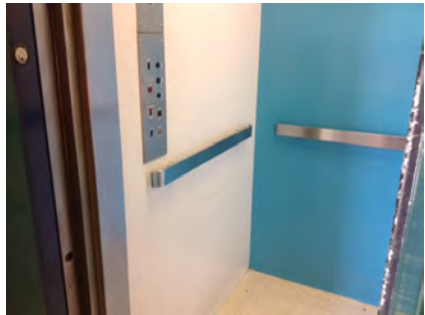
Item no., Rm no. and Name	Existing Architectural Barrier and Proposed Solution	Codes / Mitigation Info	Qty	Unit	Cost	Total
73	<ul style="list-style-type: none"> As-Built Description: Interior controls top row more than 48" from floor (front approach) or more than 54" high (side approach). As-Built: 54" AFF Proposed Solution: Lower elevator controls to 48" from floor. 	PCODE IK05 ADAAG 91 4.10.12(3)* ADA 2010 407.4.6 CBC 2007 1116B.1.8 CBC 2016 11B-407.4.6.1 Mitigated: <input type="radio"/> YES <input checked="" type="radio"/> NO	1	JOB	\$5,910	\$5,910

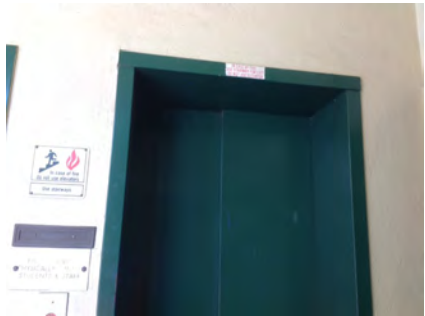
<input type="checkbox"/> Staff Only			
			Priority 2 Severity 3			
68	<ul style="list-style-type: none"> As-Built Description: Visual hall lantern, minimum 2-1/2" x 2-1/2", not provided, or installed less than 72" above floor. Proposed Solution: Provide or raise proper visual hall lantern for elevator. 	PCODE IK10A ADAAG 91 4.10.4(1) ADA 2010 407.2.2.2 CBC 2007 1116B.1.13 CBC 2016 11B-407.2.2.2 Mitigated: <input type="radio"/> YES <input checked="" type="radio"/> NO	1	JOB	\$4,650	\$4,650

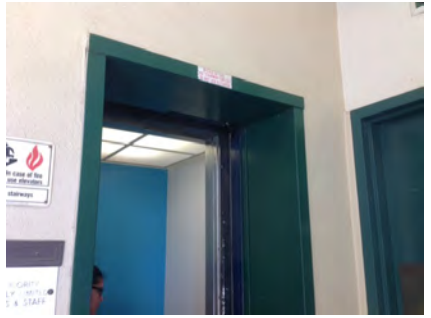
Item no., Rm no. and Name	Existing Architectural Barrier and Proposed Solution	Codes / Mitigation Info	Qty	Unit	Cost	Total
75	<ul style="list-style-type: none"> • <i>As-Built Description:</i> Audible signal not provided (one for up, two for down). • <i>Proposed Solution:</i> Provide proper audible hall signal for elevator. 	PCODE IK10B ADAAG 91 4.10.4 ADA 2010 407.2.2.3 CBC 2007 1116B.1.13 CBC 2016 11B-407.2.2.3 Mitigated: <input type="radio"/> YES <input checked="" type="radio"/> NO	1	JOB	\$4,650	\$4,650

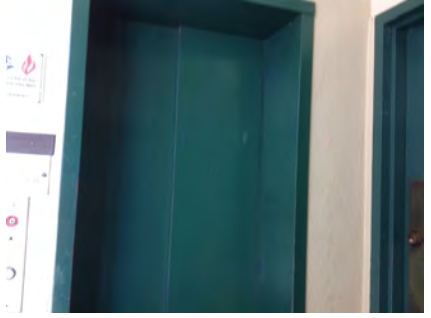
<input type="checkbox"/> Staff Only						
Priority 2 Severity 3						
69	<ul style="list-style-type: none"> • <i>As-Built Description:</i> Braille and raised floor numbers on entrance jambs located more or less than 5' above floor. • <i>Proposed Solution:</i> Relocate Braille and raised floor numbers on entrance jambs to 5' above floor. 	PCODE IK11C ADAAG 91 4.10.5 ADA 2010 703.4.1 CBC 2007 1116B.1.14 CBC 2016 11B-703.4.1 Mitigated: <input type="radio"/> YES <input checked="" type="radio"/> NO	6	JOB	\$360	\$2,160

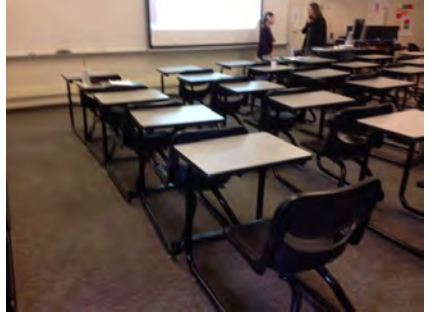
Item no., Rm no. and Name	Existing Architectural Barrier and Proposed Solution	Codes / Mitigation Info	Qty	Unit	Cost	Total
Non-Fixed Desk						
81	<ul style="list-style-type: none"> • <i>As-Built Description:</i> Accessible non-fixed table or desk (top 28" to 34" high; knee space at least 27" high x 19" deep x 30" wide) not provided. • <i>Proposed Solution:</i> Provide table or desk with accessible dimensions when purchasing new furniture. • <i>Notes:</i> 34 total seats with no accessible tables provided 	PCODE IN02A ADAAG 91 4.32.3 & .4 ADA 2010 306.1 CBC 2007 1122B.3 & 4 CBC 2016 11B-306.1 & 11B-902.3	1	JOB	\$4,800	\$4,800
Mitigated: <input type="radio"/> YES <input checked="" type="radio"/> NO

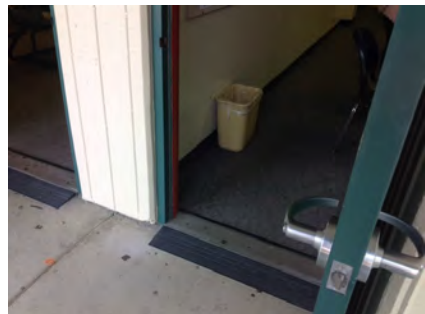
Item no., Rm no. and Name	Existing Architectural Barrier and Proposed Solution	Codes / Mitigation Info	Qty	Unit	Cost	Total
Door Swing						
86	<ul style="list-style-type: none">As-Built Description: Front approach: At push side, door does not have clear and level maneuvering space measuring door width x 48" (door width plus 12" if door has both, latch and closer).As-Built: 9.5"Proposed Solution: Provide door operator.	<p>PCODE ID24C</p> <p>ADAAG 91 Fig. 25(a)</p> <p>ADA 2010 404.2.4</p> <p>CBC 2007 11B-26A(a)</p> <p>CBC 2016 11B-404.2.4</p> <p>Mitigated:</p> <p><input type="radio"/> YES</p> <p><input checked="" type="radio"/> NO</p>	1	JOB	\$15,000	\$15,000

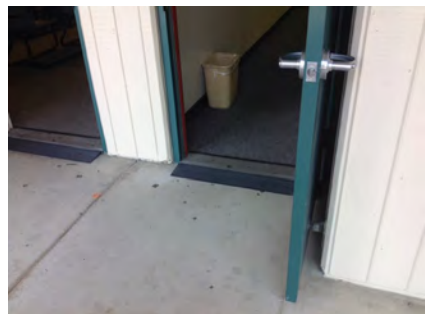
Door Threshold						
84	<ul style="list-style-type: none">As-Built Description: Door inaccessible due to threshold or step at door exceeding 1/2".As-Built: 0.75" AFFProposed Solution: Modify threshold to be no more than 1/2" by removing existing paving at door and providing landing with edge ramping (slope 1:20 max).	<p>PCODE ID02A</p> <p>ADAAG 91 4.13.8</p> <p>ADA 2010 404.2.5</p> <p>CBC 2007 1133B.2.4.1</p> <p>CBC 2016 11B-404.2.5</p> <p>Mitigated:</p> <p><input type="radio"/> YES</p> <p><input checked="" type="radio"/> NO</p>	2	JOB	\$1,200	\$2,400

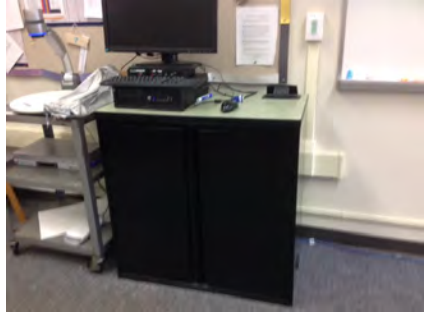
Item no., Rm no. and Name	Existing Architectural Barrier and Proposed Solution	Codes / Mitigation Info	Qty	Unit	Cost	Total
Public Counter						
114	<ul style="list-style-type: none"> As-Built Description: Service counter (stand-up): Accessible section min. 36" length and 36" max. height (in CA: 28" to 34" high) not provided. As-Built: 36" high to top of surface Proposed Solution: Retrofit existing counter to provide accessible section. Interim solution: Provide auxiliary counter, table, or clipboard. Notes: Teacher's work station. Unsure if students use this for presentations. 	PCODE IN03 ADAAG 91 7.2(2) ADA 2010 904.4 CBC 2007 1122B.4 CBC 2016 11B-904.4 Mitigated: <input type="radio"/> YES <input checked="" type="radio"/> NO	1	JOB	\$6,000	\$6,000

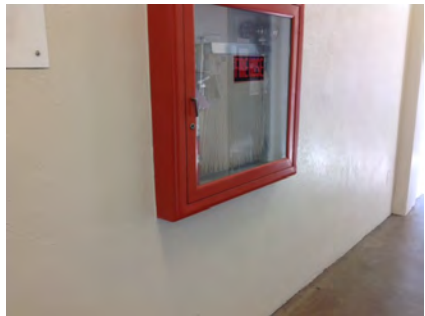
Item no., Rm no. and Name	Existing Architectural Barrier and Proposed Solution	Codes / Mitigation Info	Qty	Unit	Cost	Total
95	<ul style="list-style-type: none"> As-Built Description: Protruding objects more than 4" from wall, when bottom of object more than 27" or less than 80" above finished floor. As-Built: Fire extinguisher housing 4.5" protrusion at 40" high. Proposed Solution: Provide cane-detectable railing to mark area of low clearance. 	PCODE EG04A ADAAG 91 4.4.1 ADA 2010 307.2 CBC 2007 1133B.8.6.1 CBC 2016 11B-307.2 Mitigated: <input type="radio"/> YES <input checked="" type="radio"/> NO	6	LF	\$300	\$1,800

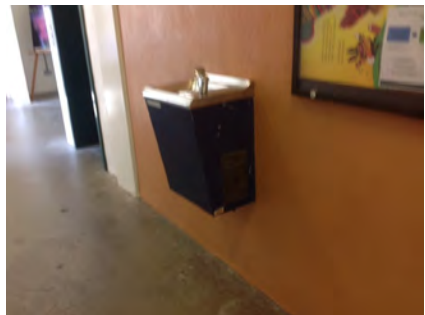
<input type="checkbox"/> Staff Only Priority 2 Severity 4						
Drinking Fountain						
92	<ul style="list-style-type: none"> As-Built Description: Where only one drinking fountain is provided per floor: Fountain is not accessible to individuals who use wheelchairs, or to those who have difficulty bending or stooping. Proposed Solution: Provide additional fountain or hi-lo combination fountain. 	PCODE IA01A ADAAG 91 4.1.3(10)(a) ADA 2010 211.1 CBC 2007 1115B.4.6.1 CBC 2016 11B-211.1 Mitigated: <input type="radio"/> YES <input checked="" type="radio"/> NO	1	JOB	\$6,000	\$6,000

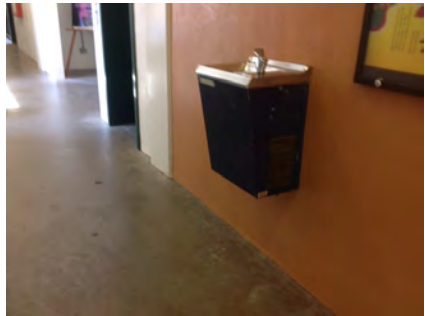
<input type="checkbox"/> Staff Only Priority 3 Severity 2						
94	<ul style="list-style-type: none"> As-Built Description: Wall- and post-mounted cantilevered units: Knee space not provided at drinking fountain (27" high, 8" deep, 30" wide from front of drinking fountain). Proposed Solution: Provide new, accessible fountain. 	PCODE IA02REF ADAAG 91 4.15.5(1) ADA 2010 602.2 CBC 2007 1115B.4.6.2 CBC 2016 11B-602.2 Mitigated: <input type="radio"/> YES <input checked="" type="radio"/> NO	REF

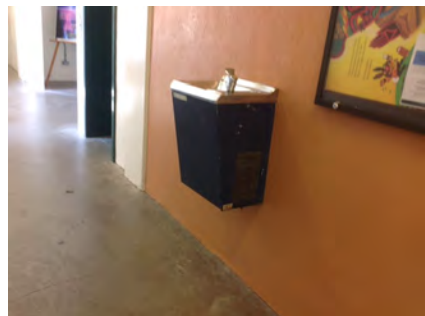
Item no., Rm no. and Name	Existing Architectural Barrier and Proposed Solution	Codes / Mitigation Info	Qty	Unit	Cost	Total
93	<ul style="list-style-type: none">• <i>As-Built Description:</i> Drinking fountain lacks protection for visually impaired persons.• <i>Proposed Solution:</i> Provide cane-detectable rails.	PCODE IA05C ADAAG 91 4.4.1 ADA 2010 307.2 CBC 2007 1115B.4.6.3 CBC 2016 11B-307.2 Mitigated: <div><input type="radio"/> YES</div> <div><input checked="" type="radio"/> NO</div>	1	JOB	\$1,500	\$1,500

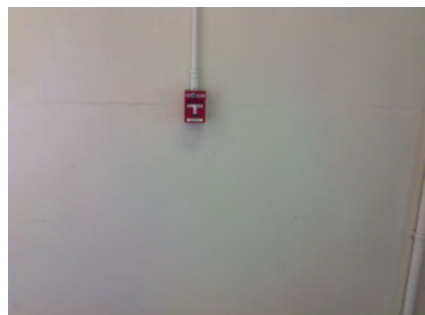
<div><input type="checkbox"/> Staff Only</div> <div>Priority <div>3</div>Severity <div>3</div></div>			
<hr/>						
<u>Reach Range</u>						
90	<ul style="list-style-type: none">• <i>As-Built Description:</i> Reach height to control or access point, exceeds 48" or is less than 15".• <i>As-Built:</i> 49" AFF• <i>Proposed Solution:</i> Modify equipment or mounting.	PCODE IE01 ADAAG 91 4.2.5 ADA 2010 308.2.1 CBC 2007 1118B.5 CBC 2016 11B-308.2.1 Mitigated: <div><input type="radio"/> YES</div> <div><input checked="" type="radio"/> NO</div>	1	JOB	\$300	\$300

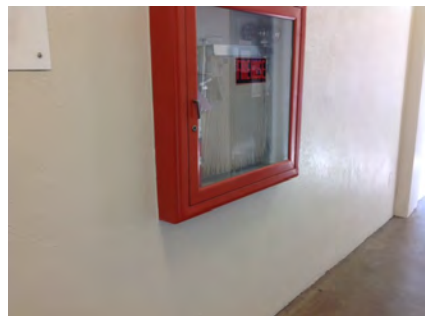
<div><input type="checkbox"/> Staff Only</div> <div>Priority <div>2</div>Severity <div>4</div></div>			
<hr/>						
214	<ul style="list-style-type: none">• <i>As-Built Description:</i> Reach height to control or access point, exceeds 48" or is less than 15".• <i>As-Built:</i> 50" high• <i>Proposed Solution:</i> Modify equipment or mounting.	PCODE IE01 ADAAG 91 4.2.5 ADA 2010 308.2.1 CBC 2007 1118B.5 CBC 2016 11B-308.2.1 Mitigated: <div><input type="radio"/> YES</div> <div><input checked="" type="radio"/> NO</div>	1	JOB	\$300	\$300

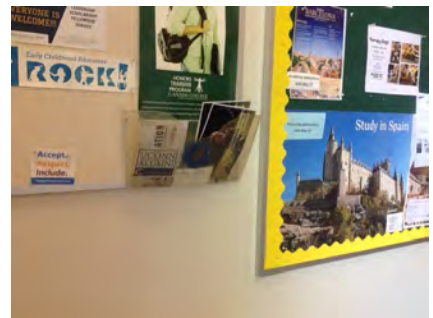
Item no., Rm no. and Name	Existing Architectural Barrier and Proposed Solution	Codes / Mitigation Info	Qty	Unit	Cost	Total
Brochure Bins						
91	<ul style="list-style-type: none"> • <i>As-Built Description:</i> Information brochure bins mounted above accessible height of 48". • <i>As-Built:</i> Brochures 54" AFF • <i>Proposed Solution:</i> Relocate/remount bins at accessible height. 	PCODE IN08 ADAAG 91 4.2.5 & 6 ADA 2010 308.2.1 CBC 2007 1118B.5 CBC 2016 11B-308.2.1 Mitigated: <input type="radio"/> YES <input checked="" type="radio"/> NO	1	JOB	\$300	\$300

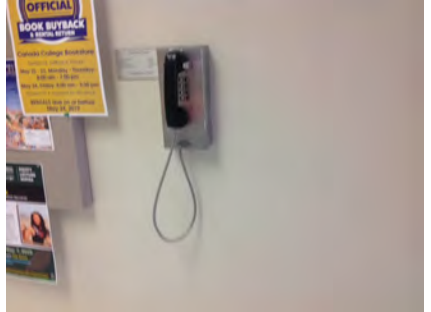
Item no., Rm no. and Name	Existing Architectural Barrier and Proposed Solution	Codes / Mitigation Info	Qty	Unit	Cost	Total
Reach Range						
98	<ul style="list-style-type: none"> As-Built Description: Reach height to control or access point, exceeds 48" or is less than 15". As-Built: 50" AFF Proposed Solution: Modify equipment or mounting. 	PCODE IE01 ADAAG 91 4.2.5 ADA 2010 308.2.1 CBC 2007 1118B.5 CBC 2016 11B-308.2.1 Mitigated: <input type="radio"/> YES <input checked="" type="radio"/> NO	1	JOB	\$300	\$300

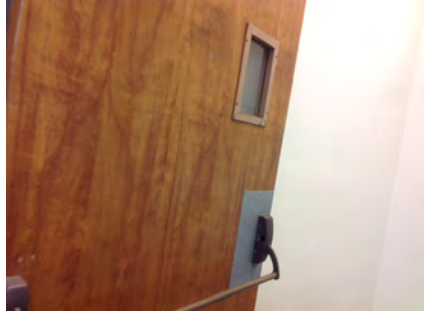
Item no., Rm no. and Name	Existing Architectural Barrier and Proposed Solution	Codes / Mitigation Info	Qty	Unit	Cost	Total
Door						
104	<ul style="list-style-type: none"> As-Built Description: Vision Light at door that permits viewing, does not have bottom of at least one glazed panel located 43 inches maximum above the finish floor. (Exception: More than 66" above finished floor.) As-Built: 60" AFF Proposed Solution: Provide new door with vision panel at 43" max. Notes: Door to stairwell 	PCODE ID06C ADA 2010 404.2.11 CBC 2016 11B-404.2.11 Mitigated: <input type="radio"/> YES <input checked="" type="radio"/> NO	1	JOB	\$7,500	\$7,500

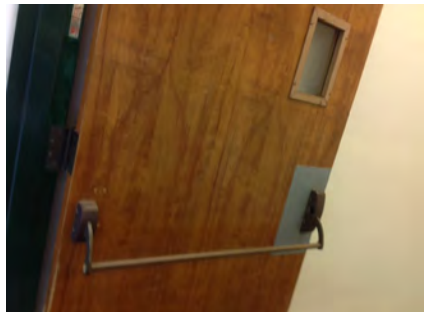
<input type="checkbox"/> Staff Only Priority Severity <input checked="" type="radio"/> 2 <input checked="" type="radio"/> 1			
107	<ul style="list-style-type: none"> As-Built Description: Vision Light at door that permits viewing, does not have bottom of at least one glazed panel located 43" maximum above the finish floor. (Exception: More than 66" above finished floor.) As-Built: 60" AFF Proposed Solution: Provide new door with vision panel at 43" max. 	PCODE ID06C ADA 2010 404.2.11 CBC 2016 11B-404.2.11 Mitigated: <input type="radio"/> YES <input checked="" type="radio"/> NO	1	JOB	\$7,500	\$7,500

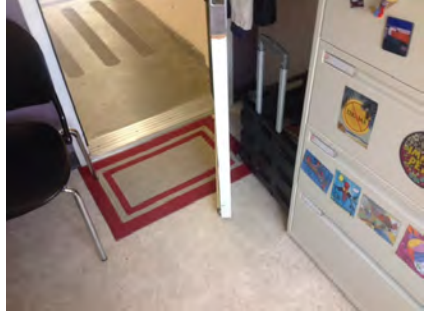
Item no., Rm no. and Name	Existing Architectural Barrier and Proposed Solution	Codes / Mitigation Info	Qty	Unit	Cost	Total
Door Swing						
110	<ul style="list-style-type: none"> As-Built Description: Front approach: At pull side, door does not have clear and level maneuvering space measuring door width plus 18" x 60". (24" x 60" at exterior doors). Proposed Solution: Remove or relocate furniture or storage items. 	PCODE ID23A ADAAG 91 Fig. 25(a) ADA 2010 404.2.4 CBC 2007 11B-26A(a) CBC 2016 11B-404.2.4 Mitigated: <input type="radio"/> YES <input checked="" type="radio"/> NO	1	JOB	\$150	\$150

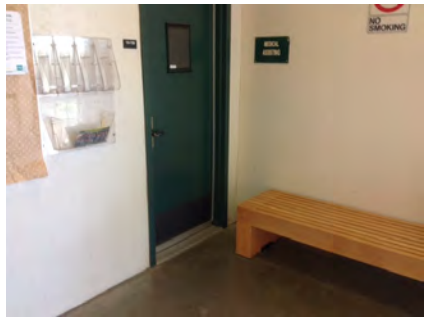
<input type="checkbox"/> Staff Only Priority 2 Severity 2			
111	<ul style="list-style-type: none"> As-Built Description: Front approach: At push side, door does not have clear and level maneuvering space measuring door width x 48" (door width plus 12" if door has both, latch and closer). Proposed Solution: Remove or relocate furniture or storage items. Notes: Bench is blocking door clear spaces. Remove to mitigate this issue. 	PCODE ID24A ADAAG 91 Fig. 25(a) ADA 2010 404.2.4 CBC 2007 11B-26A(a) CBC 2016 11B-404.2.4 Mitigated: <input type="radio"/> YES <input checked="" type="radio"/> NO	1	JOB	\$150	\$150

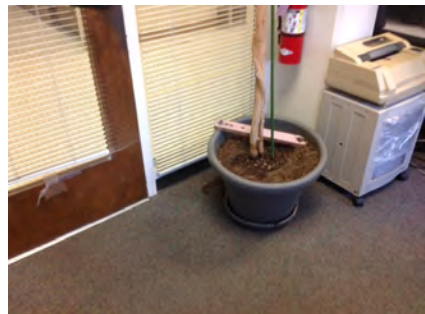
Item no., Rm no. and Name	Existing Architectural Barrier and Proposed Solution	Codes / Mitigation Info	Qty	Unit	Cost	Total
<div><div><div><div><div>126</div><div><div><div><div>• <i>As-Built Description:</i> Front approach: At pull side, door does not have clear and level maneuvering space measuring door width plus 18" x 60". (24" x 60" at exterior doors).</div><div><div>• <i>As-Built:</i> 4" to plant</div><div>• <i>Proposed Solution:</i> Remove or relocate furniture or storage items.</div></div></div></div><div><div><div>PCODE ID23A</div><div>ADAAG 91 Fig. 25(a)</div><div>ADA 2010 404.2.4</div><div>CBC 2007 11B-26A(a)</div><div>CBC 2016 11B-404.2.4</div></div><div><div>Mitigated:</div><div><div><div><div></div><div>YES</div></div><div><div></div><div>NO</div></div></div></div></div></div><div><div><div>1</div><div>JOB</div><div>\$150</div><div>\$150</div></div><div>

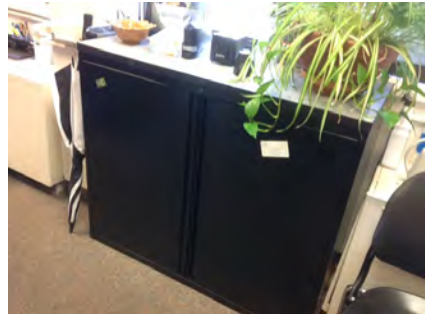
<div><div><div><div><div>127</div><div><div><div><div>• <i>As-Built Description:</i> Service counter (stand-up): Accessible section min. 36" length and 36" max. height (in CA: 28" to 34" high) not provided.</div><div><div>• <i>As-Built:</i> 36" counter</div><div>• <i>Proposed Solution:</i> Retrofit existing counter to provide accessible section. Interim solution: Provide auxiliary counter, table, or clipboard.</div></div></div></div><div><div><div>PCODE IN03</div><div>ADAAG 91 7.2(2)</div><div>ADA 2010 904.4</div><div>CBC 2007 1122B.4</div><div>CBC 2016 11B-904.4</div></div><div><div>Mitigated:</div><div><div><div><div></div><div>YES</div></div><div><div></div><div>NO</div></div></div></div></div></div><div><div><div>1</div><div>JOB</div><div>\$6,000</div><div>\$6,000</div></div><div>

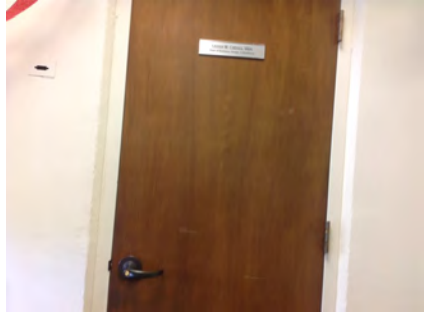
Item no., Rm no. and Name	Existing Architectural Barrier and Proposed Solution	Codes / Mitigation Info	Qty	Unit	Cost	Total
Signage						
129	<ul style="list-style-type: none"> • <i>As-Built Description:</i> Sign designating a permanent room or space does not include Grade 2 Braille. • <i>Proposed Solution:</i> Provide new compliant signage including California Grade 2 Braille (1/10" on center dots with 2/10" space between cells). 	PCODE SA07A ADAAG 91 4.30.4 ADA 2010 703.2 CBC 2007 1117B.5.6 CBC 2016 11B-703.3 Mitigated: <input type="radio"/> YES <input checked="" type="radio"/> NO	1	JOB	\$270	\$270

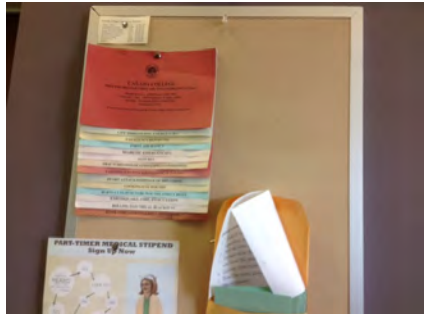
Item no., Rm no. and Name	Existing Architectural Barrier and Proposed Solution	Codes / Mitigation Info	Qty	Unit	Cost	Total
124	<ul style="list-style-type: none"> As-Built Description: Reach height to control or access point, exceeds 48" or is less than 15". As-Built: 60" AFF Proposed Solution: Modify equipment or mounting. 	PCODE IE01 ADAAG 91 4.2.5 ADA 2010 308.2.1 CBC 2007 1118B.5 CBC 2016 11B-308.2.1 Mitigated: <input type="radio"/> YES <input checked="" type="radio"/> NO	1	JOB	\$300	\$300

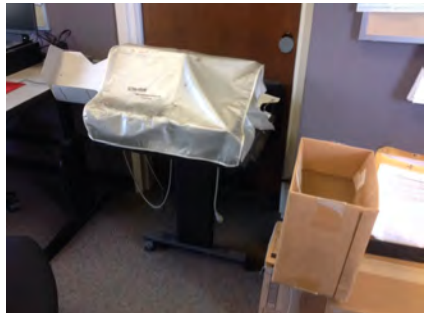
Non-Fixed Desk

123	<ul style="list-style-type: none"> As-Built Description: Accessible non-fixed table or desk (top 28" to 34" high; knee space at least 27" high x 19" deep x 30" wide) not provided. As-Built: 12" deep Proposed Solution: Provide table or desk with accessible dimensions when purchasing new furniture. 	PCODE IN02A ADAAG 91 4.32.3 & .4 ADA 2010 306.1 CBC 2007 1122B.3 & 4 CBC 2016 11B-306.1 & 11B-902.3 Mitigated: <input type="radio"/> YES <input checked="" type="radio"/> NO	1	JOB	\$4,800	\$4,800

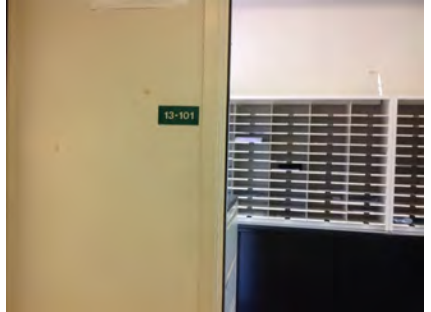
Item no., Rm no. and Name	Existing Architectural Barrier and Proposed Solution	Codes / Mitigation Info	Qty	Unit	Cost	Total
Signage						
120	<ul style="list-style-type: none"> • <i>As-Built Description:</i> Sign designating a permanent room or space does not include Grade 2 Braille. • <i>Proposed Solution:</i> Provide new compliant signage including California Grade 2 Braille (1/10" on center dots with 2/10" space between cells). • <i>Notes:</i> Braille not provided on tactile signage. 	PCODE SA07A ADAAG 91 4.30.4 ADA 2010 703.2 CBC 2007 1117B.5.6 CBC 2016 11B-703.3 Mitigated: <input type="radio"/> YES <input checked="" type="radio"/> NO	1	JOB	\$270	\$270

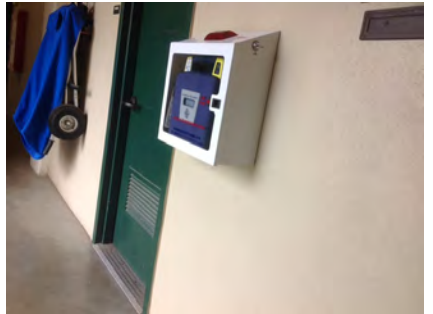
Item no., Rm no. and Name	Existing Architectural Barrier and Proposed Solution	Codes / Mitigation Info	Qty	Unit	Cost	Total
146	<ul style="list-style-type: none"> As-Built Description: Protruding objects more than 4" from wall, when bottom of object more than 27" or less than 80" above finished floor. As-Built: AED 6" protrusion at 45" high. Proposed Solution: Provide cane-detectable railing to mark area of low clearance. 	PCODE EG04A ADAAG 91 4.4.1 ADA 2010 307.2 CBC 2007 1133B.8.6.1 CBC 2016 11B-307.2 Mitigated: <input type="radio"/> YES <input checked="" type="radio"/> NO	2	LF	\$300	\$600

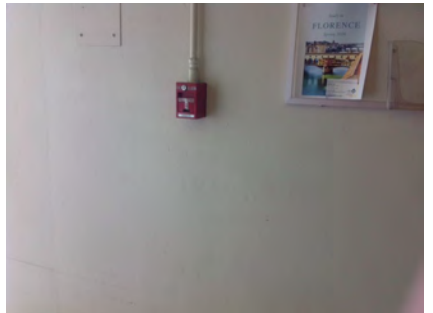
Reach Range

144	<ul style="list-style-type: none"> As-Built Description: Reach height to control or access point, exceeds 48" or is less than 15". As-Built: 48.5" AFF Proposed Solution: Modify equipment or mounting. 	PCODE IE01 ADAAG 91 4.2.5 ADA 2010 308.2.1 CBC 2007 1118B.5 CBC 2016 11B-308.2.1 Mitigated: <input type="radio"/> YES <input checked="" type="radio"/> NO	2	JOB	\$300	\$600

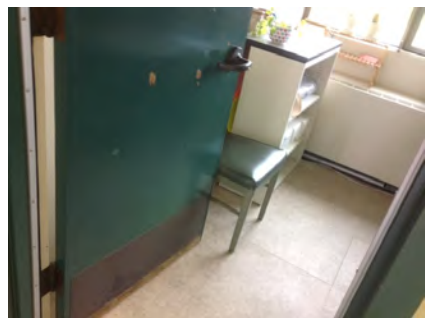
Item no., Rm no. and Name	Existing Architectural Barrier and Proposed Solution	Codes / Mitigation Info	Qty	Unit	Cost	Total
Door Swing						
151	<ul style="list-style-type: none">• <i>As-Built Description:</i> Front approach: At pull side, door does not have clear and level maneuvering space measuring door width plus 18" x 60". (24" x 60" at exterior doors).• <i>Proposed Solution:</i> Remove or relocate furniture or storage items.	PCODE ID23A ADAAG 91 Fig. 25(a) ADA 2010 404.2.4 CBC 2007 11B-26A(a) CBC 2016 11B-404.2.4 Mitigated: <input type="radio"/> YES <input checked="" type="radio"/> NO	6	JOB	\$150	\$900

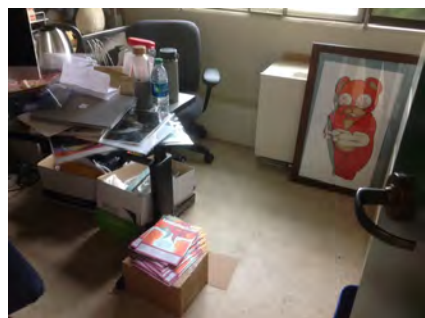
<input type="checkbox"/> Staff Only			
			Priority Severity <input checked="" type="radio"/> 2 <input checked="" type="radio"/> 3			
Turning Space						
152	<ul style="list-style-type: none">• <i>As-Built Description:</i> The area does not provide a minimum 60" diameter turning space within to allow maneuvering through the space.• <i>Proposed Solution:</i> Modify area to provide sufficient maneuvering space.• <i>Notes:</i> 60" turning space is required if students or public use the office for meetings.	PCODE IH05 ADA 2010 304.3 CBC 2016 11B-304.3 Mitigated: <input type="radio"/> YES <input checked="" type="radio"/> NO	1	JOB	\$1,500	\$1,500

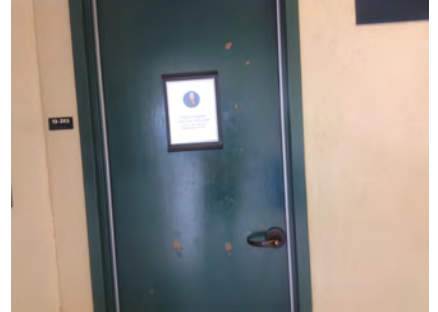
Item no., Rm no. and Name	Existing Architectural Barrier and Proposed Solution	Codes / Mitigation Info	Qty	Unit	Cost	Total
Signage						
149	<ul style="list-style-type: none"> • <i>As-Built Description:</i> Sign not located on latch side of door and/or not located at 48" min. above to baseline of the lowest Braille cells and 60" max. to baseline of the highest line of raised characters. • <i>Proposed Solution:</i> Provide compliant signage including tactile characters and Grade II Braille on latch side of door located at compliant height. 	PCODE SA07 ADAAG 91 4.30.6 ADA 2010 703.4.1 CBC 2007 1117B.5.7 CBC 2016 11B-703.4.1 Mitigated: <input type="radio"/> YES <input checked="" type="radio"/> NO	1	JOB	\$150	\$150

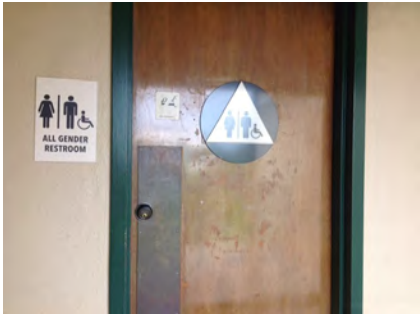
Item no., Rm no. and Name	Existing Architectural Barrier and Proposed Solution	Codes / Mitigation Info	Qty	Unit	Cost	Total
Signage						
154	<ul style="list-style-type: none">As-Built Description: Required in CA only: identification symbol centered 58" to 60" high on sanitary facility door that contrasts with the door not provided (women: 12" ø circle, men: 12" triangle, unisex: combined symbol).As-Built: 62" o.c.Proposed Solution: Provide properly mounted sanitary facility symbol when altering area. If wheelchair accessible, include International Symbol of Accessibility on sign.	PCODE SA15REF CBC 2007 1115B.6 CBC 2016 11B-703.7.2.6 Mitigated: <div><input type="radio"/> YES</div> <div><input checked="" type="radio"/> NO</div>	REF

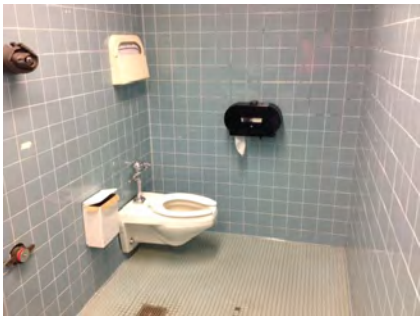
<div><input type="checkbox"/> Staff Only</div> <div><div>Priority</div><div>3</div><div>Severity</div><div>3</div></div>			
Restroom						
158	<ul style="list-style-type: none">As-Built Description: Single accommodation restroom not accessible; multiple compliance violations.Proposed Solution: Remodel area to provide single-occupant accessible restroom.Notes: 34" in front of toilet	PCODE WA01 ADAAG 91 4.22 ADA 2010 603.1 CBC 2007 1115B.3.2 CBC 2016 11B-603.1 Mitigated: <div><input type="radio"/> YES</div> <div><input checked="" type="radio"/> NO</div>	1	JOB	\$90,000	\$90,000

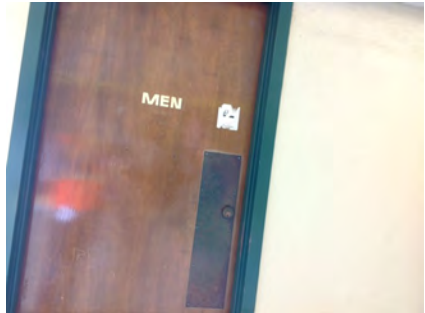
<input type="checkbox"/> Staff Only Priority 3 Severity 3			
161	<ul style="list-style-type: none"> As-Built Description: Required in CA only: identification symbol centered 58" to 60" high on sanitary facility door that contrasts with the door not provided (women: 12" ø circle, men: 12" triangle, unisex: combined symbol). Proposed Solution: Provide properly mounted sanitary facility symbol when altering area. If wheelchair accessible, include International Symbol of Accessibility on sign. 	PCODE SA15REF CBC 2007 1115B.6 CBC 2016 11B-703.7.2.6 Mitigated: <input type="radio"/> YES <input checked="" type="radio"/> NO

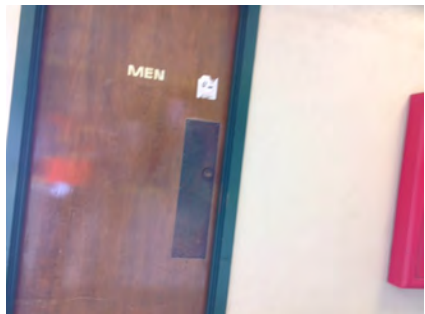
Item no., Rm no. and Name	Existing Architectural Barrier and Proposed Solution	Codes / Mitigation Info	Qty	Unit	Cost	Total
Signage						
160	<ul style="list-style-type: none"> As-Built Description: Entrance to toilet or bathing facility identified with California signage on door leaf not identified with ADAAG compliant signage. Proposed Solution: Provide ADAAG compliant sign with raised letters and pictogram, mounted 5' high on center on nearest adjacent wall, on latch side of a single door. 	PCODE SA11AREF ADAAG 91 4.1.3(16)(a) ADA 2010 216.8 CBC 2016 11B-216.8 Mitigated: <input type="radio"/> YES <input checked="" type="radio"/> NO				
			REF

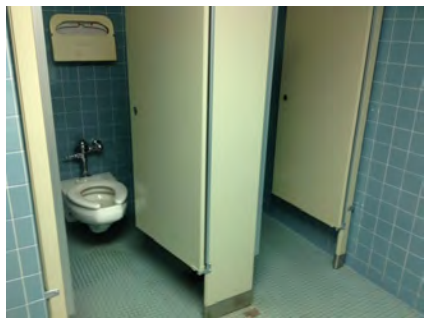
Item no., Rm no. and Name	Existing Architectural Barrier and Proposed Solution	Codes / Mitigation Info	Qty	Unit	Cost	Total
Restroom						
163	<ul style="list-style-type: none"> • <i>As-Built Description:</i> Multiple accommodation restroom not accessible; multiple compliance violations. • <i>Proposed Solution:</i> Remodel area to provide accessible restroom with one accessible stall, lavatory (and one urinal at Mens). 	PCODE WA01A ADAAG 91 4.22 ADA 2010 603.1 CBC 2007 1115B.3.1 CBC 2016 11B-603.1 Mitigated: <input type="radio"/> YES <input checked="" type="radio"/> NO	1	JOB	\$105,000	\$105,000

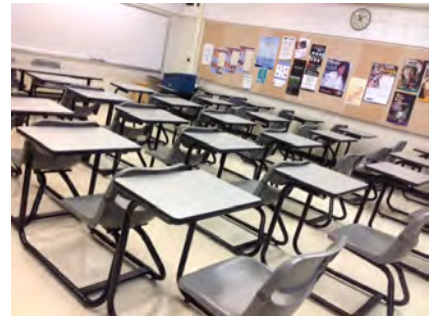
Item no., Rm no. and Name	Existing Architectural Barrier and Proposed Solution	Codes / Mitigation Info	Qty	Unit	Cost	Total
<u>Non-Fixed Desk</u>						
175	<ul style="list-style-type: none"> • <i>As-Built Description:</i> Recommended only: Accessible non-fixed table or desk (top 28" to 34" high; knee space at least 27" high x 19" deep x 30" wide) not provided. • <i>Proposed Solution:</i> Provide table or desk with accessible dimensions when purchasing new furniture. • <i>Notes:</i> 41 seats 3 accessible - OK 	PCODE IN02AREF ADAAG 91 4.32.3 & .4 ADA 2010 306.1 CBC 2007 1122B.3 & 4 CBC 2016 11B-306.1 & 11B-902.3				
Mitigated: <input type="radio"/> YES <input checked="" type="radio"/> NO			REF

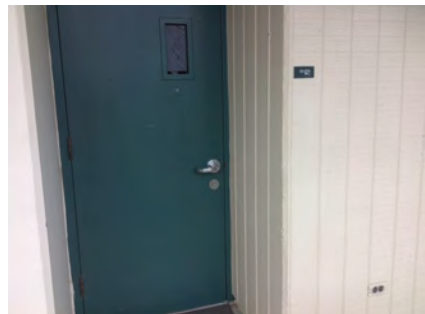
Item no., Rm no. and Name	Existing Architectural Barrier and Proposed Solution	Codes / Mitigation Info	Qty	Unit	Cost	Total
Door Swing						
179	<ul style="list-style-type: none">• <i>As-Built Description:</i> Front approach: At pull side, door does not have clear and level maneuvering space measuring door width plus 18" x 60". (24" x 60" at exterior doors).• <i>Proposed Solution:</i> Provide power door operator.	<p>PCODE ID23C</p> <p>ADAAG 91 Fig. 25(a)</p> <p>ADA 2010 404.2.4</p> <p>CBC 2007 11B-26A(a)</p> <p>CBC 2016 11B-404.2.4</p> <p>Mitigated:</p> <p><input type="radio"/> YES</p> <p><input checked="" type="radio"/> NO</p>	2	JOB	\$15,000	\$30,000

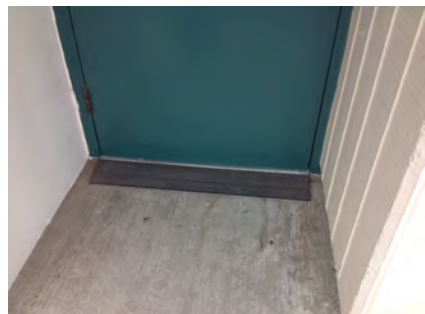
<input type="checkbox"/> Staff Only			
			Priority		Severity	
			2		2	
Door Threshold						
180	<ul style="list-style-type: none">• <i>As-Built Description:</i> Door inaccessible due to threshold or step at door exceeding 1/2".• <i>As-Built:</i> 1.5" AFF• <i>Proposed Solution:</i> Modify threshold to be no more than 1/2" by removing existing paving at door and providing landing with edge ramping (slope 1:20 max).	<p>PCODE ID02A</p> <p>ADAAG 91 4.13.8</p> <p>ADA 2010 404.2.5</p> <p>CBC 2007 1133B.2.4.1</p> <p>CBC 2016 11B-404.2.5</p> <p>Mitigated:</p> <p><input type="radio"/> YES</p> <p><input checked="" type="radio"/> NO</p>	2	JOB	\$1,200	\$2,400

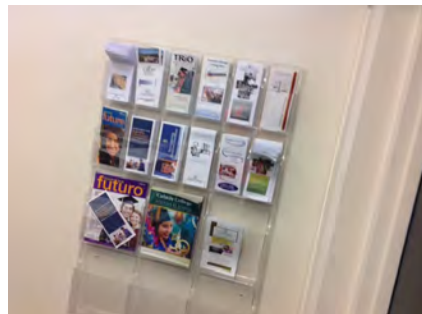
Item no., Rm no. and Name	Existing Architectural Barrier and Proposed Solution	Codes / Mitigation Info	Qty	Unit	Cost	Total
Brochure Bins						
184	<ul style="list-style-type: none">• <i>As-Built Description:</i> Information brochure bins mounted above accessible height of 48".• <i>As-Built:</i> 60" AFF• <i>Proposed Solution:</i> Relocate/remount bins at accessible height.	<p>PCODE IN08</p> <p>ADAAG 91 4.2.5 & 6</p> <p>ADA 2010 308.2.1</p> <p>CBC 2007 1118B.5</p> <p>CBC 2016 11B-308.2.1</p> <p>Mitigated:</p> <p><input type="radio"/> YES</p> <p><input checked="" type="radio"/> NO</p>	1	JOB	\$300	\$300

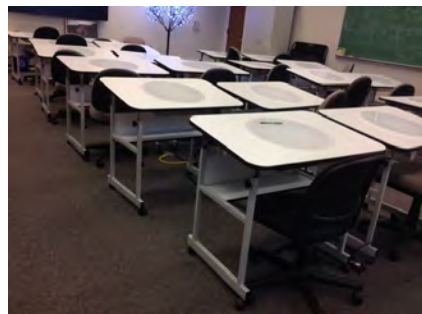
<input type="checkbox"/> Staff Only			
			Priority		Severity	
			2		2	
Non-Fixed Desk						
183	<ul style="list-style-type: none">• <i>As-Built Description:</i> Accessible non-fixed table or desk (top 28" to 34" high; knee space at least 27" high x 19" deep x 30" wide) not provided.• <i>As-Built:</i> 13" knee depth• <i>Proposed Solution:</i> Provide table or desk with accessible dimensions when purchasing new furniture.• <i>Notes:</i> 28 seats, no accessible	<p>PCODE IN02A</p> <p>ADAAG 91 4.32.3 & .4</p> <p>ADA 2010 306.1</p> <p>CBC 2007 1122B.3 & 4</p> <p>CBC 2016 11B-306.1 & 11B-902.3</p> <p>Mitigated:</p> <p><input type="radio"/> YES</p> <p><input checked="" type="radio"/> NO</p>	1	JOB	\$4,800	\$4,800

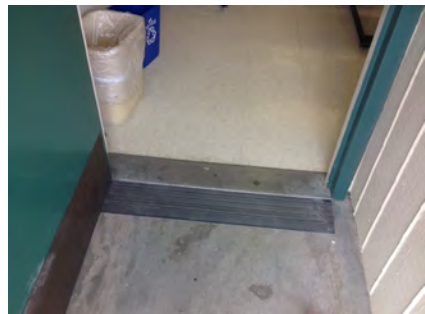
Item no., Rm no. and Name	Existing Architectural Barrier and Proposed Solution	Codes / Mitigation Info	Qty	Unit	Cost	Total
<u>Door Threshold</u>						
186	<ul style="list-style-type: none">As-Built Description: Door inaccessible due to threshold or step at door exceeding 1/2".As-Built: 1.5" AFFProposed Solution: Modify threshold to be no more than 1/2" by removing existing paving at door and providing landing with edge ramping (slope 1:20 max).	PCODE ID02A ADAAG 91 4.13.8 ADA 2010 404.2.5 CBC 2007 1133B.2.4.1 CBC 2016 11B-404.2.5 Mitigated: <input type="radio"/> YES <input checked="" type="radio"/> NO	4	JOB	\$1,200	\$4,800

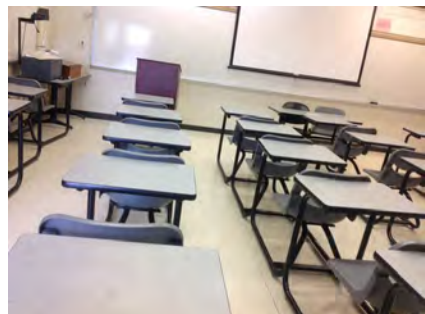
<input type="checkbox"/> Staff Only			
			Priority		Severity	
			2		3	
<u>Non-Fixed Desk</u>						
190	<ul style="list-style-type: none">As-Built Description: Accessible non-fixed table or desk (top 28" to 34" high; knee space at least 27" high x 19" deep x 30" wide) not provided.Proposed Solution: Provide table or desk with accessible dimensions when purchasing new furniture.Notes: 40 desks, 2 accessible - OK	PCODE IN02A ADAAG 91 4.32.3 & .4 ADA 2010 306.1 CBC 2007 1122B.3 & 4 CBC 2016 11B-306.1 & 11B-902.3 Mitigated: <input type="radio"/> YES <input checked="" type="radio"/> NO	1	JOB	\$4,800	\$4,800

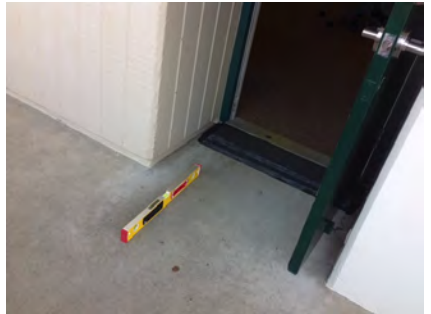
Item no., Rm no. and Name	Existing Architectural Barrier and Proposed Solution	Codes / Mitigation Info	Qty	Unit	Cost	Total
194	<ul style="list-style-type: none"> As-Built Description: Surface of required maneuvering clearance at door slopes more than 1/4":12" (2.0%). As-Built: 3.6% Proposed Solution: Modify surface slope at door. 	PCODE ID11 ADAAG 91 4.13.6 ADA 2010 404.2.4.4 CBC 2007 1133B.2.4 CBC 2016 11B-404.2.4 Mitigated: <input type="radio"/> YES <input checked="" type="radio"/> NO	25	SF	\$120	\$3,000

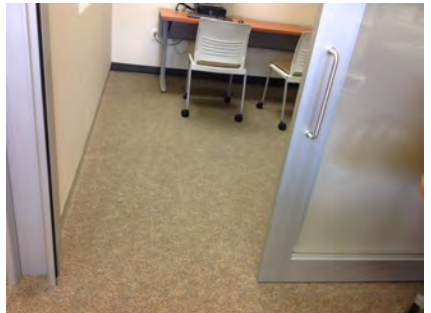
Door Closer

197	<ul style="list-style-type: none"> As-Built Description: Excessive force required to open door. As-Built: 10 lbs. Proposed Solution: Adjust regular door closer to accessible standards (5 lbs. max). 	PCODE ID03 ADAAG 91 4.13.11 ADA 2010 404.2.9 CBC 2007 1133B.2.5 CBC 2016 11B-404.2.9 Mitigated: <input type="radio"/> YES <input checked="" type="radio"/> NO	1	JOB	\$75	\$75

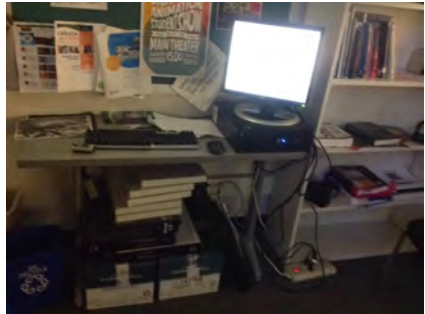
Item no., Rm no. and Name	Existing Architectural Barrier and Proposed Solution	Codes / Mitigation Info	Qty	Unit	Cost	Total
206	<ul style="list-style-type: none"> As-Built Description: Accessible non-fixed table or desk (top 28" to 34" high; knee space at least 27" high x 19" deep x 30" wide) not provided. As-Built: No knee clearance Proposed Solution: Provide table or desk with accessible dimensions when purchasing new furniture. Notes: Check in desk 	PCODE IN02A ADAAG 91 4.32.3 & .4 ADA 2010 306.1 CBC 2007 1122B.3 & 4 CBC 2016 11B-306.1 & 11B-902.3 Mitigated: <input type="radio"/> YES <input checked="" type="radio"/> NO	1	JOB	\$4,800	\$4,800

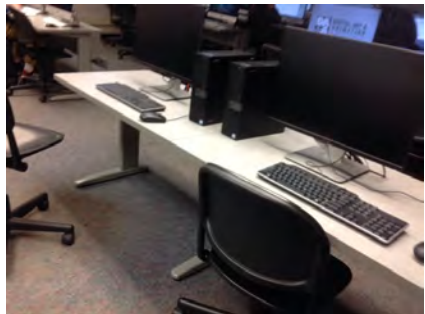
<input type="checkbox"/> Staff Only			
			Priority 2 Severity 2			
207	<ul style="list-style-type: none"> As-Built Description: Accessible non-fixed table or desk (top 28" to 34" high; knee space at least 27" high x 19" deep x 30" wide) not provided. As-Built: 26" high knee Proposed Solution: Provide table or desk with accessible dimensions when purchasing new furniture. Notes: 25 total seats 	PCODE IN02A ADAAG 91 4.32.3 & .4 ADA 2010 306.1 CBC 2007 1122B.3 & 4 CBC 2016 11B-306.1 & 11B-902.3 Mitigated: <input type="radio"/> YES <input checked="" type="radio"/> NO	1	JOB	\$4,800	\$4,800

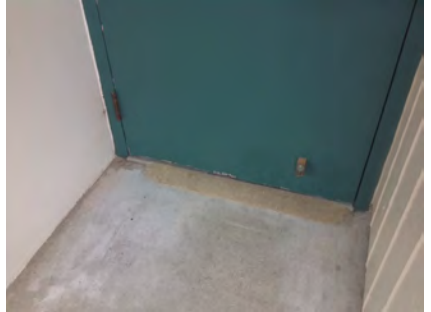
Item no., Rm no. and Name	Existing Architectural Barrier and Proposed Solution	Codes / Mitigation Info	Qty	Unit	Cost	Total
Door Threshold						
200	<ul style="list-style-type: none"> • <i>As-Built Description:</i> Door inaccessible due to threshold or step at door exceeding 1/2". • <i>As-Built:</i> 1" AFF • <i>Proposed Solution:</i> Modify threshold to be no more than 1/2" by removing existing paving at door and providing landing with edge ramping (slope 1:20 max). 	PCODE ID02A ADAAG 91 4.13.8 ADA 2010 404.2.5 CBC 2007 1133B.2.4.1 CBC 2016 11B-404.2.5 Mitigated: <input type="radio"/> YES <input checked="" type="radio"/> NO	1	JOB	\$1,200	\$1,200

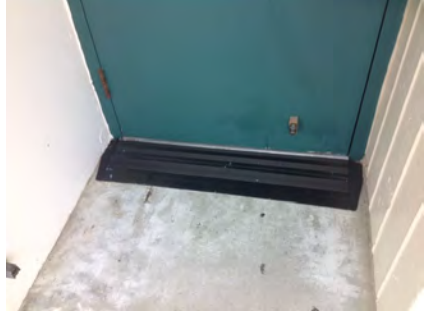
Item no., Rm no. and Name	Existing Architectural Barrier and Proposed Solution	Codes / Mitigation Info	Qty	Unit	Cost	Total
Door Threshold						
209	<ul style="list-style-type: none"> • <i>As-Built Description:</i> Door inaccessible due to threshold or step at door exceeding 1/2". • <i>As-Built:</i> 1" AFF • <i>Proposed Solution:</i> Modify threshold to be no more than 1/2" by removing existing paving at door and providing landing with edge ramping (slope 1:20 max). 	PCODE ID02A ADAAG 91 4.13.8 ADA 2010 404.2.5 CBC 2007 1133B.2.4.1 CBC 2016 11B-404.2.5 Mitigated: <input type="radio"/> YES <input checked="" type="radio"/> NO	4	JOB	\$1,200	\$4,800

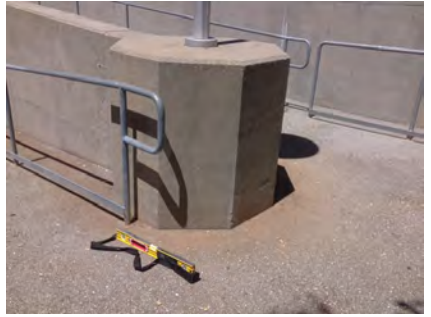
Item no., Rm no. and Name	Existing Architectural Barrier and Proposed Solution	Codes / Mitigation Info	Qty	Unit	Cost	Total
483	<ul style="list-style-type: none"> As-Built Description: Level 2% max. landing for ramp not provided. As-Built: 3.5% Proposed Solution: Rebuild ramp to provide landings for each ramp run with slopes no greater than 2% 	PCODE EB05A ADAAG 91 4.8.4 ADA 2010 405.7.1 CBC 2007 1133B.5.4.1 CBC 2016 11B-405.7.1 Mitigated: <input type="radio"/> YES <input checked="" type="radio"/> NO	100	SF	\$300	\$30,000

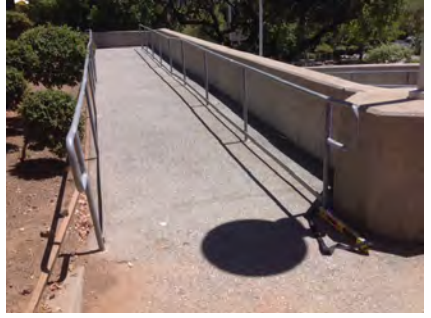
<input type="checkbox"/> Staff Only			
			Priority 1 Severity 4			
484	<ul style="list-style-type: none"> As-Built Description: Level 2% max. landing for ramp not provided. As-Built: 2.8% Proposed Solution: Rebuild ramp to provide landings for each ramp run with slopes no greater than 2% 	PCODE EB05A ADAAG 91 4.8.4 ADA 2010 405.7.1 CBC 2007 1133B.5.4.1 CBC 2016 11B-405.7.1 Mitigated: <input type="radio"/> YES <input checked="" type="radio"/> NO	75	SF	\$300	\$22,500

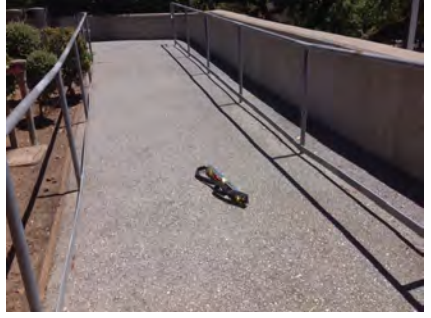
<input type="checkbox"/> Staff Only			
			Priority 1 Severity 4			
485	<ul style="list-style-type: none"> As-Built Description: Level 2% max. landing for ramp not provided. As-Built: 4.9% Proposed Solution: Rebuild ramp to provide landings for each ramp run with slopes no greater than 2% Notes: At intermediate landing 	PCODE EB05A ADAAG 91 4.8.4 ADA 2010 405.7.1 CBC 2007 1133B.5.4.1 CBC 2016 11B-405.7.1 Mitigated: <input type="radio"/> YES <input checked="" type="radio"/> NO	100	SF	\$300	\$30,000

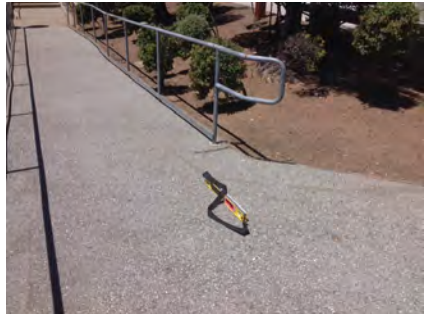
Item no., Rm no. and Name	Existing Architectural Barrier and Proposed Solution	Codes / Mitigation Info	Qty	Unit	Cost	Total
486	<ul style="list-style-type: none"> As-Built Description: Level 2% max. landing for ramp not provided. As-Built: 4.9% Proposed Solution: Rebuild ramp to provide landings for each ramp run with slopes no greater than 2% 	PCODE EB05A ADAAG 91 4.8.4 ADA 2010 405.7.1 CBC 2007 1133B.5.4.1 CBC 2016 11B-405.7.1 Mitigated: <input type="radio"/> YES <input checked="" type="radio"/> NO	100	SF	\$300	\$30,000

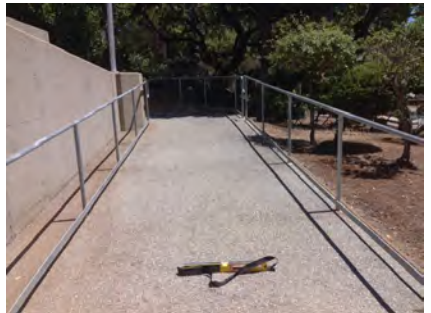
Cross Slope

482	<ul style="list-style-type: none"> As-Built Description: Cross slope more than 1":48" (2.083%). Proposed Solution: Modify cross slope. 	PCODE EF07 ADAAG 91 4.3.7 ADA 2010 403.3 CBC 2007 1133B.7.1.3 CBC 2016 11B-403.3 Mitigated: <input type="radio"/> YES <input checked="" type="radio"/> NO	100	SF	\$75	\$7,500

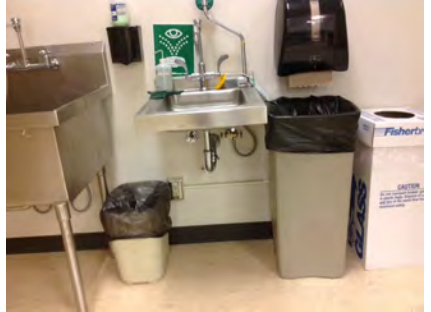
Item no., Rm no. and Name	Existing Architectural Barrier and Proposed Solution	Codes / Mitigation Info	Qty	Unit	Cost	Total
Lavatory						
394	<ul style="list-style-type: none"> • <i>As-Built Description:</i> Hot or sharp-surfaced water/drain pipe not insulated or covered. • <i>Proposed Solution:</i> Insulate or cover water/drain pipe. 	PCODE WD05 ADAAG 91 4.19.4 ADA 2010 606.5 CBC 2007 1115B.4.3.4 CBC 2016 11B-606.5 Mitigated: <input type="radio"/> YES <input checked="" type="radio"/> NO	1	JOB	\$360	\$360

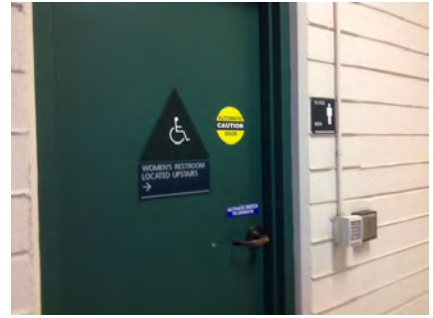
Item no., Rm no. and Name	Existing Architectural Barrier and Proposed Solution	Codes / Mitigation Info	Qty	Unit	Cost	Total
400	<ul style="list-style-type: none"> As-Built Description: Required in CA only: identification symbol centered 58" to 60" high on sanitary facility door that contrasts with the door not provided (women: 12" ø circle, men: 12" triangle, unisex: combined symbol). As-Built: No contrast Proposed Solution: Provide properly mounted sanitary facility symbol when altering area. If wheelchair accessible, include International Symbol of Accessibility on sign. 	PCODE SA15 CBC 2007 1115B.6 CBC 2016 11B-703.7.2.6 Mitigated: <input type="radio"/> YES <input checked="" type="radio"/> NO	1	JOB	\$270	\$270
