SAN MATEO COUNTY
COMMUNITY
COLLEGE DISTRICT

San Mateo County Community College District Americans with Disabilities Act Self-Evaluation and Transition Plan

Report Prepared by:

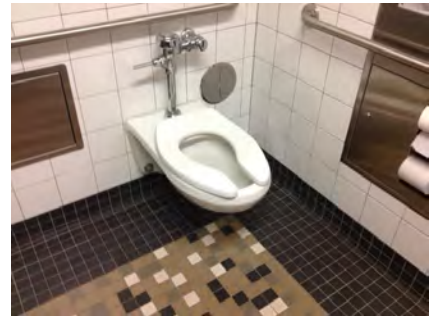
Water Closet

407	<ul style="list-style-type: none"> As-Built Description: Water closet not 16"-18" (CA: 17"-18") from near side wall to center line of water closet (2010 ADAAG: 16"-18"). As-Built: 19" o.c. Proposed Solution: Relocate existing water closet and plumbing, remount with offset closet flange to provide 18" max. from side wall. 	PCODE WB02C ADAAG 91 Fig. 28 ADA 2010 604.2 CBC 2007 1115B.4.1.1 CBC 2016 11B-604.2 Mitigated: <input type="radio"/> YES <input checked="" type="radio"/> NO	1	JOB	\$1,500	\$1,500

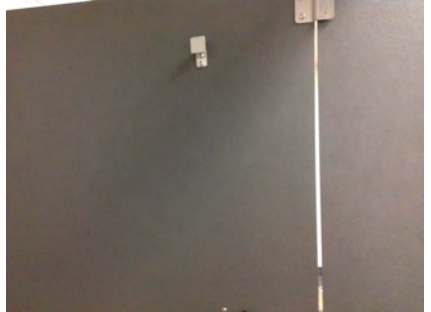
Item no., Rm no. and Name	Existing Architectural Barrier and Proposed Solution	Codes / Mitigation Info	Qty	Unit	Cost	Total
Coat Hook						
406	<ul style="list-style-type: none"> As-Built Description: Accessible coat hook not within reach range. As-Built: 72" high Proposed Solution: Adjust existing or provide new coat hook at maximum 48" height. 	PCODE WG03A ADAAG 91 4.2.5 ADA 2010 603.4 CBC 2007 1118B.5 CBC 2016 11B-603.4 Mitigated: <input type="radio"/> YES <input checked="" type="radio"/> NO	1	JOB	\$150	\$150

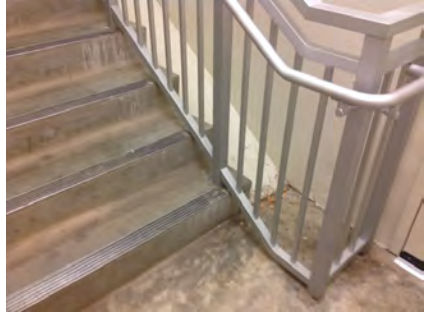
Item no., Rm no. and Name	Existing Architectural Barrier and Proposed Solution	Codes / Mitigation Info	Qty	Unit	Cost	Total
<u>Stairway</u>						
415	<ul style="list-style-type: none"> • <i>As-Built Description:</i> The leading 2" of the tread does not have visual contrast of dark-on-light or light-on-dark from the remainder of the tread. • <i>Proposed Solution:</i> Provide 2" min., 4" max. wide contrasting color strip 1" max. from nosing on top & bottom treads when altering area. 	PCODE II02B ADA 2010 504.4 CBC 2007 1133B.4.4 CBC 2016 11B-504.4.1 Mitigated: <input type="radio"/> YES <input checked="" type="radio"/> NO	24	LF	\$42	\$1,008

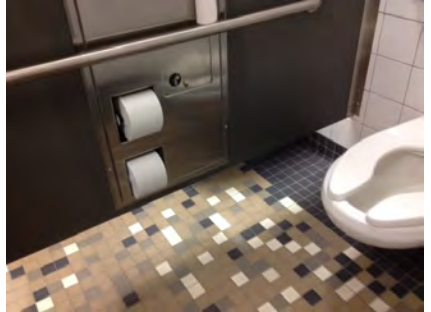
Item no., Rm no. and Name	Existing Architectural Barrier and Proposed Solution	Codes / Mitigation Info	Qty	Unit	Cost	Total
Accessories						
422	<ul style="list-style-type: none"> • <i>As-Built Description:</i> Toilet paper dispenser less than 15" (CA: 19") or more than 48" above floor or not within 7" to 9" from front of water closet (Note: CA pre-2010 is allowed within 12" from front of water closet). • <i>As-Built:</i> 13" o.c. • <i>Proposed Solution:</i> Relocate or provide new toilet paper dispenser. 	PCODE WG02 ADAAG 91 4.16.6 ADA 2010 604.7 CBC 2007 1115B.8.4 CBC 2016 11B-604.7 Mitigated: <input type="radio"/> YES <input checked="" type="radio"/> NO	1	JOB	\$225	\$225

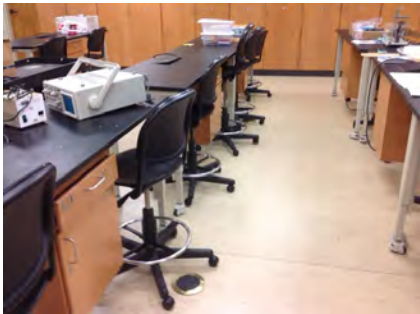
Item no., Rm no. and Name	Existing Architectural Barrier and Proposed Solution	Codes / Mitigation Info	Qty	Unit	Cost	Total
<u>Non-Fixed Desk</u>						
424	<ul style="list-style-type: none">• <i>As-Built Description:</i> Accessible non-fixed table or desk (top 28" to 34" high; knee space at least 27" high x 19" deep x 30" wide) not provided.• <i>Proposed Solution:</i> Provide table or desk with accessible dimensions when purchasing new furniture.• <i>Notes:</i> 30 seats, no accessible	<p>PCODE IN02A</p> <p>ADAAG 91 4.32.3 & .4</p> <p>ADA 2010 306.1</p> <p>CBC 2007 1122B.3 & 4</p> <p>CBC 2016 11B-306.1 & 11B-902.3</p> <p>Mitigated:</p> <p><input type="radio"/> YES</p> <p><input checked="" type="radio"/> NO</p>	1	JOB	\$4,800	\$4,800

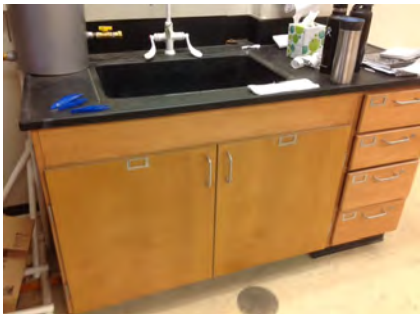
<input type="checkbox"/> Staff Only			
			Priority		Severity	
			2		2	
<u>Sink</u>						
426	<ul style="list-style-type: none">• <i>As-Built Description:</i> Sink does not have knee space min. 27" high x 19" deep x 30" wide.• <i>Proposed Solution:</i> Remodel sink cabinet.	<p>PCODE IN06A</p> <p>ADAAG 91 4.24.3</p> <p>ADA 2010 606.2</p> <p>CBC 2007 1115B.4.7.1</p> <p>CBC 2016 11B-606.2</p> <p>Mitigated:</p> <p><input type="radio"/> YES</p> <p><input checked="" type="radio"/> NO</p>	1	JOB	\$5,250	\$5,250

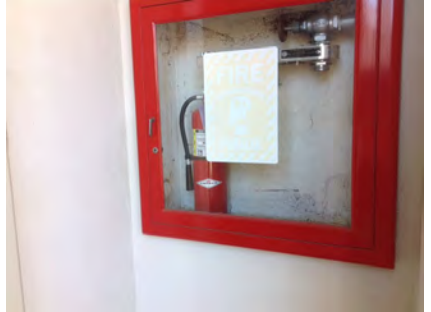
Item no., Rm no. and Name	Existing Architectural Barrier and Proposed Solution	Codes / Mitigation Info	Qty	Unit	Cost	Total
Reach Range						
428	<ul style="list-style-type: none"> As-Built Description: Reach height to control or access point, exceeds 48" or is less than 15". As-Built: 49" high Proposed Solution: Modify equipment or mounting. 	PCODE IE01 ADAAG 91 4.2.5 ADA 2010 308.2.1 CBC 2007 1118B.5 CBC 2016 11B-308.2.1 Mitigated: <input type="radio"/> YES <input checked="" type="radio"/> NO	1	JOB	\$300	\$300

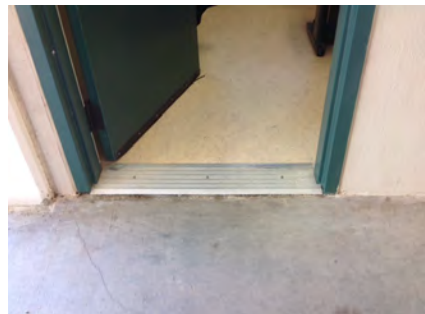
Item no., Rm no. and Name	Existing Architectural Barrier and Proposed Solution	Codes / Mitigation Info	Qty	Unit	Cost	Total
<u>Door Threshold</u>						
429	<ul style="list-style-type: none">As-Built Description: Existing threshold at door is 1/2" high or less but without a beveled edge on both sides.As-Built: 0.75" highProposed Solution: Modify threshold to have beveled edge on each side.	PCODE ID02 ADAAG 91 4.1.6(3)(d)(ii) ADA 2010 404.2.5 CBC 2007 1133B.2.4.1 CBC 2016 11B-404.2.5 Mitigated: <div><input type="radio"/> YES</div> <div><input checked="" type="radio"/> NO</div>	1	JOB	\$750	\$750

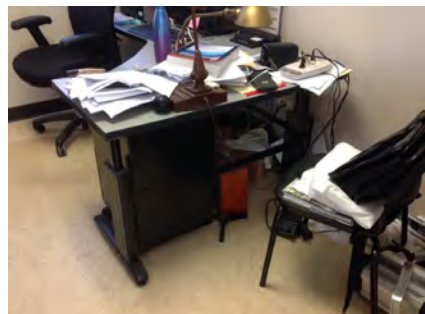
<div><input type="checkbox"/> Staff Only</div> <div><div>Priority</div><div>2</div><div>Severity</div><div>4</div></div>			
<u>Non-Fixed Desk</u>						
433	<ul style="list-style-type: none">As-Built Description: Accessible non-fixed table or desk (top 28" to 34" high; knee space at least 27" high x 19" deep x 30" wide) not provided.As-Built: If used as student work surfaceProposed Solution: Provide table or desk with accessible dimensions when purchasing new furniture.	PCODE IN02A ADAAG 91 4.32.3 & .4 ADA 2010 306.1 CBC 2007 1122B.3 & 4 CBC 2016 11B-306.1 & 11B-902.3 Mitigated: <div><input type="radio"/> YES</div> <div><input checked="" type="radio"/> NO</div>	3	JOB	\$4,800	\$14,400

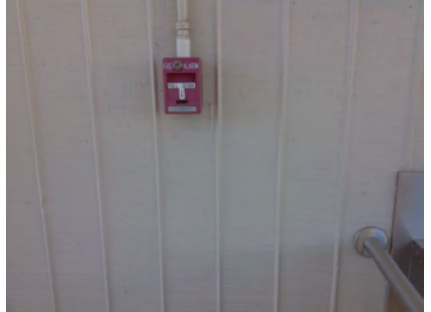
Item no., Rm no. and Name	Existing Architectural Barrier and Proposed Solution	Codes / Mitigation Info	Qty	Unit	Cost	Total
Reach Range						
443	<ul style="list-style-type: none"> As-Built Description: Reach height to control or access point, exceeds 48" or is less than 15". As-Built: 48.5" high Proposed Solution: Modify equipment or mounting. 	PCODE IE01 ADAAG 91 4.2.5 ADA 2010 308.2.1 CBC 2007 1118B.5 CBC 2016 11B-308.2.1	1	JOB	\$300	\$300
Mitigated: <input type="radio"/> YES <input checked="" type="radio"/> NO

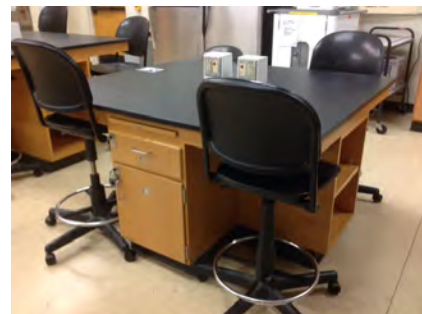
Item no., Rm no. and Name	Existing Architectural Barrier and Proposed Solution	Codes / Mitigation Info	Qty	Unit	Cost	Total
466	<ul style="list-style-type: none"> As-Built Description: Accessible non-fixed table or desk (top 28" to 34" high; knee space at least 27" high x 19" deep x 30" wide) not provided. Proposed Solution: Provide table or desk with accessible dimensions when purchasing new furniture. 	PCODE IN02A ADAAG 91 4.32.3 & .4 ADA 2010 306.1 CBC 2007 1122B.3 & 4 CBC 2016 11B-306.1 & 11B-902.3 Mitigated: <input type="radio"/> YES <input checked="" type="radio"/> NO	1	JOB	\$4,800	\$4,800

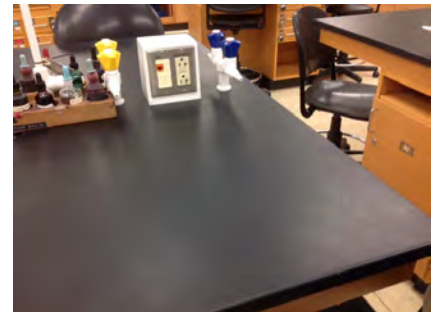
Item no., Rm no. and Name	Existing Architectural Barrier and Proposed Solution	Codes / Mitigation Info	Qty	Unit	Cost	Total
457	<ul style="list-style-type: none">As-Built Description: Reach height to control or access point, exceeds 48" or is less than 15".As-Built: 58" highProposed Solution: Modify equipment or mounting.	PCODE IE01 ADAAG 91 4.2.5 ADA 2010 308.2.1 CBC 2007 1118B.5 CBC 2016 11B-308.2.1 Mitigated: <div><input type="radio"/> YES</div> <div><input checked="" type="radio"/> NO</div>	1	JOB	\$300	\$300

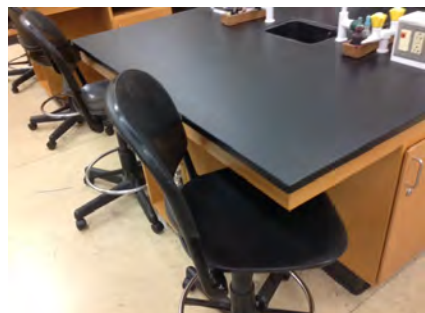
<div><input type="checkbox"/> Staff Only</div> <div>Priority <div>2</div>Severity <div>2</div></div>			
<hr/>						
456	<ul style="list-style-type: none">As-Built Description: Accessible non-fixed table or desk (top 28" to 34" high; knee space at least 27" high x 19" deep x 30" wide) not provided.Proposed Solution: Provide table or desk with accessible dimensions when purchasing new furniture.	PCODE IN02A ADAAG 91 4.32.3 & .4 ADA 2010 306.1 CBC 2007 1122B.3 & 4 CBC 2016 11B-306.1 & 11B-902.3 Mitigated: <div><input type="radio"/> YES</div> <div><input checked="" type="radio"/> NO</div>	1	JOB	\$4,800	\$4,800

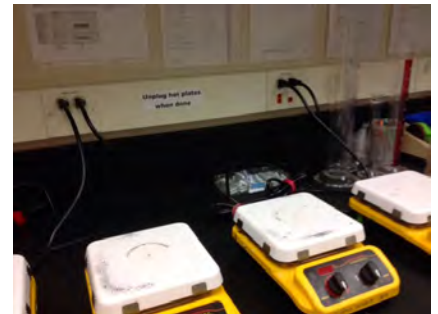
Item no., Rm no. and Name	Existing Architectural Barrier and Proposed Solution	Codes / Mitigation Info	Qty	Unit	Cost	Total
462	<ul style="list-style-type: none"> As-Built Description: Reach height to control or access point, exceeds 48" or is less than 15". As-Built: 53" high Proposed Solution: Modify equipment or mounting. 	PCODE IE01 ADAAG 91 4.2.5 ADA 2010 308.2.1 CBC 2007 1118B.5 CBC 2016 11B-308.2.1 Mitigated: <input type="radio"/> YES <input checked="" type="radio"/> NO	1	JOB	\$300	\$300

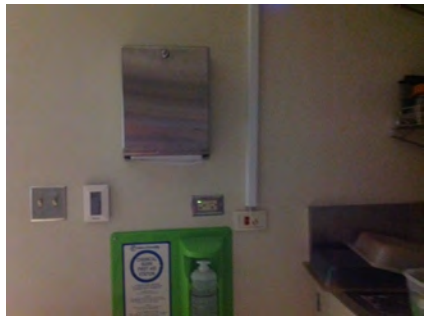
<input type="checkbox"/> Staff Only Priority 2 Severity 4						
463	<ul style="list-style-type: none"> As-Built Description: Reach height to control or access point, exceeds 48" or is less than 15". As-Built: General reach ranges Proposed Solution: Modify equipment or mounting. 	PCODE IE01 ADAAG 91 4.2.5 ADA 2010 308.2.1 CBC 2007 1118B.5 CBC 2016 11B-308.2.1 Mitigated: <input type="radio"/> YES <input checked="" type="radio"/> NO	1	JOB	\$300	\$300

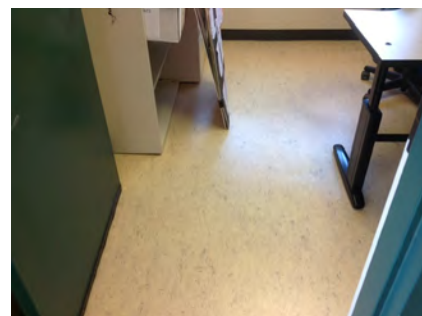
Item no., Rm no. and Name	Existing Architectural Barrier and Proposed Solution	Codes / Mitigation Info	Qty	Unit	Cost	Total
<u>Door Threshold</u>						
468	<ul style="list-style-type: none">As-Built Description: Existing threshold at door is 1/2" high or less but without a beveled edge on both sides.As-Built: 1" highProposed Solution: Modify threshold to have beveled edge on each side.	PCODE ID02 ADAAG 91 4.1.6(3)(d)(ii) ADA 2010 404.2.5 CBC 2007 1133B.2.4.1 CBC 2016 11B-404.2.5 Mitigated: <input type="radio"/> YES <input checked="" type="radio"/> NO	3	JOB	\$750	\$2,250

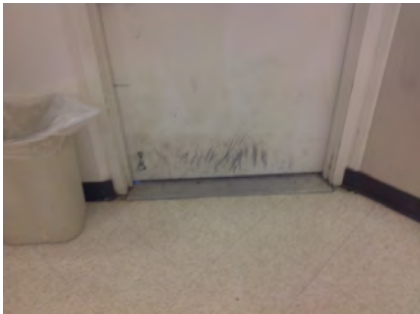
Item no., Rm no. and Name	Existing Architectural Barrier and Proposed Solution	Codes / Mitigation Info	Qty	Unit	Cost	Total
<u>Door Stopper</u>						
498	<ul style="list-style-type: none">• <i>As-Built Description:</i> At push side of door on accessible route, bottom 10" does not have a smooth, uninterrupted surface.• <i>Proposed Solution:</i> Remove door stopper when altering area. Provide rubber wedge.	<p>PCODE ID06A</p> <p>ADA 2010 404.2.10</p> <p>CBC 2007 1133B.2.6</p> <p>CBC 2016 11B-404.2.10</p> <p>Mitigated:</p> <p><input type="radio"/> YES</p> <p><input checked="" type="radio"/> NO</p>	8	JOB	\$75	\$600

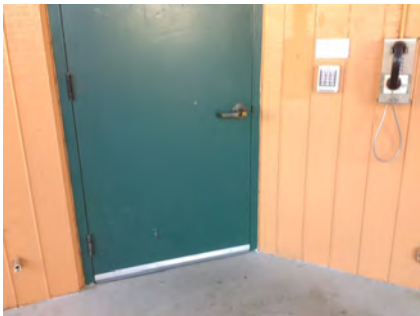
<input type="checkbox"/> Staff Only			
			Priority		Severity	
			2		3	
<u>Door Swing</u>						
516	<ul style="list-style-type: none">• <i>As-Built Description:</i> Front approach: At pull side, door does not have clear and level maneuvering space measuring door width plus 18" x 60". (24" x 60" at exterior doors).• <i>As-Built:</i> 14" pull at 8" deep• <i>Proposed Solution:</i> Provide power door operator.• Notes: Need one accessible entrance per classroom.	<p>PCODE ID23C</p> <p>ADAAG 91 Fig. 25(a)</p> <p>ADA 2010 404.2.4</p> <p>CBC 2007 11B-26A(a)</p> <p>CBC 2016 11B-404.2.4</p> <p>Mitigated:</p> <p><input type="radio"/> YES</p> <p><input checked="" type="radio"/> NO</p>	4	JOB	\$15,000	\$60,000

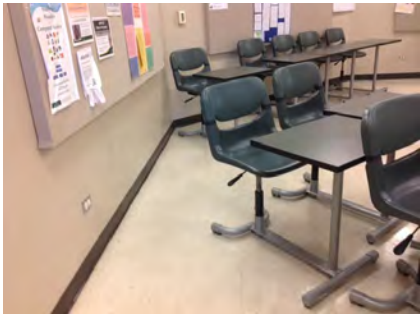
Item no., Rm no. and Name	Existing Architectural Barrier and Proposed Solution	Codes / Mitigation Info	Qty	Unit	Cost	Total
<u>Corridor</u>						
501	<ul style="list-style-type: none">• <i>As-Built Description:</i> Corridor, for occupant load less than 10, less than 36" wide.• <i>As-Built:</i> 22" wide• <i>Proposed Solution:</i> Remove or relocate furniture and storage items.• <i>Notes:</i> Path of travel to accessible seating	<p>PCODE IH03A</p> <p>ADAAG 91 4.3.3</p> <p>ADA 2010 403.5.1</p> <p>CBC 2007 1133B.3.1</p> <p>CBC 2016 11B-403.5.1</p> <p>Mitigated:</p> <p><input type="radio"/> YES</p> <p><input checked="" type="radio"/> NO</p>	1	JOB	\$150	\$150

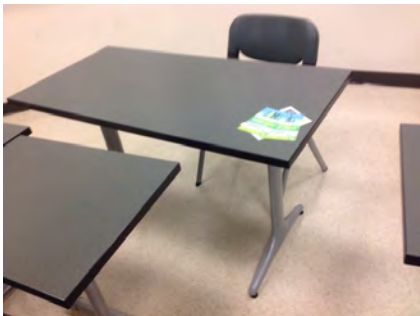
<input type="checkbox"/> Staff Only			
			Priority		Severity	
			2		1	
<u>Non-Fixed Desk</u>						
502	<ul style="list-style-type: none">• <i>As-Built Description:</i> Accessible non-fixed table or desk (top 28" to 34" high; knee space at least 27" high x 19" deep x 30" wide) not provided.• <i>Proposed Solution:</i> Provide table or desk with accessible dimensions when purchasing new furniture.• <i>Notes:</i> 44 seats, 1 accessible	<p>PCODE IN02A</p> <p>ADAAG 91 4.32.3 & .4</p> <p>ADA 2010 306.1</p> <p>CBC 2007 1122B.3 & 4</p> <p>CBC 2016 11B-306.1 & 11B-902.3</p> <p>Mitigated:</p> <p><input type="radio"/> YES</p> <p><input checked="" type="radio"/> NO</p>	4	JOB	\$4,800	\$19,200

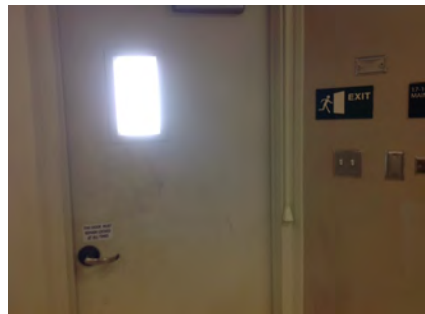
Item no., Rm no. and Name	Existing Architectural Barrier and Proposed Solution	Codes / Mitigation Info	Qty	Unit	Cost	Total
Signage						
499	<ul style="list-style-type: none">As-Built Description: Sign not located on latch side of door and/or not located at 48" min. above to baseline of the lowest Braille cells and 60" max. to baseline of the highest line of raised characters.Proposed Solution: Provide compliant signage including tactile characters and Grade II Braille on latch side of door located at compliant height.	<p>PCODE SA07</p> <p>ADAAG 91 4.30.6</p> <p>ADA 2010 703.4.1</p> <p>CBC 2007 1117B.5.7</p> <p>CBC 2016 11B-703.4.1</p> <p>Mitigated:</p> <p><input type="radio"/> YES</p> <p><input checked="" type="radio"/> NO</p>	8	JOB	\$150	\$1,200

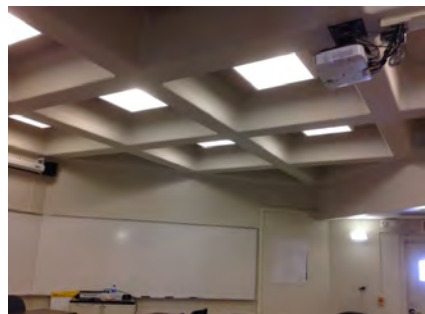
<input type="checkbox"/> Staff Only			
			Priority		Severity	
			2		3	
Assistive Listening						
504	<ul style="list-style-type: none">As-Built Description: No signs at the building or assembly area entrance to notify patrons that an assistive listening system is available.Proposed Solution: Provide assistive listening signage.Notes: No assistive listening signage	<p>PCODE GI02</p> <p>ADAAG 91 4.1.3(19)(b)</p> <p>ADA 2010 703.7.2.4</p> <p>CBC 2007 1104B.2.4</p> <p>CBC 2016 11B-703.7.2.4</p> <p>Mitigated:</p> <p><input type="radio"/> YES</p> <p><input checked="" type="radio"/> NO</p>	1	JOB	\$300	\$300

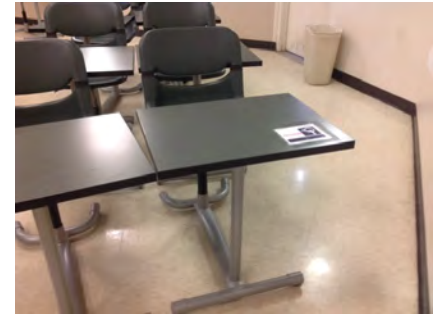
• *Proposed Solution:*CBC 2016 11B-306.1 & 11B
-902.3• **Notes:****Non-accessible desk marked with ISA. Remove
ISA from table.****Mitigated:**☐ YES☒ NO

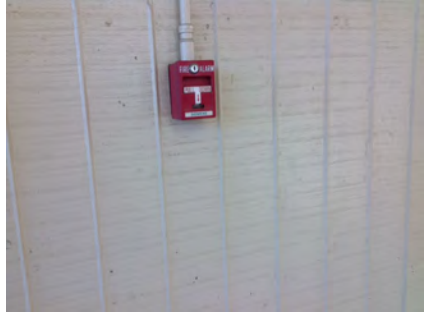
Item no., Rm no. and Name	Existing Architectural Barrier and Proposed Solution	Codes / Mitigation Info	Qty	Unit	Cost	Total
Reach Range						
507	<ul style="list-style-type: none"> As-Built Description: Reach height to control or access point, exceeds 48" or is less than 15". As-Built: 48.5" high Proposed Solution: Modify equipment or mounting. 	PCODE IE01 ADAAG 91 4.2.5 ADA 2010 308.2.1 CBC 2007 1118B.5 CBC 2016 11B-308.2.1 Mitigated: <input type="radio"/> YES <input checked="" type="radio"/> NO	1	JOB	\$300	\$300

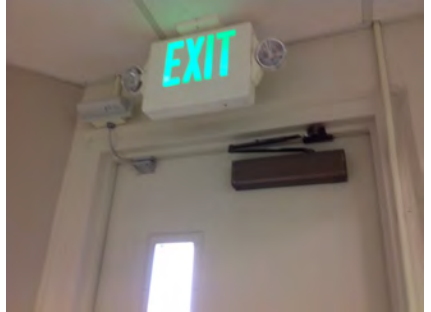
Item no., Rm no. and Name	Existing Architectural Barrier and Proposed Solution	Codes / Mitigation Info	Qty	Unit	Cost	Total
Signage						
511	<ul style="list-style-type: none"> • <i>As-Built Description:</i> At door leading into exit corridor: Where required exit signs are installed, signs to provide exiting information for people with vision impairment are not provided. • <i>Proposed Solution:</i> Provide raised letter/Braille "EXIT ROUTE" sign at door. 	PCODE SA10D ADAAG 91 4.1.3(16) ADA 2010 216.4.1 CBC 2007 1011.3 CBC 2016 11B-216.4.1 Mitigated: <input type="radio"/> YES <input checked="" type="radio"/> NO	8	JOB	\$270	\$2,160

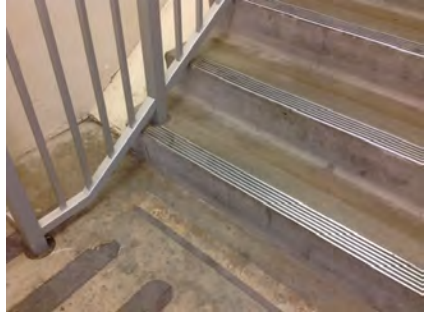
Item no., Rm no. and Name	Existing Architectural Barrier and Proposed Solution	Codes / Mitigation Info	Qty	Unit	Cost	Total
<u>Stairway</u>						
521	<ul style="list-style-type: none"> • <i>As-Built Description:</i> The leading 2" of the tread does not have visual contrast of dark-on-light or light-on-dark from the remainder of the tread. • <i>Proposed Solution:</i> Provide 2" min., 4" max. wide contrasting color strip 1" max. from nosing on top & bottom treads when altering area. 	PCODE 1102B ADA 2010 504.4 CBC 2007 1133B.4.4 CBC 2016 11B-504.4.1 Mitigated: <input type="radio"/> YES <input checked="" type="radio"/> NO	40	LF	\$42	\$1,680

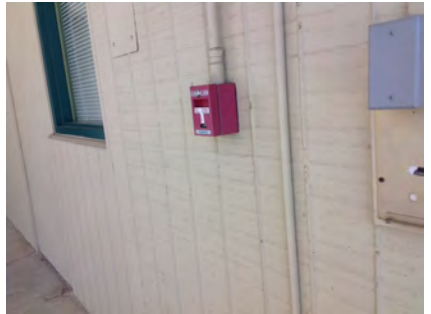
Item no., Rm no. and Name	Existing Architectural Barrier and Proposed Solution	Codes / Mitigation Info	Qty	Unit	Cost	Total
524	<ul style="list-style-type: none"> As-Built Description: Reach height to control or access point, exceeds 48" or is less than 15". As-Built: 48.5" high Proposed Solution: Modify equipment or mounting. 	PCODE IE01 ADAAG 91 4.2.5 ADA 2010 308.2.1 CBC 2007 1118B.5 CBC 2016 11B-308.2.1 Mitigated: <input type="radio"/> YES <input checked="" type="radio"/> NO	1	JOB	\$300	\$300

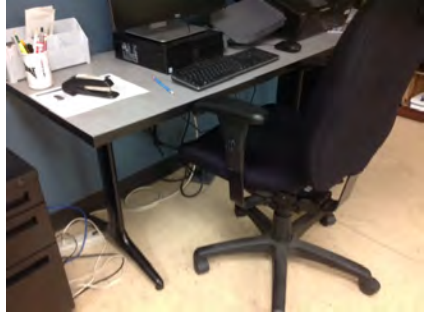
Item no., Rm no. and Name	Existing Architectural Barrier and Proposed Solution	Codes / Mitigation Info	Qty	Unit	Cost	Total
Non-Fixed Desk						
530	<ul style="list-style-type: none"> • <i>As-Built Description:</i> Accessible non-fixed table or desk (top 28" to 34" high; knee space at least 27" high x 19" deep x 30" wide) not provided. • <i>As-Built:</i> 12" knee depth • <i>Proposed Solution:</i> Provide table or desk with accessible dimensions when purchasing new furniture. 	PCODE IN02A ADAAG 91 4.32.3 & .4 ADA 2010 306.1 CBC 2007 112B.3 & 4 CBC 2016 11B-306.1 & 11B-902.3 Mitigated: <input type="radio"/> YES <input checked="" type="radio"/> NO	1	JOB	\$4,800	\$4,800

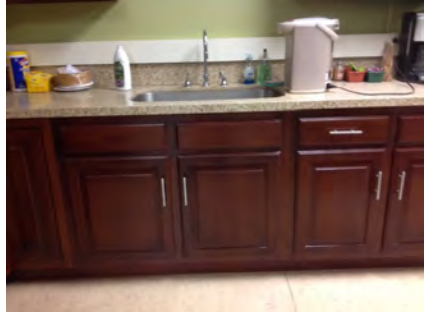
Item no., Rm no. and Name	Existing Architectural Barrier and Proposed Solution	Codes / Mitigation Info	Qty	Unit	Cost	Total
Sink						
538	<ul style="list-style-type: none"> As-Built Description: Sink rim higher than 34" above floor. As-Built: 37.5" high Proposed Solution: Remodel sink cabinet to lower sink. 	PCODE IN06 ADAAG 91 4.24.2 ADA 2010 606.3 CBC 2007 1115B.4.7.1 CBC 2016 11B-606.3 Mitigated: <input type="radio"/> YES <input checked="" type="radio"/> NO	1	JOB	\$5,250	\$5,250

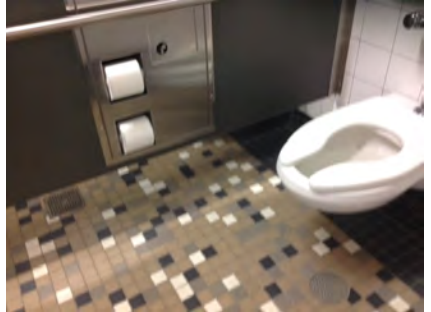
Item no., Rm no. and Name	Existing Architectural Barrier and Proposed Solution	Codes / Mitigation Info	Qty	Unit	Cost	Total
Accessories						
542	<ul style="list-style-type: none"> • <i>As-Built Description:</i> Toilet paper dispenser less than 15" (CA: 19") or more than 48" above floor or not within 7" to 9" from front of water closet (Note: CA pre-2010 is allowed within 12" from front of water closet). • <i>As-Built:</i> 12" o.c. • <i>Proposed Solution:</i> Relocate or provide new toilet paper dispenser. 	PCODE WG02 ADAAG 91 4.16.6 ADA 2010 604.7 CBC 2007 1115B.8.4 CBC 2016 11B-604.7 Mitigated: <input type="radio"/> YES <input checked="" type="radio"/> NO	1	JOB	\$225	\$225

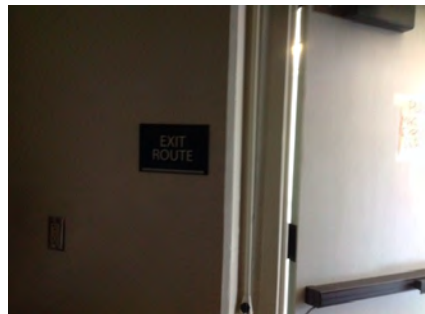
Item no., Rm no. and Name	Existing Architectural Barrier and Proposed Solution	Codes / Mitigation Info	Qty	Unit	Cost	Total
<u>Signage</u>						
551	<ul style="list-style-type: none">• <i>As-Built Description:</i> Sign not located on latch side of door and/or not located at 48" min. above to baseline of the lowest Braille cells and 60" max. to baseline of the highest line of raised characters.• <i>Proposed Solution:</i> Provide compliant signage including tactile characters and Grade II Braille on latch side of door located at compliant height.	<p>PCODE SA07 ADAAG 91 4.30.6 ADA 2010 703.4.1 CBC 2007 1117B.5.7 CBC 2016 11B-703.4.1</p> <p>Mitigated:</p> <p><input type="radio"/> YES <input checked="" type="radio"/> NO</p>	1	JOB	\$150	\$150

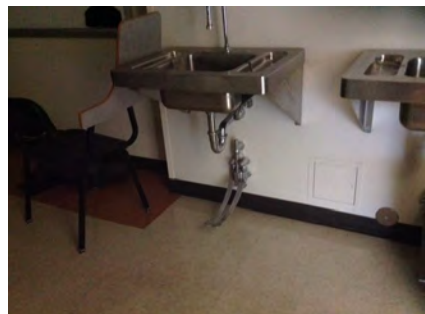
<input type="checkbox"/> Staff Only			
			Priority		Severity	
			2		3	
<u>Lavatory</u>						
553	<ul style="list-style-type: none">• <i>As-Built Description:</i> Hot or sharp-surfaced water/drain pipe not insulated or covered.• <i>Proposed Solution:</i> Insulate or cover water/drain pipe.	<p>PCODE WD05 ADAAG 91 4.19.4 ADA 2010 606.5 CBC 2007 1115B.4.3.4 CBC 2016 11B-606.5</p> <p>Mitigated:</p> <p><input type="radio"/> YES <input checked="" type="radio"/> NO</p>	1	JOB	\$360	\$360

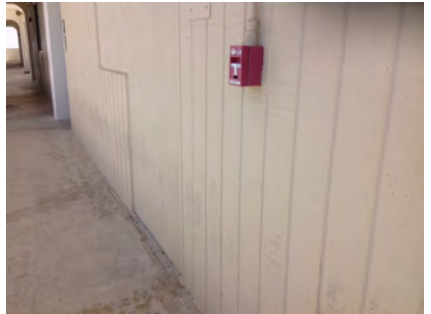
Item no., Rm no. and Name	Existing Architectural Barrier and Proposed Solution	Codes / Mitigation Info	Qty	Unit	Cost	Total
560	<ul style="list-style-type: none"> As-Built Description: Reach height to control or access point, exceeds 48" or is less than 15". As-Built: 48.5" high Proposed Solution: Modify equipment or mounting. 	PCODE IE01 ADAAG 91 4.2.5 ADA 2010 308.2.1 CBC 2007 1118B.5 CBC 2016 11B-308.2.1 Mitigated: <input type="radio"/> YES <input checked="" type="radio"/> NO	1	JOB	\$300	\$300

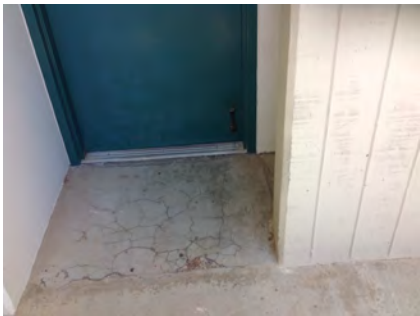
Item no., Rm no. and Name	Existing Architectural Barrier and Proposed Solution	Codes / Mitigation Info	Qty	Unit	Cost	Total
570	<ul style="list-style-type: none">• <i>As-Built Description:</i> Front approach: At push side, door does not have clear and level maneuvering space measuring door width x 48" (door width plus 12" if door has both, latch and closer).• <i>Proposed Solution:</i> Provide door operator.• <i>Notes:</i> Exterior door to Director's office	<p>PCODE ID24C</p> <p>ADAAG 91 Fig. 25(a)</p> <p>ADA 2010 404.2.4</p> <p>CBC 2007 11B-26A(a)</p> <p>CBC 2016 11B-404.2.4</p> <p>Mitigated:</p> <p><input type="radio"/> YES</p> <p><input checked="" type="radio"/> NO</p>	1	JOB	\$15,000	\$15,000

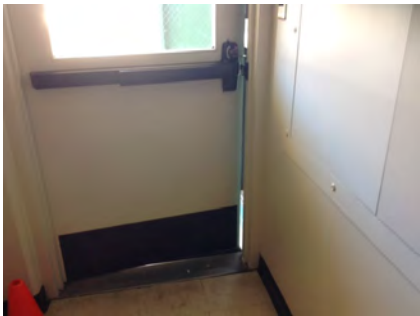
<input type="checkbox"/> Staff Only			
			Priority		Severity	
			<input checked="" type="radio"/> 4		<input checked="" type="radio"/> 2	
565	<ul style="list-style-type: none">• <i>As-Built Description:</i> Front approach: At push side, door does not have clear and level maneuvering space measuring door width x 48" (door width plus 12" if door has both, latch and closer).• <i>Proposed Solution:</i> Provide door operator.	<p>PCODE ID24CREF</p> <p>ADAAG 91 Fig. 25(a)</p> <p>ADA 2010 404.2.4</p> <p>CBC 2007 11B-26A(a)</p> <p>CBC 2016 11B-404.2.4</p> <p>Mitigated:</p> <p><input type="radio"/> YES</p> <p><input checked="" type="radio"/> NO</p>		REF

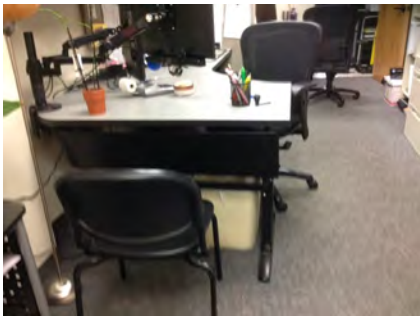
<input type="checkbox"/> Staff Only			
			Priority		Severity	
			<input checked="" type="radio"/> 4		<input checked="" type="radio"/> 2	
<u>Non-Fixed Desk</u>						
567	<ul style="list-style-type: none">• <i>As-Built Description:</i> Accessible non-fixed table or desk (top 28" to 34" high; knee space at least 27" high x 19" deep x 30" wide) not provided.• <i>As-Built:</i> No knee clearance on student side if used as work surface.• <i>Proposed Solution:</i> Provide table or desk with accessible dimensions when purchasing new furniture.	<p>PCODE IN02A</p> <p>ADAAG 91 4.32.3 & .4</p> <p>ADA 2010 306.1</p> <p>CBC 2007 1122B.3 & 4</p> <p>CBC 2016 11B-306.1 & 11B-902.3</p> <p>Mitigated:</p> <p><input type="radio"/> YES</p> <p><input checked="" type="radio"/> NO</p>	1	JOB	\$4,800	\$4,800

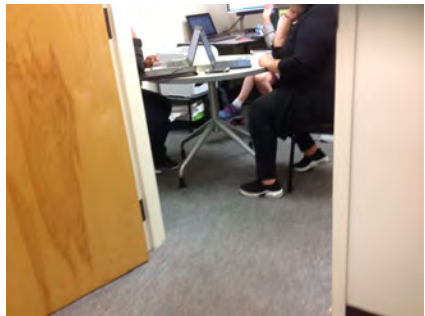
Item no., Rm no. and Name	Existing Architectural Barrier and Proposed Solution	Codes / Mitigation Info	Qty	Unit	Cost	Total
569	<ul style="list-style-type: none"> • As-Built Description: Accessible non-fixed table or desk (top 28" to 34" high; knee space at least 27" high x 19" deep x 30" wide) not provided. • Proposed Solution: Provide table or desk with accessible dimensions when purchasing new furniture. 	PCODE IN02A ADAAG 91 4.32.3 & .4 ADA 2010 306.1 CBC 2007 1122B.3 & 4 CBC 2016 11B-306.1 & 11B-902.3 Mitigated: <input type="radio"/> YES <input checked="" type="radio"/> NO	1	JOB	\$4,800	\$4,800

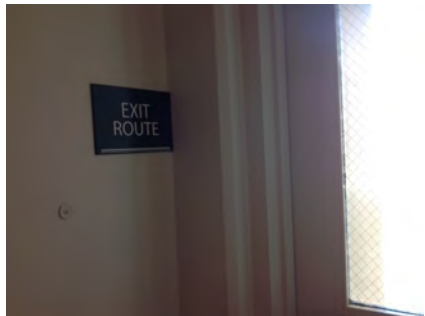
<input type="checkbox"/> Staff Only						
Priority 4 Severity 2						
<hr/>						
<u>Signage</u>						
566	<ul style="list-style-type: none"> • As-Built Description: Sign not located on latch side of door and/or not located at 48" min. above to baseline of the lowest Braille cells and 60" max. to baseline of the highest line of raised characters. • Proposed Solution: Provide compliant signage including tactile characters and Grade II Braille on latch side of door located at compliant height. 	PCODE SA07 ADAAG 91 4.30.6 ADA 2010 703.4.1 CBC 2007 1117B.5.7 CBC 2016 11B-703.4.1 Mitigated: <input type="radio"/> YES <input checked="" type="radio"/> NO	1	JOB	\$150	\$150

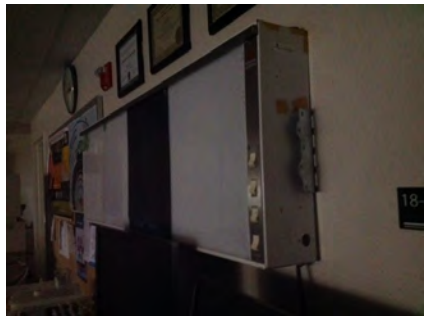
Item no., Rm no. and Name	Existing Architectural Barrier and Proposed Solution	Codes / Mitigation Info	Qty	Unit	Cost	Total
580	<ul style="list-style-type: none"> As-Built Description: Reach height to control or access point, exceeds 48" or is less than 15". As-Built: 60" high Proposed Solution: Modify equipment or mounting. 	PCODE IE01 ADAAG 91 4.2.5 ADA 2010 308.2.1 CBC 2007 1118B.5 CBC 2016 11B-308.2.1 Mitigated: <input type="radio"/> YES <input checked="" type="radio"/> NO	1	JOB	\$300	\$300

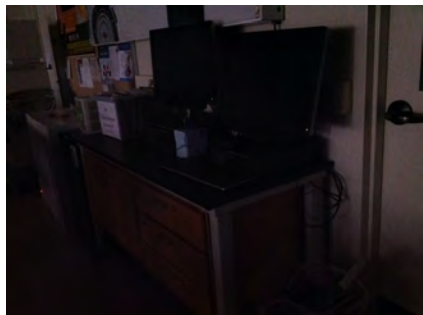
Non-Fixed Desk

579	<ul style="list-style-type: none"> As-Built Description: Accessible non-fixed table or desk (top 28" to 34" high; knee space at least 27" high x 19" deep x 30" wide) not provided. As-Built: No knee clearance Proposed Solution: Provide table or desk with accessible dimensions when purchasing new furniture. 	PCODE IN02A ADAAG 91 4.32.3 & .4 ADA 2010 306.1 CBC 2007 1122B.3 & 4 CBC 2016 11B-306.1 & 11B-902.3 Mitigated: <input type="radio"/> YES <input checked="" type="radio"/> NO	1	JOB	\$4,800	\$4,800

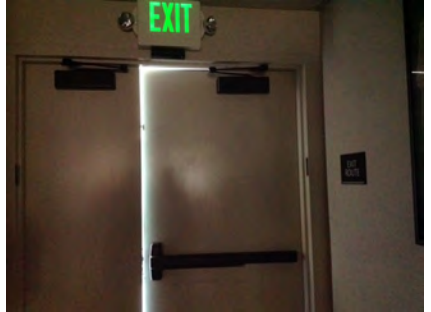
Item no., Rm no. and Name	Existing Architectural Barrier and Proposed Solution	Codes / Mitigation Info	Qty	Unit	Cost	Total
Signage						
577	<ul style="list-style-type: none"> • <i>As-Built Description:</i> Sign not located on latch side of door and/or not located at 48" min. above to baseline of the lowest Braille cells and 60" max. to baseline of the highest line of raised characters. • <i>Proposed Solution:</i> Provide compliant signage including tactile characters and Grade II Braille on latch side of door located at compliant height. 	PCODE SA07 ADAAG 91 4.30.6 ADA 2010 703.4.1 CBC 2007 1117B.5.7 CBC 2016 11B-703.4.1 Mitigated: <input type="radio"/> YES <input checked="" type="radio"/> NO	1	JOB	\$150	\$150

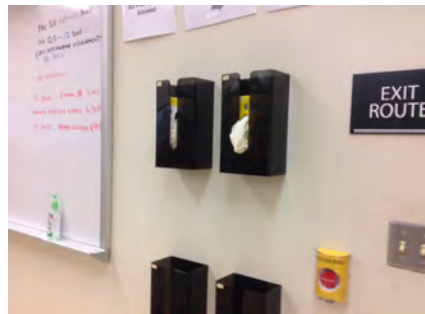
Item no., Rm no. and Name	Existing Architectural Barrier and Proposed Solution	Codes / Mitigation Info	Qty	Unit	Cost	Total
<u>Reach Range</u>						
584	<ul style="list-style-type: none">As-Built Description: Reach height to control or access point, exceeds 48" or is less than 15".As-Built: 57" highProposed Solution: Modify equipment or mounting.	PCODE IE01 ADAAG 91 4.2.5 ADA 2010 308.2.1 CBC 2007 1118B.5 CBC 2016 11B-308.2.1 Mitigated: <input type="radio"/> YES <input checked="" type="radio"/> NO	1	JOB	\$300	\$300

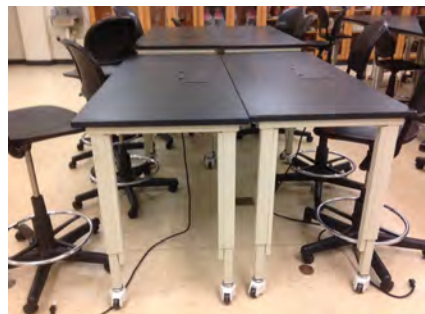
<input type="checkbox"/> Staff Only			
			Priority		Severity	
			2		3	
<u>Non-Fixed Desk</u>						
585	<ul style="list-style-type: none">As-Built Description: Accessible non-fixed table or desk (top 28" to 34" high; knee space at least 27" high x 19" deep x 30" wide) not provided.Proposed Solution: Provide table or desk with accessible dimensions when purchasing new furniture.Notes: 32 seats, no accessible	PCODE IN02A ADAAG 91 4.32.3 & .4 ADA 2010 306.1 CBC 2007 1122B.3 & 4 CBC 2016 11B-306.1 & 11B-902.3 Mitigated: <input type="radio"/> YES <input checked="" type="radio"/> NO	1	JOB	\$4,800	\$4,800

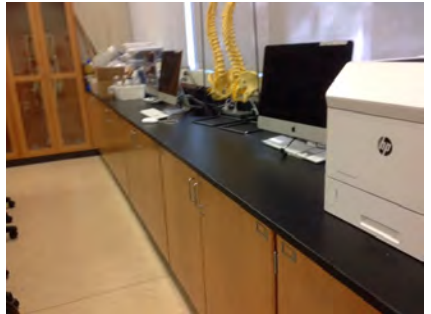
Item no., Rm no. and Name	Existing Architectural Barrier and Proposed Solution	Codes / Mitigation Info	Qty	Unit	Cost	Total
587	<ul style="list-style-type: none"> As-Built Description: Accessible non-fixed table or desk (top 28" to 34" high; knee space at least 27" high x 19" deep x 30" wide) not provided. Proposed Solution: Provide table or desk with accessible dimensions when purchasing new furniture. 	PCODE IN02A ADAAG 91 4.32.3 & .4 ADA 2010 306.1 CBC 2007 1122B.3 & 4 CBC 2016 11B-306.1 & 11B-902.3 Mitigated: <input type="radio"/> YES <input checked="" type="radio"/> NO	1	JOB	\$4,800	\$4,800

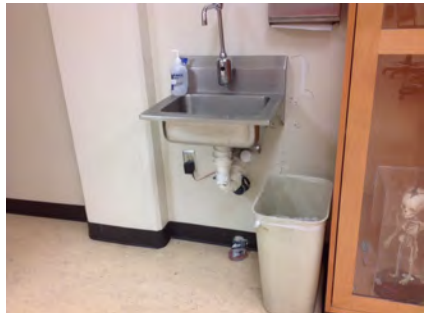
Sink

586	<ul style="list-style-type: none"> As-Built Description: Sink does not have knee space min. 27" high x 19" deep x 30" wide. Proposed Solution: Remodel sink cabinet. 	PCODE IN06A ADAAG 91 4.24.3 ADA 2010 606.2 CBC 2007 1115B.4.7.1 CBC 2016 11B-606.2 Mitigated: <input type="radio"/> YES <input checked="" type="radio"/> NO	1	JOB	\$5,250	\$5,250

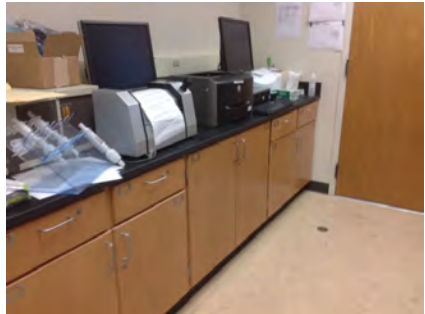
Item no., Rm no. and Name	Existing Architectural Barrier and Proposed Solution	Codes / Mitigation Info	Qty	Unit	Cost	Total
600	<ul style="list-style-type: none"> As-Built Description: Accessible non-fixed table or desk (top 28" to 34" high; knee space at least 27" high x 19" deep x 30" wide) not provided. As-Built: No knee clearance Proposed Solution: Provide table or desk with accessible dimensions when purchasing new furniture. Notes: Staff Area 	PCODE IN02A ADAAG 91 4.32.3 & .4 ADA 2010 306.1 CBC 2007 1122B.3 & 4 CBC 2016 11B-306.1 & 11B-902.3 Mitigated: <input type="radio"/> YES <input checked="" type="radio"/> NO	1	JOB	\$4,800	\$4,800

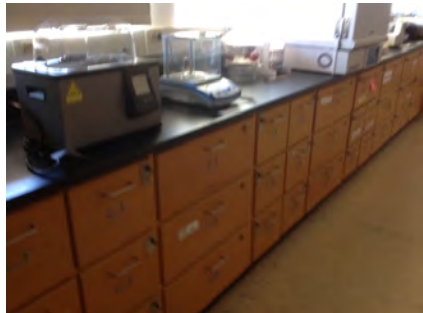
Public Counter

599	<ul style="list-style-type: none"> As-Built Description: Service counter (stand-up): Accessible section min. 36" length and 36" max. height (in CA: 28" to 34" high) not provided. As-Built: 36" high Proposed Solution: Retrofit existing counter to provide accessible section. Interim solution: Provide auxiliary counter, table, or clipboard. 	PCODE IN03 ADAAG 91 7.2(2) ADA 2010 904.4 CBC 2007 1122B.4 CBC 2016 11B-904.4 Mitigated: <input type="radio"/> YES <input checked="" type="radio"/> NO	1	JOB	\$6,000	\$6,000

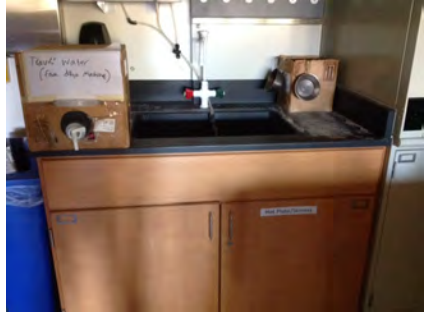
Item no., Rm no. and Name	Existing Architectural Barrier and Proposed Solution	Codes / Mitigation Info	Qty	Unit	Cost	Total
Sink						
596	<ul style="list-style-type: none"> • <i>As-Built Description:</i> Sink does not have knee space min. 27" high x 19" deep x 30" wide. • <i>Proposed Solution:</i> Remodel sink cabinet. 	PCODE IN06A ADAAG 91 4.24.3 ADA 2010 606.2 CBC 2007 1115B.4.7.1 CBC 2016 11B-606.2 Mitigated: <input type="radio"/> YES <input checked="" type="radio"/> NO	1	JOB	\$5,250	\$5,250

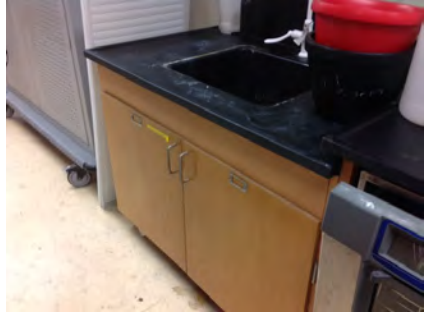
Item no., Rm no. and Name	Existing Architectural Barrier and Proposed Solution	Codes / Mitigation Info	Qty	Unit	Cost	Total
Sink						
602	<ul style="list-style-type: none"> • <i>As-Built Description:</i> Sink does not have knee space min. 27" high x 19" deep x 30" wide. • <i>Proposed Solution:</i> Remodel sink cabinet. 	PCODE IN06A ADAAG 91 4.24.3 ADA 2010 606.2 CBC 2007 1115B.4.7.1 CBC 2016 11B-606.2 Mitigated: <input type="radio"/> YES <input checked="" type="radio"/> NO	1	JOB	\$5,250	\$5,250

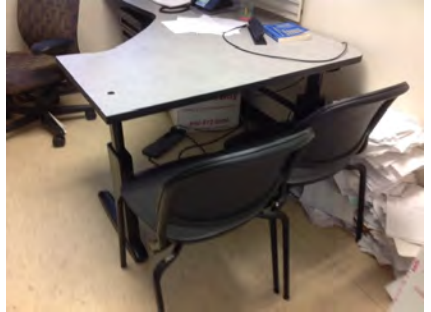
Item no., Rm no. and Name	Existing Architectural Barrier and Proposed Solution	Codes / Mitigation Info	Qty	Unit	Cost	Total
Non-Fixed Desk						
605	<ul style="list-style-type: none"> • <i>As-Built Description:</i> Accessible non-fixed table or desk (top 28" to 34" high; knee space at least 27" high x 19" deep x 30" wide) not provided. • <i>As-Built:</i> No knee on student side if used as work surface • <i>Proposed Solution:</i> Provide table or desk with accessible dimensions when purchasing new furniture. 	PCODE IN02A ADAAG 91 4.32.3 & .4 ADA 2010 306.1 CBC 2007 1122B.3 & 4 CBC 2016 11B-306.1 & 11B-902.3 Mitigated: <input type="radio"/> YES <input checked="" type="radio"/> NO	6	JOB	\$4,800	\$28,800

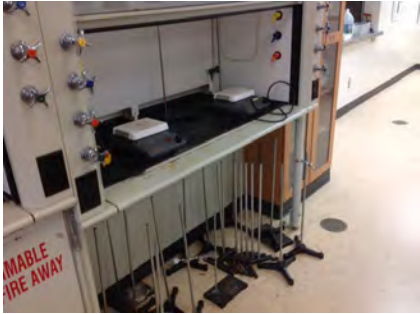
Item no., Rm no. and Name	Existing Architectural Barrier and Proposed Solution	Codes / Mitigation Info	Qty	Unit	Cost	Total
<u>Reach Range</u>						
611	<ul style="list-style-type: none">As-Built Description: Reach height to control or access point, exceeds 48" or is less than 15".As-Built: 54" reachProposed Solution: Modify equipment or mounting.	PCODE IE01 ADAAG 91 4.2.5 ADA 2010 308.2.1 CBC 2007 1118B.5 CBC 2016 11B-308.2.1 Mitigated: <div><input type="radio"/> YES</div> <div><input checked="" type="radio"/> NO</div>	1	JOB	\$300	\$300

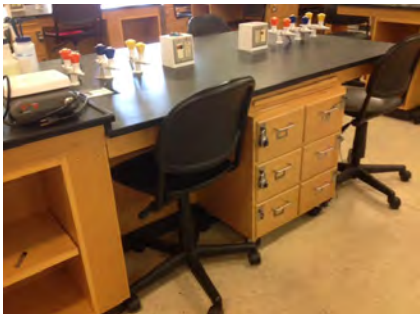
<u>Non-Fixed Desk</u>						
609	<ul style="list-style-type: none">As-Built Description: Accessible non-fixed table or desk (top 28" to 34" high; knee space at least 27" high x 19" deep x 30" wide) not provided.As-Built: 24" wideProposed Solution: Provide table or desk with accessible dimensions when purchasing new furniture.	PCODE IN02A ADAAG 91 4.32.3 & .4 ADA 2010 306.1 CBC 2007 1122B.3 & 4 CBC 2016 11B-306.1 & 11B-902.3 Mitigated: <div><input type="radio"/> YES</div> <div><input checked="" type="radio"/> NO</div>	1	JOB	\$4,800	\$4,800

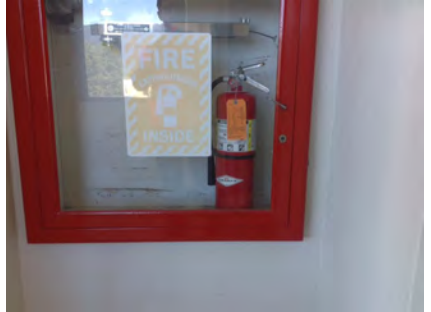
Item no., Rm no. and Name	Existing Architectural Barrier and Proposed Solution	Codes / Mitigation Info	Qty	Unit	Cost	Total
Reach Range						
612	<ul style="list-style-type: none"> • <i>As-Built Description:</i> Reach height to control or access point, exceeds 48" or is less than 15". • <i>As-Built:</i> 52" high • <i>Proposed Solution:</i> Modify equipment or mounting. 	PCODE IE01 ADAAG 91 4.2.5 ADA 2010 308.2.1 CBC 2007 1118B.5 CBC 2016 11B-308.2.1 Mitigated: <input type="radio"/> YES <input checked="" type="radio"/> NO	2	JOB	\$300	\$600

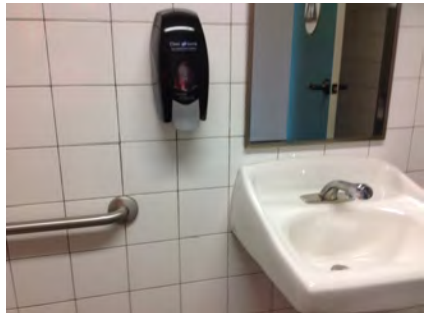
Item no., Rm no. and Name	Existing Architectural Barrier and Proposed Solution	Codes / Mitigation Info	Qty	Unit	Cost	Total
Accessories						
616	<ul style="list-style-type: none"> • <i>As-Built Description:</i> Dispensers in sanitary facilities, such as for towels, soap, sanitary napkins, seat covers, etc., and waste receptacles more than 48" (CA only: 40") from floor to highest operating slot or control. • <i>As-Built:</i> 43" high • <i>Proposed Solution:</i> Relocate existing restroom accessories. 	PCODE WG01A ADAAG 91 4.23.7 ADA 2010 308.2.1 CBC 2007 1115B.8.3 CBC 2016 11B-603.5 Mitigated: <input type="radio"/> YES <input checked="" type="radio"/> NO	1	JOB	\$300	\$300

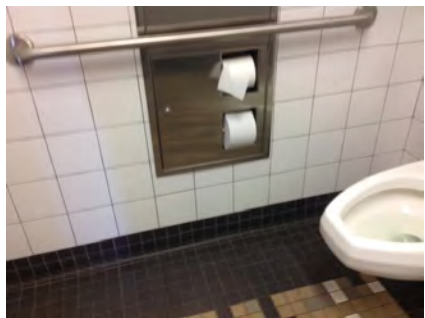
<input type="checkbox"/> Staff Only Priority 3 Severity 4			
619	<ul style="list-style-type: none"> • <i>As-Built Description:</i> Toilet paper dispenser less than 15" (CA: 19") or more than 48" above floor or not within 7" to 9" from front of water closet (Note: CA pre-2010 is allowed within 12" from front of water closet). • <i>As-Built:</i> 5" o.c. • <i>Proposed Solution:</i> Relocate or provide new toilet paper dispenser. 	PCODE WG02 ADAAG 91 4.16.6 ADA 2010 604.7 CBC 2007 1115B.8.4 CBC 2016 11B-604.7 Mitigated: <input type="radio"/> YES <input checked="" type="radio"/> NO	1	JOB	\$225	\$225

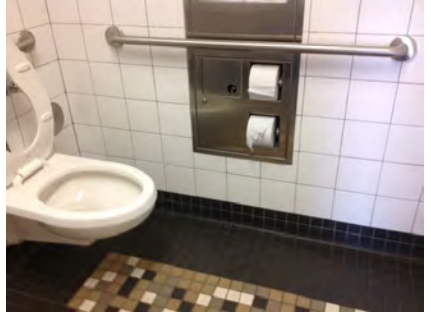
Item no., Rm no. and Name	Existing Architectural Barrier and Proposed Solution	Codes / Mitigation Info	Qty	Unit	Cost	Total
<u>Accessories</u>						
622	<ul style="list-style-type: none"> • <i>As-Built Description:</i> Toilet paper dispenser less than 15" (CA: 19") or more than 48" above floor or not within 7" to 9" from front of water closet (Note: CA pre-2010 is allowed within 12" from front of water closet). • <i>As-Built:</i> 12" o.c. • <i>Proposed Solution:</i> Relocate or provide new toilet paper dispenser. 	PCODE WG02 ADAAG 91 4.16.6 ADA 2010 604.7 CBC 2007 1115B.8.4 CBC 2016 11B-604.7 Mitigated: <input type="radio"/> YES <input checked="" type="radio"/> NO	1	JOB	\$225	\$225

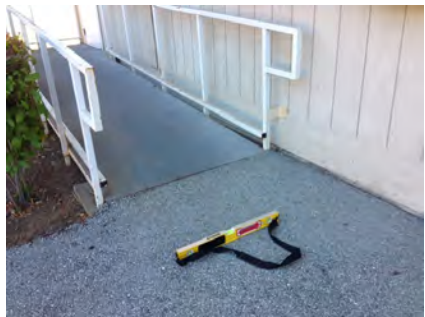
Item no., Rm no. and Name	Existing Architectural Barrier and Proposed Solution	Codes / Mitigation Info	Qty	Unit	Cost	Total
Slope						
297	<ul style="list-style-type: none"> As-Built Description: Level 2% max. landing for ramp not provided. As-Built: 3.4% Proposed Solution: Rebuild ramp to provide landings for each ramp run with slopes no greater than 2% 	PCODE EB05A ADAAG 91 4.8.4 ADA 2010 405.7.1 CBC 2007 1133B.5.4.1 CBC 2016 11B-405.7.1 Mitigated: <input type="radio"/> YES <input checked="" type="radio"/> NO	20	SF	\$300	\$6,000

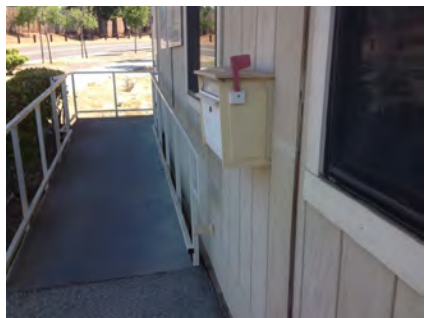
Protrusion Limits						
298	<ul style="list-style-type: none"> As-Built Description: Protruding objects more than 4" from wall, when bottom of object more than 27" or less than 80" above finished floor. As-Built: Mail box protrudes 7" at 40" high Proposed Solution: Provide cane-detectable railing to mark area of low clearance. 	PCODE EG04A ADAAG 91 4.4.1 ADA 2010 307.2 CBC 2007 1133B.8.6.1 CBC 2016 11B-307.2 Mitigated: <input type="radio"/> YES <input checked="" type="radio"/> NO	1	LF	\$300	\$300

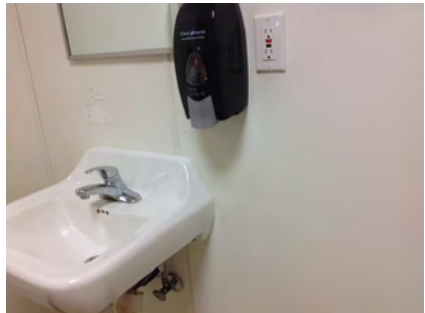
Item no., Rm no. and Name	Existing Architectural Barrier and Proposed Solution	Codes / Mitigation Info	Qty	Unit	Cost	Total
Accessories						
304	<ul style="list-style-type: none"> • <i>As-Built Description:</i> Dispensers in sanitary facilities, such as for towels, soap, sanitary napkins, seat covers, etc., and waste receptacles more than 48" (CA only: 40") from floor to highest operating slot or control. • <i>As-Built:</i> 42" high • <i>Proposed Solution:</i> Relocate existing restroom accessories. 	PCODE WG01A ADAAG 91 4.23.7 ADA 2010 308.2.1 CBC 2007 1115B.8.3 CBC 2016 11B-603.5 Mitigated: <input type="radio"/> YES <input checked="" type="radio"/> NO	1	JOB	\$300	\$300

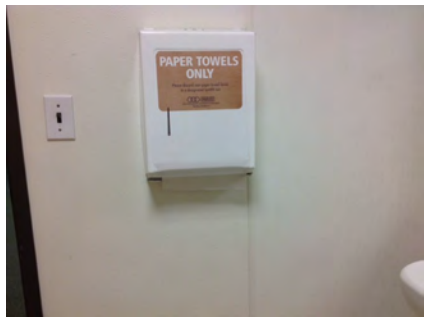
<input type="checkbox"/> Staff Only Priority 3 Severity 4			
305	<ul style="list-style-type: none"> • <i>As-Built Description:</i> Dispensers in sanitary facilities, such as for towels, soap, sanitary napkins, seat covers, etc., and waste receptacles more than 48" (CA only: 40") from floor to highest operating slot or control. • <i>As-Built:</i> 42" high • <i>Proposed Solution:</i> Relocate existing restroom accessories. 	PCODE WG01A ADAAG 91 4.23.7 ADA 2010 308.2.1 CBC 2007 1115B.8.3 CBC 2016 11B-603.5 Mitigated: <input type="radio"/> YES <input checked="" type="radio"/> NO	1	JOB	\$300	\$300

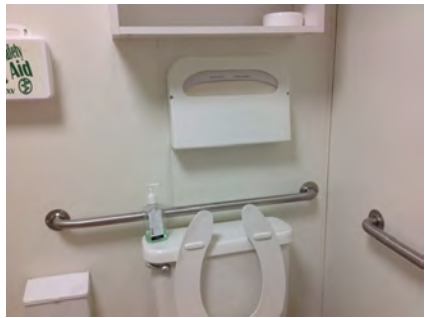
<input type="checkbox"/> Staff Only Priority 3 Severity 4			
306	<ul style="list-style-type: none"> • <i>As-Built Description:</i> Dispensers in sanitary facilities, such as for towels, soap, sanitary napkins, seat covers, etc., and waste receptacles more than 48" (CA only: 40") from floor to highest operating slot or control. • <i>As-Built:</i> 50" high • <i>Proposed Solution:</i> Relocate existing restroom accessories. • <i>Notes:</i> First aid and seat cover 	PCODE WG01A ADAAG 91 4.23.7 ADA 2010 308.2.1 CBC 2007 1115B.8.3 CBC 2016 11B-603.5 Mitigated: <input type="radio"/> YES <input checked="" type="radio"/> NO	1	JOB	\$300	\$300

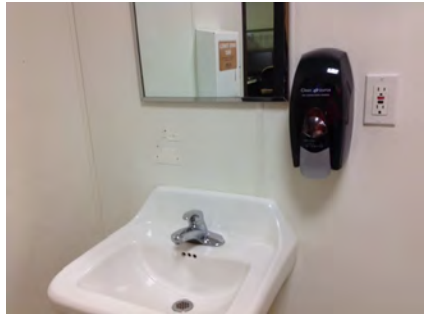
Item no., Rm no. and Name	Existing Architectural Barrier and Proposed Solution	Codes / Mitigation Info	Qty	Unit	Cost	Total
303	<ul style="list-style-type: none"> As-Built Description: Bottom of mirror located above lavatories or countertops more than 40" above floor. As-Built: 48" high Proposed Solution: Relocate or provide new accessible mirror. 	PCODE WG03 ADAAG 91 4.19.6 ADA 2010 603.3 CBC 2007 1115B.8.1 CBC 2016 11B-603.3 Mitigated: <input type="radio"/> YES <input checked="" type="radio"/> NO	1	JOB	\$450	\$450

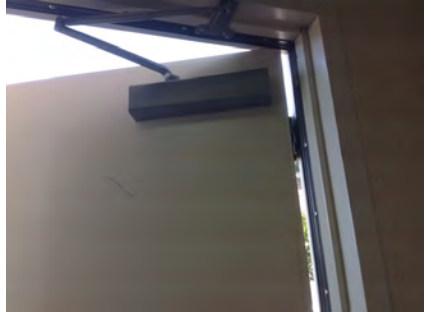
Item no., Rm no. and Name	Existing Architectural Barrier and Proposed Solution	Codes / Mitigation Info	Qty	Unit	Cost	Total
Door Closer						
285	<ul style="list-style-type: none"> • <i>As-Built Description:</i> Excessive force required to open door. • <i>As-Built:</i> 9 lbs. • <i>Proposed Solution:</i> Adjust regular door closer to accessible standards (5 lbs. max). 	PCODE ID03 ADAAG 91 4.13.11 ADA 2010 404.2.9 CBC 2007 1133B.2.5 CBC 2016 11B-404.2.9 Mitigated: <input type="radio"/> YES <input checked="" type="radio"/> NO	1	JOB	\$75	\$75

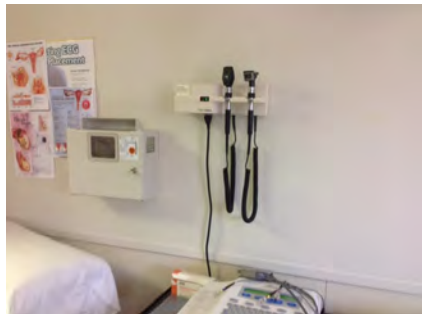
Item no., Rm no. and Name	Existing Architectural Barrier and Proposed Solution	Codes / Mitigation Info	Qty	Unit	Cost	Total
288	<ul style="list-style-type: none"> As-Built Description: Reach height to control or access point, exceeds 48" or is less than 15". As-Built: Nursing equipment 60" high Proposed Solution: Modify equipment or mounting. 	PCODE IE01 ADAAG 91 4.2.5 ADA 2010 308.2.1 CBC 2007 1118B.5 CBC 2016 11B-308.2.1 Mitigated: <input type="radio"/> YES <input checked="" type="radio"/> NO	1	JOB	\$300	\$300

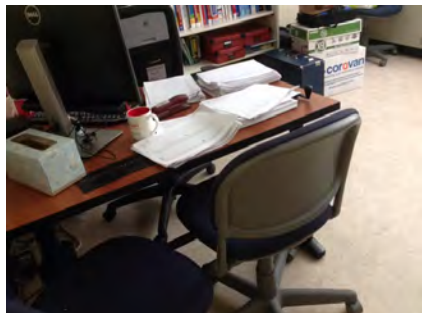
290	<ul style="list-style-type: none"> As-Built Description: Accessible non-fixed table or desk (top 28" to 34" high; knee space at least 27" high x 19" deep x 30" wide) not provided. As-Built: No knee clearance if used as work surface for students Proposed Solution: Provide table or desk with accessible dimensions when purchasing new furniture. Notes: Lounge used as staff offices. 	PCODE IN02A ADAAG 91 4.32.3 & .4 ADA 2010 306.1 CBC 2007 1122B.3 & 4 CBC 2016 11B-306.1 & 11B-902.3 Mitigated: <input type="radio"/> YES <input checked="" type="radio"/> NO	1	JOB	\$4,800	\$4,800

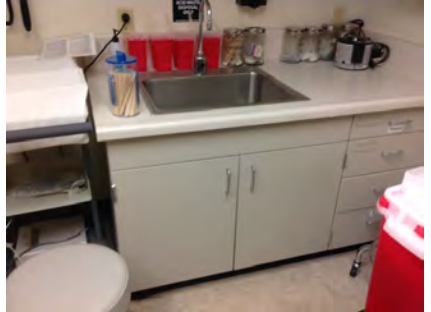
Item no., Rm no. and Name	Existing Architectural Barrier and Proposed Solution	Codes / Mitigation Info	Qty	Unit	Cost	Total
Sink						
289	<ul style="list-style-type: none"> • <i>As-Built Description:</i> Sink does not have knee space min. 27" high x 19" deep x 30" wide. • <i>Proposed Solution:</i> Remodel sink cabinet. 	PCODE IN06A ADAAG 91 4.24.3 ADA 2010 606.2 CBC 2007 1115B.4.7.1 CBC 2016 11B-606.2 Mitigated: <input type="radio"/> YES <input checked="" type="radio"/> NO	1	JOB	\$5,250	\$5,250

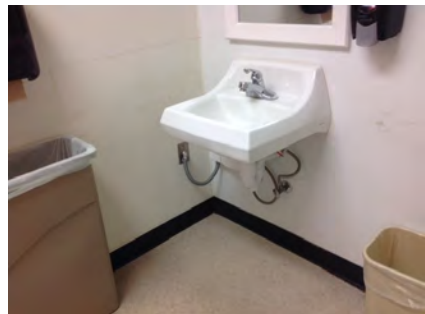
Item no., Rm no. and Name	Existing Architectural Barrier and Proposed Solution	Codes / Mitigation Info	Qty	Unit	Cost	Total
<u>Lavatory</u>						
291	<ul style="list-style-type: none">• <i>As-Built Description:</i> Wheelchair clearance under lavatory apron or lavatory counter front edge less than 29" high.• <i>As-Built:</i> 28" high• <i>Proposed Solution:</i> Provide new accessible lavatory. Remodel restroom as needed.	<p>PCODE WD03</p> <p>ADAAG 91 4.19.2</p> <p>ADA 2010 606.3</p> <p>CBC 2007 1115B.4.3.3</p> <p>CBC 2016 11B-306.3.1</p> <p>Mitigated:</p> <p><input type="radio"/> YES</p> <p><input checked="" type="radio"/> NO</p>	1	JOB	\$10,200	\$10,200

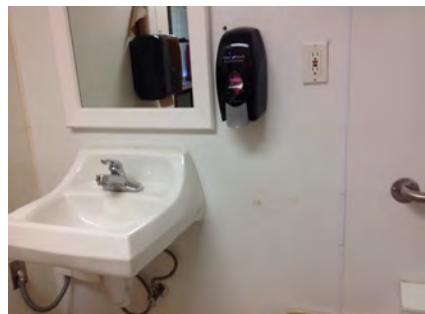
<input type="checkbox"/> Staff Only			
			Priority		Severity	
			3		2	
<u>Accessories</u>						
293	<ul style="list-style-type: none">• <i>As-Built Description:</i> Dispensers in sanitary facilities, such as for towels, soap, sanitary napkins, seat covers, etc., and waste receptacles more than 48" (CA only: 40") from floor to highest operating slot or control.• <i>As-Built:</i> Soap 42" high• <i>Proposed Solution:</i> Relocate existing restroom accessories.	<p>PCODE WG01A</p> <p>ADAAG 91 4.23.7</p> <p>ADA 2010 308.2.1</p> <p>CBC 2007 1115B.8.3</p> <p>CBC 2016 11B-603.5</p> <p>Mitigated:</p> <p><input type="radio"/> YES</p> <p><input checked="" type="radio"/> NO</p>	1	JOB	\$300	\$300

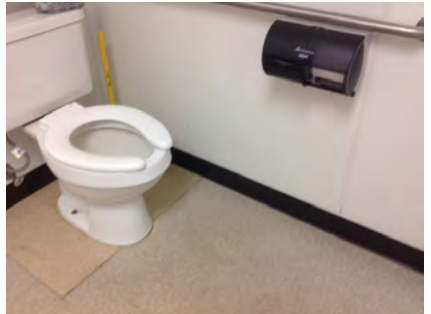
Item no., Rm no. and Name	Existing Architectural Barrier and Proposed Solution	Codes / Mitigation Info	Qty	Unit	Cost	Total
296	<ul style="list-style-type: none"> As-Built Description: Toilet paper dispenser less than 15" (CA: 19") or more than 48" above floor or not within 7" to 9" from front of water closet (Note: CA pre-2010 is allowed within 12" from front of water closet). As-Built: 14" o.c. Proposed Solution: Relocate or provide new toilet paper dispenser. 	PCODE WG02 ADAAG 91 4.16.6 ADA 2010 604.7 CBC 2007 1115B.8.4 CBC 2016 11B-604.7 Mitigated: <input type="radio"/> YES <input checked="" type="radio"/> NO	1	JOB	\$225	\$225

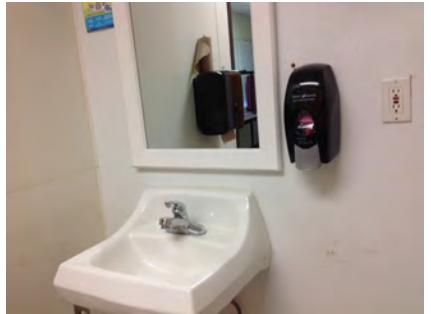
<input type="checkbox"/> Staff Only Priority 3 Severity 3			
292	<ul style="list-style-type: none"> As-Built Description: Bottom of mirror located above lavatories or countertops more than 40" above floor. As-Built: 43" high Proposed Solution: Relocate or provide new accessible mirror. 	PCODE WG03 ADAAG 91 4.19.6 ADA 2010 603.3 CBC 2007 1115B.8.1 CBC 2016 11B-603.3 Mitigated: <input type="radio"/> YES <input checked="" type="radio"/> NO	1	JOB	\$450	\$450

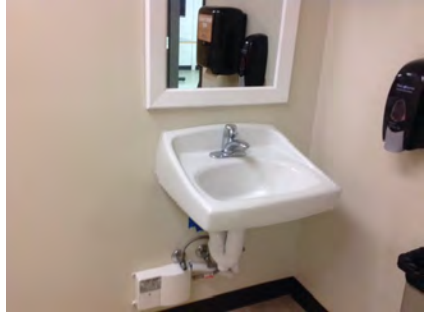
Item no., Rm no. and Name	Existing Architectural Barrier and Proposed Solution	Codes / Mitigation Info	Qty	Unit	Cost	Total
<u>Accessories</u>						
314	<ul style="list-style-type: none"> • <i>As-Built Description:</i> Bottom of mirror located above lavatories or countertops more than 40" above floor. • <i>As-Built:</i> 43" high • <i>Proposed Solution:</i> Relocate or provide new accessible mirror. 	PCODE WG03 ADAAG 91 4.19.6 ADA 2010 603.3 CBC 2007 1115B.8.1 CBC 2016 11B-603.3 Mitigated: <input type="radio"/> YES <input checked="" type="radio"/> NO	1	JOB	\$450	\$450

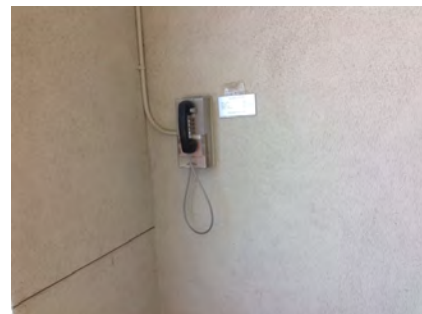
The telephone is not TTY capable. We recommend as best practice to provide TTY on each floor of the building.

CBC 2016 11B-308.2.1

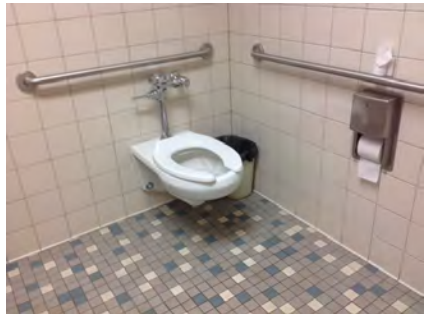
Item no., Rm no. and Name	Existing Architectural Barrier and Proposed Solution	Codes / Mitigation Info	Qty	Unit	Cost	Total
Water Closet						
345	<ul style="list-style-type: none"> • <i>As-Built Description:</i> Water closet not 16"-18" (CA: 17"-18") from near side wall to center line of water closet (2010 ADAAG: 16"-18"). • <i>As-Built:</i> 19" o.c. • <i>Proposed Solution:</i> Relocate existing water closet and plumbing, remount with offset closet flange to provide 18" max. from side wall. 	PCODE WB02C ADAAG 91 Fig. 28 ADA 2010 604.2 CBC 2007 1115B.4.1.1 CBC 2016 11B-604.2 Mitigated: <input type="radio"/> YES <input checked="" type="radio"/> NO	1	JOB	\$1,500	\$1,500
