SAN MATEO COUNTY
COMMUNITY
COLLEGE DISTRICT

San Mateo County Community College District Americans with Disabilities Act Self-Evaluation and Transition Plan

Report Prepared by:

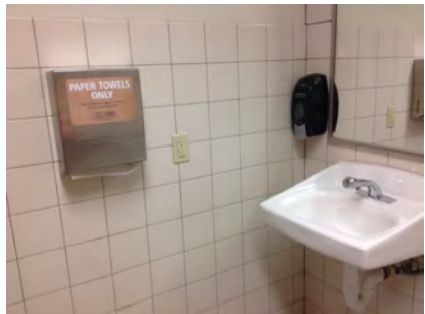
<input type="checkbox"/> Staff Only			
			Priority		Severity	
			3		4	
Accessories						
343	<ul style="list-style-type: none"> • <i>As-Built Description:</i> Dispensers in sanitary facilities, such as for towels, soap, sanitary napkins, seat covers, etc., and waste receptacles more than 48" (CA only: 40") from floor to highest operating slot or control. • <i>As-Built:</i> 41" high • <i>Proposed Solution:</i> Relocate existing restroom accessories. 	PCODE WG01A ADAAG 91 4.23.7 ADA 2010 308.2.1 CBC 2007 1115B.8.3 CBC 2016 11B-603.5 Mitigated: <input type="radio"/> YES <input checked="" type="radio"/> NO	2	JOB	\$300	\$600

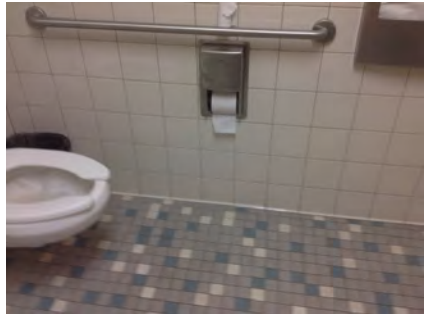
Item no., Rm no. and Name	Existing Architectural Barrier and Proposed Solution	Codes / Mitigation Info	Qty	Unit	Cost	Total
347	<ul style="list-style-type: none"> As-Built Description: Toilet paper dispenser less than 15" (CA: 19") or more than 48" above floor or not within 7" to 9" from front of water closet (Note: CA pre-2010 is allowed within 12" from front of water closet). As-Built: 13" o.c. Proposed Solution: Relocate or provide new toilet paper dispenser. 	PCODE WG02 ADAAG 91 4.16.6 ADA 2010 604.7 CBC 2007 1115B.8.4 CBC 2016 11B-604.7 Mitigated: <input type="radio"/> YES <input checked="" type="radio"/> NO	1	JOB	\$225	\$225

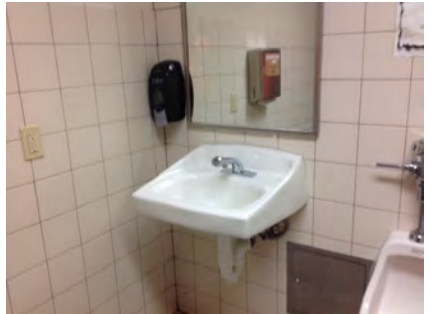
<input type="checkbox"/> Staff Only			
			Priority <input checked="" type="radio"/> 3		Severity <input checked="" type="radio"/> 3	
342	<ul style="list-style-type: none"> As-Built Description: Bottom of mirror located above lavatories or countertops more than 40" above floor. As-Built: 41" high Proposed Solution: Relocate or provide new accessible mirror. 	PCODE WG03 ADAAG 91 4.19.6 ADA 2010 603.3 CBC 2007 1115B.8.1 CBC 2016 11B-603.3 Mitigated: <input type="radio"/> YES <input checked="" type="radio"/> NO	1	JOB	\$450	\$450

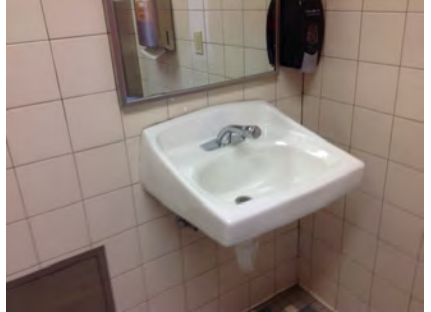
Item no., Rm no. and Name	Existing Architectural Barrier and Proposed Solution	Codes / Mitigation Info	Qty	Unit	Cost	Total
<u>Accessories</u>						
350	<ul style="list-style-type: none"> • <i>As-Built Description:</i> Bottom of mirror located above lavatories or countertops more than 40" above floor. • <i>As-Built:</i> 41" high • <i>Proposed Solution:</i> Relocate or provide new accessible mirror. 	PCODE WG03 ADAAG 91 4.19.6 ADA 2010 603.3 CBC 2007 1115B.8.1 CBC 2016 11B-603.3 Mitigated: <input type="radio"/> YES <input checked="" type="radio"/> NO	1	JOB	\$450	\$450

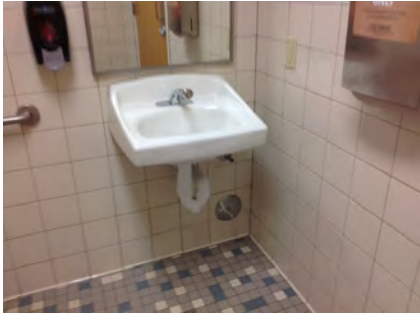
Item no., Rm no. and Name	Existing Architectural Barrier and Proposed Solution	Codes / Mitigation Info	Qty	Unit	Cost	Total
Lavatory						
369	<ul style="list-style-type: none">• <i>As-Built Description:</i> Clear floor space, 30" x 48" in front of fixture, extending 19" max. under the lavatory, not provided (CA only: Less than 18" from side wall to centerline of lavatory).• <i>As-Built:</i> 16" o.c.• <i>Proposed Solution:</i> Provide new accessible lavatory. Remodel restroom as needed.	<p>PCODE WD01</p> <p>ADAAG 91 4.19.3</p> <p>ADA 2010 606.2</p> <p>CBC 2007 1115B.4.3</p> <p>CBC 2016 11B-606.2, 11B-606.6</p> <p>Mitigated:</p> <p><input type="radio"/> YES</p> <p><input checked="" type="radio"/> NO</p>	1	JOB	\$10,200	\$10,200

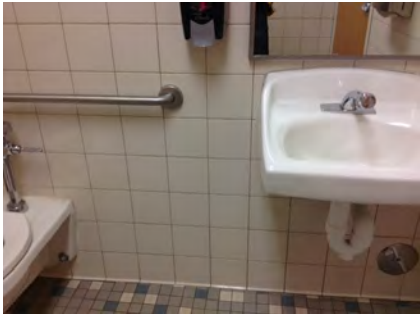
<input type="checkbox"/> Staff Only			
			Priority		Severity	
			3		2	
Accessories						
370	<ul style="list-style-type: none">• <i>As-Built Description:</i> Dispensers in sanitary facilities, such as for towels, soap, sanitary napkins, seat covers, etc., and waste receptacles more than 48" (CA only: 40") from floor to highest operating slot or control.• <i>As-Built:</i> 40.5" high• <i>Proposed Solution:</i> Relocate existing restroom accessories.	<p>PCODE WG01A</p> <p>ADAAG 91 4.23.7</p> <p>ADA 2010 308.2.1</p> <p>CBC 2007 1115B.8.3</p> <p>CBC 2016 11B-603.5</p> <p>Mitigated:</p> <p><input type="radio"/> YES</p> <p><input checked="" type="radio"/> NO</p>	1	JOB	\$300	\$300

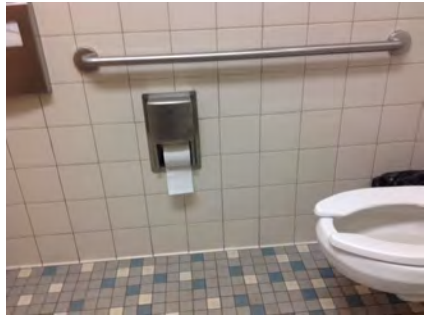
Item no., Rm no. and Name	Existing Architectural Barrier and Proposed Solution	Codes / Mitigation Info	Qty	Unit	Cost	Total
375	<ul style="list-style-type: none"> • <i>As-Built Description:</i> Toilet paper dispenser less than 15" (CA: 19") or more than 48" above floor or not within 7" to 9" from front of water closet (Note: CA pre-2010 is allowed within 12" from front of water closet). • <i>As-Built:</i> 18" o.c. • <i>Proposed Solution:</i> Relocate or provide new toilet paper dispenser. 	PCODE WG02 ADAAG 91 4.16.6 ADA 2010 604.7 CBC 2007 1115B.8.4 CBC 2016 11B-604.7 Mitigated: <input type="radio"/> YES <input checked="" type="radio"/> NO	1	JOB	\$225	\$225

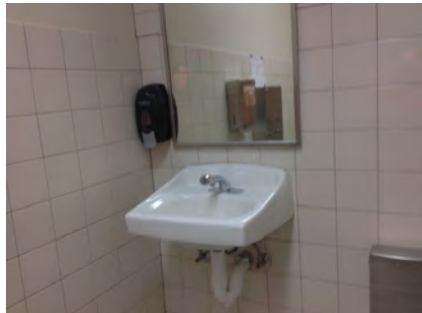
Item no., Rm no. and Name	Existing Architectural Barrier and Proposed Solution	Codes / Mitigation Info	Qty	Unit	Cost	Total
Accessories						
378	<ul style="list-style-type: none"> • <i>As-Built Description:</i> Dispensers in sanitary facilities, such as for towels, soap, sanitary napkins, seat covers, etc., and waste receptacles more than 48" (CA only: 40") from floor to highest operating slot or control. • <i>As-Built:</i> 41" high • <i>Proposed Solution:</i> Relocate existing restroom accessories. 	PCODE WG01A ADAAG 91 4.23.7 ADA 2010 308.2.1 CBC 2007 1115B.8.3 CBC 2016 11B-603.5 Mitigated: <input type="radio"/> YES <input checked="" type="radio"/> NO	1	JOB	\$300	\$300

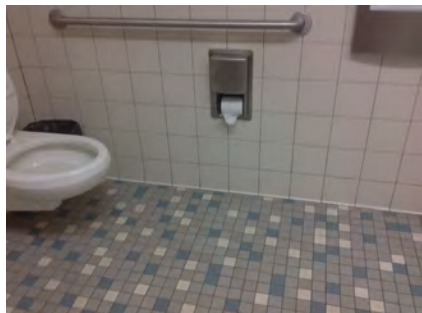
<input type="checkbox"/> Staff Only Priority 3 Severity 4			
380	<ul style="list-style-type: none"> • <i>As-Built Description:</i> Toilet paper dispenser less than 15" (CA: 19") or more than 48" above floor or not within 7" to 9" from front of water closet (Note: CA pre-2010 is allowed within 12" from front of water closet). • <i>As-Built:</i> 17" o.c. • <i>Proposed Solution:</i> Relocate or provide new toilet paper dispenser. 	PCODE WG02 ADAAG 91 4.16.6 ADA 2010 604.7 CBC 2007 1115B.8.4 CBC 2016 11B-604.7 Mitigated: <input type="radio"/> YES <input checked="" type="radio"/> NO	1	JOB	\$225	\$225

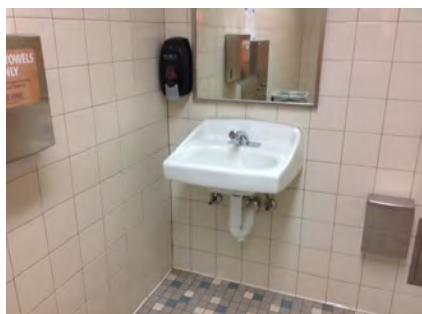
<input type="checkbox"/> Staff Only Priority 3 Severity 2			
377	<ul style="list-style-type: none"> • <i>As-Built Description:</i> Bottom of mirror located above lavatories or countertops more than 40" above floor. • <i>As-Built:</i> 41" high • <i>Proposed Solution:</i> Relocate or provide new accessible mirror. 	PCODE WG03 ADAAG 91 4.19.6 ADA 2010 603.3 CBC 2007 1115B.8.1 CBC 2016 11B-603.3 Mitigated: <input type="radio"/> YES <input checked="" type="radio"/> NO	1	JOB	\$450	\$450

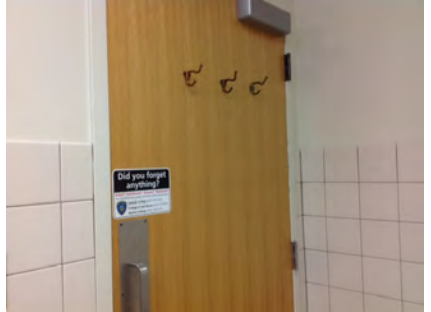
Item no., Rm no. and Name	Existing Architectural Barrier and Proposed Solution	Codes / Mitigation Info	Qty	Unit	Cost	Total
Coat Hook						
382	<ul style="list-style-type: none"> As-Built Description: Accessible coat hook not within reach range. As-Built: 70" high Proposed Solution: Adjust existing or provide new coat hook at maximum 48" height. 	PCODE WG03A ADAAG 91 4.2.5 ADA 2010 603.4 CBC 2007 1118B.5 CBC 2016 11B-603.4 Mitigated: <input type="radio"/> YES <input checked="" type="radio"/> NO	1	JOB	\$150	\$150

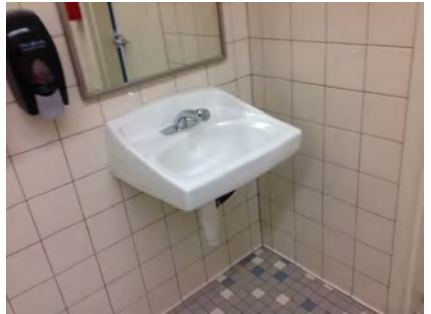
Item no., Rm no. and Name	Existing Architectural Barrier and Proposed Solution	Codes / Mitigation Info	Qty	Unit	Cost	Total
386	<ul style="list-style-type: none"> As-Built Description: Bottom of mirror located above lavatories or countertops more than 40" above floor. As-Built: 41" high Proposed Solution: Relocate or provide new accessible mirror. 	PCODE WG03 ADAAG 91 4.19.6 ADA 2010 603.3 CBC 2007 1115B.8.1 CBC 2016 11B-603.3 Mitigated: <input type="radio"/> YES <input checked="" type="radio"/> NO	1	JOB	\$450	\$450

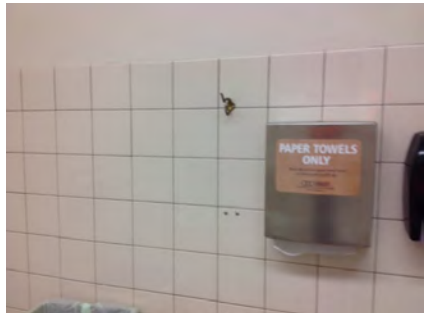
Coat Hook

387	<ul style="list-style-type: none"> As-Built Description: Accessible coat hook not within reach range. As-Built: 55" high Proposed Solution: Adjust existing or provide new coat hook at maximum 48" height. 	PCODE WG03A ADAAG 91 4.2.5 ADA 2010 603.4 CBC 2007 1118B.5 CBC 2016 11B-603.4 Mitigated: <input type="radio"/> YES <input checked="" type="radio"/> NO	1	JOB	\$150	\$150

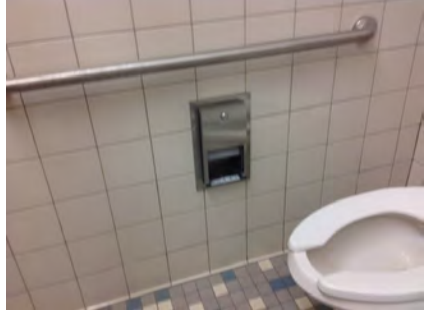
Accessories

392	<ul style="list-style-type: none"> • <i>As-Built Description:</i> Toilet paper dispenser less than 15" (CA: 19") or more than 48" above floor or not within 7" to 9" from front of water closet (Note: CA pre-2010 is allowed within 12" from front of water closet). • <i>As-Built:</i> 1" o.c. • <i>Proposed Solution:</i> Relocate or provide new toilet paper dispenser. 	PCODE WG02 ADAAG 91 4.16.6 ADA 2010 604.7 CBC 2007 1115B.8.4 CBC 2016 11B-604.7 Mitigated: <input type="radio"/> YES <input checked="" type="radio"/> NO	1	JOB	\$225	\$225

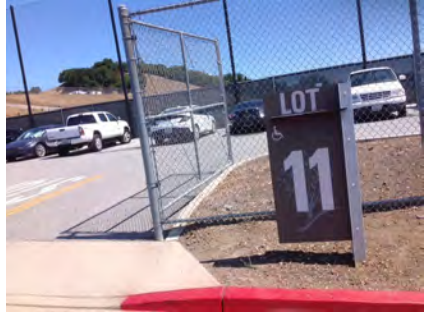
Item no., Rm no. and Name	Existing Architectural Barrier and Proposed Solution	Codes / Mitigation Info	Qty	Unit	Cost	Total
<u>Parking Signage</u>						
68	<ul style="list-style-type: none"> • <i>As-Built Description:</i> No "Tow Away" sign at parking lot entrance (required in CA only). • <i>Proposed Solution:</i> Provide "Tow Away" sign at parking lot entrance when altering area. 	PCODE EA04C CBC 2007 1129B.4 CBC 2016 11B-502.8.2 Mitigated: <input type="radio"/> YES <input checked="" type="radio"/> NO	1	JOB	\$975	\$975

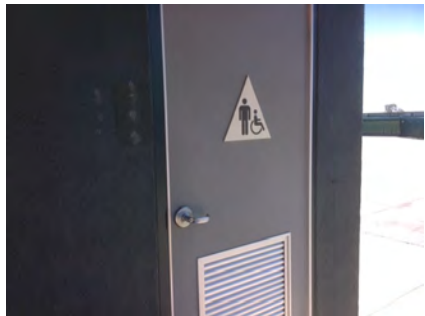
Item no., Rm no. and Name	Existing Architectural Barrier and Proposed Solution	Codes / Mitigation Info	Qty	Unit	Cost	Total
81	<ul style="list-style-type: none"> As-Built Description: Entrance to toilet or bathing facility not identified with ADAAG compliant signage. Proposed Solution: Provide ADA compliant sign mounted at 48" min. above to baseline of the lowest Braille cells and 60" max. to baseline of the highest line of raised characters on nearest adjacent wall, on latch side of a single door (located not to cause a Braille reader to stand within the door swing). 	PCODE SA11A ADAAG 91 4.1.3(16)(a) ADA 2010 216.8 CBC 2016 11B-216.8 Mitigated: <input type="radio"/> YES <input checked="" type="radio"/> NO	1	JOB	\$270	\$270

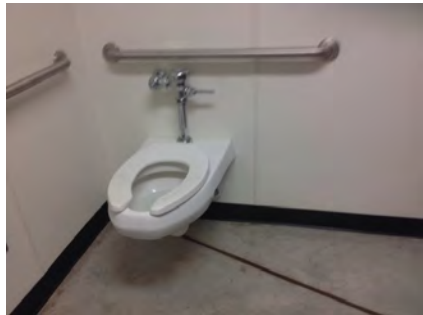
Grab Bars

80	<ul style="list-style-type: none"> As-Built Description: Accessories/dispensers in accessible stall located closer than 1-1/2" below or 12" above grab bar impedes its use. As-Built: 1" below Proposed Solution: Relocate accessories/dispensers to be no closer than 1-1/2" below and 12" above grab bars (except if accessories are recessed, flush with wall, and have no sharp edges). 	PCODE WB071 ADAAG 91 4.26.2 ADA 2010 609.3 CBC 2007 1133B.4.2.5 CBC 2016 11B-609.3 Mitigated: <input type="radio"/> YES <input checked="" type="radio"/> NO	1	JOB	\$225	\$225

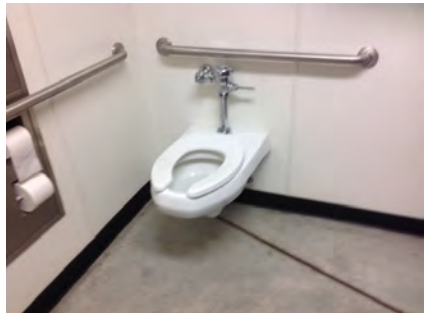
Item no., Rm no. and Name	Existing Architectural Barrier and Proposed Solution	Codes / Mitigation Info	Qty	Unit	Cost	Total
Water Closet						
79	<ul style="list-style-type: none"> • <i>As-Built Description:</i> Water closet not 16"-18" (CA: 17"-18") from near side wall to center line of water closet (2010 ADAAG: 16"-18"). • <i>As-Built:</i> 18.5" o.c. • <i>Proposed Solution:</i> Relocate existing water closet and plumbing, remount with offset closet flange to provide 18" max. from side wall. 	PCODE WB02C ADAAG 91 Fig. 28 ADA 2010 604.2 CBC 2007 1115B.4.1.1 CBC 2016 11B-604.2 Mitigated: <input type="radio"/> YES <input checked="" type="radio"/> NO	1	JOB	\$1,500	\$1,500

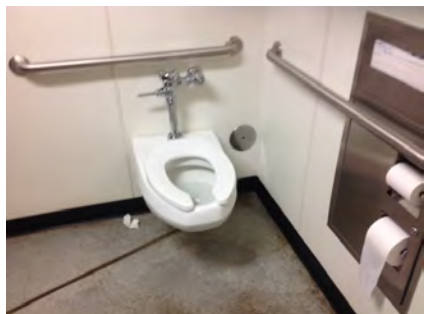
<input type="checkbox"/> Staff Only Priority 3 Severity 4			
83	<ul style="list-style-type: none"> • <i>As-Built Description:</i> Water closet not 16"-18" (CA: 17"-18") from near side wall to center line of water closet (2010 ADAAG: 16"-18"). • <i>As-Built:</i> 18.5" o.c. • <i>Proposed Solution:</i> Relocate existing water closet and plumbing, remount with offset closet flange to provide 18" max. from side wall. 	PCODE WB02C ADAAG 91 Fig. 28 ADA 2010 604.2 CBC 2007 1115B.4.1.1 CBC 2016 11B-604.2 Mitigated: <input type="radio"/> YES <input checked="" type="radio"/> NO	1	JOB	\$1,500	\$1,500

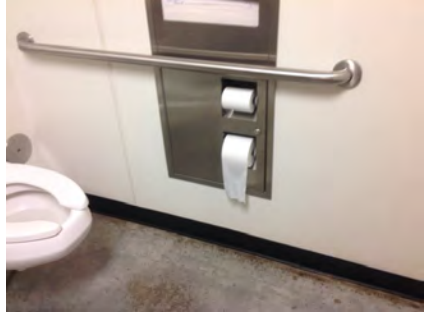
Item no., Rm no. and Name	Existing Architectural Barrier and Proposed Solution	Codes / Mitigation Info	Qty	Unit	Cost	Total
Accessories						
84	<ul style="list-style-type: none"> • <i>As-Built Description:</i> Toilet paper dispenser less than 15" (CA: 19") or more than 48" above floor or not within 7" to 9" from front of water closet (Note: CA pre-2010 is allowed within 12" from front of water closet). • <i>As-Built:</i> 14" o.c. • <i>Proposed Solution:</i> Relocate or provide new toilet paper dispenser. 	PCODE WG02 ADAAG 91 4.16.6 ADA 2010 604.7 CBC 2007 1115B.8.4 CBC 2016 11B-604.7 Mitigated: <input type="radio"/> YES <input checked="" type="radio"/> NO	1	JOB	\$225	\$225

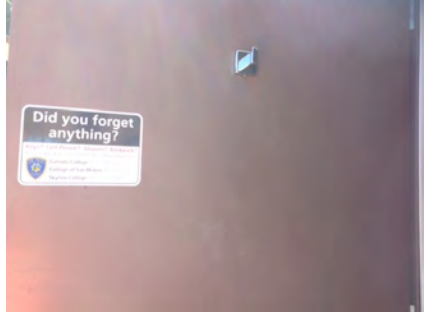
Item no., Rm no. and Name	Existing Architectural Barrier and Proposed Solution	Codes / Mitigation Info	Qty	Unit	Cost	Total
Coat Hook						
65	<ul style="list-style-type: none"> As-Built Description: Accessible coat hook not within reach range. As-Built: 65" high Proposed Solution: Adjust existing or provide new coat hook at maximum 48" height. 	PCODE WG03A ADAAG 91 4.2.5 ADA 2010 603.4 CBC 2007 1118B.5 CBC 2016 11B-603.4 Mitigated: <input type="radio"/> YES <input checked="" type="radio"/> NO	1	JOB	\$150	\$150

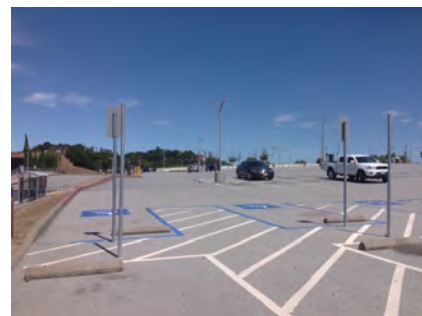
Sign for accessible parking space is missing or non-compliant.

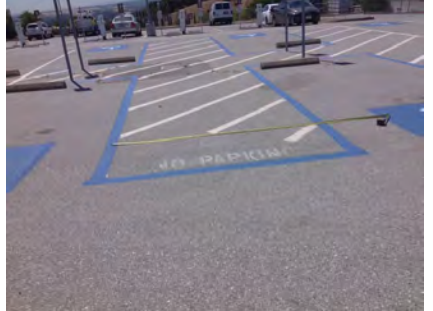
Item no., Rm no. and Name	Existing Architectural Barrier and Proposed Solution	Codes / Mitigation Info	Qty	Unit	Cost	Total
Parking						
647	<ul style="list-style-type: none"> As-Built Description: Accessible parking space does not have 5' wide access aisle; 8' wide for van accessible aisle. As-Built: 7'9" wide Proposed Solution: Modify parking aisle(s) to create accessible space by restriping. 	PCODE EA02B ADAAG 91 4.6.3 ADA 2010 502.3 CBC 2007 1129B.3.1 CBC 2016 11B-502.2; 11B-502.3.1 Mitigated: <input type="radio"/> YES <input checked="" type="radio"/> NO	1	JOB	\$600	\$600

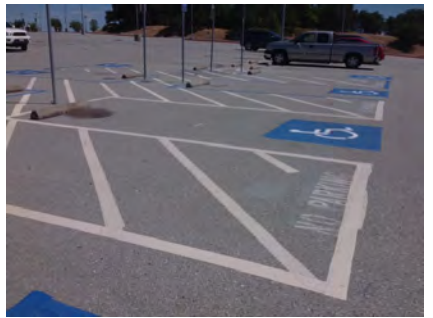
<input type="checkbox"/> Staff Only Priority 1 Severity 4			
650	<ul style="list-style-type: none"> As-Built Description: An accessible parking space shall be outlined or painted blue (required in CA only). Proposed Solution: Identify accessible parking space using blue markings. Notes: No contrast for all access aisles 	PCODE EA04K CBC 2016 11B-502.6 Mitigated: <input type="radio"/> YES <input checked="" type="radio"/> NO	1	JOB	\$360	\$360

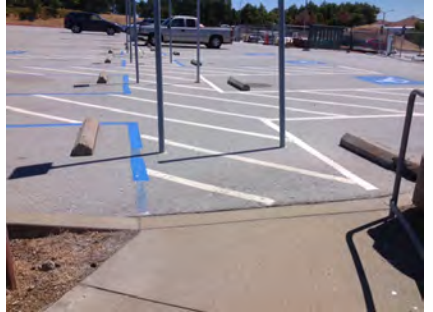
Item no., Rm no. and Name	Existing Architectural Barrier and Proposed Solution	Codes / Mitigation Info	Qty	Unit	Cost	Total
<u>Curb Ramp</u>						
652	<ul style="list-style-type: none"> • <i>As-Built Description:</i> Detectable warning not provided where pedestrian crosses vehicular area. • <i>Proposed Solution:</i> Provide detectable warning surface (i.e. in-line truncated domes) at regular curb ramp. 	PCODE EH07A ADAAG 91 4.7.7 ADA 2010 705.1 CBC 2007 1127B.5.7 CBC 2016 11B-705.1.2.2 Mitigated: <input type="radio"/> YES <input checked="" type="radio"/> NO	1	JOB	\$750	\$750

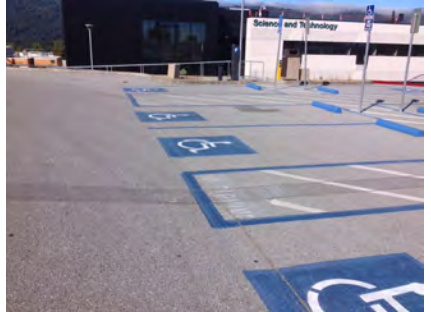
Item no., Rm no. and Name	Existing Architectural Barrier and Proposed Solution	Codes / Mitigation Info	Qty	Unit	Cost	Total
<u>Parking</u>						
732	<ul style="list-style-type: none"> As-Built Description: The words "NO PARKING" not painted on the ground within loading and unloading access aisle (12" min high white letters), located so that it is visible to traffic enforcement officials (required in CA only). Proposed Solution: Provide the words "NO PARKING" in each access aisle, painted in 12" high letters, when altering area. "No Parking" faded 	PCODE EA04D CBC 2007 1129B.3.1 CBC 2016 11B-502.3.3 Mitigated: <input type="radio"/> YES <input checked="" type="radio"/> NO	4	JOB	\$300	\$1,200

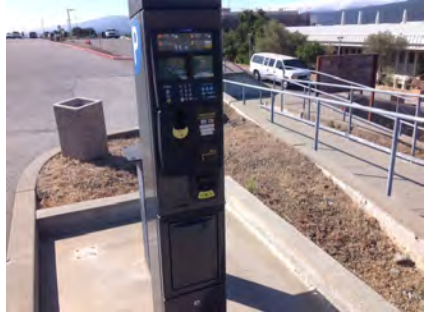
Item no., Rm no. and Name	Existing Architectural Barrier and Proposed Solution	Codes / Mitigation Info	Qty	Unit	Cost	Total
Reach Range						
737	<ul style="list-style-type: none"> As-Built Description: Reach height to control or access point, exceeds 48" or is less than 15". As-Built: 49" high Proposed Solution: Modify equipment or mounting. 	PCODE IE01 ADAAG 91 4.2.5 ADA 2010 308.2.1 CBC 2007 1118B.5 CBC 2016 11B-308.2.1 Mitigated: <input type="radio"/> YES <input checked="" type="radio"/> NO	1	JOB	\$300	\$300

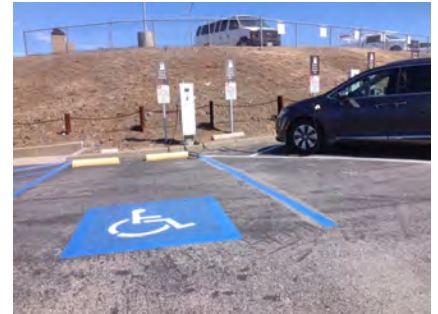
Item no., Rm no. and Name	Existing Architectural Barrier and Proposed Solution	Codes / Mitigation Info	Qty	Unit	Cost	Total
<u>Curb Ramp</u>						
640	<ul style="list-style-type: none"> • <i>As-Built Description:</i> Detectable warning not provided where pedestrian crosses vehicular area. • <i>Proposed Solution:</i> Provide detectable warning surface (i.e. in-line truncated domes) at regular curb ramp. 	PCODE EH07A ADAAG 91 4.7.7 ADA 2010 705.1 CBC 2007 1127B.5.7 CBC 2016 11B-705.1.2.2 Mitigated: <input type="radio"/> YES <input checked="" type="radio"/> NO	1	JOB	\$750	\$750

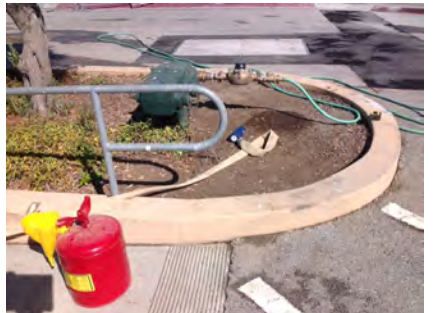
Item no., Rm no. and Name	Existing Architectural Barrier and Proposed Solution	Codes / Mitigation Info	Qty	Unit	Cost	Total
748	<ul style="list-style-type: none"> As-Built Description: Level 2% max. landing for ramp not provided. As-Built: 3.9% Proposed Solution: Rebuild ramp to provide landings for each ramp run with slopes no greater than 2% 	PCODE EB05A ADAAG 91 4.8.4 ADA 2010 405.7.1 CBC 2007 1133B.5.4.1 CBC 2016 11B-405.7.1 Mitigated: <input type="radio"/> YES <input checked="" type="radio"/> NO	50	SF	\$300	\$15,000

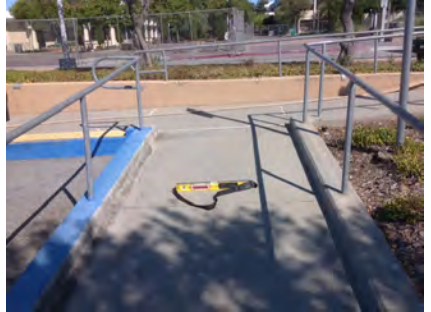
750	<ul style="list-style-type: none"> As-Built Description: Ramp handrail does not extend horizontally 12" past top and / or bottom of ramp. Proposed Solution: Provide ramp handrail extension (cost for each extension piece). 	PCODE ED05 ADAAG 91 4.8.5(2) ADA 2010 505.10.1 CBC 2007 1133B.4.2.2 & 1133B.5.5.1 CBC 2016 11B-505.10.1 Mitigated: <input type="radio"/> YES <input checked="" type="radio"/> NO	1	JOB	\$510	\$510

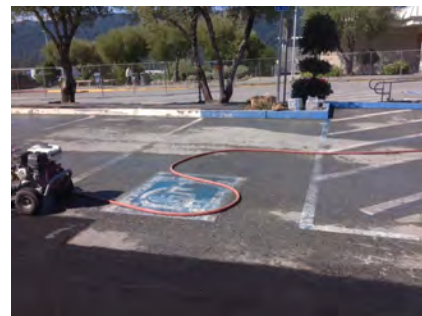
Item no., Rm no. and Name	Existing Architectural Barrier and Proposed Solution	Codes / Mitigation Info	Qty	Unit	Cost	Total
Cross Slope						
747	<ul style="list-style-type: none"> As-Built Description: Cross slope more than 1":48" (2.083%). As-Built: 3.5% Proposed Solution: Modify cross slope. 	PCODE EF07 ADAAG 91 4.3.7 ADA 2010 403.3 CBC 2007 1133B.7.1.3 CBC 2016 11B-403.3 Mitigated: <input type="radio"/> YES <input checked="" type="radio"/> NO	25	SF	\$75	\$1,875

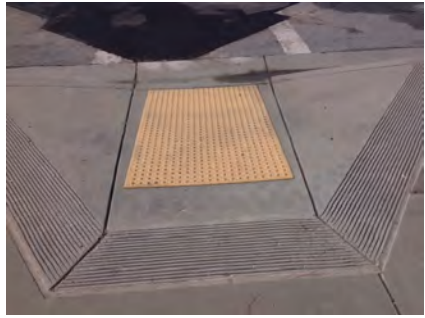
<input type="checkbox"/> Staff Only Priority 1 Severity 4			
757	<ul style="list-style-type: none"> • <i>As-Built Description:</i> Less than 48" level space at top and 1:12 flared sides not provided. • <i>As-Built:</i> 42" wide • <i>Proposed Solution:</i> Demolish existing and provide new curb ramp. 	PCODE EH05B ADAAG 91 4.7.5; Fig.12(a) ADA 2010 406.4 CBC 2007 1127B.5.4 CBC 2016 11B-406.5.3 Mitigated: <input type="radio"/> YES <input checked="" type="radio"/> NO	1	JOB	\$7,500	\$7,500

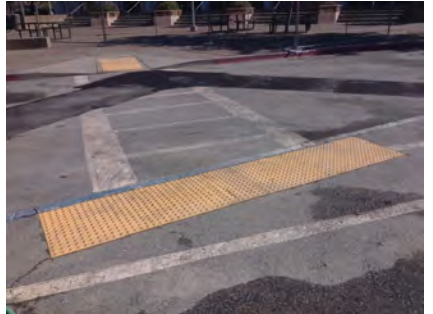
Item no., Rm no. and Name	Existing Architectural Barrier and Proposed Solution	Codes / Mitigation Info	Qty	Unit	Cost	Total
753	<ul style="list-style-type: none"> As-Built Description: Detectable warning not provided where pedestrian crosses vehicular area. As-Built: 24" deep Proposed Solution: Provide detectable warning surface (i.e. in-line truncated domes) at regular curb ramp. 	PCODE EH07A ADAAG 91 4.7.7 ADA 2010 705.1 CBC 2007 1127B.5.7 CBC 2016 11B-705.1.2.2 Mitigated: <input type="radio"/> YES <input checked="" type="radio"/> NO	1	JOB	\$750	\$750

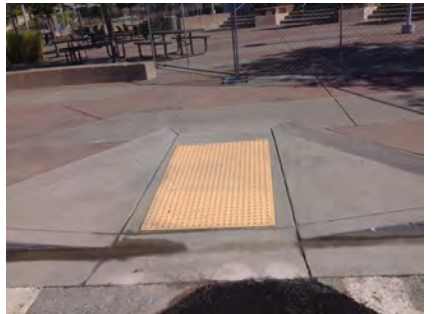
<input type="checkbox"/> Staff Only			
			Priority 1 Severity 3			
755	<ul style="list-style-type: none"> As-Built Description: Detectable warning not provided where pedestrian crosses vehicular area. As-Built: 36" wide domes Proposed Solution: Provide detectable warning surface (i.e. in-line truncated domes) at regular curb ramp. 	PCODE EH07A ADAAG 91 4.7.7 ADA 2010 705.1 CBC 2007 1127B.5.7 CBC 2016 11B-705.1.2.2 Mitigated: <input type="radio"/> YES <input checked="" type="radio"/> NO	1	JOB	\$750	\$750

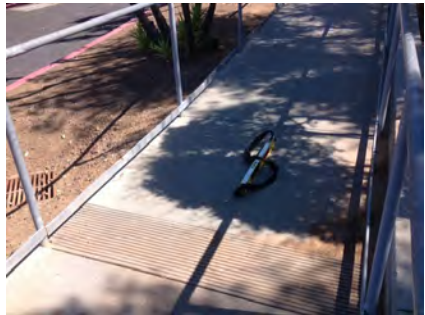
Item no., Rm no. and Name	Existing Architectural Barrier and Proposed Solution	Codes / Mitigation Info	Qty	Unit	Cost	Total
629	<ul style="list-style-type: none"> As-Built Description: Level 2% max. landing for ramp not provided. As-Built: 3.2% Proposed Solution: Rebuild ramp to provide landings for each ramp run with slopes no greater than 2% 	PCODE EB05A ADAAG 91 4.8.4 ADA 2010 405.7.1 CBC 2007 1133B.5.4.1 CBC 2016 11B-405.7.1 Mitigated: <input type="radio"/> YES <input checked="" type="radio"/> NO	30	SF	\$300	\$9,000

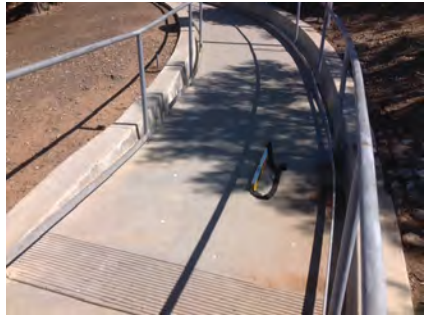
<input type="checkbox"/> Staff Only Priority 1 Severity 4			
630	<ul style="list-style-type: none"> As-Built Description: Level 2% max. landing for ramp not provided. As-Built: 2.8% Proposed Solution: Rebuild ramp to provide landings for each ramp run with slopes no greater than 2% 	PCODE EB05A ADAAG 91 4.8.4 ADA 2010 405.7.1 CBC 2007 1133B.5.4.1 CBC 2016 11B-405.7.1 Mitigated: <input type="radio"/> YES <input checked="" type="radio"/> NO	60	SF	\$300	\$18,000

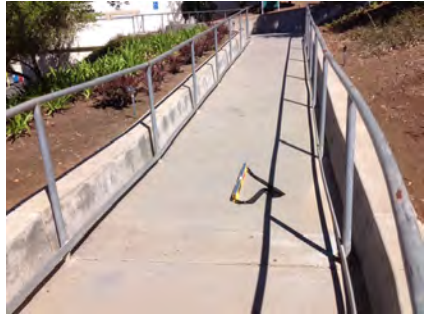
<input type="checkbox"/> Staff Only Priority 1 Severity 4			
633	<ul style="list-style-type: none"> As-Built Description: Level 2% max. landing for ramp not provided. As-Built: 4.5% Proposed Solution: Rebuild ramp to provide landings for each ramp run with slopes no greater than 2% 	PCODE EB05A ADAAG 91 4.8.4 ADA 2010 405.7.1 CBC 2007 1133B.5.4.1 CBC 2016 11B-405.7.1 Mitigated: <input type="radio"/> YES <input checked="" type="radio"/> NO	60	SF	\$300	\$18,000

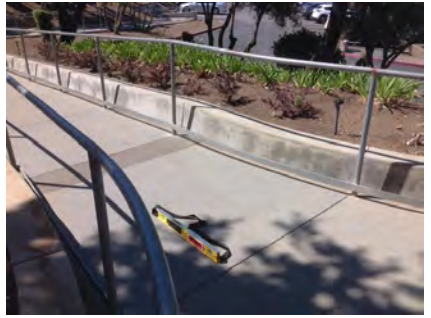
Item no., Rm no. and Name	Existing Architectural Barrier and Proposed Solution	Codes / Mitigation Info	Qty	Unit	Cost	Total
635	<ul style="list-style-type: none"> As-Built Description: Level 2% max. landing for ramp not provided. As-Built: Top landing: 4.4% Proposed Solution: Rebuild ramp to provide landings for each ramp run with slopes no greater than 2% 	PCODE EB05A ADAAG 91 4.8.4 ADA 2010 405.7.1 CBC 2007 1133B.5.4.1 CBC 2016 11B-405.7.1 Mitigated: <input type="radio"/> YES <input checked="" type="radio"/> NO	100	SF	\$300	\$30,000

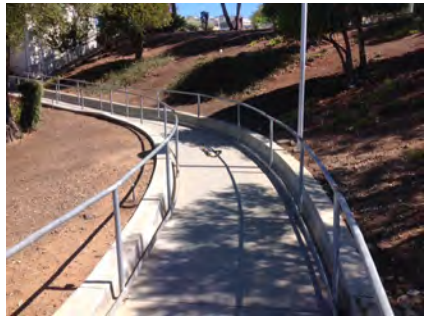
632	<ul style="list-style-type: none"> As-Built Description: Ramp landing(s): Change of direction less than 60" long. (CA Only: 72" long.) Proposed Solution: Modify ramp landing to 60" length. (Ca Only: 72' length.) 	PCODE IJ05D ADA 2010 405.7.4 CBC 2007 1133B.5.4.6 CBC 2016 11B-405.7.4 Mitigated: <input type="radio"/> YES <input checked="" type="radio"/> NO	100	SF	\$162	\$16,200

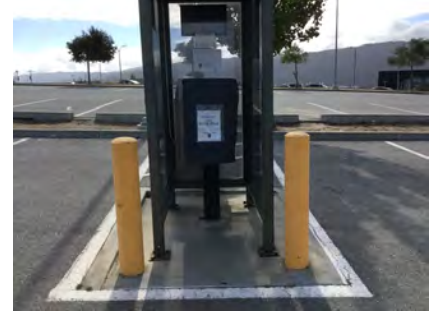
Relocate existing furniture/obstructions.

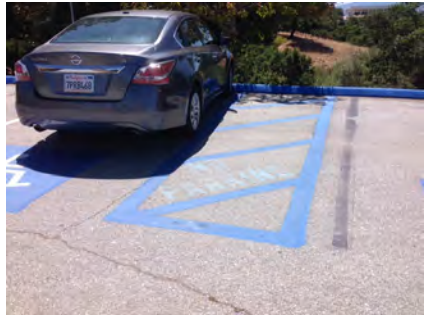
Item no., Rm no. and Name	Existing Architectural Barrier and Proposed Solution	Codes / Mitigation Info	Qty	Unit	Cost	Total
323	<ul style="list-style-type: none"> As-Built Description: The words "NO PARKING" not painted on the ground within loading and unloading access aisle (12" min high white letters), located so that it is visible to traffic enforcement officials (required in CA only). Proposed Solution: Provide the words "NO PARKING" in each access aisle, painted in 12" high letters, when altering area. 	PCODE EA04D CBC 2007 1129B.3.1 CBC 2016 11B-502.3.3 Mitigated: <input type="radio"/> YES <input checked="" type="radio"/> NO	2	JOB	\$300	\$600

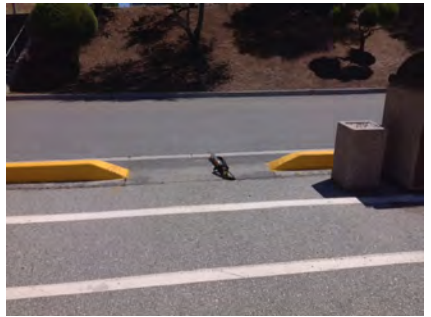
327	<ul style="list-style-type: none"> As-Built Description: Walk: Slope greater than 1:20 (5.0%), and walk does not comply with requirements for ramps. As-Built: 8% - 16.5% Proposed Solution: Modify walk/sidewalk slope to 1:20 or less. 	PCODE EF01 ADAAG 91 4.3.7 ADA 2010 403.3 CBC 2007 1133B.7.3 CBC 2016 11B-403.3 Mitigated: <input type="radio"/> YES <input checked="" type="radio"/> NO	25	SF	\$75	\$1,875

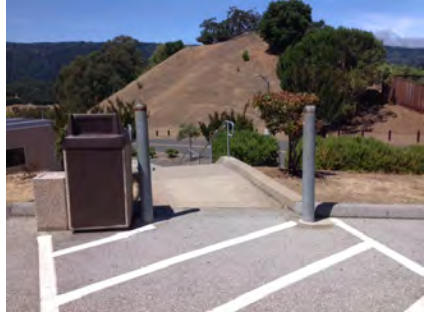
Item no., Rm no. and Name	Existing Architectural Barrier and Proposed Solution	Codes / Mitigation Info	Qty	Unit	Cost	Total
Route Sign						
326	<ul style="list-style-type: none"> • <i>As-Built Description:</i> No sign by inaccessible route directing persons to an accessible route. • <i>Proposed Solution:</i> Provide directional sign. 	PCODE SA20 ADAAG 91 35.163(b) ADA 2010 216.3 CBC 2007 1127B.3 CBC 2016 11B-216.3 Mitigated: <input type="radio"/> YES <input checked="" type="radio"/> NO	1	JOB	\$510	\$510

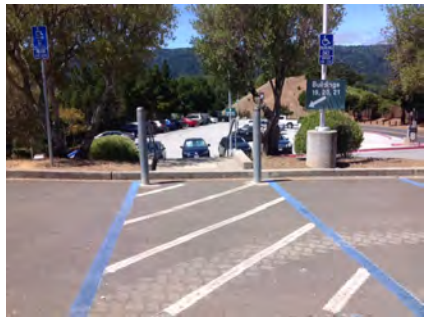
<input type="checkbox"/> Staff Only Priority 1 Severity 3			
330	<ul style="list-style-type: none"> As-Built Description: Disabled persons must wheel or walk behind parked car(s) other than their own. Proposed Solution: Relocate parking and provide curb ramp to accessible route. Notes: Accessible parking serves only stairs and patrons must travel behind cars other than their own. We recommend relocating parking near an accessible route. 	PCODE EA03 ADAAG 91 Fig.9 ADA 2010 502.3 CBC 2007 1129B.3.1 CBC 2016 11B-502.7.1 Mitigated: <input type="radio"/> YES <input checked="" type="radio"/> NO	1	JOB	\$2,190	\$2,190

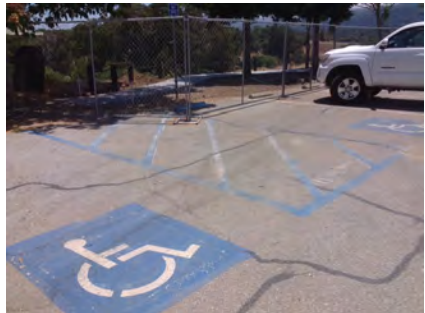
Item no., Rm no. and Name	Existing Architectural Barrier and Proposed Solution	Codes / Mitigation Info	Qty	Unit	Cost	Total
Parking						
277	<ul style="list-style-type: none"> As-Built Description: Accessible parking space smaller than 8' wide (CA only: 9' x 18'). As-Built: 17'7" Proposed Solution: Modify parking space(s) to create accessible space. 	PCODE EA02A ADAAG 91 4.6.3 ADA 2010 502.2 CBC 2007 1129B.3.1 CBC 2016 11B-502.2 Mitigated: <input type="radio"/> YES <input checked="" type="radio"/> NO	1	JOB	\$600	\$600

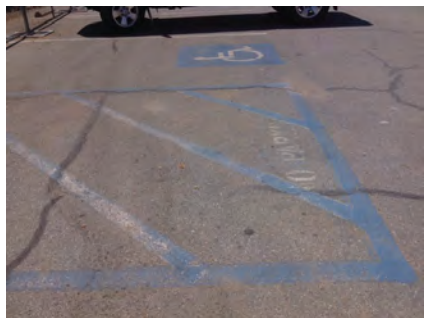
<input type="checkbox"/> Staff Only			
			Priority <input checked="" type="radio"/> 1	Severity <input checked="" type="radio"/> 4		
278	<ul style="list-style-type: none"> As-Built Description: The words "NO PARKING" not painted on the ground within loading and unloading access aisle (12" min high white letters), located so that it is visible to traffic enforcement officials (required in CA only). Proposed Solution: Provide the words "NO PARKING" in each access aisle, painted in 12" high letters, when altering area. 	PCODE EA04D CBC 2007 1129B.3.1 CBC 2016 11B-502.3.3 Mitigated: <input type="radio"/> YES <input checked="" type="radio"/> NO	1	JOB	\$300	\$300

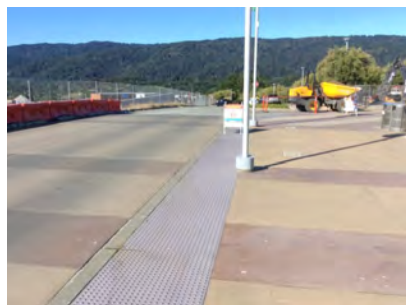
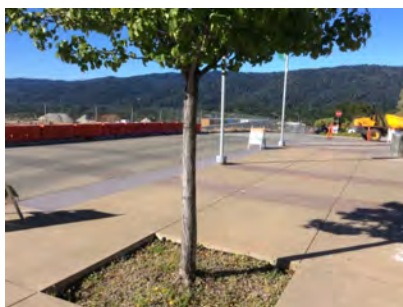
Bottom Landing Length	(in)	900.0
Bottom Landing Slope	(%)	1.0
Bottom Landing X Slope	(%)	2.0
Gutter Lip	(in)	N/A
Truncated Domes	(y/n)	YES
Dome Setback	(in)	6.0

Street Grade (Left / Right)	(%)	1.7	N/A
Stop/Yield Control:		No	
Crosswalks Served:		No X-walk	
Tee Intersection:		No	
Vertical Curb:		Vertical	
Sidewalk Width:	(ft)	20.0

Demolish existing and provide new, perpendicular curb ramp, including detectable warning surfaces, and top and bottom landings as required.

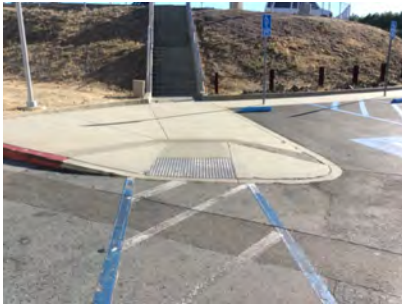
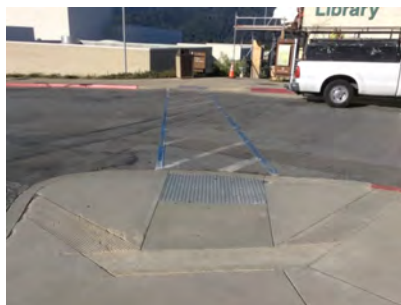
Width of Ramp / Pad	(in)	45.0
Length of Ramp / Pad	(in)	77.0
Slope of the Ramp / Pad	(%)	3.7
X Slope of the Ramp / Pad	(%)	1.8
Top Landing Length	(in)	48.0
Top Landing Slope	(%)	1.9
Top Landing X Slope	(%)	3.6

Left Flare	(%)	10.5
Right Flare	(%)	0.3
Gutter Slope	(%)	2.8
Gutter XSlope	(%)	2.0
Gutter Lip	(in)	0.0
Truncated Domes	(y/n)	YES
Dome Setback	(in)	6.0

Demolish existing and provide new, perpendicular curb ramp, including detectable warning surfaces, and top and bottom landings as required.

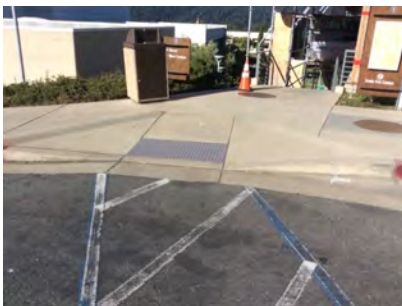
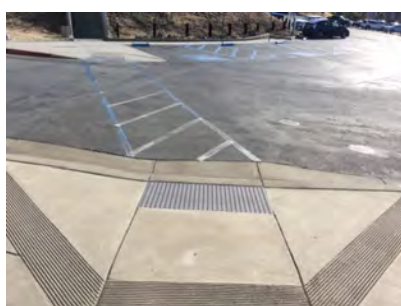
Width of Ramp / Pad	(in)	48.0
Length of Ramp / Pad	(in)	73.0
Slope of the Ramp / Pad	(%)	6.1
X Slope of the Ramp / Pad	(%)	2.5
Top Landing Length	(in)	48.0
Top Landing Slope	(%)	0.6
Top Landing X Slope	(%)	2.5

Left Flare	(%)	7.1
Right Flare	(%)	14.7
Gutter Slope	(%)	5.0
Gutter XSlope	(%)	0.3
Gutter Lip	(in)	0.5
Truncated Domes	(y/n)	YES
Dome Setback	(in)	6.0

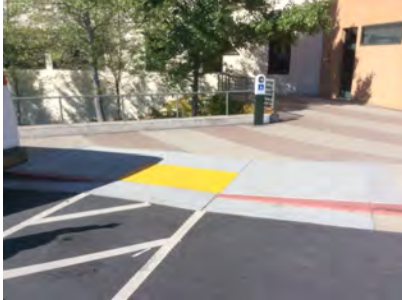
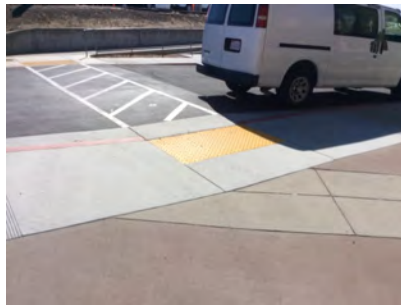
LEFT	RIGHT
Width of Ramp / Pad	(in)	72.0	72.0
Length of Ramp / Pad	(in)	79.0	76.0
Slope of the Ramp / Pad	(%)	4.1	9.8
X Slope of the Ramp / Pad	(%)	0.1	1.2
Top Landing Slope	(%)	5.6	9.4
Top Landing X Slope	(%)	1.2	0.9

Bottom Landing Length	(in)	60.0
Bottom Landing Slope	(%)	0.3
Bottom Landing X Slope	(%)	0.3
Gutter Slope	(%)	2.4
Gutter XSlope	(%)	1.5
Gutter Lip	(in)	0.0
Truncated Domes	(y/n)	YES
Dome Setback	(in)	6.0

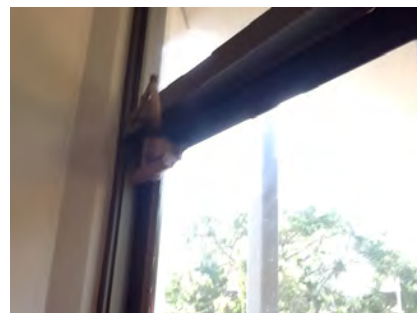
Item no., Rm no. and Name	Existing Architectural Barrier and Proposed Solution	Codes / Mitigation Info	Qty	Unit	Cost	Total
Door Swing						
323	<ul style="list-style-type: none">As-Built Description: Front approach: At pull side, door does not have clear and level maneuvering space measuring door width plus 18" x 60". (24" x 60" at exterior doors).As-Built: 2"- 9"Proposed Solution: Provide power door operator.	PCODE ID23C ADAAG 91 Fig. 25(a) ADA 2010 404.2.4 CBC 2007 11B-26A(a) CBC 2016 11B-404.2.4 Mitigated: <div><input type="radio"/> YES</div> <div><input checked="" type="radio"/> NO</div>	4	JOB	\$15,000	\$60,000

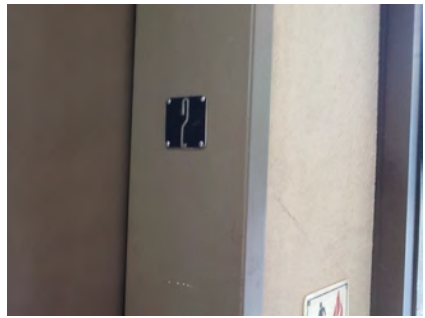
Item no., Rm no. and Name	Existing Architectural Barrier and Proposed Solution	Codes / Mitigation Info	Qty	Unit	Cost	Total
332	<ul style="list-style-type: none">• <i>As-Built Description:</i> Braille symbols on floor indicators of each elevator entrance jamb not compliant.• <i>Proposed Solution:</i> Provide compliant floor numbering on elevator door jambs.• <i>Notes:</i> Braille located on side of tactile.	<i>PCODE</i> IK11NT <i>ADA 2010</i> 407.2.3.1 <i>CBC 2007</i> 1116B.1.14 <i>CBC 2016</i> 11B-407.2.3.1 Mitigated: <input type="radio"/> YES <input checked="" type="radio"/> NO	4	SET	\$150	\$600

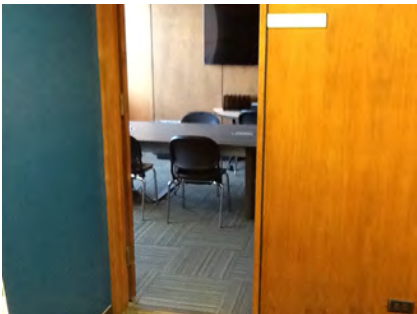
Item no., Rm no. and Name	Existing Architectural Barrier and Proposed Solution	Codes / Mitigation Info	Qty	Unit	Cost	Total
342	<ul style="list-style-type: none"> As-Built Description: Door on accessible route has less than 32" clear and 80" (78" min. to closer if provided) opening width when 90° open. As-Built: 30" wide Proposed Solution: Provide new, larger door and frame with new accessible hardware. Notes: Entry to conference room 	PCODE ID01 ADAAG 91 4.13.5 ADA 2010 404.2.3 CBC 2007 1133B.1.1.1.1 CBC 2016 11B-404.2.3 Mitigated: <input type="radio"/> YES <input checked="" type="radio"/> NO	1	JOB	\$7,800	\$7,800

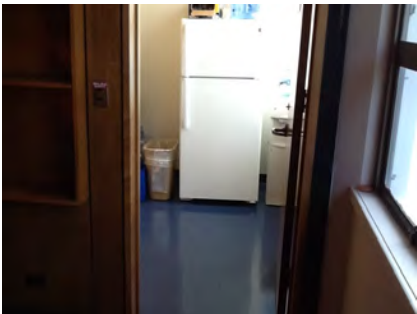
<input type="checkbox"/> Staff Only			
			Priority	Severity		
			2	3		
345	<ul style="list-style-type: none"> As-Built Description: Door on accessible route has less than 32" clear and 80" (78" min. to closer if provided) opening width when 90° open. As-Built: 29" wide Proposed Solution: Provide new, larger door and frame with new accessible hardware. Notes: Conference Room/Kitchen 	PCODE ID01 ADAAG 91 4.13.5 ADA 2010 404.2.3 CBC 2007 1133B.1.1.1.1 CBC 2016 11B-404.2.3 Mitigated: <input type="radio"/> YES <input checked="" type="radio"/> NO	1	JOB	\$7,800	\$7,800

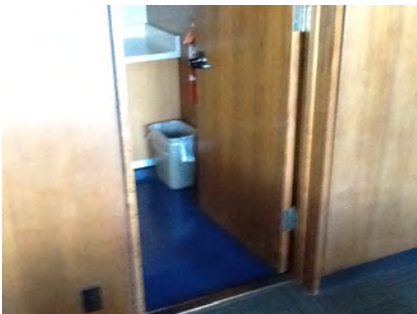
<input type="checkbox"/> Staff Only			
			Priority	Severity		
			2	3		
349	<ul style="list-style-type: none"> As-Built Description: Door on accessible route has less than 32" clear and 80" (78" min. to closer if provided) opening width when 90° open. As-Built: 27" - 29" Proposed Solution: Provide new, larger door and frame with new accessible hardware. Notes: Path of travel to squad room 	PCODE ID01 ADAAG 91 4.13.5 ADA 2010 404.2.3 CBC 2007 1133B.1.1.1.1 CBC 2016 11B-404.2.3 Mitigated: <input type="radio"/> YES <input checked="" type="radio"/> NO	2	JOB	\$7,800	\$15,600

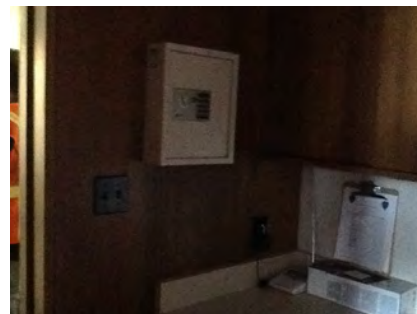
Item no., Rm no. and Name	Existing Architectural Barrier and Proposed Solution	Codes / Mitigation Info	Qty	Unit	Cost	Total
351	<ul style="list-style-type: none"> As-Built Description: Reach height to control or access point, exceeds 48" or is less than 15". As-Built: 62" AFF Proposed Solution: Modify equipment or mounting. 	PCODE IE01 ADAAG 91 4.2.5 ADA 2010 308.2.1 CBC 2007 1118B.5 CBC 2016 11B-308.2.1	1	JOB	\$300	\$300
<div>Mitigated:</div> <div> <input type="radio"/> YES <input checked="" type="radio"/> NO </div> <div> <input type="checkbox"/> Staff Only </div> <div> Priority 2 Severity 2 </div>

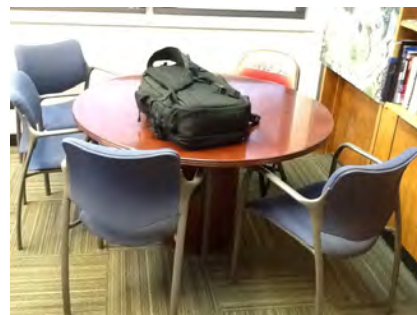
341	<ul style="list-style-type: none"> As-Built Description: Accessible non-fixed table or desk (top 28" to 34" high; knee space at least 27" high x 19" deep x 30" wide) not provided. Proposed Solution: Provide table or desk with accessible dimensions when purchasing new furniture. 	PCODE IN02A ADAAG 91 4.32.3 & .4 ADA 2010 306.1 CBC 2007 1122B.3 & 4 CBC 2016 11B-306.1 & 11B-902.3	1	JOB	\$4,800	\$4,800
<div>Mitigated:</div> <div> <input type="radio"/> YES <input checked="" type="radio"/> NO </div> <div> <input type="checkbox"/> Staff Only </div> <div> Priority 2 Severity 2 </div>

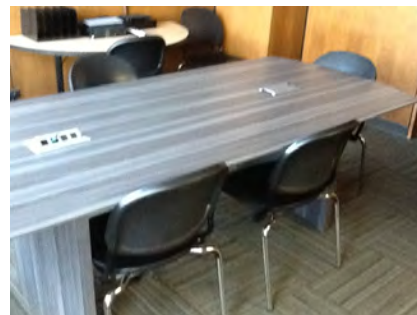
343	<ul style="list-style-type: none"> As-Built Description: Accessible non-fixed table or desk (top 28" to 34" high; knee space at least 27" high x 19" deep x 30" wide) not provided. As-Built: 14" deep Proposed Solution: Provide table or desk with accessible dimensions when purchasing new furniture. Notes: Conference Room 	PCODE IN02A ADAAG 91 4.32.3 & .4 ADA 2010 306.1 CBC 2007 1122B.3 & 4 CBC 2016 11B-306.1 & 11B-902.3	1	JOB	\$4,800	\$4,800
<div>Mitigated:</div> <div> <input type="radio"/> YES <input checked="" type="radio"/> NO </div> <div> <input type="checkbox"/> Staff Only </div> <div> Priority 2 Severity 2 </div>

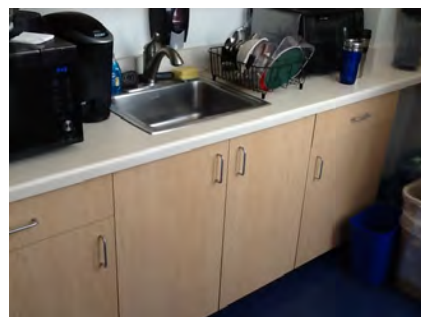
Item no., Rm no. and Name	Existing Architectural Barrier and Proposed Solution	Codes / Mitigation Info	Qty	Unit	Cost	Total
Sink						
346	<ul style="list-style-type: none">As-Built Description: Sink rim higher than 34" above floor.As-Built: 35.5" AFFProposed Solution: Remodel sink cabinet to lower sink.Notes: Conference Room/Kitchen	PCODE IN06 ADAAG 91 4.24.2 ADA 2010 606.3 CBC 2007 1115B.4.7.1 CBC 2016 11B-606.3	1	JOB	\$5,250	\$5,250

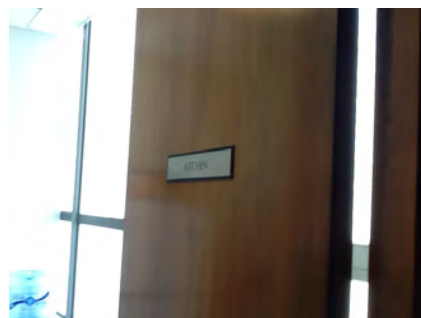
<input type="checkbox"/> Staff Only			
			Priority 2 Severity 4			
Signage						
350	<ul style="list-style-type: none">As-Built Description: Sign designating a permanent room or space does not include Grade 2 Braille.Proposed Solution: Provide new compliant signage including California Grade 2 Braille (1/10" on center dots with 2/10" space between cells).	PCODE SA07A ADAAG 91 4.30.4 ADA 2010 703.2 CBC 2007 1117B.5.6 CBC 2016 11B-703.3	5	JOB	\$270	\$1,350

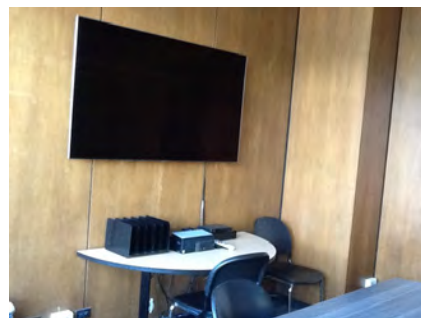
<input type="checkbox"/> Staff Only			
			Priority 2 Severity 3			
Assistive Listening						
344	<ul style="list-style-type: none">As-Built Description: No portable assistive listening system provided for small meeting room.Proposed Solution: Share existing portable assistive listening system from other facility.Notes: Conference Room	PCODE GI01E ADAAG 91 4.1.3(19)(b) & 4.33.7 ADA 2010 219.1 & 706.1 CBC 2007 1104B.2 CBC 2016 11B-219.1 & 11B-706.1	REF

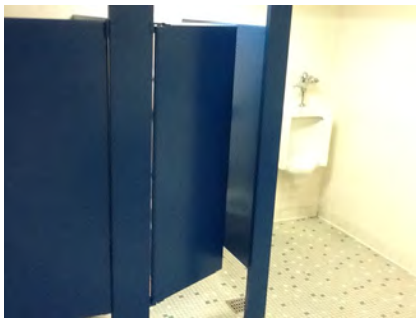
<input type="checkbox"/> Staff Only Priority 3 Severity 3
Restroom						
361	<ul style="list-style-type: none"> As-Built Description: Multiple accommodation restroom not accessible; multiple compliance violations. Proposed Solution: Remodel area to provide accessible restroom with one accessible stall, lavatory (and one urinal at Mens). 	PCODE WA01A ADAAG 91 4.22 ADA 2010 603.1 CBC 2007 1115B.3.1 CBC 2016 11B-603.1 Mitigated: <input type="radio"/> YES <input checked="" type="radio"/> NO				1 JOB ? \$105,000

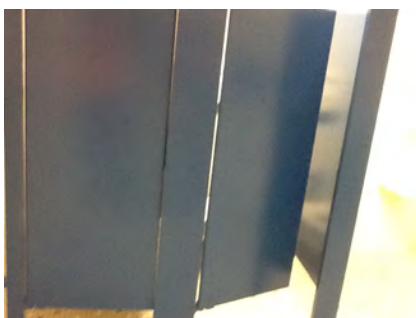
Toilet Stall						
360	<ul style="list-style-type: none"> As-Built Description: Toilet stall less than 60" wide. Proposed Solution: Provide new accessible stall 	PCODE WB06REF ADAAG 91 4.17.3 ADA 2010 604.8.1.1 CBC 2007 1115B.3.1.4.1 CBC 2016 11B-604.8.1.1 Mitigated: <input type="radio"/> YES <input checked="" type="radio"/> NO				REF

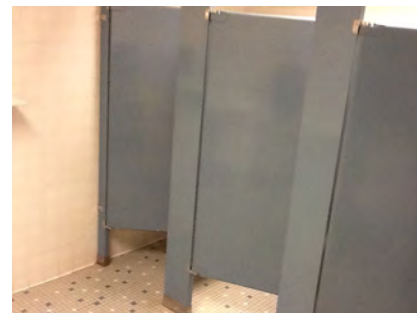
• *As-Built Description:*Multiple accommodation restroom not accessible;
multiple compliance violations.• *Proposed Solution:*Remodel area to provide accessible restroom with
one accessible stall, lavatory (and one urinal at
Mens).

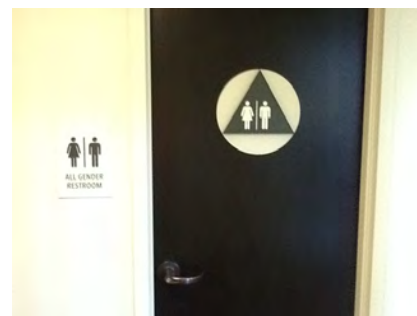
Single accommodation restroom not accessible; multiple compliance violations.

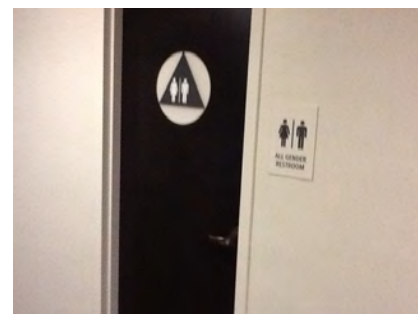
Single accommodation restroom not accessible; multiple compliance violations.

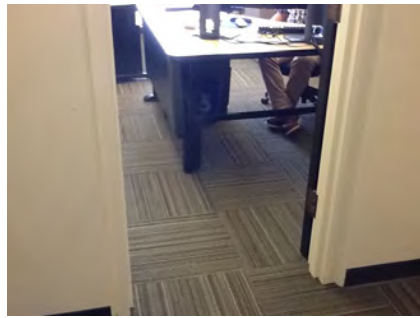
Item no., Rm no. and Name	Existing Architectural Barrier and Proposed Solution	Codes / Mitigation Info	Qty	Unit	Cost	Total
414	<ul style="list-style-type: none"> As-Built Description: Front approach: At push side, door does not have clear and level maneuvering space measuring door width x 48" (door width plus 12" if door has both, latch and closer). As-Built: 35" pull landing Proposed Solution: Remove or relocate furniture or storage items. 	PCODE ID24A ADAAG 91 Fig. 25(a) ADA 2010 404.2.4 CBC 2007 11B-26A(a) CBC 2016 11B-404.2.4 Mitigated: <input type="radio"/> YES <input checked="" type="radio"/> NO	1	JOB	\$150	\$150

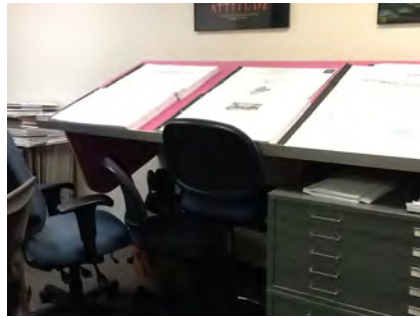
417	<ul style="list-style-type: none"> As-Built Description: Accessible non-fixed table or desk (top 28" to 34" high; knee space at least 27" high x 19" deep x 30" wide) not provided. As-Built: 42" AFF Proposed Solution: Provide table or desk with accessible dimensions when purchasing new furniture. 	PCODE IN02A ADAAG 91 4.32.3 & .4 ADA 2010 306.1 CBC 2007 1122B.3 & 4 CBC 2016 11B-306.1 & 11B-902.3 Mitigated: <input type="radio"/> YES <input checked="" type="radio"/> NO	1	JOB	\$4,800	\$4,800

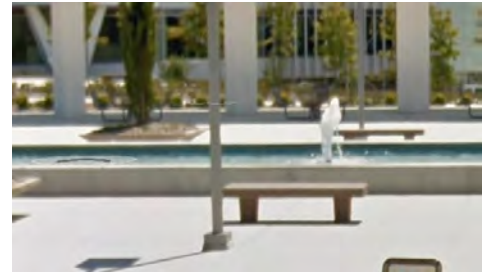
Benches throughout campus are not accessible.**Mitigated:**☐ YES☒ NO

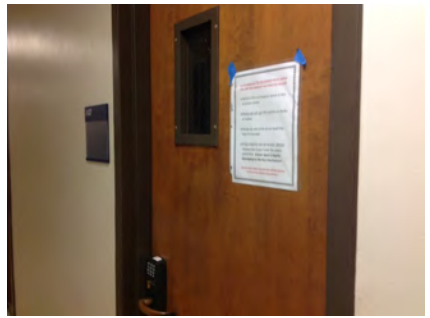
Item no., Rm no. and Name	Existing Architectural Barrier and Proposed Solution	Codes / Mitigation Info	Qty	Unit	Cost	Total
18	<ul style="list-style-type: none"> As-Built Description: Vision Light at door that permits viewing, does not have bottom of at least one glazed panel located 43 inches maximum above the finish floor. (Exception: More than 66" above finished floor.) As-Built: 55" high Proposed Solution: Provide new door with vision panel at 43" max. 	PCODE ID06C ADA 2010 404.2.11 CBC 2016 11B-404.2.11 Mitigated: <input type="radio"/> YES <input checked="" type="radio"/> NO	6	JOB	\$7,500	\$45,000

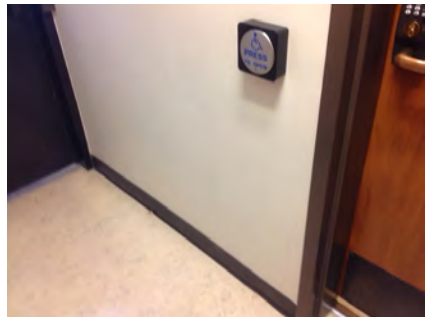
<input type="checkbox"/> Staff Only Priority 2 Severity 2						
22	<ul style="list-style-type: none"> As-Built Description: Lower push plate located at 7" minimum and 8" maximum above the floor or ground surface not provided. Proposed Solution: Provide lower push plate. Notes: Accessible door to exterior 	PCODE ID13B CBC 2007 1133B.2.3.2 CBC 2016 11B-404.2.9 2.C Mitigated: <input type="radio"/> YES <input checked="" type="radio"/> NO	2	JOB	\$1,500	\$3,000

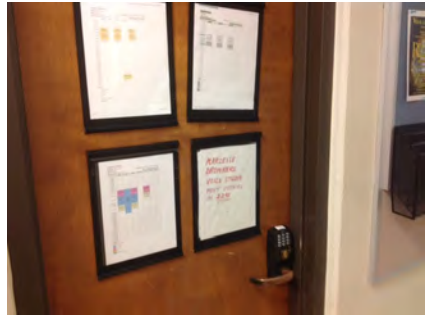
<input type="checkbox"/> Staff Only Priority 2 Severity 2						
Door Clearance						
21	<ul style="list-style-type: none"> As-Built Description: Door on accessible route has less than 32" clear and 80" (78" min. to closer if provided) opening width when 90° open. As-Built: 28" wide Proposed Solution: Provide new, larger door and frame with new accessible hardware. 	PCODE ID01 ADAAG 91 4.13.5 ADA 2010 404.2.3 CBC 2007 1133B.1.1.1.1 CBC 2016 11B-404.2.3 Mitigated: <input type="radio"/> YES <input checked="" type="radio"/> NO	10	JOB	\$7,800	\$78,000

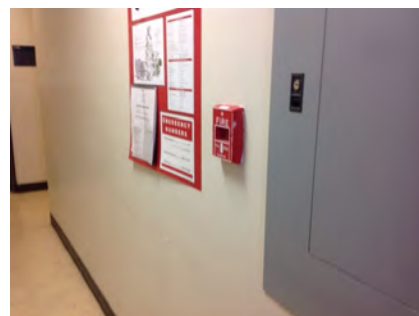
- 14
- **As-Built Description:**
Reach height to control or access point, exceeds 48" or is less than 15".
 - **As-Built:** **48.5" high**
 - **Proposed Solution:**
Modify equipment or mounting.

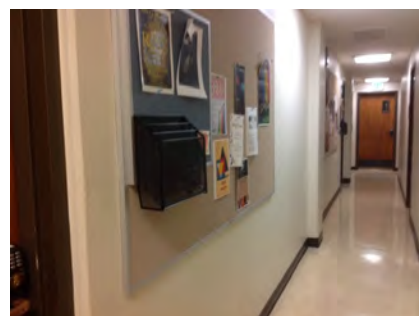
- 16
- **As-Built Description:**
Reach height to control or access point, exceeds 48" or is less than 15".
 - **As-Built:** **53" AFF**
 - **Proposed Solution:**
Modify equipment or mounting.

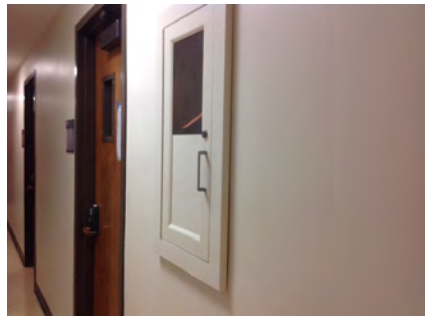
Item no., Rm no. and Name	Existing Architectural Barrier and Proposed Solution	Codes / Mitigation Info	Qty	Unit	Cost	Total
17	<ul style="list-style-type: none"> As-Built Description: Reach height to control or access point, exceeds 48" or is less than 15". As-Built: 56" AFF Proposed Solution: Modify equipment or mounting. 	PCODE IE01 ADAAG 91 4.2.5 ADA 2010 308.2.1 CBC 2007 1118B.5 CBC 2016 11B-308.2.1	1	JOB	\$300	\$300

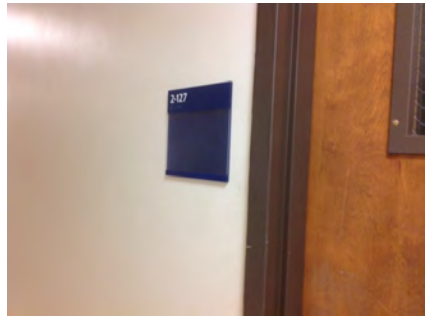
19	<ul style="list-style-type: none"> As-Built Description: Sign not located on latch side of door and/or not located at 48" min. above to baseline of the lowest Braille cells and 60" max. to baseline of the highest line of raised characters. As-Built: 62" Proposed Solution: Provide compliant signage including tactile characters and Grade II Braille on latch side of door located at compliant height. 	PCODE SA07 ADAAG 91 4.30.6 ADA 2010 703.4.1 CBC 2007 1117B.5.7 CBC 2016 11B-703.4.1	10	JOB	\$150	\$1,500

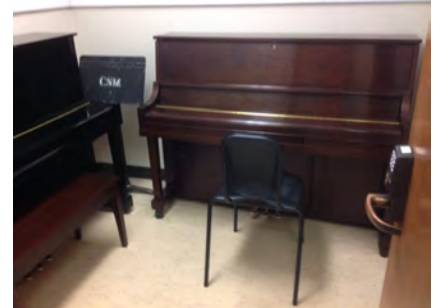
There are several individual study/practice rooms. Room 127 provides the required turning space and door landing. Provide an accessible piano in this room.

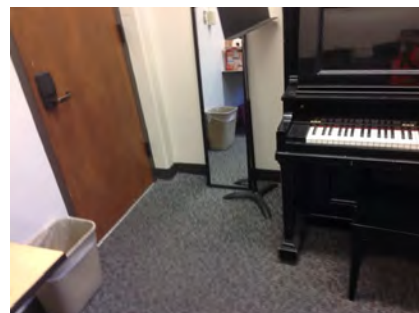
- 8 • *As-Built Description:*
Accessible non-fixed table or desk (top 28" to 34" high; knee space at least 27" high x 19" deep x 30" wide) not provided.

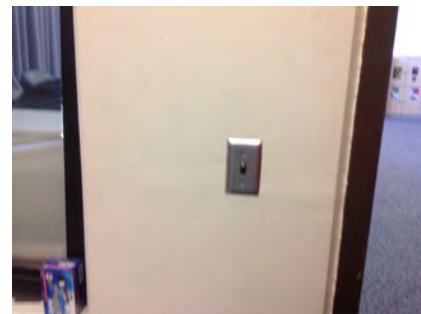
- 36 • *As-Built Description:*
Electric switch or control mounted less than 15" measured to the bottom of the outlet box or greater than 48 inches measured to the top of the outlet box.

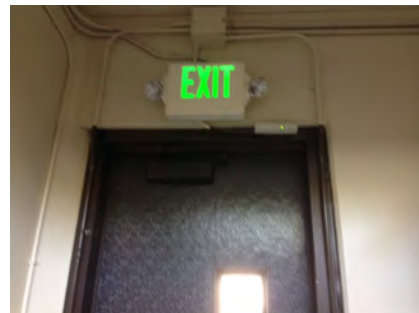
- 33
- **As-Built Description:**
Excessive force required to open door and/or door closing time of less than 5 seconds.
 - **As-Built:** **8 lbs., 2 seconds**
 - **Proposed Solution:**
Provide new door closer adjusted to accessible standards.
