SAN MATEO COUNTY
COMMUNITY
COLLEGE DISTRICT

San Mateo County Community College District Americans with Disabilities Act Self-Evaluation and Transition Plan

Report Prepared by:

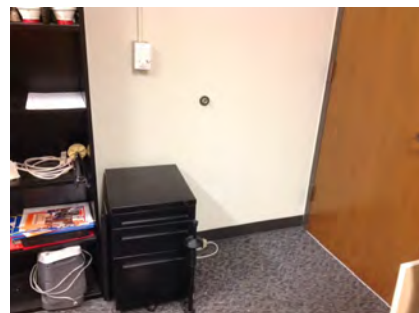
- 41
- **As-Built Description:**
Front approach: At pull side, door does not have clear and level maneuvering space measuring door width plus 18" x 60". (24" x 60" at exterior doors).
 - **As-Built:** **53"**
 - **Proposed Solution:**
Remove or relocate furniture or storage items.

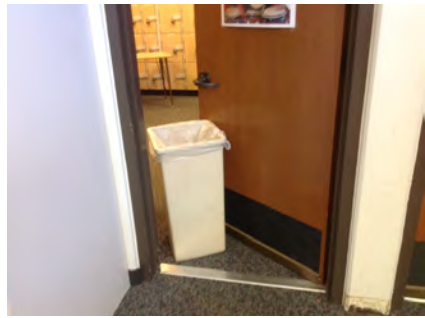
Item no., Rm no. and Name	Existing Architectural Barrier and Proposed Solution	Codes / Mitigation Info	Qty	Unit	Cost	Total
38	<ul style="list-style-type: none"> As-Built Description: Front approach: At push side, door does not have clear and level maneuvering space measuring door width x 48" (door width plus 12" if door has both, latch and closer). Proposed Solution: Remove or relocate furniture or storage items. 	PCODE ID24A ADAAG 91 Fig. 25(a) ADA 2010 404.2.4 CBC 2007 11B-26A(a) CBC 2016 11B-404.2.4 Mitigated: <input type="radio"/> YES <input checked="" type="radio"/> NO	1	JOB	\$150	\$150

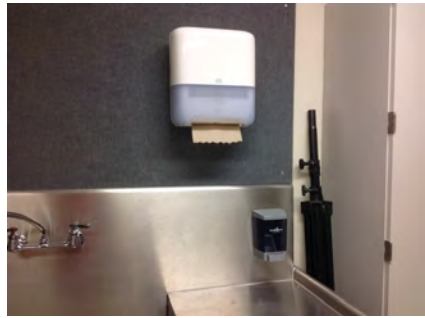
40	<ul style="list-style-type: none"> As-Built Description: Reach height to control or access point, exceeds 48" or is less than 15". As-Built: 70" high Proposed Solution: Modify equipment or mounting. 	PCODE IE01 ADAAG 91 4.2.5 ADA 2010 308.2.1 CBC 2007 1118B.5 CBC 2016 11B-308.2.1 Mitigated: <input type="radio"/> YES <input checked="" type="radio"/> NO	1	JOB	\$300	\$300

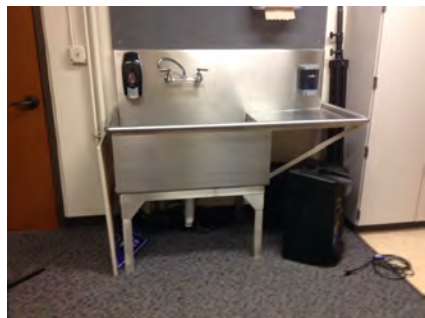
39	<ul style="list-style-type: none"> As-Built Description: Sink does not have knee space min. 27" high x 19" deep x 30" wide. Proposed Solution: Remodel sink cabinet. Notes: Unclear whether it is used by students. 	PCODE IN06A ADAAG 91 4.24.3 ADA 2010 606.2 CBC 2007 1115B.4.7.1 CBC 2016 11B-606.2 Mitigated: <input type="radio"/> YES <input checked="" type="radio"/> NO	1	JOB	\$5,250	\$5,250

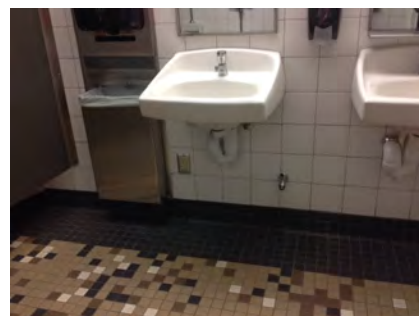
- 44
- *As-Built Description:*
Knee clearance 27" min. high starting 8" back from the front edge of the lavatory towards the wall is not provided.
 - *As-Built:* **26" knee clearance**
 - *Proposed Solution:*
Remount compliant fixture to accessible height.

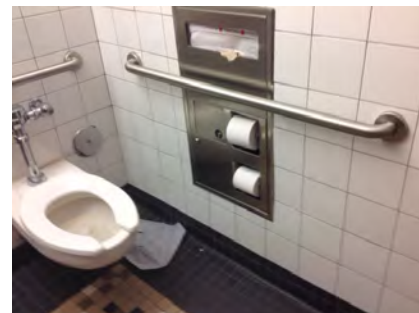
- 50
- *As-Built Description:*
Water closet not 16"-18" (CA: 17"-18") from near side wall to center line of water closet (2010 ADAAG: 16"-18").
 - *As-Built:* **18.75" o.c.**
 - *Proposed Solution:*
Relocate existing water closet and plumbing, remount with offset closet flange to provide 18" max. from side wall.

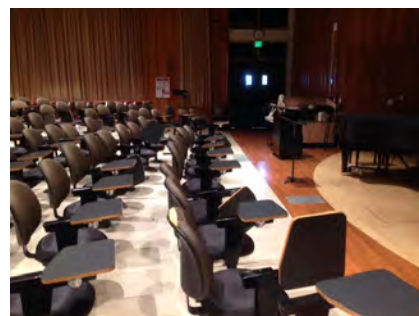
220 seats, 0 accessible provided

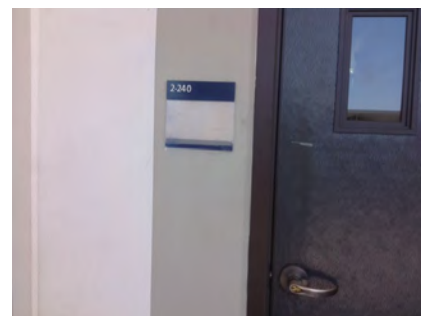
- 55
- *As-Built Description:*
Sign not located on latch side of door and/or not located at 48" min. above to baseline of the lowest Braille cells and 60" max. to baseline of the highest line of raised characters.
 - *As-Built:* **63" high**
 - *Proposed Solution:*
Provide compliant signage including tactile characters and Grade II Braille on latch side of door located at compliant height.

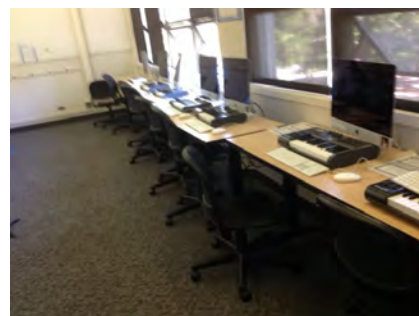
- 63
- *As-Built Description:*
Accessible non-fixed table or desk (top 28" to 34" high; knee space at least 27" high x 19" deep x 30" wide) not provided.
 - *As-Built:* **26" knee clearance**
 - *Proposed Solution:*
Provide table or desk with accessible dimensions when purchasing new furniture.

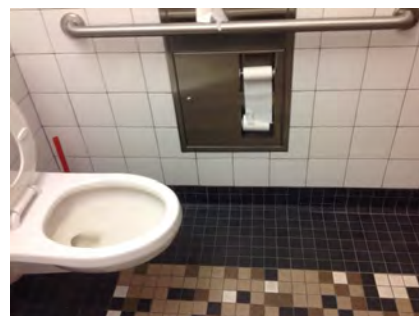
- 72
- *As-Built Description:*
Toilet paper dispenser less than 15" (CA: 19") or more than 48" above floor or not within 7" to 9" from front of water closet (Note: CA pre-2010 is allowed within 12" from front of water closet).

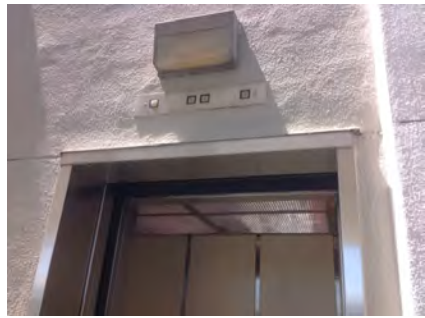
Item no., Rm no. and Name	Existing Architectural Barrier and Proposed Solution	Codes / Mitigation Info	Qty	Unit	Cost	Total
77	<ul style="list-style-type: none"> As-Built Description: Audible signal not provided (one for up, two for down). Proposed Solution: Provide proper audible hall signal for elevator. 	PCODE IK10B ADAAG 91 4.10.4 ADA 2010 407.2.2.3 CBC 2007 1116B.1.13 CBC 2016 11B-407.2.2.3 Mitigated: <input type="radio"/> YES <input checked="" type="radio"/> NO	1	JOB	\$4,650	\$4,650

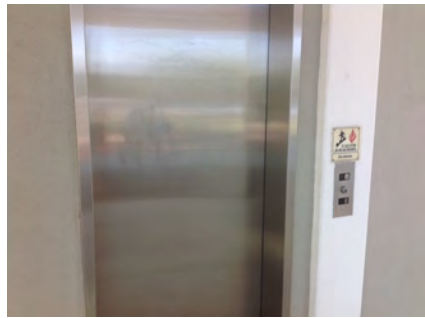
<input type="checkbox"/> Staff Only						
Priority 1 Severity 3						
74	<ul style="list-style-type: none"> As-Built Description: Grade 2 Braille (1/10" dot spacing) not provided at floor identifying jamb signs. Proposed Solution: Provide compliant floor numbering on elevator door jambs (each floor). 	PCODE IK11A ADA 2010 407.2.3.1 CBC 2007 1116B.1.14 CBC 2016 11B-407.2.3.1 Mitigated: <input type="radio"/> YES <input checked="" type="radio"/> NO	2	SET	\$150	\$300

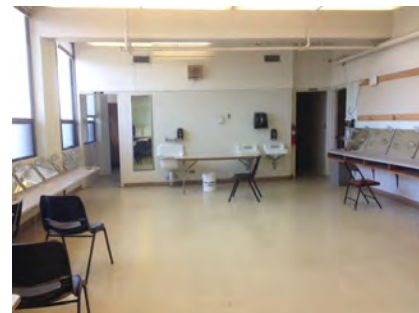
Second story of theater has no elevator access.
Restrooms, locker rooms and sound booth all
located on second floor.

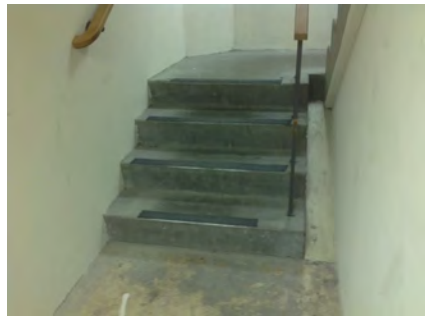
Item no., Rm no. and Name	Existing Architectural Barrier and Proposed Solution	Codes / Mitigation Info	Qty	Unit	Cost	Total
12	<ul style="list-style-type: none"> • <i>As-Built Description:</i> Stairs serving as an accessible means of egress shall have a clear width of 48" minimum between handrails. • <i>Proposed Solution:</i> Rebuild stair as needed. 	PCODE II02H CBC 2016 1007.3 Mitigated: <input type="radio"/> YES <input checked="" type="radio"/> NO	150	LF	\$60	\$9,000

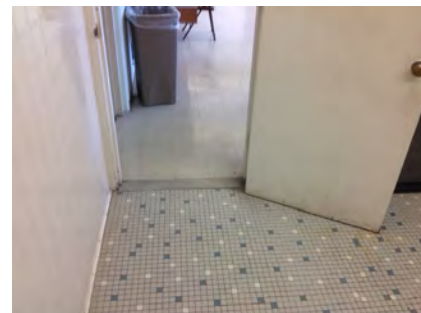
216

Multiple accommodation restroom not accessible; multiple compliance violations.

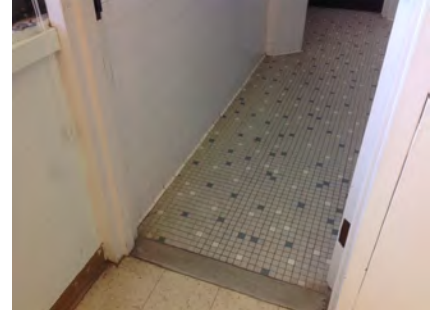
223

Multiple accommodation restroom not accessible; multiple compliance violations.

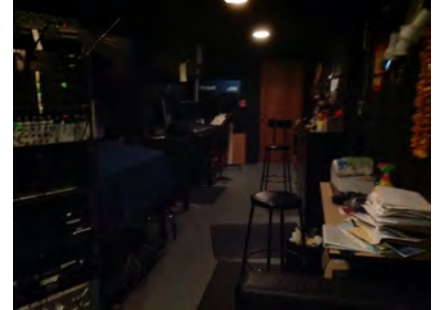
The sound control room does not provide any accessible features or elements.

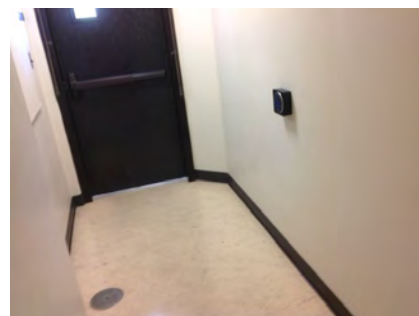
- 98 • *As-Built Description:*
Door on accessible route has less than 32" clear and 80" (78" min. to closer if provided) opening width when 90° open.

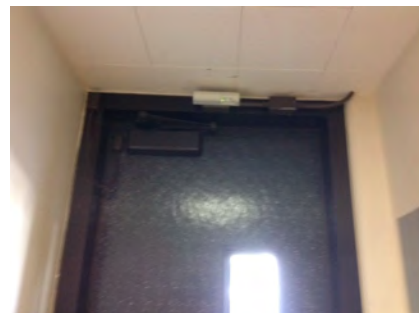
- 95
- *As-Built Description:*
Front approach: At push side, door does not have clear and level maneuvering space measuring door width x 48" (door width plus 12" if door has both, latch and closer).
 - *Proposed Solution:*
Provide door operator.
 - **Notes:**
Second door to hallway has power operator.
Provide signage at this entrance to the accessible entry.

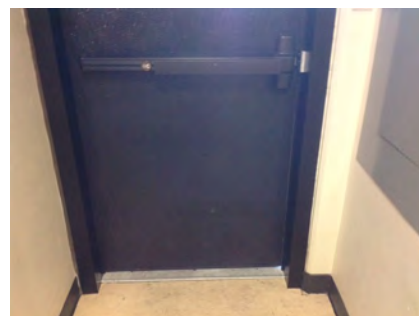
- 96
- *As-Built Description:*
Reach height to control or access point, exceeds 48" or is less than 15".
 - *As-Built:* **56" high**
 - *Proposed Solution:*
Modify equipment or mounting.

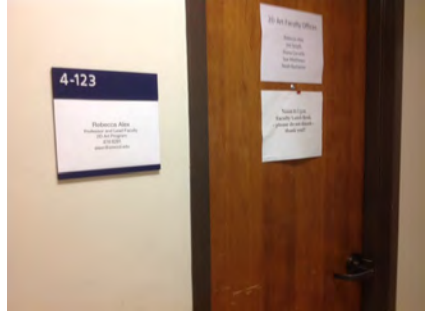
Item no., Rm no. and Name	Existing Architectural Barrier and Proposed Solution	Codes / Mitigation Info	Qty	Unit	Cost	Total
Signage						
99	<ul style="list-style-type: none"> As-Built Description: Sign not located on latch side of door and/or not located at 48" min. above to baseline of the lowest Braille cells and 60" max. to baseline of the highest line of raised characters. Proposed Solution: Provide compliant signage including tactile characters and Grade II Braille on latch side of door located at compliant height. 	PCODE SA07 ADAAG 91 4.30.6 ADA 2010 703.4.1 CBC 2007 1117B.5.7 CBC 2016 11B-703.4.1	1	JOB	\$150	\$150

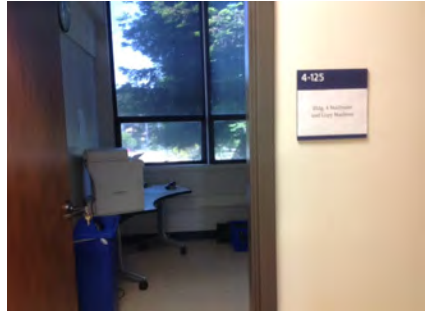
<input type="radio"/> YES <input checked="" type="radio"/> NO			
			<input type="checkbox"/> Staff Only			
			Priority	Severity		
			2	3		
100	<ul style="list-style-type: none"> As-Built Description: Sign not located on latch side of door and/or not located at 48" min. above to baseline of the lowest Braille cells and 60" max. to baseline of the highest line of raised characters. As-Built: 62" high Proposed Solution: Provide compliant signage including tactile characters and Grade II Braille on latch side of door located at compliant height. 	PCODE SA07 ADAAG 91 4.30.6 ADA 2010 703.4.1 CBC 2007 1117B.5.7 CBC 2016 11B-703.4.1	5	JOB	\$150	\$750

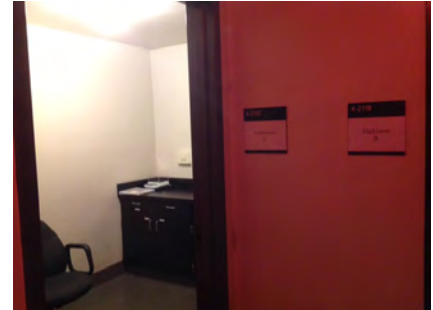
• **Notes:****3 dark rooms provided, room C accessible****Mitigated:**☐ YES☒ NO

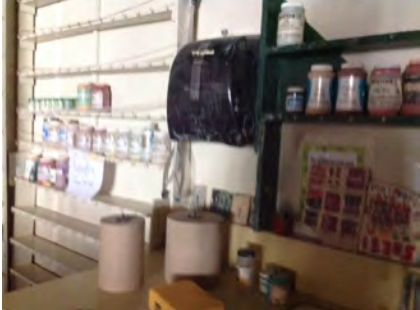
Item no., Rm no. and Name	Existing Architectural Barrier and Proposed Solution	Codes / Mitigation Info	Qty	Unit	Cost	Total
Reach Range						
258	<ul style="list-style-type: none"> As-Built Description: Reach height to control or access point, exceeds 48" or is less than 15". As-Built: 54" high Proposed Solution: Modify equipment or mounting. 	PCODE IE01 ADAAG 91 4.2.5 ADA 2010 308.2.1 CBC 2007 1118B.5 CBC 2016 11B-308.2.1	1	JOB	\$300	\$300
Mitigated: <input type="radio"/> YES <input checked="" type="radio"/> NO

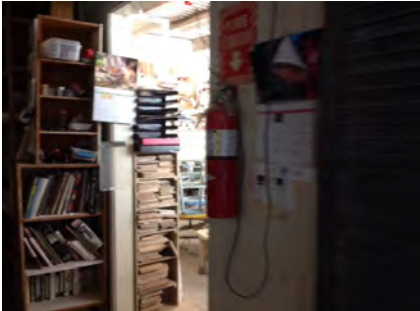
<input type="checkbox"/> Staff Only Priority 2 Severity 3			
259	<ul style="list-style-type: none"> As-Built Description: Reach height to control or access point, exceeds 48" or is less than 15". As-Built: 61" high Proposed Solution: Modify equipment or mounting. 	PCODE IE01 ADAAG 91 4.2.5 ADA 2010 308.2.1 CBC 2007 1118B.5 CBC 2016 11B-308.2.1	1	JOB	\$300	\$300
Mitigated: <input type="radio"/> YES <input checked="" type="radio"/> NO

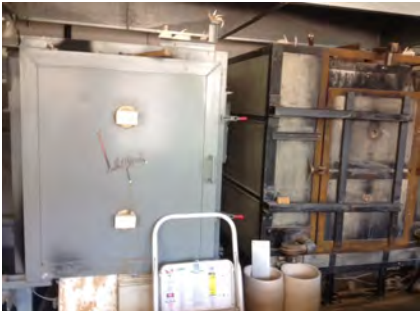
<input type="checkbox"/> Staff Only Priority 2 Severity 2			
260	<ul style="list-style-type: none"> As-Built Description: Reach height to control or access point, exceeds 48" or is less than 15". Proposed Solution: Modify equipment or mounting. 	PCODE IE01 ADAAG 91 4.2.5 ADA 2010 308.2.1 CBC 2007 1118B.5 CBC 2016 11B-308.2.1	1	JOB	\$300	\$300
Mitigated: <input type="radio"/> YES <input checked="" type="radio"/> NO

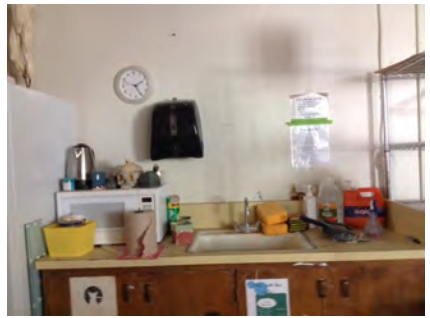
Item no., Rm no. and Name	Existing Architectural Barrier and Proposed Solution	Codes / Mitigation Info	Qty	Unit	Cost	Total
266	<ul style="list-style-type: none"> As-Built Description: Reach height to control or access point, exceeds 48" or is less than 15". As-Built: 56" high Proposed Solution: Modify equipment or mounting. 	PCODE IE01 ADAAG 91 4.2.5 ADA 2010 308.2.1 CBC 2007 1118B.5 CBC 2016 11B-308.2.1 Mitigated: <input type="radio"/> YES <input checked="" type="radio"/> NO	1	JOB	\$300	\$300

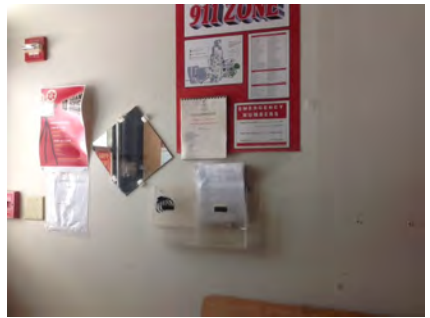
<input type="checkbox"/> Staff Only Priority 2 Severity 3			
269	<ul style="list-style-type: none"> As-Built Description: Reach height to control or access point, exceeds 48" or is less than 15". As-Built: 57" high Proposed Solution: Modify equipment or mounting. 	PCODE IE01 ADAAG 91 4.2.5 ADA 2010 308.2.1 CBC 2007 1118B.5 CBC 2016 11B-308.2.1 Mitigated: <input type="radio"/> YES <input checked="" type="radio"/> NO	1	JOB	\$300	\$300

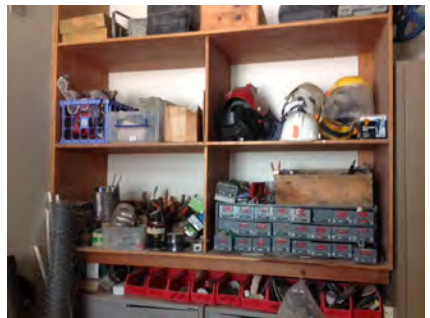
<input type="checkbox"/> Staff Only Priority 2 Severity 3			
270	<ul style="list-style-type: none"> As-Built Description: Reach height to control or access point, exceeds 48" or is less than 15". Proposed Solution: Modify equipment or mounting. Notes: Provide items within reach ranges if used by students. 	PCODE IE01 ADAAG 91 4.2.5 ADA 2010 308.2.1 CBC 2007 1118B.5 CBC 2016 11B-308.2.1 Mitigated: <input type="radio"/> YES <input checked="" type="radio"/> NO	1	JOB	\$300	\$300

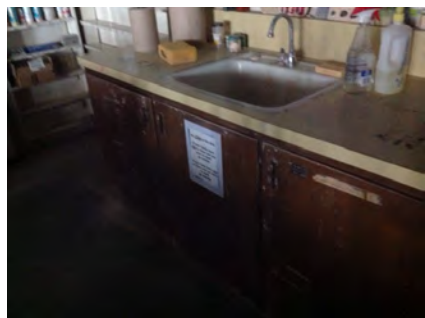
Item no., Rm no. and Name	Existing Architectural Barrier and Proposed Solution	Codes / Mitigation Info	Qty	Unit	Cost	Total
Sink						
257	<ul style="list-style-type: none"> As-Built Description: Sink rim higher than 34" above floor. As-Built: 36" high Proposed Solution: Remodel sink cabinet to lower sink. 	PCODE IN06 ADAAG 91 4.24.2 ADA 2010 606.3 CBC 2007 1115B.4.7.1 CBC 2016 11B-606.3 Mitigated: <input type="radio"/> YES <input checked="" type="radio"/> NO	1	JOB	\$5,250	\$5,250

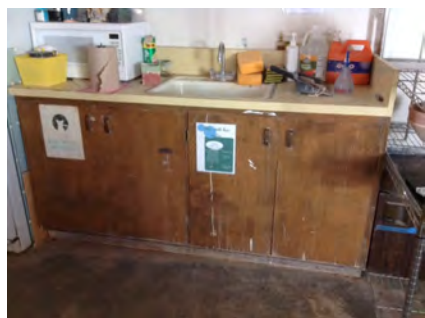
<input type="checkbox"/> Staff Only Priority 2 Severity 4			
264	<ul style="list-style-type: none"> As-Built Description: Sink rim higher than 34" above floor. Proposed Solution: Remodel sink cabinet to lower sink. 	PCODE IN06 ADAAG 91 4.24.2 ADA 2010 606.3 CBC 2007 1115B.4.7.1 CBC 2016 11B-606.3 Mitigated: <input type="radio"/> YES <input checked="" type="radio"/> NO	1	JOB	\$5,250	\$5,250

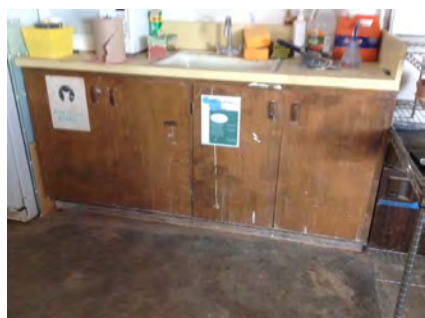
265	<ul style="list-style-type: none"> As-Built Description: Sink rim higher than 34" above floor. As-Built: 36" high Proposed Solution: Remodel sink cabinet to lower sink. 	PCODE IN06 ADAAG 91 4.24.2 ADA 2010 606.3 CBC 2007 1115B.4.7.1 CBC 2016 11B-606.3 Mitigated: <input type="radio"/> YES <input checked="" type="radio"/> NO	1	JOB	\$5,250	\$5,250

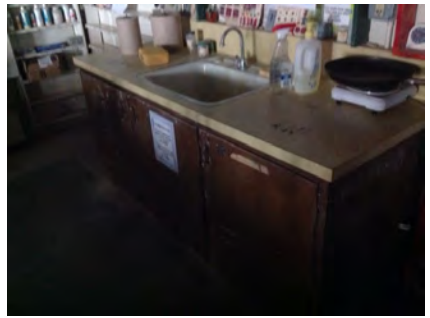
Item no., Rm no. and Name	Existing Architectural Barrier and Proposed Solution	Codes / Mitigation Info	Qty	Unit	Cost	Total
256	<ul style="list-style-type: none"> • <i>As-Built Description:</i> Sink does not have knee space min. 27" high x 19" deep x 30" wide. • <i>Proposed Solution:</i> Remodel sink cabinet. 	PCODE IN06A ADAAG 91 4.24.3 ADA 2010 606.2 CBC 2007 1115B.4.7.1 CBC 2016 11B-606.2 Mitigated: <input type="radio"/> YES <input checked="" type="radio"/> NO	1	JOB	\$5,250	\$5,250

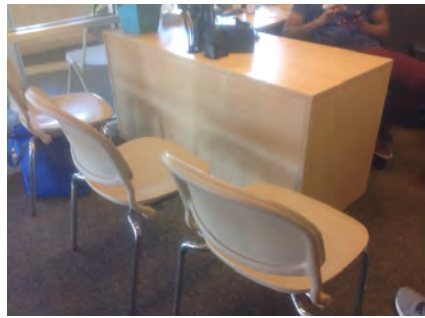
Item no., Rm no. and Name	Existing Architectural Barrier and Proposed Solution	Codes / Mitigation Info	Qty	Unit	Cost	Total
619	<ul style="list-style-type: none"> As-Built Description: Accessible non-fixed table or desk (top 28" to 34" high; knee space at least 27" high x 19" deep x 30" wide) not provided. As-Built: No knee clearance if used as work surface. Proposed Solution: Provide table or desk with accessible dimensions when purchasing new furniture. 	PCODE IN02A ADAAG 91 4.32.3 & .4 ADA 2010 306.1 CBC 2007 1122B.3 & 4 CBC 2016 11B-306.1 & 11B-902.3 Mitigated: <input type="radio"/> YES <input checked="" type="radio"/> NO	1	JOB	\$4,800	\$4,800

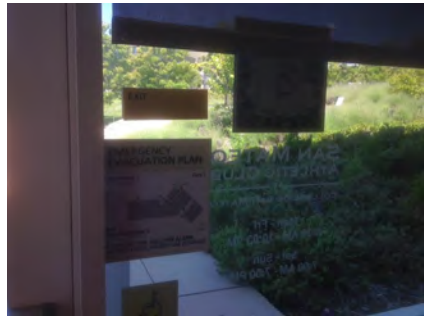
617	<ul style="list-style-type: none"> As-Built Description: Sign not located on latch side of door and/or not located at 48" min. above to baseline of the lowest Braille cells and 60" max. to baseline of the highest line of raised characters. As-Built: 60.5" high Proposed Solution: Provide compliant signage including tactile characters and Grade II Braille on latch side of door located at compliant height. 	PCODE SA07 ADAAG 91 4.30.6 ADA 2010 703.4.1 CBC 2007 1117B.5.7 Mitigated: <input type="radio"/> YES <input checked="" type="radio"/> NO	1	JOB	\$150	\$150

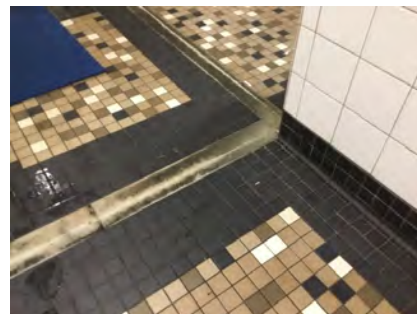
- 20
- *As-Built Description:*
Walk: Pavement dislocation creates abrupt change in level exceeding 1/2" in accessible route.
 - *As-Built:* **0.75" level change not beveled properly**
 - *Proposed Solution:*
Remove, replace or repair area of pavement sufficient to correct abrupt change in level.

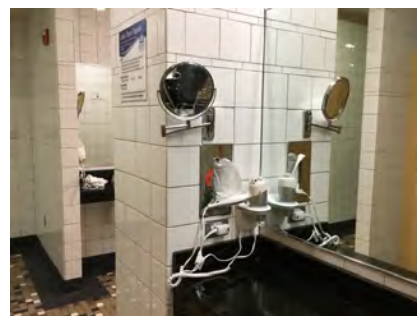
- 3
- *As-Built Description:*
Reach height to control or access point, exceeds 48" or is less than 15".
 - *As-Built:* **58.25" high**
 - *Proposed Solution:*
Modify equipment or mounting.

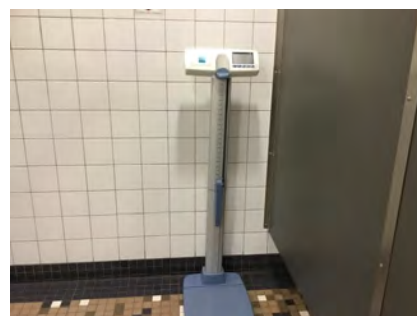
- 9
- *As-Built Description:*
Reach height to control or access point, exceeds 48" or is less than 15".
 - *As-Built:* **51.5" high**
 - *Proposed Solution:*
Modify equipment or mounting.

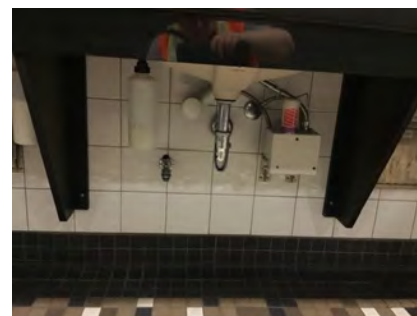
- 4
- *As-Built Description:*
Hot or sharp-surfaced water/drain pipe not insulated or covered.
 - *Proposed Solution:*
Insulate or cover water/drain pipe.
 - **Notes:**
3 other sinks have cover.

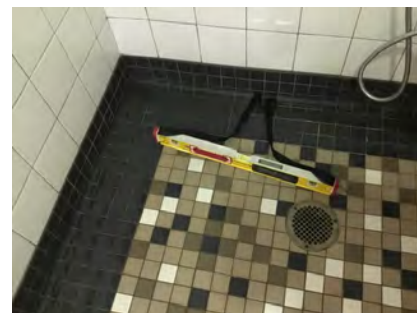
- 14
- *As-Built Description:*
Floor surface sloped greater than 2.0% (1:48) due to drain.
 - *As-Built:* **2.3%**
 - *Proposed Solution:*
Remodel floor surface to compliance.

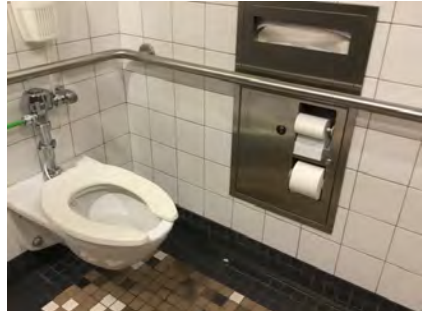
<input type="checkbox"/> Staff Only Priority 3 Severity 2			
8	<ul style="list-style-type: none"> As-Built Description: Toilet paper dispenser less than 15" (CA: 19") or more than 48" above floor or not within 7" to 9" from front of water closet (Note: CA pre-2010 is allowed within 12" from front of water closet). As-Built: 12" in front of water closet Proposed Solution: Relocate or provide new toilet paper dispenser. 	PCODE WG02 ADAAG 91 4.16.6 ADA 2010 604.7 CBC 2007 1115B.8.4 CBC 2016 11B-604.7	1	JOB	\$225	\$225

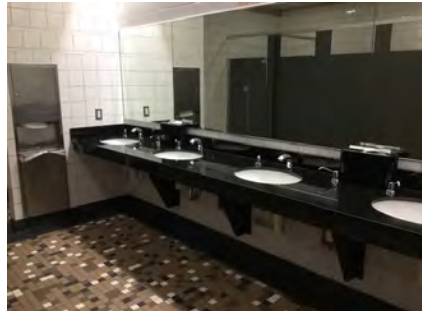
<input type="checkbox"/> Staff Only Priority 3 Severity 3			
10	<ul style="list-style-type: none"> As-Built Description: Bottom of mirror located above lavatories or countertops more than 40" above floor. As-Built: 40.5" high Proposed Solution: Relocate or provide new accessible mirror. 	PCODE WG03 ADAAG 91 4.19.6 ADA 2010 603.3 CBC 2007 1115B.8.1 CBC 2016 11B-603.3	1	JOB	\$450	\$450
Mitigated: <input type="radio"/> YES <input checked="" type="radio"/> NO

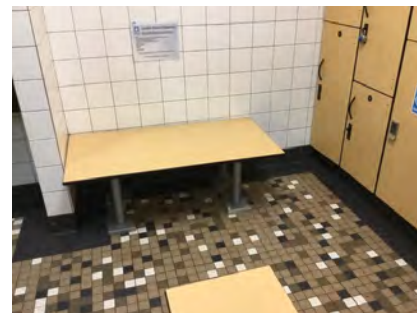
- 12
- *As-Built Description:*
Accessible locker(s) in dressing room not provided (5% of lockers; not less than one).

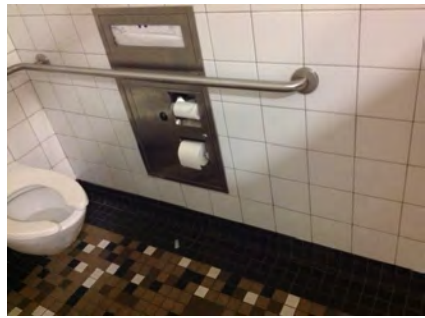
Item no., Rm no. and Name	Existing Architectural Barrier and Proposed Solution	Codes / Mitigation Info	Qty	Unit	Cost	Total
684	<ul style="list-style-type: none"> As-Built Description: Toilet paper dispenser less than 15" (CA: 19") or more than 48" above floor or not within 7" to 9" from front of water closet (Note: CA pre-2010 is allowed within 12" from front of water closet). As-Built: 12" o.c. Proposed Solution: Relocate or provide new toilet paper dispenser. 	PCODE WG02 ADAAG 91 4.16.6 ADA 2010 604.7 CBC 2007 1115B.8.4 CBC 2016 11B-604.7 Mitigated: <input type="radio"/> YES <input checked="" type="radio"/> NO	1	JOB	\$225	\$225

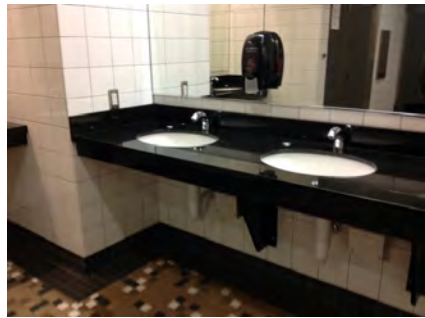
<input type="checkbox"/> Staff Only Priority 3 Severity 3			
681	<ul style="list-style-type: none"> As-Built Description: Bottom of mirror located above lavatories or countertops more than 40" above floor. As-Built: 41" high Proposed Solution: Relocate or provide new accessible mirror. 	PCODE WG03 ADAAG 91 4.19.6 ADA 2010 603.3 CBC 2007 1115B.8.1 CBC 2016 11B-603.3 Mitigated: <input type="radio"/> YES <input checked="" type="radio"/> NO	1	JOB	\$450	\$450

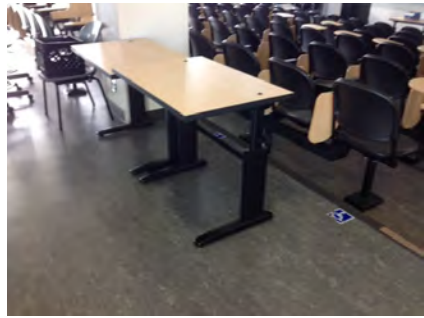
Non-Fixed Desk

690	<ul style="list-style-type: none"> As-Built Description: Accessible non-fixed table or desk (top 28" to 34" high; knee space at least 27" high x 19" deep x 30" wide) not provided. As-Built: 28" wide Proposed Solution: Provide table or desk with accessible dimensions when purchasing new furniture. Notes: 90 total, no accessible provided 	PCODE IN02A ADAAG 91 4.32.3 & .4 ADA 2010 306.1 CBC 2007 1122B.3 & 4 CBC 2016 11B-306.1 & 11B-902.3 Mitigated: <input type="radio"/> YES <input checked="" type="radio"/> NO	1	JOB	\$4,800	\$4,800

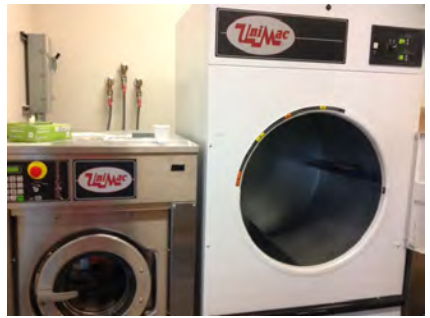
Item no., Rm no. and Name	Existing Architectural Barrier and Proposed Solution	Codes / Mitigation Info	Qty	Unit	Cost	Total
699	<ul style="list-style-type: none"> As-Built Description: Reach height to control or access point, exceeds 48" or is less than 15". As-Built: 69" high Proposed Solution: Modify equipment or mounting. 	PCODE IE01 ADAAG 91 4.2.5 ADA 2010 308.2.1 CBC 2007 1118B.5 CBC 2016 11B-308.2.1 Mitigated: <input type="radio"/> YES <input checked="" type="radio"/> NO	1	JOB	\$300	\$300

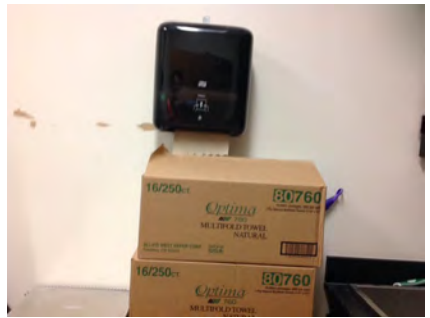
<input type="checkbox"/> Staff Only Priority 2 Severity 1						
700	<ul style="list-style-type: none"> As-Built Description: Reach height to control or access point, exceeds 48" or is less than 15". As-Built: 58" high Proposed Solution: Modify equipment or mounting. 	PCODE IE01 ADAAG 91 4.2.5 ADA 2010 308.2.1 CBC 2007 1118B.5 CBC 2016 11B-308.2.1 Mitigated: <input type="radio"/> YES <input checked="" type="radio"/> NO	1	JOB	\$300	\$300

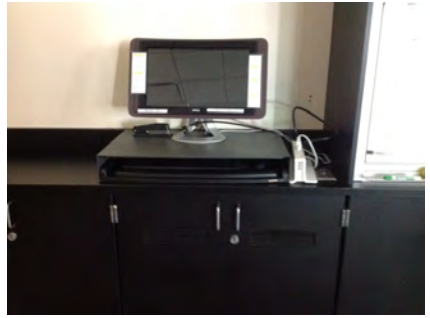
<input type="checkbox"/> Staff Only Priority 2 Severity 3						
Non-Fixed Desk						
696	<ul style="list-style-type: none"> As-Built Description: Accessible non-fixed table or desk (top 28" to 34" high; knee space at least 27" high x 19" deep x 30" wide) not provided. As-Built: No knee space Proposed Solution: Provide table or desk with accessible dimensions when purchasing new furniture. 	PCODE IN02A ADAAG 91 4.32.3 & .4 ADA 2010 306.1 CBC 2007 1122B.3 & 4 CBC 2016 11B-306.1 & 11B-902.3 Mitigated: <input type="radio"/> YES <input checked="" type="radio"/> NO	1	JOB	\$4,800	\$4,800

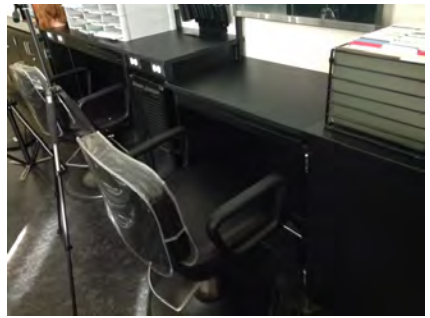
Item no., Rm no. and Name	Existing Architectural Barrier and Proposed Solution	Codes / Mitigation Info	Qty	Unit	Cost	Total
697	<ul style="list-style-type: none"> As-Built Description: Accessible non-fixed table or desk (top 28" to 34" high; knee space at least 27" high x 19" deep x 30" wide) not provided. Proposed Solution: Provide table or desk with accessible dimensions when purchasing new furniture. Notes: Approximately 85 total stations, one accessible provided 	PCODE IN02A ADAAG 91 4.32.3 & .4 ADA 2010 306.1 CBC 2007 1122B.3 & 4 CBC 2016 11B-306.1 & 11B-902.3 Mitigated: <input type="radio"/> YES <input checked="" type="radio"/> NO	1	JOB	\$4,800	\$4,800

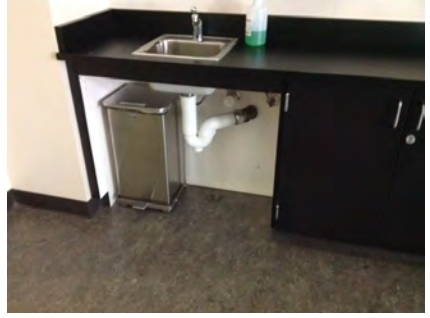
695	<ul style="list-style-type: none"> As-Built Description: Sink does not have knee space min. 27" high x 19" deep x 30" wide. Proposed Solution: Remodel sink cabinet. 	PCODE IN06A ADAAG 91 4.24.3 ADA 2010 606.2 CBC 2007 1115B.4.7.1 CBC 2016 11B-606.2 Mitigated: <input type="radio"/> YES <input checked="" type="radio"/> NO	1	JOB	\$5,250	\$5,250

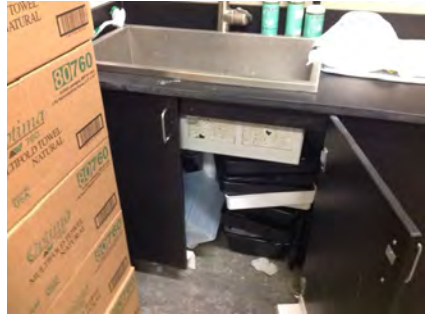
<input type="checkbox"/> Staff Only Priority 2 Severity 2						
701	<ul style="list-style-type: none"> As-Built Description: Sink does not have knee space min. 27" high x 19" deep x 30" wide. As-Built: 25" high Proposed Solution: Remodel sink cabinet. 	PCODE IN06A ADAAG 91 4.24.3 ADA 2010 606.2 CBC 2007 1115B.4.7.1 CBC 2016 11B-606.2 Mitigated: <input type="radio"/> YES <input checked="" type="radio"/> NO	1	JOB	\$5,250	\$5,250

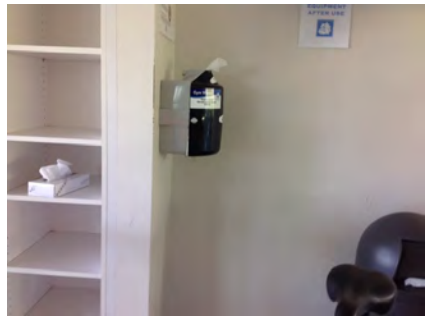
Item no., Rm no. and Name	Existing Architectural Barrier and Proposed Solution	Codes / Mitigation Info	Qty	Unit	Cost	Total
711	<ul style="list-style-type: none"> As-Built Description: Reach height to control or access point, exceeds 48" or is less than 15". As-Built: 56" high Proposed Solution: Modify equipment or mounting. 	PCODE IE01 ADAAG 91 4.2.5 ADA 2010 308.2.1 CBC 2007 1118B.5 CBC 2016 11B-308.2.1 Mitigated: <input type="radio"/> YES <input checked="" type="radio"/> NO	1	JOB	\$300	\$300

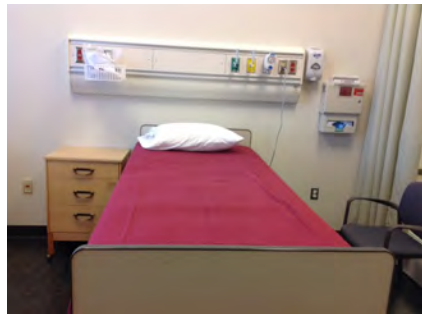
Item no., Rm no. and Name	Existing Architectural Barrier and Proposed Solution	Codes / Mitigation Info	Qty	Unit	Cost	Total
739	<ul style="list-style-type: none"> As-Built Description: Reach height to control or access point, exceeds 48" or is less than 15". As-Built: 67" reach to equipment Proposed Solution: Modify equipment or mounting. 	PCODE IE01 ADAAG 91 4.2.5 ADA 2010 308.2.1 CBC 2007 1118B.5 CBC 2016 11B-308.2.1 Mitigated: <input type="radio"/> YES <input checked="" type="radio"/> NO	1	JOB	\$300	\$300

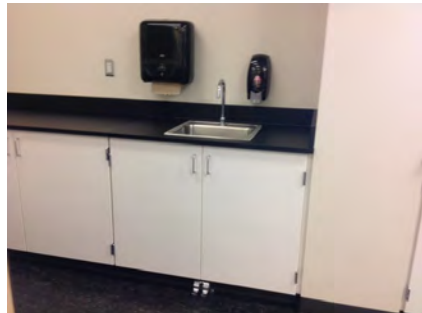
740	<ul style="list-style-type: none"> As-Built Description: Sink rim higher than 34" above floor. As-Built: 36" high no knee clearance Proposed Solution: Remodel sink cabinet to lower sink. 	PCODE IN06 ADAAG 91 4.24.2 ADA 2010 606.3 CBC 2007 1115B.4.7.1 CBC 2016 11B-606.3 Mitigated: <input type="radio"/> YES <input checked="" type="radio"/> NO	1	JOB	\$5,250	\$5,250

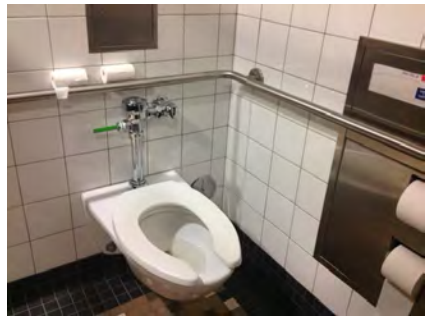
Item no., Rm no. and Name	Existing Architectural Barrier and Proposed Solution	Codes / Mitigation Info	Qty	Unit	Cost	Total
748	<ul style="list-style-type: none"> As-Built Description: Accessories/dispensers in accessible stall located closer than 1-1/2" below or 12" above grab bar impedes its use. As-Built: 1" below Proposed Solution: Relocate accessories/dispensers to be no closer than 1-1/2" below and 12" above grab bars (except if accessories are recessed, flush with wall, and have no sharp edges). 	PCODE WB071 ADAAG 91 4.26.2 ADA 2010 609.3 CBC 2007 1133B.4.2.5 CBC 2016 11B-609.3 Mitigated: <input type="radio"/> YES <input checked="" type="radio"/> NO	1	JOB	\$225	\$225

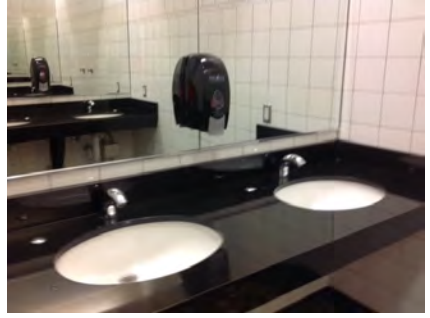
Accessories

744	<ul style="list-style-type: none"> As-Built Description: Dispensers in sanitary facilities, such as for towels, soap, sanitary napkins, seat covers, etc., and waste receptacles more than 48" (CA only: 40") from floor to highest operating slot or control. As-Built: 43" high Proposed Solution: Relocate existing restroom accessories. 	PCODE WG01A ADAAG 91 4.23.7 ADA 2010 308.2.1 CBC 2007 1115B.8.3 Mitigated: <input type="radio"/> YES <input checked="" type="radio"/> NO	1	JOB	\$300	\$300

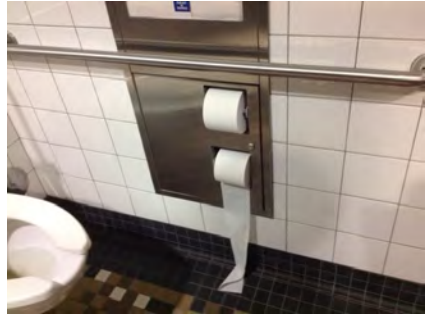
<input type="checkbox"/> Staff Only Priority 3 Severity 4						
746	<ul style="list-style-type: none"> As-Built Description: Toilet paper dispenser less than 15" (CA: 19") or more than 48" above floor or not within 7" to 9" from front of water closet (Note: CA pre-2010 is allowed within 12" from front of water closet). As-Built: 12" o.c. Proposed Solution: Relocate or provide new toilet paper dispenser. 	PCODE WG02 ADAAG 91 4.16.6 ADA 2010 604.7 CBC 2007 1115B.8.4 Mitigated: <input type="radio"/> YES <input checked="" type="radio"/> NO	1	JOB	\$225	\$225

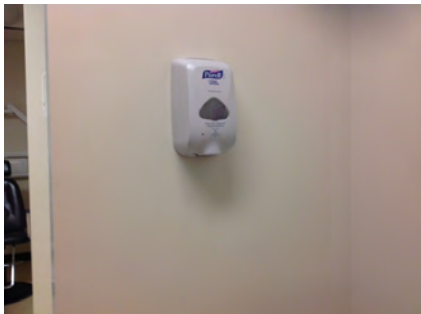
Item no., Rm no. and Name	Existing Architectural Barrier and Proposed Solution	Codes / Mitigation Info	Qty	Unit	Cost	Total
760	<ul style="list-style-type: none">As-Built Description: Reach height to control or access point, exceeds 48" or is less than 15".As-Built: 56" highProposed Solution: Modify equipment or mounting.	PCODE IE01 ADAAG 91 4.2.5 ADA 2010 308.2.1 CBC 2007 1118B.5 CBC 2016 11B-308.2.1 Mitigated: <div><input type="radio"/> YES <input checked="" type="radio"/> NO</div>	3	JOB	\$300	\$900

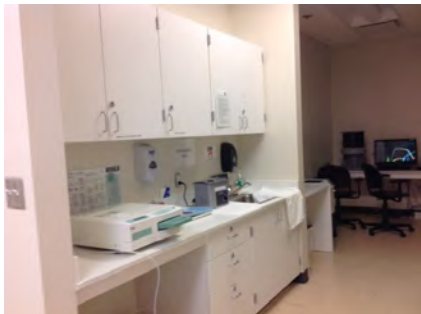
<input type="checkbox"/> Staff Only			
			Priority		Severity	
			<div>2</div>		<div>3</div>	
762	<ul style="list-style-type: none">As-Built Description: Reach height to control or access point, exceeds 48" or is less than 15".Proposed Solution: Modify equipment or mounting.Notes: Several high cabinets. Unsure if used by students or faculty.	PCODE IE01 ADAAG 91 4.2.5 ADA 2010 308.2.1 CBC 2007 1118B.5 CBC 2016 11B-308.2.1 Mitigated: <div><input type="radio"/> YES <input checked="" type="radio"/> NO</div>	1	JOB	\$300	\$300

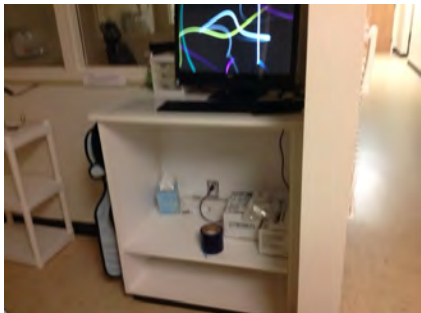
<input type="checkbox"/> Staff Only			
			Priority		Severity	
			<div>2</div>		<div>3</div>	
<u>Non-Fixed Desk</u>						
759	<ul style="list-style-type: none">As-Built Description: Accessible non-fixed table or desk (top 28" to 34" high; knee space at least 27" high x 19" deep x 30" wide) not provided.As-Built: 42" highProposed Solution: Provide table or desk with accessible dimensions when purchasing new furniture.Notes: Patient room computer station	PCODE IN02A ADAAG 91 4.32.3 & .4 ADA 2010 306.1 CBC 2007 1122B.3 & 4 CBC 2016 11B-306.1 & 11B-902.3 Mitigated: <div><input type="radio"/> YES <input checked="" type="radio"/> NO</div>	1	JOB	\$4,800	\$4,800

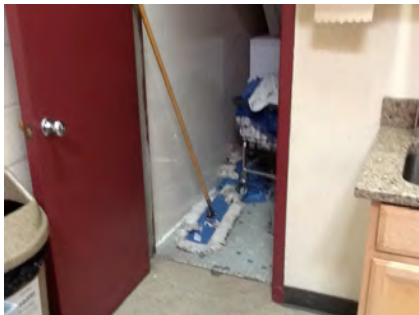
Item no., Rm no. and Name	Existing Architectural Barrier and Proposed Solution	Codes / Mitigation Info	Qty	Unit	Cost	Total
Door Clearance						
254	<ul style="list-style-type: none">As-Built Description: Door on accessible route has less than 32" clear and 80" (78" min. to closer if provided) opening width when 90° open.As-Built: 25" wideProposed Solution: Provide new, larger door and frame with new accessible hardware.	PCODE ID01 ADAAG 91 4.13.5 ADA 2010 404.2.3 CBC 2007 1133B.1.1.1.1 CBC 2016 11B-404.2.3 Mitigated: <div><input type="radio"/> YES</div> <div><input checked="" type="radio"/> NO</div>	1	JOB	\$7,800	\$7,800

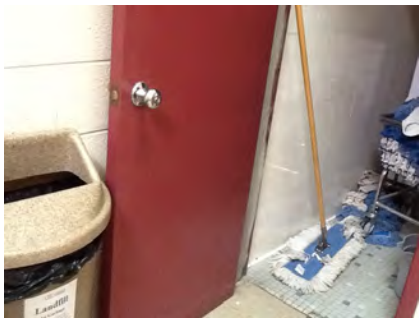
<div><input type="checkbox"/> Staff Only</div> <div>Priority <div>4</div>Severity <div>2</div></div>			
Door Hardware						
255	<ul style="list-style-type: none">As-Built Description: Non-common use areas within this facility, such as offices, do not have accessible door hardware.Proposed Solution: Provide lever handle or other accessible hardware when a specific need is identified in the future or when altering area.	PCODE ID07C ADAAG 91 4.13.9 ADA 2010 404.2.7 CBC 2007 1133B.2.5.2 CBC 2016 11B-404.2.7 Mitigated: <div><input type="radio"/> YES</div> <div><input checked="" type="radio"/> NO</div>	1	JOB	\$750	\$750

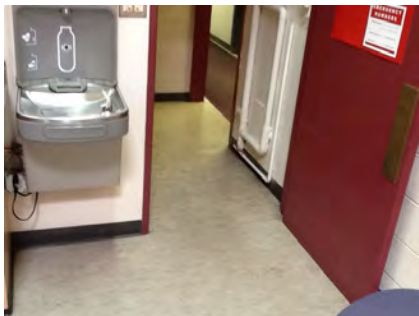
<div><input type="checkbox"/> Staff Only</div> <div>Priority <div>4</div>Severity <div>3</div></div>			
Door Swing						
248	<ul style="list-style-type: none">As-Built Description: Hinge approach: At pull side, door does not have clear and level maneuvering space measuring door width plus 36" x 60" or door width plus 42" x 54" (CA only: door width plus 36" x 60").As-Built: 8" to drinking fountainProposed Solution: Change door swing.Notes: Relocate drinking fountain/bottle filler.	PCODE ID25 ADAAG 91 Fig. 25(b) ADA 2010 404.2.4 CBC 2007 Fig. 11B-26A(b) CBC 2016 11B-404.2.4 Mitigated: <div><input type="radio"/> YES</div> <div><input checked="" type="radio"/> NO</div>	1	JOB	\$1,500	\$1,500

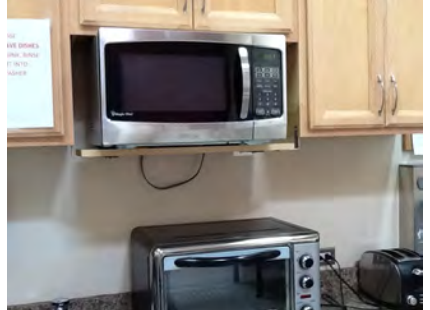
Item no., Rm no. and Name	Existing Architectural Barrier and Proposed Solution	Codes / Mitigation Info	Qty	Unit	Cost	Total
Reach Range						
256	<ul style="list-style-type: none"> As-Built Description: Reach height to control or access point, exceeds 48" or is less than 15". As-Built: 60" AFF Proposed Solution: Modify equipment or mounting. 	PCODE IE01 ADAAG 91 4.2.5 ADA 2010 308.2.1 CBC 2007 1118B.5 CBC 2016 11B-308.2.1	1	JOB	\$300	\$300
Mitigated:

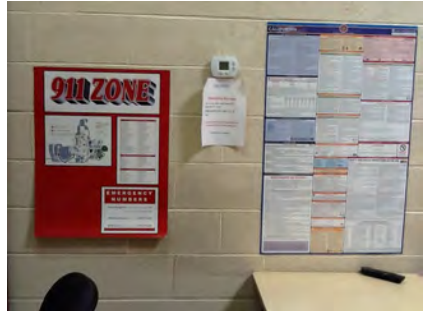
<input type="radio"/> YES <input checked="" type="radio"/> NO			<input type="checkbox"/> Staff Only Priority 4 Severity 2			
257	<ul style="list-style-type: none"> As-Built Description: Reach height to control or access point, exceeds 48" or is less than 15". As-Built: 65" AFF to thermostat Proposed Solution: Modify equipment or mounting. 	PCODE IE01 ADAAG 91 4.2.5 ADA 2010 308.2.1 CBC 2007 1118B.5 CBC 2016 11B-308.2.1	1	JOB	\$300	\$300

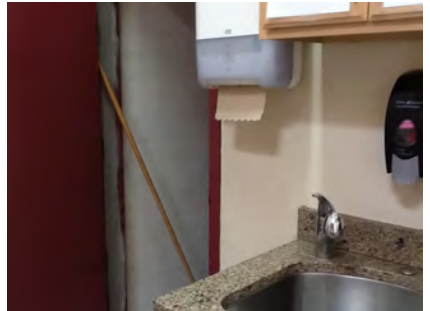
<input type="radio"/> YES <input checked="" type="radio"/> NO			<input type="checkbox"/> Staff Only Priority 4 Severity 2			
253	<ul style="list-style-type: none"> As-Built Description: Reach height to control or access point, where side approach is available, exceeds 48" or is less than 15" in height, or exceeds 10" in depth. As-Built: 50" AFF Proposed Solution: Modify equipment or mounting. 	PCODE IE02 ADAAG 91 4.2.6 ADA 2010 308.3.1 CBC 2007 1118B.6 CBC 2016 11B-308.3	1	JOB	\$300	\$300
Mitigated:

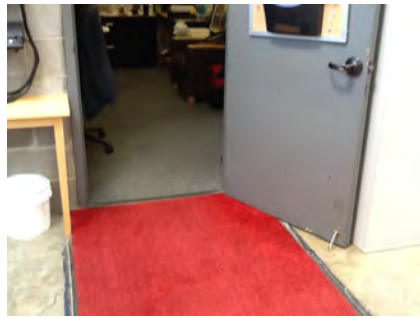
Item no., Rm no. and Name	Existing Architectural Barrier and Proposed Solution	Codes / Mitigation Info	Qty	Unit	Cost	Total
287	<ul style="list-style-type: none"> As-Built Description: At push side of door on accessible route, bottom 10" does not have a smooth, uninterrupted surface. Proposed Solution: Remove door stopper when altering area. Provide rubber wedge. 	PCODE ID06A ADA 2010 404.2.10 CBC 2007 1133B.2.6 CBC 2016 11B-404.2.10 Mitigated: <input type="radio"/> YES <input checked="" type="radio"/> NO	3	JOB	\$75	\$225

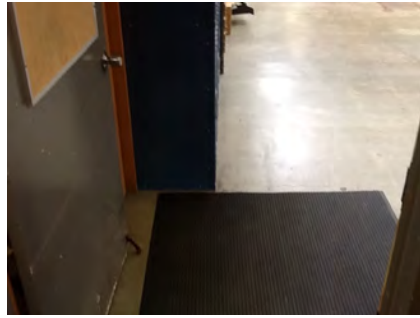
277	<ul style="list-style-type: none"> As-Built Description: Front approach: At pull side, door does not have clear and level maneuvering space measuring door width plus 18" x 60". (24" x 60" at exterior doors). As-Built: 55" to locker Proposed Solution: Remove or relocate furniture or storage items. 	PCODE ID23A ADAAG 91 Fig. 25(a) ADA 2010 404.2.4 CBC 2007 11B-26A(a) CBC 2016 11B-404.2.4 Mitigated: <input type="radio"/> YES <input checked="" type="radio"/> NO	1	JOB	\$150	\$150

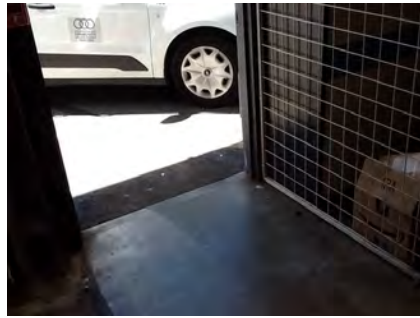
<input type="checkbox"/> Staff Only						
Priority 4 Severity 4						
282	<ul style="list-style-type: none"> As-Built Description: Front approach: At push side, door does not have clear and level maneuvering space measuring door width x 48" (door width plus 12" if door has both, latch and closer). Proposed Solution: Change door swing. Notes: Remove closer or latch to mitigate this issue. 	PCODE ID24 ADAAG 91 Fig. 25(a) ADA 2010 404.2.4 CBC 2007 11B-26A(a) CBC 2016 11B-404.2.4 Mitigated: <input type="radio"/> YES <input checked="" type="radio"/> NO	1	JOB	\$1,500	\$1,500

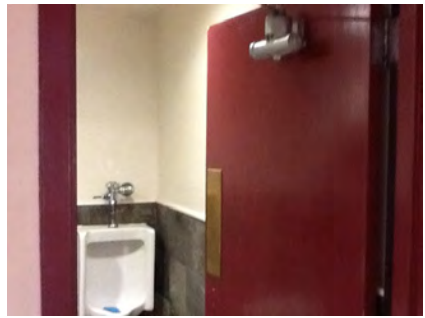
Item no., Rm no. and Name	Existing Architectural Barrier and Proposed Solution	Codes / Mitigation Info	Qty	Unit	Cost	Total
263	<ul style="list-style-type: none"> As-Built Description: Required in CA only: identification symbol centered 58" to 60" high on sanitary facility door that contrasts with the door not provided (women: 12" ø circle, men: 12" triangle, unisex: combined symbol). Proposed Solution: Provide properly mounted sanitary facility symbol when altering area. If wheelchair accessible, include International Symbol of Accessibility on sign. 	PCODE SA15 CBC 2007 1115B.6 CBC 2016 11B-703.7.2.6 Mitigated: <input type="radio"/> YES <input checked="" type="radio"/> NO	1	JOB	\$270	\$270

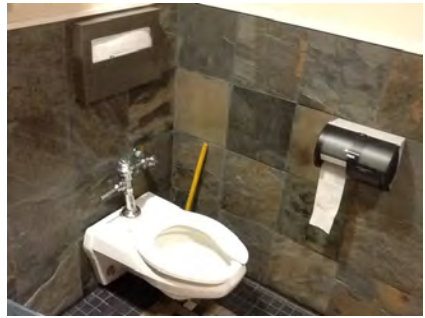
269	<ul style="list-style-type: none"> As-Built Description: Grab bars not provided or are not code compliant. Proposed Solution: Provide accessible grab bars. 	PCODE WB07 ADAAG 91 4.17.6 ADA 2010 604.5 CBC 2007 1115B.4.1.3 CBC 2016 11B-604.5 Mitigated: <input type="radio"/> YES <input checked="" type="radio"/> NO	1	JOB	\$1,500	\$1,500

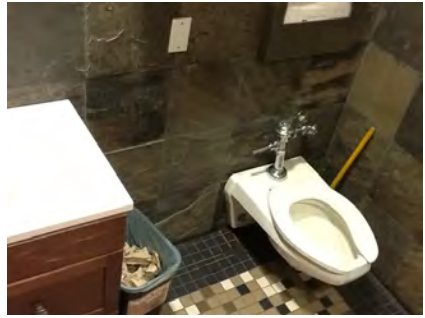
273	<ul style="list-style-type: none"> As-Built Description: 60" min. clearance around a water closet measured perpendicular from the side wall not provided (Fixtures are not allowed to overlap this clearance). As-Built: 50.25" wide Proposed Solution: Remove adjacent fixture and provide new enclosure at accessible water closet. 	PCODE WB01A ADA 2010 604.3.1; 604.3.2 CBC 2007 1115B.7.1.3 CBC 2016 11B-604.3.1; 11B-604.3.2 Mitigated: <input type="radio"/> YES <input checked="" type="radio"/> NO	1	JOB	\$6,000	\$6,000

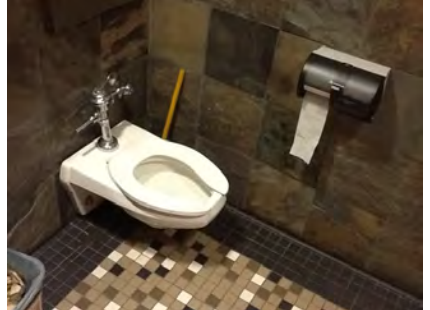
Item no., Rm no. and Name	Existing Architectural Barrier and Proposed Solution	Codes / Mitigation Info	Qty	Unit	Cost	Total
Water Closet						
271	<ul style="list-style-type: none"> • <i>As-Built Description:</i> Water closet not 16"-18" (CA: 17"-18") from near side wall to center line of water closet (2010 ADAAG: 16"-18"). • <i>As-Built:</i> 15" o.c. • <i>Proposed Solution:</i> Relocate existing water closet and plumbing, remount with offset closet flange to provide 18" max. from side wall. 	PCODE WB02C ADAAG 91 Fig. 28 ADA 2010 604.2 CBC 2007 1115B.4.1.1 CBC 2016 11B-604.2 Mitigated: <input type="radio"/> YES <input checked="" type="radio"/> NO	1	JOB	\$1,500	\$1,500

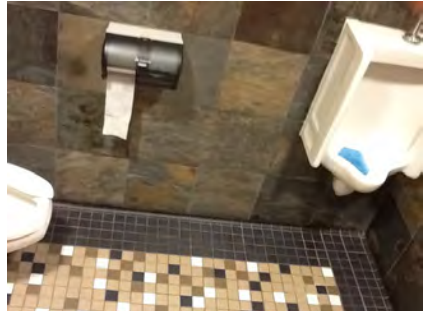
<input type="checkbox"/> Staff Only Priority 3 Severity 4			
276	<ul style="list-style-type: none"> • <i>As-Built Description:</i> CA only: In single-accommodation restroom less than 48" in front of water closet provided. • <i>As-Built:</i> 38" to urinal • <i>Proposed Solution:</i> Remodel restroom to provide at least 48" in front of water closet. 	PCODE WB03A CBC 2007 1115B.3.2.1 CBC 2016 11B-604.3.1 Mitigated: <input type="radio"/> YES <input checked="" type="radio"/> NO	1	JOB	\$15,000	\$15,000

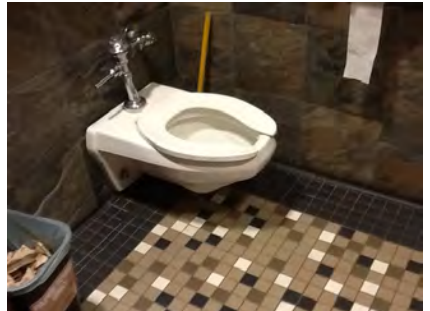
<input type="checkbox"/> Staff Only Priority 3 Severity 2			
272	<ul style="list-style-type: none"> • <i>As-Built Description:</i> Height of water closet seat less than 17" or more than 19" from floor. • <i>As-Built:</i> 16" AFF • <i>Proposed Solution:</i> Provide new accessible water closet. 	PCODE WB08 ADAAG 91 4.16.3 ADA 2010 604.4 CBC 2007 1115B.4.1.4 CBC 2016 11B-604.4 Mitigated: <input type="radio"/> YES <input checked="" type="radio"/> NO	1	JOB	\$4,200	\$4,200

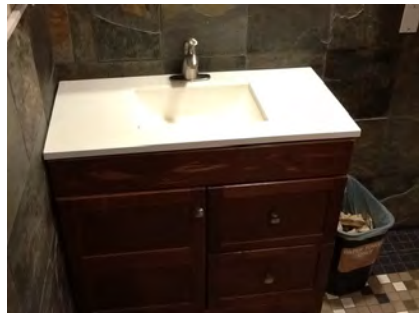
Item no., Rm no. and Name	Existing Architectural Barrier and Proposed Solution	Codes / Mitigation Info	Qty	Unit	Cost	Total
Lavatory						
265	<ul style="list-style-type: none">• <i>As-Built Description:</i> Knee clearance 27" min. high starting 8" back from the front edge of the lavatory towards the wall is not provided.• <i>Proposed Solution:</i> Provide new accessible lavatory. Remodel restroom as needed.• <i>Notes:</i> Cabinet style does not provide any knee clearance.	<p>PCODE WD04 ADAAG 91 Fig. 31 ADA 2010 306.3.3 CBC 2007 1115B.4.3 CBC 2016 11B-306.3.3</p> <p>Mitigated:</p> <p><input type="radio"/> YES <input checked="" type="radio"/> NO</p>	1	JOB	\$10,200	\$10,200

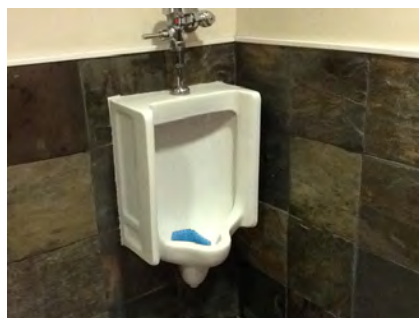
<input type="checkbox"/> Staff Only			
			Priority		Severity	
			3		2	
Urinal						
274	<ul style="list-style-type: none">• <i>As-Built Description:</i> Fixture mounted with rim more than 17" above floor.• <i>As-Built:</i> 23" AFF to front lip• <i>Proposed Solution:</i> Provide accessible urinal. Remodel restroom as needed.	<p>PCODE WE02 ADAAG 91 4.18.2 ADA 2010 605.2 CBC 2007 1115B.4.2.1 CBC 2016 11B-605.2</p> <p>Mitigated:</p> <p><input type="radio"/> YES <input checked="" type="radio"/> NO</p>	1	JOB	\$7,200	\$7,200

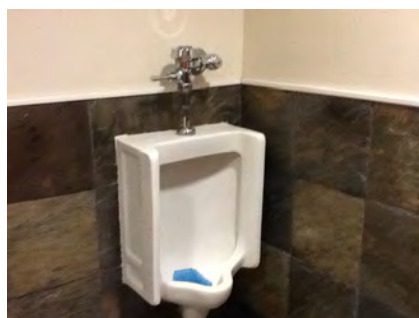
<input type="checkbox"/> Staff Only			
			Priority		Severity	
			3		3	
275	<ul style="list-style-type: none">• <i>As-Built Description:</i> Urinal flush control lever more than 48" above floor. (CA Only: 44" max.)• <i>As-Built:</i> 51" AFF to flush valve• <i>Proposed Solution:</i> Provide accessible urinal flush control.	<p>PCODE WE03 ADAAG 91 4.18.4 ADA 2010 605.4 CBC 2007 1115B.4.2.2 CBC 2016 11B-605.4</p> <p>Mitigated:</p> <p><input type="radio"/> YES <input checked="" type="radio"/> NO</p>	1	JOB	\$1,500	\$1,500

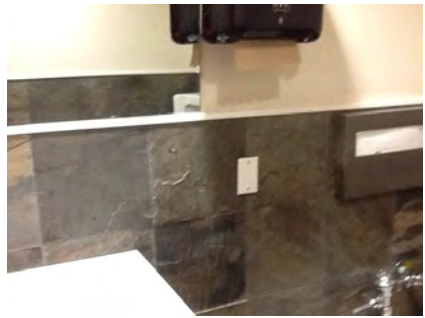
Item no., Rm no. and Name	Existing Architectural Barrier and Proposed Solution	Codes / Mitigation Info	Qty	Unit	Cost	Total
268	<ul style="list-style-type: none">As-Built Description: Bottom of mirror located above lavatories or countertops more than 40" above floor.As-Built: 49.5" AFF to bottom of mirrorProposed Solution: Relocate or provide new accessible mirror.	<p>PCODE WG03</p> <p>ADAAG 91 4.19.6</p> <p>ADA 2010 603.3</p> <p>CBC 2007 1115B.8.1</p> <p>CBC 2016 11B-603.3</p> <p>Mitigated:</p> <p><input type="radio"/> YES</p> <p><input checked="" type="radio"/> NO</p>	1	JOB	\$450	\$450

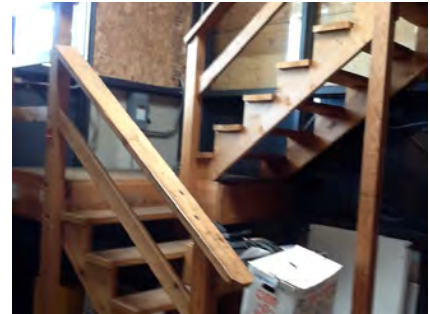
Item no., Rm no. and Name	Existing Architectural Barrier and Proposed Solution	Codes / Mitigation Info	Qty	Unit	Cost	Total
298	<ul style="list-style-type: none"> As-Built Description: Handrail not provided at stairs or ramp, required on both sides (not required at curb ramps or adjacent to seating areas). Proposed Solution: Provide new handrail for each side including extensions. 	PCODE ED01 ADAAG 91 4.8.5 & 4.9.4 ADA 2010 505.2 CBC 2007 1133B.4.1.1 & .5.5 CBC 2016 11B-505.2	25	LF	\$285	\$7,125
<div> <div>Mitigated:</div> <div> <input type="radio"/> YES <input checked="" type="radio"/> NO </div> </div> <div> <input type="checkbox"/> Staff Only </div> <div> <div>Priority</div> <div>4</div> </div> <div> <div>Severity</div> <div>2</div> </div>

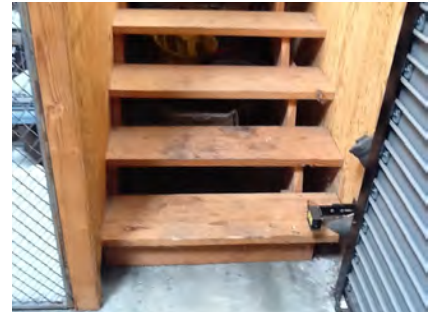
296	<ul style="list-style-type: none"> As-Built Description: The leading 2" of the tread does not have visual contrast of dark-on-light or light-on-dark from the remainder of the tread. Proposed Solution: Provide 2" min., 4" max. wide contrasting color strip 1" max. from nosing on top & bottom treads when altering area. 	PCODE II02B ADA 2010 504.4 CBC 2007 1133B.4.4 CBC 2016 11B-504.4.1	8	LF	\$42	\$336
<div> <div>Mitigated:</div> <div> <input type="radio"/> YES <input checked="" type="radio"/> NO </div> </div> <div> <input type="checkbox"/> Staff Only </div> <div> <div>Priority</div> <div>4</div> </div> <div> <div>Severity</div> <div>3</div> </div>						
300	<ul style="list-style-type: none"> As-Built Description: The leading 2" of the tread does not have visual contrast of dark-on-light or light-on-dark from the remainder of the tread. Proposed Solution: Provide 2" min., 4" max. wide contrasting color strip 1" max. from nosing on top & bottom treads when altering area. 	PCODE II02B ADA 2010 504.4 CBC 2007 1133B.4.4 CBC 2016 11B-504.4.1	16	LF	\$42	\$672

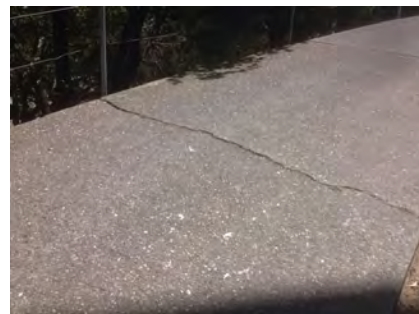
- As-Built:** **1" high cracks**

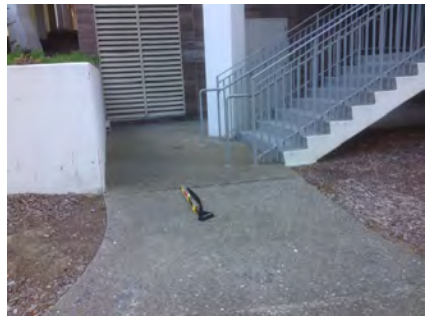
Item no., Rm no. and Name	Existing Architectural Barrier and Proposed Solution	Codes / Mitigation Info	Qty	Unit	Cost	Total
444	<ul style="list-style-type: none"> As-Built Description: Walk: Slope greater than 1:20 (5.0%), and walk does not comply with requirements for ramps. As-Built: 9.4% Proposed Solution: Modify walk/sidewalk slope to 1:20 or less. 	PCODE EF01 ADAAG 91 4.3.7 ADA 2010 403.3 CBC 2007 1133B.7.3 CBC 2016 11B-403.3 Mitigated: <input type="radio"/> YES <input checked="" type="radio"/> NO	200	SF	\$75	\$15,000

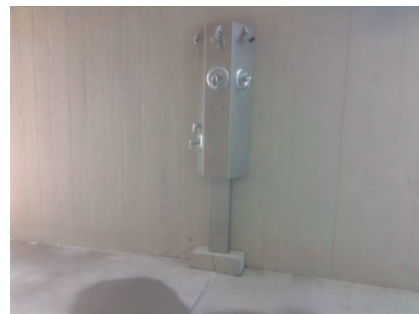
Shower not accessible; multiple compliance violations.

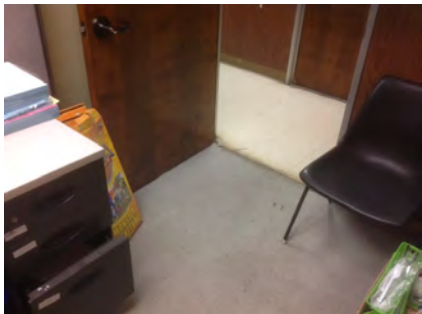
Item no., Rm no. and Name	Existing Architectural Barrier and Proposed Solution	Codes / Mitigation Info	Qty	Unit	Cost	Total
471	<ul style="list-style-type: none"> As-Built Description: Front approach: At pull side, door does not have clear and level maneuvering space measuring door width plus 18" x 60". (24" x 60" at exterior doors). Proposed Solution: Remove or relocate furniture or storage items. Notes: Typical Office 	PCODE ID23A ADAAG 91 Fig. 25(a) ADA 2010 404.2.4 CBC 2007 11B-26A(a) CBC 2016 11B-404.2.4 Mitigated: <input type="radio"/> YES <input checked="" type="radio"/> NO	6	JOB	\$150	\$900
