SAN MATEO COUNTY
COMMUNITY
COLLEGE DISTRICT

San Mateo County Community College District Americans with Disabilities Act Self-Evaluation and Transition Plan

Report Prepared by:

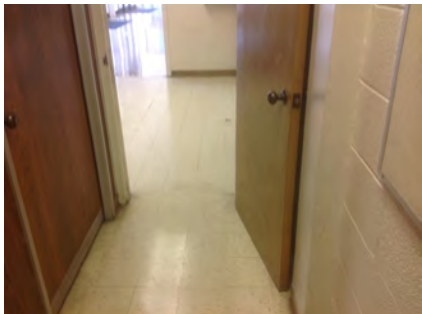
<input type="checkbox"/> Staff Only Priority 2 Severity 3			
461	<ul style="list-style-type: none"> As-Built Description: Front approach: At pull side, door does not have clear and level maneuvering space measuring door width plus 18" x 60". (24" x 60" at exterior doors). Proposed Solution: Provide power door operator. 	PCODE ID23C ADAAG 91 Fig. 25(a) ADA 2010 404.2.4 CBC 2007 11B-26A(a) CBC 2016 11B-404.2.4 Mitigated: <input type="radio"/> YES <input checked="" type="radio"/> NO	1	JOB	\$15,000	\$15,000

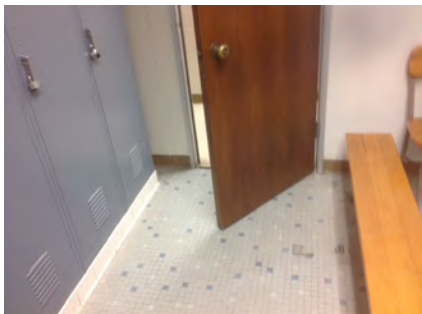
<input type="checkbox"/> Staff Only Priority 2 Severity 2			
465	<ul style="list-style-type: none"> As-Built Description: Front approach: At pull side, door does not have clear and level maneuvering space measuring door width plus 18" x 60". (24" x 60" at exterior doors). As-Built: 9" wide Proposed Solution: Provide power door operator. Notes: Faculty Locker Room 	PCODE ID23C ADAAG 91 Fig. 25(a) ADA 2010 404.2.4 CBC 2007 11B-26A(a) CBC 2016 11B-404.2.4 Mitigated: <input type="radio"/> YES <input checked="" type="radio"/> NO	1	JOB	\$15,000	\$15,000

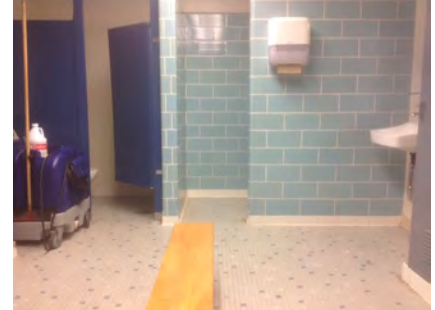
Multiple accommodation restroom not accessible;
multiple compliance violations.

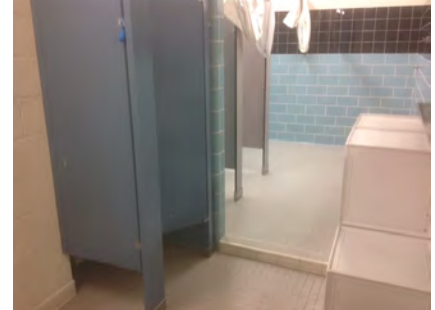
• *As-Built Description:*Multiple accommodation restroom not accessible;
multiple compliance violations.• *Proposed Solution:*Remodel area to provide accessible restroom with
one accessible stall, lavatory (and one urinal at
Mens).

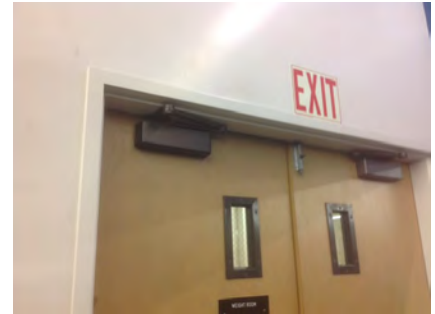
Item no., Rm no. and Name	Existing Architectural Barrier and Proposed Solution	Codes / Mitigation Info	Qty	Unit	Cost	Total
490	<ul style="list-style-type: none"> As-Built Description: Sign designating a permanent room or space does not include Grade 2 Braille. Proposed Solution: Provide new compliant signage including California Grade 2 Braille (1/10" on center dots with 2/10" space between cells). 	PCODE SA07A ADAAG 91 4.30.4 ADA 2010 703.2 CBC 2007 1117B.5.6 CBC 2016 11B-703.3 Mitigated: <input type="radio"/> YES <input checked="" type="radio"/> NO	3	JOB	\$270	\$810

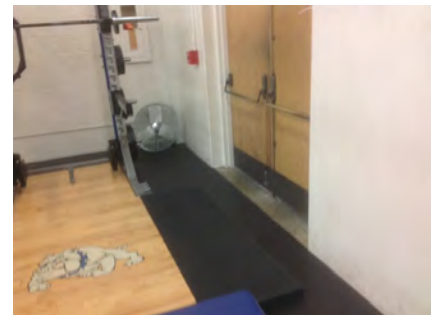
492	<ul style="list-style-type: none"> As-Built Description: Refer to notes for observation and recommendation. Proposed Solution: Notes: Emergency exit blocked by weights. 	PCODE GN01 CBC 2016 11B-703.3 Mitigated: <input type="radio"/> YES <input checked="" type="radio"/> NO
-----	---	---

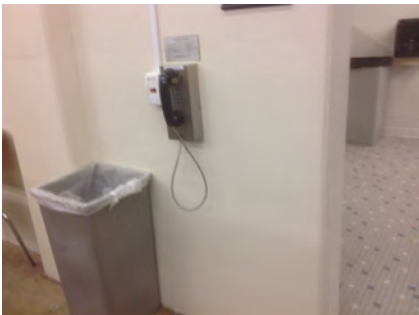
Item no., Rm no. and Name	Existing Architectural Barrier and Proposed Solution	Codes / Mitigation Info	Qty	Unit	Cost	Total
Telephone						
505	<ul style="list-style-type: none">• <i>As-Built Description:</i> Telephone mounting height more than 48" to highest operable part of phone if side reach approach is available.• <i>Proposed Solution:</i> Lower telephone enclosure and phone.	<i>PCODE</i> IB02 <i>ADAAG 91</i> 4.2.6 <i>ADA 2010</i> 704.2.2 <i>CBC 2007</i> 1118B.6 <i>CBC 2016</i> 11B-704.2.2	1	JOB	\$750	\$750

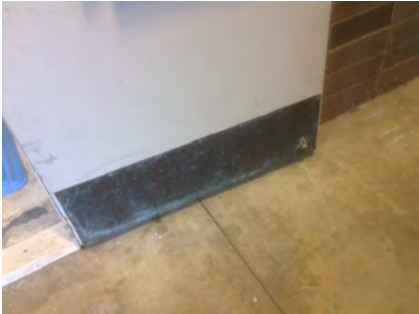
<input type="checkbox"/> Staff Only			
			<i>Priority</i>		<i>Severity</i>	
			3		4	
Door						
528	<ul style="list-style-type: none">• <i>As-Built Description:</i> At push side of door on accessible route, bottom 10" does not have a smooth, uninterrupted surface.• <i>Proposed Solution:</i> Provide 10" min. "kick plate" covering width of door when altering area.• <i>Notes:</i> Exterior Entrance	<i>PCODE</i> ID06 <i>ADA 2010</i> 404.2.10 <i>CBC 2007</i> 1133B.2.6 <i>CBC 2016</i> 11B-404.2.10	2	JOB	\$300	\$600

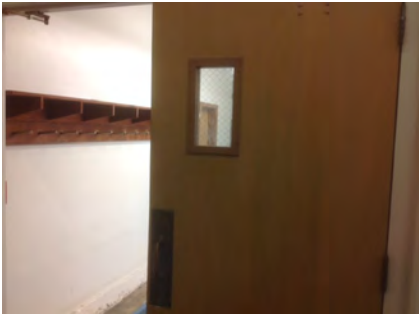
<input type="checkbox"/> Staff Only			
			<i>Priority</i>		<i>Severity</i>	
			3		3	
Door						
530	<ul style="list-style-type: none">• <i>As-Built Description:</i> Vision Light at door that permits viewing, does not have bottom of at least one glazed panel located 43 inches maximum above the finish floor. (Exception: More than 66" above finished floor.)• <i>Proposed Solution:</i> Provide new door with vision panel at 43" max.• <i>Notes:</i> Exterior Entrance	<i>PCODE</i> ID06C <i>ADA 2010</i> 404.2.11 <i>CBC 2016</i> 11B-404.2.11	1	JOB	\$7,500	\$7,500

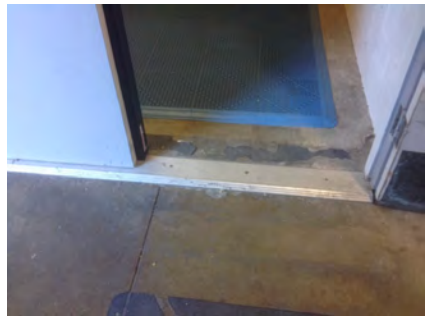
Item no., Rm no. and Name	Existing Architectural Barrier and Proposed Solution	Codes / Mitigation Info	Qty	Unit	Cost	Total
527	<ul style="list-style-type: none"> As-Built Description: Door inaccessible due to threshold or step at door exceeding 1/2". As-Built: 1" high Proposed Solution: Modify threshold to be no more than 1/2" by removing existing paving at door and providing landing with edge ramping (slope 1:20 max). Exterior Entrance	PCODE ID02A ADAAG 91 4.13.8 ADA 2010 404.2.5 CBC 2007 1133B.2.4.1 CBC 2016 11B-404.2.5 Mitigated: <input type="radio"/> YES <input checked="" type="radio"/> NO	1	JOB	\$1,200	\$1,200

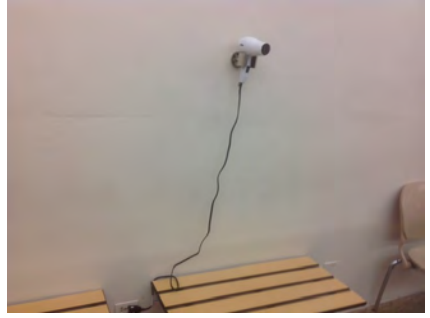
502	<ul style="list-style-type: none"> As-Built Description: Reach height to control or access point, exceeds 48" or is less than 15". As-Built: 58" high Proposed Solution: Modify equipment or mounting. 	PCODE IE01 ADAAG 91 4.2.5 ADA 2010 308.2.1 CBC 2007 1118B.5 CBC 2016 11B-308.2.1 Mitigated: <input type="radio"/> YES <input checked="" type="radio"/> NO	1	JOB	\$300	\$300

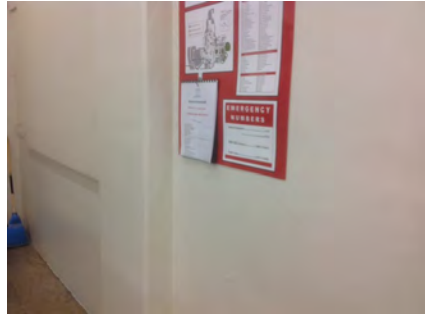
<input type="checkbox"/> Staff Only Priority 3 Severity 3						
503	<ul style="list-style-type: none"> As-Built Description: Reach height to control or access point, exceeds 48" or is less than 15". As-Built: 52" high Proposed Solution: Modify equipment or mounting. 	PCODE IE01 ADAAG 91 4.2.5 ADA 2010 308.2.1 CBC 2007 1118B.5 CBC 2016 11B-308.2.1 Mitigated: <input type="radio"/> YES <input checked="" type="radio"/> NO	1	JOB	\$300	\$300

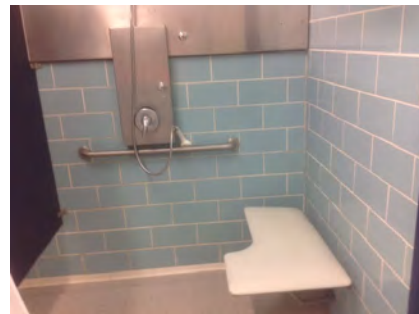
Shower not accessible; multiple compliance violations.

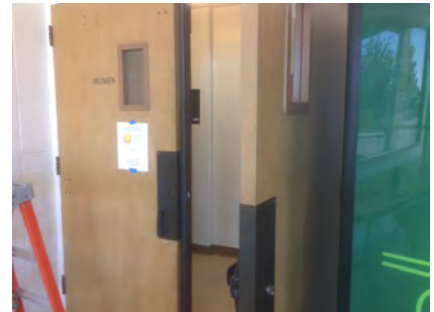
PCODE SA11A
ADAAG 91 4.1.3(16)(a)
ADA 2010 216.8
CBC 2016 11B-216.8

Provide ADA compliant sign mounted at 48" min. above to baseline of the lowest Braille cells and 60" max. to baseline of the highest line of raised characters on nearest adjacent wall, on latch side of a single door (located not to cause a Braille reader to stand within the door swing).

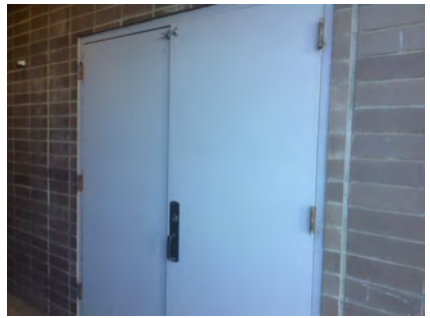
Item no., Rm no. and Name	Existing Architectural Barrier and Proposed Solution	Codes / Mitigation Info	Qty	Unit	Cost	Total
559	<ul style="list-style-type: none"> As-Built Description: Entrance to toilet or bathing facility not identified with ADAAG compliant signage. Proposed Solution: Provide ADA compliant sign mounted at 48" min. above to baseline of the lowest Braille cells and 60" max. to baseline of the highest line of raised characters on nearest adjacent wall, on latch side of a single door (located not to cause a Braille reader to stand within the door swing). Notes: Exterior entrance 	PCODE SA11A ADAAG 91 4.1.3(16)(a) ADA 2010 216.8 CBC 2016 11B-216.8 Mitigated: <input type="radio"/> YES <input checked="" type="radio"/> NO	1	JOB	\$270	\$270

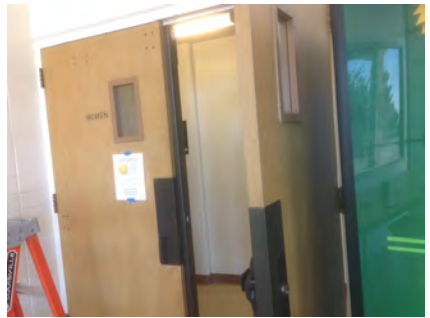
<input type="checkbox"/> Staff Only Priority 3 Severity 3			
538	<ul style="list-style-type: none"> As-Built Description: Required in CA only: identification symbol centered 58" to 60" high on sanitary facility door that contrasts with the door not provided (women: 12" ø circle, men: 12" triangle, unisex: combined symbol). Proposed Solution: Provide properly mounted sanitary facility symbol when altering area. If wheelchair accessible, include International Symbol of Accessibility on sign. 	PCODE SA15 CBC 2007 1115B.6 CBC 2016 11B-703.7.2.6 Mitigated: <input type="radio"/> YES <input checked="" type="radio"/> NO	1	JOB	\$270	\$270

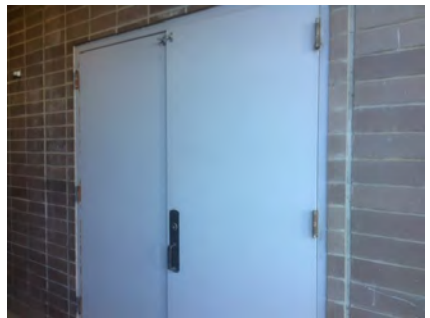
<input type="checkbox"/> Staff Only Priority 3 Severity 3			
560	<ul style="list-style-type: none"> As-Built Description: Required in CA only: identification symbol centered 58" to 60" high on sanitary facility door that contrasts with the door not provided (women: 12" ø circle, men: 12" triangle, unisex: combined symbol). Proposed Solution: Provide properly mounted sanitary facility symbol when altering area. If wheelchair accessible, include International Symbol of Accessibility on sign. Notes: Exterior entrance 	PCODE SA15 CBC 2007 1115B.6 CBC 2016 11B-703.7.2.6 Mitigated: <input type="radio"/> YES <input checked="" type="radio"/> NO	1	JOB	\$270	\$270

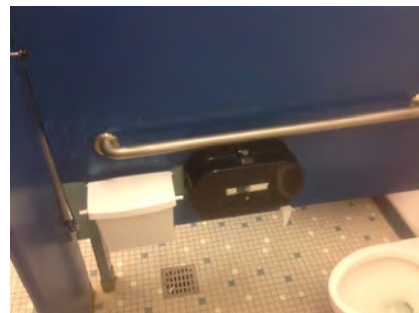
554	<ul style="list-style-type: none"> As-Built Description: Side grab bar less than 42" long, or located more than 12 inches max. from the rear wall, or extending less than 54" from rear wall (CA only: front end min. 24" in front of water closet). As-Built: 52" Proposed Solution: Provide or relocate accessible side grab bar. 	PCODE WB07A ADAAG 91 Fig. 29(b) ADA 2010 604.5.1 CBC 2007 1115B.4.1.3.1 CBC 2016 11B-604.5.1	1	JOB	\$780	\$780
-----	--	---	---	-----	-------	-------

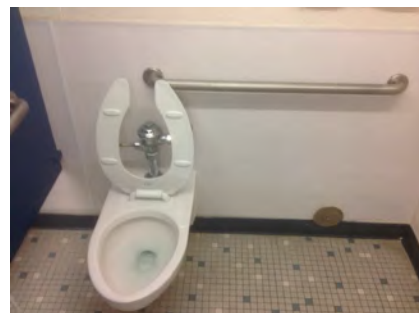
553	<ul style="list-style-type: none"> As-Built Description: The rear wall grab is less than 36" min. or does not extend from the centerline of the water closet 12" min. on one side and 24" min. on the other side. Proposed Solution: Provide or relocate accessible rear grab bar. 	PCODE WB07B ADAAG 91 4.17.6 ADA 2010 604.5.2 CBC 2007 1115B.4.1.3.2 CBC 2016 11B-604.5.2	1	JOB	\$1,020	\$1,020
-----	--	---	---	-----	---------	---------

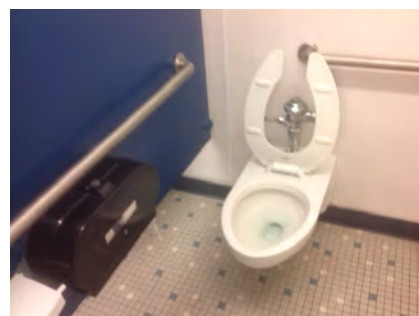
552	<ul style="list-style-type: none"> As-Built Description: Water closet not 16"-18" (CA: 17"-18") from near side wall to center line of water closet (2010 ADAAG: 16"-18"). As-Built: 16" o.c. Proposed Solution: Relocate existing water closet and plumbing, remount with offset closet flange to provide 18" max. from side wall. 	PCODE WB02C ADAAG 91 Fig. 28 ADA 2010 604.2 CBC 2007 1115B.4.1.1 CBC 2016 11B-604.2	1	JOB	\$1,500	\$1,500
-----	---	--	---	-----	---------	---------

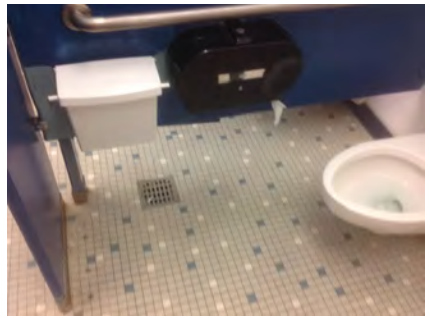
Item no., Rm no. and Name	Existing Architectural Barrier and Proposed Solution	Codes / Mitigation Info	Qty	Unit	Cost	Total
550	<ul style="list-style-type: none"> As-Built Description: CA only: In single-accommodation restroom less than 48" in front of water closet provided. As-Built: 35" Proposed Solution: Remodel restroom to provide at least 48" in front of water closet. 	PCODE WB03A CBC 2007 1115B.3.2.1 CBC 2016 11B-604.3.1 Mitigated: <input type="radio"/> YES <input checked="" type="radio"/> NO	1	JOB	\$15,000	\$15,000

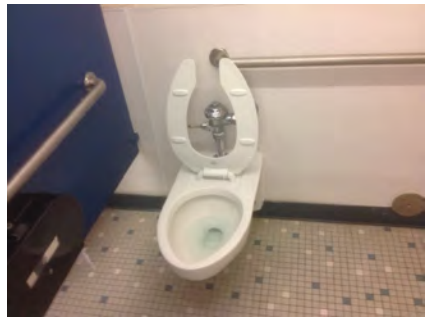
551	<ul style="list-style-type: none"> As-Built Description: Flush Control: Operating handle not mounted toward wide side of stall. Proposed Solution: Replace flush control with properly mounted accessible type, or install sensor flush. 	PCODE WB10 ADAAG 91 4.16.5 ADA 2010 604.6 CBC 2007 1115B.4.1.5 CBC 2016 11B-604.6 Mitigated: <input type="radio"/> YES <input checked="" type="radio"/> NO	1	JOB	\$1,500	\$1,500

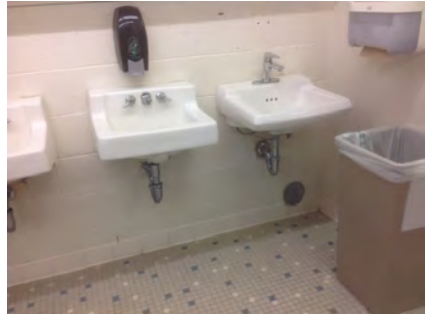
549	<ul style="list-style-type: none"> As-Built Description: Hot or sharp-surfaced water/drain pipe not insulated or covered. Proposed Solution: Insulate or cover water/drain pipe. 	PCODE WD05 ADAAG 91 4.19.4 ADA 2010 606.5 CBC 2007 1115B.4.3.4 CBC 2016 11B-606.5 Mitigated: <input type="radio"/> YES <input checked="" type="radio"/> NO	1	JOB	\$360	\$360

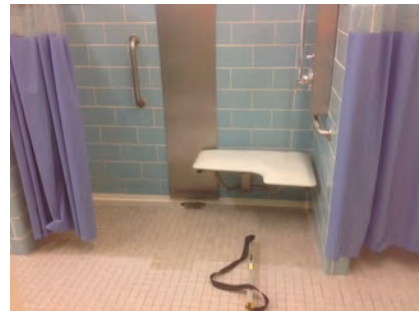
Shower not accessible; multiple compliance violations.

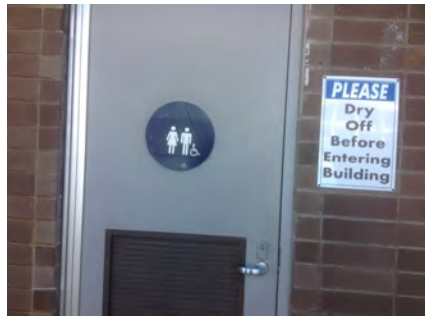
Item no., Rm no. and Name	Existing Architectural Barrier and Proposed Solution	Codes / Mitigation Info	Qty	Unit	Cost	Total
592	<ul style="list-style-type: none"> As-Built Description: Required in CA only: identification symbol centered 58" to 60" high on sanitary facility door that contrasts with the door not provided (women: 12" ø circle, men: 12" triangle, unisex: combined symbol). As-Built: Triangle not contrasting with circle. Proposed Solution: Provide properly mounted sanitary facility symbol when altering area. If wheelchair accessible, include International Symbol of Accessibility on sign. 	PCODE SA15 CBC 2007 1115B.6 CBC 2016 11B-703.7.2.6 Mitigated: <input type="radio"/> YES <input checked="" type="radio"/> NO	1	JOB	\$270	\$270

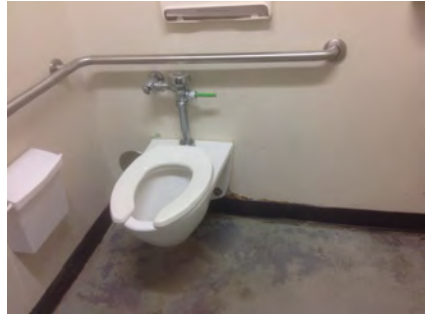
597	<ul style="list-style-type: none"> As-Built Description: Accessories/dispensers in accessible stall located closer than 1-1/2" below or 12" above grab bar impedes its use. As-Built: 1" below Proposed Solution: Relocate accessories/dispensers to be no closer than 1-1/2" below and 12" above grab bars (except if accessories are recessed, flush with wall, and have no sharp edges). 	PCODE WB07I ADAAG 91 4.26.2 ADA 2010 609.3 CBC 2007 1133B.4.2.5 CBC 2016 11B-609.3 Mitigated: <input type="radio"/> YES <input checked="" type="radio"/> NO	1	JOB	\$225	\$225

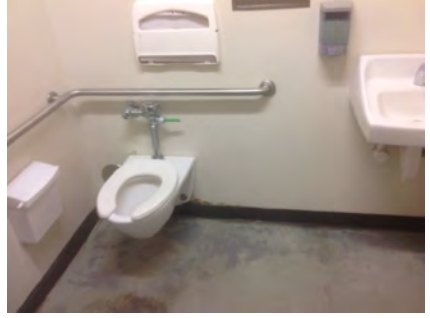
595	<ul style="list-style-type: none"> As-Built Description: Toilet stall less than 60" wide. As-Built: 58" Proposed Solution: Provide new accessible stall. Notes: 32" between WC and lavatory 	PCODE WB06 ADAAG 91 4.17.3 ADA 2010 604.8.1.1 CBC 2007 1115B.3.1.4.1 CBC 2016 11B-604.8.1.1 Mitigated: <input type="radio"/> YES <input checked="" type="radio"/> NO	1	JOB	\$4,500	\$4,500

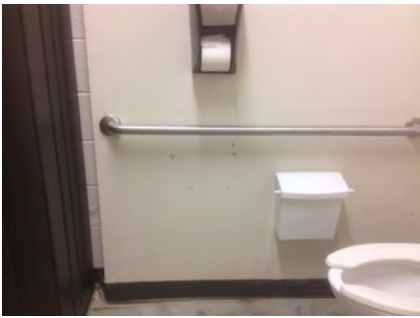
Item no., Rm no. and Name	Existing Architectural Barrier and Proposed Solution	Codes / Mitigation Info	Qty	Unit	Cost	Total
598	<ul style="list-style-type: none"> As-Built Description: Toilet paper dispenser less than 15" (CA: 19") or more than 48" above floor or not within 7" to 9" from front of water closet (Note: CA pre-2010 is allowed within 12" from front of water closet). As-Built: Toilet paper located above grab bar. Proposed Solution: Relocate or provide new toilet paper dispenser. 	PCODE WG02 ADAAG 91 4.16.6 ADA 2010 604.7 CBC 2007 1115B.8.4 CBC 2016 11B-604.7 Mitigated: <input type="radio"/> YES <input checked="" type="radio"/> NO	1	JOB	\$225	\$225

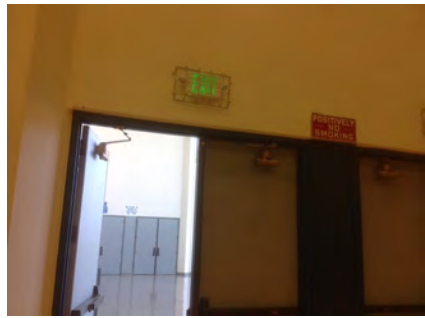
Item no., Rm no. and Name	Existing Architectural Barrier and Proposed Solution	Codes / Mitigation Info	Qty	Unit	Cost	Total
576	<ul style="list-style-type: none"> As-Built Description: At door leading into exit corridor: Where required exit signs are installed, signs to provide exiting information for people with vision impairment are not provided. Proposed Solution: Provide raised letter/Braille "EXIT ROUTE" sign at door. 	PCODE SA10D ADAAG 91 4.1.3(16) ADA 2010 216.4.1 CBC 2007 1011.3 CBC 2016 11B-216.4.1 Mitigated: <input type="radio"/> YES <input checked="" type="radio"/> NO	1	JOB	\$270	\$270

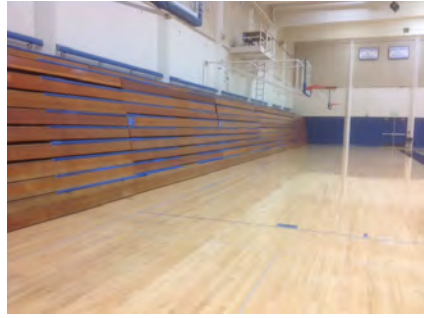
577	<ul style="list-style-type: none"> As-Built Description: Wheelchair locations not dispersed throughout seating area (n/a if floor slope greater than 1:20 or 5%). Proposed Solution: Disperse accessible wheelchair space(s). Notes: Gym not set up. Ensure seating for disabled provided. 	PCODE GE01C ADAAG 91 4.33.3 ADA 2010 221.2.3 CBC 2007 1104B.3.3 CBC 2016 11B-221.2.3 Mitigated: <input type="radio"/> YES <input checked="" type="radio"/> NO	1	EA	\$1,800	\$1,800

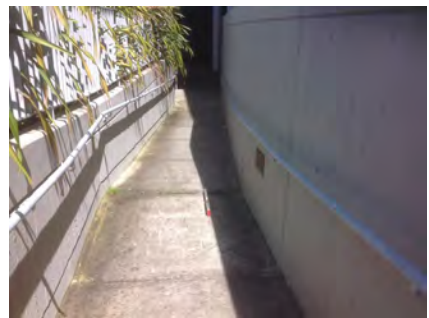
Item no., Rm no. and Name	Existing Architectural Barrier and Proposed Solution	Codes / Mitigation Info	Qty	Unit	Cost	Total
127	<ul style="list-style-type: none">As-Built Description: Level 2% max. landing for ramp not provided.As-Built: 3.2% direction of travelProposed Solution: Rebuild ramp to provide landings for each ramp run with slopes no greater than 2%Notes: Intermediate landing on the third ramp run.	PCODE EB05A ADAAG 91 4.8.4 ADA 2010 405.7.1 CBC 2007 1133B.5.4.1 CBC 2016 11B-405.7.1 Mitigated: <input type="radio"/> YES <input checked="" type="radio"/> NO	24	SF	\$300	\$7,200

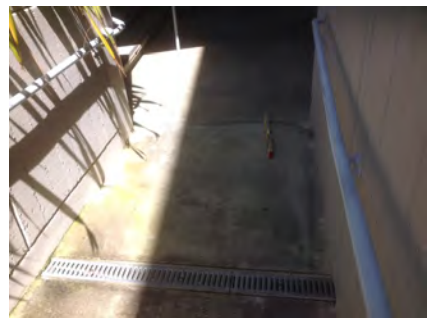
<input type="checkbox"/> Staff Only Priority 1 Severity 4			
128	<ul style="list-style-type: none">As-Built Description: Level 2% max. landing for ramp not provided.As-Built: 3.4% direction of travelProposed Solution: Rebuild ramp to provide landings for each ramp run with slopes no greater than 2%Notes: Located at the bottom landing	PCODE EB05A ADAAG 91 4.8.4 ADA 2010 405.7.1 CBC 2007 1133B.5.4.1 CBC 2016 11B-405.7.1 Mitigated: <input type="radio"/> YES <input checked="" type="radio"/> NO	40	SF	\$300	\$12,000

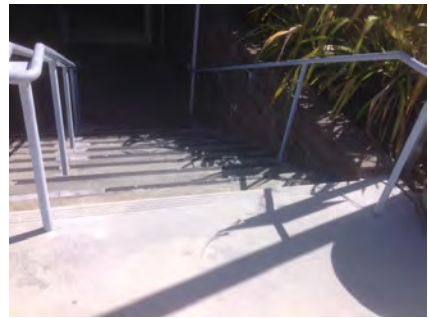
<input type="checkbox"/> Staff Only Priority 1 Severity 4			
<u>Tread Surface</u>						
121	<ul style="list-style-type: none">As-Built Description: The leading 2" of the tread does not have visual contrast of dark-on-light or light-on-dark from the remainder of the tread.Proposed Solution: Provide contrasting color strips at all exterior stair treads.	PCODE EC02 ADA 2010 504.4 CBC 2007 1133B.4.4 CBC 2016 11B-504.4.1 Mitigated: <input type="radio"/> YES <input checked="" type="radio"/> NO	180	LF	\$27	\$4,860

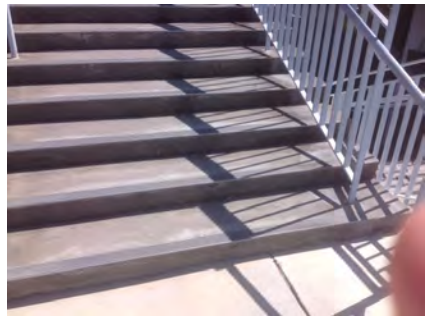
Item no., Rm no. and Name	Existing Architectural Barrier and Proposed Solution	Codes / Mitigation Info	Qty	Unit	Cost	Total
131	<ul style="list-style-type: none"> As-Built Description: The leading 2" of the tread does not have visual contrast of dark-on-light or light-on-dark from the remainder of the tread. Proposed Solution: Provide contrasting color strips at all exterior stair treads. 	PCODE EC02 ADA 2010 504.4 CBC 2007 1133B.4.4 CBC 2016 11B-504.4.1 Mitigated: <input type="radio"/> YES <input checked="" type="radio"/> NO	160	LF	\$27	\$4,320

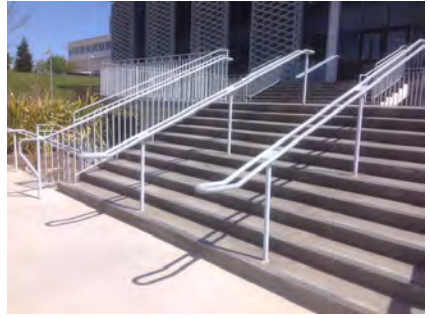
130	<ul style="list-style-type: none"> As-Built Description: Bottom extension of handrail does not return creating a hazard for blind individuals. Proposed Solution: Remodel handrail return. 	PCODE ED12 ADAAG 91 4.9.4(6) ADA 2010 505.10.3 CBC 2007 1133B.4.2.3 CBC 2016 11B-505.10.1; 11B-505.10.3 Mitigated: <input type="radio"/> YES <input checked="" type="radio"/> NO	1	JOB	\$690	\$690

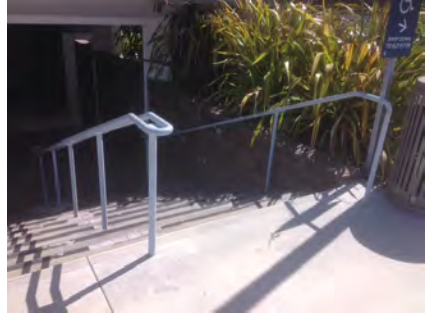
119	<ul style="list-style-type: none"> As-Built Description: Handrail gripping surface top not mounted between 34" and 38" above ramp surface or stair nosings. As-Built: 33" high Proposed Solution: Remove existing and provide new handrail. 	PCODE ED02 ADAAG 91 4.9.4(5) ADA 2010 505.4 CBC 2007 1133B.4.2.1 & B.5.5.1 CBC 2016 11B-505.4 Mitigated: <input type="radio"/> YES <input checked="" type="radio"/> NO	120	LF	\$225	\$27,000

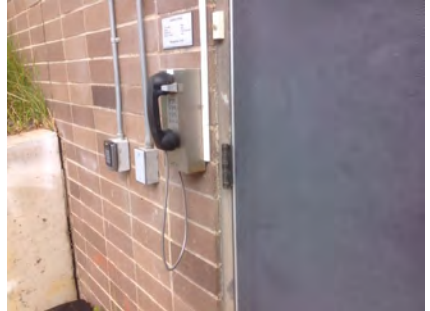
Item no., Rm no. and Name	Existing Architectural Barrier and Proposed Solution	Codes / Mitigation Info	Qty	Unit	Cost	Total
Telephone						
809	<ul style="list-style-type: none"> • <i>As-Built Description:</i> Telephone mounting height more than 48" to highest operable part of phone if side reach approach is available. • <i>As-Built:</i> 53" high • <i>Proposed Solution:</i> Lower telephone enclosure and phone. • <i>Notes:</i> Telephone and doorbell 	PCODE IB02 ADAAG 91 4.2.6 ADA 2010 704.2.2 CBC 2007 1118B.6 CBC 2016 11B-704.2.2	1	JOB	\$750	\$750
Mitigated: <input type="radio"/> YES <input checked="" type="radio"/> NO

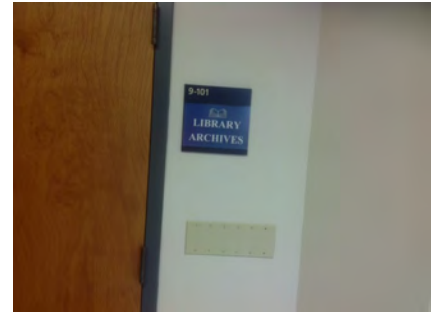
Entire building has incorrect Braille spacing.
Recommend providing Grade II Braille spacing.

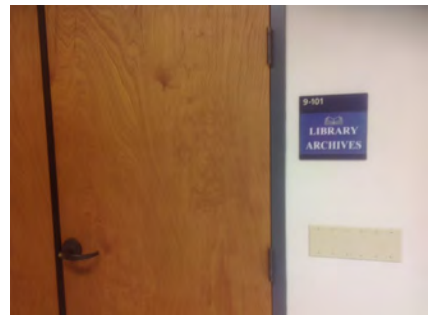
<input type="checkbox"/> Staff Only			
			Priority	Severity		
			1	4		
135	<ul style="list-style-type: none">As-Built Description: At final exit door to exterior: Where required exit signs are installed, signs to provide exiting information for people with vision impairment are not provided.Proposed Solution: Provide raised letter/Braille "EXIT" sign at door.	PCODE SA10A ADAAG 91 4.1.3(16) ADA 2010 216.4.1 CBC 2007 1011.3 CBC 2016 11B-216.4.1 Mitigated: <input type="radio"/> YES <input checked="" type="radio"/> NO	2	JOB	\$270	\$540

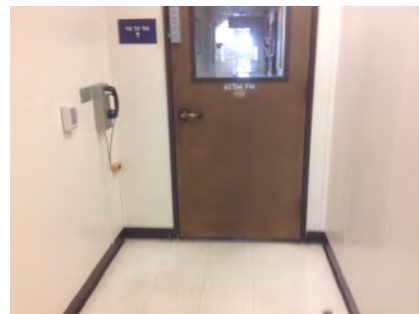
Item no., Rm no. and Name	Existing Architectural Barrier and Proposed Solution	Codes / Mitigation Info	Qty	Unit	Cost	Total
851	<ul style="list-style-type: none"> As-Built Description: Front approach: At pull side, door does not have clear and level maneuvering space measuring door width plus 18" x 60". (24" x 60" at exterior doors). As-Built: 48" to beam Proposed Solution: Provide power door operator. 	PCODE ID23C ADAAG 91 Fig. 25(a) ADA 2010 404.2.4 CBC 2007 11B-26A(a) CBC 2016 11B-404.2.4 Mitigated: <input type="radio"/> YES <input checked="" type="radio"/> NO	1	JOB	\$15,000	\$15,000

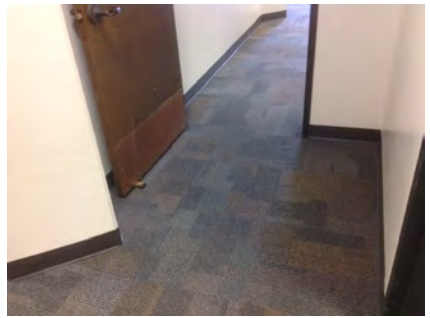
816	<ul style="list-style-type: none"> As-Built Description: Front approach: At push side, door does not have clear and level maneuvering space measuring door width x 48" (door width plus 12" if door has both, latch and closer). Proposed Solution: Provide door operator. Notes: Entry door from main lobby 	PCODE ID24CREF ADAAG 91 Fig. 25(a) ADA 2010 404.2.4 CBC 2007 11B-26A(a) CBC 2016 11B-404.2.4 Mitigated: <input type="radio"/> YES <input checked="" type="radio"/> NO

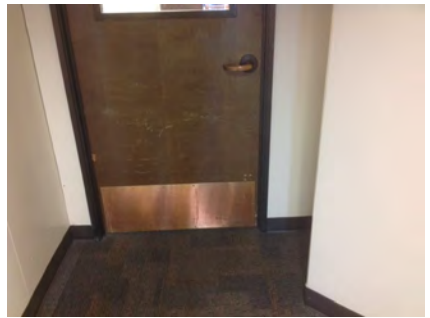
818	<ul style="list-style-type: none"> As-Built Description: Sign not located on latch side of door and/or not located at 48" min. above to baseline of the lowest Braille cells and 60" max. to baseline of the highest line of raised characters. As-Built: 62" above finished floor Proposed Solution: Provide compliant signage including tactile characters and Grade II Braille on latch side of door located at compliant height. 	PCODE SA07 ADAAG 91 4.30.6 ADA 2010 703.4.1 CBC 2007 1117B.5.7 CBC 2016 11B-703.4.1 Mitigated: <input type="radio"/> YES <input checked="" type="radio"/> NO	8	JOB	\$150	\$1,200

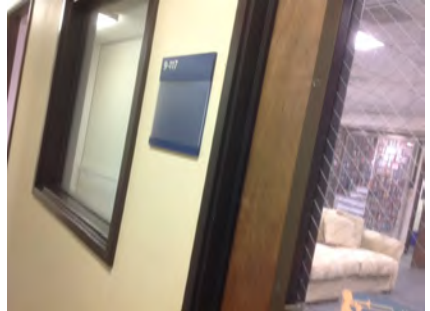
Item no., Rm no. and Name	Existing Architectural Barrier and Proposed Solution	Codes / Mitigation Info	Qty	Unit	Cost	Total
Signage						
832	<ul style="list-style-type: none"> • <i>As-Built Description:</i> Sign not located on latch side of door and/or not located at 48" min. above to baseline of the lowest Braille cells and 60" max. to baseline of the highest line of raised characters. • <i>As-Built:</i> 62" above finished floor • <i>Proposed Solution:</i> Provide compliant signage including tactile characters and Grade II Braille on latch side of door located at compliant height. 	PCODE SA07 ADAAG 91 4.30.6 ADA 2010 703.4.1 CBC 2007 1117B.5.7 CBC 2016 11B-703.4.1	6	JOB	\$150	\$900
Mitigated: <input type="radio"/> YES <input checked="" type="radio"/> NO

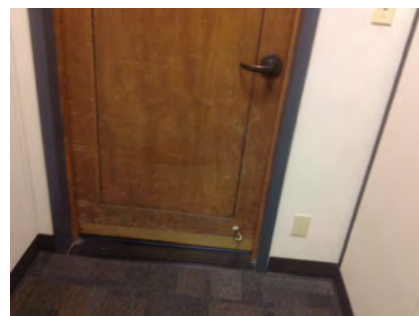
Item no., Rm no. and Name	Existing Architectural Barrier and Proposed Solution	Codes / Mitigation Info	Qty	Unit	Cost	Total
Door Swing						
844	<ul style="list-style-type: none">As-Built Description: Front approach: At pull side, door does not have clear and level maneuvering space measuring door width plus 18" x 60". (24" x 60" at exterior doors).As-Built: 17" strike side clearanceProposed Solution: Provide power door operator.	PCODE ID23C ADAAG 91 Fig. 25(a) ADA 2010 404.2.4 CBC 2007 11B-26A(a) CBC 2016 11B-404.2.4 Mitigated: <input type="radio"/> YES <input checked="" type="radio"/> NO	1	JOB	\$15,000	\$15,000

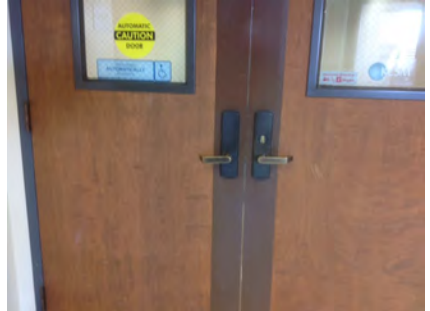
<input type="checkbox"/> Staff Only Priority 2 Severity 3			
866	<ul style="list-style-type: none"> As-Built Description: Lower push plate located at 7" minimum and 8" maximum above the floor or ground surface not provided. Proposed Solution: Provide lower push plate. Notes: Entry from lobby 	PCODE ID13B CBC 2007 1133B.2.3.2 CBC 2016 11B-404.2.9 2.C	2	JOB	\$1,500	\$3,000
		Mitigated: <input type="radio"/> YES <input checked="" type="radio"/> NO

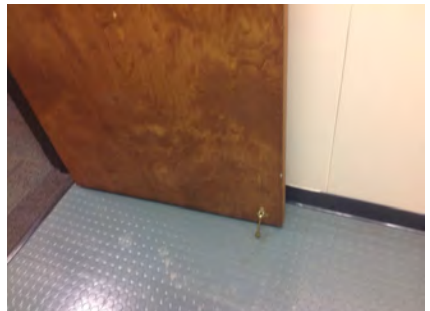
Item no., Rm no. and Name	Existing Architectural Barrier and Proposed Solution	Codes / Mitigation Info	Qty	Unit	Cost	Total
Door Swing						
854	<ul style="list-style-type: none">As-Built Description: Front approach: At pull side, door does not have clear and level maneuvering space measuring door width plus 18" x 60". (24" x 60" at exterior doors).As-Built: 17" strike side clearanceProposed Solution: Provide power door operator.Notes: Door from studio area to main office	<p>PCODE ID23C</p> <p>ADAAG 91 Fig. 25(a)</p> <p>ADA 2010 404.2.4</p> <p>CBC 2007 11B-26A(a)</p> <p>CBC 2016 11B-404.2.4</p> <p>Mitigated:</p> <p><input type="radio"/> YES</p> <p><input checked="" type="radio"/> NO</p>	1	JOB	\$15,000	\$15,000

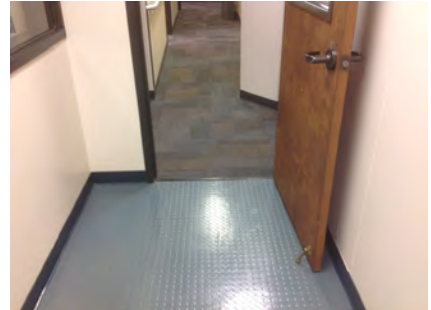
<input type="checkbox"/> Staff Only			
			Priority		Severity	
			2		4	
<hr/>						
856	<ul style="list-style-type: none">As-Built Description: Front approach: At pull side, door does not have clear and level maneuvering space measuring door width plus 18" x 60". (24" x 60" at exterior doors).As-Built: 55" to rampProposed Solution: Provide power door operator.	<p>PCODE ID23CREF</p> <p>ADAAG 91 Fig. 25(a)</p> <p>ADA 2010 404.2.4</p> <p>CBC 2007 11B-26A(a)</p> <p>CBC 2016 11B-404.2.4</p> <p>Mitigated:</p> <p><input type="radio"/> YES</p> <p><input checked="" type="radio"/> NO</p>	REF

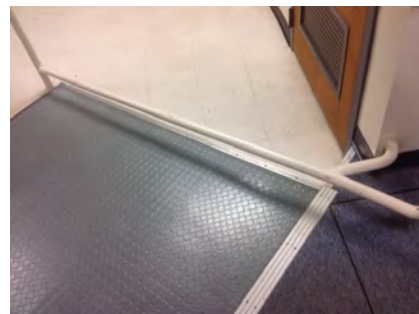
Bottom extension of handrail does not return creating a hazard for blind individuals.

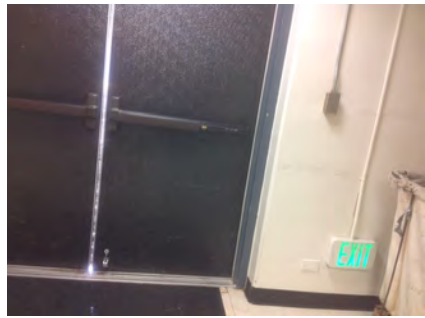
Item no., Rm no. and Name	Existing Architectural Barrier and Proposed Solution	Codes / Mitigation Info	Qty	Unit	Cost	Total
885	<ul style="list-style-type: none"> • <i>As-Built Description:</i> At final exit door to exterior: Where required exit signs are installed, signs to provide exiting information for people with vision impairment are not provided. • <i>Proposed Solution:</i> Provide raised letter/Braille "EXIT" sign at door. 	PCODE SA10A ADAAG 91 4.1.3(16) ADA 2010 216.4.1 CBC 2007 1011.3 CBC 2016 11B-216.4.1 Mitigated: <input type="radio"/> YES <input checked="" type="radio"/> NO	1	JOB	\$270	\$270

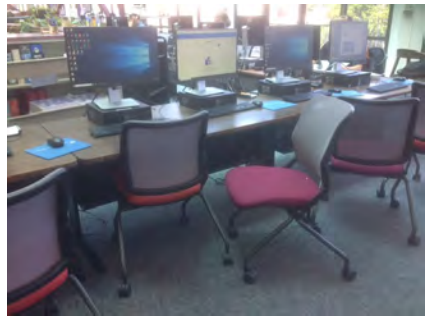
Item no., Rm no. and Name	Existing Architectural Barrier and Proposed Solution	Codes / Mitigation Info	Qty	Unit	Cost	Total
172	<ul style="list-style-type: none"> As-Built Description: Accessible non-fixed table or desk (top 28" to 34" high; knee space at least 27" high x 19" deep x 30" wide) not provided. As-Built: 25" knee height Proposed Solution: Provide table or desk with accessible dimensions when purchasing new furniture. Notes: Computer station 	PCODE IN02A ADAAG 91 4.32.3 & .4 ADA 2010 306.1 CBC 2007 1122B.3 & 4 CBC 2016 11B-306.1 & 11B-902.3 Mitigated: <input type="radio"/> YES <input checked="" type="radio"/> NO	1	JOB	\$4,800	\$4,800

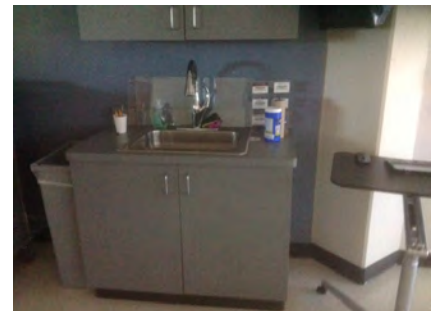
Item no., Rm no. and Name	Existing Architectural Barrier and Proposed Solution	Codes / Mitigation Info	Qty	Unit	Cost	Total
473	<ul style="list-style-type: none"> As-Built Description: Sink does not have knee space min. 27" high x 19" deep x 30" wide. Proposed Solution: Remodel sink cabinet. 	PCODE IN06A ADAAG 91 4.24.3 ADA 2010 606.2 CBC 2007 1115B.4.7.1 CBC 2016 11B-606.2 Mitigated: <input type="radio"/> YES <input checked="" type="radio"/> NO	1	JOB	\$5,250	\$5,250

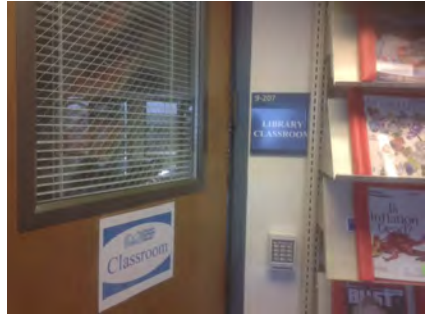
Assistive Listening

195	<ul style="list-style-type: none"> As-Built Description: No portable assistive listening system provided for small meeting room. Proposed Solution: Share existing portable assistive listening system from other facility. 	PCODE GI01E ADAAG 91 4.1.3(19)(b) & 4.33.7 ADA 2010 219.1 & 706.1 CBC 2007 1104B.2 CBC 2016 11B-219.1 & 11B-706.1 Mitigated: <input type="radio"/> YES <input checked="" type="radio"/> NO	REF

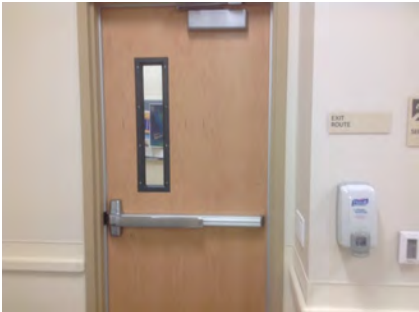
<i>Item no., Rm no. and Name</i>	<i>Existing Architectural Barrier and Proposed Solution</i>	<i>Codes / Mitigation Info</i>	<i>Qty</i>	<i>Unit</i>	<i>Cost</i>	<i>Total</i>
28	<ul style="list-style-type: none"> As-Built Description: Sign not located on latch side of door and/or not located at 48" min. above to baseline of the lowest Braille cells and 60" max. to baseline of the highest line of raised characters. As-Built: Sign not on latch side of door. Proposed Solution: Provide compliant signage including tactile characters and Grade II Braille on latch side of door located at compliant height. 	<p>PCODE SA07REF</p> <p>ADAAG 91 4.30.6</p> <p>ADA 2010 703.4.1</p> <p>CBC 2007 1117B.5.7</p> <p>CBC 2016 11B-703.4.1</p> <p>Mitigated:</p> <div style="margin-left: 20px;"> <input type="radio"/> YES <input checked="" type="radio"/> NO </div>

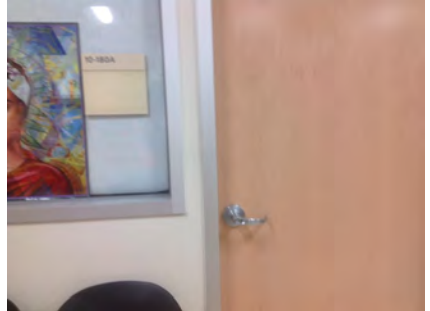
Item no., Rm no. and Name	Existing Architectural Barrier and Proposed Solution	Codes / Mitigation Info	Qty	Unit	Cost	Total
Signage						
33	<ul style="list-style-type: none"> • <i>As-Built Description:</i> Sign not located on latch side of door and/or not located at 48" min. above to baseline of the lowest Braille cells and 60" max. to baseline of the highest line of raised characters. • <i>As-Built:</i> 62" high • <i>Proposed Solution:</i> Provide compliant signage including tactile characters and Grade II Braille on latch side of door located at compliant height. 	PCODE SA07 ADAAG 91 4.30.6 ADA 2010 703.4.1 CBC 2007 1117B.5.7 CBC 2016 11B-703.4.1 Mitigated: <input type="radio"/> YES <input checked="" type="radio"/> NO	4	JOB	\$150	\$600

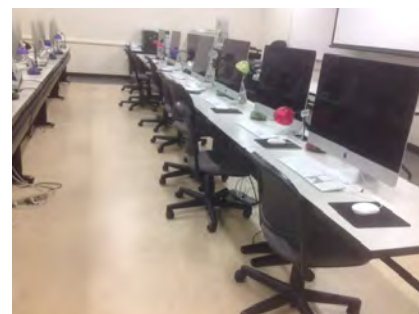
- 38 • *As-Built Description:*
Accessible non-fixed table or desk (top 28" to 34" high; knee space at least 27" high x 19" deep x 30" wide) not provided.
- *Proposed Solution:*
Provide table or desk with accessible dimensions when purchasing new furniture.
- **Notes:**
29 seats, no accessible computer stations

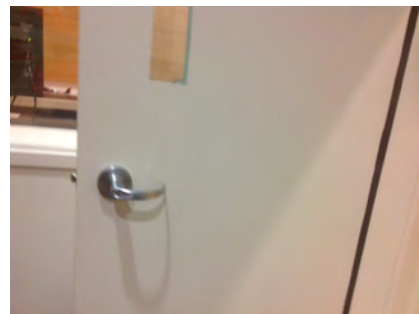
- 44 • *As-Built Description:*
Vision Light at door that permits viewing, does not have bottom of at least one glazed panel located 43 inches maximum above the finish floor. (Exception: More than 66" above finished floor.)

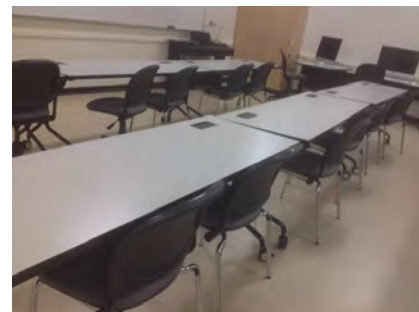
- 45
- *As-Built Description:*
Accessible non-fixed table or desk (top 28" to 34" high; knee space at least 27" high x 19" deep x 30" wide) not provided.
 - *As-Built:* **14" deep**
 - *Proposed Solution:*
Provide table or desk with accessible dimensions when purchasing new furniture.
 - *Notes:*
26 total seats, no accessible

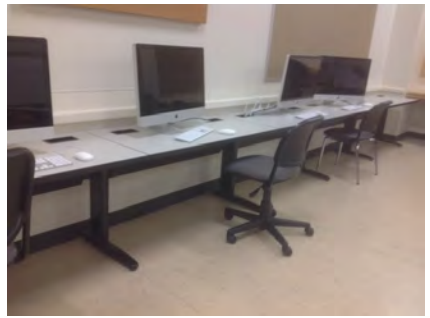
Item no., Rm no. and Name	Existing Architectural Barrier and Proposed Solution	Codes / Mitigation Info	Qty	Unit	Cost	Total
46	<ul style="list-style-type: none"> As-Built Description: Accessible non-fixed table or desk (top 28" to 34" high; knee space at least 27" high x 19" deep x 30" wide) not provided. As-Built: 26" knee height Proposed Solution: Provide table or desk with accessible dimensions when purchasing new furniture. Notes: 5 computers, no accessible 	PCODE IN02A ADAAG 91 4.32.3 & .4 ADA 2010 306.1 CBC 2007 1122B.3 & 4 CBC 2016 11B-306.1 & 11B-902.3 Mitigated: <input type="radio"/> YES <input checked="" type="radio"/> NO	1	JOB	\$4,800	\$4,800

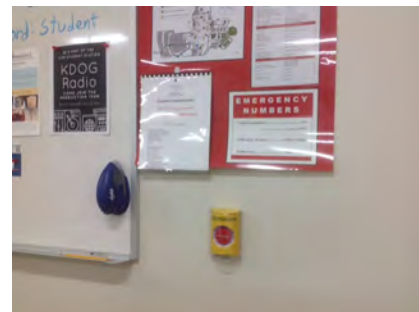
- 48
- *As-Built Description:*
Reach height to control or access point, exceeds 48" or is less than 15".
 - *As-Built:* **54" high**
 - *Proposed Solution:*
Lower item.

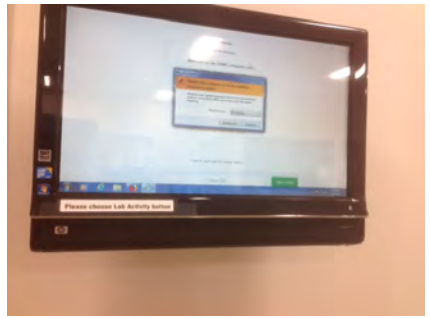
Item no., Rm no. and Name	Existing Architectural Barrier and Proposed Solution	Codes / Mitigation Info	Qty	Unit	Cost	Total
50	<ul style="list-style-type: none"> • <i>As-Built Description:</i> Reach height to control or access point, exceeds 48" or is less than 15". • <i>As-Built:</i> 62" high • <i>Proposed Solution:</i> Modify equipment or mounting. • <i>Notes:</i> If this remains an operable part 	PCODE IE01 ADAAG 91 4.2.5 ADA 2010 308.2.1 CBC 2007 1118B.5 CBC 2016 11B-308.2.1	1	JOB	\$300	\$300

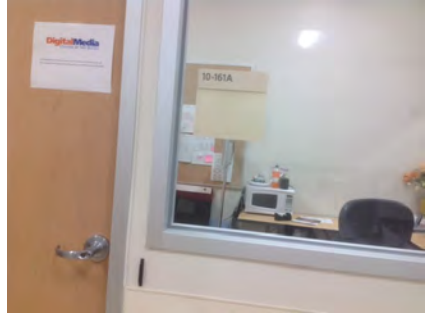
52	<ul style="list-style-type: none"> • <i>As-Built Description:</i> Sign not located on latch side of door and/or not located at 48" min. above to baseline of the lowest Braille cells and 60" max. to baseline of the highest line of raised characters. • <i>As-Built:</i> 62" high • <i>Proposed Solution:</i> Provide compliant signage including tactile characters and Grade II Braille on latch side of door located at compliant height. 	PCODE SA07 ADAAG 91 4.30.6 ADA 2010 703.4.1 CBC 2007 1117B.5.7 CBC 2016 11B-703.4.1	4	JOB	\$150	\$600

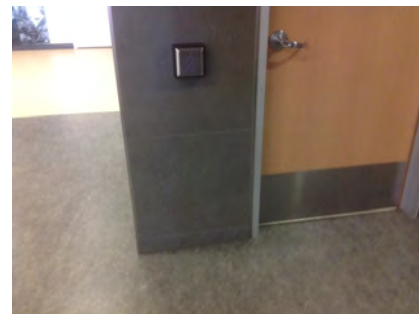
- 54
- *As-Built Description:*
Lower push plate located at 7" minimum and 8" maximum above the floor or ground surface not provided.
 - *Proposed Solution:*
Provide lower push plate.

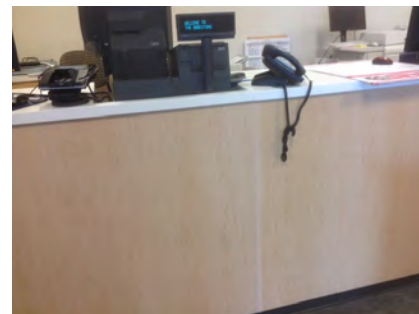
Item no., Rm no. and Name	Existing Architectural Barrier and Proposed Solution	Codes / Mitigation Info	Qty	Unit	Cost	Total
65	<ul style="list-style-type: none"> • <i>As-Built Description:</i> Service counter (stand-up): Accessible section min. 36" length and 36" max. height (in CA: 28" to 34" high) not provided. • <i>As-Built:</i> 44" high • <i>Proposed Solution:</i> Retrofit existing counter to provide accessible section. Interim solution: Provide auxiliary counter, table, or clipboard. 	PCODE IN03 ADAAG 91 7.2(2) ADA 2010 904.4 CBC 2007 1122B.4 CBC 2016 11B-904.4 Mitigated: <input type="radio"/> YES <input checked="" type="radio"/> NO	1	JOB	\$6,000	\$6,000

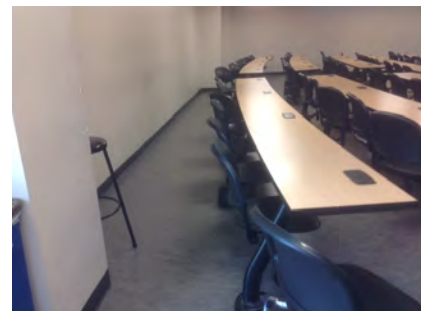
- 76
- *As-Built Description:*
Accessible non-fixed table or desk (top 28" to 34" high; knee space at least 27" high x 19" deep x 30" wide) not provided.
 - *Proposed Solution:*
Provide table or desk with accessible dimensions when purchasing new furniture.
 - **Notes:**
No accessible seats at top

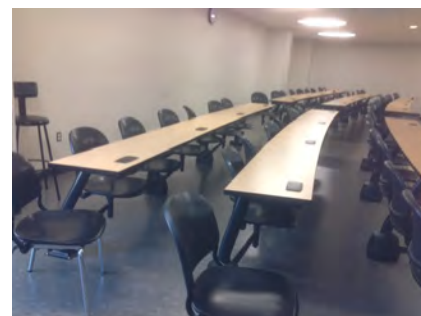
- 78
- *As-Built Description:*
Accessible non-fixed table or desk (top 28" to 34" high; knee space at least 27" high x 19" deep x 30" wide) not provided.
 - *As-Built:* **28" wide**
 - *Proposed Solution:*
Provide table or desk with accessible dimensions when purchasing new furniture.
 - **Notes:**
120 seats, 0 accessible

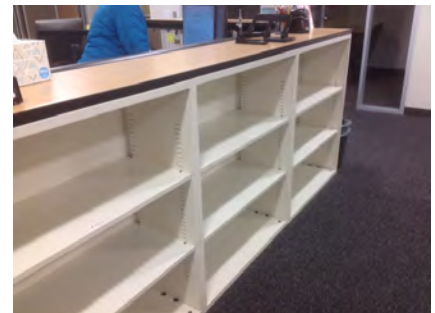
- 101 • *As-Built Description:*
Service counter (stand-up): Accessible section min. 36" length and 36" max. height (in CA: 28" to 34" high) not provided.

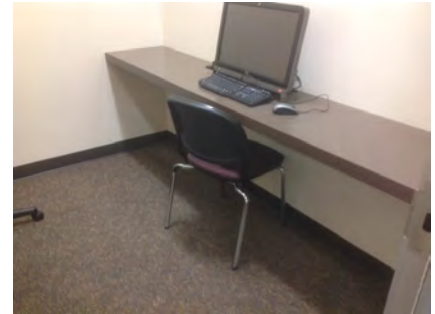
Item no., Rm no. and Name	Existing Architectural Barrier and Proposed Solution	Codes / Mitigation Info	Qty	Unit	Cost	Total
96	<ul style="list-style-type: none"> As-Built Description: Sales and service counter: Accessible section not provided (knee space min. 27" high x 19" deep x 30" wide) As-Built: 18" deep Proposed Solution: Retrofit existing counter to provide accessible seating section. Interim solution: Provide auxiliary counter, table, or clipboard. Notes: Typical Testing Room 	PCODE IN03A ADAAG 91 4.32.3 & 4 ADA 2010 306.3; 904.4 CBC 2007 1122B.3 & 4 CBC 2016 11B-306.3; 11B-904.4 Mitigated: <input type="radio"/> YES <input checked="" type="radio"/> NO	4	JOB	\$6,000	\$24,000

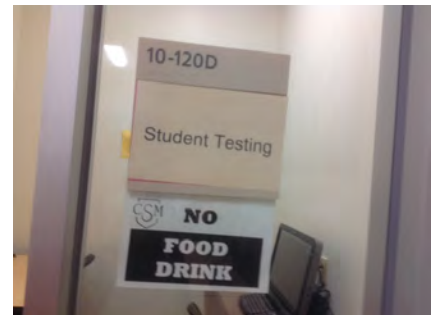
97	<ul style="list-style-type: none"> As-Built Description: Sign not located on latch side of door and/or not located at 48" min. above to baseline of the lowest Braille cells and 60" max. to baseline of the highest line of raised characters. As-Built: 62" high Proposed Solution: Provide compliant signage including tactile characters and Grade II Braille on latch side of door located at compliant height. Notes: Typical Testing Room 	PCODE SA07 ADAAG 91 4.30.6 ADA 2010 703.4.1 CBC 2007 1117B.5.7 Mitigated: <input type="radio"/> YES <input checked="" type="radio"/> NO	4	JOB	\$150	\$600
----	--	--	---	-----	-------	-------

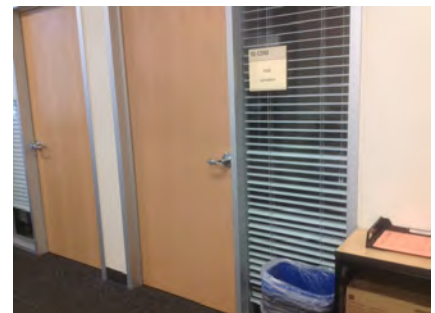
99	<ul style="list-style-type: none"> As-Built Description: Sign not located on latch side of door and/or not located at 48" min. above to baseline of the lowest Braille cells and 60" max. to baseline of the highest line of raised characters. As-Built: 62" high Proposed Solution: Provide compliant signage including tactile characters and Grade II Braille on latch side of door located at compliant height. Notes: Typical Faculty Offices 	PCODE SA07 ADAAG 91 4.30.6 ADA 2010 703.4.1 CBC 2007 1117B.5.7 Mitigated: <input type="radio"/> YES <input checked="" type="radio"/> NO	1	JOB	\$150	\$150
----	---	--	---	-----	-------	-------

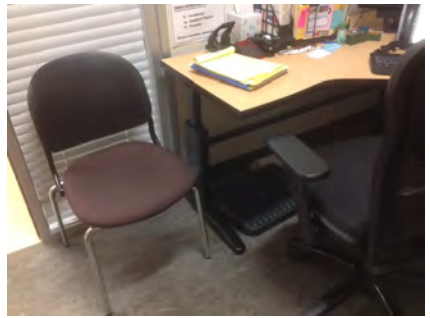
Item no., Rm no. and Name	Existing Architectural Barrier and Proposed Solution	Codes / Mitigation Info	Qty	Unit	Cost	Total
113	<ul style="list-style-type: none"> As-Built Description: Accessible non-fixed table or desk (top 28" to 34" high; knee space at least 27" high x 19" deep x 30" wide) not provided. As-Built: No knee space if used as writing surface. Proposed Solution: Provide table or desk with accessible dimensions when purchasing new furniture. 	PCODE IN02A ADAAG 91 4.32.3 & .4 ADA 2010 306.1 CBC 2007 112B.3 & 4 CBC 2016 11B-306.1 & 11B-902.3 Mitigated: <input type="radio"/> YES <input checked="" type="radio"/> NO	4	JOB	\$4,800	\$19,200

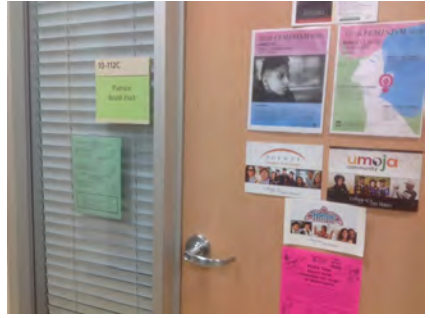
112	<ul style="list-style-type: none"> As-Built Description: Sign not located on latch side of door and/or not located at 48" min. above to baseline of the lowest Braille cells and 60" max. to baseline of the highest line of raised characters. As-Built: 62" high Proposed Solution: Provide compliant signage including tactile characters and Grade II Braille on latch side of door located at compliant height. 	PCODE SA07 ADAAG 91 4.30.6 ADA 2010 703.4.1 CBC 2007 1117B.5.7 CBC 2016 11B-703.4.1 Mitigated: <input type="radio"/> YES <input checked="" type="radio"/> NO	4	JOB	\$150	\$600

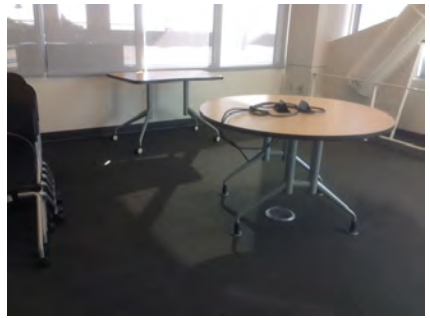
Item no., Rm no. and Name	Existing Architectural Barrier and Proposed Solution	Codes / Mitigation Info	Qty	Unit	Cost	Total
150	<ul style="list-style-type: none"> As-Built Description: Accessible non-fixed table or desk (top 28" to 34" high; knee space at least 27" high x 19" deep x 30" wide) not provided. Proposed Solution: Provide table or desk with accessible dimensions when purchasing new furniture. Notes: Group Study Room 220B,C,E 	PCODE IN02A ADAAG 91 4.32.3 & .4 ADA 2010 306.1 CBC 2007 1122B.3 & 4 CBC 2016 11B-306.1 & 11B-902.3	1	JOB	\$4,800	\$4,800
Mitigated: <input type="radio"/> YES <input checked="" type="radio"/> NO

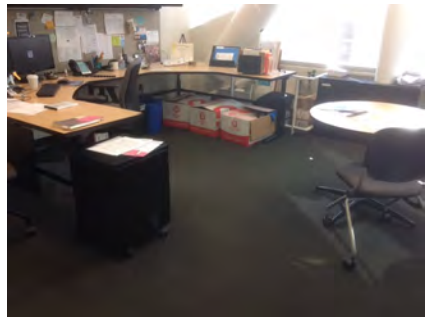
<input type="checkbox"/> Staff Only			
			Priority 2 Severity 2			
153	<ul style="list-style-type: none"> As-Built Description: Accessible non-fixed table or desk (top 28" to 34" high; knee space at least 27" high x 19" deep x 30" wide) not provided. Proposed Solution: Provide table or desk with accessible dimensions when purchasing new furniture. Notes: Faculty Office 220D 	PCODE IN02A ADAAG 91 4.32.3 & .4 ADA 2010 306.1 CBC 2007 1122B.3 & 4 CBC 2016 11B-306.1 & 11B-902.3	1	JOB	\$4,800	\$4,800

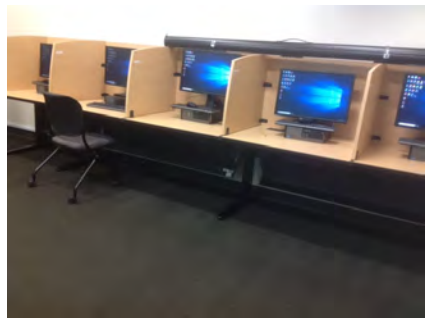
<input type="checkbox"/> Staff Only			
			Priority 2 Severity 2			
155	<ul style="list-style-type: none"> As-Built Description: Accessible non-fixed table or desk (top 28" to 34" high; knee space at least 27" high x 19" deep x 30" wide) not provided. As-Built: 26" knee space Proposed Solution: Provide table or desk with accessible dimensions when purchasing new furniture. Notes: Proctoring Room 220F 	PCODE IN02A ADAAG 91 4.32.3 & .4 ADA 2010 306.1 CBC 2007 1122B.3 & 4 CBC 2016 11B-306.1 & 11B-902.3	1	JOB	\$4,800	\$4,800
Mitigated: <input type="radio"/> YES <input checked="" type="radio"/> NO

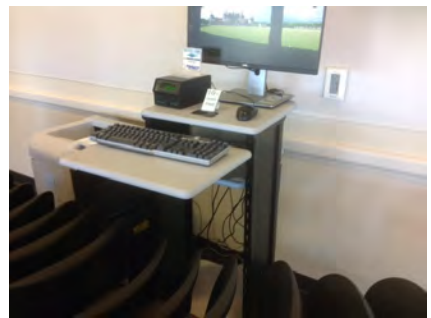
Item no., Rm no. and Name	Existing Architectural Barrier and Proposed Solution	Codes / Mitigation Info	Qty	Unit	Cost	Total
157	<ul style="list-style-type: none">• <i>As-Built Description:</i> Accessible non-fixed table or desk (top 28" to 34" high; knee space at least 27" high x 19" deep x 30" wide) not provided.• <i>Proposed Solution:</i> Provide table or desk with accessible dimensions when purchasing new furniture.• <i>Notes:</i> Printing computer	<p>PCODE IN02A</p> <p>ADAAG 91 4.32.3 & .4</p> <p>ADA 2010 306.1</p> <p>CBC 2007 1122B.3 & 4</p> <p>CBC 2016 11B-306.1 & 11B-902.3</p> <p>Mitigated:</p> <p><input type="radio"/> YES</p> <p><input checked="" type="radio"/> NO</p>	1	JOB	\$4,800	\$4,800

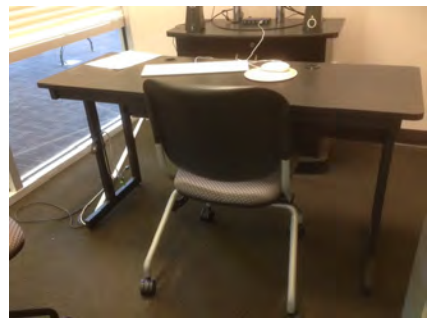
<input type="checkbox"/> Staff Only			
			Priority		Severity	
			2		2	
161	<ul style="list-style-type: none">• <i>As-Built Description:</i> Accessible non-fixed table or desk (top 28" to 34" high; knee space at least 27" high x 19" deep x 30" wide) not provided.• <i>As-Built:</i> 17.5" depth• <i>Proposed Solution:</i> Provide table or desk with accessible dimensions when purchasing new furniture.• <i>Notes:</i> Communications Studies Center 220N	<p>PCODE IN02A</p> <p>ADAAG 91 4.32.3 & .4</p> <p>ADA 2010 306.1</p> <p>CBC 2007 1122B.3 & 4</p> <p>CBC 2016 11B-306.1 & 11B-902.3</p> <p>Mitigated:</p> <p><input type="radio"/> YES</p> <p><input checked="" type="radio"/> NO</p>	2	JOB	\$4,800	\$9,600

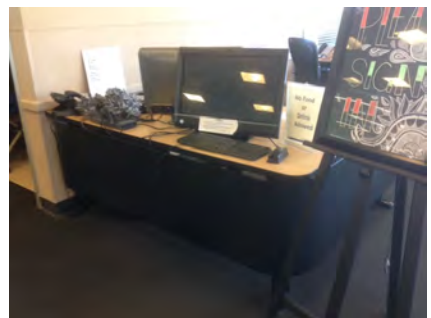
<input type="checkbox"/> Staff Only			
			Priority		Severity	
			2		2	
162	<ul style="list-style-type: none">• <i>As-Built Description:</i> Accessible non-fixed table or desk (top 28" to 34" high; knee space at least 27" high x 19" deep x 30" wide) not provided.• <i>Proposed Solution:</i> Provide table or desk with accessible dimensions when purchasing new furniture.• <i>Notes:</i> Communications Studies Center. Check-in desk no knee clearance.	<p>PCODE IN02A</p> <p>ADAAG 91 4.32.3 & .4</p> <p>ADA 2010 306.1</p> <p>CBC 2007 1122B.3 & 4</p> <p>CBC 2016 11B-306.1 & 11B-902.3</p> <p>Mitigated:</p> <p><input type="radio"/> YES</p> <p><input checked="" type="radio"/> NO</p>	1	JOB	\$4,800	\$4,800

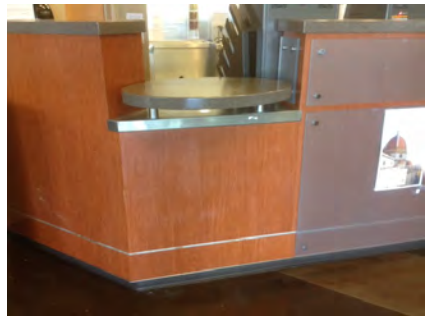
Item no., Rm no. and Name	Existing Architectural Barrier and Proposed Solution	Codes / Mitigation Info	Qty	Unit	Cost	Total
168	<ul style="list-style-type: none"> • <i>As-Built Description:</i> Service counter (stand-up): Accessible section min. 36" length and 36" max. height (in CA: 28" to 34" high) not provided. • <i>As-Built:</i> 42" high • <i>Proposed Solution:</i> Retrofit existing counter to provide accessible section. Interim solution: Provide auxiliary counter, table, or clipboard. • <i>Notes:</i> Coffee pick up counter 	PCODE IN03 ADAAG 91 7.2(2) ADA 2010 904.4 CBC 2007 1122B.4 CBC 2016 11B-904.4 Mitigated: <input type="radio"/> YES <input checked="" type="radio"/> NO	1	JOB	\$6,000	\$6,000

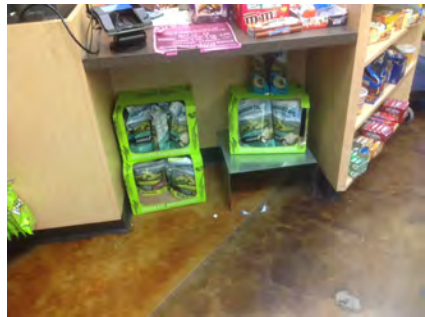
<input type="checkbox"/> Staff Only			
			Priority	Severity		
			2	3		
169	<ul style="list-style-type: none"> • <i>As-Built Description:</i> Service counter (stand-up): Accessible section min. 36" length and 36" max. height (in CA: 28" to 34" high) not provided. • <i>As-Built:</i> 35" wide • <i>Proposed Solution:</i> Retrofit existing counter to provide accessible section. Interim solution: Provide auxiliary counter, table, or clipboard. 	PCODE IN03 ADAAG 91 7.2(2) ADA 2010 904.4 CBC 2007 1122B.4 CBC 2016 11B-904.4 Mitigated: <input type="radio"/> YES <input checked="" type="radio"/> NO	1	JOB	\$6,000	\$6,000

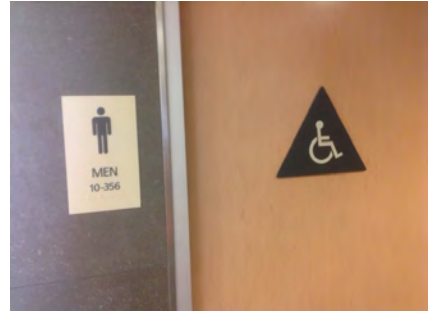
Item no., Rm no. and Name	Existing Architectural Barrier and Proposed Solution	Codes / Mitigation Info	Qty	Unit	Cost	Total
Signage						
190	<ul style="list-style-type: none">As-Built Description: Required in CA only: identification symbol centered 58" to 60" high on sanitary facility door that contrasts with the door not provided (women: 12" ø circle, men: 12" triangle, unisex: combined symbol).As-Built: Not easedProposed Solution: Provide properly mounted sanitary facility symbol when altering area. If wheelchair accessible, include International Symbol of Accessibility on sign.	<p>PCODE SA15</p> <p>CBC 2007 1115B.6</p> <p>CBC 2016 11B-703.7.2.6</p> <p>Mitigated:</p> <p><input type="radio"/> YES</p> <p><input checked="" type="radio"/> NO</p>	1	JOB	\$270	\$270
