SAN MATEO COUNTY
COMMUNITY
COLLEGE DISTRICT

San Mateo County Community College District Americans with Disabilities Act Self-Evaluation and Transition Plan

Report Prepared by:

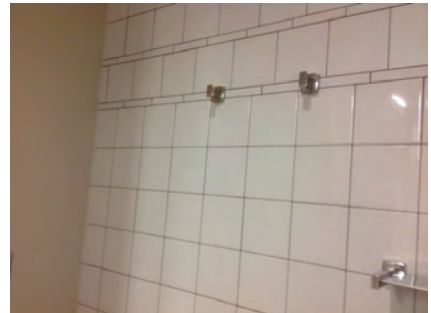
<input type="checkbox"/> Staff Only			
			<div>Priority 3Severity 3</div>			
Coat Hook						
192	<ul style="list-style-type: none">As-Built Description: Accessible coat hook not within reach range.As-Built: 68" highProposed Solution: Adjust existing or provide new coat hook at maximum 48" height.	<p>PCODE WG03A</p> <p>ADAAG 91 4.2.5</p> <p>ADA 2010 603.4</p> <p>CBC 2007 1118B.5</p> <p>CBC 2016 11B-603.4</p> <p>Mitigated:</p> <p><input type="radio"/> YES</p> <p><input checked="" type="radio"/> NO</p>	1	JOB	\$150	\$150

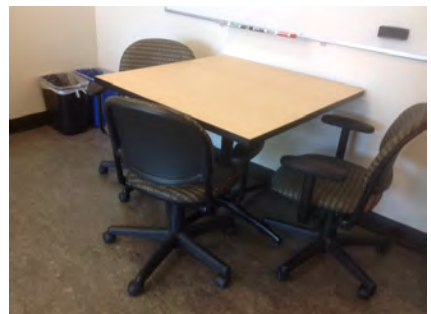
Item no., Rm no. and Name	Existing Architectural Barrier and Proposed Solution	Codes / Mitigation Info	Qty	Unit	Cost	Total
208	<ul style="list-style-type: none">• As-Built Description: Accessible non-fixed table or desk (top 28" to 34" high; knee space at least 27" high x 19" deep x 30" wide) not provided.• Proposed Solution: Provide table or desk with accessible dimensions when purchasing new furniture.• Notes: 3 tables, no accessible	<p>PCODE IN02A</p> <p>ADAAG 91 4.32.3 & .4</p> <p>ADA 2010 306.1</p> <p>CBC 2007 1122B.3 & 4</p> <p>CBC 2016 11B-306.1 & 11B-902.3</p> <p>Mitigated:</p> <p><input type="radio"/> YES</p> <p><input checked="" type="radio"/> NO</p>	1	JOB	\$4,800	\$4,800

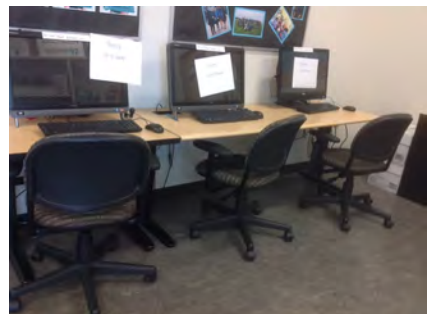
<input type="checkbox"/> Staff Only			
			Priority 2 Severity 2			
213	<ul style="list-style-type: none">• As-Built Description: Accessible non-fixed table or desk (top 28" to 34" high; knee space at least 27" high x 19" deep x 30" wide) not provided.• As-Built: No knee space• Proposed Solution: Provide table or desk with accessible dimensions when purchasing new furniture.	<p>PCODE IN02A</p> <p>ADAAG 91 4.32.3 & .4</p> <p>ADA 2010 306.1</p> <p>CBC 2007 1122B.3 & 4</p> <p>CBC 2016 11B-306.1 & 11B-902.3</p> <p>Mitigated:</p> <p><input type="radio"/> YES</p> <p><input checked="" type="radio"/> NO</p>	1	JOB	\$4,800	\$4,800

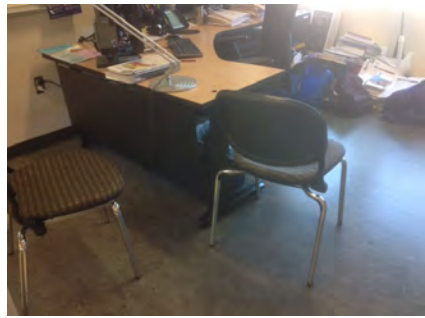
Item no., Rm no. and Name	Existing Architectural Barrier and Proposed Solution	Codes / Mitigation Info	Qty	Unit	Cost	Total
218	<ul style="list-style-type: none"> As-Built Description: Accessible non-fixed table or desk (top 28" to 34" high; knee space at least 27" high x 19" deep x 30" wide) not provided. As-Built: No knee clearance if used as work surface. Proposed Solution: Provide table or desk with accessible dimensions when purchasing new furniture. 	PCODE IN02A ADAAG 91 4.32.3 & .4 ADA 2010 306.1 CBC 2007 1122B.3 & 4 CBC 2016 11B-306.1 & 11B-902.3 Mitigated: <input type="radio"/> YES <input checked="" type="radio"/> NO	22	JOB	\$4,800	\$105,600

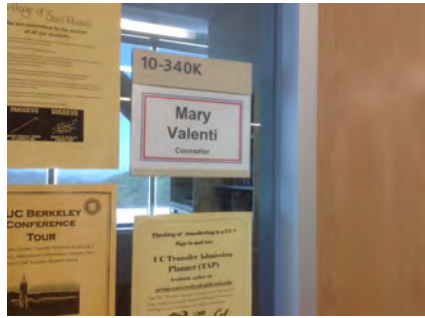
215	<ul style="list-style-type: none"> As-Built Description: Sign not located on latch side of door and/or not located at 48" min. above to baseline of the lowest Braille cells and 60" max. to baseline of the highest line of raised characters. As-Built: 63" high Proposed Solution: Provide compliant signage including tactile characters and Grade II Braille on latch side of door located at compliant height. 	PCODE SA07 ADAAG 91 4.30.6 ADA 2010 703.4.1 CBC 2007 1117B.5.7 Mitigated: <input type="radio"/> YES <input checked="" type="radio"/> NO	25	JOB	\$150	\$3,750

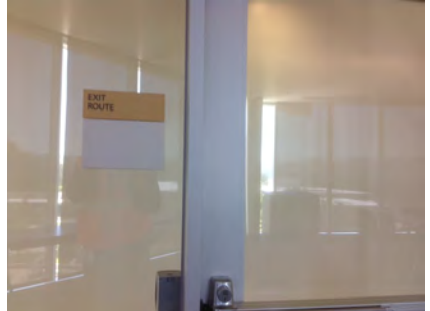
Item no., Rm no. and Name	Existing Architectural Barrier and Proposed Solution	Codes / Mitigation Info	Qty	Unit	Cost	Total
Signage						
223	<ul style="list-style-type: none"> • <i>As-Built Description:</i> Sign not located on latch side of door and/or not located at 48" min. above to baseline of the lowest Braille cells and 60" max. to baseline of the highest line of raised characters. • <i>As-Built:</i> 62" high • <i>Proposed Solution:</i> Provide compliant signage including tactile characters and Grade II Braille on latch side of door located at compliant height. 	PCODE SA07 ADAAG 91 4.30.6 ADA 2010 703.4.1 CBC 2007 1117B.5.7 CBC 2016 11B-703.4.1	2	JOB	\$150	\$300
Mitigated: <input type="radio"/> YES <input checked="" type="radio"/> NO

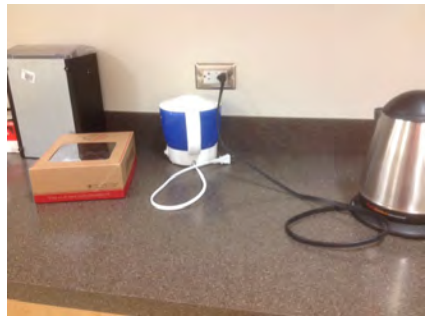
Item no., Rm no. and Name	Existing Architectural Barrier and Proposed Solution	Codes / Mitigation Info	Qty	Unit	Cost	Total
256	<ul style="list-style-type: none"> As-Built Description: Reach height to control or access point, exceeds 48" or is less than 15". As-Built: 25.5" reach Proposed Solution: Modify equipment or mounting. 	PCODE IE01 ADAAG 91 4.2.5 ADA 2010 308.2.1 CBC 2007 1118B.5 CBC 2016 11B-308.2.1	1	JOB	\$300	\$300
<div>

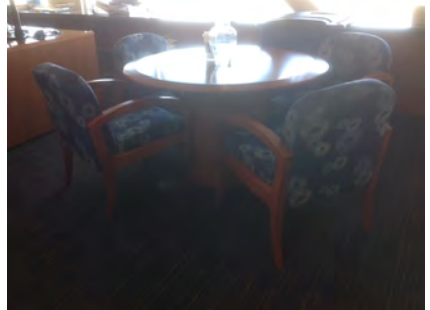
Item no., Rm no. and Name	Existing Architectural Barrier and Proposed Solution	Codes / Mitigation Info	Qty	Unit	Cost	Total
Non-Fixed Desk						
275	<ul style="list-style-type: none"> As-Built Description: Accessible non-fixed table or desk (top 28" to 34" high; knee space at least 27" high x 19" deep x 30" wide) not provided. As-Built: 13" deep Proposed Solution: Provide table or desk with accessible dimensions when purchasing new furniture. 	PCODE IN02A ADAAG 91 4.32.3 & .4 ADA 2010 306.1 CBC 2007 1122B.3 & 4 CBC 2016 11B-306.1 & 11B-902.3	1	JOB	\$4,800	\$4,800
Mitigated: <input type="radio"/> YES <input checked="" type="radio"/> NO

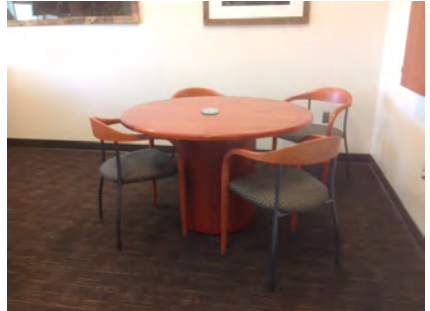
<input type="checkbox"/> Staff Only Priority 2 Severity 2			
276	<ul style="list-style-type: none"> As-Built Description: Accessible non-fixed table or desk (top 28" to 34" high; knee space at least 27" high x 19" deep x 30" wide) not provided. As-Built: 14" deep Proposed Solution: Provide table or desk with accessible dimensions when purchasing new furniture. 	PCODE IN02A ADAAG 91 4.32.3 & .4 ADA 2010 306.1 CBC 2007 1122B.3 & 4 CBC 2016 11B-306.1 & 11B-902.3	1	JOB	\$4,800	\$4,800

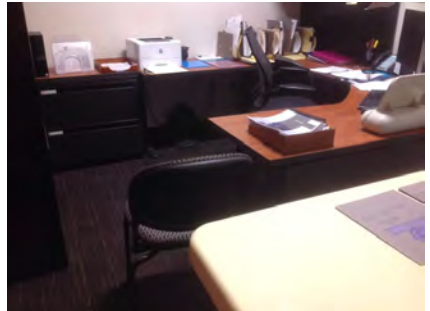
<input type="checkbox"/> Staff Only Priority 2 Severity 2			
277	<ul style="list-style-type: none"> As-Built Description: Accessible non-fixed table or desk (top 28" to 34" high; knee space at least 27" high x 19" deep x 30" wide) not provided. As-Built: No knee space Proposed Solution: Provide table or desk with accessible dimensions when purchasing new furniture. 	PCODE IN02A ADAAG 91 4.32.3 & .4 ADA 2010 306.1 CBC 2007 1122B.3 & 4 CBC 2016 11B-306.1 & 11B-902.3	4	JOB	\$4,800	\$19,200
Mitigated: <input type="radio"/> YES <input checked="" type="radio"/> NO

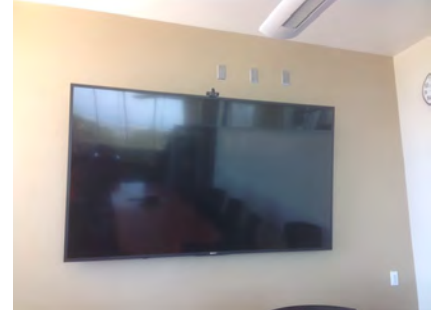
Item no., Rm no. and Name	Existing Architectural Barrier and Proposed Solution	Codes / Mitigation Info	Qty	Unit	Cost	Total
<u>Assistive Listening</u>						
281	<ul style="list-style-type: none"> • <i>As-Built Description:</i> No portable assistive listening system provided for small meeting room. • <i>Proposed Solution:</i> Share existing portable assistive listening system from other facility. 	PCODE GI01E ADAAG 91 4.1.3(19)(b) & 4.33.7 ADA 2010 219.1 & 706.1 CBC 2007 1104B.2 CBC 2016 11B-219.1 & 11B -706.1				
		Mitigated: <input type="radio"/> YES <input checked="" type="radio"/> NO				
					<input type="checkbox"/> Staff Only	
					Priority 2	Severity 3

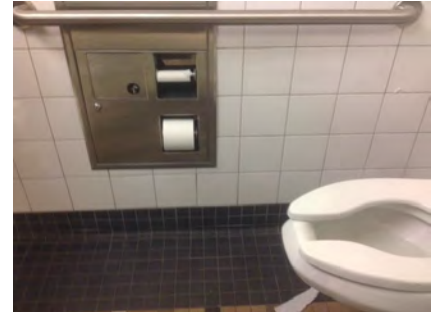
PCODE **WG02**ADAAG 91 **4.16.6**ADA 2010 **604.7**CBC 2007 **1115B.8.4**CBC 2016 **11B-604.7****Mitigated:**☐ **YES**☒ **NO**1 JOB \$225 **\$225**

Relocate or provide new toilet paper dispenser.

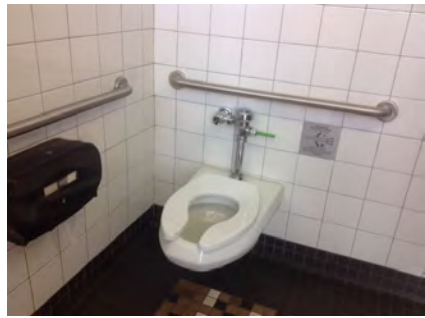
Item no., Rm no. and Name	Existing Architectural Barrier and Proposed Solution	Codes / Mitigation Info	Qty	Unit	Cost	Total
909	<ul style="list-style-type: none"> As-Built Description: The rear wall grab is less than 36" min. or does not extend from the centerline of the water closet 12" min. on one side and 24" min. on the other side. As-Built: 22" offset on the wide side Proposed Solution: Provide or relocate accessible rear grab bar. 	PCODE WB07B ADAAG 91 4.17.6 ADA 2010 604.5.2 CBC 2007 1115B.4.1.3.2 CBC 2016 11B-604.5.2 Mitigated: <input type="radio"/> YES <input checked="" type="radio"/> NO	1	JOB	\$1,020	\$1,020

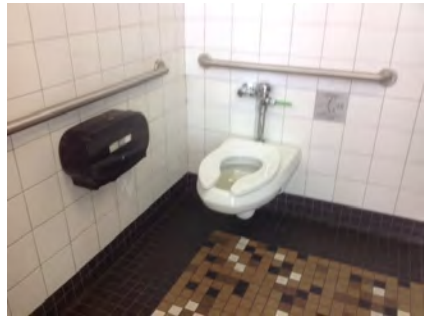
Water Closet

908	<ul style="list-style-type: none"> As-Built Description: Water closet not 16"-18" (CA: 17"-18") from near side wall to center line of water closet (2010 ADAAG: 16"-18"). As-Built: 19" o.c. Proposed Solution: Relocate existing water closet and plumbing, remount with offset closet flange to provide 18" max. from side wall. 	PCODE WB02C ADAAG 91 Fig. 28 ADA 2010 604.2 CBC 2007 1115B.4.1.1 CBC 2016 11B-604.2 Mitigated: <input type="radio"/> YES <input checked="" type="radio"/> NO	1	JOB	\$1,500	\$1,500

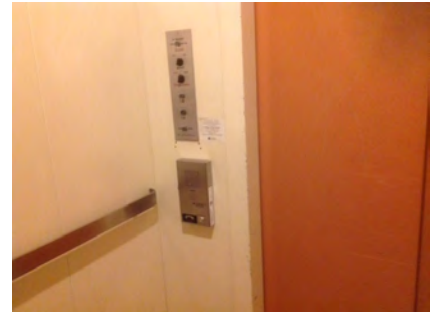
PCODE **IK05**ADAAG 91 **4.10.12(3)***ADA 2010 **407.4.6**CBC 2007 **1116B.1.8**CBC 2016 **11B-407.4.6.1****Mitigated:**☐ **YES**☒ **NO**1 JOB \$5,910 **\$5,910**

Lower elevator controls to 48" from floor.

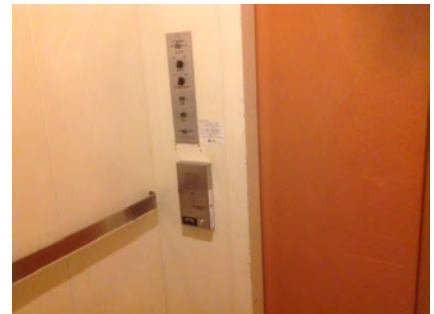
PCODE **IK07D**ADAAG 91 **4.10.12(2)**ADA 2010 **407.4.7.1**CBC 2007 **1116B.1.9**CBC 2016 **11B-407.4.7.1****Mitigated:**☐ **YES**☒ **NO**1 JOB \$330 **\$330**

Provide Braille and tactile symbols on elevator control panel.

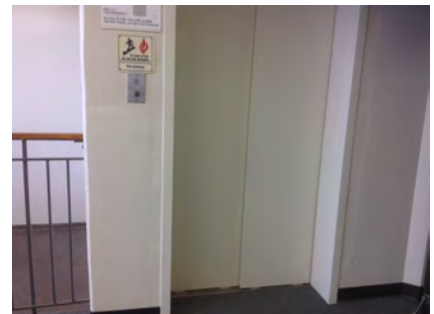
PCODE **IK09**ADAAG 91 **4.10.3**ADA 2010 **407.2.1.1**CBC 2007 **1116B.1.10**CBC 2016 **11B-407.2.1.1****Mitigated:**☐ **YES**☒ **NO**1 FLR \$1,350 **\$1,350**

Provide new or relocate elevator call buttons to 48" above floor at exterior landing.

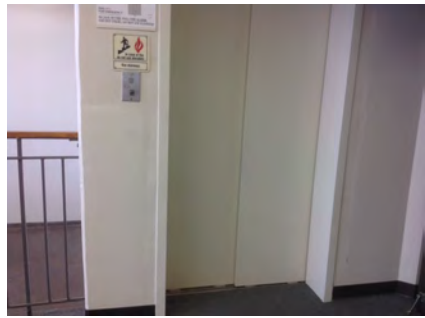
Item no., Rm no. and Name	Existing Architectural Barrier and Proposed Solution	Codes / Mitigation Info	Qty	Unit	Cost	Total
2	<ul style="list-style-type: none"> As-Built Description: Visual hall lantern, minimum 2-1/2" x 2-1/2", not provided, or installed less than 72" above floor. Proposed Solution: Provide or raise proper visual hall lantern for elevator. 	PCODE IK10A ADAAG 91 4.10.4(1) ADA 2010 407.2.2.2 CBC 2007 1116B.1.13 CBC 2016 11B-407.2.2.2 Mitigated: <input type="radio"/> YES <input checked="" type="radio"/> NO	1	JOB	\$4,650	\$4,650

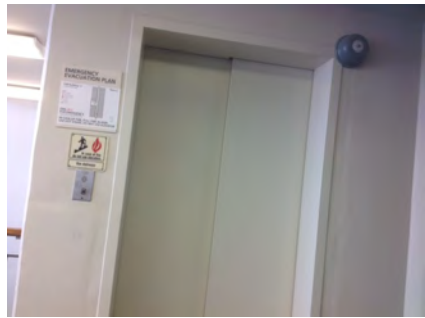
<input type="checkbox"/> Staff Only						
Priority 2 Severity 3						
981	<ul style="list-style-type: none"> As-Built Description: Audible signal not provided (one for up, two for down). Proposed Solution: Provide proper audible hall signal for elevator. 	PCODE IK10B ADAAG 91 4.10.4 ADA 2010 407.2.2.3 CBC 2007 1116B.1.13 CBC 2016 11B-407.2.2.3 Mitigated: <input type="radio"/> YES <input checked="" type="radio"/> NO	1	JOB	\$4,650	\$4,650

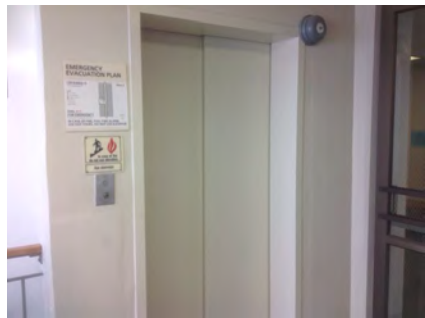
<input type="checkbox"/> Staff Only						
Priority 2 Severity 3						
978	<ul style="list-style-type: none"> As-Built Description: Braille and raised floor numbers on entrance jambs located more or less than 5' above floor. Proposed Solution: Relocate Braille and raised floor numbers on entrance jambs to 5' above floor. 	PCODE IK11C ADAAG 91 4.10.5 ADA 2010 703.4.1 CBC 2007 1116B.1.14 CBC 2016 11B-703.4.1 Mitigated: <input type="radio"/> YES <input checked="" type="radio"/> NO	4	JOB	\$360	\$1,440

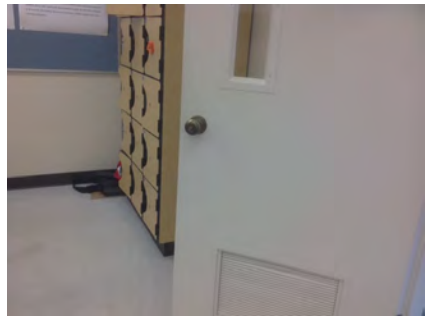
Item no., Rm no. and Name	Existing Architectural Barrier and Proposed Solution	Codes / Mitigation Info	Qty	Unit	Cost	Total
967	<ul style="list-style-type: none"> As-Built Description: Non-common use areas within this facility, such as offices, do not have accessible door hardware. Proposed Solution: Provide lever handle or other accessible hardware when a specific need is identified in the future or when altering area. 	PCODE ID07C ADAAG 91 4.13.9 ADA 2010 404.2.7 CBC 2007 1133B.2.5.2 CBC 2016 11B-404.2.7 Mitigated: <input type="radio"/> YES <input checked="" type="radio"/> NO	1	JOB	\$750	\$750

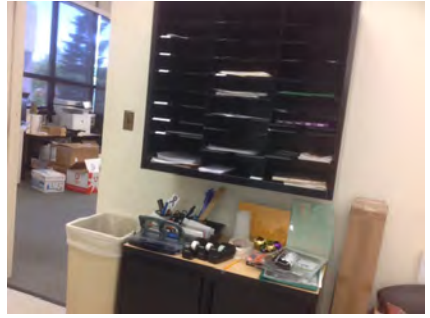
Reach Range

966	<ul style="list-style-type: none"> As-Built Description: Reach height to control or access point, exceeds 48" or is less than 15". As-Built: 56" AFF Proposed Solution: Modify equipment or mounting. 	PCODE IE01 ADAAG 91 4.2.5 ADA 2010 308.2.1 CBC 2007 1118B.5 CBC 2016 11B-308.2.1 Mitigated: <input type="radio"/> YES <input checked="" type="radio"/> NO	1	JOB	\$300	\$300

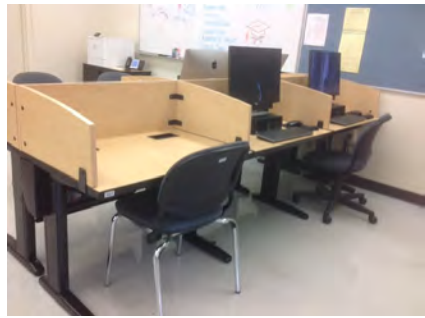
Item no., Rm no. and Name	Existing Architectural Barrier and Proposed Solution	Codes / Mitigation Info	Qty	Unit	Cost	Total
965	<ul style="list-style-type: none"> • <i>As-Built Description:</i> Accessible non-fixed table or desk (top 28" to 34" high; knee space at least 27" high x 19" deep x 30" wide) not provided. • <i>As-Built:</i> 26" high knee clearance • <i>Proposed Solution:</i> Provide table or desk with accessible dimensions when purchasing new furniture. 	PCODE IN02A ADAAG 91 4.32.3 & .4 ADA 2010 306.1 CBC 2007 1122B.3 & 4 CBC 2016 11B-306.1 & 11B-902.3 Mitigated: <input type="radio"/> YES <input checked="" type="radio"/> NO	1	JOB	\$4,800	\$4,800

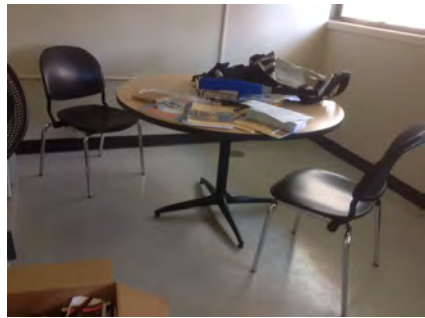
<input type="checkbox"/> Staff Only Priority 2 Severity 2			
971	<ul style="list-style-type: none"> • <i>As-Built Description:</i> Accessible non-fixed table or desk (top 28" to 34" high; knee space at least 27" high x 19" deep x 30" wide) not provided. • <i>Proposed Solution:</i> Provide table or desk with accessible dimensions when purchasing new furniture. 	PCODE IN02A ADAAG 91 4.32.3 & .4 ADA 2010 306.1 CBC 2007 1122B.3 & 4 CBC 2016 11B-306.1 & 11B-902.3 Mitigated: <input type="radio"/> YES <input checked="" type="radio"/> NO	1	JOB	\$4,800	\$4,800

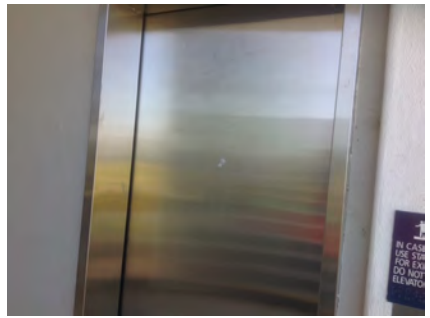
Item no., Rm no. and Name	Existing Architectural Barrier and Proposed Solution	Codes / Mitigation Info	Qty	Unit	Cost	Total
445	<ul style="list-style-type: none"> • <i>As-Built Description:</i> Braille and raised floor numbers on entrance jambs located more or less than 5' above floor. • <i>Proposed Solution:</i> Relocate Braille and raised floor numbers on entrance jambs to 5' above floor. 	PCODE IK11C ADAAG 91 4.10.5 ADA 2010 703.4.1 CBC 2007 1116B.1.14 CBC 2016 11B-703.4.1 Mitigated: <input type="radio"/> YES <input checked="" type="radio"/> NO	4	JOB	\$360	\$1,440

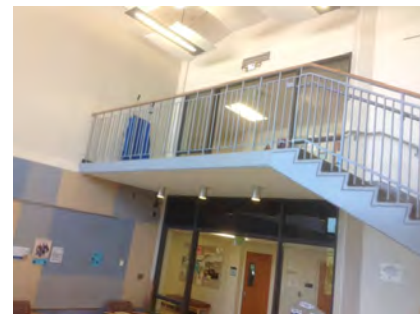
CBC 2007 1133B.5.7

CBC 2016 Section 1013.2;
1013.3**Mitigated:**☐ YES☒ NO20 LF \$360 **\$7,200**

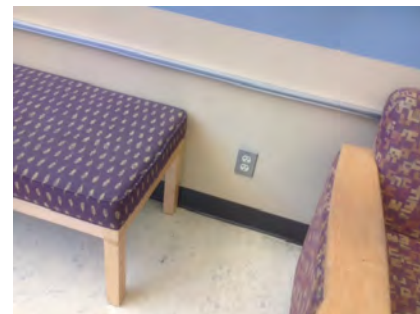
CBC 2007 1117B.6.3

CBC 2016 11B-308.2.1 &
11B-308.2.2**Mitigated:**☐ YES☒ NO1 JOB \$900 **\$900**

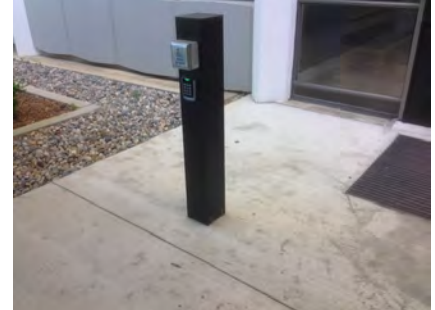
PCODE **ID13B**CBC 2007 **1133B.2.3.2**CBC 2016 **11B-404.2.9 2.C****Mitigated:**☐ **YES**☒ **NO**2 JOB \$1,500 **\$3,000**

Provide lower push plate.

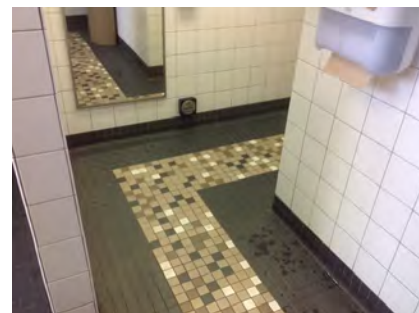
PCODE WC02A
ADAAG 91 4.3.3
ADA 2010 403.5.1
CBC 2007 1115B.3.2.4
CBC 2016 11B-403.5.1

Demolish existing partition and replace.

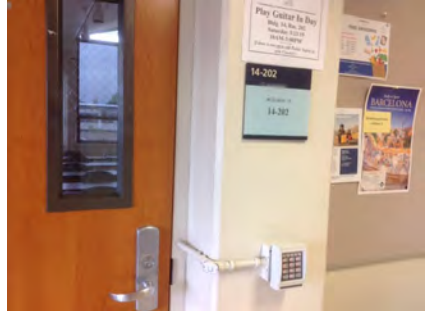
Item no., Rm no. and Name	Existing Architectural Barrier and Proposed Solution	Codes / Mitigation Info	Qty	Unit	Cost	Total
Signage						
503	<ul style="list-style-type: none"> • <i>As-Built Description:</i> Sign not located on latch side of door and/or not located at 48" min. above to baseline of the lowest Braille cells and 60" max. to baseline of the highest line of raised characters. • <i>As-Built:</i> 61.5" AFF • <i>Proposed Solution:</i> Provide compliant signage including tactile characters and Grade II Braille on latch side of door located at compliant height. 	PCODE SA07 ADAAG 91 4.30.6 ADA 2010 703.4.1 CBC 2007 1117B.5.7 CBC 2016 11B-703.4.1 Mitigated: <input type="radio"/> YES <input checked="" type="radio"/> NO	13	JOB	\$150	\$1,950

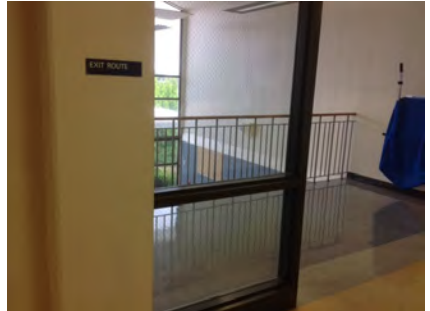
<input type="checkbox"/> Staff Only			
			Priority	Severity		
			2	3		
506	<ul style="list-style-type: none"> • <i>As-Built Description:</i> At door leading into exit stairway: Where required exit signs are installed, signs to provide exiting information for people with vision impairment are not provided. • <i>Proposed Solution:</i> Provide raised letter/Braille "EXIT STAIR UP/DOWN" sign at door. • <i>Notes:</i> Incorrect Braille sign. Provide "Exit Stair" signage. 	PCODE SA10B ADAAG 91 4.1.3(16) ADA 2010 216.4.1 CBC 2007 1011.3 CBC 2016 11B-216.4.1 Mitigated: <input type="radio"/> YES <input checked="" type="radio"/> NO	1	JOB	\$270	\$270

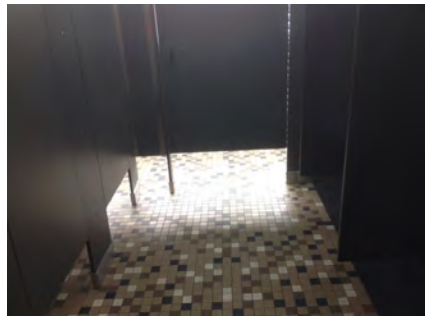
Item no., Rm no. and Name	Existing Architectural Barrier and Proposed Solution	Codes / Mitigation Info	Qty	Unit	Cost	Total
516	<ul style="list-style-type: none"> As-Built Description: Clear passage width (except doorways) from rest room entry to accessible water closet compartment less than 36" (CA only: 44" wide). As-Built: 44.5" wide Proposed Solution: Modify facility passage to be min. 44" wide. Demolish existing partition and replace. Notes: We recommend making urinal partitions shorter. 	PCODE WC02A ADAAG 91 4.3.3 ADA 2010 403.5.1 CBC 2007 1115B.3.2.4 CBC 2016 11B-403.5.1 Mitigated: <input type="radio"/> YES <input checked="" type="radio"/> NO	?10	LF	\$510	\$5,100

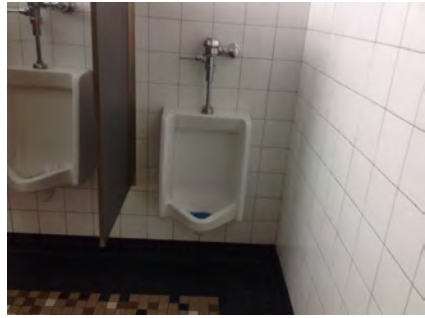
514	<ul style="list-style-type: none"> As-Built Description: Fixture mounted with rim more than 17" above floor. As-Built: 18" AFF Proposed Solution: Provide accessible urinal. Remodel restroom as needed. 	PCODE WE02 ADAAG 91 4.18.2 ADA 2010 605.2 CBC 2007 1115B.4.2.1 CBC 2016 11B-605.2 Mitigated: <input type="radio"/> YES <input checked="" type="radio"/> NO	1	JOB	\$7,200	\$7,200

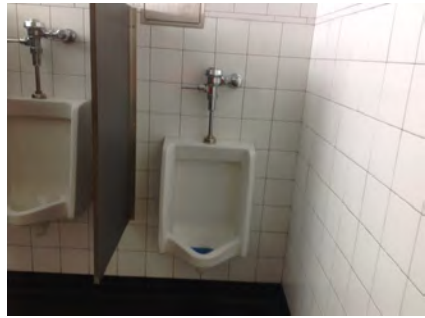
<input type="checkbox"/> Staff Only						
Priority 3 Severity 4						
515	<ul style="list-style-type: none"> As-Built Description: Urinal flush control lever more than 48" above floor. (CA Only: 44" max.) As-Built: 46" AFF Proposed Solution: Provide accessible urinal flush control. 	PCODE WE03 ADAAG 91 4.18.4 ADA 2010 605.4 CBC 2007 1115B.4.2.2 CBC 2016 11B-605.4 Mitigated: <input type="radio"/> YES <input checked="" type="radio"/> NO	1	JOB	\$1,500	\$1,500

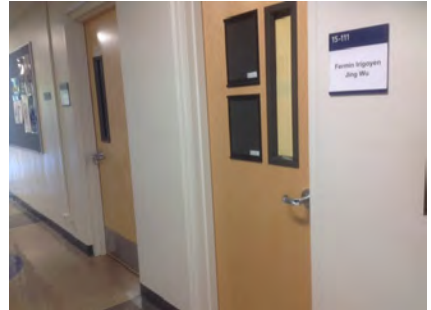
Item no., Rm no. and Name	Existing Architectural Barrier and Proposed Solution	Codes / Mitigation Info	Qty	Unit	Cost	Total
Door						
403	<ul style="list-style-type: none">As-Built Description: Vision Light at door that permits viewing, does not have bottom of at least one glazed panel located 43 inches maximum above the finish floor. (Exception: More than 66" above finished floor.)As-Built: 48" high AFFProposed Solution: Provide new door with vision panel at 43" max.	PCODE ID06C ADA 2010 404.2.11 CBC 2016 11B-404.2.11 Mitigated: <input type="radio"/> YES <input checked="" type="radio"/> NO	8	JOB	\$7,500	\$60,000

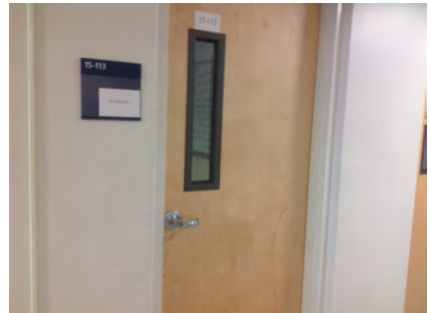
<input type="checkbox"/> Staff Only Priority 2 Severity 4			
Signage						
402	<ul style="list-style-type: none">As-Built Description: Signs containing tactile characters is not located so that a clear floor space of 18" min x 18" min., centered on the tactile characters, is provided beyond the arc of any door swing between the closed position and 45 degree open position.As-Built: 63" AFFProposed Solution: Relocate compliant signage on latch side of door located at compliant height with a clear floor space.	PCODE SA07B ADA 2010 703.4.2 CBC 2016 11B-703.4.2 Mitigated: <input type="radio"/> YES <input checked="" type="radio"/> NO	7	JOB	\$150	\$1,050

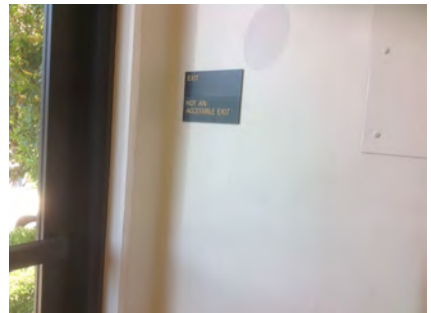
<input type="checkbox"/> Staff Only Priority 2 Severity 4			
400	<ul style="list-style-type: none">As-Built Description: Braille symbols: dots are not 1/10" on centers in each cell with 2/10" space between cells.Proposed Solution: CA only - Provide new compliant signage including Contracted Grade 2 Braille with Title 24 spacing requirements - 1/10" on center dots with 2/10" space between cells.	PCODE SA07C CBC 2007 1117B.5.6 CBC 2016 11B-703.3 Mitigated: <input type="radio"/> YES <input checked="" type="radio"/> NO	1	JOB	\$450	\$450

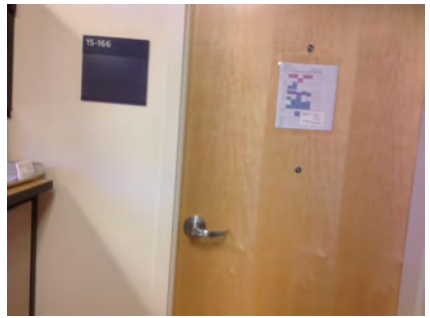
Item no., Rm no. and Name	Existing Architectural Barrier and Proposed Solution	Codes / Mitigation Info	Qty	Unit	Cost	Total
432	<ul style="list-style-type: none"> • <i>As-Built Description:</i> Braille symbols: dots are not 1/10" on centers in each cell with 2/10" space between cells. • <i>Proposed Solution:</i> CA only - Provide new compliant signage including Contracted Grade 2 Braille with Title 24 spacing requirements - 1/10" on center dots with 2/10" space between cells. 	PCODE SA07C CBC 2007 1117B.5.6 CBC 2016 11B-703.3 Mitigated: <input type="radio"/> YES <input checked="" type="radio"/> NO	1	JOB	\$450	\$450

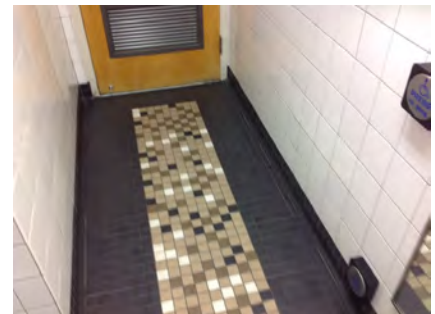
- *As-Built Description:*
Clear passage width (except doorways) from rest room entry to accessible water closet compartment less than 36" (CA only: 44" wide).
- *As-Built:* **43" wide**
- *Proposed Solution:*
Modify facility passage to be min. 44" wide.
Demolish existing partition and replace.

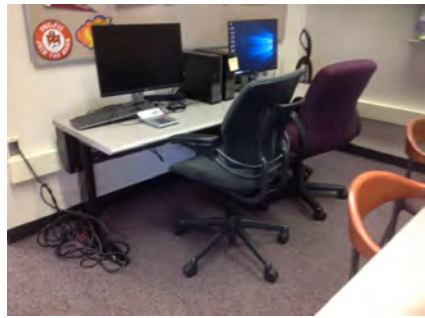
Item no., Rm no. and Name	Existing Architectural Barrier and Proposed Solution	Codes / Mitigation Info	Qty	Unit	Cost	Total
354	<ul style="list-style-type: none"> As-Built Description: Accessible non-fixed table or desk (top 28" to 34" high; knee space at least 27" high x 19" deep x 30" wide) not provided. As-Built: 26" high knee clearance Proposed Solution: Provide table or desk with accessible dimensions when purchasing new furniture. 	PCODE IN02A ADAAG 91 4.32.3 & .4 ADA 2010 306.1 CBC 2007 112B.3 & 4 CBC 2016 11B-306.1 & 11B-902.3 Mitigated: <input type="radio"/> YES <input checked="" type="radio"/> NO	1	JOB	\$4,800	\$4,800

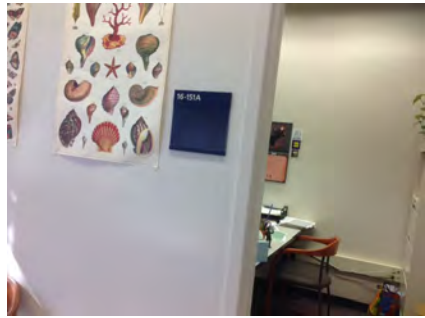
356	<ul style="list-style-type: none"> As-Built Description: Signs containing tactile characters is not located so that a clear floor space of 18" min x 18" min., centered on the tactile characters, is provided beyond the arc of any door swing between the closed position and 45 degree open position. As-Built: 65" AFF Proposed Solution: Relocate compliant signage on latch side of door located at compliant height with a clear floor space. 	PCODE SA07B ADA 2010 703.4.2 CBC 2016 11B-703.4.2 Mitigated: <input type="radio"/> YES <input checked="" type="radio"/> NO	1	JOB	\$150	\$150

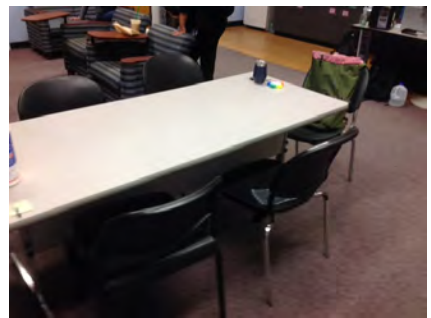
Item no., Rm no. and Name	Existing Architectural Barrier and Proposed Solution	Codes / Mitigation Info	Qty	Unit	Cost	Total
359	<ul style="list-style-type: none">As-Built Description: Accessible non-fixed table or desk (top 28" to 34" high; knee space at least 27" high x 19" deep x 30" wide) not provided.As-Built: 12" knee depthProposed Solution: Provide table or desk with accessible dimensions when purchasing new furniture.	PCODE IN02A ADAAG 91 4.32.3 & .4 ADA 2010 306.1 CBC 2007 1122B.3 & 4 CBC 2016 11B-306.1 & 11B-902.3	1	JOB	\$4,800	\$4,800
		Mitigated:

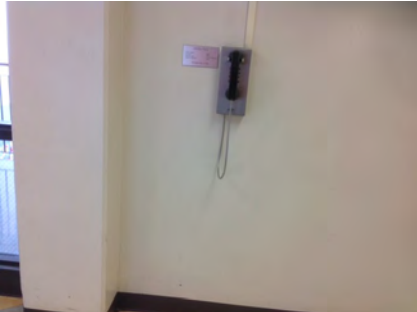
Item no., Rm no. and Name	Existing Architectural Barrier and Proposed Solution	Codes / Mitigation Info	Qty	Unit	Cost	Total
Telephone						
390	<ul style="list-style-type: none">As-Built Description: Telephone mounting height more than 48" to highest operable part of phone if side reach approach is available.As-Built: 50" AFFProposed Solution: Lower telephone enclosure and phone.	PCODE IB02 ADAAG 91 4.2.6 ADA 2010 704.2.2 CBC 2007 1118B.6 CBC 2016 11B-704.2.2	1	JOB	\$750	\$750

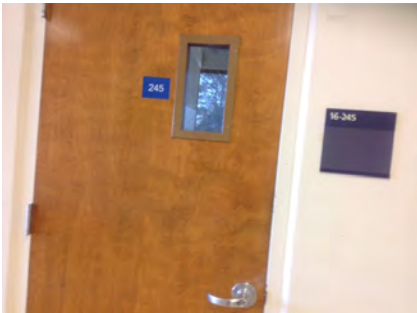
<input type="checkbox"/> Staff Only			
			Priority 2 Severity 4			
Door						
375	<ul style="list-style-type: none">As-Built Description: Vision Light at door that permits viewing, does not have bottom of at least one glazed panel located 43 inches maximum above the finish floor. (Exception: More than 66" above finished floor.)As-Built: 60" AFFProposed Solution: Provide new door with vision panel at 43" max.	PCODE ID06C ADA 2010 404.2.11 CBC 2016 11B-404.2.11	10	JOB	\$7,500	\$75,000

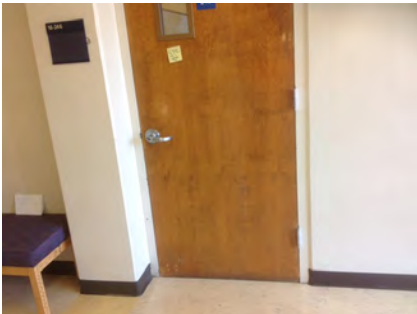
<input type="checkbox"/> Staff Only			
			Priority 2 Severity 1			
Door Swing						
378	<ul style="list-style-type: none">As-Built Description: Front approach: At pull side, door does not have clear and level maneuvering space measuring door width plus 18" x 60". (24" x 60" at exterior doors).As-Built: 8.25" - 9" deepProposed Solution: Change door swing.	PCODE ID23 ADAAG 91 Fig. 25(a) ADA 2010 404.2.4 CBC 2007 11B-26A(a) CBC 2016 11B-404.2.4	8	JOB	\$1,500	\$12,000

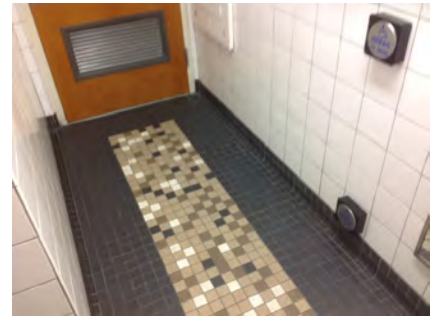
382

- *As-Built Description:*
Clear passage width (except doorways) from rest room entry to accessible water closet compartment less than 36" (CA only: 44" wide).
- *As-Built:* **41" - 43" wide**
- *Proposed Solution:*
Modify facility passage to be min. 44" wide.
Demolish existing partition and replace.

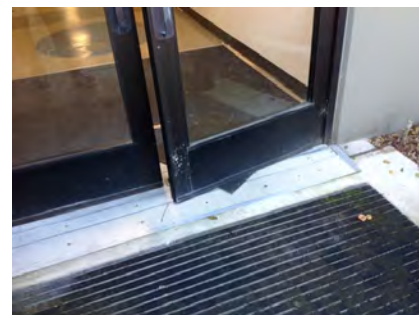
17	<ul style="list-style-type: none"> As-Built Description: Vision Light at door that permits viewing, does not have bottom of at least one glazed panel located 43 inches maximum above the finish floor. (Exception: More than 66" above finished floor.) As-Built: 44.5" high Proposed Solution: Provide new door with vision panel at 43" max. Notes: Located where vision panels in wall are not provided. When glass panels are provided adjacent to the door, we believe it is equivalent as a vision panel. 	PCODE ID06C ADA 2010 404.2.11 CBC 2016 11B-404.2.11	5	JOB	\$7,500	\$37,500
		Mitigated: <input type="radio"/> YES <input checked="" type="radio"/> NO

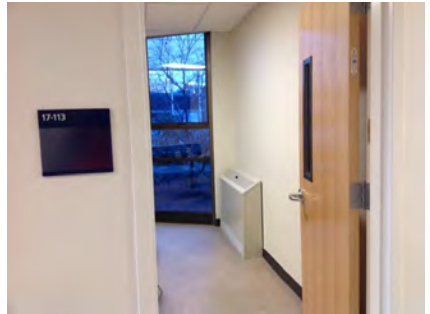
18	<ul style="list-style-type: none"> As-Built Description: Reach height to control or access point, exceeds 48" or is less than 15". As-Built: 49" high to top buttons Proposed Solution: Modify equipment or mounting. 	PCODE IE01 ADAAG 91 4.2.5 ADA 2010 308.2.1 CBC 2007 1118B.5 CBC 2016 11B-308.2.1	1	JOB	\$300	\$300
		Mitigated: <input type="radio"/> YES <input checked="" type="radio"/> NO

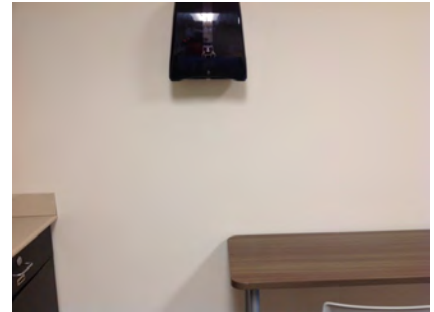
- 22 • *As-Built Description:*
Reach height to control or access point, where side approach is available, exceeds 48" or is less than 15" in height, or exceeds 10" in depth.
- *As-Built:* **27" deep to outlet.**
- *Proposed Solution:*
Modify equipment or mounting.

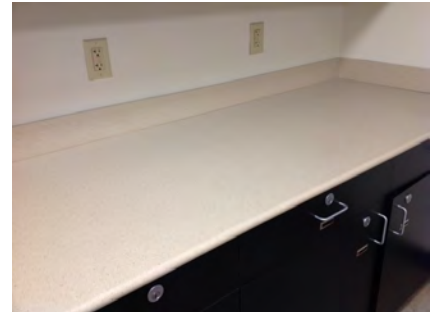
- 19 • *As-Built Description:*
Accessible non-fixed table or desk (top 28" to 34" high; knee space at least 27" high x 19" deep x 30" wide) not provided.
- *Proposed Solution:*
Provide table or desk with accessible dimensions when purchasing new furniture.

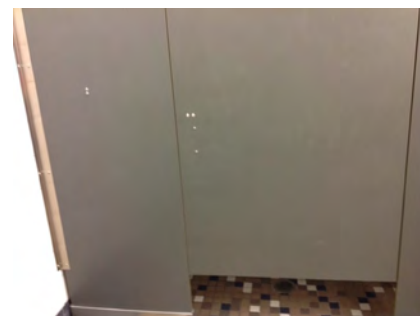
- 29
- **As-Built Description:**
Less than 59" from back wall to front wall or door swing of toilet stall, or less than 56" if water closet is wall-hung.
 - **As-Built:** **49" in front of toilet.**
 - **Proposed Solution:**
Reverse swing of stall door to mitigate the issue.

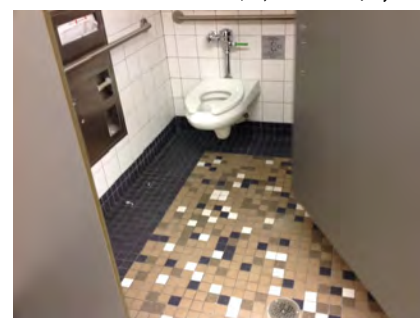
- 30
- **As-Built Description:**
Water closet not 16"-18" (CA: 17"-18") from near side wall to center line of water closet (2010 ADAAG: 16"-18").
 - **As-Built:** **18.5" o.c.**
 - **Proposed Solution:**
Relocate existing water closet and plumbing, remount with offset closet flange to provide 18" max. from side wall.

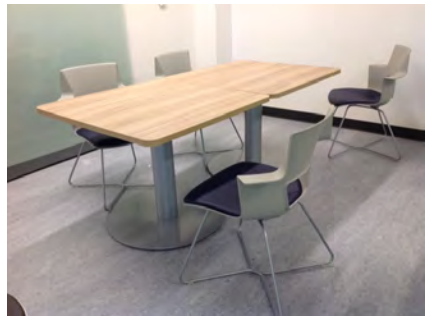
Item no., Rm no. and Name	Existing Architectural Barrier and Proposed Solution	Codes / Mitigation Info	Qty	Unit	Cost	Total
37	<ul style="list-style-type: none"> As-Built Description: Accessible non-fixed table or desk (top 28" to 34" high; knee space at least 27" high x 19" deep x 30" wide) not provided. Proposed Solution: Provide table or desk with accessible dimensions when purchasing new furniture. 	PCODE IN02A ADAAG 91 4.32.3 & .4 ADA 2010 306.1 CBC 2007 1122B.3 & 4 CBC 2016 11B-306.1 & 11B-902.3	1	JOB	\$4,800	\$4,800
		Mitigated: <input type="radio"/> YES <input checked="" type="radio"/> NO

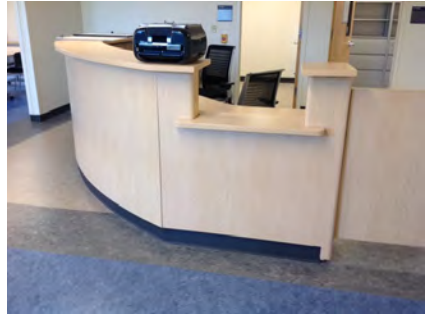
33	<ul style="list-style-type: none"> As-Built Description: Service counter (stand-up): Accessible section min. 36" length and 36" max. height (in CA: 28" to 34" high) not provided. As-Built: 33" total width, 24" opening Proposed Solution: Retrofit existing counter to provide accessible section. Interim solution: Provide auxiliary counter, table, or clipboard. 	PCODE IN03 ADAAG 91 7.2(2) ADA 2010 904.4 CBC 2007 1122B.4 CBC 2016 11B-904.4	1	JOB	\$6,000	\$6,000
		Mitigated: <input type="radio"/> YES <input checked="" type="radio"/> NO

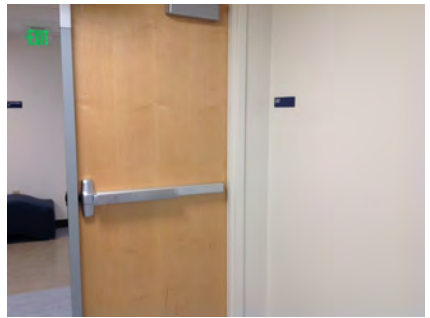
48	<ul style="list-style-type: none"> As-Built Description: At door leading into exit corridor: Where required exit signs are installed, signs to provide exiting information for people with vision impairment are not provided. Proposed Solution: Provide raised letter/Braille "EXIT ROUTE" sign at door. Notes: Signage depicts "EXIT". It should say "EXIT ROUTE". 	PCODE SA10D ADAAG 91 4.1.3(16) ADA 2010 216.4.1 CBC 2007 1011.3 CBC 2016 11B-216.4.1	1	JOB	\$270	\$270
		Mitigated: <input type="radio"/> YES <input checked="" type="radio"/> NO

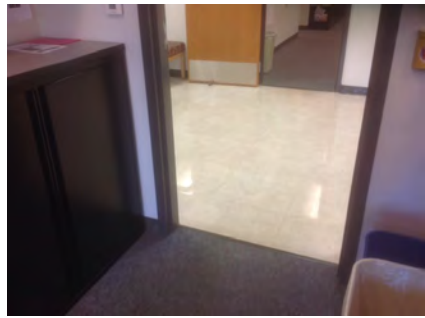
Item no., Rm no. and Name	Existing Architectural Barrier and Proposed Solution	Codes / Mitigation Info	Qty	Unit	Cost	Total
260	<ul style="list-style-type: none"> As-Built Description: Front approach: At push side, door does not have clear and level maneuvering space measuring door width x 48" (door width plus 12" if door has both, latch and closer). As-Built: 4" strike side clearance Proposed Solution: Remove or relocate furniture or storage items. 	PCODE ID24A ADAAG 91 Fig. 25(a) ADA 2010 404.2.4 CBC 2007 11B-26A(a) CBC 2016 11B-404.2.4 Mitigated: <input type="radio"/> YES <input checked="" type="radio"/> NO	1	JOB	\$150	\$150

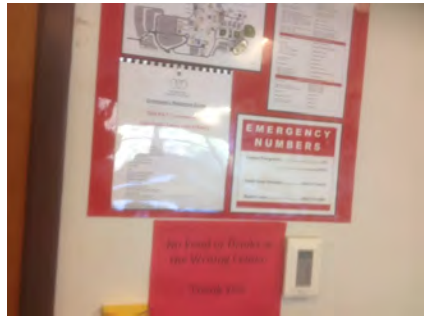
265	<ul style="list-style-type: none"> As-Built Description: Reach height to control or access point, exceeds 48" or is less than 15". As-Built: 56" AFF Proposed Solution: Modify equipment or mounting. 	PCODE IE01 ADAAG 91 4.2.5 ADA 2010 308.2.1 CBC 2007 1118B.5 CBC 2016 11B-308.2.1 Mitigated: <input type="radio"/> YES <input checked="" type="radio"/> NO	1	JOB	\$300	\$300

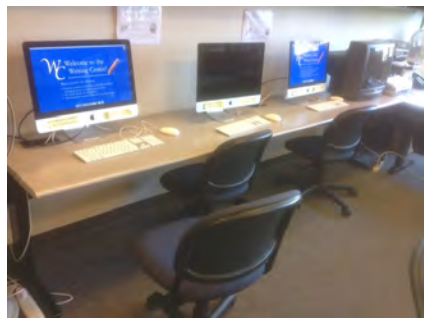
261	<ul style="list-style-type: none"> As-Built Description: Accessible non-fixed table or desk (top 28" to 34" high; knee space at least 27" high x 19" deep x 30" wide) not provided. As-Built: 26" high knee clearance Proposed Solution: Provide table or desk with accessible dimensions when purchasing new furniture. Notes: 16 computer stations, no accessible station provided 	PCODE IN02A ADAAG 91 4.32.3 & .4 ADA 2010 306.1 CBC 2007 1122B.3 & 4 CBC 2016 11B-306.1 & 11B-902.3 Mitigated: <input type="radio"/> YES <input checked="" type="radio"/> NO	1	JOB	\$4,800	\$4,800

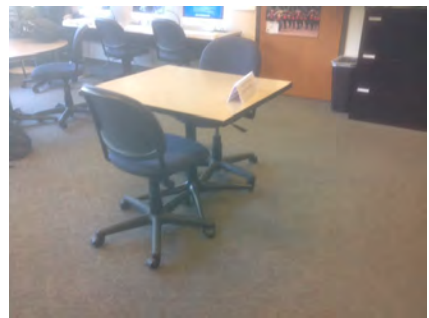
Item no., Rm no. and Name	Existing Architectural Barrier and Proposed Solution	Codes / Mitigation Info	Qty	Unit	Cost	Total
262	<ul style="list-style-type: none">• As-Built Description: Accessible non-fixed table or desk (top 28" to 34" high; knee space at least 27" high x 19" deep x 30" wide) not provided.• Proposed Solution: Provide table or desk with accessible dimensions when purchasing new furniture.• Notes: 6 tables, no accessible table provided	<p>PCODE IN02A</p> <p>ADAAG 91 4.32.3 & .4</p> <p>ADA 2010 306.1</p> <p>CBC 2007 1122B.3 & 4</p> <p>CBC 2016 11B-306.1 & 11B-902.3</p> <p>Mitigated:</p> <p><input type="radio"/> YES</p> <p><input checked="" type="radio"/> NO</p>	1	JOB	\$4,800	\$4,800

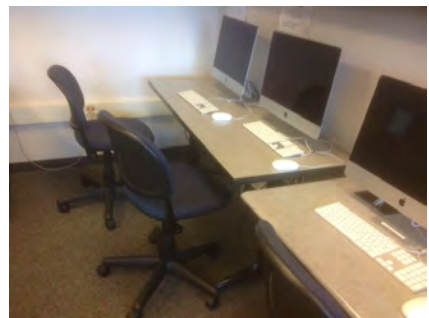
<input type="checkbox"/> Staff Only			
			Priority		Severity	
			2		2	
267	<ul style="list-style-type: none">• As-Built Description: Accessible non-fixed table or desk (top 28" to 34" high; knee space at least 27" high x 19" deep x 30" wide) not provided.• Proposed Solution: Provide table or desk with accessible dimensions when purchasing new furniture.• Notes: Quiet Room. 28 stations total, 1 accessible table provided. One additional is required.	<p>PCODE IN02A</p> <p>ADAAG 91 4.32.3 & .4</p> <p>ADA 2010 306.1</p> <p>CBC 2007 1122B.3 & 4</p> <p>CBC 2016 11B-306.1 & 11B-902.3</p> <p>Mitigated:</p> <p><input type="radio"/> YES</p> <p><input checked="" type="radio"/> NO</p>	1	JOB	\$4,800	\$4,800

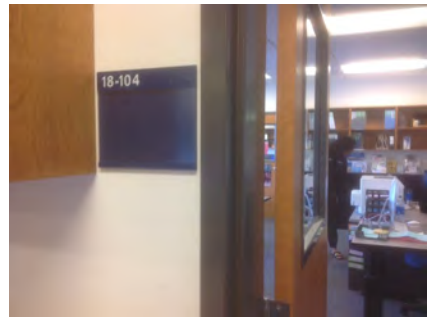
<input type="checkbox"/> Staff Only			
			Priority		Severity	
			2		2	
Signage						
263	<ul style="list-style-type: none">• As-Built Description: Signs containing tactile characters is not located so that a clear floor space of 18" min x 18" min., centered on the tactile characters, is provided beyond the arc of any door swing between the closed position and 45 degree open position.• As-Built: 63" AFF• Proposed Solution: Relocate compliant signage on latch side of door located at compliant height with a clear floor space.	<p>PCODE SA07B</p> <p>ADA 2010 703.4.2</p> <p>CBC 2016 11B-703.4.2</p> <p>Mitigated:</p> <p><input type="radio"/> YES</p> <p><input checked="" type="radio"/> NO</p>	2	JOB	\$150	\$300

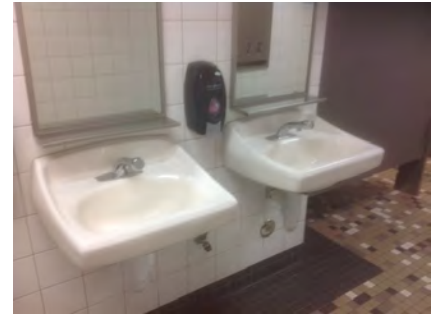
Item no., Rm no. and Name	Existing Architectural Barrier and Proposed Solution	Codes / Mitigation Info	Qty	Unit	Cost	Total
276	<ul style="list-style-type: none"> As-Built Description: Bottom of mirror located above lavatories or countertops more than 40" above floor. As-Built: 41" AFF Proposed Solution: Relocate or provide new accessible mirror. 	PCODE WG03 ADAAG 91 4.19.6 ADA 2010 603.3 CBC 2007 1115B.8.1 CBC 2016 11B-603.3 Mitigated: <input type="radio"/> YES <input checked="" type="radio"/> NO	1	JOB	\$450	\$450

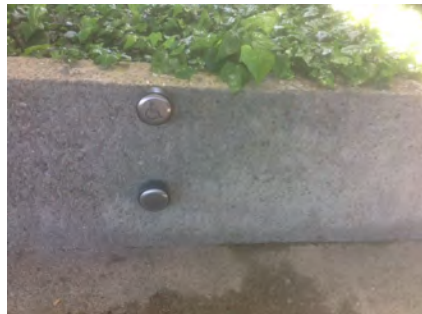
Item no., Rm no. and Name	Existing Architectural Barrier and Proposed Solution	Codes / Mitigation Info	Qty	Unit	Cost	Total
472	<ul style="list-style-type: none"> As-Built Description: High push plate located at 30" minimum and 44" maximum above the floor or ground surface not provided. As-Built: 28" high o.c. Proposed Solution: Provide higher push plate. 	PCODE ID13E CBC 2007 1133B.2.3.2 CBC 2016 11B-404.2.9 2.C Mitigated: <input type="radio"/> YES <input checked="" type="radio"/> NO	1	JOB	\$1,500	\$1,500

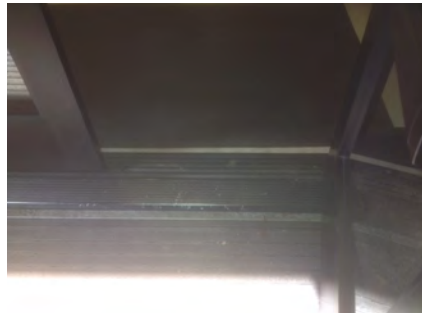
Door Threshold

278	<ul style="list-style-type: none"> As-Built Description: Door inaccessible due to threshold or step at door exceeding 1/2". As-Built: 0.75" high Proposed Solution: Modify threshold to be no more than 1/2" by removing existing paving at door and providing landing with edge ramping (slope 1:20 max). 	PCODE ID02A ADAAG 91 4.13.8 ADA 2010 404.2.5 CBC 2007 1133B.2.4.1 CBC 2016 11B-404.2.5 Mitigated: <input type="radio"/> YES <input checked="" type="radio"/> NO	1	JOB	\$1,200	\$1,200

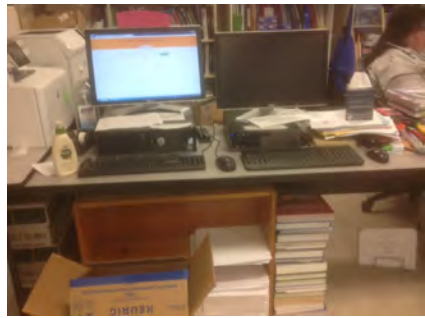
Item no., Rm no. and Name	Existing Architectural Barrier and Proposed Solution	Codes / Mitigation Info	Qty	Unit	Cost	Total
290	<ul style="list-style-type: none"> As-Built Description: Accessible non-fixed table or desk (top 28" to 34" high; knee space at least 27" high x 19" deep x 30" wide) not provided. As-Built: No knee clearance provided Proposed Solution: Provide table or desk with accessible dimensions when purchasing new furniture. 	PCODE IN02A ADAAG 91 4.32.3 & .4 ADA 2010 306.1 CBC 2007 1122B.3 & 4 CBC 2016 11B-306.1 & 11B-902.3 Mitigated: <input type="radio"/> YES <input checked="" type="radio"/> NO	1	JOB	\$4,800	\$4,800

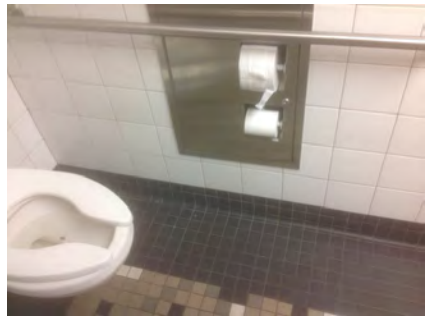
Item no., Rm no. and Name	Existing Architectural Barrier and Proposed Solution	Codes / Mitigation Info	Qty	Unit	Cost	Total
296	<ul style="list-style-type: none"> As-Built Description: Toilet paper dispenser less than 15" (CA: 19") or more than 48" above floor or not within 7" to 9" from front of water closet (Note: CA pre-2010 is allowed within 12" from front of water closet). As-Built: 12" o.c. Proposed Solution: Relocate or provide new toilet paper dispenser. 	PCODE WG02 ADAAG 91 4.16.6 ADA 2010 604.7 CBC 2007 1115B.8.4 CBC 2016 11B-604.7 Mitigated: <input type="radio"/> YES <input checked="" type="radio"/> NO	1	JOB	\$225	\$225

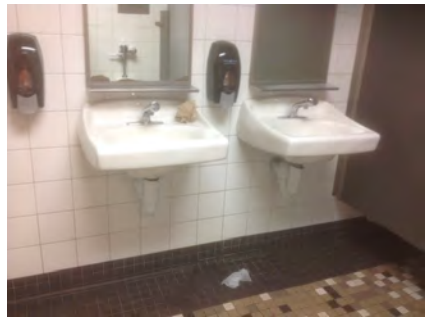
<input type="checkbox"/> Staff Only			
			Priority		Severity	
			3		3	
294	<ul style="list-style-type: none"> As-Built Description: Bottom of mirror located above lavatories or countertops more than 40" above floor. As-Built: 41" AFF Proposed Solution: Relocate or provide new accessible mirror. 	PCODE WG03 ADAAG 91 4.19.6 ADA 2010 603.3 CBC 2007 1115B.8.1 CBC 2016 11B-603.3 Mitigated: <input type="radio"/> YES <input checked="" type="radio"/> NO	1	JOB	\$450	\$450

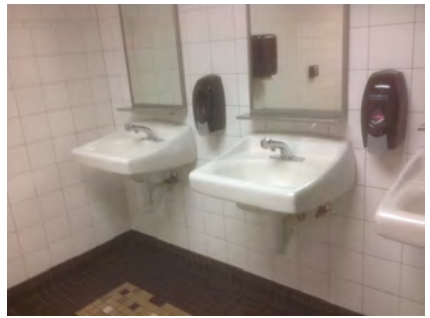
Item no., Rm no. and Name	Existing Architectural Barrier and Proposed Solution	Codes / Mitigation Info	Qty	Unit	Cost	Total
310	<ul style="list-style-type: none"> As-Built Description: Bottom of mirror located above lavatories or countertops more than 40" above floor. As-Built: 41" AFF Proposed Solution: Relocate or provide new accessible mirror. 	PCODE WG03 ADAAG 91 4.19.6 ADA 2010 603.3 CBC 2007 1115B.8.1 CBC 2016 11B-603.3 Mitigated: <input type="radio"/> YES <input checked="" type="radio"/> NO	1	JOB	\$450	\$450

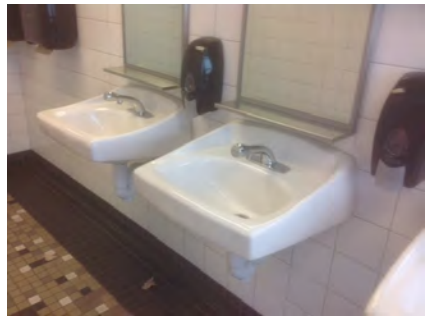
Item no., Rm no. and Name	Existing Architectural Barrier and Proposed Solution	Codes / Mitigation Info	Qty	Unit	Cost	Total
314	<ul style="list-style-type: none"> As-Built Description: Bottom of mirror located above lavatories or countertops more than 40" above floor. As-Built: 41" AFF Proposed Solution: Relocate or provide new accessible mirror. 	PCODE WG03 ADAAG 91 4.19.6 ADA 2010 603.3 CBC 2007 1115B.8.1 CBC 2016 11B-603.3 Mitigated: <input type="radio"/> YES <input checked="" type="radio"/> NO	1	JOB	\$450	\$450

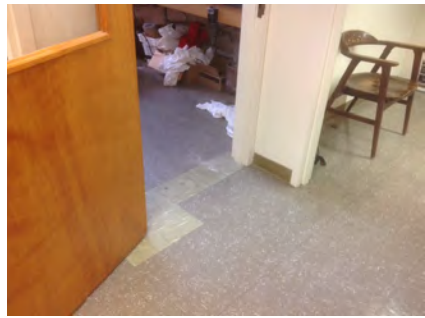
Item no., Rm no. and Name	Existing Architectural Barrier and Proposed Solution	Codes / Mitigation Info	Qty	Unit	Cost	Total
313	<ul style="list-style-type: none"> As-Built Description: Front approach: At pull side, door does not have clear and level maneuvering space measuring door width plus 18" x 60". (24" x 60" at exterior doors). As-Built: 13" deep Proposed Solution: Provide power door operator. 	PCODE ID23C ADAAG 91 Fig. 25(a) ADA 2010 404.2.4 CBC 2007 11B-26A(a) CBC 2016 11B-404.2.4 Mitigated: <input type="radio"/> YES <input checked="" type="radio"/> NO	1	JOB	\$15,000	\$15,000

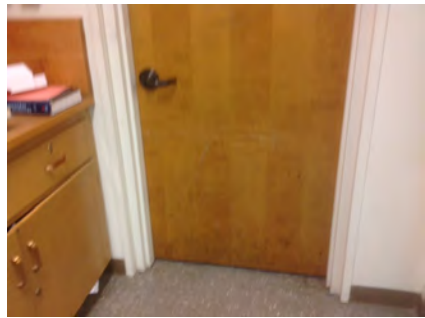
<input type="checkbox"/> Staff Only Priority 2 Severity 4						
319	<ul style="list-style-type: none"> As-Built Description: Front approach: At push side, door does not have clear and level maneuvering space measuring door width x 48" (door width plus 12" if door has both, latch and closer). As-Built: 4" strike side clearance Proposed Solution: Remove or relocate furniture or storage items. 	PCODE ID24A ADAAG 91 Fig. 25(a) ADA 2010 404.2.4 CBC 2007 11B-26A(a) Mitigated: <input type="radio"/> YES <input checked="" type="radio"/> NO	1	JOB	\$150	\$150

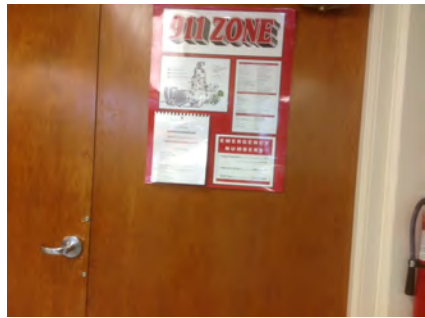
<input type="checkbox"/> Staff Only Priority 4 Severity 2						
Reach Range						
306	<ul style="list-style-type: none"> As-Built Description: Reach height to control or access point, exceeds 48" or is less than 15". As-Built: 54" high Proposed Solution: Modify equipment or mounting. 	PCODE IE01 ADAAG 91 4.2.5 ADA 2010 308.2.1 CBC 2007 1118B.5 CBC 2016 11B-308.2.1 Mitigated: <input type="radio"/> YES <input checked="" type="radio"/> NO	1	JOB	\$300	\$300

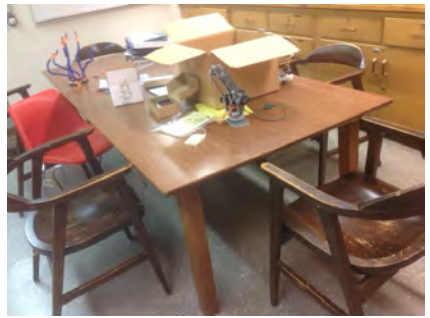
Item no., Rm no. and Name	Existing Architectural Barrier and Proposed Solution	Codes / Mitigation Info	Qty	Unit	Cost	Total
318	<ul style="list-style-type: none"> As-Built Description: Accessible non-fixed table or desk (top 28" to 34" high; knee space at least 27" high x 19" deep x 30" wide) not provided. As-Built: 25" AFF knee height Proposed Solution: Provide table or desk with accessible dimensions when purchasing new furniture. 	PCODE IN02A ADAAG 91 4.32.3 & .4 ADA 2010 306.1 CBC 2007 1122B.3 & 4 CBC 2016 11B-306.1 & 11B-902.3	1	JOB	\$4,800	\$4,800

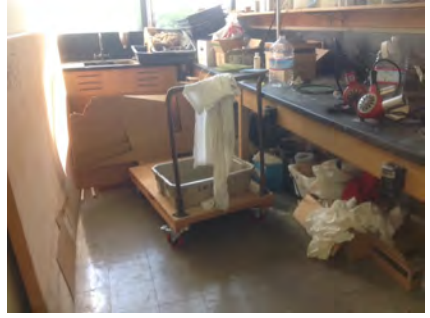
312	<ul style="list-style-type: none"> As-Built Description: Service counter (stand-up): Accessible section min. 36" length and 36" max. height (in CA: 28" to 34" high) not provided. As-Built: 36" AFF Proposed Solution: Retrofit existing counter to provide accessible section. Interim solution: Provide auxiliary counter, table, or clipboard. 	PCODE IN03 ADAAG 91 7.2(2) ADA 2010 904.4 CBC 2007 1122B.4 CBC 2016 11B-904.4	1	JOB	\$6,000	\$6,000

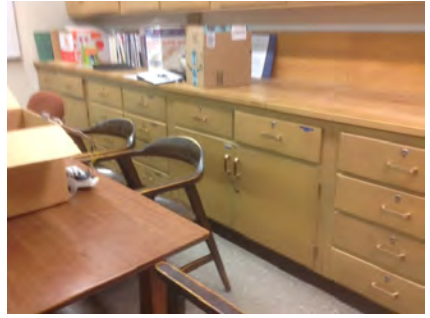
Mitigated: <input type="radio"/> YES <input checked="" type="radio"/> NO						
<input type="checkbox"/> Staff Only						
Priority Severity <input checked="" type="radio"/> 2 <input checked="" type="radio"/> 4						
317	<ul style="list-style-type: none"> As-Built Description: Service counter (stand-up): Accessible section min. 36" length and 36" max. height (in CA: 28" to 34" high) not provided. As-Built: 36" AFF Proposed Solution: Retrofit existing counter to provide accessible section. Interim solution: Provide auxiliary counter, table, or clipboard. 	PCODE IN03 ADAAG 91 7.2(2) ADA 2010 904.4 CBC 2007 1122B.4 CBC 2016 11B-904.4	1	JOB	\$6,000	\$6,000

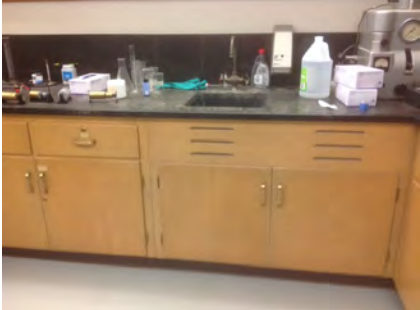
Item no., Rm no. and Name	Existing Architectural Barrier and Proposed Solution	Codes / Mitigation Info	Qty	Unit	Cost	Total
Sink						
307	<ul style="list-style-type: none"> As-Built Description: Sink rim higher than 34" above floor. As-Built: 36.5" high Proposed Solution: Remodel sink cabinet to lower sink. 	PCODE IN06 ADAAG 91 4.24.2 ADA 2010 606.3 CBC 2007 1115B.4.7.1 CBC 2016 11B-606.3 Mitigated: <input type="radio"/> YES <input checked="" type="radio"/> NO	1	JOB	\$5,250	\$5,250

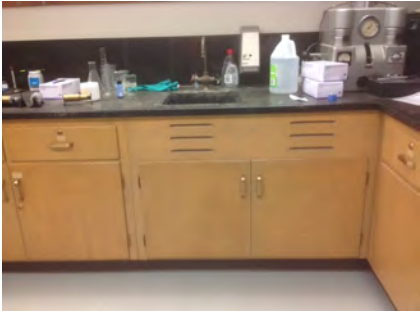
<input type="checkbox"/> Staff Only Priority 2 Severity 4			
308	<ul style="list-style-type: none"> As-Built Description: Sink does not have knee space min. 27" high x 19" deep x 30" wide. Proposed Solution: Remodel sink cabinet. 	PCODE IN06A ADAAG 91 4.24.3 ADA 2010 606.2 CBC 2007 1115B.4.7.1 CBC 2016 11B-606.2 Mitigated: <input type="radio"/> YES <input checked="" type="radio"/> NO	1	JOB	\$5,250	\$5,250

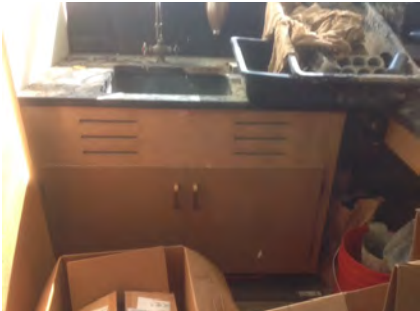
<input type="checkbox"/> Staff Only Priority 2 Severity 2			
314	<ul style="list-style-type: none"> As-Built Description: Sink does not have knee space min. 27" high x 19" deep x 30" wide. Proposed Solution: Remodel sink cabinet. 	PCODE IN06A ADAAG 91 4.24.3 ADA 2010 606.2 CBC 2007 1115B.4.7.1 CBC 2016 11B-606.2 Mitigated: <input type="radio"/> YES <input checked="" type="radio"/> NO	1	JOB	\$5,250	\$5,250

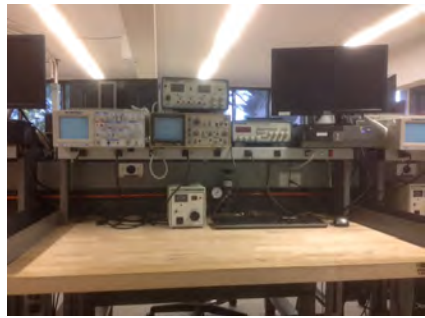
Item no., Rm no. and Name	Existing Architectural Barrier and Proposed Solution	Codes / Mitigation Info	Qty	Unit	Cost	Total
334	<ul style="list-style-type: none">• <i>As-Built Description:</i> Reach height to control or access point, exceeds 48" or is less than 15".• <i>As-Built:</i> Equipment at station greater than 48" high.• <i>Proposed Solution:</i> Modify equipment or mounting.• <i>Notes:</i> 29 seats, no accessible provided.	<i>PCODE</i> IE01 <i>ADAAG 91</i> 4.2.5 <i>ADA 2010</i> 308.2.1 <i>CBC 2007</i> 1118B.5 <i>CBC 2016</i> 11B-308.2.1 Mitigated: <input type="radio"/> YES <input checked="" type="radio"/> NO	1	JOB	\$300	\$300

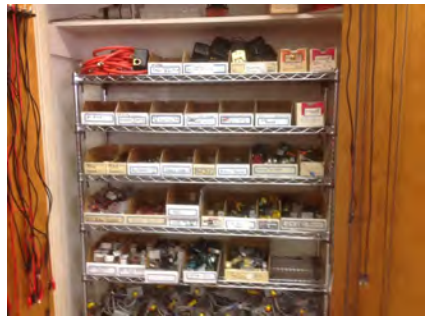
Item no., Rm no. and Name	Existing Architectural Barrier and Proposed Solution	Codes / Mitigation Info	Qty	Unit	Cost	Total
342	<ul style="list-style-type: none"> • <i>As-Built Description:</i> Reach height to control or access point, exceeds 48" or is less than 15". • <i>As-Built:</i> 65" AFF • <i>Proposed Solution:</i> Modify equipment or mounting. • <i>Notes:</i> Provide duplicate items within reach ranges if used independently by students. 	PCODE IE01 ADAAG 91 4.2.5 ADA 2010 308.2.1 CBC 2007 1118B.5 CBC 2016 11B-308.2.1 Mitigated: <input type="radio"/> YES <input checked="" type="radio"/> NO	1	JOB	\$300	\$300
