SAN MATEO COUNTY
COMMUNITY
COLLEGE DISTRICT

San Mateo County Community College District Americans with Disabilities Act Self-Evaluation and Transition Plan

Report Prepared by:

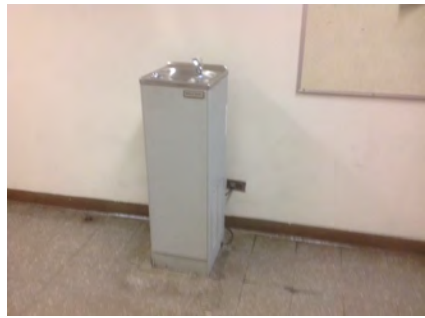
Item no., Rm no. and Name	Existing Architectural Barrier and Proposed Solution	Codes / Mitigation Info	Qty	Unit	Cost	Total
429	<ul style="list-style-type: none"> As-Built Description: Wall- and post-mounted cantilevered units: Knee space not provided at drinking fountain (27" high, 8" deep, 30" wide from front of drinking fountain). Proposed Solution: Provide new, accessible fountain. 	PCODE IA02 ADAAG 91 4.15.5(1) ADA 2010 602.2 CBC 2007 1115B.4.6.2 CBC 2016 11B-602.2 Mitigated: <input type="radio"/> YES <input checked="" type="radio"/> NO	1	JOB	\$9,600	\$9,600

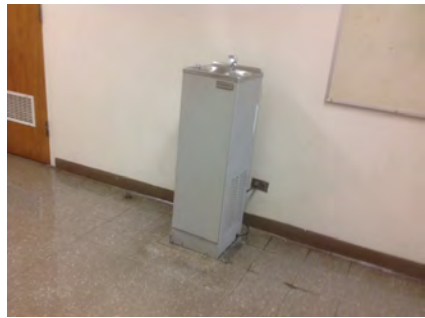
<div> <input type="checkbox"/> Staff Only </div> <div> Priority 3 Severity 2 </div>						
431	<ul style="list-style-type: none"> As-Built Description: Drinking fountain lacks protection for visually impaired persons. Proposed Solution: Provide cane-detectable rails. 	PCODE IA05C ADAAG 91 4.4.1 ADA 2010 307.2 CBC 2007 1115B.4.6.3 CBC 2016 11B-307.2 Mitigated: <input type="radio"/> YES <input checked="" type="radio"/> NO	1	JOB	\$1,500	\$1,500

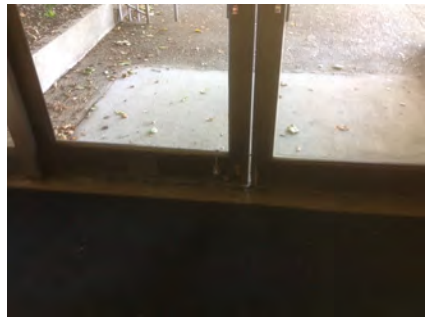
<div> <input type="checkbox"/> Staff Only </div> <div> Priority 3 Severity 3 </div>						
Door						
423	<ul style="list-style-type: none"> As-Built Description: At push side of door on accessible route, bottom 10" does not have a smooth, uninterrupted surface. As-Built: 7" AFF Proposed Solution: Provide 10" min. "kick plate" covering width of door when altering area. Notes: Power door opener provided. 	PCODE ID06 ADA 2010 404.2.10 CBC 2007 1133B.2.6 CBC 2016 11B-404.2.10 Mitigated: <input type="radio"/> YES <input checked="" type="radio"/> NO	1	JOB	\$300	\$300

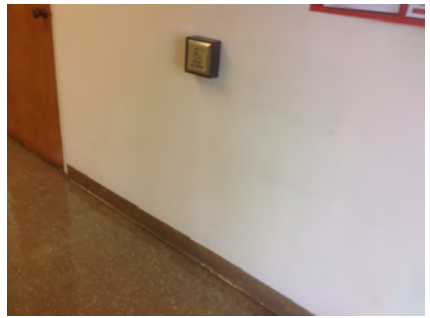
Item no., Rm no. and Name	Existing Architectural Barrier and Proposed Solution	Codes / Mitigation Info	Qty	Unit	Cost	Total
424	<ul style="list-style-type: none"> As-Built Description: Lower push plate located at 7" minimum and 8" maximum above the floor or ground surface not provided. Proposed Solution: Provide lower push plate. 	PCODE ID13B CBC 2007 1133B.2.3.2 CBC 2016 11B-404.2.9 2.C Mitigated: <input type="radio"/> YES <input checked="" type="radio"/> NO	2	JOB	\$1,500	\$3,000

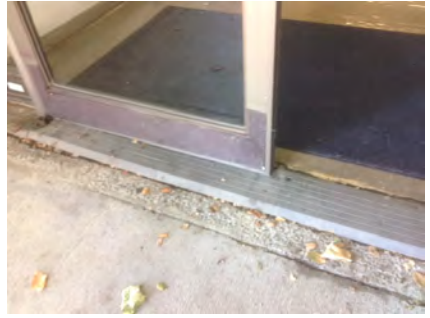
Door Threshold

425	<ul style="list-style-type: none"> As-Built Description: Door inaccessible due to threshold or step at door exceeding 1/2". As-Built: 1.25" AFF Proposed Solution: Modify threshold to be no more than 1/2" by removing existing paving at door and providing landing with edge ramping (slope 1:20 max). 	PCODE ID02A ADAAG 91 4.13.8 ADA 2010 404.2.5 CBC 2007 1133B.2.4.1 CBC 2016 11B-404.2.5 Mitigated: <input type="radio"/> YES <input checked="" type="radio"/> NO	1	JOB	\$1,200	\$1,200

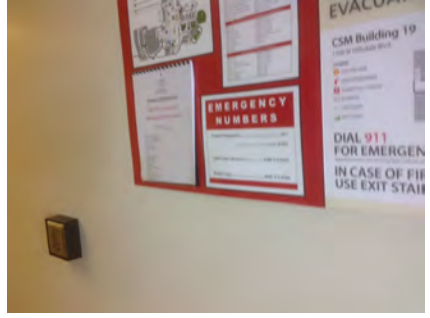
Reach Range

427	<ul style="list-style-type: none"> As-Built Description: Reach height to control or access point, exceeds 48" or is less than 15". As-Built: 50" AFF Proposed Solution: Modify equipment or mounting. 	PCODE IE01 ADAAG 91 4.2.5 ADA 2010 308.2.1 CBC 2007 1118B.5 CBC 2016 11B-308.2.1 Mitigated: <input type="radio"/> YES <input checked="" type="radio"/> NO	1	JOB	\$300	\$300

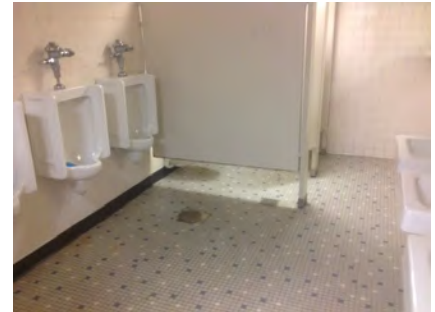
• *As-Built Description:*Multiple accommodation restroom not accessible;
multiple compliance violations.• *Proposed Solution:*Remodel area to provide accessible restroom with
one accessible stall, lavatory (and one urinal at
Mens).

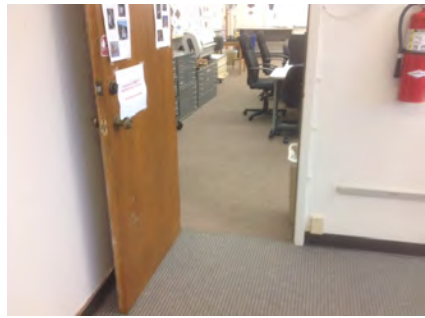
Item no., Rm no. and Name	Existing Architectural Barrier and Proposed Solution	Codes / Mitigation Info	Qty	Unit	Cost	Total
356	<ul style="list-style-type: none"> As-Built Description: Door on accessible route has less than 32" clear and 80" (78" min. to closer if provided) opening width when 90° open. As-Built: 28" wide Proposed Solution: Provide new, larger door and frame with new accessible hardware. Notes: Path of travel to adjacent classroom 	PCODE ID01 ADAAG 91 4.13.5 ADA 2010 404.2.3 CBC 2007 1133B.1.1.1.1 CBC 2016 11B-404.2.3 Mitigated: <input type="radio"/> YES <input checked="" type="radio"/> NO	1	JOB	\$7,800	\$7,800

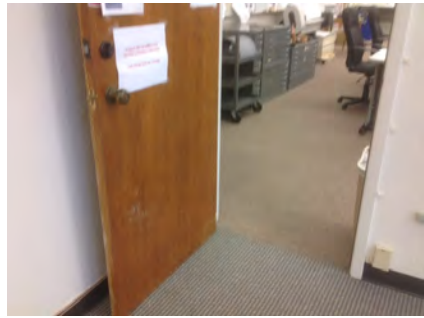
Door Hardware

357	<ul style="list-style-type: none"> As-Built Description: Door does not have accessible operating hardware. Proposed Solution: Provide lever handle or other accessible hardware. Notes: Path of travel to adjacent classroom 	PCODE ID07 ADAAG 91 4.13.9 ADA 2010 404.2.7 CBC 2007 1133B.2.5.2 CBC 2016 11B-404.2.7 Mitigated: <input type="radio"/> YES <input checked="" type="radio"/> NO	1	JOB	\$750	\$750

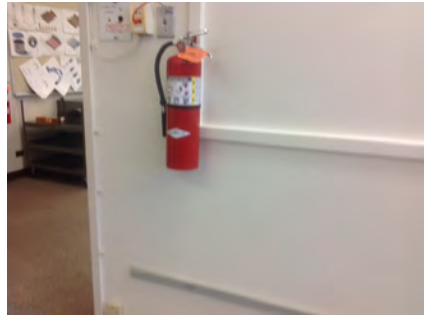
Reach Range

353	<ul style="list-style-type: none"> As-Built Description: Reach height to control or access point, exceeds 48" or is less than 15". As-Built: 57" AFF Proposed Solution: Modify equipment or mounting. 	PCODE IE01 ADAAG 91 4.2.5 ADA 2010 308.2.1 CBC 2007 1118B.5 CBC 2016 11B-308.2.1 Mitigated: <input type="radio"/> YES <input checked="" type="radio"/> NO	1	JOB	\$300	\$300

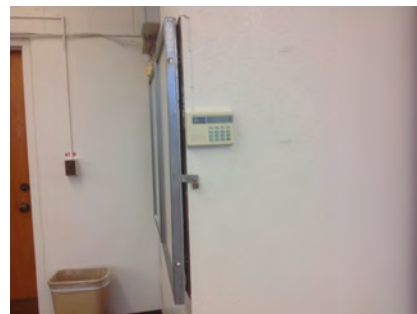
Item no., Rm no. and Name	Existing Architectural Barrier and Proposed Solution	Codes / Mitigation Info	Qty	Unit	Cost	Total
359	<ul style="list-style-type: none"> As-Built Description: Reach height to control or access point, exceeds 48" or is less than 15". As-Built: 56" AFF to alarm Proposed Solution: Modify equipment or mounting. 	PCODE IE01 ADAAG 91 4.2.5 ADA 2010 308.2.1 CBC 2007 1118B.5 CBC 2016 11B-308.2.1	1	JOB	\$300	\$300
<div>Mitigated:</div> <div> <input type="radio"/> YES <input checked="" type="radio"/> NO </div> <div> <input type="checkbox"/> Staff Only </div> <div> Priority 2 Severity 3 </div>

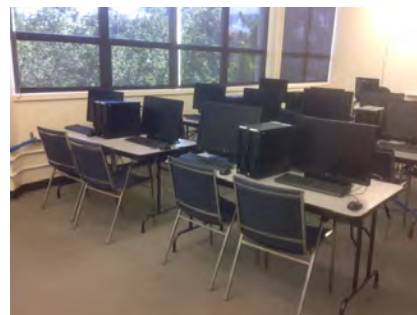
**Non-Fixed Desk**

354	<ul style="list-style-type: none"> As-Built Description: Accessible non-fixed table or desk (top 28" to 34" high; knee space at least 27" high x 19" deep x 30" wide) not provided. As-Built: 25" knee Proposed Solution: Provide table or desk with accessible dimensions when purchasing new furniture. Notes: 20 seats, no accessible seat provided 	PCODE IN02A ADAAG 91 4.32.3 & .4 ADA 2010 306.1 CBC 2007 1122B.3 & 4 CBC 2016 11B-306.1 & 11B-902.3	1	JOB	\$4,800	\$4,800
<div>Mitigated:</div> <div> <input type="radio"/> YES <input checked="" type="radio"/> NO </div> <div> <input type="checkbox"/> Staff Only </div> <div> Priority 2 Severity 2 </div>

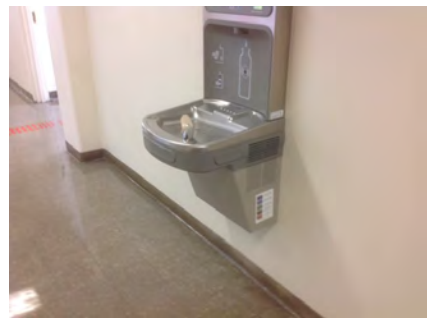
Item no., Rm no. and Name	Existing Architectural Barrier and Proposed Solution	Codes / Mitigation Info	Qty	Unit	Cost	Total
381	<ul style="list-style-type: none">• <i>As-Built Description:</i> Drinking fountain lacks protection for visually impaired persons.• <i>Proposed Solution:</i> Provide cane-detectable rails.	<p>PCODE IA05C</p> <p>ADAAG 91 4.4.1</p> <p>ADA 2010 307.2</p> <p>CBC 2007 1115B.4.6.3</p> <p>CBC 2016 11B-307.2</p> <p>Mitigated:</p> <p><input type="radio"/> YES</p> <p><input checked="" type="radio"/> NO</p>	1	JOB	\$1,500	\$1,500

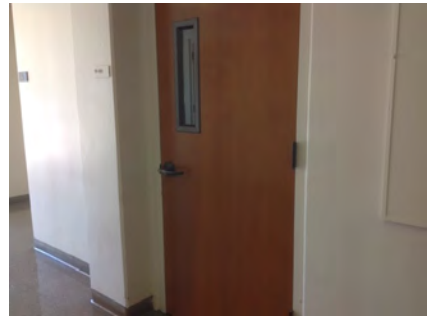
<input type="checkbox"/> Staff Only			
			Priority		Severity	
			3		3	
<hr/>						
Door						
377	<ul style="list-style-type: none">• <i>As-Built Description:</i> Vision Light at door that permits viewing, does not have bottom of at least one glazed panel located 43 inches maximum above the finish floor. (Exception: More than 66" above finished floor.)• <i>As-Built:</i> 48" AFF• <i>Proposed Solution:</i> Provide new door with vision panel at 43" max.	<p>PCODE ID06C</p> <p>ADA 2010 404.2.11</p> <p>CBC 2016 11B-404.2.11</p> <p>Mitigated:</p> <p><input type="radio"/> YES</p> <p><input checked="" type="radio"/> NO</p>	8	JOB	\$7,500	\$60,000

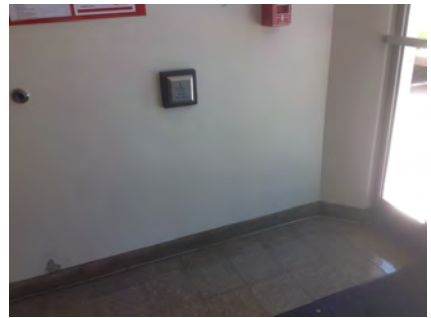
<input type="checkbox"/> Staff Only			
			Priority		Severity	
			2		4	
<hr/>						
382	<ul style="list-style-type: none">• <i>As-Built Description:</i> Lower push plate located at 7" minimum and 8" maximum above the floor or ground surface not provided.• <i>Proposed Solution:</i> Provide lower push plate.	<p>PCODE ID13B</p> <p>CBC 2007 1133B.2.3.2</p> <p>CBC 2016 11B-404.2.9 2.C</p> <p>Mitigated:</p> <p><input type="radio"/> YES</p> <p><input checked="" type="radio"/> NO</p>	2	JOB	\$1,500	\$3,000

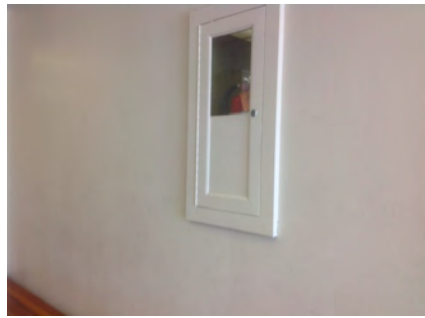
Item no., Rm no. and Name	Existing Architectural Barrier and Proposed Solution	Codes / Mitigation Info	Qty	Unit	Cost	Total
379	<ul style="list-style-type: none"> As-Built Description: Reach height to control or access point, exceeds 48" or is less than 15". As-Built: 55" AFF Proposed Solution: Modify equipment or mounting. 	PCODE IE01 ADAAG 91 4.2.5 ADA 2010 308.2.1 CBC 2007 1118B.5 CBC 2016 11B-308.2.1	2	JOB	\$300	\$600
<div>

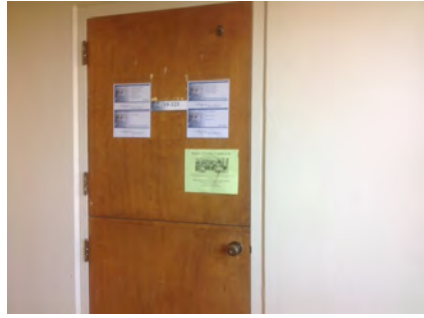
Signage

376	<ul style="list-style-type: none"> As-Built Description: Sign designating a permanent room or space does not include Grade 2 Braille. Proposed Solution: Provide new compliant signage including California Grade 2 Braille (1/10" on center dots with 2/10" space between cells). 	PCODE SA07A ADAAG 91 4.30.4 ADA 2010 703.2 CBC 2007 1117B.5.6 CBC 2016 11B-703.3	6	JOB	\$270	\$1,620
<div>

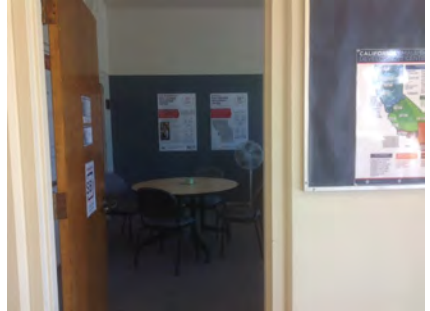
Item no., Rm no. and Name	Existing Architectural Barrier and Proposed Solution	Codes / Mitigation Info	Qty	Unit	Cost	Total
Signage						
397	<ul style="list-style-type: none"> • <i>As-Built Description:</i> Sign designating a permanent room or space does not include Grade 2 Braille. • <i>Proposed Solution:</i> Provide new compliant signage including California Grade 2 Braille (1/10" on center dots with 2/10" space between cells). 	PCODE SA07A ADAAG 91 4.30.4 ADA 2010 703.2 CBC 2007 1117B.5.6 CBC 2016 11B-703.3	1	JOB	\$270	\$270
Mitigated: <input type="radio"/> YES <input checked="" type="radio"/> NO

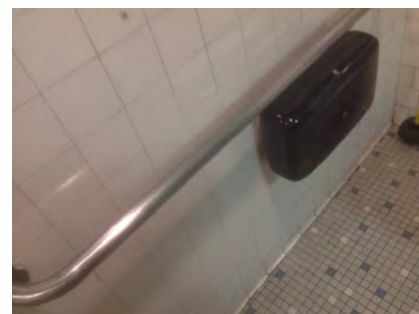
Item no., Rm no. and Name	Existing Architectural Barrier and Proposed Solution	Codes / Mitigation Info	Qty	Unit	Cost	Total
409	<ul style="list-style-type: none"> As-Built Description: Grab bar clearance not 1-1/2" from wall. As-Built: 2.5" between grab bar and wall Proposed Solution: Provide accessible grab bars. 	PCODE WB07E ADAAG 91 4.26.2 ADA 2010 609.3 CBC 2007 1115B.7.1 CBC 2016 11B-609.3	1	JOB	\$1,500	\$1,500

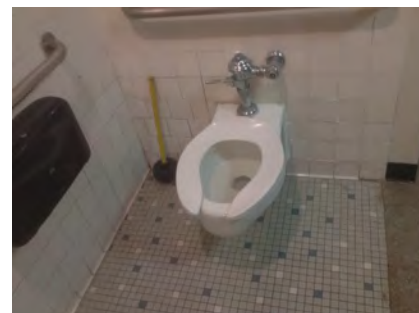
406	<ul style="list-style-type: none"> As-Built Description: Water closet not 16"-18" (CA: 17"-18") from near side wall to center line of water closet (2010 ADAAG: 16"-18"). As-Built: 22" o.c. Proposed Solution: Relocate existing water closet and plumbing, remount with offset closet flange to provide 18" max. from side wall. 	PCODE WB02C ADAAG 91 Fig. 28 ADA 2010 604.2 CBC 2007 1115B.4.1.1 CBC 2016 11B-604.2	1	JOB	\$1,500	\$1,500
-----	--	---	---	-----	---------	---------

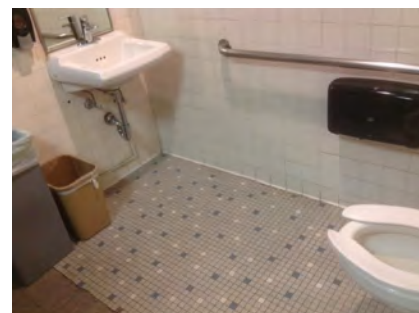
404	<ul style="list-style-type: none"> As-Built Description: CA only: In single-accommodation restroom less than 48" in front of water closet provided. As-Built: 46" to lavatory Proposed Solution: Remodel restroom to provide at least 48" in front of water closet. 	PCODE WB03A CBC 2007 1115B.3.2.1 CBC 2016 11B-604.3.1	1	JOB	\$15,000	\$15,000
-----	---	---	---	-----	----------	----------

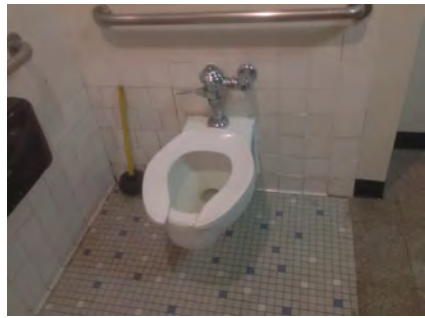
Item no., Rm no. and Name	Existing Architectural Barrier and Proposed Solution	Codes / Mitigation Info	Qty	Unit	Cost	Total
407	<ul style="list-style-type: none"> As-Built Description: Flush Control: Operating handle not mounted toward wide side of stall. Proposed Solution: Replace flush control with properly mounted accessible type, or install sensor flush. 	PCODE WB10 ADAAG 91 4.16.5 ADA 2010 604.6 CBC 2007 1115B.4.1.5 CBC 2016 11B-604.6	1	JOB	\$1,500	\$1,500

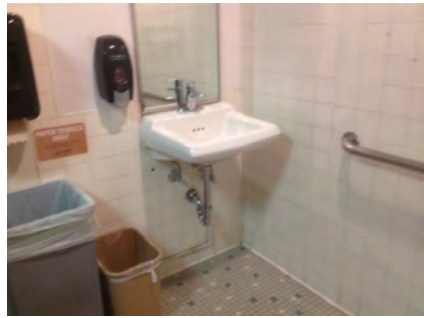
402	<ul style="list-style-type: none"> As-Built Description: Clear floor space, 30" x 48" in front of fixture, extending 19" max. under the lavatory, not provided (CA only: Less than 18" from side wall to centerline of lavatory). As-Built: 15" o.c. Proposed Solution: Relocate existing lavatory. 	PCODE WD01A ADAAG 91 4.19.3 ADA 2010 606.2 CBC 2007 1115B.4.3 CBC 2016 11B-606.2, 11B-606.6	1	JOB	\$2,700	\$2,700

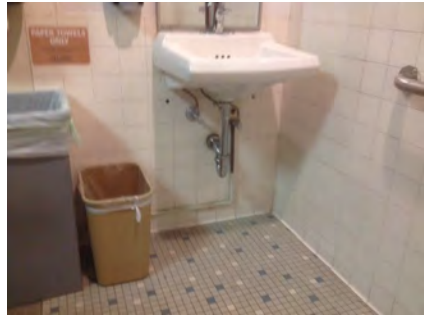
403	<ul style="list-style-type: none"> As-Built Description: Hot or sharp-surfaced water/drain pipe not insulated or covered. Proposed Solution: Insulate or cover water/drain pipe. 	PCODE WD05 ADAAG 91 4.19.4 ADA 2010 606.5 CBC 2007 1115B.4.3.4 CBC 2016 11B-606.5	1	JOB	\$360	\$360

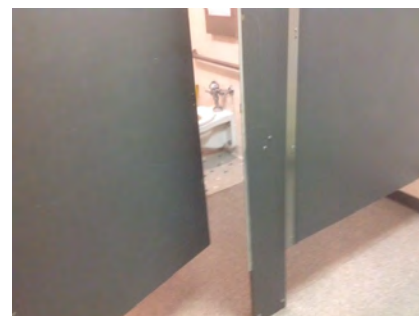
Stall partition obstructs restroom clearances. We recommend removing completely.

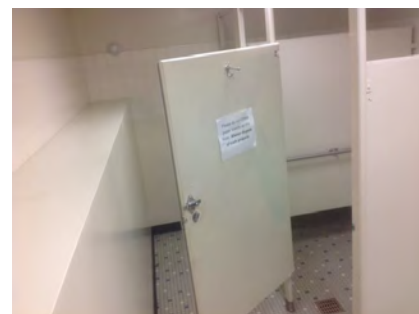
Multiple accommodation restroom not accessible; multiple compliance violations.

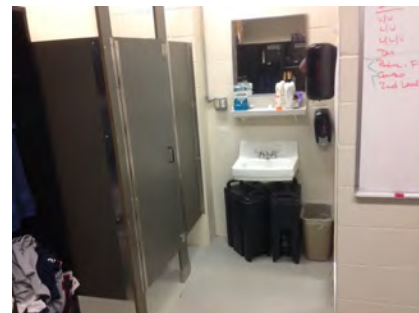
Multiple accommodation restroom not accessible;
multiple compliance violations.

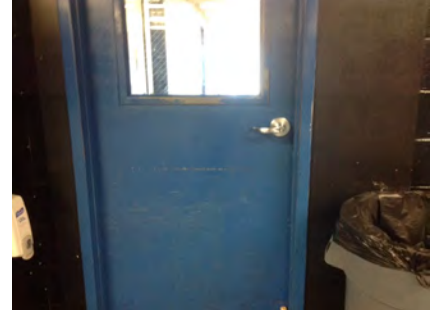
327

☐ **Staff Only****Priority****3****Severity****4****Door Stopper**

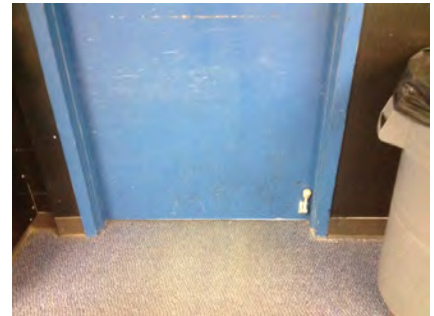
333

☐ **Staff Only****Priority****3****Severity****3****Reach Range**

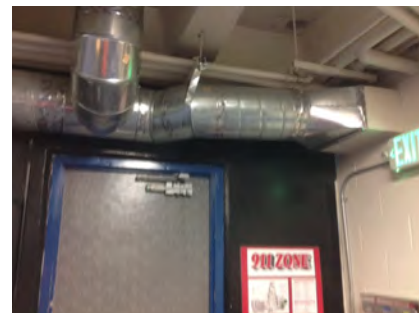
330

Multiple accommodation restroom not accessible; multiple compliance violations.

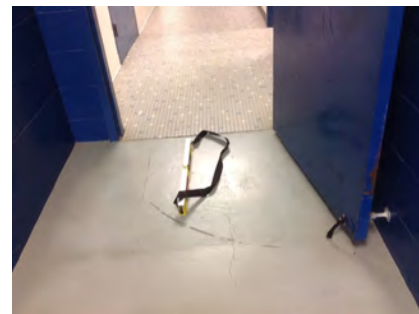
345

**Mitigated:**☐ **YES**☒ **NO**☐ **Staff Only****Priority****2****Severity****3****Door Stopper**

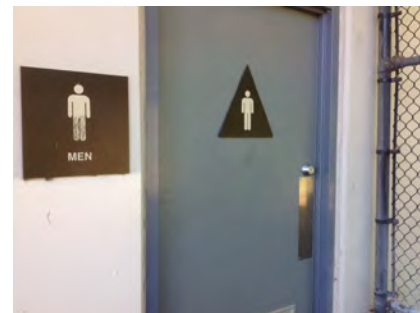
363

Multiple accommodation restroom not accessible; multiple compliance violations.

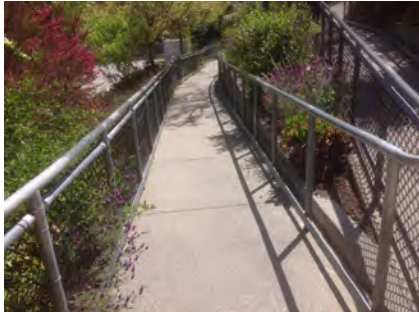
Item no., Rm no. and Name	Existing Architectural Barrier and Proposed Solution	Codes / Mitigation Info	Qty	Unit	Cost	Total
Slope						
109	<ul style="list-style-type: none"> As-Built Description: Slope greater than 1:12 (8.3%). As-Built: 8.4 - 9.3% Proposed Solution: Demolish existing and provide new ramp with handrails. Notes: Third ramp run 	PCODE EB02 ADAAG 91 4.8.2 ADA 2010 405.2 CBC 2007 1133B.5.3 CBC 2016 11B-405.2	240	SF	\$300	\$72,000
Mitigated: <input type="radio"/> YES <input checked="" type="radio"/> NO

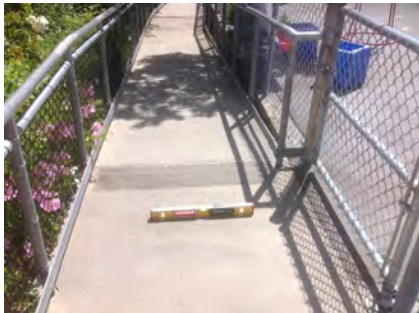
<input type="checkbox"/> Staff Only Priority 1 Severity 4			
104	<ul style="list-style-type: none"> As-Built Description: Level 2% max. landing for ramp not provided. As-Built: 3.0% Proposed Solution: Rebuild ramp to provide landings for each ramp run with slopes no greater than 2% Notes: Top landing 	PCODE EB05A ADAAG 91 4.8.4 ADA 2010 405.7.1 CBC 2007 1133B.5.4.1 CBC 2016 11B-405.7.1	36	SF	\$300	\$10,800

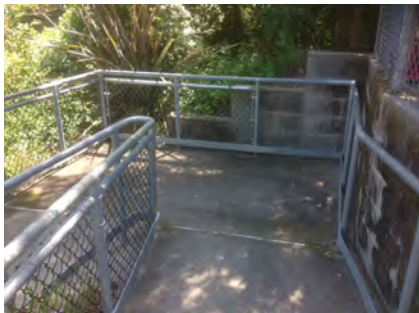
<input type="checkbox"/> Staff Only Priority 1 Severity 4			
107	<ul style="list-style-type: none"> As-Built Description: Level 2% max. landing for ramp not provided. As-Built: Intermediate landing 3.2% Proposed Solution: Rebuild ramp to provide landings for each ramp run with slopes no greater than 2% Notes: 68" deep 	PCODE EB05A ADAAG 91 4.8.4 ADA 2010 405.7.1 CBC 2007 1133B.5.4.1 CBC 2016 11B-405.7.1	36	SF	\$300	\$10,800
Mitigated: <input type="radio"/> YES <input checked="" type="radio"/> NO

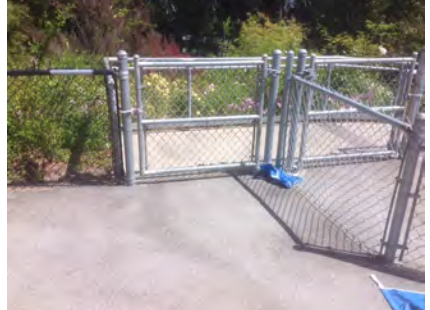
Item no., Rm no. and Name	Existing Architectural Barrier and Proposed Solution	Codes / Mitigation Info	Qty	Unit	Cost	Total
Door						
118	<ul style="list-style-type: none"> As-Built Description: At push side of door on accessible route, bottom 10" does not have a smooth, uninterrupted surface. Proposed Solution: Provide 10" min. "kick plate" covering width of door when altering area. 	PCODE ID06 ADA 2010 404.2.10 CBC 2007 1133B.2.6 CBC 2016 11B-404.2.10 Mitigated: <input type="radio"/> YES <input checked="" type="radio"/> NO	1	JOB	\$300	\$300

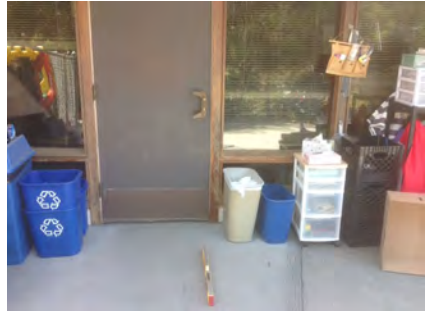
<input type="checkbox"/> Staff Only Priority 1 Severity 3			
99	<ul style="list-style-type: none"> As-Built Description: Surface of required maneuvering clearance at door slopes more than 1/4":12" (2.0%). As-Built: 5% Proposed Solution: Modify surface slope at door. 	PCODE ID11 ADAAG 91 4.13.6 ADA 2010 404.2.4.4 CBC 2007 1133B.2.4 CBC 2016 11B-404.2.4 Mitigated: <input type="radio"/> YES <input checked="" type="radio"/> NO	25	SF	\$120	\$3,000

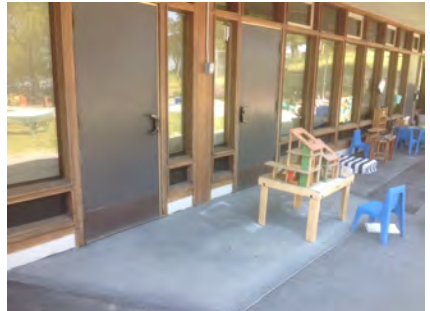
<input type="checkbox"/> Staff Only Priority 1 Severity 3			
101	<ul style="list-style-type: none"> As-Built Description: Surface of required maneuvering clearance at door slopes more than 1/4":12" (2.0%). As-Built: 4.6% Proposed Solution: Modify surface slope at door. Notes: 2 doors 	PCODE ID11 ADAAG 91 4.13.6 ADA 2010 404.2.4.4 CBC 2007 1133B.2.4 CBC 2016 11B-404.2.4 Mitigated: <input type="radio"/> YES <input checked="" type="radio"/> NO	50	SF	\$120	\$6,000

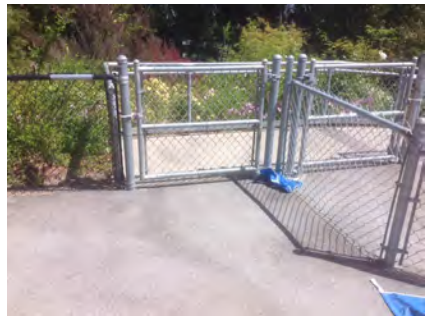
Item no., Rm no. and Name	Existing Architectural Barrier and Proposed Solution	Codes / Mitigation Info	Qty	Unit	Cost	Total
102	<ul style="list-style-type: none"> As-Built Description: Surface of required maneuvering clearance at door slopes more than 1/4":12" (2.0%). As-Built: 6% Proposed Solution: Modify surface slope at door. 	PCODE ID11 ADAAG 91 4.13.6 ADA 2010 404.2.4.4 CBC 2007 1133B.2.4 CBC 2016 11B-404.2.4 Mitigated: <input type="radio"/> YES <input checked="" type="radio"/> NO	25	SF	\$120	\$3,000

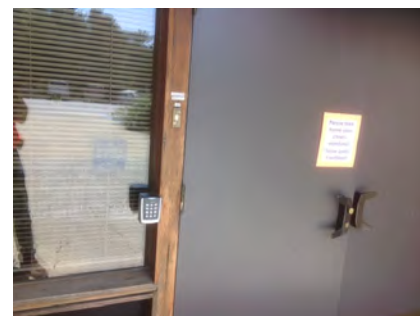
- 68
- *As-Built Description:*
Reach height to control or access point, exceeds 48" or is less than 15".
 - *As-Built:* **57" to doorbell**
 - *Proposed Solution:*
Modify equipment or mounting.

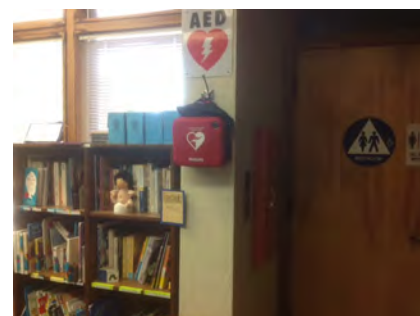
- 116
- *As-Built Description:*
Reach height to control or access point, exceeds 48" or is less than 15".
 - *As-Built:* **55"**
 - *Proposed Solution:*
Modify equipment or mounting.

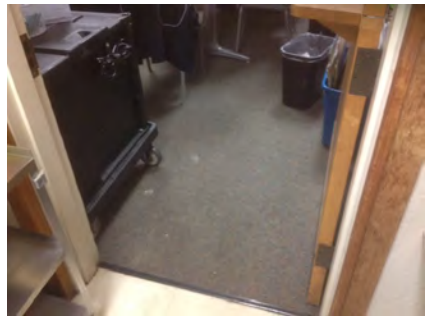
Item no., Rm no. and Name	Existing Architectural Barrier and Proposed Solution	Codes / Mitigation Info	Qty	Unit	Cost	Total
83	<ul style="list-style-type: none"> As-Built Description: Front approach: At pull side, door does not have clear and level maneuvering space measuring door width plus 18" x 60". (24" x 60" at exterior doors). As-Built: 5" Proposed Solution: Remove or relocate furniture or storage items. 	PCODE ID23A ADAAG 91 Fig. 25(a) ADA 2010 404.2.4 CBC 2007 11B-26A(a) CBC 2016 11B-404.2.4 Mitigated: <input type="radio"/> YES <input checked="" type="radio"/> NO	1	JOB	\$150	\$150

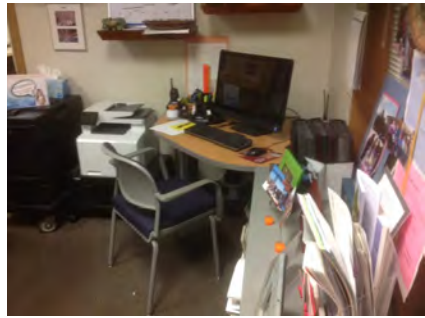
Non-Fixed Desk

82	<ul style="list-style-type: none"> As-Built Description: Accessible non-fixed table or desk (top 28" to 34" high; knee space at least 27" high x 19" deep x 30" wide) not provided. As-Built: 25" wide Proposed Solution: Provide table or desk with accessible dimensions when purchasing new furniture. 	PCODE IN02A ADAAG 91 4.32.3 & .4 ADA 2010 306.1 CBC 2007 1122B.3 & 4 CBC 2016 11B-306.1 & 11B-902.3 Mitigated: <input type="radio"/> YES <input checked="" type="radio"/> NO	1	JOB	\$4,800	\$4,800

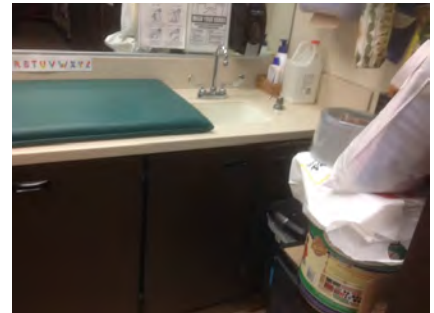
- 94
- *As-Built Description:*
Sink rim higher than 34" above floor.
 - *As-Built:* **36.5" high and no knee clearance**
 - *Proposed Solution:*
Remodel sink cabinet to lower sink.

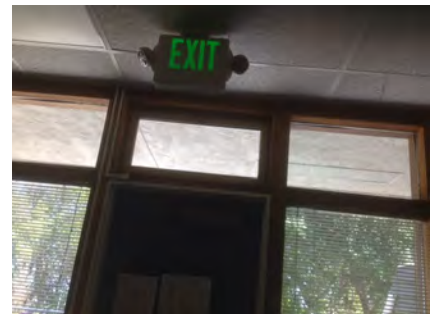
- 97
- *As-Built Description:*
At final exit door to exterior: Where required exit signs are installed, signs to provide exiting information for people with vision impairment are not provided.
 - *Proposed Solution:*
Provide raised letter/Braille "EXIT" sign at door.

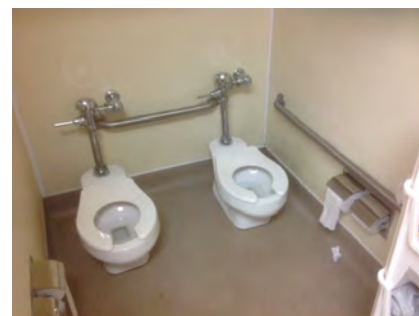
- 96
- *As-Built Description:*
Refer to notes for observation and recommendation.
 - *Proposed Solution:*
 - **Notes:**
It is unclear what age group the accessible toilet supports. There are several compliance issues present. Child accessible toilet compartments are suggested but not required per CBC.

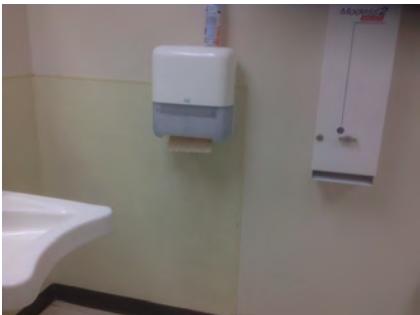
218	<div><div>As-Built Description:</div><div>Dispensers in sanitary facilities, such as for towels, soap, sanitary napkins, seat covers, etc., and waste receptacles more than 48" (CA only: 40") from floor to highest operating slot or control.</div><div><div>As-Built: 41" AFF</div><div>Proposed Solution:</div><div>Relocate existing restroom accessories.</div></div></div>	<div><div>PCODE WG01A</div><div>ADAAG 91 4.23.7</div><div>ADA 2010 308.2.1</div><div>CBC 2007 1115B.8.3</div><div>CBC 2016 11B-603.5</div></div> <div><div>Mitigated:</div><div><div><div></div>YES</div><div><div></div>NO</div></div></div>	<div><div>1</div><div>JOB</div><div>\$300</div><div>\$300</div></div> <div>

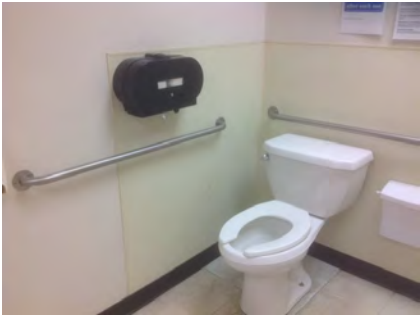
</div> <div><div><div></div>Staff Only</div><div><div>Priority3</div><div>Severity4</div></div></div>
222	<div><div>As-Built Description:</div><div>Toilet paper dispenser less than 15" (CA: 19") or more than 48" above floor or not within 7" to 9" from front of water closet (Note: CA pre-2010 is allowed within 12" from front of water closet).</div><div><div>Proposed Solution:</div><div>Relocate or provide new toilet paper dispenser.</div><div>Notes:</div><div>Toilet paper located above grab bar.</div></div></div>	<div><div>PCODE WG02</div><div>ADAAG 91 4.16.6</div><div>ADA 2010 604.7</div><div>CBC 2007 1115B.8.4</div><div>CBC 2016 11B-604.7</div></div> <div><div>Mitigated:</div><div><div><div></div>YES</div><div><div></div>NO</div></div></div>	<div><div>1</div><div>JOB</div><div>\$225</div><div>\$225</div></div> <div>

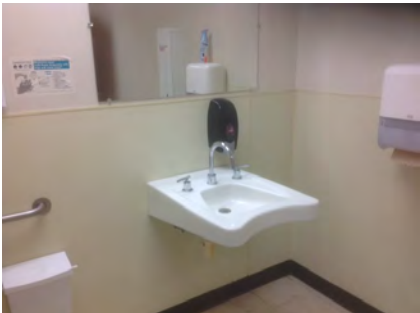
217	<div><div>As-Built Description:</div><div>Bottom of mirror located above lavatories or countertops more than 40" above floor.</div><div><div>As-Built: 47" AFF</div><div>Proposed Solution:</div><div>Relocate or provide new accessible mirror.</div></div></div>	<div><div>PCODE WG03</div><div>ADAAG 91 4.19.6</div><div>ADA 2010 603.3</div><div>CBC 2007 1115B.8.1</div><div>CBC 2016 11B-603.3</div></div> <div><div>Mitigated:</div><div><div><div></div>YES</div><div><div></div>NO</div></div></div>	<div><div>1</div><div>JOB</div><div>\$450</div><div>\$450</div></div> <div>

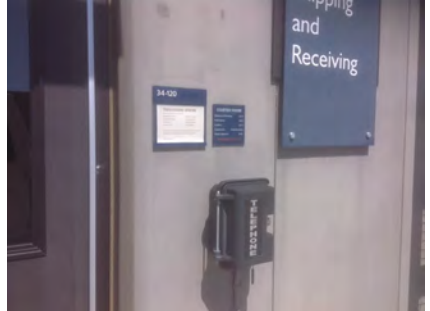
Item no., Rm no. and Name	Existing Architectural Barrier and Proposed Solution	Codes / Mitigation Info	Qty	Unit	Cost	Total
Signage						
227	<ul style="list-style-type: none"> • <i>As-Built Description:</i> Signs containing tactile characters is not located so that a clear floor space of 18" min x 18" min., centered on the tactile characters, is provided beyond the arc of any door swing between the closed position and 45 degree open position. • <i>As-Built:</i> 62" AFF • <i>Proposed Solution:</i> Relocate compliant signage on latch side of door located at compliant height with a clear floor space. 	PCODE SA07B ADA 2010 703.4.2 CBC 2016 11B-703.4.2 Mitigated: <input type="radio"/> YES <input checked="" type="radio"/> NO	1	JOB	\$150	\$150

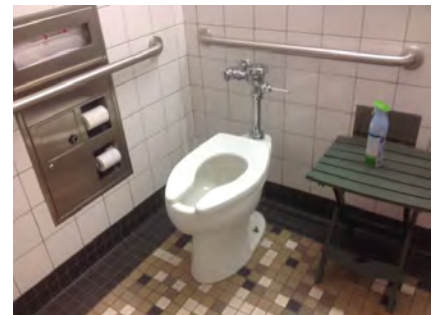
- 17 • *As-Built Description:*
Water closet not 16"-18" (CA: 17"-18") from near side wall to center line of water closet (2010 ADAAG: 16"-18").

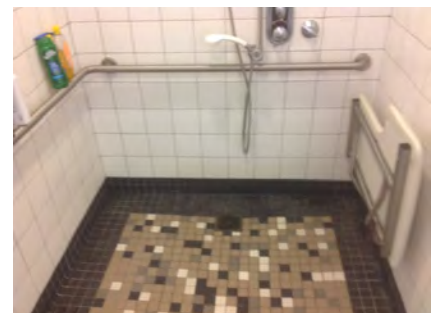
- 22 • *As-Built Description:*
Floor surface sloped greater than 2.0% (1:48) due to drain.

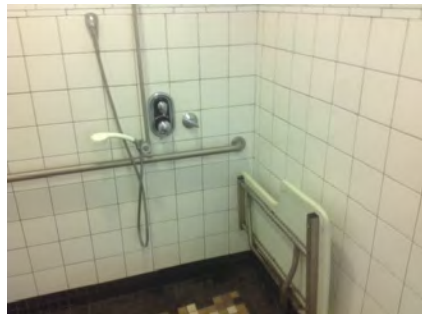
Item no., Rm no. and Name	Existing Architectural Barrier and Proposed Solution	Codes / Mitigation Info	Qty	Unit	Cost	Total
20	<ul style="list-style-type: none"> As-Built Description: Controls not located at 40" max. height or not within a range of no less than 19" and no more than 27" from the seat wall. As-Built: Diverter 14" o.c. from seat wall Proposed Solution: Provide new, or relocate, shower controls. 	PCODE WF12 ADAAG 91 4.27.3 ADA 2010 608.5 CBC 2007 1115B.4.4.4.1 CBC 2016 11B-608.5 Mitigated: <input type="radio"/> YES <input checked="" type="radio"/> NO	1	JOB	\$2,400	\$2,400

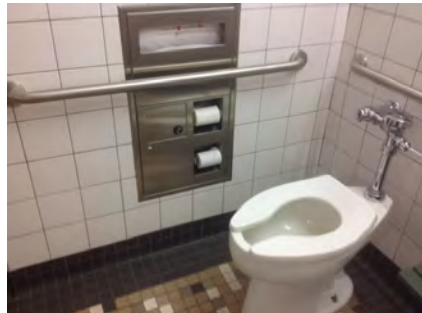
19	<ul style="list-style-type: none"> As-Built Description: Toilet paper dispenser less than 15" (CA: 19") or more than 48" above floor or not within 7" to 9" from front of water closet (Note: CA pre-2010 is allowed within 12" from front of water closet). As-Built: Behind front of toilet Proposed Solution: Relocate or provide new toilet paper dispenser. 	PCODE WG02 ADAAG 91 4.16.6 ADA 2010 604.7 CBC 2007 1115B.8.4 CBC 2016 11B-604.7 Mitigated: <input type="radio"/> YES <input checked="" type="radio"/> NO	1	JOB	\$225	\$225

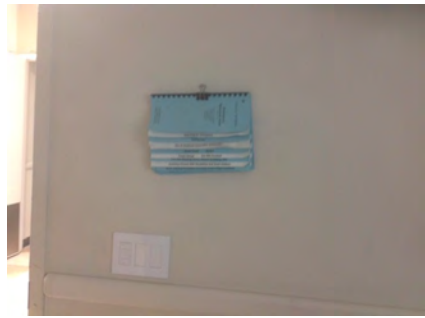
Item no., Rm no. and Name	Existing Architectural Barrier and Proposed Solution	Codes / Mitigation Info	Qty	Unit	Cost	Total
30	<ul style="list-style-type: none">As-Built Description: Reach height to control or access point, exceeds 48" or is less than 15".As-Built: 62" AFFProposed Solution: Modify equipment or mounting.	PCODE IE01 ADAAG 91 4.2.5 ADA 2010 308.2.1 CBC 2007 1118B.5 CBC 2016 11B-308.2.1 Mitigated: <input type="radio"/> YES <input checked="" type="radio"/> NO	1	JOB	\$300	\$300

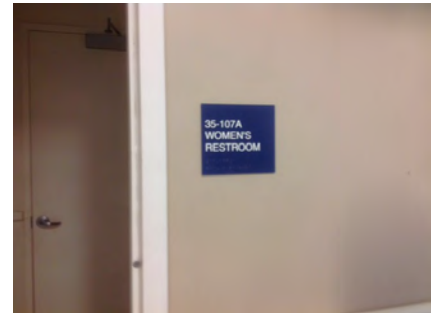
- 31
- *As-Built Description:*
Signs containing tactile characters is not located so that a clear floor space of 18" min x 18" min., centered on the tactile characters, is provided beyond the arc of any door swing between the closed position and 45 degree open position.
 - *As-Built:* **62" to bottom of highest tactile**
 - *Proposed Solution:*
Relocate compliant signage on latch side of door located at compliant height with a clear floor space.

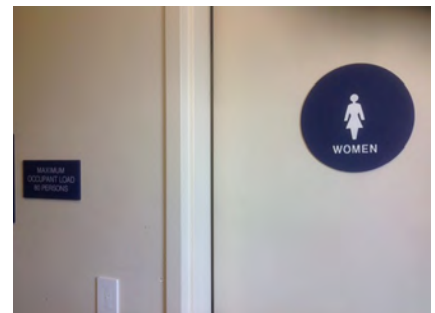
- 38
- *As-Built Description:*
Entrance to toilet or bathing facility not identified with ADAAG compliant signage.
 - *Proposed Solution:*
Provide ADA compliant sign mounted at 48" min. above to baseline of the lowest Braille cells and 60" max. to baseline of the highest line of raised characters on nearest adjacent wall, on latch side of a single door (located not to cause a Braille reader to stand within the door swing).

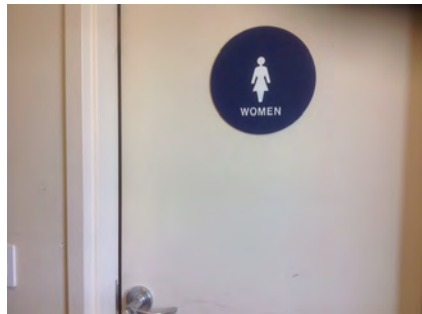
Item no., Rm no. and Name	Existing Architectural Barrier and Proposed Solution	Codes / Mitigation Info	Qty	Unit	Cost	Total
39	<ul style="list-style-type: none"> As-Built Description: Required in CA only: identification symbol centered 58" to 60" high on sanitary facility door that contrasts with the door not provided (women: 12" ø circle, men: 12" triangle, unisex: combined symbol). As-Built: 64" o.c. Proposed Solution: Provide properly mounted sanitary facility symbol when altering area. If wheelchair accessible, include International Symbol of Accessibility on sign. Notes: Door from classroom 	PCODE SA15 CBC 2007 1115B.6 CBC 2016 11B-703.7.2.6 Mitigated: <input type="radio"/> YES <input checked="" type="radio"/> NO	1	JOB	\$270	\$270

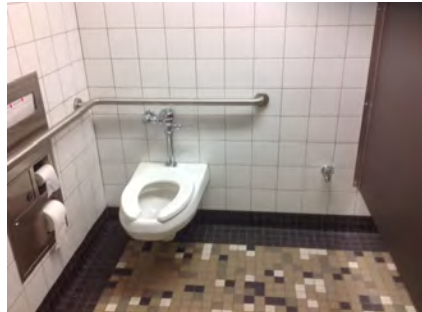
34	<ul style="list-style-type: none"> As-Built Description: The rear wall grab is less than 36" min. or does not extend from the centerline of the water closet 12" min. on one side and 24" min. on the other side. As-Built: 20" offset Proposed Solution: Provide or relocate accessible rear grab bar. 	PCODE WB07B ADAAG 91 4.17.6 ADA 2010 604.5.2 CBC 2007 1115B.4.1.3.2 CBC 2016 11B-604.5.2 Mitigated: <input type="radio"/> YES <input checked="" type="radio"/> NO	1	JOB	\$1,020	\$1,020

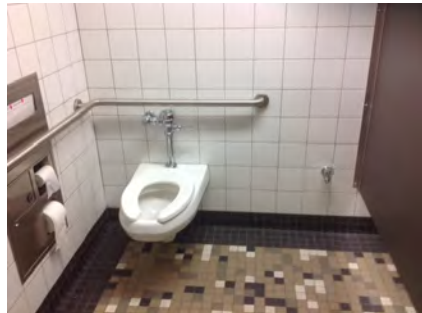
<input type="checkbox"/> Staff Only Priority 3 Severity 3						
468	<ul style="list-style-type: none"> As-Built Description: Accessories/dispensers in accessible stall located closer than 1-1/2" below or 12" above grab bar impedes its use. As-Built: 1" to flush valve Proposed Solution: Relocate accessories/dispensers to be no closer than 1-1/2" below and 12" above grab bars (except if accessories are recessed, flush with wall, and have no sharp edges). 	PCODE WB07I ADAAG 91 4.26.2 ADA 2010 609.3 CBC 2007 1133B.4.2.5 CBC 2016 11B-609.3 Mitigated: <input type="radio"/> YES <input checked="" type="radio"/> NO	1	JOB	\$225	\$225

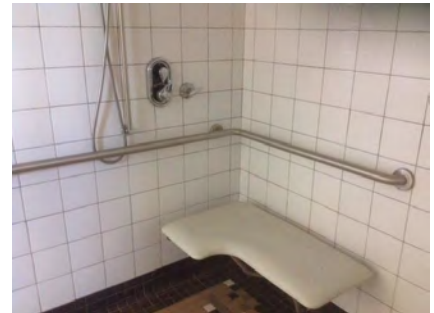
- 469
- *As-Built Description:*
In a standard roll-in type shower, grab bars are not provided on the back wall and side wall opposite the seat. Grab bars shall not be provided above the seat.

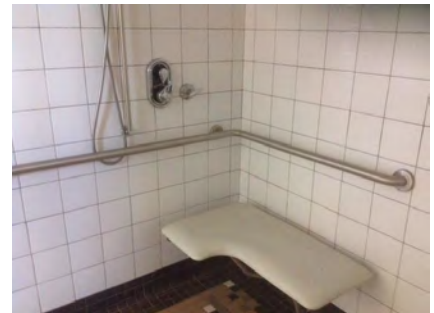
- 37
- *As-Built Description:*
Controls not located at 40" max. height or not within a range of no less than 19" and no more than 27" from the seat wall.

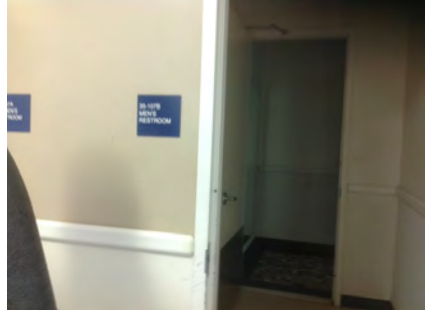
Item no., Rm no. and Name	Existing Architectural Barrier and Proposed Solution	Codes / Mitigation Info	Qty	Unit	Cost	Total
Signage						
41	<ul style="list-style-type: none"> As-Built Description: Signs containing tactile characters is not located so that a clear floor space of 18" min x 18" min., centered on the tactile characters, is provided beyond the arc of any door swing between the closed position and 45 degree open position. As-Built: 62" to bottom of highest tactile Proposed Solution: Relocate compliant signage on latch side of door located at compliant height with a clear floor space. 	PCODE SA07B ADA 2010 703.4.2 CBC 2016 11B-703.4.2 Mitigated: <input type="radio"/> YES <input checked="" type="radio"/> NO	1	JOB	\$150	\$150

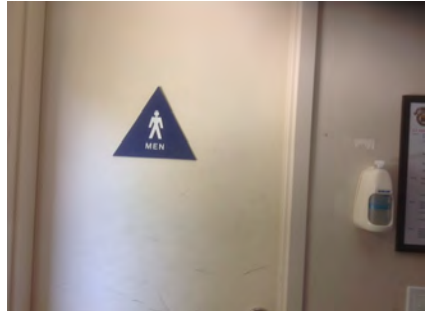
<input type="checkbox"/> Staff Only Priority 3 Severity 4			
49	<ul style="list-style-type: none"> As-Built Description: Entrance to toilet or bathing facility not identified with ADAAG compliant signage. Proposed Solution: Provide ADA compliant sign mounted at 48" min. above to baseline of the lowest Braille cells and 60" max. to baseline of the highest line of raised characters on nearest adjacent wall, on latch side of a single door (located not to cause a Braille reader to stand within the door swing). Notes: From class room 	PCODE SA11A ADAAG 91 4.1.3(16)(a) ADA 2010 216.8 CBC 2016 11B-216.8 Mitigated: <input type="radio"/> YES <input checked="" type="radio"/> NO	1	JOB	\$270	\$270

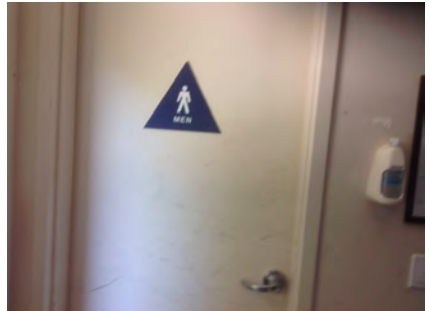
<input type="checkbox"/> Staff Only Priority 3 Severity 3			
50	<ul style="list-style-type: none"> As-Built Description: Required in CA only: identification symbol centered 58" to 60" high on sanitary facility door that contrasts with the door not provided (women: 12" ø circle, men: 12" triangle, unisex: combined symbol). As-Built: 65" Proposed Solution: Provide properly mounted sanitary facility symbol when altering area. If wheelchair accessible, include International Symbol of Accessibility on sign. 	PCODE SA15 CBC 2007 1115B.6 CBC 2016 11B-703.7.2.6 Mitigated: <input type="radio"/> YES <input checked="" type="radio"/> NO	1	JOB	\$270	\$270

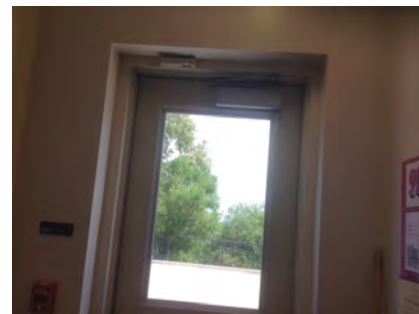
- 51 • *As-Built Description:*
Excessive force required to open door.

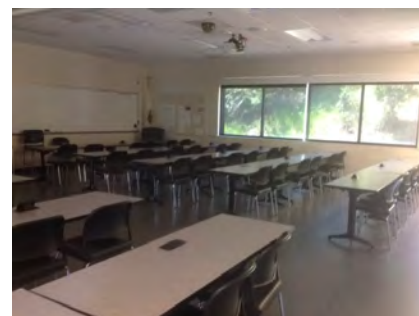
- 58
- *As-Built Description:*
Accessible non-fixed table or desk (top 28" to 34" high; knee space at least 27" high x 19" deep x 30" wide) not provided.
 - *As-Built:* **16" deep at 26" high**
 - *Proposed Solution:*
Provide table or desk with accessible dimensions when purchasing new furniture.
 - **Notes:**
56 seats

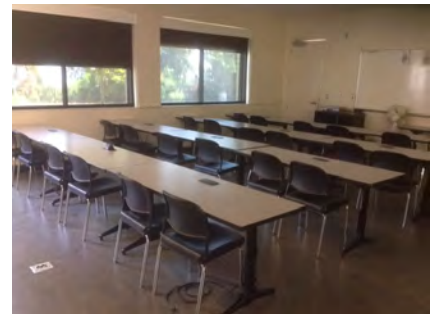
- 57
- *As-Built Description:*
Accessible non-fixed table or desk (top 28" to 34" high; knee space at least 27" high x 19" deep x 30" wide) not provided.
 - *As-Built:* **16" deep at 26" knee**
 - *Proposed Solution:*
Provide table or desk with accessible dimensions when purchasing new furniture.
 - *Notes:*
48 total seats

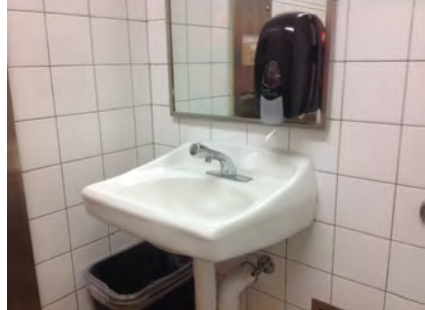
Item no., Rm no. and Name	Existing Architectural Barrier and Proposed Solution	Codes / Mitigation Info	Qty	Unit	Cost	Total
Accessories						
568	<ul style="list-style-type: none"> As-Built Description: Dispensers in sanitary facilities, such as for towels, soap, sanitary napkins, seat covers, etc., and waste receptacles more than 48" (CA only: 40") from floor to highest operating slot or control. As-Built: Soap dispenser 41" high Proposed Solution: Relocate existing restroom accessories. 	PCODE WG01A ADAAG 91 4.23.7 ADA 2010 308.2.1 CBC 2007 1115B.8.3 CBC 2016 11B-603.5 Mitigated: <input type="radio"/> YES <input checked="" type="radio"/> NO	1	JOB	\$300	\$300

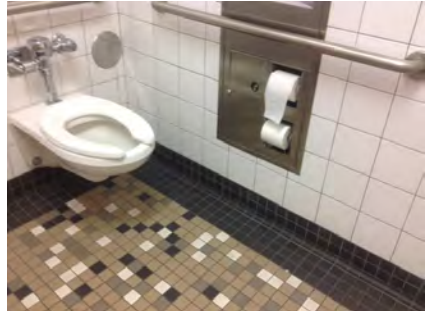
<input type="checkbox"/> Staff Only Priority 3 Severity 4			
570	<ul style="list-style-type: none"> As-Built Description: Toilet paper dispenser less than 15" (CA: 19") or more than 48" above floor or not within 7" to 9" from front of water closet (Note: CA pre-2010 is allowed within 12" from front of water closet). As-Built: 12" o.c. Proposed Solution: Relocate or provide new toilet paper dispenser. 	PCODE WG02 ADAAG 91 4.16.6 ADA 2010 604.7 CBC 2007 1115B.8.4 CBC 2016 11B-604.7 Mitigated: <input type="radio"/> YES <input checked="" type="radio"/> NO	1	JOB	\$225	\$225

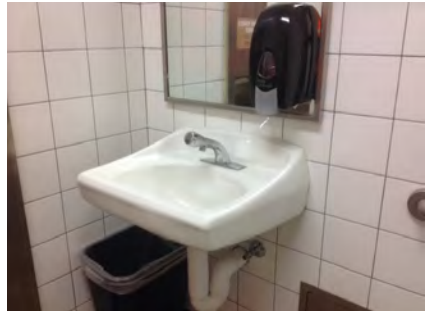
<input type="checkbox"/> Staff Only Priority 3 Severity 3			
567	<ul style="list-style-type: none"> As-Built Description: Bottom of mirror located above lavatories or countertops more than 40" above floor. As-Built: 41" high Proposed Solution: Relocate or provide new accessible mirror. 	PCODE WG03 ADAAG 91 4.19.6 ADA 2010 603.3 CBC 2007 1115B.8.1 CBC 2016 11B-603.3 Mitigated: <input type="radio"/> YES <input checked="" type="radio"/> NO	1	JOB	\$450	\$450

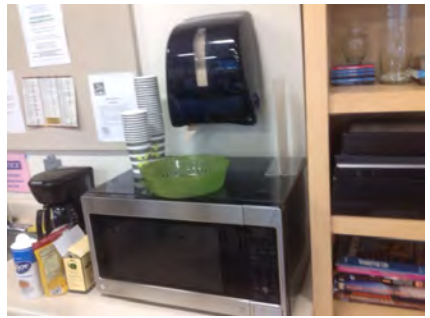
Item no., Rm no. and Name	Existing Architectural Barrier and Proposed Solution	Codes / Mitigation Info	Qty	Unit	Cost	Total
598	<ul style="list-style-type: none"> As-Built Description: Reach height to control or access point, exceeds 48" or is less than 15". As-Built: 59" high Proposed Solution: Modify equipment or mounting. 	PCODE IE01 ADAAG 91 4.2.5 ADA 2010 308.2.1 CBC 2007 1118B.5 CBC 2016 11B-308.2.1	1	JOB	\$300	\$300

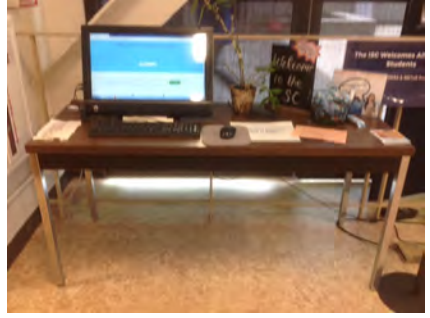
596	<ul style="list-style-type: none"> As-Built Description: Accessible non-fixed table or desk (top 28" to 34" high; knee space at least 27" high x 19" deep x 30" wide) not provided. As-Built: 25" knee height Proposed Solution: Provide table or desk with accessible dimensions when purchasing new furniture. 	PCODE IN02A ADAAG 91 4.32.3 & .4 ADA 2010 306.1 CBC 2007 1122B.3 & 4 CBC 2016 11B-306.1 & 11B-902.3	1	JOB	\$4,800	\$4,800

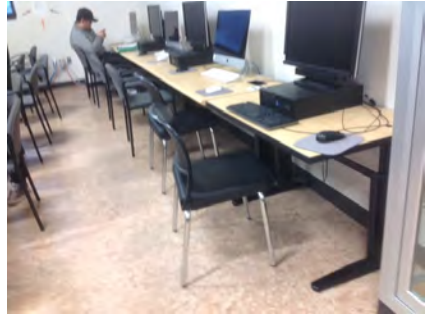
Mitigated: <input type="radio"/> YES <input checked="" type="radio"/> NO						
<input type="checkbox"/> Staff Only						
Priority 2 Severity 2						
600	<ul style="list-style-type: none"> As-Built Description: Accessible non-fixed table or desk (top 28" to 34" high; knee space at least 27" high x 19" deep x 30" wide) not provided. As-Built: 25" high Proposed Solution: Provide table or desk with accessible dimensions when purchasing new furniture. Notes: 20 total, 0 accessible 	PCODE IN02A ADAAG 91 4.32.3 & .4 ADA 2010 306.1 CBC 2007 1122B.3 & 4 CBC 2016 11B-306.1 & 11B-902.3	1	JOB	\$4,800	\$4,800

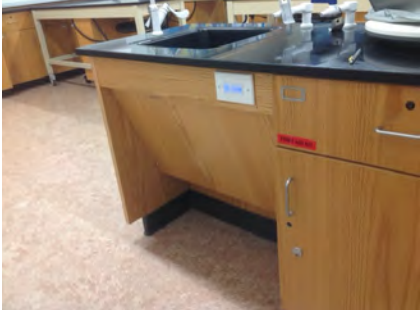
Item no., Rm no. and Name	Existing Architectural Barrier and Proposed Solution	Codes / Mitigation Info	Qty	Unit	Cost	Total
Sink						
608	<ul style="list-style-type: none"> As-Built Description: Sink does not have knee space min. 27" high x 19" deep x 30" wide. Proposed Solution: Remodel sink cabinet. Notes: Teacher/display sink 	PCODE IN06A ADAAG 91 4.24.3 ADA 2010 606.2 CBC 2007 1115B.4.7.1 CBC 2016 11B-606.2	1	JOB	\$5,250	\$5,250

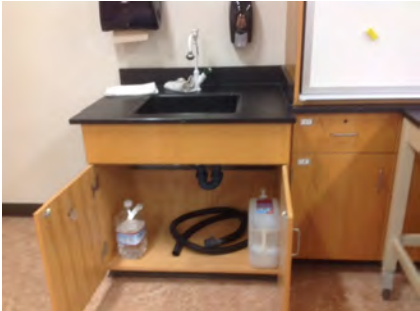
<input type="radio"/> YES <input checked="" type="radio"/> NO			
			<input type="checkbox"/> Staff Only			
			Priority 2 Severity 2			
609	<ul style="list-style-type: none"> As-Built Description: Sink does not have knee space min. 27" high x 19" deep x 30" wide. Proposed Solution: Remodel sink cabinet. 	PCODE IN06A ADAAG 91 4.24.3 ADA 2010 606.2 CBC 2007 1115B.4.7.1 CBC 2016 11B-606.2	1	JOB	\$5,250	\$5,250

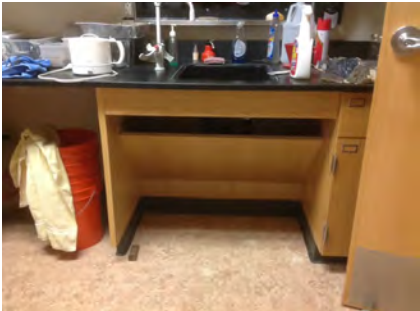
<input type="checkbox"/> Staff Only			
			Priority 2 Severity 2			
612	<ul style="list-style-type: none"> As-Built Description: Sink does not have knee space min. 27" high x 19" deep x 30" wide. Proposed Solution: Remodel sink cabinet. 	PCODE IN06A ADAAG 91 4.24.3 ADA 2010 606.2 CBC 2007 1115B.4.7.1 CBC 2016 11B-606.2	1	JOB	\$5,250	\$5,250

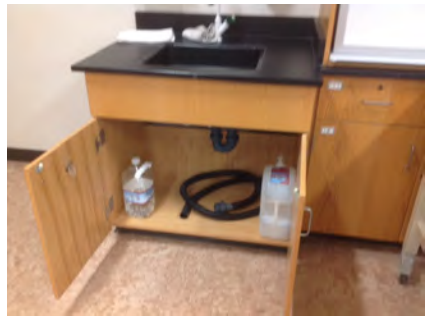
Item no., Rm no. and Name	Existing Architectural Barrier and Proposed Solution	Codes / Mitigation Info	Qty	Unit	Cost	Total
610	<ul style="list-style-type: none"> As-Built Description: Sink rim higher than 34" above floor. As-Built: 36" high Proposed Solution: Remodel sink cabinet to lower sink. 	PCODE IN06REF ADAAG 91 4.24.2 ADA 2010 606.3 CBC 2007 1115B.4.7.1 CBC 2016 11B-606.3 Mitigated: <input type="radio"/> YES <input checked="" type="radio"/> NO				
			REF

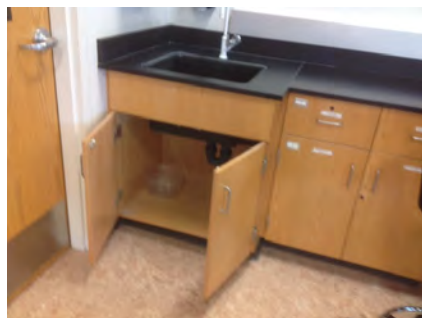
Item no., Rm no. and Name	Existing Architectural Barrier and Proposed Solution	Codes / Mitigation Info	Qty	Unit	Cost	Total
Sink						
617	<ul style="list-style-type: none"> As-Built Description: Sink rim higher than 34" above floor. As-Built: 36" high Proposed Solution: Remodel sink cabinet to lower sink. 	PCODE IN06 ADAAG 91 4.24.2 ADA 2010 606.3 CBC 2007 1115B.4.7.1 CBC 2016 11B-606.3 Mitigated: <input type="radio"/> YES <input checked="" type="radio"/> NO	1	JOB	\$5,250	\$5,250

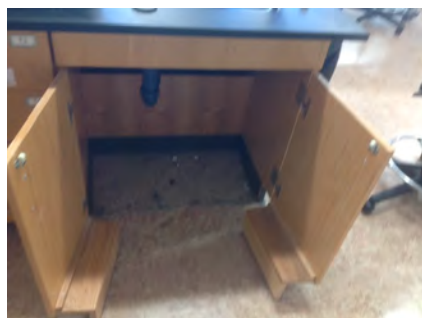
<input type="checkbox"/> Staff Only Priority 2 Severity 4			
616	<ul style="list-style-type: none"> As-Built Description: Sink does not have knee space min. 27" high x 19" deep x 30" wide. As-Built: 28" wide Proposed Solution: Remodel sink cabinet. Notes: Teachers/display sink 	PCODE IN06A ADAAG 91 4.24.3 ADA 2010 606.2 CBC 2007 1115B.4.7.1 CBC 2016 11B-606.2 Mitigated: <input type="radio"/> YES <input checked="" type="radio"/> NO	1	JOB	\$5,250	\$5,250

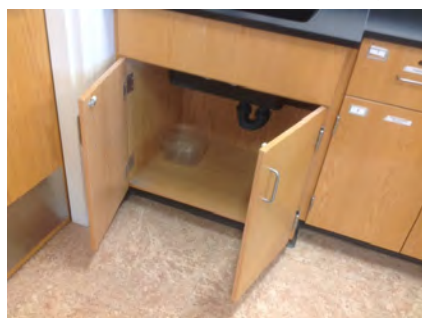
<input type="checkbox"/> Staff Only Priority 2 Severity 2			
618	<ul style="list-style-type: none"> As-Built Description: Sink does not have knee space min. 27" high x 19" deep x 30" wide. Proposed Solution: Remodel sink cabinet. 	PCODE IN06A ADAAG 91 4.24.3 ADA 2010 606.2 CBC 2007 1115B.4.7.1 CBC 2016 11B-606.2 Mitigated: <input type="radio"/> YES <input checked="" type="radio"/> NO	1	JOB	\$5,250	\$5,250

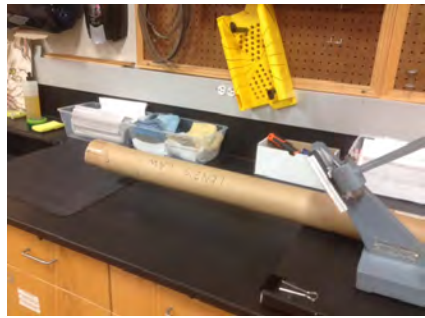
Item no., Rm no. and Name	Existing Architectural Barrier and Proposed Solution	Codes / Mitigation Info	Qty	Unit	Cost	Total
620	<ul style="list-style-type: none"> As-Built Description: Reach height for side approach to control or access point over an obstruction that is 34" max. high and 24" max. deep exceeds 46". As-Built: 26" reach depth Proposed Solution: Modify equipment or mounting. 	PCODE IE02A ADAAG 91 Fig. 6(c) ADA 2010 308.3.2 CBC 2007 Fig. 11B-5D(c) CBC 2016 11B-308.3.2 Mitigated: <input type="radio"/> YES <input checked="" type="radio"/> NO	1	JOB	\$300	\$300

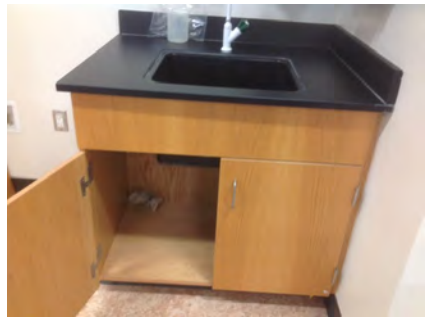
Item no., Rm no. and Name	Existing Architectural Barrier and Proposed Solution	Codes / Mitigation Info	Qty	Unit	Cost	Total
624	<ul style="list-style-type: none"> As-Built Description: Sink does not have knee space min. 27" high x 19" deep x 30" wide. As-Built: 28" wide Proposed Solution: Remodel sink cabinet. Notes: Teacher/display sink 	PCODE IN06A ADAAG 91 4.24.3 ADA 2010 606.2 CBC 2007 1115B.4.7.1 CBC 2016 11B-606.2 Mitigated: <input type="radio"/> YES <input checked="" type="radio"/> NO	1	JOB	\$5,250	\$5,250

<input type="checkbox"/> Staff Only			
			Priority 2 Severity 2			
626	<ul style="list-style-type: none"> As-Built Description: Sink does not have knee space min. 27" high x 19" deep x 30" wide. Proposed Solution: Remodel sink cabinet. 	PCODE IN06A ADAAG 91 4.24.3 ADA 2010 606.2 CBC 2007 1115B.4.7.1 CBC 2016 11B-606.2 Mitigated: <input type="radio"/> YES <input checked="" type="radio"/> NO	1	JOB	\$5,250	\$5,250

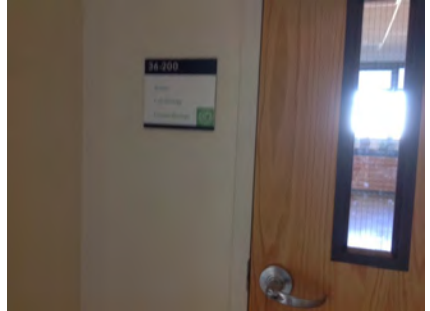
Item no., Rm no. and Name	Existing Architectural Barrier and Proposed Solution	Codes / Mitigation Info	Qty	Unit	Cost	Total
Signage						
640	<ul style="list-style-type: none"> • <i>As-Built Description:</i> Sign not located on latch side of door and/or not located at 48" min. above to baseline of the lowest Braille cells and 60" max. to baseline of the highest line of raised characters. • <i>As-Built:</i> 62" high • <i>Proposed Solution:</i> Provide compliant signage including tactile characters and Grade II Braille on latch side of door located at compliant height. 	PCODE SA07 ADAAG 91 4.30.6 ADA 2010 703.4.1 CBC 2007 1117B.5.7 CBC 2016 11B-703.4.1 Mitigated: <input type="radio"/> YES <input checked="" type="radio"/> NO	15	JOB	\$150	\$2,250

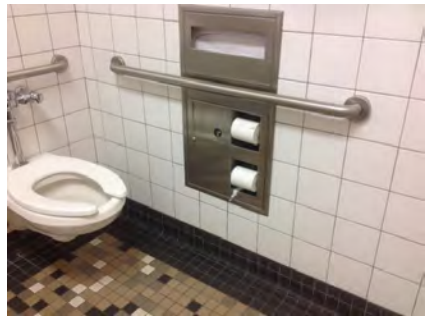
Item no., Rm no. and Name	Existing Architectural Barrier and Proposed Solution	Codes / Mitigation Info	Qty	Unit	Cost	Total
655	<ul style="list-style-type: none"> As-Built Description: Toilet paper dispenser less than 15" (CA: 19") or more than 48" above floor or not within 7" to 9" from front of water closet (Note: CA pre-2010 is allowed within 12" from front of water closet). As-Built: 12" o.c. Proposed Solution: Relocate or provide new toilet paper dispenser. 	PCODE WG02 ADAAG 91 4.16.6 ADA 2010 604.7 CBC 2007 1115B.8.4 CBC 2016 11B-604.7 Mitigated: <input type="radio"/> YES <input checked="" type="radio"/> NO	1	JOB	\$225	\$225

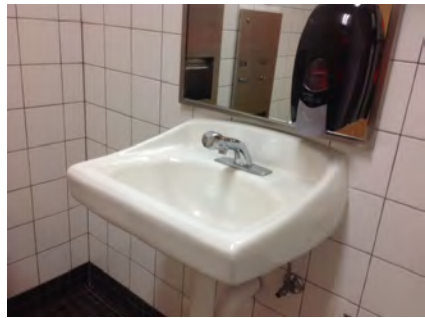
<input type="checkbox"/> Staff Only Priority Severity <input checked="" type="radio"/> 3 <input checked="" type="radio"/> 3			
650	<ul style="list-style-type: none"> As-Built Description: Bottom of mirror located above lavatories or countertops more than 40" above floor. As-Built: 40.5" high Proposed Solution: Relocate or provide new accessible mirror. 	PCODE WG03 ADAAG 91 4.19.6 ADA 2010 603.3 CBC 2007 1115B.8.1 CBC 2016 11B-603.3 Mitigated: <input type="radio"/> YES <input checked="" type="radio"/> NO	1	JOB	\$450	\$450
