SAN MATEO COUNTY
COMMUNITY
COLLEGE DISTRICT

San Mateo County Community College District Americans with Disabilities Act Self-Evaluation and Transition Plan

Report Prepared by:

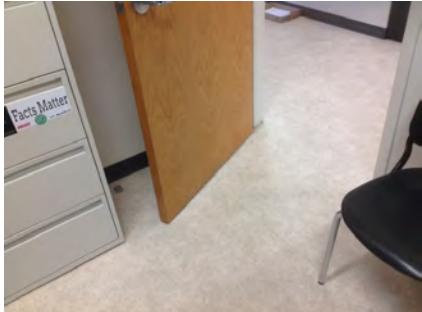
Item no., Rm no. and Name	Existing Architectural Barrier and Proposed Solution	Codes / Mitigation Info	Qty	Unit	Cost	Total
Door Swing						
662	<ul style="list-style-type: none">• <i>As-Built Description:</i> Front approach: At pull side, door does not have clear and level maneuvering space measuring door width plus 18" x 60". (24" x 60" at exterior doors).• <i>Proposed Solution:</i> Remove or relocate furniture or storage items.	<p>PCODE ID23A ADAAG 91 Fig. 25(a) ADA 2010 404.2.4 CBC 2007 11B-26A(a) CBC 2016 11B-404.2.4</p> <p>Mitigated:</p> <p><input type="radio"/> YES <input checked="" type="radio"/> NO</p>	1	JOB	\$150	\$150

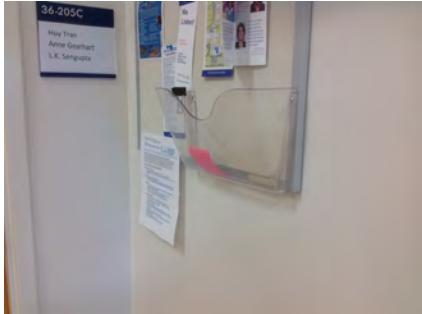
<input type="checkbox"/> Staff Only			
			Priority 2 Severity 3			
Brochure Bins						
660	<ul style="list-style-type: none">• <i>As-Built Description:</i> Information brochure bins mounted above accessible height of 48".• <i>As-Built:</i> 55" high• <i>Proposed Solution:</i> Relocate/remount bins at accessible height.	<p>PCODE IN08 ADAAG 91 4.2.5 & 6 ADA 2010 308.2.1 CBC 2007 1118B.5 CBC 2016 11B-308.2.1</p> <p>Mitigated:</p> <p><input type="radio"/> YES <input checked="" type="radio"/> NO</p>	1	JOB	\$300	\$300

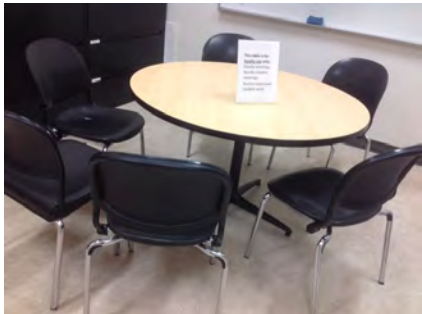
<input type="checkbox"/> Staff Only			
			Priority 2 Severity 3			
Non-Fixed Desk						
661	<ul style="list-style-type: none">• <i>As-Built Description:</i> Accessible non-fixed table or desk (top 28" to 34" high; knee space at least 27" high x 19" deep x 30" wide) not provided.• <i>Proposed Solution:</i> Provide table or desk with accessible dimensions when purchasing new furniture.	<p>PCODE IN02A ADAAG 91 4.32.3 & .4 ADA 2010 306.1 CBC 2007 1122B.3 & 4 CBC 2016 11B-306.1 & 11B-902.3</p> <p>Mitigated:</p> <p><input type="radio"/> YES <input checked="" type="radio"/> NO</p>	1	JOB	\$4,800	\$4,800

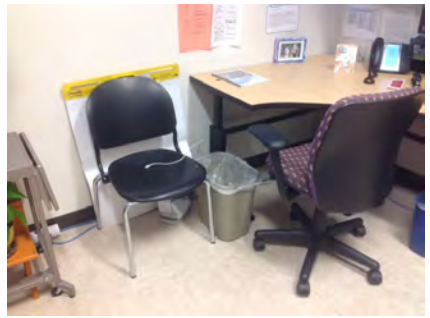
Item no., Rm no. and Name	Existing Architectural Barrier and Proposed Solution	Codes / Mitigation Info	Qty	Unit	Cost	Total
663	<ul style="list-style-type: none"> As-Built Description: Accessible non-fixed table or desk (top 28" to 34" high; knee space at least 27" high x 19" deep x 30" wide) not provided. As-Built: No knee space if used by students as writing surface. Proposed Solution: Provide table or desk with accessible dimensions when purchasing new furniture. 	PCODE IN02A ADAAG 91 4.32.3 & .4 ADA 2010 306.1 CBC 2007 1122B.3 & 4 CBC 2016 11B-306.1 & 11B-902.3 Mitigated: <input type="radio"/> YES <input checked="" type="radio"/> NO	1	JOB	\$4,800	\$4,800

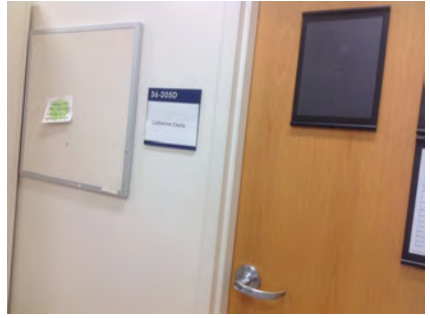
Signage

658	<ul style="list-style-type: none"> As-Built Description: Sign not located on latch side of door and/or not located at 48" min. above to baseline of the lowest Braille cells and 60" max. to baseline of the highest line of raised characters. As-Built: 62" high Proposed Solution: Provide compliant signage including tactile characters and Grade II Braille on latch side of door located at compliant height. 	PCODE SA07 ADAAG 91 4.30.6 ADA 2010 703.4.1 CBC 2007 1117B.5.7 CBC 2016 11B-703.4.1 Mitigated: <input type="radio"/> YES <input checked="" type="radio"/> NO	1	JOB	\$150	\$150

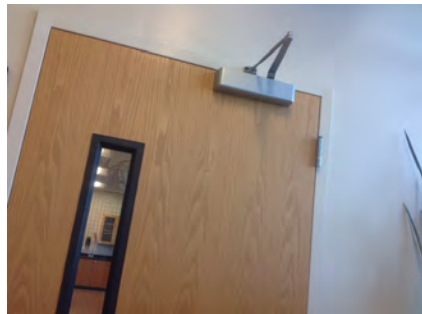
Item no., Rm no. and Name	Existing Architectural Barrier and Proposed Solution	Codes / Mitigation Info	Qty	Unit	Cost	Total
677	<ul style="list-style-type: none"> As-Built Description: Excessive force required to open door and/or door closing time of less than 5 seconds. As-Built: 2 seconds Proposed Solution: Provide new door closer adjusted to accessible standards. 	PCODE ID03A ADAAG 91 4.13.10 & 11 ADA 2010 404.2.8 & 404.2.9 CBC 2007 1133B.2.5.1 CBC 2016 11B-404.2.9 Mitigated: <input type="radio"/> YES <input checked="" type="radio"/> NO	1	JOB	\$1,125	\$1,125

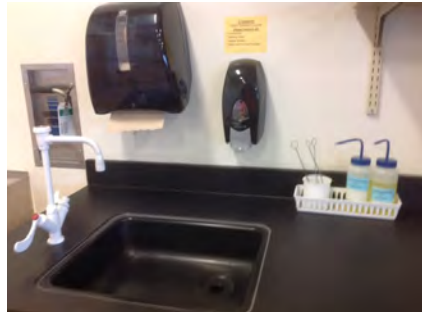
Reach Range

669	<ul style="list-style-type: none"> As-Built Description: Reach height to control or access point, exceeds 48" or is less than 15". As-Built: 26" deep Proposed Solution: Modify equipment or mounting. 	PCODE IE01 ADAAG 91 4.2.5 ADA 2010 308.2.1 CBC 2007 1118B.5 CBC 2016 11B-308.2.1 Mitigated: <input type="radio"/> YES <input checked="" type="radio"/> NO	1	JOB	\$300	\$300

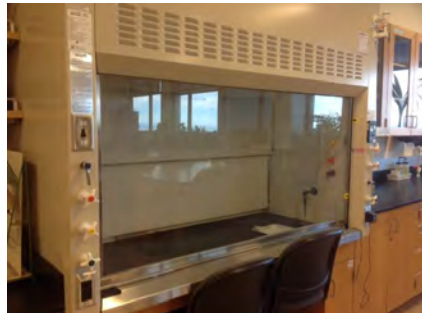
<input type="checkbox"/> Staff Only Priority 2 Severity 4						
670	<ul style="list-style-type: none"> As-Built Description: Reach height to control or access point, exceeds 48" or is less than 15". As-Built: 56" high Proposed Solution: Modify equipment or mounting. 	PCODE IE01 ADAAG 91 4.2.5 ADA 2010 308.2.1 CBC 2007 1118B.5 CBC 2016 11B-308.2.1 Mitigated: <input type="radio"/> YES <input checked="" type="radio"/> NO	1	JOB	\$300	\$300

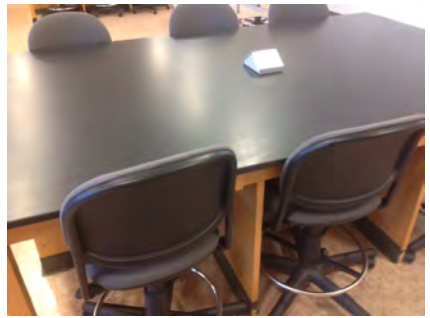
Item no., Rm no. and Name	Existing Architectural Barrier and Proposed Solution	Codes / Mitigation Info	Qty	Unit	Cost	Total
671	<ul style="list-style-type: none"> As-Built Description: Reach height to control or access point, exceeds 48" or is less than 15". As-Built: 26" reach to outlet Proposed Solution: Modify equipment or mounting. 	PCODE IE01 ADAAG 91 4.2.5 ADA 2010 308.2.1 CBC 2007 1118B.5 CBC 2016 11B-308.2.1	1	JOB	\$300	\$300

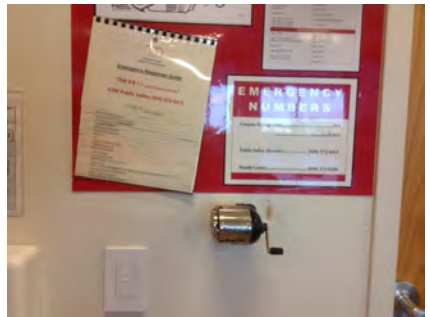
678	<ul style="list-style-type: none"> As-Built Description: Reach height to control or access point, exceeds 48" or is less than 15". As-Built: 54" high Proposed Solution: Modify equipment or mounting. 	PCODE IE01 ADAAG 91 4.2.5 ADA 2010 308.2.1 CBC 2007 1118B.5 CBC 2016 11B-308.2.1	1	JOB	\$300	\$300

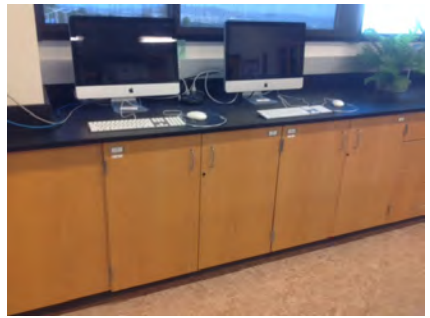
Item no., Rm no. and Name	Existing Architectural Barrier and Proposed Solution	Codes / Mitigation Info	Qty	Unit	Cost	Total
674	<ul style="list-style-type: none"> As-Built Description: Accessible non-fixed table or desk (top 28" to 34" high; knee space at least 27" high x 19" deep x 30" wide) not provided. Proposed Solution: Provide table or desk with accessible dimensions when purchasing new furniture. Notes: No knee space for work station. 	PCODE IN02A ADAAG 91 4.32.3 & .4 ADA 2010 306.1 CBC 2007 1122B.3 & 4 CBC 2016 11B-306.1 & 11B-902.3 Mitigated: <input type="radio"/> YES <input checked="" type="radio"/> NO	1	JOB	\$4,800	\$4,800

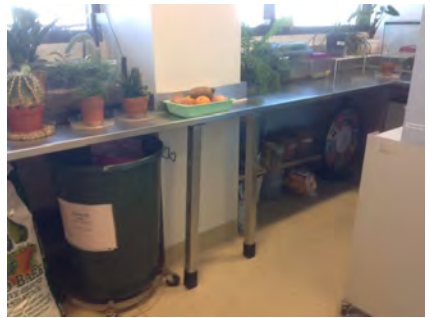
<input type="checkbox"/> Staff Only Priority 2 Severity 2			
675	<ul style="list-style-type: none"> As-Built Description: Accessible non-fixed table or desk (top 28" to 34" high; knee space at least 27" high x 19" deep x 30" wide) not provided. As-Built: 37" high Proposed Solution: Provide table or desk with accessible dimensions when purchasing new furniture. Notes: If used by students 	PCODE IN02A ADAAG 91 4.32.3 & .4 ADA 2010 306.1 CBC 2007 1122B.3 & 4 CBC 2016 11B-306.1 & 11B-902.3 Mitigated: <input type="radio"/> YES <input checked="" type="radio"/> NO	1	JOB	\$4,800	\$4,800

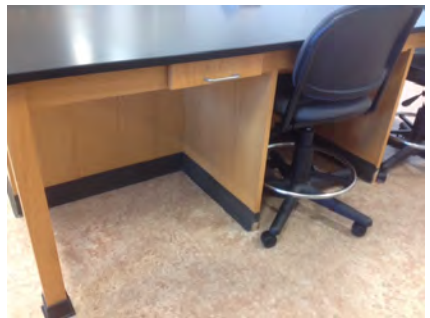
<input type="checkbox"/> Staff Only Priority 2 Severity 2			
673	<ul style="list-style-type: none"> As-Built Description: Recommended only: Accessible non-fixed table or desk (top 28" to 34" high; knee space at least 27" high x 19" deep x 30" wide) not provided. As-Built: 26.5" knee space Proposed Solution: Provide table or desk with accessible dimensions when purchasing new furniture. 	PCODE IN02AREF ADAAG 91 4.32.3 & .4 ADA 2010 306.1 CBC 2007 1122B.3 & 4 CBC 2016 11B-306.1 & 11B-902.3 Mitigated: <input type="radio"/> YES <input checked="" type="radio"/> NO		REF

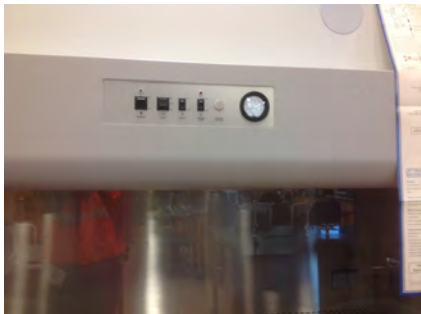
Item no., Rm no. and Name	Existing Architectural Barrier and Proposed Solution	Codes / Mitigation Info	Qty	Unit	Cost	Total
682	<ul style="list-style-type: none">As-Built Description: Reach height to control or access point, exceeds 48" or is less than 15".As-Built: 65" highProposed Solution: Modify equipment or mounting.	<div>PCODE IE01</div> <div>ADAAG 91 4.2.5</div> <div>ADA 2010 308.2.1</div> <div>CBC 2007 1118B.5</div> <div>CBC 2016 11B-308.2.1</div> <div>Mitigated:</div> <div><div><input type="radio"/> YES</div><div><input checked="" type="radio"/> NO</div></div>	1	JOB	\$300	\$300
			<div>

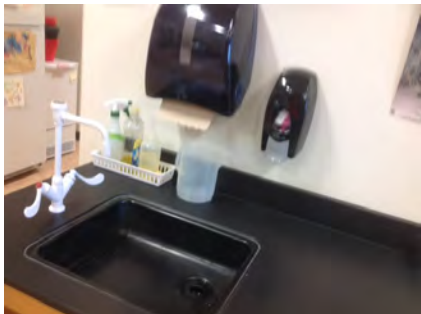
</div> <div><input type="checkbox"/> Staff Only</div> <div><div>Priority2</div><div>Severity2</div></div>			
692	<ul style="list-style-type: none">As-Built Description: Reach height to control or access point, exceeds 48" or is less than 15".As-Built: 26" reach depthProposed Solution: Modify equipment or mounting.Notes: Class Lab Service 206B	<div>PCODE IE01</div> <div>ADAAG 91 4.2.5</div> <div>ADA 2010 308.2.1</div> <div>CBC 2007 1118B.5</div> <div>CBC 2016 11B-308.2.1</div> <div>Mitigated:</div> <div><div><input type="radio"/> YES</div><div><input checked="" type="radio"/> NO</div></div>	1	JOB	\$300	\$300

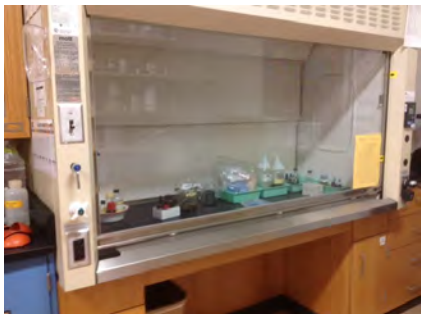
</div> <div><input type="checkbox"/> Staff Only</div> <div><div>Priority2</div><div>Severity4</div></div>			
693	<ul style="list-style-type: none">As-Built Description: Reach height to control or access point, exceeds 48" or is less than 15".As-Built: 52" highProposed Solution: Modify equipment or mounting.Notes: Class Lab Service 206B	<div>PCODE IE01</div> <div>ADAAG 91 4.2.5</div> <div>ADA 2010 308.2.1</div> <div>CBC 2007 1118B.5</div> <div>CBC 2016 11B-308.2.1</div> <div>Mitigated:</div> <div><div><input type="radio"/> YES</div><div><input checked="" type="radio"/> NO</div></div>	1	JOB	\$300	\$300
			<div>

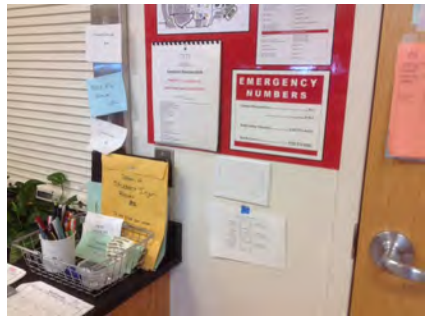
Item no., Rm no. and Name	Existing Architectural Barrier and Proposed Solution	Codes / Mitigation Info	Qty	Unit	Cost	Total
694	<ul style="list-style-type: none"> As-Built Description: Reach height to control or access point, exceeds 48" or is less than 15". As-Built: 54" high Proposed Solution: Modify equipment or mounting. Notes: Class Lab Service 206B 	PCODE IE01 ADAAG 91 4.2.5 ADA 2010 308.2.1 CBC 2007 1118B.5 CBC 2016 11B-308.2.1 Mitigated: <input type="radio"/> YES <input checked="" type="radio"/> NO	1	JOB	\$300	\$300

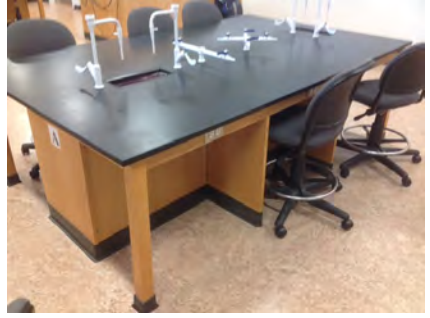
683	<ul style="list-style-type: none"> As-Built Description: Accessible non-fixed table or desk (top 28" to 34" high; knee space at least 27" high x 19" deep x 30" wide) not provided. As-Built: 28.5" wide Proposed Solution: Provide table or desk with accessible dimensions when purchasing new furniture. 	PCODE IN02A ADAAG 91 4.32.3 & .4 ADA 2010 306.1 CBC 2007 1122B.3 & 4 CBC 2016 11B-306.1 & 11B-902.3 Mitigated: <input type="radio"/> YES <input checked="" type="radio"/> NO	1	JOB	\$4,800	\$4,800

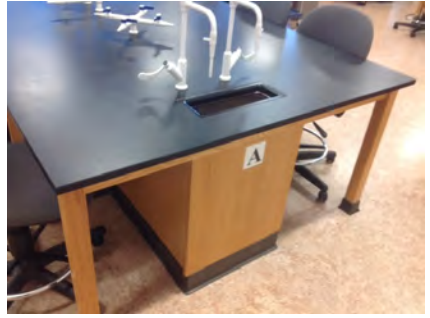
<input type="checkbox"/> Staff Only Priority 2 Severity 2						
686	<ul style="list-style-type: none"> As-Built Description: Accessible non-fixed table or desk (top 28" to 34" high; knee space at least 27" high x 19" deep x 30" wide) not provided. Proposed Solution: Provide table or desk with accessible dimensions when purchasing new furniture. 	PCODE IN02A ADAAG 91 4.32.3 & .4 ADA 2010 306.1 CBC 2007 1122B.3 & 4 CBC 2016 11B-306.1 & 11B-902.3 Mitigated: <input type="radio"/> YES <input checked="" type="radio"/> NO	1	JOB	\$4,800	\$4,800

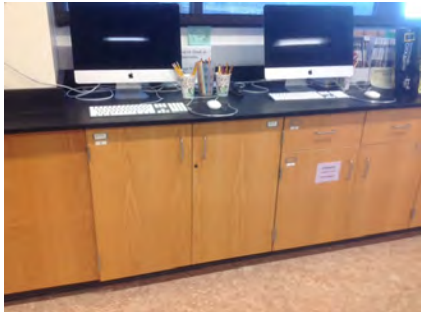
Item no., Rm no. and Name	Existing Architectural Barrier and Proposed Solution	Codes / Mitigation Info	Qty	Unit	Cost	Total
688	<ul style="list-style-type: none"> As-Built Description: Accessible non-fixed table or desk (top 28" to 34" high; knee space at least 27" high x 19" deep x 30" wide) not provided. Proposed Solution: Provide table or desk with accessible dimensions when purchasing new furniture. Notes: No knee space at computer station. 	<p>PCODE IN02A</p> <p>ADAAG 91 4.32.3 & .4</p> <p>ADA 2010 306.1</p> <p>CBC 2007 1122B.3 & 4</p> <p>CBC 2016 11B-306.1 & 11B-902.3</p> <p>Mitigated:</p> <p><input type="radio"/> YES</p> <p><input checked="" type="radio"/> NO</p>	1	JOB	\$4,800	\$4,800

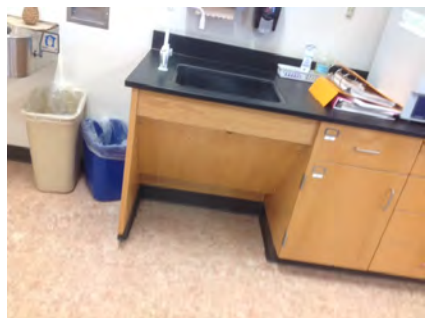
Item no., Rm no. and Name	Existing Architectural Barrier and Proposed Solution	Codes / Mitigation Info	Qty	Unit	Cost	Total
Sink						
680	<ul style="list-style-type: none"> As-Built Description: Sink does not have knee space min. 27" high x 19" deep x 30" wide. Proposed Solution: Remodel sink cabinet. 	PCODE IN06A ADAAG 91 4.24.3 ADA 2010 606.2 CBC 2007 1115B.4.7.1 CBC 2016 11B-606.2	1	JOB	\$5,250	\$5,250

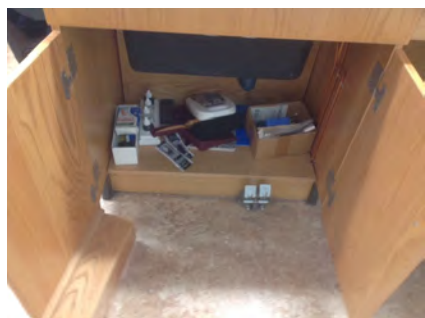
<input type="radio"/> YES <input checked="" type="radio"/> NO			
			<input type="checkbox"/> Staff Only			
			Priority 2 Severity 2			
687	<ul style="list-style-type: none"> As-Built Description: Sink does not have knee space min. 27" high x 19" deep x 30" wide. Proposed Solution: Remodel sink cabinet. Notes: Sink not finished under. 	PCODE IN06A ADAAG 91 4.24.3 ADA 2010 606.2 CBC 2007 1115B.4.7.1 CBC 2016 11B-606.2	1	JOB	\$5,250	\$5,250

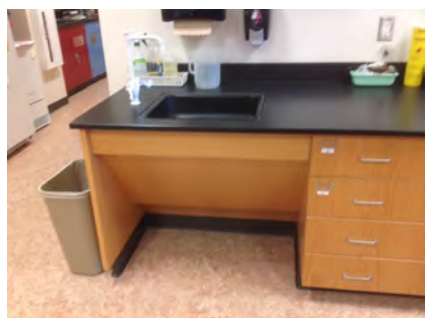
<input type="checkbox"/> Staff Only			
			Priority 2 Severity 2			
691	<ul style="list-style-type: none"> As-Built Description: Sink does not have knee space min. 27" high x 19" deep x 30" wide. Proposed Solution: Remodel sink cabinet. Notes: Class Lab Service 206B 	PCODE IN06A ADAAG 91 4.24.3 ADA 2010 606.2 CBC 2007 1115B.4.7.1 CBC 2016 11B-606.2	1	JOB	\$5,250	\$5,250

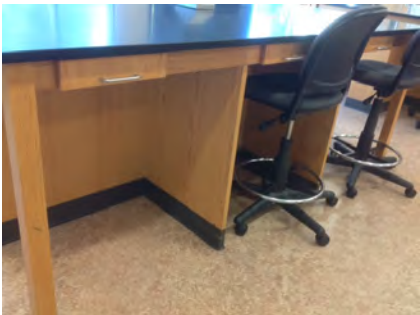
Item no., Rm no. and Name	Existing Architectural Barrier and Proposed Solution	Codes / Mitigation Info	Qty	Unit	Cost	Total
Non-Fixed Desk						
700	<ul style="list-style-type: none">As-Built Description: Accessible non-fixed table or desk (top 28" to 34" high; knee space at least 27" high x 19" deep x 30" wide) not provided.As-Built: 28" wideProposed Solution: Provide table or desk with accessible dimensions when purchasing new furniture.Notes: 32 seats, no accessible	<p>PCODE IN02A</p> <p>ADAAG 91 4.32.3 & .4</p> <p>ADA 2010 306.1</p> <p>CBC 2007 1122B.3 & 4</p> <p>CBC 2016 11B-306.1 & 11B-902.3</p> <p>Mitigated:</p> <p><input type="radio"/> YES</p> <p><input checked="" type="radio"/> NO</p>	1	JOB	\$4,800	\$4,800

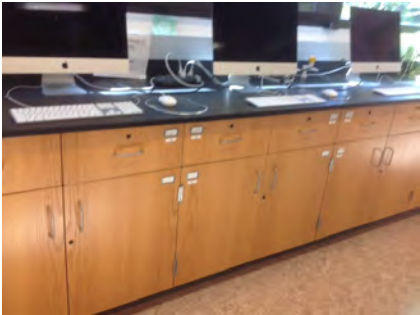
<input type="checkbox"/> Staff Only			
			Priority		Severity	
			2		2	
701	<ul style="list-style-type: none">As-Built Description: Accessible non-fixed table or desk (top 28" to 34" high; knee space at least 27" high x 19" deep x 30" wide) not provided.Proposed Solution: Provide table or desk with accessible dimensions when purchasing new furniture.Notes: No knee space at computer station	<p>PCODE IN02A</p> <p>ADAAG 91 4.32.3 & .4</p> <p>ADA 2010 306.1</p> <p>CBC 2007 1122B.3 & 4</p> <p>CBC 2016 11B-306.1 & 11B-902.3</p> <p>Mitigated:</p> <p><input type="radio"/> YES</p> <p><input checked="" type="radio"/> NO</p>	1	JOB	\$4,800	\$4,800

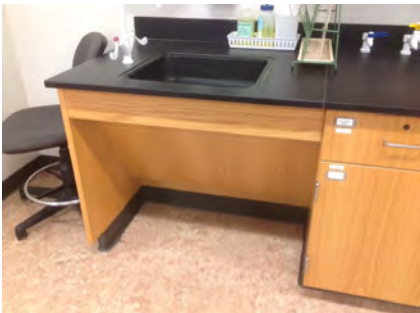
<input type="checkbox"/> Staff Only			
			Priority		Severity	
			2		2	
Sink						
698	<ul style="list-style-type: none">As-Built Description: Sink does not have knee space min. 27" high x 19" deep x 30" wide.Proposed Solution: Remodel sink cabinet.	<p>PCODE IN06A</p> <p>ADAAG 91 4.24.3</p> <p>ADA 2010 606.2</p> <p>CBC 2007 1115B.4.7.1</p> <p>CBC 2016 11B-606.2</p> <p>Mitigated:</p> <p><input type="radio"/> YES</p> <p><input checked="" type="radio"/> NO</p>	1	JOB	\$5,250	\$5,250

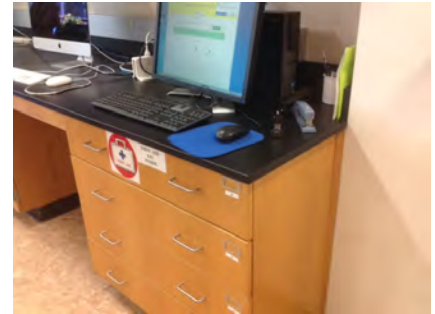
Item no., Rm no. and Name	Existing Architectural Barrier and Proposed Solution	Codes / Mitigation Info	Qty	Unit	Cost	Total
711	<ul style="list-style-type: none"> As-Built Description: Accessible fixed table or desk (top 28" to 34" high; knee space at least 27" high x 19" deep x 30" wide) not provided. Proposed Solution: Provide new fixed accessible table or desk. Notes: Check-in station 	PCODE IN02 ADAAG 91 4.32.3 & .4 ADA 2010 306.1 & 902.3 CBC 2007 1122B.3 & 4 CBC 2016 11B-306.1 & 11B-902.3 Mitigated: <input type="radio"/> YES <input checked="" type="radio"/> NO	1	JOB	\$7,500	\$7,500

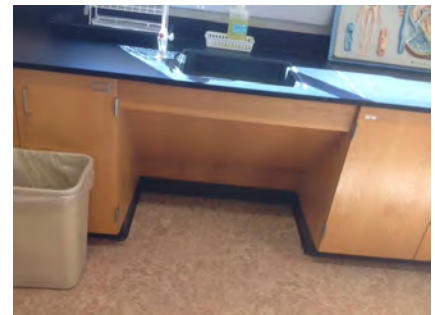
705	<ul style="list-style-type: none"> As-Built Description: Sink does not have knee space min. 27" high x 19" deep x 30" wide. Proposed Solution: Remodel sink cabinet. 	PCODE IN06A ADAAG 91 4.24.3 ADA 2010 606.2 CBC 2007 1115B.4.7.1 CBC 2016 11B-606.2 Mitigated: <input type="radio"/> YES <input checked="" type="radio"/> NO	1	JOB	\$5,250	\$5,250
-----	--	---	---	-----	---------	----------------

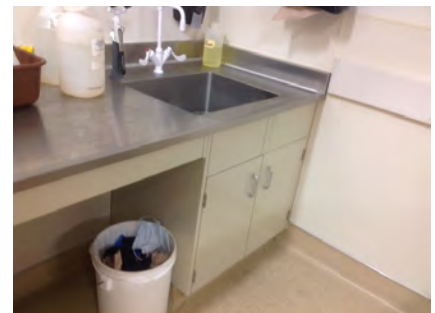
709	<ul style="list-style-type: none"> As-Built Description: Sink does not have knee space min. 27" high x 19" deep x 30" wide. Proposed Solution: Remodel sink cabinet. 	PCODE IN06A ADAAG 91 4.24.3 ADA 2010 606.2 CBC 2007 1115B.4.7.1 CBC 2016 11B-606.2 Mitigated: <input type="radio"/> YES <input checked="" type="radio"/> NO	1	JOB	\$5,250	\$5,250
-----	--	---	---	-----	---------	----------------

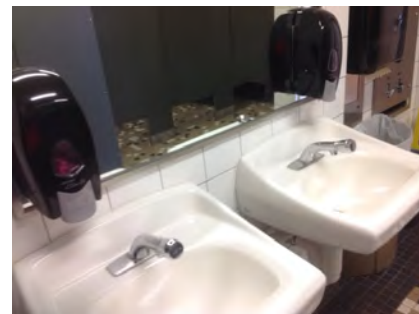
Item no., Rm no. and Name	Existing Architectural Barrier and Proposed Solution	Codes / Mitigation Info	Qty	Unit	Cost	Total
727	<ul style="list-style-type: none"> As-Built Description: Bottom of mirror located above lavatories or countertops more than 40" above floor. As-Built: 41" high Proposed Solution: Relocate or provide new accessible mirror. 	PCODE WG03 ADAAG 91 4.19.6 ADA 2010 603.3 CBC 2007 1115B.8.1 CBC 2016 11B-603.3	1	JOB	\$450	\$450
<div> <div>Mitigated:</div> <div> <input type="radio"/> YES <input checked="" type="radio"/> NO </div> </div> <div> <input type="checkbox"/> Staff Only </div> <div> Priority 3 Severity 4 </div>

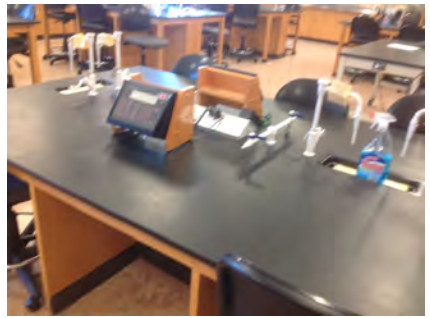
Item no., Rm no. and Name	Existing Architectural Barrier and Proposed Solution	Codes / Mitigation Info	Qty	Unit	Cost	Total
765	<ul style="list-style-type: none"> As-Built Description: Reach height for side approach to control or access point over an obstruction that is 34" max. high and 24" max. deep exceeds 46". As-Built: Greater than 24" reach to accessories mounted on desk Proposed Solution: Modify equipment or mounting. 	PCODE IE02A ADAAG 91 Fig. 6(c) ADA 2010 308.3.2 CBC 2007 Fig. 11B-5D(c) CBC 2016 11B-308.3.2 Mitigated: <input type="radio"/> YES <input checked="" type="radio"/> NO	1	JOB	\$300	\$300

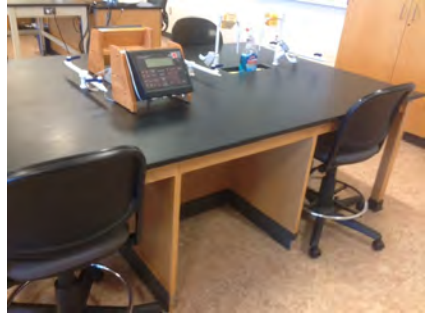
Non-Fixed Desk

764	<ul style="list-style-type: none"> As-Built Description: Accessible non-fixed table or desk (top 28" to 34" high; knee space at least 27" high x 19" deep x 30" wide) not provided. As-Built: 28" wide Proposed Solution: Provide table or desk with accessible dimensions when purchasing new furniture. Notes: 32 total, no accessible 	PCODE IN02A ADAAG 91 4.32.3 & .4 ADA 2010 306.1 CBC 2007 1122B.3 & 4 CBC 2016 11B-306.1 & 11B-902.3 Mitigated: <input type="radio"/> YES <input checked="" type="radio"/> NO	1	JOB	\$4,800	\$4,800

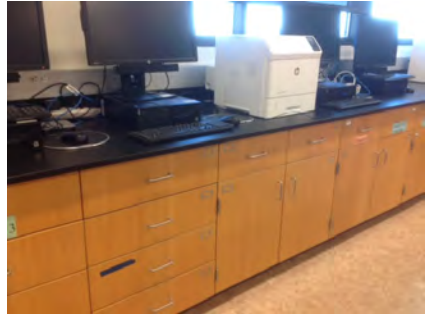
<input type="checkbox"/> Staff Only Priority 2 Severity 2						
767	<ul style="list-style-type: none"> As-Built Description: Accessible non-fixed table or desk (top 28" to 34" high; knee space at least 27" high x 19" deep x 30" wide) not provided. As-Built: No knee clearance Proposed Solution: Provide table or desk with accessible dimensions when purchasing new furniture. 	PCODE IN02A ADAAG 91 4.32.3 & .4 ADA 2010 306.1 CBC 2007 1122B.3 & 4 CBC 2016 11B-306.1 & 11B-902.3 Mitigated: <input type="radio"/> YES <input checked="" type="radio"/> NO	1	JOB	\$4,800	\$4,800

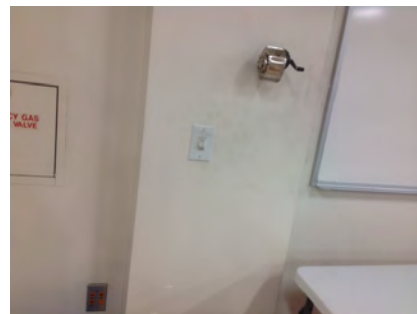
Item no., Rm no. and Name	Existing Architectural Barrier and Proposed Solution	Codes / Mitigation Info	Qty	Unit	Cost	Total
795	<ul style="list-style-type: none"> As-Built Description: Reach height to control or access point, exceeds 48" or is less than 15". As-Built: 54" high Proposed Solution: Modify equipment or mounting. 	PCODE IE01 ADAAG 91 4.2.5 ADA 2010 308.2.1 CBC 2007 1118B.5 CBC 2016 11B-308.2.1	1	JOB	\$300	\$300
<div> <div>Mitigated:</div> <div> <input type="radio"/> YES <input checked="" type="radio"/> NO </div> </div> <div> <input type="checkbox"/> Staff Only </div> <div> <div>Priority</div> <div>2</div> </div> <div> <div>Severity</div> <div>3</div> </div>

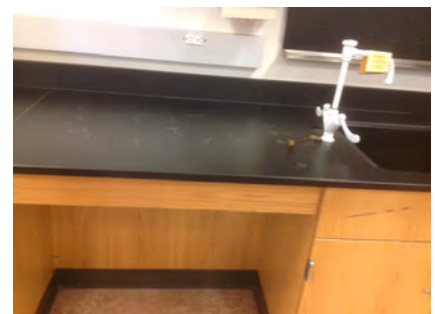
Item no., Rm no. and Name	Existing Architectural Barrier and Proposed Solution	Codes / Mitigation Info	Qty	Unit	Cost	Total
804	<ul style="list-style-type: none"> As-Built Description: Reach height to control or access point, exceeds 48" or is less than 15". As-Built: 28" to mounted items Proposed Solution: Modify equipment or mounting. 	PCODE IE01 ADAAG 91 4.2.5 ADA 2010 308.2.1 CBC 2007 1118B.5 CBC 2016 11B-308.2.1	1	JOB	\$300	\$300
<div>Mitigated:</div> <div> <input type="radio"/> YES <input checked="" type="radio"/> NO </div> <div> <input type="checkbox"/> Staff Only </div> <div> Priority 2 Severity 4 </div>

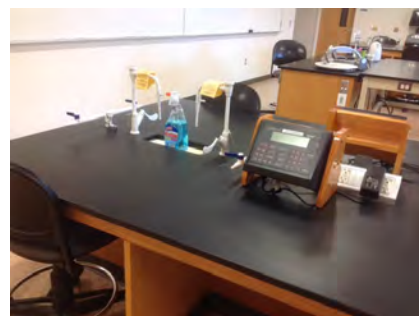
**Desk**

802	<ul style="list-style-type: none"> As-Built Description: Accessible fixed table or desk (top 28" to 34" high; knee space at least 27" high x 19" deep x 30" wide) not provided. As-Built: 36" high, no knee space Proposed Solution: Provide new fixed accessible table or desk. 	PCODE IN02 ADAAG 91 4.32.3 & .4 ADA 2010 306.1 & 902.3 CBC 2007 1122B.3 & 4 CBC 2016 11B-306.1 & 11B-902.3	1	JOB	\$7,500	\$7,500
<div>Mitigated:</div> <div> <input type="radio"/> YES <input checked="" type="radio"/> NO </div> <div> <input type="checkbox"/> Staff Only </div> <div> Priority 2 Severity 4 </div>

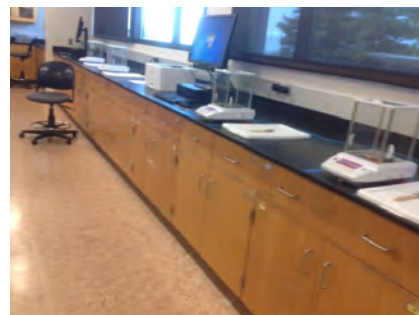
**Non-Fixed Desk**

801	<ul style="list-style-type: none"> As-Built Description: Accessible non-fixed table or desk (top 28" to 34" high; knee space at least 27" high x 19" deep x 30" wide) not provided. As-Built: 28" wide Proposed Solution: Provide table or desk with accessible dimensions when purchasing new furniture. Notes: 32 seats, no accessible 	PCODE IN02A ADAAG 91 4.32.3 & .4 ADA 2010 306.1 CBC 2007 1122B.3 & 4 CBC 2016 11B-306.1 & 11B-902.3	1	JOB	\$4,800	\$4,800
<div>Mitigated:</div> <div> <input type="radio"/> YES <input checked="" type="radio"/> NO </div> <div> <input type="checkbox"/> Staff Only </div> <div> Priority 2 Severity 2 </div>

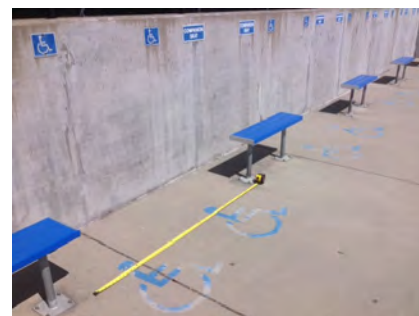
Item no., Rm no. and Name	Existing Architectural Barrier and Proposed Solution	Codes / Mitigation Info	Qty	Unit	Cost	Total
371	<ul style="list-style-type: none"> As-Built Description: Proper amount of seating for disabled persons at public seating is not provided (4 to 25=1; 26 to 50=2; 51 to 150=4; 151 to 300=5; 301 to 500=6; 501 to 5000=6+1 for each hundred; >5001=46+1 for each 200. Proposed Solution: Modify seating to provide clear and level wheelchair space 33" x 48" or 33" x 60", including companion seat, as required. Notes: 20 lower seats, 20 upper seats. Ensure total number of accessible seats are provided. 	PCODE GE01 ADAAG 91 4.1.2(19)a ADA 2010 221.2.1 CBC 2007 1104B.3.4 CBC 2016 11B-221.2.1 Mitigated: <input type="radio"/> YES <input checked="" type="radio"/> NO	1	EA	\$1,800	\$1,800

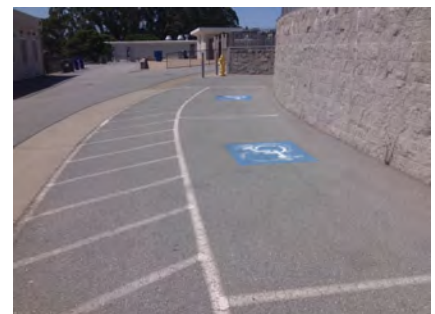
Item no., Rm no. and Name	Existing Architectural Barrier and Proposed Solution	Codes / Mitigation Info	Qty	Unit	Cost	Total
378	<ul style="list-style-type: none"> • <i>As-Built Description:</i> No van parking provided (one in every 6 or fraction of 6 accessible spaces, but not less than one). • <i>Proposed Solution:</i> Provide van parking space(s) by restriping; provide van sign. 	PCODE EA07 ADAAG 91 4.1.2(5)(b) ADA 2010 208.2; 502.1 CBC 2007 1129B.3.2 CBC 2016 11B-208.2.4 Mitigated: <input type="radio"/> YES <input checked="" type="radio"/> NO	1	JOB	\$1,050	\$1,050

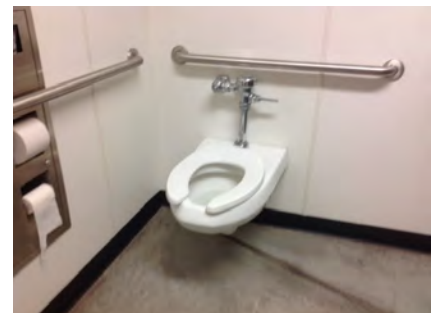
Item no., Rm no. and Name	Existing Architectural Barrier and Proposed Solution	Codes / Mitigation Info	Qty	Unit	Cost	Total
384	<ul style="list-style-type: none"> As-Built Description: Water closet not 16"-18" (CA: 17"-18") from near side wall to center line of water closet (2010 ADAAG: 16"-18"). As-Built: 18.5" o.c. Proposed Solution: Relocate existing water closet and plumbing, remount with offset closet flange to provide 18" max. from side wall. 	PCODE WB02C ADAAG 91 Fig. 28 ADA 2010 604.2 CBC 2007 1115B.4.1.1 CBC 2016 11B-604.2 Mitigated: <input type="radio"/> YES <input checked="" type="radio"/> NO	1	JOB	\$1,500	\$1,500

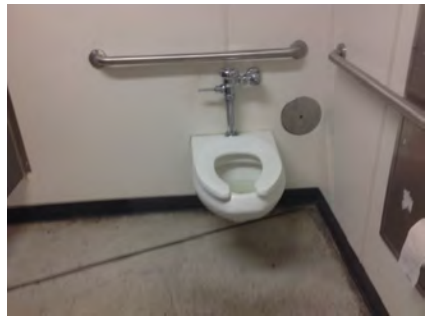
Accessories

385	<ul style="list-style-type: none"> As-Built Description: Toilet paper dispenser less than 15" (CA: 19") or more than 48" above floor or not within 7" to 9" from front of water closet (Note: CA pre-2010 is allowed within 12" from front of water closet). As-Built: 13" o.c. Proposed Solution: Relocate or provide new toilet paper dispenser. 	PCODE WG02 ADAAG 91 4.16.6 ADA 2010 604.7 CBC 2007 1115B.8.4 Mitigated: <input type="radio"/> YES <input checked="" type="radio"/> NO	1	JOB	\$225	\$225

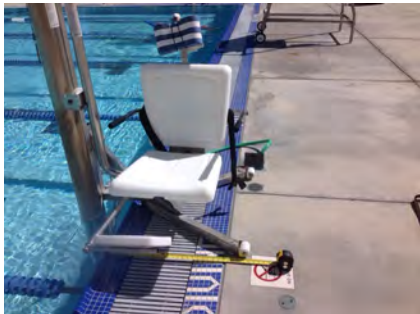
<div><input type="checkbox"/> Staff Only</div> <div>Priority <div>1</div>Severity <div>2</div></div>			
General Note						
767	<ul style="list-style-type: none">• <i>As-Built Description:</i> Refer to notes for observation and recommendation.• <i>As-Built:</i> 12" o.c. from pool deck• <i>Proposed Solution:</i>• <i>Notes:</i> 11B- 1009.2.2 requires 16" minimum from the pool edge.	PCODE GN01 CBC 2016 11B-308.2.1 Mitigated: <div><input type="radio"/> YES</div> <div><input checked="" type="radio"/> NO</div>		REF

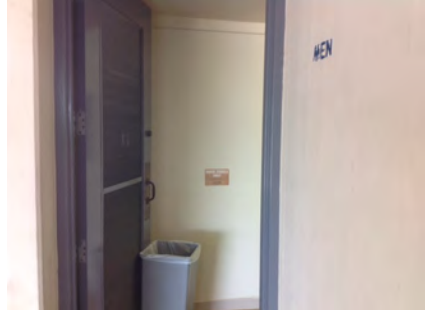
Item no., Rm no. and Name	Existing Architectural Barrier and Proposed Solution	Codes / Mitigation Info	Qty	Unit	Cost	Total
Signage						
285	<ul style="list-style-type: none"> As-Built Description: Entrance to toilet or bathing facility not identified with ADAAG compliant signage. Proposed Solution: Provide ADA compliant sign mounted at 48" min. above to baseline of the lowest Braille cells and 60" max. to baseline of the highest line of raised characters on nearest adjacent wall, on latch side of a single door (located not to cause a Braille reader to stand within the door swing). 	PCODE SA11A ADAAG 91 4.1.3(16)(a) ADA 2010 216.8 CBC 2016 11B-216.8 Mitigated: <input type="radio"/> YES <input checked="" type="radio"/> NO	1	JOB	\$270	\$270

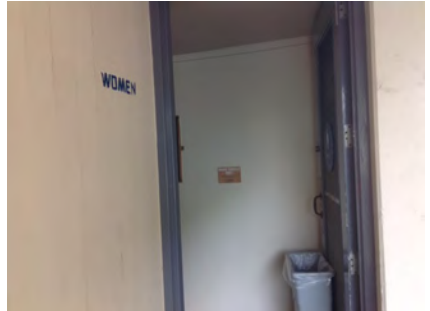
<input type="checkbox"/> Staff Only Priority 3 Severity 3			
290	<ul style="list-style-type: none"> As-Built Description: Entrance to toilet or bathing facility not identified with ADAAG compliant signage. Proposed Solution: Provide ADA compliant sign mounted at 48" min. above to baseline of the lowest Braille cells and 60" max. to baseline of the highest line of raised characters on nearest adjacent wall, on latch side of a single door (located not to cause a Braille reader to stand within the door swing). 	PCODE SA11A ADAAG 91 4.1.3(16)(a) ADA 2010 216.8 CBC 2016 11B-216.8 Mitigated: <input type="radio"/> YES <input checked="" type="radio"/> NO	1	JOB	\$270	\$270

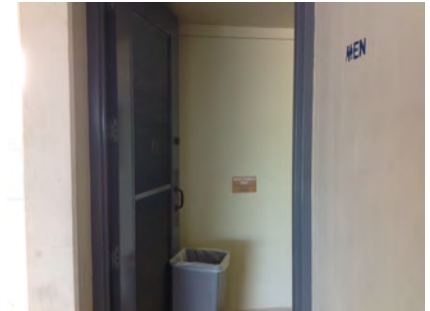
<input type="checkbox"/> Staff Only Priority 3 Severity 3			
286	<ul style="list-style-type: none"> As-Built Description: Required in CA only: identification symbol centered 58" to 60" high on sanitary facility door that contrasts with the door not provided (women: 12" ø circle, men: 12" triangle, unisex: combined symbol). Proposed Solution: Provide properly mounted sanitary facility symbol when altering area. If wheelchair accessible, include International Symbol of Accessibility on sign. 	PCODE SA15 CBC 2007 1115B.6 CBC 2016 11B-703.7.2.6 Mitigated: <input type="radio"/> YES <input checked="" type="radio"/> NO	1	JOB	\$270	\$270

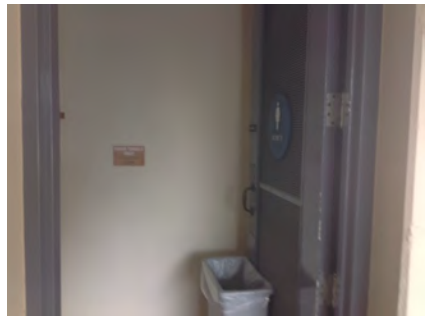
Item no., Rm no. and Name	Existing Architectural Barrier and Proposed Solution	Codes / Mitigation Info	Qty	Unit	Cost	Total
289	<ul style="list-style-type: none"> As-Built Description: Required in CA only: identification symbol centered 58" to 60" high on sanitary facility door that contrasts with the door not provided (women: 12" ø circle, men: 12" triangle, unisex: combined symbol). As-Built: No contrast Proposed Solution: Provide properly mounted sanitary facility symbol when altering area. If wheelchair accessible, include International Symbol of Accessibility on sign. 	PCODE SA15 CBC 2007 1115B.6 CBC 2016 11B-703.7.2.6 Mitigated: <input type="radio"/> YES <input checked="" type="radio"/> NO	1	JOB	\$270	\$270

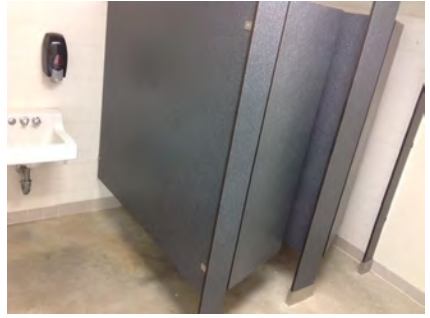
<input type="checkbox"/> Staff Only Priority 3 Severity 1						
291	<ul style="list-style-type: none"> As-Built Description: Multiple accommodation restroom not accessible; multiple compliance violations. Proposed Solution: Remodel area to provide accessible restroom with one accessible stall, lavatory (and one urinal at Mens). 	PCODE WA01A ADAAG 91 4.22 ADA 2010 603.1 CBC 2007 1115B.3.1 CBC 2016 11B-603.1 Mitigated: <input type="radio"/> YES <input checked="" type="radio"/> NO	1	JOB	? \$105,000

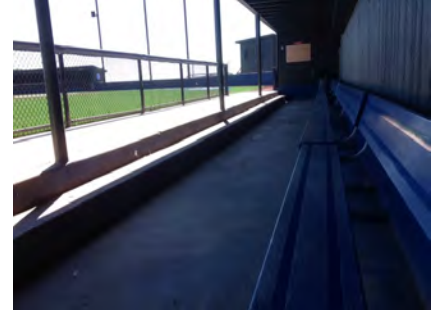
Refer to notes for observation and recommendation.

• **Notes:****Two steps to dugout, no accessible route provided****Mitigated:**☐ YES☒ NO

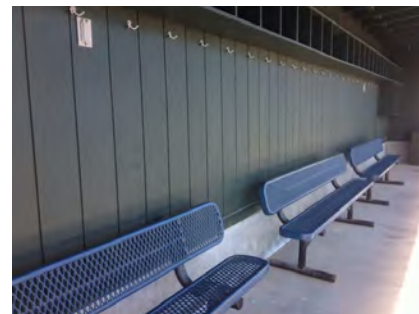
- 28 • *As-Built Description:*
Refer to notes for observation and recommendation.

- *Notes:*

Two steps down to dugout. No accessible route.**Mitigated:**☐ YES☒ NO

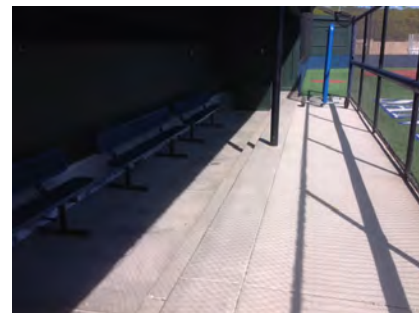
- 31 • *As-Built Description:*
Refer to notes for observation and recommendation.

- *Notes:*

No accessible gate onto field.**Mitigated:**☐ YES☒ NO

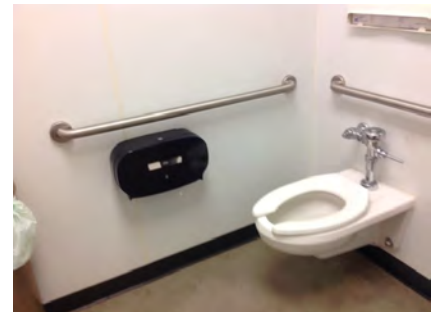
Item no., Rm no. and Name	Existing Architectural Barrier and Proposed Solution	Codes / Mitigation Info	Qty	Unit	Cost	Total
12	<ul style="list-style-type: none"> As-Built Description: Accessories/dispensers in accessible stall located closer than 1-1/2" below or 12" above grab bar impedes its use. Proposed Solution: Relocate accessories/dispensers to be no closer than 1-1/2" below and 12" above grab bars (except if accessories are recessed, flush with wall, and have no sharp edges). 	PCODE WB071 ADAAG 91 4.26.2 ADA 2010 609.3 CBC 2007 1133B.4.2.5 CBC 2016 11B-609.3 Mitigated: <input type="radio"/> YES <input checked="" type="radio"/> NO	1	JOB	\$225	\$225

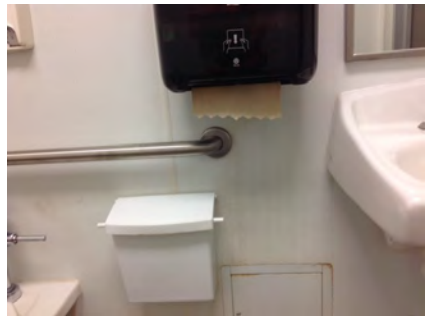
Toilet Stall

11	<ul style="list-style-type: none"> As-Built Description: Toilet stall less than 60" wide. As-Built: 54" Proposed Solution: Provide new accessible stall. Notes: 28" between WC and lavatory 	PCODE WB06 ADAAG 91 4.17.3 ADA 2010 604.8.1.1 CBC 2007 1115B.3.1.4.1 CBC 2016 11B-604.8.1.1 Mitigated: <input type="radio"/> YES <input checked="" type="radio"/> NO	1	JOB	\$4,500	\$4,500

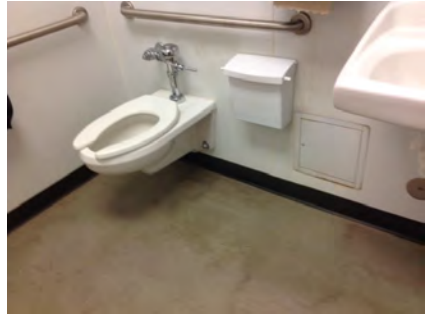
Accessories

13	<ul style="list-style-type: none"> As-Built Description: Dispensers in sanitary facilities, such as for towels, soap, sanitary napkins, seat covers, etc., and waste receptacles more than 48" (CA only: 40") from floor to highest operating slot or control. As-Built: 50" high Proposed Solution: Relocate existing restroom accessories. 	PCODE WG01A ADAAG 91 4.23.7 ADA 2010 308.2.1 CBC 2007 1115B.8.3 CBC 2016 11B-603.5 Mitigated: <input type="radio"/> YES <input checked="" type="radio"/> NO	1	JOB	\$300	\$300

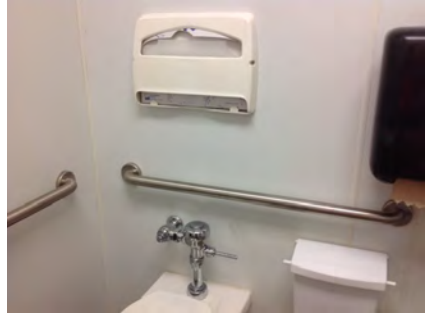
Item no., Rm no. and Name	Existing Architectural Barrier and Proposed Solution	Codes / Mitigation Info	Qty	Unit	Cost	Total
6 All Gender Restroom						
Grab Bars						
18	<ul style="list-style-type: none">As-Built Description: Side grab bar less than 42" long, or located more than 12 inches max. from the rear wall, or extending less than 54" from rear wall (CA only: front end min. 24" in front of water closet).As-Built: 49"Proposed Solution: Provide or relocate accessible side grab bar.	PCODE WB07A ADAAG 91 Fig. 29(b) ADA 2010 604.5.1 CBC 2007 1115B.4.1.3.1 CBC 2016 11B-604.5.1	1	JOB	\$780	\$780

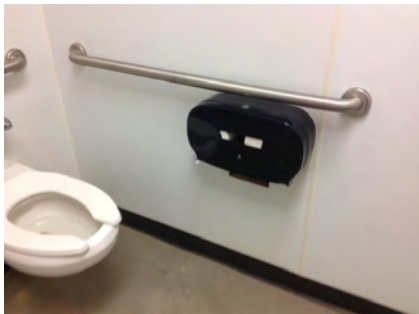
<input type="checkbox"/> Staff Only			
			Priority 3 Severity 3			
15	<ul style="list-style-type: none">As-Built Description: Accessories/dispensers in accessible stall located closer than 1-1/2" below or 12" above grab bar impedes its use.Proposed Solution: Relocate accessories/dispensers to be no closer than 1-1/2" below and 12" above grab bars (except if accessories are recessed, flush with wall, and have no sharp edges).	PCODE WB07I ADAAG 91 4.26.2 ADA 2010 609.3 CBC 2007 1133B.4.2.5 CBC 2016 11B-609.3	1	JOB	\$225	\$225

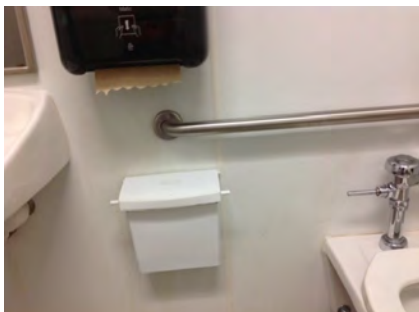
<input type="checkbox"/> Staff Only			
			Priority 3 Severity 2			
19	<ul style="list-style-type: none">As-Built Description: Accessories/dispensers in accessible stall located closer than 1-1/2" below or 12" above grab bar impedes its use.Proposed Solution: Relocate accessories/dispensers to be no closer than 1-1/2" below and 12" above grab bars (except if accessories are recessed, flush with wall, and have no sharp edges).	PCODE WB07I ADAAG 91 4.26.2 ADA 2010 609.3 CBC 2007 1133B.4.2.5 CBC 2016 11B-609.3	1	JOB	\$225	\$225

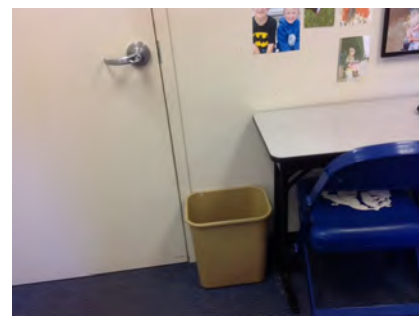
Item no., Rm no. and Name	Existing Architectural Barrier and Proposed Solution	Codes / Mitigation Info	Qty	Unit	Cost	Total
20	<ul style="list-style-type: none"> As-Built Description: Front approach: At push side, door does not have clear and level maneuvering space measuring door width x 48" (door width plus 12" if door has both, latch and closer). Proposed Solution: Remove or relocate furniture or storage items. 	PCODE ID24A ADAAG 91 Fig. 25(a) ADA 2010 404.2.4 CBC 2007 11B-26A(a) CBC 2016 11B-404.2.4 Mitigated: <input type="radio"/> YES <input checked="" type="radio"/> NO	1	JOB	\$150	\$150

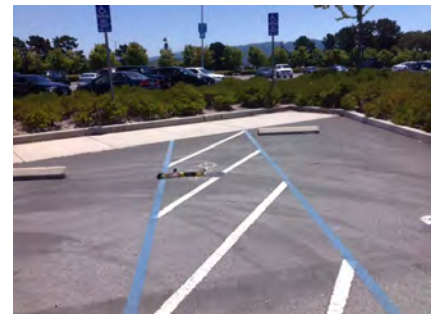
Item no., Rm no. and Name	Existing Architectural Barrier and Proposed Solution	Codes / Mitigation Info	Qty	Unit	Cost	Total
Minimum Number						
19	<ul style="list-style-type: none">As-Built Description: At parking lot with 501-1000 spaces, the number of accessible spaces is less than required by code; 2% of total number of spaces required.Proposed Solution: Provide required accessible parking spaces with signs including van spaces as required.Notes: 583 total parking spaces, 5 accessible spaces provided.	<p>PCODE EA01J</p> <p>ADAAG 91 4.1.2(5)*</p> <p>ADA 2010 208.2</p> <p>CBC 2007 Tbl. 11B-6</p> <p>CBC 2016 11B-208.2 Tbl. 11B-208.2</p> <p>Mitigated:</p> <p><input type="radio"/> YES</p> <p><input checked="" type="radio"/> NO</p>	1	JOB	\$900	\$900

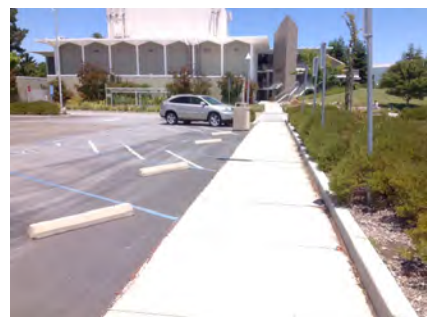
236	<ul style="list-style-type: none">As-Built Description: International Symbol of Accessibility (36" square, in white on blue) is not painted on the pavement near the rear end of the parking space (required in CA only).Proposed Solution: Apply symbol on parking space pavement when altering area.	<p>PCODE EA04A</p> <p>CBC 2007 1129B.4</p> <p>CBC 2016 11B-502.6.4.1</p> <p>Mitigated:</p> <p><input type="radio"/> YES</p> <p><input checked="" type="radio"/> NO</p>	6	JOB	\$360	\$2,160

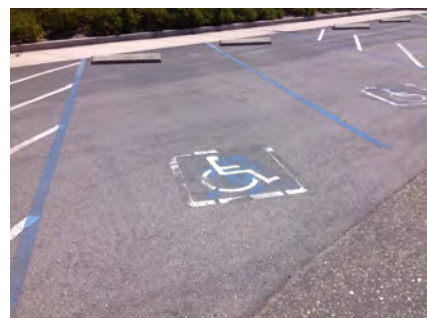
<input type="checkbox"/> Staff Only			
			<div><div>Priority</div><div>1</div></div> <div><div>Severity</div><div>4</div></div>			
235	<ul style="list-style-type: none">As-Built Description: The words "NO PARKING" not painted on the ground within loading and unloading access aisle (12" min high white letters), located so that it is visible to traffic enforcement officials (required in CA only).Proposed Solution: Provide the words "NO PARKING" in each access aisle, painted in 12" high letters, when altering area.	<p>PCODE EA04D</p> <p>CBC 2007 1129B.3.1</p> <p>CBC 2016 11B-502.3.3</p> <p>Mitigated:</p> <p><input type="radio"/> YES</p> <p><input checked="" type="radio"/> NO</p>	3	JOB	\$300	\$900

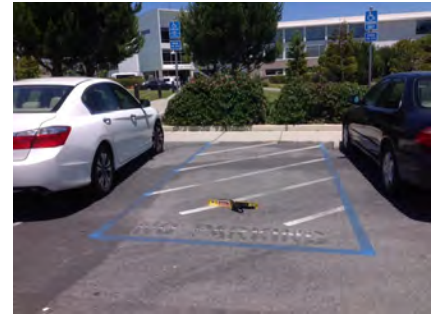
Item no., Rm no. and Name	Existing Architectural Barrier and Proposed Solution	Codes / Mitigation Info	Qty	Unit	Cost	Total
243	<ul style="list-style-type: none"> As-Built Description: Access aisle at accessible parking space has slope greater than 1/4":12" (2%). As-Built: 3.3% Proposed Solution: Modify slope at accessible parking space aisle. 	PCODE EA05B ADAAG 91 4.6.3 ADA 2010 502.4 CBC 2007 1129B.3.3 CBC 2016 11B-502.4	100	SF	\$36	\$3,600
<div>Mitigated:</div> <div> <input type="radio"/> YES <input checked="" type="radio"/> NO </div> <div> <input type="checkbox"/> Staff Only </div> <div> Priority 1 Severity 4 </div>

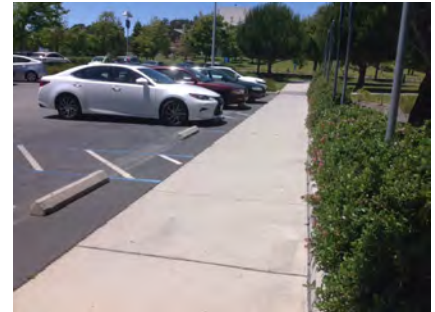
20	<ul style="list-style-type: none"> As-Built Description: At parking lot with 301-400 spaces, the number of accessible spaces is less than required by code; 8 spaces required. Proposed Solution: Provide required accessible parking spaces with signs including a minimum of one van space. Notes: There are 316 total parking spaces with 7 accessible provided. 	PCODE EA01H ADAAG 91 4.1.2(5)* ADA 2010 208.2 CBC 2007 Tbl. 11B-6 CBC 2016 11B-208.2 Tbl. 11B-208.2	1	JOB	\$900	\$900
<div>Mitigated:</div> <div> <input type="radio"/> YES <input checked="" type="radio"/> NO </div> <div> <input type="checkbox"/> Staff Only </div> <div> Priority 1 Severity 2 </div>

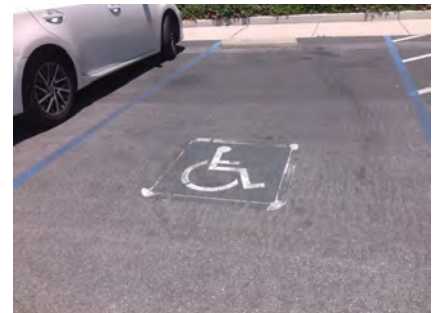
244	<ul style="list-style-type: none"> As-Built Description: International Symbol of Accessibility (36" square, in white on blue) is not painted on the pavement near the rear end of the parking space (required in CA only). Proposed Solution: Apply symbol on parking space pavement when altering area. 	PCODE EA04A CBC 2007 1129B.4 CBC 2016 11B-502.6.4.1	8	JOB	\$360	\$2,880
<div>Mitigated:</div> <div> <input type="radio"/> YES <input checked="" type="radio"/> NO </div> <div> <input type="checkbox"/> Staff Only </div> <div> Priority 1 Severity 4 </div>

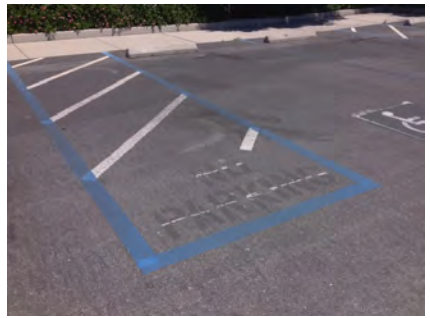
Item no., Rm no. and Name	Existing Architectural Barrier and Proposed Solution	Codes / Mitigation Info	Qty	Unit	Cost	Total
245	<ul style="list-style-type: none"> As-Built Description: The words "NO PARKING" not painted on the ground within loading and unloading access aisle (12" min high white letters), located so that it is visible to traffic enforcement officials (required in CA only). Proposed Solution: Provide the words "NO PARKING" in each access aisle, painted in 12" high letters, when altering area. 	PCODE EA04D CBC 2007 1129B.3.1 CBC 2016 11B-502.3.3 Mitigated: <input type="radio"/> YES <input checked="" type="radio"/> NO	4	JOB	\$300	\$1,200

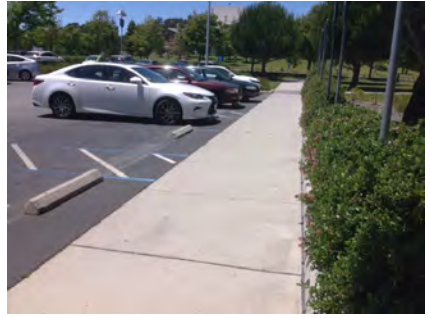
246	<ul style="list-style-type: none"> As-Built Description: Detectable warning not provided where pedestrian crosses vehicular area. Proposed Solution: Provide detectable warning surface (i.e. in-line truncated domes) at regular curb ramp. 	PCODE EH07A ADAAG 91 4.7.7 ADA 2010 705.1 CBC 2007 1127B.5.7 CBC 2016 11B-705.1.2.2 Mitigated: <input type="radio"/> YES <input checked="" type="radio"/> NO	4	JOB	\$750	\$3,000

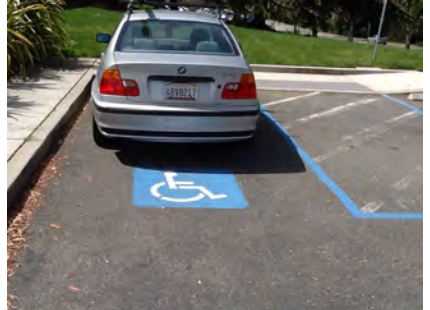
Item no., Rm no. and Name	Existing Architectural Barrier and Proposed Solution	Codes / Mitigation Info	Qty	Unit	Cost	Total
Parking						
422	<ul style="list-style-type: none"> As-Built Description: Accessible parking space smaller than 8' wide (CA only: 9' x 18'). As-Built: 8'10" Proposed Solution: Modify parking space(s) to create accessible space. Notes: Left space 	PCODE EA02A ADAAG 91 4.6.3 ADA 2010 502.2 CBC 2007 1129B.3.1 CBC 2016 11B-502.2	1	JOB	\$600	\$600

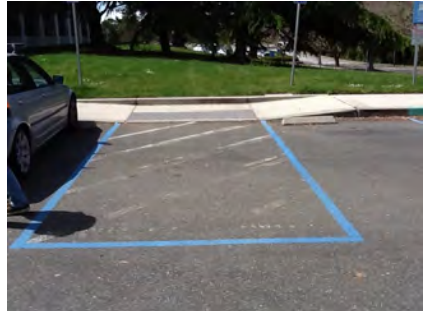
<input type="checkbox"/> Staff Only			
			Priority 1 Severity 4			
420	<ul style="list-style-type: none"> As-Built Description: The words "NO PARKING" not painted on the ground within loading and unloading access aisle (12" min high white letters), located so that it is visible to traffic enforcement officials (required in CA only). Proposed Solution: Provide the words "NO PARKING" in each access aisle, painted in 12" high letters, when altering area. 	PCODE EA04D CBC 2007 1129B.3.1 CBC 2016 11B-502.3.3	1	JOB	\$300	\$300

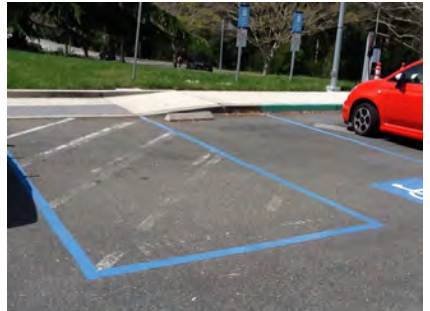
<input type="checkbox"/> Staff Only			
			Priority 1 Severity 4			
421	<ul style="list-style-type: none"> As-Built Description: CA only: The area within the blue borderlines not marked with hatched lines a maximum of 36" on center. Proposed Solution: Restripe to provide hatched lines at 36" on center within access aisle. Notes: Contrast and "NO PARKING" faded 	PCODE EA04I CBC 2007 1129B.3.1 CBC 2016 11B-502.3.3	1	JOB	\$300	\$300

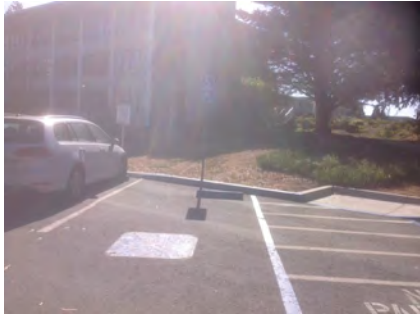
Item no., Rm no. and Name	Existing Architectural Barrier and Proposed Solution	Codes / Mitigation Info	Qty	Unit	Cost	Total
Parking						
235	<ul style="list-style-type: none">As-Built Description: No van parking provided (one in every 6 or fraction of 6 accessible spaces, but not less than one).Proposed Solution: Provide van parking space(s) by restriping; provide van sign.	PCODE EA07 ADAAG 91 4.1.2(5)(b) ADA 2010 208.2; 502.1 CBC 2007 1129B.3.2 CBC 2016 11B-208.2.4 Mitigated: <div><input type="radio"/> YES</div> <div><input checked="" type="radio"/> NO</div>	1	JOB	\$1,050	\$1,050

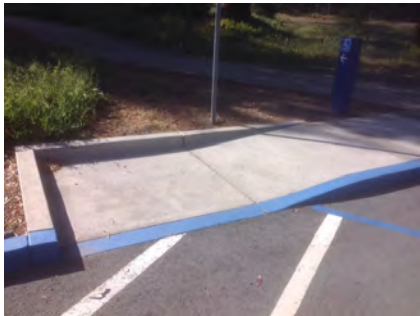
<div><input type="checkbox"/> Staff Only</div> <div><div>Priority</div><div>1</div><div>Severity</div><div>2</div></div>			
Cross Slope						
238	<ul style="list-style-type: none">As-Built Description: Cross slope more than 1":48" (2.083%).As-Built: Bottom landing 2.7%Proposed Solution: Modify cross slope.	PCODE EF07 ADAAG 91 4.3.7 ADA 2010 403.3 CBC 2007 1133B.7.1.3 CBC 2016 11B-403.3 Mitigated: <div><input type="radio"/> YES</div> <div><input checked="" type="radio"/> NO</div>	16	SF	\$75	\$1,200

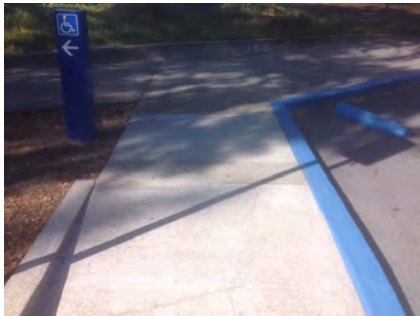
<div><input type="checkbox"/> Staff Only</div> <div><div>Priority</div><div>1</div><div>Severity</div><div>4</div></div>			
Curb Ramp						
239	<ul style="list-style-type: none">As-Built Description: Less than 48" level space at top and 1:12 flared sides not provided.As-Built: Top landing 3.2% direction of travelProposed Solution: Demolish existing and provide new curb ramp.	PCODE EH05B ADAAG 91 4.7.5; Fig.12(a) ADA 2010 406.4 CBC 2007 1127B.5.4 CBC 2016 11B-406.5.3 Mitigated: <div><input type="radio"/> YES</div> <div><input checked="" type="radio"/> NO</div>	1	JOB	\$7,500	\$7,500

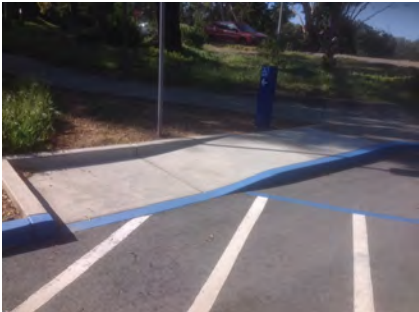
Item no., Rm no. and Name	Existing Architectural Barrier and Proposed Solution	Codes / Mitigation Info	Qty	Unit	Cost	Total
236	<ul style="list-style-type: none">• <i>As-Built Description:</i> Detectable warning not provided where pedestrian crosses vehicular area.• <i>Proposed Solution:</i> Provide detectable warning surface (i.e. in-line truncated domes) at regular curb ramp.	<p>PCODE EH07A</p> <p>ADAAG 91 4.7.7</p> <p>ADA 2010 705.1</p> <p>CBC 2007 1127B.5.7</p> <p>CBC 2016 11B-705.1.2.2</p> <p>Mitigated:</p> <p><input type="radio"/> YES</p> <p><input checked="" type="radio"/> NO</p>	1	JOB	\$750	\$750

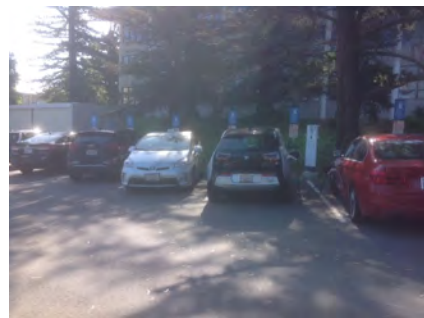
- **As-Built Description:**
Refer to notes for observation and recommendation.
- **Proposed Solution:**
- **Notes:**
8 total EV charging stations with no accessible station provided. 1 standard accessible and 1 van accessible space are required. Existing EV spaces have slopes of 5% in the direction of travel.

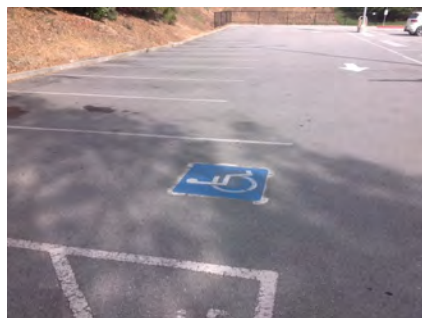
Item no., Rm no. and Name	Existing Architectural Barrier and Proposed Solution	Codes / Mitigation Info	Qty	Unit	Cost	Total
Parking						
6	<ul style="list-style-type: none"> As-Built Description: International Symbol of Accessibility (36" square, in white on blue) is not painted on the pavement near the rear end of the parking space (required in CA only). As-Built: Faded 32 x 32 Proposed Solution: Apply symbol on parking space pavement when altering area. 	PCODE EA04A CBC 2007 1129B.4 CBC 2016 11B-502.6.4.1 Mitigated: <input type="radio"/> YES <input checked="" type="radio"/> NO	1	JOB	\$360	\$360

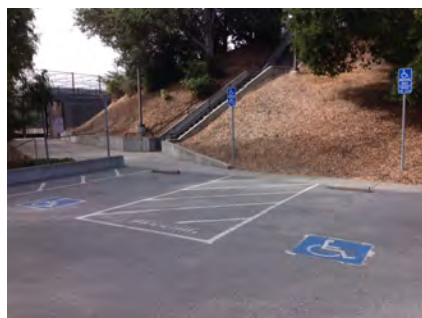
<input type="checkbox"/> Staff Only Priority 1 Severity 4			
4	<ul style="list-style-type: none"> As-Built Description: An accessible parking space shall be outlined or painted blue (required in CA only). As-Built: No blue contrast Proposed Solution: Identify accessible parking space using blue markings. 	PCODE EA04K CBC 2016 11B-502.6 Mitigated: <input type="radio"/> YES <input checked="" type="radio"/> NO	1	JOB	\$360	\$360

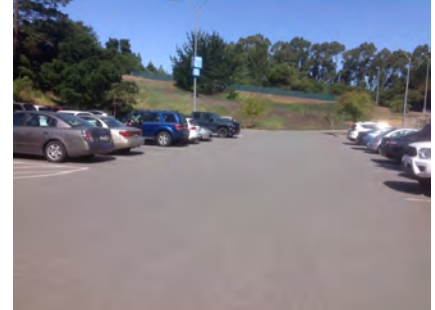
- 5 • *As-Built Description:*
International Symbol of Accessibility (36" square, in white on blue) is not painted on the pavement near the rear end of the parking space (required in CA only).

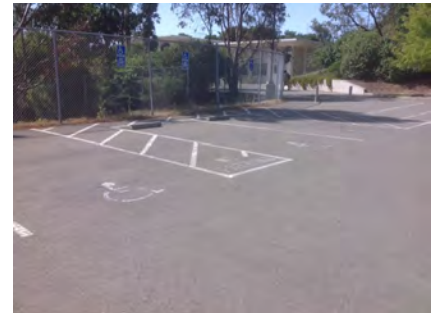
- 4 • *As-Built Description:*
The words "NO PARKING" not painted on the ground within loading and unloading access aisle (12" min high white letters), located so that it is visible to traffic enforcement officials (required in CA only).
