SAN MATEO COUNTY
COMMUNITY
COLLEGE DISTRICT

San Mateo County Community College District Americans with Disabilities Act Self-Evaluation and Transition Plan

Report Prepared by:

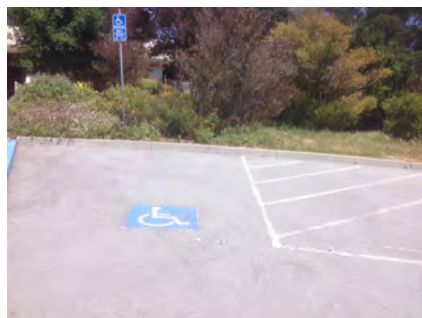
Item no., Rm no. and Name	Existing Architectural Barrier and Proposed Solution	Codes / Mitigation Info	Qty	Unit	Cost	Total
Parking						
62	<ul style="list-style-type: none"> As-Built Description: International Symbol of Accessibility (36" square, in white on blue) is not painted on the pavement near the rear end of the parking space (required in CA only). As-Built: 30 x 30 Proposed Solution: Apply symbol on parking space pavement when altering area. 	PCODE EA04A CBC 2007 1129B.4 CBC 2016 11B-502.6.4.1 Mitigated: <input type="radio"/> YES <input checked="" type="radio"/> NO	1	JOB	\$360	\$360

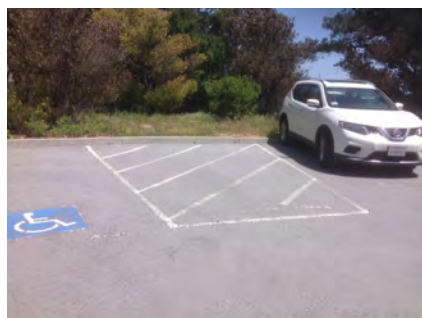
<input type="checkbox"/> Staff Only Priority 1 Severity 4			
63	<ul style="list-style-type: none"> As-Built Description: An accessible parking space shall be outlined or painted blue (required in CA only). Proposed Solution: Identify accessible parking space using blue markings. 	PCODE EA04K CBC 2016 11B-502.6 Mitigated: <input type="radio"/> YES <input checked="" type="radio"/> NO	1	JOB	\$360	\$360

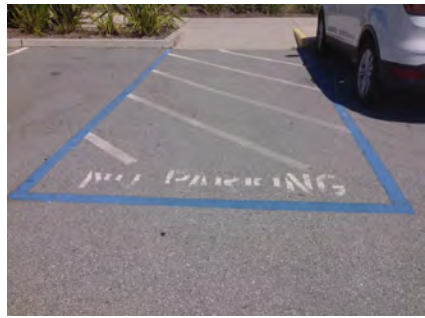
Item no., Rm no. and Name	Existing Architectural Barrier and Proposed Solution	Codes / Mitigation Info	Qty	Unit	Cost	Total
773	<ul style="list-style-type: none"> As-Built Description: The words "NO PARKING" not painted on the ground within loading and unloading access aisle (12" min high white letters), located so that it is visible to traffic enforcement officials (required in CA only). Proposed Solution: Provide the words "NO PARKING" in each access aisle, painted in 12" high letters, when altering area. 	PCODE EA04D CBC 2007 1129B.3.1 CBC 2016 11B-502.3.3 Mitigated: <input type="radio"/> YES <input checked="" type="radio"/> NO	2	JOB	\$300	\$600

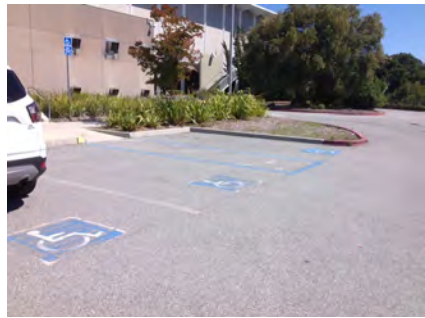
<input type="checkbox"/> Staff Only Priority 1 Severity 4			
772	<ul style="list-style-type: none"> As-Built Description: CA only: The area within the blue borderlines not marked with hatched lines a maximum of 36" on center. As-Built: Contrast faded Proposed Solution: Restripe to provide hatched lines at 36" on center within access aisle. 	PCODE EA04I CBC 2007 1129B.3.1 CBC 2016 11B-502.3.3 Mitigated: <input type="radio"/> YES <input checked="" type="radio"/> NO	1	JOB	\$300	\$300

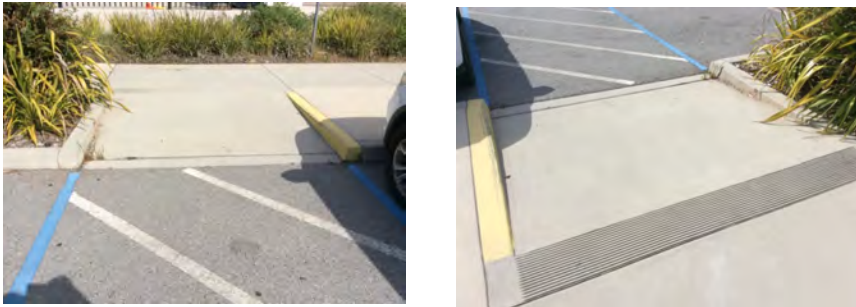
Perpendicular225 Detectable Warnings

- As-Built Description:**
Detectable warning surface not provided where a curb ramp, landing, blended transition, pedestrian pad, or island cut through connects to a street.
- Proposed Solution:**
Install a truncated dome surface that extends the full width and depth (36" min.) of the curb ramp, landing, blended transition, pedestrian pad, or island cut through

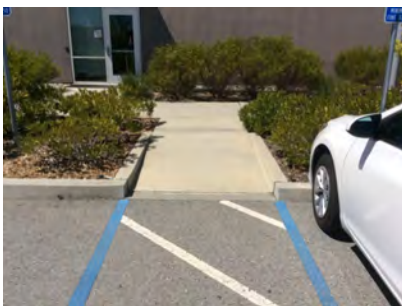
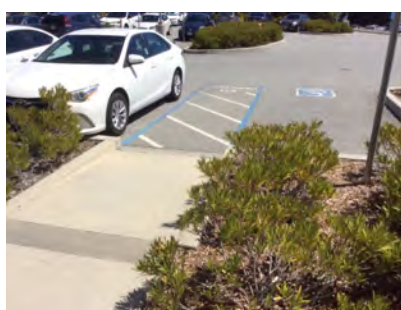
CBC 2016 **11B-406.5.3**CBC 2007 **1127B.5.4**ADAAG **4.8.4; 4.8.6**PROWAG **R304.2.2**Unit Cost **\$6500.00****Priority
109**

Width of Ramp / Pad	(in)	60.0
Length of Ramp / Pad	(in)	93.0
Slope of the Ramp / Pad	(%)	7.3
X Slope of the Ramp / Pad	(%)	0.3
Top Landing Length	(in)	48.0
Top Landing Slope	(%)	2.9
Top Landing X Slope	(%)	0.4

Left Flare	(%)	N/A
Right Flare	(%)	N/A
Gutter Lip	(in)	N/A
Truncated Domes	(y/n)	NO

Demolish existing and provide new, perpendicular curb ramp, including detectable warning surfaces, and top and bottom landings as required.

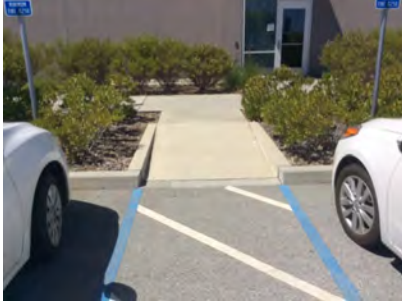
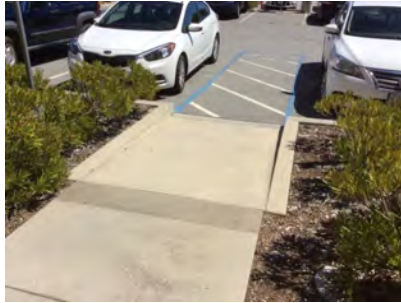
CBC 2016 **11B-406.2.1**CBC 2007 **1127B.5.3**ADAAG **4.7.2; 4.8.2**ADA-2010 **405.2**PROWAG **R304.2.2**Unit Cost **\$6500.00**

Width of Ramp / Pad	(in)	60.0
Length of Ramp / Pad	(in)	85.0
Slope of the Ramp / Pad	(%)	8.8
X Slope of the Ramp / Pad	(%)	1.5
Top Landing Length	(in)	48.0
Top Landing Slope	(%)	0.1
Top Landing X Slope	(%)	0.3

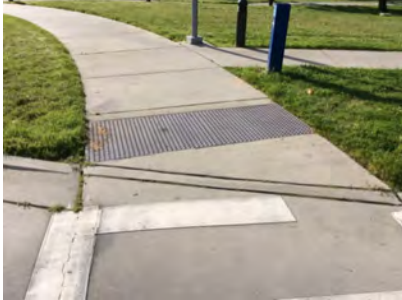
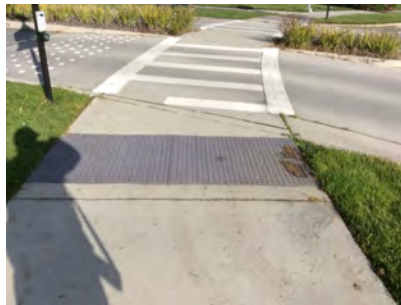
CBC 2016 **11B-406.3.2**ADAAG **4.8.4; 4.8.6**PROWAG **R304.3.2**Unit Cost **\$3500.00****Priority
100**

Bottom Landing Length	(in)	96.0
Bottom Landing Slope	(%)	0.2
Bottom Landing X Slope	(%)	2.4
Gutter Lip	(in)	N/A
Truncated Domes	(y/n)	YES
Dome Setback	(in)	42.0

Demolish existing and provide new, blended transition, including detectable warning surfaces, and top and bottom landings as required.

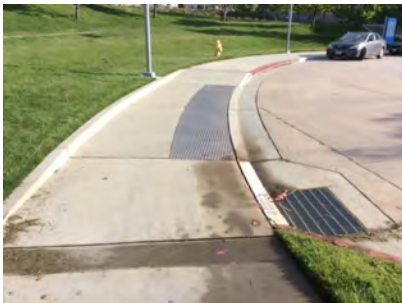
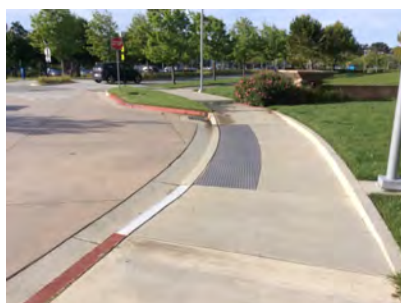
CBC 2016 **11B-406.5.8**CBC 2007 **1127B.5.3**ADAAG **4.7.2**ADA-2010 **406.2**PROWAG **R304.5.4**Unit Cost **\$3000.00****Priority
109**

LEFT	RIGHT
Width of Ramp / Pad	(in)	95.5	96.0
Length of Ramp / Pad	(in)	87.0	84.0
Slope of the Ramp / Pad	(%)	5.2	9.1
X Slope of the Ramp / Pad	(%)	1.0	1.8
Top Landing Length	(in)	48.0	48.0
Top Landing Slope	(%)	0.8	0.2
Top Landing X Slope	(%)	1.8	1.9

Bottom Landing Length	(in)	246.0
Bottom Landing Slope	(%)	0.1
Bottom Landing X Slope	(%)	1.1
Gutter Slope	(%)	11.1
Gutter XSlope	(%)	1.1
Gutter Lip	(in)	0.25
Truncated Domes	(y/n)	YES
Dome Setback	(in)	6.0

Demolish gutter or street area as required and provide 48" x 48" area at foot of curb ramp, blended transition, pedestrian pad, or island cut through with slope no

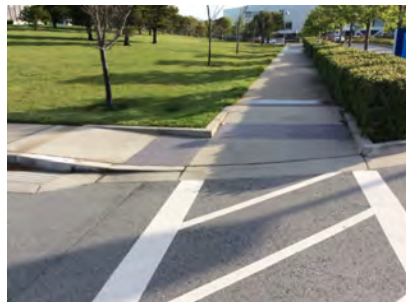
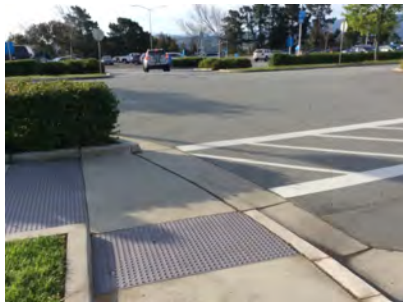
CBC 2016 **11B-406.5.7**ADAAG **4.8.6**PROWAG **R304.5.3**Unit Cost **\$7000.00****Priority****107.5**

LEFT	RIGHT
Width of Ramp / Pad	(in)	72.0	96.0
Length of Ramp / Pad	(in)	101.0	96.0
Slope of the Ramp / Pad	(%)	7.0	6.4
X Slope of the Ramp / Pad	(%)	2.5	0.3
Top Landing Length	(in)	48.0	48.0
Top Landing Slope	(%)	1.8	1.3
Top Landing X Slope	(%)	1.6	0.2

Demolish existing and provide new parallel curb ramp including detectable warning surfaces, and top and bottom landings as required.

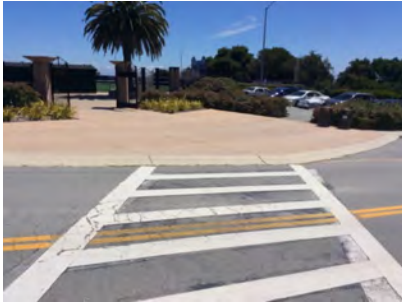
- **As-Built Description:**
Curb ramp or blended transition not provided where a pedestrian access route crosses a curb.
- **Proposed Solution:**
Provide a parallel curb ramp, including detectable warning surfaces, and top and bottom landings as required.

CBC 2007 **1127B.5.1**ADAAG **4.7.1**PROWAG **R207.1**Unit Cost **\$7000.00****Priority****100**

Stop/Yield Control:	No
Crosswalks Served:	1 X-walk
Tee Intersection:	No
Vertical Curb:	Rolled
Sidewalk Width: (ft)	5.0

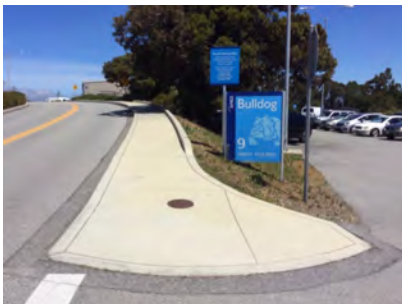
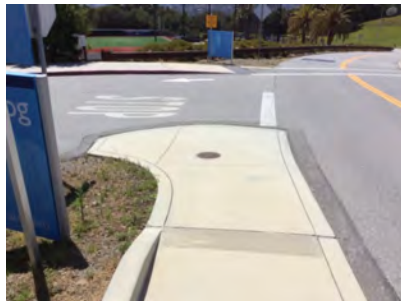
- **As-Built Description:**
Running slope of existing perpendicular curb ramp is less than 5% or greater than 8.3%.
- **As-is** **12.0%**
- **Proposed Solution:**
Demolish existing and provide new, perpendicular curb ramp, including detectable warning surfaces, and top and bottom landings as required.

CBC 2016 **11B-406.2.1**CBC 2007 **1127B.5.3**ADAAG **4.7.2; 4.8.2**ADA-2010 **405.2**PROWAG **R304.2.2**Unit Cost **\$6500.00****Priority****127**

Width of Ramp / Pad (in)	63.0
Length of Ramp / Pad (in)	171.0
Slope of the Ramp / Pad (%)	12.0
X Slope of the Ramp / Pad (%)	1.9
Top Landing Length (in)	48.0
Top Landing Slope (%)	6.4
Top Landing X Slope (%)	1.3

Left Flare (%)	N/A
Right Flare (%)	N/A
Gutter Slope (%)	4.1
Gutter XSlope (%)	5.8
Gutter Lip (in)	1.0
Truncated Domes (y/n)	NO

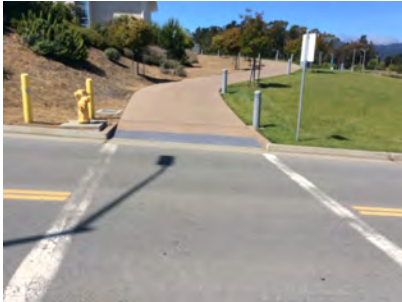
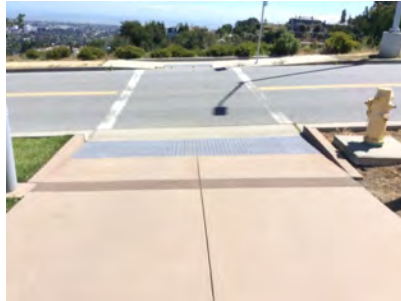
Width of Ramp / Pad	(in)	144.0
Length of Ramp / Pad	(in)	72.0
Slope of the Ramp / Pad	(%)	6.5
X Slope of the Ramp / Pad	(%)	4.9
Top Landing Length	(in)	48.0
Top Landing Slope	(%)	6.5
Top Landing X Slope	(%)	4.6

Left Flare	(%)	N/A
Right Flare	(%)	N/A
Gutter Slope	(%)	5.7
Gutter XSlope	(%)	6.9
Gutter Lip	(in)	0.0
Truncated Domes	(y/n)	YES
Dome Setback	(in)	6.0

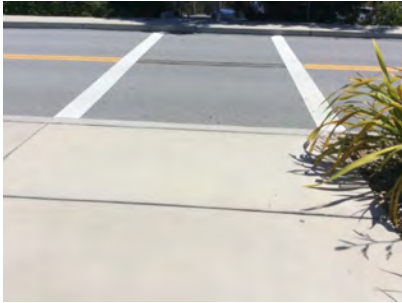
Curb Ramp Required**266 Access Route**

- **As-Built Description:**
Curb ramp or blended transition not provided where a pedestrian access route crosses a curb.
- **Proposed Solution:**
Provide a parallel curb ramp, including detectable warning surfaces, and top and bottom landings as required.

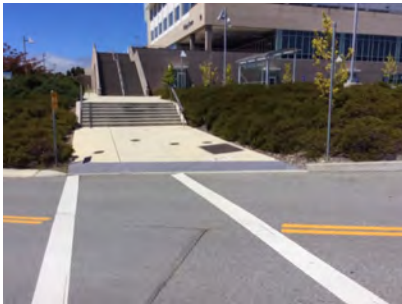
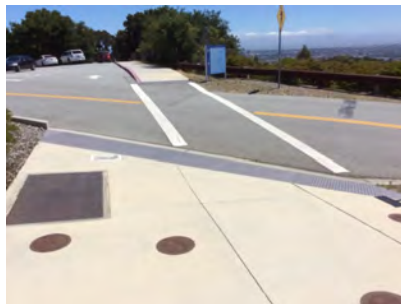
Perpendicular**281 Ramp Slope**

- **As-Built Description:**
Running slope of existing perpendicular curb ramp is less than 5% or greater than 8.3%.
- **As-is** **13.5%**
- **Proposed Solution:**
Demolish existing and provide new, perpendicular curb ramp, including detectable warning surfaces, and top and bottom landings as required.

Width of Ramp / Pad	(in)	264.0
Length of Ramp / Pad	(in)	36.0
Slope of the Ramp / Pad	(%)	13.5
X Slope of the Ramp / Pad	(%)	8.2
Top Landing Length	(in)	48.0
Top Landing Slope	(%)	5.9
Top Landing X Slope	(%)	6.0

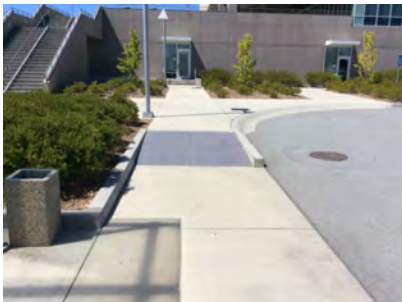
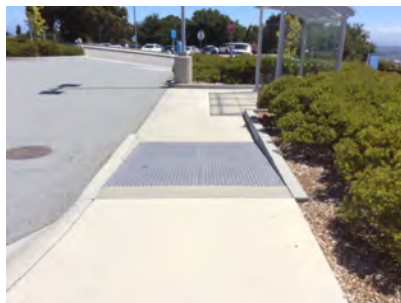
Left Flare	(%)	N/A
Right Flare	(%)	N/A
Gutter Lip	(in)	N/A
Truncated Domes	(y/n)	YES
Dome Setback	(in)	30.0

Relocate the detectable warning surface.

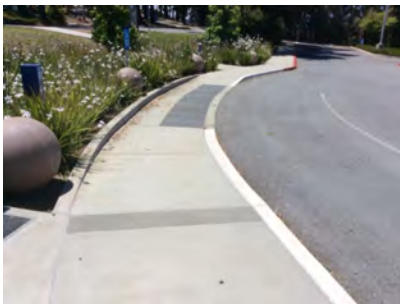
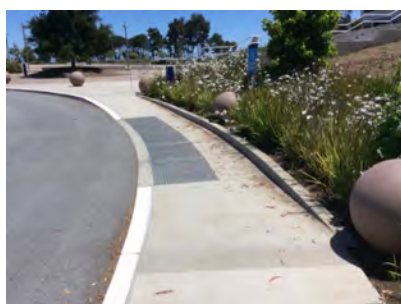
LEFT	RIGHT
Width of Ramp / Pad	(in)	74.0	73.0
Length of Ramp / Pad	(in)	170.0	79.0
Slope of the Ramp / Pad	(%)	7.3	5.7
X Slope of the Ramp / Pad	(%)	1.9	2.0
Top Landing Length	(in)	0.7	2.4
Top Landing Slope	(%)	0.7	1.3
Top Landing X Slope	(%)

Bottom Landing Length	(in)	250.0
Bottom Landing Slope	(%)	0.8
Bottom Landing X Slope	(%)	0.1
Gutter Lip	(in)	N/A
Truncated Domes	(y/n)	YES
Dome Setback	(in)	8.0

Relocate the detectable warning surface.

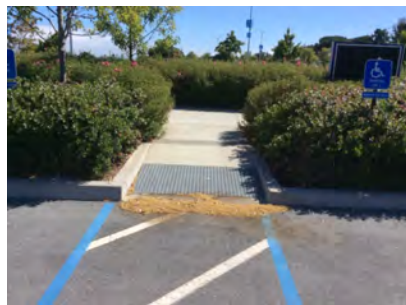
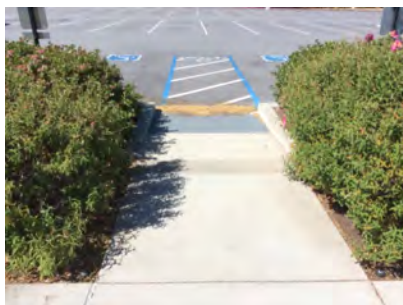
Width of Ramp / Pad	(in)	60.0
Length of Ramp / Pad	(in)	80.0
Slope of the Ramp / Pad	(%)	6.3
X Slope of the Ramp / Pad	(%)	0.2
Top Landing Length	(in)	48.0
Top Landing Slope	(%)	1.4
Top Landing X Slope	(%)	0.3

Left Flare	(%)	N/A
Right Flare	(%)	N/A
Gutter Lip	(in)	N/A
Truncated Domes	(y/n)	YES
Dome Setback	(in)	6.0

Provide routine inspection and maintenance to maintain accessible access route.

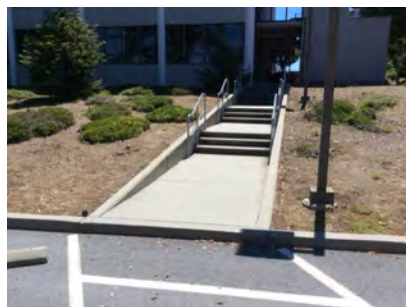
LEFT	RIGHT
Width of Ramp / Pad	(in)	
Slope of the Ramp / Pad	(%)	
X Slope of the Ramp / Pad	(%)

Stop/Yield Control:	No
Crosswalks Served:	1 X-walk
Tee Intersection:	No
Vertical Curb:	Vertical
Sidewalk Width:	(ft) 5.0

Provide a parallel curb ramp, including detectable warning surfaces, and top and bottom landings as required.

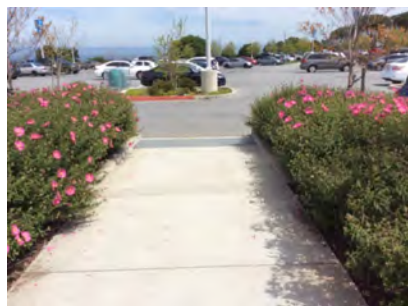
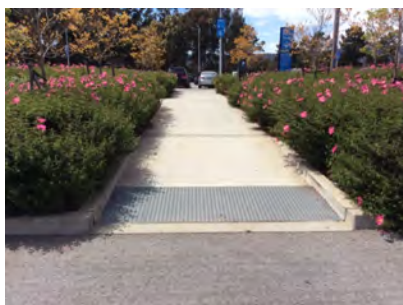
Width of Ramp / Pad	(in)	96.0
Length of Ramp / Pad	(in)	142.0
Slope of the Ramp / Pad	(%)	7.0
X Slope of the Ramp / Pad	(%)	0.6
Top Landing Length	(in)	48.0
Top Landing Slope	(%)	1.2
Top Landing X Slope	(%)	1.6

Left Flare	(%)	N/A
Right Flare	(%)	YES
Gutter Lip	(in)	8.0
Truncated Domes	(y/n)	
Dome Setback	(in)

Provide routine inspection and maintenance to maintain accessible access route.

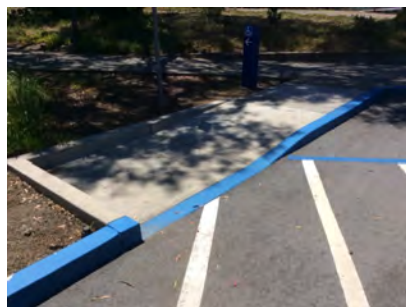
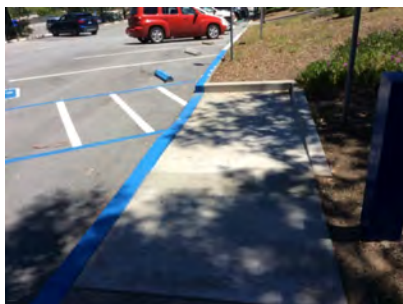
LEFT	RIGHT
Width of Ramp / Pad	(in)	N/A	66.0
Length of Ramp / Pad	(in)	N/A	72.0
Slope of the Ramp / Pad	(%)	N/A	7.6
X Slope of the Ramp / Pad	(%)	N/A	0.6
Top Landing Length	(in)	N/A	48.0
Top Landing Slope	(%)	N/A	2.8
Top Landing X Slope	(%)	N/A	0.8

Bottom Landing Length	(in)	60.0
Bottom Landing Slope	(%)	1.8
Bottom Landing X Slope	(%)	0.7
Gutter Lip	(in)	N/A
Truncated Domes	(y/n)	NO

Street Grade (Left / Right)	(%)	0.9	N/A
Stop/Yield Control:		No	
Crosswalks Served:		No X-walk	
Tee Intersection:		No	
Vertical Curb:		Vertical	
Sidewalk Width:	(ft)	5.0

Install a truncated dome surface that extends the full width and depth (36" min.) of the curb ramp, landing, blended transition, pedestrian pad, or island cut through

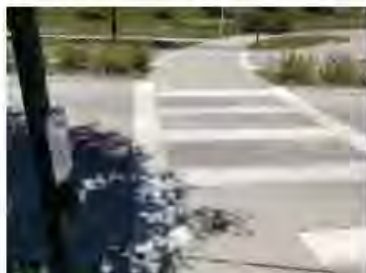
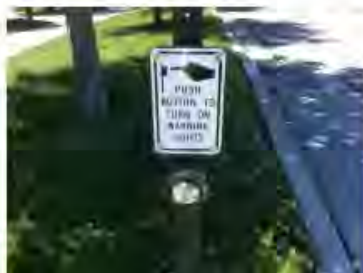
• Proposed Solution:		Modify or repave the ground surface as necessary to provide slope (s) not exceeding the required 1:48 (2%) maximum in any direction.					Within 5 ft from crosswalk (y/n) Yes 1.5 - 6.0 ft from curb (y/n) Yes 10 ft minimum separation N/A

• Additional Items:		Remount push button to 42" min. and 48" max. height to center of button. Provide 2" wide color coding with 1" wide dark borders located directly above control button. Provide an tactile arrow aligned parallel to the crosswalk direction on the sign. Provide voice or tone audible indication of the WALK interval at the pedestrian signal device. Provide a vibrotactile signal device that is integrated with the pedestrian pushbutton. Provide a button locator tone.

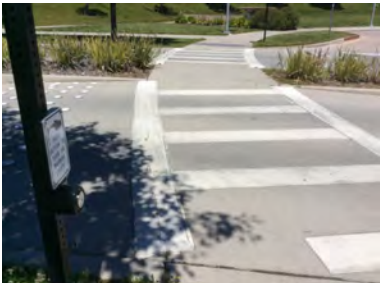
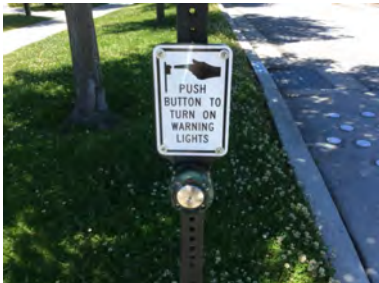
202	<u>Clear Floor Space</u>	ADAAG: 4.3.7 ADA 2010: 302.1 CBC 2016: 11B-302.1 PROWAG: R404.2	Accessible Path (y/n) Yes Clear Floor Space (y/n) Yes Clear Floor Slope (%) 0.8 Clear Floor X Slope (%) 2.6 Button Ht. (in) 36.0 Button Reach (in) 10.0 Button Diameter (in) 2.0 Button Pressure (lbs) 2.0 Closed Fist Operation (y/n) Yes Visual Contrast (y/n) Yes Contrasting Color Bands (y/n) No Vibrotactile Feedback (y/n) No Audible Walk Indicator (y/n) No Button Locator Tone (y/n) No Tactile Arrow (y/n) No Within 5 ft from crosswalk (y/n) Yes 1.5 - 6.0 ft from curb (y/n) Yes 10 ft minimum separation N/A
	<ul style="list-style-type: none"> As-Built Description: The cross slope of the floor or ground surface at the pedestrian signal device exceed 1:48 (2%). As-is Measurement: 2.6% Proposed Solution: Modify or repave the ground surface as necessary to provide slope (s) not exceeding the required 1:48 (2%) maximum in any direction. Additional Items: Remount push button to 42" min. and 48" max. height to center of button. Provide 2" wide color coding with 1" wide dark borders located directly above control button. Provide an tactile arrow aligned parallel to the crosswalk direction on the sign. Provide voice or tone audible indication of the WALK interval at the pedestrian signal device. Provide a vibrotactile signal device that is integrated with the pedestrian pushbutton. Provide a button locator tone. 	Unit Cost \$7950.00 Priority 133.5
